# Site ID: **a-307635**

## Management with Targeted Refurbishment Survey – PART 1

1-83 Bangor House  
Forth Drive  
Chelmsley Wood  
Solihull  
B37 6PH  
United Kingdom

**27th May 2021**

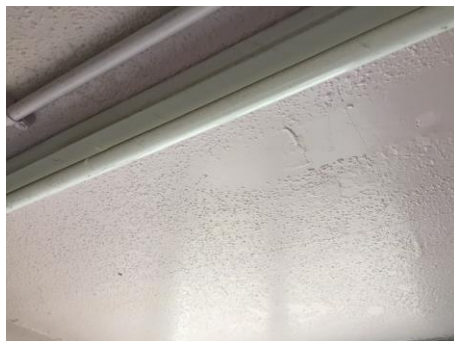
Condition ..... **Low Damage**

Spatter pattern textured coating.

The material was seen to be in fair condition at the time of the initial inspection.

The condition of the material should be managed by a competent person/company and its presence made aware to those at risk, as part of a Control of Asbestos Regulations (CAR) 2012 compliant management strategy.

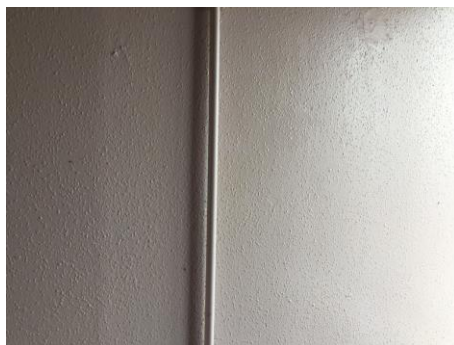
Condition ..... **Low Damage**

Spatter pattern textured coating.

The material was seen to be in fair condition at the time of the initial inspection.

The condition of the material should be managed by a competent person/company and its presence made aware to those at risk, as part of a Control of Asbestos Regulations (CAR) 2012 compliant management strategy.

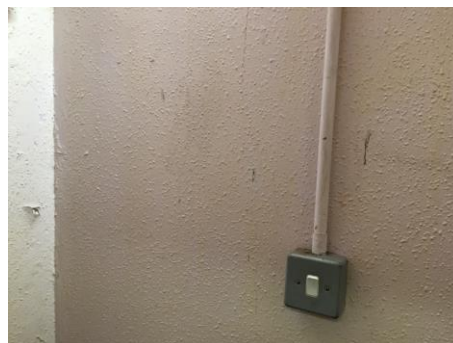
Condition ..... **Low Damage**

Spatter pattern textured coating.

The material was seen to be in fair condition at the time of the initial inspection.

The condition of the material should be managed by a competent person/company and its presence made aware to those at risk, as part of a Control of Asbestos Regulations (CAR) 2012 compliant management strategy.

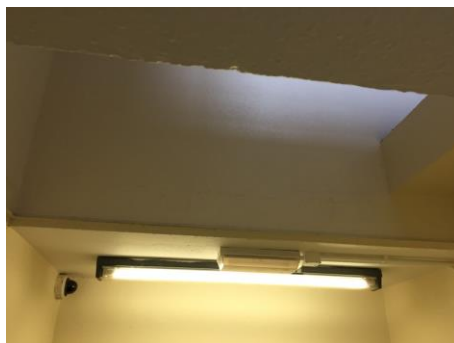
Condition ..... **Low Damage**

Spatter pattern textured coating.

The material was seen to be in fair condition at the time of the initial inspection.

The condition of the material should be managed by a competent person/company and its presence made aware to those at risk, as part of a Control of Asbestos Regulations (CAR) 2012 compliant management strategy.

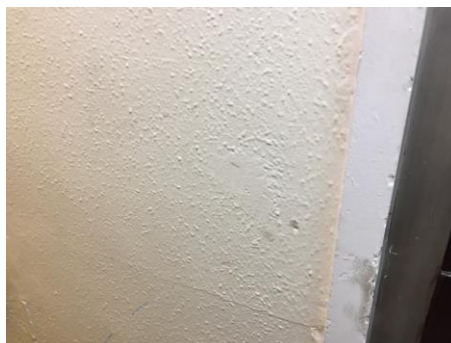
Condition ..... **Low Damage**

Spatter pattern textured coating.

The material was seen to be in fair condition at the time of the initial inspection.

The condition of the material should be managed by a competent person/company and its presence made aware to those at risk, as part of a Control of Asbestos Regulations (CAR) 2012 compliant management strategy.

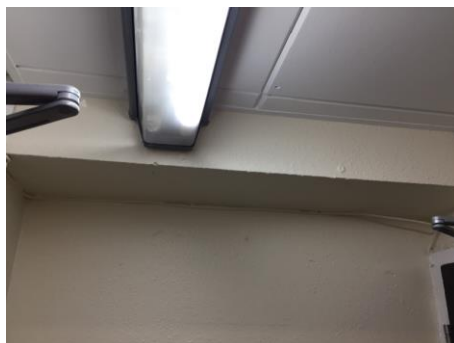
Condition ..... **Low Damage**

Cement boxing between doors.

The material was seen to be in fair condition at the time of the initial inspection.

The condition of the material should be managed by a competent person/company and its presence made aware to those at risk, as part of a Control of Asbestos Regulations (CAR) 2012 compliant management strategy.

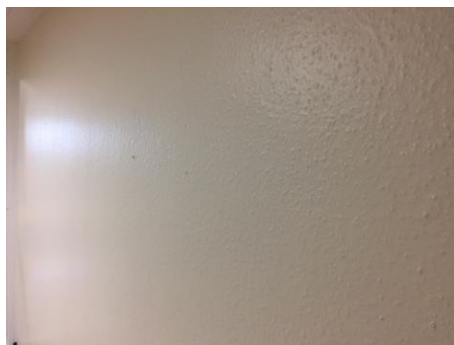
Condition ..... **Low Damage**

Spatter pattern textured coating.

The material was seen to be in fair condition at the time of the initial inspection.

The condition of the material should be managed by a competent person/company and its presence made aware to those at risk, as part of a Control of Asbestos Regulations (CAR) 2012 compliant management strategy.

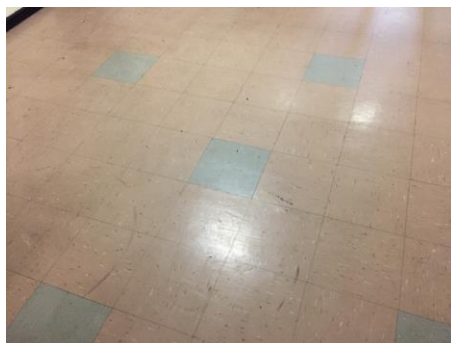
Pink and grey floor tiles.

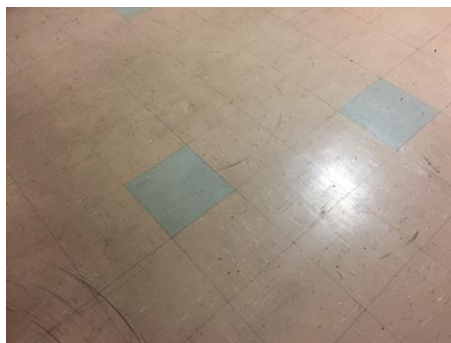
Condition ..... **Low Damage**

Bitumen adhesive beneath floor tiles.

The material was seen to be in fair condition at the time of the initial inspection.

The condition of the material should be managed by a competent person/company and its presence made aware to those at risk, as part of a Control of Asbestos Regulations (CAR) 2012 compliant management strategy.

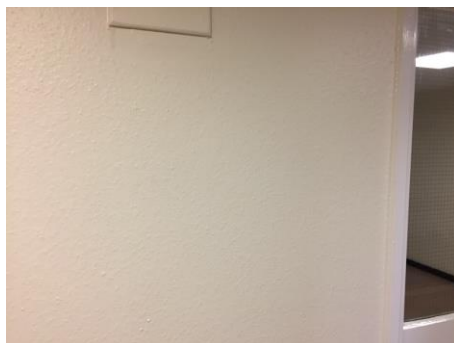
Condition ..... **Low Damage**

Spatter pattern textured coating.

The material was seen to be in fair condition at the time of the initial inspection.

The condition of the material should be managed by a competent person/company and its presence made aware to those at risk, as part of a Control of Asbestos Regulations (CAR) 2012 compliant management strategy.

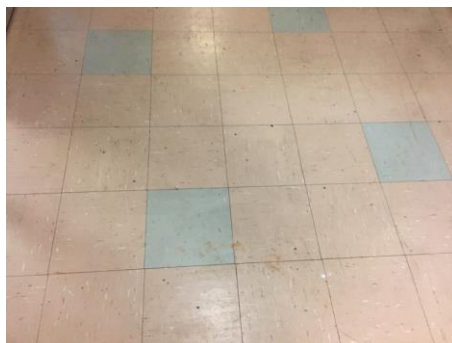
Pink and grey floor tiles.

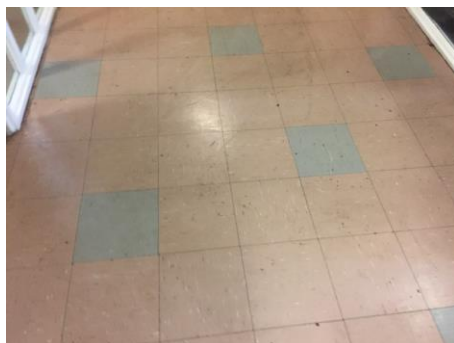
Condition ..... **Low Damage**

Bitumen adhesive beneath floor tiles.

The material was seen to be in fair condition at the time of the initial inspection.

The condition of the material should be managed by a competent person/company and its presence made aware to those at risk, as part of a Control of Asbestos Regulations (CAR) 2012 compliant management strategy.

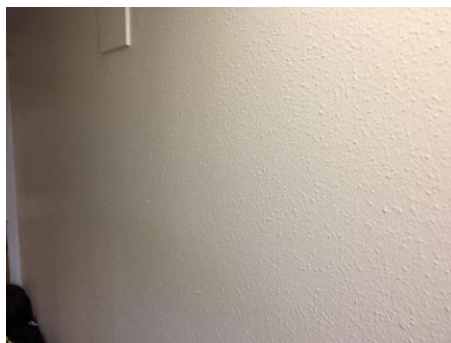
Condition ..... **Low Damage**

Spatter pattern textured coating.

The material was seen to be in fair condition at the time of the initial inspection.

The condition of the material should be managed by a competent person/company and its presence made aware to those at risk, as part of a Control of Asbestos Regulations (CAR) 2012 compliant management strategy.

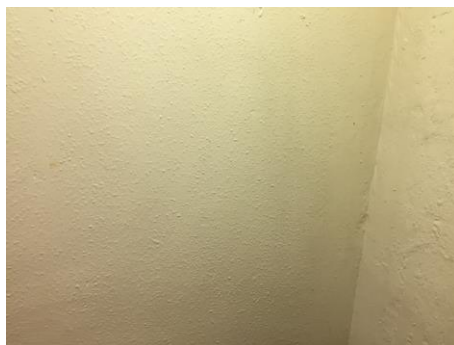
Condition ..... **Low Damage**

Spatter pattern textured coating.

The material was seen to be in fair condition at the time of the initial inspection.

The condition of the material should be managed by a competent person/company and its presence made aware to those at risk, as part of a Control of Asbestos Regulations (CAR) 2012 compliant management strategy.

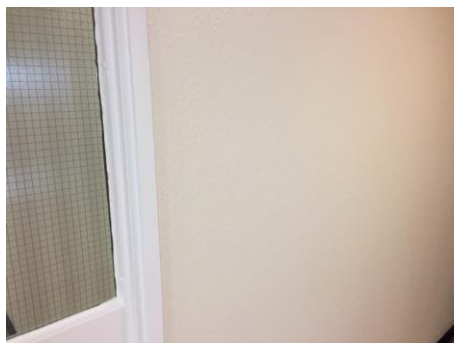
Condition ..... **Low Damage**

Spatter pattern textured coating.

The material was seen to be in fair condition at the time of the initial inspection.

The condition of the material should be managed by a competent person/company and its presence made aware to those at risk, as part of a Control of Asbestos Regulations (CAR) 2012 compliant management strategy.

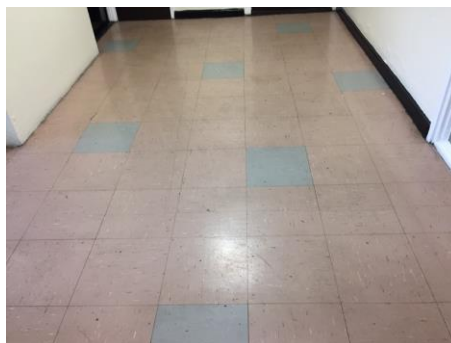
Pink and grey floor tiles.

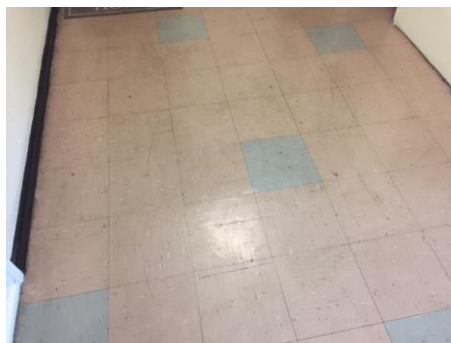
Condition ..... **Low Damage**

Bitumen adhesive beneath floor tiles.

The material was seen to be in fair condition at the time of the initial inspection.

The condition of the material should be managed by a competent person/company and its presence made aware to those at risk, as part of a Control of Asbestos Regulations (CAR) 2012 compliant management strategy.

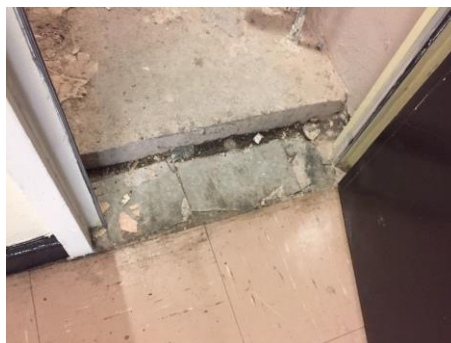
Condition ..... **Low Damage**

Grey floor tiles.

The material was seen to be in fair condition at the time of the initial inspection.

The condition of the material should be managed by a competent person/company and its presence made aware to those at risk, as part of a Control of Asbestos Regulations (CAR) 2012 compliant management strategy.

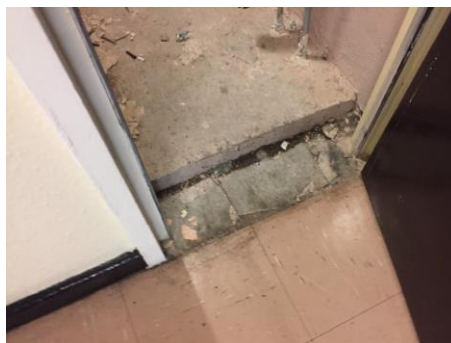
Condition ..... **Low Damage**

Bitumen adhesive beneath floor tiles.

The material was seen to be in fair condition at the time of the initial inspection.

The condition of the material should be managed by a competent person/company and its presence made aware to those at risk, as part of a Control of Asbestos Regulations (CAR) 2012 compliant management strategy.

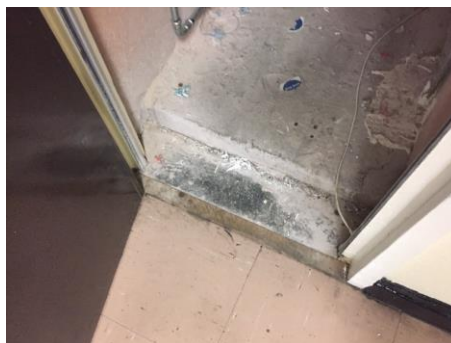
Condition ..... **Low Damage**

Bitumen adhesive.

The material was seen to be in fair condition at the time of the initial inspection.

The condition of the material should be managed by a competent person/company and its presence made aware to those at risk, as part of a Control of Asbestos Regulations (CAR) 2012 compliant management strategy.

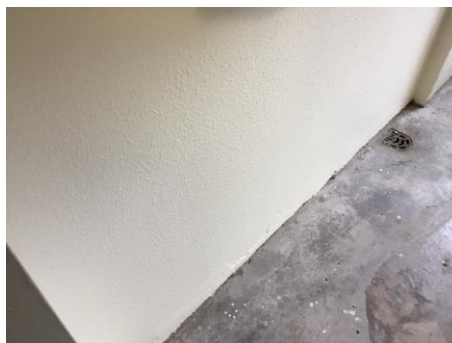
Condition ..... **Low Damage**

Spatter pattern textured coating.

The material was seen to be in fair condition at the time of the initial inspection.

The condition of the material should be managed by a competent person/company and its presence made aware to those at risk, as part of a Control of Asbestos Regulations (CAR) 2012 compliant management strategy.

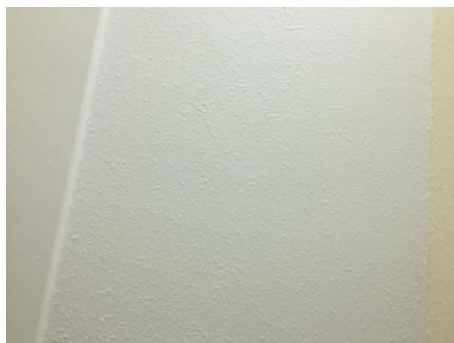
Condition ..... **Low Damage**

Spatter pattern textured coating.

The material was seen to be in fair condition at the time of the initial inspection.

The condition of the material should be managed by a competent person/company and its presence made aware to those at risk, as part of a Control of Asbestos Regulations (CAR) 2012 compliant management strategy.

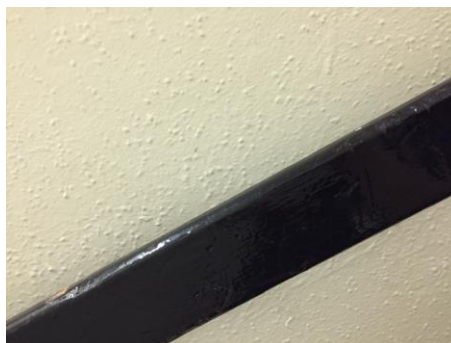
Condition ..... **Low Damage**

Spatter pattern textured coating.

The material was seen to be in fair condition at the time of the initial inspection.

The condition of the material should be managed by a competent person/company and its presence made aware to those at risk, as part of a Control of Asbestos Regulations (CAR) 2012 compliant management strategy.

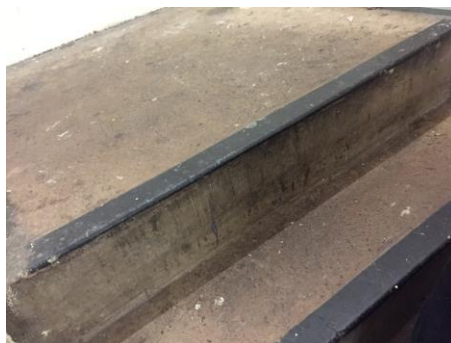
Condition ..... **Low Damage**

Resin nosing to edge of stairs.

The material was seen to be in fair condition at the time of the initial inspection.

The condition of the material should be managed by a competent person/company and its presence made aware to those at risk, as part of a Control of Asbestos Regulations (CAR) 2012 compliant management strategy.

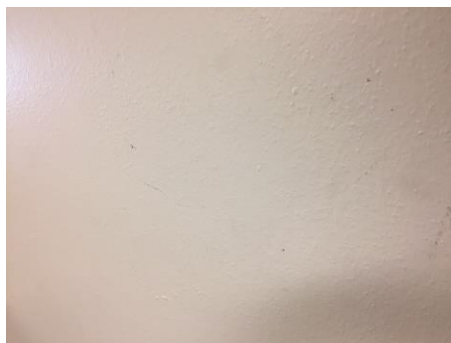
Condition ..... **Low Damage**

Spatter pattern textured coating.

The material was seen to be in fair condition at the time of the initial inspection.

The condition of the material should be managed by a competent person/company and its presence made aware to those at risk, as part of a Control of Asbestos Regulations (CAR) 2012 compliant management strategy.

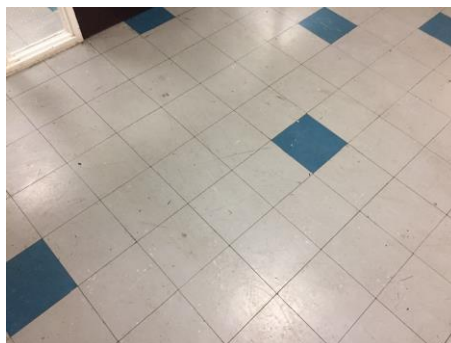
Condition ..... **Low Damage**

Blue and grey floor tiles.

The material was seen to be in fair condition at the time of the initial inspection.

The condition of the material should be managed by a competent person/company and its presence made aware to those at risk, as part of a Control of Asbestos Regulations (CAR) 2012 compliant management strategy.

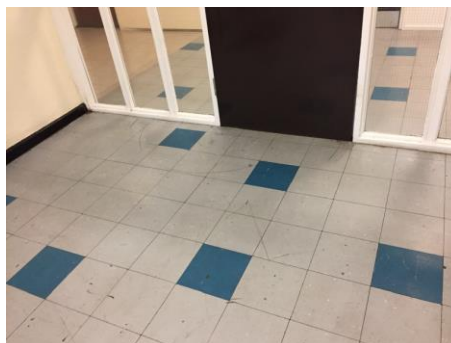
Condition ..... **Low Damage**

Bitumen adhesive beneath floor tiles.

The material was seen to be in fair condition at the time of the initial inspection.

The condition of the material should be managed by a competent person/company and its presence made aware to those at risk, as part of a Control of Asbestos Regulations (CAR) 2012 compliant management strategy.

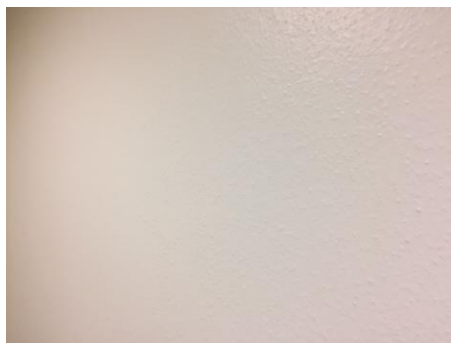
Condition ..... **Low Damage**

Spatter pattern textured coating.

The material was seen to be in fair condition at the time of the initial inspection.

The condition of the material should be managed by a competent person/company and its presence made aware to those at risk, as part of a Control of Asbestos Regulations (CAR) 2012 compliant management strategy.

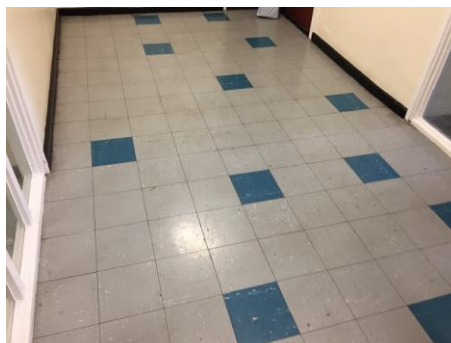
Condition ..... **Low Damage**

Blue and grey floor tiles.

The material was seen to be in fair condition at the time of the initial inspection.

The condition of the material should be managed by a competent person/company and its presence made aware to those at risk, as part of a Control of Asbestos Regulations (CAR) 2012 compliant management strategy.

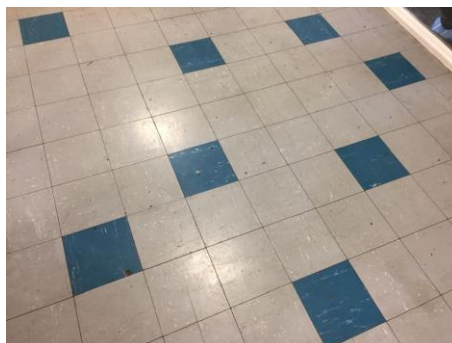
Condition ..... **Low Damage**

Bitumen adhesive beneath floor tiles.

The material was seen to be in fair condition at the time of the initial inspection.

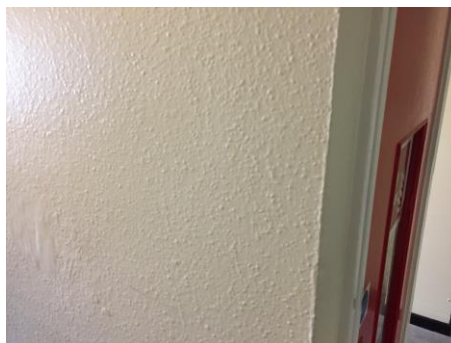
Condition ..... **Low Damage**

Spatter pattern textured coating.

The material was seen to be in fair condition at the time of the initial inspection.

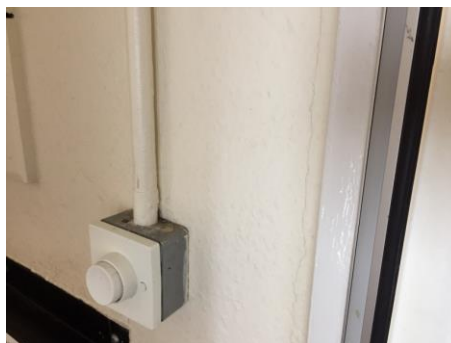
Spatter pattern textured coating.

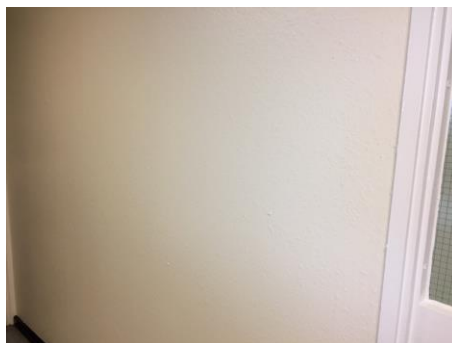
Spatter pattern textured coating.

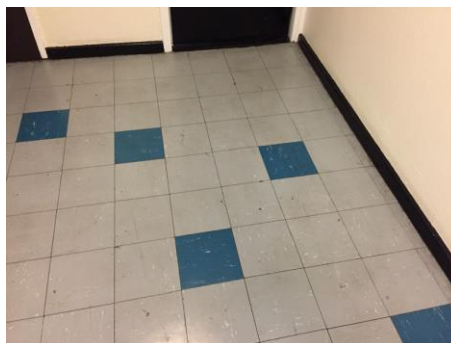
Blue and grey floor tiles.

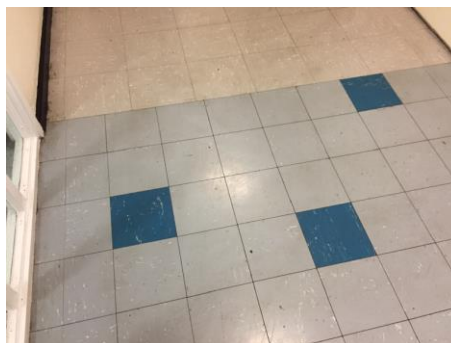
Bitumen adhesive beneath floor tiles.

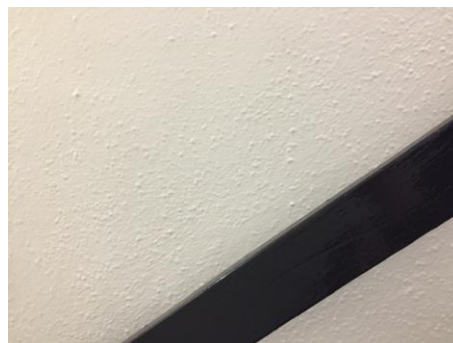
Spatter pattern textured coating.

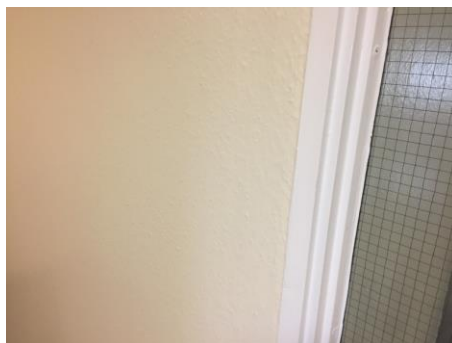
Spatter pattern textured coating.

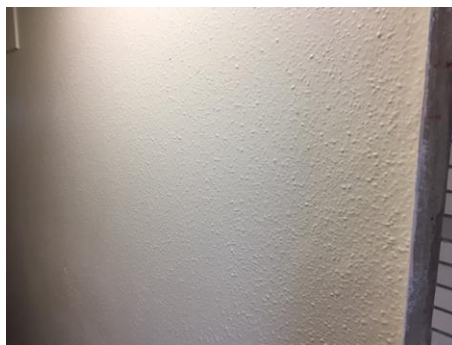
Spatter pattern textured coating.

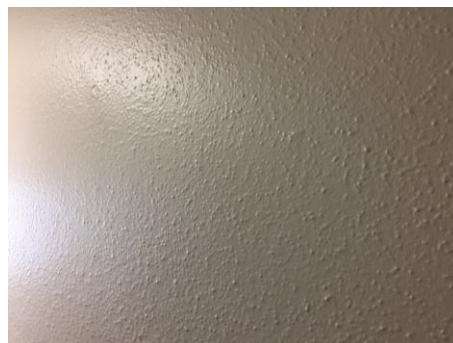
Spatter pattern textured coating.

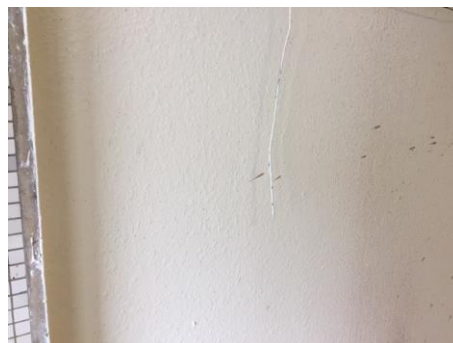
Spatter pattern textured coating.

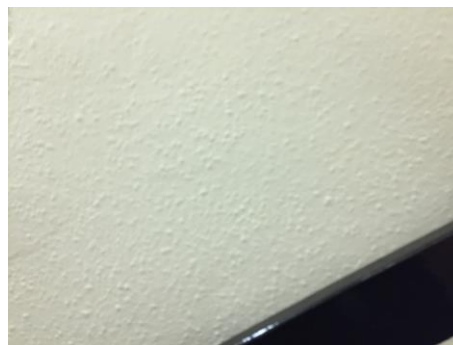
Spatter pattern textured coating.

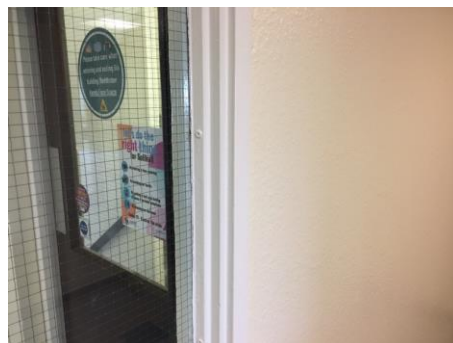
Spatter pattern textured coating.

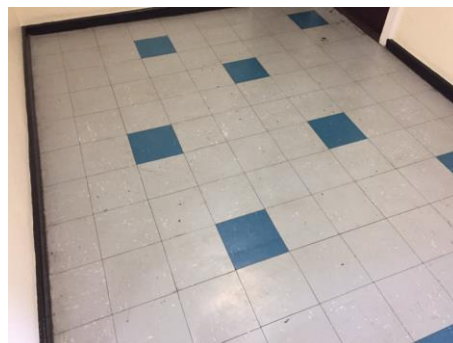
Bitumen adhesive beneath floor tiles.

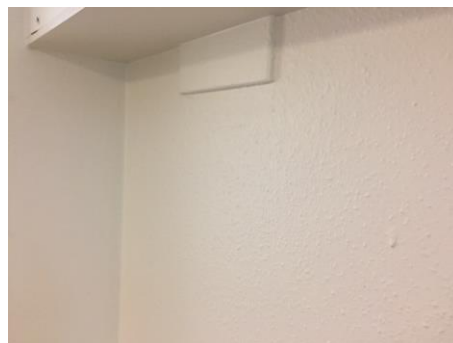
Spatter pattern textured coating.

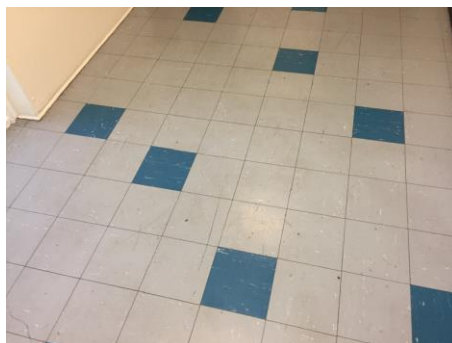
Bitumen adhesive beneath floor tiles.

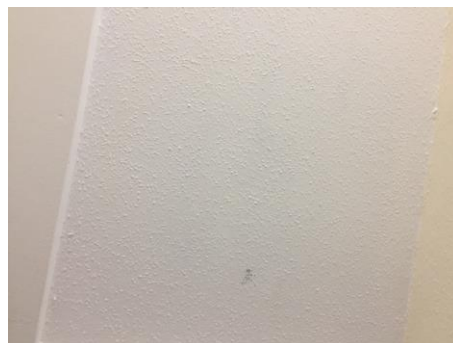
Spatter pattern textured coating.

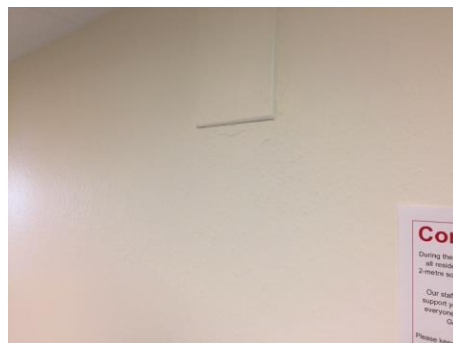
Spatter pattern textured coating.

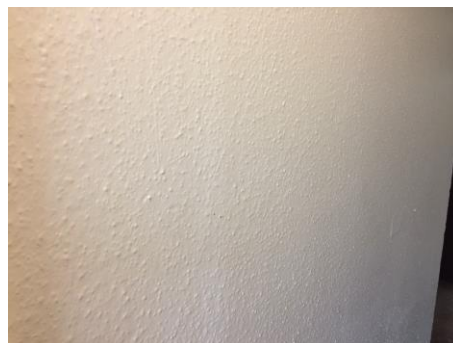
Spatter pattern textured coating.

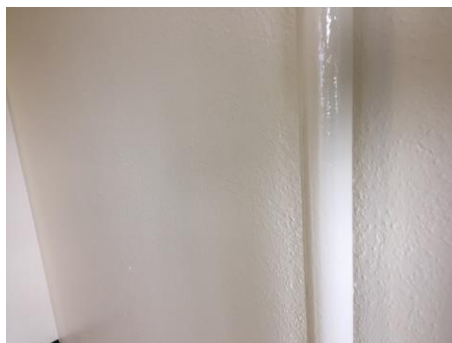
Spatter pattern textured coating.

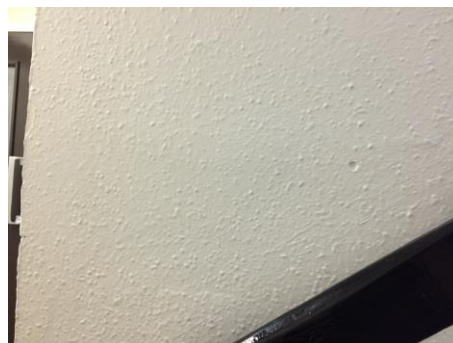
Spatter pattern textured coating.

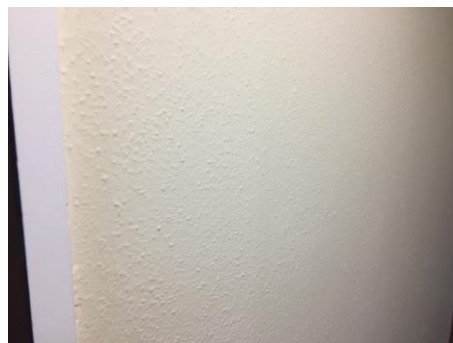
Spatter pattern textured coating.

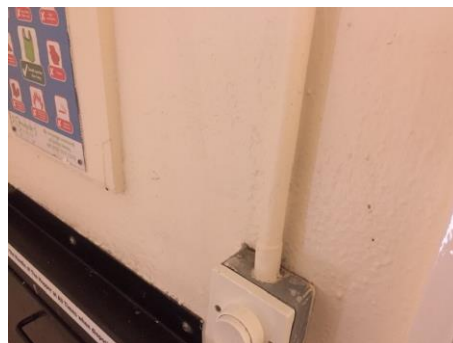
Spatter pattern textured coating.

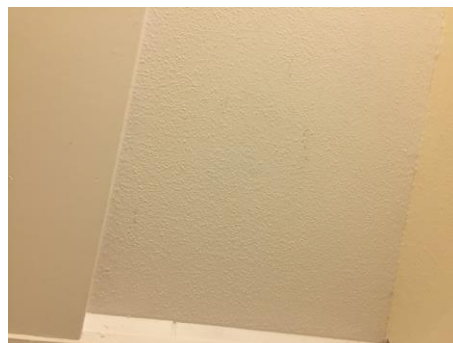
Spatter pattern textured coating.

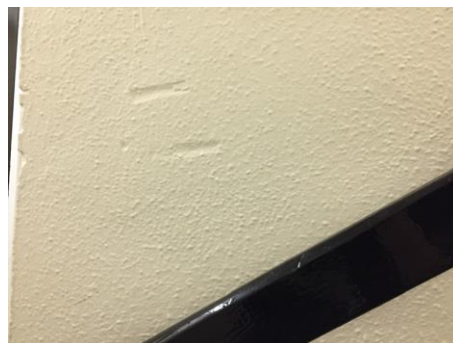
Spatter pattern textured coating.

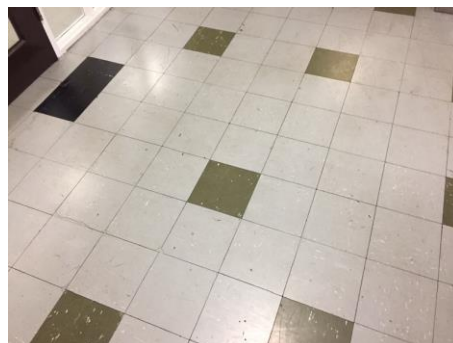
Blue and grey floor tiles.

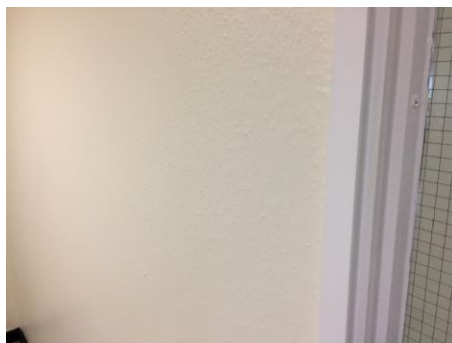
Spatter pattern textured coating.

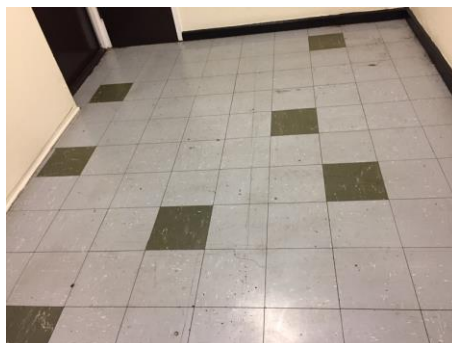
Green and grey floor tiles.

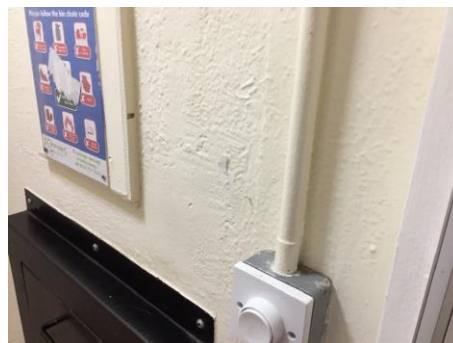
Spatter pattern textured coating.

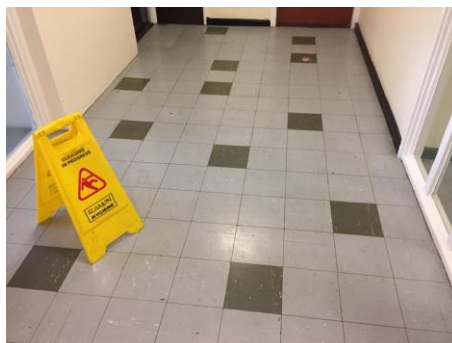
Green and grey floor tiles.

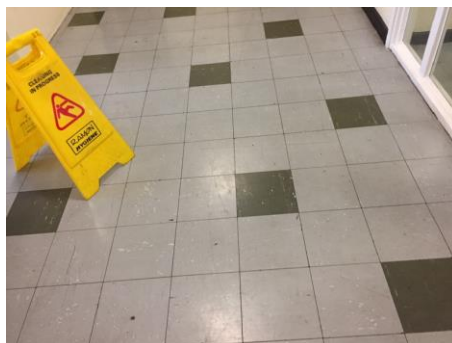
Bitumen adhesive beneath floor tiles.
