Site ID: **a-308038**

Management with Targeted Refurbishment Survey – PART 2

1-83 Bangor House
Forth Drive
Chelmsley Wood
Solihull
B37 6PH
United Kingdom

27th May 2021

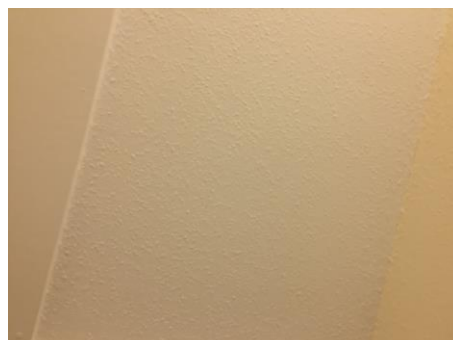
Spatter pattern textured coating.

The material was seen to be in fair condition at the time of the initial inspection.

The condition of the material should be managed by a competent person/company and its presence made aware to those at risk, as part of a Control of Asbestos Regulations (CAR) 2012 compliant management strategy.

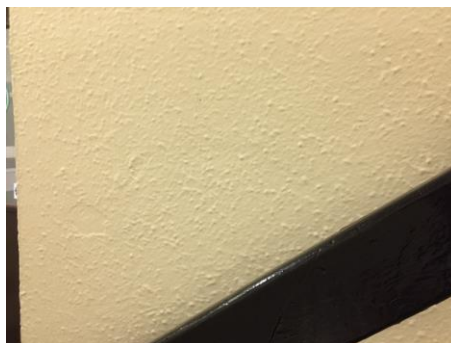
Spatter pattern textured coating.

The material was seen to be in fair condition at the time of the initial inspection.

The condition of the material should be managed by a competent person/company and its presence made aware to those at risk, as part of a Control of Asbestos Regulations (CAR) 2012 compliant management strategy.

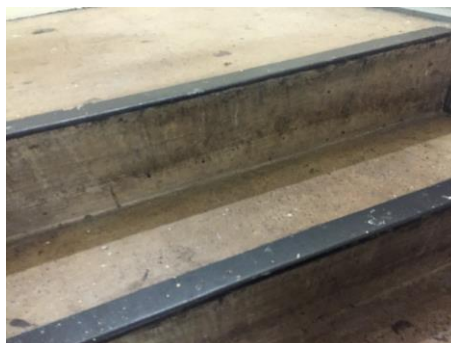
Resin nosing to edge of stairs.

The material was seen to be in fair condition at the time of the initial inspection.

The condition of the material should be managed by a competent person/company and its presence made aware to those at risk, as part of a Control of Asbestos Regulations (CAR) 2012 compliant management strategy.

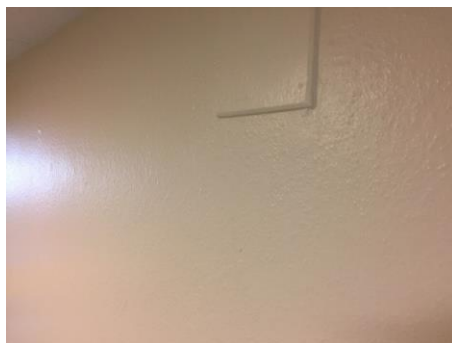
Spatter pattern textured coating.

The material was seen to be in fair condition at the time of the initial inspection.

The condition of the material should be managed by a competent person/company and its presence made aware to those at risk, as part of a Control of Asbestos Regulations (CAR) 2012 compliant management strategy.

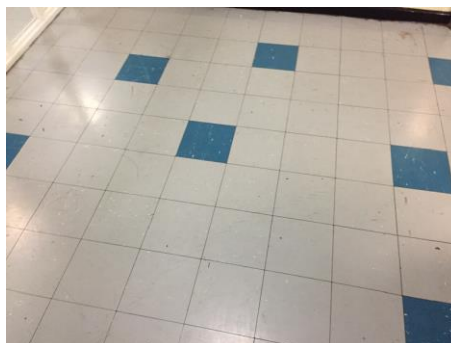
Blue and grey floor tiles.

The material was seen to be in fair condition at the time of the initial inspection.

The condition of the material should be managed by a competent person/company and its presence made aware to those at risk, as part of a Control of Asbestos Regulations (CAR) 2012 compliant management strategy.

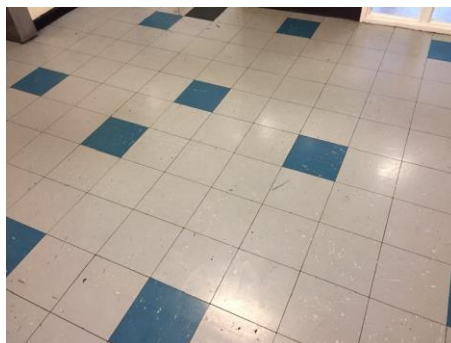
Bitumen adhesive beneath floor tiles.

The material was seen to be in fair condition at the time of the initial inspection.

The condition of the material should be managed by a competent person/company and its presence made aware to those at risk, as part of a Control of Asbestos Regulations (CAR) 2012 compliant management strategy.

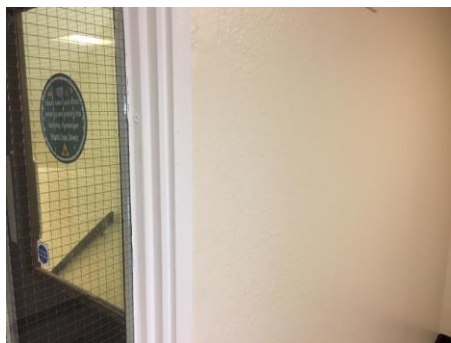
Spatter pattern textured coating.

The material was seen to be in fair condition at the time of the initial inspection.

The condition of the material should be managed by a competent person/company and its presence made aware to those at risk, as part of a Control of Asbestos Regulations (CAR) 2012 compliant management strategy.

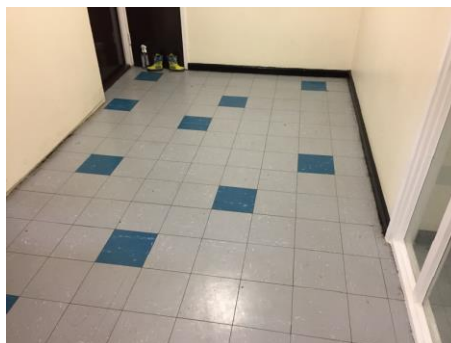
Blue and grey floor tiles.

The material was seen to be in fair condition at the time of the initial inspection.

The condition of the material should be managed by a competent person/company and its presence made aware to those at risk, as part of a Control of Asbestos Regulations (CAR) 2012 compliant management strategy.

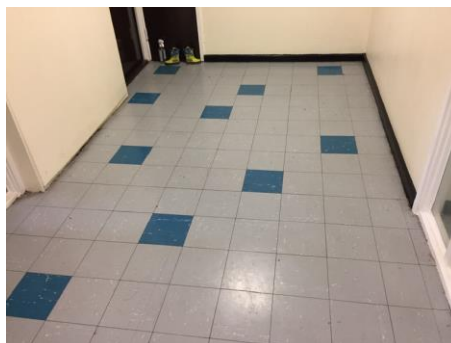
Bitumen adhesive beneath floor tiles.

The material was seen to be in fair condition at the time of the initial inspection.

The condition of the material should be managed by a competent person/company and its presence made aware to those at risk, as part of a Control of Asbestos Regulations (CAR) 2012 compliant management strategy.

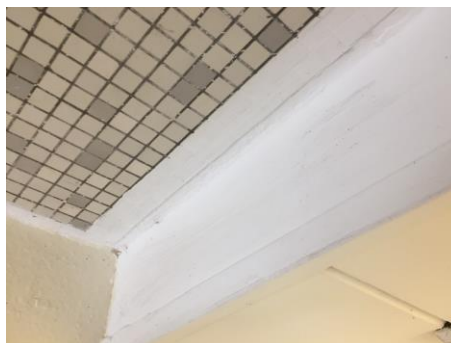
Spatter pattern textured coating above suspended ceiling.

The material was seen to be in fair condition at the time of the initial inspection.

The condition of the material should be managed by a competent person/company and its presence made aware to those at risk, as part of a Control of Asbestos Regulations (CAR) 2012 compliant management strategy.

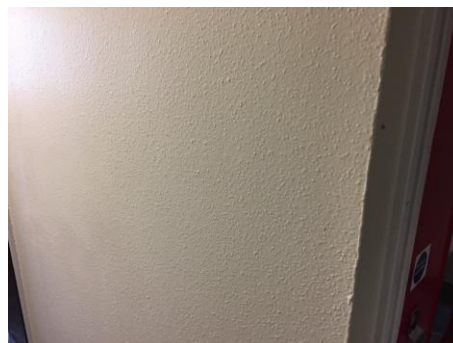
Spatter pattern textured coating.

The material was seen to be in fair condition at the time of the initial inspection.

The condition of the material should be managed by a competent person/company and its presence made aware to those at risk, as part of a Control of Asbestos Regulations (CAR) 2012 compliant management strategy.

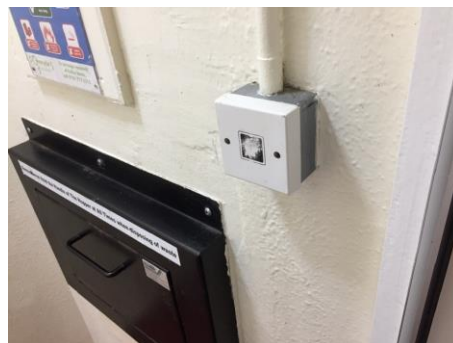
Spatter pattern textured coating.

The material was seen to be in fair condition at the time of the initial inspection.

The condition of the material should be managed by a competent person/company and its presence made aware to those at risk, as part of a Control of Asbestos Regulations (CAR) 2012 compliant management strategy.

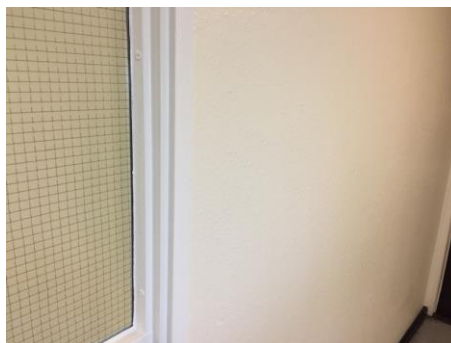
Spatter pattern textured coating.

The material was seen to be in fair condition at the time of the initial inspection.

The condition of the material should be managed by a competent person/company and its presence made aware to those at risk, as part of a Control of Asbestos Regulations (CAR) 2012 compliant management strategy.

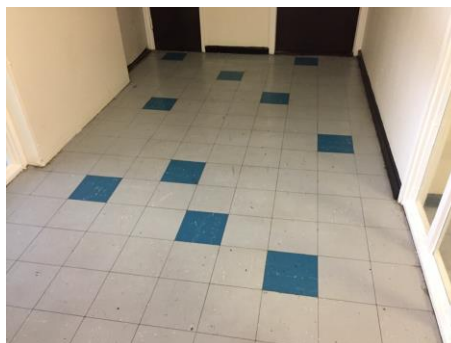
Blue and grey floor tiles.

The material was seen to be in fair condition at the time of the initial inspection.

The condition of the material should be managed by a competent person/company and its presence made aware to those at risk, as part of a Control of Asbestos Regulations (CAR) 2012 compliant management strategy.

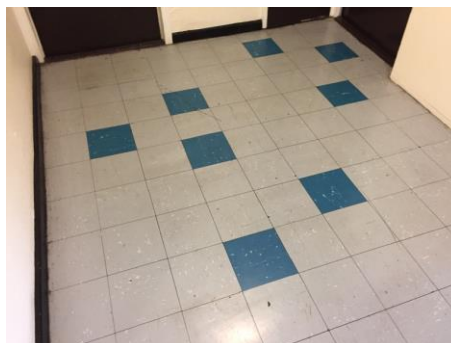
Bitumen adhesive beneath floor tiles.

The material was seen to be in fair condition at the time of the initial inspection.

The condition of the material should be managed by a competent person/company and its presence made aware to those at risk, as part of a Control of Asbestos Regulations (CAR) 2012 compliant management strategy.

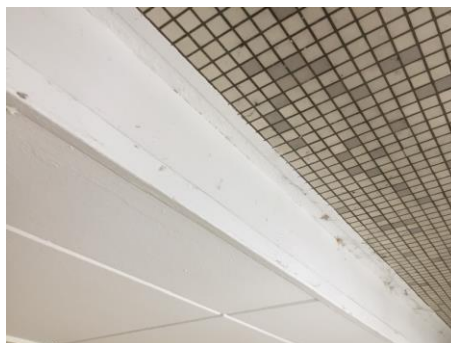
Spatter pattern textured coating above suspended ceiling.

The material was seen to be in fair condition at the time of the initial inspection.

The condition of the material should be managed by a competent person/company and its presence made aware to those at risk, as part of a Control of Asbestos Regulations (CAR) 2012 compliant management strategy.

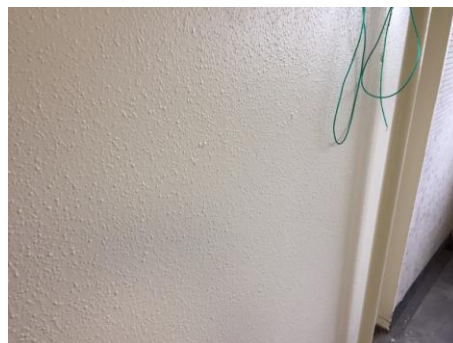
Spatter pattern textured coating.

The material was seen to be in fair condition at the time of the initial inspection.

The condition of the material should be managed by a competent person/company and its presence made aware to those at risk, as part of a Control of Asbestos Regulations (CAR) 2012 compliant management strategy.

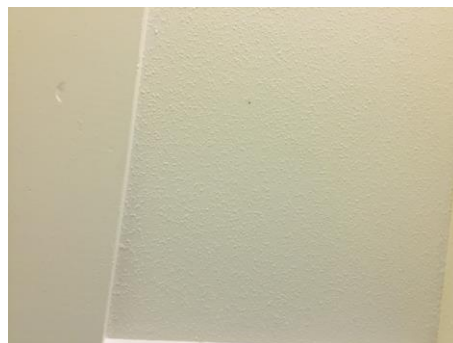
Spatter pattern textured coating.

The material was seen to be in fair condition at the time of the initial inspection.

The condition of the material should be managed by a competent person/company and its presence made aware to those at risk, as part of a Control of Asbestos Regulations (CAR) 2012 compliant management strategy.

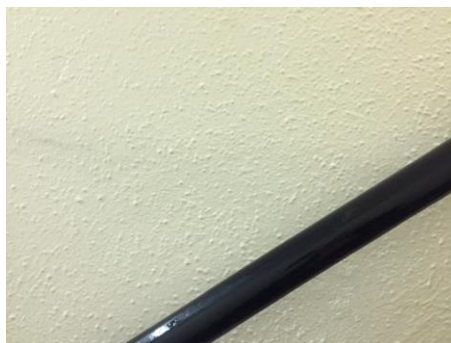
Spatter pattern textured coating.

The material was seen to be in fair condition at the time of the initial inspection.

The condition of the material should be managed by a competent person/company and its presence made aware to those at risk, as part of a Control of Asbestos Regulations (CAR) 2012 compliant management strategy.

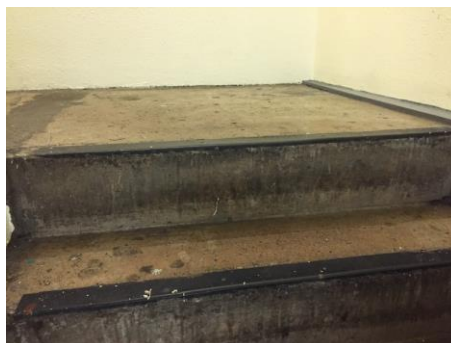
Resin nosing to edge of stairs.

The material was seen to be in fair condition at the time of the initial inspection.

The condition of the material should be managed by a competent person/company and its presence made aware to those at risk, as part of a Control of Asbestos Regulations (CAR) 2012 compliant management strategy.

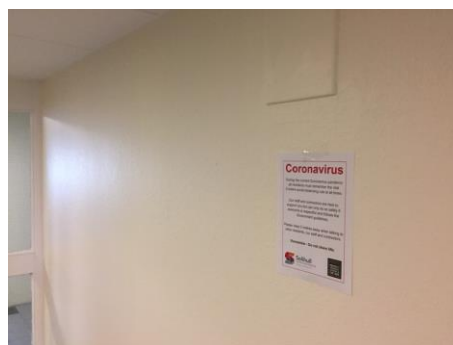
Spatter pattern textured coating.

The material was seen to be in fair condition at the time of the initial inspection.

The condition of the material should be managed by a competent person/company and its presence made aware to those at risk, as part of a Control of Asbestos Regulations (CAR) 2012 compliant management strategy.

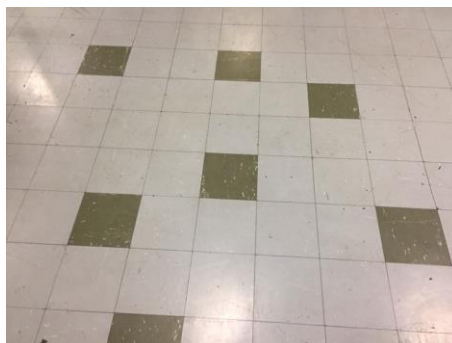
Green and grey floor tiles.

The material was seen to be in fair condition at the time of the initial inspection.

The condition of the material should be managed by a competent person/company and its presence made aware to those at risk, as part of a Control of Asbestos Regulations (CAR) 2012 compliant management strategy.

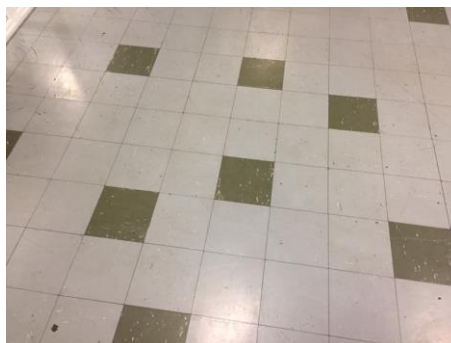
Bitumen adhesive beneath floor tiles.

The material was seen to be in fair condition at the time of the initial inspection.

The condition of the material should be managed by a competent person/company and its presence made aware to those at risk, as part of a Control of Asbestos Regulations (CAR) 2012 compliant management strategy.

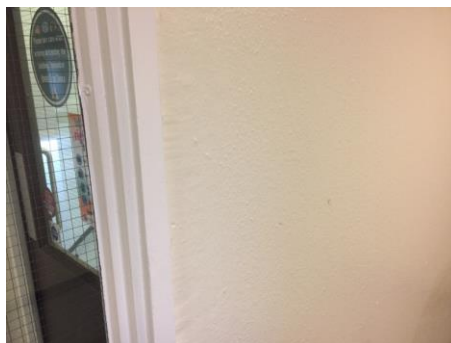
Spatter pattern textured coating.

The material was seen to be in fair condition at the time of the initial inspection.

The condition of the material should be managed by a competent person/company and its presence made aware to those at risk, as part of a Control of Asbestos Regulations (CAR) 2012 compliant management strategy.

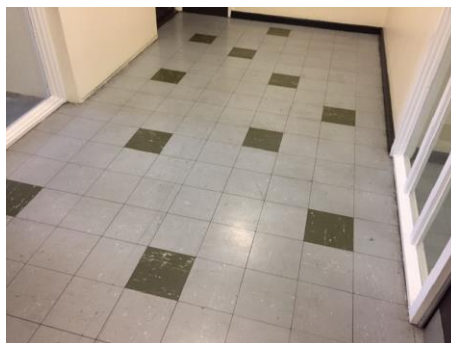
Green and grey floor tiles.

The material was seen to be in fair condition at the time of the initial inspection.

The condition of the material should be managed by a competent person/company and its presence made aware to those at risk, as part of a Control of Asbestos Regulations (CAR) 2012 compliant management strategy.

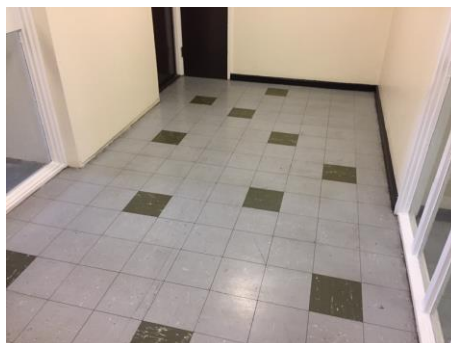
Bitumen adhesive beneath floor tiles.

The material was seen to be in fair condition at the time of the initial inspection.

The condition of the material should be managed by a competent person/company and its presence made aware to those at risk, as part of a Control of Asbestos Regulations (CAR) 2012 compliant management strategy.

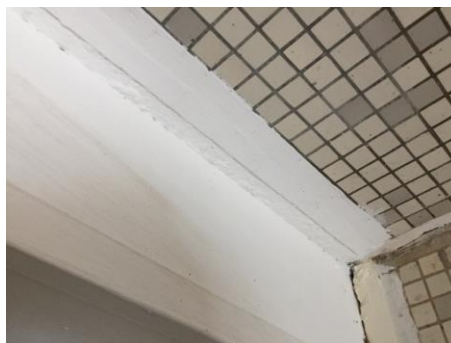
Spatter pattern textured coating above suspended ceiling.

The material was seen to be in fair condition at the time of the initial inspection.

The condition of the material should be managed by a competent person/company and its presence made aware to those at risk, as part of a Control of Asbestos Regulations (CAR) 2012 compliant management strategy.

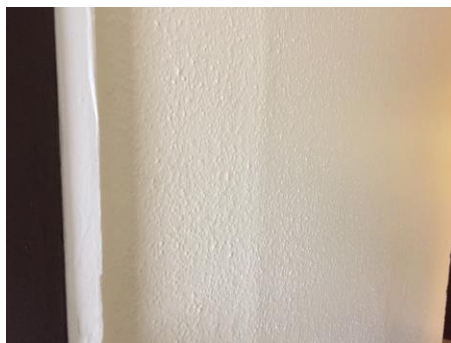
Spatter pattern textured coating.

The material was seen to be in fair condition at the time of the initial inspection.

The condition of the material should be managed by a competent person/company and its presence made aware to those at risk, as part of a Control of Asbestos Regulations (CAR) 2012 compliant management strategy.

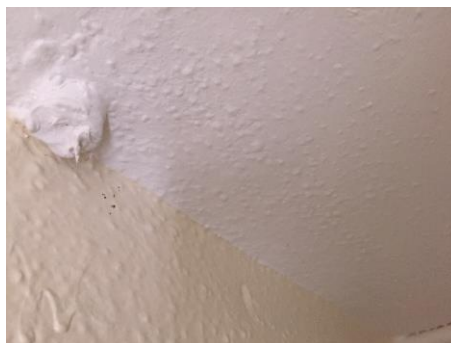
Spatter pattern textured coating.

The material was seen to be in fair condition at the time of the initial inspection.

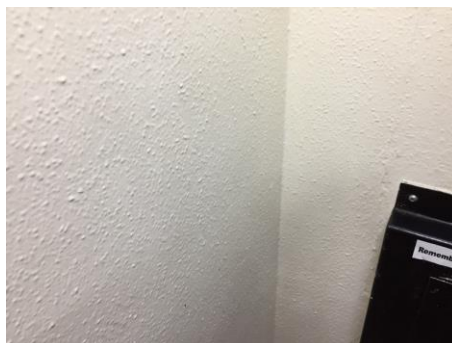
Spatter pattern textured coating.

The material was seen to be in fair condition at the time of the initial inspection.

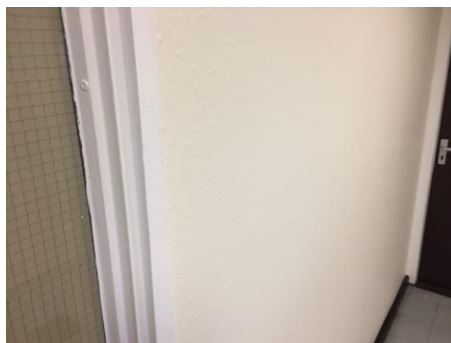
Spatter pattern textured coating.

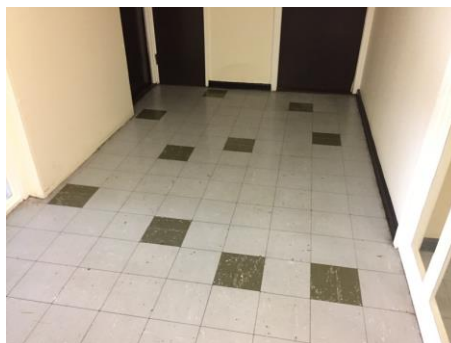
Green and grey floor tiles.

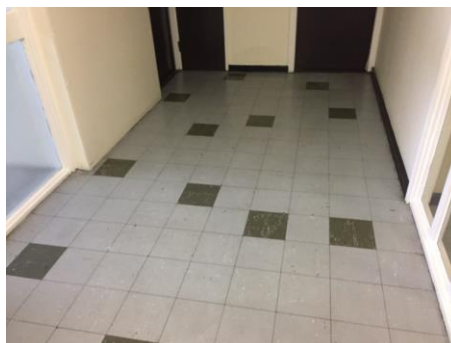
Bitumen adhesive beneath floor tiles.

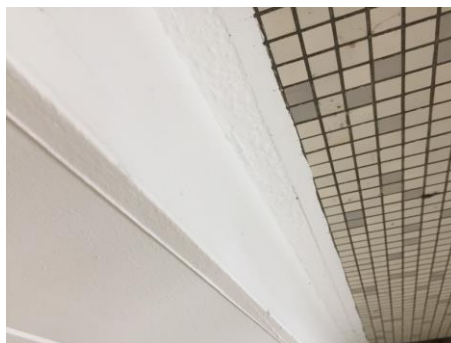
Spatter pattern textured coating above suspended ceiling.

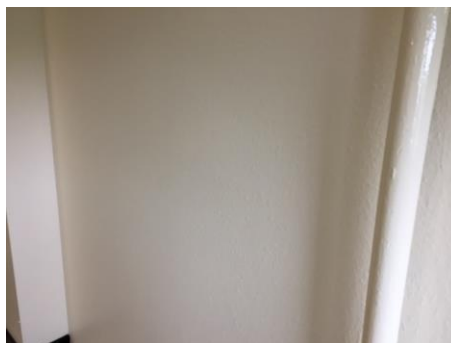
Spatter pattern textured coating.

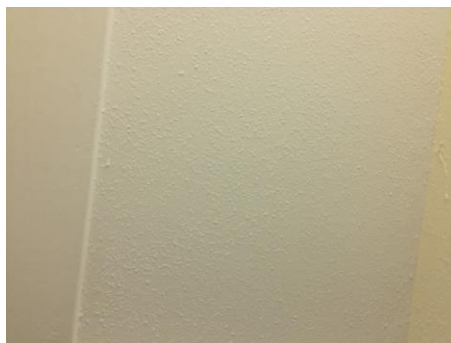
Spatter pattern textured coating.

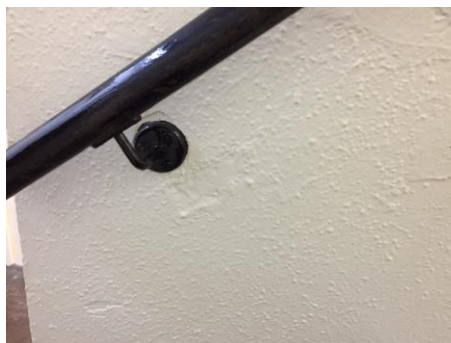
Spatter pattern textured coating.

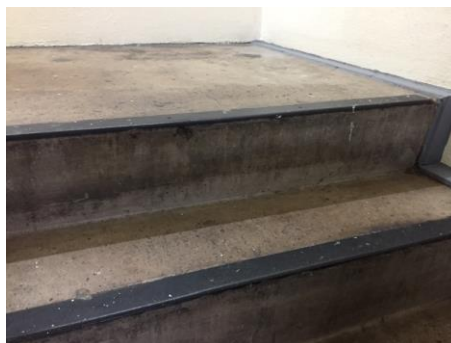
Resin nosing to edge of stairs.

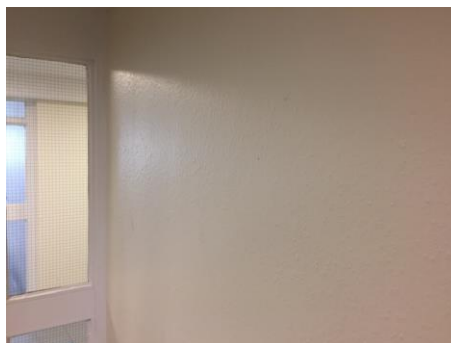
Spatter pattern textured coating.

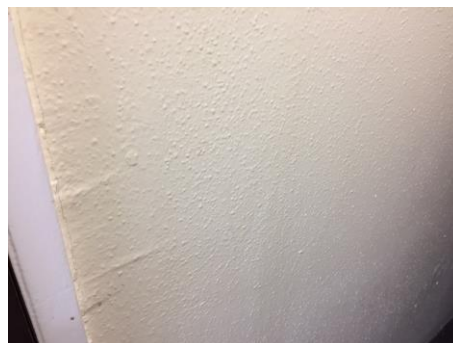
Spatter pattern textured coating.

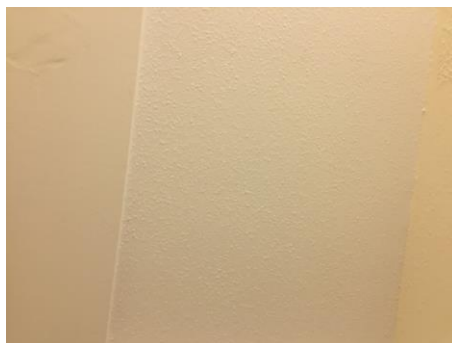
Spatter pattern textured coating.

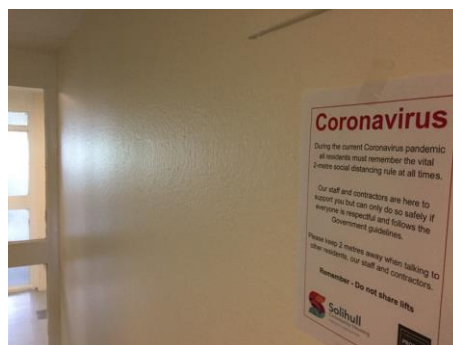
Spatter pattern textured coating.

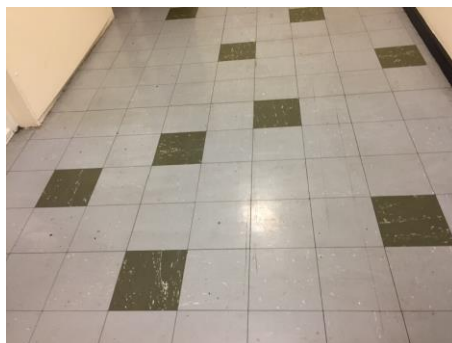
Green and grey floor tiles.

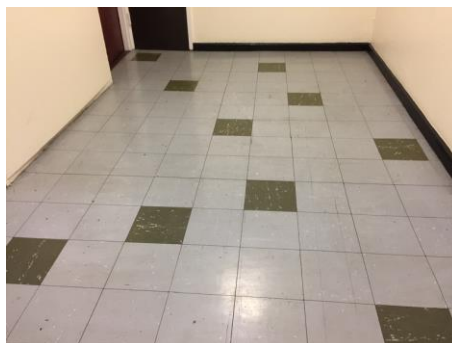
Bitumen adhesive beneath floor tiles.

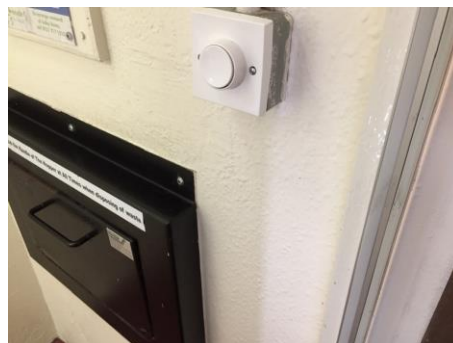
Spatter pattern textured coating.

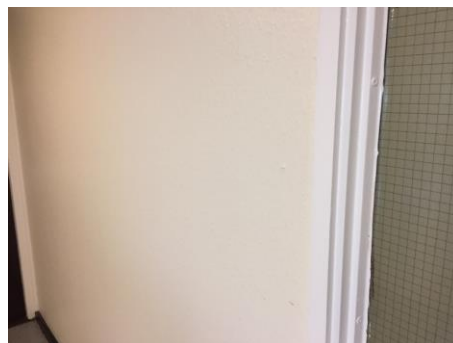
Spatter pattern textured coating.

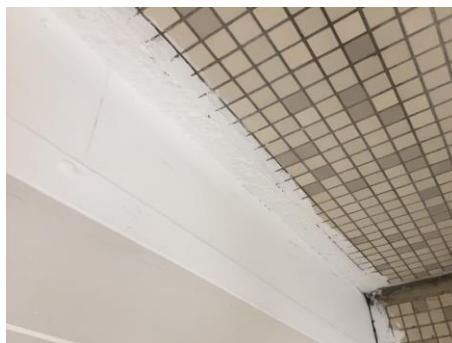
Spatter pattern textured coating above suspended ceiling.

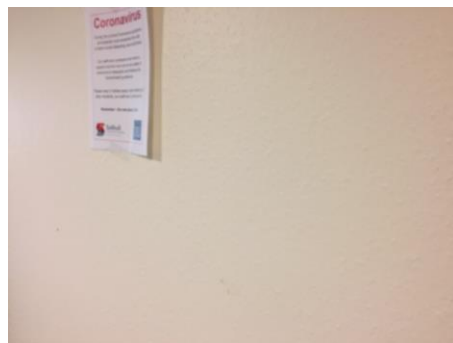
Spatter pattern textured coating.

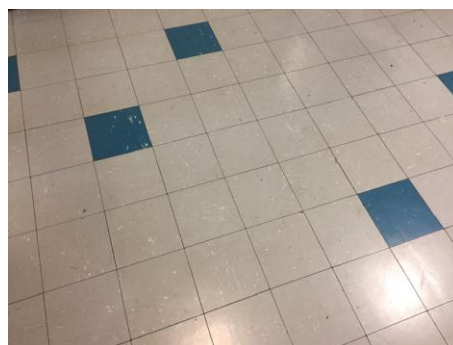
Blue and grey floor tiles.

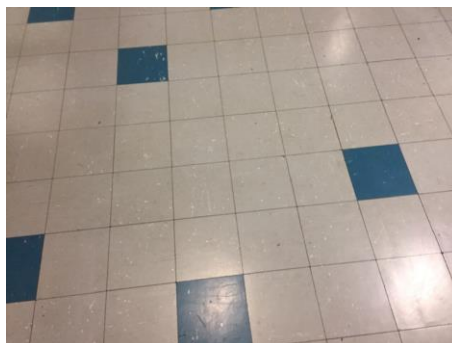
Bitumen adhesive beneath floor tiles.

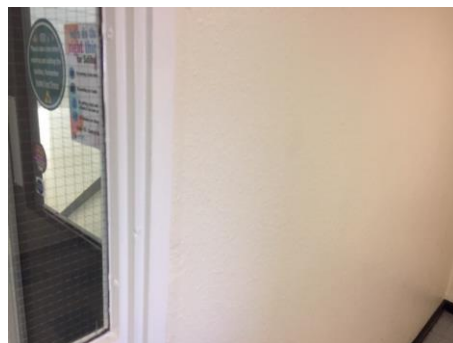
Spatter pattern textured coating.

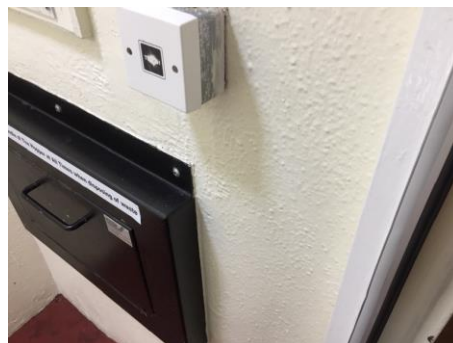
Spatter pattern textured coating.

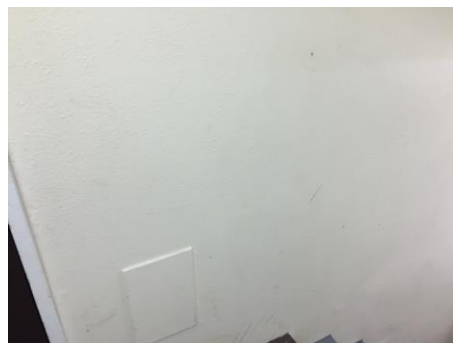
Spatter pattern textured coating.

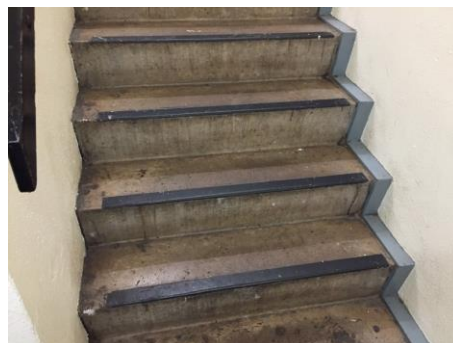
Resin nosing to edge of stairs.

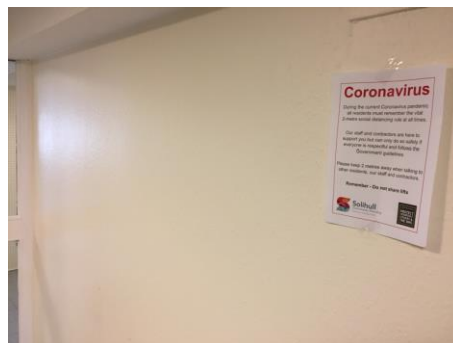
Spatter pattern textured coating.

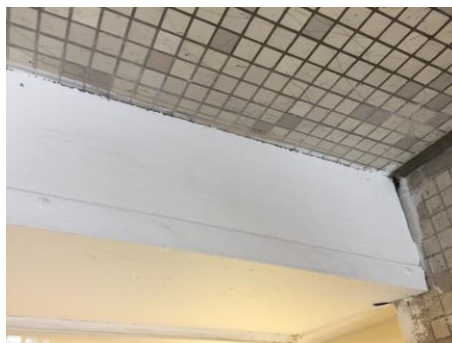
Spatter pattern textured coating above suspended ceiling.

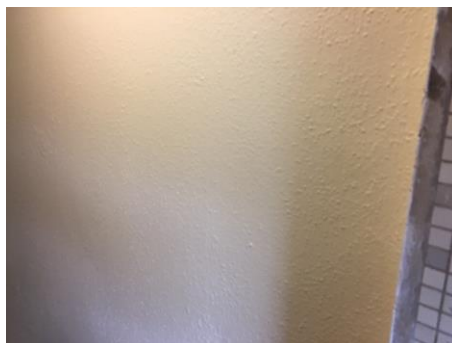
Spatter pattern textured coating.

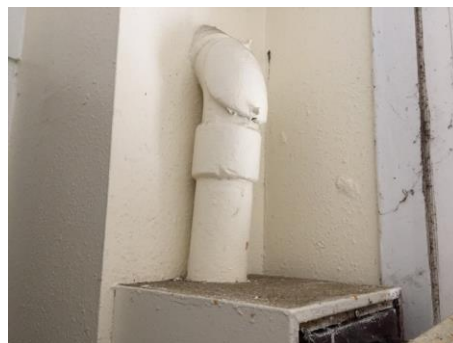
Cement flue from incinerator.

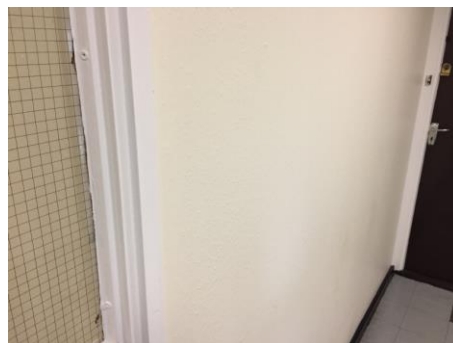
Spatter pattern textured coating.

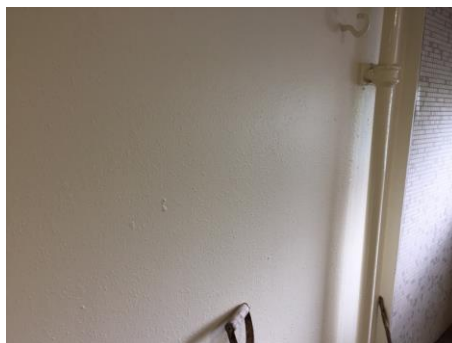
Spatter pattern textured coating.

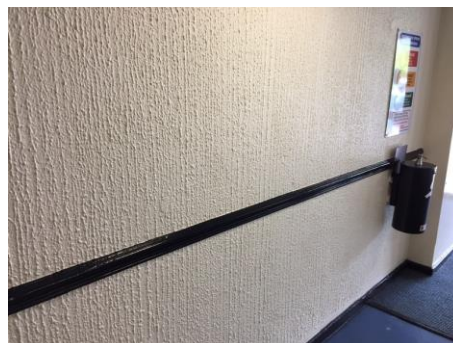
Lined stipple pattern textured coating.
