# Solihull Community Housing

## Asbestos Refurbishment & Demolition Survey Report

**Dillington House  
Moorend Avenue  
Chelmsley Wood  
B37 5TD**

**Date of Report:** 15 Aug 2014

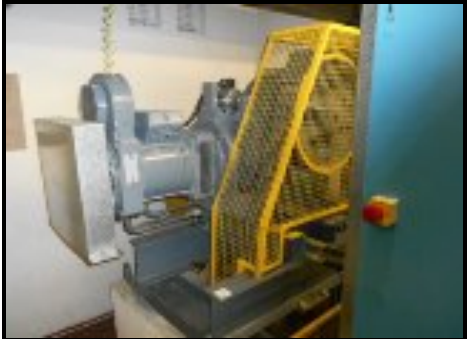
Sample No.	001	Building (Floor)	Main Building (Roof)	Comments

Room Area	Lift Motor Room	Description of Location	Lift Motor		
Product Description	Flash Pad	Asbestos Type	No Asbestos Detected		
Approx Quantity	1.00m2	HSE Notifiable	N/A

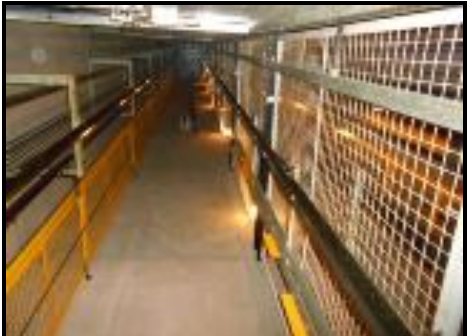
Sample No.	003	Building (Floor)	Main Building (Ground to Eighth Floor)	Comments

Room Area	Lift Shaft	Description of Location	Panel		
Product Description	Bitumen	Asbestos Type	No Asbestos Detected		
Approx Quantity	2.00m2	HSE Notifiable	N/A

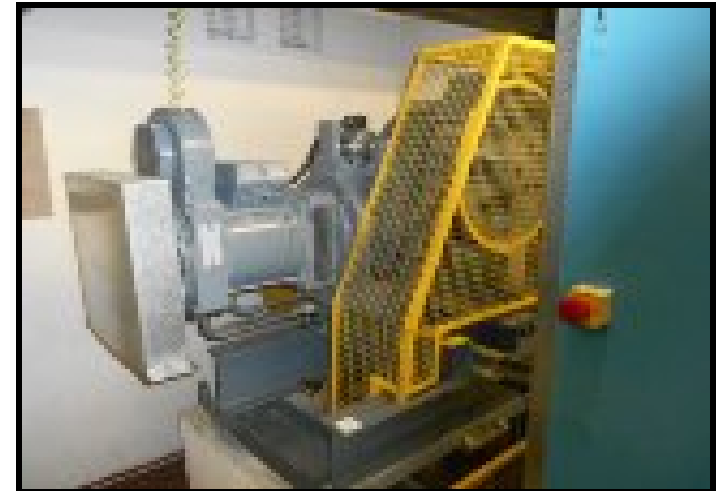
## SAMPLE REFERENCE 001

Building	Floor	Room	Location		
Main Building	Roof	Lift Motor Room	Lift Motor		
Description	Brake lining to lift motor (Even Lift) Concrete walls, floor, ceiling and external walls, timber door, modern electrics to wall, lift control units x2 were manufactured in 1993.				
MATERIAL ASSESSMENT					SCORE
Product Type	Flash Pad	Extent of Damage	Low damage		-
Asbestos Type	No Asbestos Detected	Surface Treatment	Unsealed (3)		
PRIORITY ASSESSMENT					SCORE
Occupant Activity	Not Applicable	Extent / Amount	1.00 m2		-
Accessibility	Occasionally disturb	Location	Not Applicable		
Avg Time in Use	Not Applicable	Frequency of Use	Not Applicable		
No. of Occupants	Not Applicable	Secondary Activity	Not Applicable		
Maintenance	Not Applicable	Maintenance Frequency	Not Applicable		
MANAGEMENT ACTION					SCORE
Recommendation	NO ACTION REQUIRED				-
Recommendation Due		Next Inspection	None		
Apply Labels	No	Permit to Work Required	No

Asbestos not detected in Sample

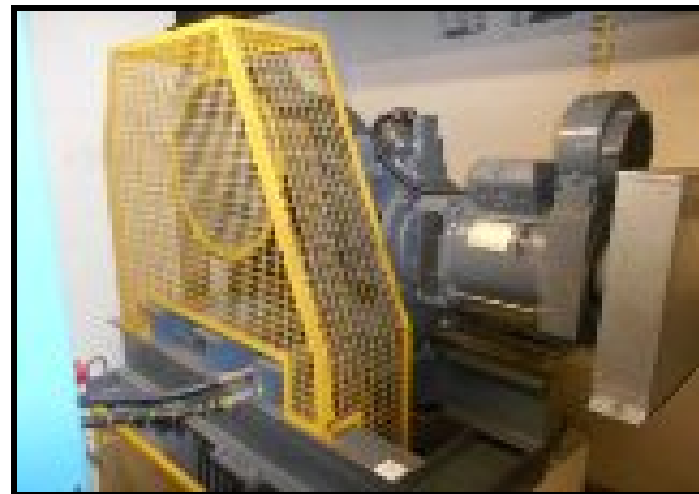
## SAMPLE REFERENCE 002

Building	Floor	Room	Location		
Main Building	Roof	Lift Motor Room	Lift Motor		
Description	Brake lining to lift motor (Odd Lift) Concrete walls, floor, ceiling and external walls, timber door, modern electrics to wall, lift control units x2 were manufactured in 1993.				
MATERIAL ASSESSMENT				SCORE	
Product Type	Flash Pad	Extent of Damage	Low damage		-
Asbestos Type	No Asbestos Detected	Surface Treatment	Unsealed (3)		
PRIORITY ASSESSMENT				SCORE	
Occupant Activity	Not Applicable	Extent / Amount	1.00 m2		-
Accessibility	Occasionally disturb	Location	Not Applicable		
Avg Time in Use	Not Applicable	Frequency of Use	Not Applicable		
No. of Occupants	Not Applicable	Secondary Activity	Not Applicable		
Maintenance	Not Applicable	Maintenance Frequency	Not Applicable		
MANAGEMENT ACTION				SCORE	
Recommendation	NO ACTION REQUIRED				-
Recommendation Due		Next Inspection	None		
Apply Labels	No	Permit to Work Required	No

**No Asbestos Presumed in Sample**

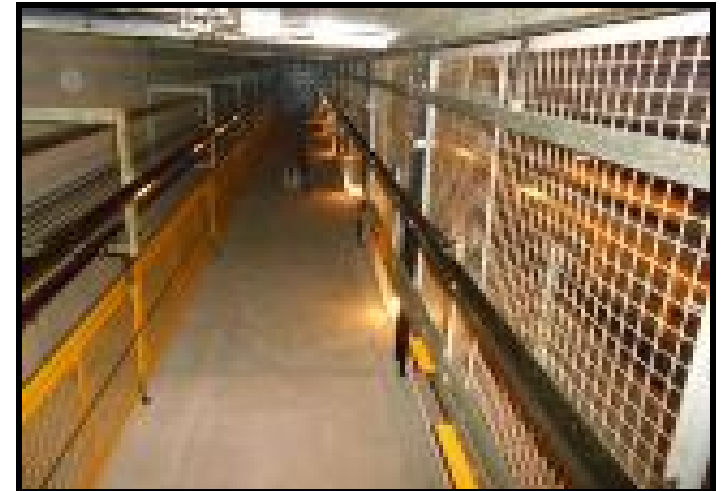
## SAMPLE REFERENCE 003

Building	Floor	Room	Location		
Main Building	Ground to Eighth Floor	Lift Shaft	Panel		
Description	Accoustic pads to external panels of even lift, concrete flooring, walls and ceiling, metal door				
MATERIAL ASSESSMENT					SCORE
Product Type	Bitumen	Extent of Damage	Low damage		-
Asbestos Type	No Asbestos Detected	Surface Treatment	Composite materials		
PRIORITY ASSESSMENT					SCORE
Occupant Activity	Not Applicable	Extent / Amount	2.00 m2		-
Accessibility	Occasionally disturb	Location	Not Applicable		
Avg Time in Use	Not Applicable	Frequency of Use	Not Applicable		
No. of Occupants	Not Applicable	Secondary Activity	Not Applicable		
Maintenance	Not Applicable	Maintenance Frequency	Not Applicable		
MANAGEMENT ACTION					SCORE
Recommendation	NO ACTION REQUIRED				-
Recommendation Due		Next Inspection	None		
Apply Labels	No	Permit to Work Required	No		
Survey Type	Refurb/Demo	Lead Surveyor	John Noonan		
Survey Date	13 Aug 2014	UKAS Laboratory	DMW Environmental Safety Ltd / [D-72945]

**Asbestos not detected in Sample**

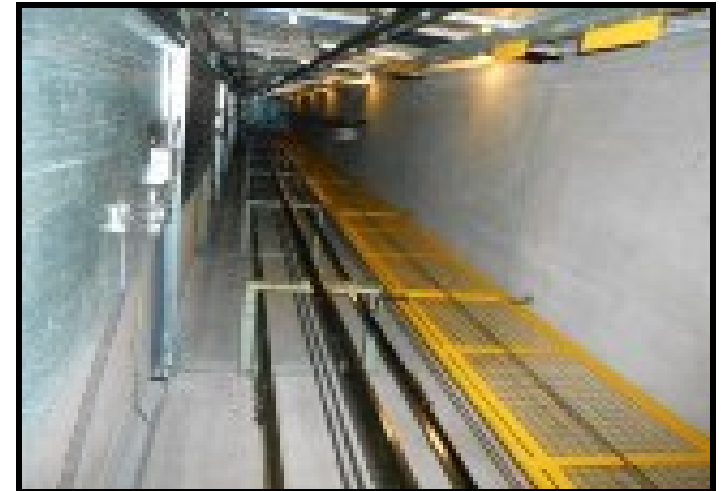
## SAMPLE REFERENCE 004

Building	Floor	Room	Location		
Main Building	Ground to Eighth Floor	Lift Shaft	Panel		
Description	Acoustic pads to external panels of odd lift, concrete flooring, walls and ceiling, metal door				
MATERIAL ASSESSMENT					SCORE
Product Type	Bitumen	Extent of Damage	Low damage		-
Asbestos Type	No Asbestos Detected	Surface Treatment	Composite materials		
PRIORITY ASSESSMENT					SCORE
Occupant Activity	Not Applicable	Extent / Amount	2.00 m2		-
Accessibility	Occasionally disturb	Location	Not Applicable		
Avg Time in Use	Not Applicable	Frequency of Use	Not Applicable		
No. of Occupants	Not Applicable	Secondary Activity	Not Applicable		
Maintenance	Not Applicable	Maintenance Frequency	Not Applicable		
MANAGEMENT ACTION					SCORE
Recommendation	NO ACTION REQUIRED				-
Recommendation Due		Next Inspection	None		
Apply Labels	No	Permit to Work Required	No		
Survey Type	Refurb/Demo	Lead Surveyor	John Noonan		
Survey Date	13 Aug 2014	UKAS Laboratory	NOT SAMPLED (Cross Referenced)

**No Asbestos Presumed in Sample**
