Solihull Community Housing

Asbestos Management Survey Report

**I-43 (Communal) Keble House
Moat Croft
Solihull
B37 5HD**

Date of Report: 14 Jan 2013

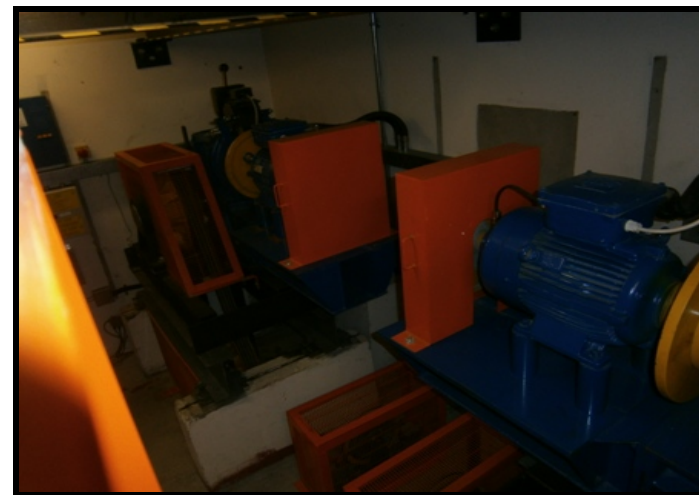
SAMPLE REFERENCE 001a

Building	Floor	Room	Location		
Main	Roof	Lift Motor Room	Lift Motor		
Description					
MATERIAL ASSESSMENT					
Product Type	Flash Pad	Extent of Damage	Low damage		
Asbestos Type	Presumed ACM	Surface Treatment	Unsealed (3)		
PRIORITY ASSESSMENT					
Occupant Activity	Not Applicable	Extent / Amount	1.00 small item(s)		
Accessibility	Unlikely to be disturbed	Location	Not Applicable		
Avg Time in Use	Not Applicable	Frequency of Use	Not Applicable		
No. of Occupants	Not Applicable	Secondary Activity	Not Applicable		
Maintenance	Not Applicable	Maintenance Frequency	Not Applicable		
MANAGEMENT ACTION					
Recommendation	LABEL & MONITOR				
Recommendation Due		Next Inspection	11 Jun 2012		
Apply Labels	No	Permit to Work Required	No		
Survey Type	Re-Inspection	Lead Surveyor	Gavin Hooper		
Survey Date	11 Dec 2012	UKAS Laboratory	NOT SAMPLED		
Site Reference	I29280000A	Licensed Material	Yes	Notifiable Non Licensed Work	No

Asbestos Presumed in Sample

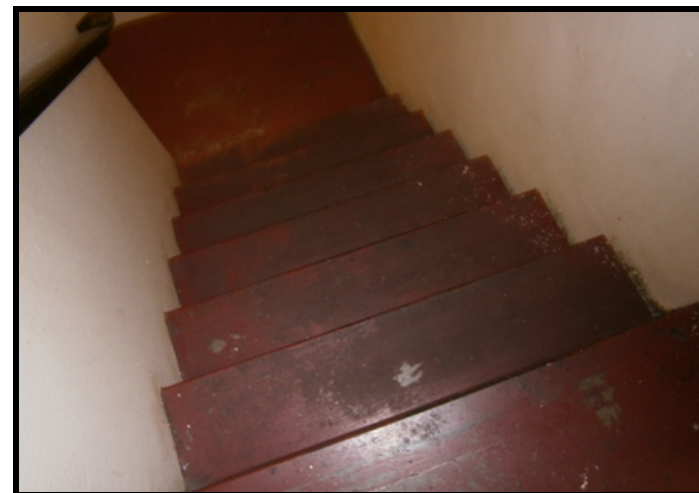
SAMPLE REFERENCE 001b

Building	Floor	Room	Location
Main	Roof	Stairwell	Staircase
Description	Bitumen stair nosing		
MATERIAL ASSESSMENT			
Product Type	Bitumen	Extent of Damage	Low damage
Asbestos Type	Chrysotile	Surface Treatment	Composite materials
PRIORITY ASSESSMENT			
Occupant Activity	Not Applicable	Extent / Amount	15.00 m2
Accessibility	Easily disturbed	Location	Not Applicable
Avg Time in Use	Not Applicable	Frequency of Use	Not Applicable
No. of Occupants	Not Applicable	Secondary Activity	Not Applicable
Maintenance	Not Applicable	Maintenance Frequency	Not Applicable
MANAGEMENT ACTION			
Recommendation	LABEL & MONITOR		
Recommendation Due		Next Inspection	11 Dec 2013
Apply Labels	No	Permit to Work Required	No
Survey Type	Re-Inspection	Lead Surveyor	Gavin Hooper
Survey Date	11 Dec 2012	UKAS Laboratory	NOT SAMPLED (Cross Referenced)
Site Reference	I29280000A	Licensed Material	No
		Notifiable Non Licensed Work	No

Asbestos Presumed in Sample

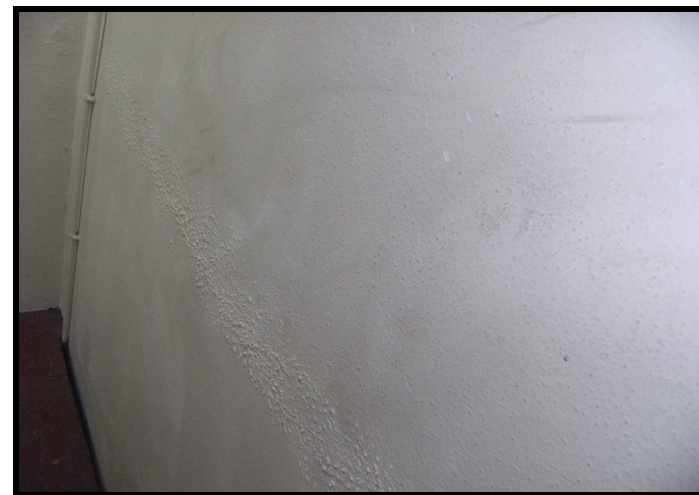
SAMPLE REFERENCE 003

Building	Floor	Room	Location		
Main	Roof	Entrance Stairwell	Wall		
Description					
MATERIAL ASSESSMENT					SCORE
Product Type	Textured Coating	Extent of Damage	Good condition		-
Asbestos Type	No Asbestos Detected	Surface Treatment	Textured Coating		
PRIORITY ASSESSMENT					SCORE
Occupant Activity	Not Applicable	Extent / Amount	15.00 m2		-
Accessibility	Easily disturbed	Location	Not Applicable		
Avg Time in Use	Not Applicable	Frequency of Use	Not Applicable		
No. of Occupants	Not Applicable	Secondary Activity	Not Applicable		
Maintenance	Not Applicable	Maintenance Frequency	Not Applicable		
MANAGEMENT ACTION					SCORE
Recommendation	NO ACTION REQUIRED				-
Recommendation Due		Next Inspection	None		
Apply Labels	No	Permit to Work Required	No		
Survey Type	Re-Inspection	Lead Surveyor	Gavin Hooper		
Survey Date	22 Mar 2011	UKAS Laboratory	DMW Environmental Safety Ltd / [P-75205]		
Site Reference	I29280000A	Licensed Material	N/A	Notifiable Non Licensed Work	N/A

Asbestos not detected in Sample

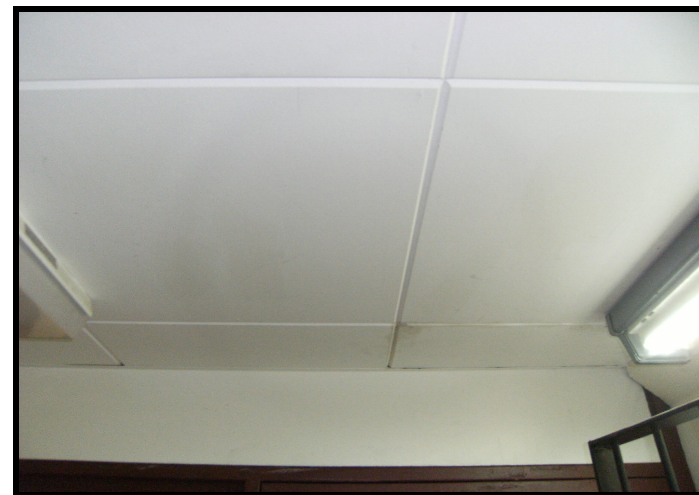
SAMPLE REFERENCE 005

Asbestos not detected in Sample

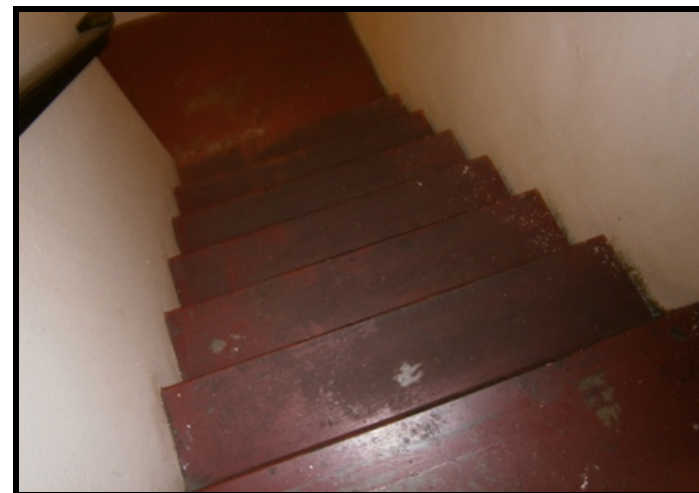
SAMPLE REFERENCE 005a

Building	Floor	Room	Location
Main	Tenth Floor	Stairwell	Staircase
Description	Bitumen stair nosing		
MATERIAL ASSESSMENT			
Product Type	Bitumen	Extent of Damage	Low damage
Asbestos Type	Chrysotile	Surface Treatment	Composite materials
PRIORITY ASSESSMENT			
Occupant Activity	Not Applicable	Extent / Amount	15.00 m2
Accessibility	Easily disturbed	Location	Not Applicable
Avg Time in Use	Not Applicable	Frequency of Use	Not Applicable
No. of Occupants	Not Applicable	Secondary Activity	Not Applicable
Maintenance	Not Applicable	Maintenance Frequency	Not Applicable
MANAGEMENT ACTION			
Recommendation	LABEL & MONITOR		
Recommendation Due		Next Inspection	11 Dec 2013
Apply Labels	No	Permit to Work Required	No
Survey Type	Re-Inspection	Lead Surveyor	Gavin Hooper
Survey Date	11 Dec 2012	UKAS Laboratory	NOT SAMPLED (Cross Referenced)
Site Reference	I29280000A	Licensed Material	No
		Notifiable Non Licensed Work	No

Asbestos Presumed in Sample

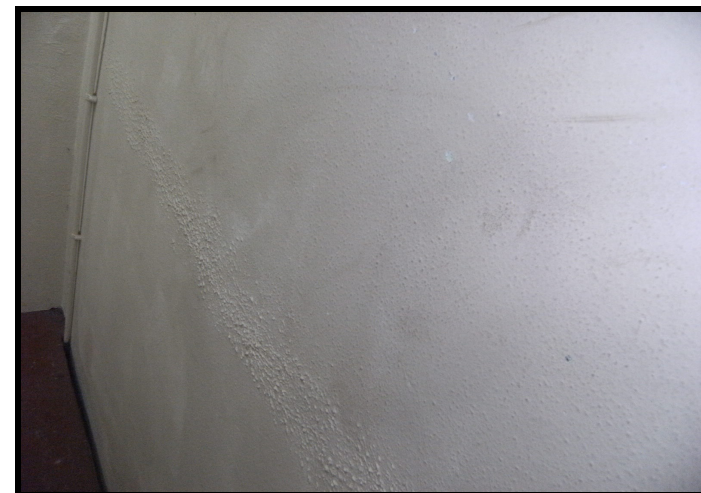
SAMPLE REFERENCE 006

Building	Floor	Room	Location		
Main	Tenth Floor	Stairwell	Wall		
Description	Modern supalux fire break.				
MATERIAL ASSESSMENT				SCORE	
Product Type	Textured Coating	Extent of Damage	Good condition		-
Asbestos Type	No Asbestos Detected	Surface Treatment	Textured Coating		
PRIORITY ASSESSMENT				SCORE	
Occupant Activity	Not Applicable	Extent / Amount	15.00 m2		-
Accessibility	Easily disturbed	Location	Not Applicable		
Avg Time in Use	Not Applicable	Frequency of Use	Not Applicable		
No. of Occupants	Not Applicable	Secondary Activity	Not Applicable		
Maintenance	Not Applicable	Maintenance Frequency	Not Applicable		
MANAGEMENT ACTION				SCORE	
Recommendation	NO ACTION REQUIRED			-	
Recommendation Due		Next Inspection	None		
Apply Labels	No	Permit to Work Required	No		
Survey Type	Re-Inspection	Lead Surveyor	Gavin Hooper		
Survey Date	22 Mar 2011	UKAS Laboratory	NOT SAMPLED (Cross Referenced)		
Site Reference	I29280000A	Licensed Material	N/A	Notifiable Non Licensed Work	N/A

No Asbestos Presumed in Sample

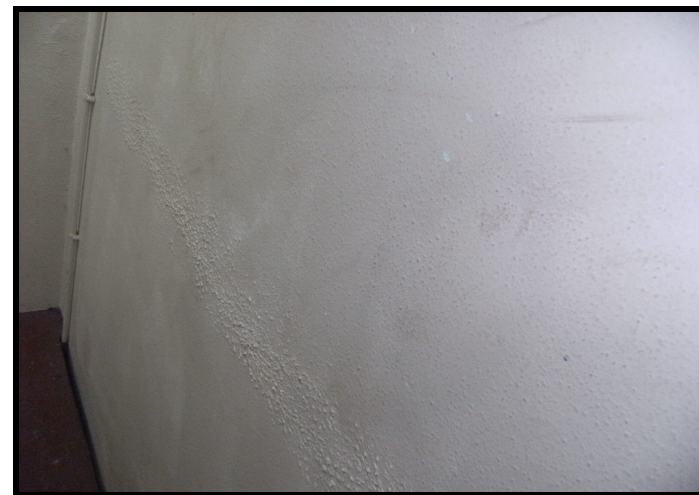
SAMPLE REFERENCE 007

No Asbestos Presumed in Sample

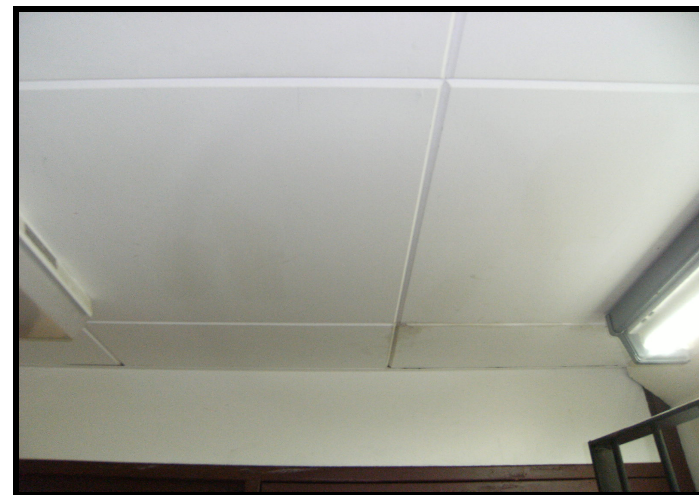
SAMPLE REFERENCE 008

No Asbestos Presumed in Sample

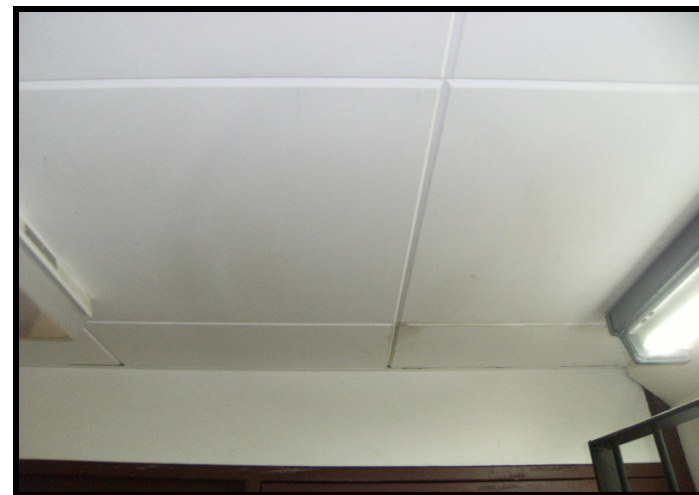
SAMPLE REFERENCE 011

No Asbestos Presumed in Sample

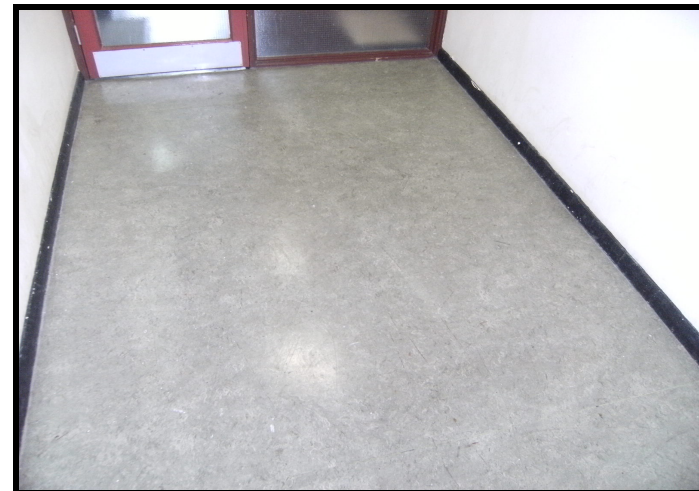
SAMPLE REFERENCE 017

Building	Floor	Room	Location
Main	Tenth Floor	Bin Chute	Floor
Description	No access within board riser.		
MATERIAL ASSESSMENT			
Product Type	Linoleum	Extent of Damage	Good condition
Asbestos Type	No Asbestos Detected	Surface Treatment	Composite materials
PRIORITY ASSESSMENT			
Occupant Activity	Not Applicable	Extent / Amount	2.00 m2
Accessibility	Occasionally disturb	Location	Not Applicable
Avg Time in Use	Not Applicable	Frequency of Use	Not Applicable
No. of Occupants	Not Applicable	Secondary Activity	Not Applicable
Maintenance	Not Applicable	Maintenance Frequency	Not Applicable
MANAGEMENT ACTION			
Recommendation	NO ACTION REQUIRED		
Recommendation Due		Next Inspection	None
Apply Labels	No	Permit to Work Required	No
Survey Type	Re-Inspection	Lead Surveyor	Gavin Hooper
Survey Date	22 Mar 2011	UKAS Laboratory	NOT SAMPLED (Cross Referenced)
Site Reference	I29280000A	Licensed Material	N/A
		Notifiable Non Licensed Work	N/A

No Asbestos Presumed in Sample

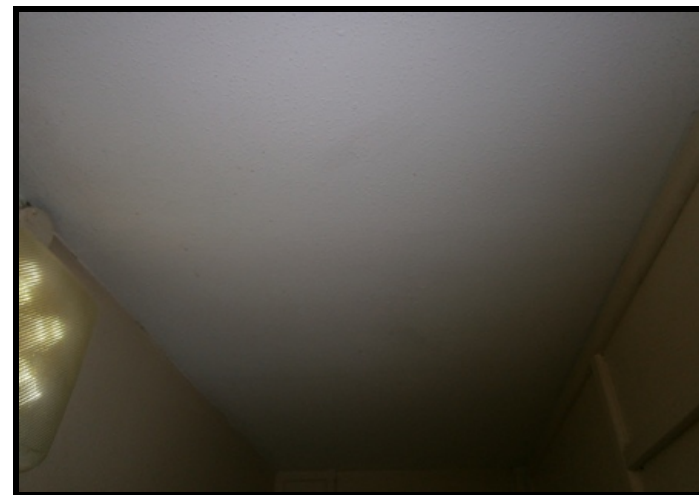
SAMPLE REFERENCE 018

Asbestos Presumed in Sample

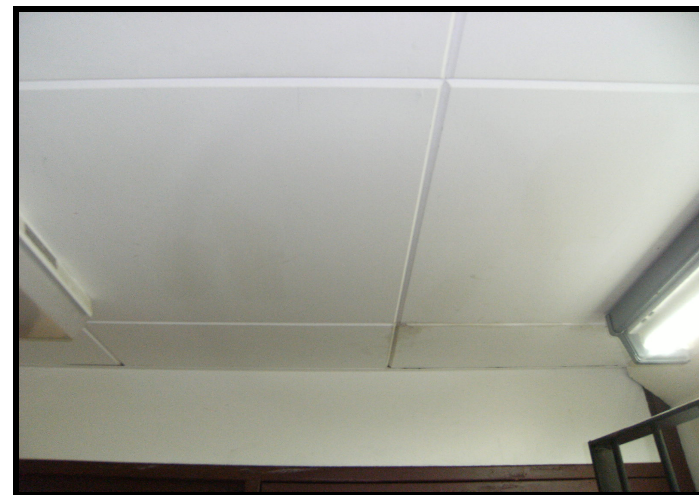
SAMPLE REFERENCE 024

No Asbestos Presumed in Sample

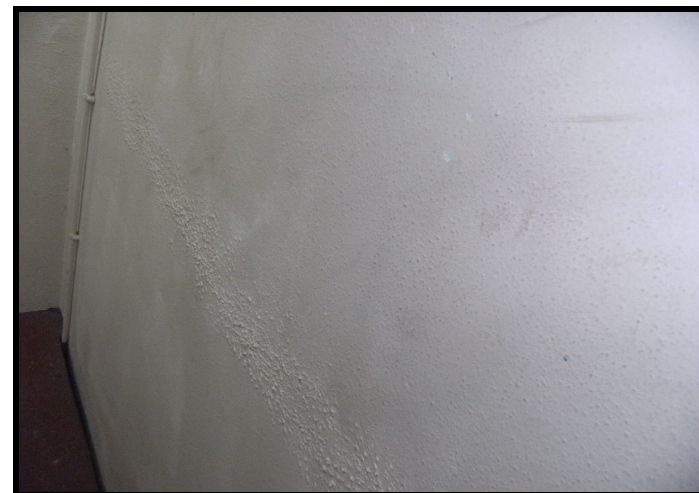
SAMPLE REFERENCE 026

Building	Floor	Room	Location		
Main	Tenth Floor	Riser I	Wall		
Description					
MATERIAL ASSESSMENT					SCORE
Product Type	Textured Coating	Extent of Damage	Good condition		-
Asbestos Type	No Asbestos Detected	Surface Treatment	Textured Coating		
PRIORITY ASSESSMENT					SCORE
Occupant Activity	Not Applicable	Extent / Amount	2.00 m2		-
Accessibility	Easily disturbed	Location	Not Applicable		
Avg Time in Use	Not Applicable	Frequency of Use	Not Applicable		
No. of Occupants	Not Applicable	Secondary Activity	Not Applicable		
Maintenance	Not Applicable	Maintenance Frequency	Not Applicable		
MANAGEMENT ACTION					SCORE
Recommendation	NO ACTION REQUIRED				-
Recommendation Due		Next Inspection	None		
Apply Labels	No	Permit to Work Required	No		
Survey Type	Re-Inspection	Lead Surveyor	Gavin Hooper		
Survey Date	22 Mar 2011	UKAS Laboratory	NOT SAMPLED (Cross Referenced)		
Site Reference	I29280000A	Licensed Material	N/A	Notifiable Non Licensed Work	N/A

No Asbestos Presumed in Sample

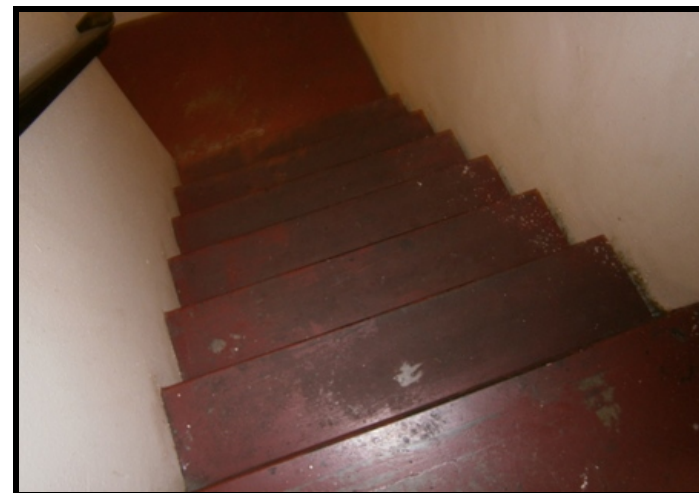
SAMPLE REFERENCE 028a

Building	Floor	Room	Location
Main	Ninth Floor	Stairwell	Staircase
Description	Bitumen stair nosing		
MATERIAL ASSESSMENT			
Product Type	Bitumen	Extent of Damage	Low damage
Asbestos Type	Chrysotile	Surface Treatment	Composite materials
PRIORITY ASSESSMENT			
Occupant Activity	Not Applicable	Extent / Amount	15.00 m2
Accessibility	Easily disturbed	Location	Not Applicable
Avg Time in Use	Not Applicable	Frequency of Use	Not Applicable
No. of Occupants	Not Applicable	Secondary Activity	Not Applicable
Maintenance	Not Applicable	Maintenance Frequency	Not Applicable
MANAGEMENT ACTION			
Recommendation	LABEL & MONITOR		
Recommendation Due		Next Inspection	11 Dec 2013
Apply Labels	No	Permit to Work Required	No
Survey Type	Re-Inspection	Lead Surveyor	Gavin Hooper
Survey Date	11 Dec 2012	UKAS Laboratory	NOT SAMPLED (Cross Referenced)
Site Reference	I29280000A	Licensed Material	No
		Notifiable Non Licensed Work	No

Asbestos Presumed in Sample

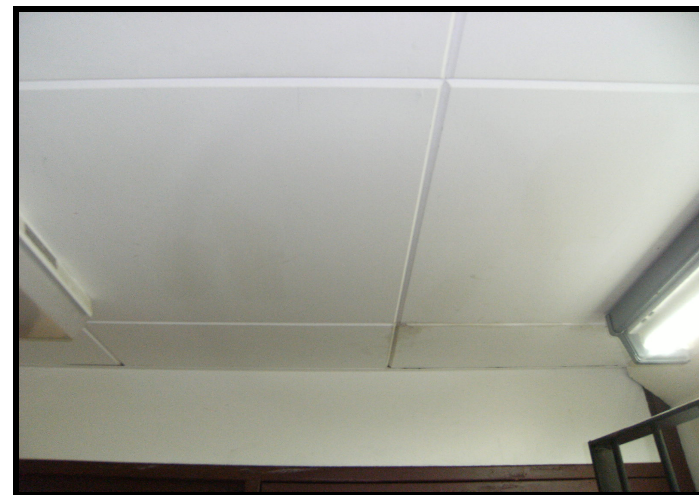
SAMPLE REFERENCE 029

No Asbestos Presumed in Sample

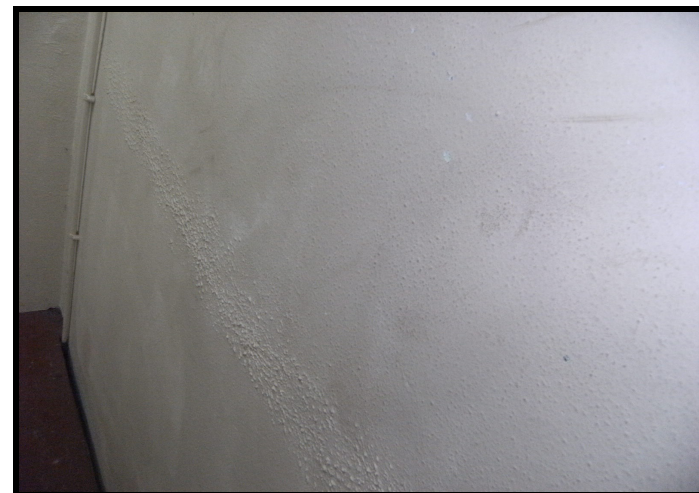
SAMPLE REFERENCE 033

Building	Floor	Room	Location		
Main	Ninth Floor	Riser I Lobby	Wall		
Description	Modern supalux fire break.				
MATERIAL ASSESSMENT					SCORE
Product Type	Textured Coating	Extent of Damage	Good condition		-
Asbestos Type	No Asbestos Detected	Surface Treatment	Textured Coating		
PRIORITY ASSESSMENT					SCORE
Occupant Activity	Not Applicable	Extent / Amount	2.00 m2		-
Accessibility	Easily disturbed	Location	Not Applicable		
Avg Time in Use	Not Applicable	Frequency of Use	Not Applicable		
No. of Occupants	Not Applicable	Secondary Activity	Not Applicable		
Maintenance	Not Applicable	Maintenance Frequency	Not Applicable		
MANAGEMENT ACTION					SCORE
Recommendation	NO ACTION REQUIRED				-
Recommendation Due		Next Inspection	None		
Apply Labels	No	Permit to Work Required	No		
Survey Type	Re-Inspection	Lead Surveyor	Gavin Hooper		
Survey Date	22 Mar 2011	UKAS Laboratory	NOT SAMPLED (Cross Referenced)		
Site Reference	I29280000A	Licensed Material	N/A	Notifiable Non Licensed Work	N/A

No Asbestos Presumed in Sample

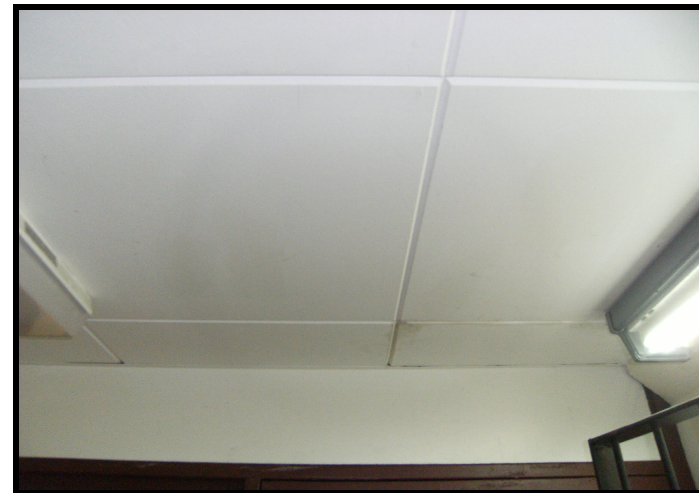
SAMPLE REFERENCE 034

Building	Floor	Room	Location		
Main	Ninth Floor	Riser I Lobby	Ceiling		
Description	Modern supalux fire break.				
MATERIAL ASSESSMENT					SCORE
Product Type	Board	Extent of Damage	Good condition		-
Asbestos Type	No Asbestos Detected	Surface Treatment	Sealed Board (Encapsulated)		
PRIORITY ASSESSMENT					SCORE
Occupant Activity	Not Applicable	Extent / Amount	2.00 m2		-
Accessibility	Occasionally disturb	Location	Not Applicable		
Avg Time in Use	Not Applicable	Frequency of Use	Not Applicable		
No. of Occupants	Not Applicable	Secondary Activity	Not Applicable		
Maintenance	Not Applicable	Maintenance Frequency	Not Applicable		
MANAGEMENT ACTION					SCORE
Recommendation	NO ACTION REQUIRED				-
Recommendation Due		Next Inspection	None		
Apply Labels	No	Permit to Work Required	No		
Survey Type	Re-Inspection	Lead Surveyor	Gavin Hooper		
Survey Date	22 Mar 2011	UKAS Laboratory	NOT SAMPLED (Cross Referenced)		
Site Reference	I29280000A	Licensed Material	N/A	Notifiable Non Licensed Work	N/A

No Asbestos Presumed in Sample

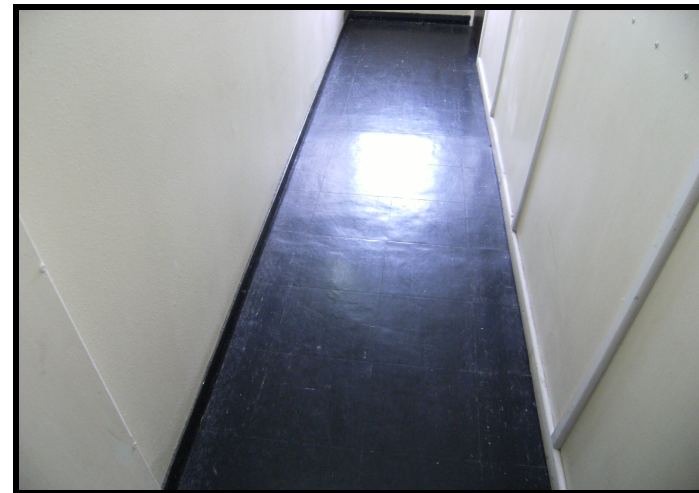
SAMPLE REFERENCE 035

Building	Floor	Room	Location		
Main	Ninth Floor	Riser I Lobby	Floor		
Description	Modern supalux fire break.				
MATERIAL ASSESSMENT					SCORE
Product Type	Floor Tiles	Extent of Damage	Good condition		-
Asbestos Type	No Asbestos Detected	Surface Treatment	Composite materials		
PRIORITY ASSESSMENT					SCORE
Occupant Activity	Not Applicable	Extent / Amount	2.00 m2		-
Accessibility	Occasionally disturb	Location	Not Applicable		
Avg Time in Use	Not Applicable	Frequency of Use	Not Applicable		
No. of Occupants	Not Applicable	Secondary Activity	Not Applicable		
Maintenance	Not Applicable	Maintenance Frequency	Not Applicable		
MANAGEMENT ACTION					SCORE
Recommendation	NO ACTION REQUIRED				-
Recommendation Due		Next Inspection	None		
Apply Labels	No	Permit to Work Required	No		
Survey Type	Re-Inspection	Lead Surveyor	Gavin Hooper		
Survey Date	22 Mar 2011	UKAS Laboratory	NOT SAMPLED (Cross Referenced)		
Site Reference	I29280000A	Licensed Material	N/A	Notifiable Non Licensed Work	N/A

No Asbestos Presumed in Sample

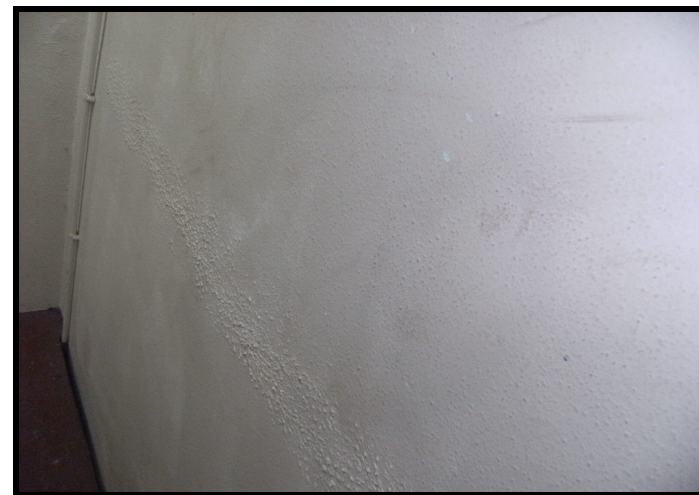
SAMPLE REFERENCE 036

Building	Floor	Room	Location		
Main	Ninth Floor	Riser I	Wall		
Description					
MATERIAL ASSESSMENT					SCORE
Product Type	Textured Coating	Extent of Damage	Good condition		-
Asbestos Type	No Asbestos Detected	Surface Treatment	Textured Coating		
PRIORITY ASSESSMENT					SCORE
Occupant Activity	Not Applicable	Extent / Amount	2.00 m2		-
Accessibility	Easily disturbed	Location	Not Applicable		
Avg Time in Use	Not Applicable	Frequency of Use	Not Applicable		
No. of Occupants	Not Applicable	Secondary Activity	Not Applicable		
Maintenance	Not Applicable	Maintenance Frequency	Not Applicable		
MANAGEMENT ACTION					SCORE
Recommendation	NO ACTION REQUIRED				-
Recommendation Due		Next Inspection	None		
Apply Labels	No	Permit to Work Required	No		
Survey Type	Re-Inspection	Lead Surveyor	Gavin Hooper		
Survey Date	22 Mar 2011	UKAS Laboratory	NOT SAMPLED (Cross Referenced)		
Site Reference	I29280000A	Licensed Material	N/A	Notifiable Non Licensed Work	N/A

No Asbestos Presumed in Sample

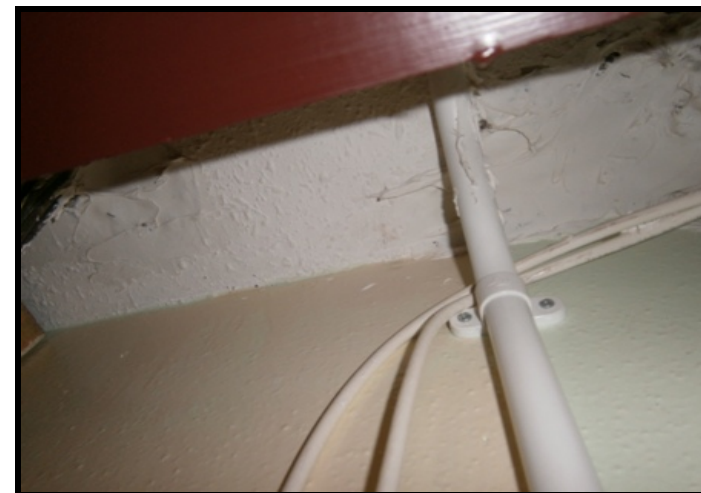
SAMPLE REFERENCE 037

Building	Floor	Room	Location
Main	Ninth Floor	Riser I	Ceiling
Description			
MATERIAL ASSESSMENT			
Product Type	Textured Coating	Extent of Damage	Good condition
Asbestos Type	Chrysotile	Surface Treatment	Textured Coating
PRIORITY ASSESSMENT			
Occupant Activity	Not Applicable	Extent / Amount	1.00 small item(s)
Accessibility	Occasionally disturb	Location	Not Applicable
Avg Time in Use	Not Applicable	Frequency of Use	Not Applicable
No. of Occupants	Not Applicable	Secondary Activity	Not Applicable
Maintenance	Not Applicable	Maintenance Frequency	Not Applicable
MANAGEMENT ACTION			
Recommendation	LABEL & MONITOR		
Recommendation Due		Next Inspection	22 Mar 2012
Apply Labels	No	Permit to Work Required	No
Survey Type	Re-Inspection	Lead Surveyor	Gavin Hooper
Survey Date	11 Dec 2012	UKAS Laboratory	NOT SAMPLED (Cross Referenced)
Site Reference	I29280000A	Licensed Material	No
		Notifiable Non Licensed Work	No

Asbestos Presumed in Sample

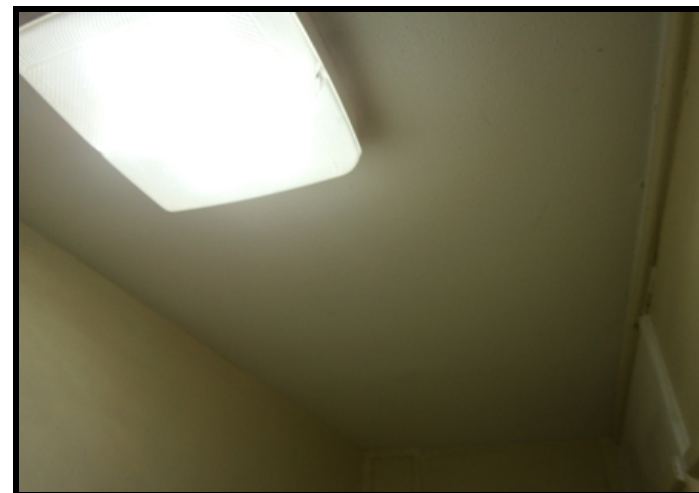
SAMPLE REFERENCE 045

Building	Floor	Room	Location
Main	Ninth Floor	Bin Chute	Ceiling
Description			
MATERIAL ASSESSMENT			
Product Type	Textured Coating	Extent of Damage	Good condition
Asbestos Type	Chrysotile	Surface Treatment	Textured Coating
PRIORITY ASSESSMENT			
Occupant Activity	Not Applicable	Extent / Amount	3.00 m2
Accessibility	Occasionally disturb	Location	Not Applicable
Avg Time in Use	Not Applicable	Frequency of Use	Not Applicable
No. of Occupants	Not Applicable	Secondary Activity	Not Applicable
Maintenance	Not Applicable	Maintenance Frequency	Not Applicable
MANAGEMENT ACTION			
Recommendation	LABEL & MONITOR		
Recommendation Due		Next Inspection	22 Mar 2012
Apply Labels	No	Permit to Work Required	No
Survey Type	Re-Inspection	Lead Surveyor	Gavin Hooper
Survey Date	11 Dec 2012	UKAS Laboratory	NOT SAMPLED (Cross Referenced)
Site Reference	I29280000A	Licensed Material	No
		Notifiable Non Licensed Work	No

Asbestos Presumed in Sample

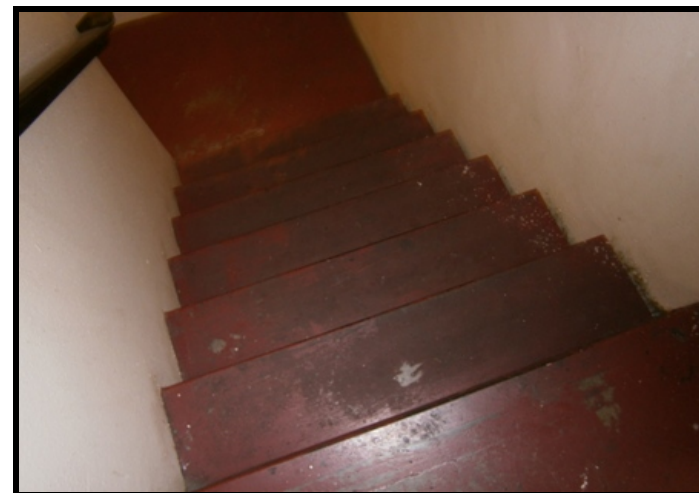
SAMPLE REFERENCE 049a

Building	Floor	Room	Location
Main	Eighth Floor	Stairwell	Staircase
Description	Bitumen stair nosing		
MATERIAL ASSESSMENT			
Product Type	Bitumen	Extent of Damage	Low damage
Asbestos Type	Chrysotile	Surface Treatment	Composite materials
SCORE			
			3
PRIORITY ASSESSMENT			
Occupant Activity	Not Applicable	Extent / Amount	15.00 m2
Accessibility	Easily disturbed	Location	Not Applicable
Avg Time in Use	Not Applicable	Frequency of Use	Not Applicable
No. of Occupants	Not Applicable	Secondary Activity	Not Applicable
Maintenance	Not Applicable	Maintenance Frequency	Not Applicable
SCORE			
			1
MANAGEMENT ACTION			
Recommendation	LABEL & MONITOR		
Recommendation Due		Next Inspection	11 Dec 2013
Apply Labels	No	Permit to Work Required	No
SCORE			
			4
Survey Type	Re-Inspection	Lead Surveyor	Gavin Hooper
Survey Date	11 Dec 2012	UKAS Laboratory	NOT SAMPLED (Cross Referenced)
Site Reference	I29280000A	Licensed Material	No
		Notifiable Non Licensed Work	No

Asbestos Presumed in Sample

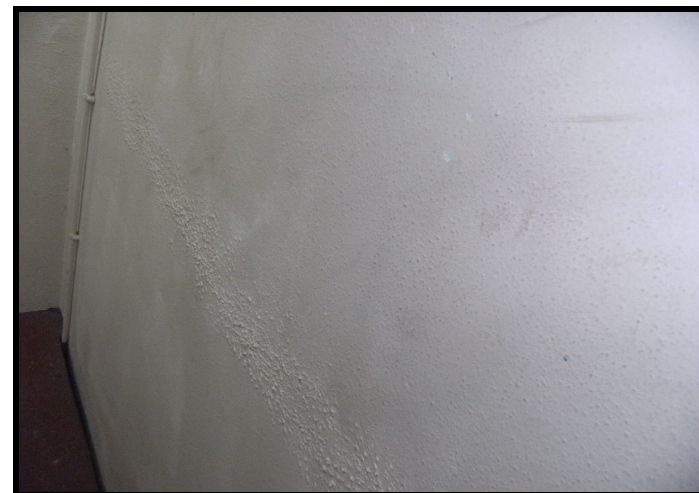
SAMPLE REFERENCE 057

Building	Floor	Room	Location		
Main	Eighth Floor	Riser I	Wall		
Description					
MATERIAL ASSESSMENT				SCORE	
Product Type	Textured Coating	Extent of Damage	Good condition	-	
Asbestos Type	No Asbestos Detected	Surface Treatment	Textured Coating		
PRIORITY ASSESSMENT				SCORE	
Occupant Activity	Not Applicable	Extent / Amount	2.00 m2	-	
Accessibility	Easily disturbed	Location	Not Applicable		
Avg Time in Use	Not Applicable	Frequency of Use	Not Applicable		
No. of Occupants	Not Applicable	Secondary Activity	Not Applicable		
Maintenance	Not Applicable	Maintenance Frequency	Not Applicable		
MANAGEMENT ACTION				SCORE	
Recommendation	NO ACTION REQUIRED			-	
Recommendation Due		Next Inspection	None		
Apply Labels	No	Permit to Work Required	No		
Survey Type	Re-Inspection	Lead Surveyor	Gavin Hooper		
Survey Date	22 Mar 2011	UKAS Laboratory	NOT SAMPLED (Cross Referenced)		
Site Reference	I29280000A	Licensed Material	N/A	Notifiable Non Licensed Work	N/A

No Asbestos Presumed in Sample

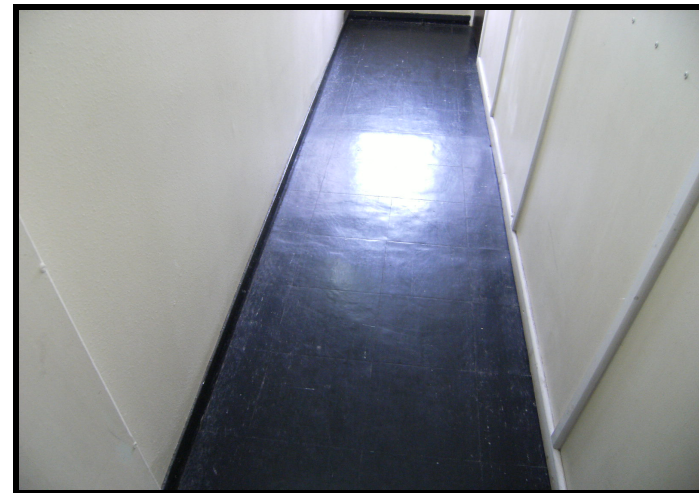
SAMPLE REFERENCE 061

Building	Floor	Room	Location		
Main	Eighth Floor	Bin Chute Lobby	Floor		
Description	Modern supalux fire break.				
MATERIAL ASSESSMENT					SCORE
Product Type	Floor Tiles	Extent of Damage	Good condition		-
Asbestos Type	No Asbestos Detected	Surface Treatment	Composite materials		
PRIORITY ASSESSMENT					SCORE
Occupant Activity	Not Applicable	Extent / Amount	2.00 m2		-
Accessibility	Occasionally disturb	Location	Not Applicable		
Avg Time in Use	Not Applicable	Frequency of Use	Not Applicable		
No. of Occupants	Not Applicable	Secondary Activity	Not Applicable		
Maintenance	Not Applicable	Maintenance Frequency	Not Applicable		
MANAGEMENT ACTION					SCORE
Recommendation	NO ACTION REQUIRED				-
Recommendation Due		Next Inspection	None		
Apply Labels	No	Permit to Work Required	No		
Survey Type	Re-Inspection	Lead Surveyor	Gavin Hooper		
Survey Date	22 Mar 2011	UKAS Laboratory	NOT SAMPLED (Cross Referenced)		
Site Reference	I29280000A	Licensed Material	N/A	Notifiable Non Licensed Work	N/A

No Asbestos Presumed in Sample

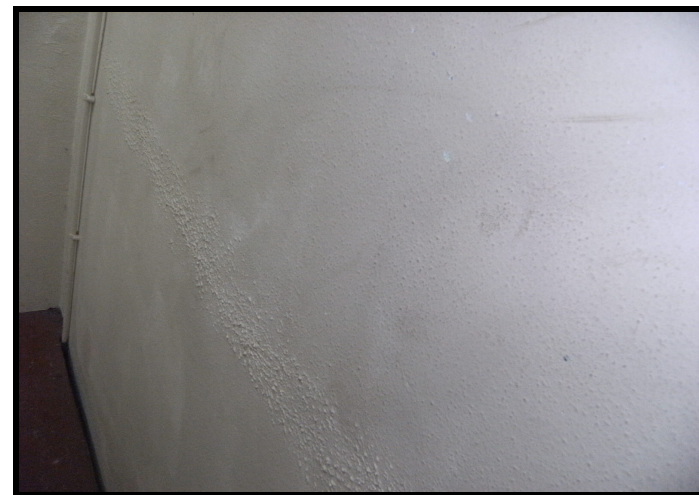
SAMPLE REFERENCE 065

Building	Floor	Room	Location		
Main	Eighth Floor	Bin Chute	Wall		
Description					
MATERIAL ASSESSMENT					SCORE
Product Type	Textured Coating	Extent of Damage	Good condition		-
Asbestos Type	No Asbestos Detected	Surface Treatment	Textured Coating		
PRIORITY ASSESSMENT					SCORE
Occupant Activity	Not Applicable	Extent / Amount	2.00 m2		-
Accessibility	Easily disturbed	Location	Not Applicable		
Avg Time in Use	Not Applicable	Frequency of Use	Not Applicable		
No. of Occupants	Not Applicable	Secondary Activity	Not Applicable		
Maintenance	Not Applicable	Maintenance Frequency	Not Applicable		
MANAGEMENT ACTION					SCORE
Recommendation	NO ACTION REQUIRED				-
Recommendation Due		Next Inspection	None		
Apply Labels	No	Permit to Work Required	No		
Survey Type	Re-Inspection	Lead Surveyor	Gavin Hooper		
Survey Date	22 Mar 2011	UKAS Laboratory	NOT SAMPLED (Cross Referenced)		
Site Reference	I29280000A	Licensed Material	N/A	Notifiable Non Licensed Work	N/A

No Asbestos Presumed in Sample

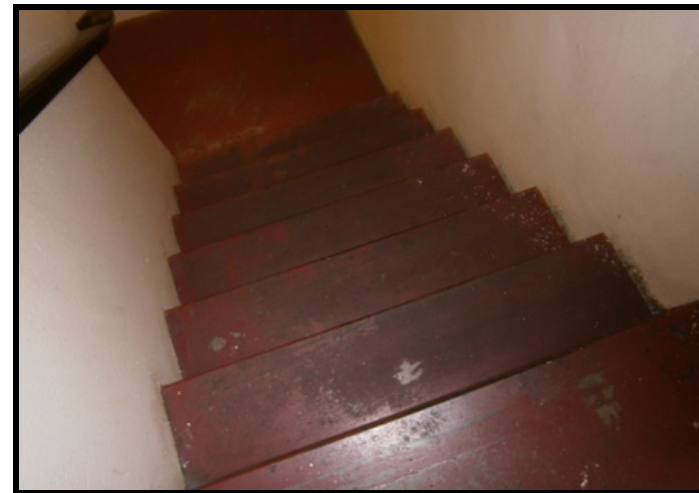
SAMPLE REFERENCE 070a

Building	Floor	Room	Location
Main	Seventh Floor	Stairwell	Staircase
Description	Bitumen stair nosing		
MATERIAL ASSESSMENT			
Product Type	Bitumen	Extent of Damage	Low damage
Asbestos Type	Chrysotile	Surface Treatment	Composite materials
PRIORITY ASSESSMENT			
Occupant Activity	Not Applicable	Extent / Amount	15.00 m2
Accessibility	Easily disturbed	Location	Not Applicable
Avg Time in Use	Not Applicable	Frequency of Use	Not Applicable
No. of Occupants	Not Applicable	Secondary Activity	Not Applicable
Maintenance	Not Applicable	Maintenance Frequency	Not Applicable
MANAGEMENT ACTION			
Recommendation	LABEL & MONITOR		
Recommendation Due		Next Inspection	11 Dec 2013
Apply Labels	No	Permit to Work Required	No
Survey Type	Re-Inspection	Lead Surveyor	Gavin Hooper
Survey Date	11 Dec 2012	UKAS Laboratory	NOT SAMPLED (Cross Referenced)
Site Reference	I29280000A	Licensed Material	No
		Notifiable Non Licensed Work	No

Asbestos Presumed in Sample

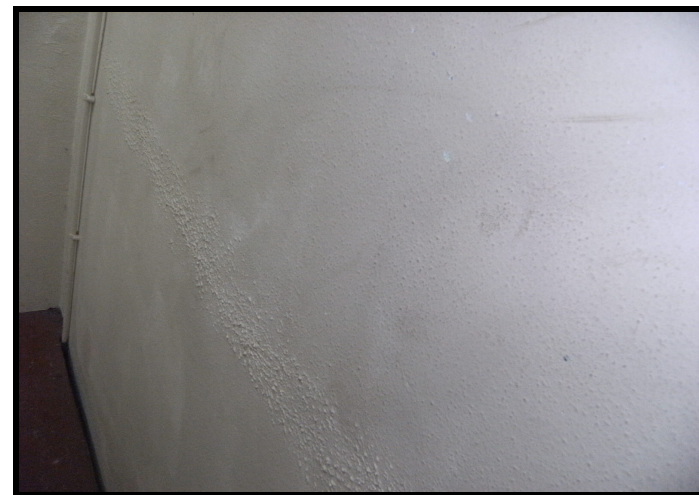
SAMPLE REFERENCE 072

Building	Floor	Room	Location		
Main	Seventh Floor	Riser I Lobby	Wall		
Description	No access within timber riser.				
MATERIAL ASSESSMENT					SCORE
Product Type	Textured Coating	Extent of Damage	Good condition		-
Asbestos Type	No Asbestos Detected	Surface Treatment	Textured Coating		
PRIORITY ASSESSMENT					SCORE
Occupant Activity	Not Applicable	Extent / Amount	2.00 m2		-
Accessibility	Easily disturbed	Location	Not Applicable		
Avg Time in Use	Not Applicable	Frequency of Use	Not Applicable		
No. of Occupants	Not Applicable	Secondary Activity	Not Applicable		
Maintenance	Not Applicable	Maintenance Frequency	Not Applicable		
MANAGEMENT ACTION					SCORE
Recommendation	NO ACTION REQUIRED				-
Recommendation Due		Next Inspection	None		
Apply Labels	No	Permit to Work Required	No		
Survey Type	Re-Inspection	Lead Surveyor	Gavin Hooper		
Survey Date	22 Mar 2011	UKAS Laboratory	NOT SAMPLED (Cross Referenced)		
Site Reference	I29280000A	Licensed Material	N/A	Notifiable Non Licensed Work	N/A

No Asbestos Presumed in Sample

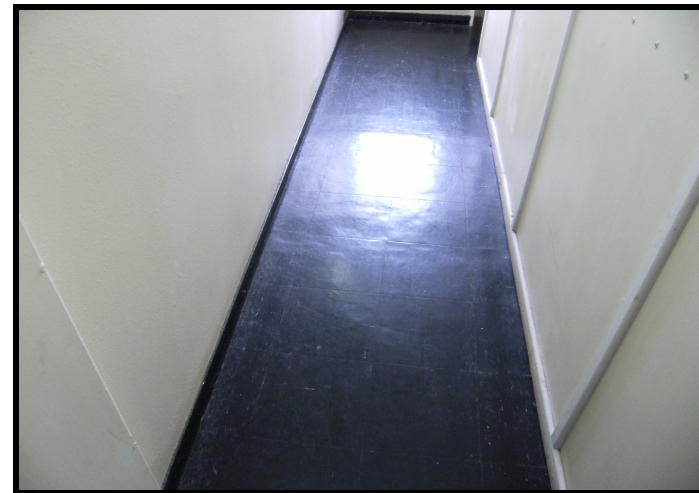
SAMPLE REFERENCE 074

No Asbestos Presumed in Sample

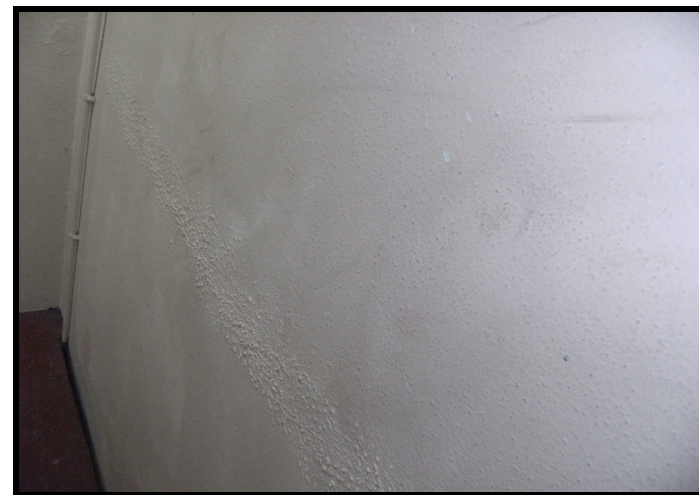
SAMPLE REFERENCE 075

No Asbestos Presumed in Sample

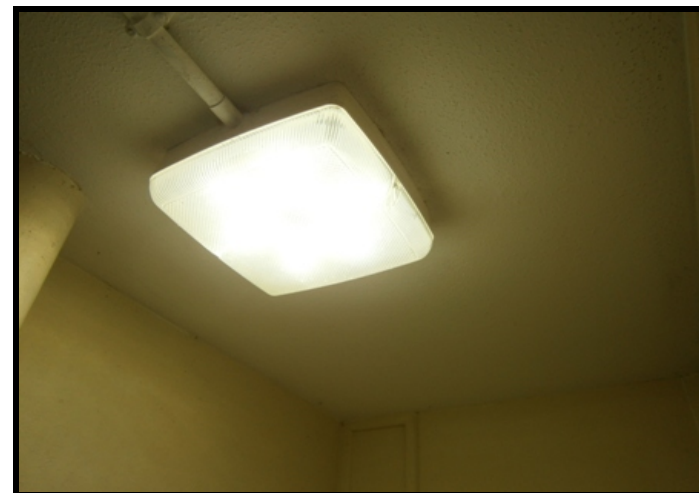
SAMPLE REFERENCE 076

Asbestos Presumed in Sample

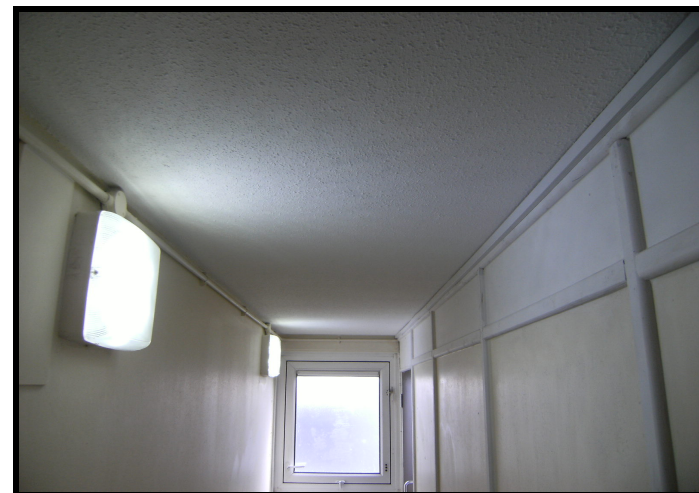
SAMPLE REFERENCE 079

Asbestos Presumed in Sample

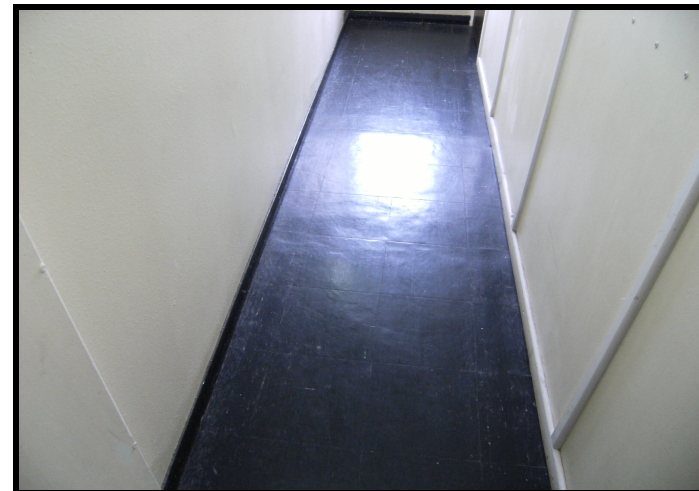
SAMPLE REFERENCE 080

No Asbestos Presumed in Sample

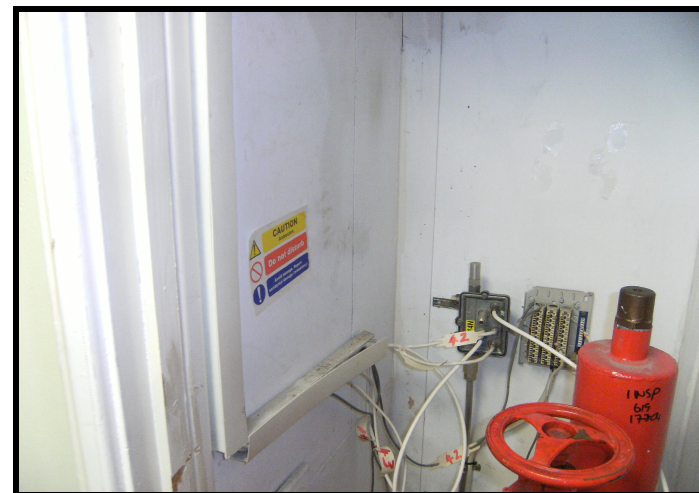
SAMPLE REFERENCE 082

Asbestos Presumed in Sample

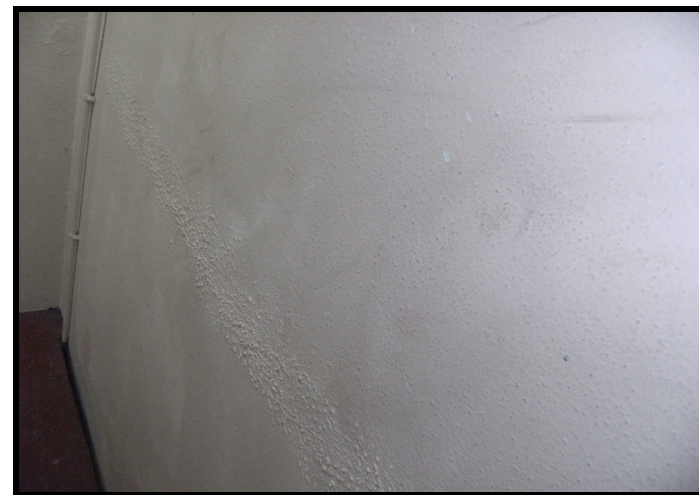
SAMPLE REFERENCE 083

No Asbestos Presumed in Sample

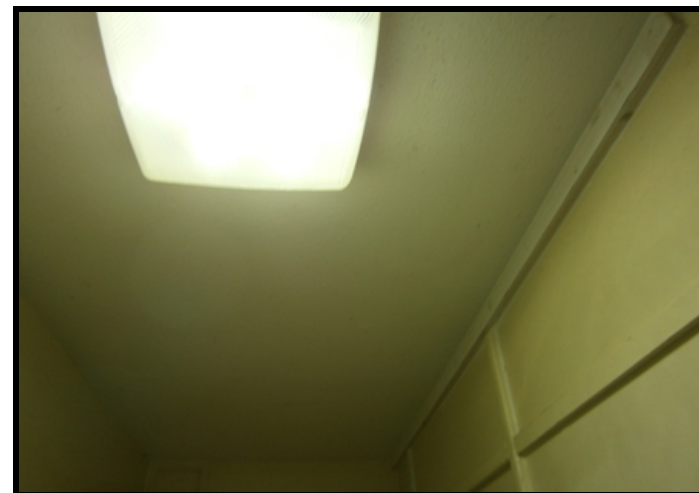
SAMPLE REFERENCE 085

Asbestos Presumed in Sample

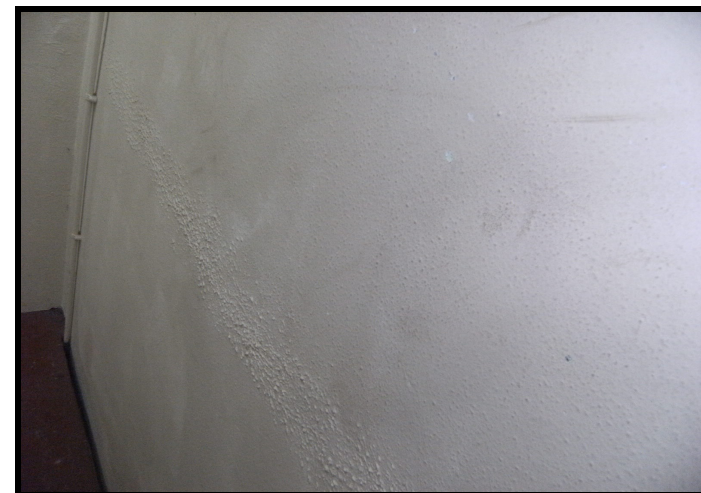
SAMPLE REFERENCE 088

No Asbestos Presumed in Sample

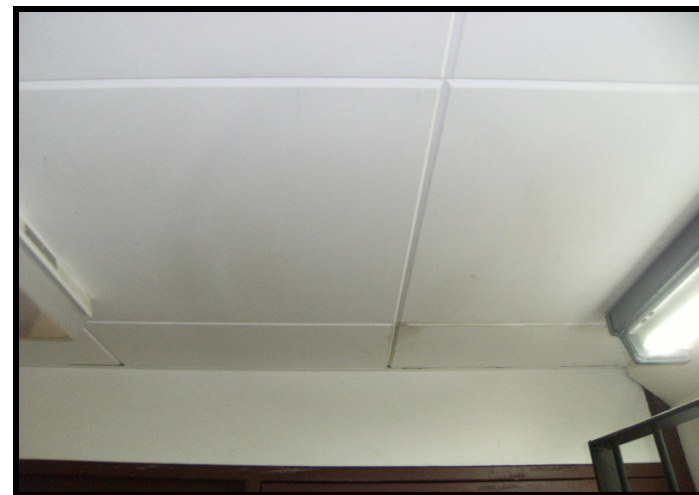
SAMPLE REFERENCE 089

No Asbestos Presumed in Sample

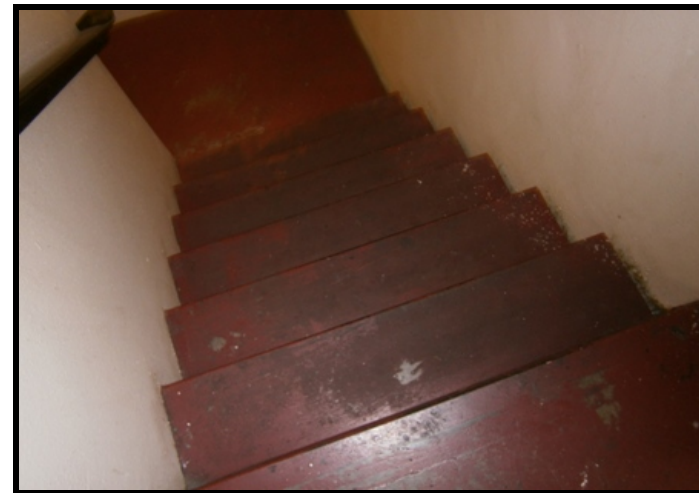
SAMPLE REFERENCE 091a

Asbestos Presumed in Sample

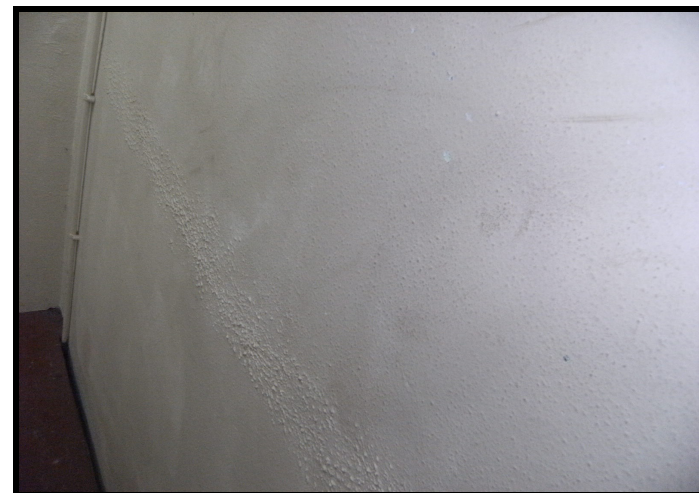
SAMPLE REFERENCE 099

No Asbestos Presumed in Sample

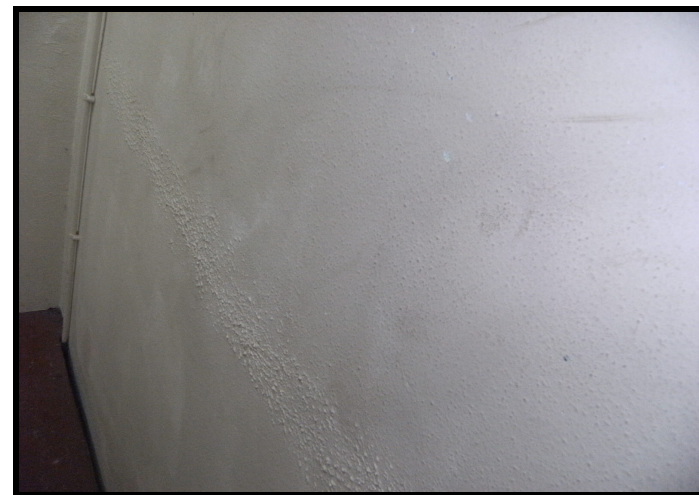
SAMPLE REFERENCE 101

No Asbestos Presumed in Sample

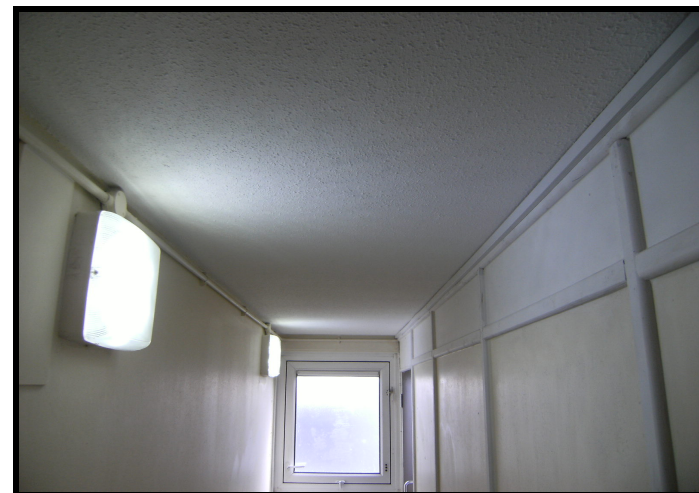
SAMPLE REFERENCE 103

Asbestos Presumed in Sample

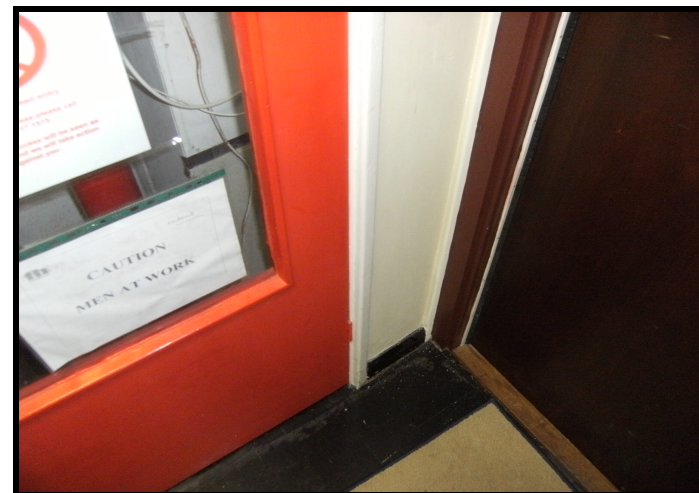
SAMPLE REFERENCE 105

Asbestos Presumed in Sample

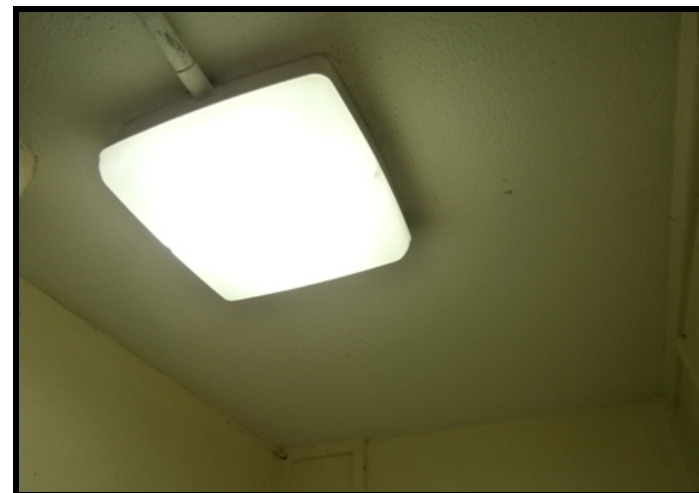
SAMPLE REFERENCE 107

Asbestos Presumed in Sample

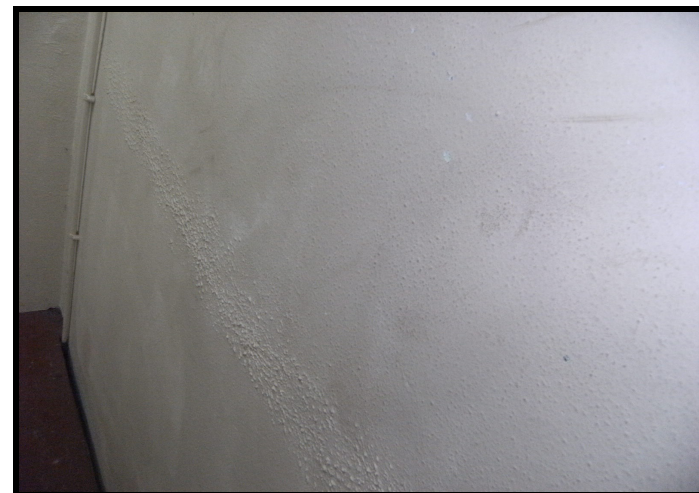
SAMPLE REFERENCE 120

No Asbestos Presumed in Sample

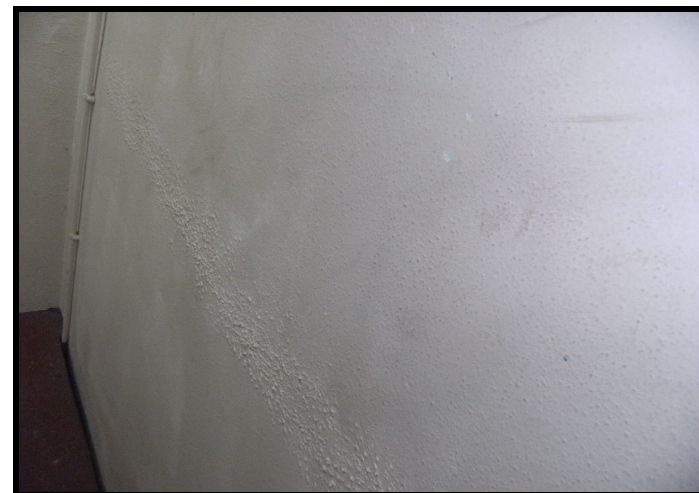
SAMPLE REFERENCE 128

No Asbestos Presumed in Sample

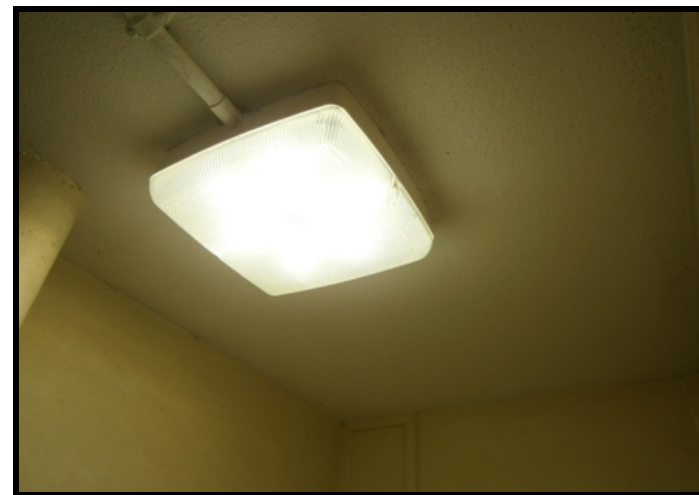
SAMPLE REFERENCE I30

Asbestos Presumed in Sample

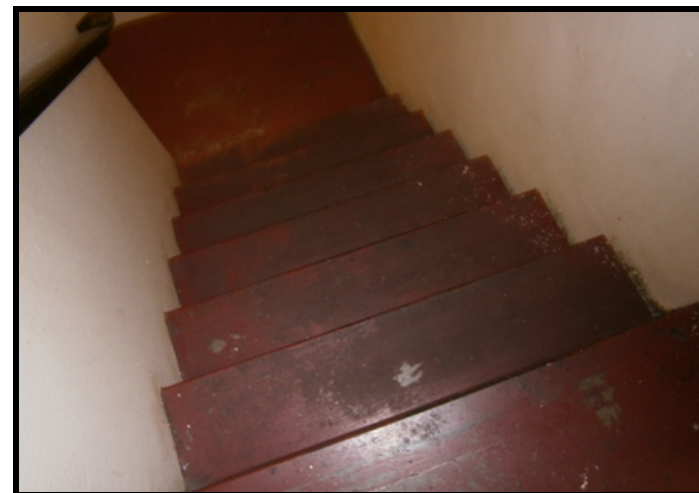
SAMPLE REFERENCE I33a

Asbestos Presumed in Sample

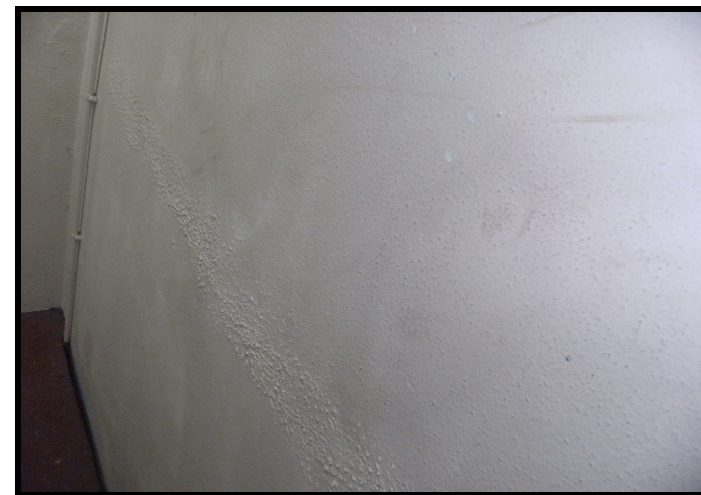
SAMPLE REFERENCE I4I

No Asbestos Presumed in Sample
