Solihull Community Housing

Asbestos Management Survey Report

**I-43 (Communal) Keble House
Moat Croft
Solihull
B37 5HD**

Date of Report: 14 Jan 2013

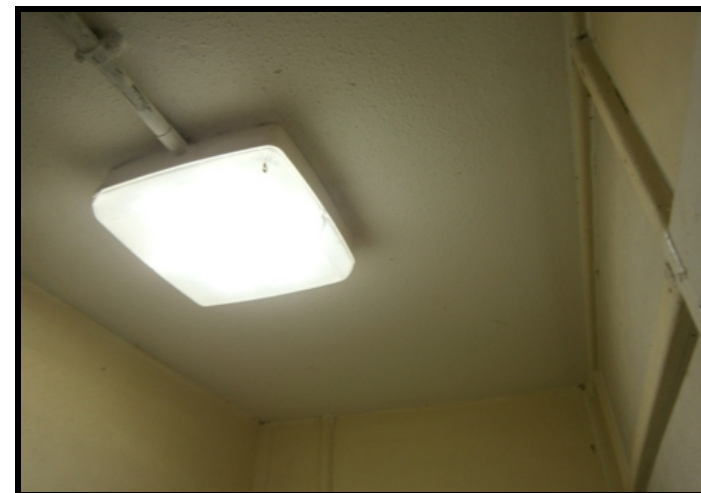
SAMPLE REFERENCE 151

Asbestos Presumed in Sample

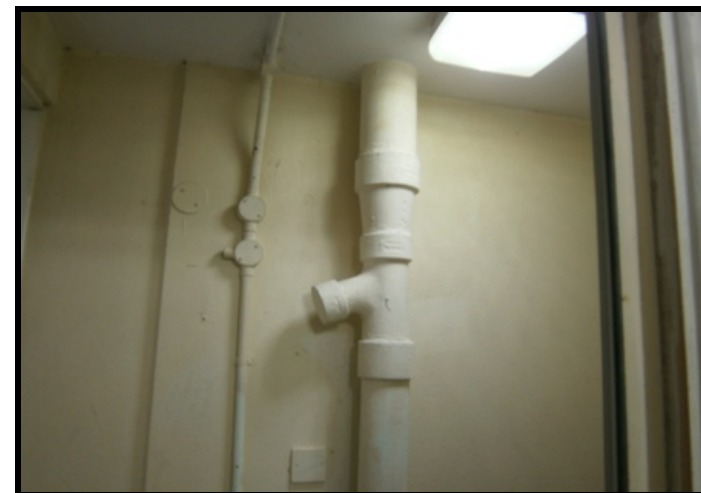
SAMPLE REFERENCE 152

Asbestos Presumed in Sample

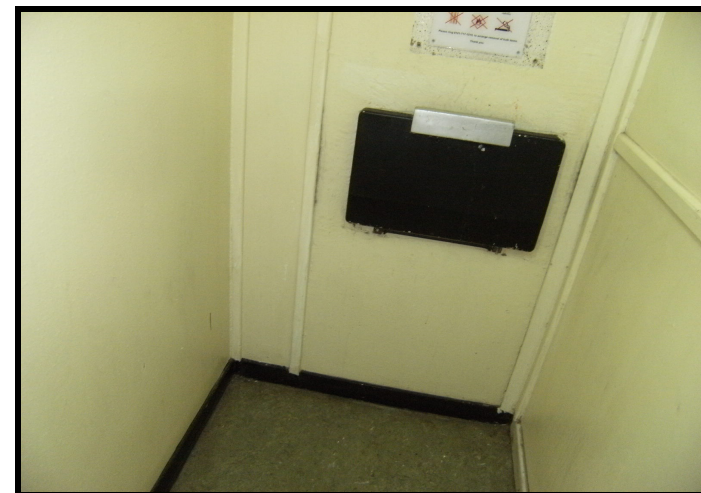
SAMPLE REFERENCE 153

Asbestos Presumed in Sample

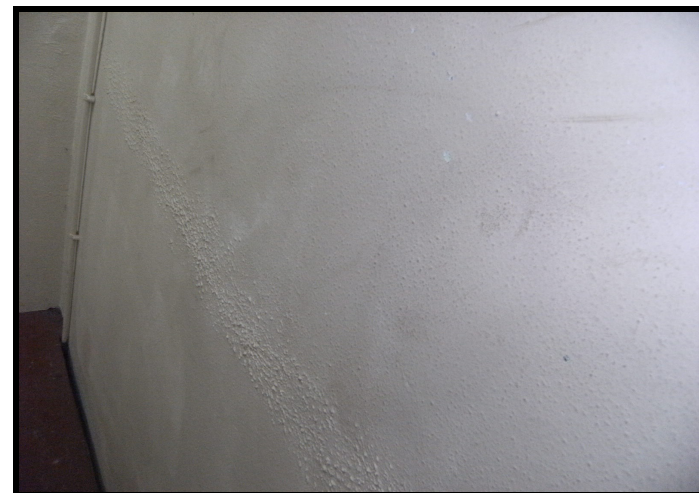
SAMPLE REFERENCE I59

No Asbestos Presumed in Sample

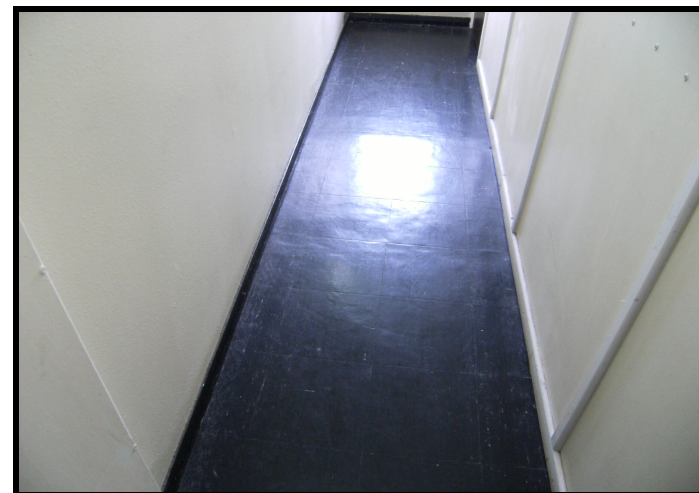
SAMPLE REFERENCE I6I

No Asbestos Presumed in Sample

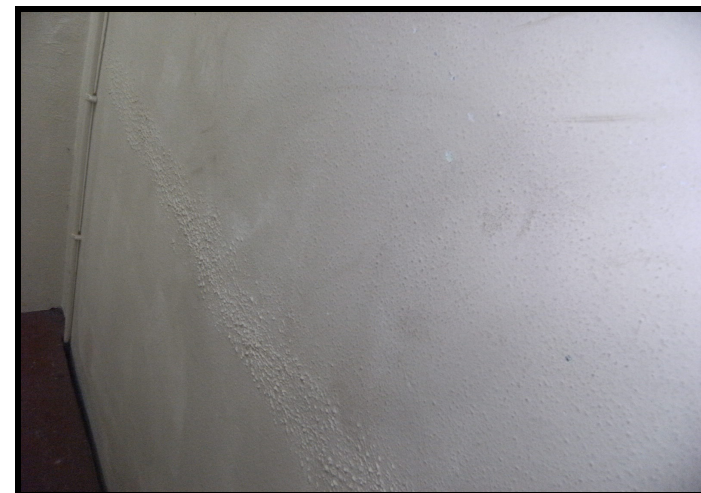
SAMPLE REFERENCE I62

No Asbestos Presumed in Sample

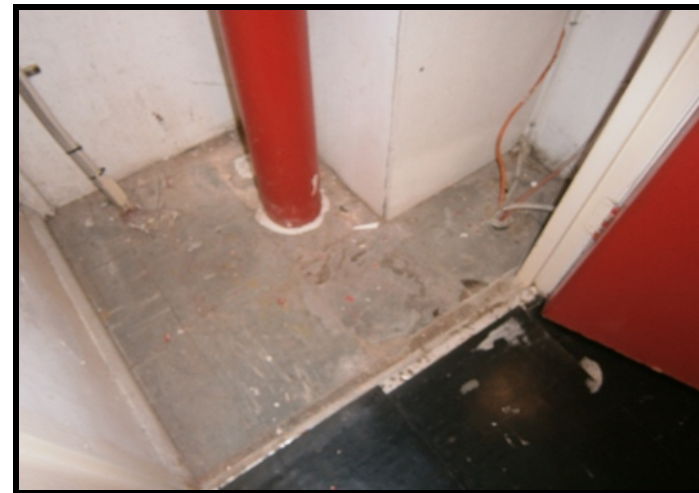
SAMPLE REFERENCE I69a

Asbestos detected in Sample

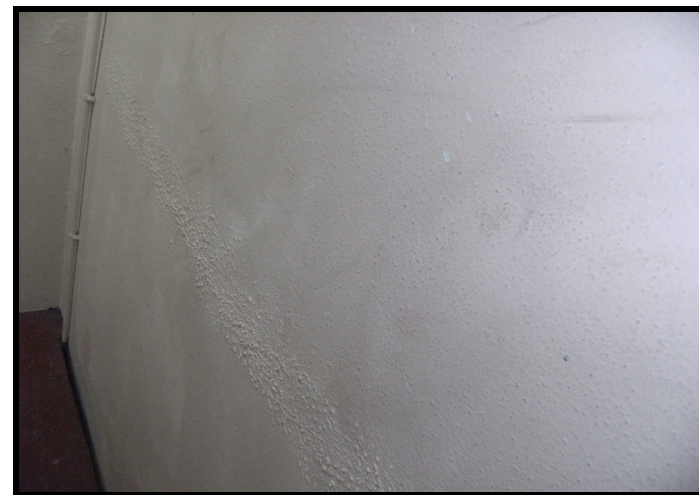
SAMPLE REFERENCE I70

No Asbestos Presumed in Sample

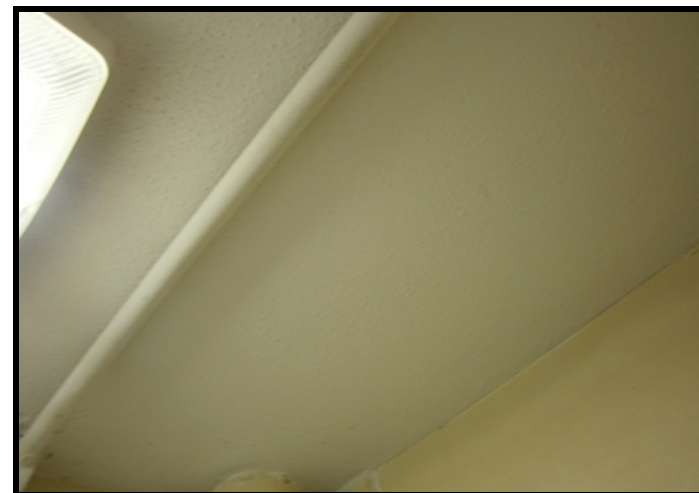
SAMPLE REFERENCE I72

Asbestos Presumed in Sample

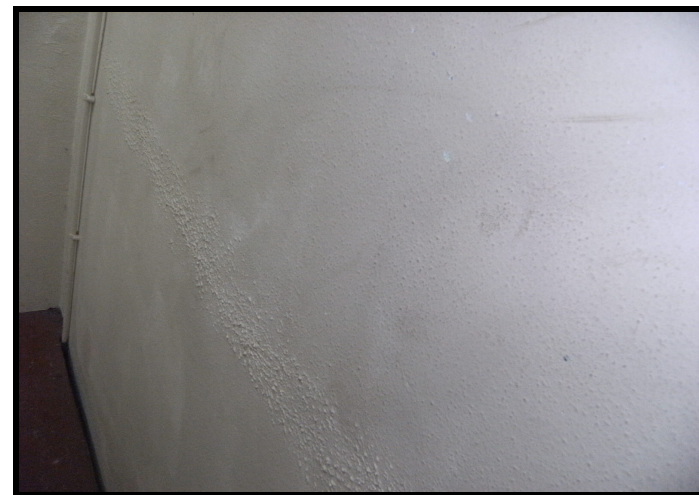
SAMPLE REFERENCE 183

No Asbestos Presumed in Sample

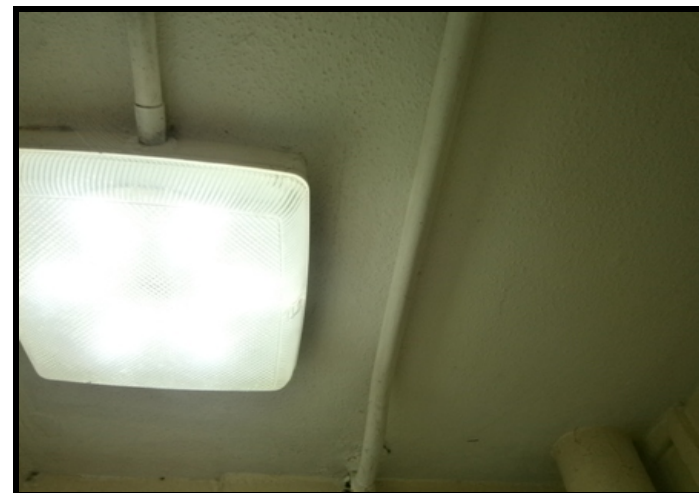
SAMPLE REFERENCE I94

Asbestos Presumed in Sample

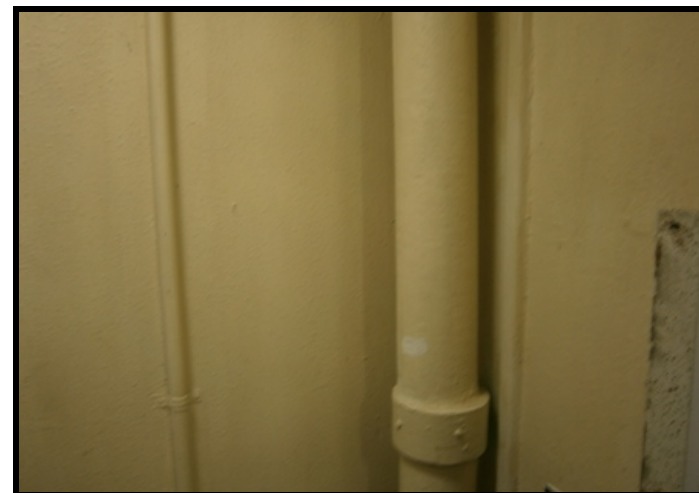
SAMPLE REFERENCE I95

Asbestos Presumed in Sample

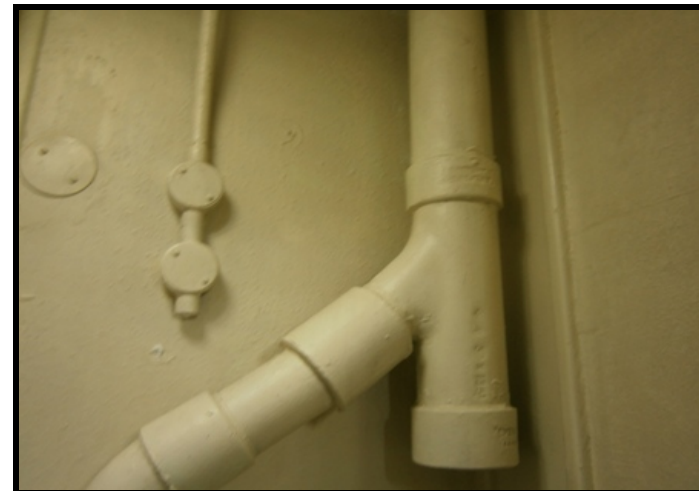
SAMPLE REFERENCE I97b

Asbestos Presumed in Sample

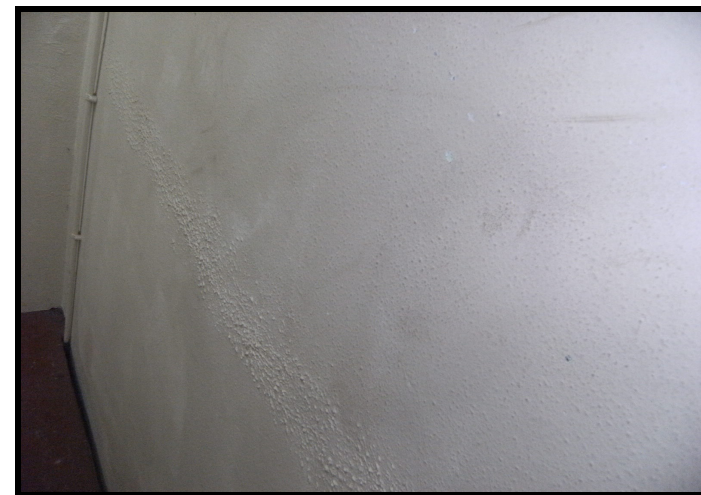
SAMPLE REFERENCE 205

No Asbestos Presumed in Sample

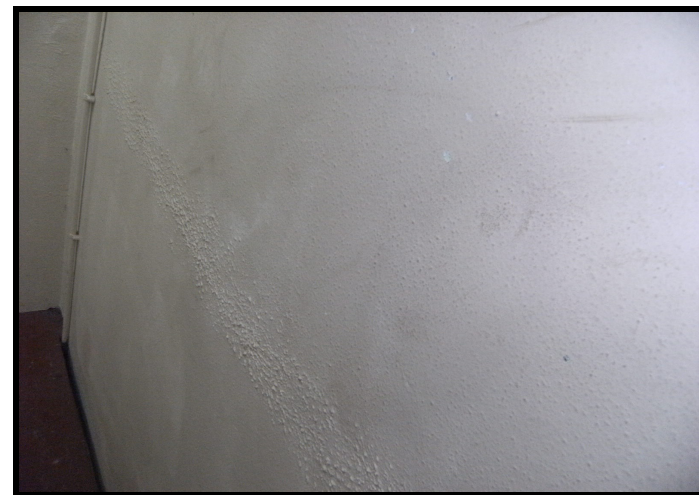
SAMPLE REFERENCE 215

No Asbestos Presumed in Sample

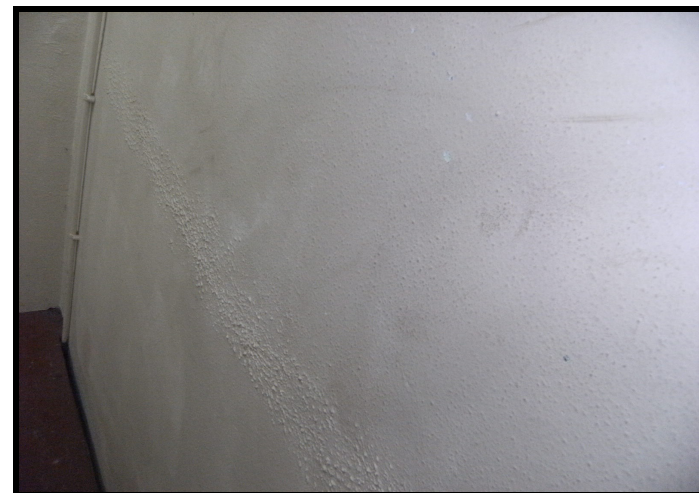
SAMPLE REFERENCE 218

No Asbestos Presumed in Sample

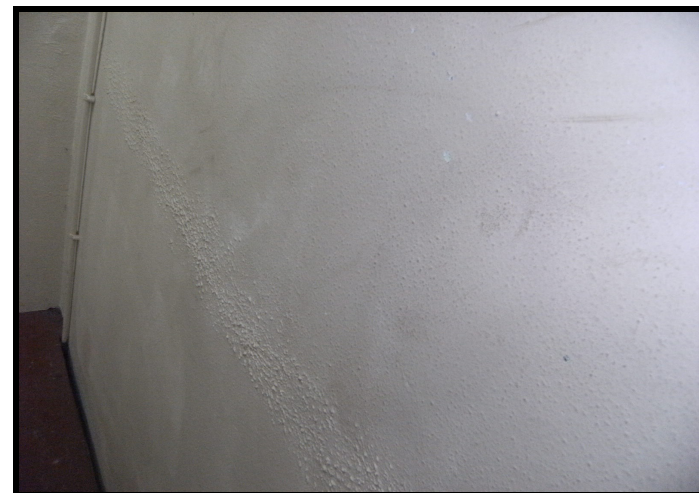
SAMPLE REFERENCE 225

No Asbestos Presumed in Sample

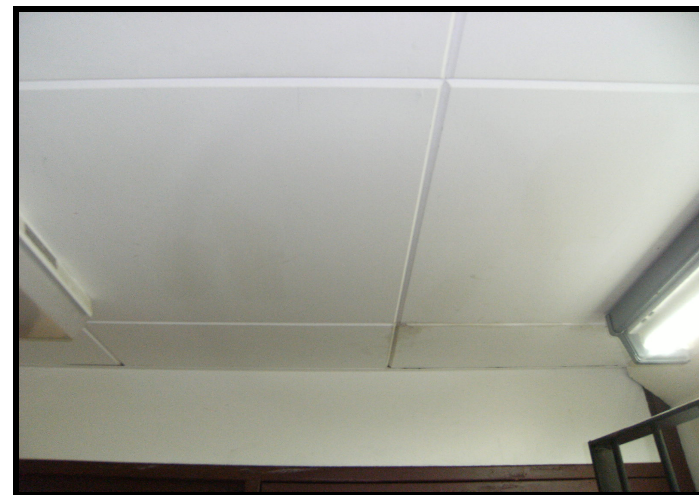
SAMPLE REFERENCE 226

No Asbestos Presumed in Sample

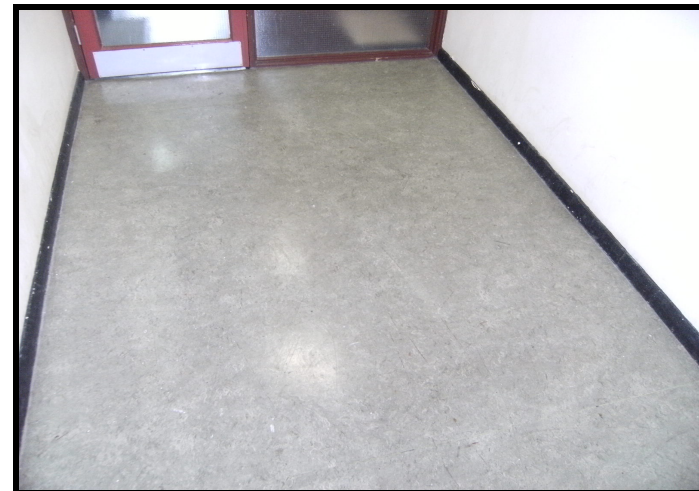
SAMPLE REFERENCE 227

No Asbestos Presumed in Sample
