# Solihull Community Housing

## Asbestos Management Survey Report

**AVONCROFT HOUSE  
(COMMUNAL)  
WINCHESTER DRIVE  
SOLIHULL  
B37 5QH**

Date of Report: 29 Jan 2015

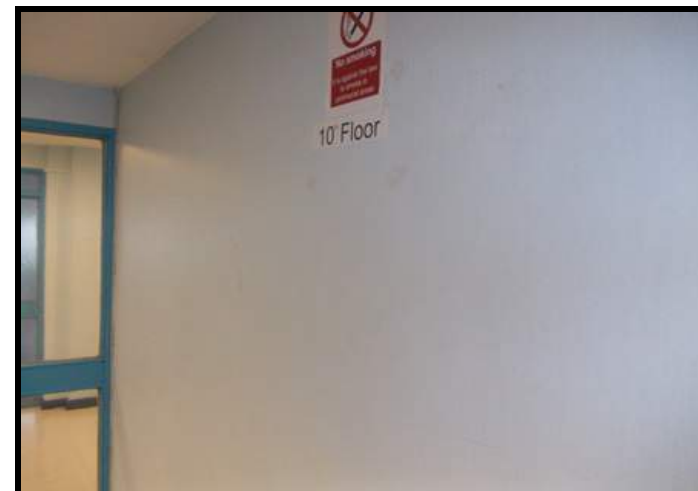
## SAMPLE REFERENCE 009

Building	Floor	Room	Location			
Main	Tenth Floor	Drying Room	Ceiling And Walls			
Description						
MATERIAL ASSESSMENT				SCORE		
Product Type	Textured Coating	Extent of Damage	Low damage		3	
Asbestos Type	Chrysotile	Surface Treatment	Textured Coating			
PRIORITY ASSESSMENT				SCORE		
Occupant Activity	Not Applicable	Extent / Amount	30.00 m2		1	
Accessibility	Easily disturbed	Location	Not Applicable			
Avg Time in Use	Not Applicable	Frequency of Use	Not Applicable			
No. of Occupants	Not Applicable	Secondary Activity	Not Applicable			
Maintenance	Not Applicable	Maintenance Frequency	Not Applicable			
MANAGEMENT ACTION				SCORE		
Recommendation	LABEL & MONITOR			4		
Recommendation Due		Next Inspection	12 Jan 2016			
Apply Labels	No	Permit to Work Required	No			
Survey Type	Management	Lead Surveyor	Gavin Hooper			
Survey Date	12 Jan 2015	UKAS Laboratory	NOT SAMPLED (Cross Referenced)			
Site Reference	I39470000A	Licensed Material	No	Notifiable Non Licensed Work	No

**Asbestos Presumed**

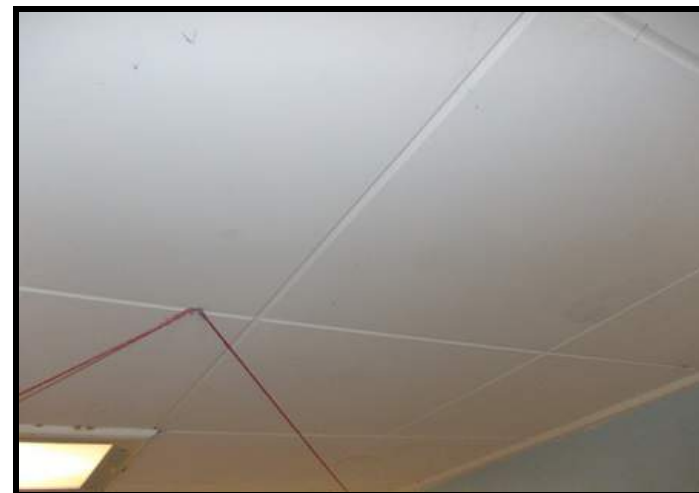
## SAMPLE REFERENCE 009a

Building	Floor	Room	Location		
Main	Tenth Floor	Drying Room	Ceiling		
Description					
MATERIAL ASSESSMENT					SCORE
Product Type	Insulation Board	Extent of Damage	Low damage		-
Asbestos Type	No Asbestos Detected	Surface Treatment	Sealed Board (Encapsulated)		
PRIORITY ASSESSMENT					SCORE
Occupant Activity	Not Applicable	Extent / Amount	30.00 m2		-
Accessibility	Easily disturbed	Location	Not Applicable		
Avg Time in Use	Not Applicable	Frequency of Use	Not Applicable		
No. of Occupants	Not Applicable	Secondary Activity	Not Applicable		
Maintenance	Not Applicable	Maintenance Frequency	Not Applicable		
MANAGEMENT ACTION					SCORE
Recommendation	NO ACTION REQUIRED				-
Recommendation Due		Next Inspection	None		
Apply Labels	No	Permit to Work Required	No		
Survey Type	Management	Lead Surveyor	Gavin Hooper		
Survey Date	12 Jan 2015	UKAS Laboratory	NOT SAMPLED (Cross Referenced)		
Site Reference	I39470000A	Licensed Material	N/A	Notifiable Non Licensed Work	N/A

**No Asbestos Presumed in Sample**

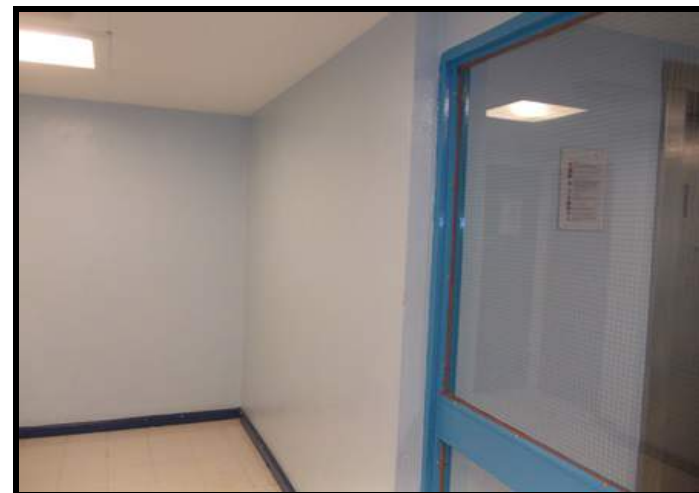
## SAMPLE REFERENCE 011a

Building	Floor	Room	Location			
Main	Tenth Floor	Lobby 2	Walls			
Description						
MATERIAL ASSESSMENT				SCORE		
Product Type	Textured Coating	Extent of Damage	Low damage		3	
Asbestos Type	Chrysotile	Surface Treatment	Textured Coating			
PRIORITY ASSESSMENT				SCORE		
Occupant Activity	Not Applicable	Extent / Amount	20.00 m2		1	
Accessibility	Easily disturbed	Location	Not Applicable			
Avg Time in Use	Not Applicable	Frequency of Use	Not Applicable			
No. of Occupants	Not Applicable	Secondary Activity	Not Applicable			
Maintenance	Not Applicable	Maintenance Frequency	Not Applicable			
MANAGEMENT ACTION				SCORE		
Recommendation	LABEL & MONITOR			4		
Recommendation Due		Next Inspection	12 Jan 2016			
Apply Labels	No	Permit to Work Required	No			
Survey Type	Management	Lead Surveyor	Gavin Hooper			
Survey Date	12 Jan 2015	UKAS Laboratory	NOT SAMPLED (Cross Referenced)			
Site Reference	I39470000A	Licensed Material	No	Notifiable Non Licensed Work	No

**Asbestos Presumed**

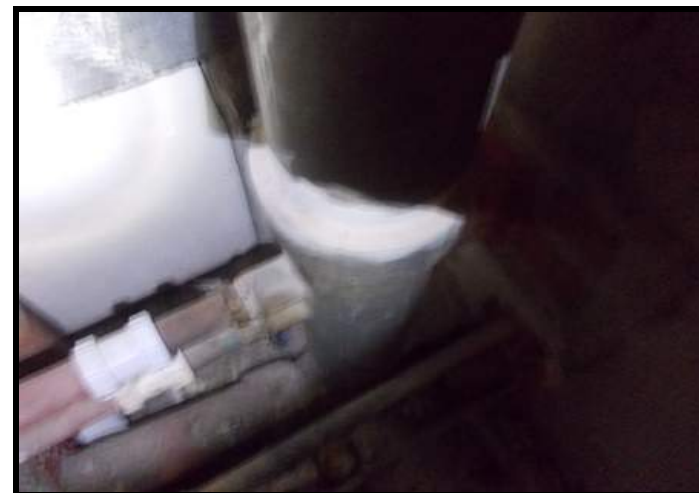
## SAMPLE REFERENCE 012

Building	Floor	Room	Location		
Main	Tenth Floor	Riser 3	Pipe Work		
Description					
MATERIAL ASSESSMENT					
Product Type	Lagging	Extent of Damage	Low damage		
Asbestos Type	Amosite / Chrysotile	Surface Treatment	Sealed (I)		
PRIORITY ASSESSMENT					
Occupant Activity	Not Applicable	Extent / Amount	1.00 m2		
Accessibility	Occasionally disturb	Location	Not Applicable		
Avg Time in Use	Not Applicable	Frequency of Use	Not Applicable		
No. of Occupants	Not Applicable	Secondary Activity	Not Applicable		
Maintenance	Not Applicable	Maintenance Frequency	Not Applicable		
MANAGEMENT ACTION					
Recommendation	LABEL & MONITOR				
Recommendation Due		Next Inspection	12 Jul 2015		
Apply Labels	No	Permit to Work Required	No		
Survey Type	Management	Lead Surveyor	Gavin Hooper		
Survey Date	12 Jan 2015	UKAS Laboratory	DMW Environmental Safety Ltd / [A-11710]		
Site Reference	I39470000A	Licensed Material	Yes	Notifiable Non Licensed Work	No

**Asbestos detected in Sample**

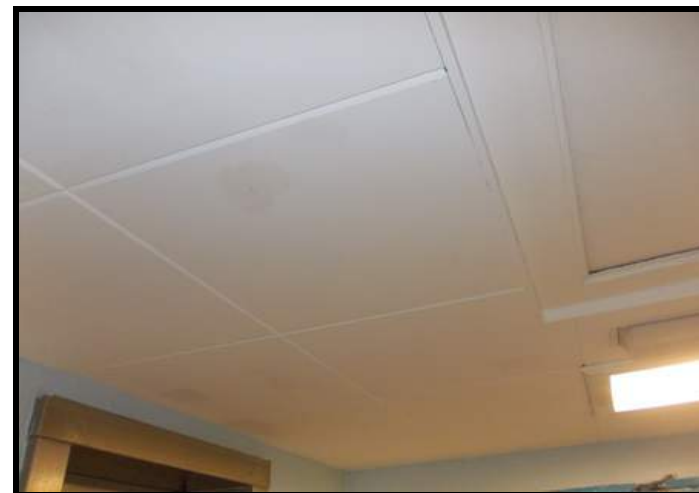
## SAMPLE REFERENCE 015e

Building	Floor	Room	Location		
Main	Tenth Floor	Lift lobby	Ceiling		
Description					
MATERIAL ASSESSMENT					SCORE
Product Type	Insulation Board	Extent of Damage	Low damage		-
Asbestos Type	No Asbestos Detected	Surface Treatment	Sealed Board (Encapsulated)		
PRIORITY ASSESSMENT					SCORE
Occupant Activity	Not Applicable	Extent / Amount	20.00 m2		-
Accessibility	Easily disturbed	Location	Not Applicable		
Avg Time in Use	Not Applicable	Frequency of Use	Not Applicable		
No. of Occupants	Not Applicable	Secondary Activity	Not Applicable		
Maintenance	Not Applicable	Maintenance Frequency	Not Applicable		
MANAGEMENT ACTION					SCORE
Recommendation	NO ACTION REQUIRED				-
Recommendation Due		Next Inspection	None		
Apply Labels	No	Permit to Work Required	No		
Survey Type	Management	Lead Surveyor	Gavin Hooper		
Survey Date	12 Jan 2015	UKAS Laboratory	NOT SAMPLED (Cross Referenced)		
Site Reference	I39470000A	Licensed Material	N/A	Notifiable Non Licensed Work	N/A

**No Asbestos Presumed in Sample**

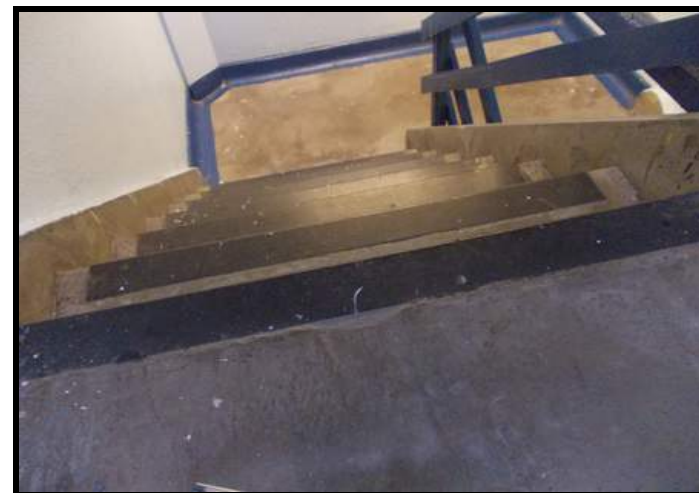
## SAMPLE REFERENCE 016a

Building	Floor	Room	Location		
Main	Tenth to Ninth Floor	Stairwell	Staircase		
Description					
MATERIAL ASSESSMENT					
Product Type	Bitumen	Extent of Damage	Low damage		
Asbestos Type	<b>Chrysotile</b>	Surface Treatment	Composite materials		
PRIORITY ASSESSMENT					
Occupant Activity	Not Applicable	Extent / Amount	14.00 small item(s)		
Accessibility	Routinely disturbed	Location	Not Applicable		
Avg Time in Use	Not Applicable	Frequency of Use	Not Applicable		
No. of Occupants	Not Applicable	Secondary Activity	Not Applicable		
Maintenance	Not Applicable	Maintenance Frequency	Not Applicable		
MANAGEMENT ACTION					
Recommendation	LABEL & MONITOR				
Recommendation Due		Next Inspection	12 Jan 2016		
Apply Labels	No	Permit to Work Required	No		
Survey Type	Management	Lead Surveyor	Gavin Hooper		
Survey Date	12 Jan 2015	UKAS Laboratory	DMW Environmental Safety Ltd / [A-11710]		
Site Reference	I39470000A	Licensed Material	No	Notifiable Non Licensed Work	No

**Asbestos detected in Sample**

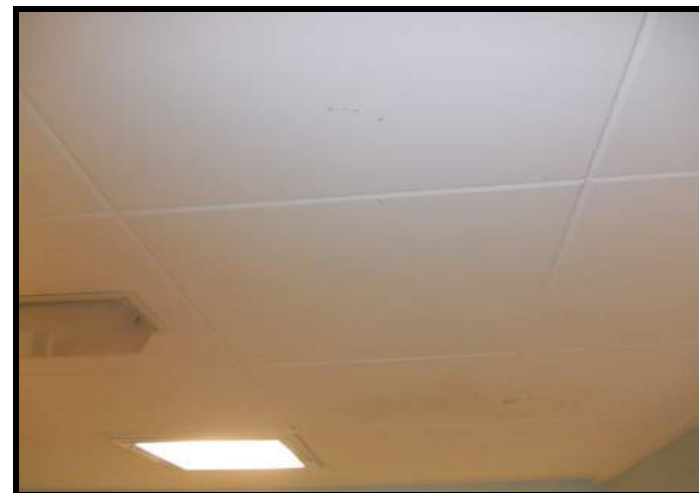
## SAMPLE REFERENCE 020b

Building	Floor	Room	Location		
Main	Ninth Floor	Lift lobby	Ceiling		
Description					
MATERIAL ASSESSMENT					SCORE
Product Type	Insulation Board	Extent of Damage	Low damage		-
Asbestos Type	No Asbestos Detected	Surface Treatment	Sealed Board (Encapsulated)		
PRIORITY ASSESSMENT					SCORE
Occupant Activity	Not Applicable	Extent / Amount	20.00 m2		-
Accessibility	Easily disturbed	Location	Not Applicable		
Avg Time in Use	Not Applicable	Frequency of Use	Not Applicable		
No. of Occupants	Not Applicable	Secondary Activity	Not Applicable		
Maintenance	Not Applicable	Maintenance Frequency	Not Applicable		
MANAGEMENT ACTION					SCORE
Recommendation	NO ACTION REQUIRED				-
Recommendation Due		Next Inspection	None		
Apply Labels	No	Permit to Work Required	No		
Survey Type	Management	Lead Surveyor	Gavin Hooper		
Survey Date	12 Jan 2015	UKAS Laboratory	NOT SAMPLED (Cross Referenced)		
Site Reference	I39470000A	Licensed Material	N/A	Notifiable Non Licensed Work	N/A

**No Asbestos Presumed in Sample**

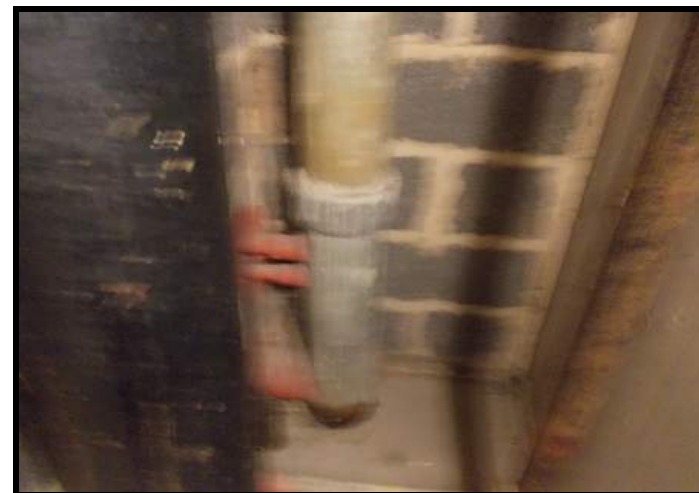
## SAMPLE REFERENCE 022

Building	Floor	Room	Location			
Main	Ninth Floor	Riser 2	Pipe Work			
Description						
MATERIAL ASSESSMENT				SCORE		
Product Type	Lagging	Extent of Damage	Low damage		6	
Asbestos Type	Amosite / Chrysotile	Surface Treatment	Sealed (0)			
PRIORITY ASSESSMENT				SCORE		
Occupant Activity	Not Applicable	Extent / Amount	1.00 m2		1	
Accessibility	Occasionally disturb	Location	Not Applicable			
Avg Time in Use	Not Applicable	Frequency of Use	Not Applicable			
No. of Occupants	Not Applicable	Secondary Activity	Not Applicable			
Maintenance	Not Applicable	Maintenance Frequency	Not Applicable			
MANAGEMENT ACTION				SCORE		
Recommendation	LABEL & MONITOR			7		
Recommendation Due		Next Inspection	12 Jul 2015			
Apply Labels	No	Permit to Work Required	No			
Survey Type	Management	Lead Surveyor	Gavin Hooper			
Survey Date	12 Jan 2015	UKAS Laboratory	NOT SAMPLED (Cross Referenced)			
Site Reference	I39470000A	Licensed Material	Yes	Notifiable Non Licensed Work	No

Asbestos Presumed

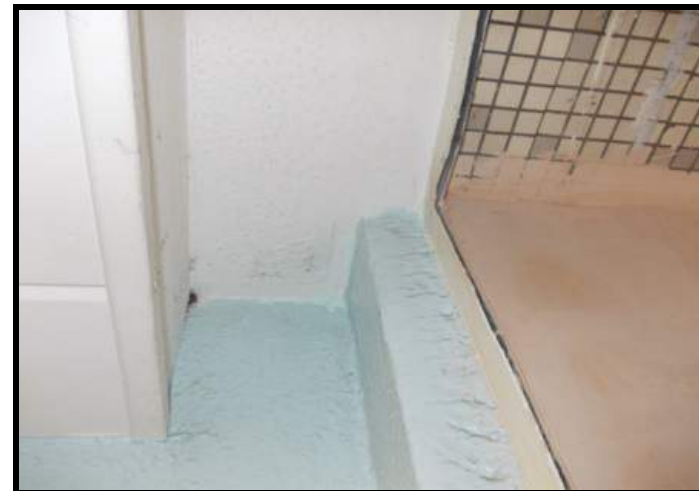
## SAMPLE REFERENCE 024a

Building	Floor	Room	Location			
Main	Ninth Floor	Bin chute lobby	Ceiling And Walls			
Description						
MATERIAL ASSESSMENT				SCORE		
Product Type	Textured Coating	Extent of Damage	Low damage		3	
Asbestos Type	Chrysotile	Surface Treatment	Textured Coating			
PRIORITY ASSESSMENT				SCORE		
Occupant Activity	Not Applicable	Extent / Amount	30.00 m2		1	
Accessibility	Easily disturbed	Location	Not Applicable			
Avg Time in Use	Not Applicable	Frequency of Use	Not Applicable			
No. of Occupants	Not Applicable	Secondary Activity	Not Applicable			
Maintenance	Not Applicable	Maintenance Frequency	Not Applicable			
MANAGEMENT ACTION				SCORE		
Recommendation	LABEL & MONITOR			4		
Recommendation Due		Next Inspection	12 Jan 2016			
Apply Labels	No	Permit to Work Required	No			
Survey Type	Management	Lead Surveyor	Gavin Hooper			
Survey Date	12 Jan 2015	UKAS Laboratory	NOT SAMPLED (Cross Referenced)			
Site Reference	I39470000A	Licensed Material	No	Notifiable Non Licensed Work	No

**Asbestos Presumed**

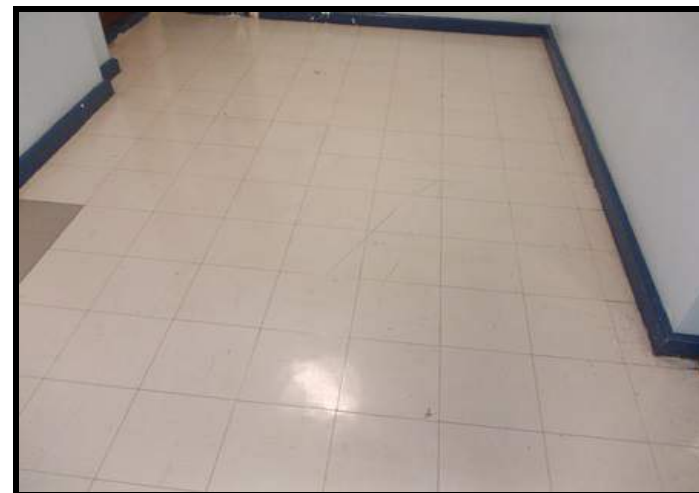
## SAMPLE REFERENCE 025

Building	Floor	Room	Location		
Main	Ninth Floor	Lobby 2	Floor		
Description	NO ACCESS WITHIN TIMBER ELECTRIC BOXING ON EACH FLOOR.				
MATERIAL ASSESSMENT				SCORE	
Product Type	Floor Tiles	Extent of Damage	Low damage		3
Asbestos Type	Chrysotile	Surface Treatment	Composite materials		
PRIORITY ASSESSMENT				SCORE	
Occupant Activity	Not Applicable	Extent / Amount	20.00 m2		1
Accessibility	Occasionally disturb	Location	Not Applicable		
Avg Time in Use	Not Applicable	Frequency of Use	Not Applicable		
No. of Occupants	Not Applicable	Secondary Activity	Not Applicable		
Maintenance	Not Applicable	Maintenance Frequency	Not Applicable		
MANAGEMENT ACTION				SCORE	
Recommendation	NO ACTION REQUIRED			4	
Recommendation Due		Next Inspection	None		
Apply Labels	No	Permit to Work Required	No		
Survey Type	Management	Lead Surveyor	Gavin Hooper		
Survey Date	12 Jan 2015	UKAS Laboratory	NOT SAMPLED (Cross Referenced)		
Site Reference	I39470000A	Licensed Material	No	Notifiable Non Licensed Work	No

Asbestos Presumed

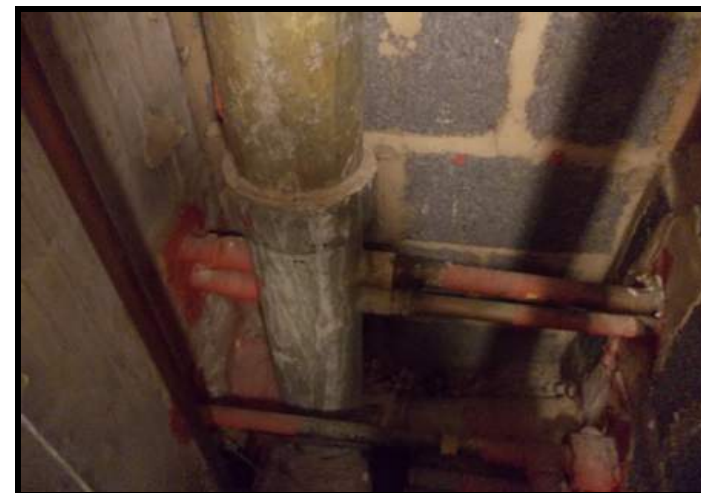
## SAMPLE REFERENCE 029

Building	Floor	Room	Location		
Main	Ninth Floor	Riser 4	Pipe Work		
Description					
MATERIAL ASSESSMENT					
Product Type	Lagging	Extent of Damage	Low damage		
Asbestos Type	Amosite / Chrysotile	Surface Treatment	Sealed (0)		
PRIORITY ASSESSMENT					
Occupant Activity	Not Applicable	Extent / Amount	1.00 m2		
Accessibility	Occasionally disturb	Location	Not Applicable		
Avg Time in Use	Not Applicable	Frequency of Use	Not Applicable		
No. of Occupants	Not Applicable	Secondary Activity	Not Applicable		
Maintenance	Not Applicable	Maintenance Frequency	Not Applicable		
MANAGEMENT ACTION					
Recommendation	LABEL & MONITOR				
Recommendation Due		Next Inspection	12 Jul 2015		
Apply Labels	No	Permit to Work Required	No		
Survey Type	Management	Lead Surveyor	Gavin Hooper		
Survey Date	12 Jan 2015	UKAS Laboratory	NOT SAMPLED (Cross Referenced)		
Site Reference	I39470000A	Licensed Material	Yes	Notifiable Non Licensed Work	No

**Asbestos Presumed**

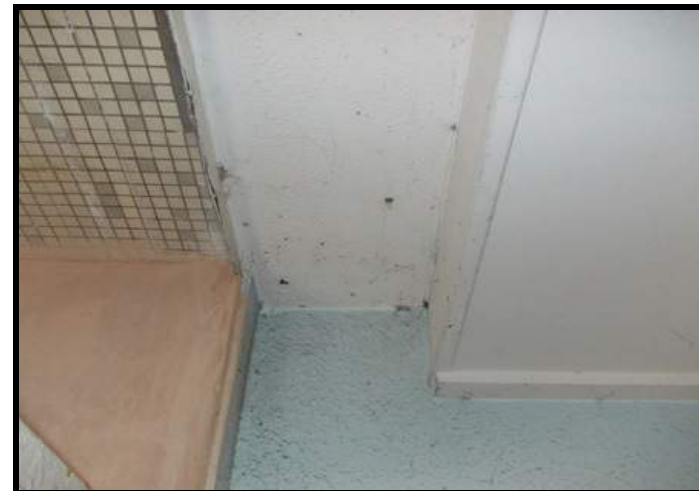
## SAMPLE REFERENCE 030

Building	Floor	Room	Location			
Main	Ninth Floor	Drying Room	Ceiling And Walls			
Description						
MATERIAL ASSESSMENT				SCORE		
Product Type	Textured Coating	Extent of Damage	Low damage		3	
Asbestos Type	Chrysotile	Surface Treatment	Textured Coating			
PRIORITY ASSESSMENT				SCORE		
Occupant Activity	Not Applicable	Extent / Amount	30.00 m2		1	
Accessibility	Easily disturbed	Location	Not Applicable			
Avg Time in Use	Not Applicable	Frequency of Use	Not Applicable			
No. of Occupants	Not Applicable	Secondary Activity	Not Applicable			
Maintenance	Not Applicable	Maintenance Frequency	Not Applicable			
MANAGEMENT ACTION				SCORE		
Recommendation	LABEL & MONITOR			4		
Recommendation Due		Next Inspection	12 Jan 2016			
Apply Labels	No	Permit to Work Required	No			
Survey Type	Management	Lead Surveyor	Gavin Hooper			
Survey Date	12 Jan 2015	UKAS Laboratory	NOT SAMPLED (Cross Referenced)			
Site Reference	I39470000A	Licensed Material	No	Notifiable Non Licensed Work	No

**Asbestos Presumed**

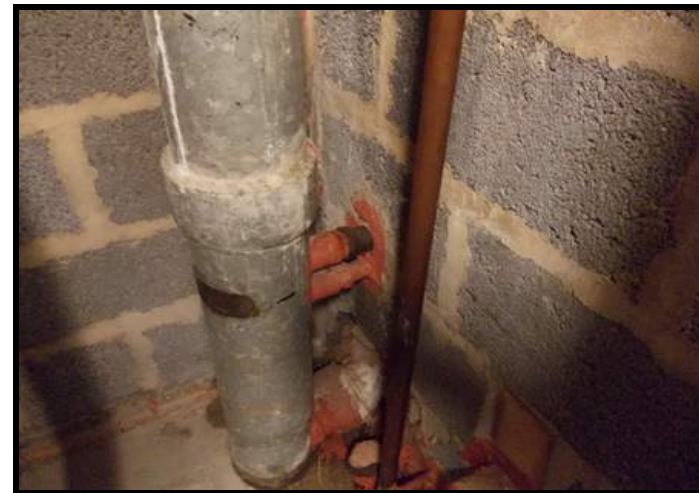
## SAMPLE REFERENCE 036

Building	Floor	Room	Location		
Main	Eighth Floor	Riser 1	Pipe Work		
Description					
MATERIAL ASSESSMENT				SCORE	
Product Type	Lagging	Extent of Damage	Low damage	6	
Asbestos Type	Amosite / Chrysotile	Surface Treatment	Sealed (0)		
PRIORITY ASSESSMENT				SCORE	
Occupant Activity	Not Applicable	Extent / Amount	1.00 m2	1	
Accessibility	Occasionally disturb	Location	Not Applicable		
Avg Time in Use	Not Applicable	Frequency of Use	Not Applicable		
No. of Occupants	Not Applicable	Secondary Activity	Not Applicable		
Maintenance	Not Applicable	Maintenance Frequency	Not Applicable		
MANAGEMENT ACTION				SCORE	
Recommendation	LABEL & MONITOR			7	
Recommendation Due		Next Inspection	12 Jul 2015		
Apply Labels	No	Permit to Work Required	No		
Survey Type	Management	Lead Surveyor	Gavin Hooper		
Survey Date	12 Jan 2015	UKAS Laboratory	NOT SAMPLED (Cross Referenced)		
Site Reference	139470000A	Licensed Material	Yes	Notifiable Non Licensed Work	No

Asbestos Presumed

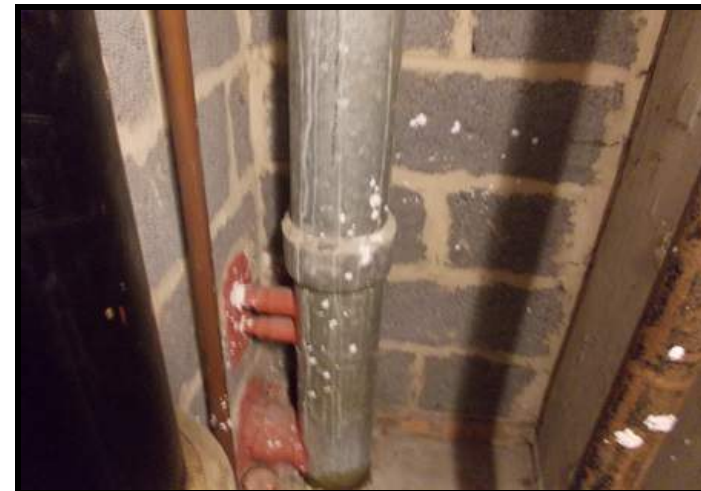
## SAMPLE REFERENCE 037

Building	Floor	Room	Location		
Main	Eighth Floor	Riser 2	Pipe Work		
Description					
MATERIAL ASSESSMENT					
Product Type	Lagging	Extent of Damage	Low damage		
Asbestos Type	Amosite / Chrysotile	Surface Treatment	Sealed (0)		
PRIORITY ASSESSMENT					
Occupant Activity	Not Applicable	Extent / Amount	1.00 m2		
Accessibility	Occasionally disturb	Location	Not Applicable		
Avg Time in Use	Not Applicable	Frequency of Use	Not Applicable		
No. of Occupants	Not Applicable	Secondary Activity	Not Applicable		
Maintenance	Not Applicable	Maintenance Frequency	Not Applicable		
MANAGEMENT ACTION					
Recommendation	LABEL & MONITOR				
Recommendation Due		Next Inspection	12 Jul 2015		
Apply Labels	No	Permit to Work Required	No		
Survey Type	Management	Lead Surveyor	Gavin Hooper		
Survey Date	12 Jan 2015	UKAS Laboratory	NOT SAMPLED (Cross Referenced)		
Site Reference	I39470000A	Licensed Material	Yes	Notifiable Non Licensed Work	No

Asbestos Presumed

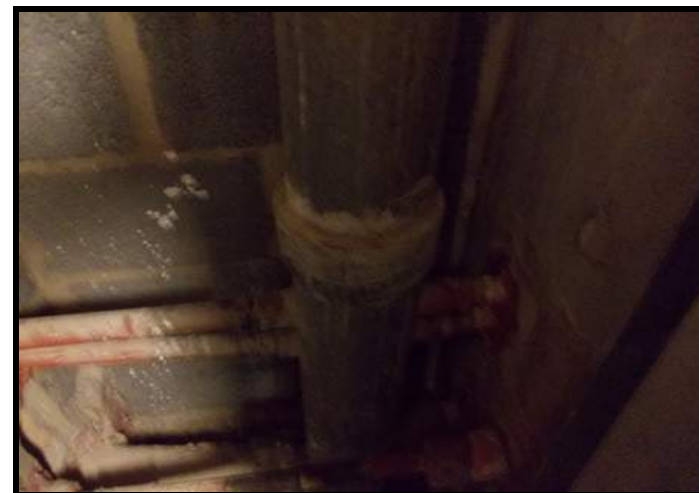
## SAMPLE REFERENCE 043

Building	Floor	Room	Location		
Main	Eighth Floor	Riser 3	Pipe Work		
Description					
MATERIAL ASSESSMENT					
Product Type	Lagging	Extent of Damage	Low damage		
Asbestos Type	Amosite / Chrysotile	Surface Treatment	Sealed (0)		
PRIORITY ASSESSMENT					
Occupant Activity	Not Applicable	Extent / Amount	1.00 m2		
Accessibility	Occasionally disturb	Location	Not Applicable		
Avg Time in Use	Not Applicable	Frequency of Use	Not Applicable		
No. of Occupants	Not Applicable	Secondary Activity	Not Applicable		
Maintenance	Not Applicable	Maintenance Frequency	Not Applicable		
MANAGEMENT ACTION					
Recommendation	LABEL & MONITOR				
Recommendation Due		Next Inspection	12 Jul 2015		
Apply Labels	No	Permit to Work Required	No		
Survey Type	Management	Lead Surveyor	Gavin Hooper		
Survey Date	12 Jan 2015	UKAS Laboratory	NOT SAMPLED (Cross Referenced)		
Site Reference	I39470000A	Licensed Material	Yes	Notifiable Non Licensed Work	No

Asbestos Presumed

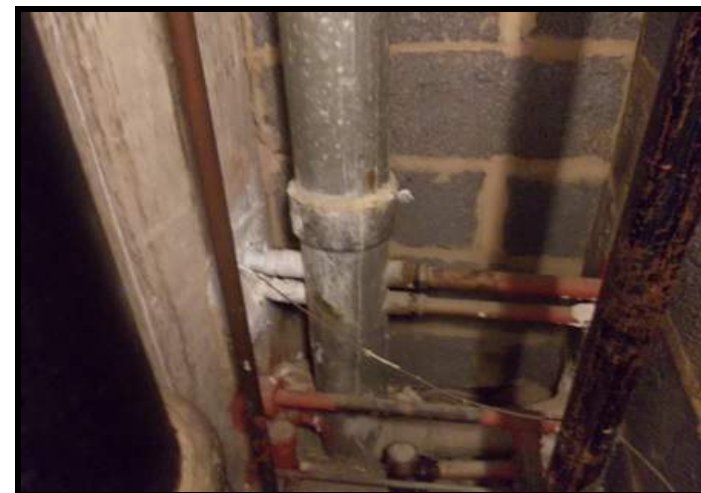
## SAMPLE REFERENCE 044

Building	Floor	Room	Location			
Main	Eighth Floor	Riser 4	Pipe Work			
Description						
MATERIAL ASSESSMENT				SCORE		
Product Type	Lagging	Extent of Damage	Low damage		6	
Asbestos Type	Amosite / Chrysotile	Surface Treatment	Sealed (0)			
PRIORITY ASSESSMENT				SCORE		
Occupant Activity	Not Applicable	Extent / Amount	1.00 m2		1	
Accessibility	Occasionally disturb	Location	Not Applicable			
Avg Time in Use	Not Applicable	Frequency of Use	Not Applicable			
No. of Occupants	Not Applicable	Secondary Activity	Not Applicable			
Maintenance	Not Applicable	Maintenance Frequency	Not Applicable			
MANAGEMENT ACTION				SCORE		
Recommendation	LABEL & MONITOR			7		
Recommendation Due		Next Inspection	12 Jul 2015			
Apply Labels	No	Permit to Work Required	No			
Survey Type	Management	Lead Surveyor	Gavin Hooper			
Survey Date	12 Jan 2015	UKAS Laboratory	NOT SAMPLED (Cross Referenced)			
Site Reference	I39470000A	Licensed Material	Yes	Notifiable Non Licensed Work	No

Asbestos Presumed

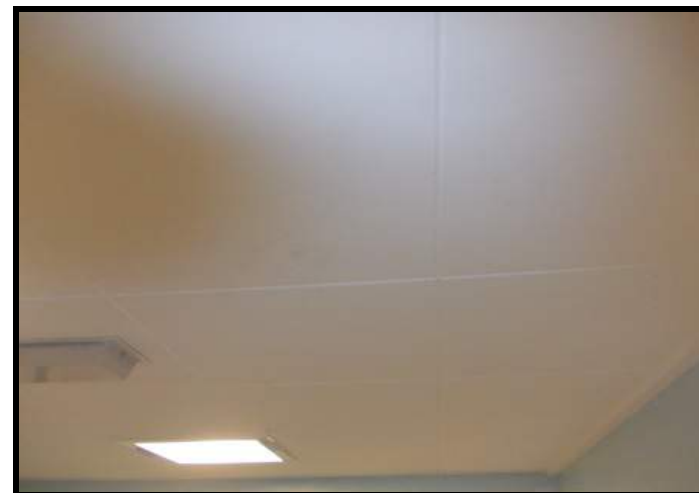
## SAMPLE REFERENCE 045c

Building	Floor	Room	Location		
Main	Eighth Floor	Lift lobby	Ceiling		
Description					
MATERIAL ASSESSMENT					SCORE
Product Type	Insulation Board	Extent of Damage	Low damage		-
Asbestos Type	No Asbestos Detected	Surface Treatment	Sealed Board (Encapsulated)		
PRIORITY ASSESSMENT					SCORE
Occupant Activity	Not Applicable	Extent / Amount	20.00 m2		-
Accessibility	Easily disturbed	Location	Not Applicable		
Avg Time in Use	Not Applicable	Frequency of Use	Not Applicable		
No. of Occupants	Not Applicable	Secondary Activity	Not Applicable		
Maintenance	Not Applicable	Maintenance Frequency	Not Applicable		
MANAGEMENT ACTION					SCORE
Recommendation	NO ACTION REQUIRED				-
Recommendation Due		Next Inspection	None		
Apply Labels	No	Permit to Work Required	No		
Survey Type	Management	Lead Surveyor	Gavin Hooper		
Survey Date	12 Jan 2015	UKAS Laboratory	NOT SAMPLED (Cross Referenced)		
Site Reference	I39470000A	Licensed Material	N/A	Notifiable Non Licensed Work	N/A

**No Asbestos Presumed in Sample**

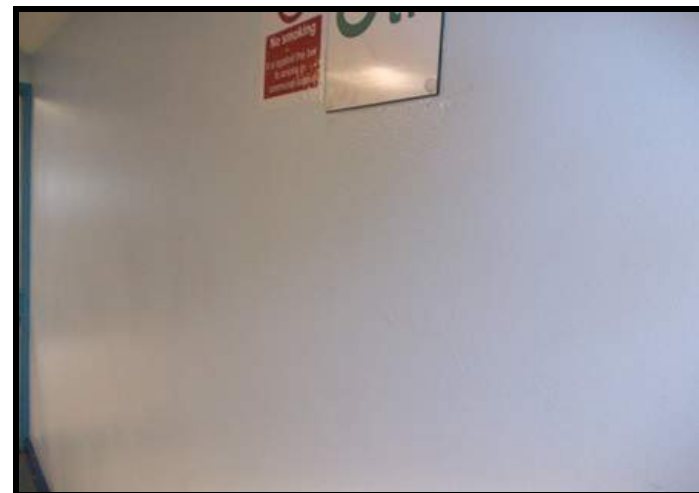
## SAMPLE REFERENCE 045d

Building	Floor	Room	Location			
Main	Eighth Floor	Lift lobby	Walls			
Description						
MATERIAL ASSESSMENT				SCORE		
Product Type	Textured Coating	Extent of Damage	Low damage		3	
Asbestos Type	Chrysotile	Surface Treatment	Textured Coating			
PRIORITY ASSESSMENT				SCORE		
Occupant Activity	Not Applicable	Extent / Amount	20.00 m2		1	
Accessibility	Easily disturbed	Location	Not Applicable			
Avg Time in Use	Not Applicable	Frequency of Use	Not Applicable			
No. of Occupants	Not Applicable	Secondary Activity	Not Applicable			
Maintenance	Not Applicable	Maintenance Frequency	Not Applicable			
MANAGEMENT ACTION				SCORE		
Recommendation	LABEL & MONITOR			4		
Recommendation Due		Next Inspection	12 Jan 2016			
Apply Labels	No	Permit to Work Required	No			
Survey Type	Management	Lead Surveyor	Gavin Hooper			
Survey Date	12 Jan 2015	UKAS Laboratory	NOT SAMPLED (Cross Referenced)			
Site Reference	I39470000A	Licensed Material	No	Notifiable Non Licensed Work	No

**Asbestos Presumed**

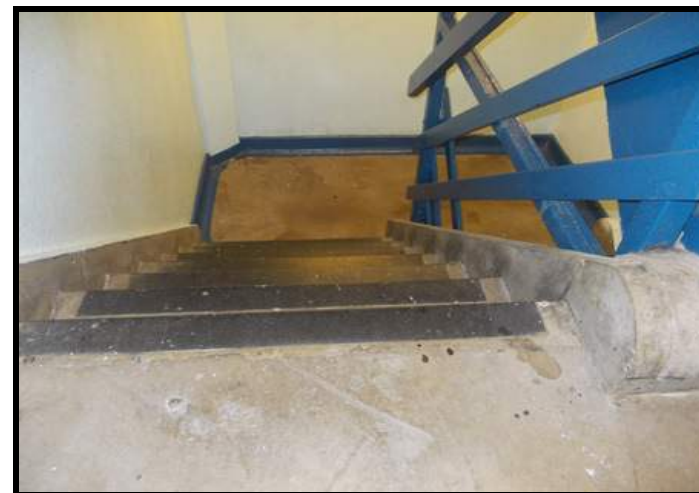
SAMPLE REFERENCE 046a

Building	Floor	Room	Location			
Main	Eighth to Seventh Floor	Stairwell	Staircase			
Description						
MATERIAL ASSESSMENT				SCORE		
Product Type	Bitumen	Extent of Damage	Low damage		3	
Asbestos Type	Chrysotile	Surface Treatment	Composite materials			
PRIORITY ASSESSMENT				SCORE		
Occupant Activity	Not Applicable	Extent / Amount	14.00 small item(s)		1	
Accessibility	Routinely disturbed	Location	Not Applicable			
Avg Time in Use	Not Applicable	Frequency of Use	Not Applicable			
No. of Occupants	Not Applicable	Secondary Activity	Not Applicable			
Maintenance	Not Applicable	Maintenance Frequency	Not Applicable			
MANAGEMENT ACTION				SCORE		
Recommendation	LABEL & MONITOR			4		
Recommendation Due		Next Inspection	12 Jan 2016			
Apply Labels	No	Permit to Work Required	No			
Survey Type	Management	Lead Surveyor	Gavin Hooper			
Survey Date	12 Jan 2015	UKAS Laboratory	NOT SAMPLED (Cross Referenced)			
Site Reference	I39470000A	Licensed Material	No	Notifiable Non Licensed Work	No

**Asbestos Presumed**

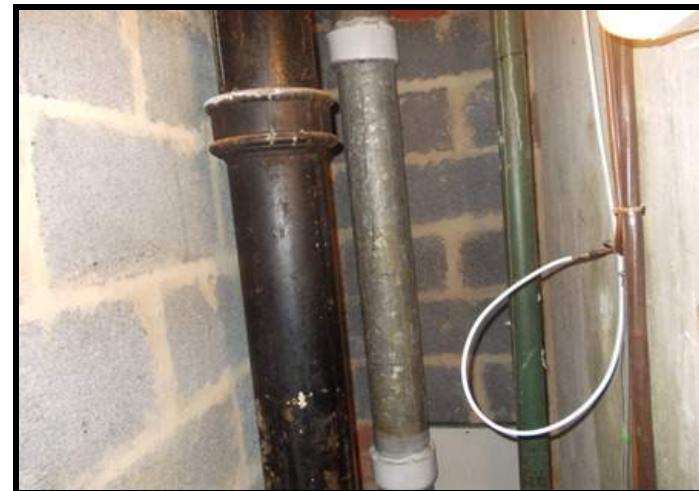
## SAMPLE REFERENCE 052

Building	Floor	Room	Location
Main	Seventh Floor	Riser 2	Pipe Work
Description			
MATERIAL ASSESSMENT			
Product Type	Lagging	Extent of Damage	Low damage
Asbestos Type	Amosite / Chrysotile	Surface Treatment	Sealed (0)
SCORE			
6			
PRIORITY ASSESSMENT			
Occupant Activity	Not Applicable	Extent / Amount	1.00 m2
Accessibility	Occasionally disturb	Location	Not Applicable
Avg Time in Use	Not Applicable	Frequency of Use	Not Applicable
No. of Occupants	Not Applicable	Secondary Activity	Not Applicable
Maintenance	Not Applicable	Maintenance Frequency	Not Applicable
SCORE			
1			
MANAGEMENT ACTION			
Recommendation	LABEL & MONITOR		
Recommendation Due		Next Inspection	12 Jul 2015
Apply Labels	No	Permit to Work Required	No
SCORE			
7			
Survey Type	Management	Lead Surveyor	Gavin Hooper
Survey Date	12 Jan 2015	UKAS Laboratory	NOT SAMPLED (Cross Referenced)
Site Reference	I39470000A	Licensed Material	Yes
		Notifiable Non Licensed Work	No

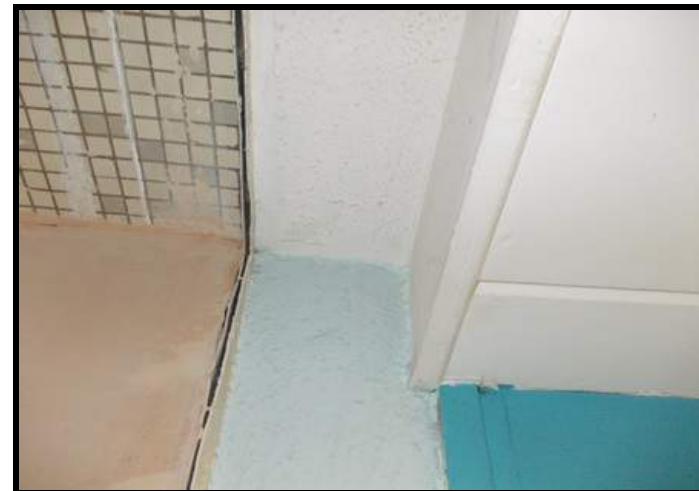
## SAMPLE REFERENCE 054a

**Asbestos Presumed**

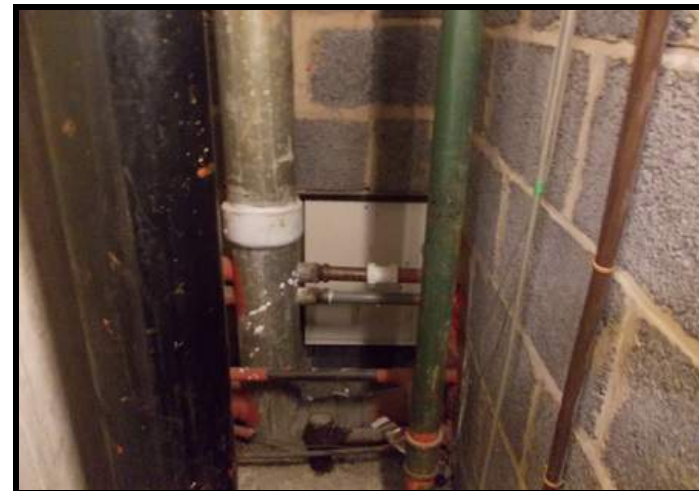
## SAMPLE REFERENCE 059

Asbestos Presumed

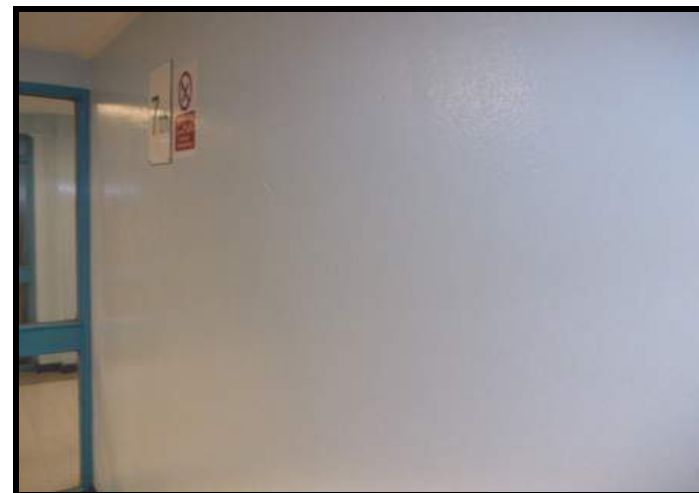
## SAMPLE REFERENCE 060c

**Asbestos Presumed**

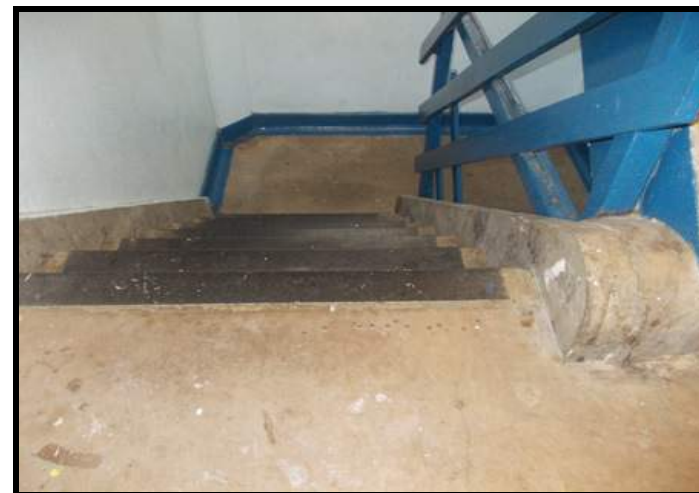
## SAMPLE REFERENCE 061a

**Asbestos Presumed**

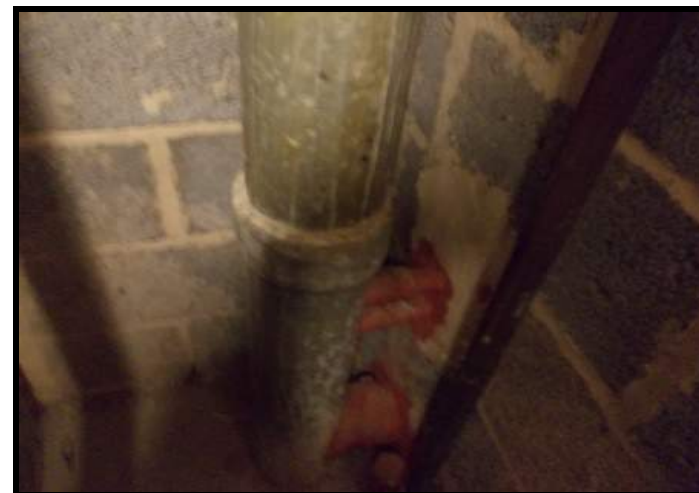
## SAMPLE REFERENCE 066

Asbestos Presumed

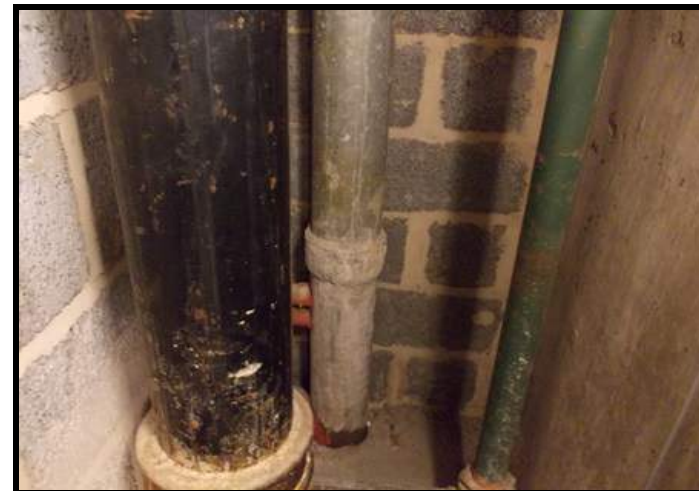
## SAMPLE REFERENCE 067

**Asbestos Presumed**

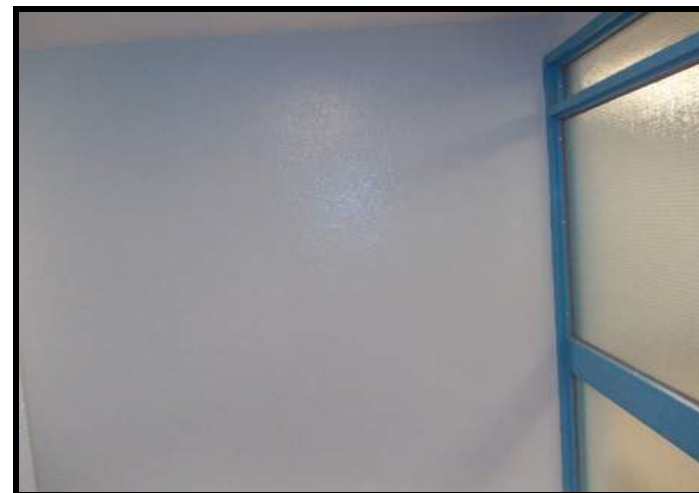
## SAMPLE REFERENCE 069b

**Asbestos Presumed**

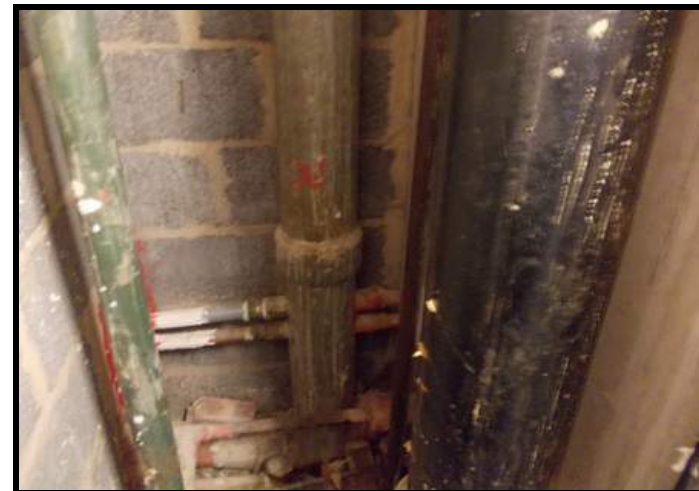
## SAMPLE REFERENCE 073

**Asbestos Presumed**

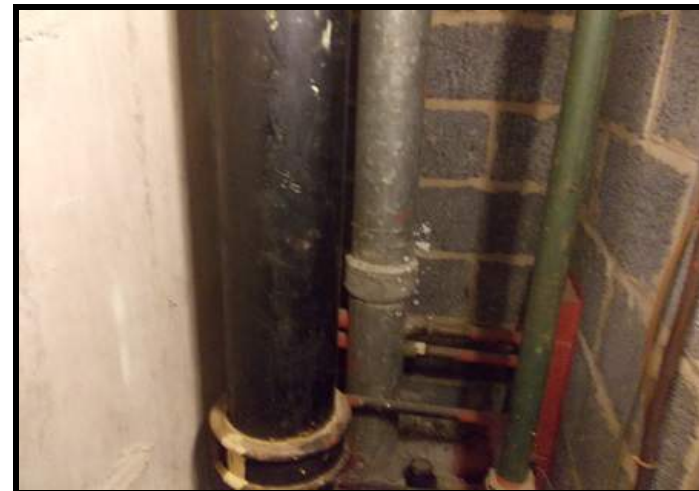
## SAMPLE REFERENCE 074

Asbestos Presumed

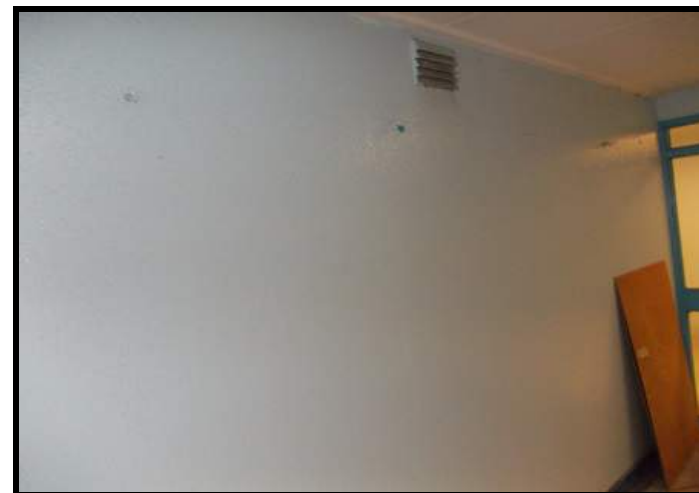
## SAMPLE REFERENCE 075

**Asbestos Presumed**

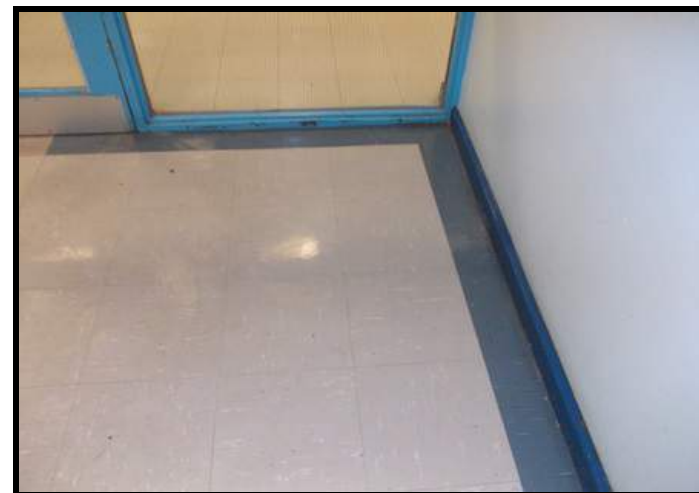
## SAMPLE REFERENCE 075b

**No Asbestos Presumed in Sample**

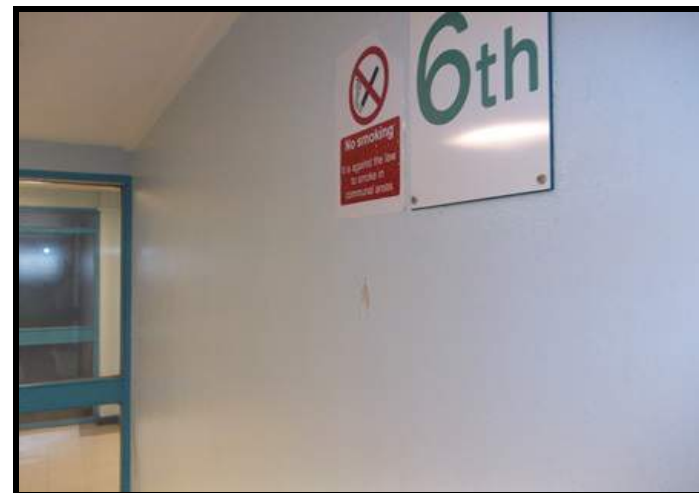
## SAMPLE REFERENCE 075c

**Asbestos Presumed**

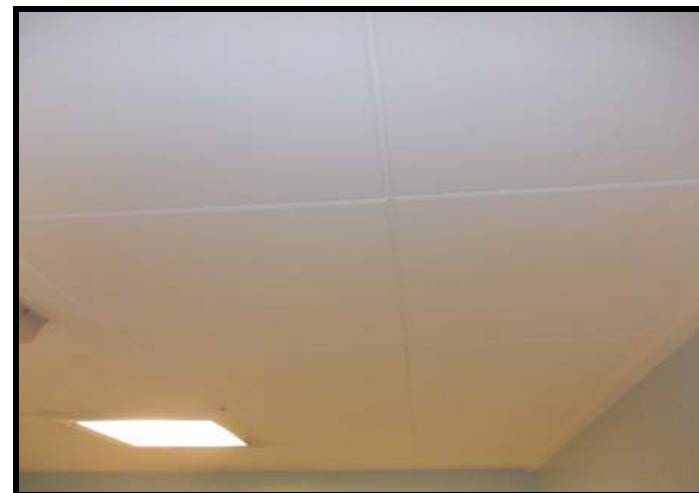
## SAMPLE REFERENCE 075d

**No Asbestos Presumed in Sample**

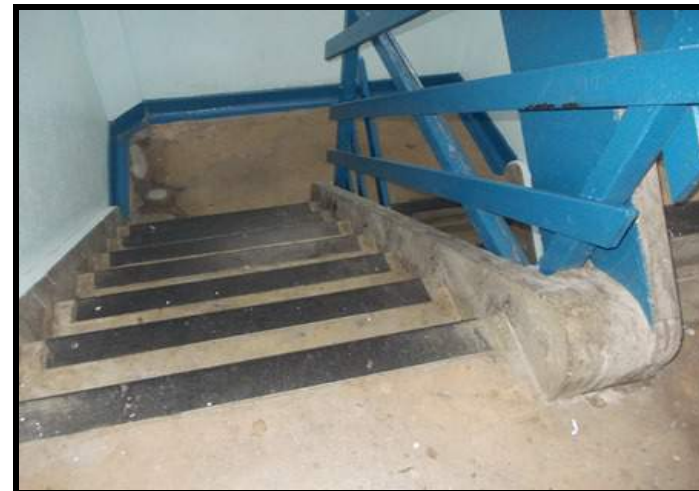
## SAMPLE REFERENCE 076a

Asbestos Presumed

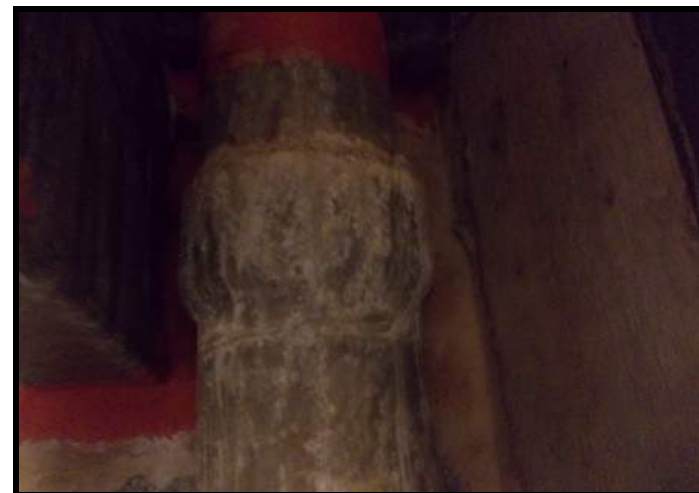
## SAMPLE REFERENCE 088

Asbestos Presumed

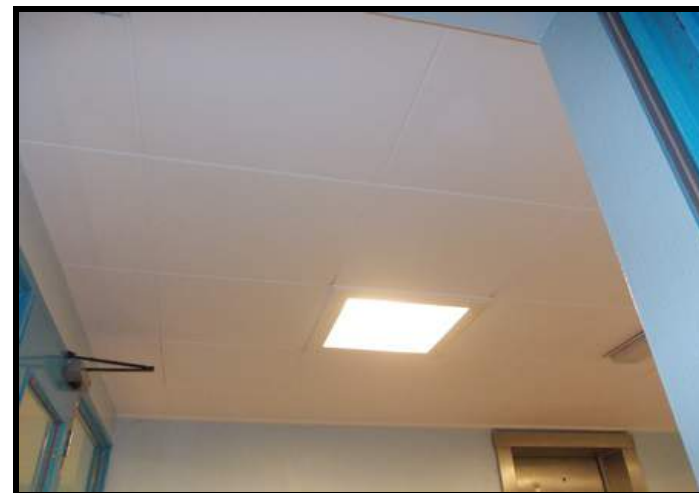
## SAMPLE REFERENCE 089b

**No Asbestos Presumed in Sample**

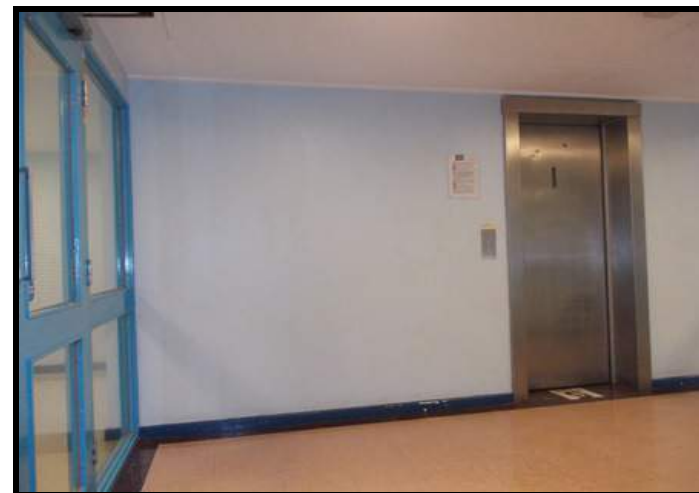
## SAMPLE REFERENCE 089c

**Asbestos Presumed**

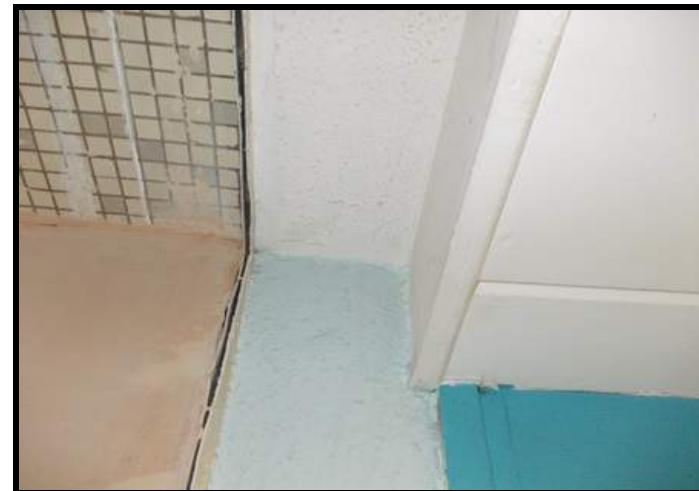
## SAMPLE REFERENCE 090

**Asbestos Presumed**

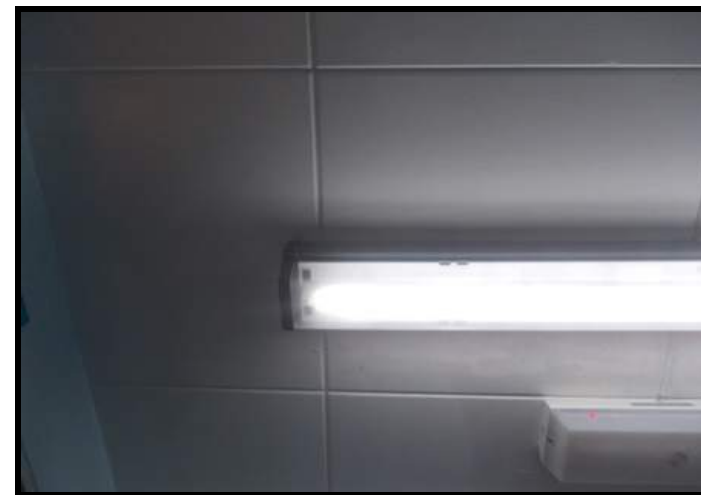
## SAMPLE REFERENCE 091

**No Asbestos Presumed in Sample**

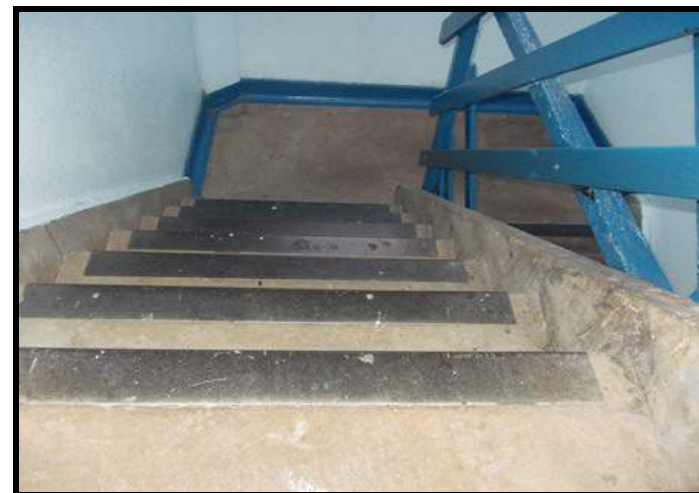
## SAMPLE REFERENCE 091a

Asbestos Presumed

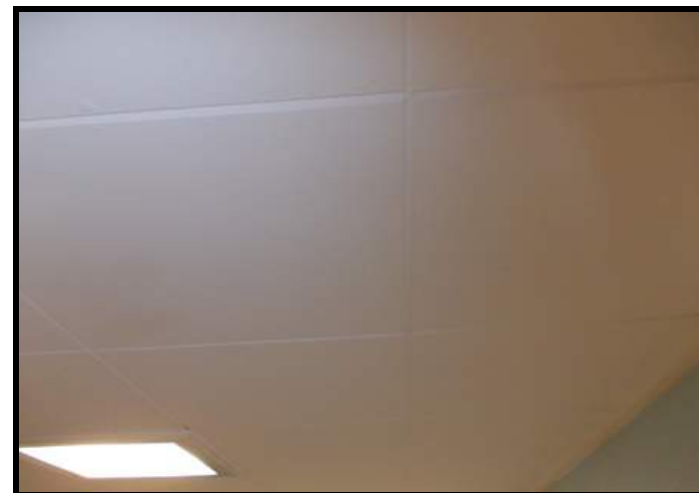
## SAMPLE REFERENCE 095b

**No Asbestos Presumed in Sample**

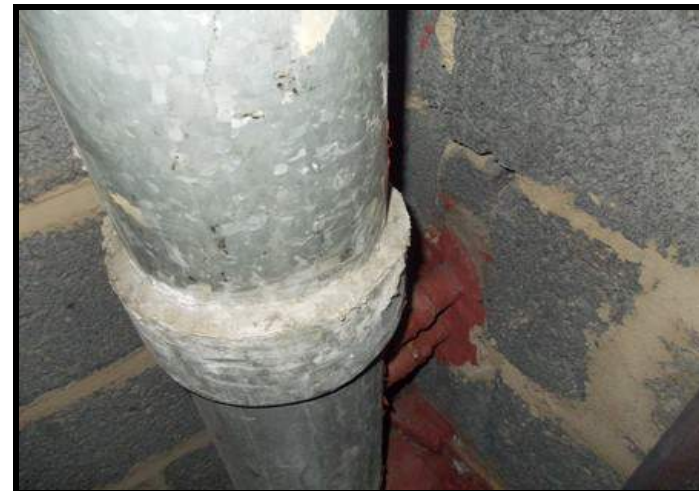
## SAMPLE REFERENCE 097

**Asbestos Presumed**

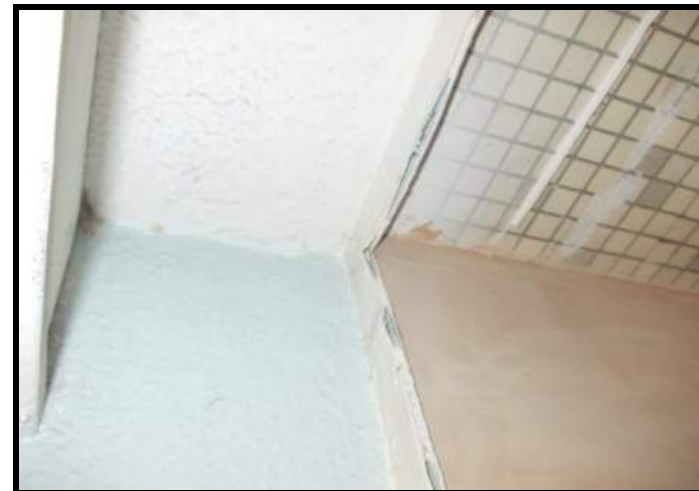
## SAMPLE REFERENCE 099a

**Asbestos Presumed**

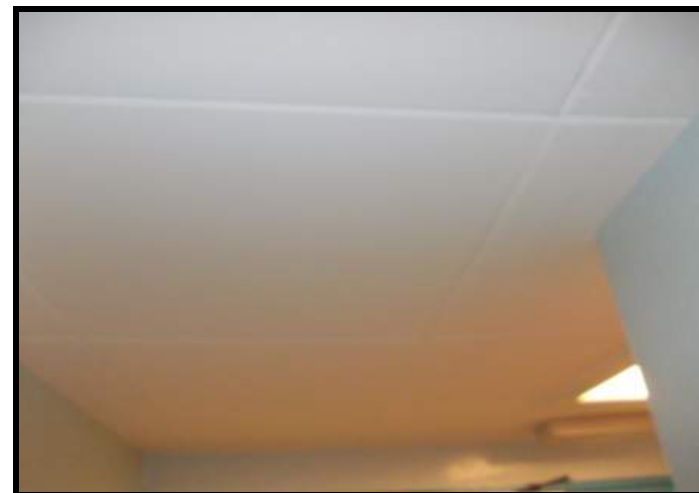
## SAMPLE REFERENCE 099b

**No Asbestos Presumed in Sample**

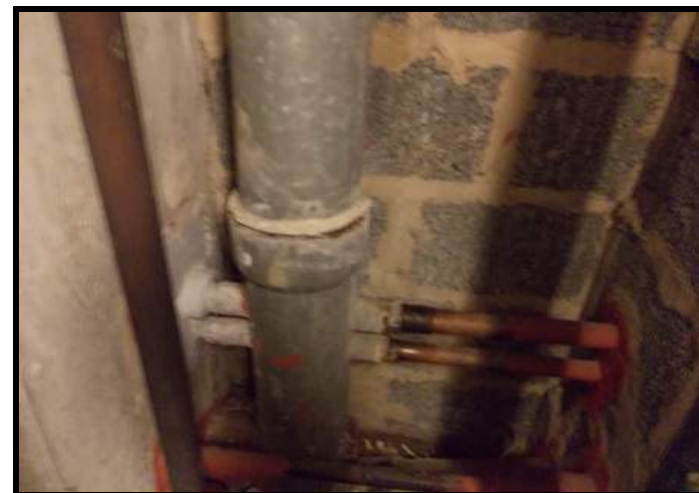
## SAMPLE REFERENCE 104

Asbestos Presumed

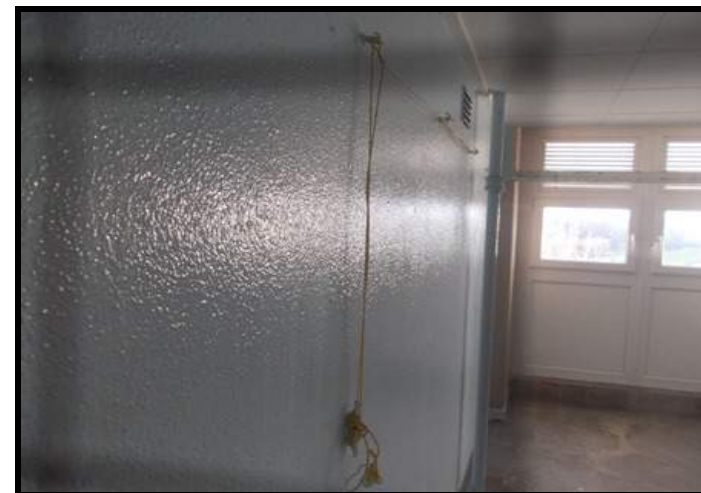
## SAMPLE REFERENCE 105

**Asbestos Presumed**

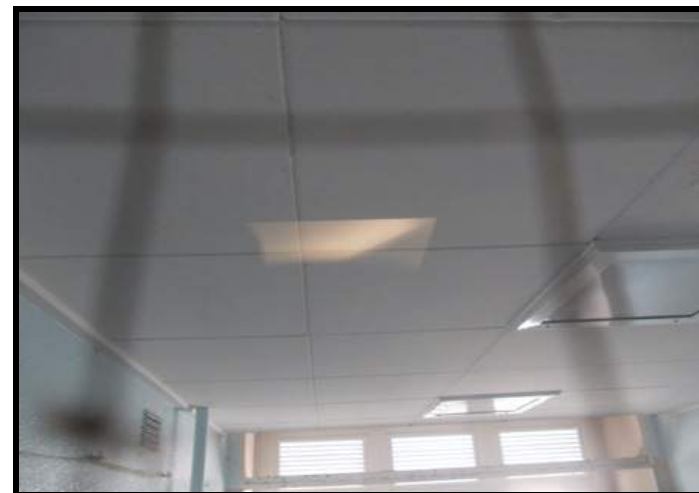
SAMPLE REFERENCE I05a

**No Asbestos Presumed in Sample**

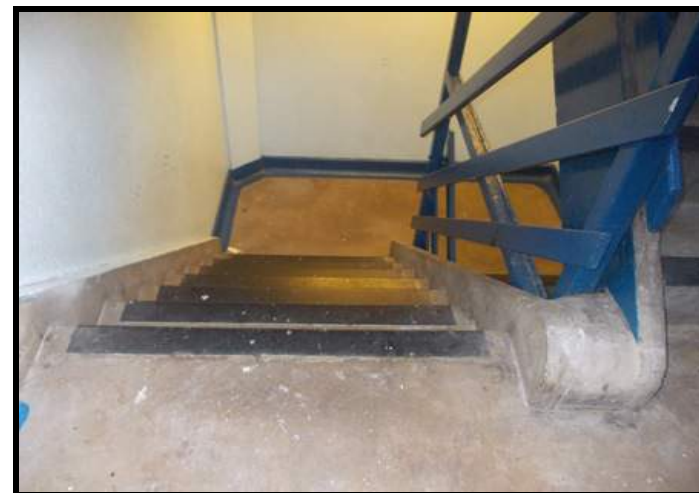
## SAMPLE REFERENCE I06a

Asbestos Presumed
