# Solihull Community Housing

## Asbestos Management Survey Report

**AVONCROFT HOUSE  
(COMMUNAL)  
WINCHESTER DRIVE  
SOLIHULL  
B37 5QH**

Date of Report: 29 Jan 2015

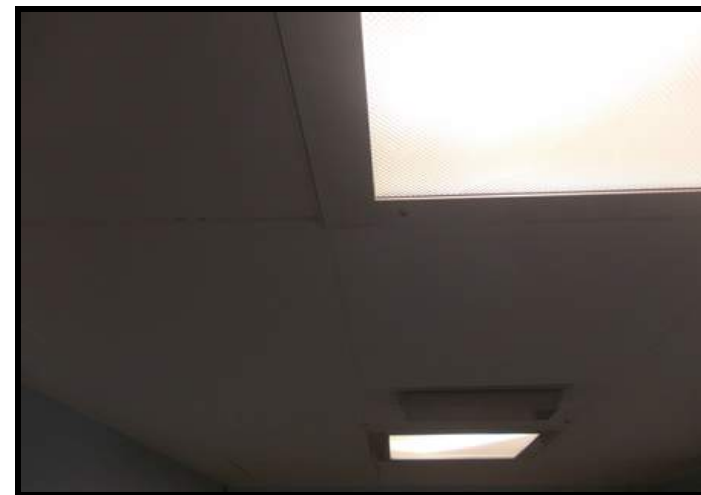
## SAMPLE REFERENCE 109

**No Asbestos Presumed in Sample**

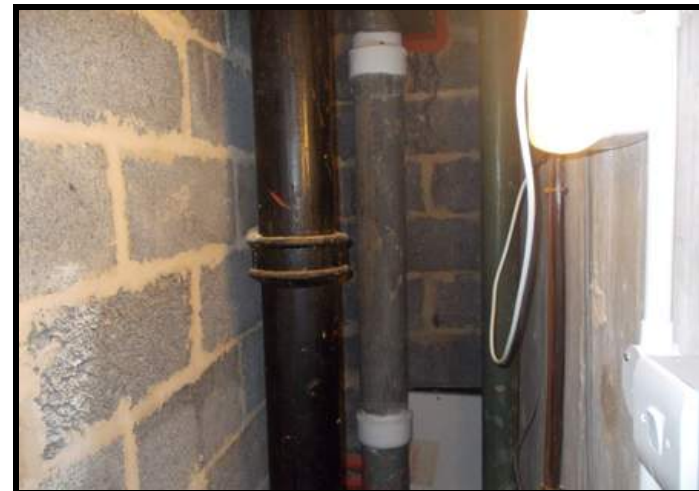
## SAMPLE REFERENCE I 12

Asbestos Presumed

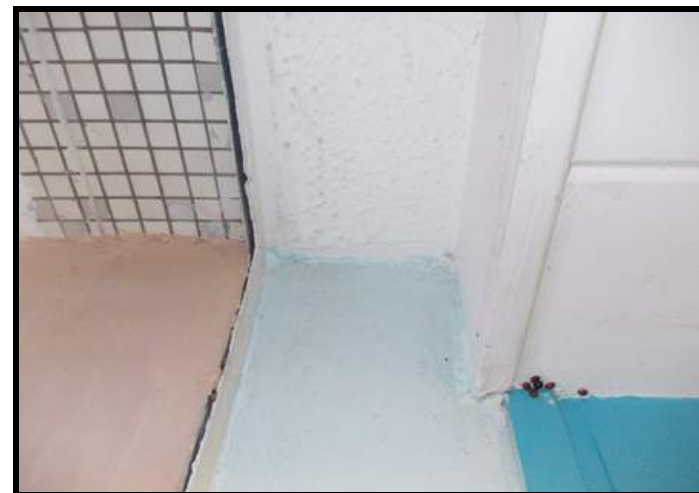
## SAMPLE REFERENCE I14b

**Asbestos Presumed**

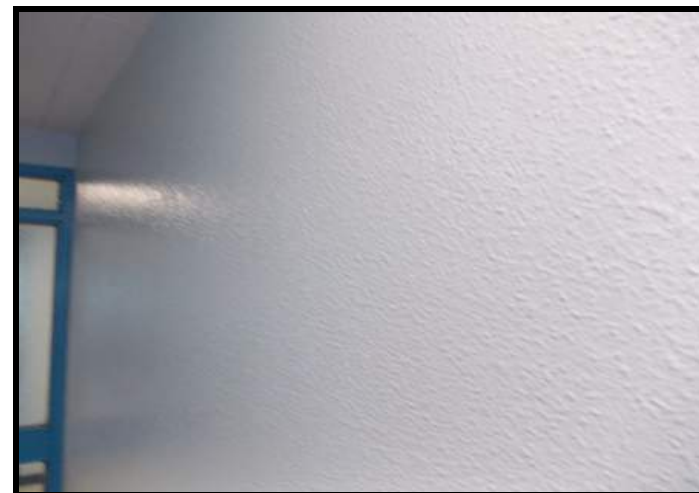
## SAMPLE REFERENCE I29a

**Asbestos Presumed**

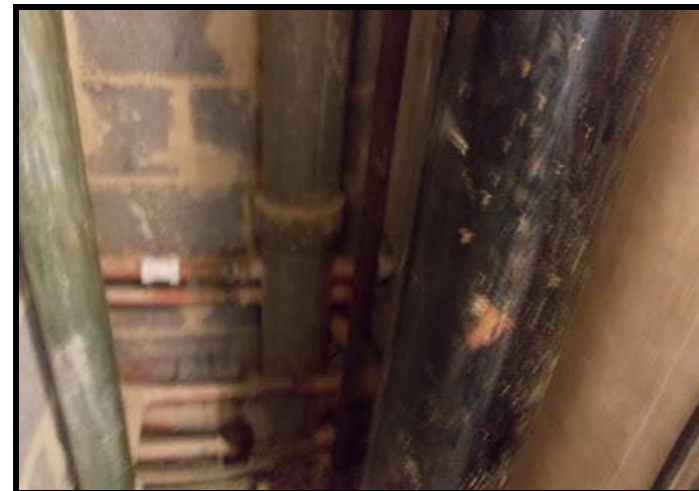
## SAMPLE REFERENCE 133

Asbestos Presumed

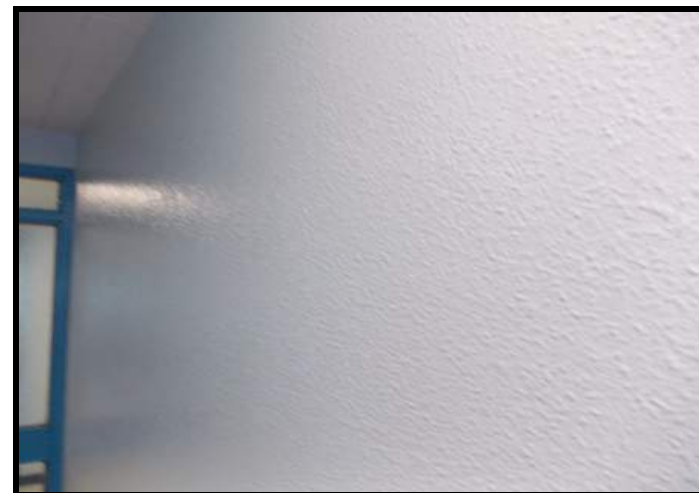
## SAMPLE REFERENCE I35

**Asbestos Presumed**

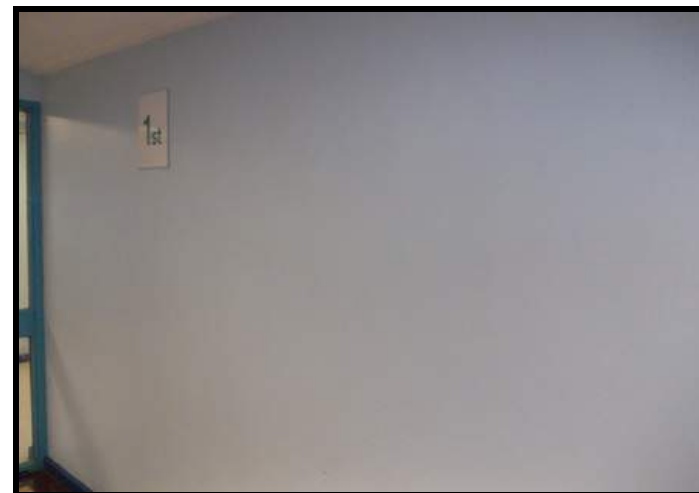
## SAMPLE REFERENCE I40b

**Asbestos Presumed**

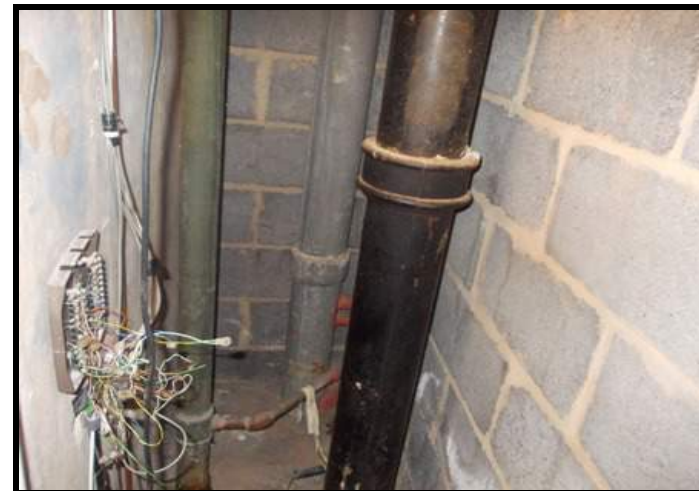
## SAMPLE REFERENCE 141

Asbestos Presumed

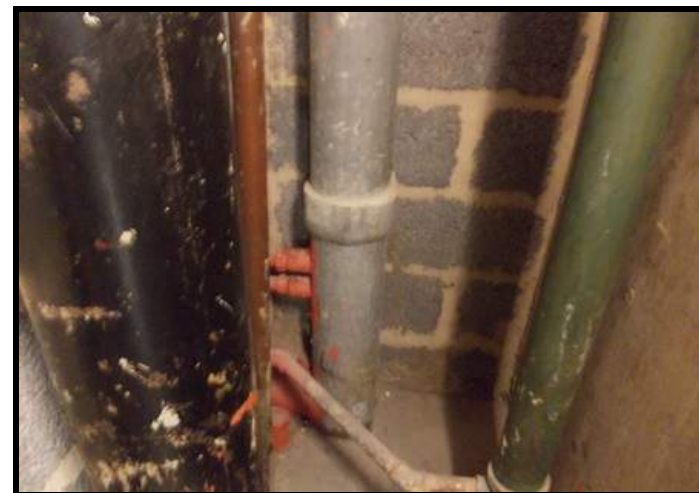
## SAMPLE REFERENCE 142

**Asbestos Presumed**

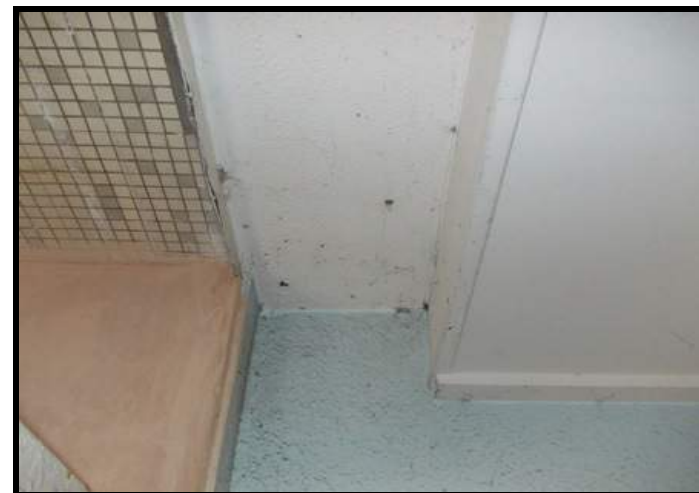
## SAMPLE REFERENCE 150

**Asbestos Presumed**

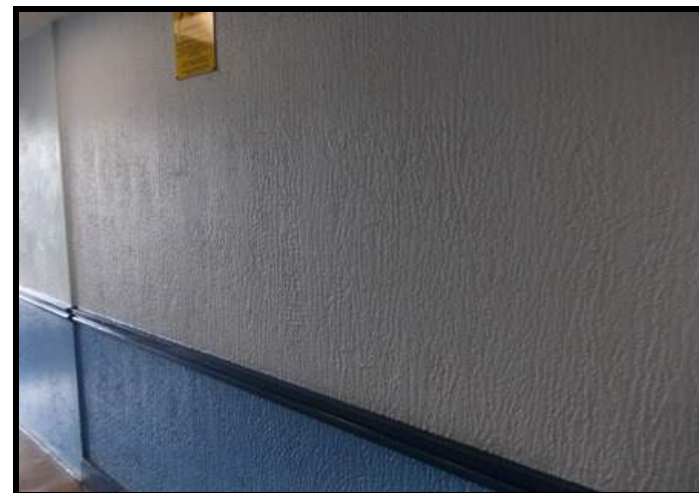
## SAMPLE REFERENCE I54a

Asbestos Presumed

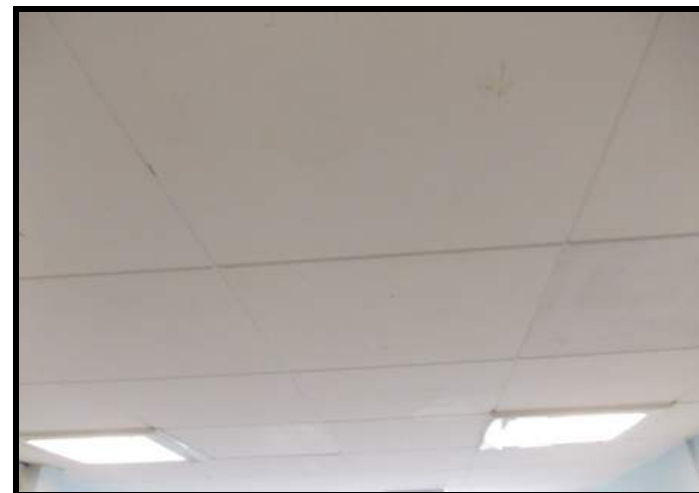
## SAMPLE REFERENCE I54b

**No Asbestos Presumed in Sample**

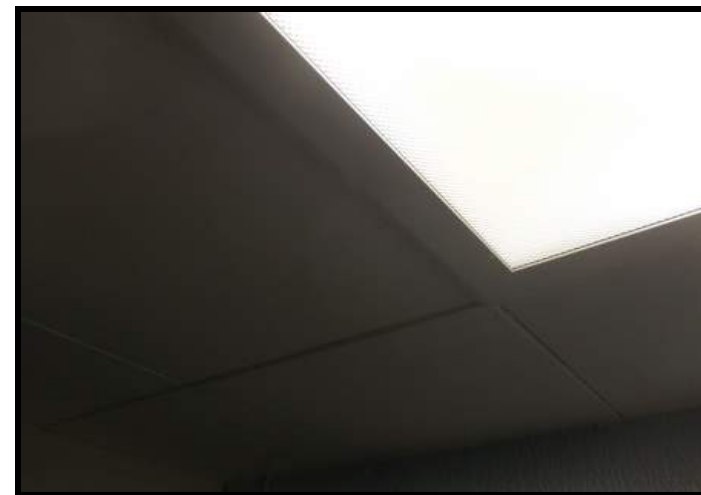
## SAMPLE REFERENCE 159

**No Asbestos Presumed in Sample**

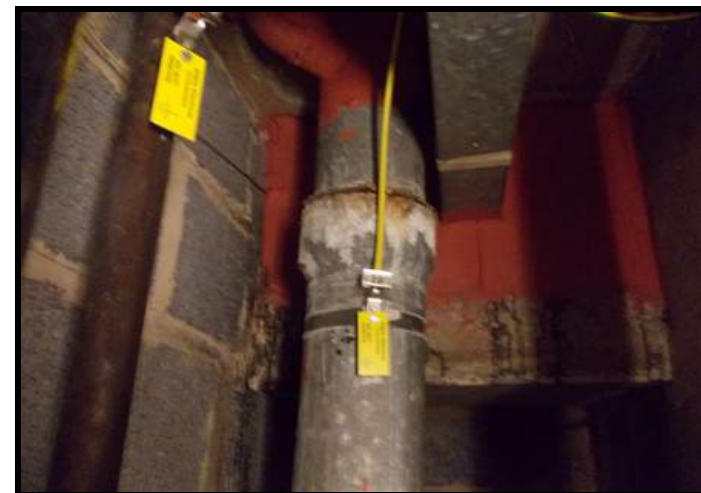
## SAMPLE REFERENCE 171

Asbestos Presumed

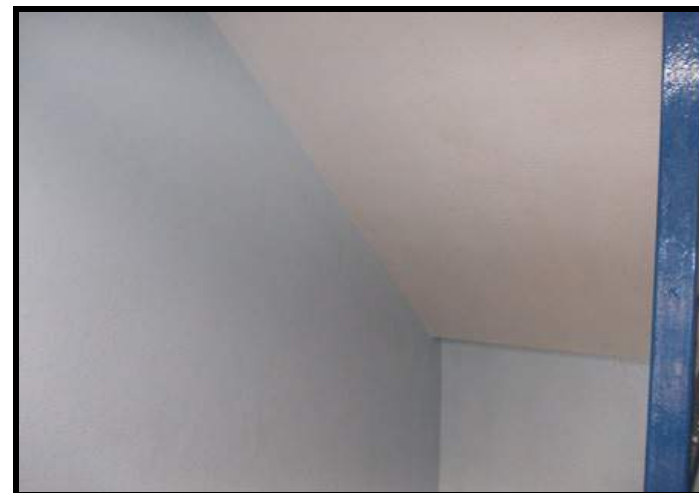
## SAMPLE REFERENCE 174

Asbestos Presumed
