Solihull Community Housing

Asbestos Management Survey Report

**Balliol House
Grandys Croft
Chelmsley Wood
B37 5BS**

Date of Report: 31 Mar 2012

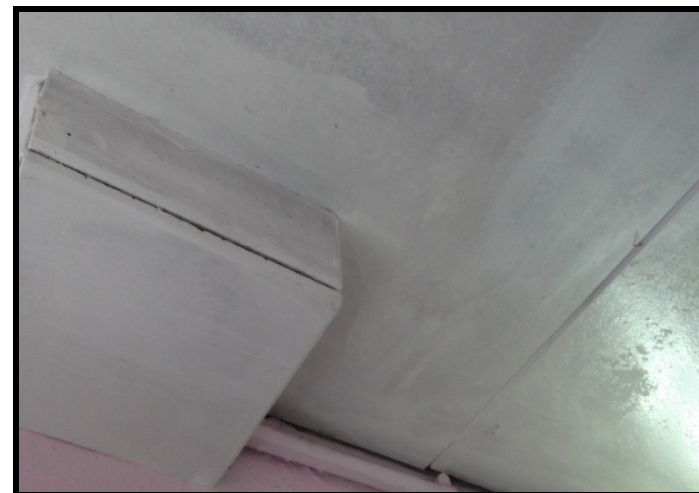
SAMPLE REFERENCE 005

Building	Floor	Room	Location	
Main Building	Ninth Floor	Bin Chute	Ceiling	
Description	Metal cageing to window			
MATERIAL ASSESSMENT				SCORE
Product Type	Board	Extent of Damage	Low damage	-
Asbestos Type	No Asbestos Detected	Surface Treatment	Sealed Board (Encapsulated)	
PRIORITY ASSESSMENT				SCORE
Occupant Activity	Not Applicable	Extent / Amount	5.00 m2	-
Accessibility	Unlikely to be disturbed	Location	Not Applicable	
Avg Time in Use	Not Applicable	Frequency of Use	Not Applicable	
No. of Occupants	Not Applicable	Secondary Activity	Not Applicable	
Maintenance	Not Applicable	Maintenance Frequency	Not Applicable	
MANAGEMENT ACTION				SCORE
Recommendation	NO ACTION REQUIRED			-
Recommendation Due		Next Inspection	None	
Apply Labels	No	Permit to Work Required	No	
Survey Type	Management	Lead Surveyor	Jane Openshaw	
Survey Date	20 Mar 2012	UKAS Laboratory	NOT SAMPLED (Cross Referenced)	
Site Reference	I13070000A	Licensed Material	N/A

No Asbestos Presumed in Sample

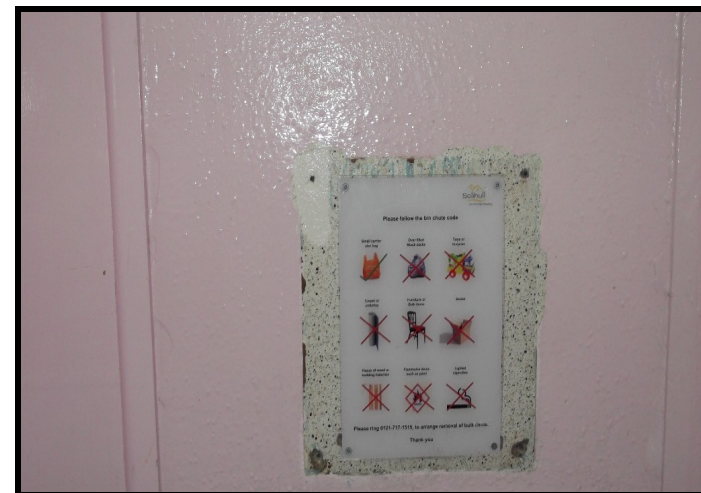
SAMPLE REFERENCE 006

Building	Floor	Room	Location	
Main Building	Tenth Floor	Bin Chute	Walls	
Description	Metal cageing to window			
MATERIAL ASSESSMENT				SCORE
Product Type	Paint	Extent of Damage	Low damage	-
Asbestos Type	No Asbestos Detected	Surface Treatment	Composite materials	
PRIORITY ASSESSMENT				SCORE
Occupant Activity	Not Applicable	Extent / Amount	16.00 m2	-
Accessibility	Easily disturbed	Location	Not Applicable	
Avg Time in Use	Not Applicable	Frequency of Use	Not Applicable	
No. of Occupants	Not Applicable	Secondary Activity	Not Applicable	
Maintenance	Not Applicable	Maintenance Frequency	Not Applicable	
MANAGEMENT ACTION				SCORE
Recommendation	NO ACTION REQUIRED			-
Recommendation Due		Next Inspection	None	
Apply Labels	No	Permit to Work Required	No	
Survey Type	Management	Lead Surveyor	Jane Openshaw	
Survey Date	20 Mar 2012	UKAS Laboratory	DMW Environmental Safety Ltd / [P-96019]	
Site Reference	I13070000A	Licensed Material	N/A

Asbestos not detected in Sample

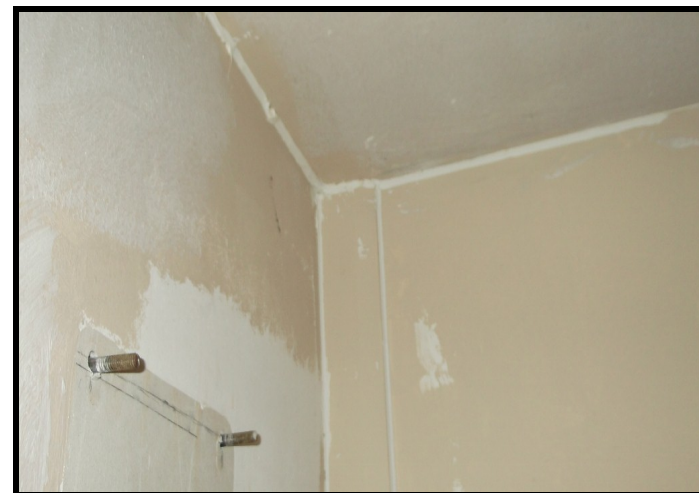
SAMPLE REFERENCE 007

Building	Floor	Room	Location	
Main Building	Tenth Floor	Dry Riser	Ceiling And Walls	
Description	To wall and ceiling			
MATERIAL ASSESSMENT				SCORE
Product Type	Board	Extent of Damage	Good condition	5
Asbestos Type	Amosite / Chrysotile	Surface Treatment	Sealed Board (Encapsulated)	
PRIORITY ASSESSMENT				SCORE
Occupant Activity	Not Applicable	Extent / Amount	8.00 m2	1
Accessibility	Occasionally disturb	Location	Not Applicable	
Avg Time in Use	Not Applicable	Frequency of Use	Not Applicable	
No. of Occupants	Not Applicable	Secondary Activity	Not Applicable	
Maintenance	Not Applicable	Maintenance Frequency	Not Applicable	
MANAGEMENT ACTION				SCORE
Recommendation	LABEL & MONITOR			6
Recommendation Due		Next Inspection	20 Sep 2012	
Apply Labels	No	Permit to Work Required	No	
Survey Type	Management	Lead Surveyor	Jane Openshaw	
Survey Date	20 Mar 2012	UKAS Laboratory	DMW Environmental Safety Ltd / [P-96019]	
Site Reference	113070000A	Licensed Material	Yes

Asbestos detected in Sample

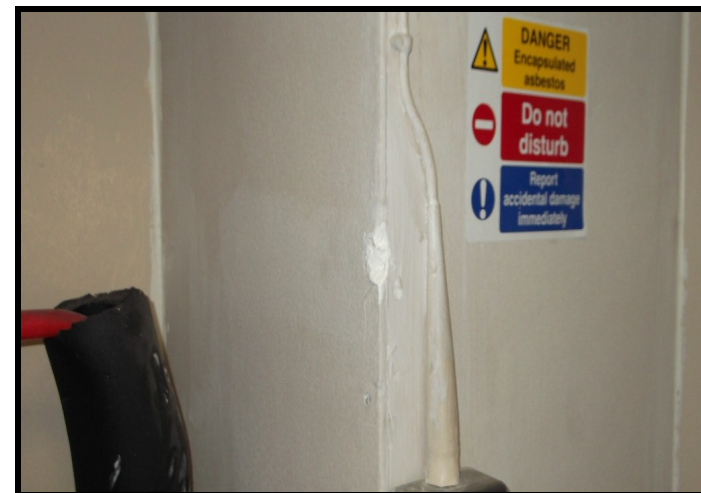
SAMPLE REFERENCE 008

Building	Floor	Room	Location
Main Building	Tenth Floor	Dry Riser	Boxing
Description	To boxing		
MATERIAL ASSESSMENT			
Product Type	Board	Extent of Damage	Good condition
Asbestos Type	Amosite / Chrysotile	Surface Treatment	Sealed Board (Encapsulated)
SCORE			
			5
PRIORITY ASSESSMENT			
Occupant Activity	Not Applicable	Extent / Amount	4.00 m2
Accessibility	Occasionally disturb	Location	Not Applicable
Avg Time in Use	Not Applicable	Frequency of Use	Not Applicable
No. of Occupants	Not Applicable	Secondary Activity	Not Applicable
Maintenance	Not Applicable	Maintenance Frequency	Not Applicable
SCORE			
			1
MANAGEMENT ACTION			
Recommendation	LABEL & MONITOR		
Recommendation Due		Next Inspection	20 Sep 2012
Apply Labels	No	Permit to Work Required	No
SCORE			
			6
Survey Type	Management	Lead Surveyor	Jane Openshaw
Survey Date	20 Mar 2012	UKAS Laboratory	DMW Environmental Safety Ltd / [P-96019]
Site Reference	I13070000A	Licensed Material	Yes

Asbestos detected in Sample

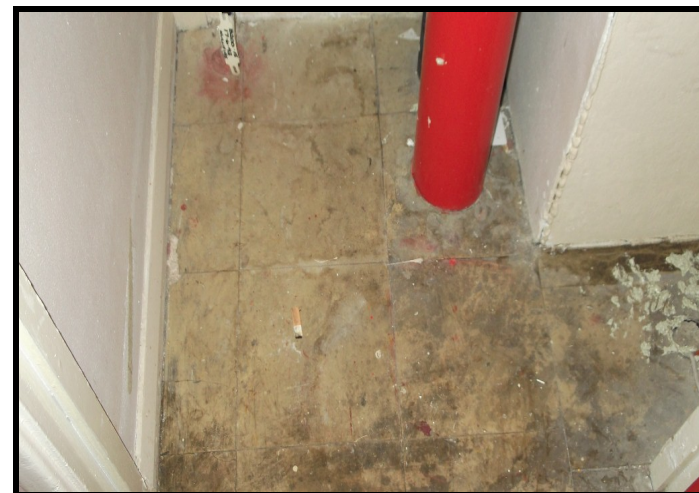
SAMPLE REFERENCE 010

Building	Floor	Room	Location	
Main Building	Tenth Floor	Dry Riser	Floor	
Description	Yellow and adhesive			
MATERIAL ASSESSMENT				SCORE
Product Type	Floor Tiles	Extent of Damage	Medium damage	4
Asbestos Type	Chrysotile	Surface Treatment	Composite materials	
PRIORITY ASSESSMENT				SCORE
Occupant Activity	Not Applicable	Extent / Amount	1.00 m2	1
Accessibility	Easily disturbed	Location	Not Applicable	
Avg Time in Use	Not Applicable	Frequency of Use	Not Applicable	
No. of Occupants	Not Applicable	Secondary Activity	Not Applicable	
Maintenance	Not Applicable	Maintenance Frequency	Not Applicable	
MANAGEMENT ACTION				SCORE
Recommendation	LABEL & MONITOR			5
Recommendation Due		Next Inspection	20 Mar 2013	
Apply Labels	No	Permit to Work Required	No	
Survey Type	Management	Lead Surveyor	Jane Openshaw	
Survey Date	20 Mar 2012	UKAS Laboratory	DMW Environmental Safety Ltd / [P-96019]	
Site Reference	I13070000A	Licensed Material	No

Asbestos detected in Sample

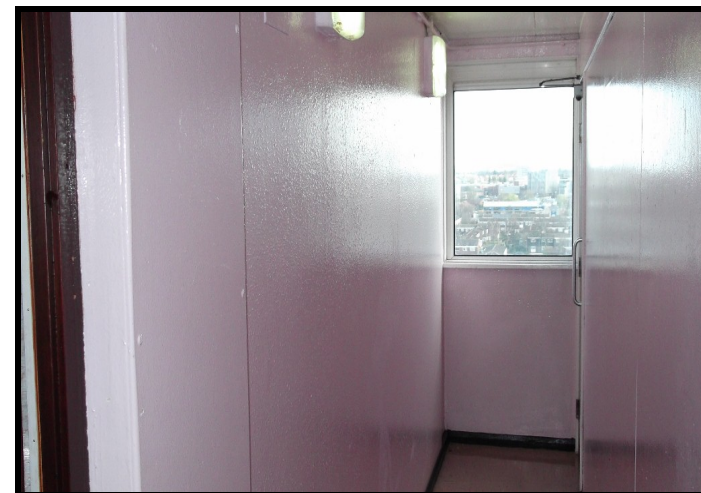
SAMPLE REFERENCE 013

Building	Floor	Room	Location	
Main Building	Tenth Floor	Lobby	Walls	
Description	Timber beading to glazing			
MATERIAL ASSESSMENT				SCORE
Product Type	Paint	Extent of Damage	Good condition	-
Asbestos Type	No Asbestos Detected	Surface Treatment	Sealed (1)	
PRIORITY ASSESSMENT				SCORE
Occupant Activity	Not Applicable	Extent / Amount	13.00 m2	-
Accessibility	Easily disturbed	Location	Not Applicable	
Avg Time in Use	Not Applicable	Frequency of Use	Not Applicable	
No. of Occupants	Not Applicable	Secondary Activity	Not Applicable	
Maintenance	Not Applicable	Maintenance Frequency	Not Applicable	
MANAGEMENT ACTION				SCORE
Recommendation	NO ACTION REQUIRED			-
Recommendation Due		Next Inspection	None	
Apply Labels	No	Permit to Work Required	No	
Survey Type	Management	Lead Surveyor	Jane Openshaw	
Survey Date	20 Mar 2012	UKAS Laboratory	NOT SAMPLED (Cross Referenced)	
Site Reference	113070000A	Licensed Material	N/A

No Asbestos Presumed in Sample

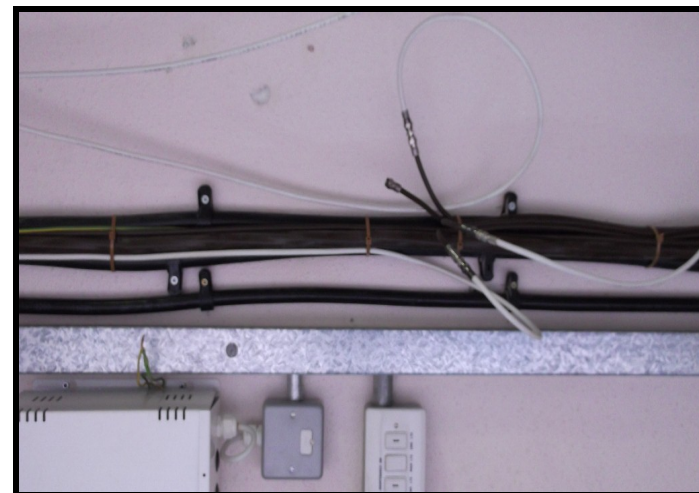
SAMPLE REFERENCE 014

Building	Floor	Room	Location	
Main Building	Tenth Floor	Service Riser	Walls	
Description				
MATERIAL ASSESSMENT				SCORE
Product Type	Paint	Extent of Damage	Good condition	-
Asbestos Type	No Asbestos Detected	Surface Treatment	Sealed (1)	
PRIORITY ASSESSMENT				SCORE
Occupant Activity	Not Applicable	Extent / Amount	3.00 m2	-
Accessibility	Easily disturbed	Location	Not Applicable	
Avg Time in Use	Not Applicable	Frequency of Use	Not Applicable	
No. of Occupants	Not Applicable	Secondary Activity	Not Applicable	
Maintenance	Not Applicable	Maintenance Frequency	Not Applicable	
MANAGEMENT ACTION				SCORE
Recommendation	NO ACTION REQUIRED			-
Recommendation Due		Next Inspection	None	
Apply Labels	No	Permit to Work Required	No	
Survey Type	Management	Lead Surveyor	Jane Openshaw	
Survey Date	20 Mar 2012	UKAS Laboratory	NOT SAMPLED (Cross Referenced)	
Site Reference	113070000A	Licensed Material	N/A

No Asbestos Presumed in Sample

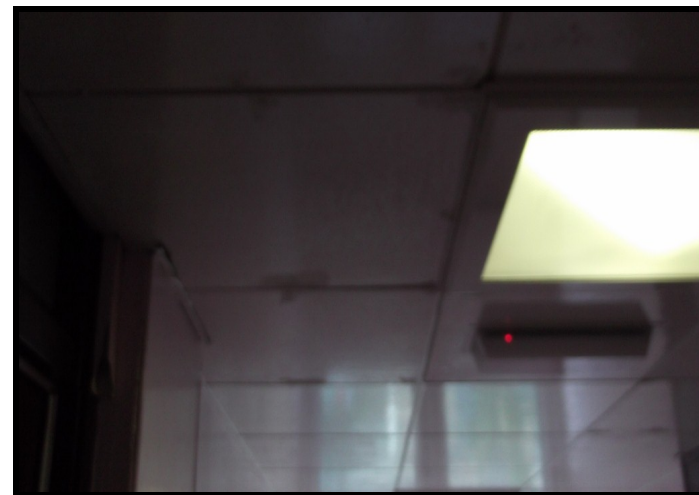
SAMPLE REFERENCE 016

Building	Floor	Room	Location	
Main Building	Tenth Floor	Corridor 2	Ceiling	
Description	Timber boxing adjacent to front doors			
MATERIAL ASSESSMENT				SCORE
Product Type	Board	Extent of Damage	Low damage	-
Asbestos Type	No Asbestos Detected	Surface Treatment	Textured Coating	
PRIORITY ASSESSMENT				SCORE
Occupant Activity	Not Applicable	Extent / Amount	7.00 m2	-
Accessibility	Occasionally disturb	Location	Not Applicable	
Avg Time in Use	Not Applicable	Frequency of Use	Not Applicable	
No. of Occupants	Not Applicable	Secondary Activity	Not Applicable	
Maintenance	Not Applicable	Maintenance Frequency	Not Applicable	
MANAGEMENT ACTION				SCORE
Recommendation	NO ACTION REQUIRED			-
Recommendation Due		Next Inspection	None	
Apply Labels	No	Permit to Work Required	No	
Survey Type	Management	Lead Surveyor	Jane Openshaw	
Survey Date	20 Mar 2012	UKAS Laboratory	NOT SAMPLED (Cross Referenced)	
Site Reference	I13070000A	Licensed Material	N/A

No Asbestos Presumed in Sample

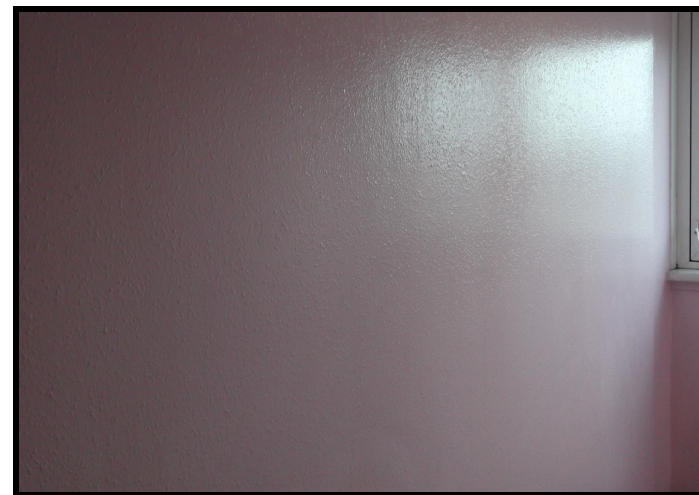
SAMPLE REFERENCE 017

Building	Floor	Room	Location	
Main Building	Tenth Floor	Corridor 2	Walls	
Description				
MATERIAL ASSESSMENT				SCORE
Product Type	Paint	Extent of Damage	Good condition	-
Asbestos Type	No Asbestos Detected	Surface Treatment	Sealed (1)	
PRIORITY ASSESSMENT				SCORE
Occupant Activity	Not Applicable	Extent / Amount	13.00 m2	-
Accessibility	Easily disturbed	Location	Not Applicable	
Avg Time in Use	Not Applicable	Frequency of Use	Not Applicable	
No. of Occupants	Not Applicable	Secondary Activity	Not Applicable	
Maintenance	Not Applicable	Maintenance Frequency	Not Applicable	
MANAGEMENT ACTION				SCORE
Recommendation	NO ACTION REQUIRED			-
Recommendation Due		Next Inspection	None	
Apply Labels	No	Permit to Work Required	No	
Survey Type	Management	Lead Surveyor	Jane Openshaw	
Survey Date	20 Mar 2012	UKAS Laboratory	NOT SAMPLED (Cross Referenced)	
Site Reference	113070000A	Licensed Material	N/A

No Asbestos Presumed in Sample

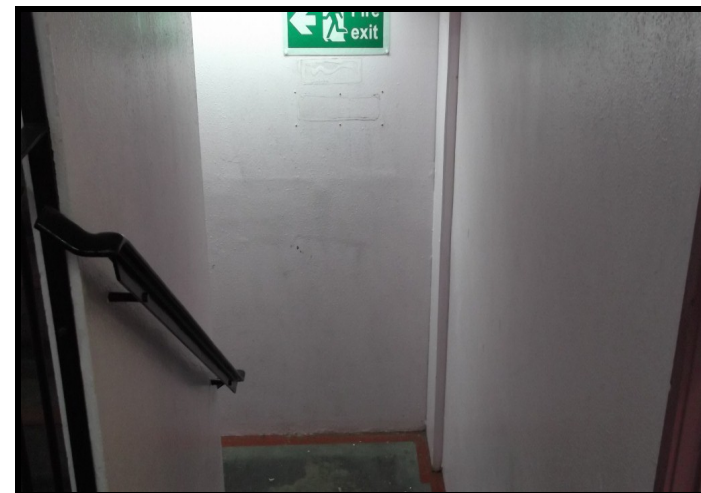
SAMPLE REFERENCE 018

Building	Floor	Room	Location	
Main Building	Tenth Floor	Stairs	Walls	
Description	No access into lift meter room			
MATERIAL ASSESSMENT				SCORE
Product Type	Paint	Extent of Damage	Low damage	-
Asbestos Type	No Asbestos Detected	Surface Treatment	Sealed (1)	
PRIORITY ASSESSMENT				SCORE
Occupant Activity	Not Applicable	Extent / Amount	30.00 m2	-
Accessibility	Easily disturbed	Location	Not Applicable	
Avg Time in Use	Not Applicable	Frequency of Use	Not Applicable	
No. of Occupants	Not Applicable	Secondary Activity	Not Applicable	
Maintenance	Not Applicable	Maintenance Frequency	Not Applicable	
MANAGEMENT ACTION				SCORE
Recommendation	NO ACTION REQUIRED			-
Recommendation Due		Next Inspection	None	
Apply Labels	No	Permit to Work Required	No	
Survey Type	Management	Lead Surveyor	Jane Openshaw	
Survey Date	20 Mar 2012	UKAS Laboratory	NOT SAMPLED (Cross Referenced)	
Site Reference	I13070000A	Licensed Material	N/A

No Asbestos Presumed in Sample

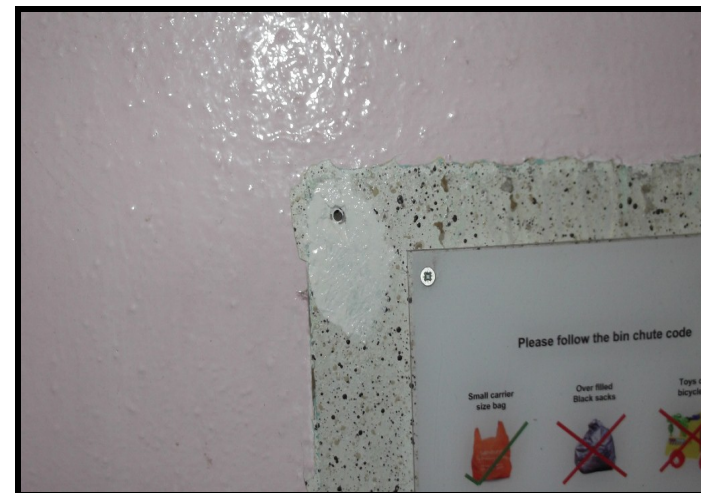
SAMPLE REFERENCE 021

Building	Floor	Room	Location	
Main Building	Ninth Floor	Bin Chute	Wall	
Description				
MATERIAL ASSESSMENT				SCORE
Product Type	Paint	Extent of Damage	Low damage	-
Asbestos Type	No Asbestos Detected	Surface Treatment	Sealed (1)	
PRIORITY ASSESSMENT				SCORE
Occupant Activity	Not Applicable	Extent / Amount	15.00 m2	-
Accessibility	Easily disturbed	Location	Not Applicable	
Avg Time in Use	Not Applicable	Frequency of Use	Not Applicable	
No. of Occupants	Not Applicable	Secondary Activity	Not Applicable	
Maintenance	Not Applicable	Maintenance Frequency	Not Applicable	
MANAGEMENT ACTION				SCORE
Recommendation	NO ACTION REQUIRED			-
Recommendation Due		Next Inspection	None	
Apply Labels	No	Permit to Work Required	No	
Survey Type	Management	Lead Surveyor	Jane Openshaw	
Survey Date	20 Mar 2012	UKAS Laboratory	DMW Environmental Safety Ltd / [P-96019]	
Site Reference	113070000A	Licensed Material	N/A

Asbestos not detected in Sample

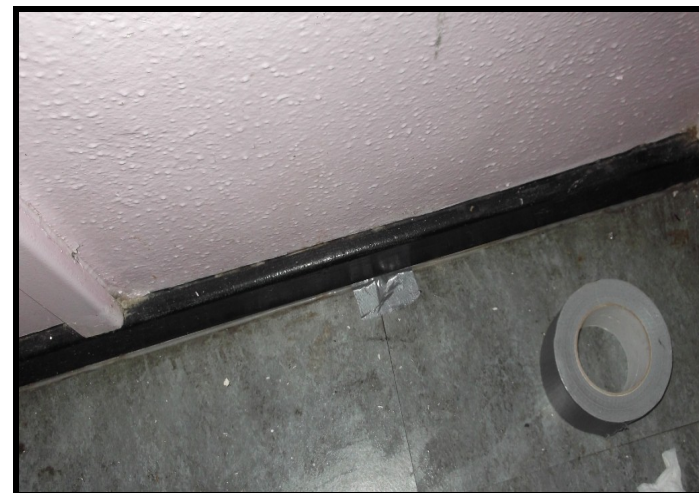
SAMPLE REFERENCE 023

Building	Floor	Room	Location	
Main Building	Ninth Floor	Bin Chute	Floor	
Description	Blue			
MATERIAL ASSESSMENT				SCORE
Product Type	Paper	Extent of Damage	Good condition	-
Asbestos Type	No Asbestos Detected	Surface Treatment	Sealed (1)	
PRIORITY ASSESSMENT				SCORE
Occupant Activity	Not Applicable	Extent / Amount	5.00 m2	-
Accessibility	Unlikely to be disturbed	Location	Not Applicable	
Avg Time in Use	Not Applicable	Frequency of Use	Not Applicable	
No. of Occupants	Not Applicable	Secondary Activity	Not Applicable	
Maintenance	Not Applicable	Maintenance Frequency	Not Applicable	
MANAGEMENT ACTION				SCORE
Recommendation	NO ACTION REQUIRED			-
Recommendation Due		Next Inspection	None	
Apply Labels	No	Permit to Work Required	No	
Survey Type	Management	Lead Surveyor	Jane Openshaw	
Survey Date	20 Mar 2012	UKAS Laboratory	DMW Environmental Safety Ltd / [P-96019]	
Site Reference	I13070000A	Licensed Material	N/A

Asbestos not detected in Sample

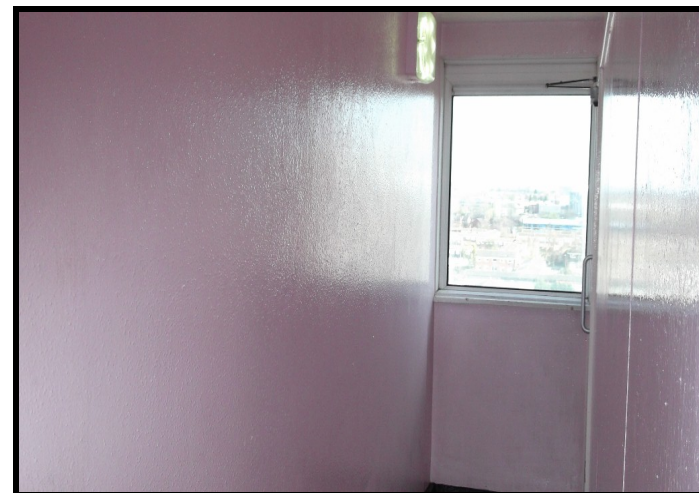
SAMPLE REFERENCE 024

Building	Floor	Room	Location	
Main Building	Ninth Floor	Corridor I	Wall	
Description	Timber boxing adjacent to flat doors			
MATERIAL ASSESSMENT				SCORE
Product Type	Paint	Extent of Damage	Good condition	-
Asbestos Type	No Asbestos Detected	Surface Treatment	Sealed (I)	
PRIORITY ASSESSMENT				SCORE
Occupant Activity	Not Applicable	Extent / Amount	10.00 m2	-
Accessibility	Easily disturbed	Location	Not Applicable	
Avg Time in Use	Not Applicable	Frequency of Use	Not Applicable	
No. of Occupants	Not Applicable	Secondary Activity	Not Applicable	
Maintenance	Not Applicable	Maintenance Frequency	Not Applicable	
MANAGEMENT ACTION				SCORE
Recommendation	NO ACTION REQUIRED			-
Recommendation Due		Next Inspection	None	
Apply Labels	No	Permit to Work Required	No	
Survey Type	Management	Lead Surveyor	Jane Openshaw	
Survey Date	20 Mar 2012	UKAS Laboratory	NOT SAMPLED (Cross Referenced)	
Site Reference	I13070000A	Licensed Material	N/A

No Asbestos Presumed in Sample

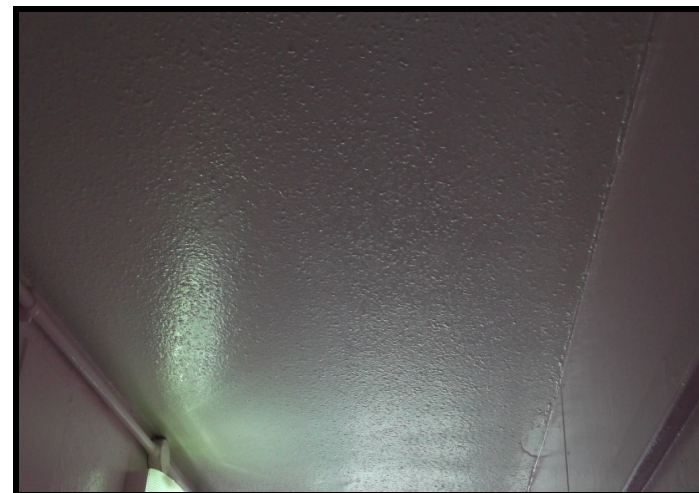
SAMPLE REFERENCE 025

Building	Floor	Room	Location	
Main Building	Ninth Floor	Corridor I	Ceiling	
Description	Timber boxing adjacent to flat doors			
MATERIAL ASSESSMENT				SCORE
Product Type	Paint	Extent of Damage	Good condition	-
Asbestos Type	No Asbestos Detected	Surface Treatment	Sealed (I)	
PRIORITY ASSESSMENT				SCORE
Occupant Activity	Not Applicable	Extent / Amount	5.00 m2	-
Accessibility	Occasionally disturb	Location	Not Applicable	
Avg Time in Use	Not Applicable	Frequency of Use	Not Applicable	
No. of Occupants	Not Applicable	Secondary Activity	Not Applicable	
Maintenance	Not Applicable	Maintenance Frequency	Not Applicable	
MANAGEMENT ACTION				SCORE
Recommendation	NO ACTION REQUIRED			-
Recommendation Due		Next Inspection	None	
Apply Labels	No	Permit to Work Required	No	
Survey Type	Management	Lead Surveyor	Jane Openshaw	
Survey Date	20 Mar 2012	UKAS Laboratory	NOT SAMPLED (Cross Referenced)	
Site Reference	I13070000A	Licensed Material	N/A

No Asbestos Presumed in Sample

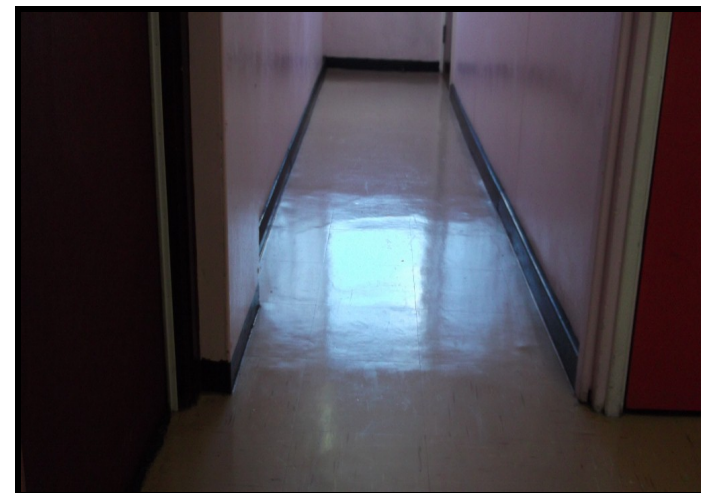
SAMPLE REFERENCE 026

Building	Floor	Room	Location	
Main Building	Ninth Floor	Corridor I	Floor	
Description	Buff, Timber boxing adjacent to flat doors			
MATERIAL ASSESSMENT				SCORE
Product Type	Floor Tiles	Extent of Damage	Good condition	-
Asbestos Type	No Asbestos Detected	Surface Treatment	Composite materials	
PRIORITY ASSESSMENT				SCORE
Occupant Activity	Not Applicable	Extent / Amount	7.00 m2	-
Accessibility	Routinely disturbed	Location	Not Applicable	
Avg Time in Use	Not Applicable	Frequency of Use	Not Applicable	
No. of Occupants	Not Applicable	Secondary Activity	Not Applicable	
Maintenance	Not Applicable	Maintenance Frequency	Not Applicable	
MANAGEMENT ACTION				SCORE
Recommendation	NO ACTION REQUIRED			-
Recommendation Due		Next Inspection	None	
Apply Labels	No	Permit to Work Required	No	
Survey Type	Management	Lead Surveyor	Jane Openshaw	
Survey Date	20 Mar 2012	UKAS Laboratory	NOT SAMPLED (Cross Referenced)	
Site Reference	I13070000A	Licensed Material	N/A

No Asbestos Presumed in Sample

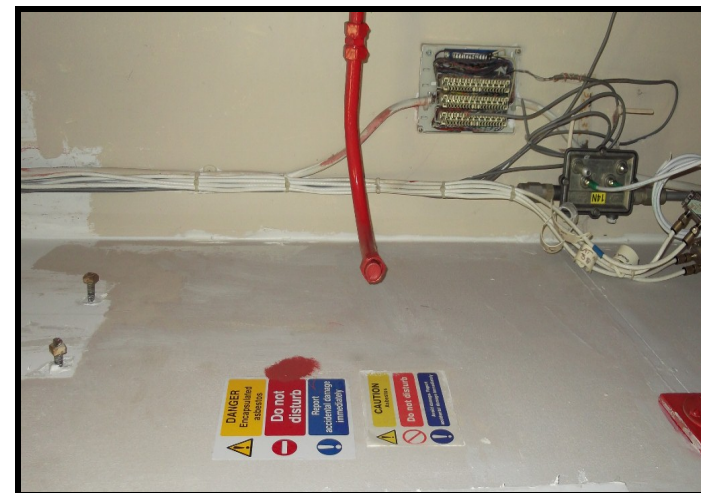
SAMPLE REFERENCE 027

Building	Floor	Room	Location	
Main Building	Ninth Floor	Dry Riser	Ceiling And Walls	
Description				
MATERIAL ASSESSMENT				SCORE
Product Type	Board	Extent of Damage	Good condition	5
Asbestos Type	Amosite / Chrysotile	Surface Treatment	Sealed Board (Encapsulated)	
PRIORITY ASSESSMENT				SCORE
Occupant Activity	Not Applicable	Extent / Amount	8.00 m2	1
Accessibility	Occasionally disturb	Location	Not Applicable	
Avg Time in Use	Not Applicable	Frequency of Use	Not Applicable	
No. of Occupants	Not Applicable	Secondary Activity	Not Applicable	
Maintenance	Not Applicable	Maintenance Frequency	Not Applicable	
MANAGEMENT ACTION				SCORE
Recommendation	LABEL & MONITOR			6
Recommendation Due		Next Inspection	20 Sep 2012	
Apply Labels	No	Permit to Work Required	No	
Survey Type	Management	Lead Surveyor	Jane Openshaw	
Survey Date	20 Mar 2012	UKAS Laboratory	NOT SAMPLED (Cross Referenced)	
Site Reference	I13070000A	Licensed Material	Yes

Asbestos Presumed in Sample

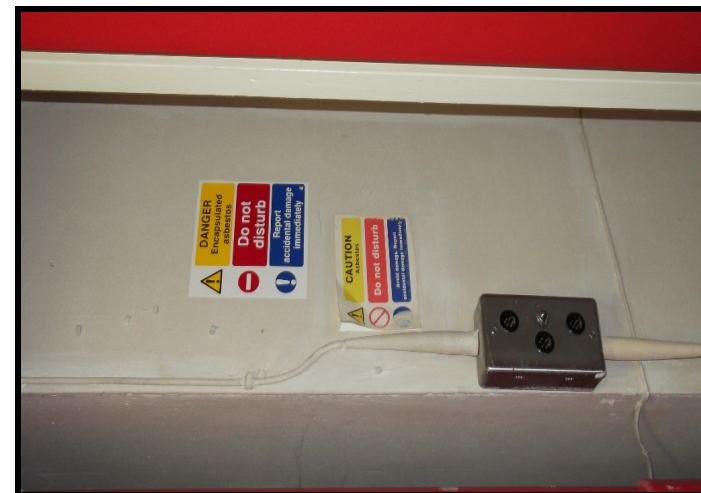
SAMPLE REFERENCE 028

Building	Floor	Room	Location	
Main Building	Ninth Floor	Dry Riser	Boxing	
Description	To boxing in			
MATERIAL ASSESSMENT				SCORE
Product Type	Board	Extent of Damage	Good condition	5
Asbestos Type	Amosite / Chrysotile	Surface Treatment	Sealed Board (Encapsulated)	
PRIORITY ASSESSMENT				SCORE
Occupant Activity	Not Applicable	Extent / Amount	5.00 m2	0
Accessibility	Unlikely to be disturbed	Location	Not Applicable	
Avg Time in Use	Not Applicable	Frequency of Use	Not Applicable	
No. of Occupants	Not Applicable	Secondary Activity	Not Applicable	
Maintenance	Not Applicable	Maintenance Frequency	Not Applicable	
MANAGEMENT ACTION				SCORE
Recommendation	LABEL & MONITOR			5
Recommendation Due		Next Inspection	20 Sep 2012	
Apply Labels	No	Permit to Work Required	No	
Survey Type	Management	Lead Surveyor	Jane Openshaw	
Survey Date	20 Mar 2012	UKAS Laboratory	NOT SAMPLED (Cross Referenced)	
Site Reference	I13070000A	Licensed Material	Yes

Asbestos Presumed in Sample

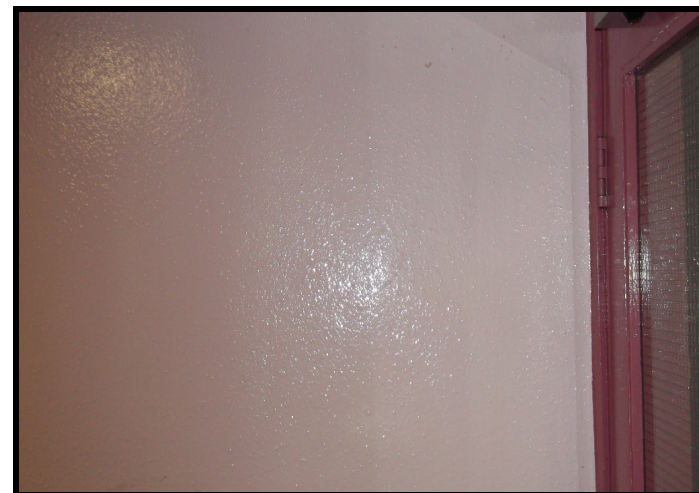
SAMPLE REFERENCE 030

Building	Floor	Room	Location	
Main Building	Ninth Floor	Lobby	Walls	
Description				
MATERIAL ASSESSMENT				SCORE
Product Type	Paint	Extent of Damage	Good condition	-
Asbestos Type	No Asbestos Detected	Surface Treatment	Sealed (1)	
PRIORITY ASSESSMENT				SCORE
Occupant Activity	Not Applicable	Extent / Amount	13.00 m2	-
Accessibility	Easily disturbed	Location	Not Applicable	
Avg Time in Use	Not Applicable	Frequency of Use	Not Applicable	
No. of Occupants	Not Applicable	Secondary Activity	Not Applicable	
Maintenance	Not Applicable	Maintenance Frequency	Not Applicable	
MANAGEMENT ACTION				SCORE
Recommendation	NO ACTION REQUIRED			-
Recommendation Due		Next Inspection	None	
Apply Labels	No	Permit to Work Required	No	
Survey Type	Management	Lead Surveyor	Jane Openshaw	
Survey Date	20 Mar 2012	UKAS Laboratory	NOT SAMPLED (Cross Referenced)	
Site Reference	113070000A	Licensed Material	N/A

No Asbestos Presumed in Sample

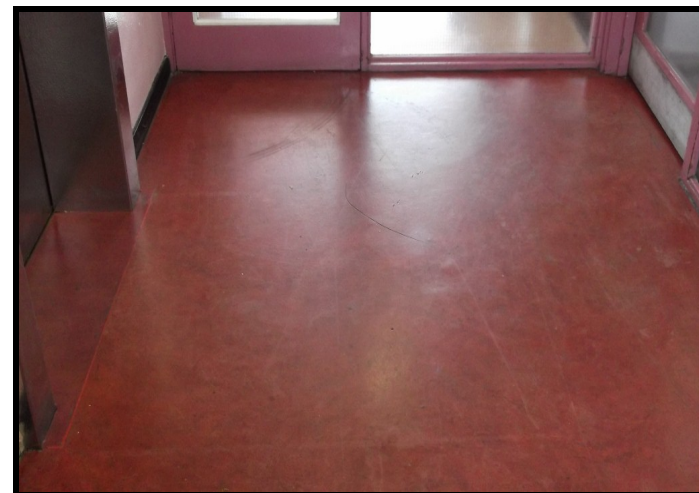
SAMPLE REFERENCE 031

Building	Floor	Room	Location	
Main Building	Ninth Floor	Lobby	Floor	
Description	Red			
MATERIAL ASSESSMENT				SCORE
Product Type	Paper	Extent of Damage	Low damage	-
Asbestos Type	No Asbestos Detected	Surface Treatment	Sealed (1)	
PRIORITY ASSESSMENT				SCORE
Occupant Activity	Not Applicable	Extent / Amount	8.00 m2	-
Accessibility	Unlikely to be disturbed	Location	Not Applicable	
Avg Time in Use	Not Applicable	Frequency of Use	Not Applicable	
No. of Occupants	Not Applicable	Secondary Activity	Not Applicable	
Maintenance	Not Applicable	Maintenance Frequency	Not Applicable	
MANAGEMENT ACTION				SCORE
Recommendation	NO ACTION REQUIRED			-
Recommendation Due		Next Inspection	None	
Apply Labels	No	Permit to Work Required	No	
Survey Type	Management	Lead Surveyor	Jane Openshaw	
Survey Date	20 Mar 2012	UKAS Laboratory	NOT SAMPLED (Cross Referenced)	
Site Reference	I13070000A	Licensed Material	N/A

No Asbestos Presumed in Sample

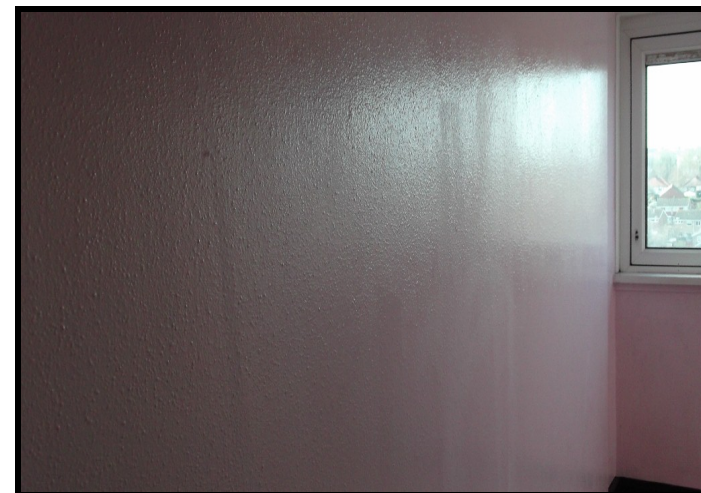
SAMPLE REFERENCE 032

Building	Floor	Room	Location	
Main Building	Ninth Floor	Corridor 2	Walls	
Description				
MATERIAL ASSESSMENT				SCORE
Product Type	Paint	Extent of Damage	Good condition	-
Asbestos Type	No Asbestos Detected	Surface Treatment	Sealed (1)	
PRIORITY ASSESSMENT				SCORE
Occupant Activity	Not Applicable	Extent / Amount	13.00 m2	-
Accessibility	Easily disturbed	Location	Not Applicable	
Avg Time in Use	Not Applicable	Frequency of Use	Not Applicable	
No. of Occupants	Not Applicable	Secondary Activity	Not Applicable	
Maintenance	Not Applicable	Maintenance Frequency	Not Applicable	
MANAGEMENT ACTION				SCORE
Recommendation	NO ACTION REQUIRED			-
Recommendation Due		Next Inspection	None	
Apply Labels	No	Permit to Work Required	No	
Survey Type	Management	Lead Surveyor	Jane Openshaw	
Survey Date	20 Mar 2012	UKAS Laboratory	NOT SAMPLED (Cross Referenced)	
Site Reference	113070000A	Licensed Material	N/A

No Asbestos Presumed in Sample

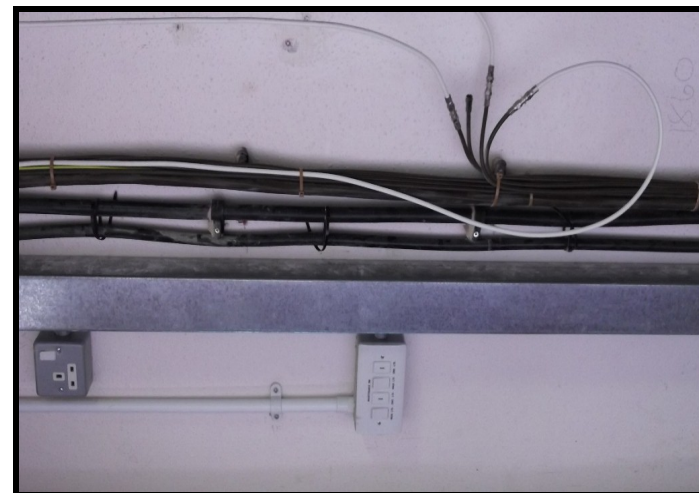
SAMPLE REFERENCE 034

Building	Floor	Room	Location	
Main Building	Ninth Floor	Service Riser	Walls	
Description				
MATERIAL ASSESSMENT				SCORE
Product Type	Paint	Extent of Damage	Good condition	-
Asbestos Type	No Asbestos Detected	Surface Treatment	Sealed (1)	
PRIORITY ASSESSMENT				SCORE
Occupant Activity	Not Applicable	Extent / Amount	3.00 m2	-
Accessibility	Easily disturbed	Location	Not Applicable	
Avg Time in Use	Not Applicable	Frequency of Use	Not Applicable	
No. of Occupants	Not Applicable	Secondary Activity	Not Applicable	
Maintenance	Not Applicable	Maintenance Frequency	Not Applicable	
MANAGEMENT ACTION				SCORE
Recommendation	NO ACTION REQUIRED			-
Recommendation Due		Next Inspection	None	
Apply Labels	No	Permit to Work Required	No	
Survey Type	Management	Lead Surveyor	Jane Openshaw	
Survey Date	20 Mar 2012	UKAS Laboratory	NOT SAMPLED (Cross Referenced)	
Site Reference	I13070000A	Licensed Material	N/A

No Asbestos Presumed in Sample

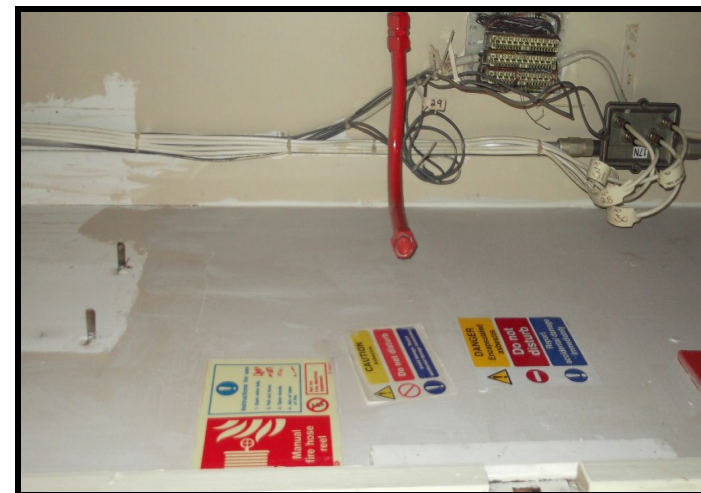
SAMPLE REFERENCE 058

Asbestos Presumed in Sample

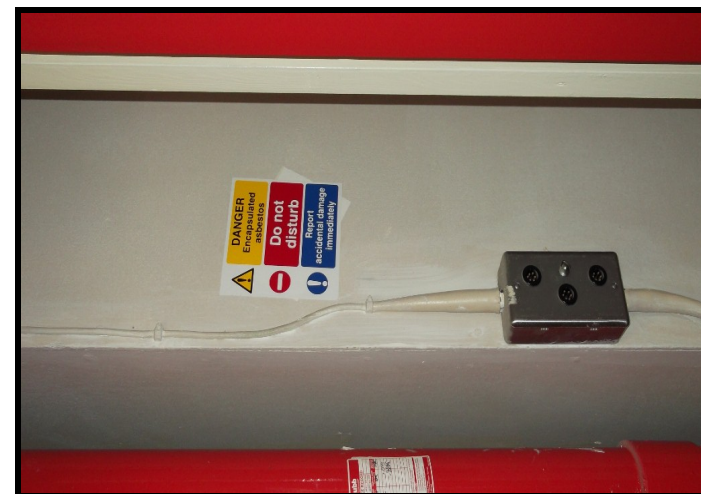
SAMPLE REFERENCE 059

Asbestos Presumed in Sample

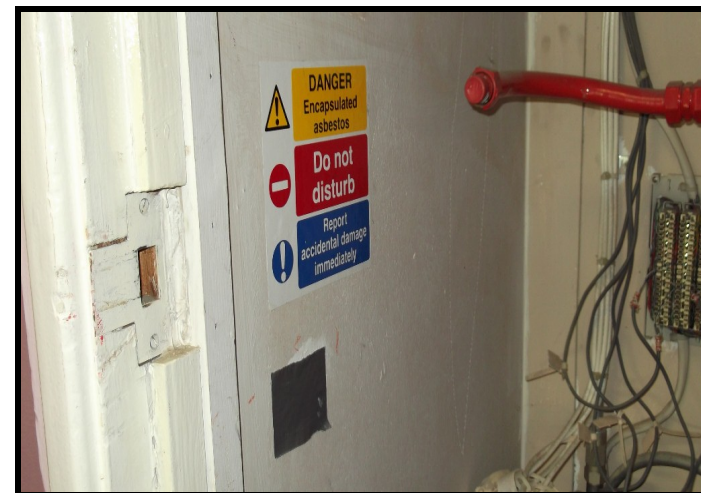
SAMPLE REFERENCE 087

Asbestos detected in Sample

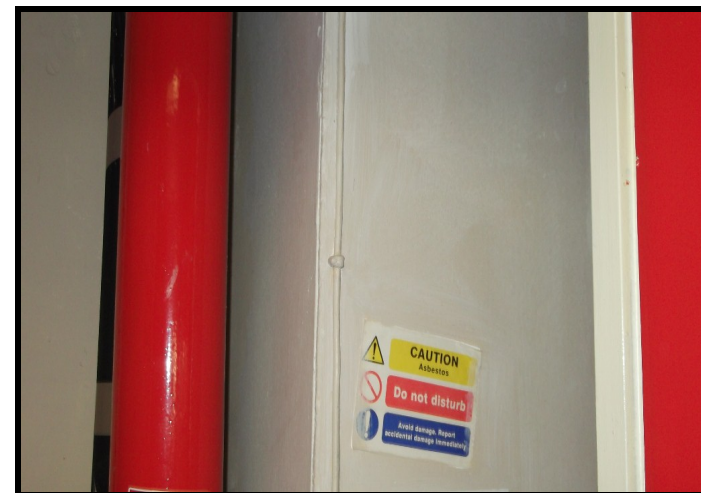
SAMPLE REFERENCE 103

Asbestos Presumed in Sample

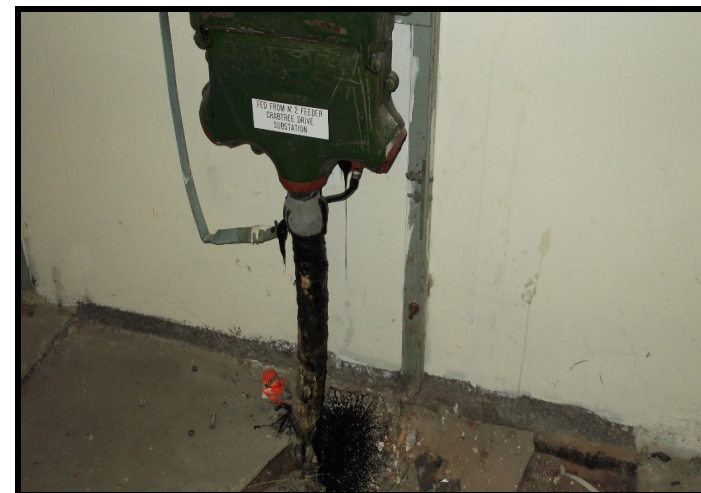
SAMPLE REFERENCE 160

Asbestos Presumed in Sample
