Management with Targeted Refurbishment Survey

Solihull Community Housing

1-59 Bedford House
Sanda Croft
Chelmsley Wood
Solihull
B36 0NG
United Kingdom

12th June 2021

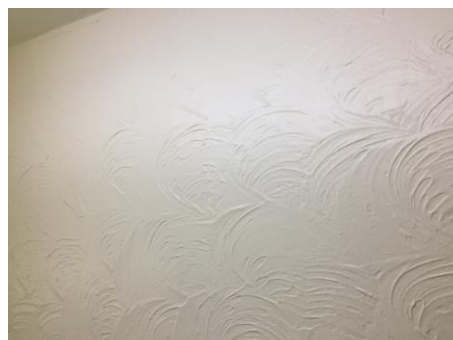
Swirl pattern textured coating.

The material was seen to be in fair condition at the time of the initial inspection.

The condition of the material should be managed by a competent person/company and its presence made aware to those at risk, as part of a Control of Asbestos Regulations (CAR) 2012 compliant management strategy.

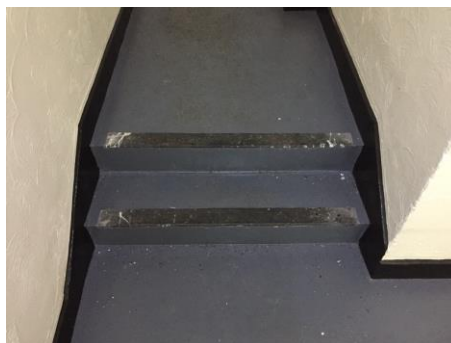
Resin nosing to edge of stairs.

The material was seen to be in fair condition at the time of the initial inspection.

The condition of the material should be managed by a competent person/company and its presence made aware to those at risk, as part of a Control of Asbestos Regulations (CAR) 2012 compliant management strategy.

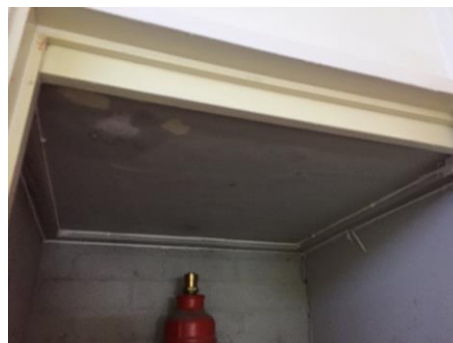
Insulating board panel ceiling.

The material was seen to be in fair condition at the time of the initial inspection.

The condition of the material should be managed by a competent person/company and its presence made aware to those at risk, as part of a Control of Asbestos Regulations (CAR) 2012 compliant management strategy.

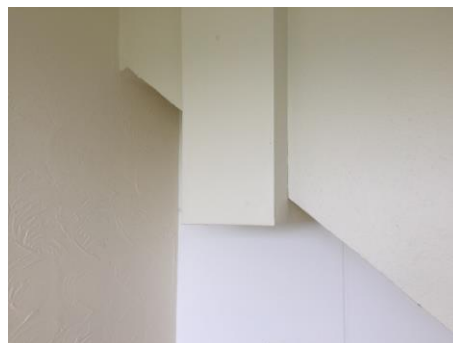
Spatter pattern textured coating beneath more modern swirl pattern texture.

The material was seen to be in fair condition at the time of the initial inspection.

The condition of the material should be managed by a competent person/company and its presence made aware to those at risk, as part of a Control of Asbestos Regulations (CAR) 2012 compliant management strategy.

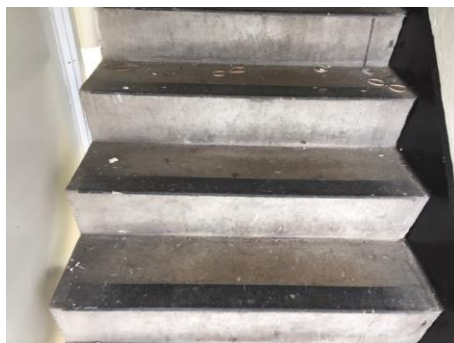
Resin nosing to edge of stairs.

The material was seen to be in fair condition at the time of the initial inspection.

The condition of the material should be managed by a competent person/company and its presence made aware to those at risk, as part of a Control of Asbestos Regulations (CAR) 2012 compliant management strategy.

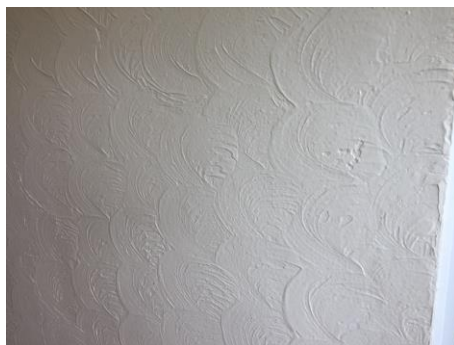
Spatter pattern textured coating beneath more modern swirl pattern texture.

The material was seen to be in fair condition at the time of the initial inspection.

The condition of the material should be managed by a competent person/company and its presence made aware to those at risk, as part of a Control of Asbestos Regulations (CAR) 2012 compliant management strategy.

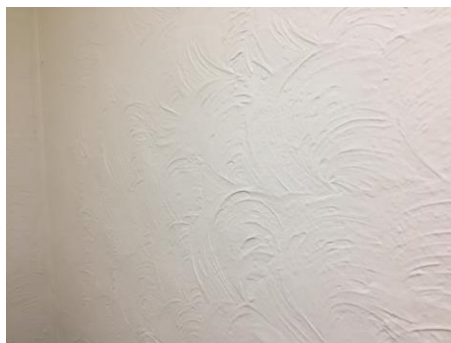
Spatter pattern textured coating beneath more modern swirl pattern texture.

The material was seen to be in fair condition at the time of the initial inspection.

The condition of the material should be managed by a competent person/company and its presence made aware to those at risk, as part of a Control of Asbestos Regulations (CAR) 2012 compliant management strategy.

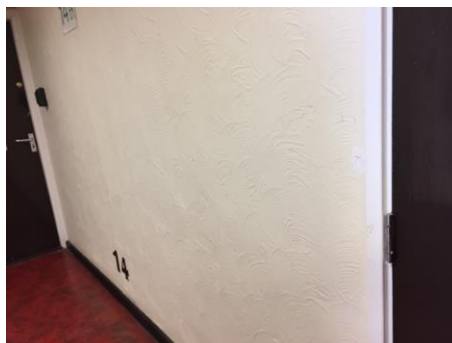
Spatter pattern textured coating beneath more modern swirl pattern texture.

The material was seen to be in fair condition at the time of the initial inspection.

The condition of the material should be managed by a competent person/company and its presence made aware to those at risk, as part of a Control of Asbestos Regulations (CAR) 2012 compliant management strategy.

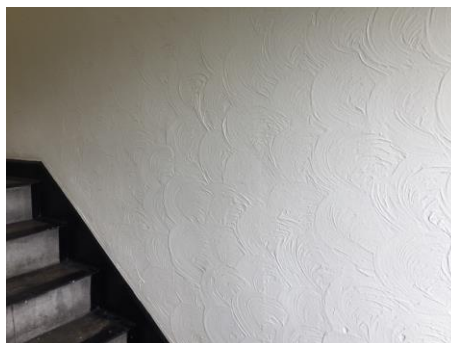
Spatter pattern textured coating beneath more modern swirl pattern texture.

The material was seen to be in fair condition at the time of the initial inspection.

The condition of the material should be managed by a competent person/company and its presence made aware to those at risk, as part of a Control of Asbestos Regulations (CAR) 2012 compliant management strategy.

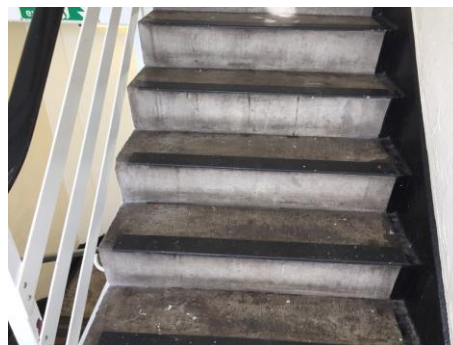
Resin nosing to edge of stairs.

The material was seen to be in fair condition at the time of the initial inspection.

The condition of the material should be managed by a competent person/company and its presence made aware to those at risk, as part of a Control of Asbestos Regulations (CAR) 2012 compliant management strategy.

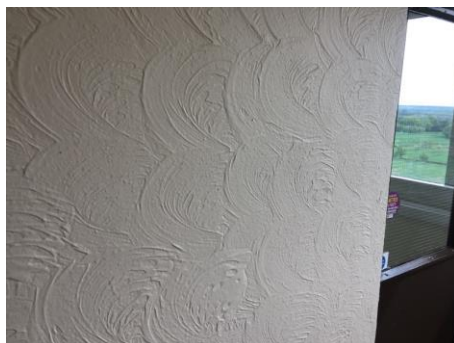
Spatter pattern textured coating beneath more modern swirl pattern texture.

The material was seen to be in fair condition at the time of the initial inspection.

The condition of the material should be managed by a competent person/company and its presence made aware to those at risk, as part of a Control of Asbestos Regulations (CAR) 2012 compliant management strategy.

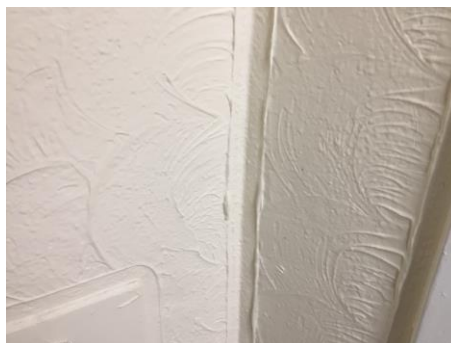
Spatter pattern textured coating beneath more modern swirl pattern texture.

The material was seen to be in fair condition at the time of the initial inspection.

The condition of the material should be managed by a competent person/company and its presence made aware to those at risk, as part of a Control of Asbestos Regulations (CAR) 2012 compliant management strategy.

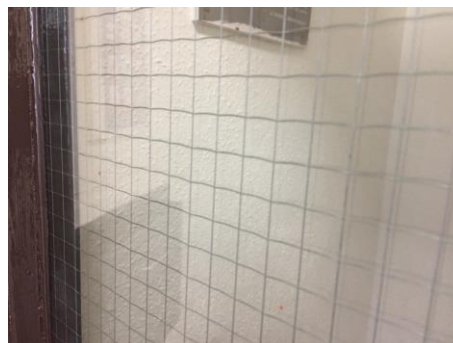
Spatter pattern textured coating beneath more modern swirl pattern texture. Cloned due to the TC being clearly visible through window.

The material was seen to be in fair condition at the time of the initial inspection.

The condition of the material should be managed by a competent person/company and its presence made aware to those at risk, as part of a Control of Asbestos Regulations (CAR) 2012 compliant management strategy.

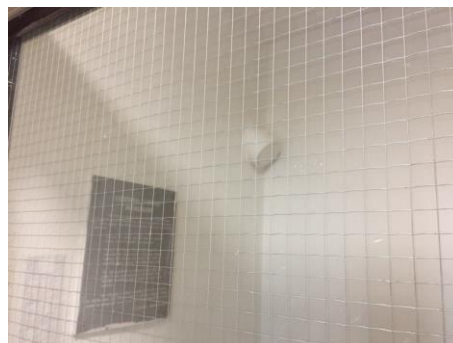
Possible cement flue cutoff from previously removed incinerator. Clearly visible through window.

It has been noted in previous experience that this type of material has been known to contain asbestos.

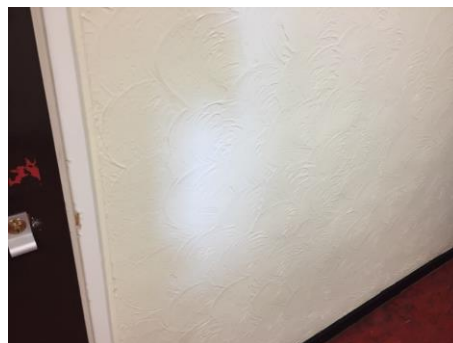
Spatter pattern textured coating beneath more modern swirl pattern texture.

The material was seen to be in fair condition at the time of the initial inspection.

The condition of the material should be managed by a competent person/company and its presence made aware to those at risk, as part of a Control of Asbestos Regulations (CAR) 2012 compliant management strategy.

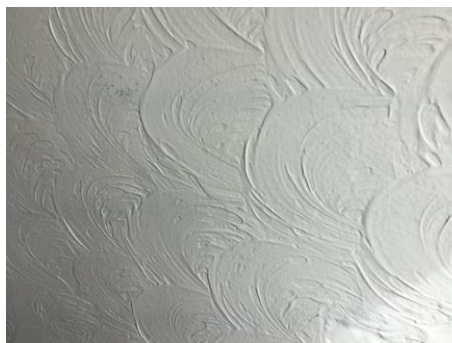
Spatter pattern textured coating beneath more modern swirl pattern texture.

The material was seen to be in fair condition at the time of the initial inspection.

The condition of the material should be managed by a competent person/company and its presence made aware to those at risk, as part of a Control of Asbestos Regulations (CAR) 2012 compliant management strategy.

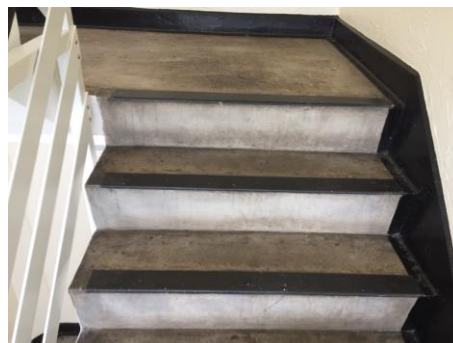
Resin nosing to edge of stairs.

The material was seen to be in fair condition at the time of the initial inspection.

The condition of the material should be managed by a competent person/company and its presence made aware to those at risk, as part of a Control of Asbestos Regulations (CAR) 2012 compliant management strategy.

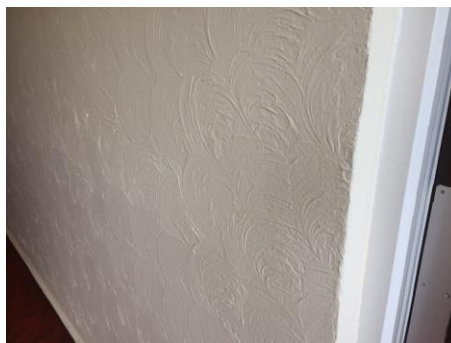
Spatter pattern textured coating beneath more modern swirl pattern texture.

The material was seen to be in fair condition at the time of the initial inspection.

The condition of the material should be managed by a competent person/company and its presence made aware to those at risk, as part of a Control of Asbestos Regulations (CAR) 2012 compliant management strategy.

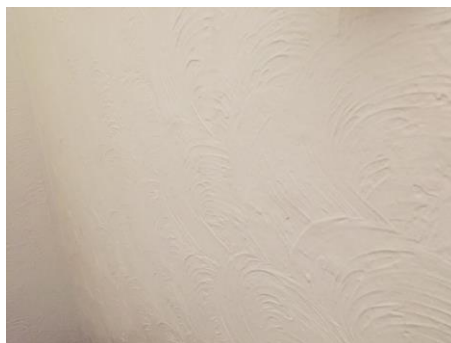
Spatter pattern textured coating beneath more modern swirl pattern texture.

The material was seen to be in fair condition at the time of the initial inspection.

The condition of the material should be managed by a competent person/company and its presence made aware to those at risk, as part of a Control of Asbestos Regulations (CAR) 2012 compliant management strategy.

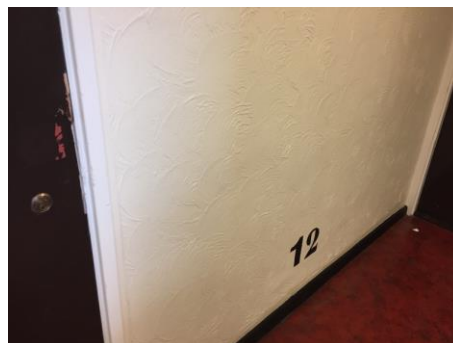
Spatter pattern textured coating beneath more modern swirl pattern texture.

The material was seen to be in fair condition at the time of the initial inspection.

The condition of the material should be managed by a competent person/company and its presence made aware to those at risk, as part of a Control of Asbestos Regulations (CAR) 2012 compliant management strategy.

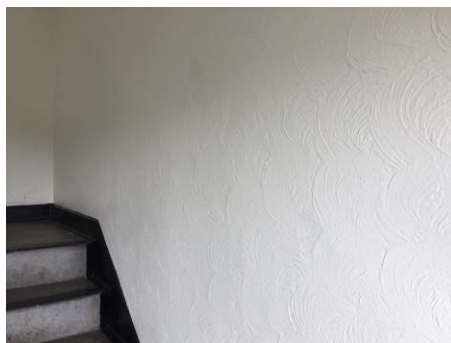
Spatter pattern textured coating beneath more modern swirl pattern texture.

The material was seen to be in fair condition at the time of the initial inspection.

The condition of the material should be managed by a competent person/company and its presence made aware to those at risk, as part of a Control of Asbestos Regulations (CAR) 2012 compliant management strategy.

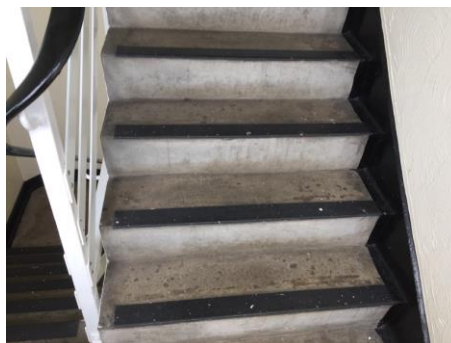
Resin nosing to edge of stairs.

The material was seen to be in fair condition at the time of the initial inspection.

The condition of the material should be managed by a competent person/company and its presence made aware to those at risk, as part of a Control of Asbestos Regulations (CAR) 2012 compliant management strategy.

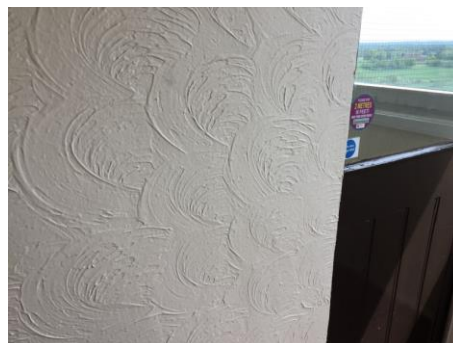
Spatter pattern textured coating beneath more modern swirl pattern texture.

The material was seen to be in fair condition at the time of the initial inspection.

The condition of the material should be managed by a competent person/company and its presence made aware to those at risk, as part of a Control of Asbestos Regulations (CAR) 2012 compliant management strategy.

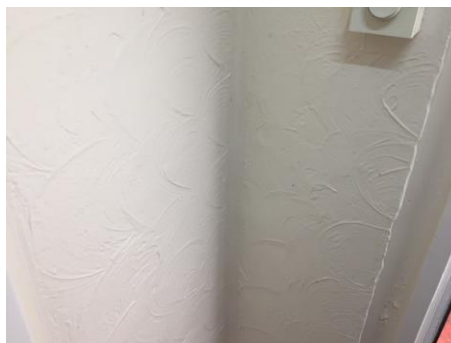
Spatter pattern textured coating beneath more modern swirl pattern texture.

The material was seen to be in fair condition at the time of the initial inspection.

The condition of the material should be managed by a competent person/company and its presence made aware to those at risk, as part of a Control of Asbestos Regulations (CAR) 2012 compliant management strategy.

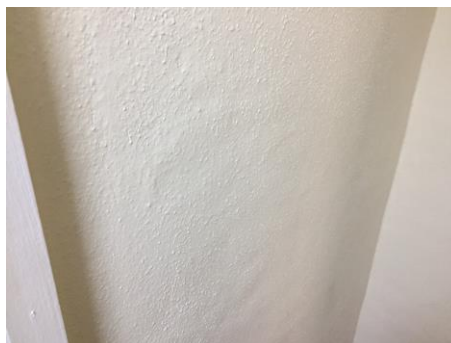
Spatter pattern textured coating.

The material was seen to be in fair condition at the time of the initial inspection.

The condition of the material should be managed by a competent person/company and its presence made aware to those at risk, as part of a Control of Asbestos Regulations (CAR) 2012 compliant management strategy.

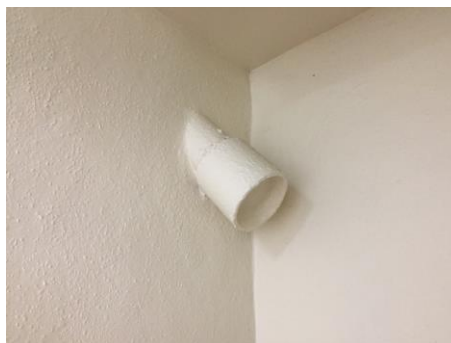
Cement flue cutoff from previously removed incinerator.

It has been noted in previous experience that this type of material has been known to contain asbestos.

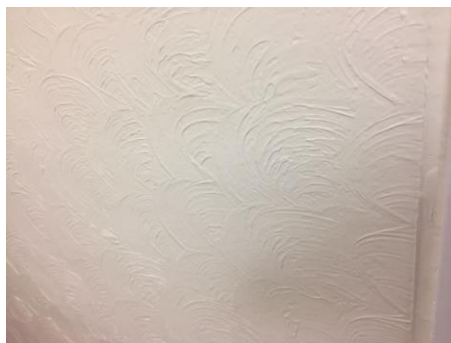
Spatter pattern textured coating beneath more modern swirl pattern texture.

The material was seen to be in fair condition at the time of the initial inspection.

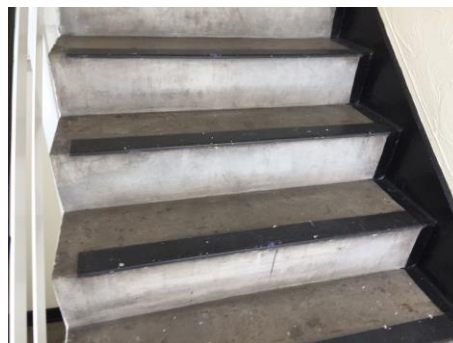
Resin nosing to edge of stairs.

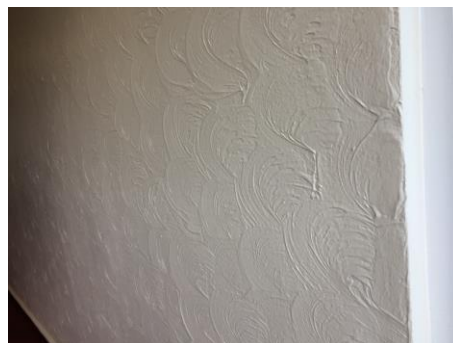
Spatter pattern textured coating beneath more modern swirl pattern texture.

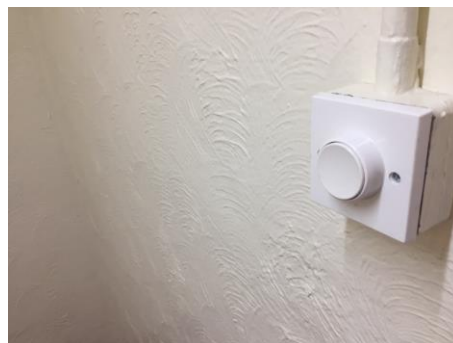
Spatter pattern textured coating beneath more modern swirl pattern texture.

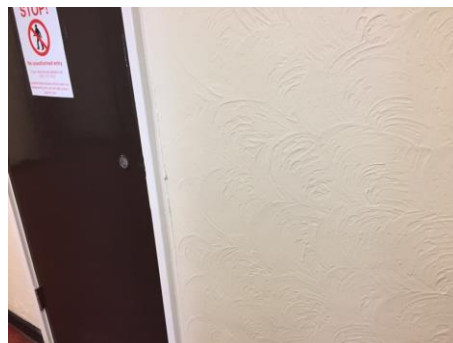
Spatter pattern textured coating beneath more modern swirl pattern texture.

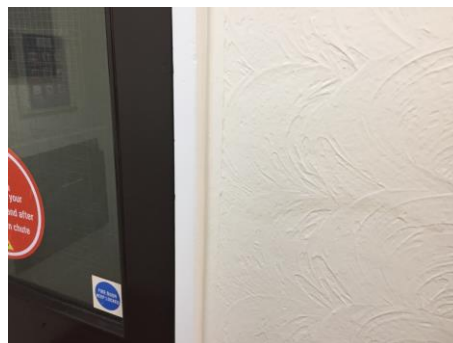
Spatter pattern textured coating beneath more modern swirl pattern texture.

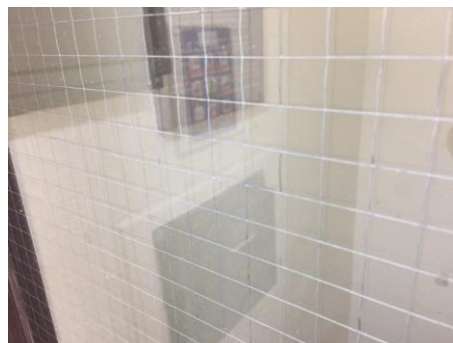
Spatter pattern textured coating. Visible through window.

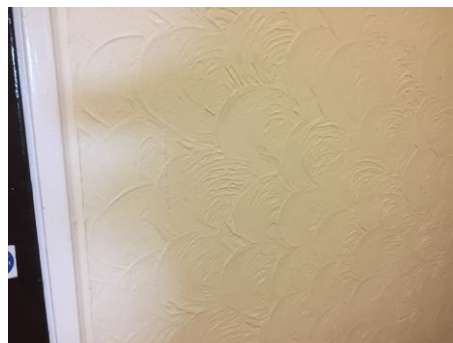
Spatter pattern textured coating beneath more modern swirl pattern texture.

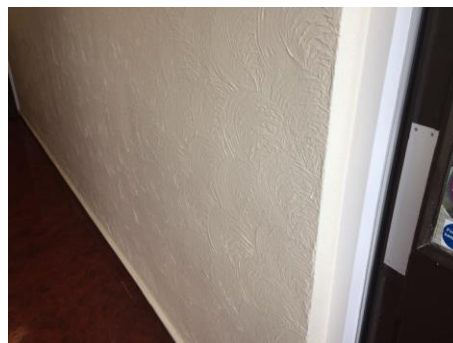
Spatter pattern textured coating beneath more modern swirl pattern texture.

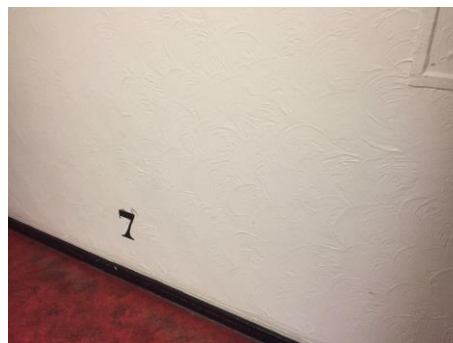
Spatter pattern textured coating beneath more modern swirl pattern texture.

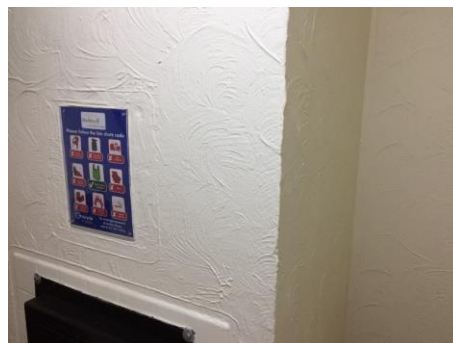
Spatter pattern textured coating beneath more modern swirl pattern texture.

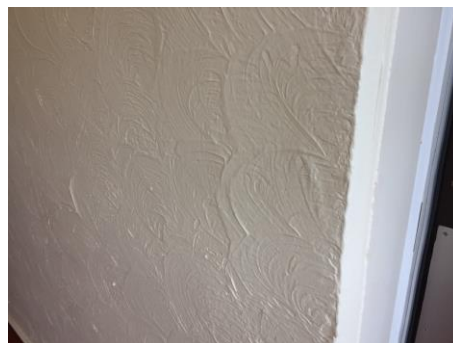
Spatter pattern textured coating beneath more modern swirl pattern texture.

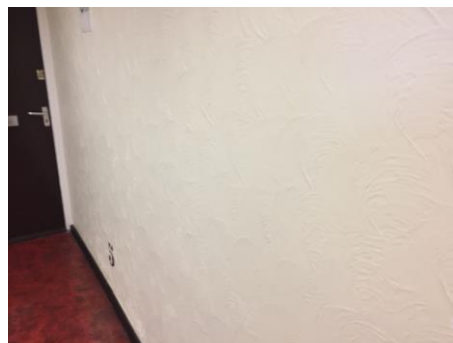
Spatter pattern textured coating beneath more modern swirl pattern texture.

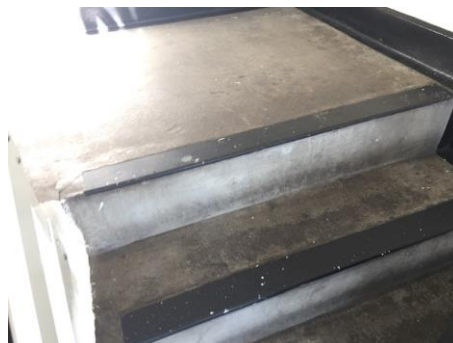
Resin nosing to edge of stairs.

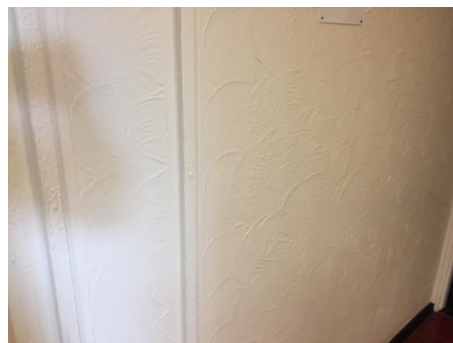
Spatter pattern textured coating beneath more modern swirl pattern texture.

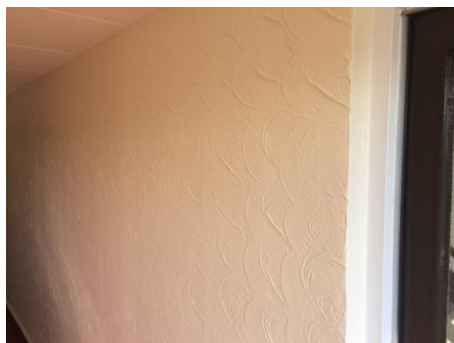
Spatter pattern textured coating beneath more modern swirl pattern texture.

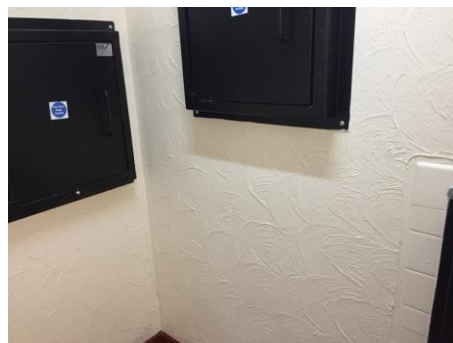
Spatter pattern textured coating beneath more modern swirl pattern texture.

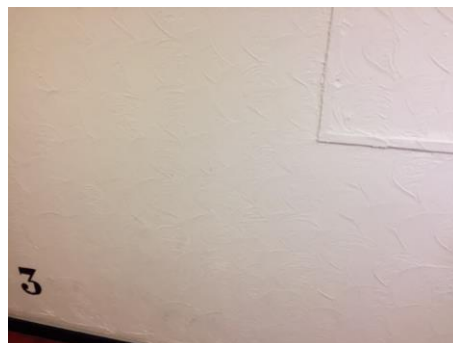
Spatter pattern textured coating beneath more modern swirl pattern texture.

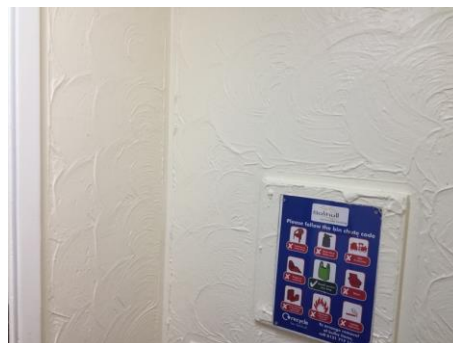
Spatter pattern textured coating beneath more modern swirl pattern texture.

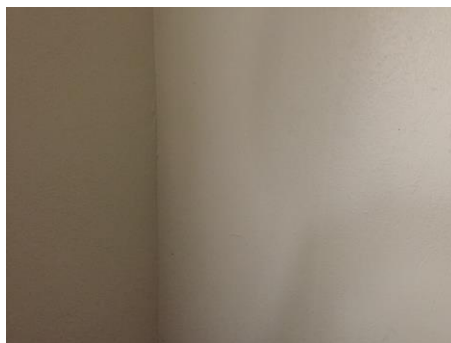
Spatter pattern textured coating that is found beneath swirl in other areas.

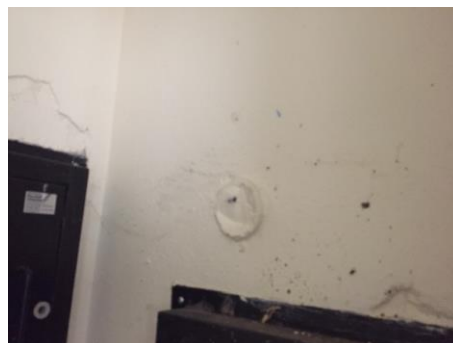
Cement flue cutoff from previously removed incinerator.

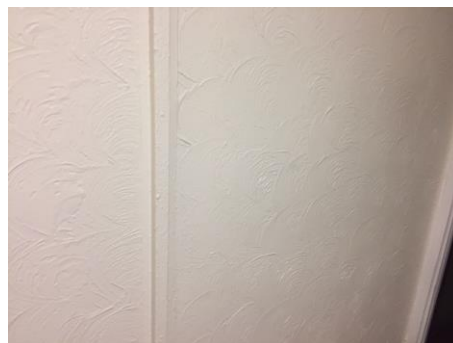
Spatter pattern textured coating beneath more modern swirl pattern texture.

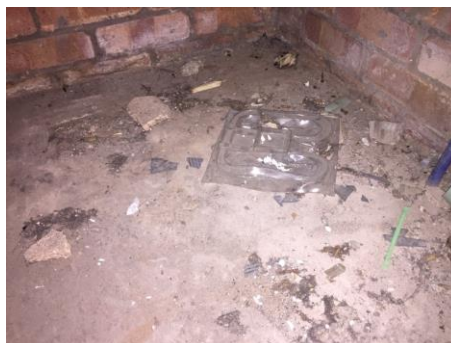
Broken floor tile debris found to floor of cupboard.

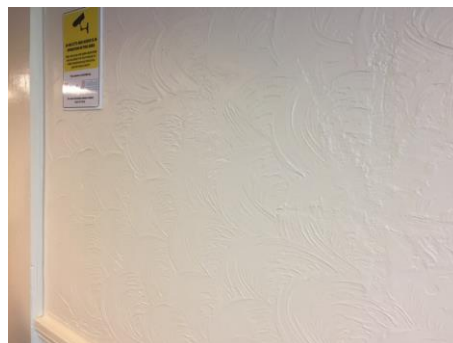
Spatter pattern textured coating beneath more modern swirl pattern texture.

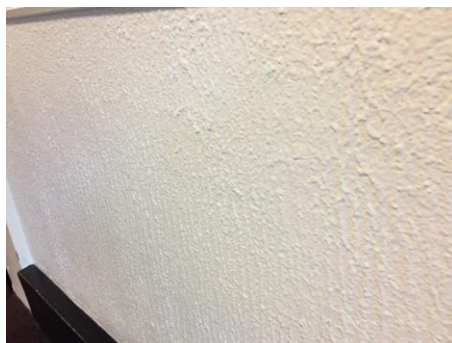
Stipple pattern textured coating.

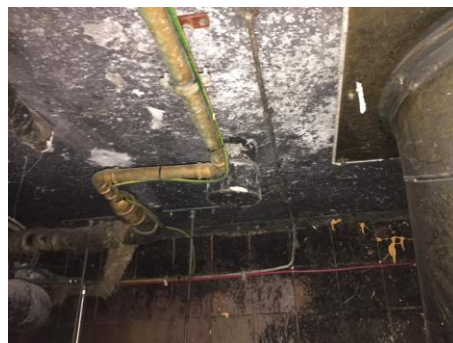
Cement cap for incinerator flue.

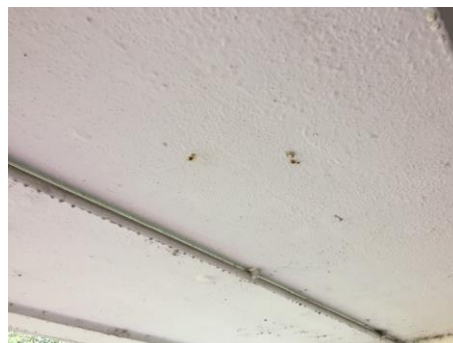
Textured coating to underside of canopies to front and rear.
