Management with Targeted Refurbishment Survey

1-51 Birkbeck House
Guernsey Drive
Chelmsley Wood
Solihull
Solihull
B36 0PG
United Kingdom

16th June 2021

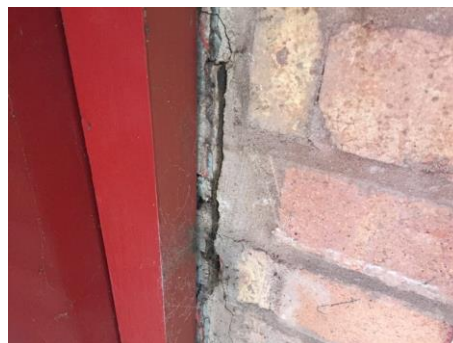
Bitumen felt damp proof course around timber door frames.

The material was seen to be in fair condition at the time of the initial inspection.

The condition of the material should be managed by a competent person/company and its presence made aware to those at risk, as part of a Control of Asbestos Regulations (CAR) 2012 compliant management strategy.

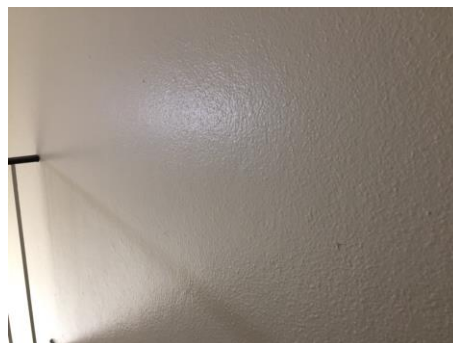
Spatter pattern textured coating.

The material was seen to be in fair condition at the time of the initial inspection.

The condition of the material should be managed by a competent person/company and its presence made aware to those at risk, as part of a Control of Asbestos Regulations (CAR) 2012 compliant management strategy.

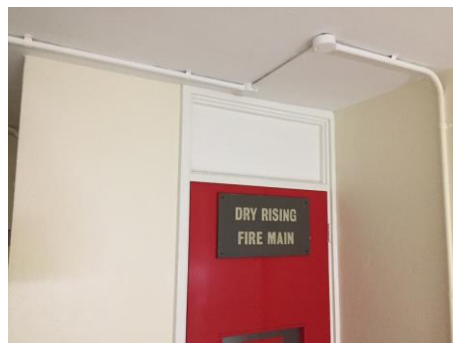
Insulating board transom panel over door to dry riser.

The material was seen to be in fair condition at the time of the initial inspection.

The condition of the material should be managed by a competent person/company and its presence made aware to those at risk, as part of a Control of Asbestos Regulations (CAR) 2012 compliant management strategy.

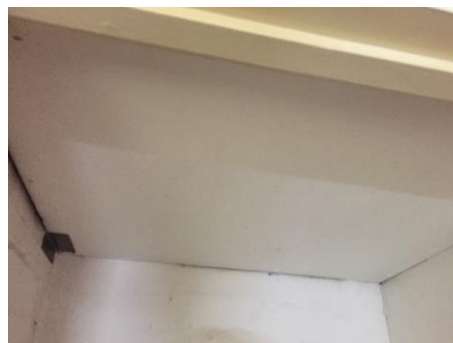
Insulating board panel ceiling.

The material was seen to be in fair condition at the time of the initial inspection.

The condition of the material should be managed by a competent person/company and its presence made aware to those at risk, as part of a Control of Asbestos Regulations (CAR) 2012 compliant management strategy.

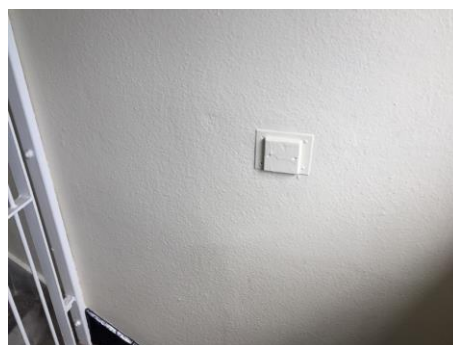
Stipple pattern textured coating.

The material was seen to be in fair condition at the time of the initial inspection.

The condition of the material should be managed by a competent person/company and its presence made aware to those at risk, as part of a Control of Asbestos Regulations (CAR) 2012 compliant management strategy.

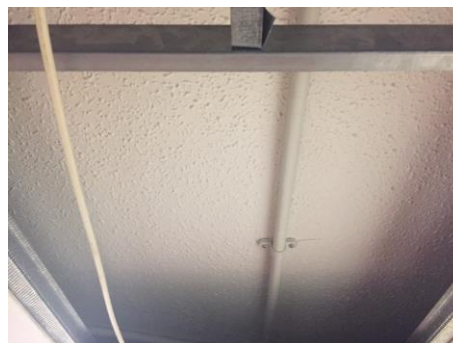
Spatter pattern textured coating above suspended ceiling.

The material was seen to be in fair condition at the time of the initial inspection.

The condition of the material should be managed by a competent person/company and its presence made aware to those at risk, as part of a Control of Asbestos Regulations (CAR) 2012 compliant management strategy.

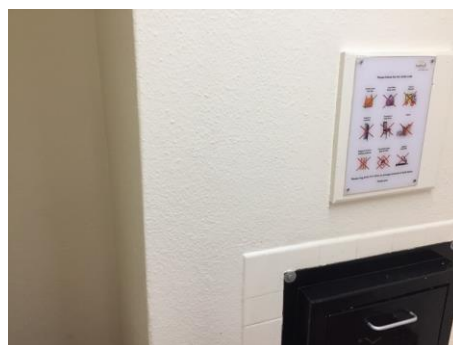
Stipple pattern textured coating.

The material was seen to be in fair condition at the time of the initial inspection.

The condition of the material should be managed by a competent person/company and its presence made aware to those at risk, as part of a Control of Asbestos Regulations (CAR) 2012 compliant management strategy.

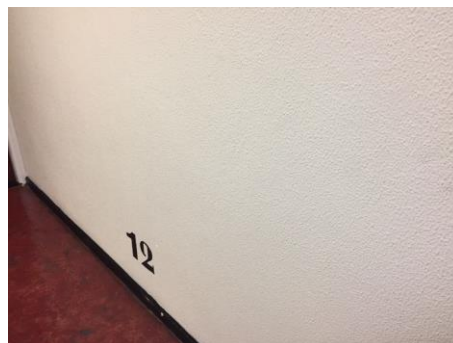
Stipple pattern textured coating.

The material was seen to be in fair condition at the time of the initial inspection.

The condition of the material should be managed by a competent person/company and its presence made aware to those at risk, as part of a Control of Asbestos Regulations (CAR) 2012 compliant management strategy.

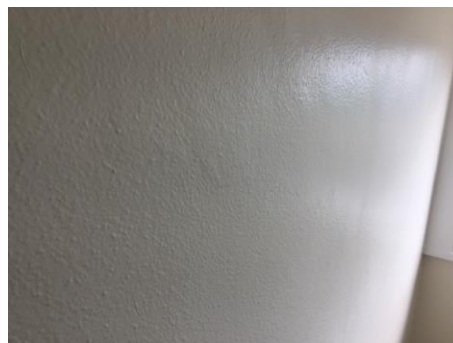
Stipple pattern textured coating.

The material was seen to be in fair condition at the time of the initial inspection.

The condition of the material should be managed by a competent person/company and its presence made aware to those at risk, as part of a Control of Asbestos Regulations (CAR) 2012 compliant management strategy.

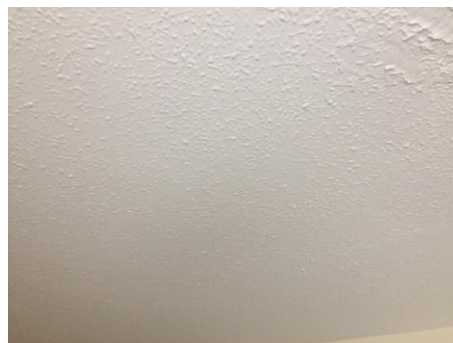
Spatter pattern textured coating.

The material was seen to be in fair condition at the time of the initial inspection.

The condition of the material should be managed by a competent person/company and its presence made aware to those at risk, as part of a Control of Asbestos Regulations (CAR) 2012 compliant management strategy.

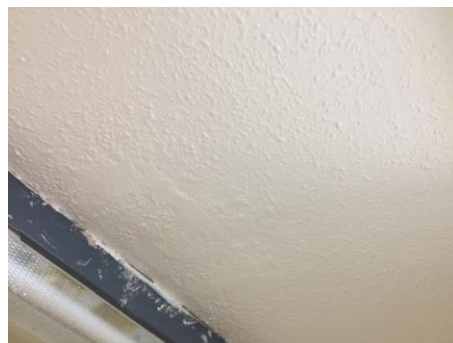
Spatter pattern textured coating.

The material was seen to be in fair condition at the time of the initial inspection.

The condition of the material should be managed by a competent person/company and its presence made aware to those at risk, as part of a Control of Asbestos Regulations (CAR) 2012 compliant management strategy.

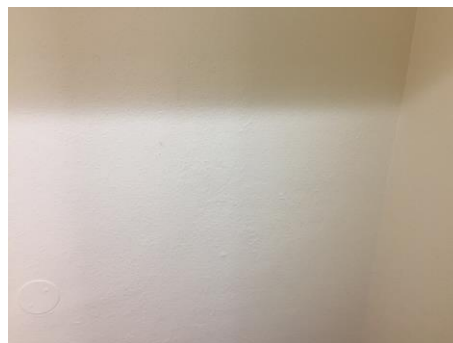
Stipple pattern textured coating.

The material was seen to be in fair condition at the time of the initial inspection.

The condition of the material should be managed by a competent person/company and its presence made aware to those at risk, as part of a Control of Asbestos Regulations (CAR) 2012 compliant management strategy.

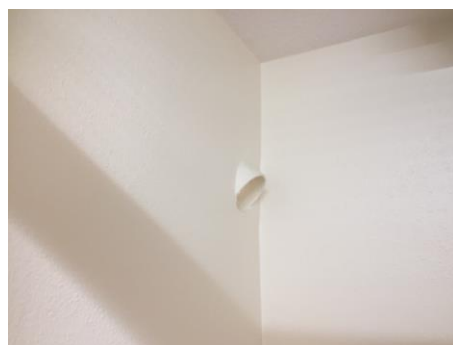
Cement incinerator flue cutoff.

The material was seen to be in fair condition at the time of the initial inspection.

The condition of the material should be managed by a competent person/company and its presence made aware to those at risk, as part of a Control of Asbestos Regulations (CAR) 2012 compliant management strategy.

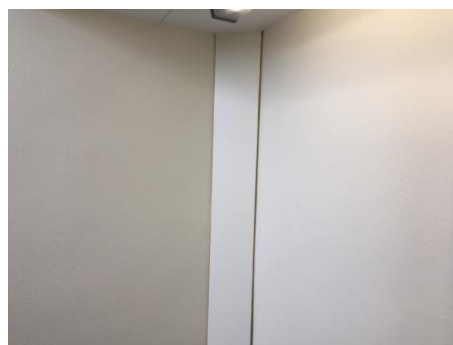
Possible insulating board riser panel hidden behind modern wood fibre panel.

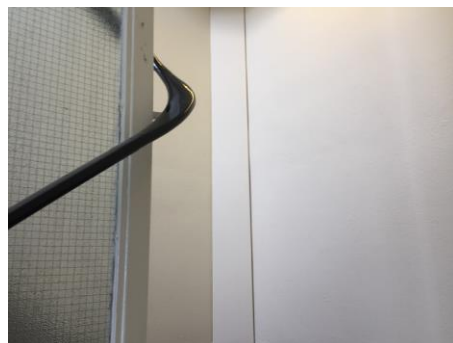
Possible insulating board riser panel hidden behind modern wood fibre panel.

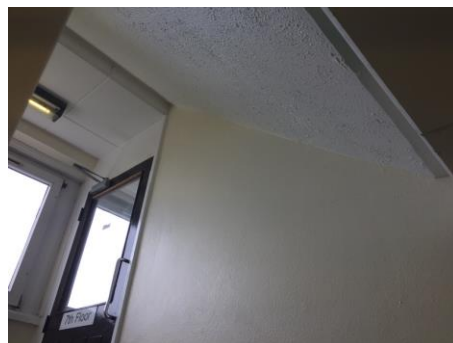
| a-311260-i44-65 | Sixth Floor Landing (6) | Stipple pattern textured coating found to underside of staircase leading to Landing (7) only. | Textured Coating - Ceiling | 3 | Manage | Chrysotile (white) |

Stipple pattern textured coating found to underside of staircase leading to Landing (7) only.

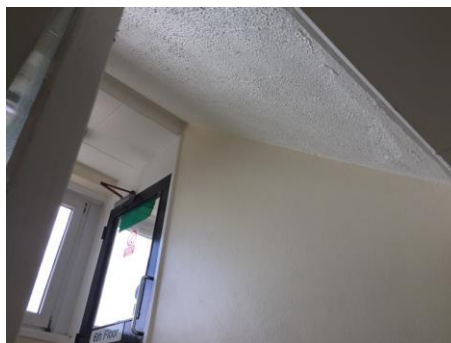
| a-311260-i50-73 | Fifth Floor Landing (5) | Stipple pattern textured coating found to underside of staircase leading to Landing (6) only. | Textured Coating - Ceiling | 0 | NA | NAD |

Stipple pattern textured coating found to underside of staircase leading to Landing (6) only.

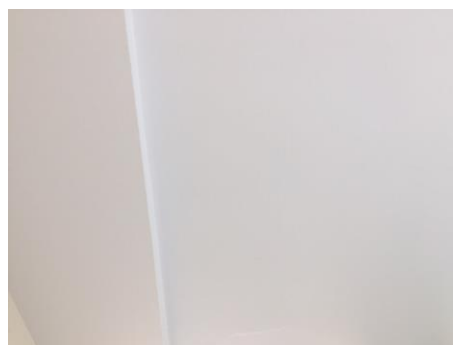
Faint stipple pattern to underside of staircase including Supalux boxing.
