# Solihull Community Housing

## Asbestos Management Survey Report

**Catesby House I-36 (Communal)**  
**Kingshurst Way**  
**Solihull**  
**B37 6DZ**

**Date of Report:** 15 Jan 2015  
**Survey Ref:** 257900000A

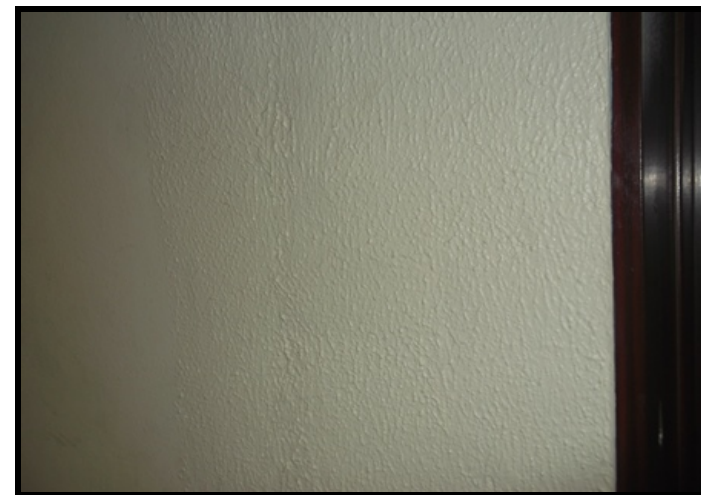
## SAMPLE REFERENCE 005

Building	Floor	Room	Location		
Main Building	Ground Floor	Landing/Stairs	Wall		
Description					
MATERIAL ASSESSMENT					SCORE
Product Type	Textured Coating	Extent of Damage	Good condition		-
Asbestos Type	No Asbestos Detected	Surface Treatment	Textured Coating		
PRIORITY ASSESSMENT					SCORE
Occupant Activity	Not Applicable	Extent / Amount	15.00 m2		-
Accessibility	Easily disturbed	Location	Not Applicable		
Avg Time in Use	Not Applicable	Frequency of Use	Not Applicable		
No. of Occupants	Not Applicable	Secondary Activity	Not Applicable		
Maintenance	Not Applicable	Maintenance Frequency	Not Applicable		
MANAGEMENT ACTION					SCORE
Recommendation	NO ACTION REQUIRED				-
Recommendation Due		Next Inspection	None		
Apply Labels	No	Permit to Work Required	No		
Survey Type	Management	Lead Surveyor	Adam James		
Survey Date	09 Dec 2014	UKAS Laboratory	DMW Environmental Safety Ltd / [A-8971]		
Site Reference	257900000A	Licensed Material	N/A	Notifiable Non Licensed Work	N/A

Asbestos not detected in Sample

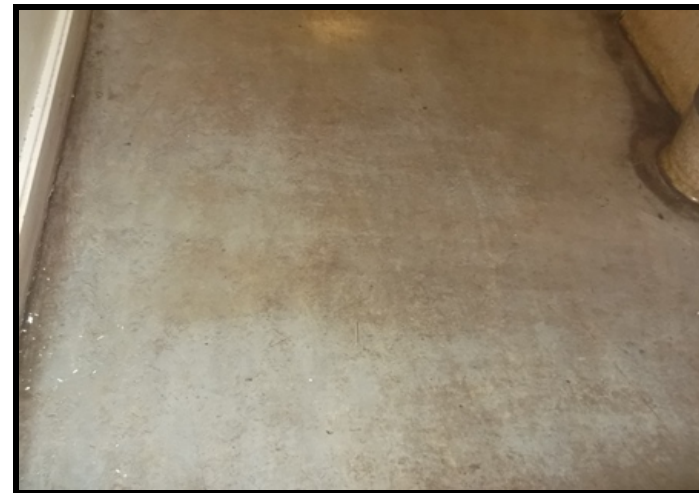
## SAMPLE REFERENCE 006

Building	Floor	Room	Location		
Main Building	Ground Floor	Landing/Stairs	Floor		
Description	Paper backing to lino				
MATERIAL ASSESSMENT				SCORE	
Product Type	Paper	Extent of Damage	Good condition		-
Asbestos Type	No Asbestos Detected	Surface Treatment	Sealed (0)		
PRIORITY ASSESSMENT				SCORE	
Occupant Activity	Not Applicable	Extent / Amount	10.00 m2		-
Accessibility	Occasionally disturb	Location	Not Applicable		
Avg Time in Use	Not Applicable	Frequency of Use	Not Applicable		
No. of Occupants	Not Applicable	Secondary Activity	Not Applicable		
Maintenance	Not Applicable	Maintenance Frequency	Not Applicable		
MANAGEMENT ACTION				SCORE	
Recommendation	NO ACTION REQUIRED				-
Recommendation Due		Next Inspection	None		
Apply Labels	No	Permit to Work Required	No		
Survey Type	Management	Lead Surveyor	Adam James		
Survey Date	09 Dec 2014	UKAS Laboratory	DMW Environmental Safety Ltd / [A-8971]		
Site Reference	257900000A	Licensed Material	N/A	Notifiable Non Licensed Work	N/A

**Asbestos not detected in Sample**

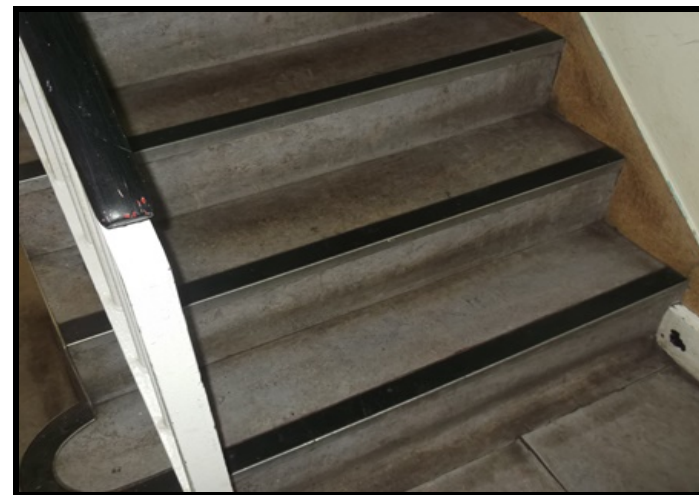
## SAMPLE REFERENCE 007

Building	Floor	Room	Location		
Main Building	Ground Floor	Landing/Stairs	Staircase		
Description					
MATERIAL ASSESSMENT					SCORE
Product Type	Bitumen	Extent of Damage	Good condition		-
Asbestos Type	No Asbestos Detected	Surface Treatment	Composite materials		
PRIORITY ASSESSMENT					SCORE
Occupant Activity	Not Applicable	Extent / Amount	30.00 m2		-
Accessibility	Occasionally disturb	Location	Not Applicable		
Avg Time in Use	Not Applicable	Frequency of Use	Not Applicable		
No. of Occupants	Not Applicable	Secondary Activity	Not Applicable		
Maintenance	Not Applicable	Maintenance Frequency	Not Applicable		
MANAGEMENT ACTION					SCORE
Recommendation	NO ACTION REQUIRED				-
Recommendation Due		Next Inspection	None		
Apply Labels	No	Permit to Work Required	No		
Survey Type	Management	Lead Surveyor	Adam James		
Survey Date	09 Dec 2014	UKAS Laboratory	DMW Environmental Safety Ltd / [A-8971]		
Site Reference	257900000A	Licensed Material	N/A	Notifiable Non Licensed Work	N/A

Asbestos not detected in Sample

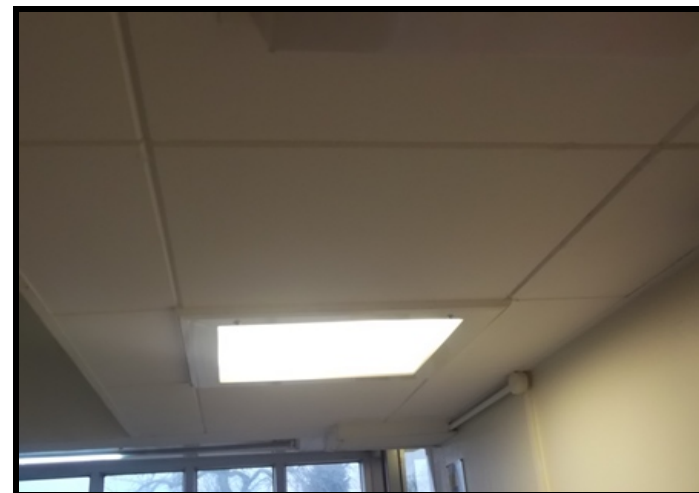
## SAMPLE REFERENCE 008

Building	Floor	Room	Location			
Main Building	Ground Floor	Stairs	Ceiling			
Description						
MATERIAL ASSESSMENT				SCORE		
Product Type	Insulation Board	Extent of Damage	Good condition		-	
Asbestos Type	No Asbestos Detected	Surface Treatment	Sealed Board (Encapsulated)			
PRIORITY ASSESSMENT				SCORE		
Occupant Activity	Not Applicable	Extent / Amount	10.00 m2		-	
Accessibility	Occasionally disturb	Location	Not Applicable			
Avg Time in Use	Not Applicable	Frequency of Use	Not Applicable			
No. of Occupants	Not Applicable	Secondary Activity	Not Applicable			
Maintenance	Not Applicable	Maintenance Frequency	Not Applicable			
MANAGEMENT ACTION				SCORE		
Recommendation	NO ACTION REQUIRED			-		
Recommendation Due		Next Inspection	None			
Apply Labels	No	Permit to Work Required	No			
Survey Type	Management	Lead Surveyor	Adam James			
Survey Date	09 Dec 2014	UKAS Laboratory	NOT SAMPLED (Cross Referenced)			
Site Reference	257900000A	Licensed Material	N/A	Notifiable Non Licensed Work	N/A

**No Asbestos Presumed in Sample**

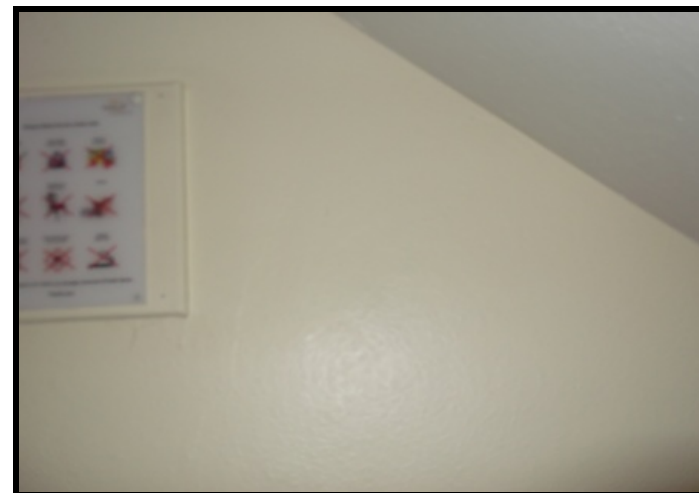
## SAMPLE REFERENCE 009

Building	Floor	Room	Location		
Main Building	Ground Floor	Stairs	Wall		
Description					
MATERIAL ASSESSMENT					SCORE
Product Type	Textured Coating	Extent of Damage	Good condition		-
Asbestos Type	No Asbestos Detected	Surface Treatment	Textured Coating		
PRIORITY ASSESSMENT					SCORE
Occupant Activity	Not Applicable	Extent / Amount	15.00 m2		-
Accessibility	Easily disturbed	Location	Not Applicable		
Avg Time in Use	Not Applicable	Frequency of Use	Not Applicable		
No. of Occupants	Not Applicable	Secondary Activity	Not Applicable		
Maintenance	Not Applicable	Maintenance Frequency	Not Applicable		
MANAGEMENT ACTION					SCORE
Recommendation	NO ACTION REQUIRED				-
Recommendation Due		Next Inspection	None		
Apply Labels	No	Permit to Work Required	No		
Survey Type	Management	Lead Surveyor	Adam James		
Survey Date	09 Dec 2014	UKAS Laboratory	NOT SAMPLED (Cross Referenced)		
Site Reference	257900000A	Licensed Material	N/A	Notifiable Non Licensed Work	N/A

**No Asbestos Presumed in Sample**

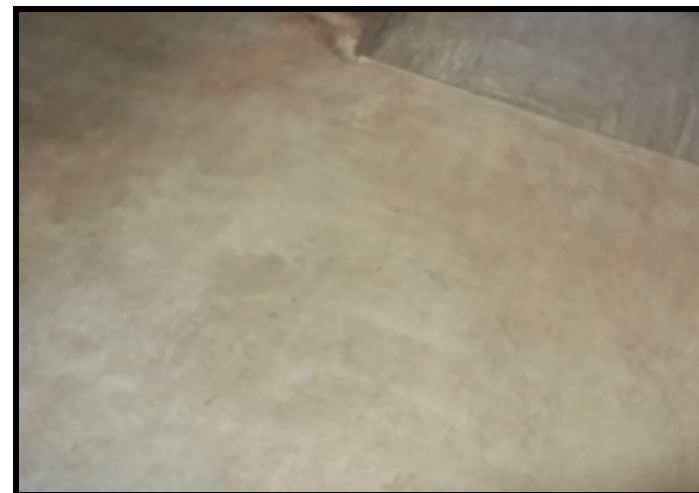
## SAMPLE REFERENCE 010

Building	Floor	Room	Location		
Main Building	Ground Floor	Stairs	Floor		
Description	Paper backing to lino				
MATERIAL ASSESSMENT				SCORE	
Product Type	Paper	Extent of Damage	Good condition		-
Asbestos Type	No Asbestos Detected	Surface Treatment	Sealed (0)		
PRIORITY ASSESSMENT				SCORE	
Occupant Activity	Not Applicable	Extent / Amount	10.00 m2		-
Accessibility	Occasionally disturb	Location	Not Applicable		
Avg Time in Use	Not Applicable	Frequency of Use	Not Applicable		
No. of Occupants	Not Applicable	Secondary Activity	Not Applicable		
Maintenance	Not Applicable	Maintenance Frequency	Not Applicable		
MANAGEMENT ACTION				SCORE	
Recommendation	NO ACTION REQUIRED				-
Recommendation Due		Next Inspection	None		
Apply Labels	No	Permit to Work Required	No		
Survey Type	Management	Lead Surveyor	Adam James		
Survey Date	09 Dec 2014	UKAS Laboratory	NOT SAMPLED (Cross Referenced)		
Site Reference	257900000A	Licensed Material	N/A	Notifiable Non Licensed Work	N/A

**No Asbestos Presumed in Sample**

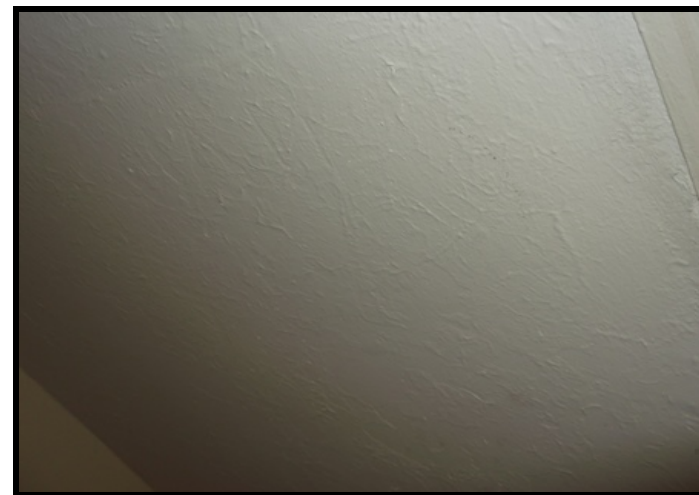
## SAMPLE REFERENCE 011

Building	Floor	Room	Location			
Main Building	Ground Floor	Stairs	Ceiling			
Description						
MATERIAL ASSESSMENT				SCORE		
Product Type	Textured Coating	Extent of Damage	Good condition		-	
Asbestos Type	No Asbestos Detected	Surface Treatment	Textured Coating			
PRIORITY ASSESSMENT				SCORE		
Occupant Activity	Not Applicable	Extent / Amount	4.00 m2		-	
Accessibility	Occasionally disturb	Location	Not Applicable			
Avg Time in Use	Not Applicable	Frequency of Use	Not Applicable			
No. of Occupants	Not Applicable	Secondary Activity	Not Applicable			
Maintenance	Not Applicable	Maintenance Frequency	Not Applicable			
MANAGEMENT ACTION				SCORE		
Recommendation	NO ACTION REQUIRED			-		
Recommendation Due		Next Inspection	None			
Apply Labels	No	Permit to Work Required	No			
Survey Type	Management	Lead Surveyor	Adam James			
Survey Date	09 Dec 2014	UKAS Laboratory	DMW Environmental Safety Ltd / [A-8971]			
Site Reference	257900000A	Licensed Material	N/A	Notifiable Non Licensed Work	N/A

Asbestos not detected in Sample

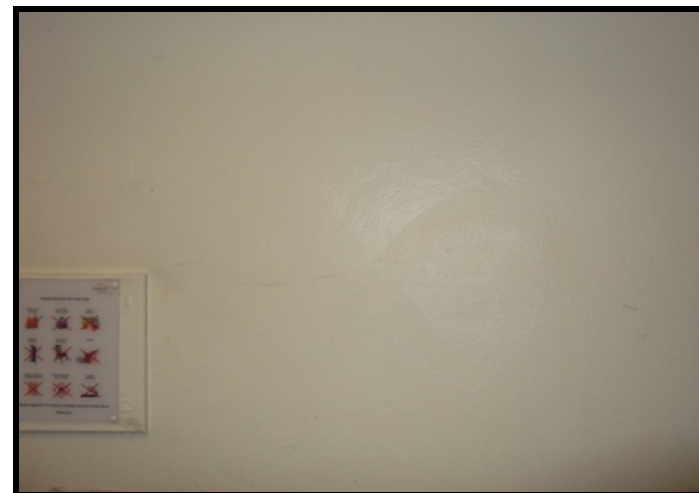
## SAMPLE REFERENCE 015

Building	Floor	Room	Location		
Main Building	First Floor	Landing/Stairs	Wall		
Description					
MATERIAL ASSESSMENT					SCORE
Product Type	Textured Coating	Extent of Damage	Good condition		-
Asbestos Type	No Asbestos Detected	Surface Treatment	Textured Coating		
PRIORITY ASSESSMENT					SCORE
Occupant Activity	Not Applicable	Extent / Amount	15.00 m2		-
Accessibility	Easily disturbed	Location	Not Applicable		
Avg Time in Use	Not Applicable	Frequency of Use	Not Applicable		
No. of Occupants	Not Applicable	Secondary Activity	Not Applicable		
Maintenance	Not Applicable	Maintenance Frequency	Not Applicable		
MANAGEMENT ACTION					SCORE
Recommendation	NO ACTION REQUIRED				-
Recommendation Due		Next Inspection	None		
Apply Labels	No	Permit to Work Required	No		
Survey Type	Management	Lead Surveyor	Adam James		
Survey Date	09 Dec 2014	UKAS Laboratory	NOT SAMPLED (Cross Referenced)		
Site Reference	257900000A	Licensed Material	N/A	Notifiable Non Licensed Work	N/A

**No Asbestos Presumed in Sample**

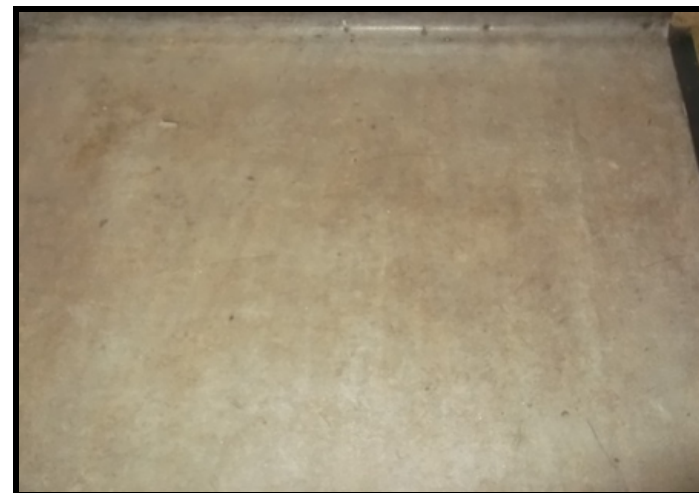
## SAMPLE REFERENCE 016

Building	Floor	Room	Location		
Main Building	First Floor	Landing/Stairs	Floor		
Description	Paper backing to lino				
MATERIAL ASSESSMENT				SCORE	
Product Type	Paper	Extent of Damage	Good condition		-
Asbestos Type	No Asbestos Detected	Surface Treatment	Sealed (0)		
PRIORITY ASSESSMENT				SCORE	
Occupant Activity	Not Applicable	Extent / Amount	10.00 m2		-
Accessibility	Occasionally disturb	Location	Not Applicable		
Avg Time in Use	Not Applicable	Frequency of Use	Not Applicable		
No. of Occupants	Not Applicable	Secondary Activity	Not Applicable		
Maintenance	Not Applicable	Maintenance Frequency	Not Applicable		
MANAGEMENT ACTION				SCORE	
Recommendation	NO ACTION REQUIRED				-
Recommendation Due		Next Inspection	None		
Apply Labels	No	Permit to Work Required	No		
Survey Type	Management	Lead Surveyor	Adam James		
Survey Date	09 Dec 2014	UKAS Laboratory	NOT SAMPLED (Cross Referenced)		
Site Reference	257900000A	Licensed Material	N/A	Notifiable Non Licensed Work	N/A

**No Asbestos Presumed in Sample**

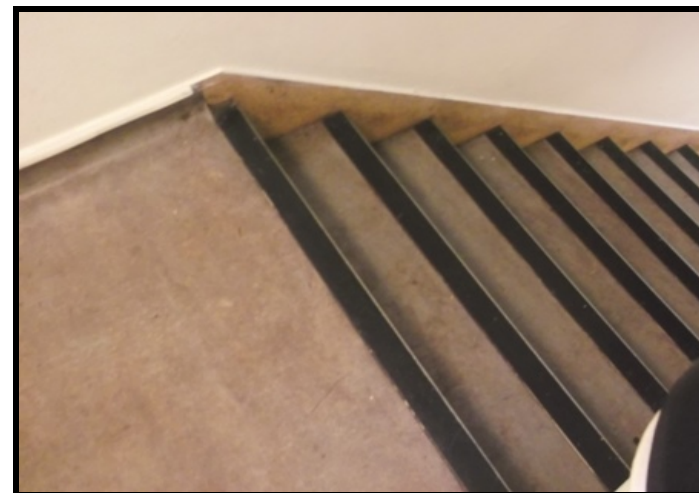
## SAMPLE REFERENCE 017

Building	Floor	Room	Location		
Main Building	First Floor	Landing/Stairs	Floor		
Description					
MATERIAL ASSESSMENT					SCORE
Product Type	Bitumen	Extent of Damage	Good condition		-
Asbestos Type	No Asbestos Detected	Surface Treatment	Composite materials		
PRIORITY ASSESSMENT					SCORE
Occupant Activity	Not Applicable	Extent / Amount	30.00 m2		-
Accessibility	Occasionally disturb	Location	Not Applicable		
Avg Time in Use	Not Applicable	Frequency of Use	Not Applicable		
No. of Occupants	Not Applicable	Secondary Activity	Not Applicable		
Maintenance	Not Applicable	Maintenance Frequency	Not Applicable		
MANAGEMENT ACTION					SCORE
Recommendation	NO ACTION REQUIRED				-
Recommendation Due		Next Inspection	None		
Apply Labels	No	Permit to Work Required	No		
Survey Type	Management	Lead Surveyor	Adam James		
Survey Date	09 Dec 2014	UKAS Laboratory	NOT SAMPLED (Cross Referenced)		
Site Reference	257900000A	Licensed Material	N/A	Notifiable Non Licensed Work	N/A

**No Asbestos Presumed in Sample**

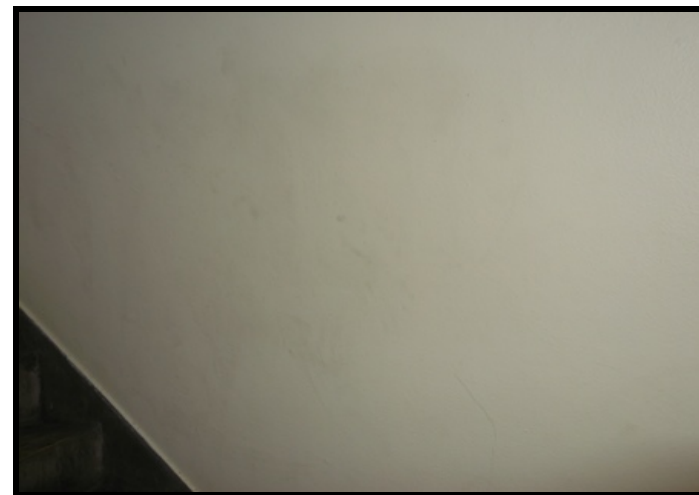
## SAMPLE REFERENCE 019

Building	Floor	Room	Location		
Main Building	First Floor	Stairs	Wall		
Description					
MATERIAL ASSESSMENT					SCORE
Product Type	Textured Coating	Extent of Damage	Good condition		-
Asbestos Type	No Asbestos Detected	Surface Treatment	Textured Coating		
PRIORITY ASSESSMENT					SCORE
Occupant Activity	Not Applicable	Extent / Amount	15.00 m2		-
Accessibility	Easily disturbed	Location	Not Applicable		
Avg Time in Use	Not Applicable	Frequency of Use	Not Applicable		
No. of Occupants	Not Applicable	Secondary Activity	Not Applicable		
Maintenance	Not Applicable	Maintenance Frequency	Not Applicable		
MANAGEMENT ACTION					SCORE
Recommendation	NO ACTION REQUIRED				-
Recommendation Due		Next Inspection	None		
Apply Labels	No	Permit to Work Required	No		
Survey Type	Management	Lead Surveyor	Adam James		
Survey Date	09 Dec 2014	UKAS Laboratory	NOT SAMPLED (Cross Referenced)		
Site Reference	257900000A	Licensed Material	N/A	Notifiable Non Licensed Work	N/A

**No Asbestos Presumed in Sample**

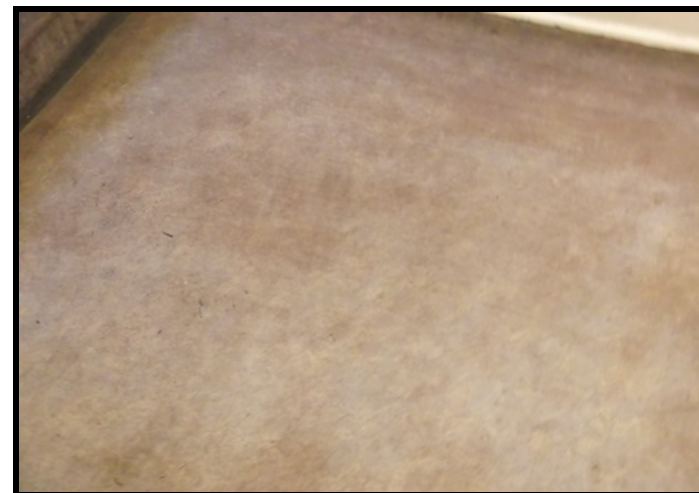
## SAMPLE REFERENCE 020

Building	Floor	Room	Location		
Main Building	First Floor	Stairs	Floor		
Description	Paper backing to lino				
MATERIAL ASSESSMENT				SCORE	
Product Type	Paper	Extent of Damage	Good condition		-
Asbestos Type	No Asbestos Detected	Surface Treatment	Sealed (0)		
PRIORITY ASSESSMENT				SCORE	
Occupant Activity	Not Applicable	Extent / Amount	10.00 m2		-
Accessibility	Occasionally disturb	Location	Not Applicable		
Avg Time in Use	Not Applicable	Frequency of Use	Not Applicable		
No. of Occupants	Not Applicable	Secondary Activity	Not Applicable		
Maintenance	Not Applicable	Maintenance Frequency	Not Applicable		
MANAGEMENT ACTION				SCORE	
Recommendation	NO ACTION REQUIRED				-
Recommendation Due		Next Inspection	None		
Apply Labels	No	Permit to Work Required	No		
Survey Type	Management	Lead Surveyor	Adam James		
Survey Date	09 Dec 2014	UKAS Laboratory	NOT SAMPLED (Cross Referenced)		
Site Reference	257900000A	Licensed Material	N/A	Notifiable Non Licensed Work	N/A

**No Asbestos Presumed in Sample**

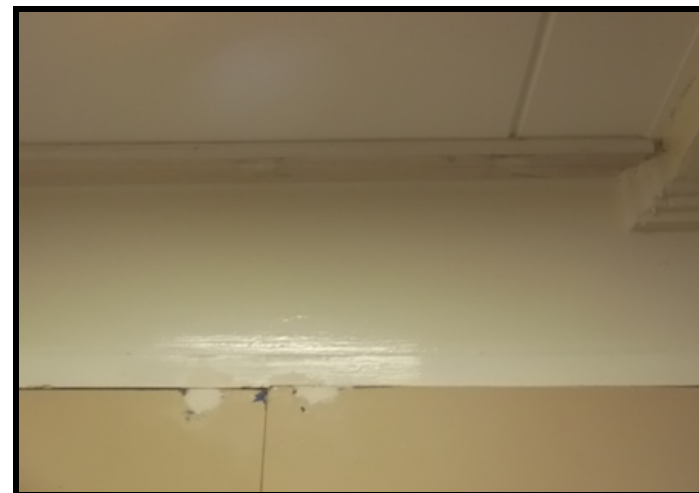
## SAMPLE REFERENCE 023

Building	Floor	Room	Location		
Main Building	First Floor	Electricity Riser	Transom Panel		
Description					
MATERIAL ASSESSMENT					SCORE
Product Type	Insulation Board	Extent of Damage	Good condition		-
Asbestos Type	No Asbestos Detected	Surface Treatment	Sealed Board (Encapsulated)		
PRIORITY ASSESSMENT					SCORE
Occupant Activity	Not Applicable	Extent / Amount	1.00 m2		-
Accessibility	Occasionally disturb	Location	Not Applicable		
Avg Time in Use	Not Applicable	Frequency of Use	Not Applicable		
No. of Occupants	Not Applicable	Secondary Activity	Not Applicable		
Maintenance	Not Applicable	Maintenance Frequency	Not Applicable		
MANAGEMENT ACTION					SCORE
Recommendation	NO ACTION REQUIRED				-
Recommendation Due		Next Inspection	None		
Apply Labels	No	Permit to Work Required	No		
Survey Type	Management	Lead Surveyor	Adam James		
Survey Date	09 Dec 2014	UKAS Laboratory	NOT SAMPLED (Cross Referenced)		
Site Reference	257900000A	Licensed Material	N/A	Notifiable Non Licensed Work	N/A

**No Asbestos Presumed in Sample**

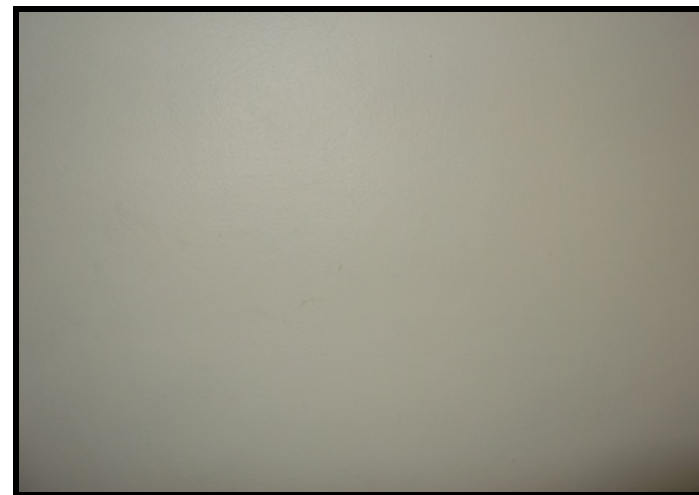
## SAMPLE REFERENCE 025

Building	Floor	Room	Location		
Main Building	Second Floor	Landing/Stairs	Wall		
Description					
MATERIAL ASSESSMENT					SCORE
Product Type	Textured Coating	Extent of Damage	Good condition		-
Asbestos Type	No Asbestos Detected	Surface Treatment	Textured Coating		
PRIORITY ASSESSMENT					SCORE
Occupant Activity	Not Applicable	Extent / Amount	15.00 m2		-
Accessibility	Easily disturbed	Location	Not Applicable		
Avg Time in Use	Not Applicable	Frequency of Use	Not Applicable		
No. of Occupants	Not Applicable	Secondary Activity	Not Applicable		
Maintenance	Not Applicable	Maintenance Frequency	Not Applicable		
MANAGEMENT ACTION					SCORE
Recommendation	NO ACTION REQUIRED				-
Recommendation Due		Next Inspection	None		
Apply Labels	No	Permit to Work Required	No		
Survey Type	Management	Lead Surveyor	Adam James		
Survey Date	09 Dec 2014	UKAS Laboratory	NOT SAMPLED (Cross Referenced)		
Site Reference	257900000A	Licensed Material	N/A	Notifiable Non Licensed Work	N/A

**No Asbestos Presumed in Sample**

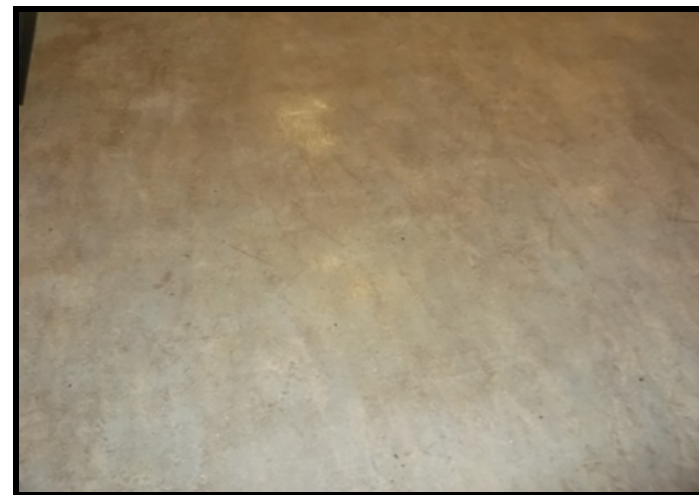
## SAMPLE REFERENCE 026

Building	Floor	Room	Location		
Main Building	Second Floor	Landing/Stairs	Floor		
Description	Paper backing to lino				
MATERIAL ASSESSMENT				SCORE	
Product Type	Paper	Extent of Damage	Good condition		-
Asbestos Type	No Asbestos Detected	Surface Treatment	Sealed (0)		
PRIORITY ASSESSMENT				SCORE	
Occupant Activity	Not Applicable	Extent / Amount	10.00 m2		-
Accessibility	Occasionally disturb	Location	Not Applicable		
Avg Time in Use	Not Applicable	Frequency of Use	Not Applicable		
No. of Occupants	Not Applicable	Secondary Activity	Not Applicable		
Maintenance	Not Applicable	Maintenance Frequency	Not Applicable		
MANAGEMENT ACTION				SCORE	
Recommendation	NO ACTION REQUIRED				-
Recommendation Due		Next Inspection	None		
Apply Labels	No	Permit to Work Required	No		
Survey Type	Management	Lead Surveyor	Adam James		
Survey Date	09 Dec 2014	UKAS Laboratory	NOT SAMPLED (Cross Referenced)		
Site Reference	257900000A	Licensed Material	N/A	Notifiable Non Licensed Work	N/A

**No Asbestos Presumed in Sample**

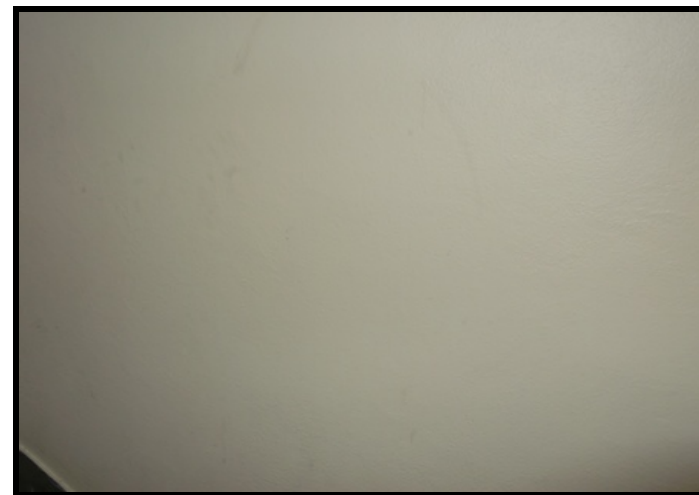
## SAMPLE REFERENCE 028

Building	Floor	Room	Location		
Main Building	Second Floor	Stairs	Wall		
Description					
MATERIAL ASSESSMENT					SCORE
Product Type	Textured Coating	Extent of Damage	Good condition		-
Asbestos Type	No Asbestos Detected	Surface Treatment	Textured Coating		
PRIORITY ASSESSMENT					SCORE
Occupant Activity	Not Applicable	Extent / Amount	15.00 m2		-
Accessibility	Easily disturbed	Location	Not Applicable		
Avg Time in Use	Not Applicable	Frequency of Use	Not Applicable		
No. of Occupants	Not Applicable	Secondary Activity	Not Applicable		
Maintenance	Not Applicable	Maintenance Frequency	Not Applicable		
MANAGEMENT ACTION					SCORE
Recommendation	NO ACTION REQUIRED				-
Recommendation Due		Next Inspection	None		
Apply Labels	No	Permit to Work Required	No		
Survey Type	Management	Lead Surveyor	Adam James		
Survey Date	09 Dec 2014	UKAS Laboratory	NOT SAMPLED (Cross Referenced)		
Site Reference	257900000A	Licensed Material	N/A	Notifiable Non Licensed Work	N/A

**No Asbestos Presumed in Sample**
