Solihull Community Housing

Asbestos Management Survey Report

**Cheshunt House
Kington Gardens
Chelmsley Wood
B37 5TB**

Date of Report: 27 Apr 2012

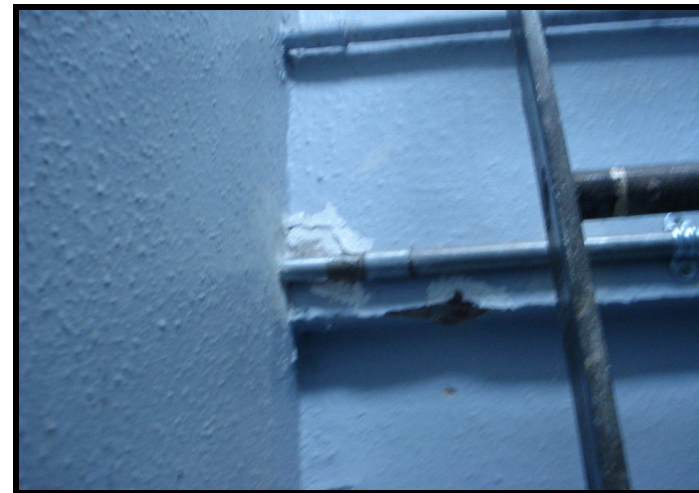
SAMPLE REFERENCE 002

Building	Floor	Room	Location	
Main Building	Tenth Floor	Upper Lobby	Walls	
Description				
MATERIAL ASSESSMENT				SCORE
Product Type	Paint	Extent of Damage	Medium damage	-
Asbestos Type	No Asbestos Detected	Surface Treatment	Sealed (1)	
PRIORITY ASSESSMENT				SCORE
Occupant Activity	Not Applicable	Extent / Amount	30.00 m2	-
Accessibility	Easily disturbed	Location	Not Applicable	
Avg Time in Use	Not Applicable	Frequency of Use	Not Applicable	
No. of Occupants	Not Applicable	Secondary Activity	Not Applicable	
Maintenance	Not Applicable	Maintenance Frequency	Not Applicable	
MANAGEMENT ACTION				SCORE
Recommendation	NO ACTION REQUIRED			-
Recommendation Due		Next Inspection	None	
Apply Labels	No	Permit to Work Required	No	
Survey Type	Management	Lead Surveyor	Jane Openshaw	
Survey Date	22 Mar 2012	UKAS Laboratory	DMW Environmental Safety Ltd / [P-96015]	
Site Reference	I49620000A	Licensed Material	N/A

Asbestos not detected in Sample

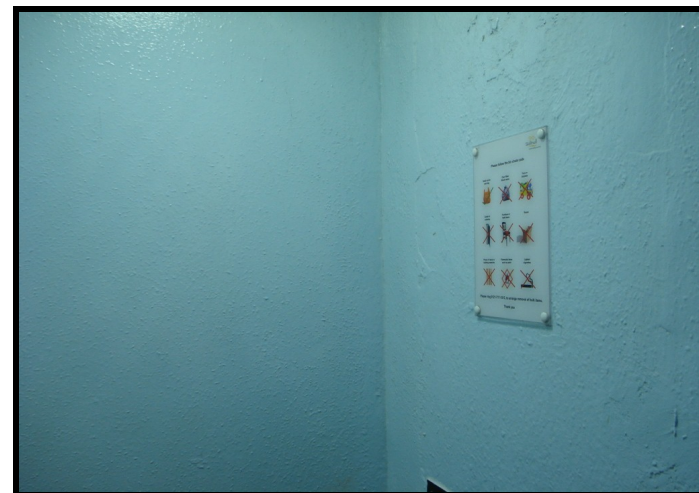
SAMPLE REFERENCE 005

Building	Floor	Room	Location	
Main Building	Nineth Floor	Bin Chute	Walls	
Description				
MATERIAL ASSESSMENT				SCORE
Product Type	Paint	Extent of Damage	Low damage	-
Asbestos Type	No Asbestos Detected	Surface Treatment	Sealed (1)	
PRIORITY ASSESSMENT				SCORE
Occupant Activity	Not Applicable	Extent / Amount	11.00 m2	-
Accessibility	Easily disturbed	Location	Not Applicable	
Avg Time in Use	Not Applicable	Frequency of Use	Not Applicable	
No. of Occupants	Not Applicable	Secondary Activity	Not Applicable	
Maintenance	Not Applicable	Maintenance Frequency	Not Applicable	
MANAGEMENT ACTION				SCORE
Recommendation	NO ACTION REQUIRED			-
Recommendation Due		Next Inspection	None	
Apply Labels	No	Permit to Work Required	No	
Survey Type	Management	Lead Surveyor	Jane Openshaw	
Survey Date	22 Mar 2012	UKAS Laboratory	NOT SAMPLED (Cross Referenced)	
Site Reference	I49620000A	Licensed Material	N/A

No Asbestos Presumed in Sample

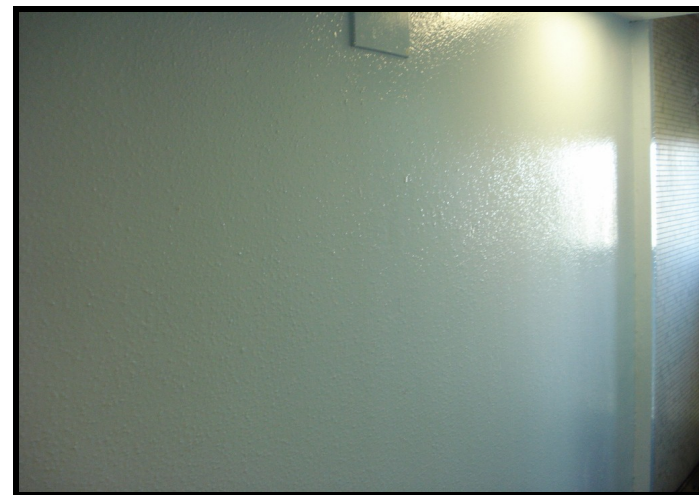
SAMPLE REFERENCE 007

Building	Floor	Room	Location	
Main Building	Nineth Floor	Lobby	Walls	
Description				
MATERIAL ASSESSMENT				SCORE
Product Type	Paint	Extent of Damage	Good condition	-
Asbestos Type	No Asbestos Detected	Surface Treatment	Sealed (1)	
PRIORITY ASSESSMENT				SCORE
Occupant Activity	Not Applicable	Extent / Amount	30.00 m2	-
Accessibility	Easily disturbed	Location	Not Applicable	
Avg Time in Use	Not Applicable	Frequency of Use	Not Applicable	
No. of Occupants	Not Applicable	Secondary Activity	Not Applicable	
Maintenance	Not Applicable	Maintenance Frequency	Not Applicable	
MANAGEMENT ACTION				SCORE
Recommendation	NO ACTION REQUIRED			-
Recommendation Due		Next Inspection	None	
Apply Labels	No	Permit to Work Required	No	
Survey Type	Management	Lead Surveyor	Jane Openshaw	
Survey Date	22 Mar 2012	UKAS Laboratory	NOT SAMPLED (Cross Referenced)	
Site Reference	I49620000A	Licensed Material	N/A

No Asbestos Presumed in Sample

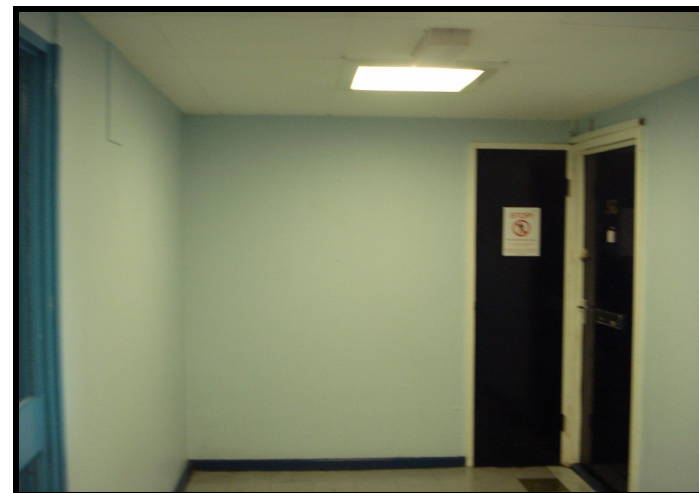
SAMPLE REFERENCE 008

Building	Floor	Room	Location	
Main Building	Nineth Floor	Corridor I	Walls	
Description				
MATERIAL ASSESSMENT				SCORE
Product Type	Paint	Extent of Damage	Good condition	-
Asbestos Type	No Asbestos Detected	Surface Treatment	Sealed (I)	
PRIORITY ASSESSMENT				SCORE
Occupant Activity	Not Applicable	Extent / Amount	25.00 m2	-
Accessibility	Easily disturbed	Location	Not Applicable	
Avg Time in Use	Not Applicable	Frequency of Use	Not Applicable	
No. of Occupants	Not Applicable	Secondary Activity	Not Applicable	
Maintenance	Not Applicable	Maintenance Frequency	Not Applicable	
MANAGEMENT ACTION				SCORE
Recommendation	NO ACTION REQUIRED			-
Recommendation Due		Next Inspection	None	
Apply Labels	No	Permit to Work Required	No	
Survey Type	Management	Lead Surveyor	Jane Openshaw	
Survey Date	22 Mar 2012	UKAS Laboratory	NOT SAMPLED (Cross Referenced)	
Site Reference	I49620000A	Licensed Material	N/A

No Asbestos Presumed in Sample

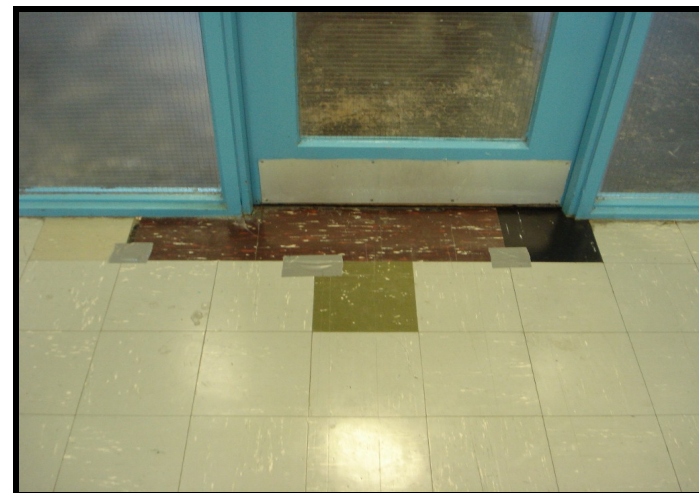
SAMPLE REFERENCE 009

Building	Floor	Room	Location	
Main Building	Nineth Floor	Corridor I	Floor	
Description				
MATERIAL ASSESSMENT				SCORE
Product Type	Floor Tiles	Extent of Damage	Medium damage	4
Asbestos Type	Chrysotile	Surface Treatment	Composite materials	
PRIORITY ASSESSMENT				SCORE
Occupant Activity	Not Applicable	Extent / Amount	18.00 m2	2
Accessibility	Routinely disturbed	Location	Not Applicable	
Avg Time in Use	Not Applicable	Frequency of Use	Not Applicable	
No. of Occupants	Not Applicable	Secondary Activity	Not Applicable	
Maintenance	Not Applicable	Maintenance Frequency	Not Applicable	
MANAGEMENT ACTION				SCORE
Recommendation	LABEL & MONITOR			6
Recommendation Due		Next Inspection	22 Mar 2013	
Apply Labels	No	Permit to Work Required	No	
Survey Type	Management	Lead Surveyor	Jane Openshaw	
Survey Date	22 Mar 2012	UKAS Laboratory	DMW Environmental Safety Ltd / [P-96015]	
Site Reference	I49620000A	Licensed Material	No

Asbestos detected in Sample

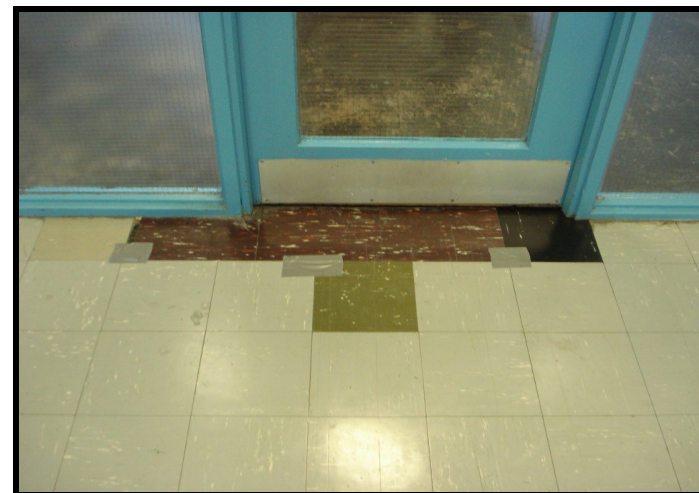
SAMPLE REFERENCE 010

Building	Floor	Room	Location
Main Building	Nineth Floor	Corridor I	Floor
Description			
MATERIAL ASSESSMENT			
Product Type	Floor Tiles	Extent of Damage	Medium damage
Asbestos Type	Chrysotile	Surface Treatment	Composite materials
PRIORITY ASSESSMENT			
Occupant Activity	Not Applicable	Extent / Amount	2.00 m2
Accessibility	Routinely disturbed	Location	Not Applicable
Avg Time in Use	Not Applicable	Frequency of Use	Not Applicable
No. of Occupants	Not Applicable	Secondary Activity	Not Applicable
Maintenance	Not Applicable	Maintenance Frequency	Not Applicable
MANAGEMENT ACTION			
Recommendation	LABEL & MONITOR		
Recommendation Due		Next Inspection	22 Mar 2013
Apply Labels	No	Permit to Work Required	No
Survey Type	Management	Lead Surveyor	Jane Openshaw
Survey Date	22 Mar 2012	UKAS Laboratory	DMW Environmental Safety Ltd / [P-96015]
Site Reference	I49620000A	Licensed Material	No

Asbestos detected in Sample

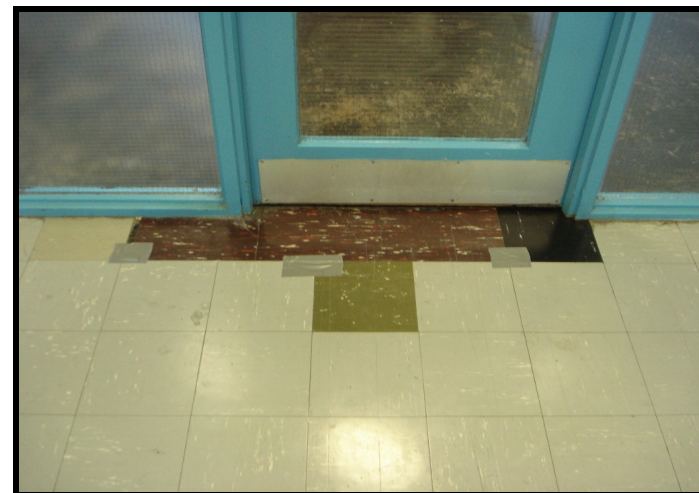
SAMPLE REFERENCE 011

Building	Floor	Room	Location
Main Building	Nineth Floor	Corridor I	Floor
Description	Adhesive		
MATERIAL ASSESSMENT			
Product Type	Bitumen	Extent of Damage	Low damage
Asbestos Type	Chrysotile	Surface Treatment	Composite materials
PRIORITY ASSESSMENT			
Occupant Activity	Not Applicable	Extent / Amount	1.00 m2
Accessibility	Routinely disturbed	Location	Not Applicable
Avg Time in Use	Not Applicable	Frequency of Use	Not Applicable
No. of Occupants	Not Applicable	Secondary Activity	Not Applicable
Maintenance	Not Applicable	Maintenance Frequency	Not Applicable
MANAGEMENT ACTION			
Recommendation	LABEL & MONITOR		
Recommendation Due		Next Inspection	22 Mar 2013
Apply Labels	No	Permit to Work Required	No
Survey Type	Management	Lead Surveyor	Jane Openshaw
Survey Date	22 Mar 2012	UKAS Laboratory	DMW Environmental Safety Ltd / [P-96015]
Site Reference	I49620000A	Licensed Material	No

Asbestos detected in Sample

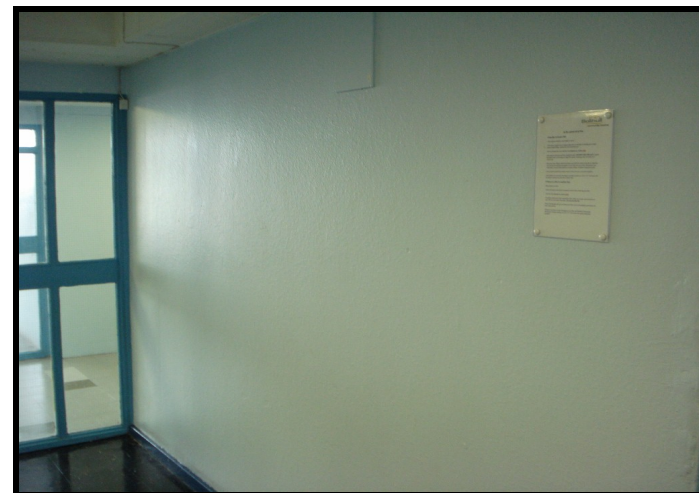
SAMPLE REFERENCE 016

Building	Floor	Room	Location	
Main Building	Nineth Floor	Lift Lobby	Walls	
Description				
MATERIAL ASSESSMENT				SCORE
Product Type	Paint	Extent of Damage	Good condition	-
Asbestos Type	No Asbestos Detected	Surface Treatment	Sealed (I)	
PRIORITY ASSESSMENT				SCORE
Occupant Activity	Not Applicable	Extent / Amount	20.00 m2	-
Accessibility	Easily disturbed	Location	Not Applicable	
Avg Time in Use	Not Applicable	Frequency of Use	Not Applicable	
No. of Occupants	Not Applicable	Secondary Activity	Not Applicable	
Maintenance	Not Applicable	Maintenance Frequency	Not Applicable	
MANAGEMENT ACTION				SCORE
Recommendation	NO ACTION REQUIRED			-
Recommendation Due		Next Inspection	None	
Apply Labels	No	Permit to Work Required	No	
Survey Type	Management	Lead Surveyor	Jane Openshaw	
Survey Date	22 Mar 2012	UKAS Laboratory	NOT SAMPLED (Cross Referenced)	
Site Reference	I49620000A	Licensed Material	N/A

No Asbestos Presumed in Sample

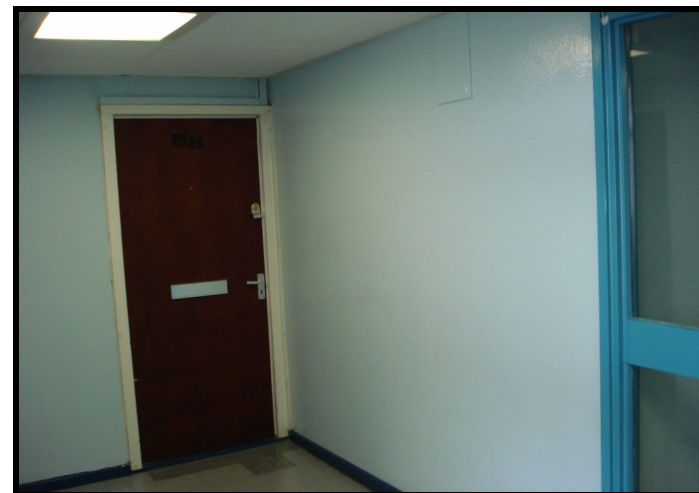
SAMPLE REFERENCE 018

Building	Floor	Room	Location	
Main Building	Nineth Floor	Corridor 2	Walls	
Description				
MATERIAL ASSESSMENT				SCORE
Product Type	Paint	Extent of Damage	Good condition	-
Asbestos Type	No Asbestos Detected	Surface Treatment	Sealed (1)	
PRIORITY ASSESSMENT				SCORE
Occupant Activity	Not Applicable	Extent / Amount	25.00 m2	-
Accessibility	Easily disturbed	Location	Not Applicable	
Avg Time in Use	Not Applicable	Frequency of Use	Not Applicable	
No. of Occupants	Not Applicable	Secondary Activity	Not Applicable	
Maintenance	Not Applicable	Maintenance Frequency	Not Applicable	
MANAGEMENT ACTION				SCORE
Recommendation	NO ACTION REQUIRED			-
Recommendation Due		Next Inspection	None	
Apply Labels	No	Permit to Work Required	No	
Survey Type	Management	Lead Surveyor	Jane Openshaw	
Survey Date	22 Mar 2012	UKAS Laboratory	NOT SAMPLED (Cross Referenced)	
Site Reference	I49620000A	Licensed Material	N/A

No Asbestos Presumed in Sample

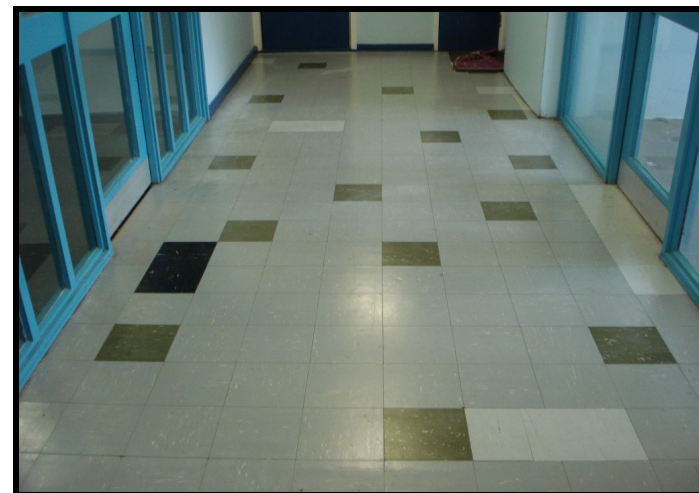
SAMPLE REFERENCE 020

Building	Floor	Room	Location	
Main Building	Nineth Floor	Corridor 2	Floor	
Description				
MATERIAL ASSESSMENT				SCORE
Product Type	Floor Tiles	Extent of Damage	Medium damage	4
Asbestos Type	Chrysotile	Surface Treatment	Composite materials	
PRIORITY ASSESSMENT				SCORE
Occupant Activity	Not Applicable	Extent / Amount	18.00 m2	2
Accessibility	Routinely disturbed	Location	Not Applicable	
Avg Time in Use	Not Applicable	Frequency of Use	Not Applicable	
No. of Occupants	Not Applicable	Secondary Activity	Not Applicable	
Maintenance	Not Applicable	Maintenance Frequency	Not Applicable	
MANAGEMENT ACTION				SCORE
Recommendation	LABEL & MONITOR			6
Recommendation Due		Next Inspection	22 Mar 2013	
Apply Labels	No	Permit to Work Required	No	
Survey Type	Management	Lead Surveyor	Jane Openshaw	
Survey Date	22 Mar 2012	UKAS Laboratory	NOT SAMPLED (Cross Referenced)	
Site Reference	I49620000A	Licensed Material	No

Asbestos Presumed in Sample

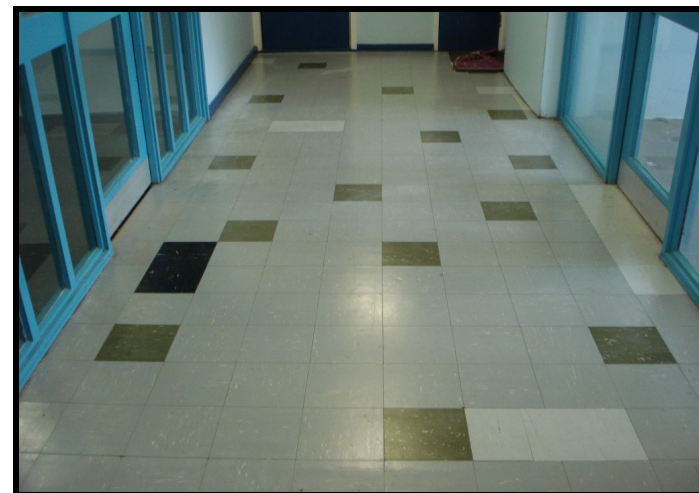
SAMPLE REFERENCE 022

Building	Floor	Room	Location	
Main Building	Nineth Floor	Corridor 2	Floor	
Description				
MATERIAL ASSESSMENT				SCORE
Product Type	Floor Tiles	Extent of Damage	Good condition	-
Asbestos Type	No Asbestos Detected	Surface Treatment	Composite materials	
PRIORITY ASSESSMENT				SCORE
Occupant Activity	Not Applicable	Extent / Amount	1.00 m2	-
Accessibility	Routinely disturbed	Location	Not Applicable	
Avg Time in Use	Not Applicable	Frequency of Use	Not Applicable	
No. of Occupants	Not Applicable	Secondary Activity	Not Applicable	
Maintenance	Not Applicable	Maintenance Frequency	Not Applicable	
MANAGEMENT ACTION				SCORE
Recommendation	NO ACTION REQUIRED			-
Recommendation Due		Next Inspection	None	
Apply Labels	No	Permit to Work Required	No	
Survey Type	Management	Lead Surveyor	Jane Openshaw	
Survey Date	22 Mar 2012	UKAS Laboratory	NOT SAMPLED (Cross Referenced)	
Site Reference	I49620000A	Licensed Material	N/A

No Asbestos Presumed in Sample

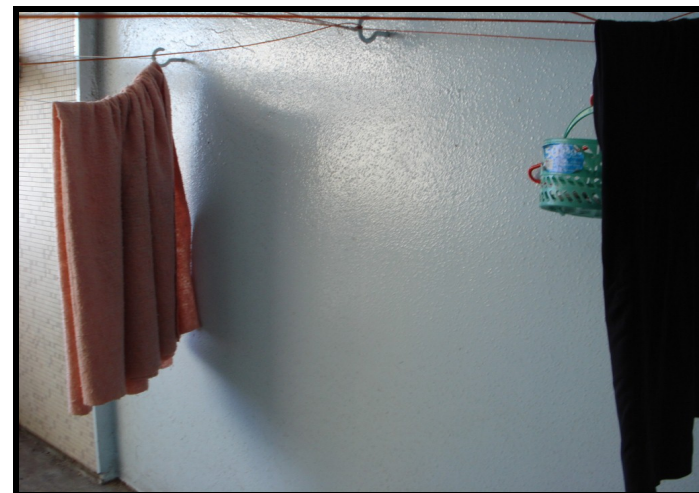
SAMPLE REFERENCE 025

Building	Floor	Room	Location	
Main Building	Nineth Floor	Drying Area	Walls	
Description				
MATERIAL ASSESSMENT				SCORE
Product Type	Paint	Extent of Damage	Good condition	-
Asbestos Type	No Asbestos Detected	Surface Treatment	Sealed (1)	
PRIORITY ASSESSMENT				SCORE
Occupant Activity	Not Applicable	Extent / Amount	18.00 m2	-
Accessibility	Easily disturbed	Location	Not Applicable	
Avg Time in Use	Not Applicable	Frequency of Use	Not Applicable	
No. of Occupants	Not Applicable	Secondary Activity	Not Applicable	
Maintenance	Not Applicable	Maintenance Frequency	Not Applicable	
MANAGEMENT ACTION				SCORE
Recommendation	NO ACTION REQUIRED			-
Recommendation Due		Next Inspection	None	
Apply Labels	No	Permit to Work Required	No	
Survey Type	Management	Lead Surveyor	Jane Openshaw	
Survey Date	22 Mar 2012	UKAS Laboratory	NOT SAMPLED (Cross Referenced)	
Site Reference	I49620000A	Licensed Material	N/A

No Asbestos Presumed in Sample

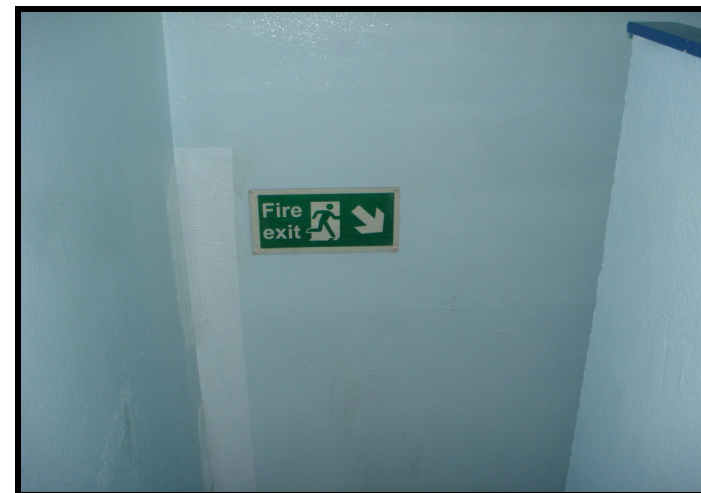
SAMPLE REFERENCE 026

Building	Floor	Room	Location	
Main Building	Nineth Floor	Stairs	Walls	
Description				
MATERIAL ASSESSMENT				SCORE
Product Type	Paint	Extent of Damage	Good condition	-
Asbestos Type	No Asbestos Detected	Surface Treatment	Sealed (I)	
PRIORITY ASSESSMENT				SCORE
Occupant Activity	Not Applicable	Extent / Amount	50.00 m2	-
Accessibility	Easily disturbed	Location	Not Applicable	
Avg Time in Use	Not Applicable	Frequency of Use	Not Applicable	
No. of Occupants	Not Applicable	Secondary Activity	Not Applicable	
Maintenance	Not Applicable	Maintenance Frequency	Not Applicable	
MANAGEMENT ACTION				SCORE
Recommendation	NO ACTION REQUIRED			-
Recommendation Due		Next Inspection	None	
Apply Labels	No	Permit to Work Required	No	
Survey Type	Management	Lead Surveyor	Jane Openshaw	
Survey Date	22 Mar 2012	UKAS Laboratory	NOT SAMPLED (Cross Referenced)	
Site Reference	I49620000A	Licensed Material	N/A

No Asbestos Presumed in Sample

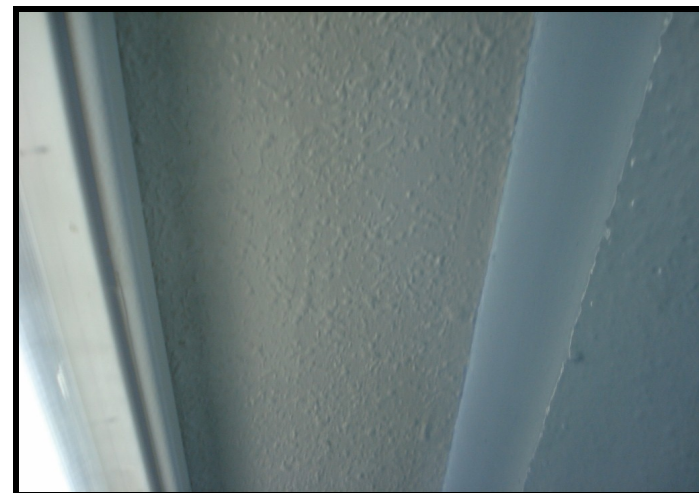
SAMPLE REFERENCE 027

Building	Floor	Room	Location	
Main Building	Nineth Floor	Stairs	Ceiling	
Description				
MATERIAL ASSESSMENT				SCORE
Product Type	Paint	Extent of Damage	Good condition	-
Asbestos Type	No Asbestos Detected	Surface Treatment	Sealed (1)	
PRIORITY ASSESSMENT				SCORE
Occupant Activity	Not Applicable	Extent / Amount	3.00 m2	-
Accessibility	Occasionally disturb	Location	Not Applicable	
Avg Time in Use	Not Applicable	Frequency of Use	Not Applicable	
No. of Occupants	Not Applicable	Secondary Activity	Not Applicable	
Maintenance	Not Applicable	Maintenance Frequency	Not Applicable	
MANAGEMENT ACTION				SCORE
Recommendation	NO ACTION REQUIRED			-
Recommendation Due		Next Inspection	None	
Apply Labels	No	Permit to Work Required	No	
Survey Type	Management	Lead Surveyor	Jane Openshaw	
Survey Date	22 Mar 2012	UKAS Laboratory	NOT SAMPLED (Cross Referenced)	
Site Reference	I49620000A	Licensed Material	N/A

No Asbestos Presumed in Sample

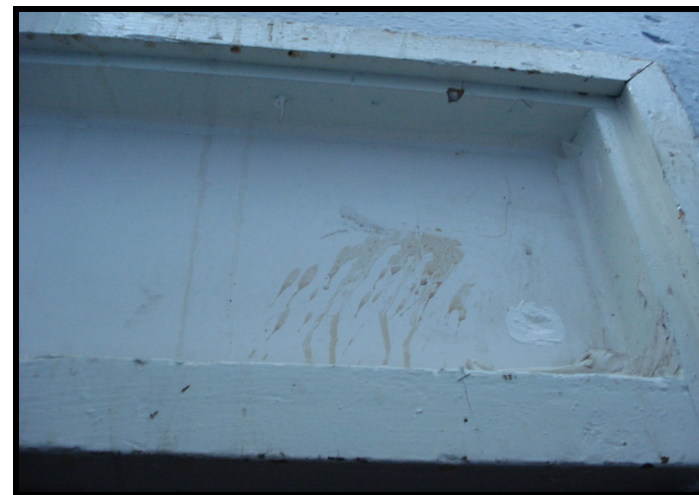
SAMPLE REFERENCE 028

Building	Floor	Room	Location	
Main Building	Nineth Floor	Lift Access Room	Door	
Description				
MATERIAL ASSESSMENT				SCORE
Product Type	Board	Extent of Damage	Low damage	-
Asbestos Type	No Asbestos Detected	Surface Treatment	Sealed Board (Encapsulated)	
PRIORITY ASSESSMENT				SCORE
Occupant Activity	Not Applicable	Extent / Amount	1.00 m2	-
Accessibility	Easily disturbed	Location	Not Applicable	
Avg Time in Use	Not Applicable	Frequency of Use	Not Applicable	
No. of Occupants	Not Applicable	Secondary Activity	Not Applicable	
Maintenance	Not Applicable	Maintenance Frequency	Not Applicable	
MANAGEMENT ACTION				SCORE
Recommendation	NO ACTION REQUIRED			-
Recommendation Due		Next Inspection	None	
Apply Labels	No	Permit to Work Required	No	
Survey Type	Management	Lead Surveyor	Jane Openshaw	
Survey Date	22 Mar 2012	UKAS Laboratory	DMW Environmental Safety Ltd / [P-96015]	
Site Reference	I49620000A	Licensed Material	N/A

Asbestos not detected in Sample

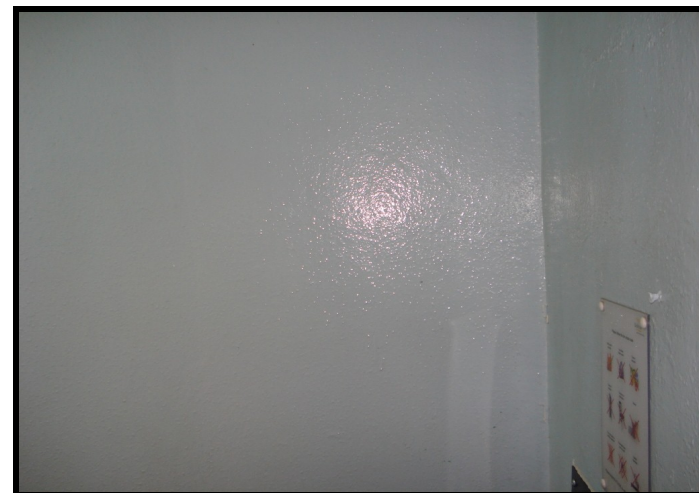
SAMPLE REFERENCE 029

Building	Floor	Room	Location	
Main Building	Eighth Floor	Bin Chute	Walls	
Description				
MATERIAL ASSESSMENT				SCORE
Product Type	Paint	Extent of Damage	Good condition	-
Asbestos Type	No Asbestos Detected	Surface Treatment	Sealed (1)	
PRIORITY ASSESSMENT				SCORE
Occupant Activity	Not Applicable	Extent / Amount	11.00 m2	-
Accessibility	Easily disturbed	Location	Not Applicable	
Avg Time in Use	Not Applicable	Frequency of Use	Not Applicable	
No. of Occupants	Not Applicable	Secondary Activity	Not Applicable	
Maintenance	Not Applicable	Maintenance Frequency	Not Applicable	
MANAGEMENT ACTION				SCORE
Recommendation	NO ACTION REQUIRED			-
Recommendation Due		Next Inspection	None	
Apply Labels	No	Permit to Work Required	No	
Survey Type	Management	Lead Surveyor	Jane Openshaw	
Survey Date	22 Mar 2012	UKAS Laboratory	NOT SAMPLED (Cross Referenced)	
Site Reference	I49620000A	Licensed Material	N/A

No Asbestos Presumed in Sample

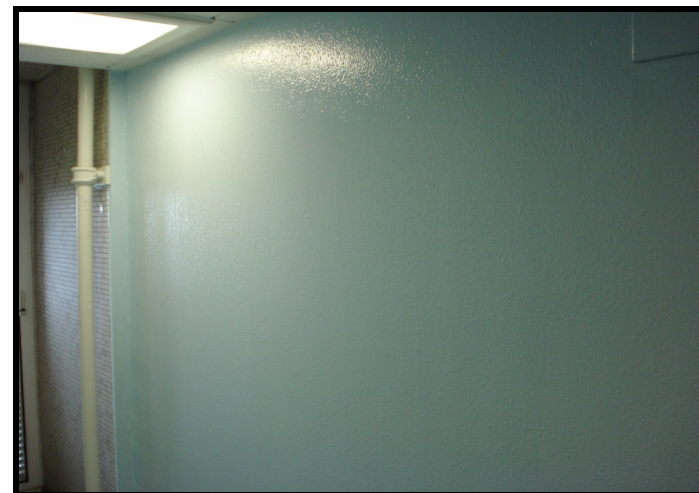
SAMPLE REFERENCE 030

Building	Floor	Room	Location	
Main Building	Eighth Floor	Lobby	Walls	
Description				
MATERIAL ASSESSMENT				SCORE
Product Type	Paint	Extent of Damage	Good condition	-
Asbestos Type	No Asbestos Detected	Surface Treatment	Sealed (1)	
PRIORITY ASSESSMENT				SCORE
Occupant Activity	Not Applicable	Extent / Amount	30.00 m2	-
Accessibility	Easily disturbed	Location	Not Applicable	
Avg Time in Use	Not Applicable	Frequency of Use	Not Applicable	
No. of Occupants	Not Applicable	Secondary Activity	Not Applicable	
Maintenance	Not Applicable	Maintenance Frequency	Not Applicable	
MANAGEMENT ACTION				SCORE
Recommendation	NO ACTION REQUIRED			-
Recommendation Due		Next Inspection	None	
Apply Labels	No	Permit to Work Required	No	
Survey Type	Management	Lead Surveyor	Jane Openshaw	
Survey Date	22 Mar 2012	UKAS Laboratory	NOT SAMPLED (Cross Referenced)	
Site Reference	I49620000A	Licensed Material	N/A

No Asbestos Presumed in Sample

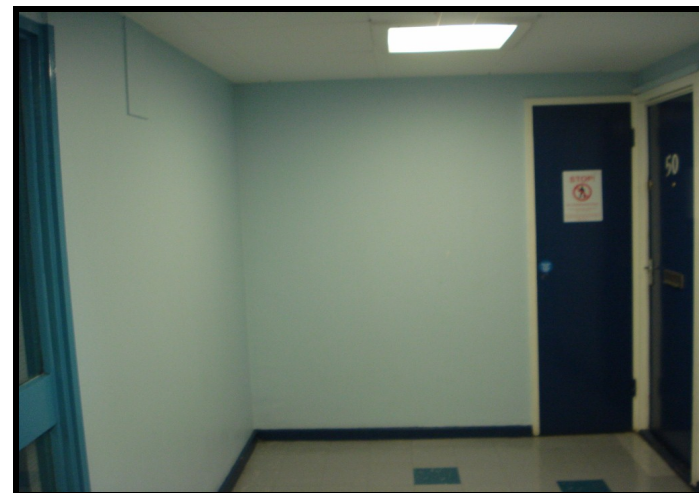
SAMPLE REFERENCE 032

Building	Floor	Room	Location	
Main Building	Eighth Floor	Corridor I	Walls	
Description				
MATERIAL ASSESSMENT				SCORE
Product Type	Paint	Extent of Damage	Good condition	-
Asbestos Type	No Asbestos Detected	Surface Treatment	Sealed (I)	
PRIORITY ASSESSMENT				SCORE
Occupant Activity	Not Applicable	Extent / Amount	25.00 m2	-
Accessibility	Easily disturbed	Location	Not Applicable	
Avg Time in Use	Not Applicable	Frequency of Use	Not Applicable	
No. of Occupants	Not Applicable	Secondary Activity	Not Applicable	
Maintenance	Not Applicable	Maintenance Frequency	Not Applicable	
MANAGEMENT ACTION				SCORE
Recommendation	NO ACTION REQUIRED			-
Recommendation Due		Next Inspection	None	
Apply Labels	No	Permit to Work Required	No	
Survey Type	Management	Lead Surveyor	Jane Openshaw	
Survey Date	22 Mar 2012	UKAS Laboratory	NOT SAMPLED (Cross Referenced)	
Site Reference	I49620000A	Licensed Material	N/A

No Asbestos Presumed in Sample

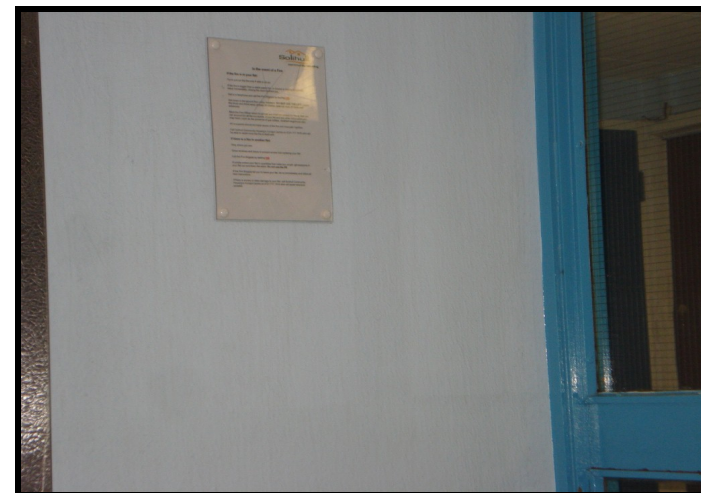
SAMPLE REFERENCE 037

Building	Floor	Room	Location	
Main Building	Eighth Floor	Corridor I	Walls	
Description				
MATERIAL ASSESSMENT				SCORE
Product Type	Paint	Extent of Damage	Good condition	-
Asbestos Type	No Asbestos Detected	Surface Treatment	Sealed (I)	
PRIORITY ASSESSMENT				SCORE
Occupant Activity	Not Applicable	Extent / Amount	20.00 m2	-
Accessibility	Easily disturbed	Location	Not Applicable	
Avg Time in Use	Not Applicable	Frequency of Use	Not Applicable	
No. of Occupants	Not Applicable	Secondary Activity	Not Applicable	
Maintenance	Not Applicable	Maintenance Frequency	Not Applicable	
MANAGEMENT ACTION				SCORE
Recommendation	NO ACTION REQUIRED			-
Recommendation Due		Next Inspection	None	
Apply Labels	No	Permit to Work Required	No	
Survey Type	Management	Lead Surveyor	Jane Openshaw	
Survey Date	22 Mar 2012	UKAS Laboratory	NOT SAMPLED (Cross Referenced)	
Site Reference	I49620000A	Licensed Material	N/A

No Asbestos Presumed in Sample

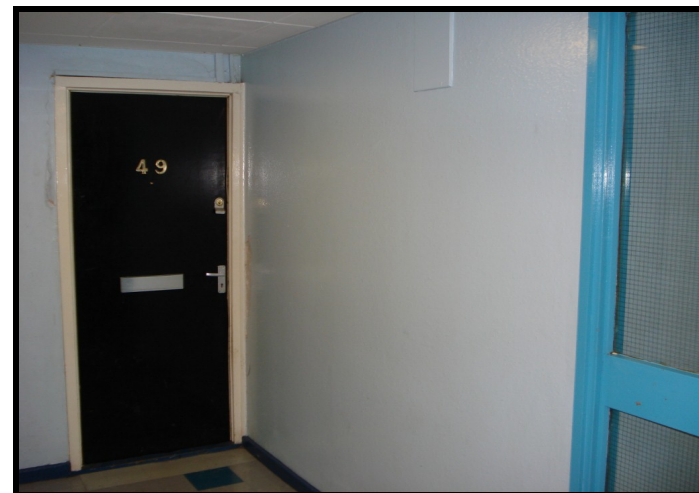
SAMPLE REFERENCE 045

Building	Floor	Room	Location	
Main Building	Eighth Floor	Corridor 2	Walls	
Description				
MATERIAL ASSESSMENT				SCORE
Product Type	Paint	Extent of Damage	Good condition	-
Asbestos Type	No Asbestos Detected	Surface Treatment	Sealed (1)	
PRIORITY ASSESSMENT				SCORE
Occupant Activity	Not Applicable	Extent / Amount	25.00 m2	-
Accessibility	Easily disturbed	Location	Not Applicable	
Avg Time in Use	Not Applicable	Frequency of Use	Not Applicable	
No. of Occupants	Not Applicable	Secondary Activity	Not Applicable	
Maintenance	Not Applicable	Maintenance Frequency	Not Applicable	
MANAGEMENT ACTION				SCORE
Recommendation	NO ACTION REQUIRED			-
Recommendation Due		Next Inspection	None	
Apply Labels	No	Permit to Work Required	No	
Survey Type	Management	Lead Surveyor	Jane Openshaw	
Survey Date	22 Mar 2012	UKAS Laboratory	NOT SAMPLED (Cross Referenced)	
Site Reference	I49620000A	Licensed Material	N/A

No Asbestos Presumed in Sample

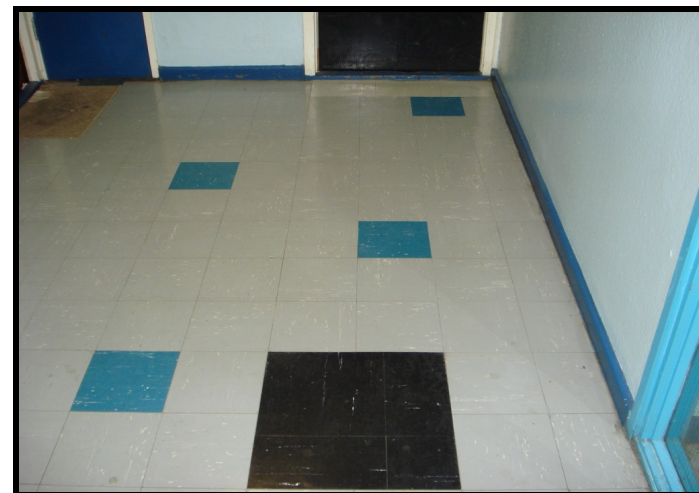
SAMPLE REFERENCE 046

Building	Floor	Room	Location
Main Building	Eighth Floor	Corridor 2	Floor
Description			
MATERIAL ASSESSMENT			
Product Type	Floor Tiles	Extent of Damage	Low damage
Asbestos Type	Chrysotile	Surface Treatment	Composite materials
PRIORITY ASSESSMENT			
Occupant Activity	Not Applicable	Extent / Amount	18.00 m2
Accessibility	Routinely disturbed	Location	Not Applicable
Avg Time in Use	Not Applicable	Frequency of Use	Not Applicable
No. of Occupants	Not Applicable	Secondary Activity	Not Applicable
Maintenance	Not Applicable	Maintenance Frequency	Not Applicable
MANAGEMENT ACTION			
Recommendation	LABEL & MONITOR		
Recommendation Due		Next Inspection	22 Mar 2013
Apply Labels	No	Permit to Work Required	No
Survey Type	Management	Lead Surveyor	Jane Openshaw
Survey Date	22 Mar 2012	UKAS Laboratory	NOT SAMPLED (Cross Referenced)
Site Reference	I49620000A	Licensed Material	No

Asbestos Presumed in Sample

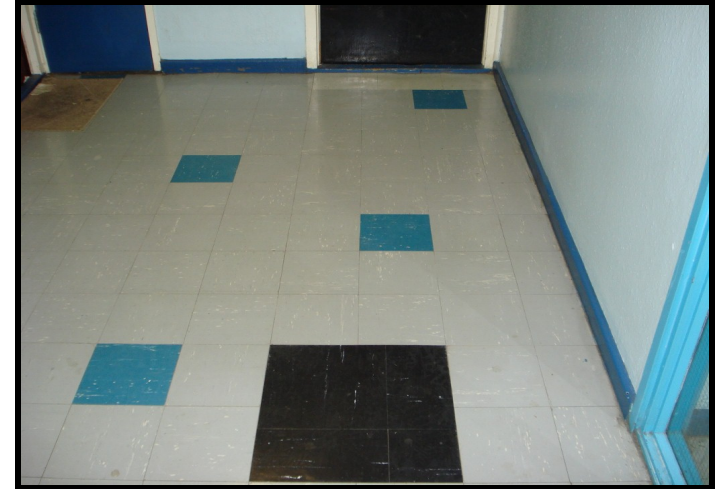
SAMPLE REFERENCE 047

Asbestos Presumed in Sample

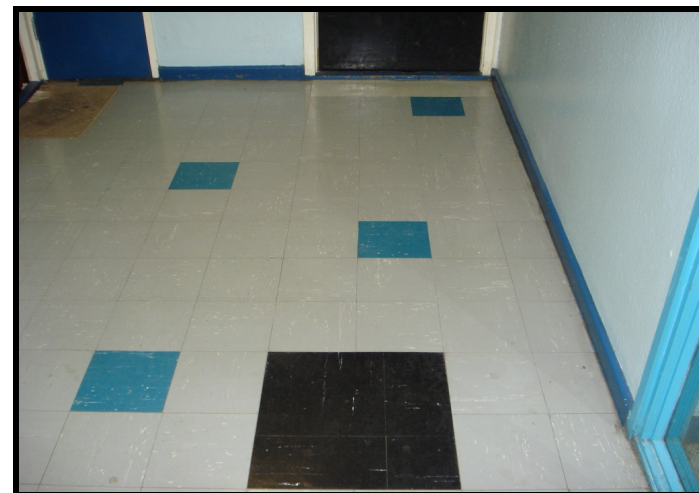
SAMPLE REFERENCE 049

No Asbestos Presumed in Sample

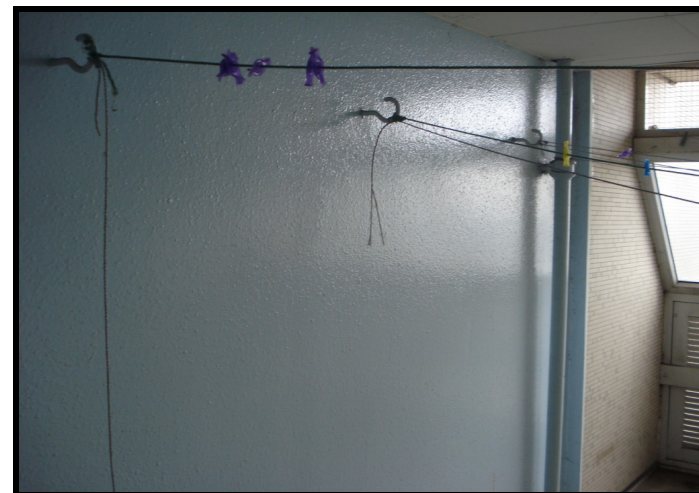
SAMPLE REFERENCE 052

No Asbestos Presumed in Sample

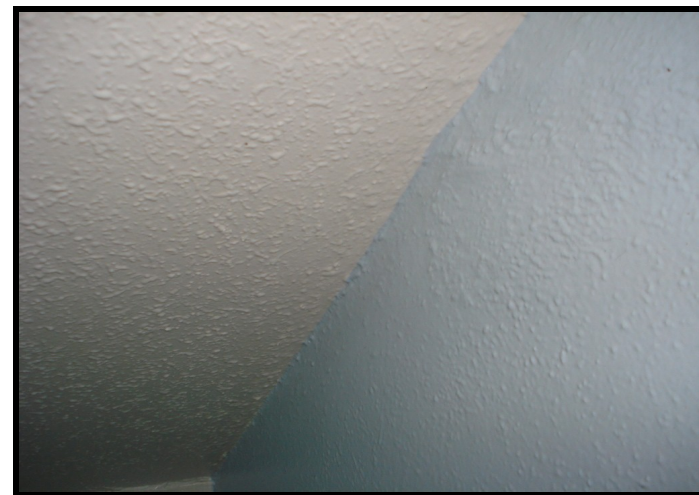
SAMPLE REFERENCE 053

No Asbestos Presumed in Sample

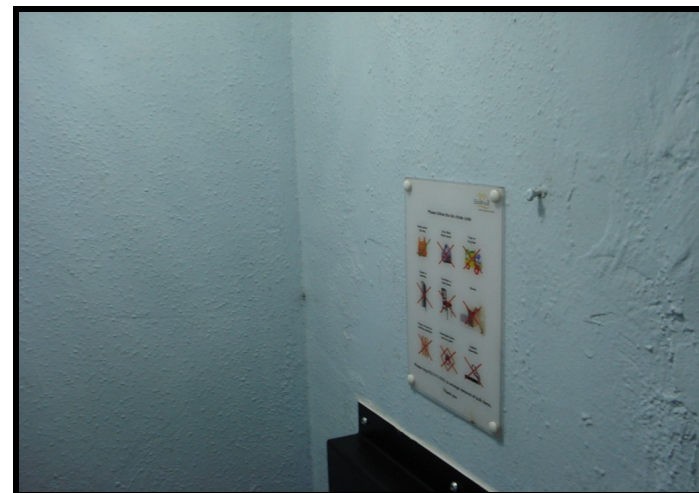
SAMPLE REFERENCE 055

Asbestos not detected in Sample

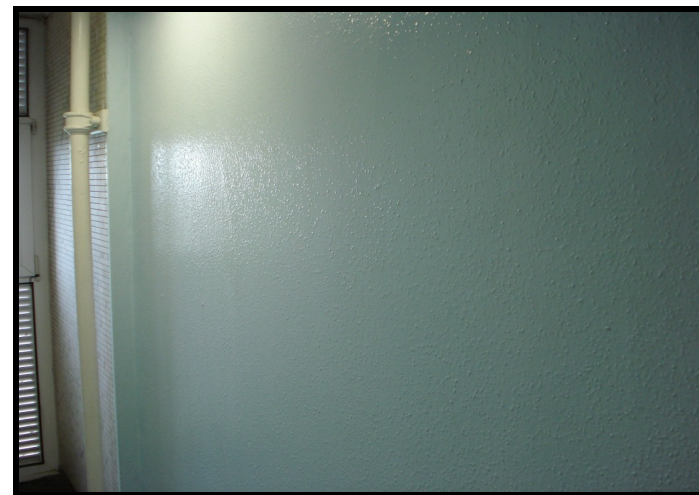
SAMPLE REFERENCE 056

No Asbestos Presumed in Sample

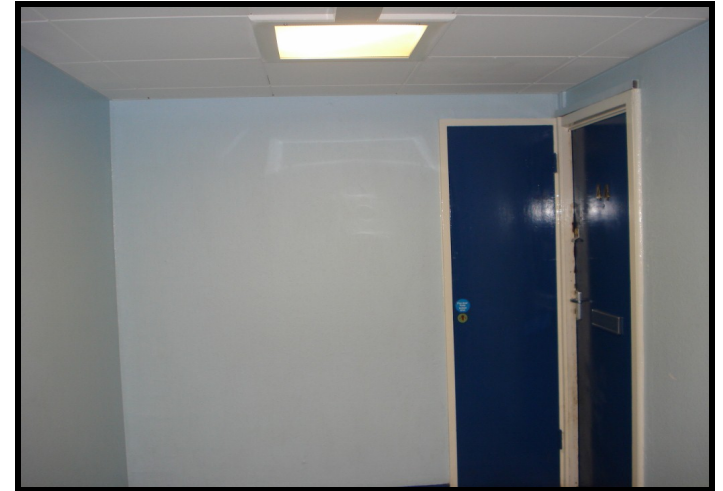
SAMPLE REFERENCE 058

No Asbestos Presumed in Sample

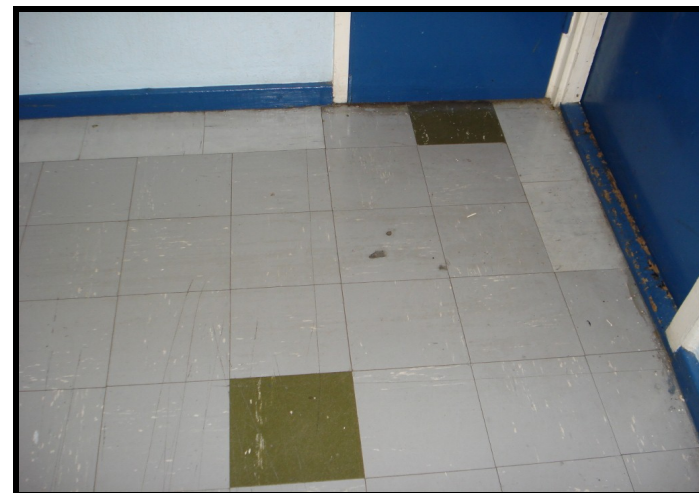
SAMPLE REFERENCE 061

No Asbestos Presumed in Sample

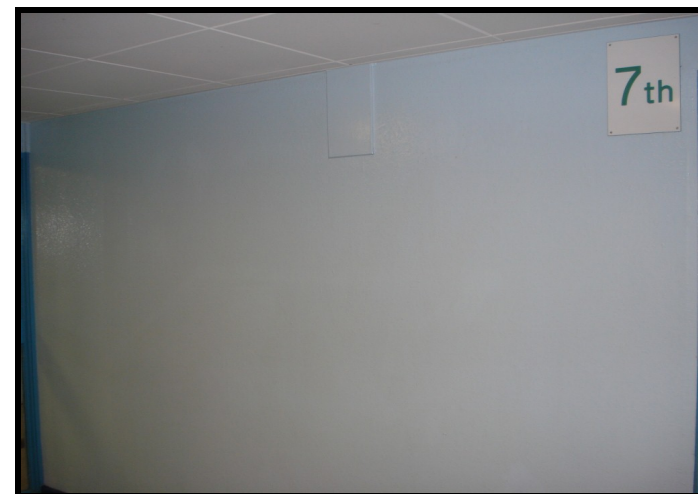
SAMPLE REFERENCE 064

No Asbestos Presumed in Sample

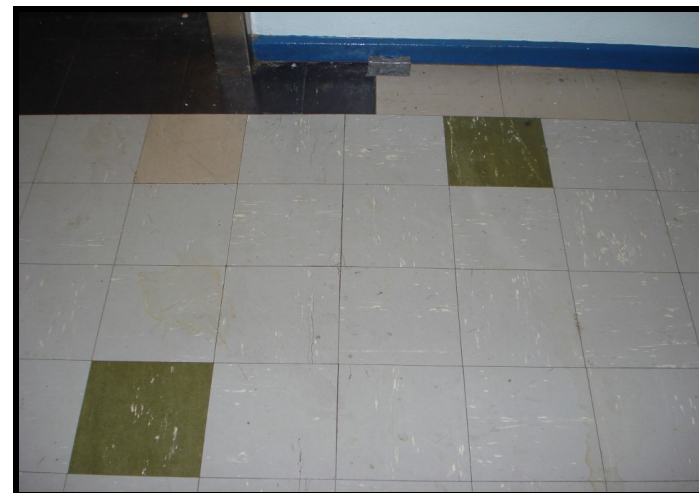
SAMPLE REFERENCE 065

Asbestos Presumed in Sample

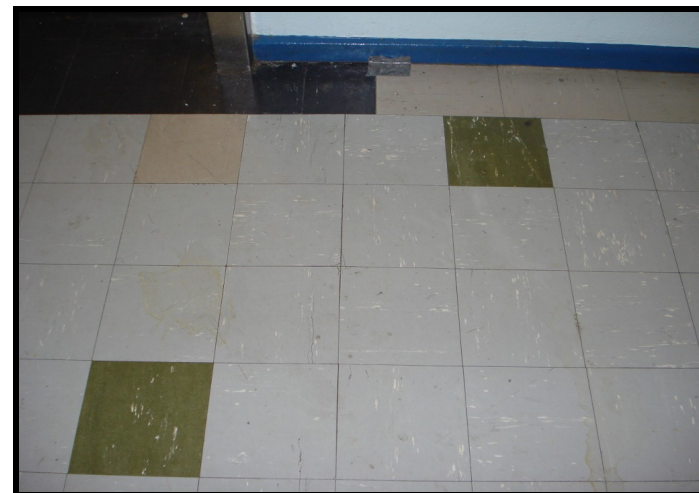
SAMPLE REFERENCE 066

Asbestos Presumed in Sample

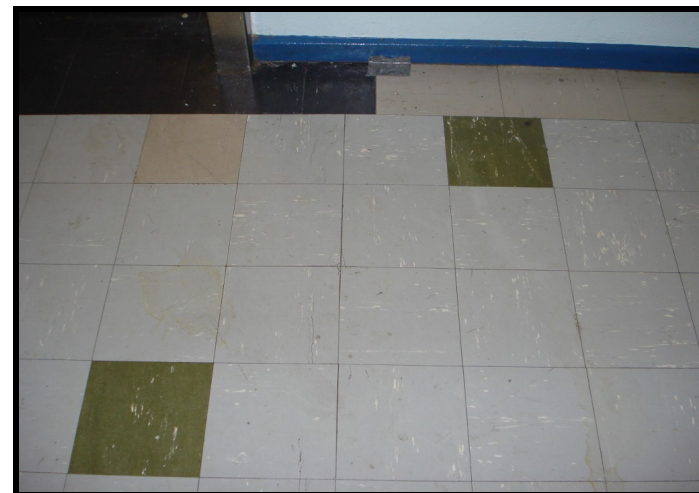
SAMPLE REFERENCE 067

Asbestos Presumed in Sample

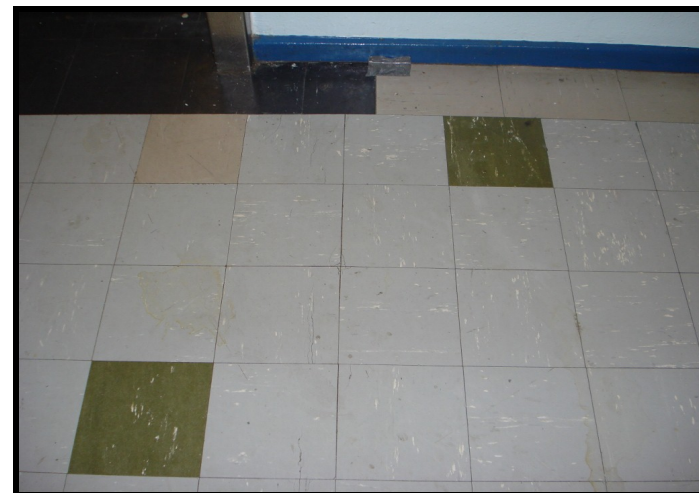
SAMPLE REFERENCE 068

Asbestos not detected in Sample

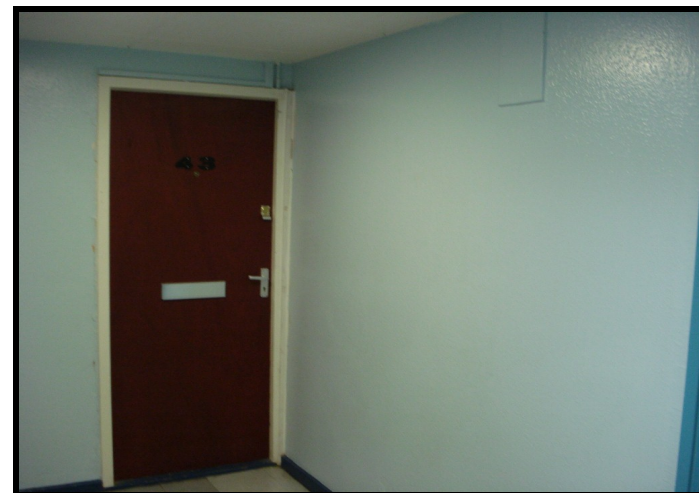
SAMPLE REFERENCE 069

No Asbestos Presumed in Sample

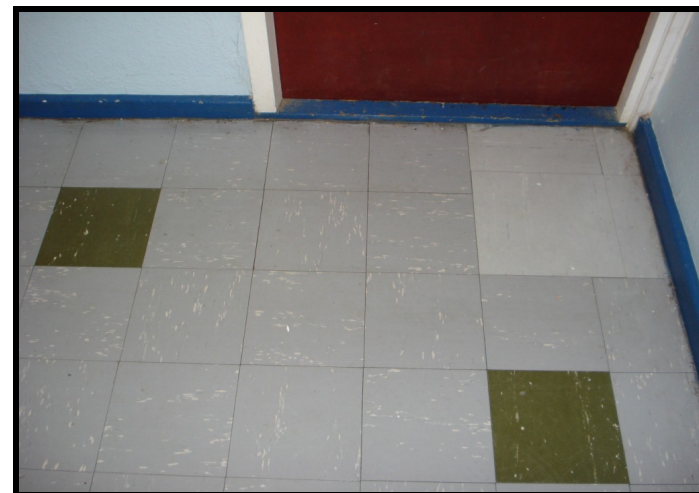
SAMPLE REFERENCE 070

Asbestos Presumed in Sample

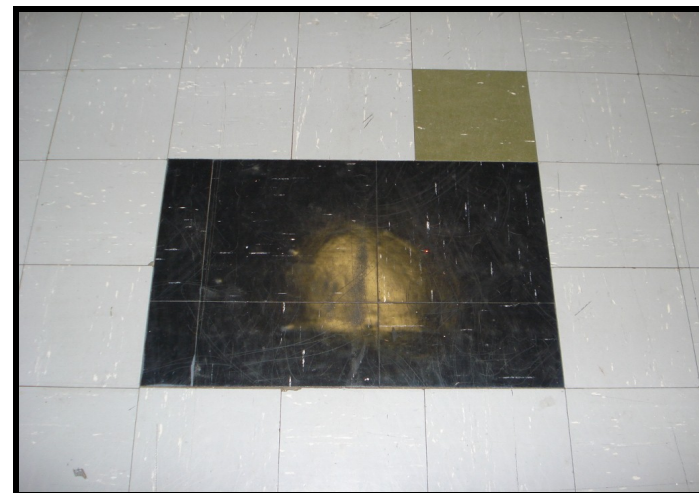
SAMPLE REFERENCE 073

No Asbestos Presumed in Sample

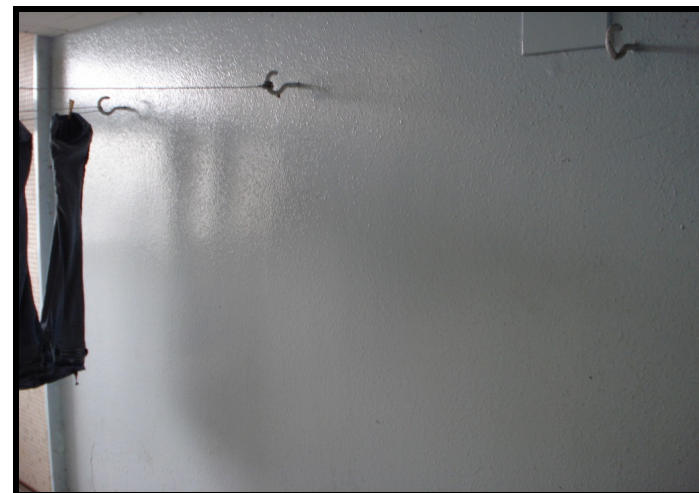
SAMPLE REFERENCE 076

No Asbestos Presumed in Sample

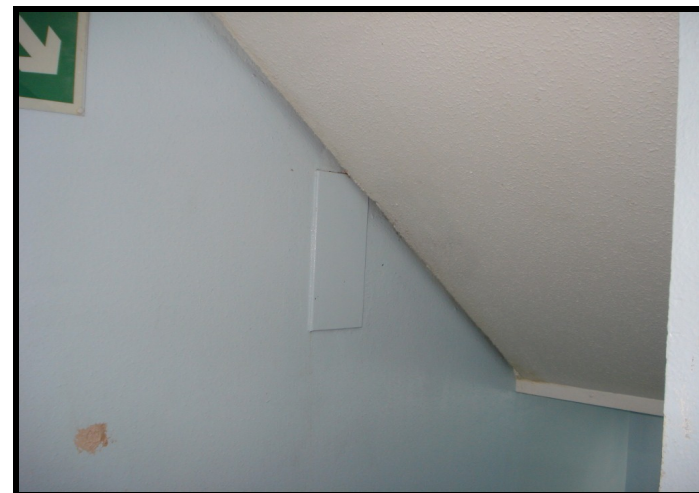
SAMPLE REFERENCE 077

No Asbestos Presumed in Sample

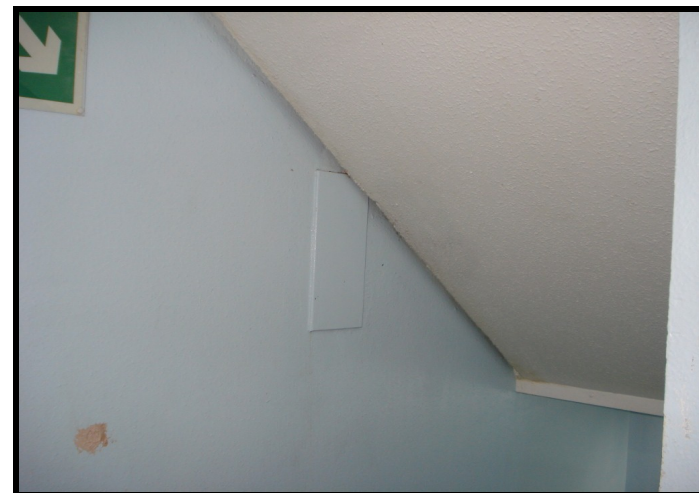
SAMPLE REFERENCE 078

No Asbestos Presumed in Sample

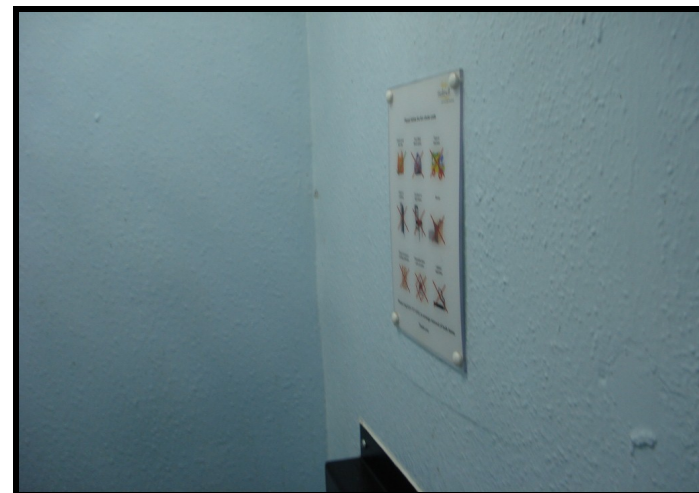
SAMPLE REFERENCE 079

No Asbestos Presumed in Sample

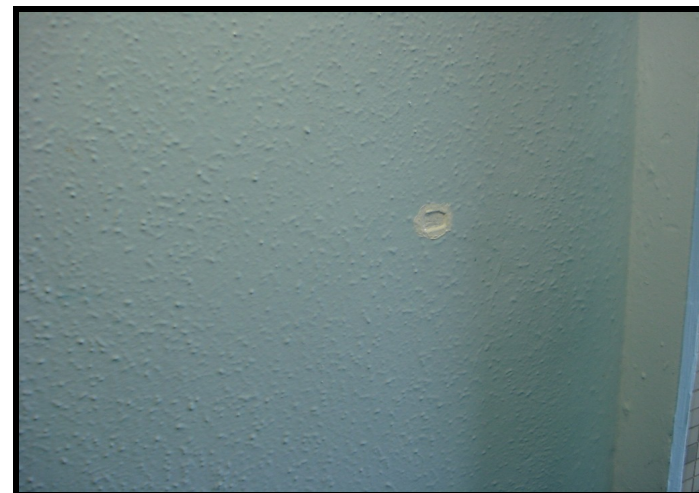
SAMPLE REFERENCE 080

Asbestos not detected in Sample

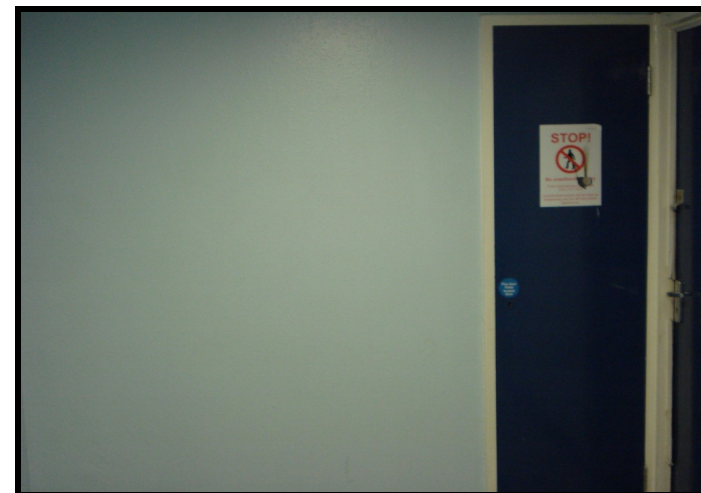
SAMPLE REFERENCE 082

No Asbestos Presumed in Sample

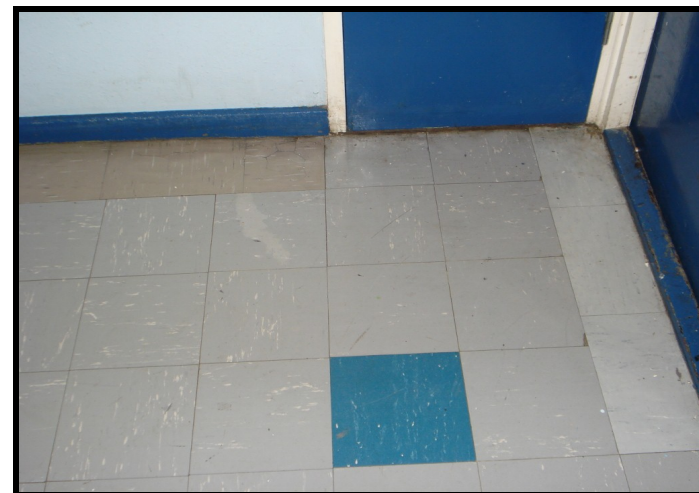
SAMPLE REFERENCE 083

Asbestos Presumed in Sample

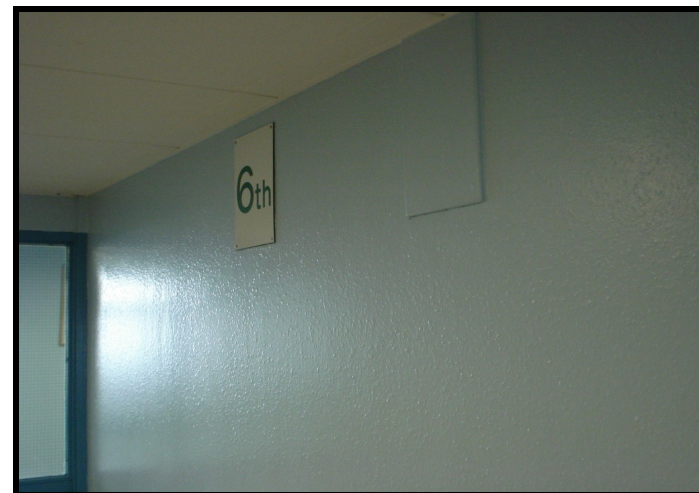
SAMPLE REFERENCE 089

No Asbestos Presumed in Sample

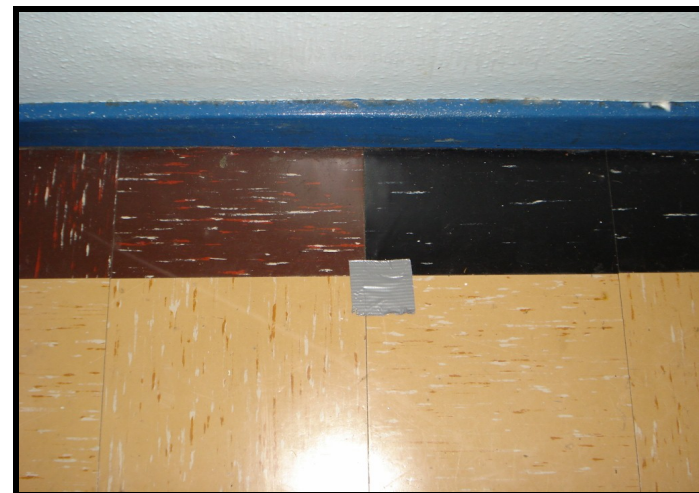
SAMPLE REFERENCE 090

Asbestos detected in Sample

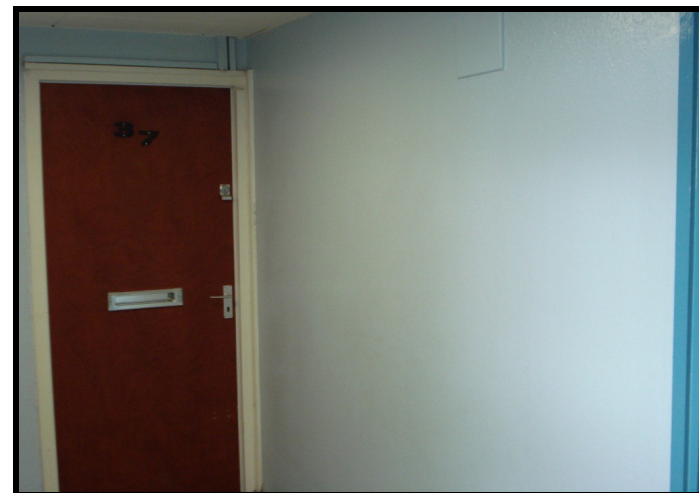
SAMPLE REFERENCE 093

No Asbestos Presumed in Sample

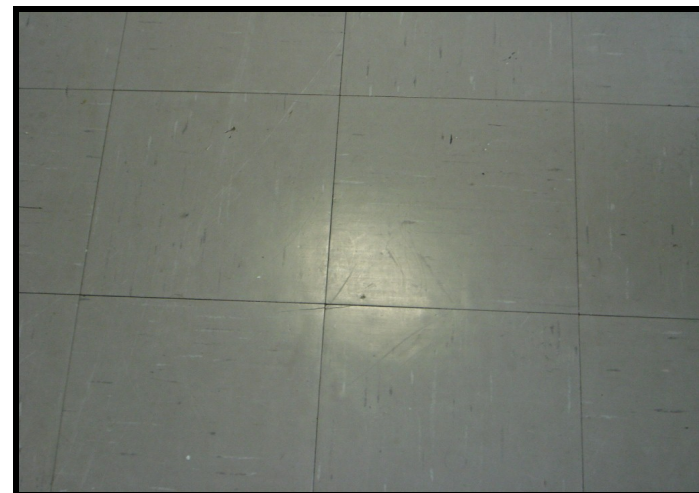
SAMPLE REFERENCE 094

No Asbestos Presumed in Sample
