Solihull Community Housing

Asbestos Management Survey Report

**Cheshunt House
Kington Gardens
Chelmsley Wood
B37 5TB**

Date of Report: 27 Apr 2012

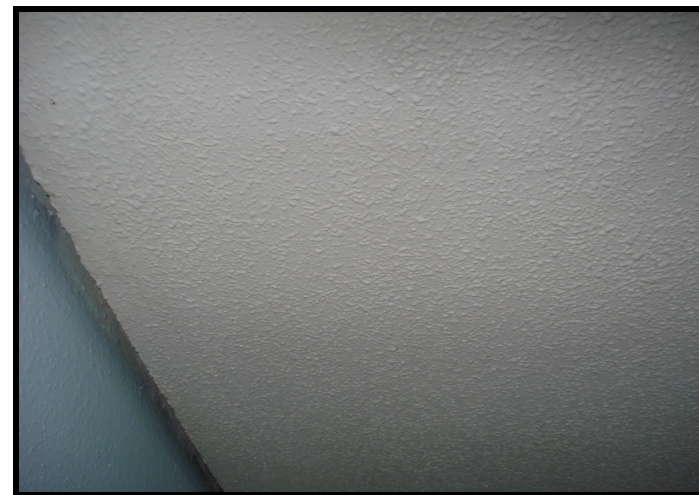
SAMPLE REFERENCE 098

No Asbestos Presumed in Sample

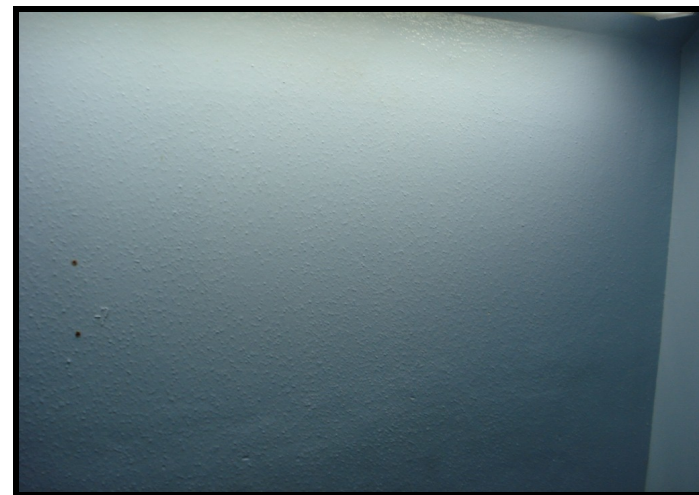
SAMPLE REFERENCE 099

No Asbestos Presumed in Sample

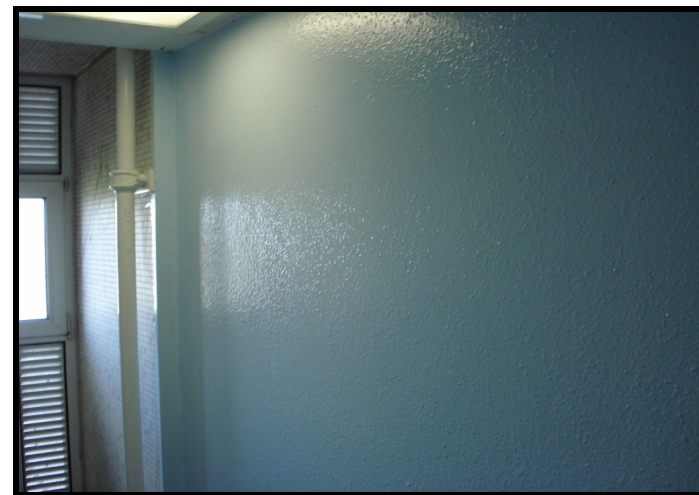
SAMPLE REFERENCE 101

No Asbestos Presumed in Sample

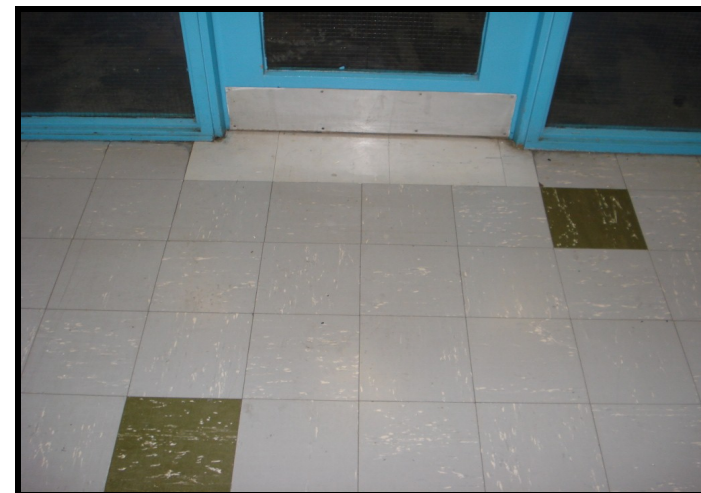
SAMPLE REFERENCE 104

Asbestos Presumed in Sample

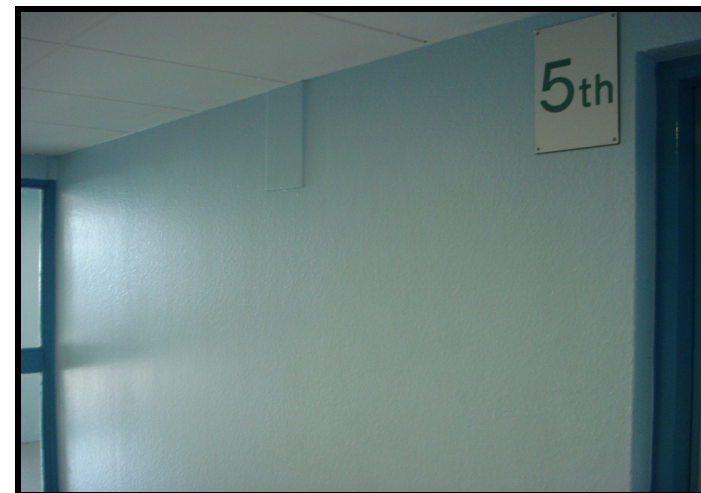
SAMPLE REFERENCE I 10

No Asbestos Presumed in Sample

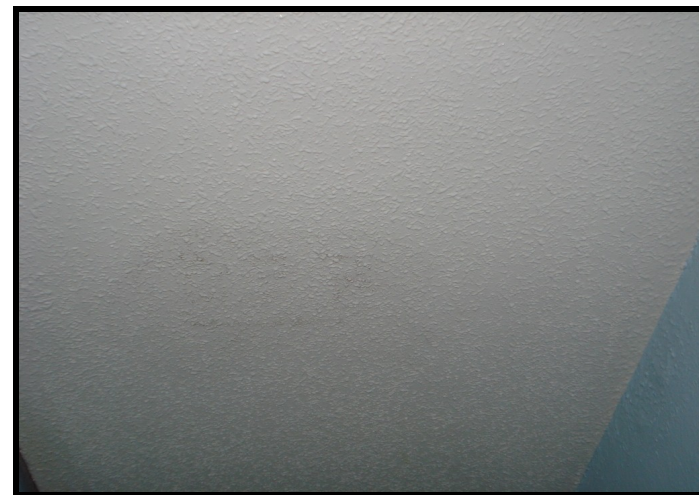
SAMPLE REFERENCE 123

No Asbestos Presumed in Sample

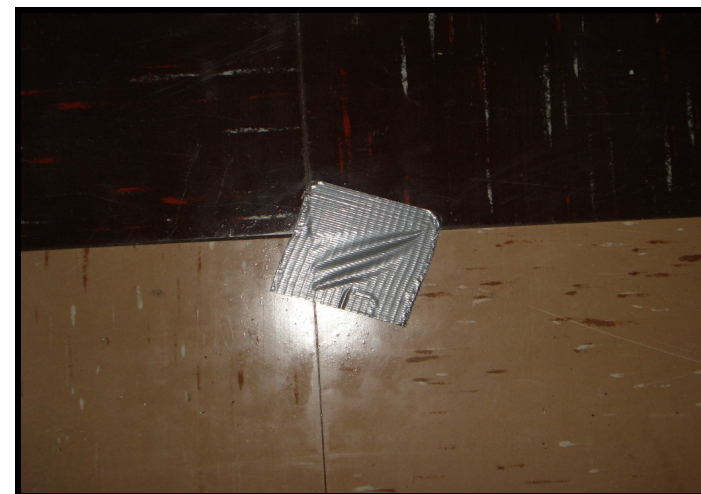
SAMPLE REFERENCE 134

Asbestos Presumed in Sample

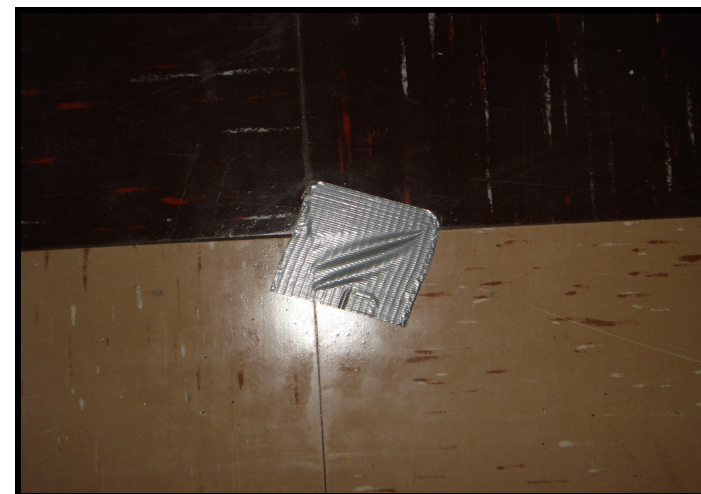
SAMPLE REFERENCE I35

Asbestos detected in Sample

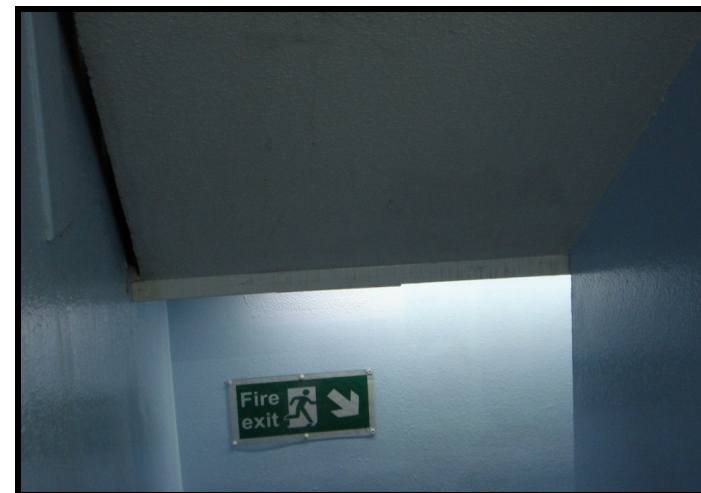
SAMPLE REFERENCE I46

No Asbestos Presumed in Sample

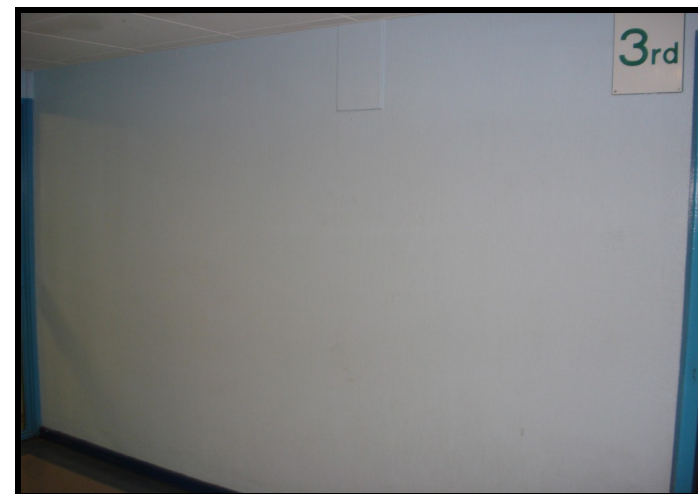
SAMPLE REFERENCE 158

No Asbestos Presumed in Sample

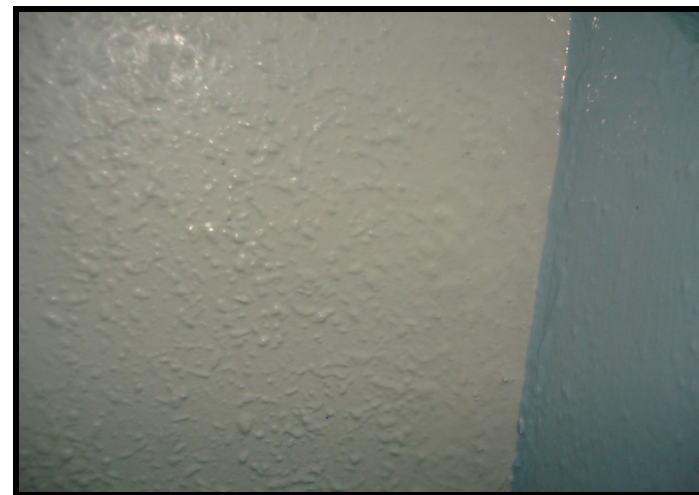
SAMPLE REFERENCE 169

No Asbestos Presumed in Sample

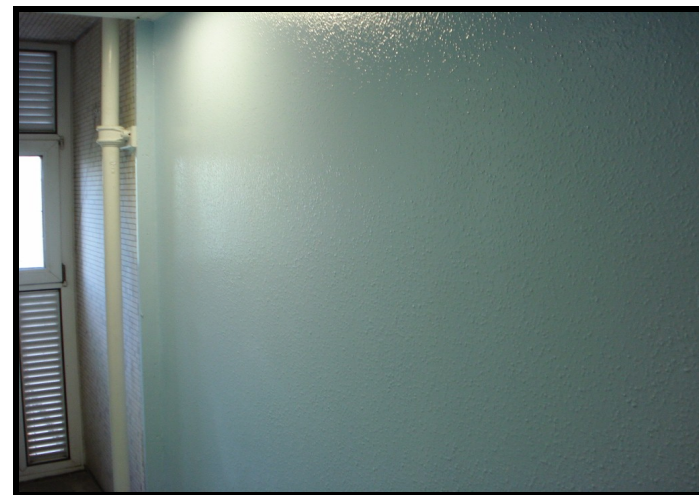
SAMPLE REFERENCE 174

No Asbestos Presumed in Sample

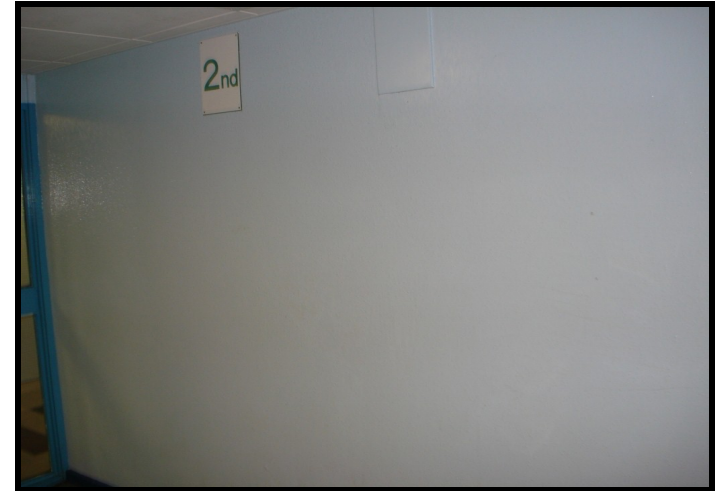
SAMPLE REFERENCE 183

No Asbestos Presumed in Sample

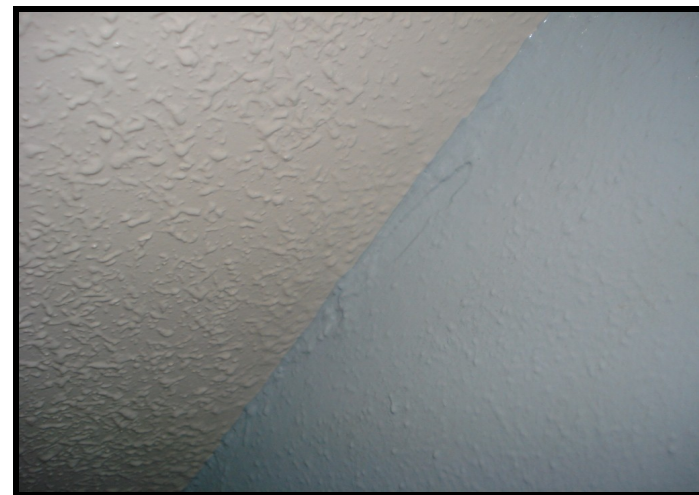
SAMPLE REFERENCE 198

No Asbestos Presumed in Sample

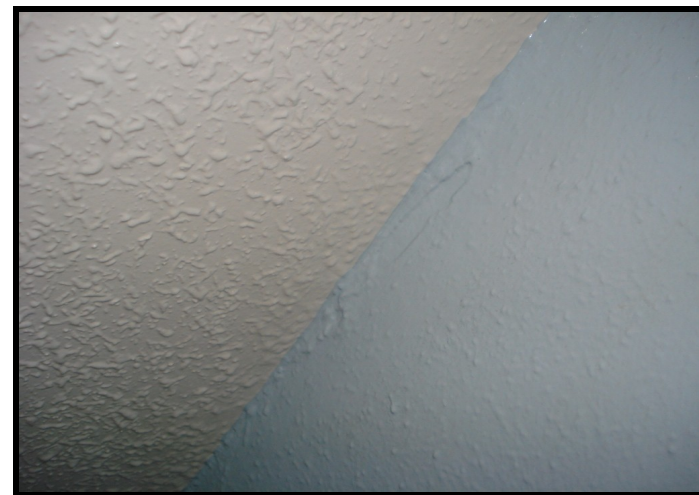
SAMPLE REFERENCE 199

No Asbestos Presumed in Sample

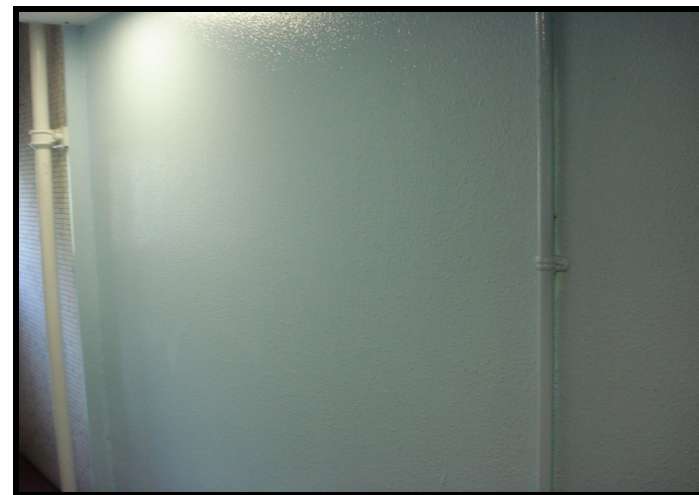
SAMPLE REFERENCE 201

No Asbestos Presumed in Sample

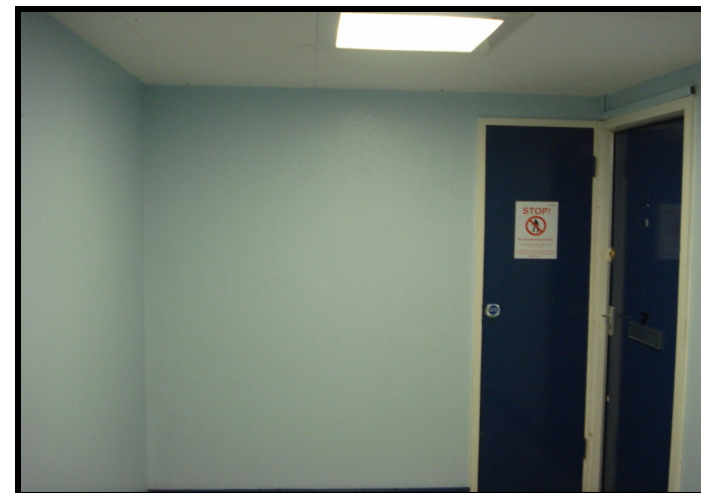
SAMPLE REFERENCE 203

No Asbestos Presumed in Sample

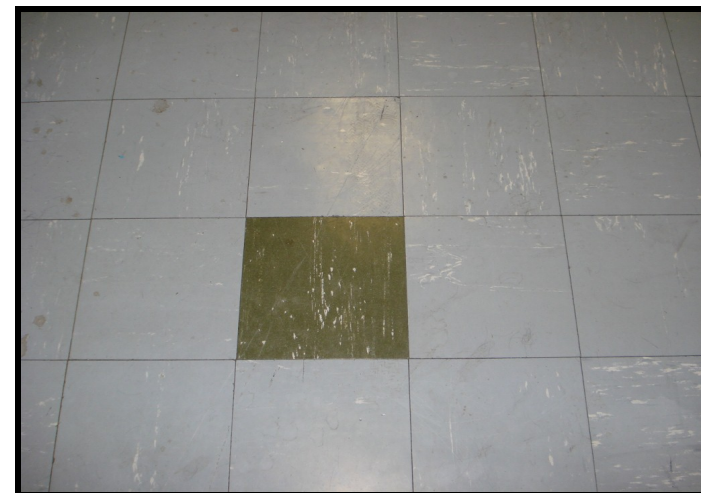
SAMPLE REFERENCE 204

Asbestos Presumed in Sample

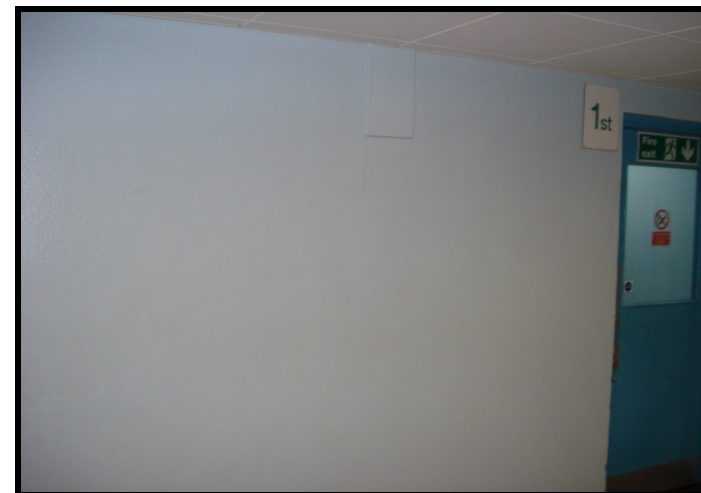
SAMPLE REFERENCE 210

No Asbestos Presumed in Sample

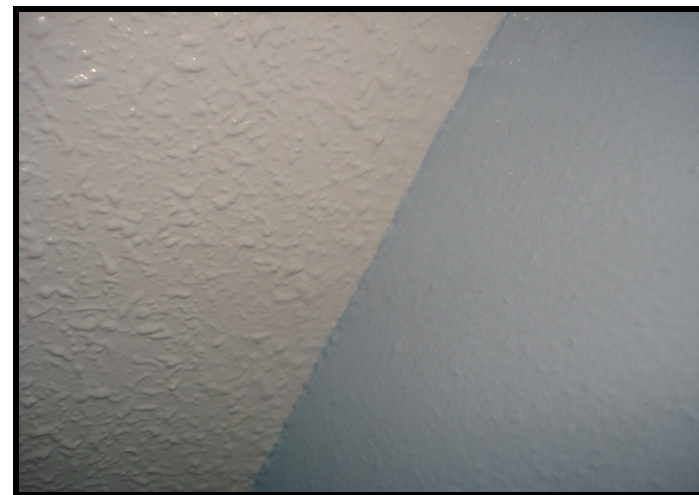
SAMPLE REFERENCE 222

No Asbestos Presumed in Sample

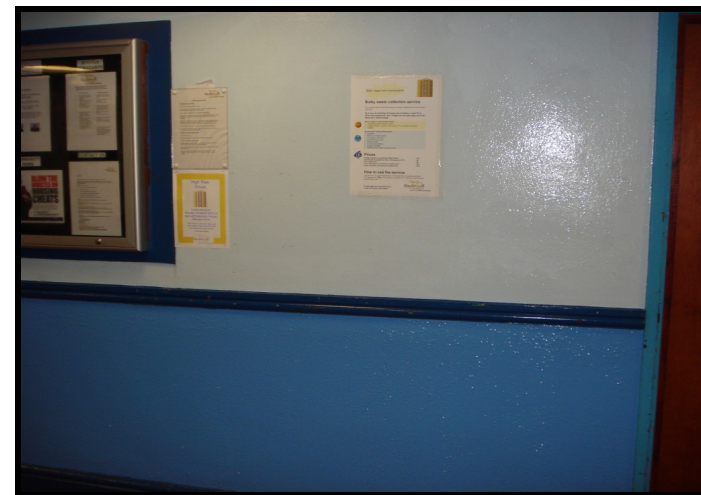
SAMPLE REFERENCE 231

No Asbestos Presumed in Sample

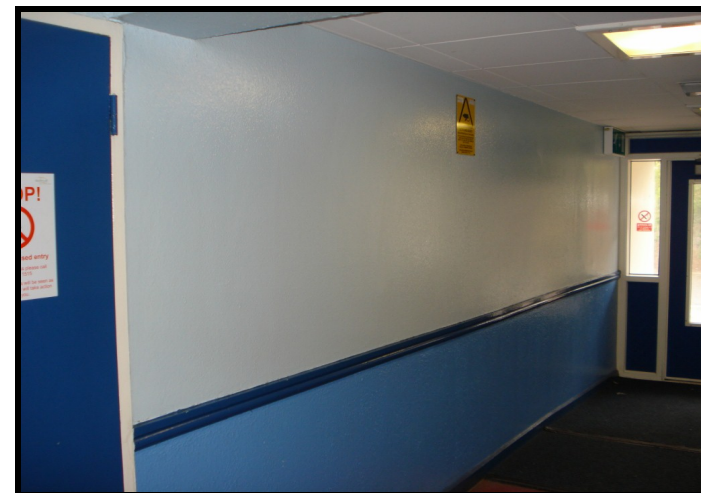
SAMPLE REFERENCE 238

No Asbestos Presumed in Sample
