# **Solihull Community Housing**

## **Asbestos Management Survey Report**

**Chester Court  
Hedingham Grove  
Chelmsley Wood  
B37 7TN**

**Date of Report: 16 May 2012**

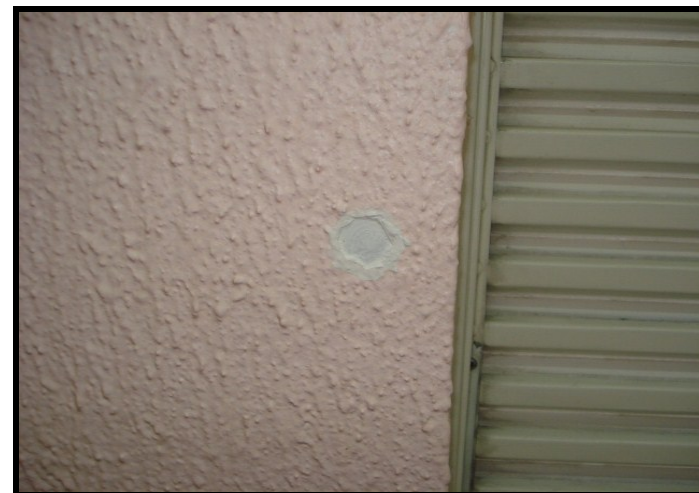
## SAMPLE REFERENCE 002

| 002 | Main Building (Tenth Floor) | Stairs | Walls | Textured Coating | No Asbestos Detected | 40.00m2 | Good condition | Textured Coating | - | - | - | NO ACTION REQUIRED | |

Asbestos not detected in Sample

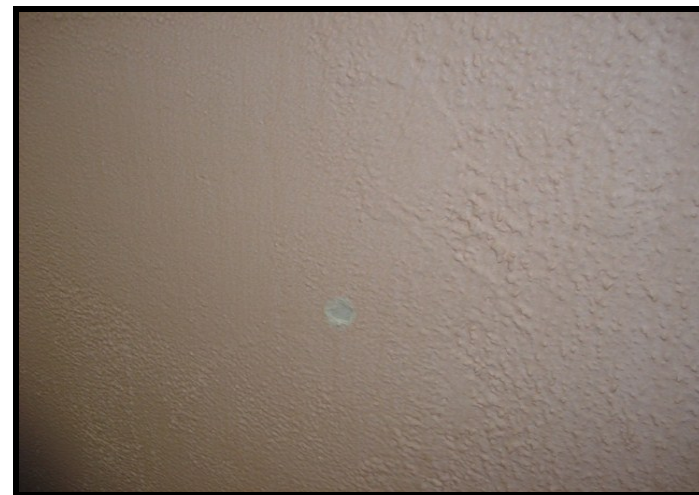
## SAMPLE REFERENCE 003

| 003 | Main Building (Tenth Floor) | Stairs | Wall | Textured Coating | No Asbestos Detected | 5.00m2 | Good condition | Textured Coating | - | - | - | NO ACTION REQUIRED | |

Asbestos not detected in Sample

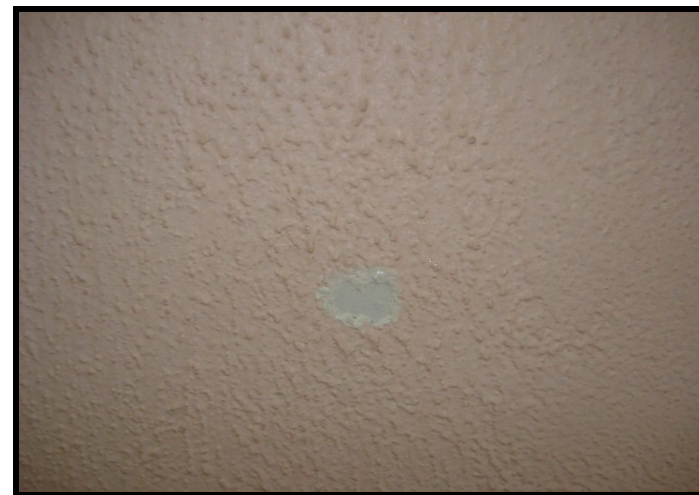
## SAMPLE REFERENCE 004

| 004 | Main Building (Tenth Floor) | Stairs | Wall | Textured Coating | No Asbestos Detected | 3.00m2 | Good condition | Textured Coating | - | - | - | NO ACTION REQUIRED | |

**Asbestos not detected in Sample**

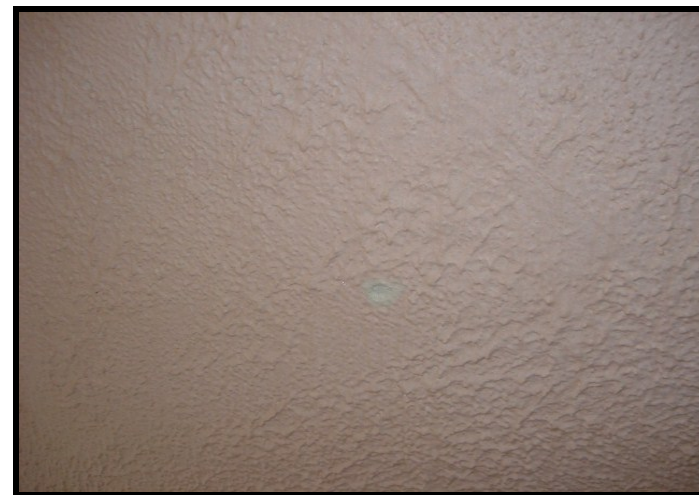
## SAMPLE REFERENCE 005

| Unique Sample No. | Building Reference (Floor) | Room Area | Description of Location | Product Description | Asbestos Type | Approx. Quantity | Material Condition | Surface Treatment | Material Risk Score | Priority Risk Score | Total Risk Score | Management Action | Next Review Date |
|---|---|---|---|---|---|---|---|---|---|---|---|---|---|
| 005 | Main Building (Tenth Floor) | Stairs | Wall | Textured Coating | No Asbestos Detected | 5.00m2 | Good condition | Textured Coating | - | - | - | NO ACTION REQUIRED | |

**Asbestos not detected in Sample**

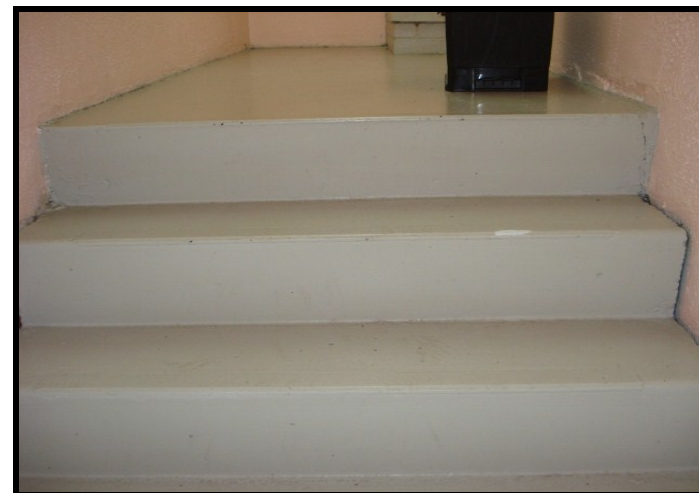
## SAMPLE REFERENCE 006

| Unique Sample No. | Building Reference (Floor) | Room Area | Description of Location | Product Description | Asbestos Type | Approx. Quantity | Material Condition | Surface Treatment | Material Risk Score | Priority Risk Score | Total Risk Score | Management Action | Next Review Date |
|---|---|---|---|---|---|---|---|---|---|---|---|---|---|
| 006 | Main Building (Tenth Floor) | Stairs | Staircase | Bitumen | Chrysotile | 210.00small item(s) | Good condition | Composite materials | 2 | 1 | 3 | LABEL & MONITOR | 04 Apr 2013 |

**Asbestos detected in Sample**

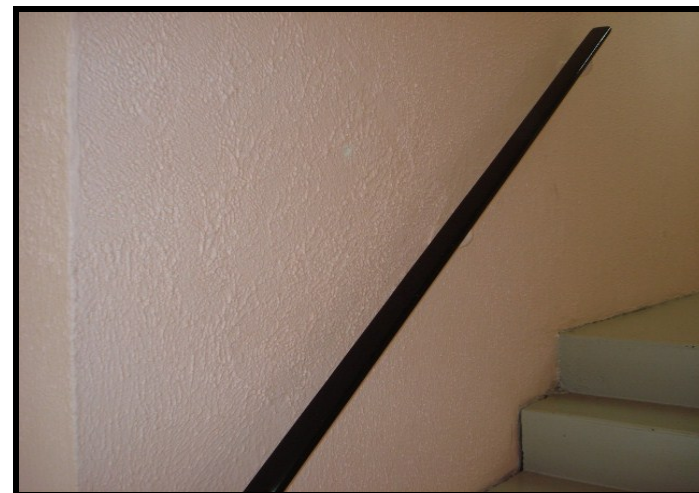
## SAMPLE REFERENCE 007

| Unique Sample No. | Building Reference (Floor) | Room Area | Description of Location | Product Description | Asbestos Type | Approx. Quantity | Material Condition | Surface Treatment | Material Risk Score | Priority Risk Score | Total Risk Score | Management Action | Next Review Date |
|---|---|---|---|---|---|---|---|---|---|---|---|---|---|
| 007 | Main Building (Tenth Floor) | Stairs | Staircase | Bitumen | No Asbestos Detected | 40.00small item(s) | Good condition | Composite materials | - | - | - | NO ACTION REQUIRED | |

Asbestos not detected in Sample

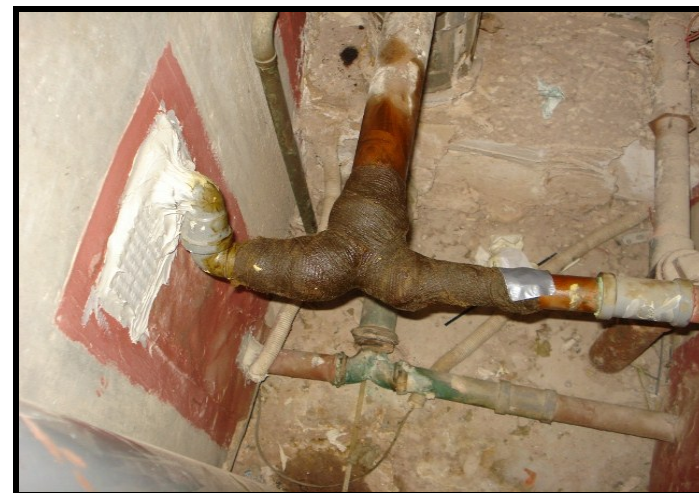
## SAMPLE REFERENCE 008

| Unique Sample No. | Building Reference (Floor) | Room Area | Description of Location | Product Description | Asbestos Type | Approx. Quantity | Material Condition | Surface Treatment | Material Risk Score | Priority Risk Score | Total Risk Score | Management Action | Next Review Date |
|---|---|---|---|---|---|---|---|---|---|---|---|---|---|
| 008 | Main Building (Nineth Floor) | Service Riser | Pipe Work | Lagging | No Asbestos Detected | 2.00small item(s) | Good condition | Sealed (1) | - | - | - | NO ACTION REQUIRED | |

**Asbestos not detected in Sample**

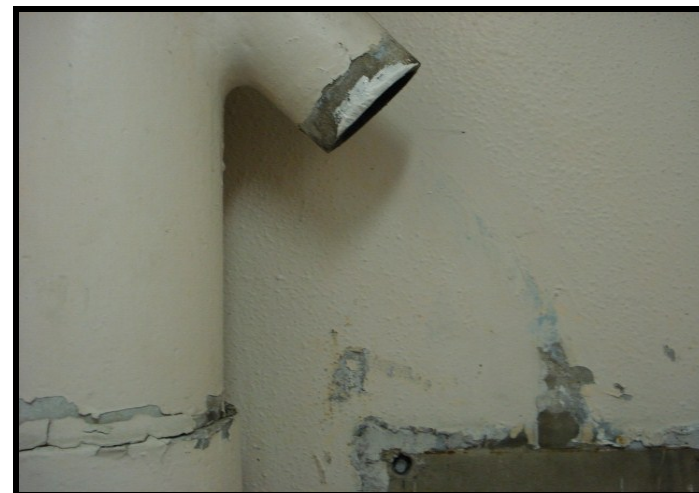
## SAMPLE REFERENCE 009

| Unique Sample No. | Building Reference (Floor) | Room Area | Description of Location | Product Description | Asbestos Type | Approx. Quantity | Material Condition | Surface Treatment | Material Risk Score | Priority Risk Score | Total Risk Score | Management Action | Next Review Date |
|---|---|---|---|---|---|---|---|---|---|---|---|---|---|
| 009 | Main Building (First Floor) | Bin Chute Cupboard | Pipe Work | Cement | Chrysotile / Crocidolite | 3.00small item(s) | Good condition | Sealed (Cement products) | 5 | 0 | 5 | LABEL & MONITOR | 04 Apr 2013 |

**Asbestos detected in Sample**

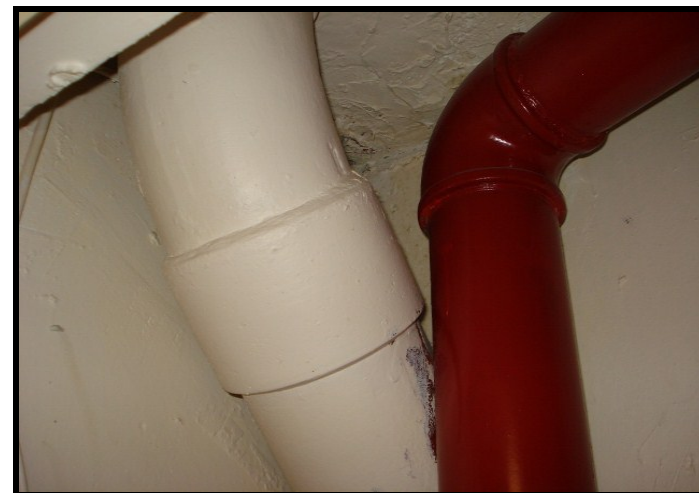
## SAMPLE REFERENCE 010

| Unique Sample No. | Building Reference (Floor) | Room Area | Description of Location | Product Description | Asbestos Type | Approx. Quantity | Material Condition | Surface Treatment | Material Risk Score | Priority Risk Score | Total Risk Score | Management Action | Next Review Date |
|---|---|---|---|---|---|---|---|---|---|---|---|---|---|
| 010 | Main Building (Nineth Floor) | Dry Riser | Pipe Work | Cement | Chrysotile / Crocidolite | 2.00small item(s) | Good condition | Sealed (Cement products) | 5 | 0 | 5 | LABEL & MONITOR | 04 Apr 2013 |

Asbestos Presumed in Sample

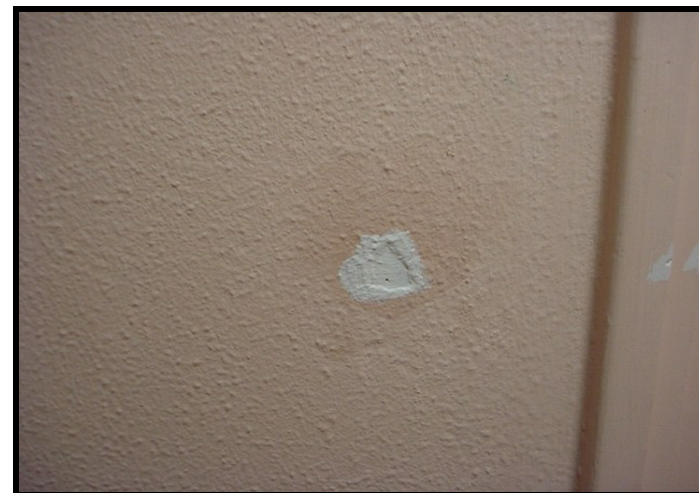
## SAMPLE REFERENCE 012

| Unique Sample No. | Building Reference (Floor) | Room Area | Description of Location | Product Description | Asbestos Type | Approx. Quantity | Material Condition | Surface Treatment | Material Risk Score | Priority Risk Score | Total Risk Score | Management Action | Next Review Date |
|---|---|---|---|---|---|---|---|---|---|---|---|---|---|
| 012 | Main Building (Nineth Floor) | Lift Lobby | Walls | Paint | No Asbestos Detected | 30.00m2 | Good condition | Sealed (1) | - | - | - | NO ACTION REQUIRED | |

**Asbestos not detected in Sample**

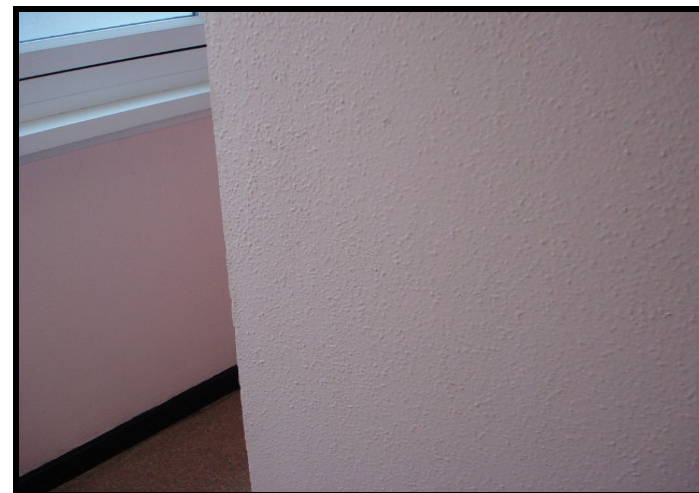
## SAMPLE REFERENCE 013

| Unique Sample No. | Building Reference (Floor) | Room Area | Description of Location | Product Description | Asbestos Type | Approx. Quantity | Material Condition | Surface Treatment | Material Risk Score | Priority Risk Score | Total Risk Score | Management Action | Next Review Date |
|---|---|---|---|---|---|---|---|---|---|---|---|---|---|
| 013 | Main Building (Nineth Floor) | Corridor I | Walls | Paint | No Asbestos Detected | 20.00m2 | Good condition | Sealed (1) | - | - | - | NO ACTION REQUIRED | |

**No Asbestos Presumed in Sample**

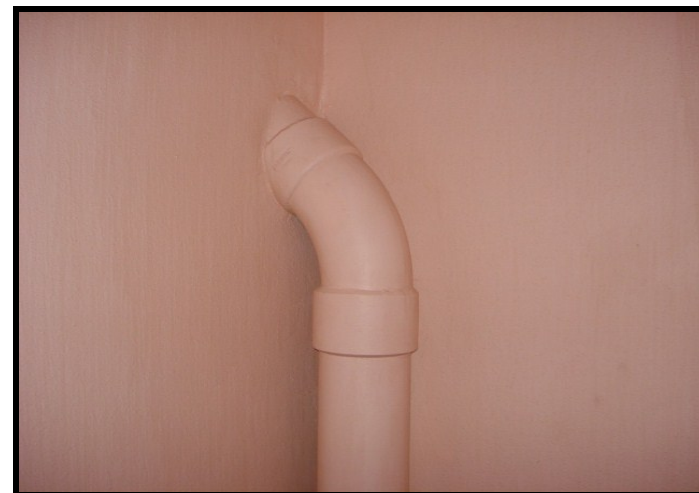
## SAMPLE REFERENCE 014

| Unique Sample No. | Building Reference (Floor) | Room Area | Description of Location | Product Description | Asbestos Type | Approx. Quantity | Material Condition | Surface Treatment | Material Risk Score | Priority Risk Score | Total Risk Score | Management Action | Next Review Date |
|---|---|---|---|---|---|---|---|---|---|---|---|---|---|
| 014 | Main Building (Nineth Floor) | Bin Chute | Walls | Paint | No Asbestos Detected | 18.00m2 | Good condition | Sealed (1) | - | - | - | NO ACTION REQUIRED | |

**No Asbestos Presumed in Sample**

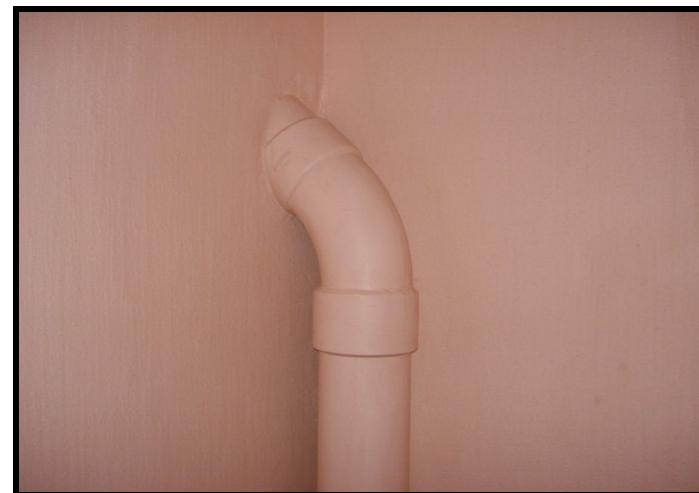
## SAMPLE REFERENCE 015

| Unique Sample No. | Building Reference (Floor) | Room Area | Description of Location | Product Description | Asbestos Type | Approx. Quantity | Material Condition | Surface Treatment | Material Risk Score | Priority Risk Score | Total Risk Score | Management Action | Next Review Date |
|---|---|---|---|---|---|---|---|---|---|---|---|---|---|
| 015 | Main Building (Nineth Floor) | Bin Chute | Pipe Work | Cement | Chrysotile / Crocidolite | 2.00small item(s) | Good condition | Sealed (Cement products) | 5 | 0 | 5 | LABEL & MONITOR | 04 Apr 2013 |

Asbestos Presumed in Sample

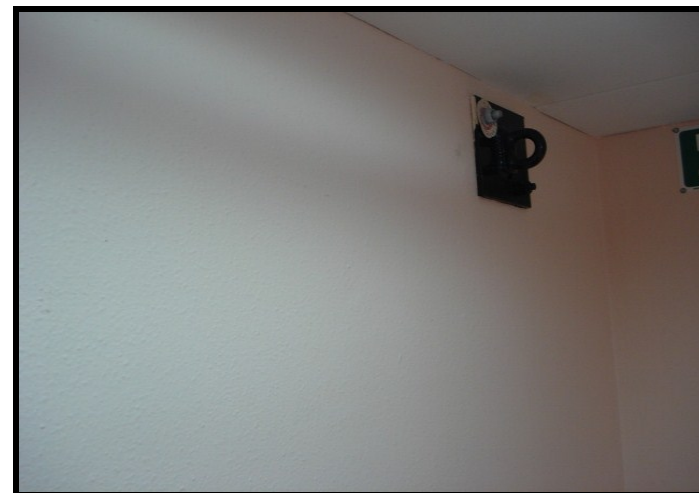
## SAMPLE REFERENCE 016

| Unique Sample No. | Building Reference (Floor) | Room Area | Description of Location | Product Description | Asbestos Type | Approx. Quantity | Material Condition | Surface Treatment | Material Risk Score | Priority Risk Score | Total Risk Score | Management Action | Next Review Date |
|---|---|---|---|---|---|---|---|---|---|---|---|---|---|
| 016 | Main Building (Nineth Floor) | Stairs | Walls | Paint | No Asbestos Detected | 40.00m2 | Good condition | Sealed (1) | - | - | - | NO ACTION REQUIRED | |

**No Asbestos Presumed in Sample**

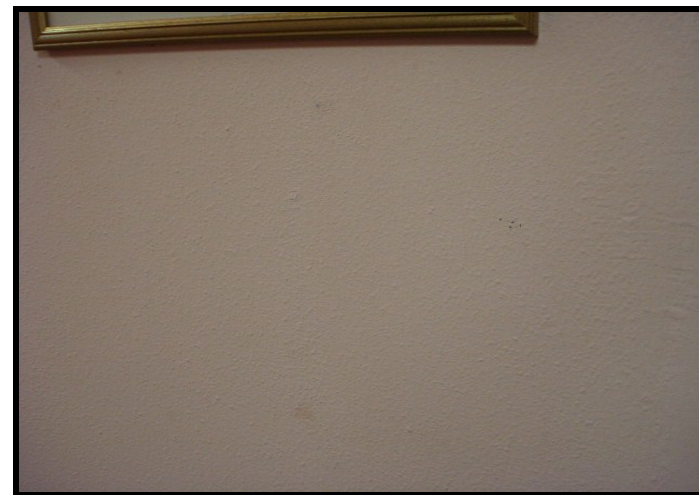
## SAMPLE REFERENCE 020

| Unique Sample No. | Building Reference (Floor) | Room Area | Description of Location | Product Description | Asbestos Type | Approx. Quantity | Material Condition | Surface Treatment | Material Risk Score | Priority Risk Score | Total Risk Score | Management Action | Next Review Date |
|---|---|---|---|---|---|---|---|---|---|---|---|---|---|
| 020 | Main Building (Eighth Floor) | Lift Lobby | Walls | Paint | No Asbestos Detected | 30.00m2 | Good condition | Sealed (1) | - | - | - | NO ACTION REQUIRED | |

**No Asbestos Presumed in Sample**

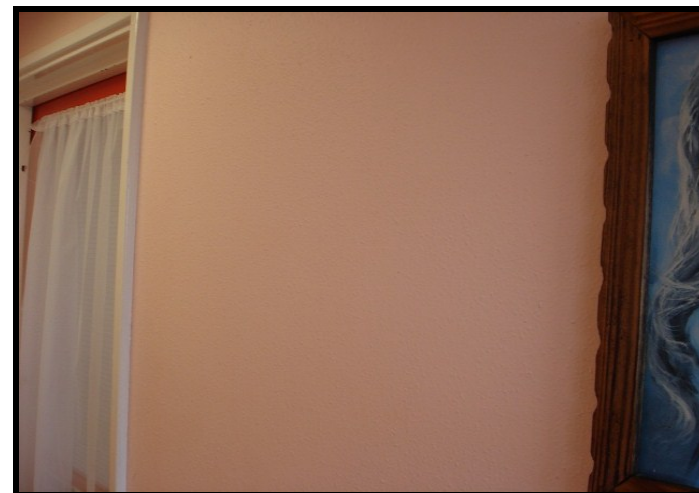
## SAMPLE REFERENCE 02 I

| Unique Sample No. | Building Reference (Floor) | Room Area | Description of Location | Product Description | Asbestos Type | Approx. Quantity | Material Condition | Surface Treatment | Material Risk Score | Priority Risk Score | Total Risk Score | Management Action | Next Review Date |
|---|---|---|---|---|---|---|---|---|---|---|---|---|---|
| 021 | Main Building (Eighth Floor) | Corridor 1 | Walls | Paint | No Asbestos Detected | 20.00m2 | Good condition | Sealed (1) | - | - | - | NO ACTION REQUIRED | |

**No Asbestos Presumed in Sample**

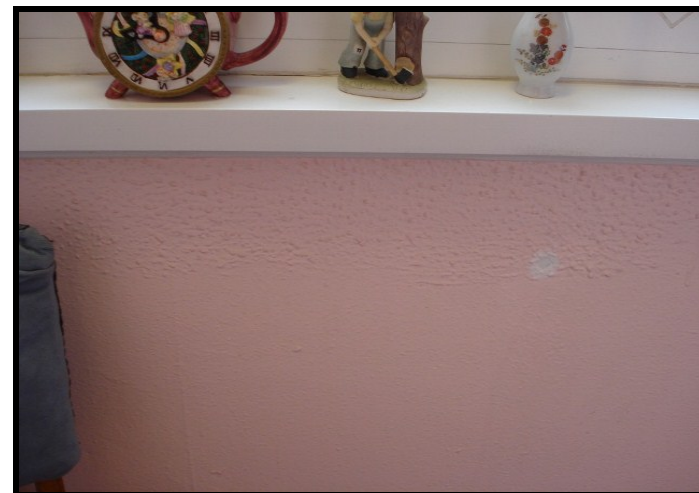
## SAMPLE REFERENCE 022

| Unique Sample No. | Building Reference (Floor) | Room Area | Description of Location | Product Description | Asbestos Type | Approx. Quantity | Material Condition | Surface Treatment | Material Risk Score | Priority Risk Score | Total Risk Score | Management Action | Next Review Date |
|---|---|---|---|---|---|---|---|---|---|---|---|---|---|
| 022 | Main Building (Eighth Floor) | Corridor 1 | Wall | Textured Coating | No Asbestos Detected | 1.00m2 | Good condition | Textured Coating | - | - | - | NO ACTION REQUIRED | |

**Asbestos not detected in Sample**

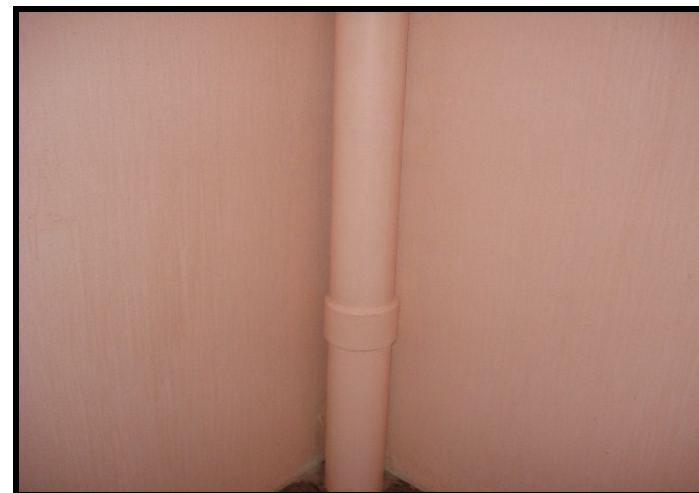
## SAMPLE REFERENCE 023

| Unique Sample No. | Building Reference (Floor) | Room Area | Description of Location | Product Description | Asbestos Type | Approx. Quantity | Material Condition | Surface Treatment | Material Risk Score | Priority Risk Score | Total Risk Score | Management Action | Next Review Date |
|---|---|---|---|---|---|---|---|---|---|---|---|---|---|
| 023 | Main Building (Eighth Floor) | Bin Chute | Walls | Paint | No Asbestos Detected | 18.00m2 | Good condition | Sealed (1) | - | - | - | NO ACTION REQUIRED | |

**No Asbestos Presumed in Sample**

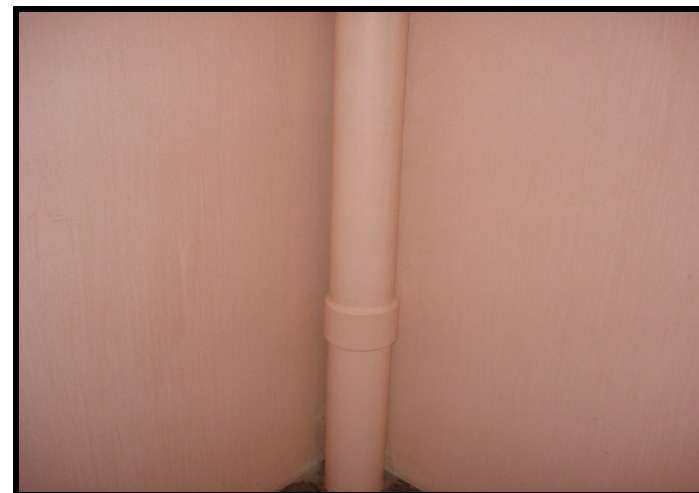
## SAMPLE REFERENCE 024

| Unique Sample No. | Building Reference (Floor) | Room Area | Description of Location | Product Description | Asbestos Type | Approx. Quantity | Material Condition | Surface Treatment | Material Risk Score | Priority Risk Score | Total Risk Score | Management Action | Next Review Date |
|---|---|---|---|---|---|---|---|---|---|---|---|---|---|
| 024 | Main Building (Eighth Floor) | Bin Chute | Pipe Work | Cement | Chrysotile / Crocidolite | 3.00small item(s) | Good condition | Sealed (Cement products) | 5 | 0 | 5 | LABEL & MONITOR | 04 Apr 2013 |

Asbestos Presumed in Sample

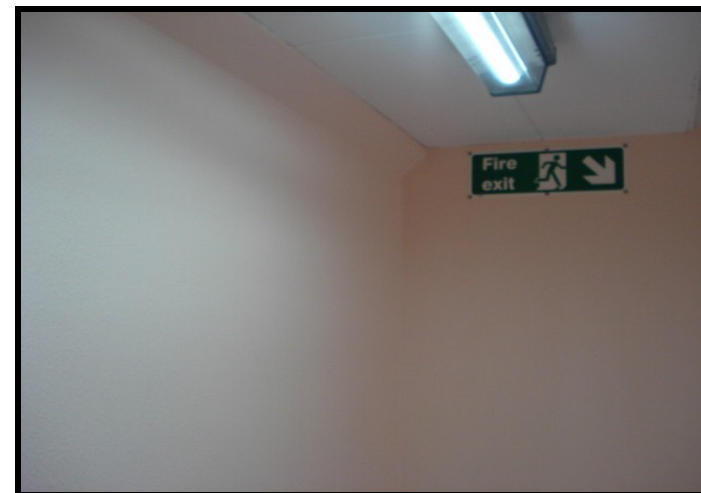
## SAMPLE REFERENCE 025

| Unique Sample No. | Building Reference (Floor) | Room Area | Description of Location | Product Description | Asbestos Type | Approx. Quantity | Material Condition | Surface Treatment | Material Risk Score | Priority Risk Score | Total Risk Score | Management Action | Next Review Date |
|---|---|---|---|---|---|---|---|---|---|---|---|---|---|
| 025 | Main Building (Eighth Floor) | Stairs | Walls | Paint | No Asbestos Detected | 40.00m2 | Good condition | Sealed (1) | - | - | - | NO ACTION REQUIRED | |

**No Asbestos Presumed in Sample**

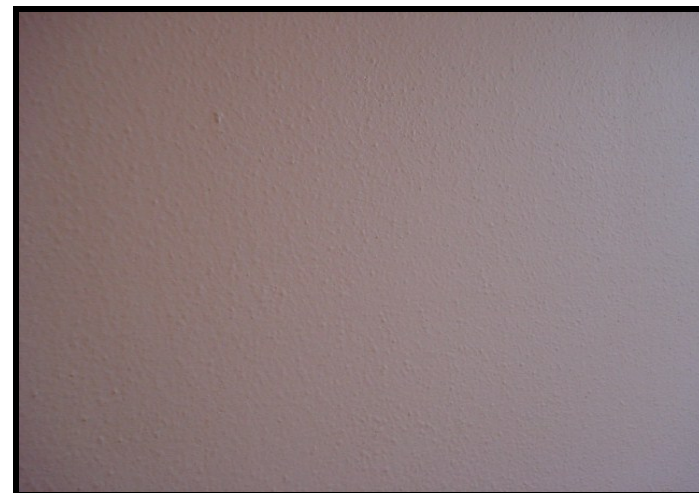
## SAMPLE REFERENCE 030

| Unique Sample No. | Building Reference (Floor) | Room Area | Description of Location | Product Description | Asbestos Type | Approx. Quantity | Material Condition | Surface Treatment | Material Risk Score | Priority Risk Score | Total Risk Score | Management Action | Next Review Date |
|---|---|---|---|---|---|---|---|---|---|---|---|---|---|
| 030 | Main Building (Seventh Floor) | Corridor I | Walls | Paint | No Asbestos Detected | 20.00m2 | Good condition | Sealed (1) | - | - | - | NO ACTION REQUIRED | |

**No Asbestos Presumed in Sample**

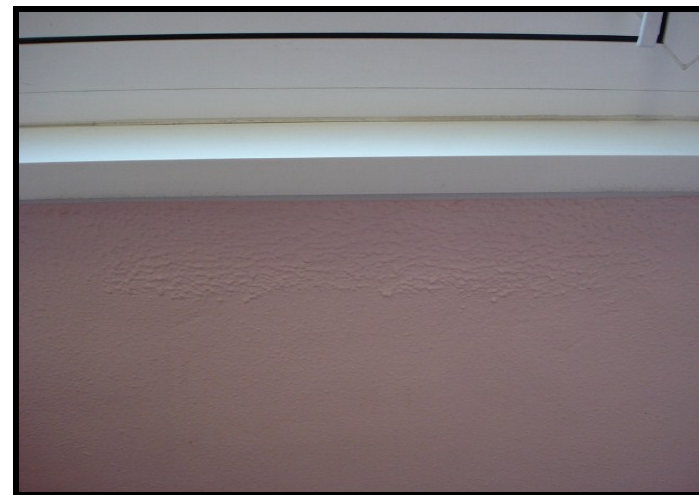
## SAMPLE REFERENCE 031

| Unique Sample No. | Building Reference (Floor) | Room Area | Description of Location | Product Description | Asbestos Type | Approx. Quantity | Material Condition | Surface Treatment | Material Risk Score | Priority Risk Score | Total Risk Score | Management Action | Next Review Date |
|---|---|---|---|---|---|---|---|---|---|---|---|---|---|
| 031 | Main Building (Seventh Floor) | Corridor I | Wall | Textured Coating | No Asbestos Detected | 1.00m2 | Good condition | Textured Coating | - | - | - | NO ACTION REQUIRED | |

**No Asbestos Presumed in Sample**

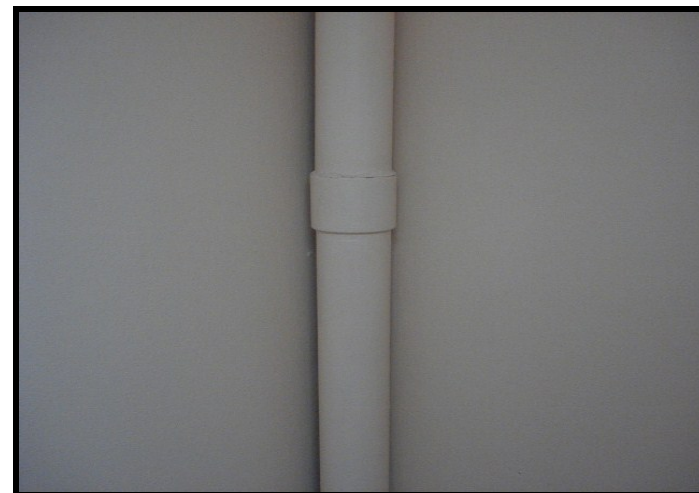
## SAMPLE REFERENCE 032

| Unique Sample No. | Building Reference (Floor) | Room Area | Description of Location | Product Description | Asbestos Type | Approx. Quantity | Material Condition | Surface Treatment | Material Risk Score | Priority Risk Score | Total Risk Score | Management Action | Next Review Date |
|---|---|---|---|---|---|---|---|---|---|---|---|---|---|
| 032 | Main Building (Seventh Floor) | Bin Chute | Walls | Paint | No Asbestos Detected | 17.00m2 | Good condition | Sealed (1) | - | - | - | NO ACTION REQUIRED | |

**No Asbestos Presumed in Sample**

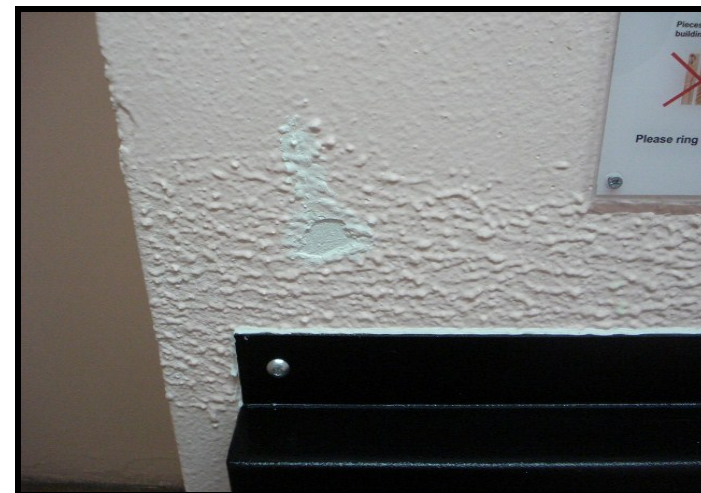
## SAMPLE REFERENCE 033

| Unique Sample No. | Building Reference (Floor) | Room Area | Description of Location | Product Description | Asbestos Type | Approx. Quantity | Material Condition | Surface Treatment | Material Risk Score | Priority Risk Score | Total Risk Score | Management Action | Next Review Date |
|---|---|---|---|---|---|---|---|---|---|---|---|---|---|
| 033 | Main Building (Seventh Floor) | Bin Chute | Wall | Textured Coating | No Asbestos Detected | 1.00m2 | Good condition | Textured Coating | - | - | - | NO ACTION REQUIRED | |

Asbestos not detected in Sample

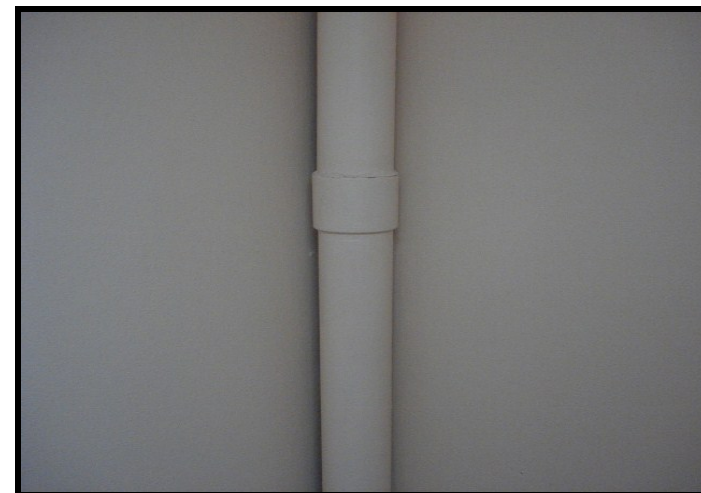
## SAMPLE REFERENCE 034

| Unique Sample No. | Building Reference (Floor) | Room Area | Description of Location | Product Description | Asbestos Type | Approx. Quantity | Material Condition | Surface Treatment | Material Risk Score | Priority Risk Score | Total Risk Score | Management Action | Next Review Date |
|---|---|---|---|---|---|---|---|---|---|---|---|---|---|
| 034 | Main Building (Seventh Floor) | Bin Chute | Pipe Work | Cement | Chrysotile / Crocidolite | 3.00small item(s) | Good condition | Sealed (Cement products) | 5 | 0 | 5 | LABEL & MONITOR | 04 Apr 2013 |

Asbestos Presumed in Sample

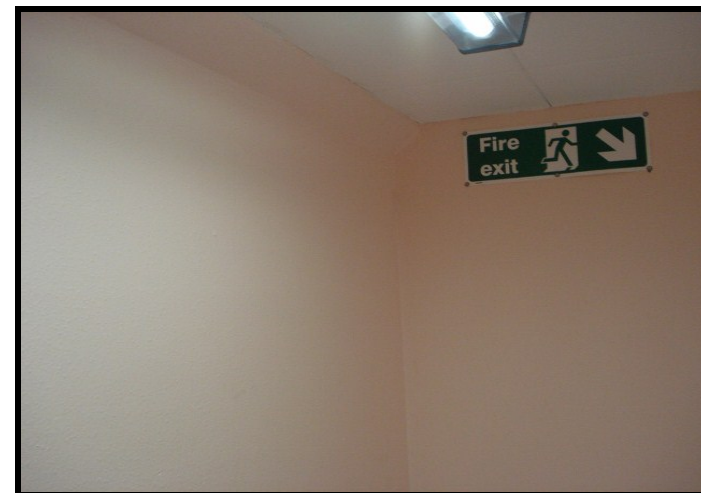
## SAMPLE REFERENCE 035

| Unique Sample No. | Building Reference (Floor) | Room Area | Description of Location | Product Description | Asbestos Type | Approx. Quantity | Material Condition | Surface Treatment | Material Risk Score | Priority Risk Score | Total Risk Score | Management Action | Next Review Date |
|---|---|---|---|---|---|---|---|---|---|---|---|---|---|
| 035 | Main Building (Seventh Floor) | Stairs | Walls | Paint | No Asbestos Detected | 40.00m2 | Good condition | Sealed (1) | - | - | - | NO ACTION REQUIRED | |

**No Asbestos Presumed in Sample**

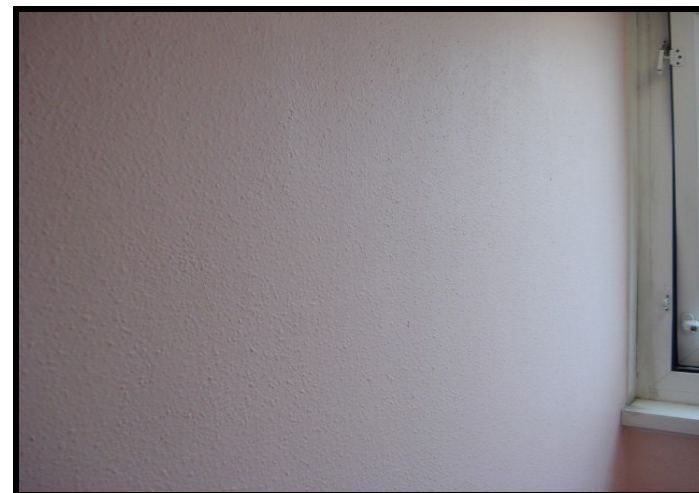
## SAMPLE REFERENCE 040

| Unique Sample No. | Building Reference (Floor) | Room Area | Description of Location | Product Description | Asbestos Type | Approx. Quantity | Material Condition | Surface Treatment | Material Risk Score | Priority Risk Score | Total Risk Score | Management Action | Next Review Date |
|---|---|---|---|---|---|---|---|---|---|---|---|---|---|
| 040 | Main Building (Sixth Floor) | Corridor 1 | Walls | Paint | No Asbestos Detected | 20.00m2 | Good condition | Sealed (1) | - | - | - | NO ACTION REQUIRED | |

**No Asbestos Presumed in Sample**

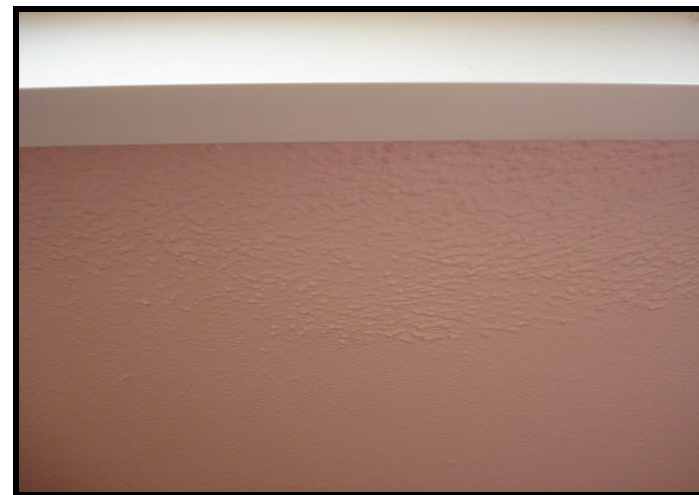
## SAMPLE REFERENCE 041

| Unique Sample No. | Building Reference (Floor) | Room Area | Description of Location | Product Description | Asbestos Type | Approx. Quantity | Material Condition | Surface Treatment | Material Risk Score | Priority Risk Score | Total Risk Score | Management Action | Next Review Date |
|---|---|---|---|---|---|---|---|---|---|---|---|---|---|
| 041 | Main Building (Sixth Floor) | Corridor 1 | Wall | Textured Coating | No Asbestos Detected | 1.00m2 | Good condition | Textured Coating | - | - | - | NO ACTION REQUIRED | |

**No Asbestos Presumed in Sample**

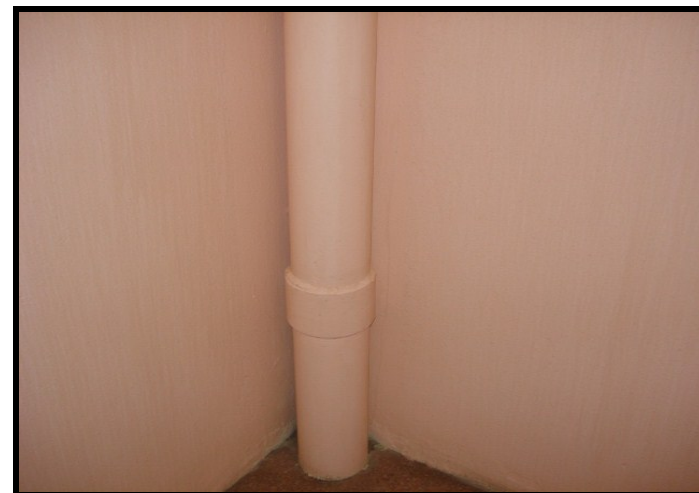
## SAMPLE REFERENCE 042

| Unique Sample No. | Building Reference (Floor) | Room Area | Description of Location | Product Description | Asbestos Type | Approx. Quantity | Material Condition | Surface Treatment | Material Risk Score | Priority Risk Score | Total Risk Score | Management Action | Next Review Date |
|---|---|---|---|---|---|---|---|---|---|---|---|---|---|
| 042 | Main Building (Sixth Floor) | Bin Chute | Walls | Paint | No Asbestos Detected | 17.00m2 | Good condition | Sealed (1) | - | - | - | NO ACTION REQUIRED | |

**No Asbestos Presumed in Sample**

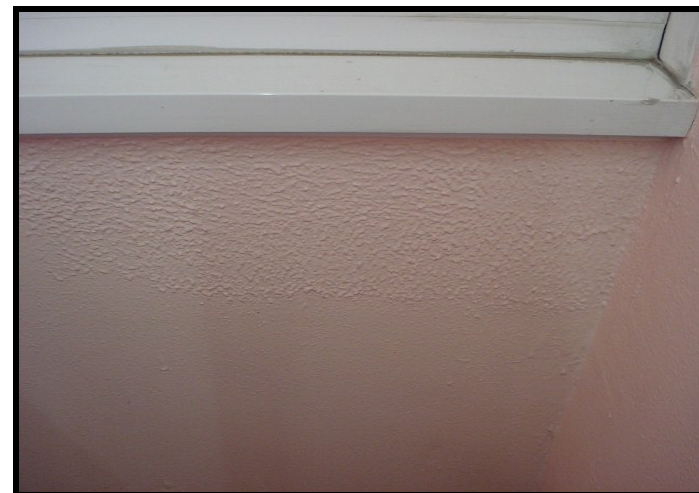
## SAMPLE REFERENCE 043

| Unique Sample No. | Building Reference (Floor) | Room Area | Description of Location | Product Description | Asbestos Type | Approx. Quantity | Material Condition | Surface Treatment | Material Risk Score | Priority Risk Score | Total Risk Score | Management Action | Next Review Date |
|---|---|---|---|---|---|---|---|---|---|---|---|---|---|
| 043 | Main Building (Sixth Floor) | Bin Chute | Wall | Textured Coating | No Asbestos Detected | 1.00m2 | Good condition | Textured Coating | - | - | - | NO ACTION REQUIRED | |

**No Asbestos Presumed in Sample**

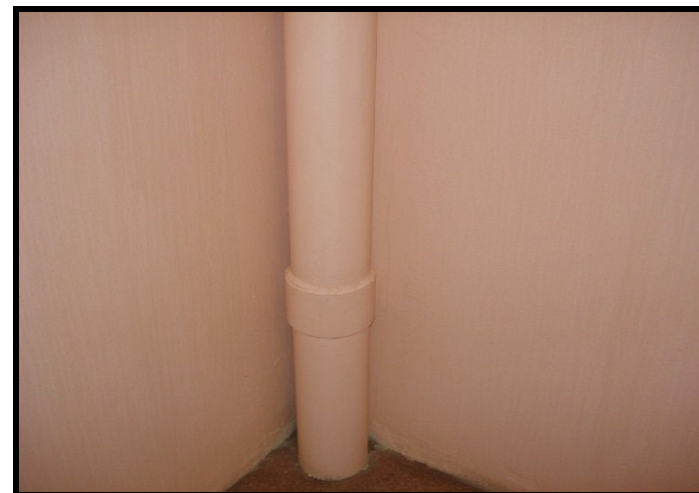
## SAMPLE REFERENCE 044

| Unique Sample No. | Building Reference (Floor) | Room Area | Description of Location | Product Description | Asbestos Type | Approx. Quantity | Material Condition | Surface Treatment | Material Risk Score | Priority Risk Score | Total Risk Score | Management Action | Next Review Date |
|---|---|---|---|---|---|---|---|---|---|---|---|---|---|
| 044 | Main Building (Sixth Floor) | Bin Chute | Pipe Work | Cement | Chrysotile / Crocidolite | 3.00small item(s) | Good condition | Sealed (Cement products) | 5 | 0 | 5 | LABEL & MONITOR | 04 Apr 2013 |

Asbestos Presumed in Sample

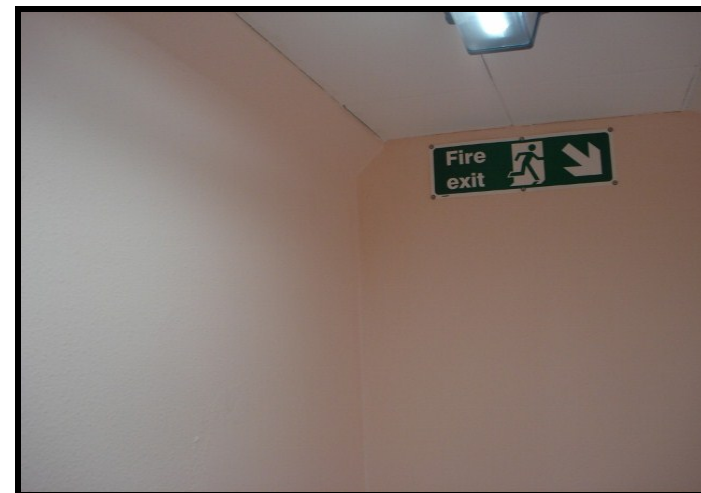
## SAMPLE REFERENCE 045

| Unique Sample No. | Building Reference (Floor) | Room Area | Description of Location | Product Description | Asbestos Type | Approx. Quantity | Material Condition | Surface Treatment | Material Risk Score | Priority Risk Score | Total Risk Score | Management Action | Next Review Date |
|---|---|---|---|---|---|---|---|---|---|---|---|---|---|
| 045 | Main Building (Sixth Floor) | Stairs | Walls | Paint | No Asbestos Detected | 40.00m2 | Good condition | Sealed (1) | - | - | - | NO ACTION REQUIRED | |

**No Asbestos Presumed in Sample**

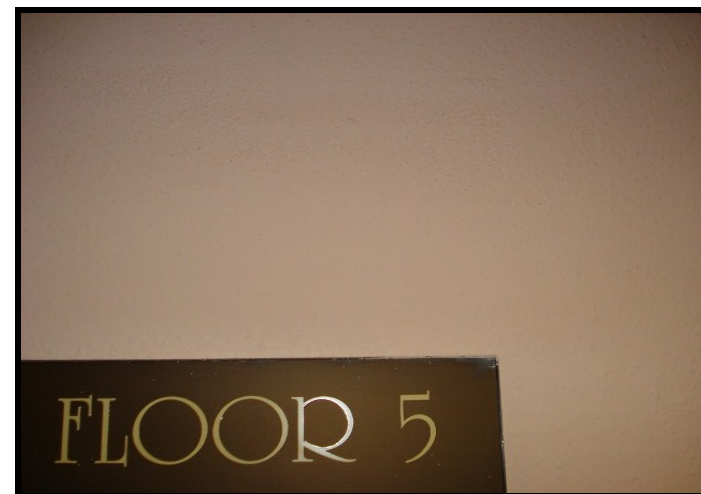
## SAMPLE REFERENCE 049

| Unique Sample No. | Building Reference (Floor) | Room Area | Description of Location | Product Description | Asbestos Type | Approx. Quantity | Material Condition | Surface Treatment | Material Risk Score | Priority Risk Score | Total Risk Score | Management Action | Next Review Date |
|---|---|---|---|---|---|---|---|---|---|---|---|---|---|
| 049 | Main Building (Fifth Floor) | Lift Lobby | Walls | Paint | No Asbestos Detected | 30.00m2 | Good condition | Sealed (1) | - | - | - | NO ACTION REQUIRED | |

**No Asbestos Presumed in Sample**

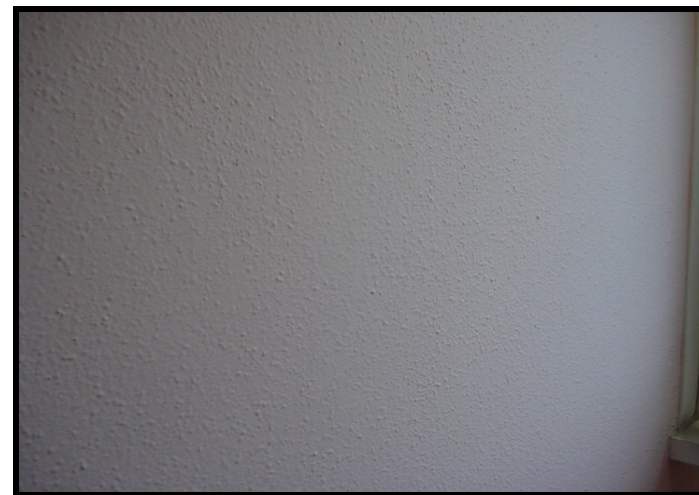
## SAMPLE REFERENCE 050

| Unique Sample No. | Building Reference (Floor) | Room Area | Description of Location | Product Description | Asbestos Type | Approx. Quantity | Material Condition | Surface Treatment | Material Risk Score | Priority Risk Score | Total Risk Score | Management Action | Next Review Date |
|---|---|---|---|---|---|---|---|---|---|---|---|---|---|
| 050 | Main Building (Fifth Floor) | Corridor I | Walls | Paint | No Asbestos Detected | 20.00m2 | Good condition | Sealed (1) | - | - | - | NO ACTION REQUIRED | |

**No Asbestos Presumed in Sample**

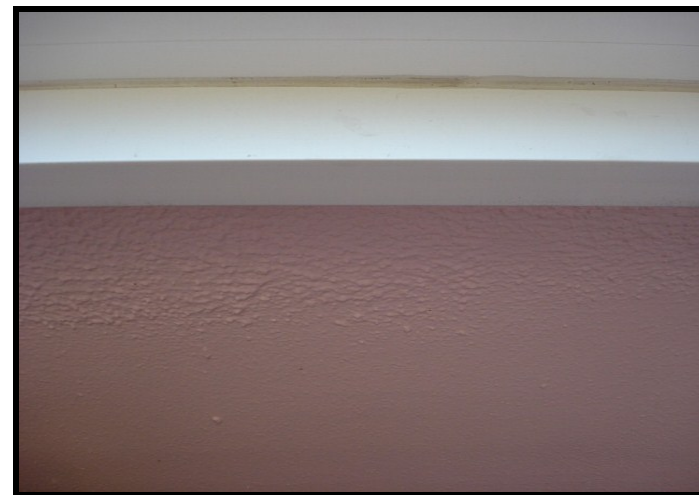
## SAMPLE REFERENCE 051

| Unique Sample No. | Building Reference (Floor) | Room Area | Description of Location | Product Description | Asbestos Type | Approx. Quantity | Material Condition | Surface Treatment | Material Risk Score | Priority Risk Score | Total Risk Score | Management Action | Next Review Date |
|---|---|---|---|---|---|---|---|---|---|---|---|---|---|
| 051 | Main Building (Fifth Floor) | Corridor I | Wall | Textured Coating | No Asbestos Detected | 1.00m2 | Good condition | Textured Coating | - | - | - | NO ACTION REQUIRED | |

**No Asbestos Presumed in Sample**

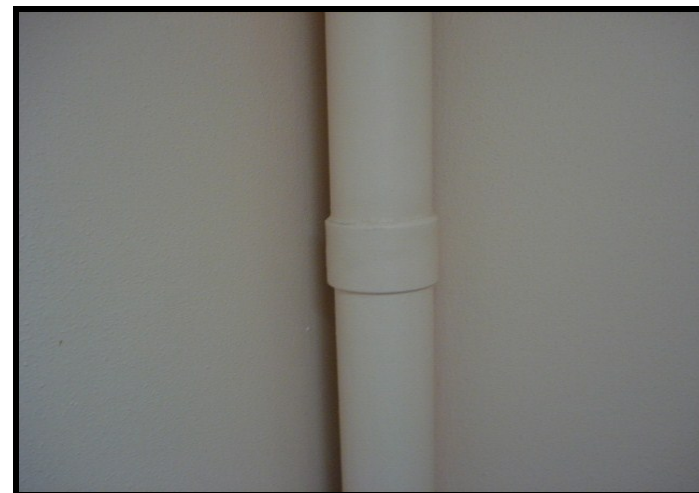
## SAMPLE REFERENCE 052

| Unique Sample No. | Building Reference (Floor) | Room Area | Description of Location | Product Description | Asbestos Type | Approx. Quantity | Material Condition | Surface Treatment | Material Risk Score | Priority Risk Score | Total Risk Score | Management Action | Next Review Date |
|---|---|---|---|---|---|---|---|---|---|---|---|---|---|
| 052 | Main Building (Fifth Floor) | Bin Chute | Walls | Paint | No Asbestos Detected | 18.00m2 | Good condition | Sealed (1) | - | - | - | NO ACTION REQUIRED | |

**No Asbestos Presumed in Sample**

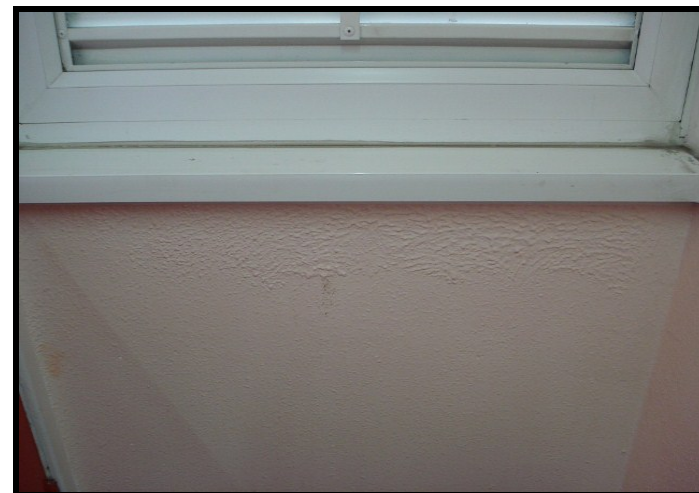
## SAMPLE REFERENCE 053

**No Asbestos Presumed in Sample**

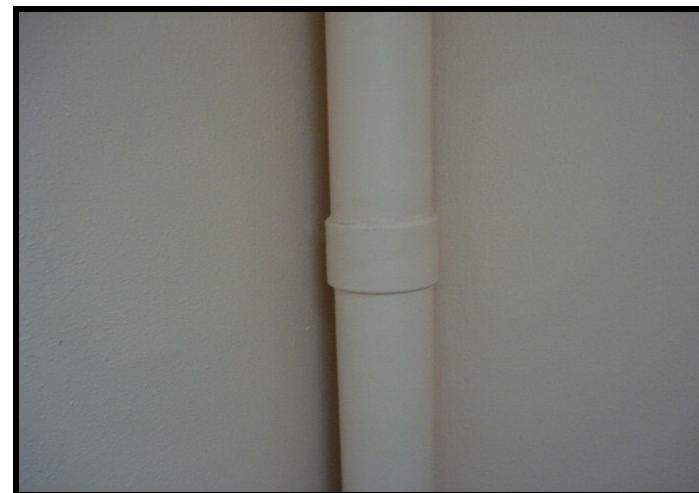
## SAMPLE REFERENCE 054

Asbestos Presumed in Sample

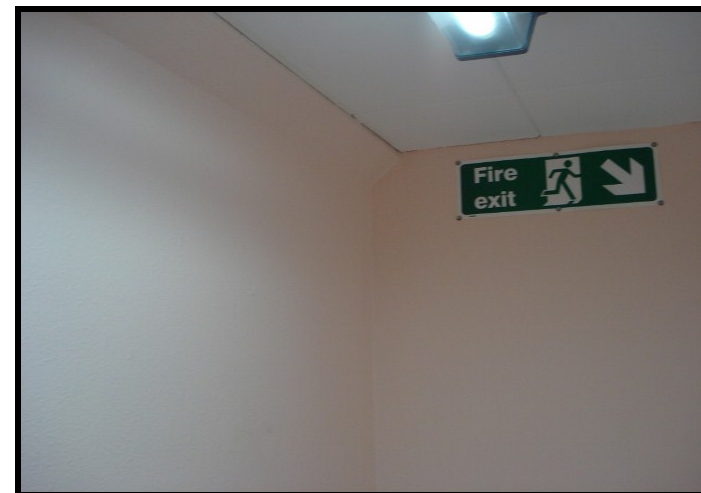
## SAMPLE REFERENCE 055

**No Asbestos Presumed in Sample**

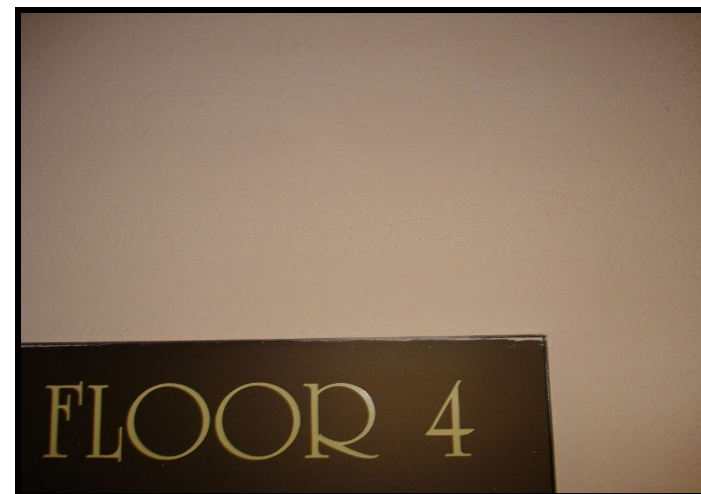
## SAMPLE REFERENCE 059

**No Asbestos Presumed in Sample**

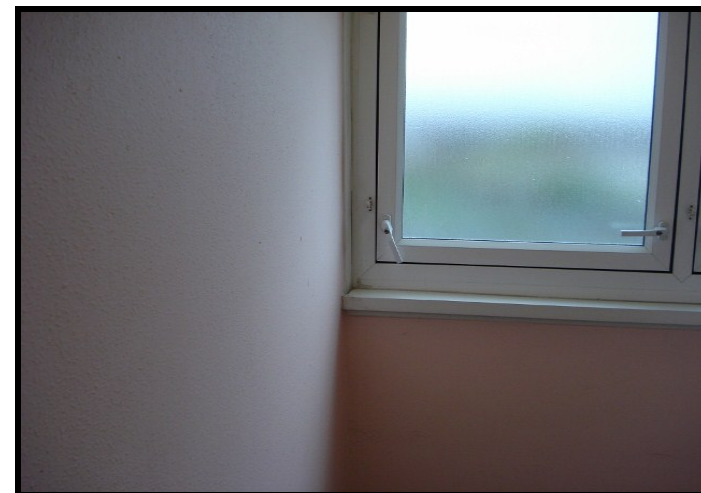
## SAMPLE REFERENCE 060

**No Asbestos Presumed in Sample**

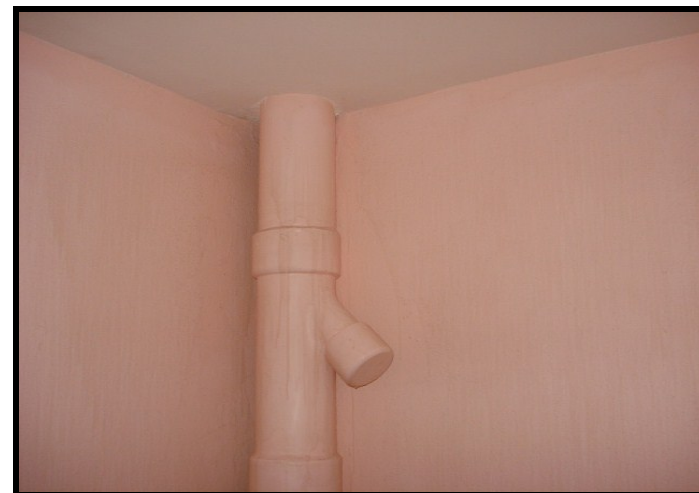
## SAMPLE REFERENCE 061

**No Asbestos Presumed in Sample**

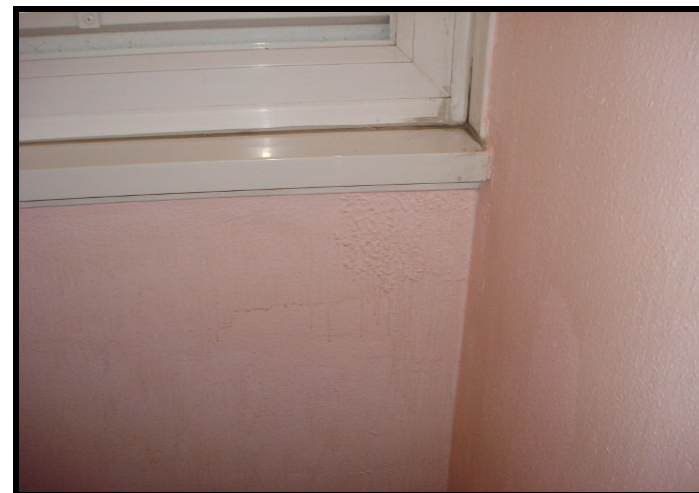
## SAMPLE REFERENCE 062

**No Asbestos Presumed in Sample**

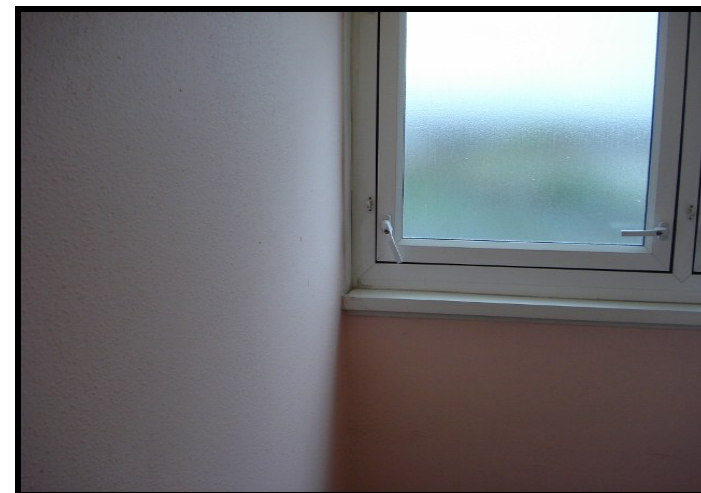
## SAMPLE REFERENCE 063

Asbestos Presumed in Sample

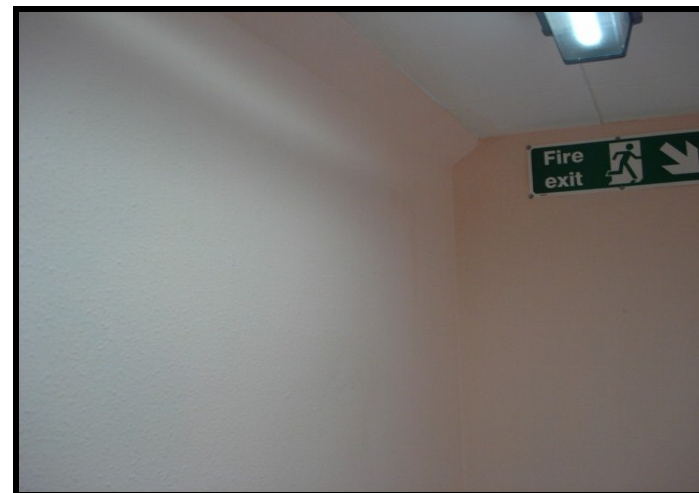
## SAMPLE REFERENCE 064

**No Asbestos Presumed in Sample**

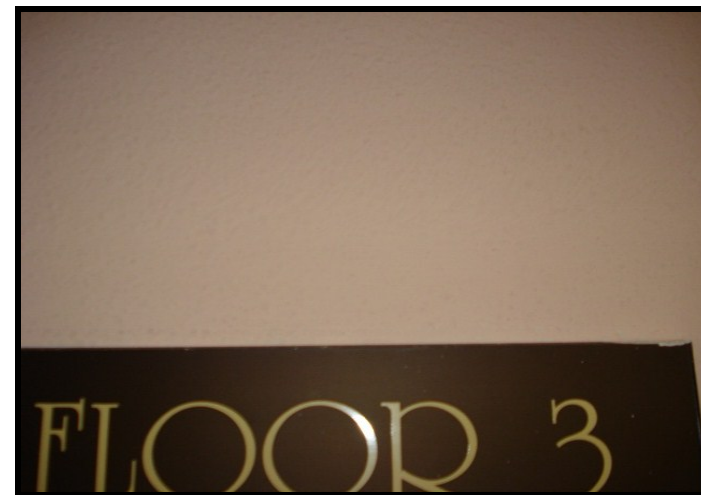
## SAMPLE REFERENCE 068

**No Asbestos Presumed in Sample**

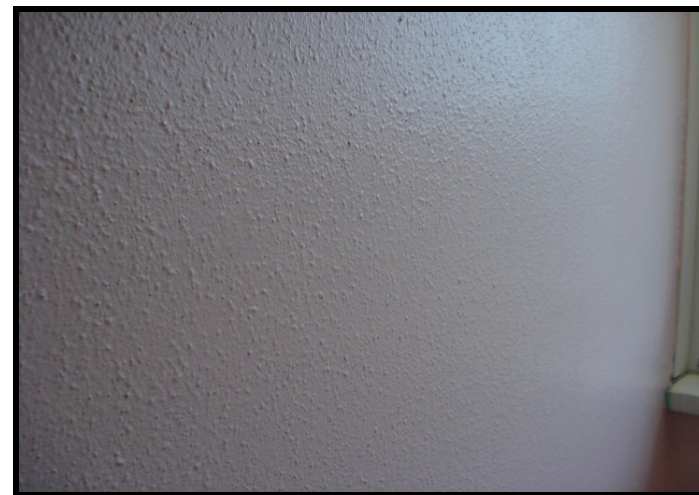
## SAMPLE REFERENCE 069

**No Asbestos Presumed in Sample**

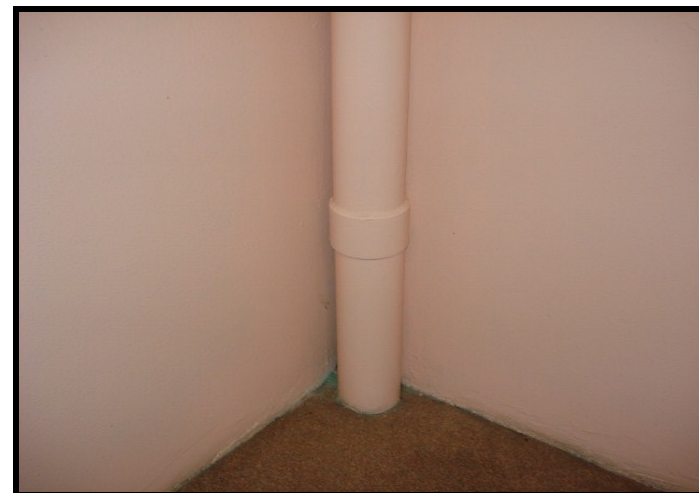
## SAMPLE REFERENCE 070

**No Asbestos Presumed in Sample**

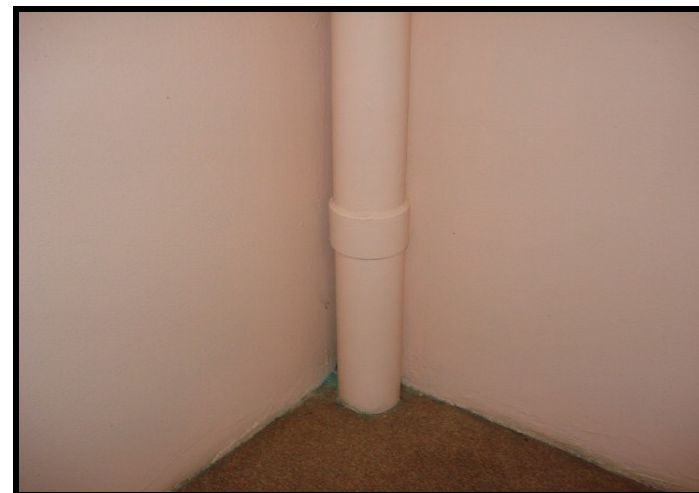
## SAMPLE REFERENCE 071

Asbestos Presumed in Sample
