# **Solihull Community Housing**

## **Asbestos Management Survey Report**

**Chester Court  
Hedingham Grove  
Chelmsley Wood  
B37 7TN**

**Date of Report: 16 May 2012**

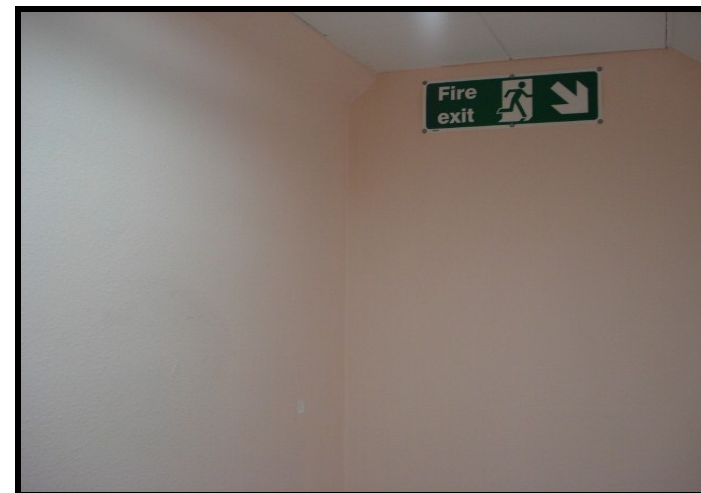
## SAMPLE REFERENCE 072

Asbestos not detected in Sample

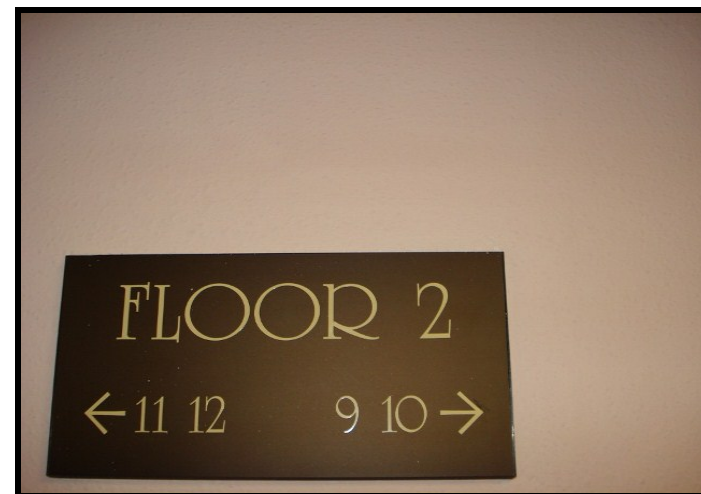
## SAMPLE REFERENCE 076

**No Asbestos Presumed in Sample**

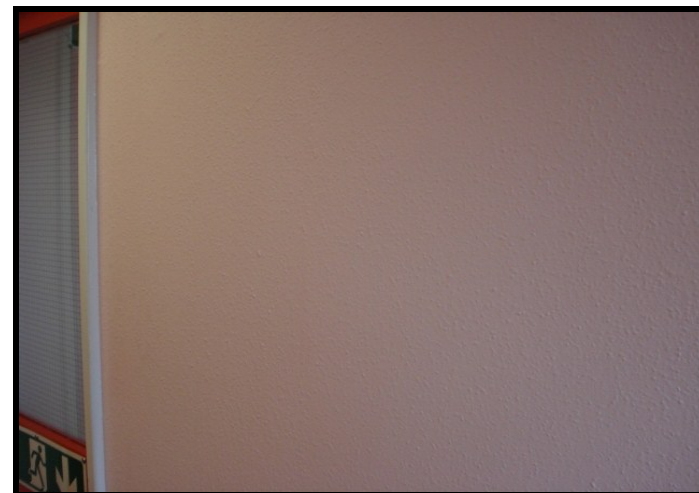
## SAMPLE REFERENCE 077

**No Asbestos Presumed in Sample**

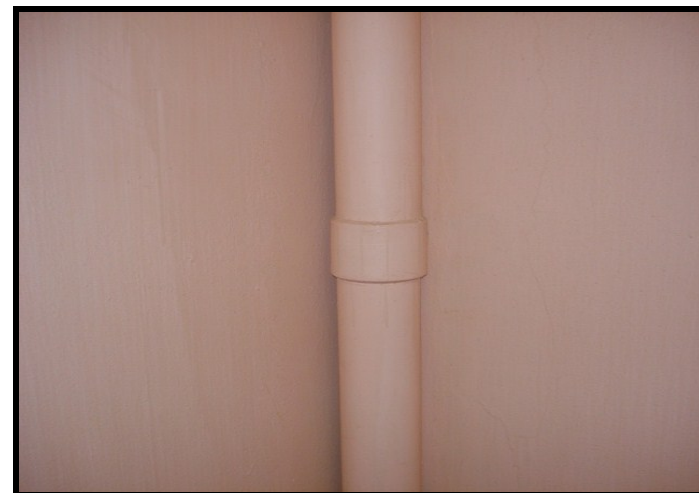
## SAMPLE REFERENCE 078

**No Asbestos Presumed in Sample**

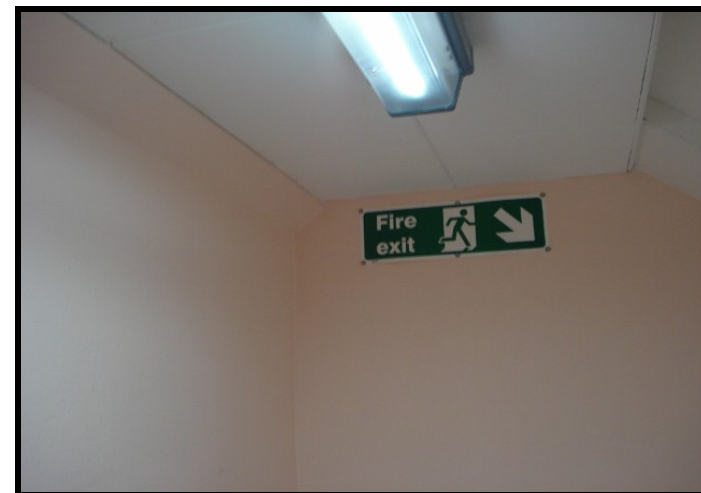
## SAMPLE REFERENCE 080

**No Asbestos Presumed in Sample**

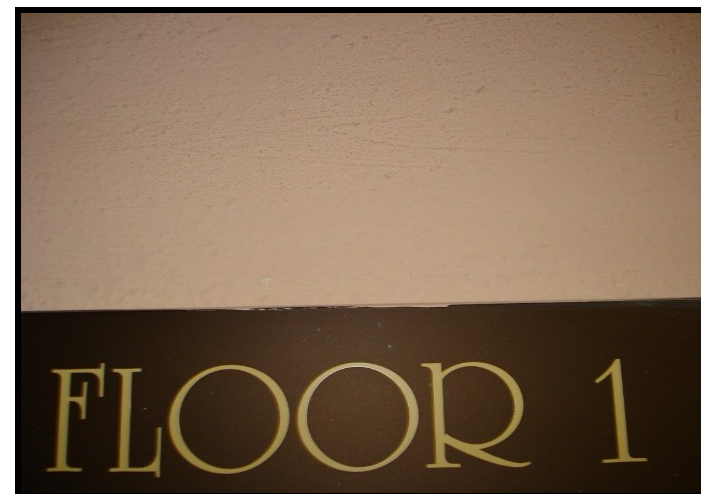
## SAMPLE REFERENCE 084

**No Asbestos Presumed in Sample**

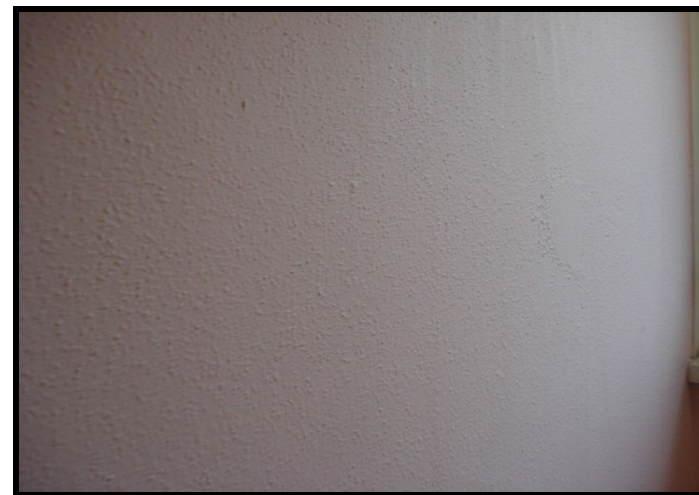
## SAMPLE REFERENCE 085

**No Asbestos Presumed in Sample**

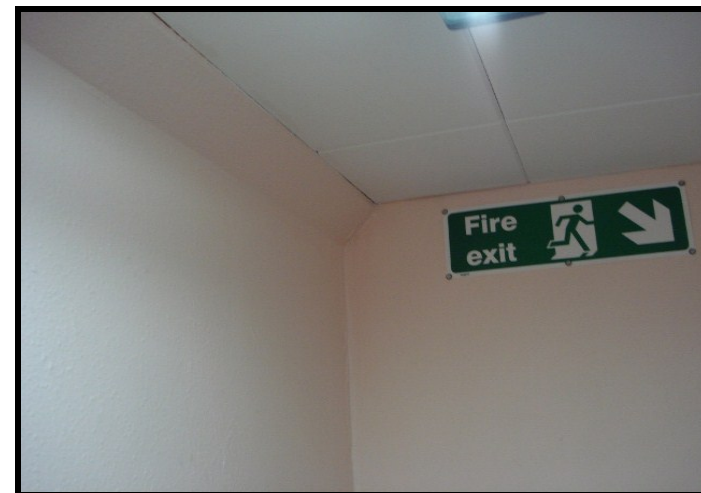
## SAMPLE REFERENCE 090

**No Asbestos Presumed in Sample**

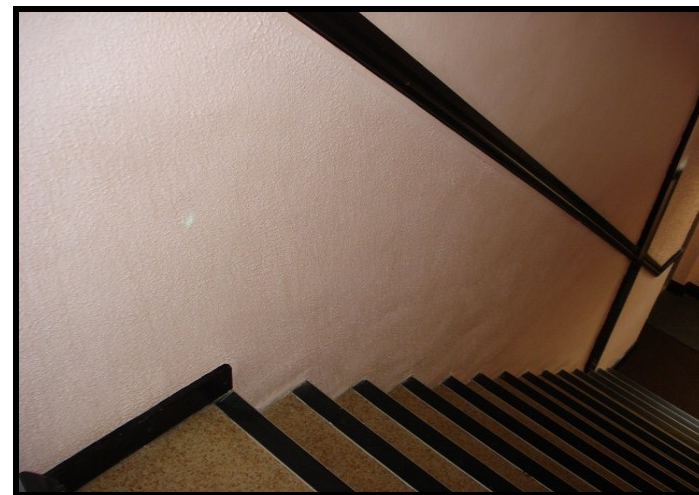
## SAMPLE REFERENCE 091

**Asbestos not detected in Sample**

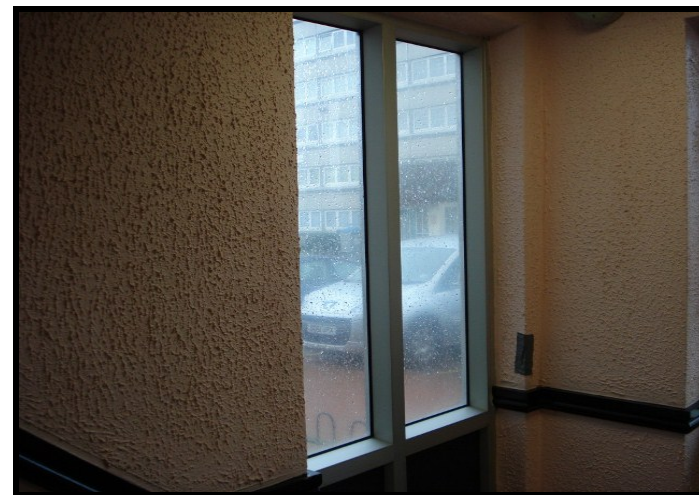
## SAMPLE REFERENCE 092

**Asbestos not detected in Sample**

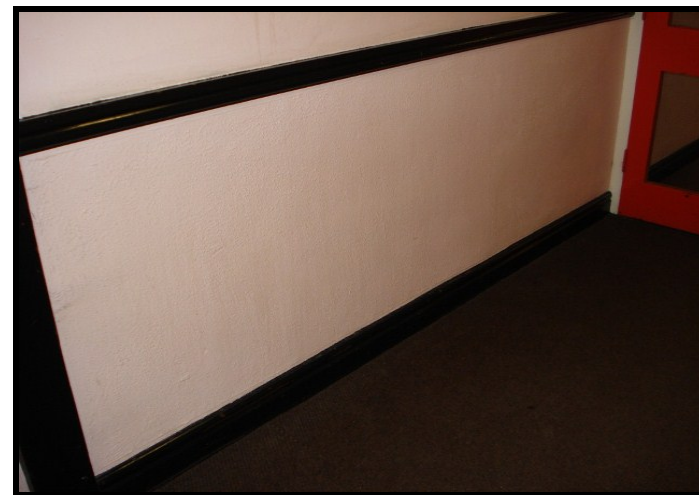
## SAMPLE REFERENCE 093

**No Asbestos Presumed in Sample**

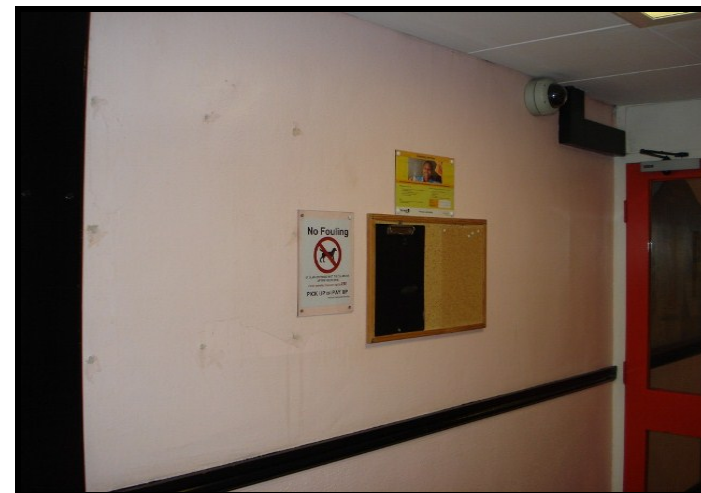
## SAMPLE REFERENCE 094

**No Asbestos Presumed in Sample**

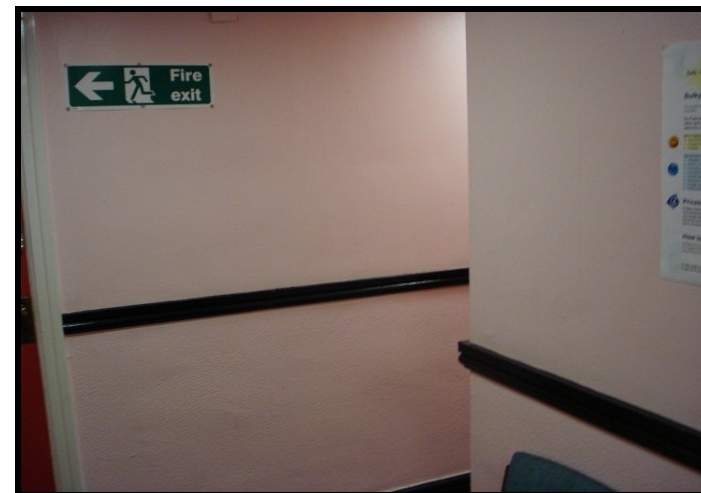
## SAMPLE REFERENCE 095

**No Asbestos Presumed in Sample**

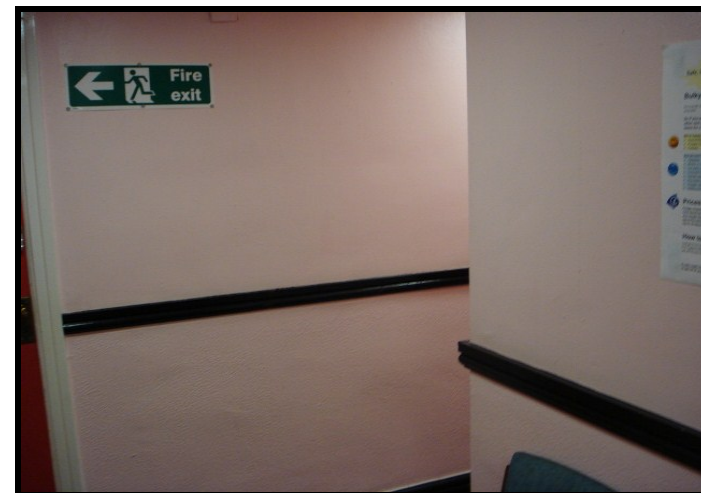
## SAMPLE REFERENCE 096

**No Asbestos Presumed in Sample**

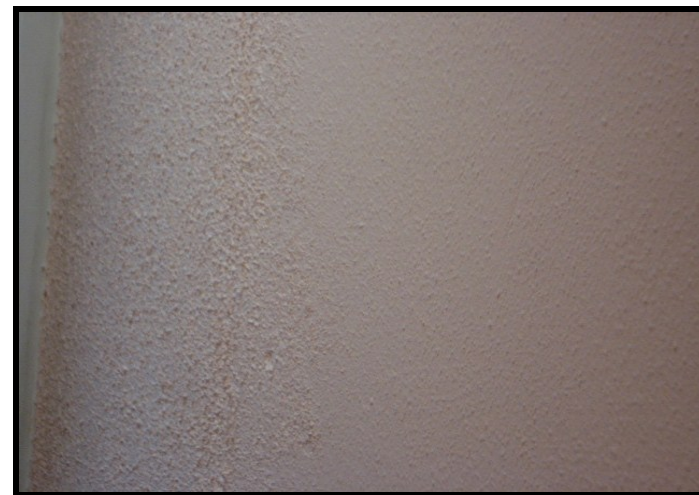
## SAMPLE REFERENCE 097

**No Asbestos Presumed in Sample**

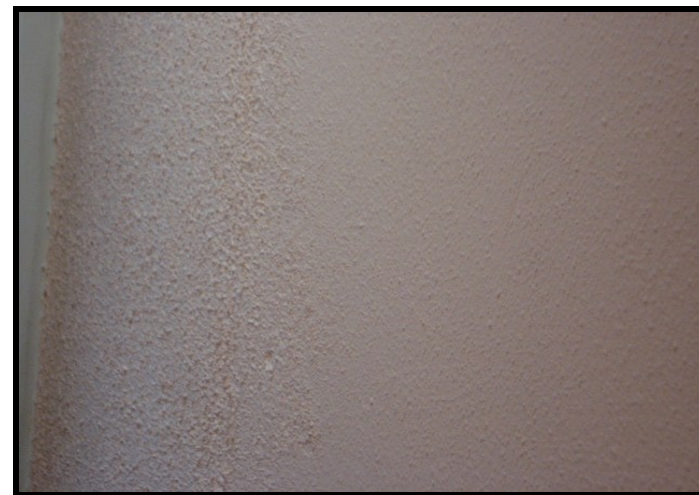
## SAMPLE REFERENCE 098

**No Asbestos Presumed in Sample**

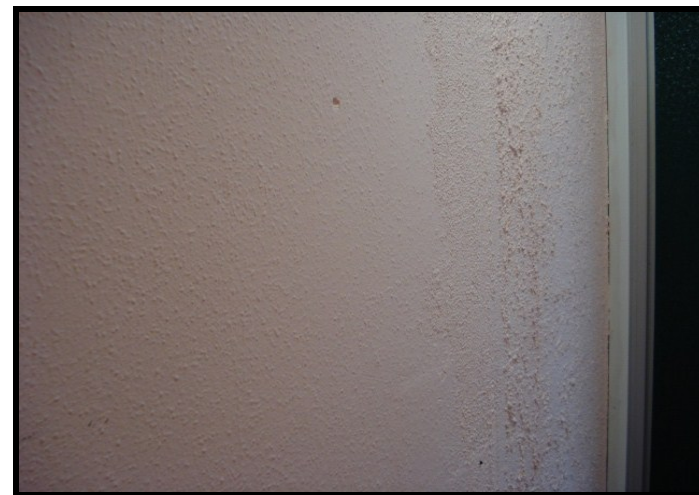
## SAMPLE REFERENCE 100

**No Asbestos Presumed in Sample**

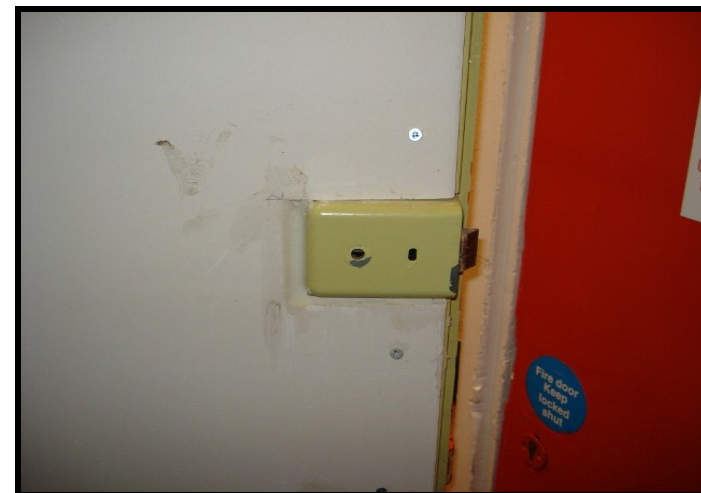
## SAMPLE REFERENCE 103

**Asbestos not detected in Sample**

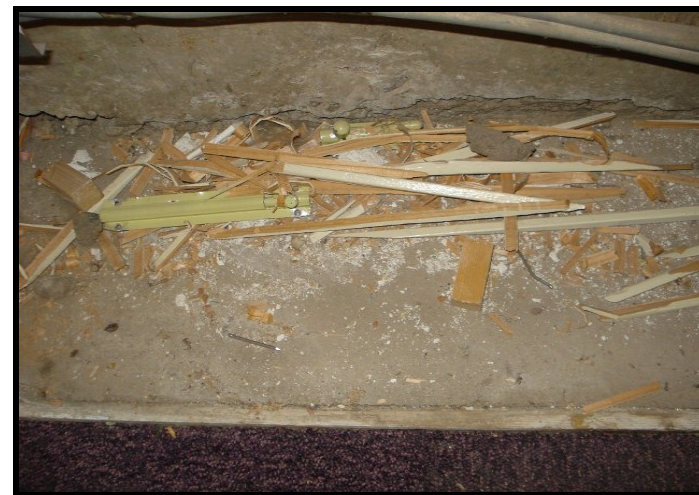
## SAMPLE REFERENCE 104

**Asbestos not detected in Sample**

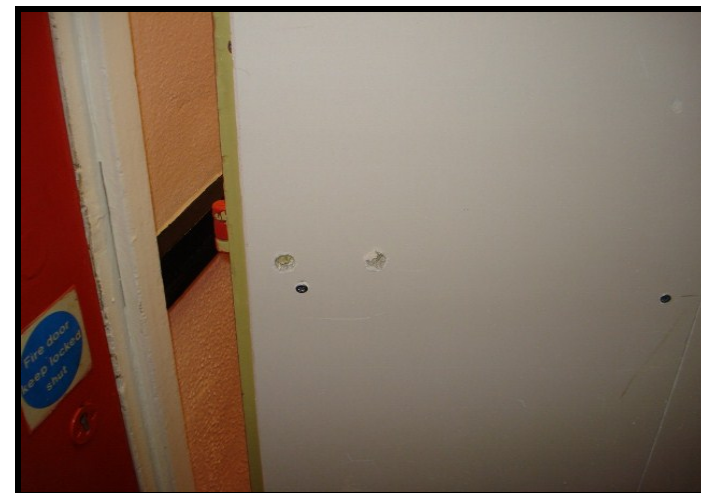
## SAMPLE REFERENCE 107

**No Asbestos Presumed in Sample**
