Management with Targeted Refurbishment Survey – PART 1

1-61 Clare House, Barle Grove
Chelmsley Wood
Solihull
B36 0UB
United Kingdom

3rd June 2021

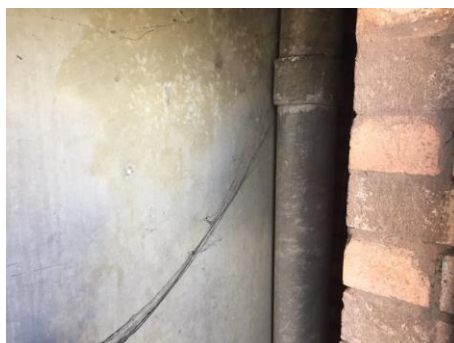
Cement flue from incinerator.

The material was seen to be in fair condition at the time of the initial inspection.

The condition of the material should be managed by a competent person/company and its presence made aware to those at risk, as part of a Control of Asbestos Regulations (CAR) 2012 compliant management strategy.

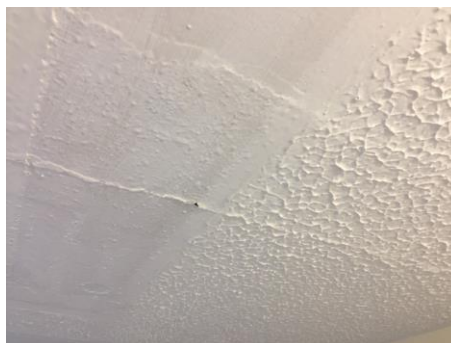
Stipple and spatter pattern textured coating.

The material was seen to be in fair condition at the time of the initial inspection.

The condition of the material should be managed by a competent person/company and its presence made aware to those at risk, as part of a Control of Asbestos Regulations (CAR) 2012 compliant management strategy.

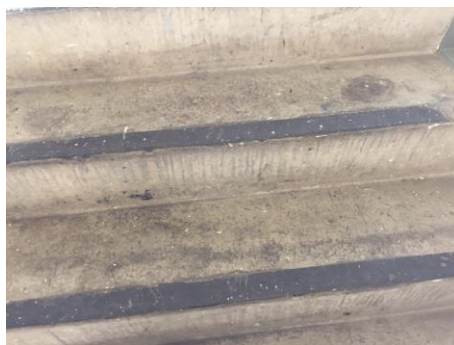
Resin nosing to edges of stairs.

The material was seen to be in fair condition at the time of the initial inspection.

The condition of the material should be managed by a competent person/company and its presence made aware to those at risk, as part of a Control of Asbestos Regulations (CAR) 2012 compliant management strategy.

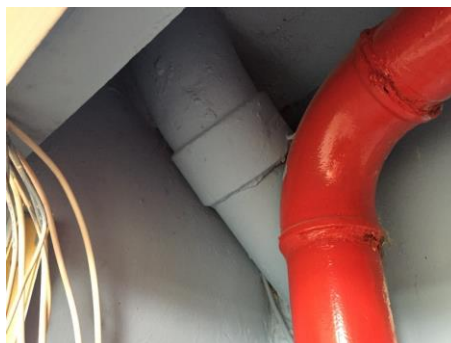
Cement flue from incinerator.

The material was seen to be in fair condition at the time of the initial inspection.

The condition of the material should be managed by a competent person/company and its presence made aware to those at risk, as part of a Control of Asbestos Regulations (CAR) 2012 compliant management strategy.

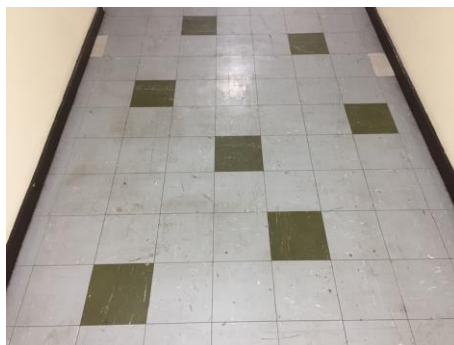
Green and grey floor tile.

The material was seen to be in fair condition at the time of the initial inspection.

The condition of the material should be managed by a competent person/company and its presence made aware to those at risk, as part of a Control of Asbestos Regulations (CAR) 2012 compliant management strategy.

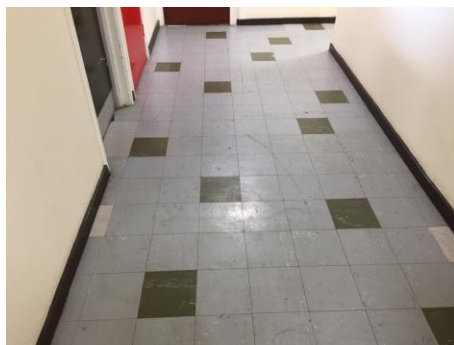
Bitumen adhesive beneath floor tiles.

The material was seen to be in fair condition at the time of the initial inspection.

The condition of the material should be managed by a competent person/company and its presence made aware to those at risk, as part of a Control of Asbestos Regulations (CAR) 2012 compliant management strategy.

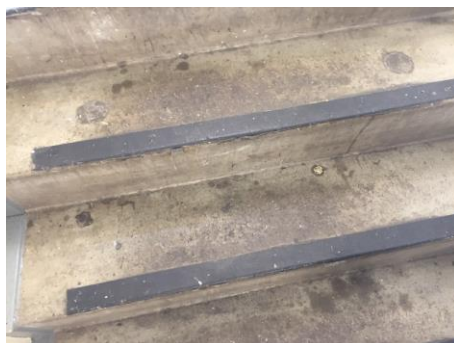
Resin nosing to edge of stairs.

The material was seen to be in fair condition at the time of the initial inspection.

The condition of the material should be managed by a competent person/company and its presence made aware to those at risk, as part of a Control of Asbestos Regulations (CAR) 2012 compliant management strategy.

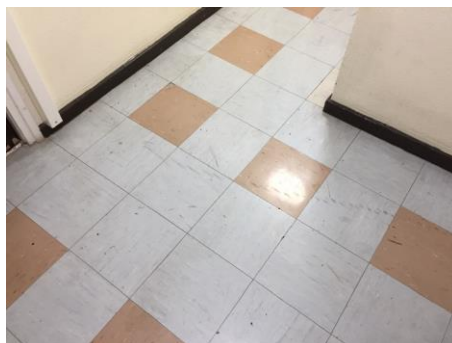
Blue and grey floor tiles beneath layer of modern rubber grey and peach floor tiles.

The material was seen to be in fair condition at the time of the initial inspection.

The condition of the material should be managed by a competent person/company and its presence made aware to those at risk, as part of a Control of Asbestos Regulations (CAR) 2012 compliant management strategy.

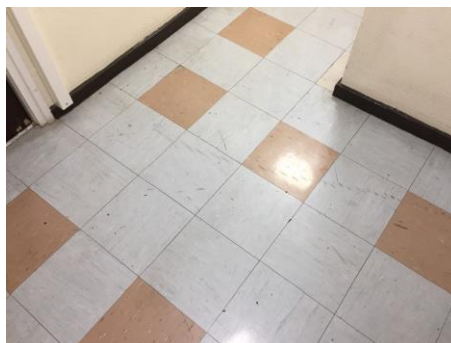
Bitumen adhesive beneath floor tiles.

The material was seen to be in fair condition at the time of the initial inspection.

The condition of the material should be managed by a competent person/company and its presence made aware to those at risk, as part of a Control of Asbestos Regulations (CAR) 2012 compliant management strategy.

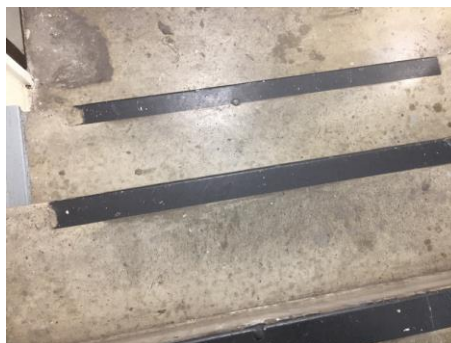
Resin nosing to edge of stairs.

The material was seen to be in fair condition at the time of the initial inspection.

The condition of the material should be managed by a competent person/company and its presence made aware to those at risk, as part of a Control of Asbestos Regulations (CAR) 2012 compliant management strategy.

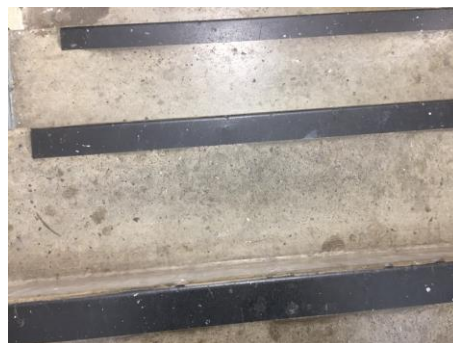
Resin nosing to edge of stairs.

The material was seen to be in fair condition at the time of the initial inspection.

The condition of the material should be managed by a competent person/company and its presence made aware to those at risk, as part of a Control of Asbestos Regulations (CAR) 2012 compliant management strategy.

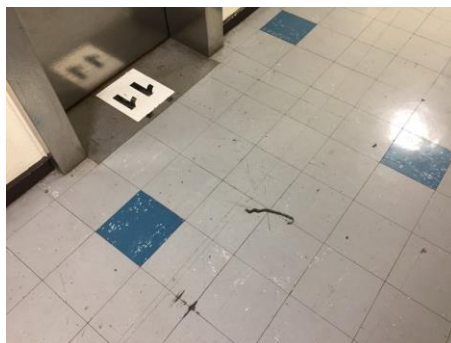
Blue and grey floor tiles.

The material was seen to be in fair condition at the time of the initial inspection.

The condition of the material should be managed by a competent person/company and its presence made aware to those at risk, as part of a Control of Asbestos Regulations (CAR) 2012 compliant management strategy.

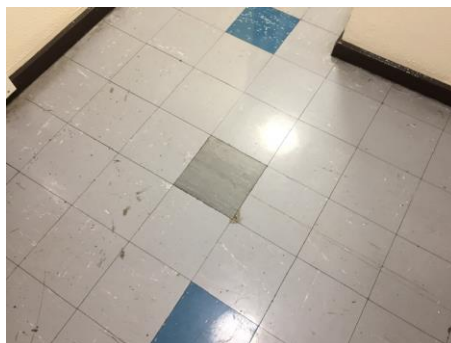
Bitumen adhesive beneath floor tiles.

The material was seen to be in fair condition at the time of the initial inspection.

The condition of the material should be managed by a competent person/company and its presence made aware to those at risk, as part of a Control of Asbestos Regulations (CAR) 2012 compliant management strategy.

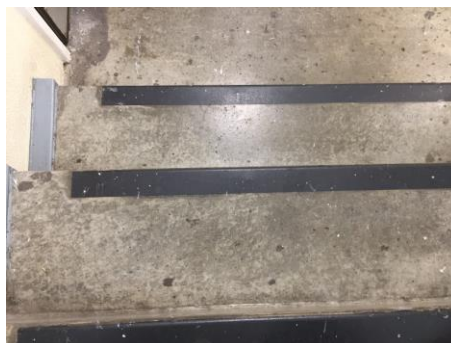
Resin nosing to edge of stairs.

The material was seen to be in fair condition at the time of the initial inspection.

The condition of the material should be managed by a competent person/company and its presence made aware to those at risk, as part of a Control of Asbestos Regulations (CAR) 2012 compliant management strategy.

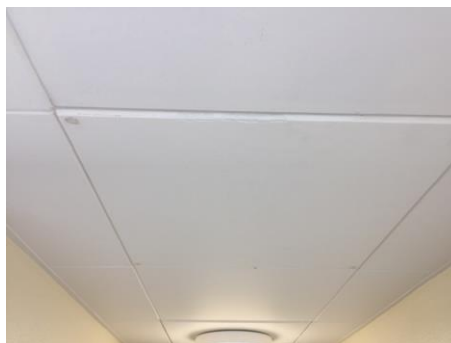
Spatter pattern textured coating above suspended ceiling.

The material was seen to be in fair condition at the time of the initial inspection.

The condition of the material should be managed by a competent person/company and its presence made aware to those at risk, as part of a Control of Asbestos Regulations (CAR) 2012 compliant management strategy.

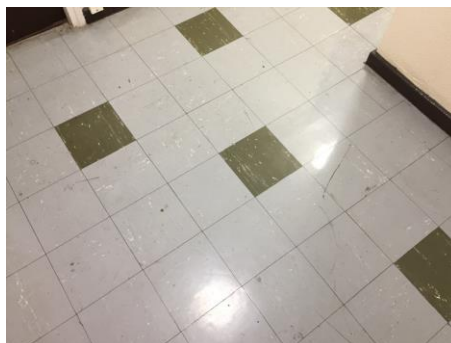
Green and grey floor tile.

The material was seen to be in fair condition at the time of the initial inspection.

The condition of the material should be managed by a competent person/company and its presence made aware to those at risk, as part of a Control of Asbestos Regulations (CAR) 2012 compliant management strategy.

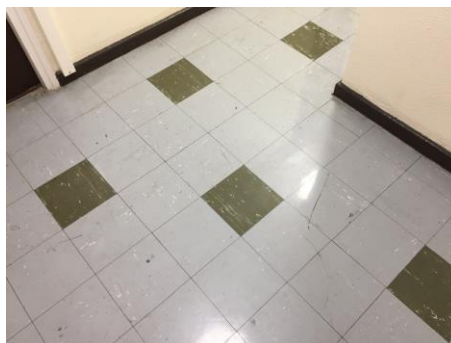
Bitumen adhesive beneath floor tiles.

The material was seen to be in fair condition at the time of the initial inspection.

The condition of the material should be managed by a competent person/company and its presence made aware to those at risk, as part of a Control of Asbestos Regulations (CAR) 2012 compliant management strategy.

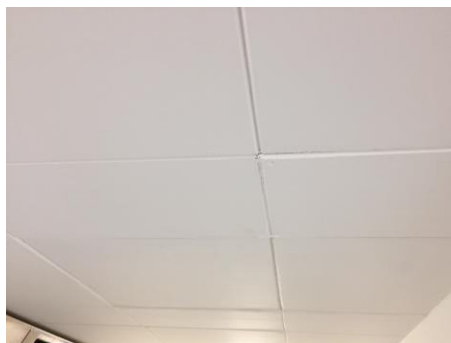
Spatter pattern textured coating above suspended ceiling.

The material was seen to be in fair condition at the time of the initial inspection.

The condition of the material should be managed by a competent person/company and its presence made aware to those at risk, as part of a Control of Asbestos Regulations (CAR) 2012 compliant management strategy.

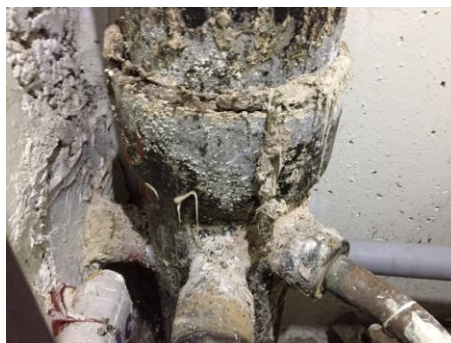
Condition **High Damage**

Rope seal to joint of soil pipe hanging loosely.

The material was seen to be in poor condition at the time of the initial inspection.

It is recommended that the material be removed by a HSE licensed asbestos contractor. As an ACM (asbestos Containing Material), it's condition should be monitored by a competent person/company and it's presence made aware to those at risk, as part of a Control of Asbestos Regulations (CAR) 2012 compliant management strategy.

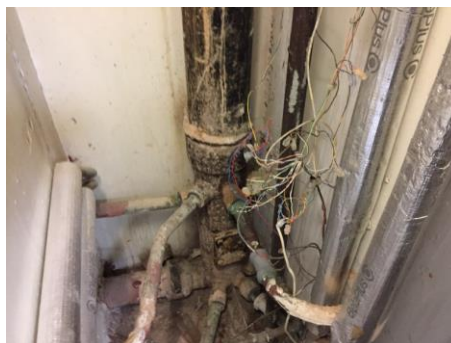
Condition **High Damage**

Rope seal to joint of soil pipe hanging loosely.

The material was seen to be in poor condition at the time of the initial inspection.

It is recommended that the material be removed by a HSE licensed asbestos contractor. As an ACM (asbestos Containing Material), it's condition should be monitored by a competent person/company and it's presence made aware to those at risk, as part of a Control of Asbestos Regulations (CAR) 2012 compliant management strategy.

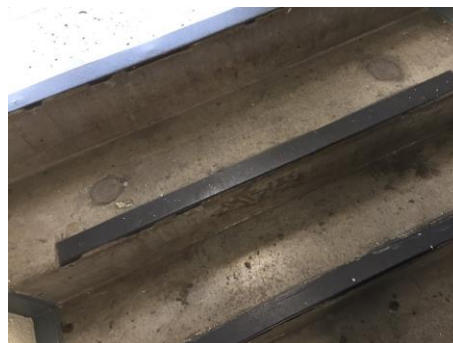
Resin nosing to edge of stairs.

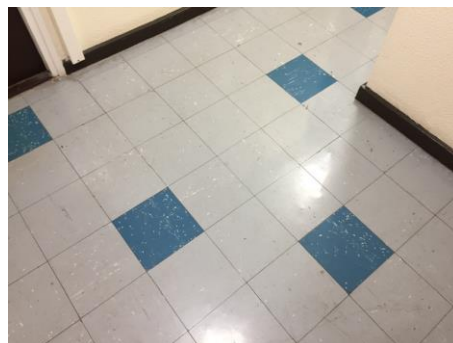
Bitumen adhesive beneath floor tiles.

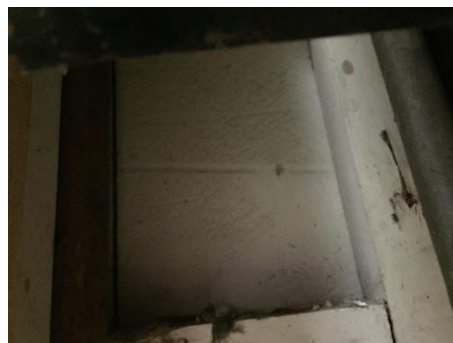
Insulating board panels to party walls for flats within MEB cabinets.
