Management with Targeted Refurbishment Survey – PART 2

1-61 Clare House
Barle Grove
Chelmsley Wood
Solihull
West Midlands
B36 0UB
United Kingdom

3rd June 2021

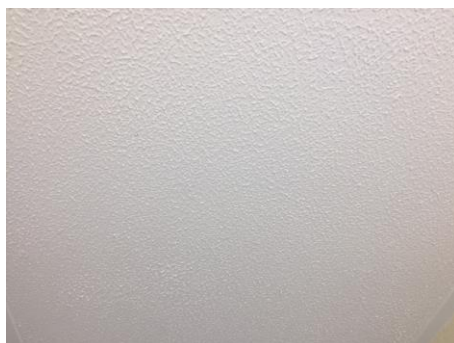
Stipple pattern textured coating.

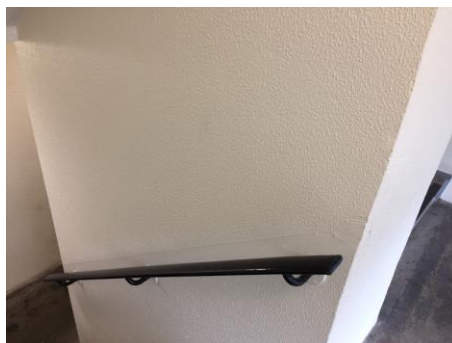
Stipple pattern textured coating.

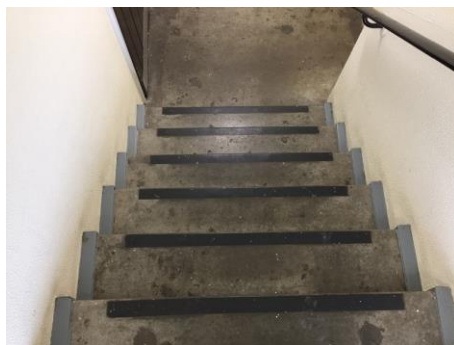
Condition **Low Damage**

Resin nosing to edge of stairs.

The material was seen to be in fair condition at the time of the initial inspection.

The condition of the material should be managed by a competent person/company and its presence made aware to those at risk, as part of a Control of Asbestos Regulations (CAR) 2012 compliant management strategy.

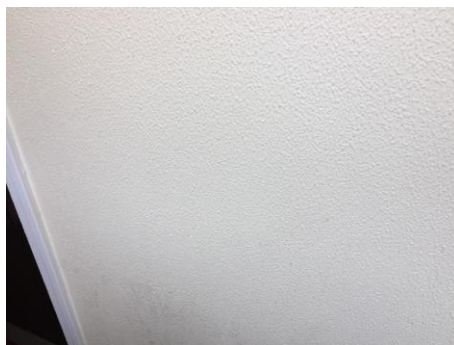
Stipple pattern textured coating.

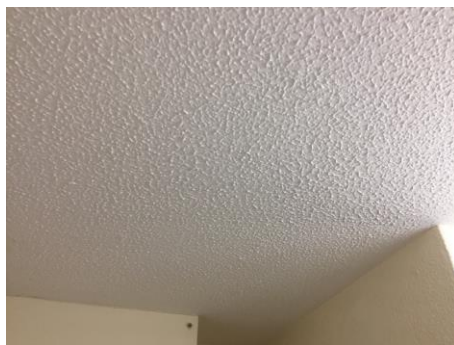
Stipple pattern textured coating.

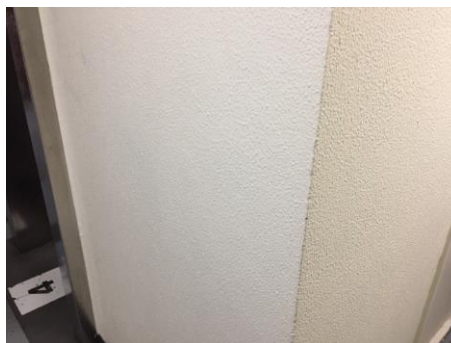
Stipple pattern textured coating.

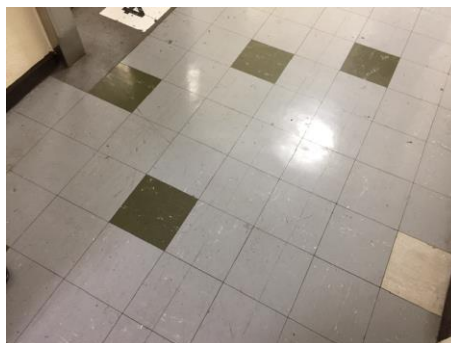
Condition **Low Damage**

Green and grey floor tiles.

The material was seen to be in fair condition at the time of the initial inspection.

The condition of the material should be managed by a competent person/company and its presence made aware to those at risk, as part of a Control of Asbestos Regulations (CAR) 2012 compliant management strategy.

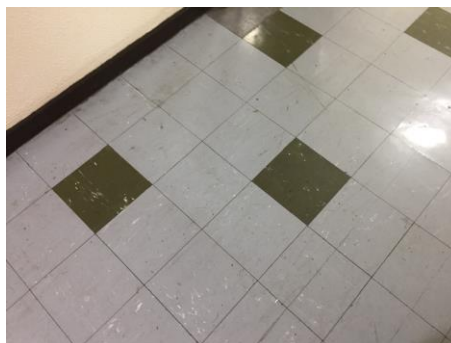
Condition **Low Damage**

Bitumen adhesive beneath floor tiles.

The material was seen to be in fair condition at the time of the initial inspection.

The condition of the material should be managed by a competent person/company and its presence made aware to those at risk, as part of a Control of Asbestos Regulations (CAR) 2012 compliant management strategy.

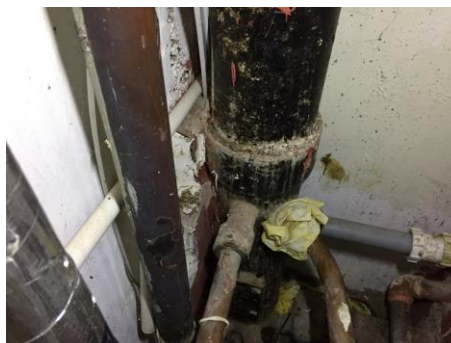
Condition **High Damage**

Rope seal to joint of soil pipe.

The material was seen to be in fair condition at the time of the initial inspection.

The condition of the material should be managed by a competent person/company and its presence made aware to those at risk, as part of a Control of Asbestos Regulations (CAR) 2012 compliant management strategy.

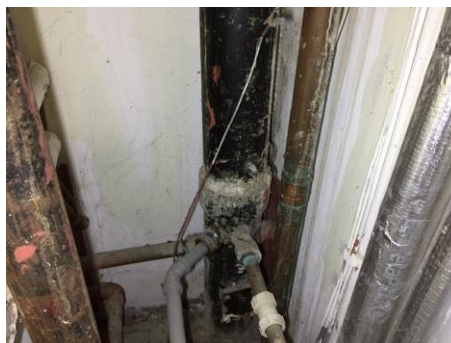
Condition **High Damage**

Rope seal to joint of soil pipe.

The material was seen to be in fair condition at the time of the initial inspection.

The condition of the material should be managed by a competent person/company and its presence made aware to those at risk, as part of a Control of Asbestos Regulations (CAR) 2012 compliant management strategy.

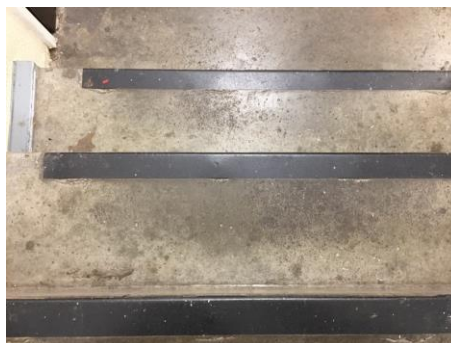
Condition **Low Damage**

Resin nosing to edge of stairs.

The material was seen to be in fair condition at the time of the initial inspection.

The condition of the material should be managed by a competent person/company and its presence made aware to those at risk, as part of a Control of Asbestos Regulations (CAR) 2012 compliant management strategy.

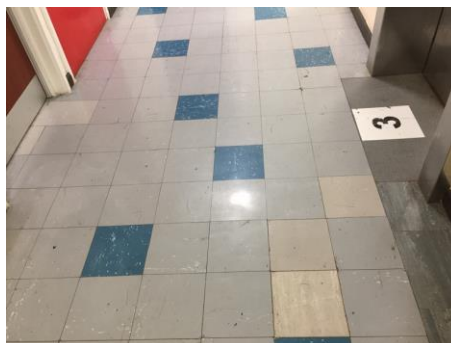
Condition **Low Damage**

Blue and grey floor tiles.

The material was seen to be in fair condition at the time of the initial inspection.

The condition of the material should be managed by a competent person/company and its presence made aware to those at risk, as part of a Control of Asbestos Regulations (CAR) 2012 compliant management strategy.

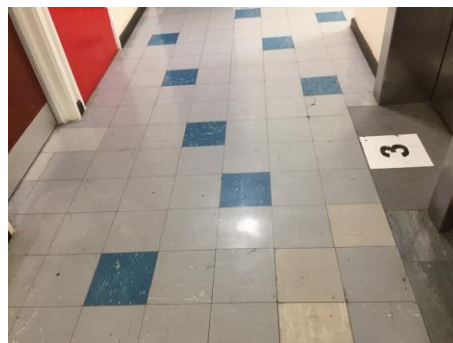
Condition **Low Damage**

Bitumen adhesive beneath floor tiles.

The material was seen to be in fair condition at the time of the initial inspection.

The condition of the material should be managed by a competent person/company and its presence made aware to those at risk, as part of a Control of Asbestos Regulations (CAR) 2012 compliant management strategy.

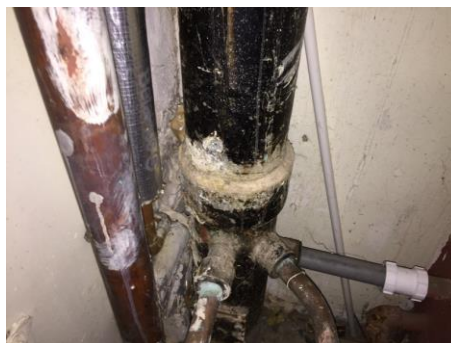
Condition **High Damage**

Rope seal to joint of soil pipe.

The material was seen to be in fair condition at the time of the initial inspection.

The condition of the material should be managed by a competent person/company and its presence made aware to those at risk, as part of a Control of Asbestos Regulations (CAR) 2012 compliant management strategy.

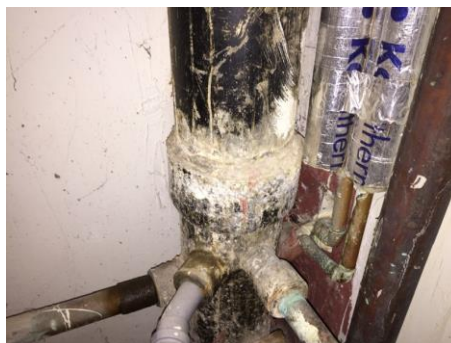
Condition **High Damage**

Rope seal to joint of soil pipe.

The material was seen to be in fair condition at the time of the initial inspection.

The condition of the material should be managed by a competent person/company and its presence made aware to those at risk, as part of a Control of Asbestos Regulations (CAR) 2012 compliant management strategy.

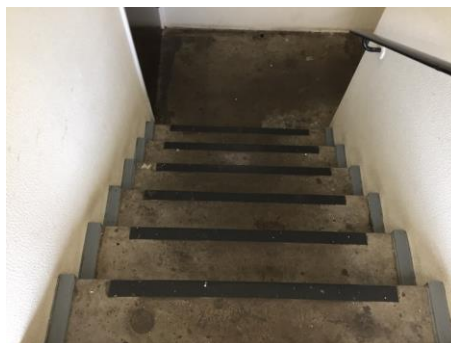
Condition **Low Damage**

Resin nosing to edge of stairs.

The material was seen to be in fair condition at the time of the initial inspection.

The condition of the material should be managed by a competent person/company and its presence made aware to those at risk, as part of a Control of Asbestos Regulations (CAR) 2012 compliant management strategy.

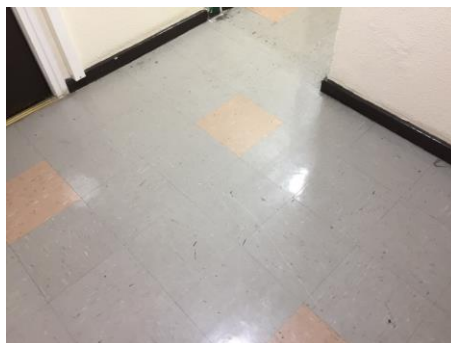
Condition **Low Damage**

Bitumen adhesive beneath floor tiles.

The material was seen to be in fair condition at the time of the initial inspection.

The condition of the material should be managed by a competent person/company and its presence made aware to those at risk, as part of a Control of Asbestos Regulations (CAR) 2012 compliant management strategy.

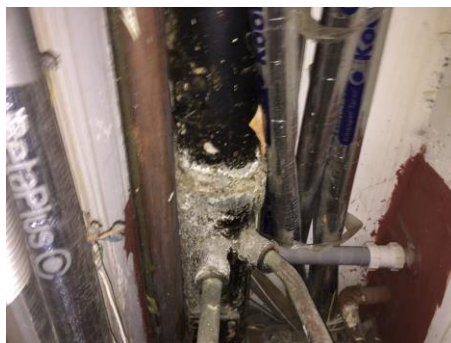
Condition **High Damage**

Rope seal to joint of soil pipe.

The material was seen to be in fair condition at the time of the initial inspection.

The condition of the material should be managed by a competent person/company and its presence made aware to those at risk, as part of a Control of Asbestos Regulations (CAR) 2012 compliant management strategy.

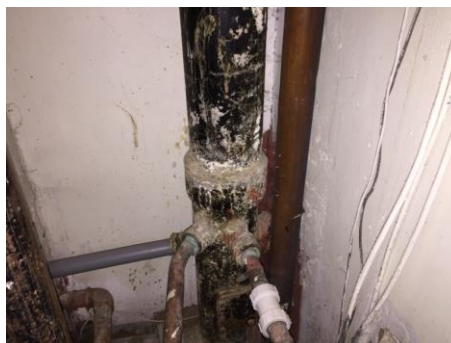
Condition **High Damage**

Rope seal to joint of soil pipe.

The material was seen to be in fair condition at the time of the initial inspection.

The condition of the material should be managed by a competent person/company and its presence made aware to those at risk, as part of a Control of Asbestos Regulations (CAR) 2012 compliant management strategy.

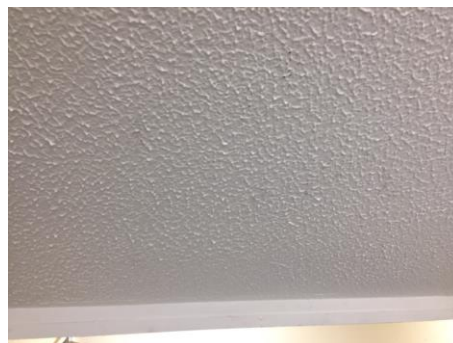
Condition **Low Damage**

Stipple pattern textured coating.

The material was seen to be in fair condition at the time of the initial inspection.

The condition of the material should be managed by a competent person/company and its presence made aware to those at risk, as part of a Control of Asbestos Regulations (CAR) 2012 compliant management strategy.

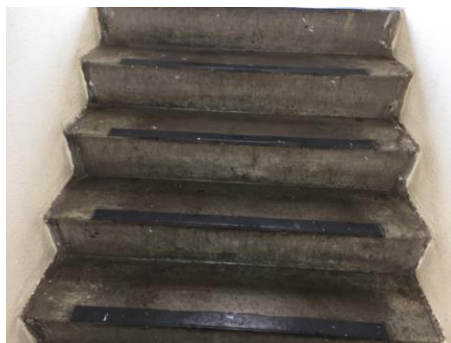
Condition **Low Damage**

Resin nosing to edge of stairs.

The material was seen to be in fair condition at the time of the initial inspection.

The condition of the material should be managed by a competent person/company and its presence made aware to those at risk, as part of a Control of Asbestos Regulations (CAR) 2012 compliant management strategy.

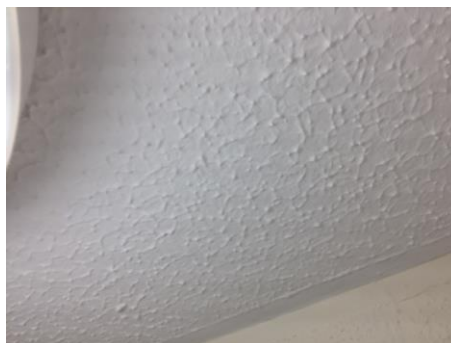
Condition **Low Damage**

Stipple pattern textured coating.

The material was seen to be in fair condition at the time of the initial inspection.

The condition of the material should be managed by a competent person/company and its presence made aware to those at risk, as part of a Control of Asbestos Regulations (CAR) 2012 compliant management strategy.

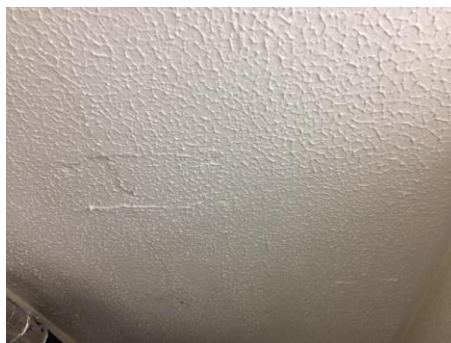
Condition **Low Damage**

Stipple pattern textured coating.

The material was seen to be in fair condition at the time of the initial inspection.

The condition of the material should be managed by a competent person/company and its presence made aware to those at risk, as part of a Control of Asbestos Regulations (CAR) 2012 compliant management strategy.

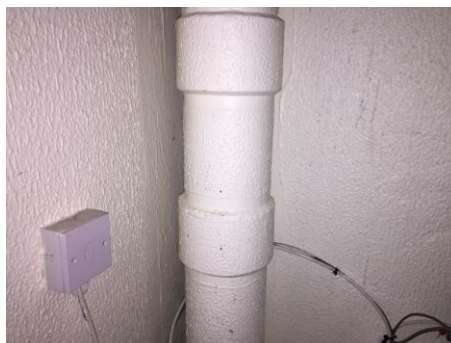
Condition **Low Damage**

Cement flue with textured coating.

The material was seen to be in fair condition at the time of the initial inspection.

The condition of the material should be managed by a competent person/company and its presence made aware to those at risk, as part of a Control of Asbestos Regulations (CAR) 2012 compliant management strategy.

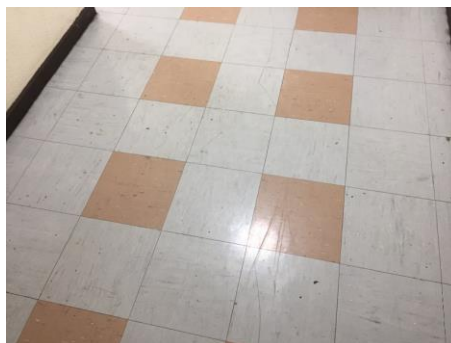
Condition **Low Damage**

Grey and indeterminate colour floor tiles. Indeterminate colour due to modern rubber floor tiles fixed to tiles.

The material was seen to be in fair condition at the time of the initial inspection.

The condition of the material should be managed by a competent person/company and its presence made aware to those at risk, as part of a Control of Asbestos Regulations (CAR) 2012 compliant management strategy.

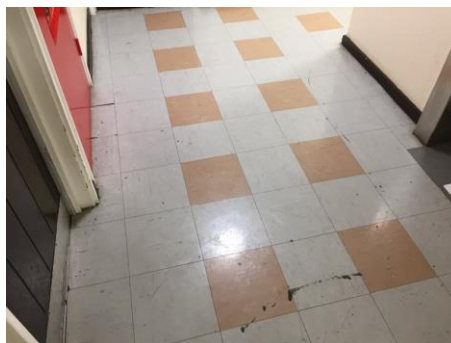
Condition **Low Damage**

Bitumen adhesive beneath floor tiles.

The material was seen to be in fair condition at the time of the initial inspection.

The condition of the material should be managed by a competent person/company and its presence made aware to those at risk, as part of a Control of Asbestos Regulations (CAR) 2012 compliant management strategy.

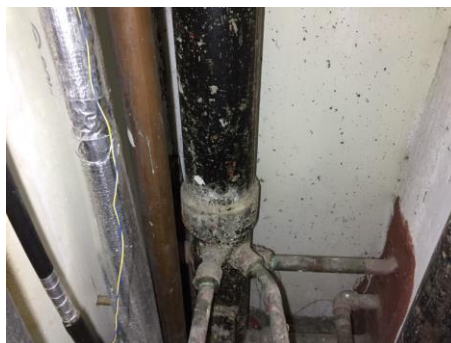
Condition **High Damage**

Rope seal to joint of soil pipe.

The material was seen to be in fair condition at the time of the initial inspection.

The condition of the material should be managed by a competent person/company and its presence made aware to those at risk, as part of a Control of Asbestos Regulations (CAR) 2012 compliant management strategy.

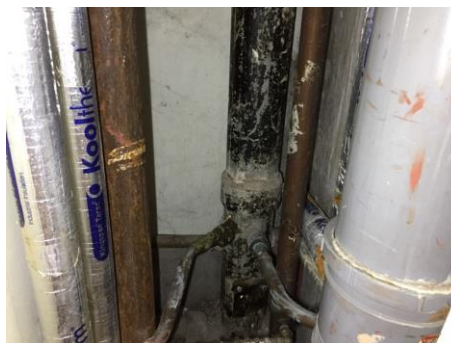
Condition **High Damage**

Rope seal to joint of soil pipe.

The material was seen to be in fair condition at the time of the initial inspection.

The condition of the material should be managed by a competent person/company and its presence made aware to those at risk, as part of a Control of Asbestos Regulations (CAR) 2012 compliant management strategy.

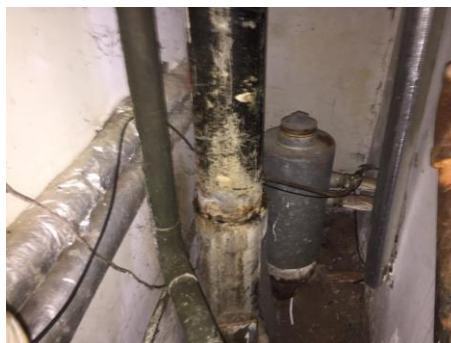
Condition **High Damage**

Rope seal to joint of soil pipe.

The material was seen to be in fair condition at the time of the initial inspection.

The condition of the material should be managed by a competent person/company and its presence made aware to those at risk, as part of a Control of Asbestos Regulations (CAR) 2012 compliant management strategy.

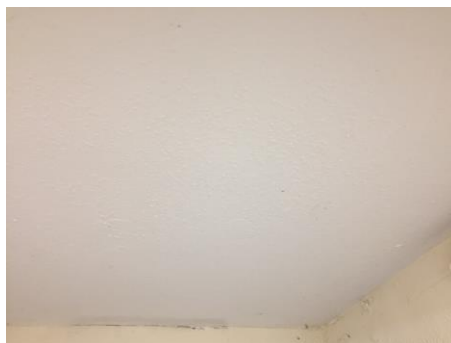
Condition **Low Damage**

Stipple pattern textured coating.

The material was seen to be in fair condition at the time of the initial inspection.

The condition of the material should be managed by a competent person/company and its presence made aware to those at risk, as part of a Control of Asbestos Regulations (CAR) 2012 compliant management strategy.

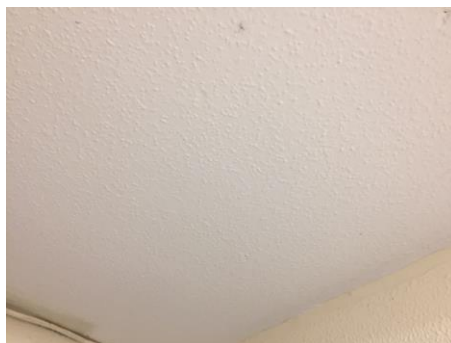
Condition **Low Damage**

Stipple pattern textured coating.

The material was seen to be in fair condition at the time of the initial inspection.

The condition of the material should be managed by a competent person/company and its presence made aware to those at risk, as part of a Control of Asbestos Regulations (CAR) 2012 compliant management strategy.

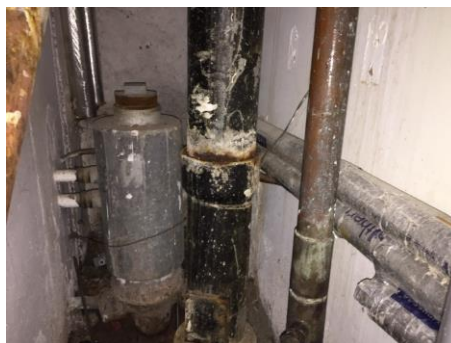
Condition **High Damage**

Rope seal to joint of soil pipe.

The material was seen to be in fair condition at the time of the initial inspection.

The condition of the material should be managed by a competent person/company and its presence made aware to those at risk, as part of a Control of Asbestos Regulations (CAR) 2012 compliant management strategy.

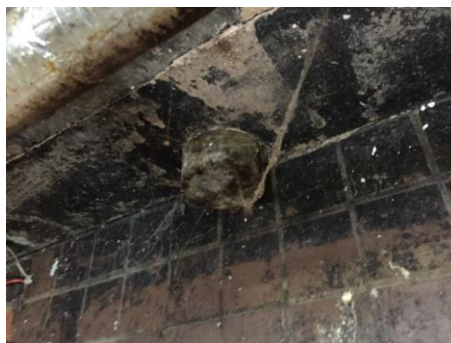
Condition **Low Damage**

Cement incinerator flue cap.

The material was seen to be in fair condition at the time of the initial inspection.
