Solihull Community Housing

Asbestos Management Survey Report

Darwin House I-37 (Communal)
Alder Court
Solihull
B37 7QF

Date of Report: 27 Feb 2015

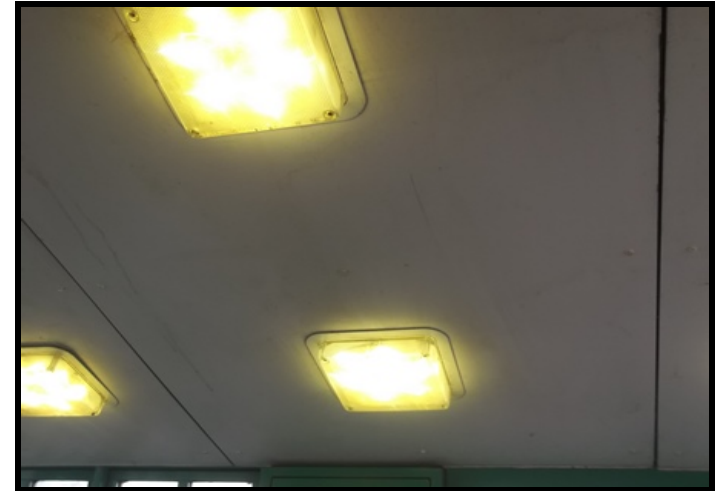
SAMPLE REFERENCE 001

Asbestos not detected in Sample

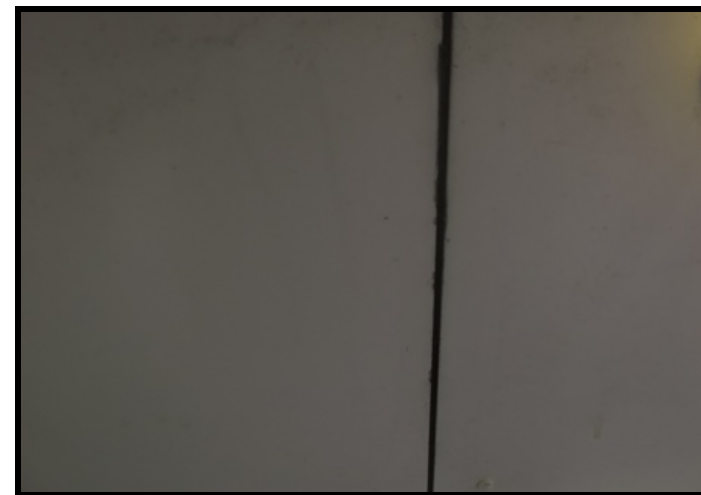
SAMPLE REFERENCE 006

Asbestos not detected in Sample

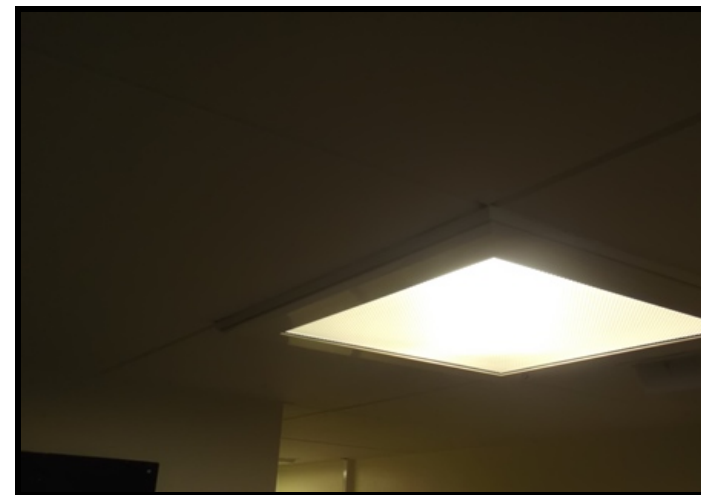
SAMPLE REFERENCE 007

No Asbestos Presumed in Sample

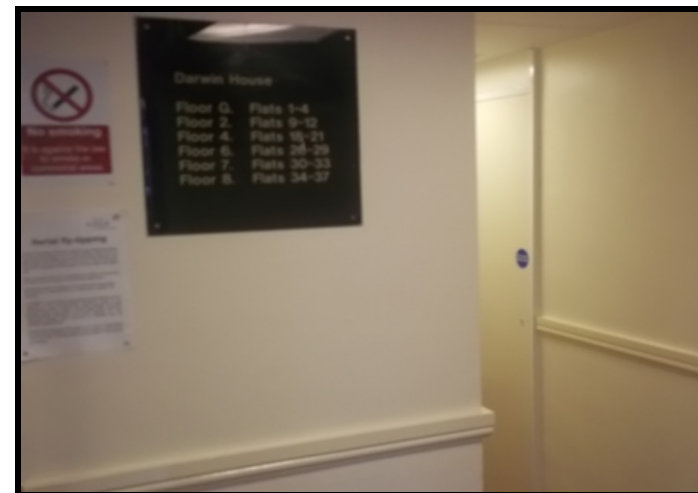
SAMPLE REFERENCE 008

No Asbestos Presumed in Sample

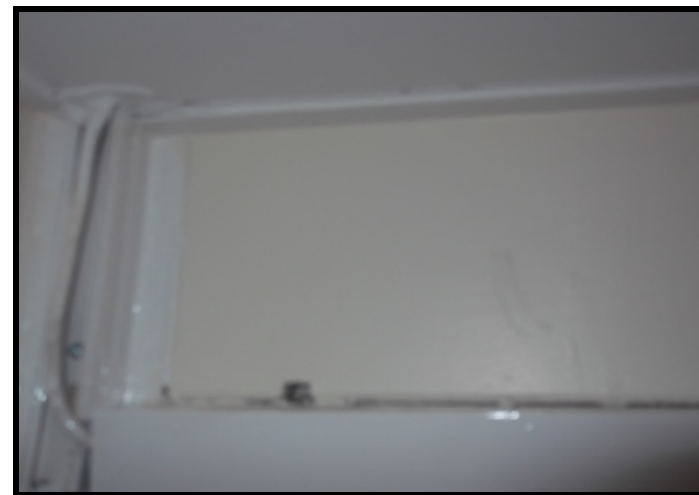
SAMPLE REFERENCE 009

Asbestos not detected in Sample

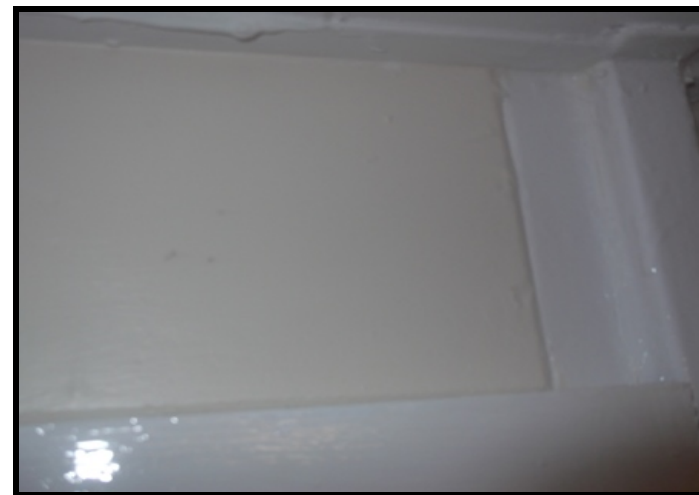
SAMPLE REFERENCE 010

Asbestos not detected in Sample

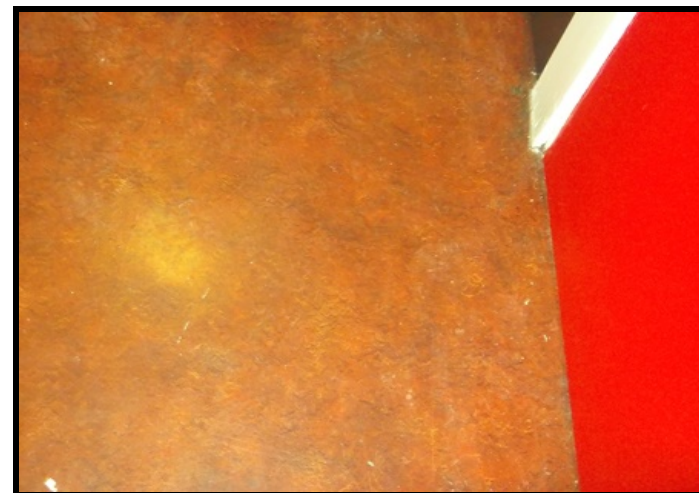
SAMPLE REFERENCE 011

No Asbestos Presumed in Sample

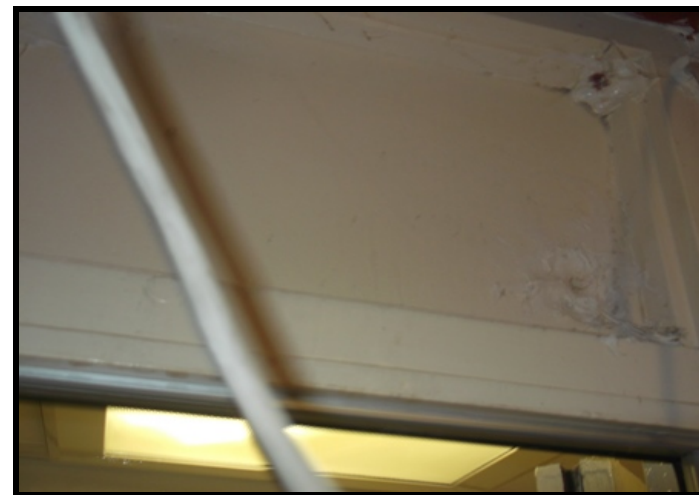
SAMPLE REFERENCE 015

No Asbestos Presumed in Sample

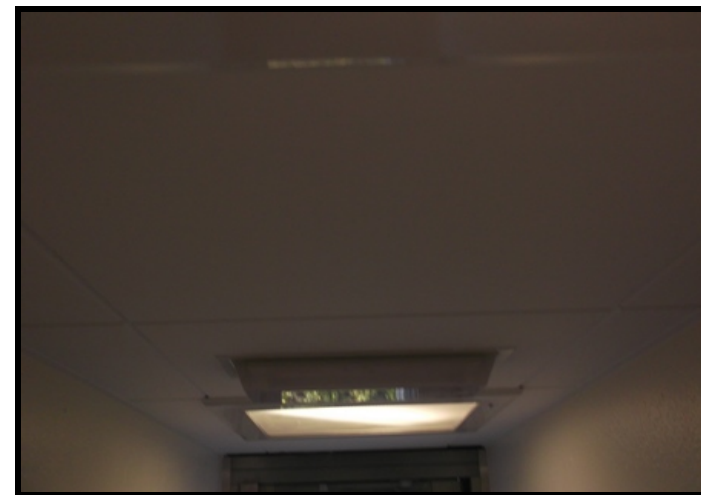
SAMPLE REFERENCE 016

No Asbestos Presumed in Sample

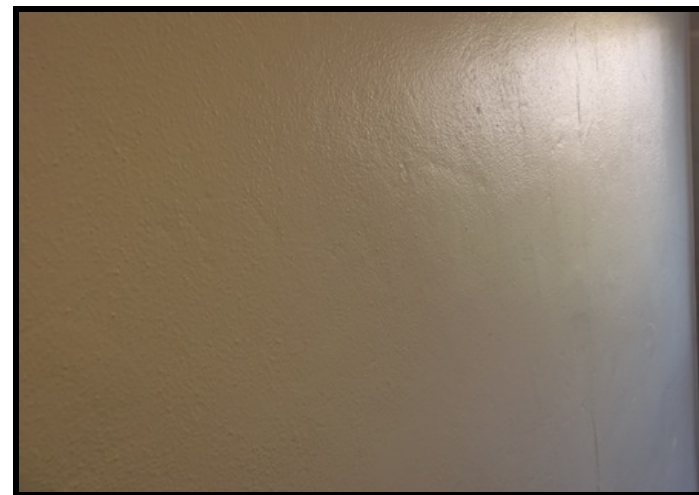
SAMPLE REFERENCE 017

No Asbestos Presumed in Sample

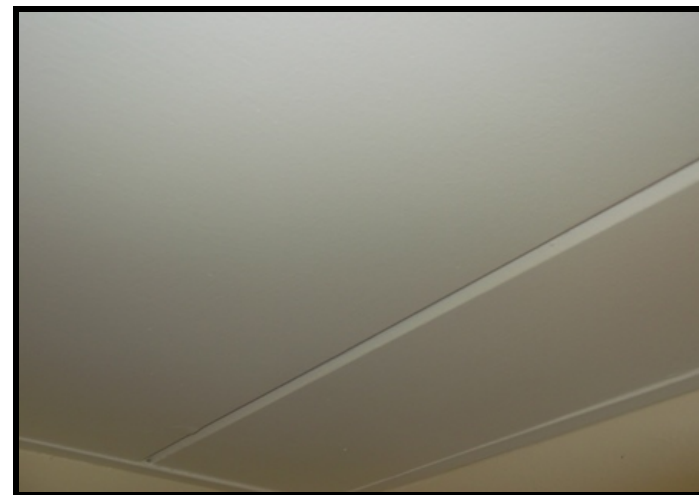
SAMPLE REFERENCE 018

No Asbestos Presumed in Sample

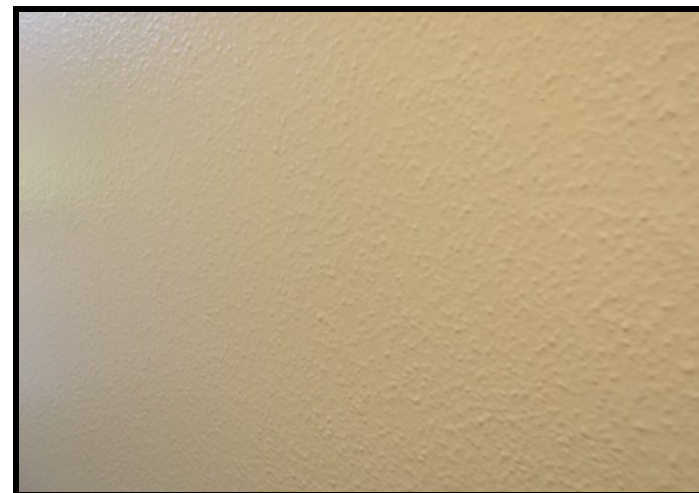
SAMPLE REFERENCE 019

No Asbestos Presumed in Sample

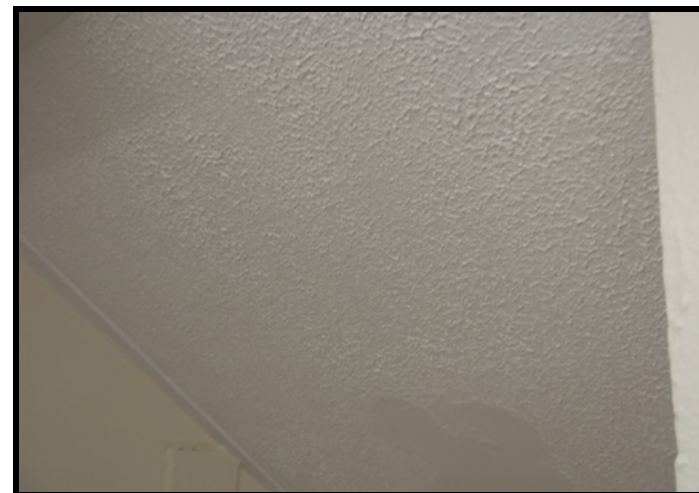
SAMPLE REFERENCE 028

No Asbestos Presumed in Sample

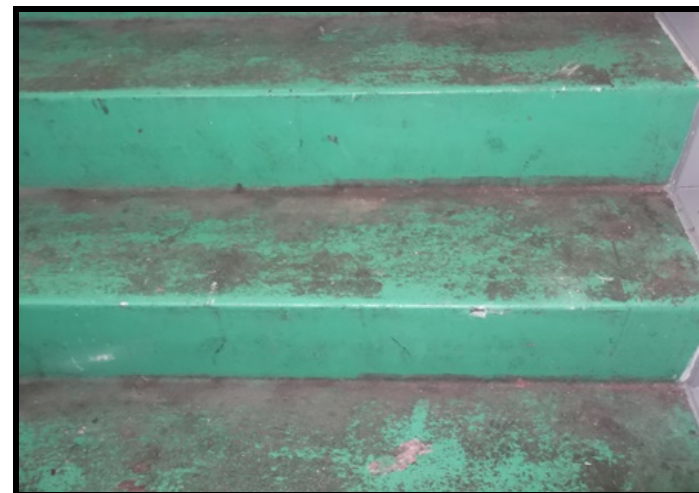
SAMPLE REFERENCE 031a

Building	Floor	Room	Location
Main Building	First Floor	Stairs and Landing	Staircase
Description			
MATERIAL ASSESSMENT			
Product Type	Bitumen	Extent of Damage	Low damage
Asbestos Type	Chrysotile	Surface Treatment	Composite materials
PRIORITY ASSESSMENT			
Occupant Activity	Not Applicable	Extent / Amount	14.00 small item(s)
Accessibility	Easily disturbed	Location	Not Applicable
Avg Time in Use	Not Applicable	Frequency of Use	Not Applicable
No. of Occupants	Not Applicable	Secondary Activity	Not Applicable
Maintenance	Not Applicable	Maintenance Frequency	Not Applicable
MANAGEMENT ACTION			
Recommendation	LABEL & MONITOR		
Recommendation Due		Next Inspection	19 Dec 2015
Apply Labels	No	Permit to Work Required	No
Survey Type	Management	Lead Surveyor	Gavin Hooper
Survey Date	19 Dec 2014	UKAS Laboratory	DMW Environmental Safety Ltd / [A-10222]
Site Reference	I33510000A	Licensed Material	No
		Notifiable Non Licensed Work	No

Asbestos detected in Sample

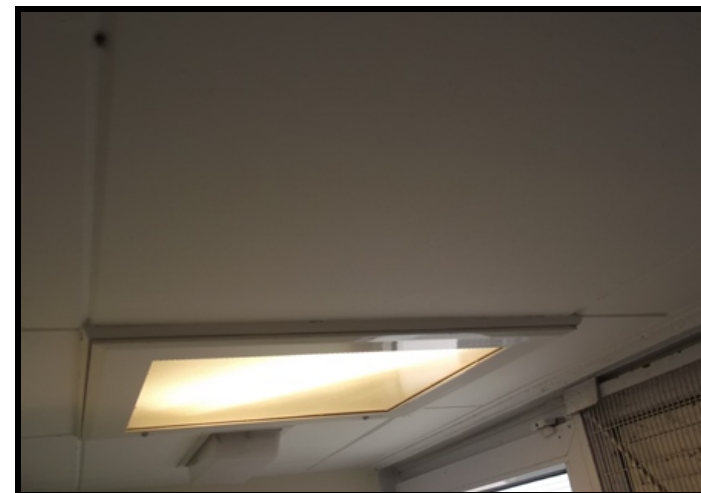
SAMPLE REFERENCE 032

No Asbestos Presumed in Sample

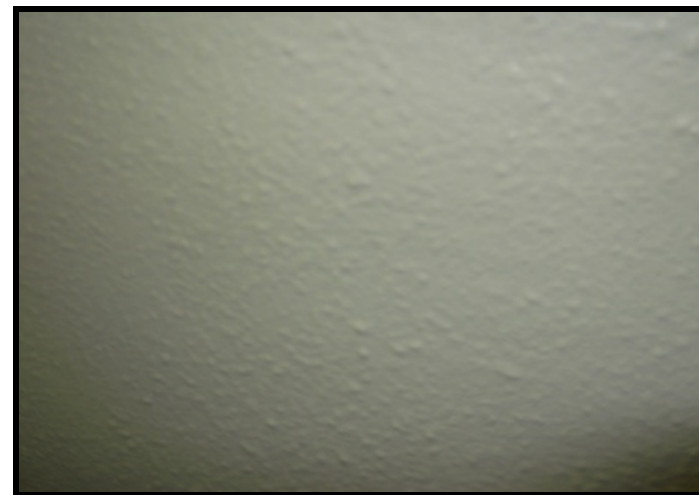
SAMPLE REFERENCE 033

No Asbestos Presumed in Sample

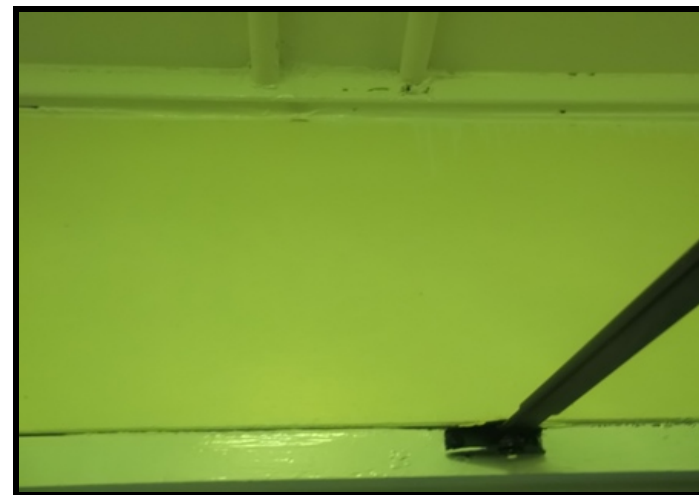
SAMPLE REFERENCE 035

Asbestos not detected in Sample

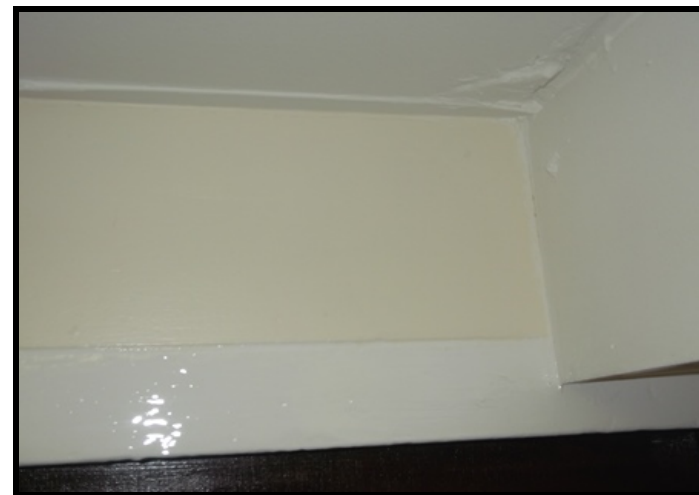
SAMPLE REFERENCE 039

No Asbestos Presumed in Sample

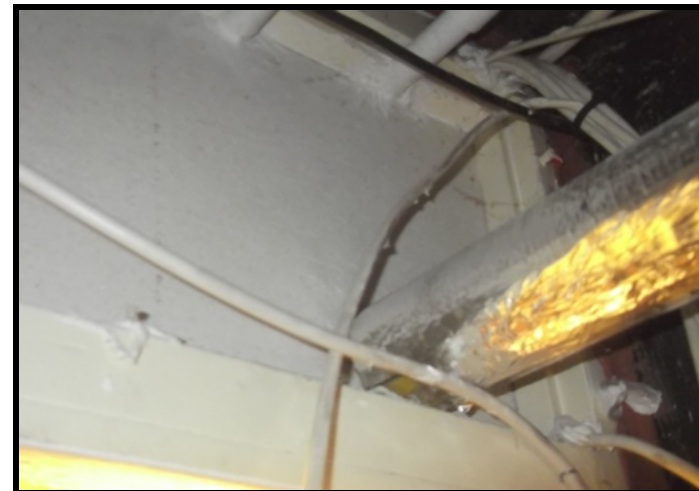
SAMPLE REFERENCE 041

No Asbestos Presumed in Sample

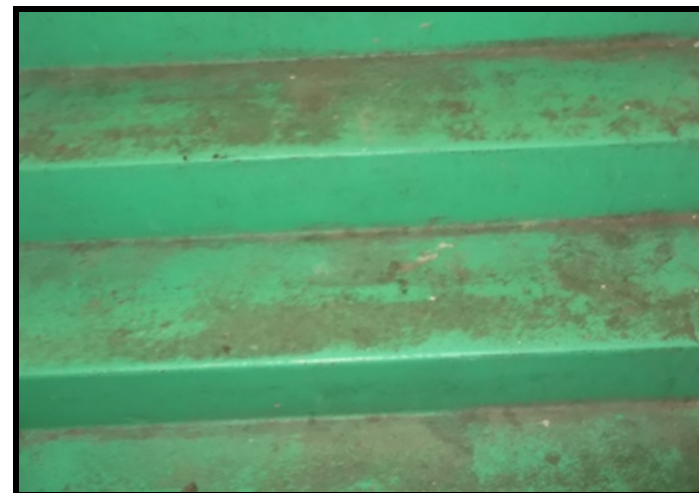
SAMPLE REFERENCE 043a

Building	Floor	Room	Location
Main Building	Second Floor	Stairs and Landing	Floor
Description			
MATERIAL ASSESSMENT			
Product Type	Bitumen	Extent of Damage	Low damage
Asbestos Type	Chrysotile	Surface Treatment	Composite materials
PRIORITY ASSESSMENT			
Occupant Activity	Not Applicable	Extent / Amount	4.00 m2
Accessibility	Easily disturbed	Location	Not Applicable
Avg Time in Use	Not Applicable	Frequency of Use	Not Applicable
No. of Occupants	Not Applicable	Secondary Activity	Not Applicable
Maintenance	Not Applicable	Maintenance Frequency	Not Applicable
MANAGEMENT ACTION			
Recommendation	LABEL & MONITOR		
Recommendation Due		Next Inspection	19 Dec 2015
Apply Labels	No	Permit to Work Required	No
Survey Type	Management	Lead Surveyor	Gavin Hooper
Survey Date	19 Dec 2014	UKAS Laboratory	NOT SAMPLED (Cross Referenced)
Site Reference	133510000A	Licensed Material	No
		Notifiable Non Licensed Work	No

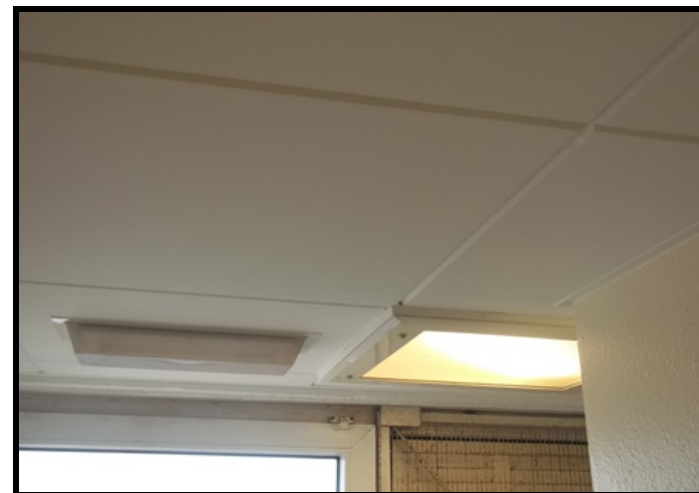
SAMPLE REFERENCE 046

No Asbestos Presumed in Sample

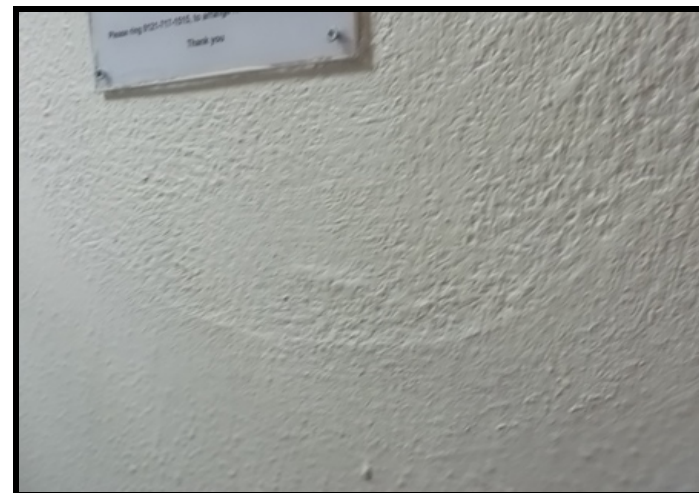
SAMPLE REFERENCE 047

No Asbestos Presumed in Sample

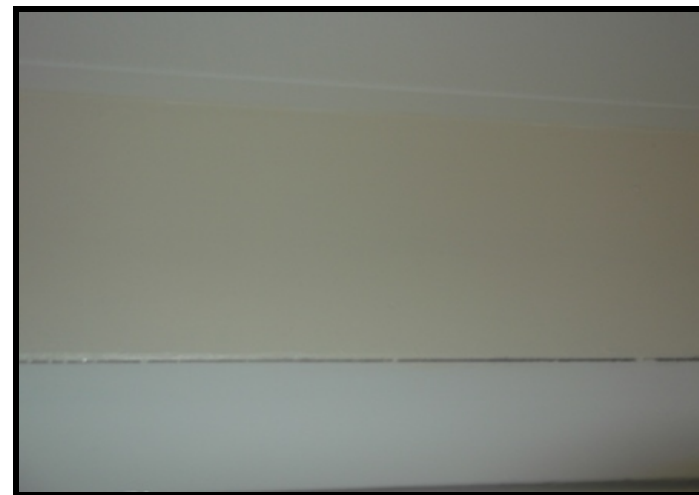
SAMPLE REFERENCE 049

No Asbestos Presumed in Sample

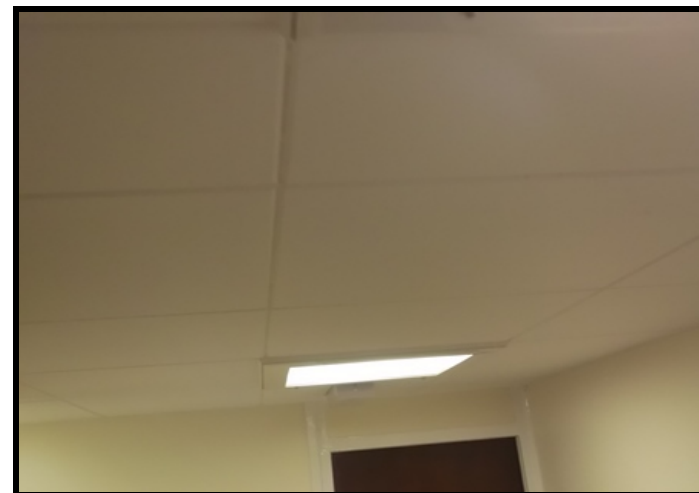
SAMPLE REFERENCE 050

No Asbestos Presumed in Sample

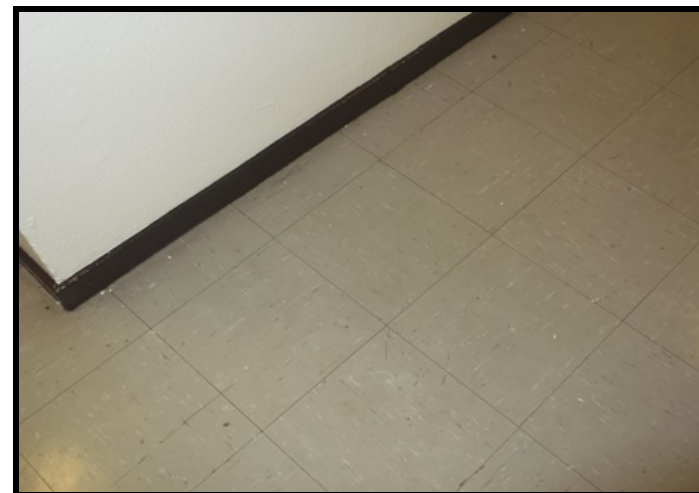
SAMPLE REFERENCE 050a

Building	Floor	Room	Location		
Main Building	Second Floor	Lift Landing	Floor		
Description	Grey floor tiles and adhesive				
MATERIAL ASSESSMENT				SCORE	
Product Type	Bitumen	Extent of Damage	Low damage		3
Asbestos Type	Chrysotile	Surface Treatment	Composite materials		
PRIORITY ASSESSMENT				SCORE	
Occupant Activity	Not Applicable	Extent / Amount	20.00 m2		1
Accessibility	Easily disturbed	Location	Not Applicable		
Avg Time in Use	Not Applicable	Frequency of Use	Not Applicable		
No. of Occupants	Not Applicable	Secondary Activity	Not Applicable		
Maintenance	Not Applicable	Maintenance Frequency	Not Applicable		
MANAGEMENT ACTION				SCORE	
Recommendation	LABEL & MONITOR				4
Recommendation Due		Next Inspection	19 Dec 2015		
Apply Labels	No	Permit to Work Required	No		
Survey Type	Management	Lead Surveyor	Gavin Hooper		
Survey Date	19 Dec 2014	UKAS Laboratory	DMW Environmental Safety Ltd / [A-10222]		
Site Reference	I33510000A	Licensed Material	No	Notifiable Non Licensed Work	No

Asbestos detected in Sample

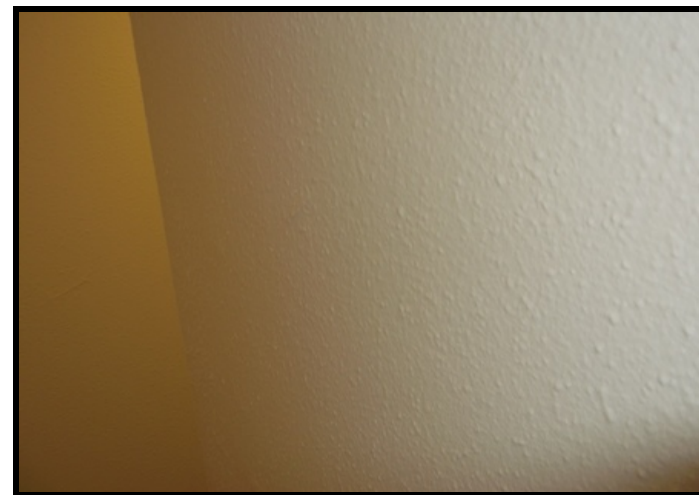
SAMPLE REFERENCE 051

No Asbestos Presumed in Sample

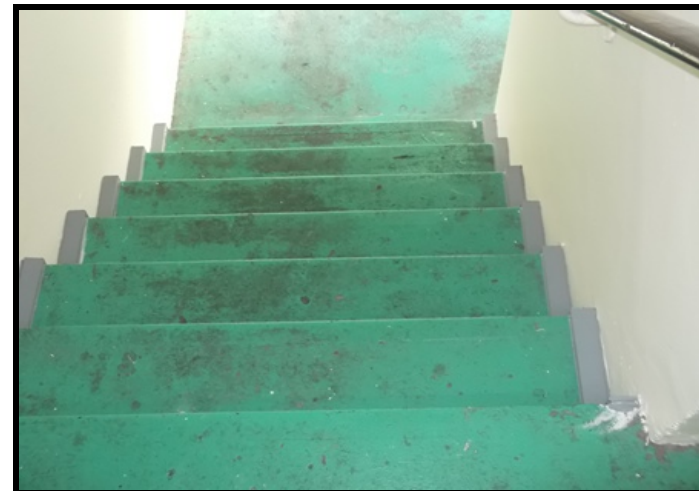
SAMPLE REFERENCE 060a

Asbestos Presumed

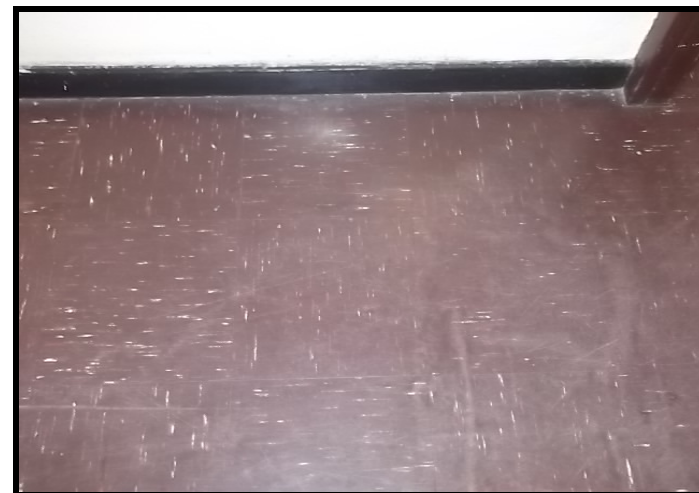
SAMPLE REFERENCE 083a

Asbestos not detected in Sample

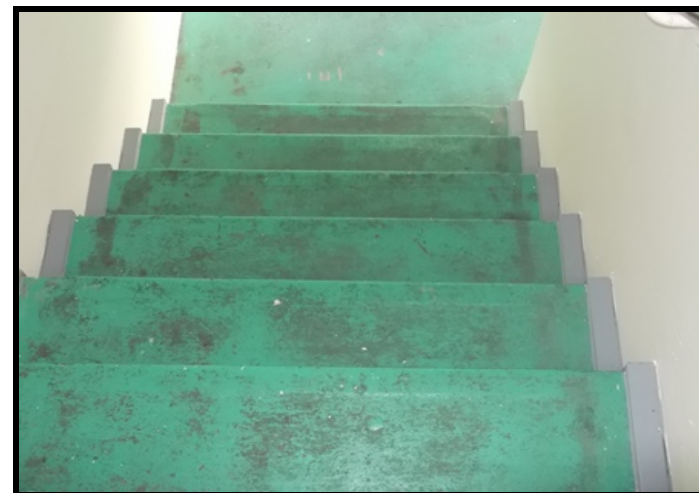
SAMPLE REFERENCE 090a

Asbestos Presumed

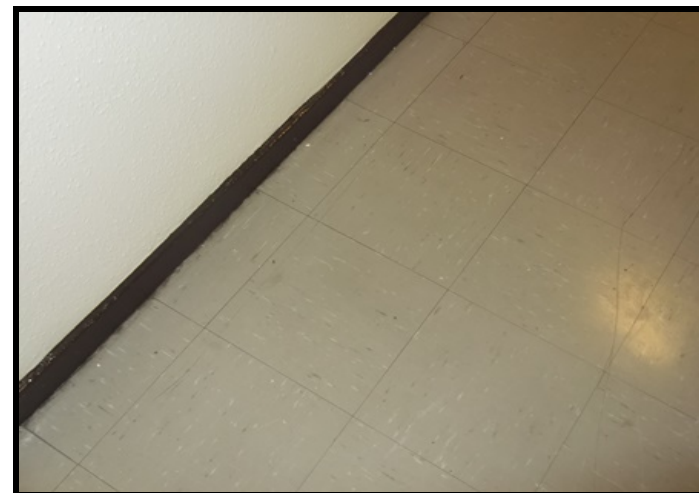
SAMPLE REFERENCE I 13a

Asbestos Presumed

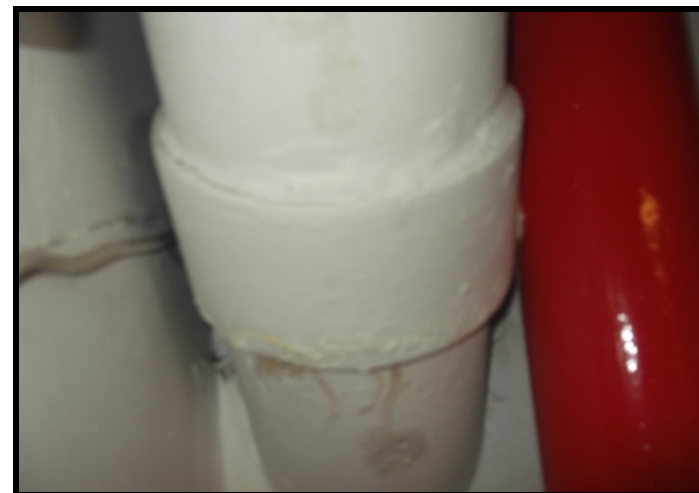
SAMPLE REFERENCE 131

No Asbestos Containing Materials Identified
