# Solihull Community Housing

## Asbestos Management Survey Report

**Demontfort House I-36  
(Communal)  
Shirral Grove  
Solihull  
B37 6JR**

**Date of Report: 25 Feb 2015**

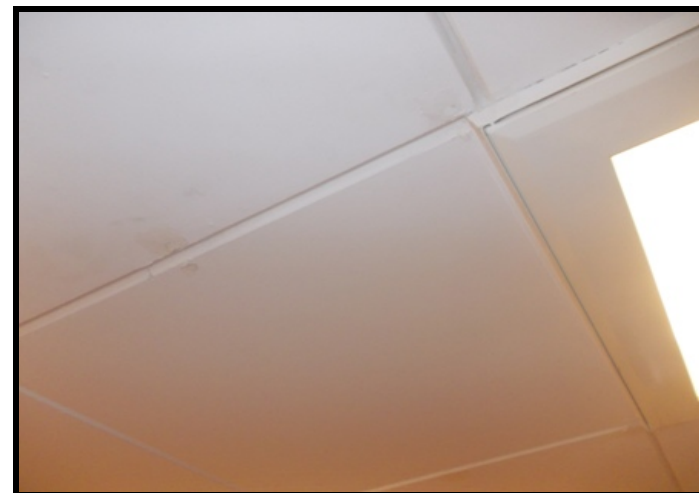
## SAMPLE REFERENCE 001

**Asbestos not detected in Sample**

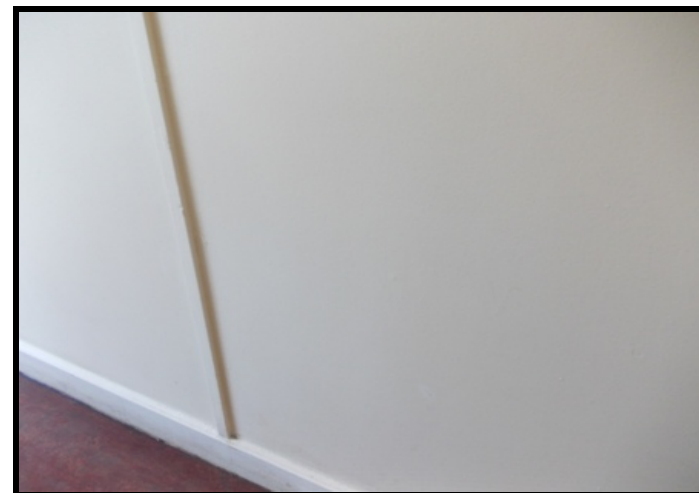
## SAMPLE REFERENCE 001a

Asbestos not detected in Sample

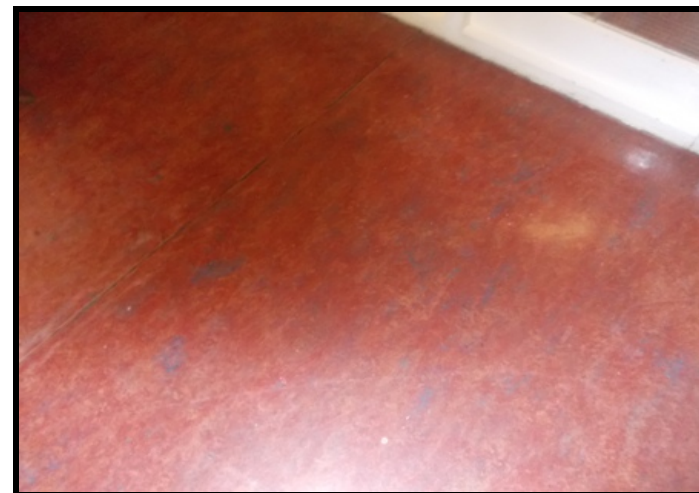
## SAMPLE REFERENCE 002

**Asbestos not detected in Sample**

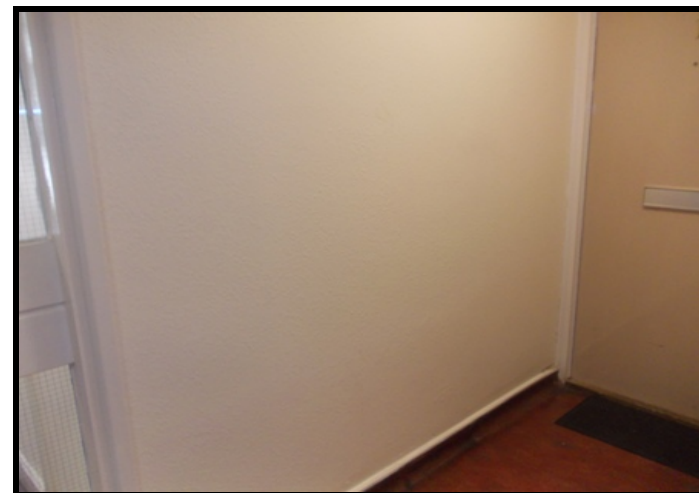
## SAMPLE REFERENCE 003

Asbestos not detected in Sample

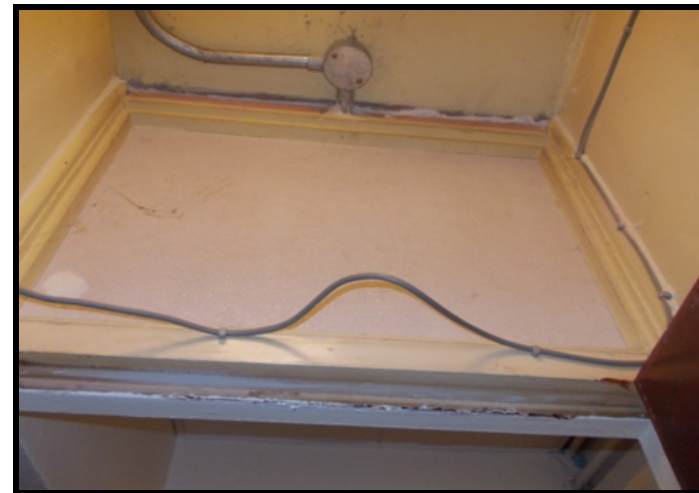
## SAMPLE REFERENCE 003a

**Asbestos not detected in Sample**

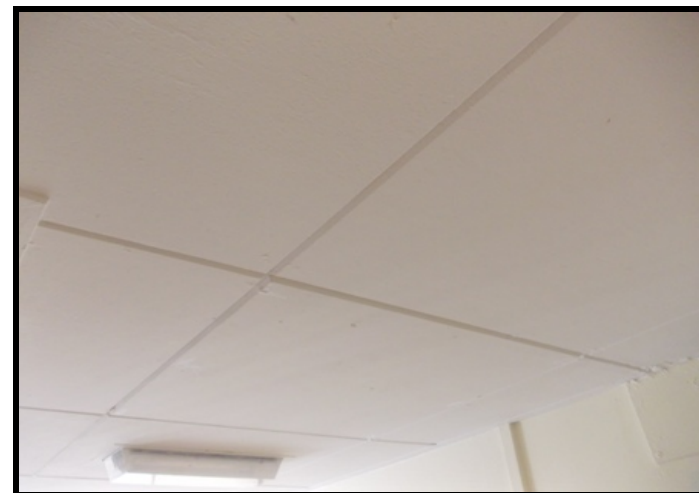
## SAMPLE REFERENCE 004

**No Asbestos Presumed in Sample**

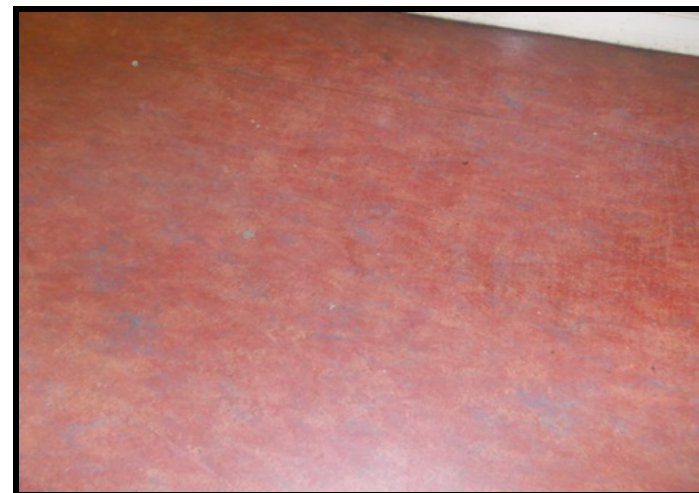
## SAMPLE REFERENCE 005

**No Asbestos Presumed in Sample**

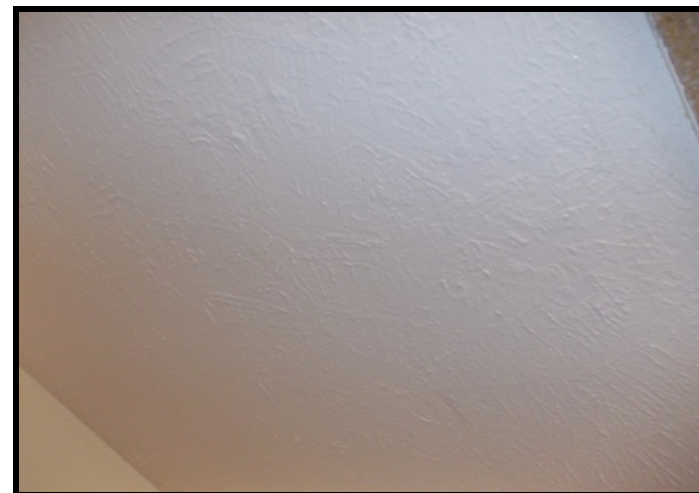
## SAMPLE REFERENCE 006

**Asbestos not detected in Sample**

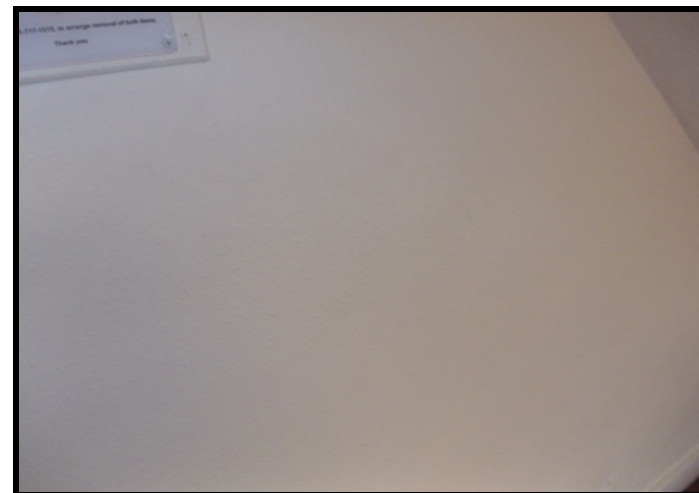
## SAMPLE REFERENCE 007

**No Asbestos Presumed in Sample**

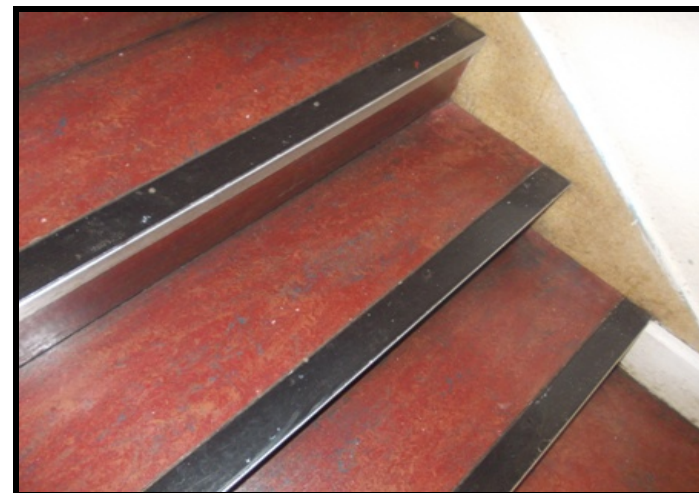
## SAMPLE REFERENCE 008

**Asbestos detected in Sample**

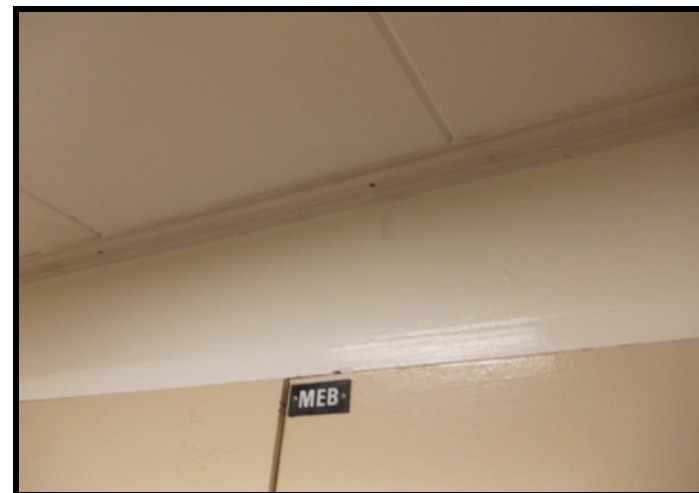
## SAMPLE REFERENCE 009

Asbestos not detected in Sample

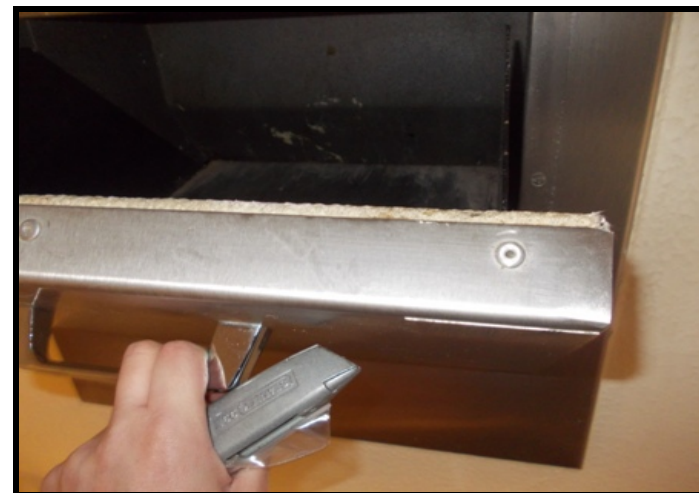
## SAMPLE REFERENCE 010a

Asbestos not detected in Sample

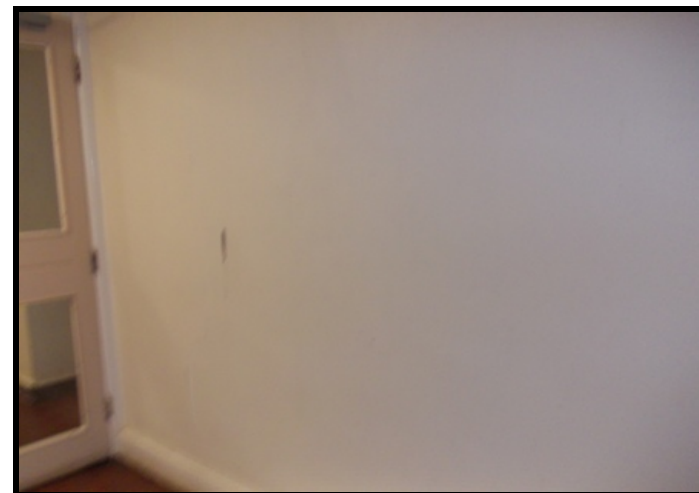
## SAMPLE REFERENCE 010b

Asbestos not detected in Sample

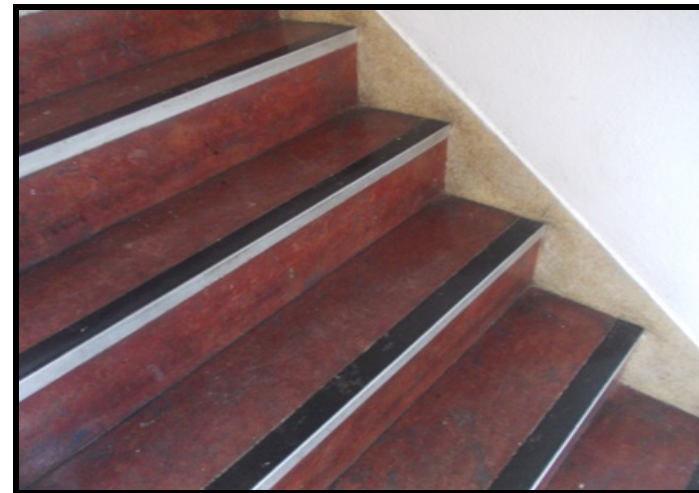
## SAMPLE REFERENCE 010c

Asbestos Presumed

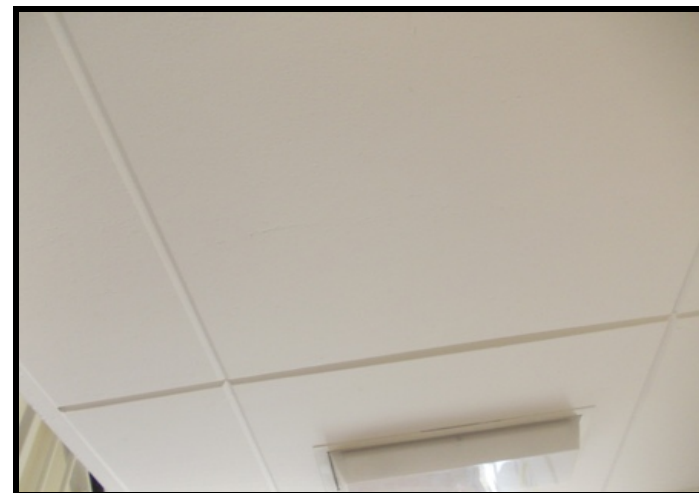
## SAMPLE REFERENCE 010d

**No Asbestos Presumed in Sample**

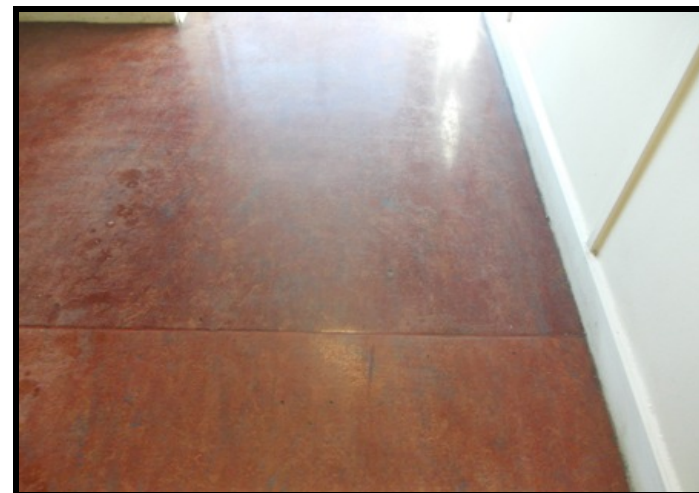
## SAMPLE REFERENCE 010e

**No Asbestos Presumed in Sample**

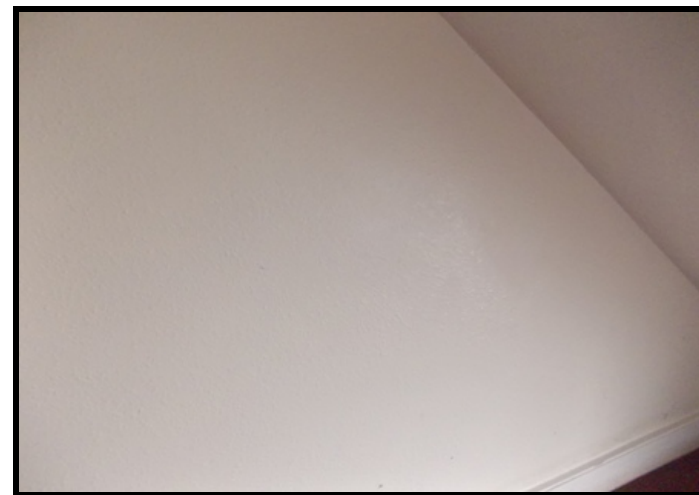
## SAMPLE REFERENCE 010f

**No Asbestos Presumed in Sample**

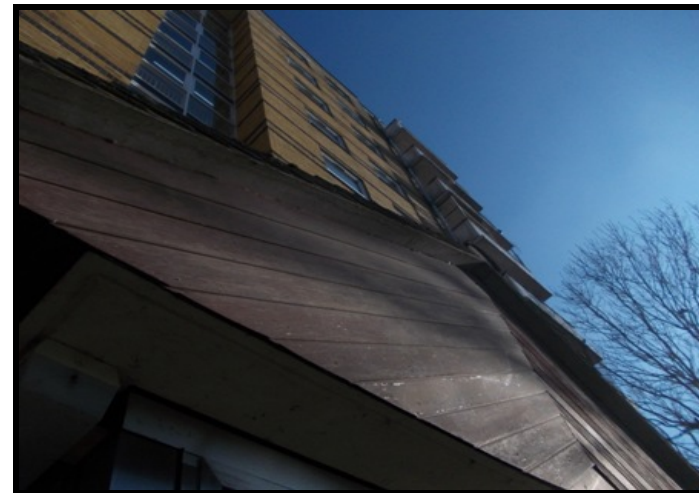
## SAMPLE REFERENCE 010h

**Asbestos detected in Sample**

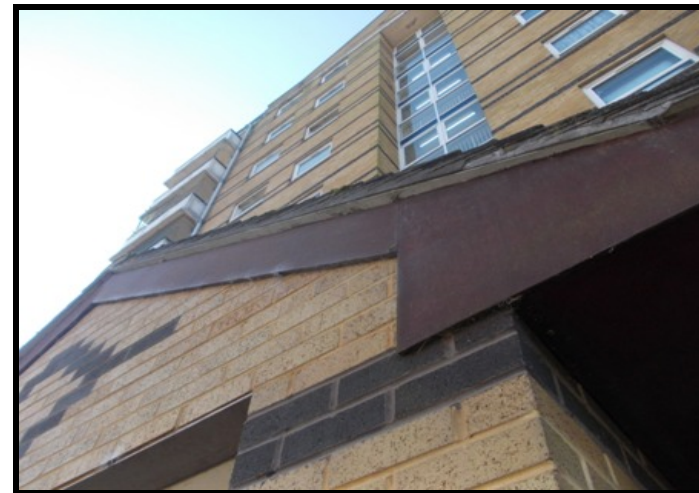
## SAMPLE REFERENCE 010i

**Asbestos Presumed**
