Solihull Community Housing

Asbestos Management Survey Report

I-36 (Communal) Digby House
Colletts Grove
Solihull
B37 6JE

Date of Report: 11 Apr 2011

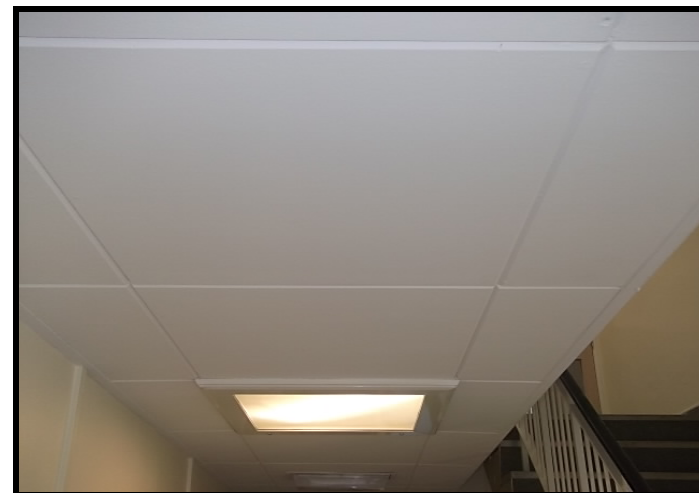
SAMPLE REFERENCE 001

Building	Floor	Room	Location	
Main	Ground Floor	Front Entrance	Ceiling	
Description				
MATERIAL ASSESSMENT				SCORE
Product Type	Board	Extent of Damage	Good condition	-
Asbestos Type	No Asbestos Detected	Surface Treatment	Sealed Board (Encapsulated)	
PRIORITY ASSESSMENT				SCORE
Occupant Activity	Not Applicable	Extent / Amount	20.00 m2	-
Accessibility	Occasionally disturb	Location	Not Applicable	
Avg Time in Use	Not Applicable	Frquency of Use	Not Applicable	
No. of Occupants	Not Applicable	Secondary Activity	Not Applicable	
Maintenance	Not Applicable	Maintenace Frequency	Not Applicable	
MANAGEMENT ACTION				SCORE
Recommendation	NO ACTION REQUIRED			-
Recommendation Due		Next Inspection	None	
Apply Labels	No	Permit to Work Required	No	
Survey Type	Management	Lead Surveyor	Richard Saunders	
Survey Date	23 Mar 2011	UKAS Laboratory	DMW Environmental Safety Ltd / [P-75203]	
Site Reference	257810000A	Licensed Material	N/A

Asbestos not detected in Sample

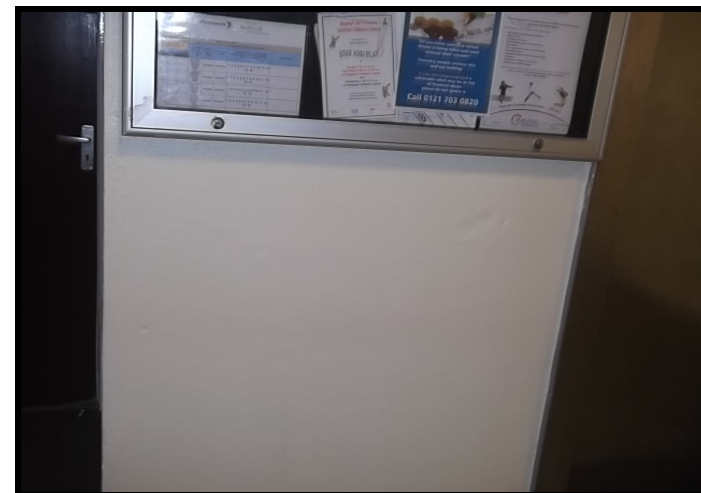
SAMPLE REFERENCE 002

Building	Floor	Room	Location	
Main	Ground Floor	Front Entrance	Wall	
Description				
MATERIAL ASSESSMENT				SCORE
Product Type	Textured Coating	Extent of Damage	Good condition	-
Asbestos Type	No Asbestos Detected	Surface Treatment	Textured Coating	
PRIORITY ASSESSMENT				SCORE
Occupant Activity	Not Applicable	Extent / Amount	20.00 m2	-
Accessibility	Easily disturbed	Location	Not Applicable	
Avg Time in Use	Not Applicable	Frquency of Use	Not Applicable	
No. of Occupants	Not Applicable	Secondary Activity	Not Applicable	
Maintenance	Not Applicable	Maintenace Frequency	Not Applicable	
MANAGEMENT ACTION				SCORE
Recommendation	NO ACTION REQUIRED			-
Recommendation Due		Next Inspection	None	
Apply Labels	No	Permit to Work Required	No	
Survey Type	Management	Lead Surveyor	Richard Saunders	
Survey Date	23 Mar 2011	UKAS Laboratory	DMW Environmental Safety Ltd / [P-75203]	
Site Reference	257810000A	Licensed Material	N/A

Asbestos not detected in Sample

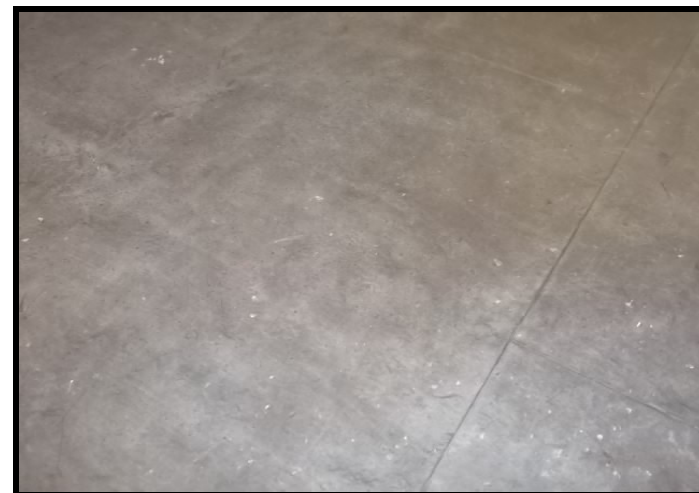
SAMPLE REFERENCE 003

Building	Floor	Room	Location	
Main	Ground Floor	Front Entrance	Floor	
Description				
MATERIAL ASSESSMENT				SCORE
Product Type	Linoleum	Extent of Damage	Good condition	-
Asbestos Type	No Asbestos Detected	Surface Treatment	Composite materials	
PRIORITY ASSESSMENT				SCORE
Occupant Activity	Not Applicable	Extent / Amount	20.00 m2	-
Accessibility	Occasionally disturb	Location	Not Applicable	
Avg Time in Use	Not Applicable	Frquency of Use	Not Applicable	
No. of Occupants	Not Applicable	Secondary Activity	Not Applicable	
Maintenance	Not Applicable	Maintenace Frequency	Not Applicable	
MANAGEMENT ACTION				SCORE
Recommendation	NO ACTION REQUIRED			-
Recommendation Due		Next Inspection	None	
Apply Labels	No	Permit to Work Required	No	
Survey Type	Management	Lead Surveyor	Richard Saunders	
Survey Date	23 Mar 2011	UKAS Laboratory	DMW Environmental Safety Ltd / [P-75203]	
Site Reference	257810000A	Licensed Material	N/A

Asbestos not detected in Sample

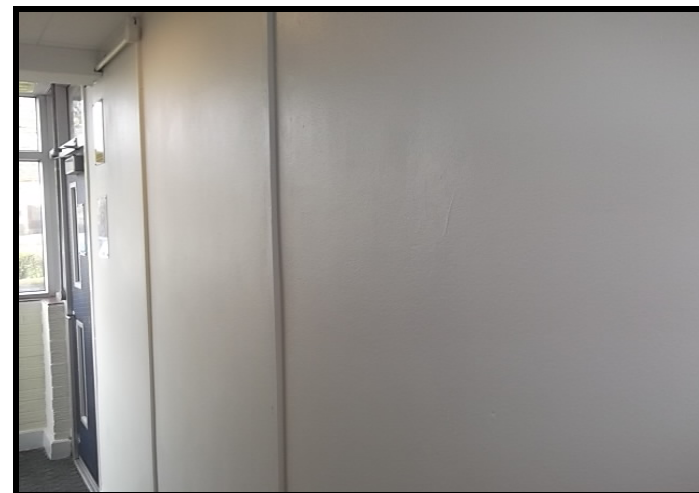
SAMPLE REFERENCE 004

Building	Floor	Room	Location	
Main	Ground Floor	Front Entrance	Wall	
Description				
MATERIAL ASSESSMENT				SCORE
Product Type	Cement Board	Extent of Damage	Good condition	-
Asbestos Type	No Asbestos Detected	Surface Treatment	Cement Board	
PRIORITY ASSESSMENT				SCORE
Occupant Activity	Not Applicable	Extent / Amount	15.00 m2	-
Accessibility	Easily disturbed	Location	Not Applicable	
Avg Time in Use	Not Applicable	Frquency of Use	Not Applicable	
No. of Occupants	Not Applicable	Secondary Activity	Not Applicable	
Maintenance	Not Applicable	Maintenace Frequency	Not Applicable	
MANAGEMENT ACTION				SCORE
Recommendation	NO ACTION REQUIRED			-
Recommendation Due		Next Inspection	None	
Apply Labels	No	Permit to Work Required	No	
Survey Type	Management	Lead Surveyor	Richard Saunders	
Survey Date	23 Mar 2011	UKAS Laboratory	DMW Environmental Safety Ltd / [P-75203]	
Site Reference	257810000A	Licensed Material	N/A

Asbestos not detected in Sample

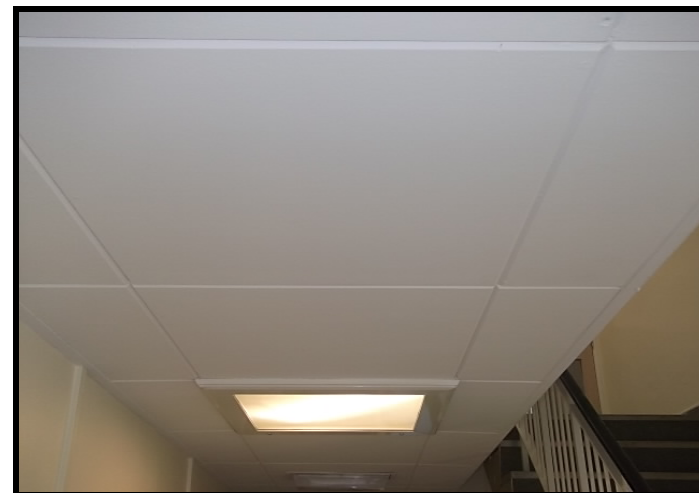
SAMPLE REFERENCE 005

Building	Floor	Room	Location
Main	Ground Floor	Lift/Flat Area	Ceiling
Description			
MATERIAL ASSESSMENT			
Product Type	Board	Extent of Damage	Good condition
Asbestos Type	No Asbestos Detected	Surface Treatment	Sealed Board (Encapsulated)
PRIORITY ASSESSMENT			
Occupant Activity	Not Applicable	Extent / Amount	20.00 m2
Accessibility	Occasionally disturb	Location	Not Applicable
Avg Time in Use	Not Applicable	Frequency of Use	Not Applicable
No. of Occupants	Not Applicable	Secondary Activity	Not Applicable
Maintenance	Not Applicable	Maintenance Frequency	Not Applicable
MANAGEMENT ACTION			
Recommendation	NO ACTION REQUIRED		
Recommendation Due		Next Inspection	None
Apply Labels	No	Permit to Work Required	No
Survey Type	Management	Lead Surveyor	Richard Saunders
Survey Date	23 Mar 2011	UKAS Laboratory	NOT SAMPLED (Cross Referenced)
Site Reference	257810000A	Licensed Material	N/A

No Asbestos Presumed in Sample

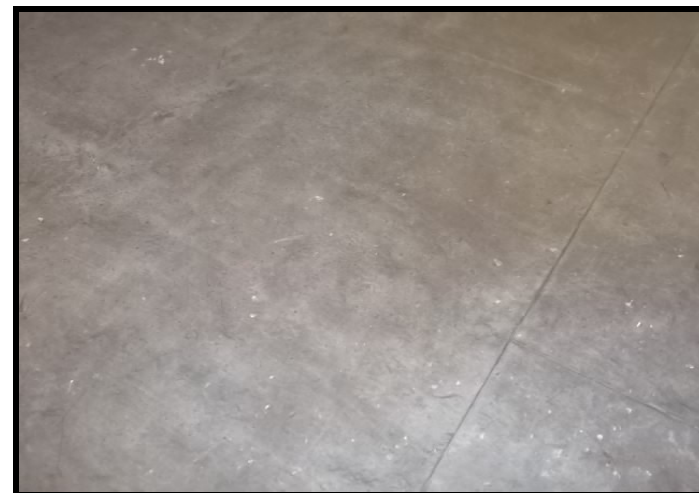
SAMPLE REFERENCE 007

Building	Floor	Room	Location	
Main	Ground Floor	Lift/Flat Area	Floor	
Description				
MATERIAL ASSESSMENT				SCORE
Product Type	Linoleum	Extent of Damage	Good condition	-
Asbestos Type	No Asbestos Detected	Surface Treatment	Composite materials	
PRIORITY ASSESSMENT				SCORE
Occupant Activity	Not Applicable	Extent / Amount	20.00 m2	-
Accessibility	Occasionally disturb	Location	Not Applicable	
Avg Time in Use	Not Applicable	Frquency of Use	Not Applicable	
No. of Occupants	Not Applicable	Secondary Activity	Not Applicable	
Maintenance	Not Applicable	Maintenace Frequency	Not Applicable	
MANAGEMENT ACTION				SCORE
Recommendation	NO ACTION REQUIRED			-
Recommendation Due		Next Inspection	None	
Apply Labels	No	Permit to Work Required	No	
Survey Type	Management	Lead Surveyor	Richard Saunders	
Survey Date	23 Mar 2011	UKAS Laboratory	NOT SAMPLED (Cross Referenced)	
Site Reference	257810000A	Licensed Material	N/A

No Asbestos Presumed in Sample

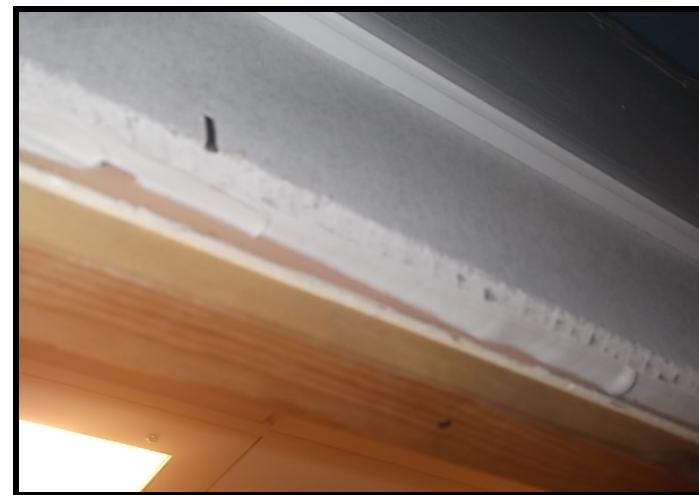
SAMPLE REFERENCE 008

Building	Floor	Room	Location	
Main	Ground Floor	Electric Cupboard	Transom Panel	
Description	No access within electrics.			
MATERIAL ASSESSMENT				SCORE
Product Type	Board	Extent of Damage	Good condition	-
Asbestos Type	No Asbestos Detected	Surface Treatment	Sealed Board (Encapsulated)	
PRIORITY ASSESSMENT				SCORE
Occupant Activity	Not Applicable	Extent / Amount	1.00 m2	-
Accessibility	Occasionally disturb	Location	Not Applicable	
Avg Time in Use	Not Applicable	Frquency of Use	Not Applicable	
No. of Occupants	Not Applicable	Secondary Activity	Not Applicable	
Maintenance	Not Applicable	Maintenace Frequency	Not Applicable	
MANAGEMENT ACTION				SCORE
Recommendation	NO ACTION REQUIRED			-
Recommendation Due		Next Inspection	None	
Apply Labels	No	Permit to Work Required	No	
Survey Type	Management	Lead Surveyor	Richard Saunders	
Survey Date	23 Mar 2011	UKAS Laboratory	DMW Environmental Safety Ltd / [P-75203]	
Site Reference	257810000A	Licensed Material	N/A

Asbestos not detected in Sample

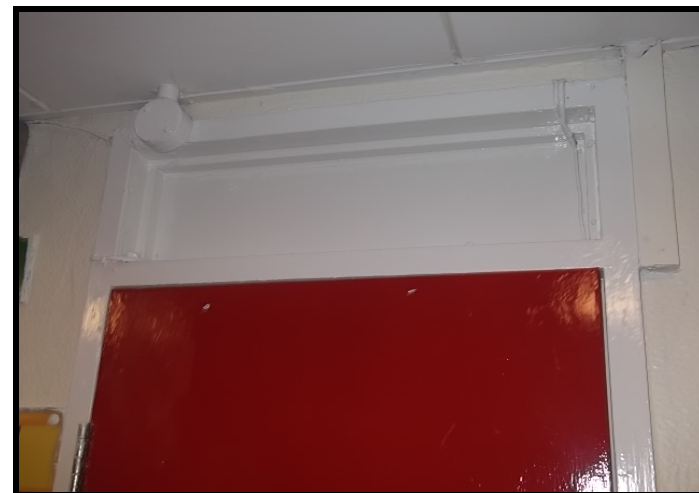
SAMPLE REFERENCE 009

Building	Floor	Room	Location	
Main	Ground Floor	Dry Riser	Transom Panel	
Description				
MATERIAL ASSESSMENT				SCORE
Product Type	Board	Extent of Damage	Good condition	-
Asbestos Type	No Asbestos Detected	Surface Treatment	Sealed Board (Encapsulated)	
PRIORITY ASSESSMENT				SCORE
Occupant Activity	Not Applicable	Extent / Amount	1.00 m2	-
Accessibility	Occasionally disturb	Location	Not Applicable	
Avg Time in Use	Not Applicable	Frquency of Use	Not Applicable	
No. of Occupants	Not Applicable	Secondary Activity	Not Applicable	
Maintenance	Not Applicable	Maintenace Frequency	Not Applicable	
MANAGEMENT ACTION				SCORE
Recommendation	NO ACTION REQUIRED			-
Recommendation Due		Next Inspection	None	
Apply Labels	No	Permit to Work Required	No	
Survey Type	Management	Lead Surveyor	Richard Saunders	
Survey Date	23 Mar 2011	UKAS Laboratory	DMW Environmental Safety Ltd / [P-75203]	
Site Reference	257810000A	Licensed Material	N/A

Asbestos not detected in Sample

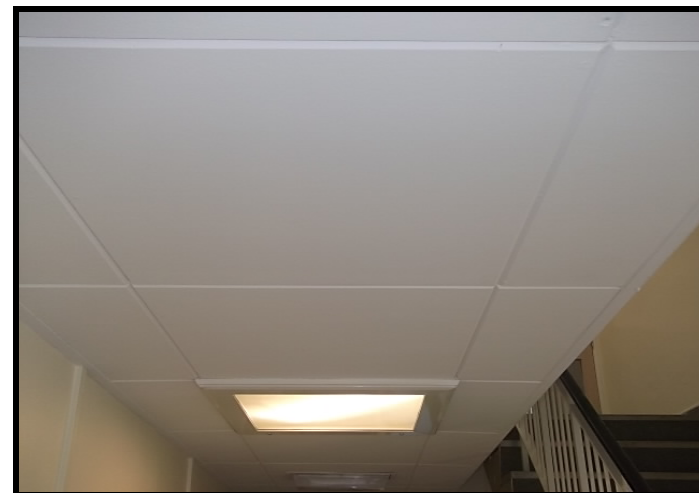
SAMPLE REFERENCE 012

Building	Floor	Room	Location	
Main	Ground Floor	Rear Entrance	Ceiling	
Description				
MATERIAL ASSESSMENT				SCORE
Product Type	Board	Extent of Damage	Good condition	-
Asbestos Type	No Asbestos Detected	Surface Treatment	Sealed Board (Encapsulated)	
PRIORITY ASSESSMENT				SCORE
Occupant Activity	Not Applicable	Extent / Amount	20.00 m2	-
Accessibility	Occasionally disturb	Location	Not Applicable	
Avg Time in Use	Not Applicable	Frquency of Use	Not Applicable	
No. of Occupants	Not Applicable	Secondary Activity	Not Applicable	
Maintenance	Not Applicable	Maintenace Frequency	Not Applicable	
MANAGEMENT ACTION				SCORE
Recommendation	NO ACTION REQUIRED			-
Recommendation Due		Next Inspection	None	
Apply Labels	No	Permit to Work Required	No	
Survey Type	Management	Lead Surveyor	Richard Saunders	
Survey Date	23 Mar 2011	UKAS Laboratory	NOT SAMPLED (Cross Referenced)	
Site Reference	257810000A	Licensed Material	N/A

No Asbestos Presumed in Sample

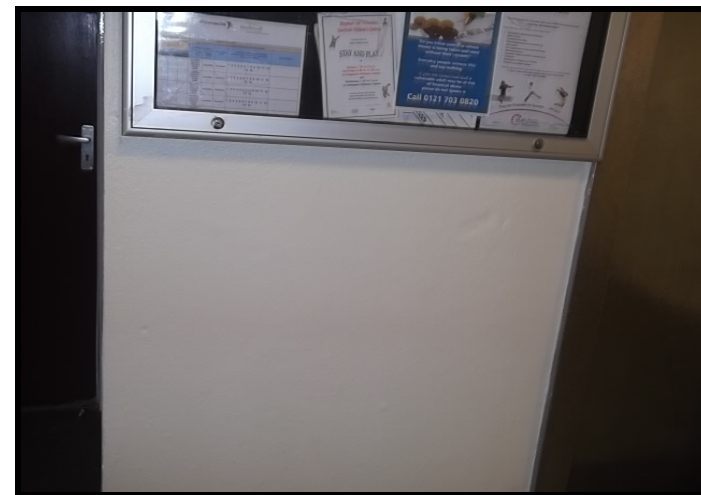
SAMPLE REFERENCE 013

Building	Floor	Room	Location	
Main	Ground Floor	Rear Entrance	Wall	
Description				
MATERIAL ASSESSMENT				SCORE
Product Type	Textured Coating	Extent of Damage	Good condition	-
Asbestos Type	No Asbestos Detected	Surface Treatment	Textured Coating	
PRIORITY ASSESSMENT				SCORE
Occupant Activity	Not Applicable	Extent / Amount	20.00 m2	-
Accessibility	Easily disturbed	Location	Not Applicable	
Avg Time in Use	Not Applicable	Frquency of Use	Not Applicable	
No. of Occupants	Not Applicable	Secondary Activity	Not Applicable	
Maintenance	Not Applicable	Maintenace Frequency	Not Applicable	
MANAGEMENT ACTION				SCORE
Recommendation	NO ACTION REQUIRED			-
Recommendation Due		Next Inspection	None	
Apply Labels	No	Permit to Work Required	No	
Survey Type	Management	Lead Surveyor	Richard Saunders	
Survey Date	23 Mar 2011	UKAS Laboratory	NOT SAMPLED (Cross Referenced)	
Site Reference	257810000A	Licensed Material	N/A

No Asbestos Presumed in Sample

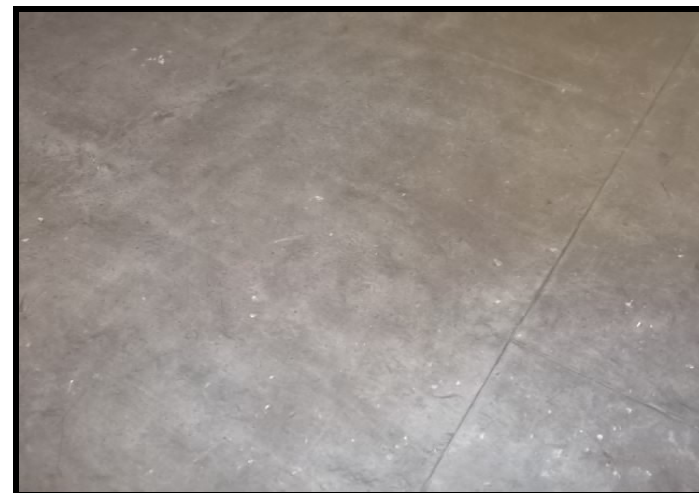
SAMPLE REFERENCE 014

Building	Floor	Room	Location	
Main	Ground Floor	Rear Entrance	Floor	
Description				
MATERIAL ASSESSMENT				SCORE
Product Type	Linoleum	Extent of Damage	Good condition	-
Asbestos Type	No Asbestos Detected	Surface Treatment	Composite materials	
PRIORITY ASSESSMENT				SCORE
Occupant Activity	Not Applicable	Extent / Amount	20.00 m2	-
Accessibility	Occasionally disturb	Location	Not Applicable	
Avg Time in Use	Not Applicable	Frquency of Use	Not Applicable	
No. of Occupants	Not Applicable	Secondary Activity	Not Applicable	
Maintenance	Not Applicable	Maintenace Frequency	Not Applicable	
MANAGEMENT ACTION				SCORE
Recommendation	NO ACTION REQUIRED			-
Recommendation Due		Next Inspection	None	
Apply Labels	No	Permit to Work Required	No	
Survey Type	Management	Lead Surveyor	Richard Saunders	
Survey Date	23 Mar 2011	UKAS Laboratory	NOT SAMPLED (Cross Referenced)	
Site Reference	257810000A	Licensed Material	N/A

No Asbestos Presumed in Sample

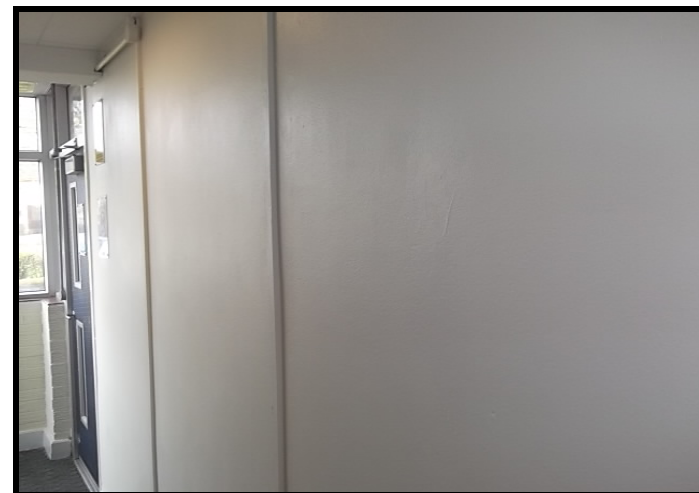
SAMPLE REFERENCE 015

Building	Floor	Room	Location	
Main	Ground Floor	Rear Entrance	Wall	
Description				
MATERIAL ASSESSMENT				SCORE
Product Type	Cement Board	Extent of Damage	Good condition	-
Asbestos Type	No Asbestos Detected	Surface Treatment	Cement Board	
PRIORITY ASSESSMENT				SCORE
Occupant Activity	Not Applicable	Extent / Amount	15.00 m2	-
Accessibility	Easily disturbed	Location	Not Applicable	
Avg Time in Use	Not Applicable	Frquency of Use	Not Applicable	
No. of Occupants	Not Applicable	Secondary Activity	Not Applicable	
Maintenance	Not Applicable	Maintenace Frequency	Not Applicable	
MANAGEMENT ACTION				SCORE
Recommendation	NO ACTION REQUIRED			-
Recommendation Due		Next Inspection	None	
Apply Labels	No	Permit to Work Required	No	
Survey Type	Management	Lead Surveyor	Richard Saunders	
Survey Date	23 Mar 2011	UKAS Laboratory	NOT SAMPLED (Cross Referenced)	
Site Reference	257810000A	Licensed Material	N/A

No Asbestos Presumed in Sample

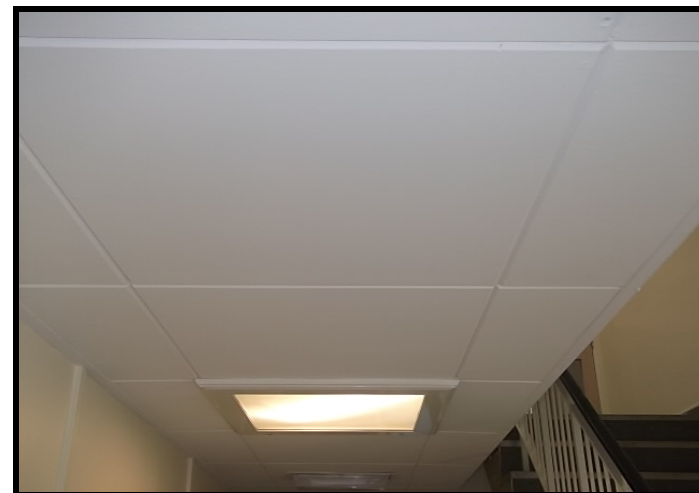
SAMPLE REFERENCE 016

Building	Floor	Room	Location	
Main	Ground-First Floor	Stairs and Landings	Ceiling	
Description				
MATERIAL ASSESSMENT				SCORE
Product Type	Board	Extent of Damage	Good condition	-
Asbestos Type	No Asbestos Detected	Surface Treatment	Sealed Board (Encapsulated)	
PRIORITY ASSESSMENT				SCORE
Occupant Activity	Not Applicable	Extent / Amount	40.00 m2	-
Accessibility	Occasionally disturb	Location	Not Applicable	
Avg Time in Use	Not Applicable	Frquency of Use	Not Applicable	
No. of Occupants	Not Applicable	Secondary Activity	Not Applicable	
Maintenance	Not Applicable	Maintenace Frequency	Not Applicable	
MANAGEMENT ACTION				SCORE
Recommendation	NO ACTION REQUIRED			-
Recommendation Due		Next Inspection	None	
Apply Labels	No	Permit to Work Required	No	
Survey Type	Management	Lead Surveyor	Richard Saunders	
Survey Date	23 Mar 2011	UKAS Laboratory	NOT SAMPLED (Cross Referenced)	
Site Reference	257810000A	Licensed Material	N/A

No Asbestos Presumed in Sample

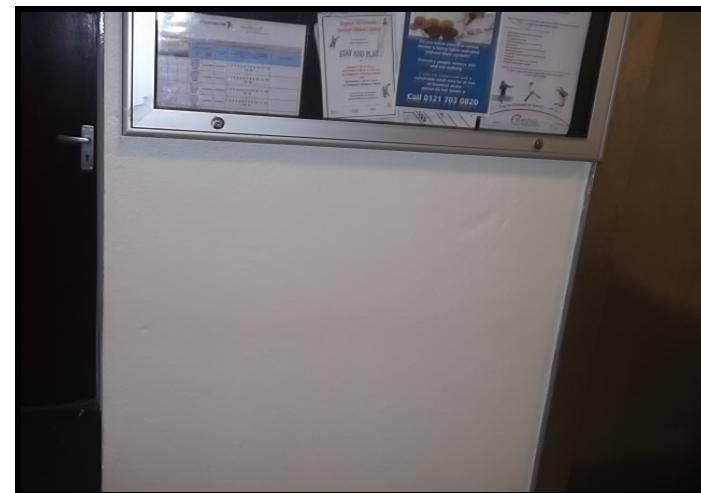
SAMPLE REFERENCE 017

Building	Floor	Room	Location	
Main	Ground-First Floor	Stairs and Landings	Wall	
Description				
MATERIAL ASSESSMENT				SCORE
Product Type	Textured Coating	Extent of Damage	Good condition	-
Asbestos Type	No Asbestos Detected	Surface Treatment	Textured Coating	
PRIORITY ASSESSMENT				SCORE
Occupant Activity	Not Applicable	Extent / Amount	40.00 m2	-
Accessibility	Easily disturbed	Location	Not Applicable	
Avg Time in Use	Not Applicable	Frquency of Use	Not Applicable	
No. of Occupants	Not Applicable	Secondary Activity	Not Applicable	
Maintenance	Not Applicable	Maintenace Frequency	Not Applicable	
MANAGEMENT ACTION				SCORE
Recommendation	NO ACTION REQUIRED			-
Recommendation Due		Next Inspection	None	
Apply Labels	No	Permit to Work Required	No	
Survey Type	Management	Lead Surveyor	Richard Saunders	
Survey Date	23 Mar 2011	UKAS Laboratory	NOT SAMPLED (Cross Referenced)	
Site Reference	257810000A	Licensed Material	N/A

No Asbestos Presumed in Sample

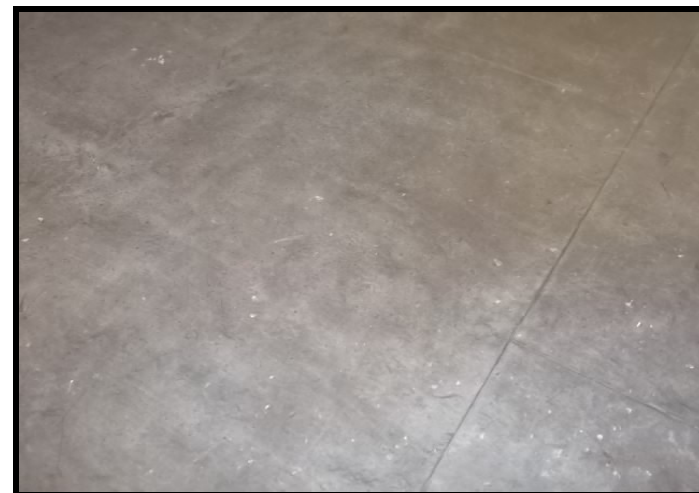
SAMPLE REFERENCE 018

Building	Floor	Room	Location	
Main	Ground-First Floor	Stairs and Landings	Floor	
Description				
MATERIAL ASSESSMENT				SCORE
Product Type	Linoleum	Extent of Damage	Good condition	-
Asbestos Type	No Asbestos Detected	Surface Treatment	Composite materials	
PRIORITY ASSESSMENT				SCORE
Occupant Activity	Not Applicable	Extent / Amount	40.00 m2	-
Accessibility	Occasionally disturb	Location	Not Applicable	
Avg Time in Use	Not Applicable	Frquency of Use	Not Applicable	
No. of Occupants	Not Applicable	Secondary Activity	Not Applicable	
Maintenance	Not Applicable	Maintenace Frequency	Not Applicable	
MANAGEMENT ACTION				SCORE
Recommendation	NO ACTION REQUIRED			-
Recommendation Due		Next Inspection	None	
Apply Labels	No	Permit to Work Required	No	
Survey Type	Management	Lead Surveyor	Richard Saunders	
Survey Date	23 Mar 2011	UKAS Laboratory	NOT SAMPLED (Cross Referenced)	
Site Reference	257810000A	Licensed Material	N/A

No Asbestos Presumed in Sample

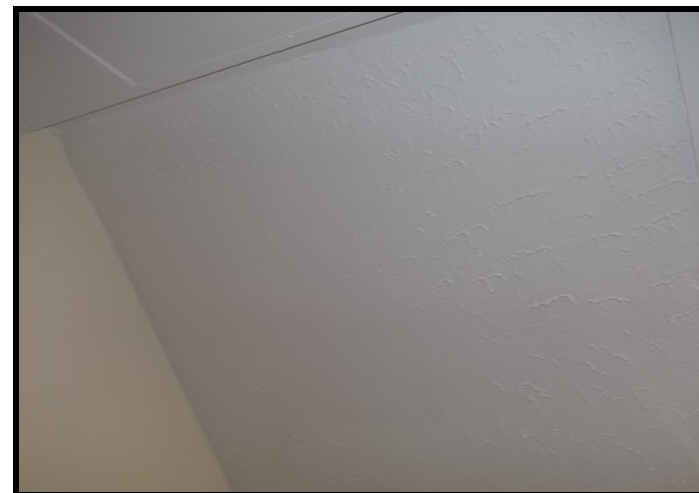
SAMPLE REFERENCE 019

Building	Floor	Room	Location	
Main	Ground-First Floor	Stairs and Landings	Staircase	
Description				
MATERIAL ASSESSMENT				SCORE
Product Type	Textured Coating	Extent of Damage	Good condition	-
Asbestos Type	No Asbestos Detected	Surface Treatment	Textured Coating	
PRIORITY ASSESSMENT				SCORE
Occupant Activity	Not Applicable	Extent / Amount	20.00 m2	-
Accessibility	Occasionally disturb	Location	Not Applicable	
Avg Time in Use	Not Applicable	Frquency of Use	Not Applicable	
No. of Occupants	Not Applicable	Secondary Activity	Not Applicable	
Maintenance	Not Applicable	Maintenace Frequency	Not Applicable	
MANAGEMENT ACTION				SCORE
Recommendation	NO ACTION REQUIRED			-
Recommendation Due		Next Inspection	None	
Apply Labels	No	Permit to Work Required	No	
Survey Type	Management	Lead Surveyor	Richard Saunders	
Survey Date	23 Mar 2011	UKAS Laboratory	DMW Environmental Safety Ltd / [P-75203]	
Site Reference	257810000A	Licensed Material	N/A

Asbestos not detected in Sample

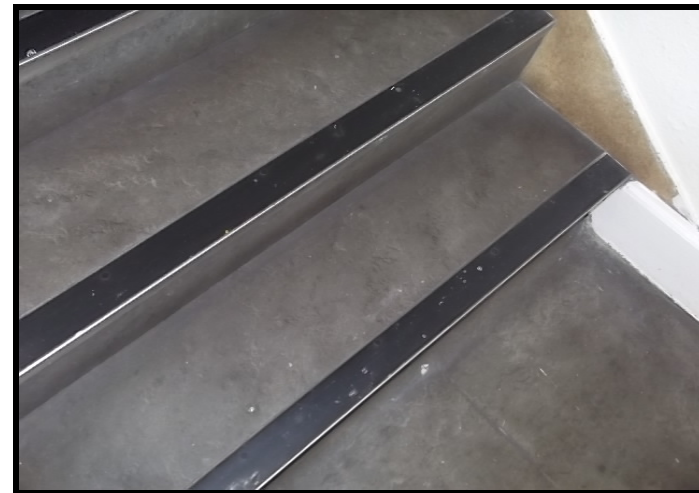
SAMPLE REFERENCE 020

Building	Floor	Room	Location	
Main	Ground-First Floor	Stairs and Landings	Floor	
Description				
MATERIAL ASSESSMENT				SCORE
Product Type	Stair Nosing	Extent of Damage	Good condition	-
Asbestos Type	No Asbestos Detected	Surface Treatment	Composite materials	
PRIORITY ASSESSMENT				SCORE
Occupant Activity	Not Applicable	Extent / Amount	30.00 m2	-
Accessibility	Occasionally disturb	Location	Not Applicable	
Avg Time in Use	Not Applicable	Frquency of Use	Not Applicable	
No. of Occupants	Not Applicable	Secondary Activity	Not Applicable	
Maintenance	Not Applicable	Maintenace Frequency	Not Applicable	
MANAGEMENT ACTION				SCORE
Recommendation	NO ACTION REQUIRED			-
Recommendation Due		Next Inspection	None	
Apply Labels	No	Permit to Work Required	No	
Survey Type	Management	Lead Surveyor	Richard Saunders	
Survey Date	23 Mar 2011	UKAS Laboratory	DMW Environmental Safety Ltd / [P-75203]	
Site Reference	257810000A	Licensed Material	N/A

Asbestos not detected in Sample

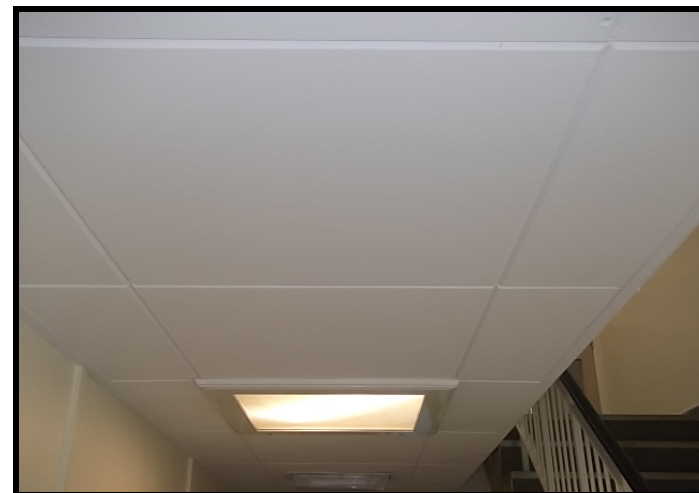
SAMPLE REFERENCE 022

Building	Floor	Room	Location
Main	First Floor	Lift/Flat Landing	Ceiling
Description			
MATERIAL ASSESSMENT			
Product Type	Board	Extent of Damage	Good condition
Asbestos Type	No Asbestos Detected	Surface Treatment	Sealed Board (Encapsulated)
PRIORITY ASSESSMENT			
Occupant Activity	Not Applicable	Extent / Amount	20.00 m2
Accessibility	Occasionally disturb	Location	Not Applicable
Avg Time in Use	Not Applicable	Frequency of Use	Not Applicable
No. of Occupants	Not Applicable	Secondary Activity	Not Applicable
Maintenance	Not Applicable	Maintenance Frequency	Not Applicable
MANAGEMENT ACTION			
Recommendation	NO ACTION REQUIRED		
Recommendation Due		Next Inspection	None
Apply Labels	No	Permit to Work Required	No
Survey Type	Management	Lead Surveyor	Richard Saunders
Survey Date	23 Mar 2011	UKAS Laboratory	NOT SAMPLED (Cross Referenced)
Site Reference	257810000A	Licensed Material	N/A

No Asbestos Presumed in Sample

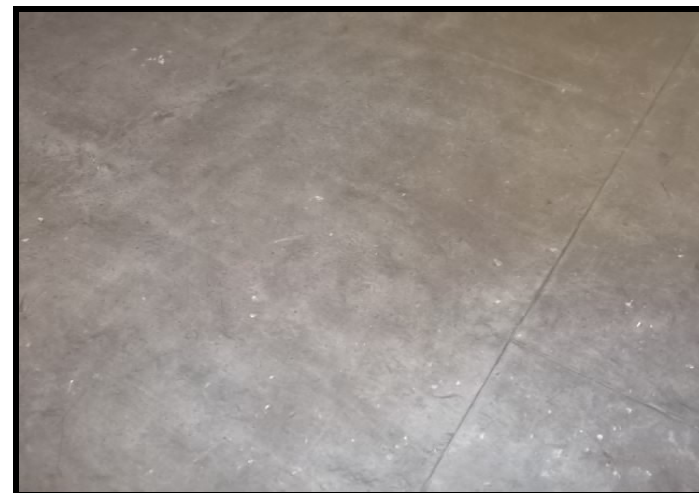
SAMPLE REFERENCE 024

Building	Floor	Room	Location
Main	First Floor	Lift/Flat Landing	Floor
Description			
MATERIAL ASSESSMENT			
Product Type	Linoleum	Extent of Damage	Good condition
Asbestos Type	No Asbestos Detected	Surface Treatment	Composite materials
PRIORITY ASSESSMENT			
Occupant Activity	Not Applicable	Extent / Amount	20.00 m2
Accessibility	Occasionally disturb	Location	Not Applicable
Avg Time in Use	Not Applicable	Frequency of Use	Not Applicable
No. of Occupants	Not Applicable	Secondary Activity	Not Applicable
Maintenance	Not Applicable	Maintenance Frequency	Not Applicable
MANAGEMENT ACTION			
Recommendation	NO ACTION REQUIRED		
Recommendation Due		Next Inspection	None
Apply Labels	No	Permit to Work Required	No
Survey Type	Management	Lead Surveyor	Richard Saunders
Survey Date	23 Mar 2011	UKAS Laboratory	NOT SAMPLED (Cross Referenced)
Site Reference	257810000A	Licensed Material	N/A

No Asbestos Presumed in Sample

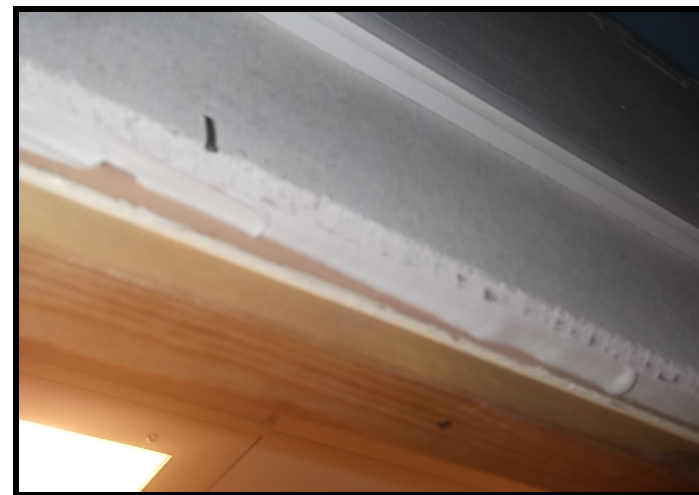
SAMPLE REFERENCE 025

Building	Floor	Room	Location	
Main	First Floor	Electric Cupboard	Transom Panel	
Description				
MATERIAL ASSESSMENT				SCORE
Product Type	Board	Extent of Damage	Good condition	-
Asbestos Type	No Asbestos Detected	Surface Treatment	Sealed Board (Encapsulated)	
PRIORITY ASSESSMENT				SCORE
Occupant Activity	Not Applicable	Extent / Amount	1.00 m2	-
Accessibility	Occasionally disturb	Location	Not Applicable	
Avg Time in Use	Not Applicable	Frquency of Use	Not Applicable	
No. of Occupants	Not Applicable	Secondary Activity	Not Applicable	
Maintenance	Not Applicable	Maintenace Frequency	Not Applicable	
MANAGEMENT ACTION				SCORE
Recommendation	NO ACTION REQUIRED			-
Recommendation Due		Next Inspection	None	
Apply Labels	No	Permit to Work Required	No	
Survey Type	Management	Lead Surveyor	Richard Saunders	
Survey Date	23 Mar 2011	UKAS Laboratory	NOT SAMPLED (Cross Referenced)	
Site Reference	257810000A	Licensed Material	N/A

No Asbestos Presumed in Sample

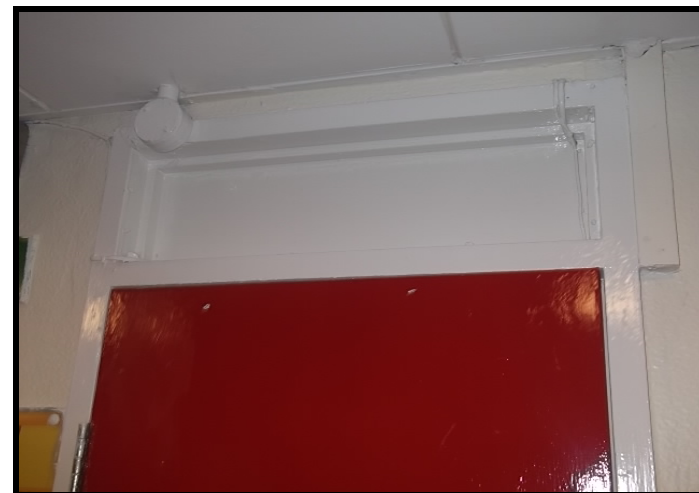
SAMPLE REFERENCE 026

Building	Floor	Room	Location	
Main	First Floor	Dry Riser	Transom Panel	
Description				
MATERIAL ASSESSMENT				SCORE
Product Type	Board	Extent of Damage	Good condition	-
Asbestos Type	No Asbestos Detected	Surface Treatment	Sealed Board (Encapsulated)	
PRIORITY ASSESSMENT				SCORE
Occupant Activity	Not Applicable	Extent / Amount	1.00 m2	-
Accessibility	Occasionally disturb	Location	Not Applicable	
Avg Time in Use	Not Applicable	Frquency of Use	Not Applicable	
No. of Occupants	Not Applicable	Secondary Activity	Not Applicable	
Maintenance	Not Applicable	Maintenace Frequency	Not Applicable	
MANAGEMENT ACTION				SCORE
Recommendation	NO ACTION REQUIRED			-
Recommendation Due		Next Inspection	None	
Apply Labels	No	Permit to Work Required	No	
Survey Type	Management	Lead Surveyor	Richard Saunders	
Survey Date	23 Mar 2011	UKAS Laboratory	NOT SAMPLED (Cross Referenced)	
Site Reference	257810000A	Licensed Material	N/A

No Asbestos Presumed in Sample
