Solihull Community Housing

Asbestos Management Survey Report

**Downing House
Willow Way
Chelmsley Wood
B37 7PN**

Date of Report: 26 Jan 2015

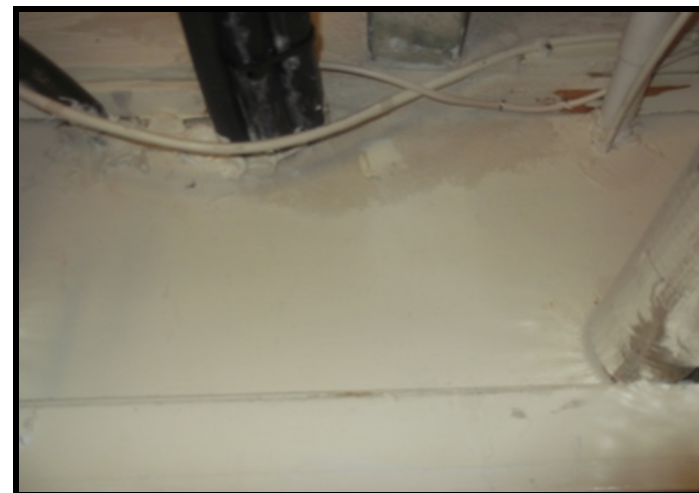
SAMPLE REFERENCE 001

Asbestos not detected in Sample

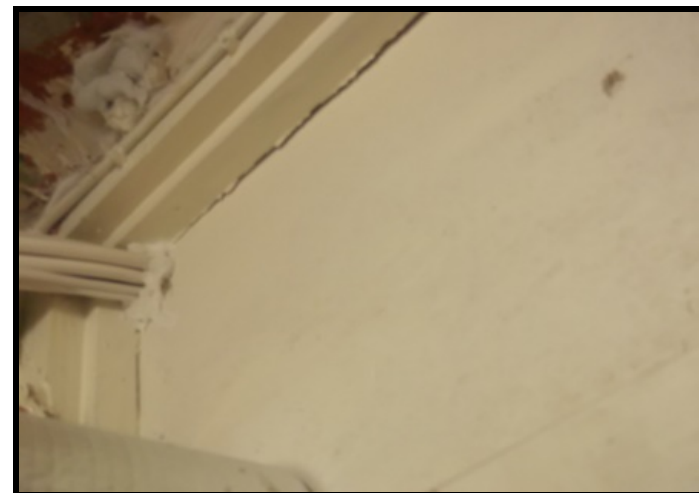
SAMPLE REFERENCE 002

Asbestos not detected in Sample

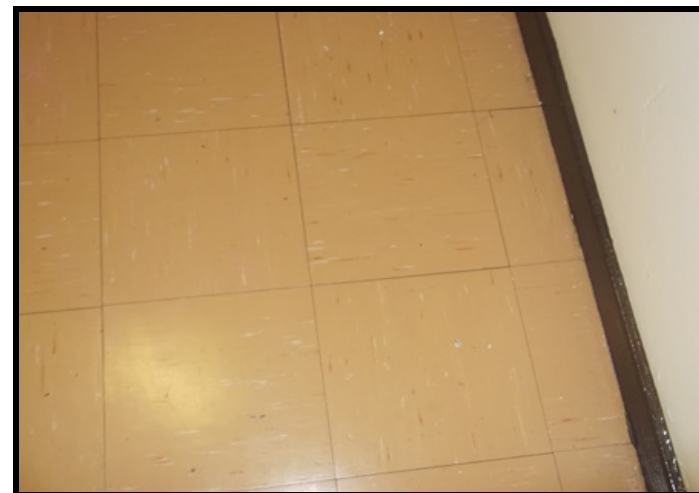
SAMPLE REFERENCE 003

Asbestos not detected in Sample

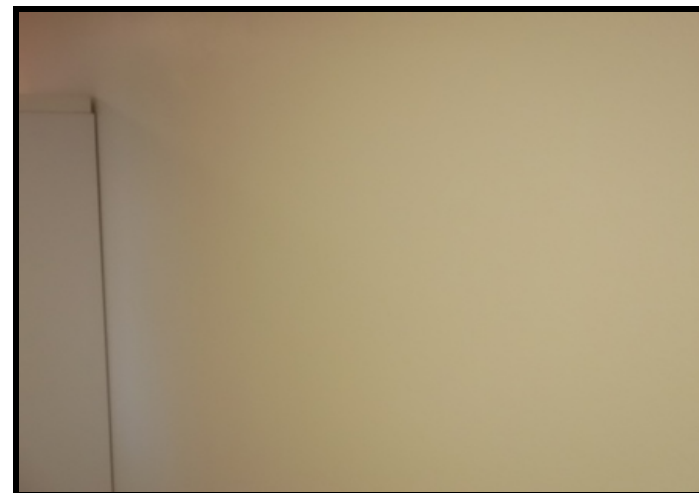
SAMPLE REFERENCE 004

Asbestos not detected in Sample

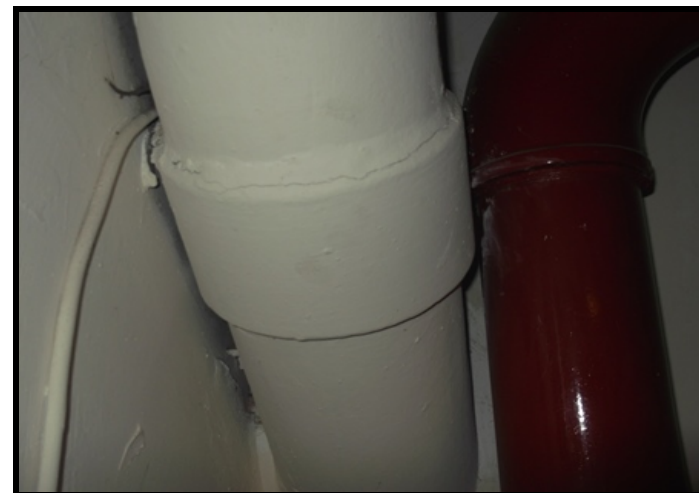
SAMPLE REFERENCE 005

Asbestos Presumed

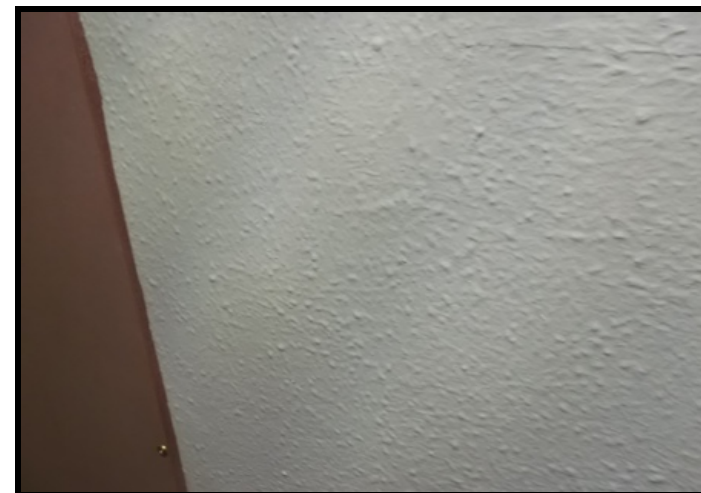
SAMPLE REFERENCE 006

No Asbestos Presumed in Sample

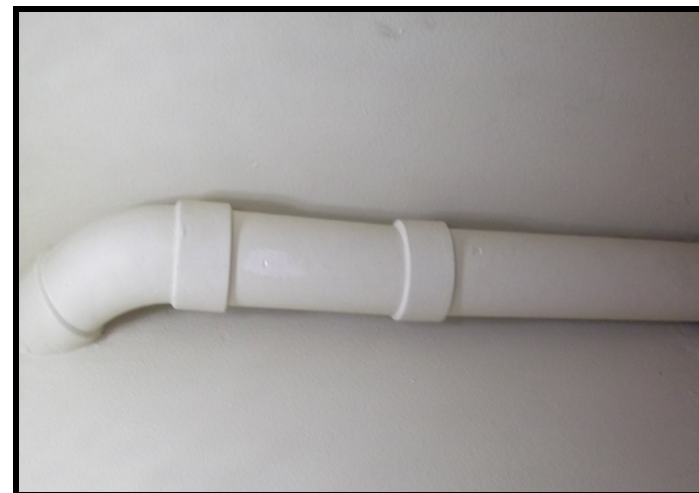
SAMPLE REFERENCE 007

Asbestos detected in Sample

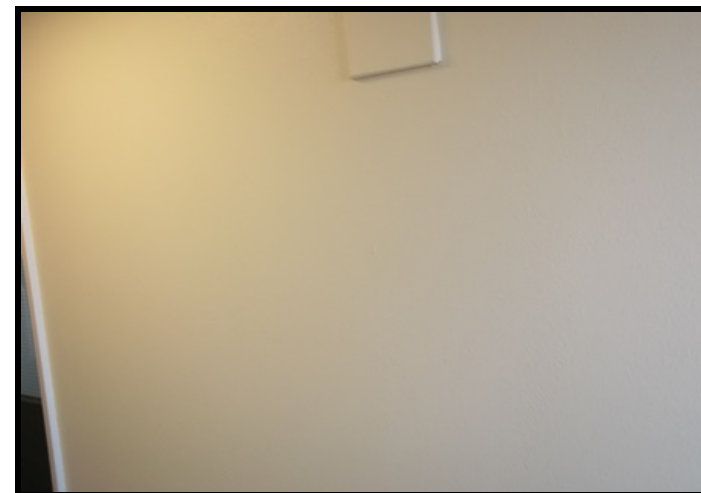
SAMPLE REFERENCE 008

No Asbestos Presumed in Sample

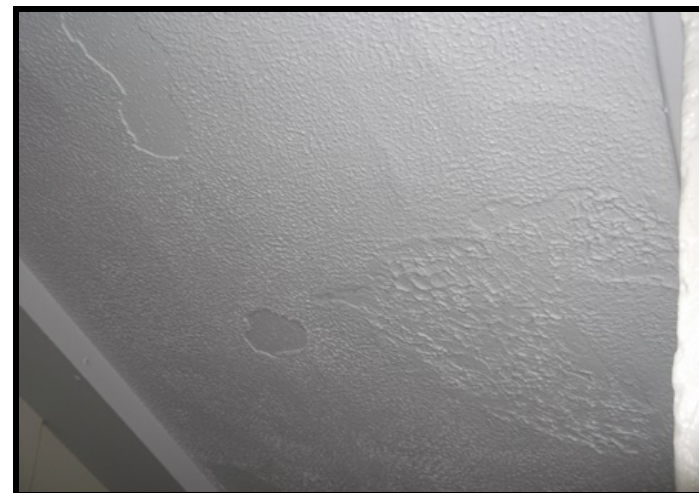
SAMPLE REFERENCE 009

Asbestos not detected in Sample

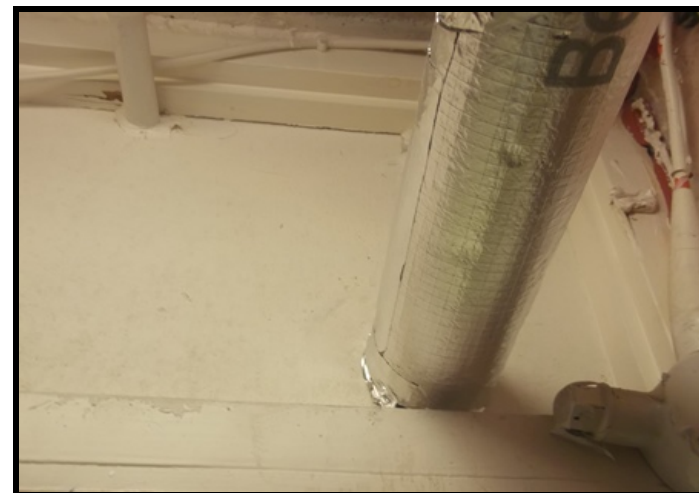
SAMPLE REFERENCE 010

No Asbestos Presumed in Sample

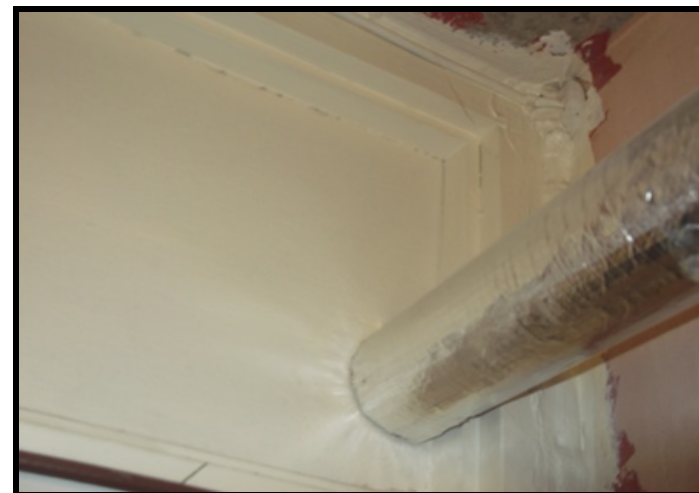
SAMPLE REFERENCE 011

No Asbestos Presumed in Sample

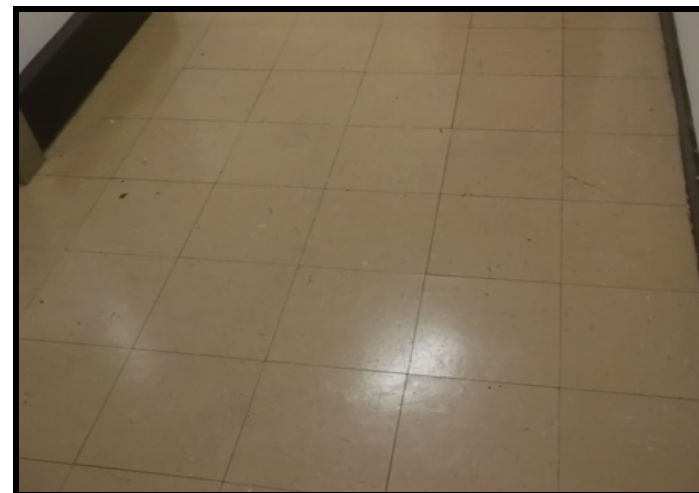
SAMPLE REFERENCE 012

No Asbestos Presumed in Sample

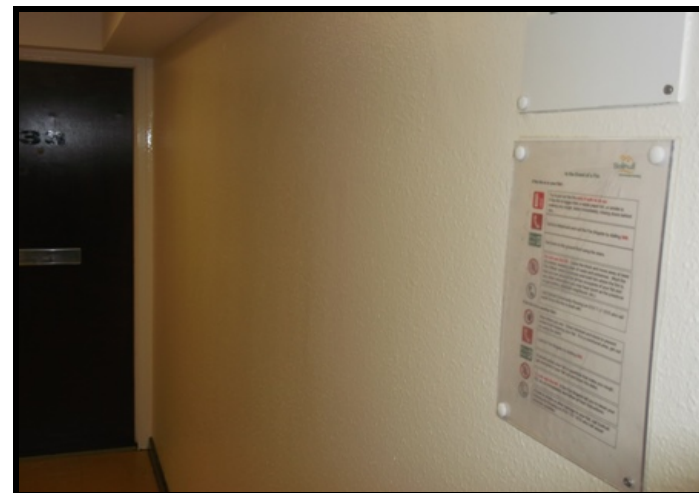
SAMPLE REFERENCE 013

No Asbestos Presumed in Sample

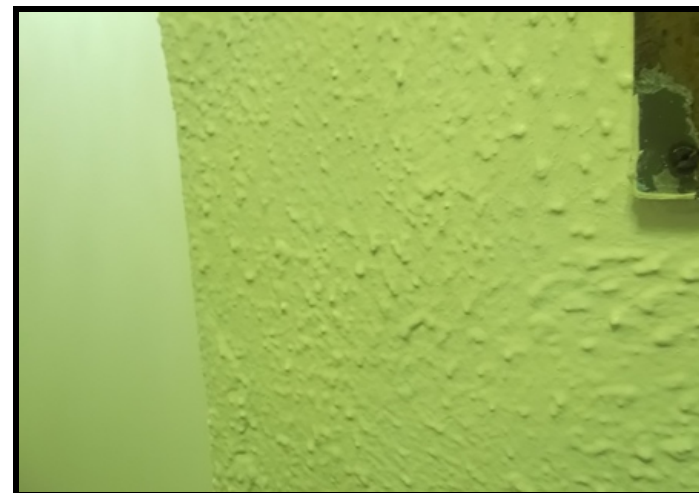
SAMPLE REFERENCE 015

No Asbestos Presumed in Sample

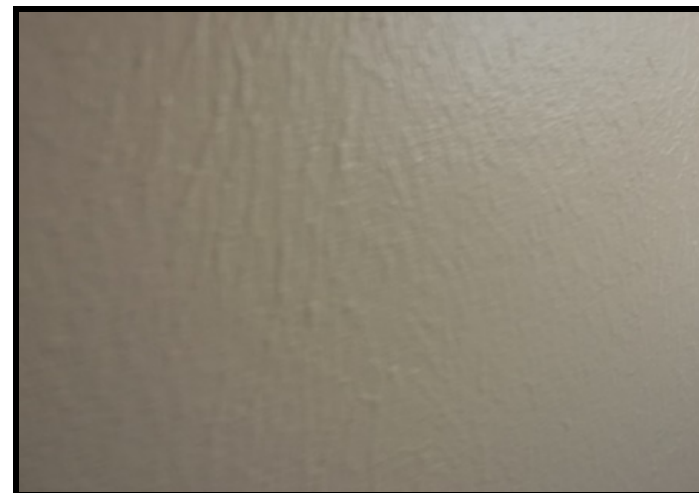
SAMPLE REFERENCE 016

No Asbestos Presumed in Sample

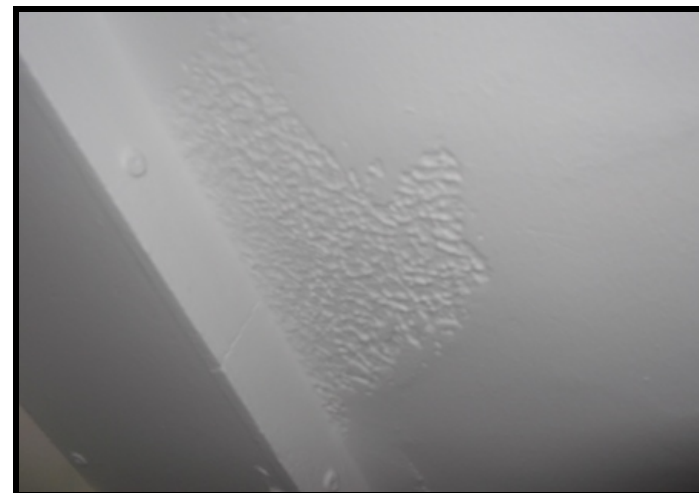
SAMPLE REFERENCE 017

No Asbestos Presumed in Sample

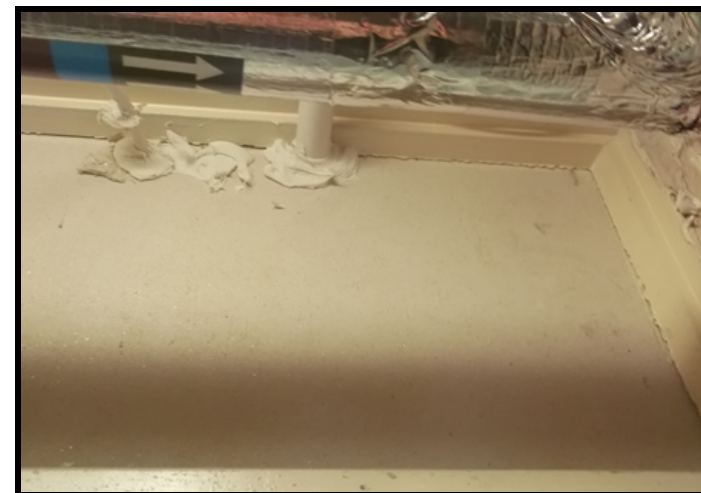
SAMPLE REFERENCE 020

No Asbestos Presumed in Sample

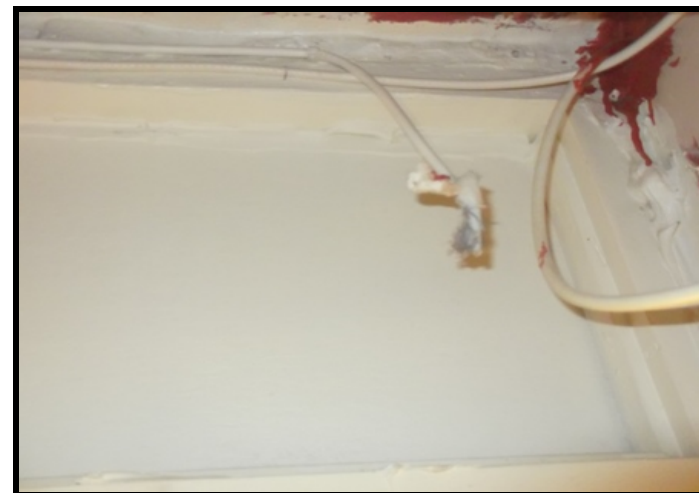
SAMPLE REFERENCE 021

No Asbestos Presumed in Sample

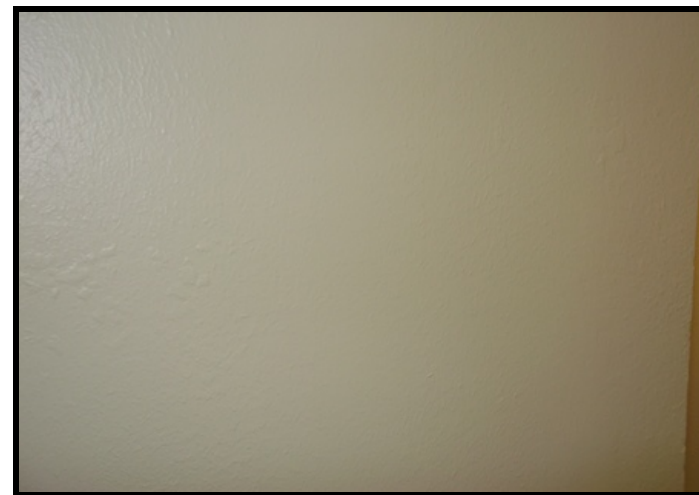
SAMPLE REFERENCE 022

No Asbestos Presumed in Sample

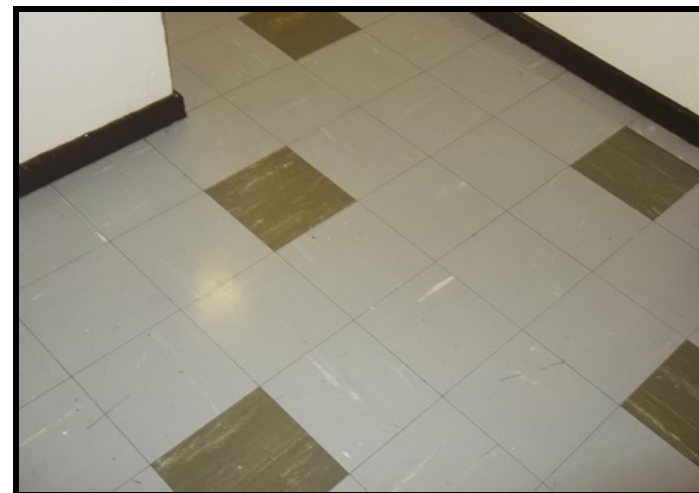
SAMPLE REFERENCE 023

Asbestos detected in Sample

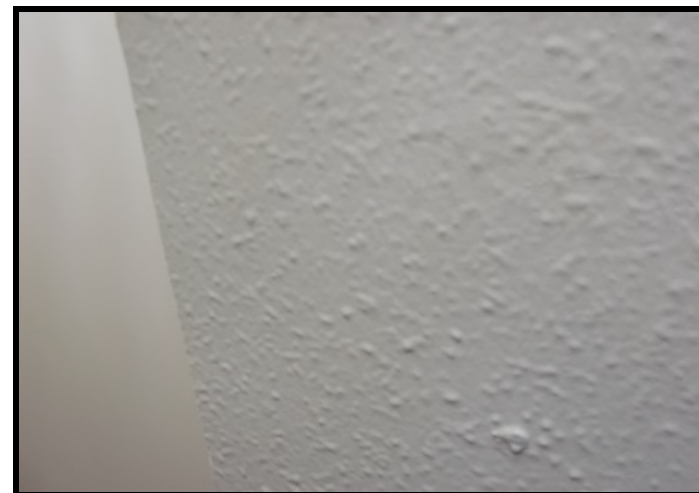
SAMPLE REFERENCE 024

No Asbestos Presumed in Sample

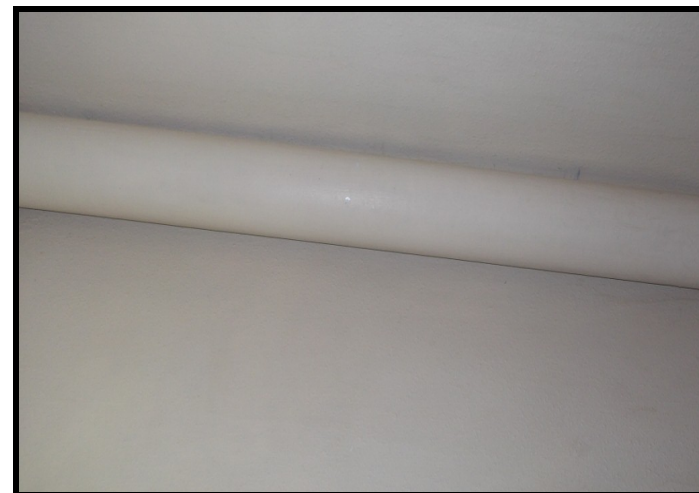
SAMPLE REFERENCE 025

Asbestos Presumed

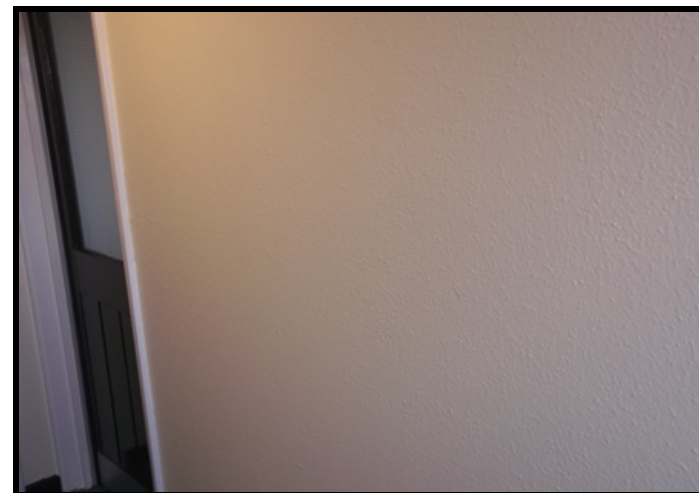
SAMPLE REFERENCE 026

No Asbestos Presumed in Sample

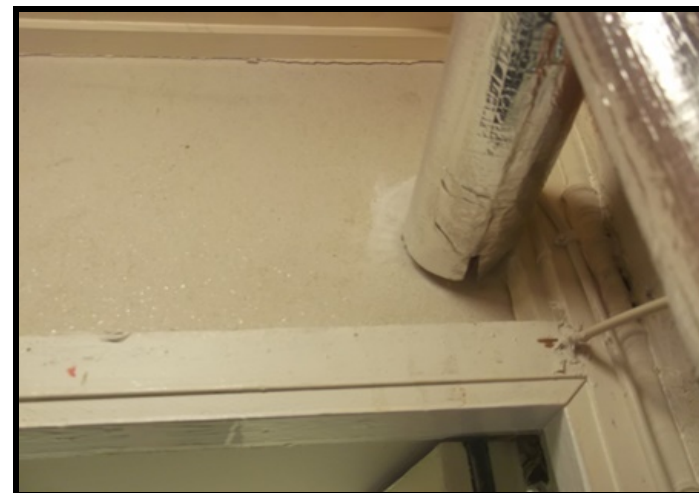
SAMPLE REFERENCE 030

No Asbestos Presumed in Sample

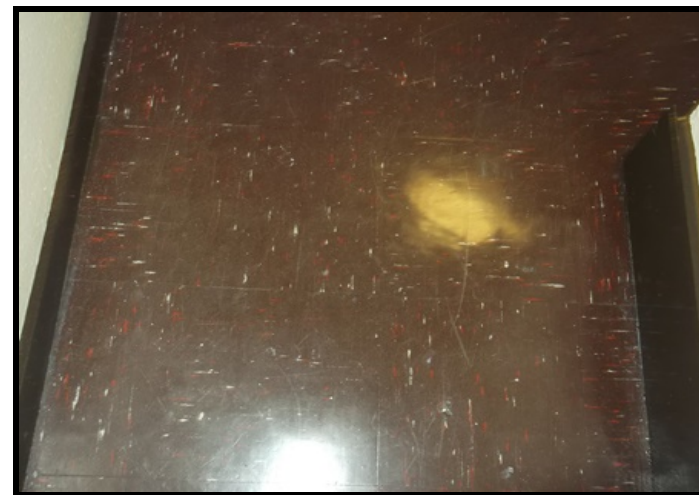
SAMPLE REFERENCE 03 I

Asbestos not detected in Sample

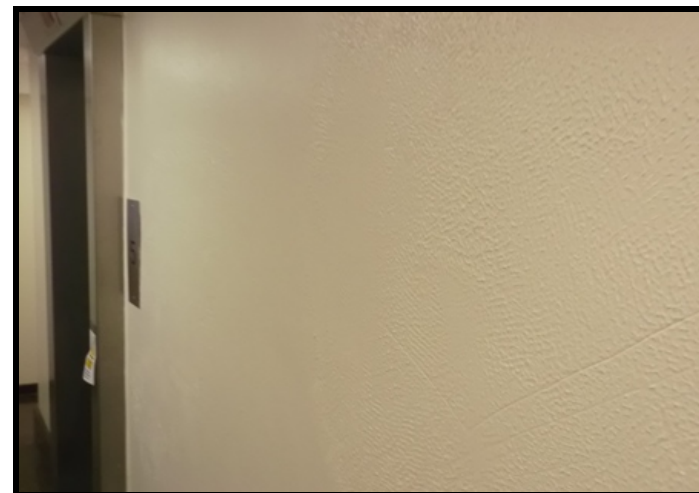
SAMPLE REFERENCE 032

No Asbestos Presumed in Sample

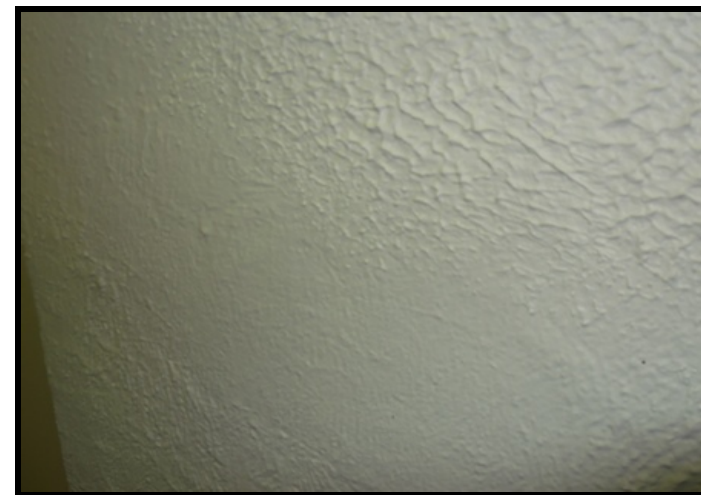
SAMPLE REFERENCE 034

No Asbestos Presumed in Sample

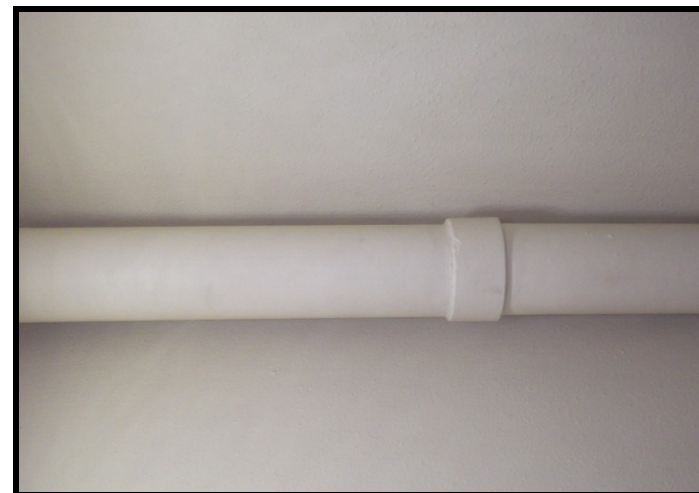
SAMPLE REFERENCE 035

Asbestos Presumed

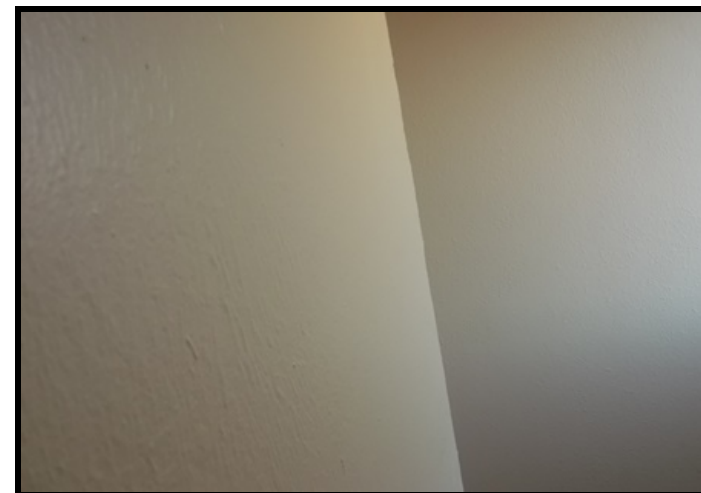
SAMPLE REFERENCE 036

No Asbestos Presumed in Sample

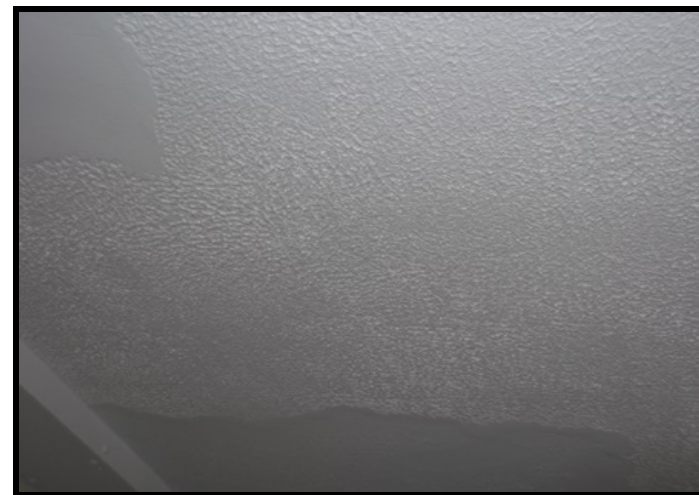
SAMPLE REFERENCE 037

No Asbestos Presumed in Sample

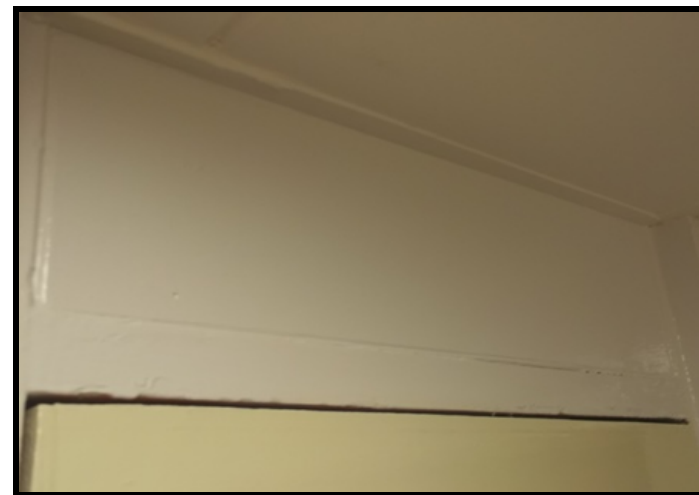
SAMPLE REFERENCE 039

No Asbestos Presumed in Sample

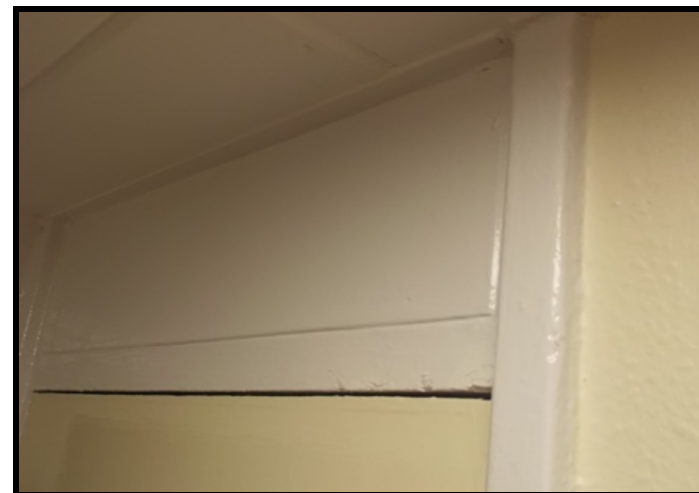
SAMPLE REFERENCE 040

No Asbestos Presumed in Sample

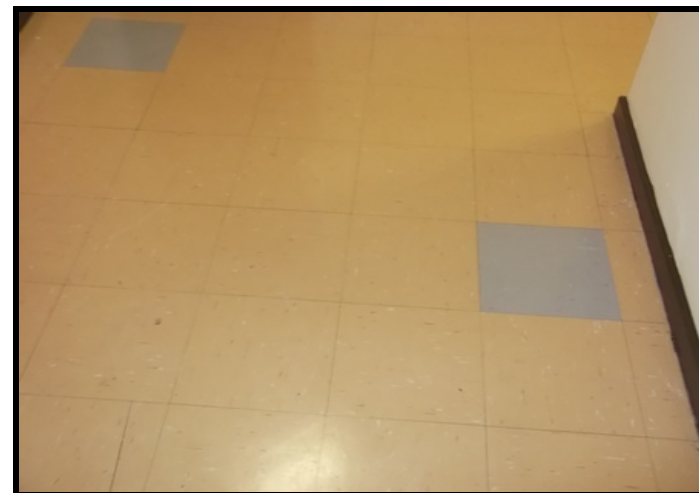
SAMPLE REFERENCE 041

Asbestos not detected in Sample

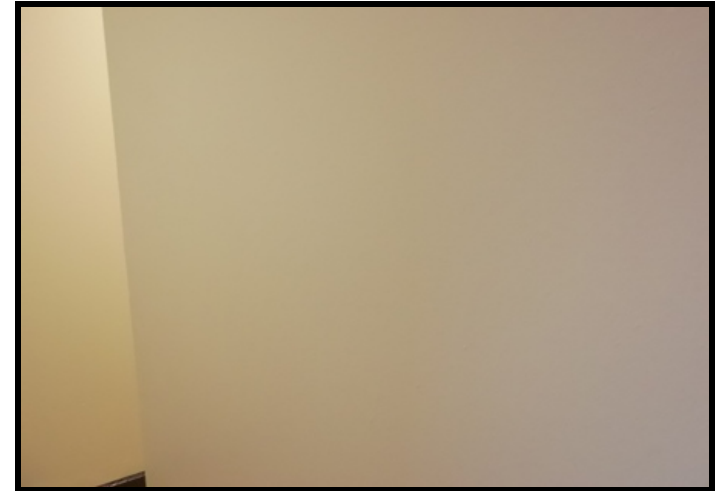
SAMPLE REFERENCE 042

Asbestos not detected in Sample

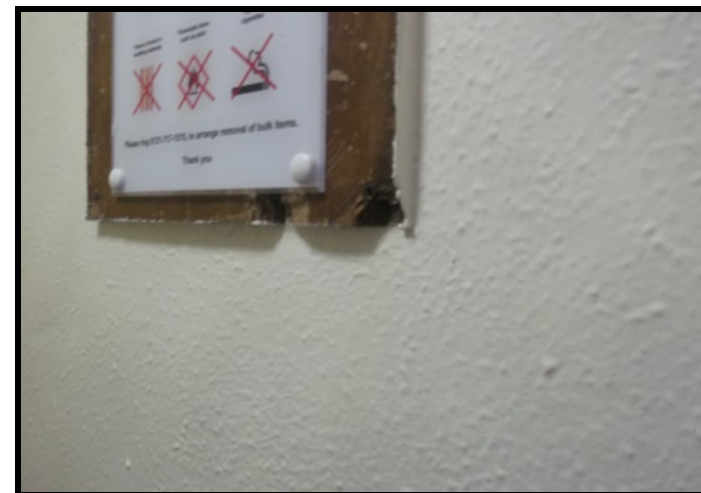
SAMPLE REFERENCE 044

No Asbestos Presumed in Sample

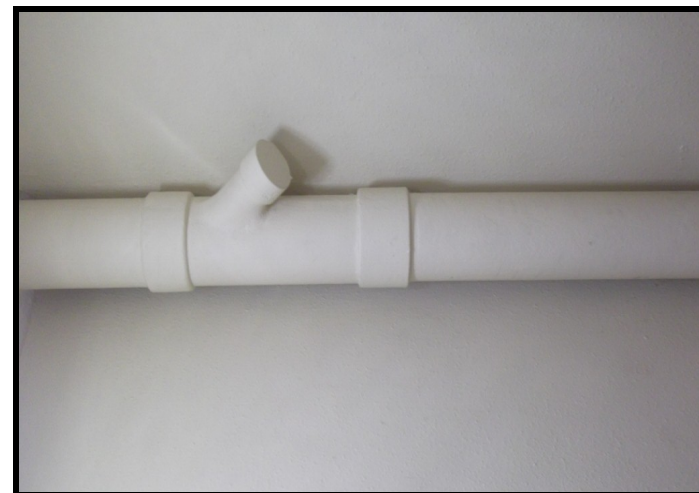
SAMPLE REFERENCE 045

Asbestos Presumed

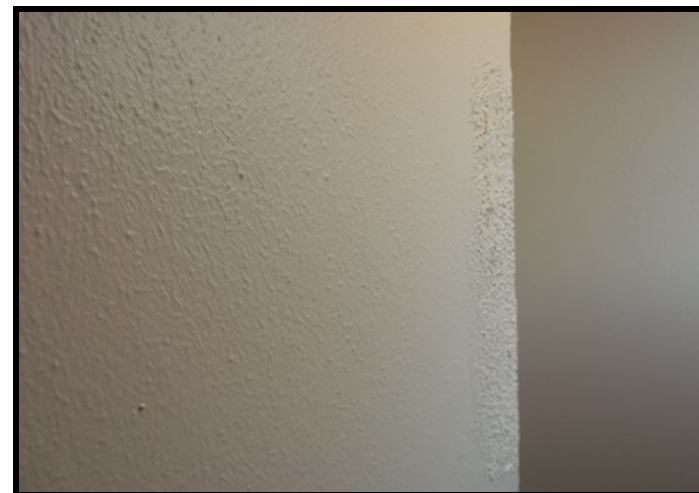
SAMPLE REFERENCE 046

No Asbestos Presumed in Sample

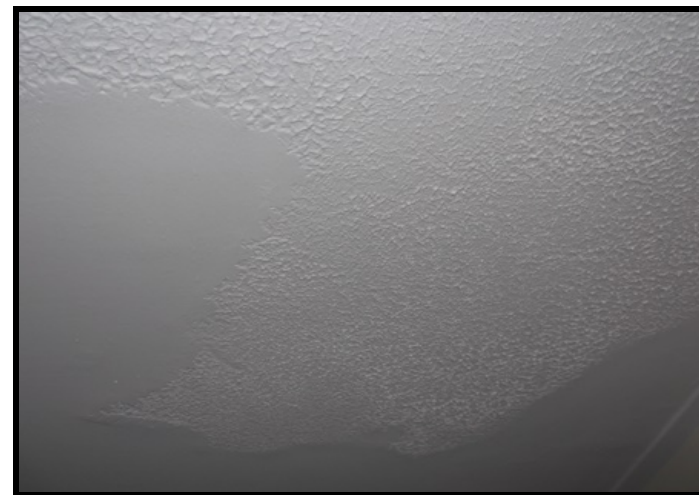
SAMPLE REFERENCE 047

No Asbestos Presumed in Sample

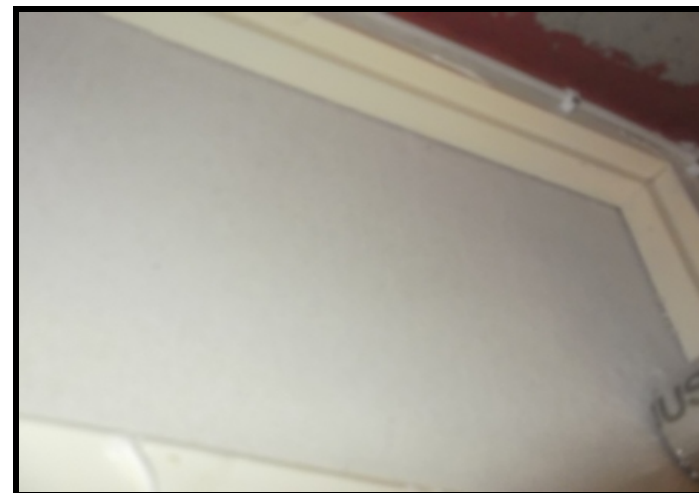
SAMPLE REFERENCE 049

No Asbestos Presumed in Sample

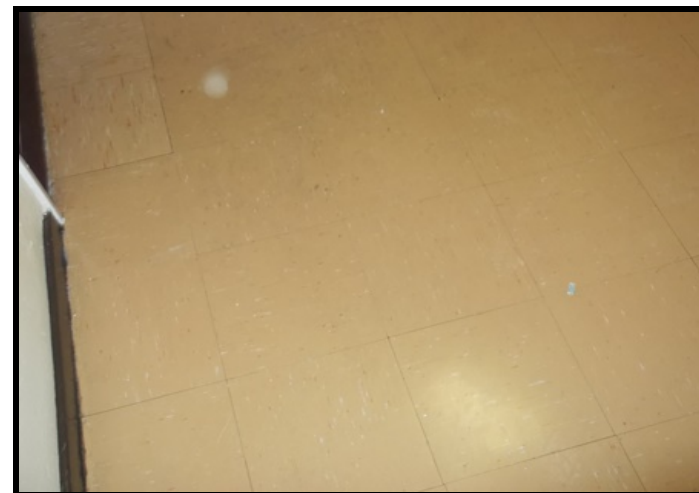
SAMPLE REFERENCE 050

No Asbestos Presumed in Sample

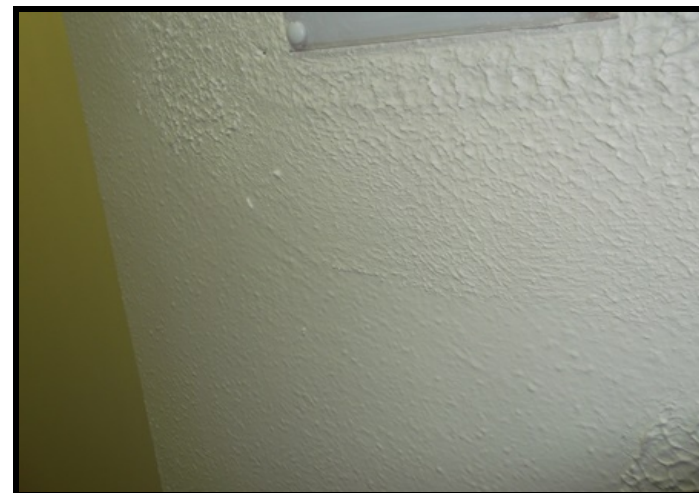
SAMPLE REFERENCE 053

No Asbestos Presumed in Sample

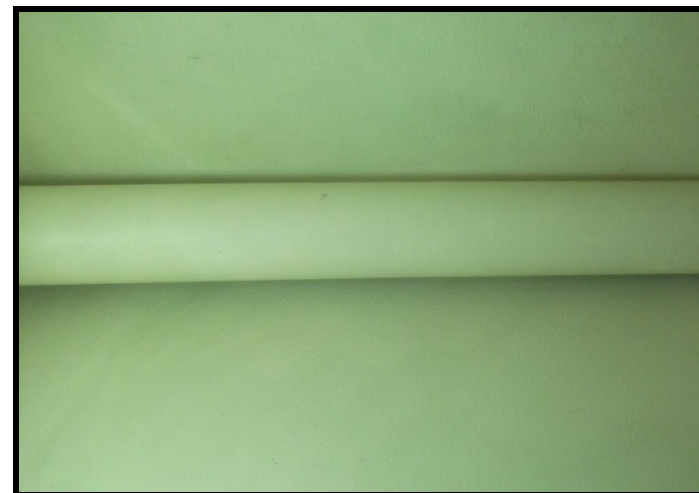
SAMPLE REFERENCE 054

Asbestos Presumed

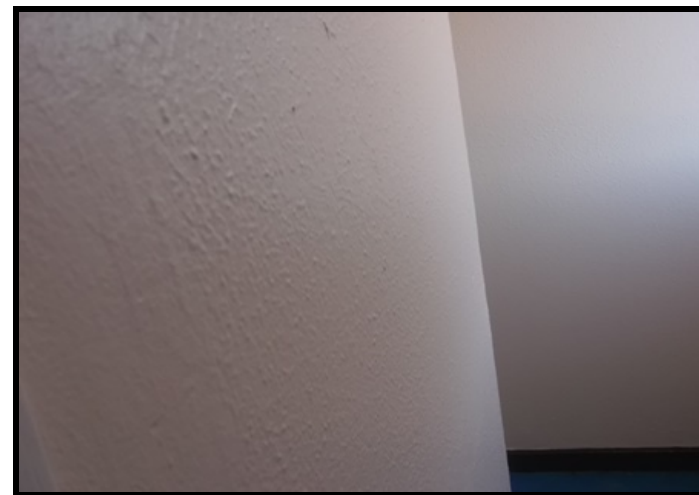
SAMPLE REFERENCE 055

No Asbestos Presumed in Sample

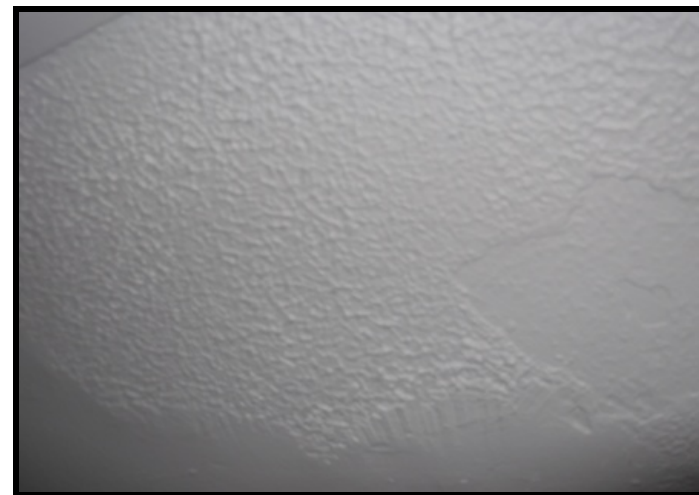
SAMPLE REFERENCE 056

No Asbestos Presumed in Sample

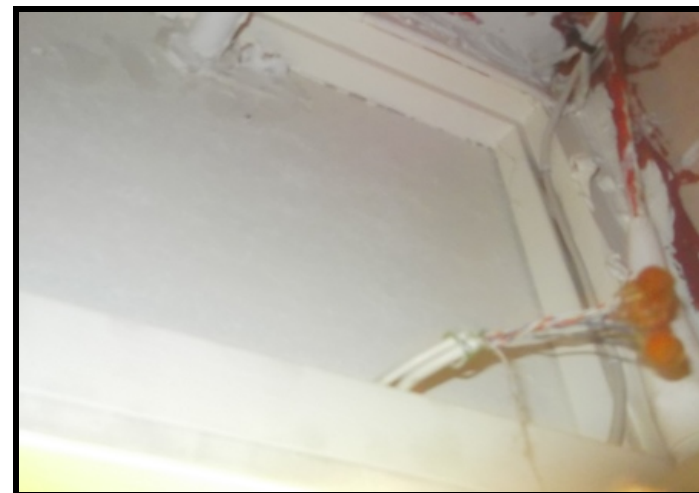
SAMPLE REFERENCE 057

No Asbestos Presumed in Sample

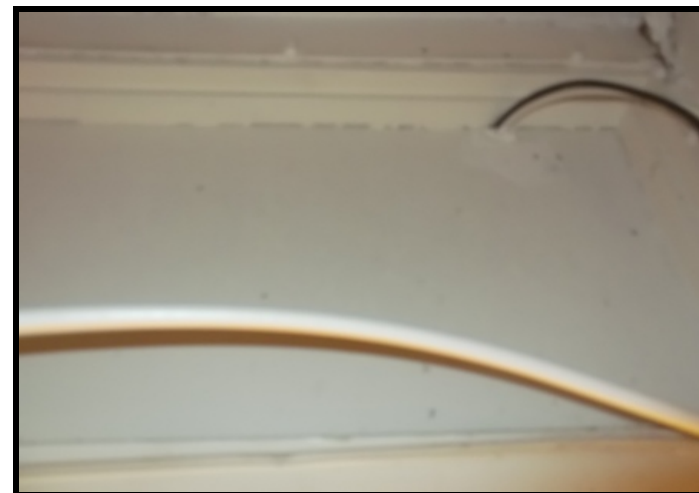
SAMPLE REFERENCE 058

No Asbestos Presumed in Sample

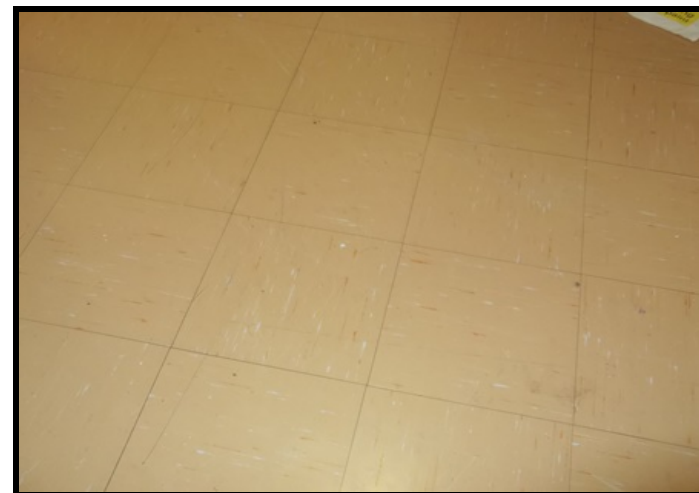
SAMPLE REFERENCE 059

No Asbestos Presumed in Sample

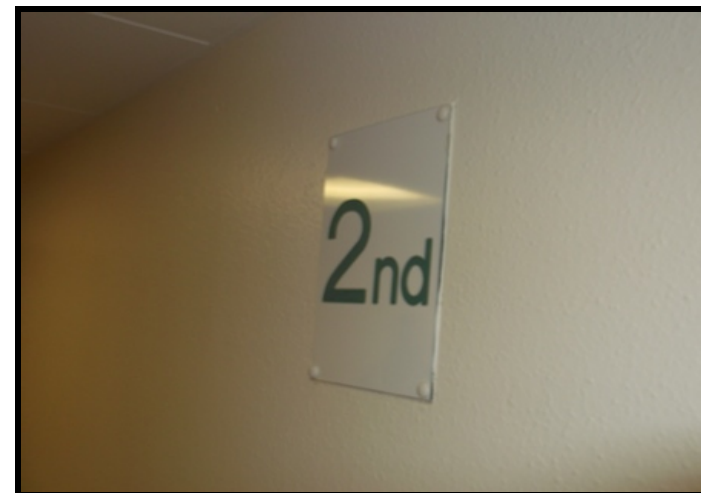
SAMPLE REFERENCE 060

No Asbestos Presumed in Sample

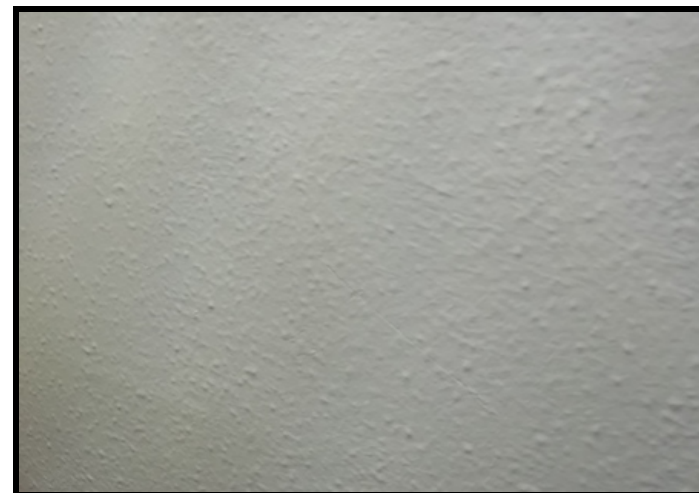
SAMPLE REFERENCE 062

No Asbestos Presumed in Sample

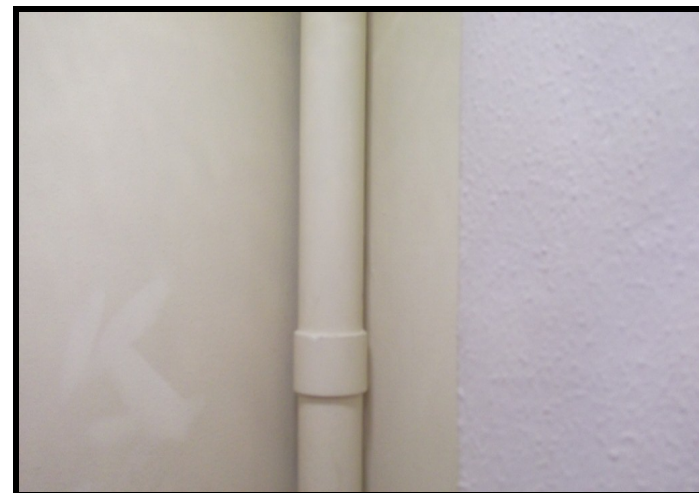
SAMPLE REFERENCE 063

Asbestos Presumed

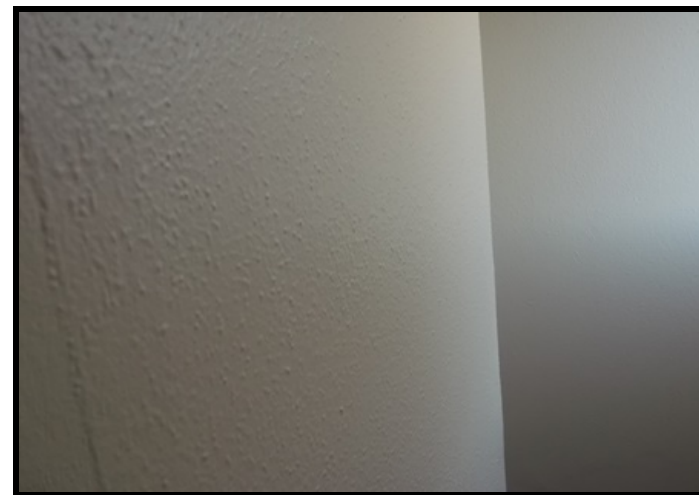
SAMPLE REFERENCE 064

No Asbestos Presumed in Sample

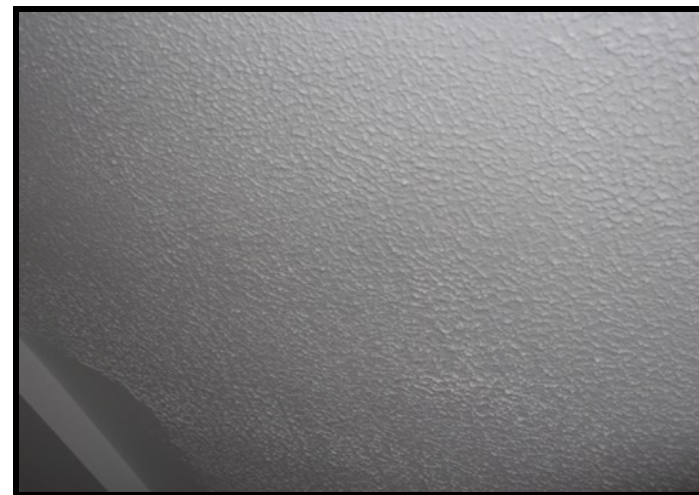
SAMPLE REFERENCE 065

No Asbestos Presumed in Sample

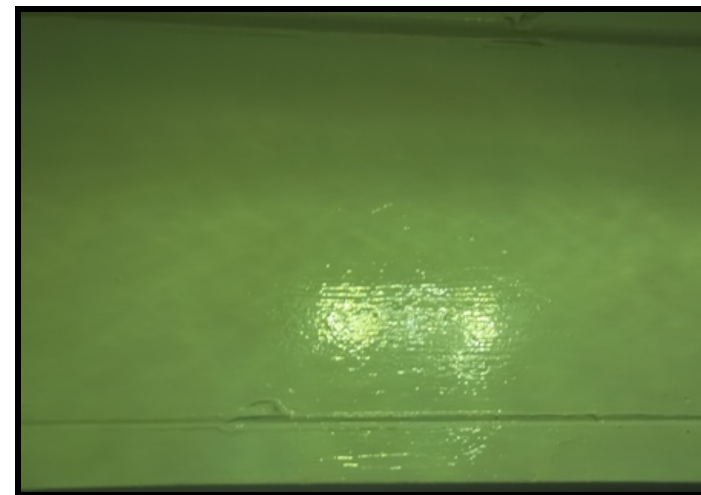
SAMPLE REFERENCE 066

No Asbestos Presumed in Sample

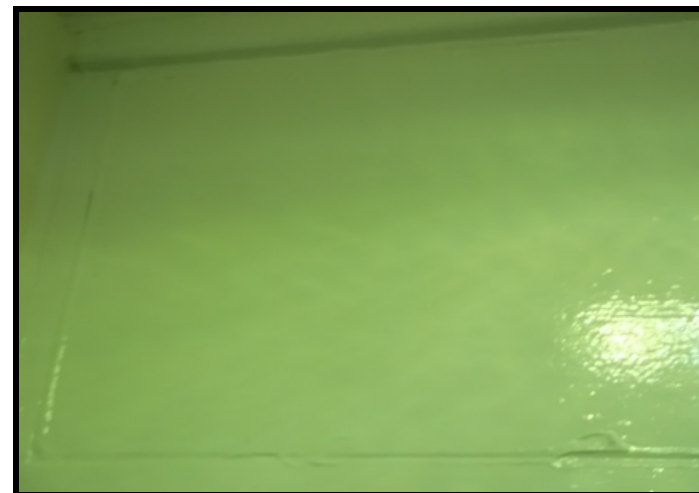
SAMPLE REFERENCE 067

No Asbestos Presumed in Sample

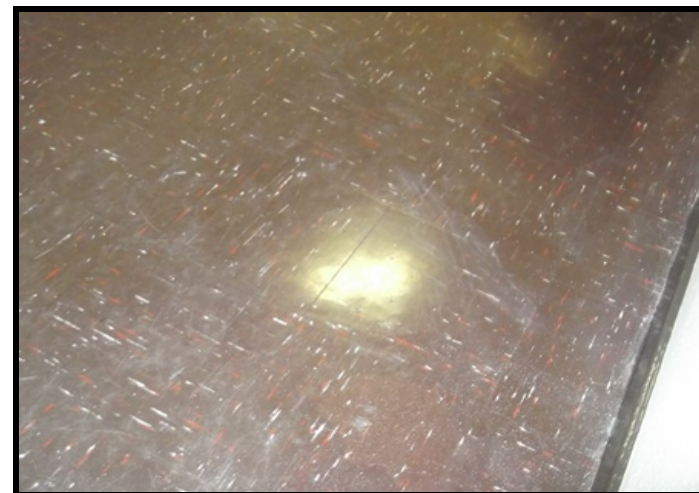
SAMPLE REFERENCE 068

No Asbestos Presumed in Sample

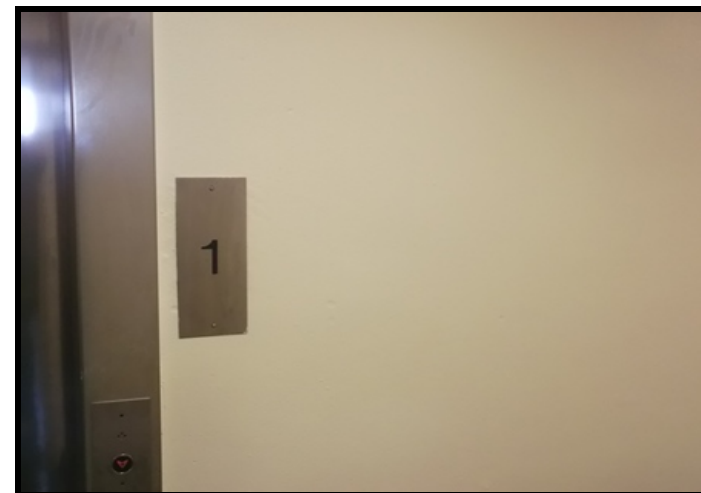
SAMPLE REFERENCE 069

No Asbestos Presumed in Sample

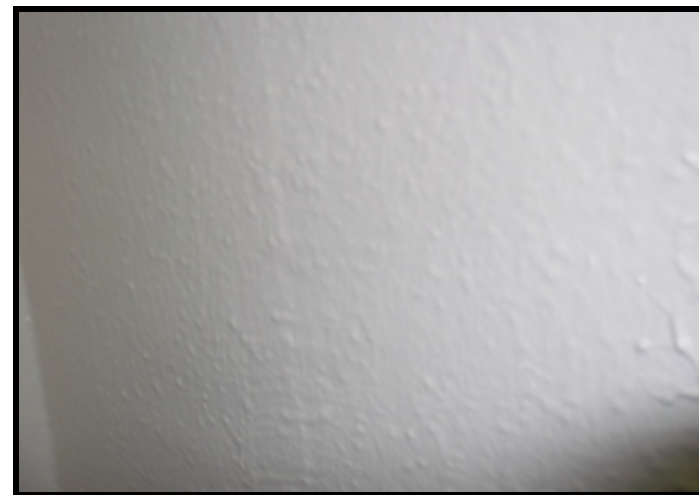
SAMPLE REFERENCE 071

No Asbestos Presumed in Sample

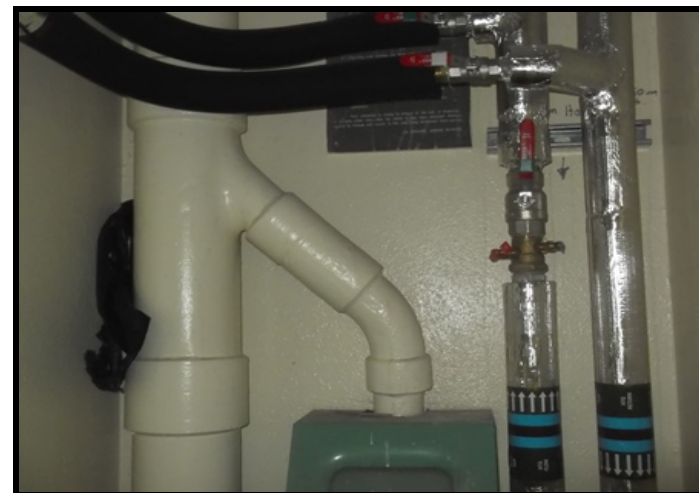
SAMPLE REFERENCE 072

Asbestos Presumed

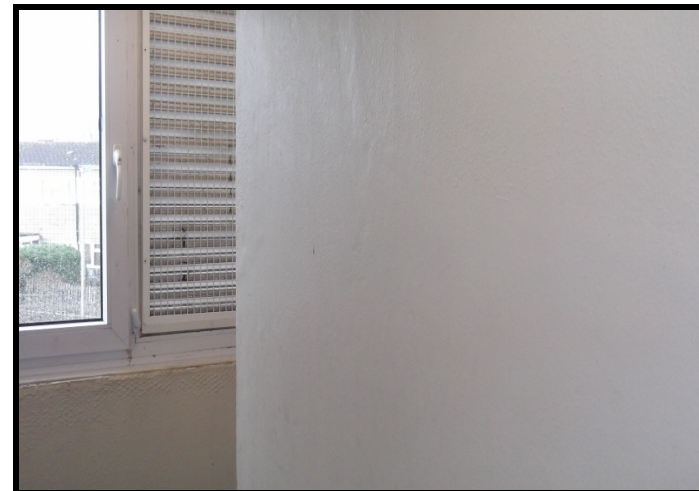
SAMPLE REFERENCE 073

No Asbestos Presumed in Sample

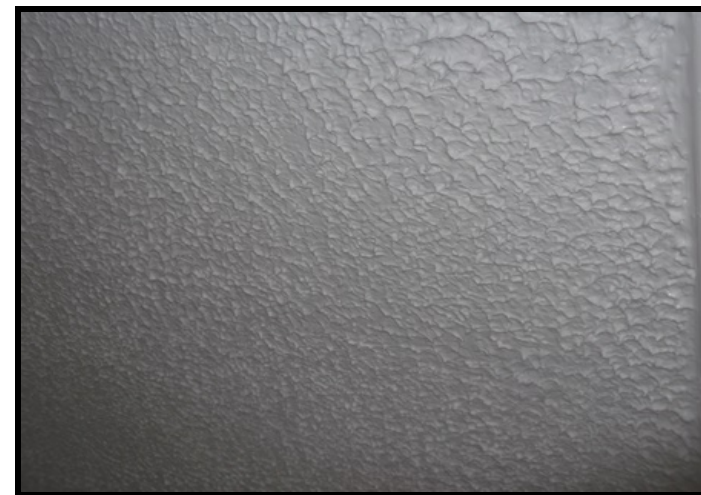
SAMPLE REFERENCE 074

No Asbestos Presumed in Sample

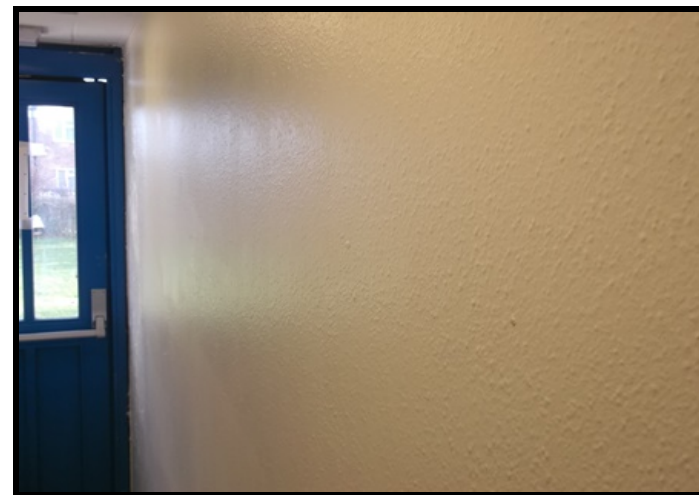
SAMPLE REFERENCE 079

Asbestos not detected in Sample

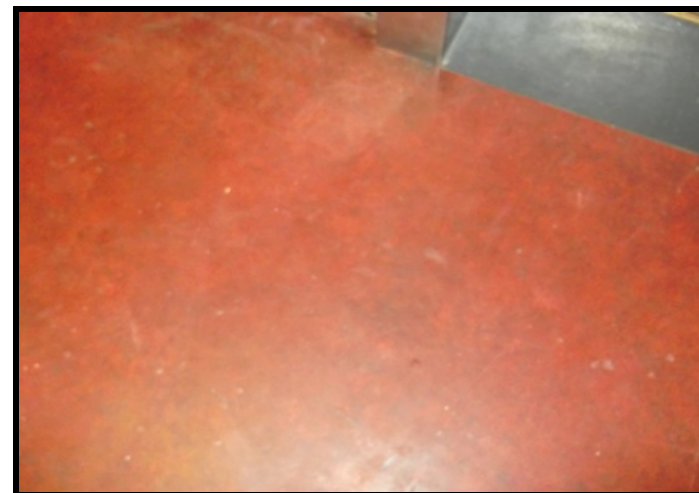
SAMPLE REFERENCE 081

Asbestos not detected in Sample

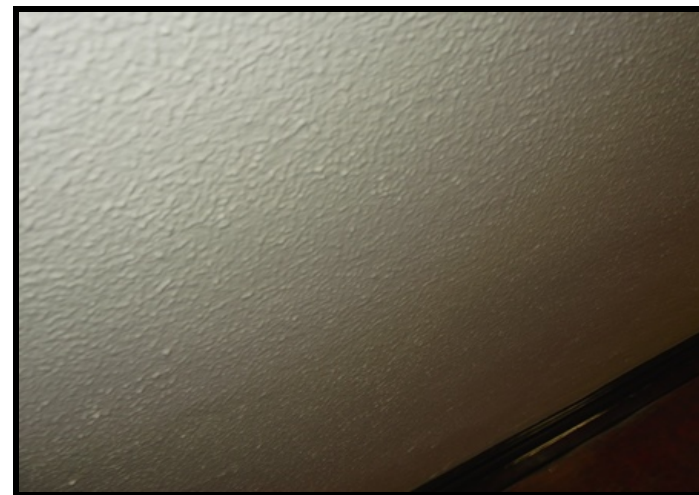
SAMPLE REFERENCE 086

No Asbestos Presumed in Sample

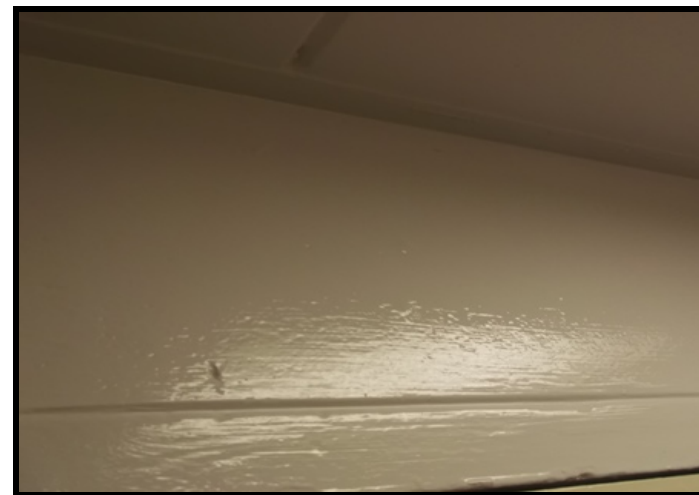
SAMPLE REFERENCE 088

No Asbestos Presumed in Sample
