Solihull Community Housing

Asbestos Management Survey Report

**Downing House
Willow Way
Chelmsley Wood
B37 7PN**

Date of Report: 26 Jan 2015

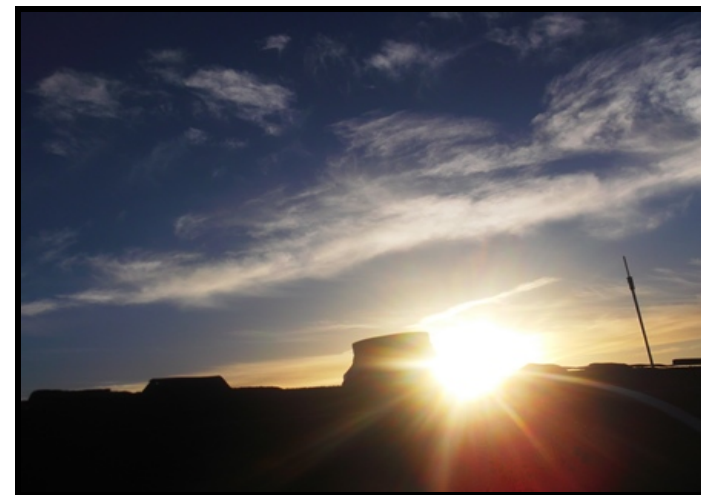
SAMPLE REFERENCE 093

Asbestos detected in Sample

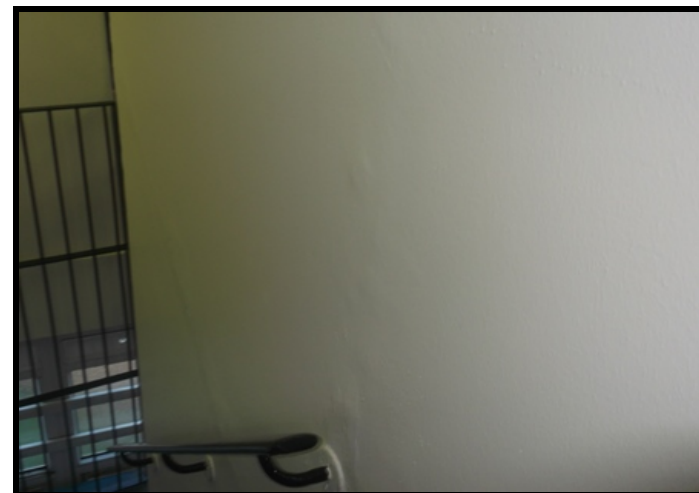
SAMPLE REFERENCE 093b

Asbestos not detected in Sample
