# Site ID: **a-235827** Management Survey

**Solihull Community Housing**  
Client ID: **S135**

1 Fircroft House  
Winchester Drive  
Chelmsley Wood  
Solihull  
West Midlands  
B37 5QB  
United Kingdom

**12th November 2019**

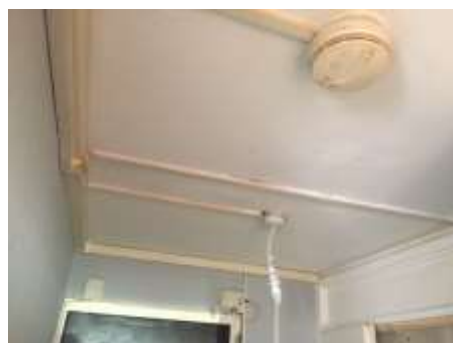
Stipple pattern to ceiling above skim

The material was seen to be in fair condition at the time of the initial inspection.

The condition of the material should be managed by a competent person/company and its presence made aware to those at risk, as part of a Control of Asbestos Regulations (CAR) 2012 compliant management strategy.

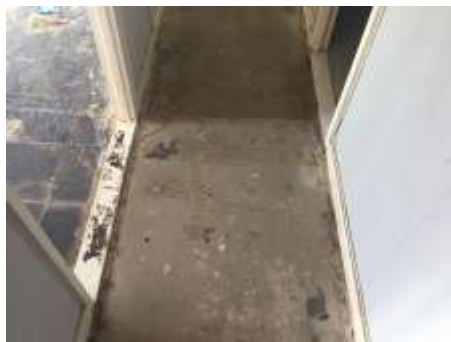
Bitumen adhesive to floor visible through gaps in screed

The material was seen to be in fair condition at the time of the initial inspection.

The condition of the material should be managed by a competent person/company and its presence made aware to those at risk, as part of a Control of Asbestos Regulations (CAR) 2012 compliant management strategy.

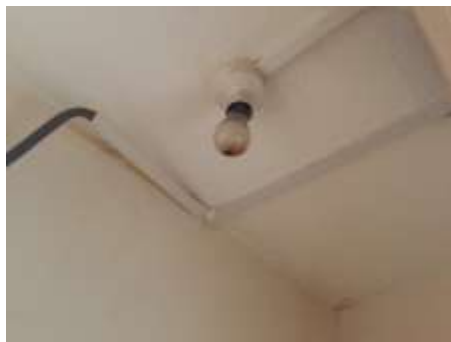
Stipple pattern to ceiling

The material was seen to be in fair condition at the time of the initial inspection.

The condition of the material should be managed by a competent person/company and its presence made aware to those at risk, as part of a Control of Asbestos Regulations (CAR) 2012 compliant management strategy.

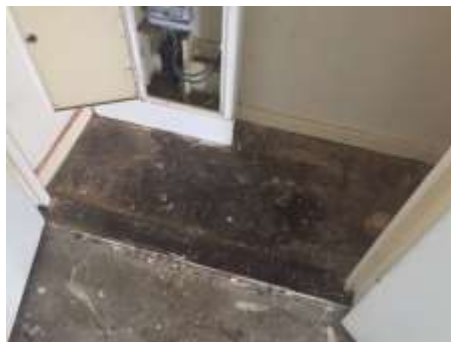
Condition ..... **Low Damage**

The material was seen to be in fair condition at the time of the initial inspection.

The condition of the material should be managed by a competent person/company and its presence made aware to those at risk, as part of a Control of Asbestos Regulations (CAR) 2012 compliant management strategy.

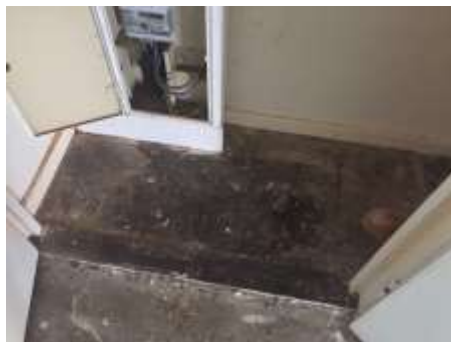
Condition ..... **Low Damage**

The material was seen to be in fair condition at the time of the initial inspection.

The condition of the material should be managed by a competent person/company and its presence made aware to those at risk, as part of a Control of Asbestos Regulations (CAR) 2012 compliant management strategy.

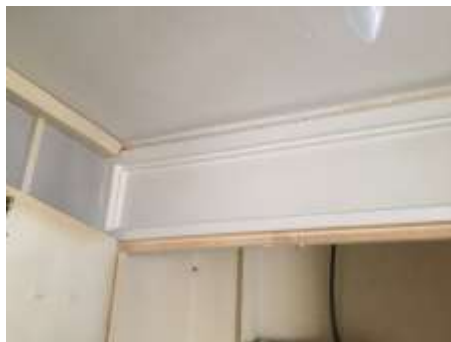
Board transom panel

The material was seen to be in fair condition at the time of the initial inspection.

The condition of the material should be managed by a competent person/company and its presence made aware to those at risk, as part of a Control of Asbestos Regulations (CAR) 2012 compliant management strategy.

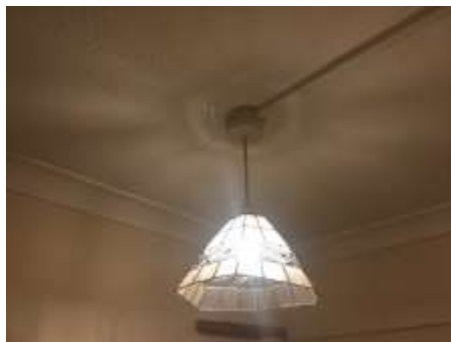
Stipple pattern to ceiling

The material was seen to be in fair condition at the time of the initial inspection.

The condition of the material should be managed by a competent person/company and its presence made aware to those at risk, as part of a Control of Asbestos Regulations (CAR) 2012 compliant management strategy.

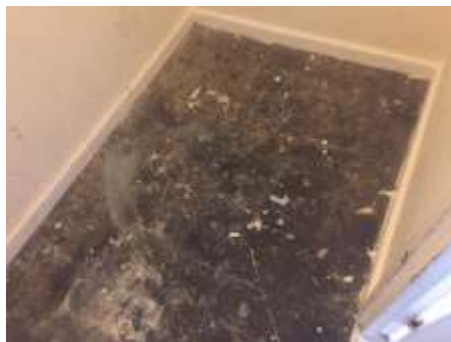
Bitumen adhesive to floor

The material was seen to be in fair condition at the time of the initial inspection.

The condition of the material should be managed by a competent person/company and its presence made aware to those at risk, as part of a Control of Asbestos Regulations (CAR) 2012 compliant management strategy.

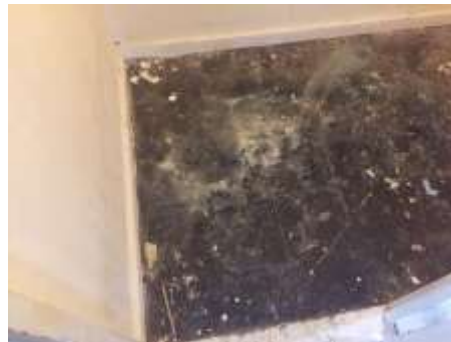
Brown floor tile

The material was seen to be in fair condition at the time of the initial inspection.

The condition of the material should be managed by a competent person/company and its presence made aware to those at risk, as part of a Control of Asbestos Regulations (CAR) 2012 compliant management strategy.

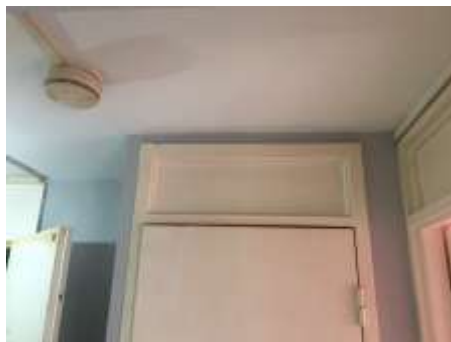
Board transom panel

The material was seen to be in fair condition at the time of the initial inspection.

The condition of the material should be managed by a competent person/company and its presence made aware to those at risk, as part of a Control of Asbestos Regulations (CAR) 2012 compliant management strategy.

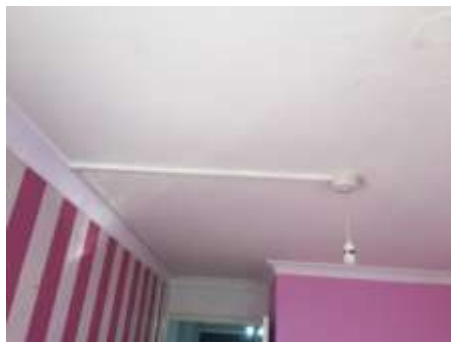
Stipple pattern to ceiling

The material was seen to be in fair condition at the time of the initial inspection.

The condition of the material should be managed by a competent person/company and its presence made aware to those at risk, as part of a Control of Asbestos Regulations (CAR) 2012 compliant management strategy.

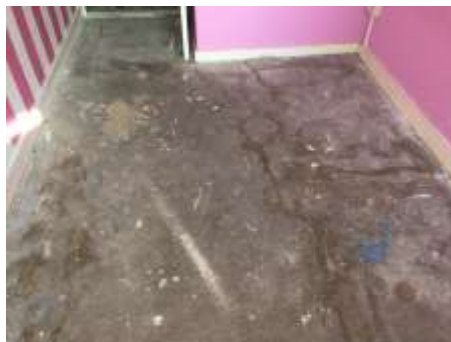
Bitumen adhesive to floor visible through gaps in screed

The material was seen to be in fair condition at the time of the initial inspection.

The condition of the material should be managed by a competent person/company and its presence made aware to those at risk, as part of a Control of Asbestos Regulations (CAR) 2012 compliant management strategy.

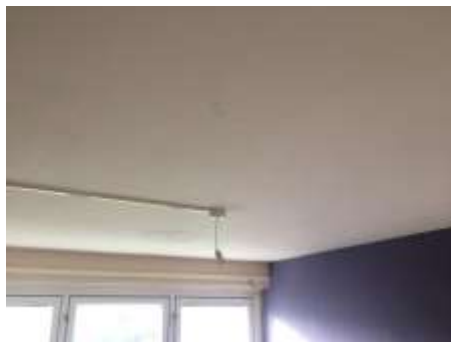
Stipple pattern to ceiling

The material was seen to be in fair condition at the time of the initial inspection.

The condition of the material should be managed by a competent person/company and its presence made aware to those at risk, as part of a Control of Asbestos Regulations (CAR) 2012 compliant management strategy.

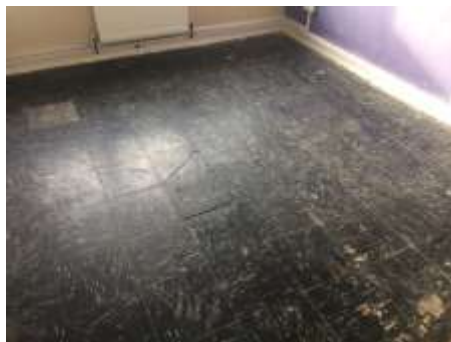
Bitumen adhesive to floor

The material was seen to be in fair condition at the time of the initial inspection.

The condition of the material should be managed by a competent person/company and its presence made aware to those at risk, as part of a Control of Asbestos Regulations (CAR) 2012 compliant management strategy.

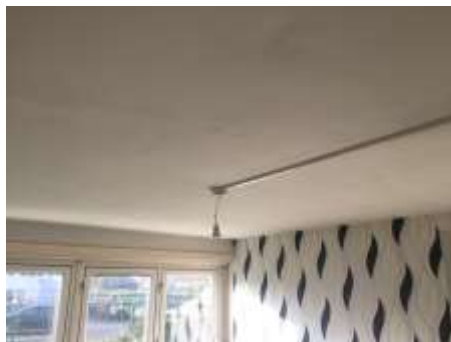
Stipple pattern to ceiling above skim

The material was seen to be in fair condition at the time of the initial inspection.

The condition of the material should be managed by a competent person/company and its presence made aware to those at risk, as part of a Control of Asbestos Regulations (CAR) 2012 compliant management strategy.

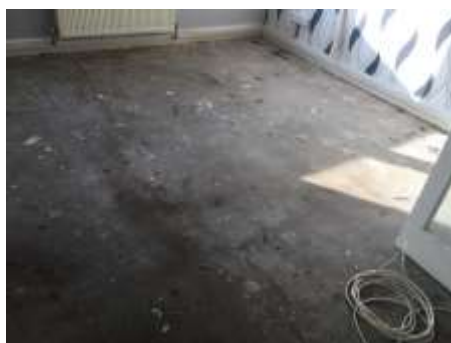
Condition ..... **Low Damage**

The material was seen to be in fair condition at the time of the initial inspection.

The condition of the material should be managed by a competent person/company and its presence made aware to those at risk, as part of a Control of Asbestos Regulations (CAR) 2012 compliant management strategy.

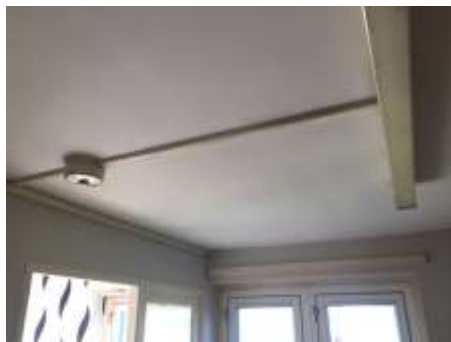
Stipple pattern to ceiling above skim

The material was seen to be in fair condition at the time of the initial inspection.

The condition of the material should be managed by a competent person/company and its presence made aware to those at risk, as part of a Control of Asbestos Regulations (CAR) 2012 compliant management strategy.

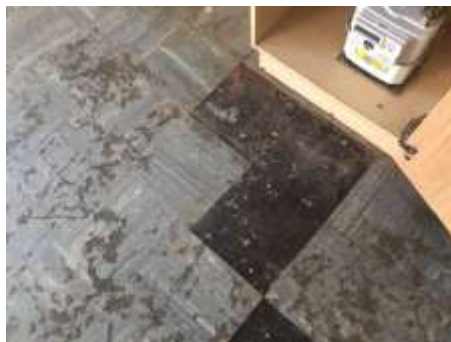
Bitumen adhesive to floor

The material was seen to be in fair condition at the time of the initial inspection.

The condition of the material should be managed by a competent person/company and its presence made aware to those at risk, as part of a Control of Asbestos Regulations (CAR) 2012 compliant management strategy.

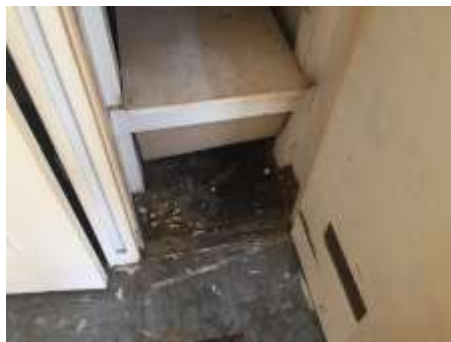
Condition ..... **Low Damage**

The material was seen to be in fair condition at the time of the initial inspection.

The condition of the material should be managed by a competent person/company and its presence made aware to those at risk, as part of a Control of Asbestos Regulations (CAR) 2012 compliant management strategy.

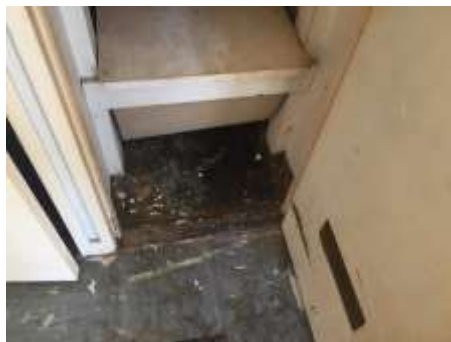
Condition ..... **Low Damage**

The material was seen to be in fair condition at the time of the initial inspection.

The condition of the material should be managed by a competent person/company and its presence made aware to those at risk, as part of a Control of Asbestos Regulations (CAR) 2012 compliant management strategy.

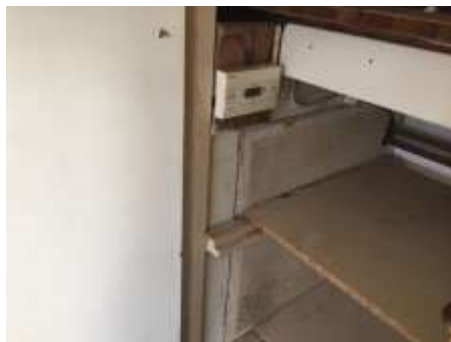
Condition ..... **Low Damage**

It has been noted in previous experience that this type of material has been known to contain asbestos.

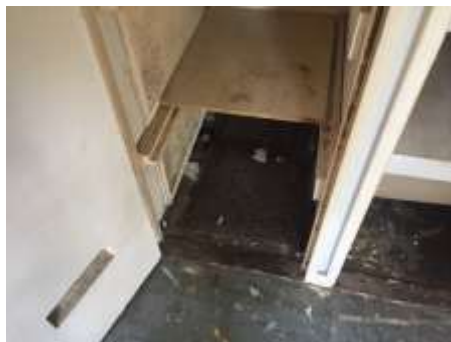
Bitumen adhesive to floor

The material was seen to be in fair condition at the time of the initial inspection.

The condition of the material should be managed by a competent person/company and its presence made aware to those at risk, as part of a Control of Asbestos Regulations (CAR) 2012 compliant management strategy.

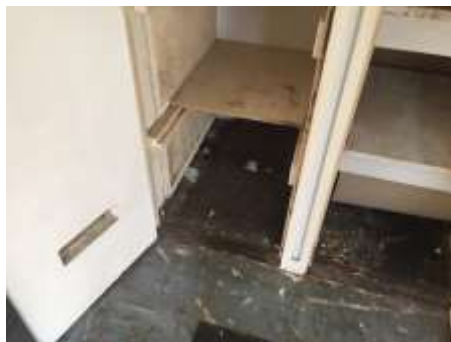
Brown floor tile

The material was seen to be in fair condition at the time of the initial inspection.

The condition of the material should be managed by a competent person/company and its presence made aware to those at risk, as part of a Control of Asbestos Regulations (CAR) 2012 compliant management strategy.

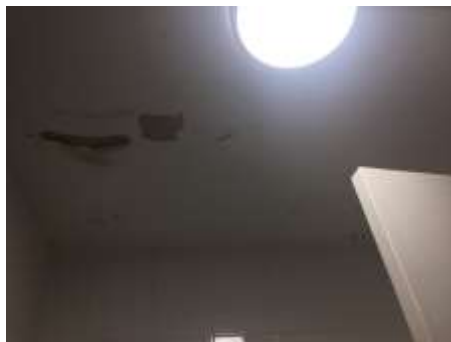
Stipple pattern to ceiling above skim

The material was seen to be in fair condition at the time of the initial inspection.

The condition of the material should be managed by a competent person/company and its presence made aware to those at risk, as part of a Control of Asbestos Regulations (CAR) 2012 compliant management strategy.

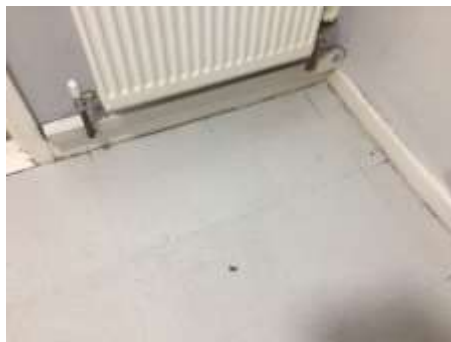
Bitumen adhesive to floor

The material was seen to be in fair condition at the time of the initial inspection.

The condition of the material should be managed by a competent person/company and its presence made aware to those at risk, as part of a Control of Asbestos Regulations (CAR) 2012 compliant management strategy.
