# Solihull Community Housing

## Asbestos Management Survey Report

**Greyfriars House  
Kington Gardens  
Chelmsley Wood  
B37 5HY**

**Survey Ref: 129250000A**

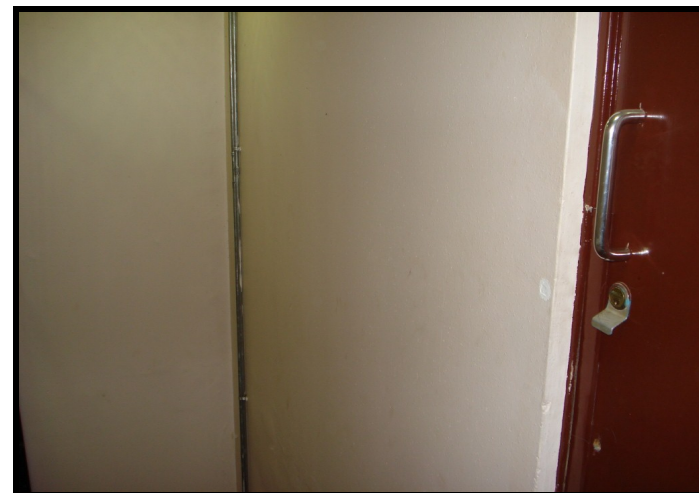
## SAMPLE REFERENCE 002

| 002 | Main Building (Ninth Floor) | Stair Lobby | Walls | Paint | No Asbestos Detected | 50.00m2 | Good condition | Sealed (1) | - | - | - | NO ACTION REQUIRED | | |

Asbestos not detected in Sample

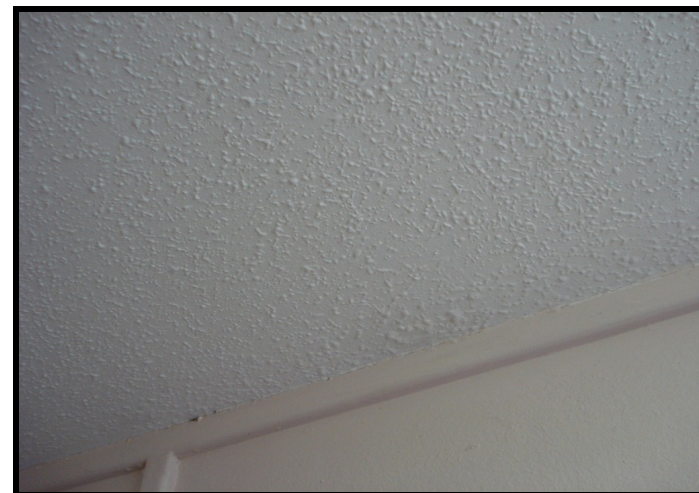
## SAMPLE REFERENCE 003

| 003 | Main Building (Eighth Floor) | Bin Chute | Ceiling | Board | Amosite / Chrysotile | 3.00m2 | Good condition | Sealed Board (Encapsulated) | 5 | I | 6 | LABEL & MONITOR | 21 Sep 2012 | |

**Asbestos detected in Sample**

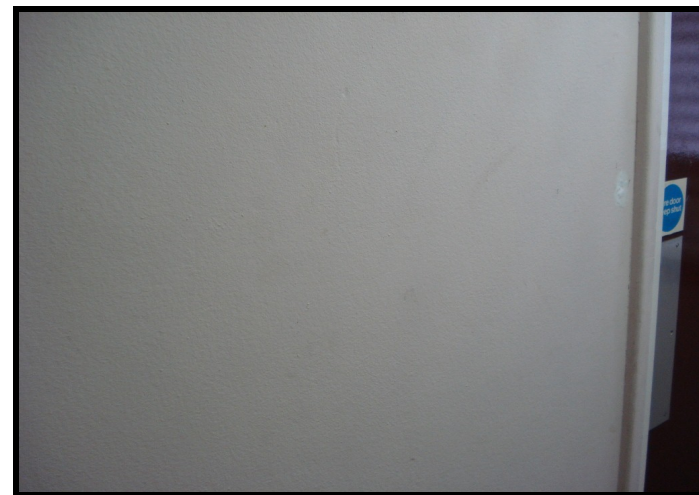
## SAMPLE REFERENCE 004

| 004 | Main Building (Eighth Floor) | Bin Chute | Wall | Board | Amosite / Chrysotile | 5.00m2 | Good condition | Sealed Board (Encapsulated) | 5 | I | 6 | LABEL & MONITOR | 21 Sep 2012 | |

**Asbestos detected in Sample**

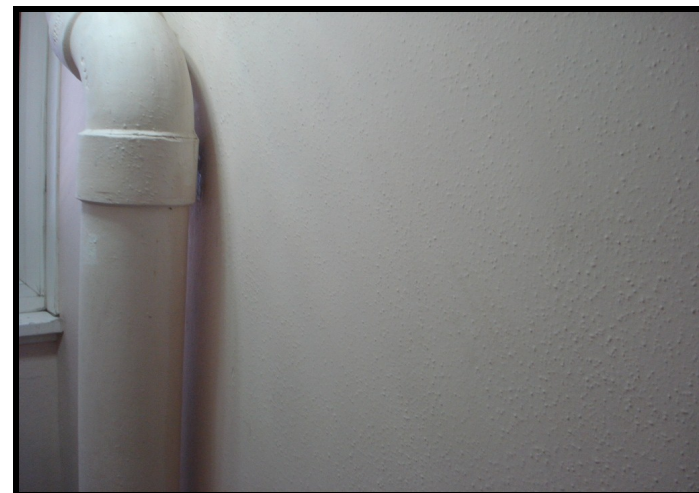
## SAMPLE REFERENCE 005

| Unique Sample No. | Building Reference (Floor) | Room Area | Description of Location | Product Description | Asbestos Type | Approx. Quantity | Material Condition | Surface Treatment | Material Risk Score | Priority Risk Score | Total Risk Score | Management Action | Next Review Date |
|---|---|---|---|---|---|---|---|---|---|---|---|---|---|
| 005 | Main Building (Eighth Floor) | Bin Chute | Walls | Paint | No Asbestos Detected | 8.00m2 | Good condition | Sealed (1) | - | - | - | NO ACTION REQUIRED | |

**No Asbestos Presumed in Sample**

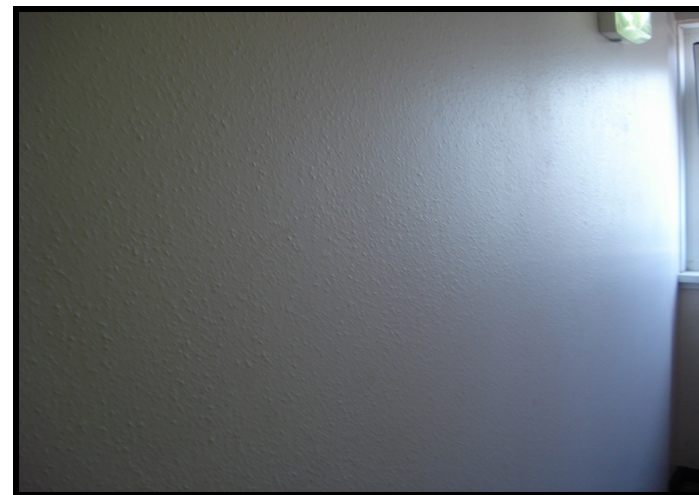
## SAMPLE REFERENCE 006

| Unique Sample No. | Building Reference (Floor) | Room Area | Description of Location | Product Description | Asbestos Type | Approx. Quantity | Material Condition | Surface Treatment | Material Risk Score | Priority Risk Score | Total Risk Score | Management Action | Next Review Date |
|---|---|---|---|---|---|---|---|---|---|---|---|---|---|
| 006 | Main Building (Eighth Floor) | Corridor 1 | Walls | Paint | No Asbestos Detected | 10.00m2 | Good condition | Sealed (1) | - | - | - | NO ACTION REQUIRED | |

**No Asbestos Presumed in Sample**

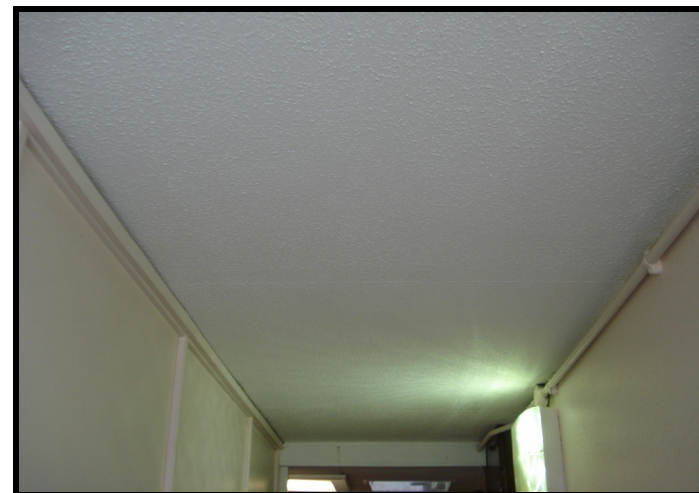
## SAMPLE REFERENCE 007

| Unique Sample No. | Building Reference (Floor) | Room Area | Description of Location | Product Description | Asbestos Type | Approx. Quantity | Material Condition | Surface Treatment | Material Risk Score | Priority Risk Score | Total Risk Score | Management Action | Next Review Date |
|---|---|---|---|---|---|---|---|---|---|---|---|---|---|
| 007 | Main Building (Eighth Floor) | Corridor 1 | Ceiling | Board | Amosite / Chrysotile | 5.00m2 | Good condition | Sealed Board (Encapsulated) | 5 | 1 | 6 | LABEL & MONITOR | 21 Sep 2012 |

Asbestos Presumed in Sample

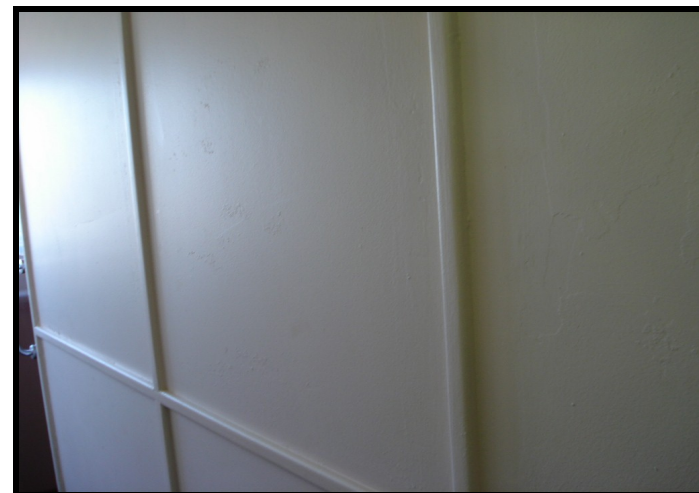
## SAMPLE REFERENCE 008

| Unique Sample No. | Building Reference (Floor) | Room Area | Description of Location | Product Description | Asbestos Type | Approx. Quantity | Material Condition | Surface Treatment | Material Risk Score | Priority Risk Score | Total Risk Score | Management Action | Next Review Date |
|---|---|---|---|---|---|---|---|---|---|---|---|---|---|
| 008 | Main Building (Eighth Floor) | Corridor 1 | Wall | Board | Amosite / Chrysotile | 10.00m2 | Good condition | Sealed Board (Encapsulated) | 5 | 1 | 6 | LABEL & MONITOR | 21 Sep 2012 |

Asbestos Presumed in Sample

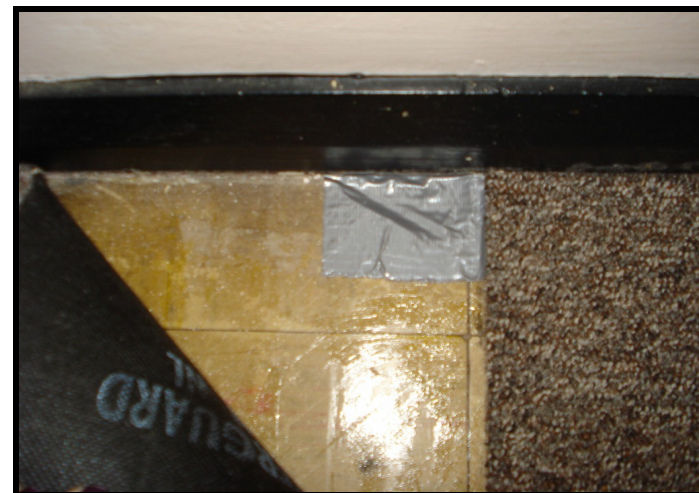
## SAMPLE REFERENCE 009

| Unique Sample No. | Building Reference (Floor) | Room Area | Description of Location | Product Description | Asbestos Type | Approx. Quantity | Material Condition | Surface Treatment | Material Risk Score | Priority Risk Score | Total Risk Score | Management Action | Next Review Date |
|---|---|---|---|---|---|---|---|---|---|---|---|---|---|
| 009 | Main Building (Eighth Floor) | Corridor 1 | Floor | Floor Tiles | Chrysotile | 8.00m2 | Good condition | Composite materials | 2 | 1 | 3 | LABEL & MONITOR | 21 Mar 2013 |

**Asbestos detected in Sample**

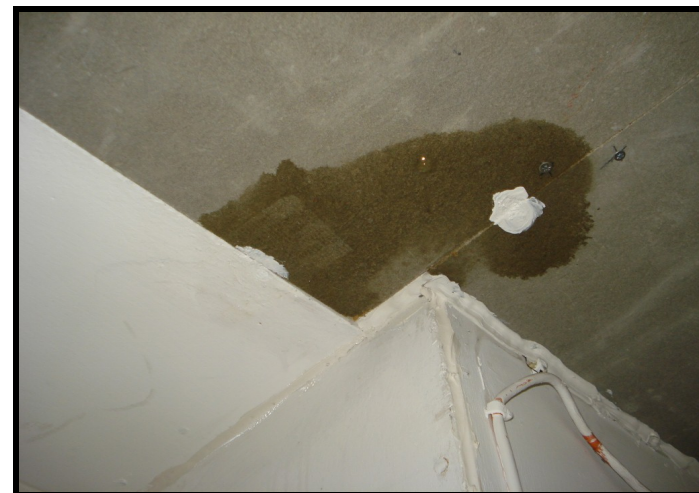
## SAMPLE REFERENCE 010

| Unique Sample No. | Building Reference (Floor) | Room Area | Description of Location | Product Description | Asbestos Type | Approx. Quantity | Material Condition | Surface Treatment | Material Risk Score | Priority Risk Score | Total Risk Score | Management Action | Next Review Date |
|---|---|---|---|---|---|---|---|---|---|---|---|---|---|
| 010 | Main Building (Eighth Floor) | Dry Riser | Ceiling | Board | No Asbestos Detected | 3.00m2 | Medium damage | Unsealed (Board) | - | - | - | NO ACTION REQUIRED | |

**Asbestos not detected in Sample**

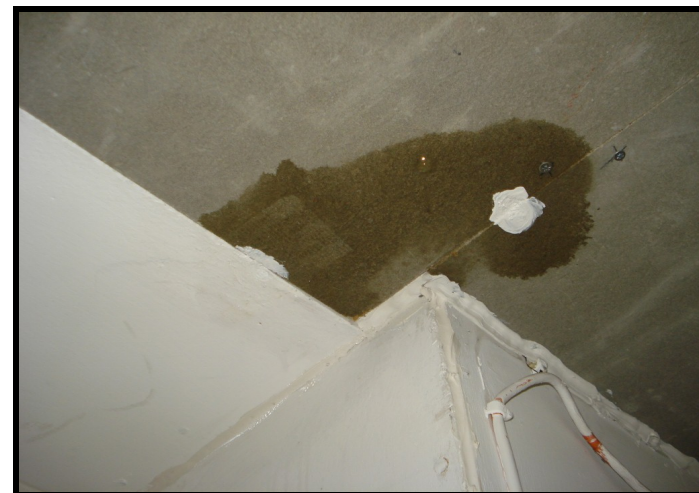
## SAMPLE REFERENCE 011

| Unique Sample No. | Building Reference (Floor) | Room Area | Description of Location | Product Description | Asbestos Type | Approx. Quantity | Material Condition | Surface Treatment | Material Risk Score | Priority Risk Score | Total Risk Score | Management Action | Next Review Date |
|---|---|---|---|---|---|---|---|---|---|---|---|---|---|
| 011 | Main Building (Eighth Floor) | Dry Riser | Ceiling | Board | Amosite / Chrysotile | 1.00m2 | Good condition | Sealed Board (Encapsulated) | 5 | 1 | 6 | LABEL & MONITOR | 21 Sep 2012 |

**Asbestos detected in Sample**

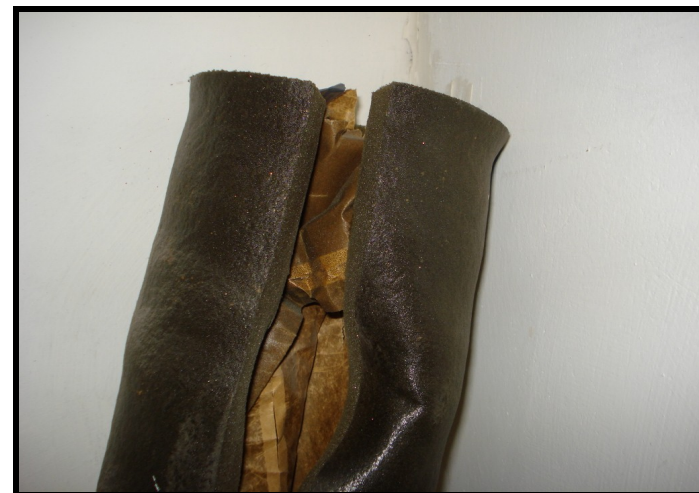
## SAMPLE REFERENCE 012

| Unique Sample No. | Building Reference (Floor) | Room Area | Description of Location | Product Description | Asbestos Type | Approx. Quantity | Material Condition | Surface Treatment | Material Risk Score | Priority Risk Score | Total Risk Score | Management Action | Next Review Date |
|---|---|---|---|---|---|---|---|---|---|---|---|---|---|
| 012 | Main Building (Eighth Floor) | Dry Riser | Riser | Paint | No Asbestos Detected | 31.00lm | Low damage | Composite materials | - | - | - | NO ACTION REQUIRED | |

**Asbestos not detected in Sample**

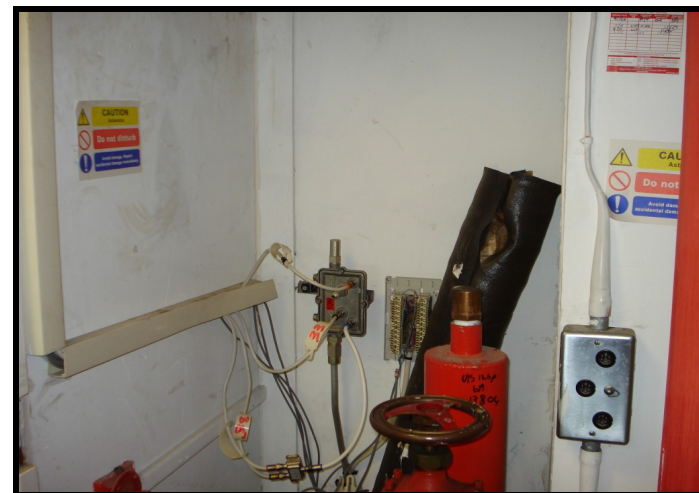
## SAMPLE REFERENCE 013

| Unique Sample No. | Building Reference (Floor) | Room Area | Description of Location | Product Description | Asbestos Type | Approx. Quantity | Material Condition | Surface Treatment | Material Risk Score | Priority Risk Score | Total Risk Score | Management Action | Next Review Date |
|---|---|---|---|---|---|---|---|---|---|---|---|---|---|
| 013 | Main Building (Eighth Floor) | Dry Riser | Door | Board | Amosite / Chrysotile | 8.00m2 | Medium damage | Unsealed (Board) | 8 | 1 | 9 | ENCAPSULATE, LABEL & MONITOR | 21 Sep 2012 |

Asbestos Presumed in Sample

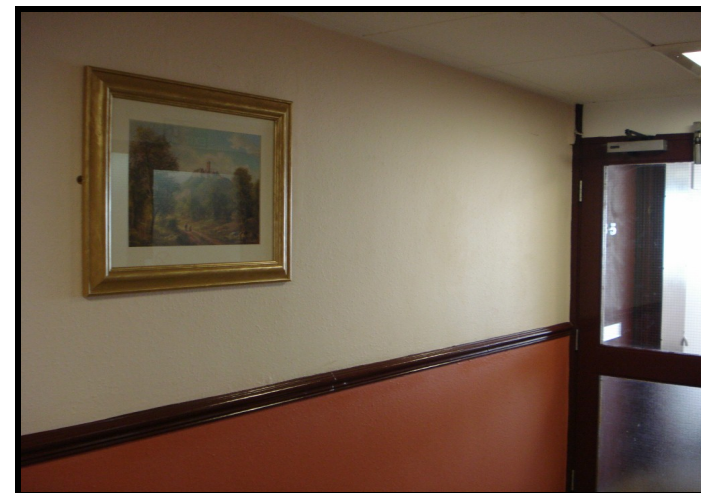
## SAMPLE REFERENCE 015

| Unique Sample No. | Building Reference (Floor) | Room Area | Description of Location | Product Description | Asbestos Type | Approx. Quantity | Material Condition | Surface Treatment | Material Risk Score | Priority Risk Score | Total Risk Score | Management Action | Next Review Date |
|---|---|---|---|---|---|---|---|---|---|---|---|---|---|
| 015 | Main Building (Eighth Floor) | Lift Lobby | Walls | Paint | No Asbestos Detected | 20.00m2 | Good condition | Sealed (1) | - | - | - | NO ACTION REQUIRED | |

**No Asbestos Presumed in Sample**

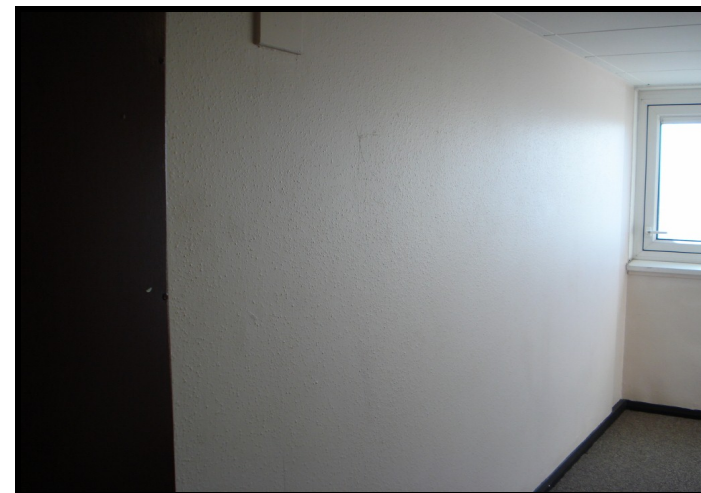
## SAMPLE REFERENCE 016

| Unique Sample No. | Building Reference (Floor) | Room Area | Description of Location | Product Description | Asbestos Type | Approx. Quantity | Material Condition | Surface Treatment | Material Risk Score | Priority Risk Score | Total Risk Score | Management Action | Next Review Date |
|---|---|---|---|---|---|---|---|---|---|---|---|---|---|
| 016 | Main Building (Eighth Floor) | Corridor 2 | Walls | Paint | No Asbestos Detected | 15.00m2 | Good condition | Sealed (1) | - | - | - | NO ACTION REQUIRED | |

**No Asbestos Presumed in Sample**

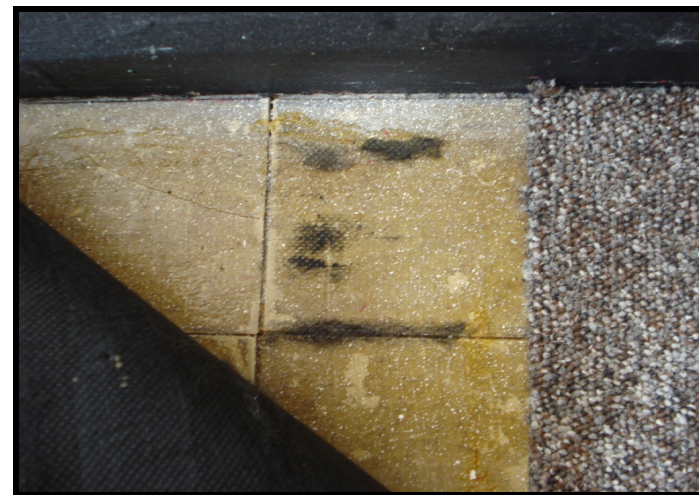
## SAMPLE REFERENCE 017

| Unique Sample No. | Building Reference (Floor) | Room Area | Description of Location | Product Description | Asbestos Type | Approx. Quantity | Material Condition | Surface Treatment | Material Risk Score | Priority Risk Score | Total Risk Score | Management Action | Next Review Date |
|---|---|---|---|---|---|---|---|---|---|---|---|---|---|
| 017 | Main Building (Eighth Floor) | Corridor 2 | Floor | Floor Tiles | Chrysotile | 12.00m2 | Good condition | Composite materials | 2 | 2 | 4 | LABEL & MONITOR | 21 Mar 2013 |

Asbestos Presumed in Sample

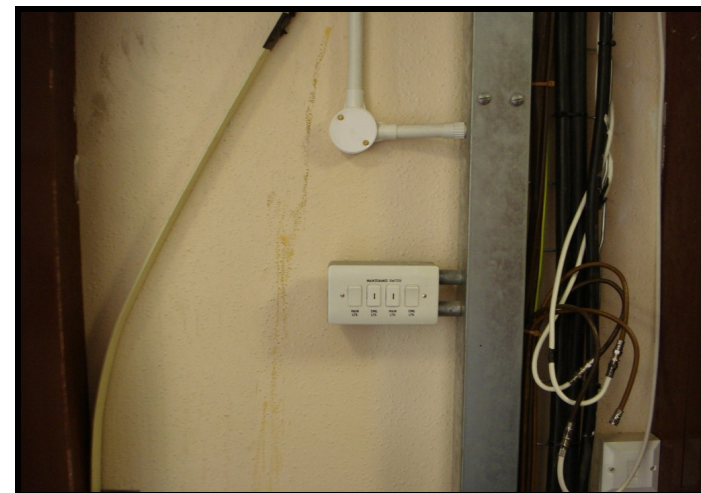
## SAMPLE REFERENCE 018

| Unique Sample No. | Building Reference (Floor) | Room Area | Description of Location | Product Description | Asbestos Type | Approx. Quantity | Material Condition | Surface Treatment | Material Risk Score | Priority Risk Score | Total Risk Score | Management Action | Next Review Date |
|---|---|---|---|---|---|---|---|---|---|---|---|---|---|
| 018 | Main Building (Eighth Floor) | Service Riser | Walls | Paint | No Asbestos Detected | 3.00m2 | Good condition | Sealed (1) | - | - | - | NO ACTION REQUIRED | |

**No Asbestos Presumed in Sample**

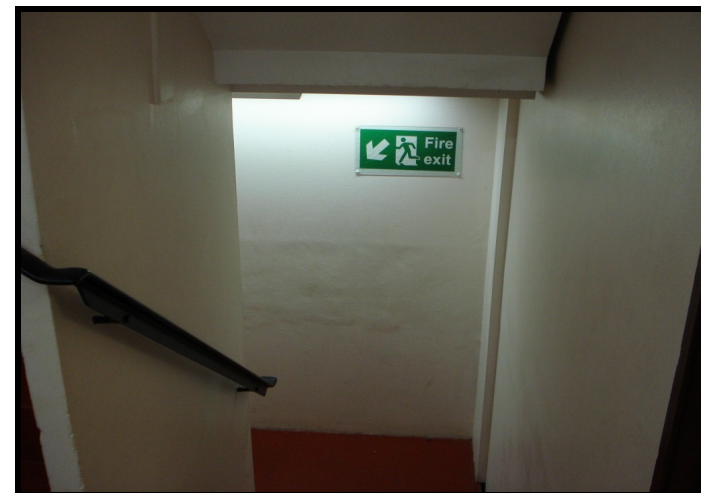
## SAMPLE REFERENCE 019

| Unique Sample No. | Building Reference (Floor) | Room Area | Description of Location | Product Description | Asbestos Type | Approx. Quantity | Material Condition | Surface Treatment | Material Risk Score | Priority Risk Score | Total Risk Score | Management Action | Next Review Date |
|---|---|---|---|---|---|---|---|---|---|---|---|---|---|
| 019 | Main Building (Eighth Floor) | Stairs | Walls | Paint | No Asbestos Detected | 30.00m2 | Good condition | Sealed (1) | - | - | - | NO ACTION REQUIRED | |

**No Asbestos Presumed in Sample**

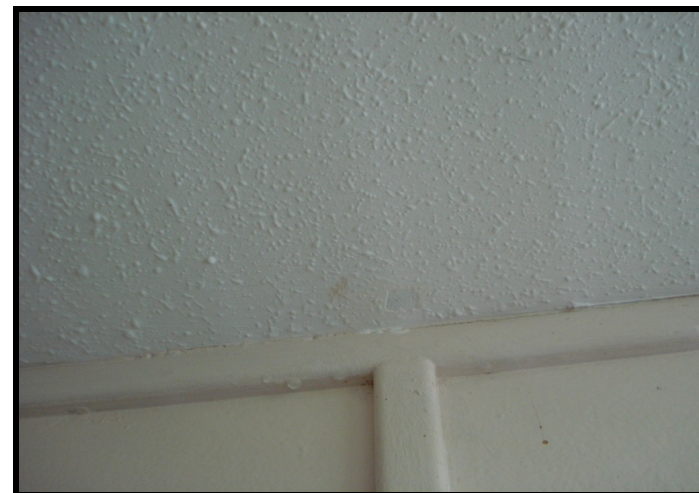
## SAMPLE REFERENCE 020

| Unique Sample No. | Building Reference (Floor) | Room Area | Description of Location | Product Description | Asbestos Type | Approx. Quantity | Material Condition | Surface Treatment | Material Risk Score | Priority Risk Score | Total Risk Score | Management Action | Next Review Date |
|---|---|---|---|---|---|---|---|---|---|---|---|---|---|
| 020 | Main Building (Seventh Floor) | Bin Chute | Ceiling | Paint | No Asbestos Detected | 3.00m2 | Good condition | Sealed (1) | - | - | - | NO ACTION REQUIRED | |

**Asbestos not detected in Sample**

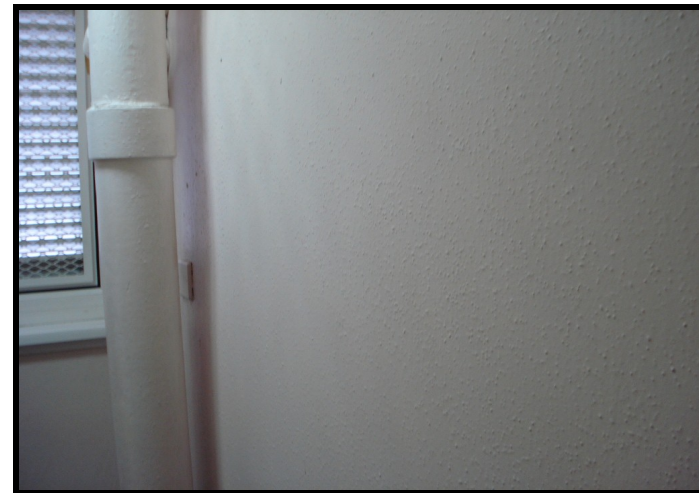
## SAMPLE REFERENCE 021

| Unique Sample No. | Building Reference (Floor) | Room Area | Description of Location | Product Description | Asbestos Type | Approx. Quantity | Material Condition | Surface Treatment | Material Risk Score | Priority Risk Score | Total Risk Score | Management Action | Next Review Date |
|---|---|---|---|---|---|---|---|---|---|---|---|---|---|
| 021 | Main Building (Seventh Floor) | Bin Chute | Walls | Paint | No Asbestos Detected | 8.00m2 | Good condition | Sealed (1) | - | - | - | NO ACTION REQUIRED | |

**No Asbestos Presumed in Sample**

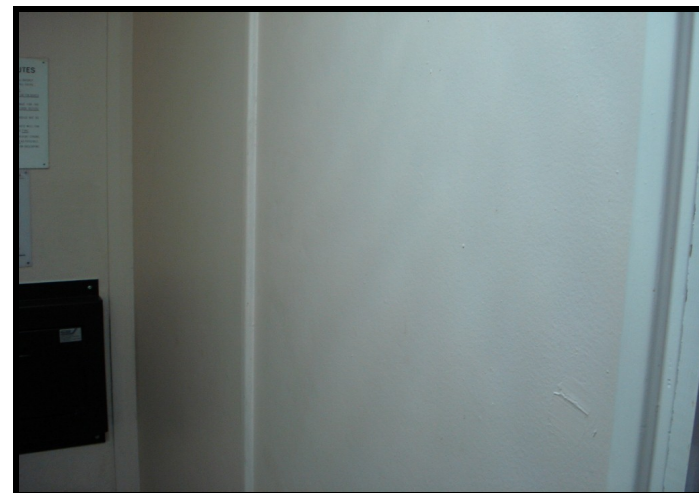
## SAMPLE REFERENCE 022

| Unique Sample No. | Building Reference (Floor) | Room Area | Description of Location | Product Description | Asbestos Type | Approx. Quantity | Material Condition | Surface Treatment | Material Risk Score | Priority Risk Score | Total Risk Score | Management Action | Next Review Date |
|---|---|---|---|---|---|---|---|---|---|---|---|---|---|
| 022 | Main Building (Seventh Floor) | Bin Chute | Wall | Board | Amosite / Chrysotile | 5.00m2 | Good condition | Sealed Board (Encapsulated) | 5 | 1 | 6 | LABEL & MONITOR | 21 Sep 2012 |

Asbestos Presumed in Sample

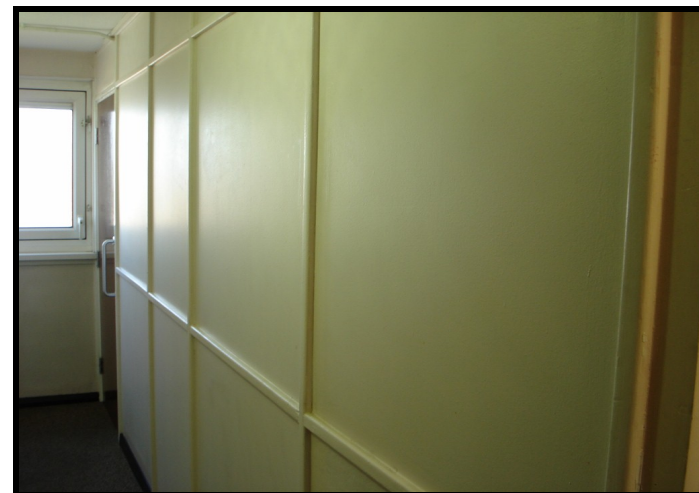
## SAMPLE REFERENCE 023

| Unique Sample No. | Building Reference (Floor) | Room Area | Description of Location | Product Description | Asbestos Type | Approx. Quantity | Material Condition | Surface Treatment | Material Risk Score | Priority Risk Score | Total Risk Score | Management Action | Next Review Date |
|---|---|---|---|---|---|---|---|---|---|---|---|---|---|
| 023 | Main Building (Seventh Floor) | Corridor 1 | Wall | Board | Amosite / Chrysotile | 10.00m2 | Good condition | Sealed Board (Encapsulated) | 5 | 1 | 6 | LABEL & MONITOR | 21 Sep 2012 |

Asbestos Presumed in Sample

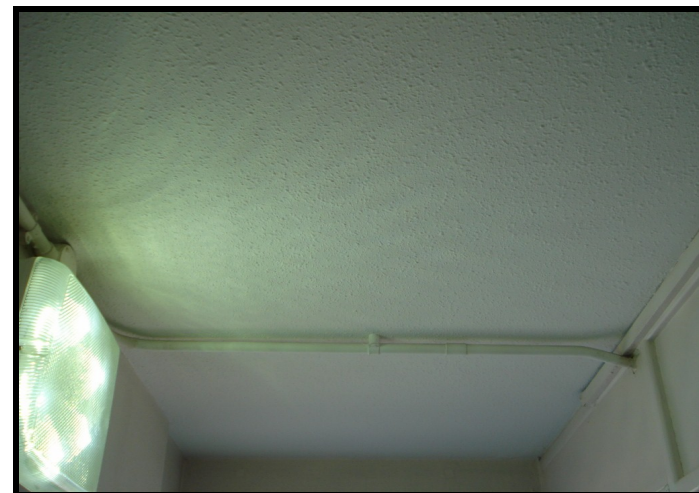
## SAMPLE REFERENCE 024

| Unique Sample No. | Building Reference (Floor) | Room Area | Description of Location | Product Description | Asbestos Type | Approx. Quantity | Material Condition | Surface Treatment | Material Risk Score | Priority Risk Score | Total Risk Score | Management Action | Next Review Date |
|---|---|---|---|---|---|---|---|---|---|---|---|---|---|
| 024 | Main Building (Seventh Floor) | Corridor 1 | Ceiling | Paint | No Asbestos Detected | 5.00m2 | Good condition | Sealed (1) | - | - | - | NO ACTION REQUIRED | |

**No Asbestos Presumed in Sample**

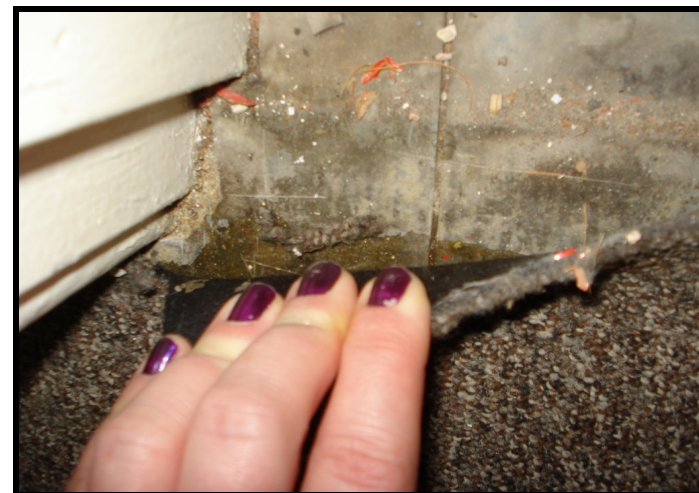
## SAMPLE REFERENCE 025

| Unique Sample No. | Building Reference (Floor) | Room Area | Description of Location | Product Description | Asbestos Type | Approx. Quantity | Material Condition | Surface Treatment | Material Risk Score | Priority Risk Score | Total Risk Score | Management Action | Next Review Date |
|---|---|---|---|---|---|---|---|---|---|---|---|---|---|
| 025 | Main Building (Seventh Floor) | Corridor 1 | Floor | Floor Tiles | Chrysotile | 8.00m2 | Good condition | Composite materials | 2 | 1 | 3 | LABEL & MONITOR | 21 Mar 2013 |

Asbestos Presumed in Sample

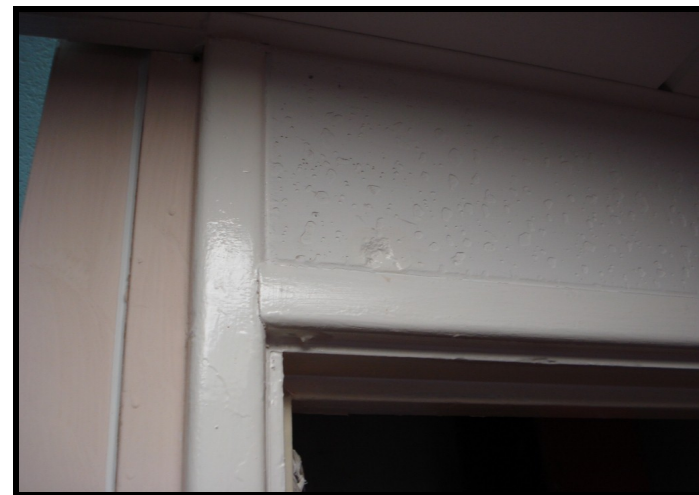
## SAMPLE REFERENCE 026

| Unique Sample No. | Building Reference (Floor) | Room Area | Description of Location | Product Description | Asbestos Type | Approx. Quantity | Material Condition | Surface Treatment | Material Risk Score | Priority Risk Score | Total Risk Score | Management Action | Next Review Date |
|---|---|---|---|---|---|---|---|---|---|---|---|---|---|
| 026 | Main Building (Seventh Floor) | Corridor 1 | Transom Panel | Board | No Asbestos Detected | 2.00m2 | Good condition | Sealed Board (Encapsulated) | - | - | - | NO ACTION REQUIRED | |

**Asbestos not detected in Sample**

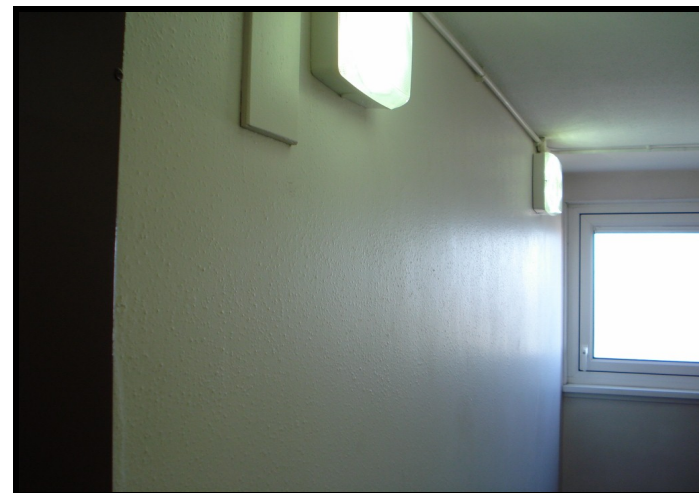
## SAMPLE REFERENCE 027

| Unique Sample No. | Building Reference (Floor) | Room Area | Description of Location | Product Description | Asbestos Type | Approx. Quantity | Material Condition | Surface Treatment | Material Risk Score | Priority Risk Score | Total Risk Score | Management Action | Next Review Date |
|---|---|---|---|---|---|---|---|---|---|---|---|---|---|
| 027 | Main Building (Seventh Floor) | Corridor 1 | Walls | Paint | No Asbestos Detected | 10.00m2 | Good condition | Sealed (1) | - | - | - | NO ACTION REQUIRED | |

**No Asbestos Presumed in Sample**

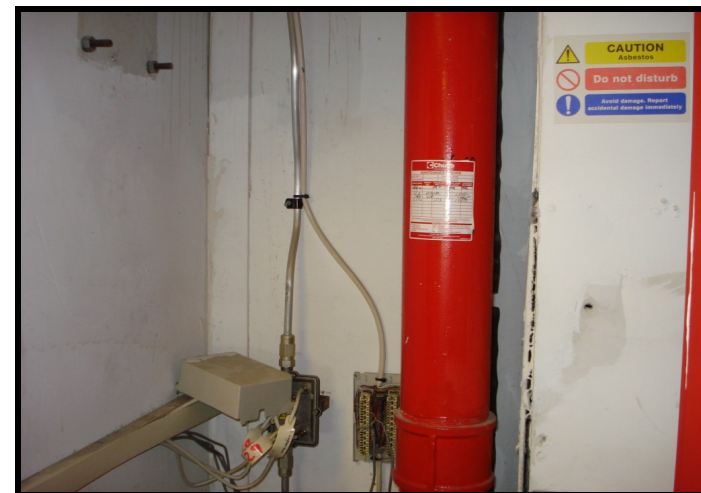
## SAMPLE REFERENCE 028

| Unique Sample No. | Building Reference (Floor) | Room Area | Description of Location | Product Description | Asbestos Type | Approx. Quantity | Material Condition | Surface Treatment | Material Risk Score | Priority Risk Score | Total Risk Score | Management Action | Next Review Date |
|---|---|---|---|---|---|---|---|---|---|---|---|---|---|
| 028 | Main Building (Seventh Floor) | Dry Riser | Door | Board | Amosite / Chrysotile | 8.00m2 | Low damage | Unsealed (Board) | 7 | 1 | 8 | ENCAPSULATE, LABEL & MONITOR | 21 Sep 2012 |

**Asbestos Presumed in Sample**

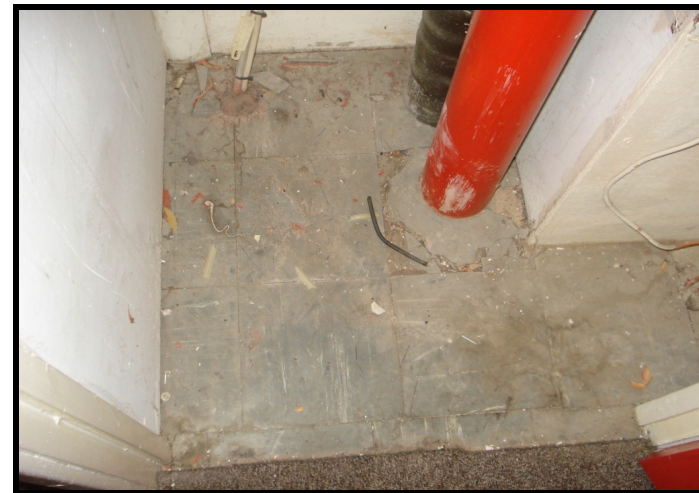
## SAMPLE REFERENCE 030

| Unique Sample No. | Building Reference (Floor) | Room Area | Description of Location | Product Description | Asbestos Type | Approx. Quantity | Material Condition | Surface Treatment | Material Risk Score | Priority Risk Score | Total Risk Score | Management Action | Next Review Date |
|---|---|---|---|---|---|---|---|---|---|---|---|---|---|
| 030 | Main Building (Seventh Floor) | Dry Riser | Floor | Floor Tiles | Chrysotile | 2.00m2 | Medium damage | Composite materials | 4 | 1 | 5 | REMOVAL BY LICENSED CONTRACTOR | |

**Asbestos detected in Sample**

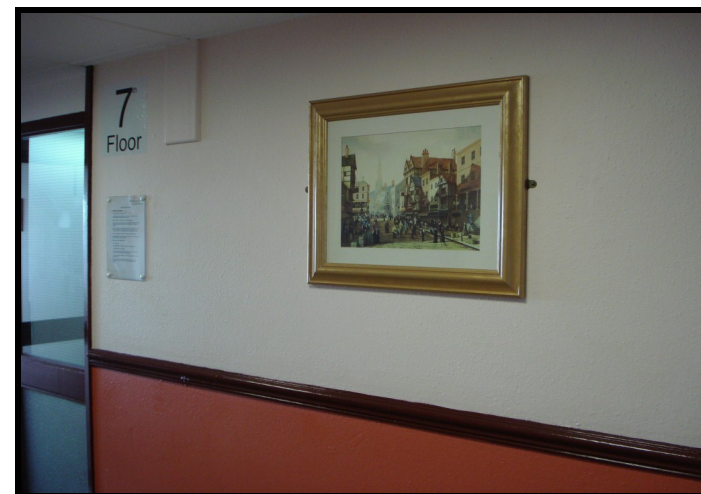
## SAMPLE REFERENCE 03 I

| Unique Sample No. | Building Reference (Floor) | Room Area | Description of Location | Product Description | Asbestos Type | Approx. Quantity | Material Condition | Surface Treatment | Material Risk Score | Priority Risk Score | Total Risk Score | Management Action | Next Review Date |
|---|---|---|---|---|---|---|---|---|---|---|---|---|---|
| 031 | Main Building (Seventh Floor) | Lift Lobby | Walls | Paint | No Asbestos Detected | 20.00m2 | Good condition | Sealed (1) | - | - | - | NO ACTION REQUIRED | |

**No Asbestos Presumed in Sample**

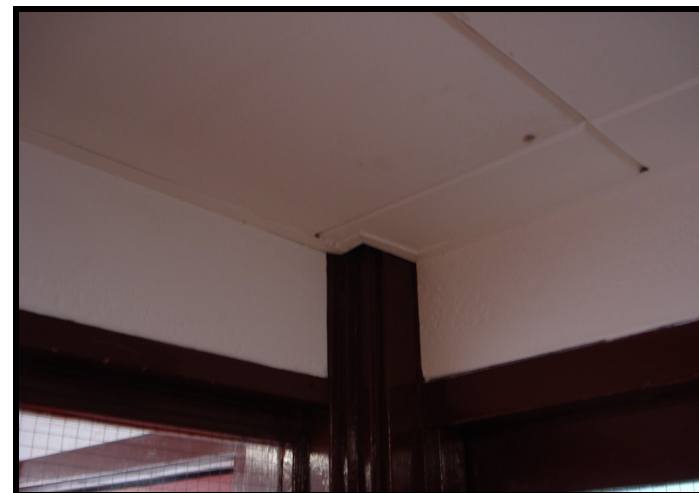
## SAMPLE REFERENCE 032

| Unique Sample No. | Building Reference (Floor) | Room Area | Description of Location | Product Description | Asbestos Type | Approx. Quantity | Material Condition | Surface Treatment | Material Risk Score | Priority Risk Score | Total Risk Score | Management Action | Next Review Date |
|---|---|---|---|---|---|---|---|---|---|---|---|---|---|
| 032 | Main Building (Seventh Floor) | Lift Lobby | Transom Panel | Board | No Asbestos Detected | 3.00m2 | Good condition | Sealed Board (Encapsulated) | - | - | - | NO ACTION REQUIRED | |

**No Asbestos Presumed in Sample**

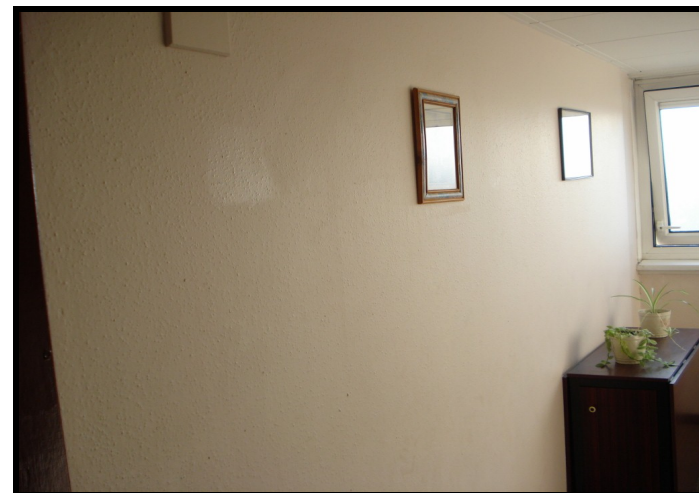
## SAMPLE REFERENCE 033

| Unique Sample No. | Building Reference (Floor) | Room Area | Description of Location | Product Description | Asbestos Type | Approx. Quantity | Material Condition | Surface Treatment | Material Risk Score | Priority Risk Score | Total Risk Score | Management Action | Next Review Date |
|---|---|---|---|---|---|---|---|---|---|---|---|---|---|
| 033 | Main Building (Seventh Floor) | Corridor 2 | Walls | Paint | No Asbestos Detected | 15.00m2 | Good condition | Sealed (1) | - | - | - | NO ACTION REQUIRED | |

**No Asbestos Presumed in Sample**

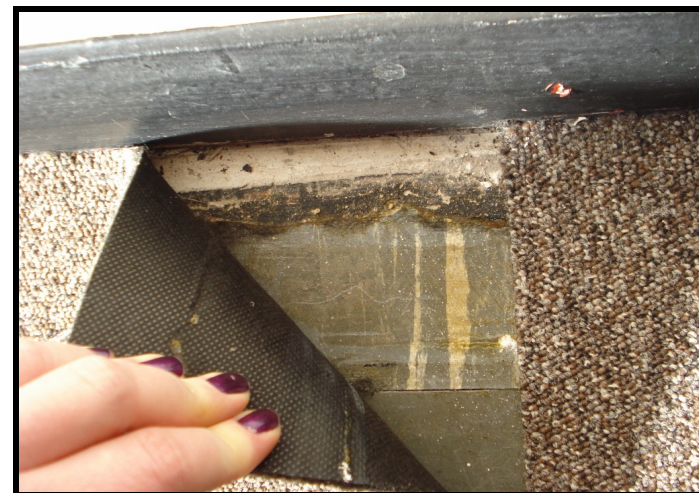
## SAMPLE REFERENCE 034

| Unique Sample No. | Building Reference (Floor) | Room Area | Description of Location | Product Description | Asbestos Type | Approx. Quantity | Material Condition | Surface Treatment | Material Risk Score | Priority Risk Score | Total Risk Score | Management Action | Next Review Date |
|---|---|---|---|---|---|---|---|---|---|---|---|---|---|
| 034 | Main Building (Seventh Floor) | Corridor 2 | Floor | Floor Tiles | Chrysotile | 12.00m2 | Low damage | Composite materials | 3 | 2 | 5 | LABEL & MONITOR | 21 Mar 2013 |

Asbestos Presumed in Sample

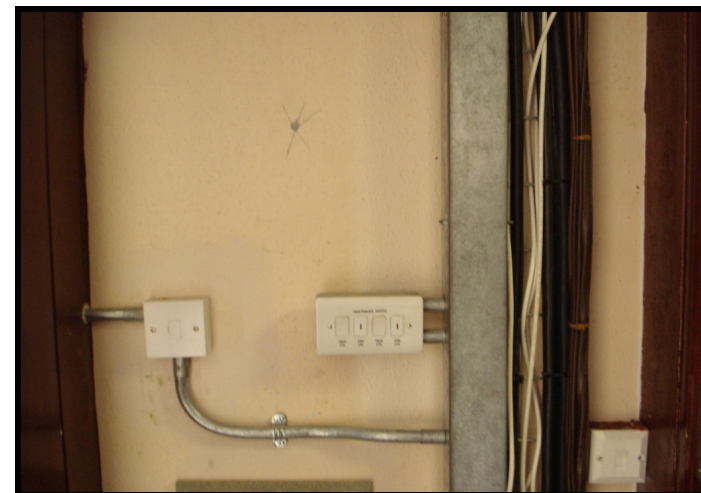
## SAMPLE REFERENCE 035

| Unique Sample No. | Building Reference (Floor) | Room Area | Description of Location | Product Description | Asbestos Type | Approx. Quantity | Material Condition | Surface Treatment | Material Risk Score | Priority Risk Score | Total Risk Score | Management Action | Next Review Date |
|---|---|---|---|---|---|---|---|---|---|---|---|---|---|
| 035 | Main Building (Seventh Floor) | Service Riser | Walls | Paint | No Asbestos Detected | 3.00m2 | Good condition | Sealed (1) | - | - | - | NO ACTION REQUIRED | |

**No Asbestos Presumed in Sample**

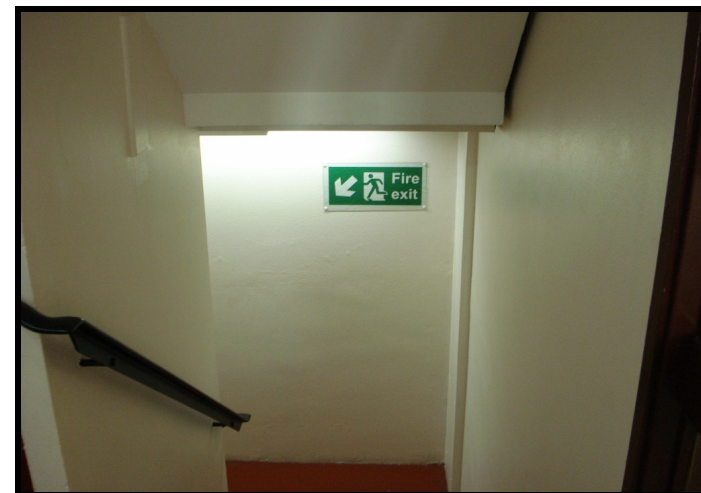
## SAMPLE REFERENCE 037

| Unique Sample No. | Building Reference (Floor) | Room Area | Description of Location | Product Description | Asbestos Type | Approx. Quantity | Material Condition | Surface Treatment | Material Risk Score | Priority Risk Score | Total Risk Score | Management Action | Next Review Date |
|---|---|---|---|---|---|---|---|---|---|---|---|---|---|
| 037 | Main Building (Seventh Floor) | Stairs | Walls | Paint | No Asbestos Detected | 30.00m2 | Good condition | Sealed (1) | - | - | - | NO ACTION REQUIRED | |

**No Asbestos Presumed in Sample**

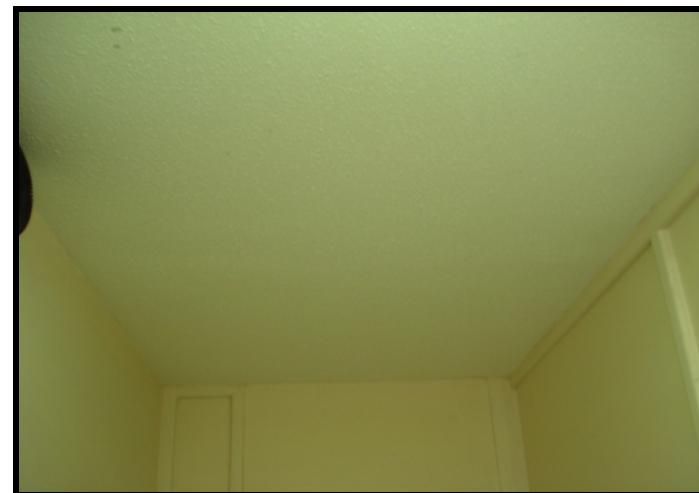
## SAMPLE REFERENCE 038

| Unique Sample No. | Building Reference (Floor) | Room Area | Description of Location | Product Description | Asbestos Type | Approx. Quantity | Material Condition | Surface Treatment | Material Risk Score | Priority Risk Score | Total Risk Score | Management Action | Next Review Date |
|---|---|---|---|---|---|---|---|---|---|---|---|---|---|
| 038 | Main Building (Sixth Floor) | Bin Chute | Ceiling | Paint | No Asbestos Detected | 3.00m2 | Good condition | Sealed (1) | - | - | - | NO ACTION REQUIRED | |

**No Asbestos Presumed in Sample**

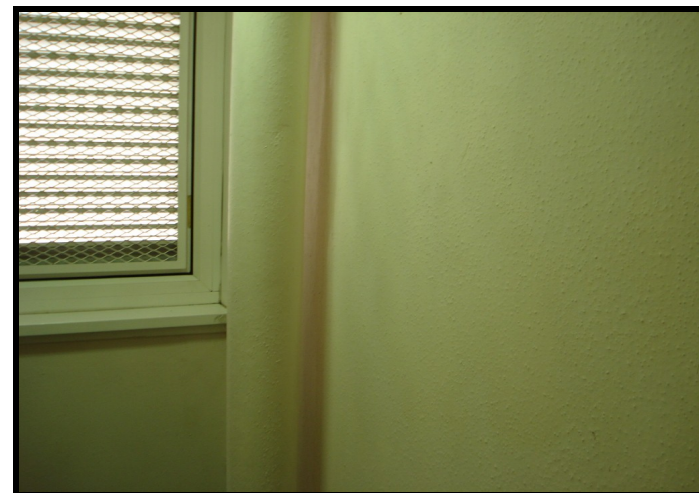
## SAMPLE REFERENCE 039

| Unique Sample No. | Building Reference (Floor) | Room Area | Description of Location | Product Description | Asbestos Type | Approx. Quantity | Material Condition | Surface Treatment | Material Risk Score | Priority Risk Score | Total Risk Score | Management Action | Next Review Date |
|---|---|---|---|---|---|---|---|---|---|---|---|---|---|
| 039 | Main Building (Sixth Floor) | Bin Chute | Walls | Paint | No Asbestos Detected | 8.00m2 | Low damage | Sealed (1) | - | - | - | NO ACTION REQUIRED | |

**No Asbestos Presumed in Sample**

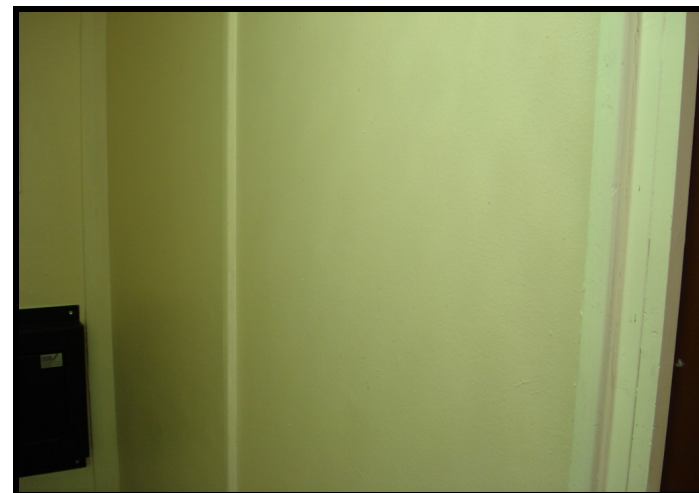
## SAMPLE REFERENCE 040

| Unique Sample No. | Building Reference (Floor) | Room Area | Description of Location | Product Description | Asbestos Type | Approx. Quantity | Material Condition | Surface Treatment | Material Risk Score | Priority Risk Score | Total Risk Score | Management Action | Next Review Date |
|---|---|---|---|---|---|---|---|---|---|---|---|---|---|
| 040 | Main Building (Sixth Floor) | Bin Chute | Wall | Board | Amosite / Chrysotile | 5.00m2 | Good condition | Sealed Board (Encapsulated) | 5 | 1 | 6 | LABEL & MONITOR | 21 Sep 2012 |

Asbestos Presumed in Sample

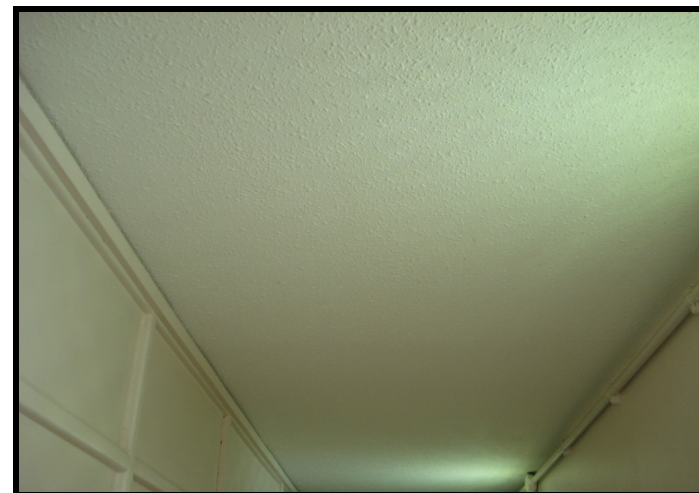
## SAMPLE REFERENCE 041

| Unique Sample No. | Building Reference (Floor) | Room Area | Description of Location | Product Description | Asbestos Type | Approx. Quantity | Material Condition | Surface Treatment | Material Risk Score | Priority Risk Score | Total Risk Score | Management Action | Next Review Date |
|---|---|---|---|---|---|---|---|---|---|---|---|---|---|
| 041 | Main Building (Sixth Floor) | Corridor 1 | Ceiling | Paint | No Asbestos Detected | 5.00m2 | Good condition | Sealed (1) | - | - | - | NO ACTION REQUIRED | |

**No Asbestos Presumed in Sample**

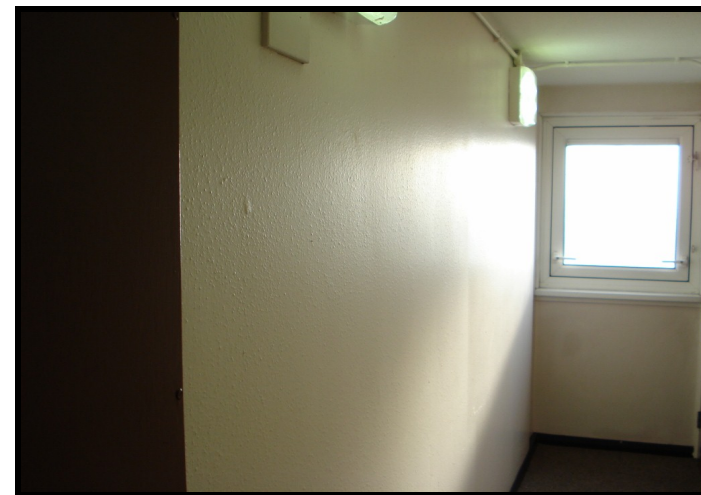
## SAMPLE REFERENCE 042

| Unique Sample No. | Building Reference (Floor) | Room Area | Description of Location | Product Description | Asbestos Type | Approx. Quantity | Material Condition | Surface Treatment | Material Risk Score | Priority Risk Score | Total Risk Score | Management Action | Next Review Date |
|---|---|---|---|---|---|---|---|---|---|---|---|---|---|
| 042 | Main Building (Sixth Floor) | Corridor 1 | Walls | Paint | No Asbestos Detected | 10.00m2 | Good condition | Sealed (1) | - | - | - | NO ACTION REQUIRED | |

**No Asbestos Presumed in Sample**

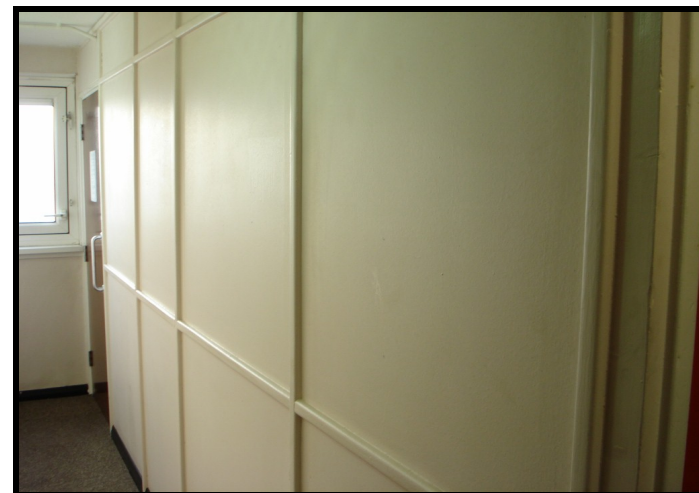
## SAMPLE REFERENCE 043

| Unique Sample No. | Building Reference (Floor) | Room Area | Description of Location | Product Description | Asbestos Type | Approx. Quantity | Material Condition | Surface Treatment | Material Risk Score | Priority Risk Score | Total Risk Score | Management Action | Next Review Date |
|---|---|---|---|---|---|---|---|---|---|---|---|---|---|
| 043 | Main Building (Sixth Floor) | Corridor 1 | Wall | Board | Amosite / Chrysotile | 10.00m2 | Good condition | Sealed Board (Encapsulated) | 5 | 1 | 6 | LABEL & MONITOR | 21 Sep 2012 |

Asbestos Presumed in Sample

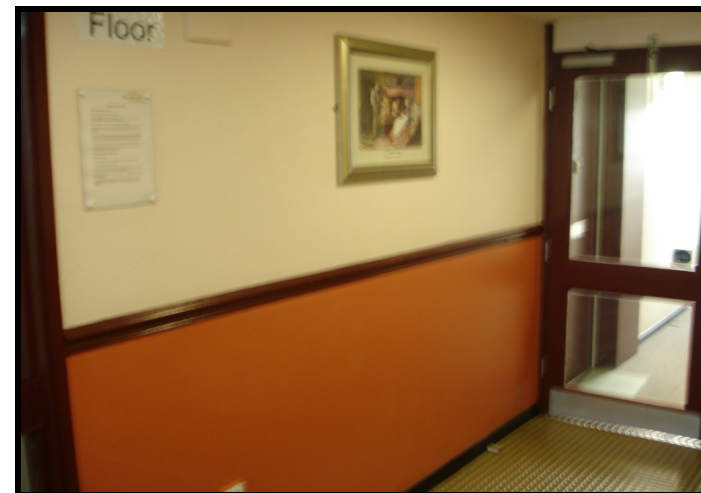
## SAMPLE REFERENCE 045

| Unique Sample No. | Building Reference (Floor) | Room Area | Description of Location | Product Description | Asbestos Type | Approx. Quantity | Material Condition | Surface Treatment | Material Risk Score | Priority Risk Score | Total Risk Score | Management Action | Next Review Date |
|---|---|---|---|---|---|---|---|---|---|---|---|---|---|
| 045 | Main Building (Sixth Floor) | Lift Lobby | Walls | Paint | No Asbestos Detected | 20.00m2 | No visible damage | Sealed (1) | - | - | - | NO ACTION REQUIRED | |

**No Asbestos Presumed in Sample**

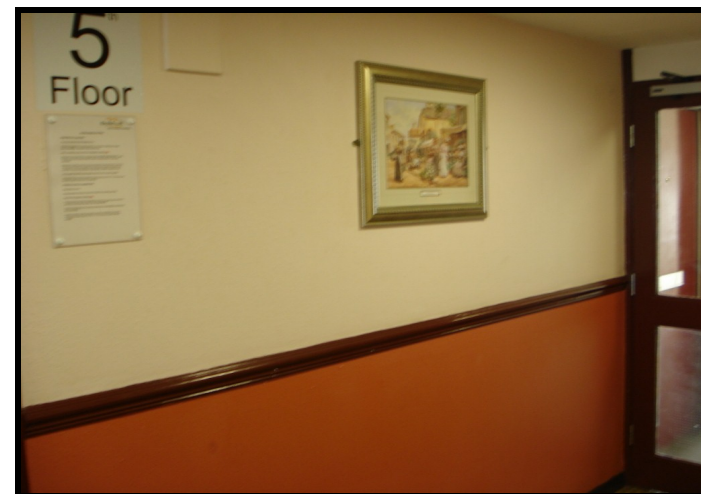
## SAMPLE REFERENCE 060

**No Asbestos Presumed in Sample**

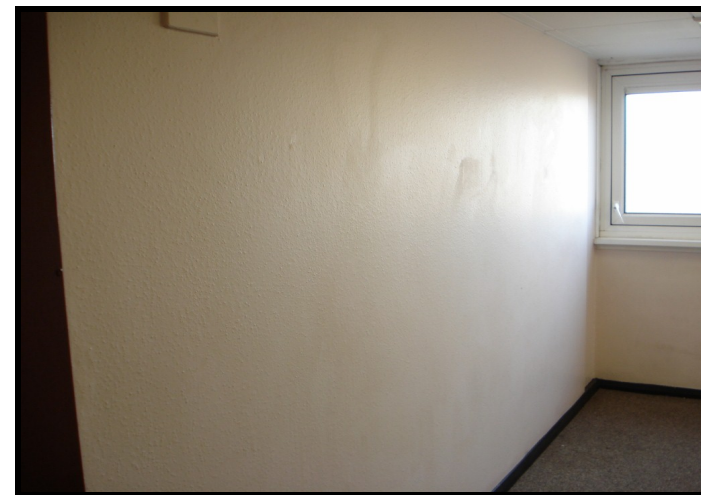
## SAMPLE REFERENCE 061

**No Asbestos Presumed in Sample**

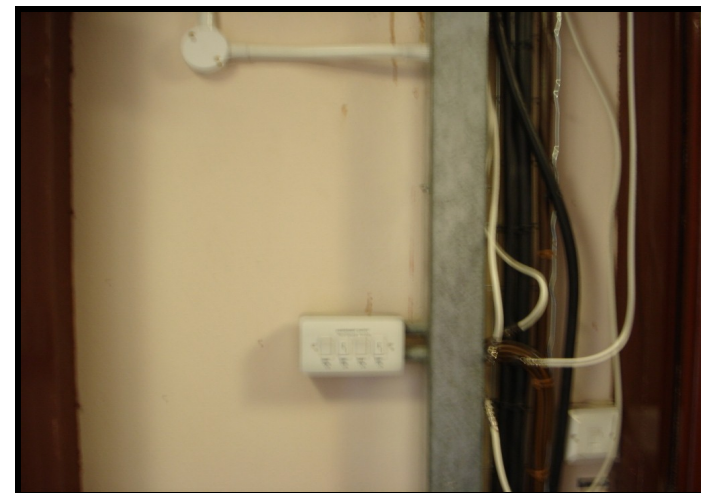
## SAMPLE REFERENCE 063

**No Asbestos Presumed in Sample**

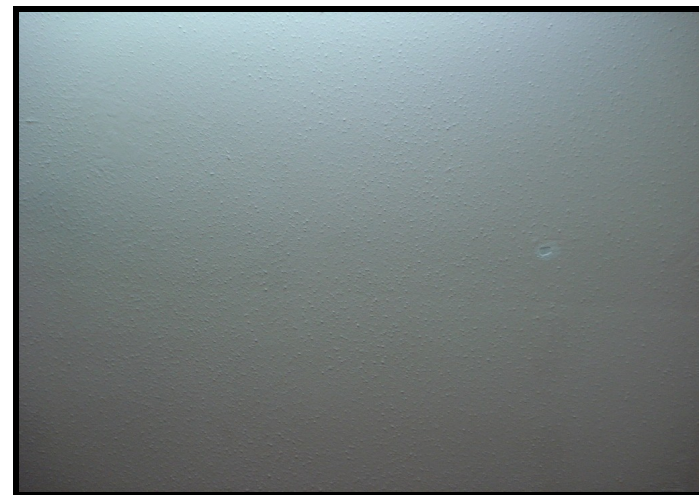
## SAMPLE REFERENCE 064

**Asbestos not detected in Sample**

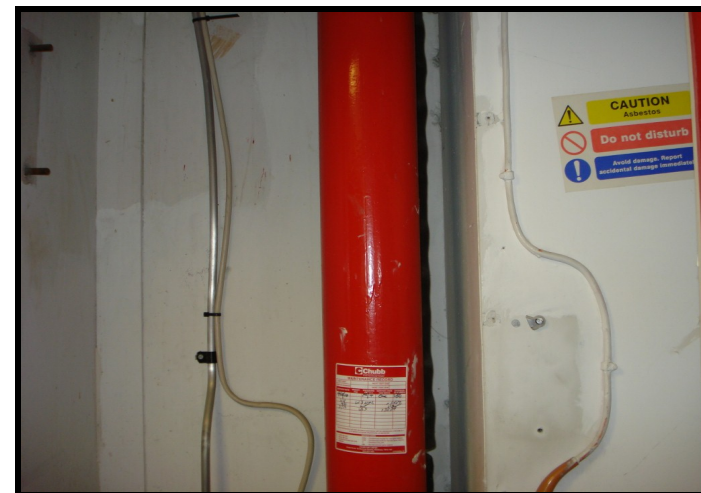
## SAMPLE REFERENCE 068

**No Asbestos Presumed in Sample**

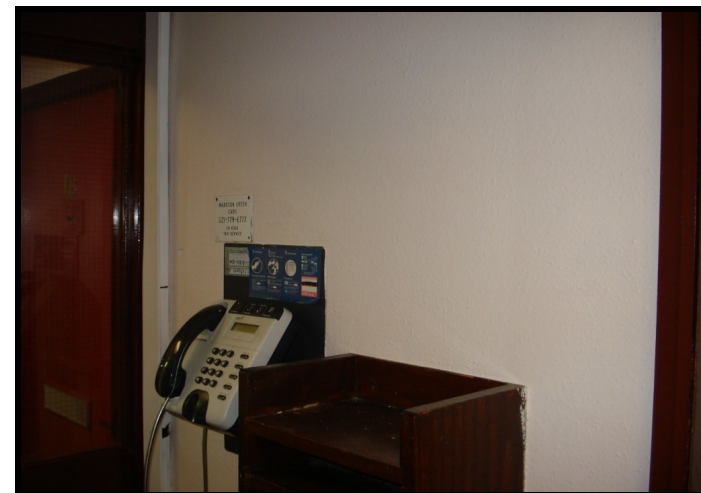
## SAMPLE REFERENCE 083

**No Asbestos Presumed in Sample**

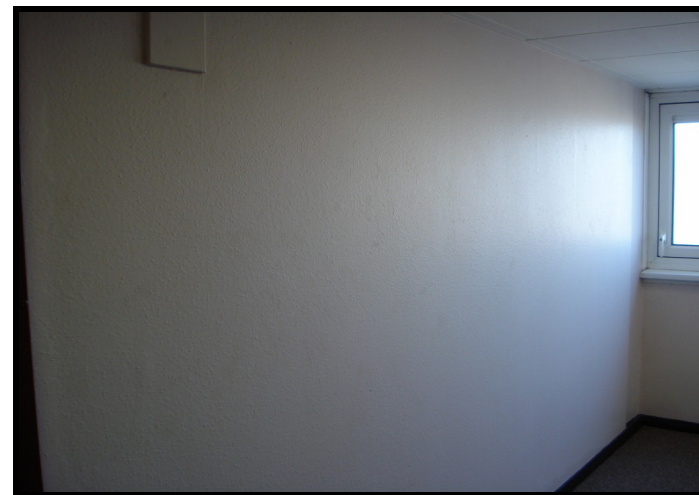
## SAMPLE REFERENCE 084

**No Asbestos Presumed in Sample**
