# Solihull Community Housing

## Asbestos Management Survey Report

**Greyfriars House  
Kington Gardens  
Chelmsley Wood  
B37 5HY**

**Survey Ref: 129250000A**

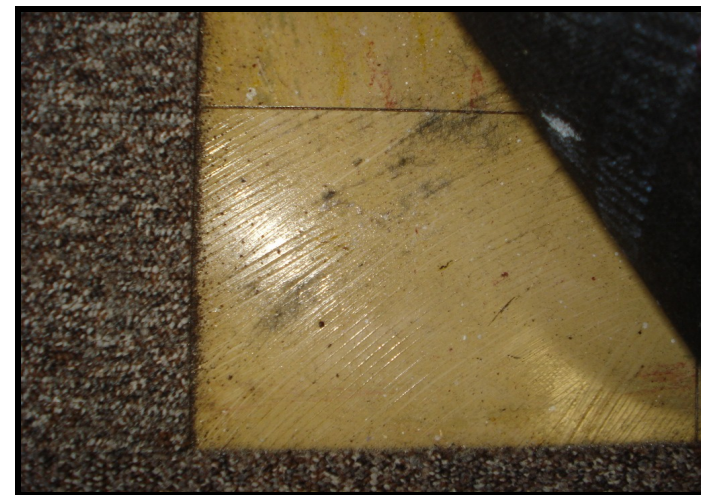
## SAMPLE REFERENCE 085

**No Asbestos Presumed in Sample**

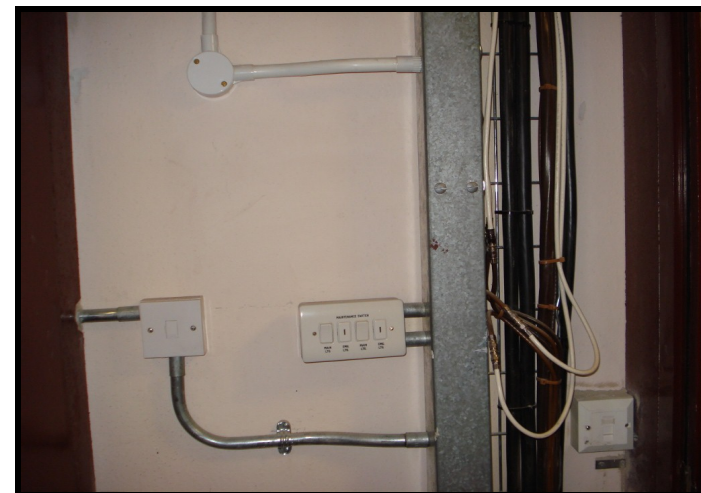
## SAMPLE REFERENCE 086

**No Asbestos Presumed in Sample**

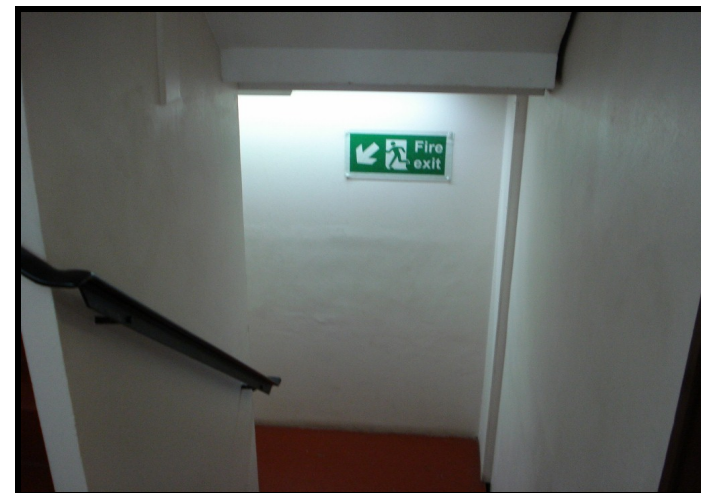
## SAMPLE REFERENCE 087

Asbestos Presumed in Sample

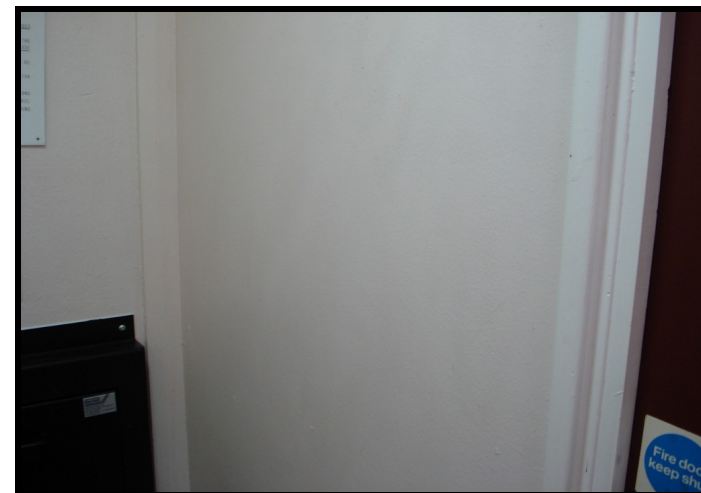
## SAMPLE REFERENCE 090

Asbestos Presumed in Sample

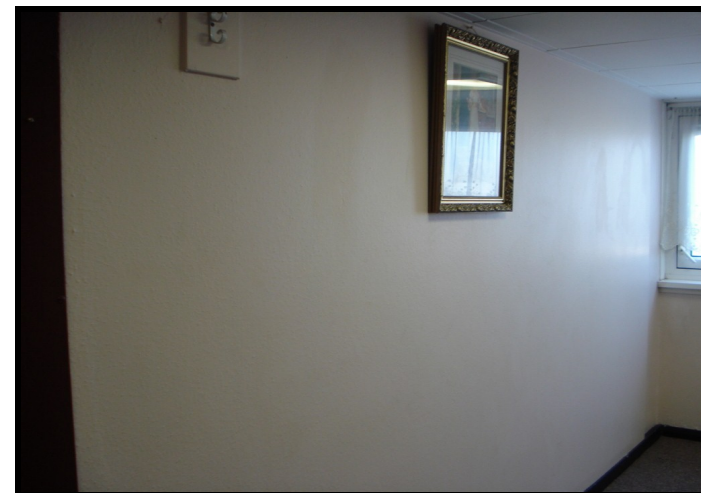
## SAMPLE REFERENCE 099

**No Asbestos Presumed in Sample**

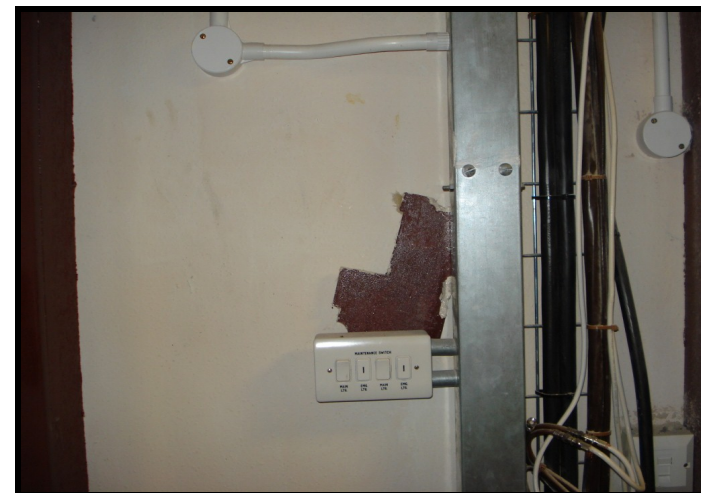
## SAMPLE REFERENCE 100

**No Asbestos Presumed in Sample**

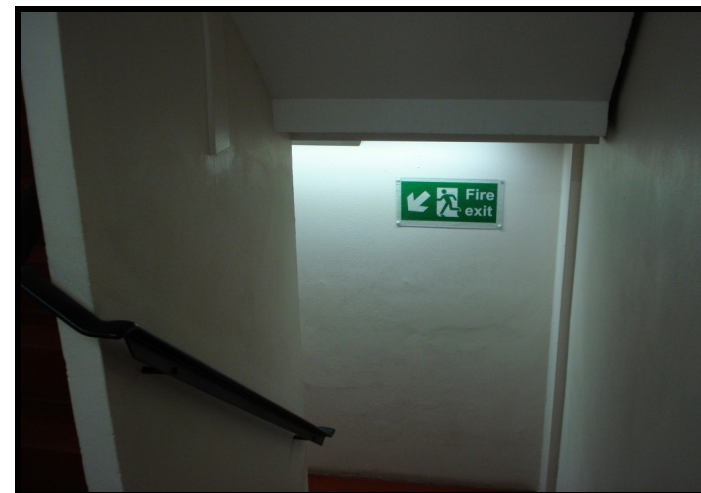
## SAMPLE REFERENCE 101

**No Asbestos Presumed in Sample**

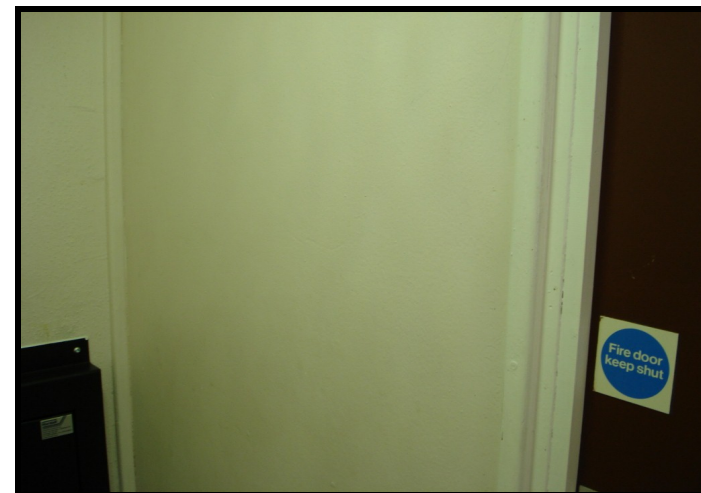
## SAMPLE REFERENCE 105

Asbestos Presumed in Sample

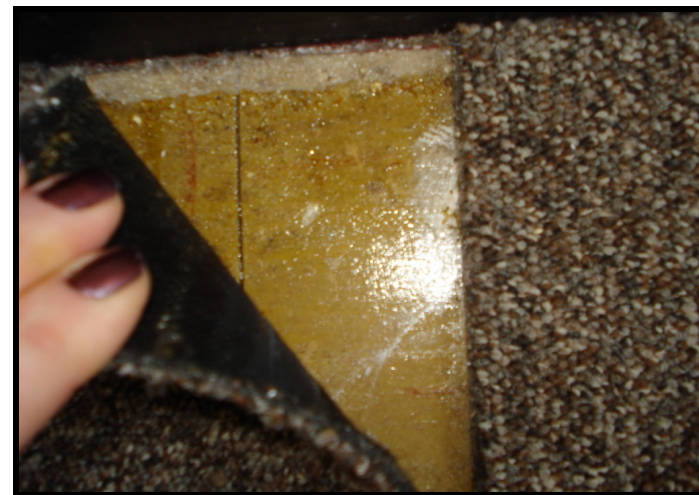
## SAMPLE REFERENCE 109

Asbestos Presumed in Sample

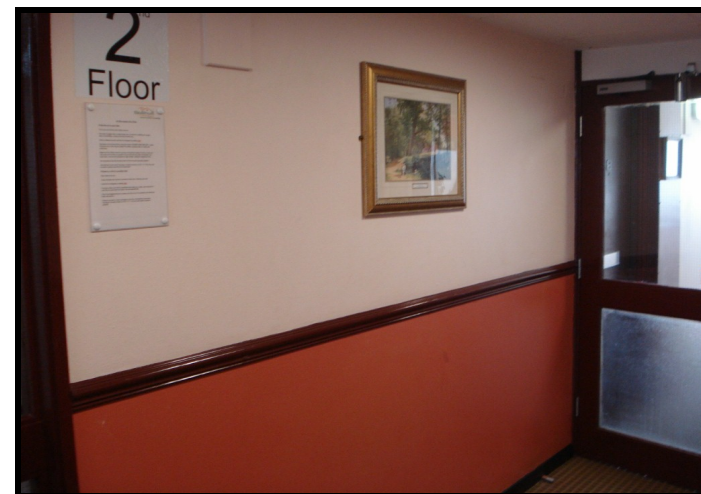
## SAMPLE REFERENCE I I 3

**No Asbestos Presumed in Sample**

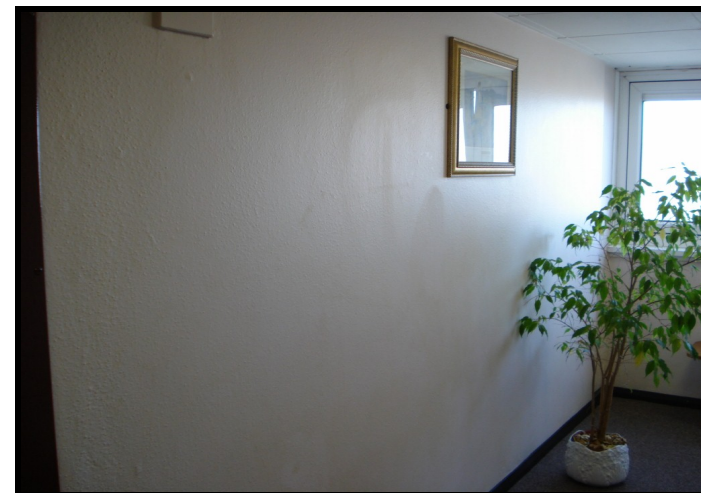
## SAMPLE REFERENCE I I 4

**No Asbestos Presumed in Sample**

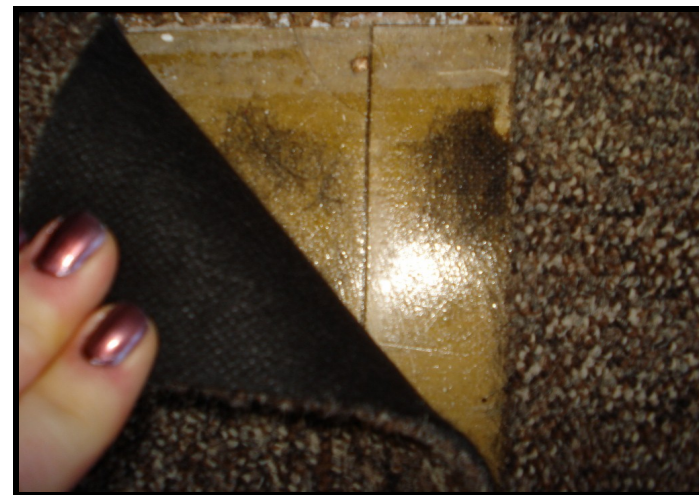
## SAMPLE REFERENCE I I 5

**No Asbestos Presumed in Sample**

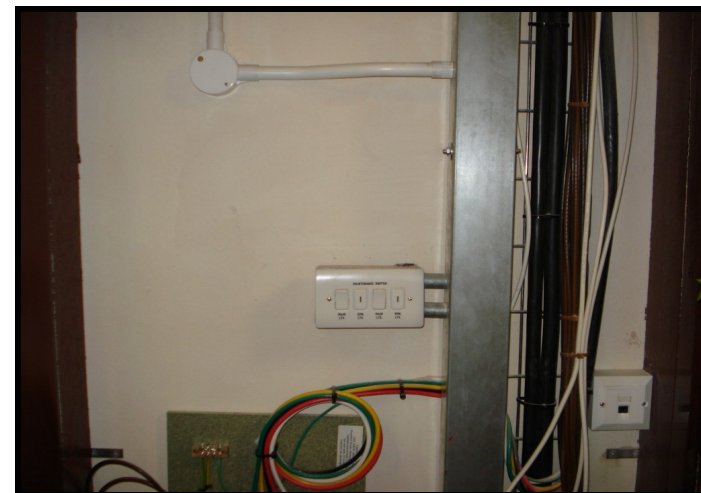
## SAMPLE REFERENCE I 16

**No Asbestos Presumed in Sample**

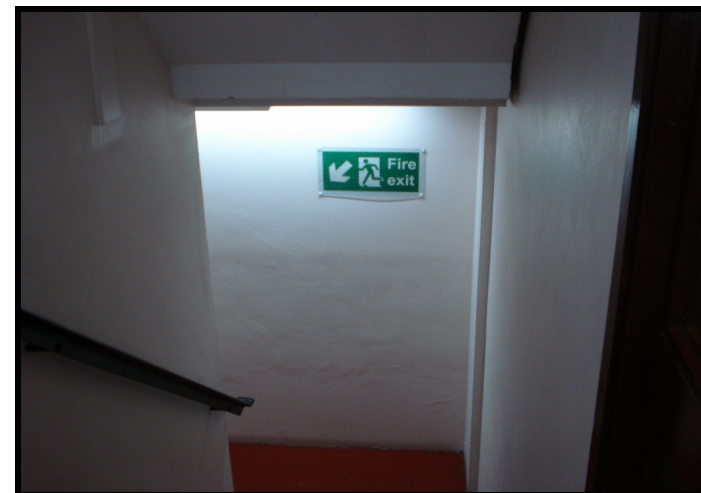
## SAMPLE REFERENCE I I 7

Asbestos Presumed in Sample

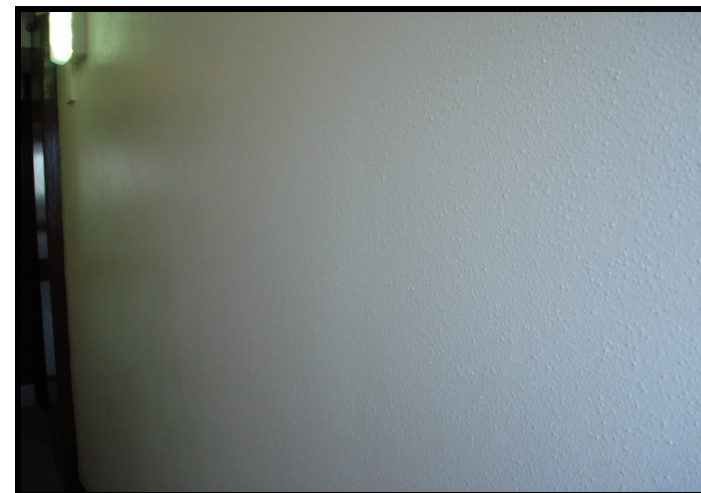
## SAMPLE REFERENCE 123

Asbestos Presumed in Sample

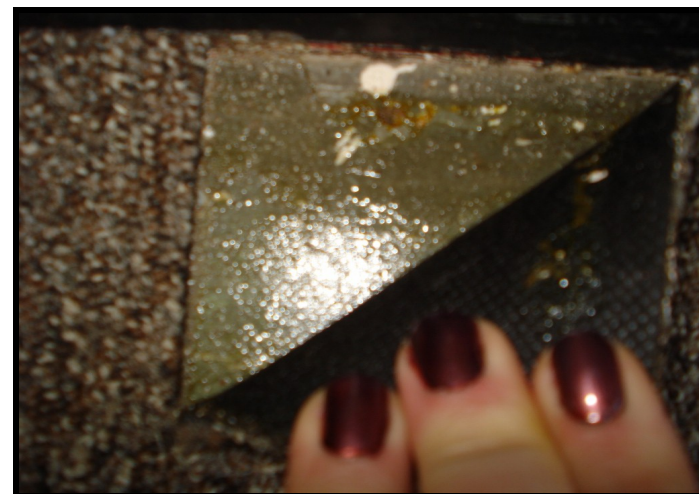
## SAMPLE REFERENCE 125

Asbestos Presumed in Sample

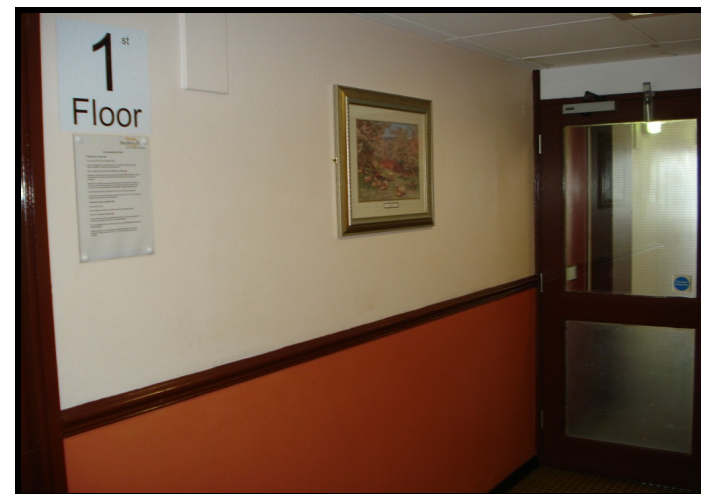
## SAMPLE REFERENCE 130

**No Asbestos Presumed in Sample**

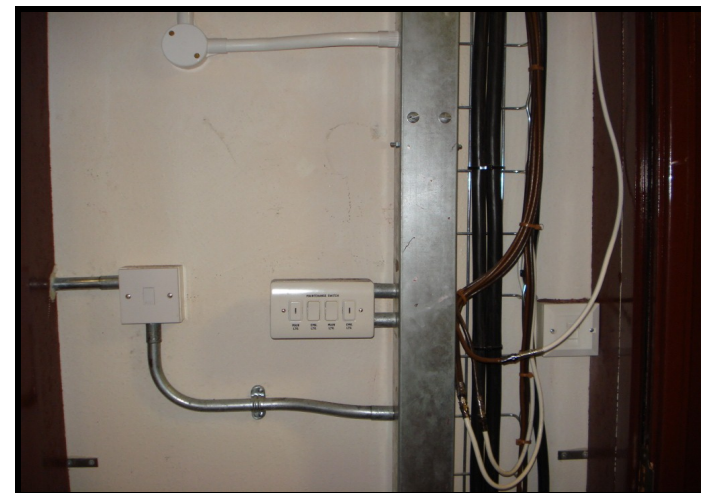
## SAMPLE REFERENCE 134

**Asbestos not detected in Sample**

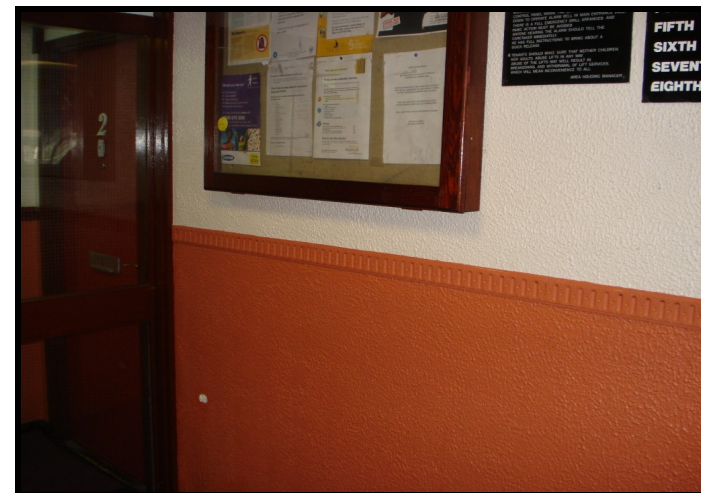
## SAMPLE REFERENCE 140

Asbestos Presumed in Sample

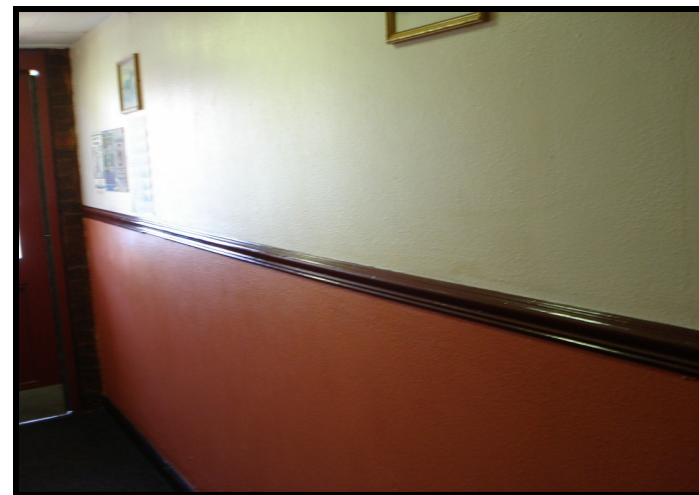
## SAMPLE REFERENCE I45

**No Asbestos Presumed in Sample**
