# Site ID: **a-306148**

## Management with Targeted Refurbishment Survey – PART 1

1-83 Keele House  
Forth Drive  
Chelmsley Wood  
Solihull  
West Midlands  
B37 6PN  
United Kingdom

**25th May 2021**

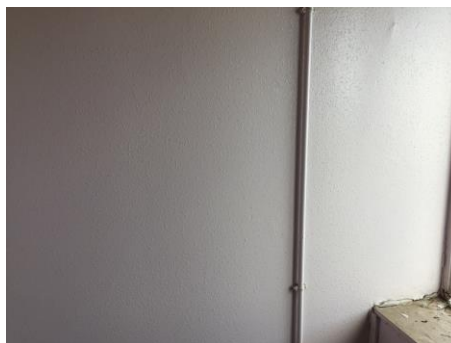
Spatter pattern textured coating.

The material was seen to be in fair condition at the time of the initial inspection.

The condition of the material should be managed by a competent person/company and its presence made aware to those at risk, as part of a Control of Asbestos Regulations (CAR) 2012 compliant management strategy.

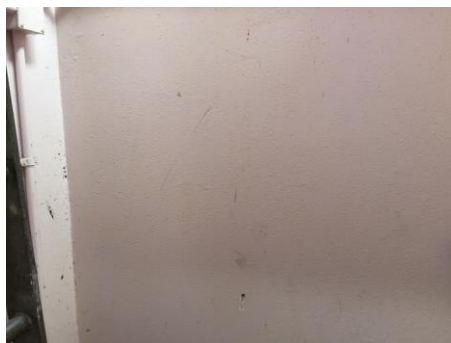
Spatter pattern textured coating.

The material was seen to be in fair condition at the time of the initial inspection.

The condition of the material should be managed by a competent person/company and its presence made aware to those at risk, as part of a Control of Asbestos Regulations (CAR) 2012 compliant management strategy.

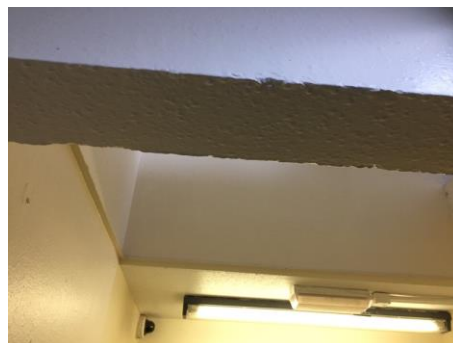
Spatter pattern textured coating.

The material was seen to be in fair condition at the time of the initial inspection.

The condition of the material should be managed by a competent person/company and its presence made aware to those at risk, as part of a Control of Asbestos Regulations (CAR) 2012 compliant management strategy.

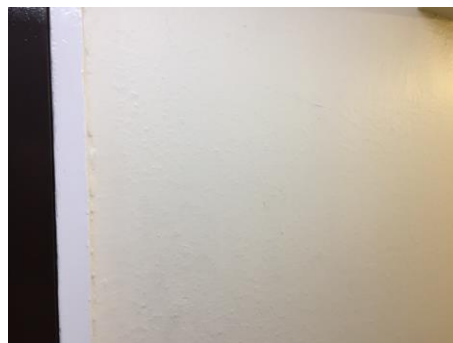
Spatter pattern textured coating.

The material was seen to be in fair condition at the time of the initial inspection.

The condition of the material should be managed by a competent person/company and its presence made aware to those at risk, as part of a Control of Asbestos Regulations (CAR) 2012 compliant management strategy.

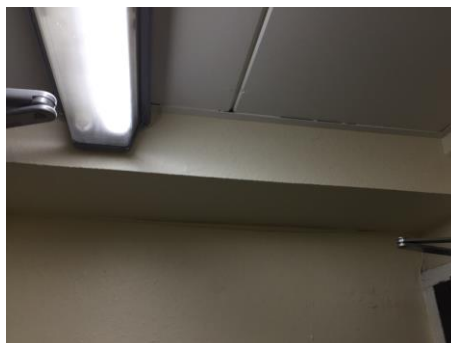
Cement boxing between doors.

The material was seen to be in fair condition at the time of the initial inspection.

The condition of the material should be managed by a competent person/company and its presence made aware to those at risk, as part of a Control of Asbestos Regulations (CAR) 2012 compliant management strategy.

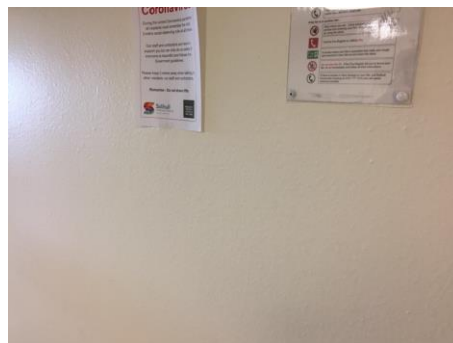
Spatter pattern textured coating.

The material was seen to be in fair condition at the time of the initial inspection.

The condition of the material should be managed by a competent person/company and its presence made aware to those at risk, as part of a Control of Asbestos Regulations (CAR) 2012 compliant management strategy.

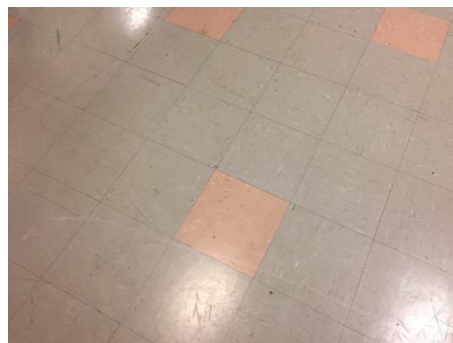
Pink and grey floor tiles.

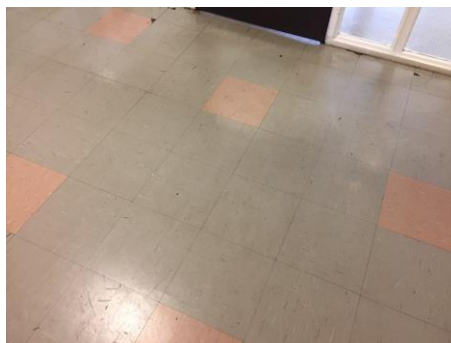
Bitumen adhesive beneath floor tiles.

The material was seen to be in fair condition at the time of the initial inspection.

The condition of the material should be managed by a competent person/company and its presence made aware to those at risk, as part of a Control of Asbestos Regulations (CAR) 2012 compliant management strategy.

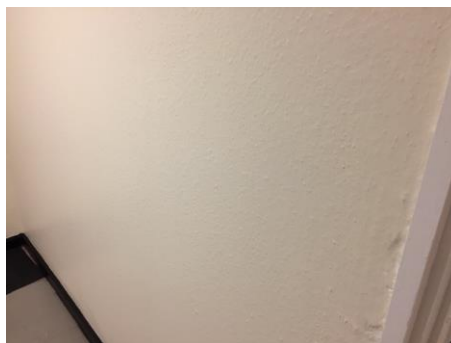
Spatter pattern textured coating.

The material was seen to be in fair condition at the time of the initial inspection.

The condition of the material should be managed by a competent person/company and its presence made aware to those at risk, as part of a Control of Asbestos Regulations (CAR) 2012 compliant management strategy.

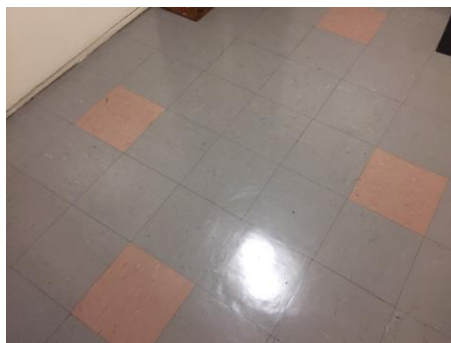
Pink and grey floor tiles.

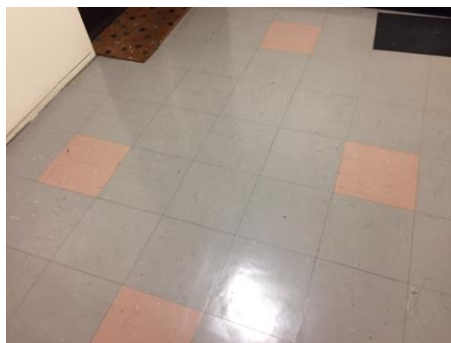
Bitumen adhesive beneath floor tiles.

The material was seen to be in fair condition at the time of the initial inspection.

The condition of the material should be managed by a competent person/company and its presence made aware to those at risk, as part of a Control of Asbestos Regulations (CAR) 2012 compliant management strategy.

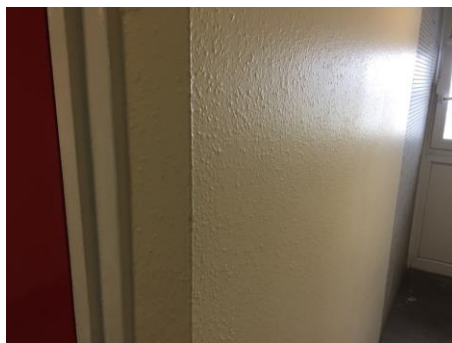
Spatter pattern textured coating.

The material was seen to be in fair condition at the time of the initial inspection.

The condition of the material should be managed by a competent person/company and its presence made aware to those at risk, as part of a Control of Asbestos Regulations (CAR) 2012 compliant management strategy.

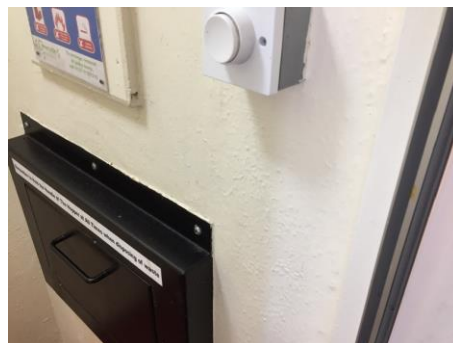
Spatter pattern textured coating.

The material was seen to be in fair condition at the time of the initial inspection.

The condition of the material should be managed by a competent person/company and its presence made aware to those at risk, as part of a Control of Asbestos Regulations (CAR) 2012 compliant management strategy.

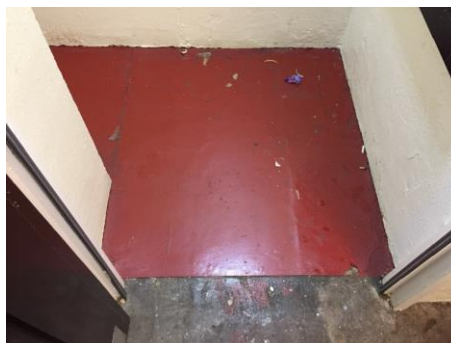
Brown floor tiles painted red.

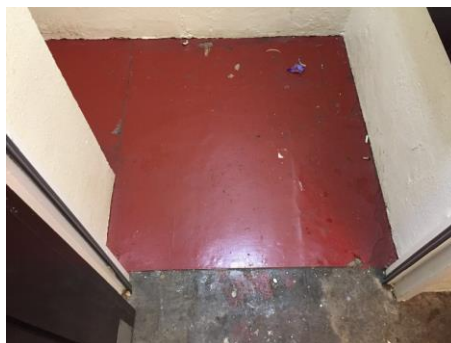
Bitumen adhesive beneath floor tiles.

The material was seen to be in fair condition at the time of the initial inspection.

The condition of the material should be managed by a competent person/company and its presence made aware to those at risk, as part of a Control of Asbestos Regulations (CAR) 2012 compliant management strategy.

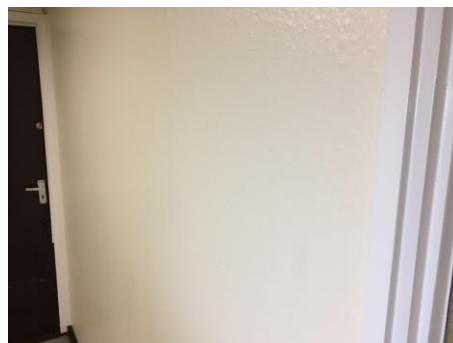
Spatter pattern textured coating.

The material was seen to be in fair condition at the time of the initial inspection.

The condition of the material should be managed by a competent person/company and its presence made aware to those at risk, as part of a Control of Asbestos Regulations (CAR) 2012 compliant management strategy.

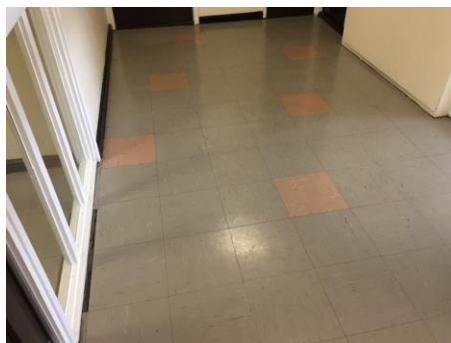
Pink and grey floor tiles.

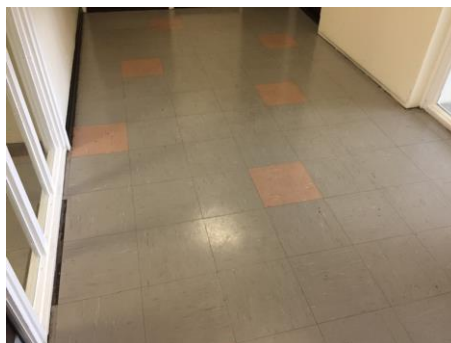
Bitumen adhesive beneath floor tiles.

The material was seen to be in fair condition at the time of the initial inspection.

The condition of the material should be managed by a competent person/company and its presence made aware to those at risk, as part of a Control of Asbestos Regulations (CAR) 2012 compliant management strategy.

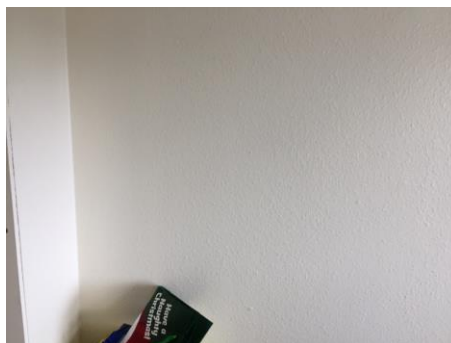
Spatter pattern textured coating.

The material was seen to be in fair condition at the time of the initial inspection.

The condition of the material should be managed by a competent person/company and its presence made aware to those at risk, as part of a Control of Asbestos Regulations (CAR) 2012 compliant management strategy.

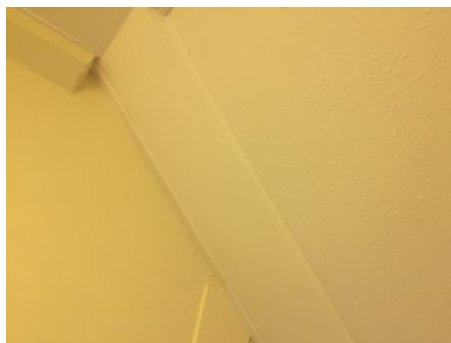
Spatter pattern textured coating.

The material was seen to be in fair condition at the time of the initial inspection.

The condition of the material should be managed by a competent person/company and its presence made aware to those at risk, as part of a Control of Asbestos Regulations (CAR) 2012 compliant management strategy.

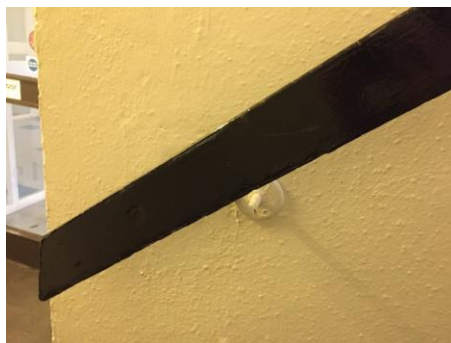
Spatter pattern textured coating.

The material was seen to be in fair condition at the time of the initial inspection.

The condition of the material should be managed by a competent person/company and its presence made aware to those at risk, as part of a Control of Asbestos Regulations (CAR) 2012 compliant management strategy.

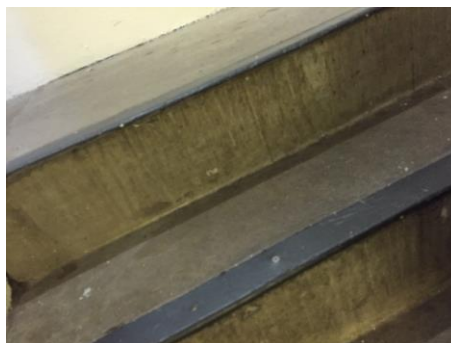
Resin nosing to edge of stairs.

The material was seen to be in fair condition at the time of the initial inspection.

The condition of the material should be managed by a competent person/company and its presence made aware to those at risk, as part of a Control of Asbestos Regulations (CAR) 2012 compliant management strategy.

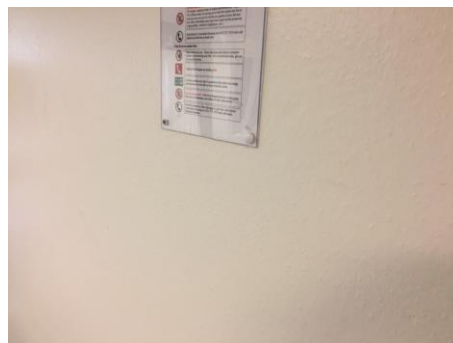
Spatter pattern textured coating.

The material was seen to be in fair condition at the time of the initial inspection.

The condition of the material should be managed by a competent person/company and its presence made aware to those at risk, as part of a Control of Asbestos Regulations (CAR) 2012 compliant management strategy.

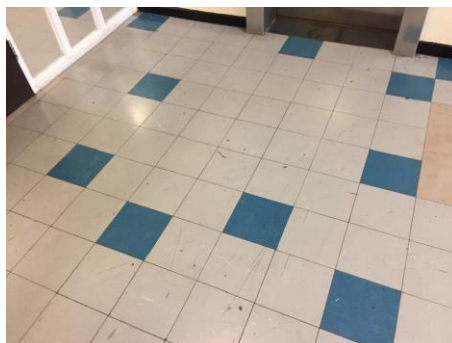
Blue and grey floor tiles.

The material was seen to be in fair condition at the time of the initial inspection.

The condition of the material should be managed by a competent person/company and its presence made aware to those at risk, as part of a Control of Asbestos Regulations (CAR) 2012 compliant management strategy.

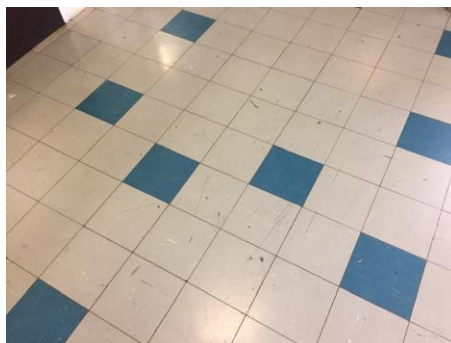
Bitumen adhesive beneath floor tiles.

The material was seen to be in fair condition at the time of the initial inspection.

The condition of the material should be managed by a competent person/company and its presence made aware to those at risk, as part of a Control of Asbestos Regulations (CAR) 2012 compliant management strategy.

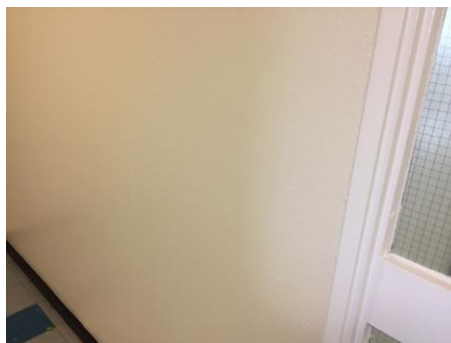
Spatter pattern textured coating.

The material was seen to be in fair condition at the time of the initial inspection.

The condition of the material should be managed by a competent person/company and its presence made aware to those at risk, as part of a Control of Asbestos Regulations (CAR) 2012 compliant management strategy.

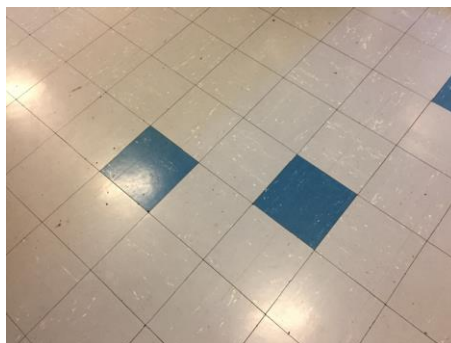
Blue and grey floor tiles.

The material was seen to be in fair condition at the time of the initial inspection.

The condition of the material should be managed by a competent person/company and its presence made aware to those at risk, as part of a Control of Asbestos Regulations (CAR) 2012 compliant management strategy.

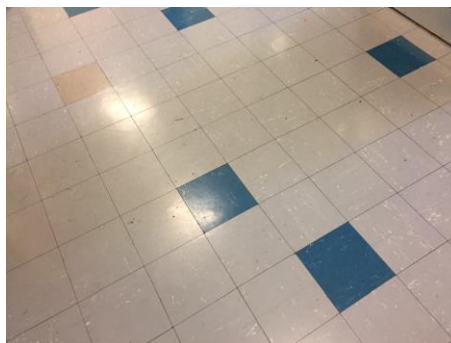
Bitumen adhesive beneath floor tiles.

The material was seen to be in fair condition at the time of the initial inspection.

The condition of the material should be managed by a competent person/company and its presence made aware to those at risk, as part of a Control of Asbestos Regulations (CAR) 2012 compliant management strategy.

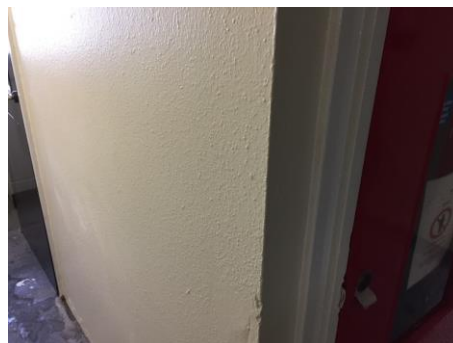
Spatter pattern textured coating.

The material was seen to be in fair condition at the time of the initial inspection.

The condition of the material should be managed by a competent person/company and its presence made aware to those at risk, as part of a Control of Asbestos Regulations (CAR) 2012 compliant management strategy.

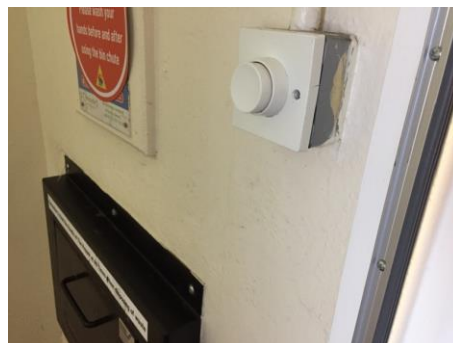
Spatter pattern textured coating.

The material was seen to be in fair condition at the time of the initial inspection.

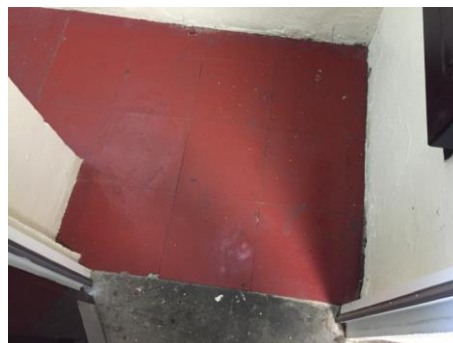
Brown floor tiles painted red.

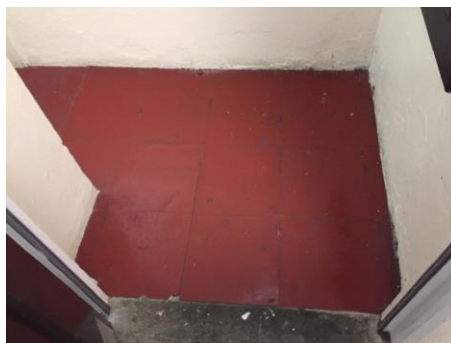
Bitumen adhesive beneath floor tiles.

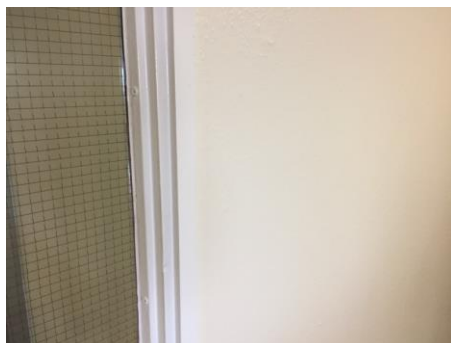
Spatter pattern textured coating.

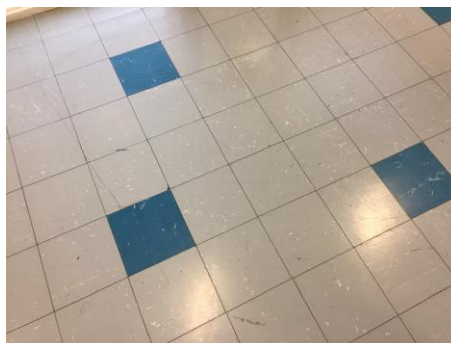
Blue and grey floor tiles.

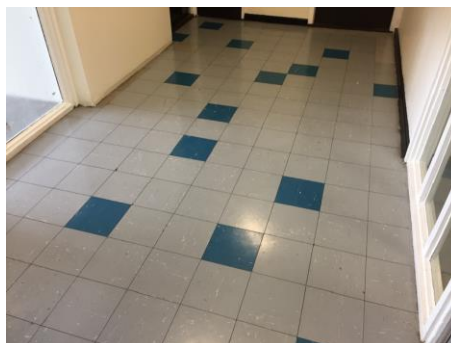
Bitumen adhesive beneath floor tiles.

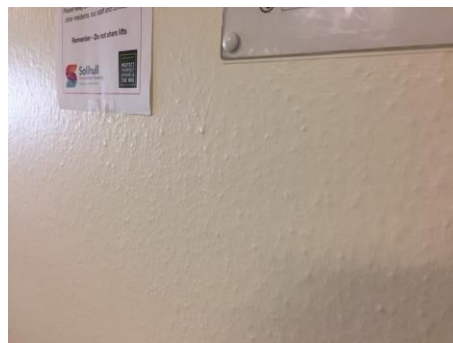
Spatter pattern textured coating.

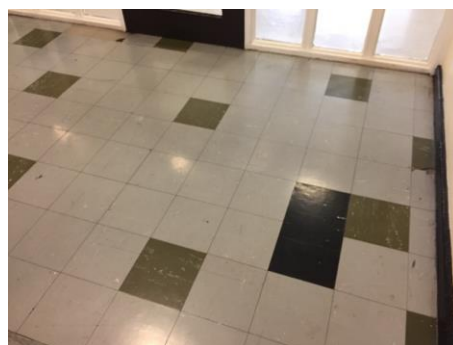
Green and grey floor tiles.

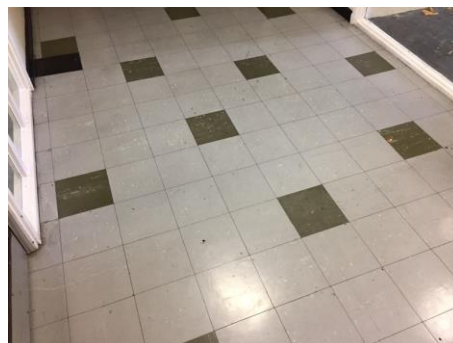
Green and grey floor tiles.

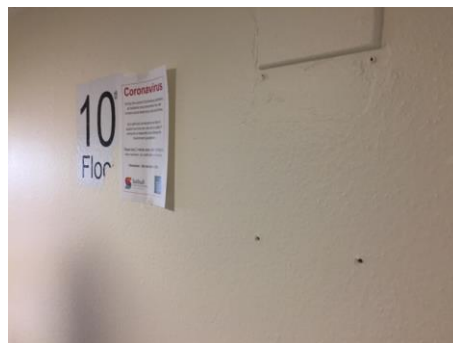
Spatter pattern textured coating.

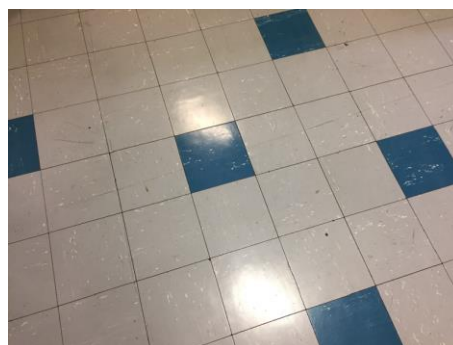
Blue and grey floor tiles.

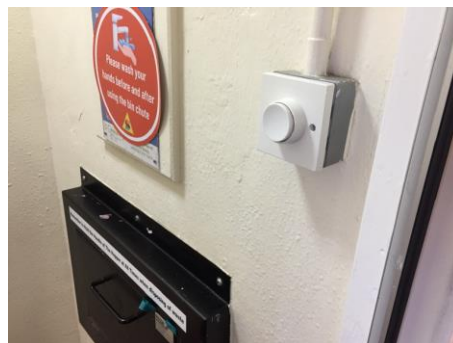
Spatter pattern textured coating.

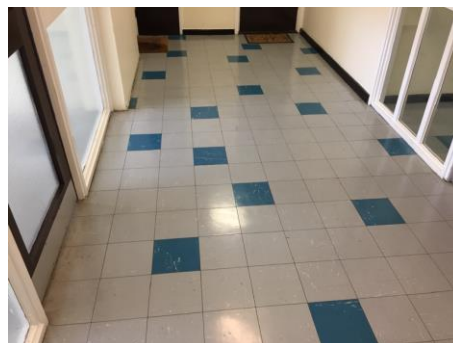
Blue and grey floor tiles.

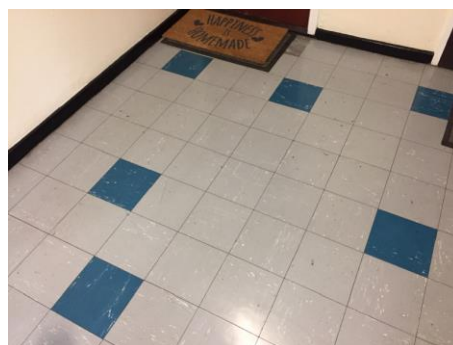
Bitumen adhesive beneath floor tiles.

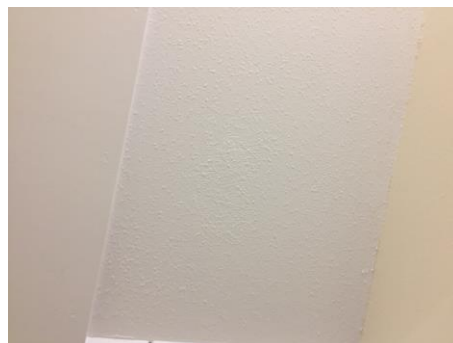
Spatter pattern textured coating.

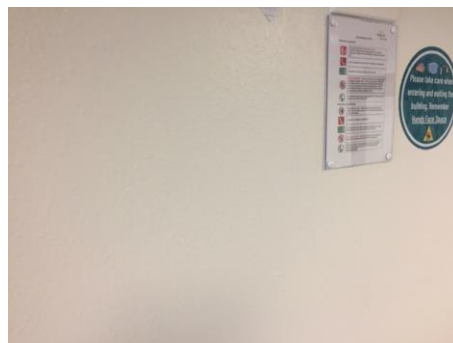
Spatter pattern textured coating.

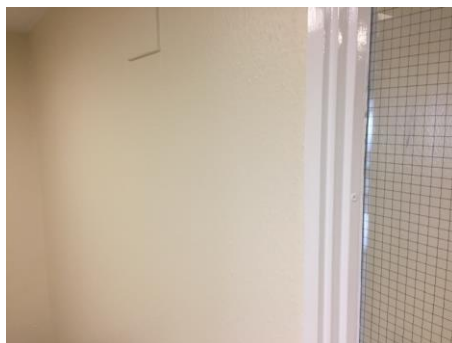
Spatter pattern textured coating.

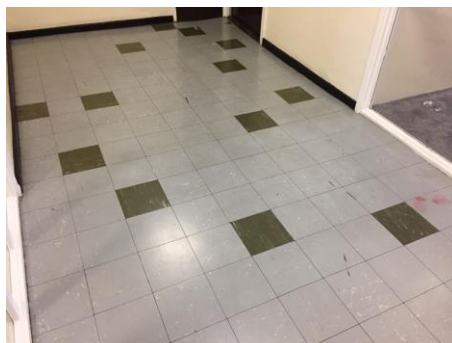
Green and grey floor tiles.

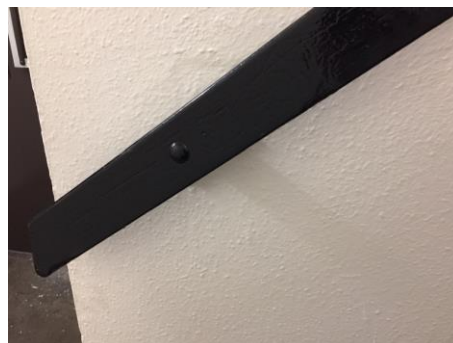
Spatter pattern textured coating.

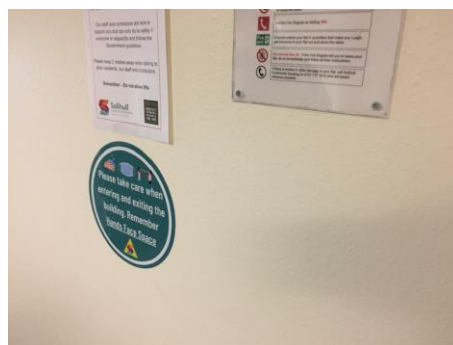
Spatter pattern textured coating.

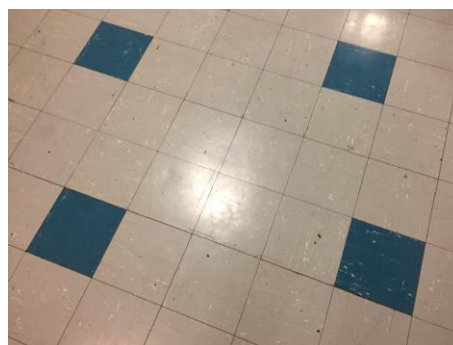
Blue and grey floor tiles.

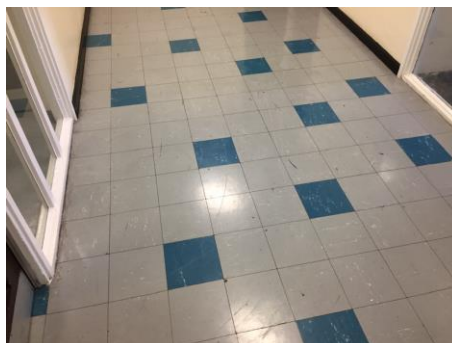
Blue and grey floor tiles.

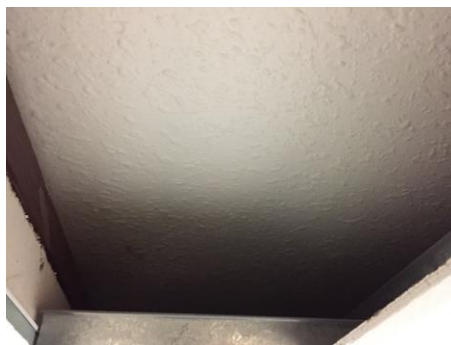
Spatter pattern textured coating above suspended ceiling.

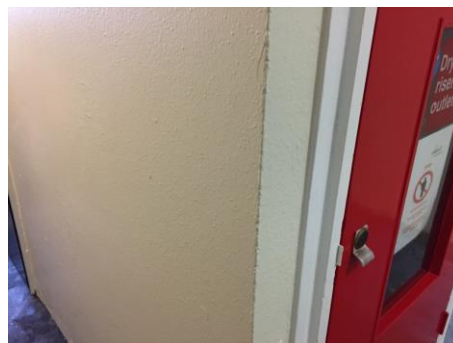
Spatter pattern textured coating.

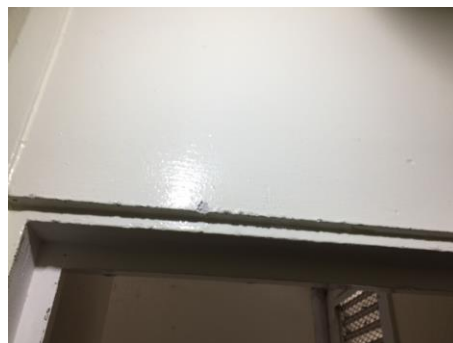
Insulating board transom panel over Incinerator door.

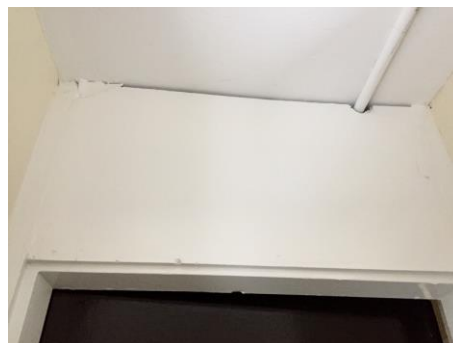
Insulating board transom panel over bin chute door.

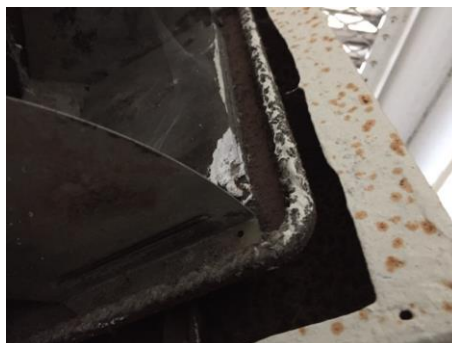
Rope seal to drawer of incinerator.

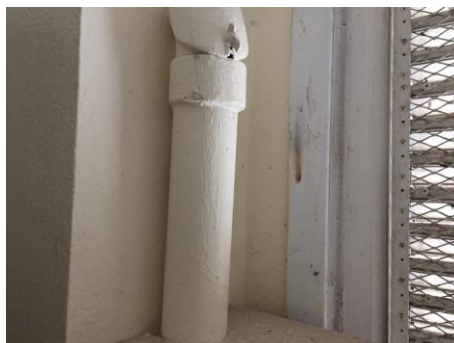
Cement flue for incinerator.

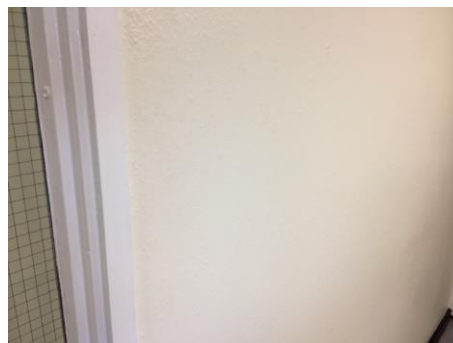
Spatter pattern textured coating.

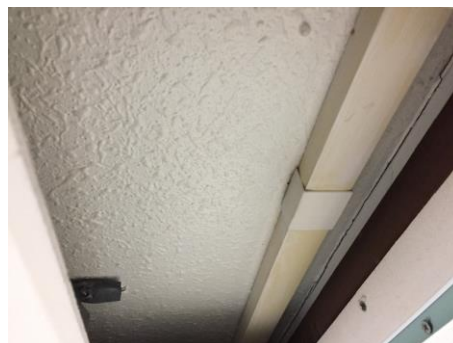
Spatter pattern textured coating above suspended ceiling.

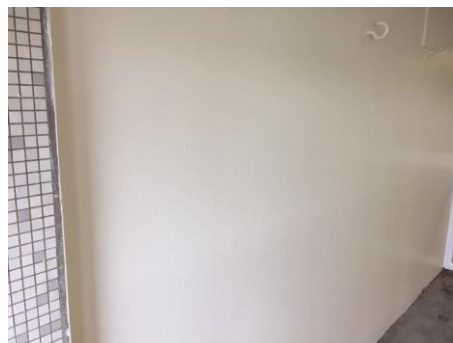
Spatter pattern textured coating.

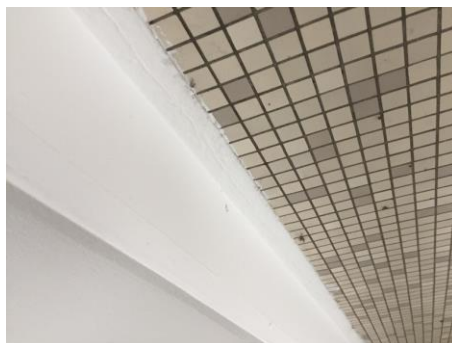
Spatter pattern textured coating above suspended ceiling.
