# Site ID: **a-307203**

## Management with Targeted Refurbishment Survey – PART 2

1-83 Keele House  
Forth Drive  
Chelmsley Wood  
Solihull  
B37 6PN  
United Kingdom

**26th May 2021**

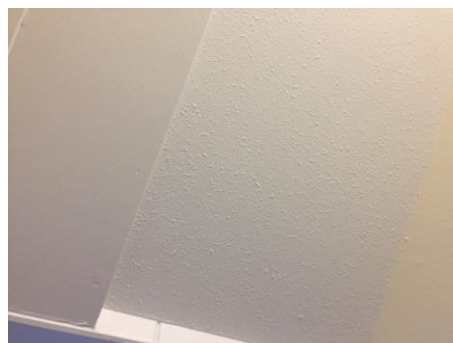
Spatter pattern textured coating.

The material was seen to be in fair condition at the time of the initial inspection.

The condition of the material should be managed by a competent person/company and its presence made aware to those at risk, as part of a Control of Asbestos Regulations (CAR) 2012 compliant management strategy.

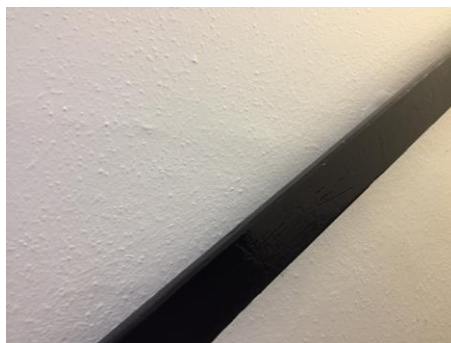
Spatter pattern textured coating.

The material was seen to be in fair condition at the time of the initial inspection.

The condition of the material should be managed by a competent person/company and its presence made aware to those at risk, as part of a Control of Asbestos Regulations (CAR) 2012 compliant management strategy.

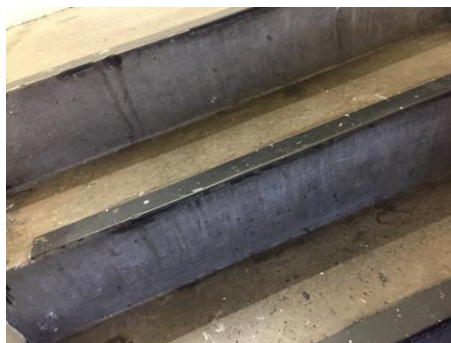
Resin nosing to edge of stairs.

The material was seen to be in fair condition at the time of the initial inspection.

The condition of the material should be managed by a competent person/company and its presence made aware to those at risk, as part of a Control of Asbestos Regulations (CAR) 2012 compliant management strategy.

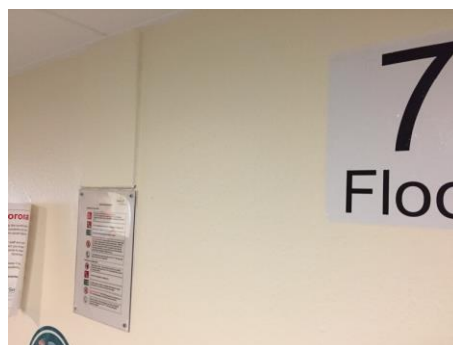
Spatter pattern textured coating.

The material was seen to be in fair condition at the time of the initial inspection.

The condition of the material should be managed by a competent person/company and its presence made aware to those at risk, as part of a Control of Asbestos Regulations (CAR) 2012 compliant management strategy.

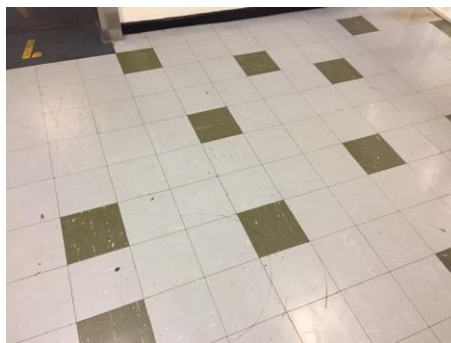
Green and grey floor tiles.

The material was seen to be in fair condition at the time of the initial inspection.

The condition of the material should be managed by a competent person/company and its presence made aware to those at risk, as part of a Control of Asbestos Regulations (CAR) 2012 compliant management strategy.

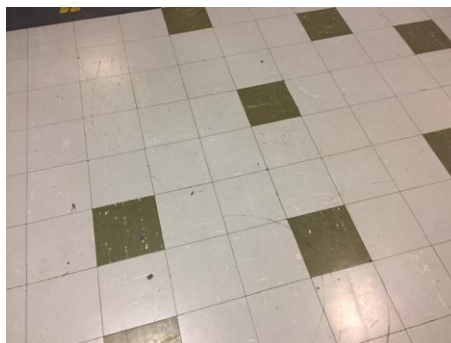
Bitumen adhesive beneath floor tiles.

The material was seen to be in fair condition at the time of the initial inspection.

The condition of the material should be managed by a competent person/company and its presence made aware to those at risk, as part of a Control of Asbestos Regulations (CAR) 2012 compliant management strategy.

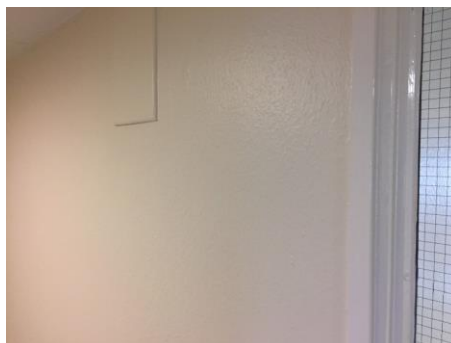
Spatter pattern textured coating.

The material was seen to be in fair condition at the time of the initial inspection.

The condition of the material should be managed by a competent person/company and its presence made aware to those at risk, as part of a Control of Asbestos Regulations (CAR) 2012 compliant management strategy.

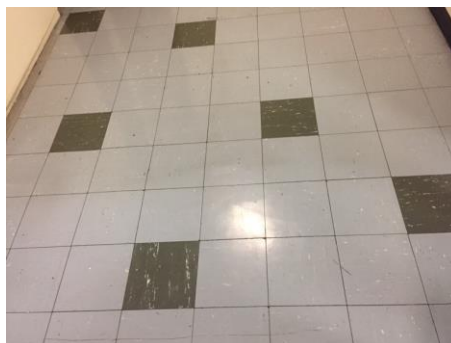
Green and grey floor tiles.

The material was seen to be in fair condition at the time of the initial inspection.

The condition of the material should be managed by a competent person/company and its presence made aware to those at risk, as part of a Control of Asbestos Regulations (CAR) 2012 compliant management strategy.

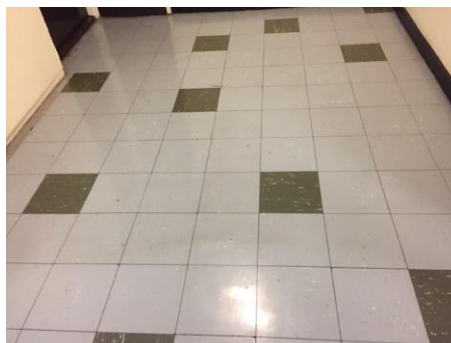
Bitumen adhesive beneath floor tiles.

The material was seen to be in fair condition at the time of the initial inspection.

The condition of the material should be managed by a competent person/company and its presence made aware to those at risk, as part of a Control of Asbestos Regulations (CAR) 2012 compliant management strategy.

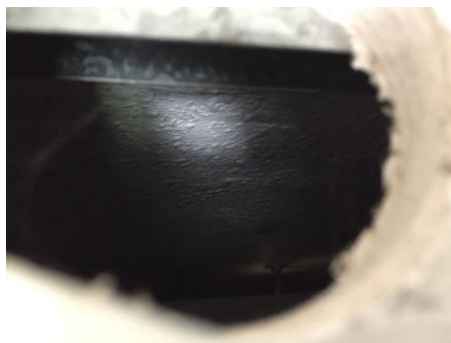
Spatter pattern textured coating.

The material was seen to be in fair condition at the time of the initial inspection.

The condition of the material should be managed by a competent person/company and its presence made aware to those at risk, as part of a Control of Asbestos Regulations (CAR) 2012 compliant management strategy.

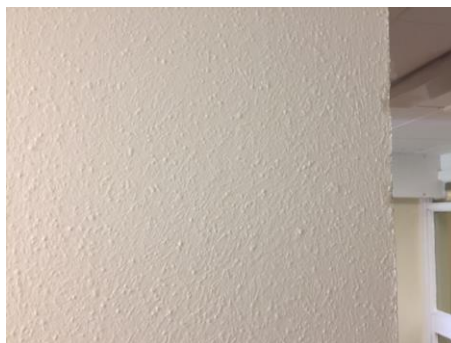
Spatter pattern textured coating.

The material was seen to be in fair condition at the time of the initial inspection.

The condition of the material should be managed by a competent person/company and its presence made aware to those at risk, as part of a Control of Asbestos Regulations (CAR) 2012 compliant management strategy.

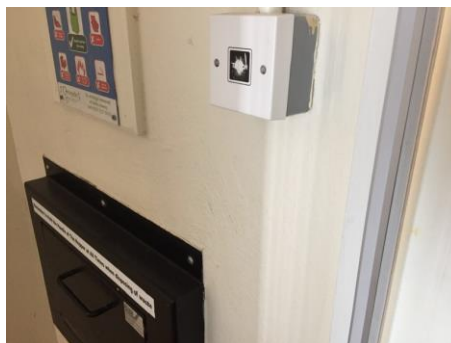
Spatter pattern textured coating.

The material was seen to be in fair condition at the time of the initial inspection.

The condition of the material should be managed by a competent person/company and its presence made aware to those at risk, as part of a Control of Asbestos Regulations (CAR) 2012 compliant management strategy.

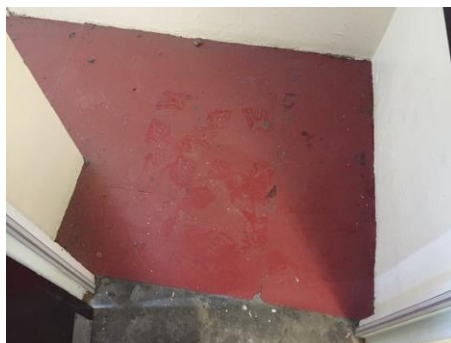
Brown floor tiles painted red.

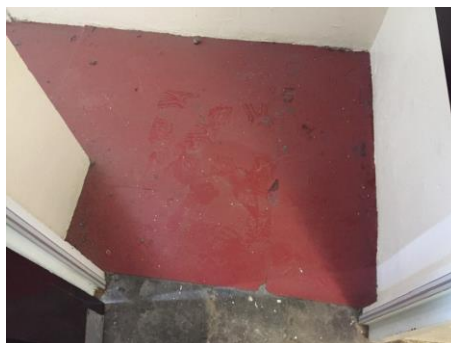
Bitumen adhesive beneath floor tiles.

The material was seen to be in fair condition at the time of the initial inspection.

The condition of the material should be managed by a competent person/company and its presence made aware to those at risk, as part of a Control of Asbestos Regulations (CAR) 2012 compliant management strategy.

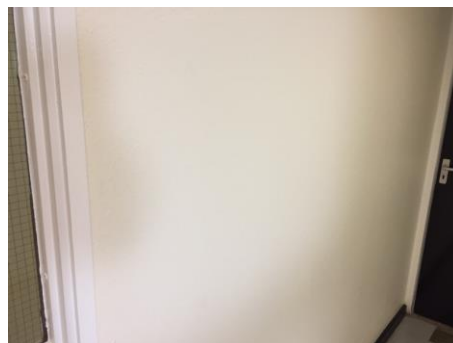
Spatter pattern textured coating.

The material was seen to be in fair condition at the time of the initial inspection.

The condition of the material should be managed by a competent person/company and its presence made aware to those at risk, as part of a Control of Asbestos Regulations (CAR) 2012 compliant management strategy.

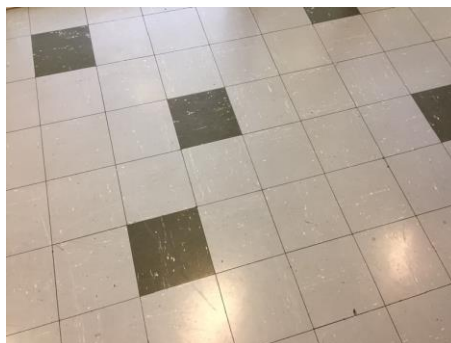
Green and grey floor tiles.

The material was seen to be in fair condition at the time of the initial inspection.

The condition of the material should be managed by a competent person/company and its presence made aware to those at risk, as part of a Control of Asbestos Regulations (CAR) 2012 compliant management strategy.

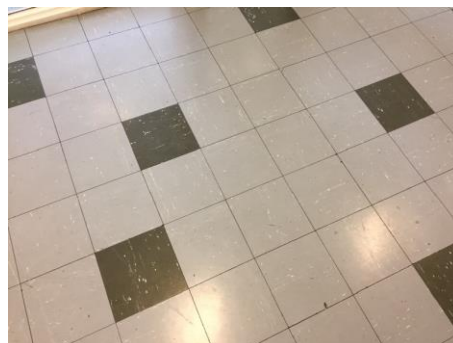
Bitumen adhesive beneath floor tiles.

The material was seen to be in fair condition at the time of the initial inspection.

The condition of the material should be managed by a competent person/company and its presence made aware to those at risk, as part of a Control of Asbestos Regulations (CAR) 2012 compliant management strategy.

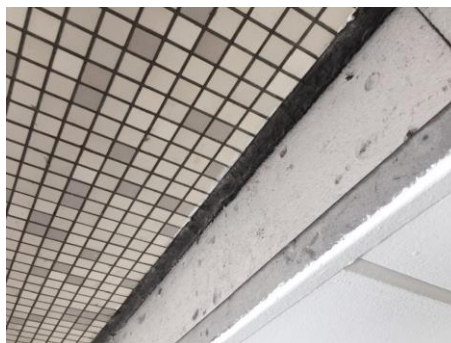
Spatter pattern textured coating.

The material was seen to be in fair condition at the time of the initial inspection.

The condition of the material should be managed by a competent person/company and its presence made aware to those at risk, as part of a Control of Asbestos Regulations (CAR) 2012 compliant management strategy.

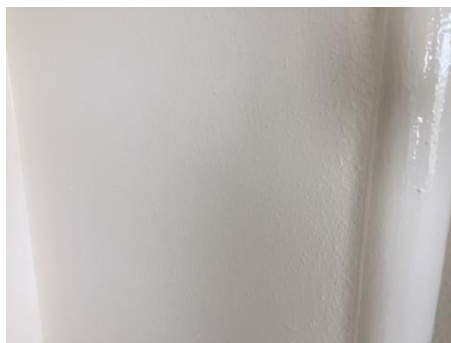
Spatter pattern textured coating.

The material was seen to be in fair condition at the time of the initial inspection.

The condition of the material should be managed by a competent person/company and its presence made aware to those at risk, as part of a Control of Asbestos Regulations (CAR) 2012 compliant management strategy.

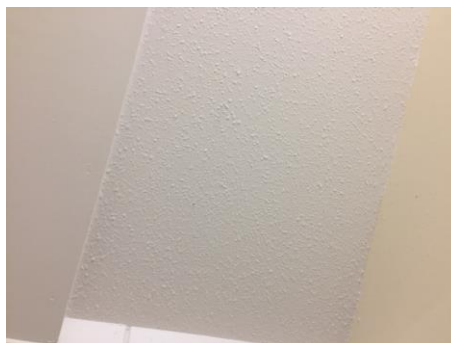
Spatter pattern textured coating.

The material was seen to be in fair condition at the time of the initial inspection.

The condition of the material should be managed by a competent person/company and its presence made aware to those at risk, as part of a Control of Asbestos Regulations (CAR) 2012 compliant management strategy.

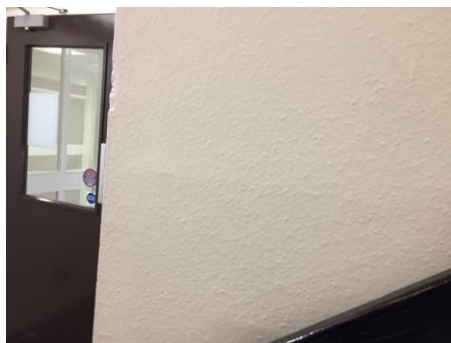
Spatter pattern textured coating.

The material was seen to be in fair condition at the time of the initial inspection.

The condition of the material should be managed by a competent person/company and its presence made aware to those at risk, as part of a Control of Asbestos Regulations (CAR) 2012 compliant management strategy.

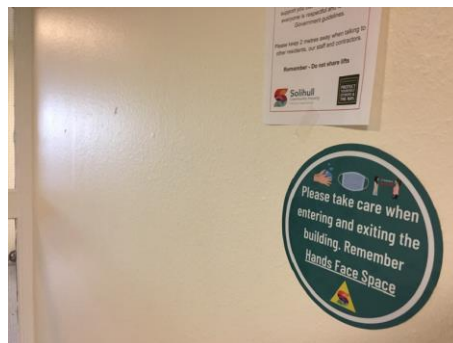
Spatter pattern textured coating.

The material was seen to be in fair condition at the time of the initial inspection.

The condition of the material should be managed by a competent person/company and its presence made aware to those at risk, as part of a Control of Asbestos Regulations (CAR) 2012 compliant management strategy.

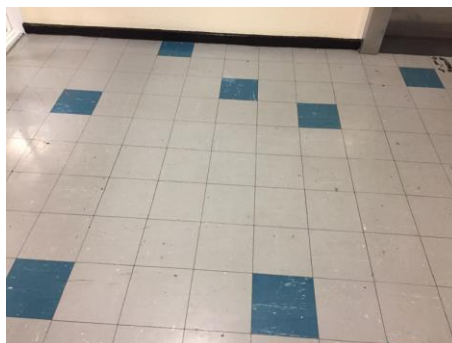
Blue and grey floor tiles.

The material was seen to be in fair condition at the time of the initial inspection.

The condition of the material should be managed by a competent person/company and its presence made aware to those at risk, as part of a Control of Asbestos Regulations (CAR) 2012 compliant management strategy.

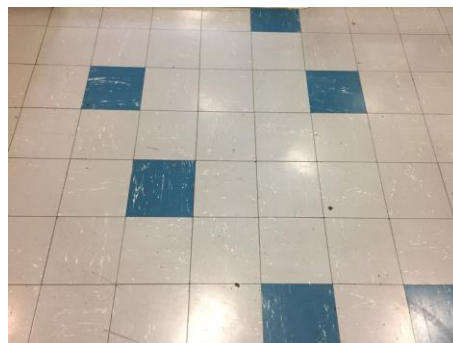
Blue and grey floor tiles.

The material was seen to be in fair condition at the time of the initial inspection.

The condition of the material should be managed by a competent person/company and its presence made aware to those at risk, as part of a Control of Asbestos Regulations (CAR) 2012 compliant management strategy.

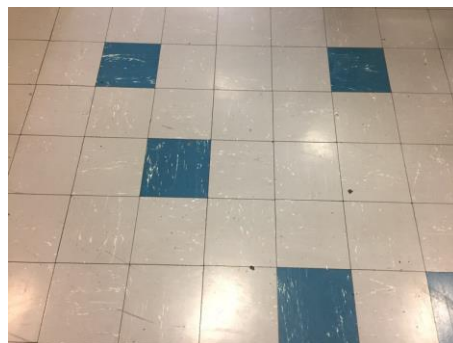
Bitumen adhesive beneath floor tiles.

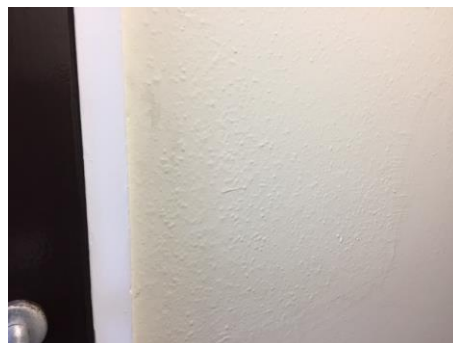
Spatter pattern textured coating.

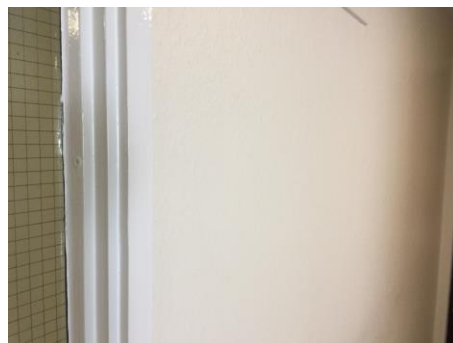
Spatter pattern textured coating.

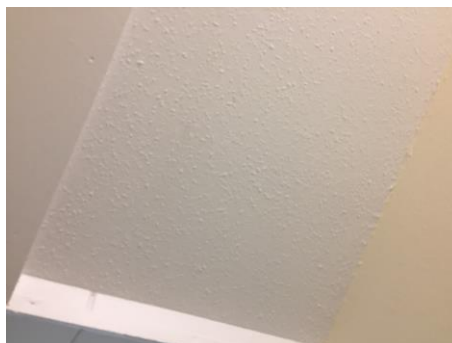
Spatter pattern textured coating.

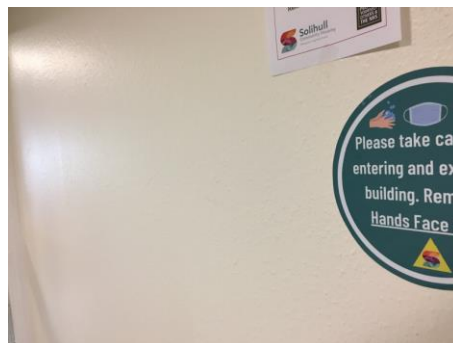
Spatter pattern textured coating.

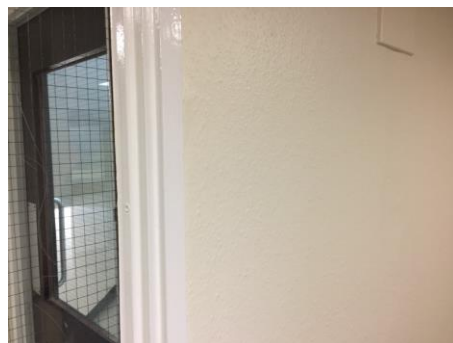
Spatter pattern textured coating.

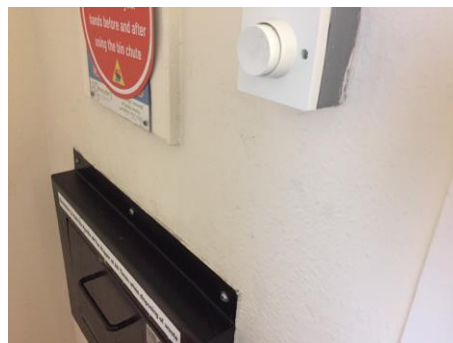
Spatter pattern textured coating.

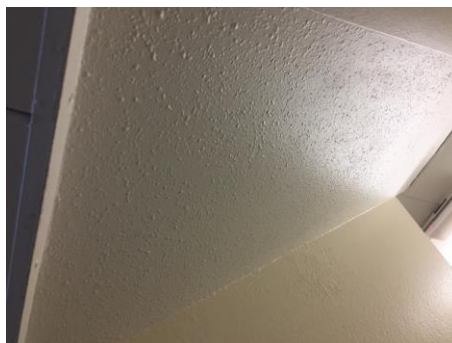
Spatter pattern textured coating.

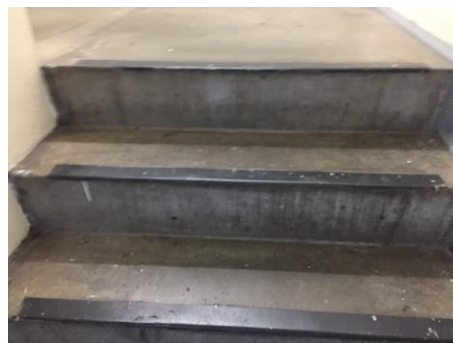
Resin nosing to edge of stairs.

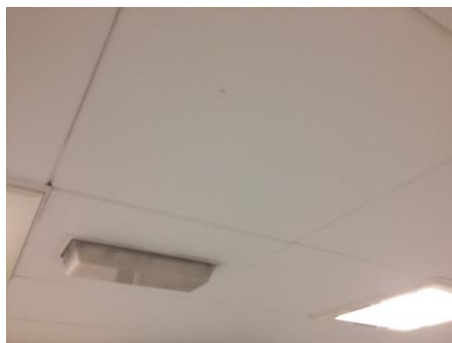
Spatter pattern textured coating above suspended ceiling.

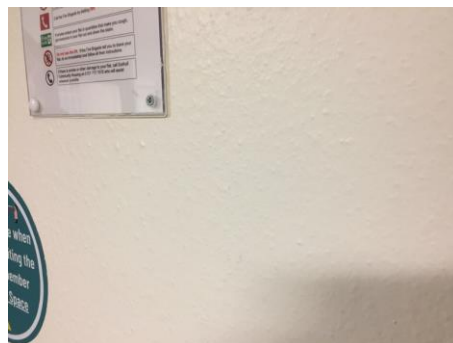
Spatter pattern textured coating.

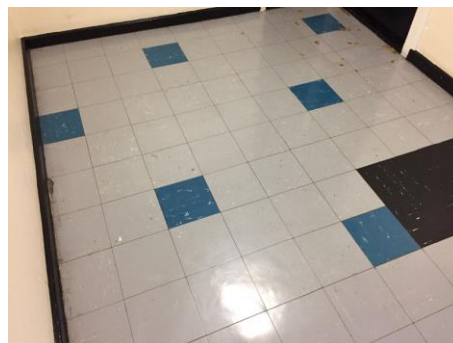
Blue and grey floor tiles.

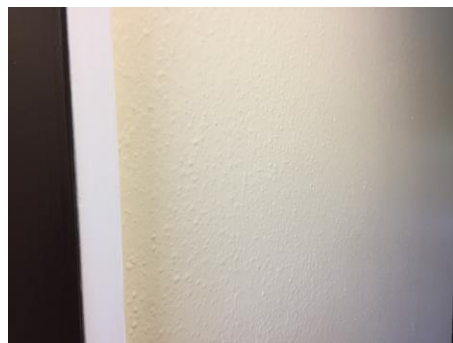
Spatter pattern textured coating.

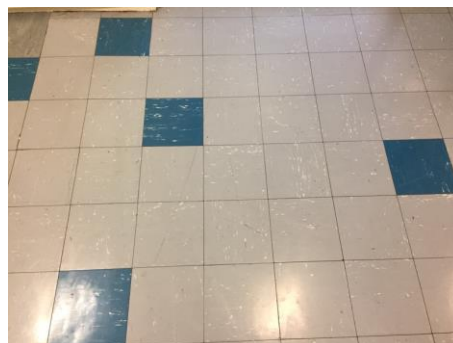
Blue and grey floor tiles.

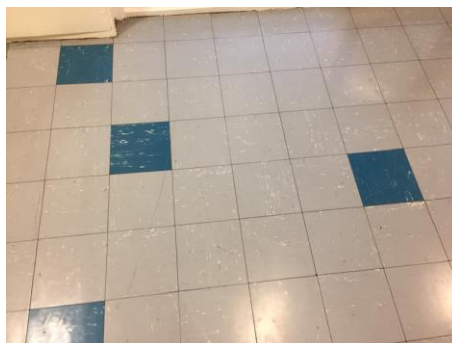
Bitumen adhesive beneath floor tiles.

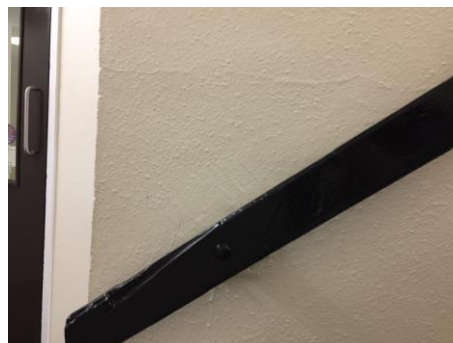
Spatter pattern textured coating.

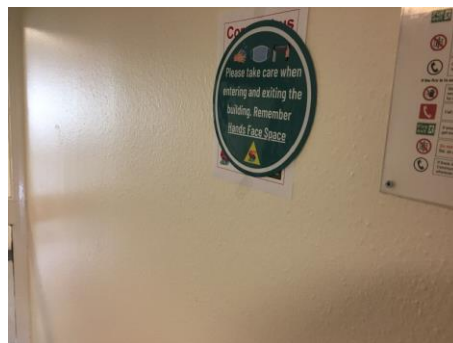
Spatter pattern textured coating.

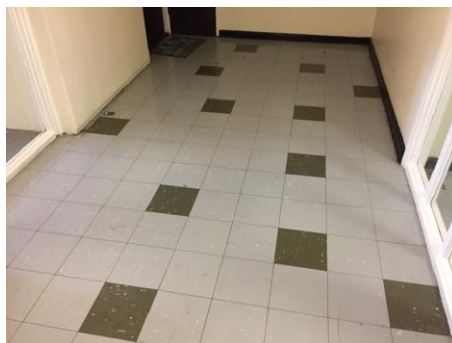
Green and grey floor tiles.

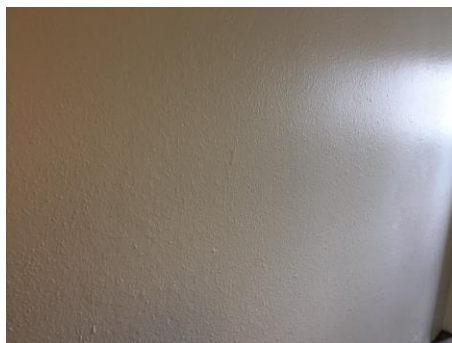
Spatter pattern textured coating.

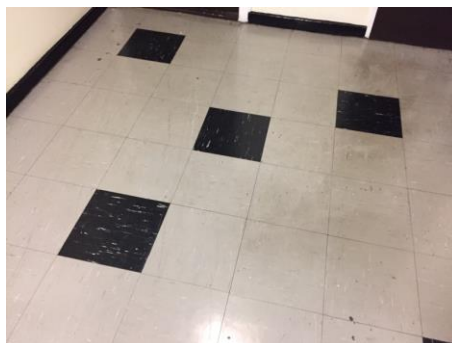
Bitumen adhesive beneath floor tiles.

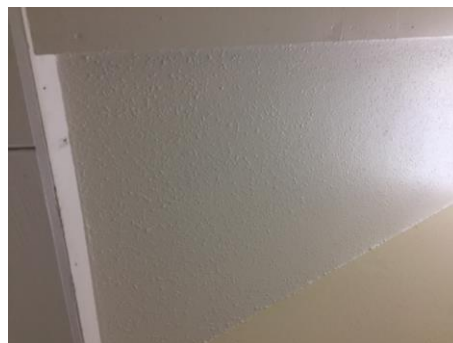
Spatter pattern textured coating.

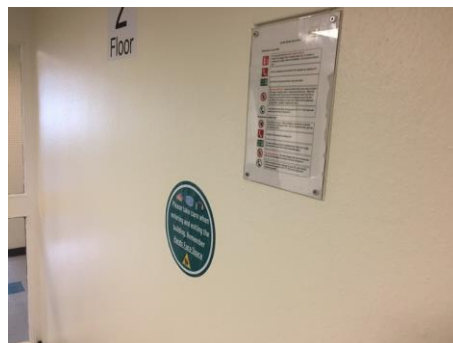
Spatter pattern textured coating.

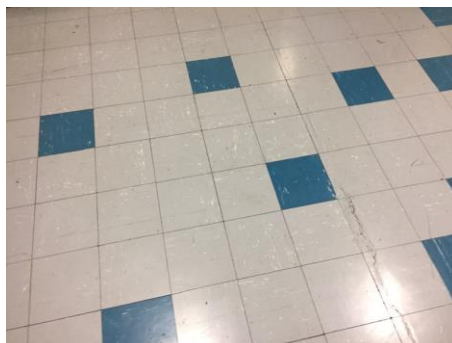
Blue and grey floor tiles.

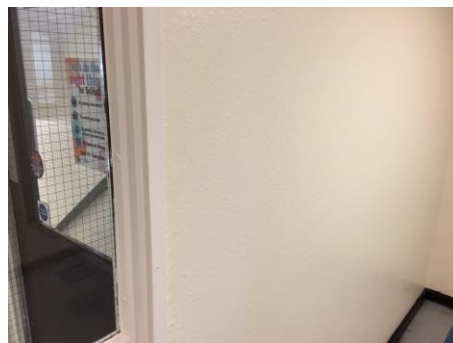
Spatter pattern textured coating.

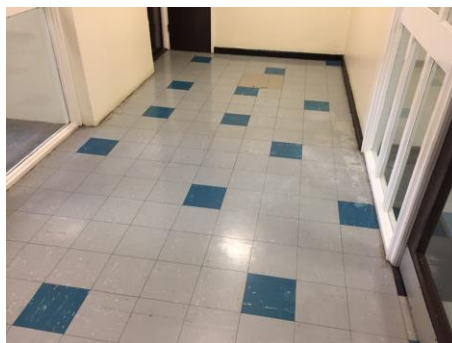
Blue and grey floor tiles.

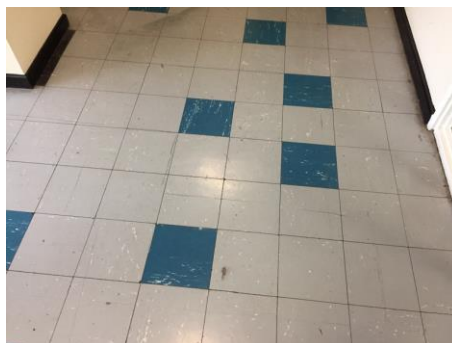
Blue and grey floor tiles.

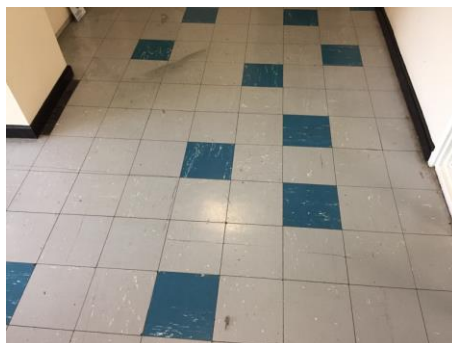
Bitumen adhesive beneath floor tiles.

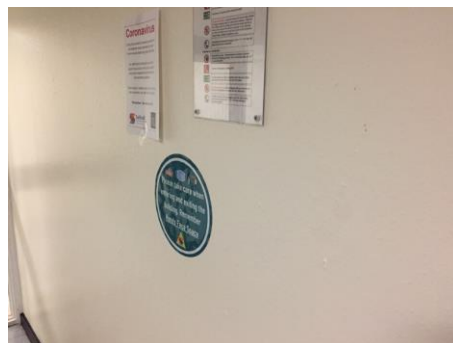
Spatter pattern textured coating.

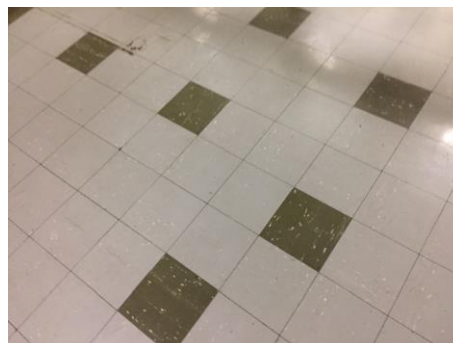
Green and grey floor tiles.

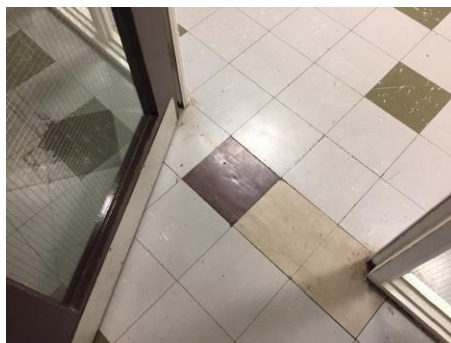
Brown patch repair tile.

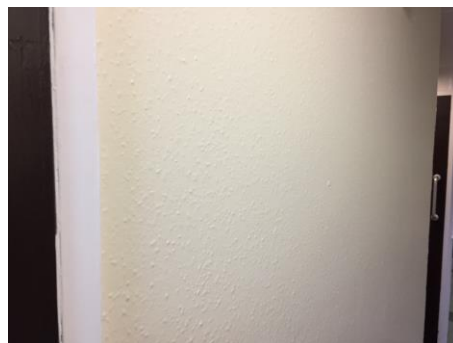
Spatter pattern textured coating.

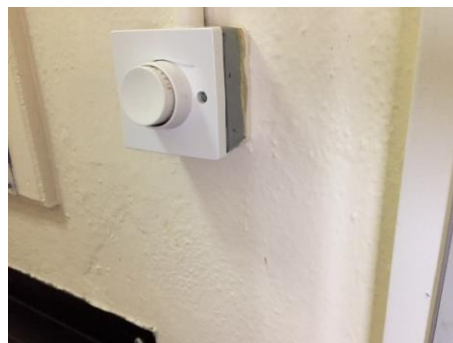
Spatter pattern textured coating.

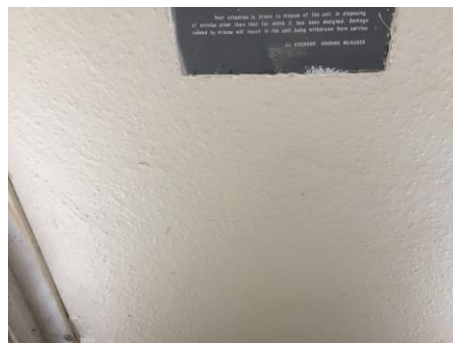
Spatter pattern textured coating.

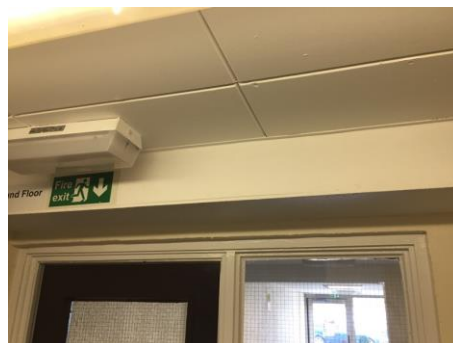
Cement boxing over door.

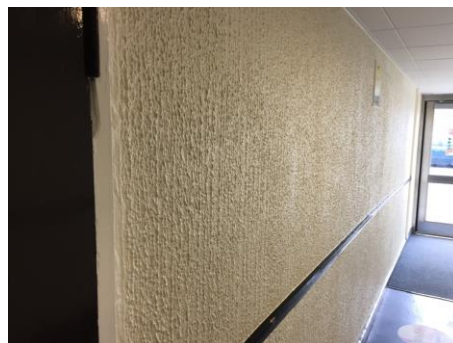
Lined stipple pattern textured coating.

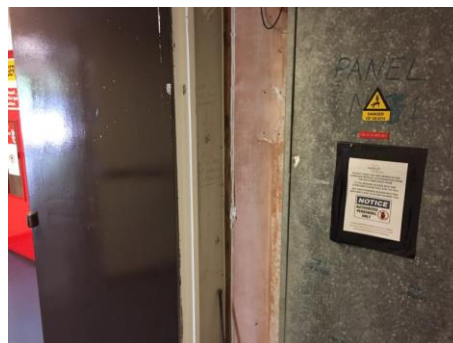
Insulating board lining panels to sides of electrical cabinets.
