Site ID: **a-303622**

Management with Targeted Refurbishment Survey – PART 1

1-65 Kingsgate House
Winchester Drive
Chelmsley Wood
Solihull
West Midlands
B37 5PX
United Kingdom

22nd April 2021

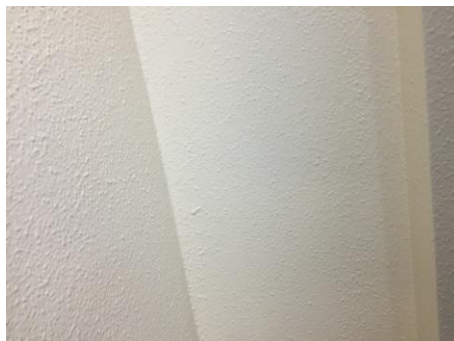
Spatter pattern textured coating.

The material was seen to be in fair condition at the time of the initial inspection.

The condition of the material should be managed by a competent person/company and its presence made aware to those at risk, as part of a Control of Asbestos Regulations (CAR) 2012 compliant management strategy.

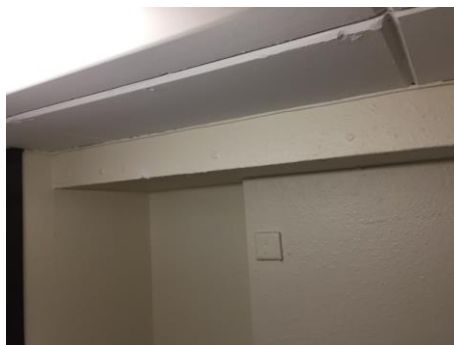
Insulating board boxing at ceiling level between doors.

The material was seen to be in fair condition at the time of the initial inspection.

The condition of the material should be managed by a competent person/company and its presence made aware to those at risk, as part of a Control of Asbestos Regulations (CAR) 2012 compliant management strategy.

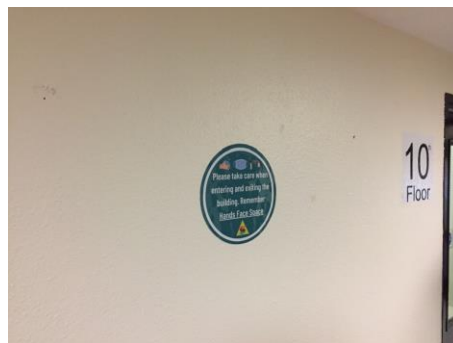
Spatter pattern textured coating.

The material was seen to be in fair condition at the time of the initial inspection.

The condition of the material should be managed by a competent person/company and its presence made aware to those at risk, as part of a Control of Asbestos Regulations (CAR) 2012 compliant management strategy.

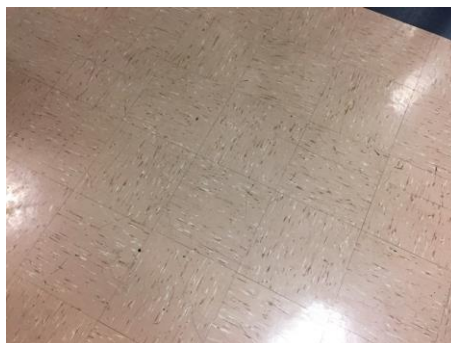
Pink floor tiles.

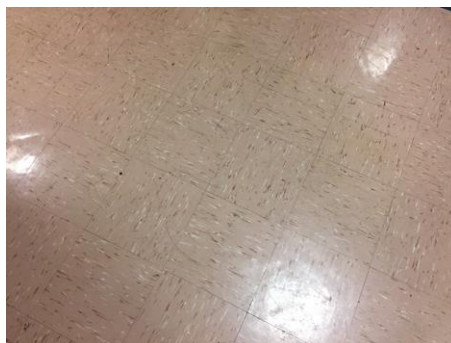
Bitumen adhesive beneath floor tiles.

The material was seen to be in fair condition at the time of the initial inspection.

The condition of the material should be managed by a competent person/company and its presence made aware to those at risk, as part of a Control of Asbestos Regulations (CAR) 2012 compliant management strategy.

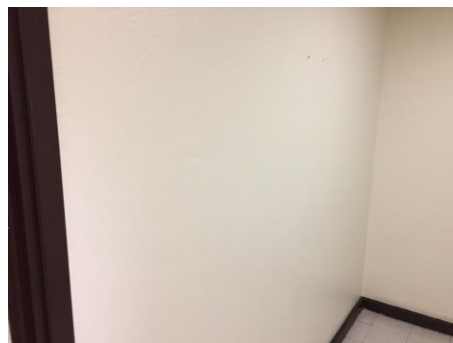
The material was seen to be in fair condition at the time of the initial inspection.

The condition of the material should be managed by a competent person/company and its presence made aware to those at risk, as part of a Control of Asbestos Regulations (CAR) 2012 compliant management strategy.

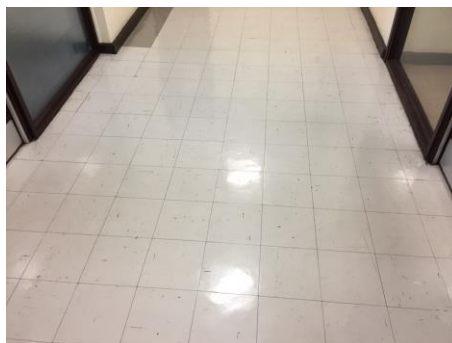
Grey floor tiles.

The material was seen to be in fair condition at the time of the initial inspection.

The condition of the material should be managed by a competent person/company and its presence made aware to those at risk, as part of a Control of Asbestos Regulations (CAR) 2012 compliant management strategy.

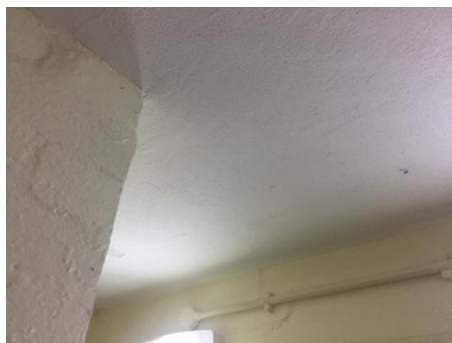
Stipple pattern textured coating.

The material was seen to be in fair condition at the time of the initial inspection.

The condition of the material should be managed by a competent person/company and its presence made aware to those at risk, as part of a Control of Asbestos Regulations (CAR) 2012 compliant management strategy.

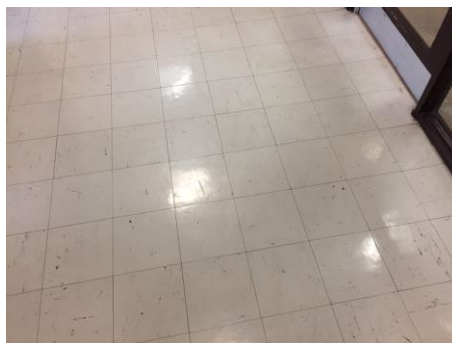
Bitumen adhesive beneath floor tiles.

The material was seen to be in fair condition at the time of the initial inspection.

The condition of the material should be managed by a competent person/company and its presence made aware to those at risk, as part of a Control of Asbestos Regulations (CAR) 2012 compliant management strategy.

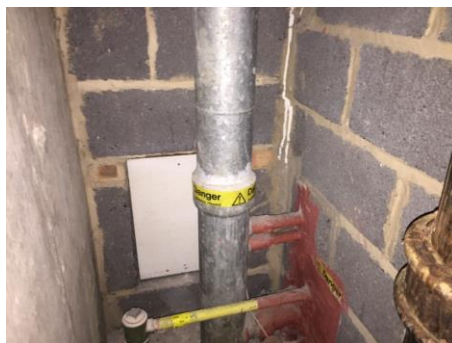
Lagging packing to joints of metal soil pipe.

The material was seen to be in fair condition at the time of the initial inspection.

The condition of the material should be managed by a competent person/company and its presence made aware to those at risk, as part of a Control of Asbestos Regulations (CAR) 2012 compliant management strategy.

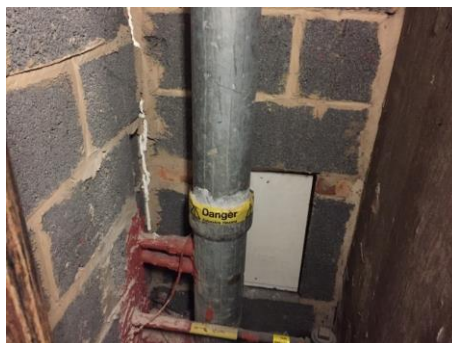
Lagging packing to joints of metal soil pipe.

The material was seen to be in fair condition at the time of the initial inspection.

The condition of the material should be managed by a competent person/company and its presence made aware to those at risk, as part of a Control of Asbestos Regulations (CAR) 2012 compliant management strategy.

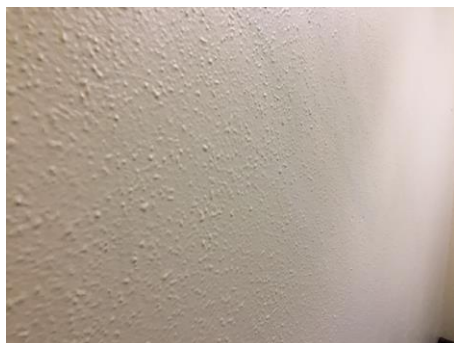
Spatter pattern textured coating.

The material was seen to be in fair condition at the time of the initial inspection.

The condition of the material should be managed by a competent person/company and its presence made aware to those at risk, as part of a Control of Asbestos Regulations (CAR) 2012 compliant management strategy.

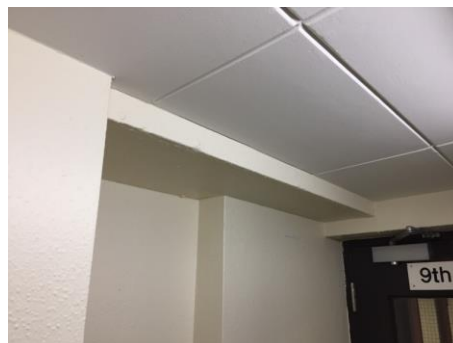
Insulating board boxing at ceiling level between doors.

The material was seen to be in fair condition at the time of the initial inspection.

The condition of the material should be managed by a competent person/company and its presence made aware to those at risk, as part of a Control of Asbestos Regulations (CAR) 2012 compliant management strategy.

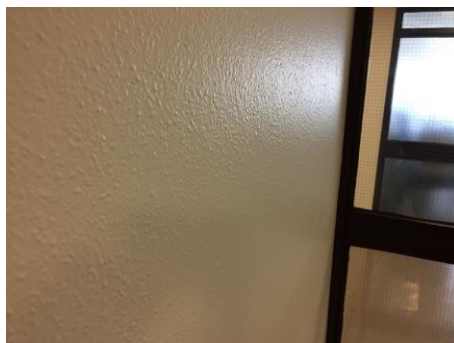
Spatter pattern textured coating.

The material was seen to be in fair condition at the time of the initial inspection.

The condition of the material should be managed by a competent person/company and its presence made aware to those at risk, as part of a Control of Asbestos Regulations (CAR) 2012 compliant management strategy.

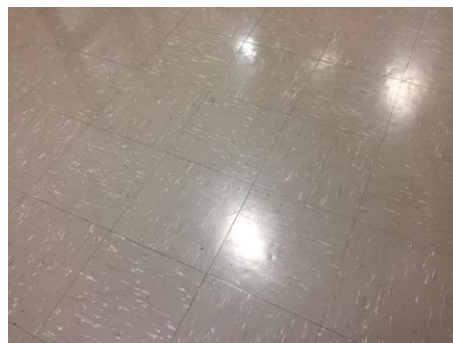
Grey floor tiles.

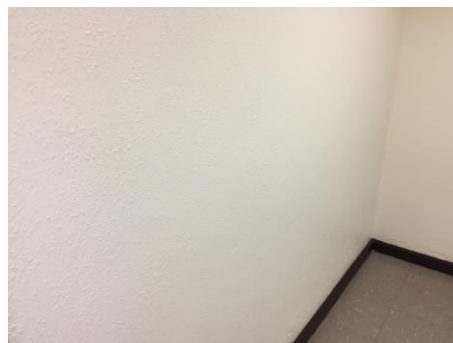
Spatter pattern textured coating.

The material was seen to be in fair condition at the time of the initial inspection.

The condition of the material should be managed by a competent person/company and its presence made aware to those at risk, as part of a Control of Asbestos Regulations (CAR) 2012 compliant management strategy.

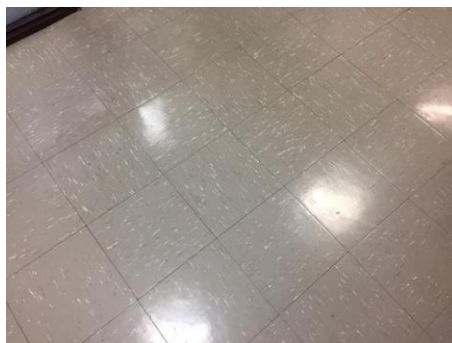
Bitumen adhesive beneath floor tiles.

The material was seen to be in fair condition at the time of the initial inspection.

The condition of the material should be managed by a competent person/company and its presence made aware to those at risk, as part of a Control of Asbestos Regulations (CAR) 2012 compliant management strategy.

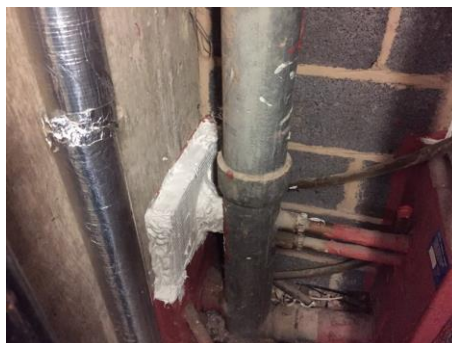
Lagging packing to joints of metal soil pipe.

The material was seen to be in fair condition at the time of the initial inspection.

The condition of the material should be managed by a competent person/company and its presence made aware to those at risk, as part of a Control of Asbestos Regulations (CAR) 2012 compliant management strategy.

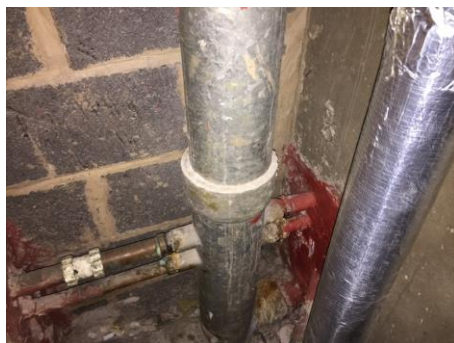
Lagging packing to joints of metal soil pipe.

The material was seen to be in fair condition at the time of the initial inspection.

The condition of the material should be managed by a competent person/company and its presence made aware to those at risk, as part of a Control of Asbestos Regulations (CAR) 2012 compliant management strategy.

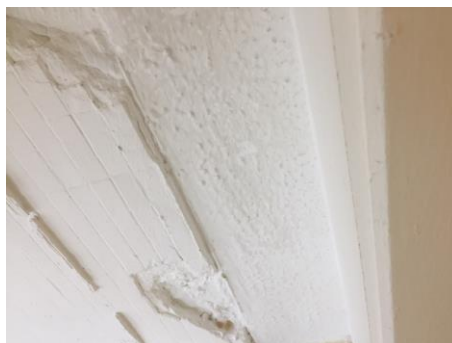
Stipple pattern textured coating.

The material was seen to be in fair condition at the time of the initial inspection.

The condition of the material should be managed by a competent person/company and its presence made aware to those at risk, as part of a Control of Asbestos Regulations (CAR) 2012 compliant management strategy.

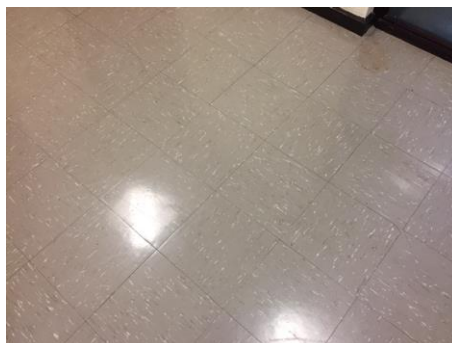
Bitumen adhesive beneath floor tiles.

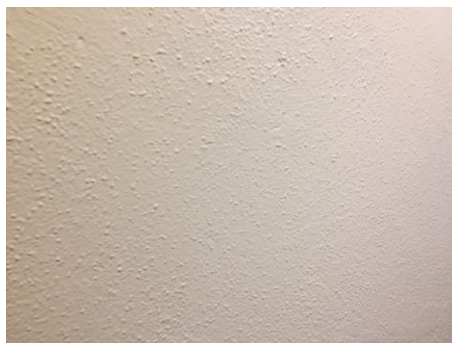
Spatter pattern textured coating.

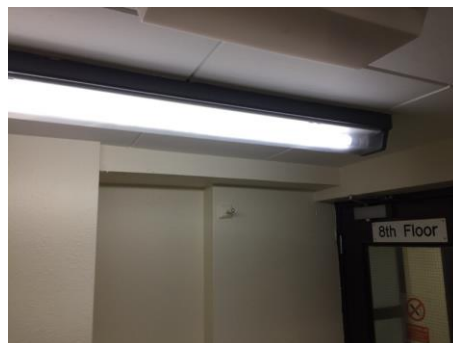
Insulating board boxing at ceiling level between doors.

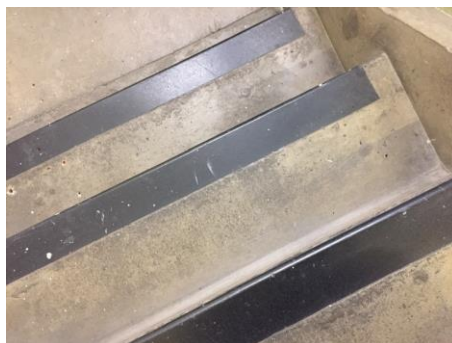
Resin stair nosing to edge of stairs.

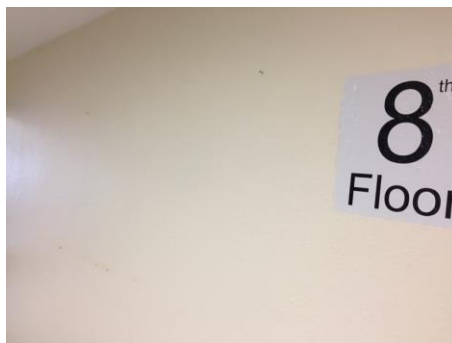
Spatter pattern textured coating.

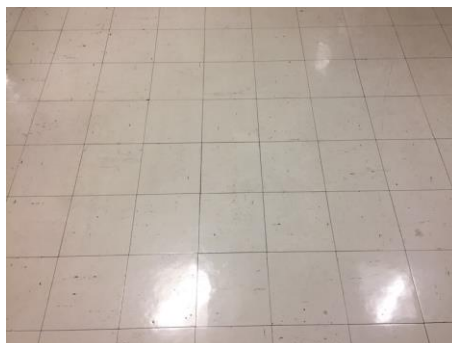
Grey floor tiles.

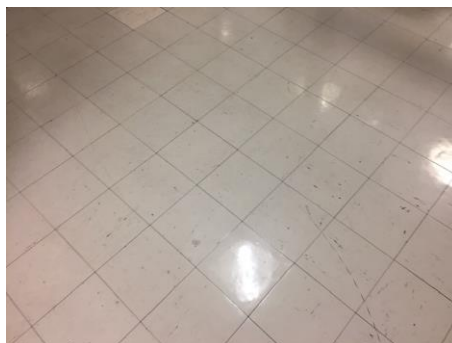
Bitumen adhesive beneath floor tiles.

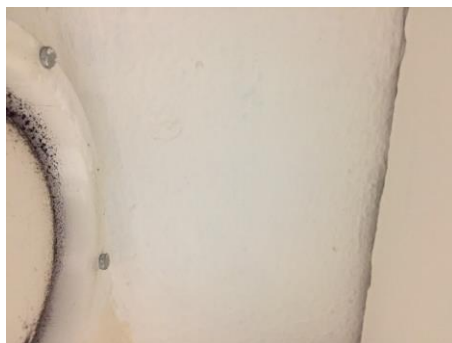
Stipple pattern textured coating visible above extractor.

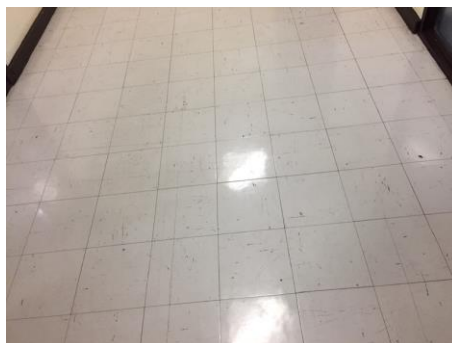
Bitumen adhesive beneath floor tiles.

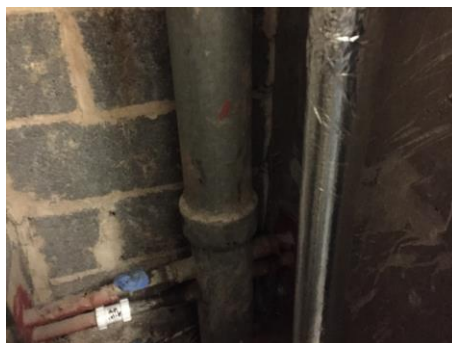
Lagging packing to joints of metal soil pipe.

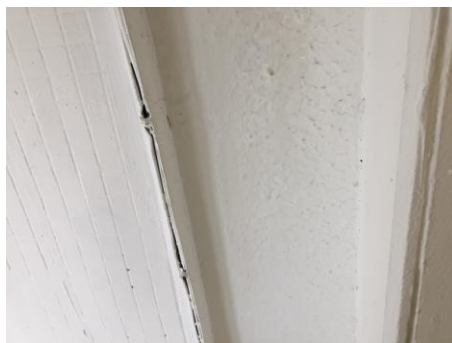
Stipple pattern textured coating.

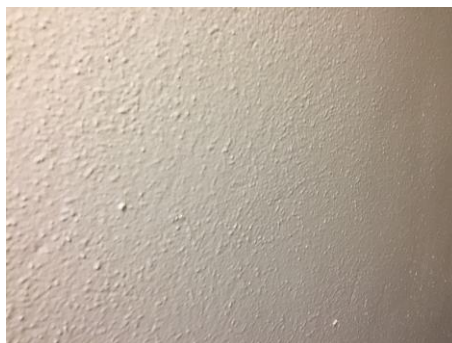
Spatter pattern textured coating.

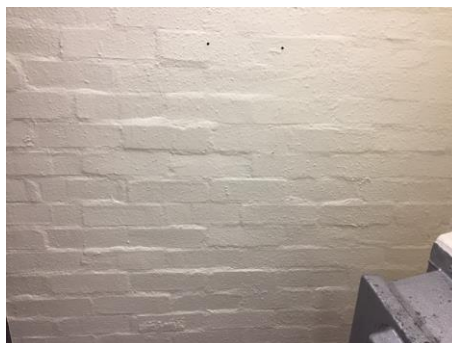
Spatter pattern textured coating.

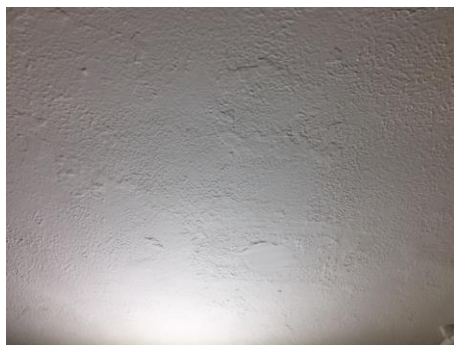
Stipple pattern textured coating.

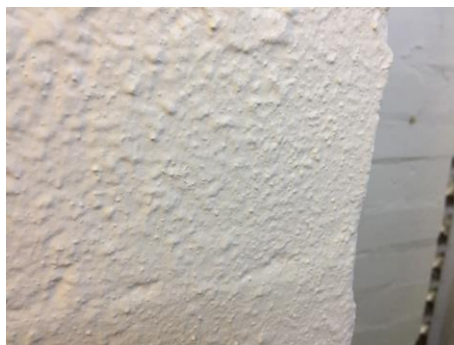
Spatter pattern textured coating.

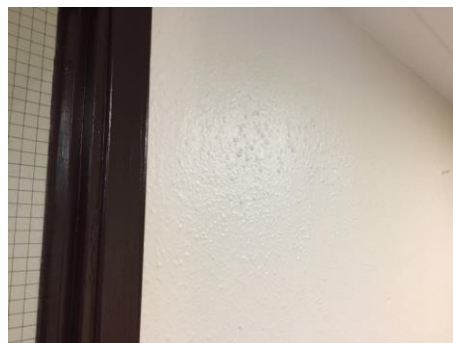
Spatter pattern textured coating.

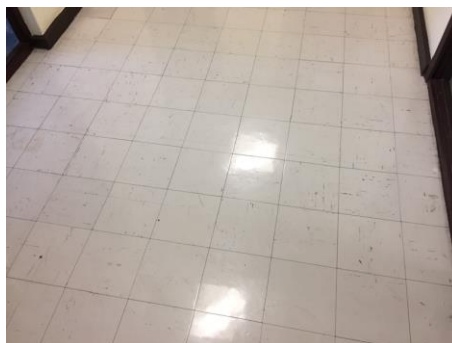
Bitumen adhesive beneath floor tiles.

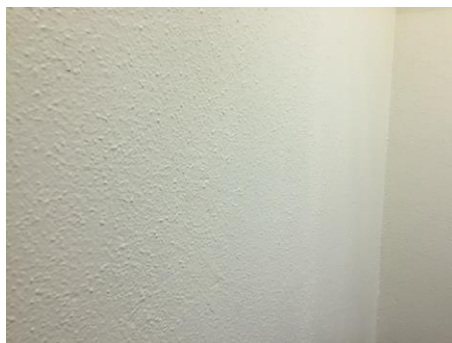
Spatter pattern textured coating.

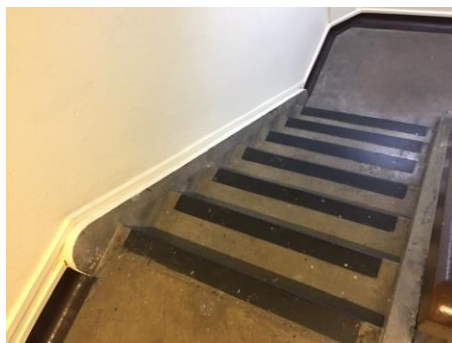
Resin nosing to edge of stairs.

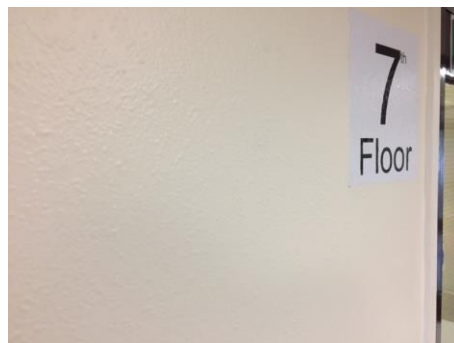
Spatter pattern textured coating.

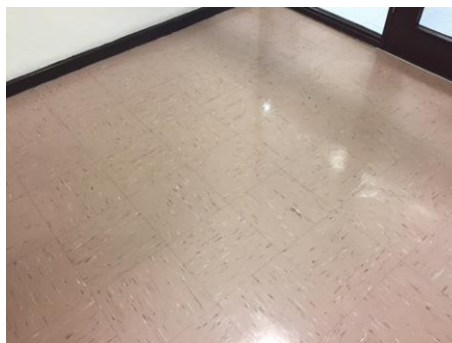
Bitumen adhesive beneath floor tiles.

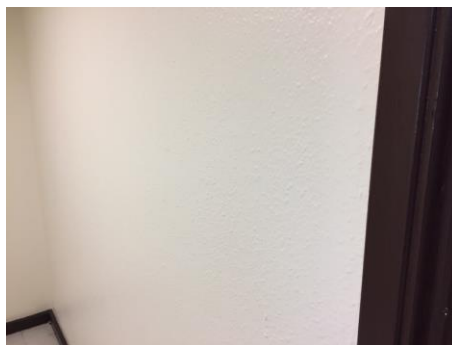
Spatter pattern textured coating.

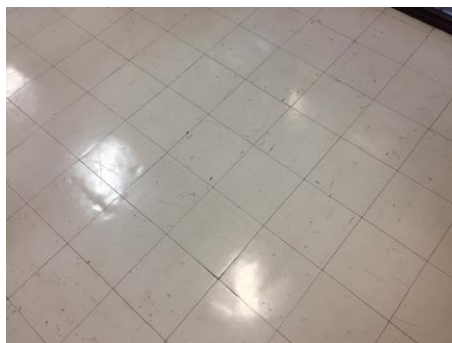
Bitumen adhesive beneath floor tiles.

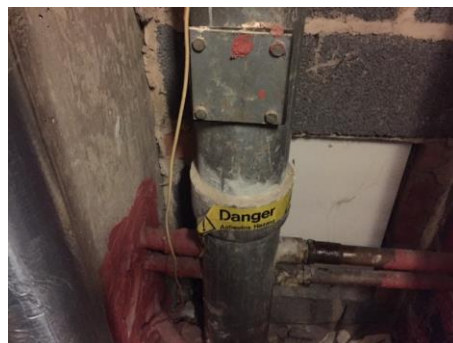
Lagging packing to joints of metal soil pipe.

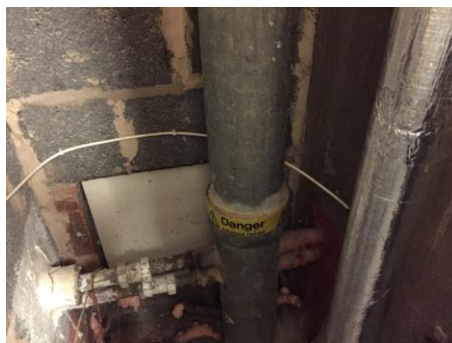
Lagging packing to joints of metal soil pipe.

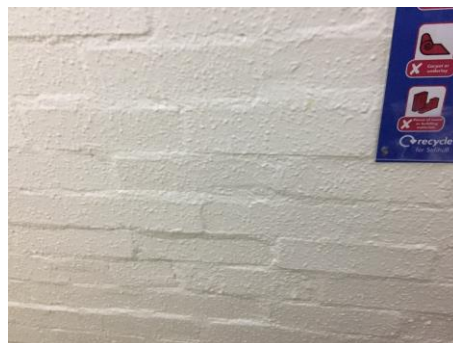
Spatter pattern textured coating.

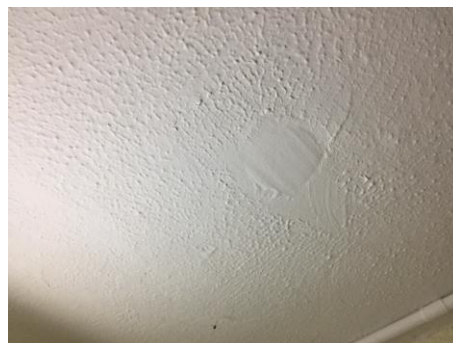
Stipple pattern textured coating.

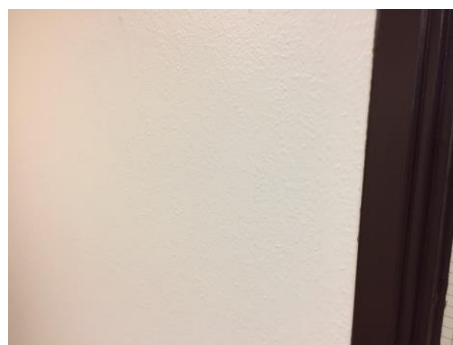
Spatter pattern textured coating.

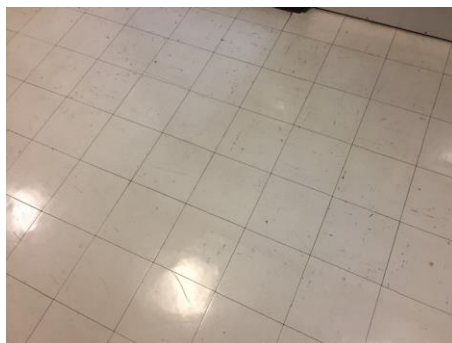
Grey floor tiles.

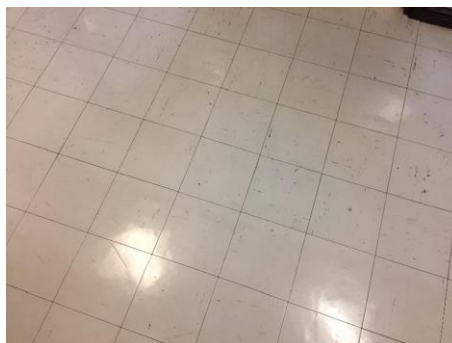
Bitumen adhesive beneath floor tiles.

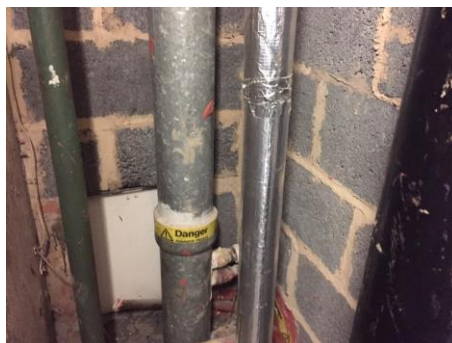
Lagging packing to joints of metal soil pipe.

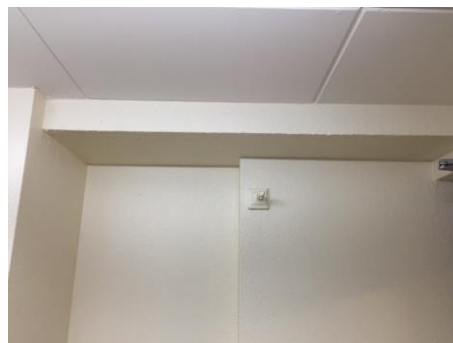
Insulating board boxing at ceiling level between doors.

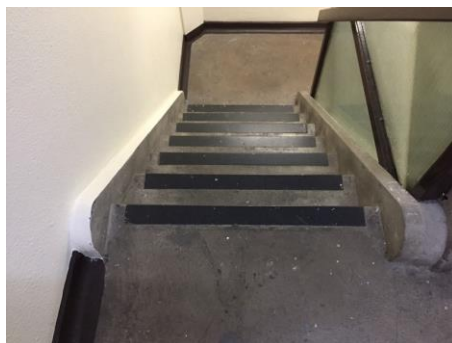
Resin stair nosing to edge of stairs.

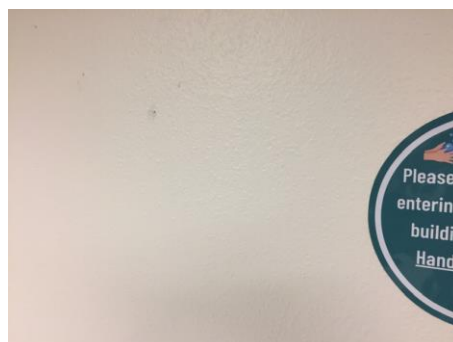
Spatter pattern textured coating.

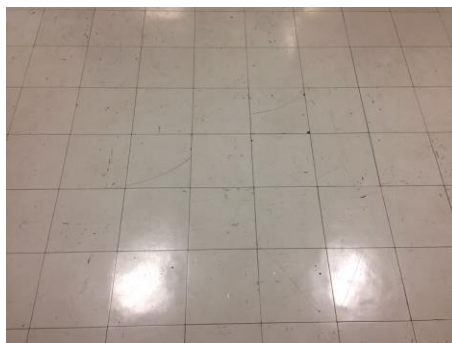
Bitumen adhesive beneath floor tiles.

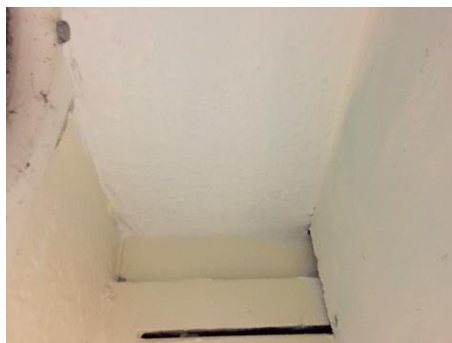
Stipple pattern textured coating visible above extractor.

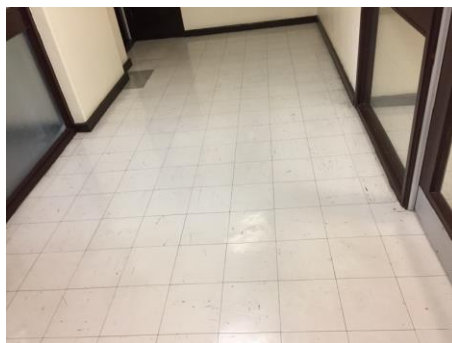
Bitumen adhesive beneath floor tiles.

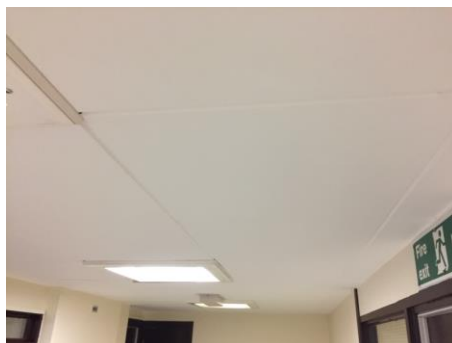
Stipple pattern textured coating above Supalux suspended ceiling.

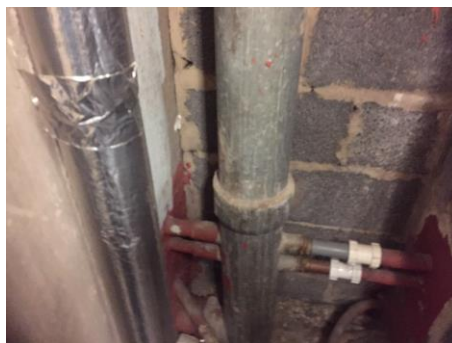
Lagging packing to joints of metal soil pipe.

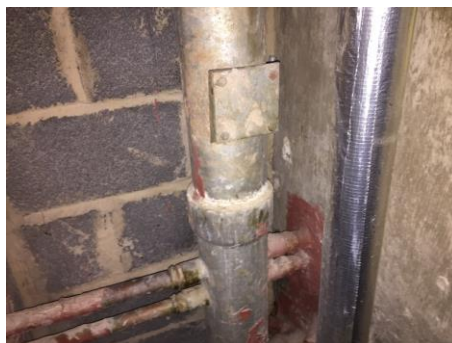
Lagging packing to joints of metal soil pipe.

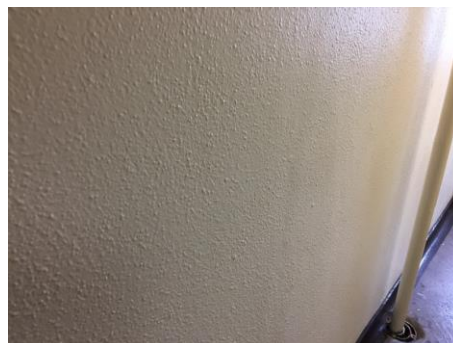
Spatter pattern textured coating.

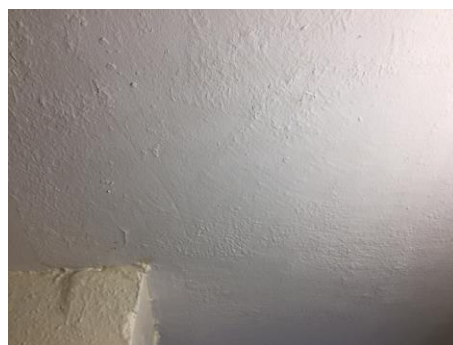
Stipple pattern textured coating.

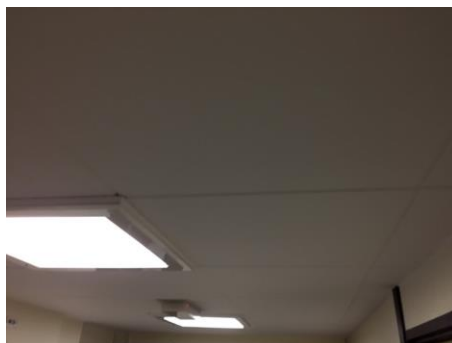
Stipple pattern textured coating above Supalux suspended ceiling.
