Management with Targeted Refurbishment Survey – PART 2

1-65 Kingsgate House
Winchester Drive
Chelmsley Wood
Solihull
West Midlands
B37 5PX
United Kingdom

28th April 2021

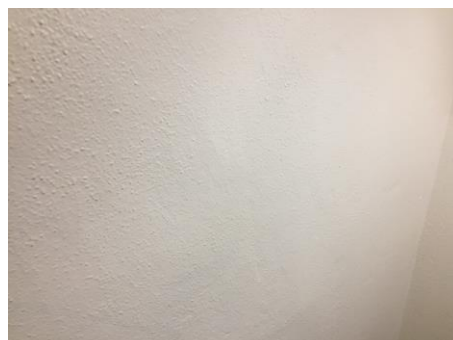
Spatter pattern textured coating.

The material was seen to be in fair condition at the time of the initial inspection.

The condition of the material should be managed by a competent person/company and its presence made aware to those at risk, as part of a Control of Asbestos Regulations (CAR) 2012 compliant management strategy.

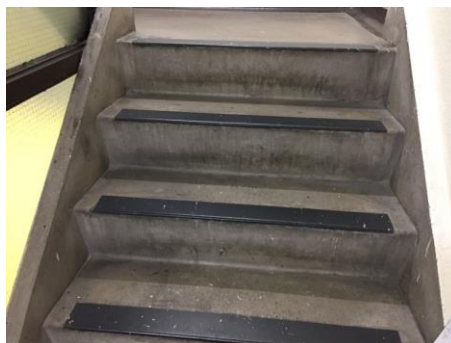
Resin nosing to edge of stairs.

The material was seen to be in fair condition at the time of the initial inspection.

The condition of the material should be managed by a competent person/company and its presence made aware to those at risk, as part of a Control of Asbestos Regulations (CAR) 2012 compliant management strategy.

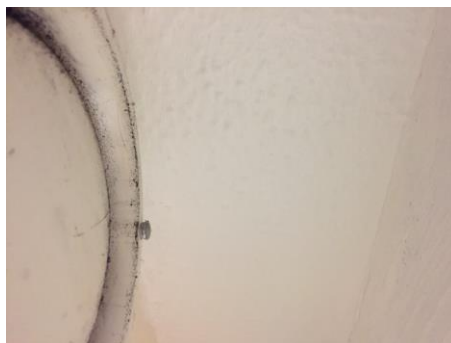
Stipple pattern textured coating visible above extractor.

The material was seen to be in fair condition at the time of the initial inspection.

The condition of the material should be managed by a competent person/company and its presence made aware to those at risk, as part of a Control of Asbestos Regulations (CAR) 2012 compliant management strategy.

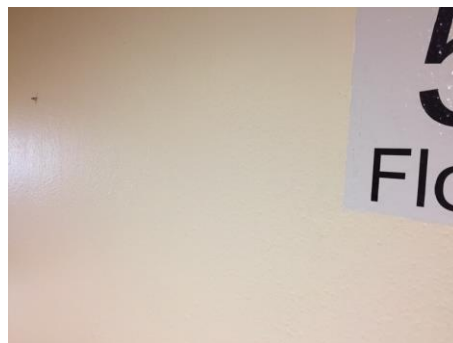
Spatter pattern textured coating.

The material was seen to be in fair condition at the time of the initial inspection.

The condition of the material should be managed by a competent person/company and its presence made aware to those at risk, as part of a Control of Asbestos Regulations (CAR) 2012 compliant management strategy.

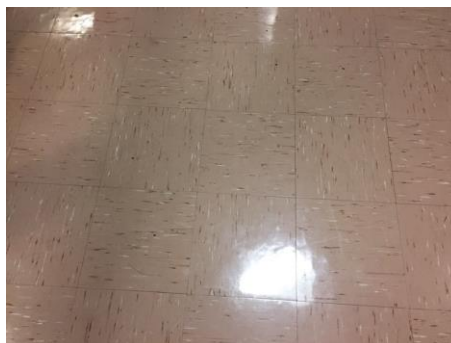
Pink floor tiles.

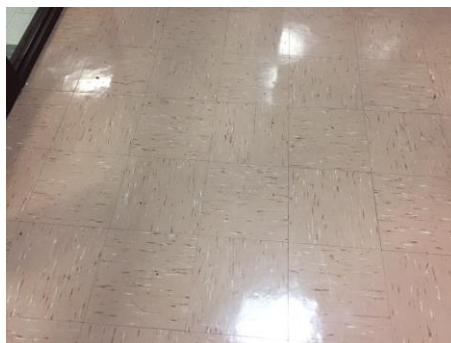
Bitumen adhesive beneath floor tiles.

The material was seen to be in fair condition at the time of the initial inspection.

The condition of the material should be managed by a competent person/company and its presence made aware to those at risk, as part of a Control of Asbestos Regulations (CAR) 2012 compliant management strategy.

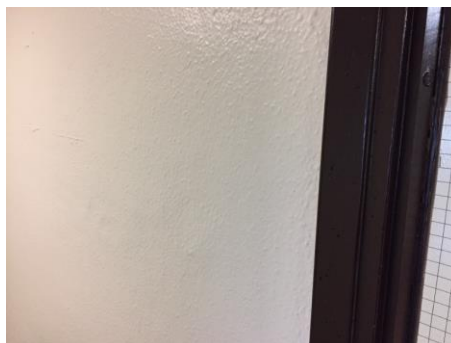
Spatter pattern textured coating.

The material was seen to be in fair condition at the time of the initial inspection.

The condition of the material should be managed by a competent person/company and its presence made aware to those at risk, as part of a Control of Asbestos Regulations (CAR) 2012 compliant management strategy.

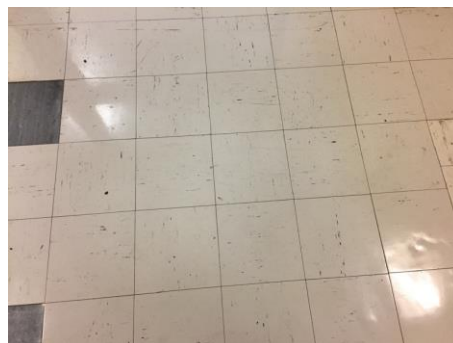
Grey floor tiles.

The material was seen to be in fair condition at the time of the initial inspection.

The condition of the material should be managed by a competent person/company and its presence made aware to those at risk, as part of a Control of Asbestos Regulations (CAR) 2012 compliant management strategy.

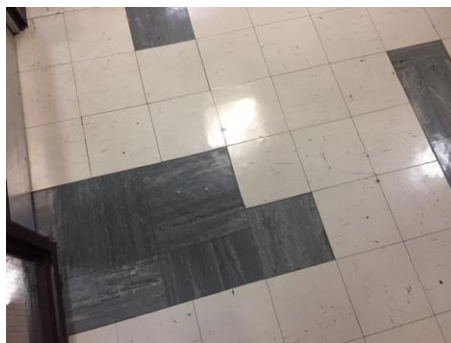
Bitumen adhesive beneath floor tiles.

The material was seen to be in fair condition at the time of the initial inspection.

The condition of the material should be managed by a competent person/company and its presence made aware to those at risk, as part of a Control of Asbestos Regulations (CAR) 2012 compliant management strategy.

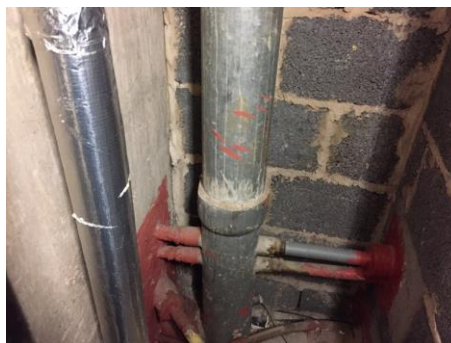
Lagging packing to joints of soil pipe.

The material was seen to be in fair condition at the time of the initial inspection.

The condition of the material should be managed by a competent person/company and its presence made aware to those at risk, as part of a Control of Asbestos Regulations (CAR) 2012 compliant management strategy.

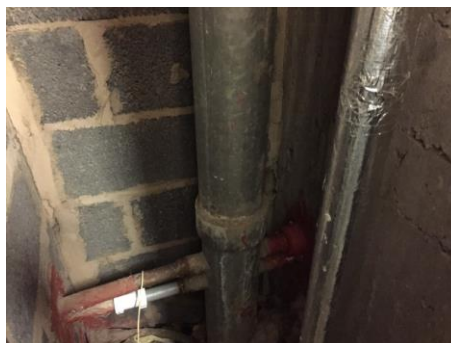
Lagging packing to joints of soil pipe.

The material was seen to be in fair condition at the time of the initial inspection.

The condition of the material should be managed by a competent person/company and its presence made aware to those at risk, as part of a Control of Asbestos Regulations (CAR) 2012 compliant management strategy.

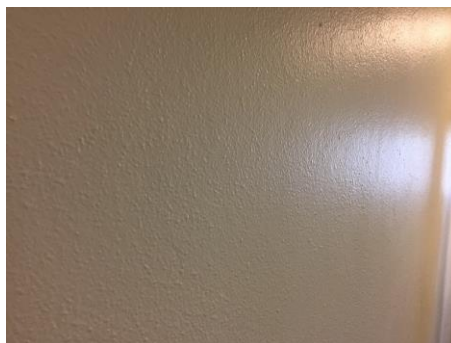
Spatter pattern textured coating.

The material was seen to be in fair condition at the time of the initial inspection.

The condition of the material should be managed by a competent person/company and its presence made aware to those at risk, as part of a Control of Asbestos Regulations (CAR) 2012 compliant management strategy.

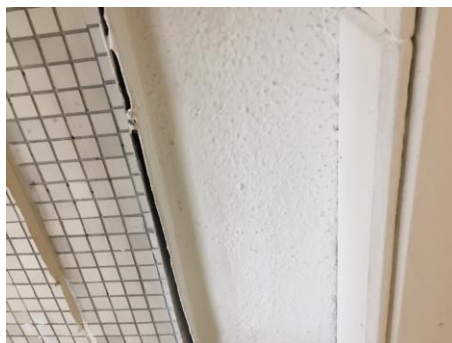
Stipple pattern textured coating.

The material was seen to be in fair condition at the time of the initial inspection.

The condition of the material should be managed by a competent person/company and its presence made aware to those at risk, as part of a Control of Asbestos Regulations (CAR) 2012 compliant management strategy.

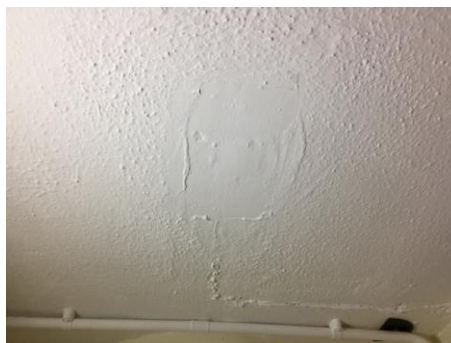
Stipple pattern textured coating.

The material was seen to be in fair condition at the time of the initial inspection.

The condition of the material should be managed by a competent person/company and its presence made aware to those at risk, as part of a Control of Asbestos Regulations (CAR) 2012 compliant management strategy.

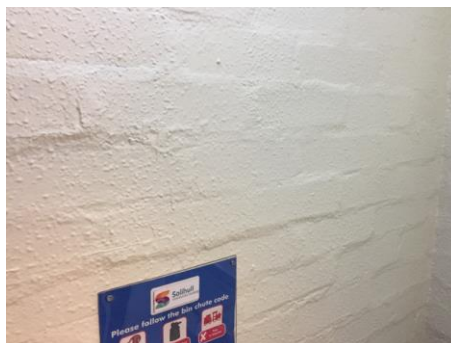
Spatter pattern textured coating.

The material was seen to be in fair condition at the time of the initial inspection.

The condition of the material should be managed by a competent person/company and its presence made aware to those at risk, as part of a Control of Asbestos Regulations (CAR) 2012 compliant management strategy.

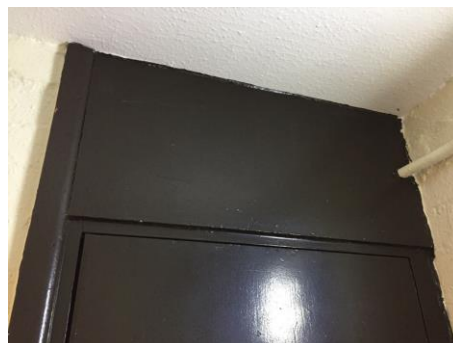
Insulating board transom panel over Incinerator room door.

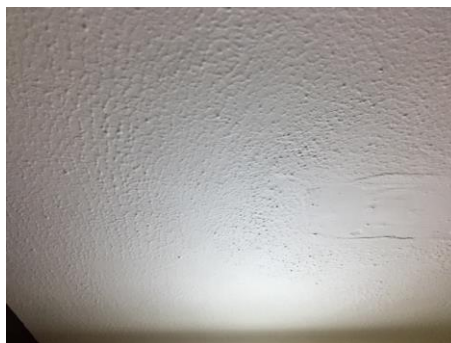
Stipple pattern textured coating.

The material was seen to be in fair condition at the time of the initial inspection.

The condition of the material should be managed by a competent person/company and its presence made aware to those at risk, as part of a Control of Asbestos Regulations (CAR) 2012 compliant management strategy.

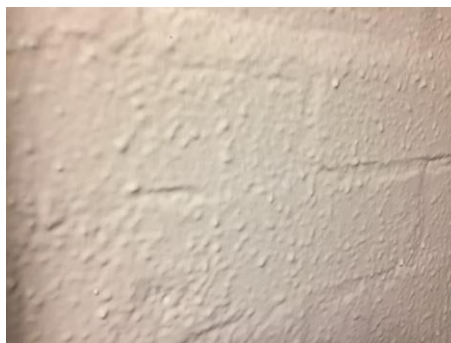
Spatter pattern textured coating.

The material was seen to be in fair condition at the time of the initial inspection.

The condition of the material should be managed by a competent person/company and its presence made aware to those at risk, as part of a Control of Asbestos Regulations (CAR) 2012 compliant management strategy.

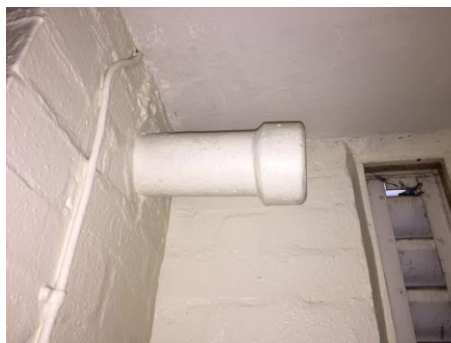
Cutoff cement Incinerator flue.

The material was seen to be in fair condition at the time of the initial inspection.

The condition of the material should be managed by a competent person/company and its presence made aware to those at risk, as part of a Control of Asbestos Regulations (CAR) 2012 compliant management strategy.

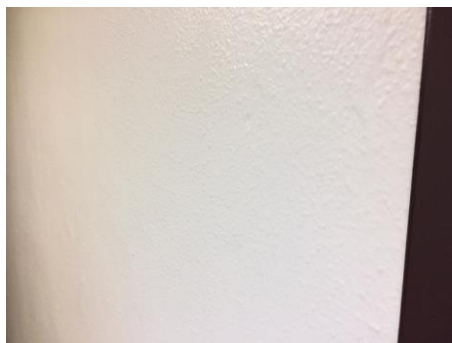
Spatter pattern textured coating.

The material was seen to be in fair condition at the time of the initial inspection.

The condition of the material should be managed by a competent person/company and its presence made aware to those at risk, as part of a Control of Asbestos Regulations (CAR) 2012 compliant management strategy.

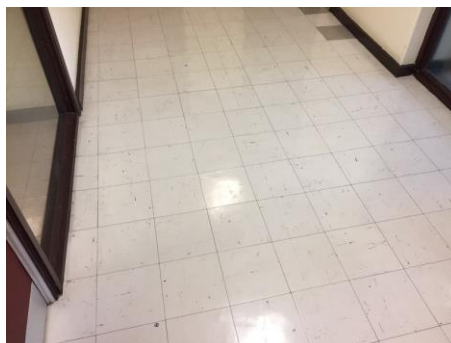
Grey floor tiles.

The material was seen to be in fair condition at the time of the initial inspection.

The condition of the material should be managed by a competent person/company and its presence made aware to those at risk, as part of a Control of Asbestos Regulations (CAR) 2012 compliant management strategy.

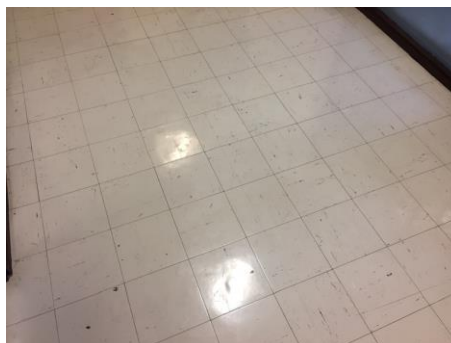
Bitumen adhesive beneath floor tiles.

The material was seen to be in fair condition at the time of the initial inspection.

The condition of the material should be managed by a competent person/company and its presence made aware to those at risk, as part of a Control of Asbestos Regulations (CAR) 2012 compliant management strategy.

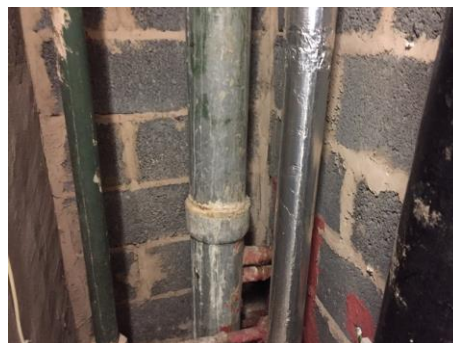
Lagging packing to joints of soil pipe.

The material was seen to be in fair condition at the time of the initial inspection.

The condition of the material should be managed by a competent person/company and its presence made aware to those at risk, as part of a Control of Asbestos Regulations (CAR) 2012 compliant management strategy.

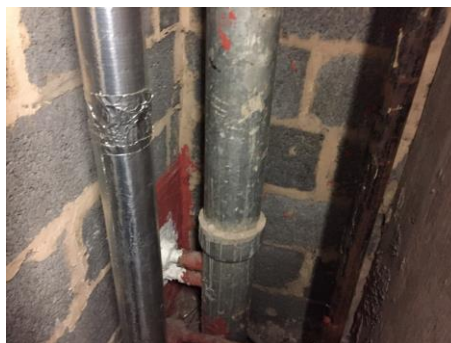
Lagging packing to joints of soil pipe.

The material was seen to be in fair condition at the time of the initial inspection.

The condition of the material should be managed by a competent person/company and its presence made aware to those at risk, as part of a Control of Asbestos Regulations (CAR) 2012 compliant management strategy.

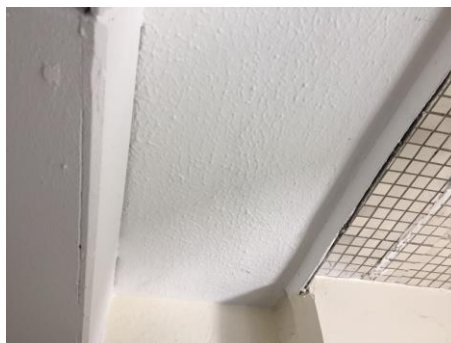
Stipple pattern textured coating.

The material was seen to be in fair condition at the time of the initial inspection.

The condition of the material should be managed by a competent person/company and its presence made aware to those at risk, as part of a Control of Asbestos Regulations (CAR) 2012 compliant management strategy.

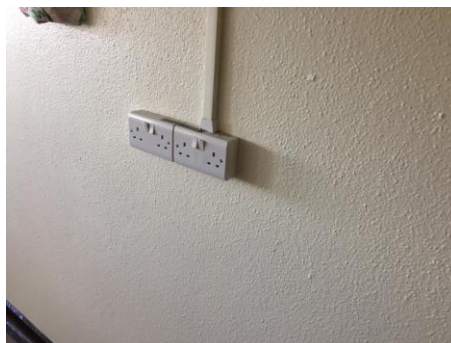
Spatter pattern textured coating.

The material was seen to be in fair condition at the time of the initial inspection.

The condition of the material should be managed by a competent person/company and its presence made aware to those at risk, as part of a Control of Asbestos Regulations (CAR) 2012 compliant management strategy.

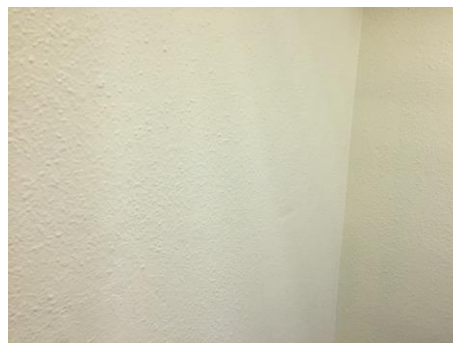
Spatter pattern textured coating.

The material was seen to be in fair condition at the time of the initial inspection.

The condition of the material should be managed by a competent person/company and its presence made aware to those at risk, as part of a Control of Asbestos Regulations (CAR) 2012 compliant management strategy.

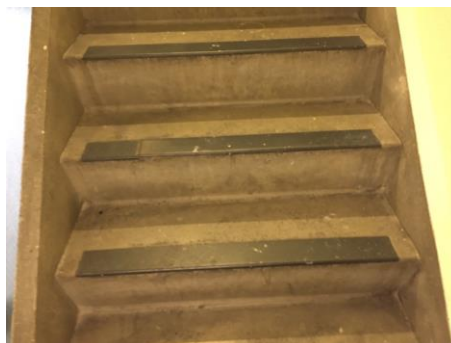
Resin nosing to edge of stairs.

The material was seen to be in fair condition at the time of the initial inspection.

The condition of the material should be managed by a competent person/company and its presence made aware to those at risk, as part of a Control of Asbestos Regulations (CAR) 2012 compliant management strategy.

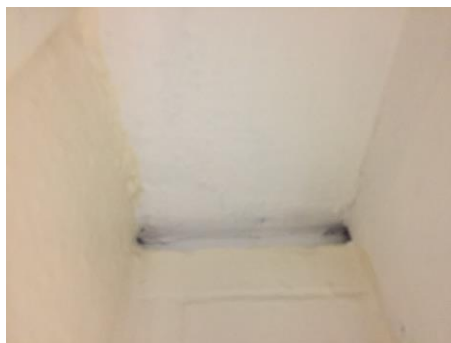
Stipple pattern textured coating visible above extractor.

The material was seen to be in fair condition at the time of the initial inspection.

The condition of the material should be managed by a competent person/company and its presence made aware to those at risk, as part of a Control of Asbestos Regulations (CAR) 2012 compliant management strategy.

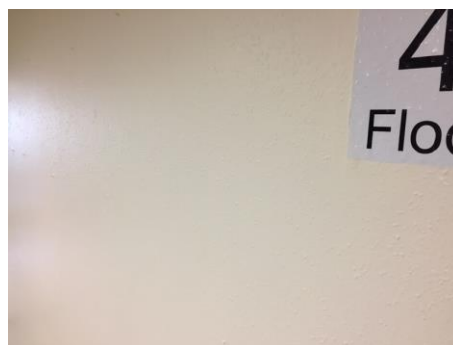
Spatter pattern textured coating.

The material was seen to be in fair condition at the time of the initial inspection.

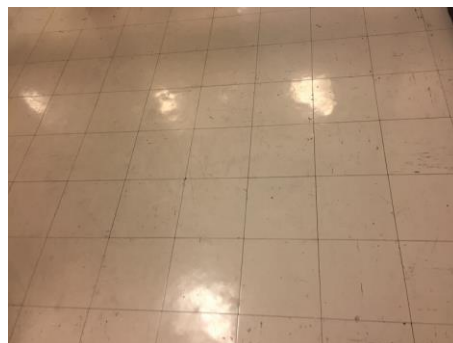
Grey floor tiles.

The material was seen to be in fair condition at the time of the initial inspection.

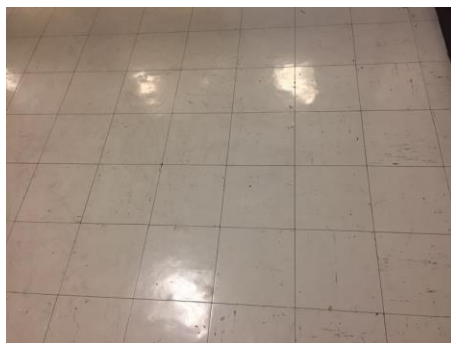
Bitumen adhesive beneath floor tiles.

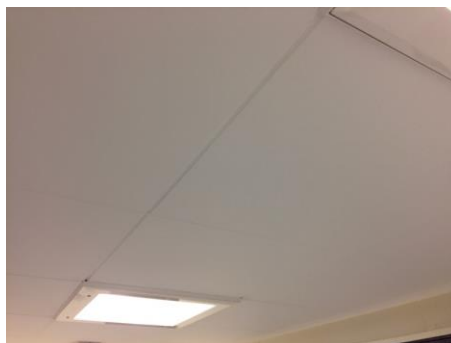
Spatter pattern textured coating above modern Supalux suspended ceiling.

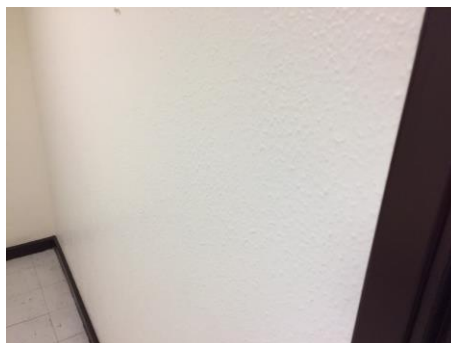
Spatter pattern textured coating.

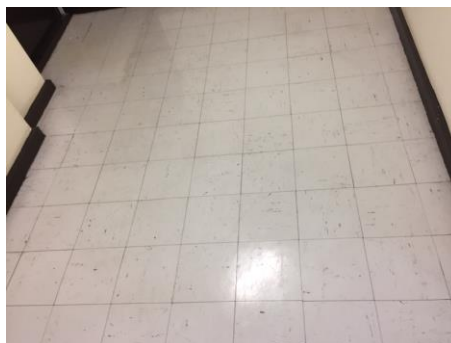
Grey floor tiles.

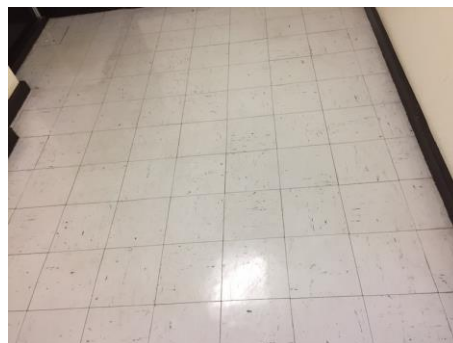
Bitumen adhesive beneath floor tiles.

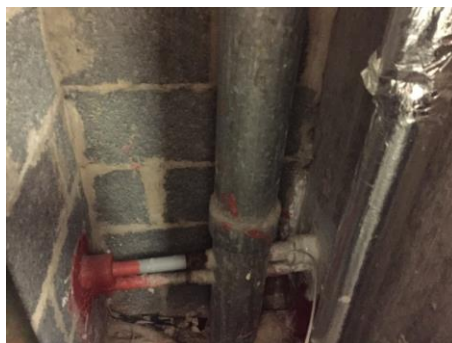
Lagging packing to joints of soil pipe.

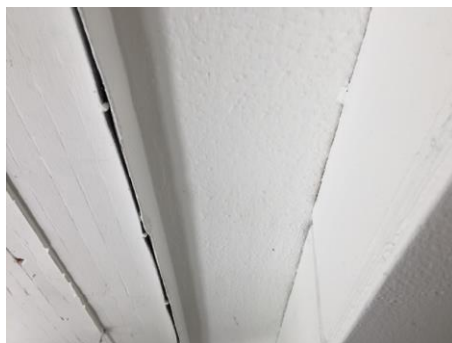
Stipple pattern textured coating.

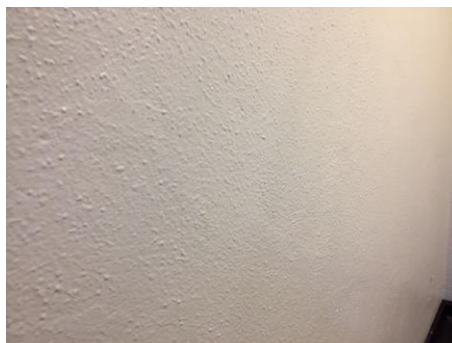
Spatter pattern textured coating.

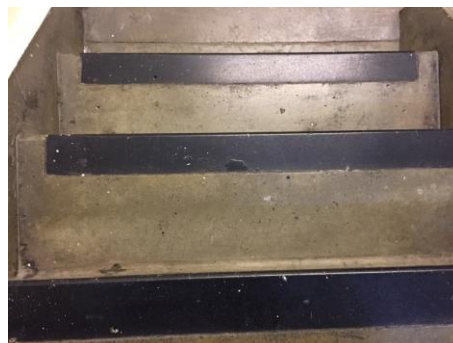
Resin nosing to edge of stairs.

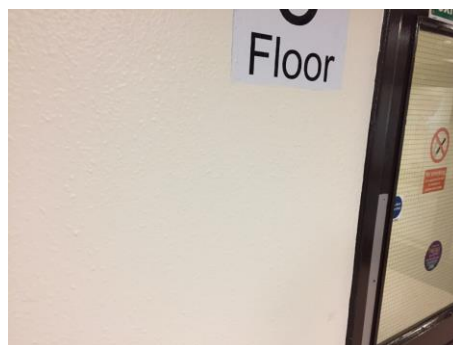
Spatter pattern textured coating.

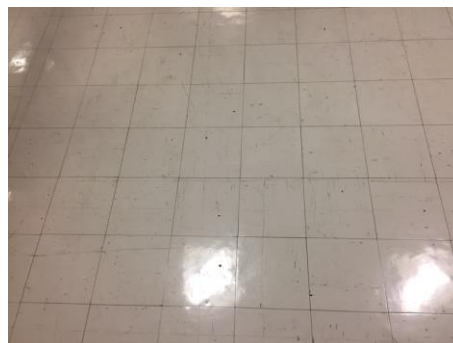
Grey floor tiles.

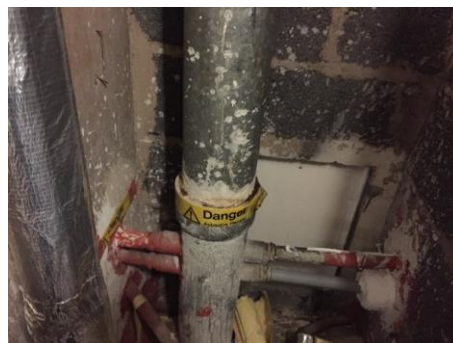
Lagging packing to joints of soil pipe.

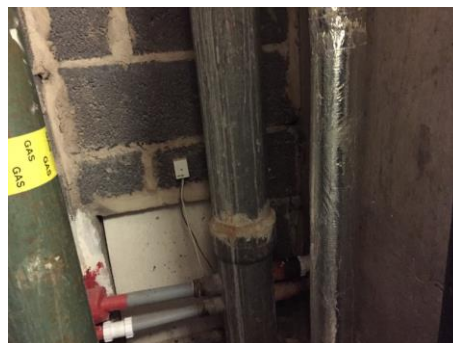
Lagging packing to joints of soil pipe.

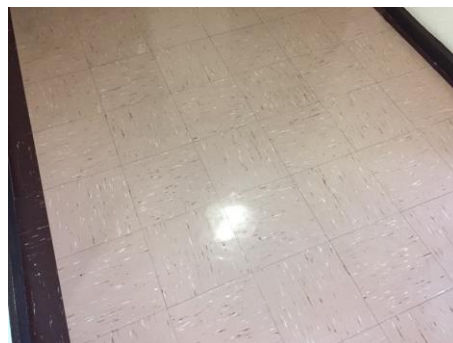
Pink floor tiles.

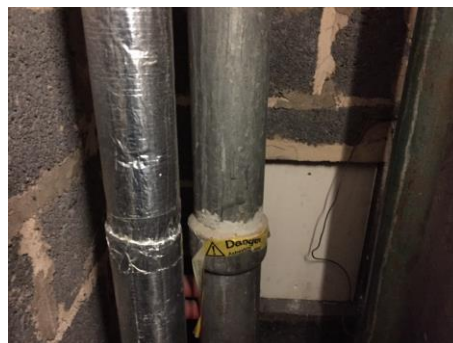
Lagging packing to joints of soil pipe.

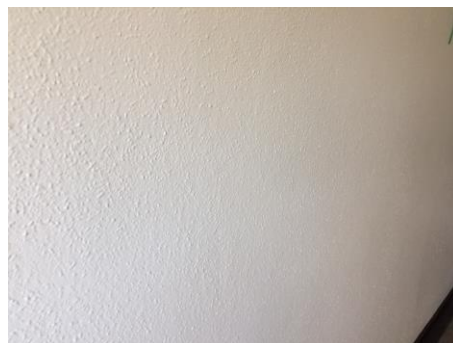
Spatter pattern textured coating.

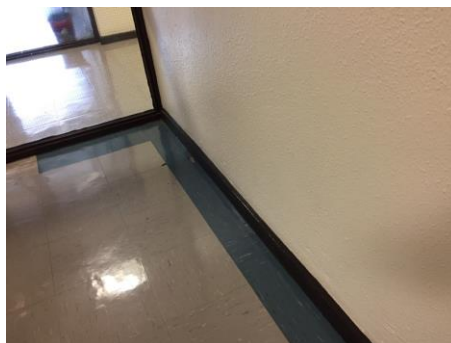
Blue floor tiles.

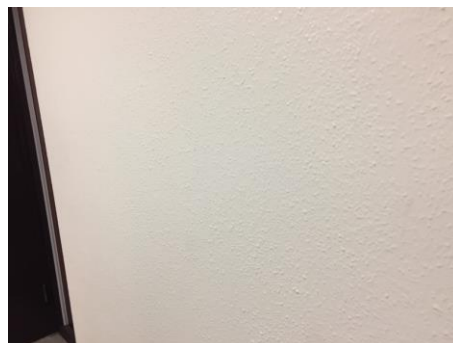
Spatter pattern textured coating.

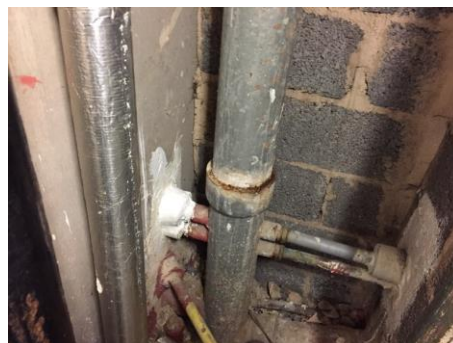
Lagging packing to joints of soil pipe.

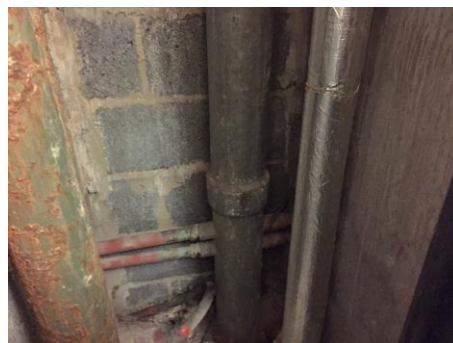
Lagging packing to joints of soil pipe.

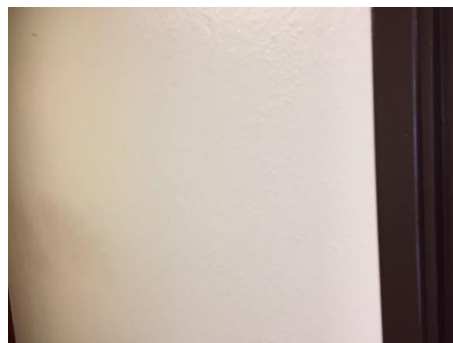
Spatter pattern textured coating.

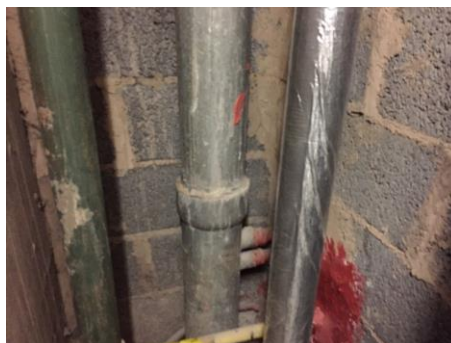
Sample taken? **Clone of S#10**
 Product Type **Lagging**
 Surface Treatment **Unsealed Non-Composite Material**
 Condition **Low Damage**
 Surface **Soil Pipe**
 Material Risk Assessment **9**
 Quantity: **1 Lin M**
 Next Inspection Date: **As per client policy/plan.**

Lagging packing to joints of soil pipe.

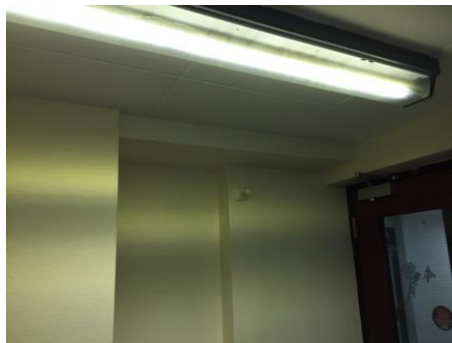
Insulating board boxing by door.

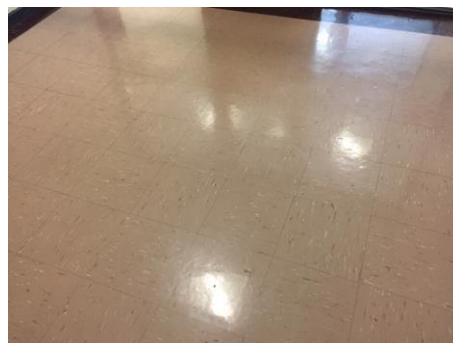
Bitumen adhesive beneath floor tiles.

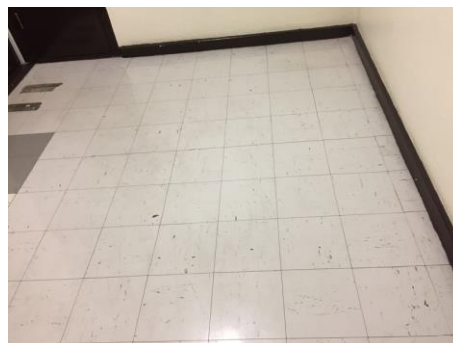
Grey floor tiles.

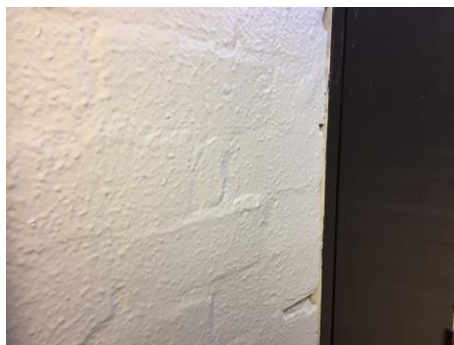
Spatter pattern textured coating.

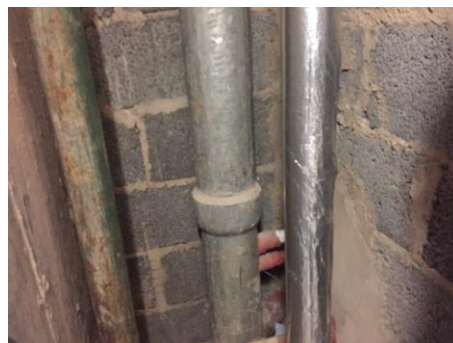
Sample taken? **Clone of S#10**
 Product Type **Lagging**
 Surface Treatment **Unsealed Non-Composite Material**
 Condition **Low Damage**
 Surface **Soil Pipe**
 Material Risk Assessment **9**
 Quantity: **1 Lin M**
 Next Inspection Date: **As per client policy/plan.**

Lagging packing to joints of soil pipe.

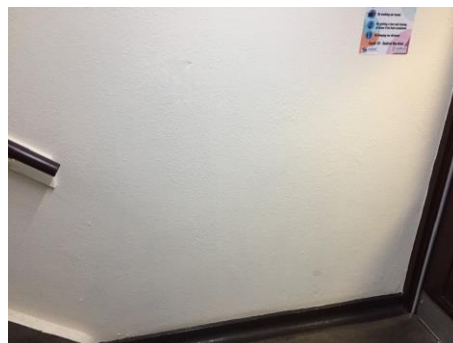
Spatter pattern textured coating.

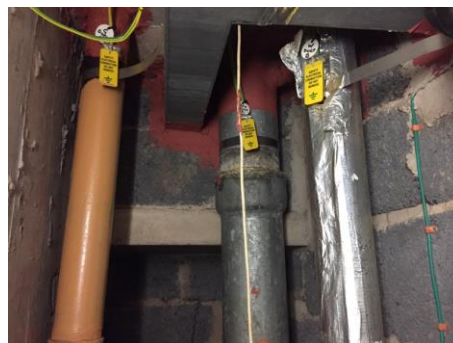
Lagging packing to joints of soil pipe.
