# Site ID: **a-304229**

## Management with Targeted Refurbishment Survey – PART 3

1-65 Kingsgate House  
Winchester Drive  
Chelmsley Wood  
Solihull  
B37 5PX  
United Kingdom

**27th April 2021**

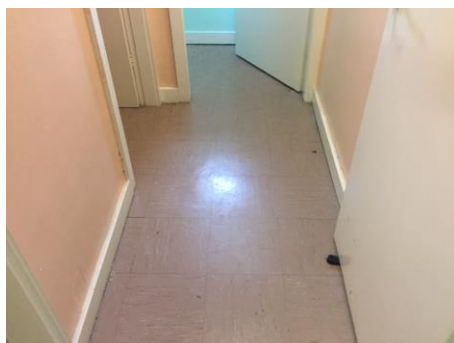
**a-304229-i03-01**

Adhesive to floor

**No asbestos was detected in the material tested.**

**No further action is required.**

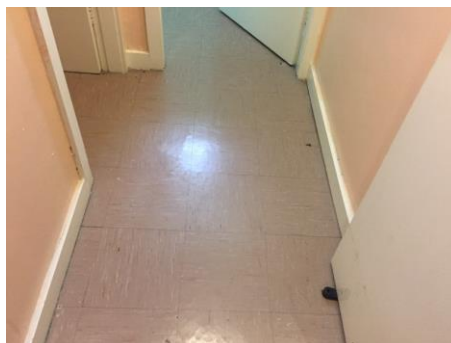
**a-304229-i03-02**

Beige floor tile

**No asbestos was detected in the material tested.**

**No further action is required.**

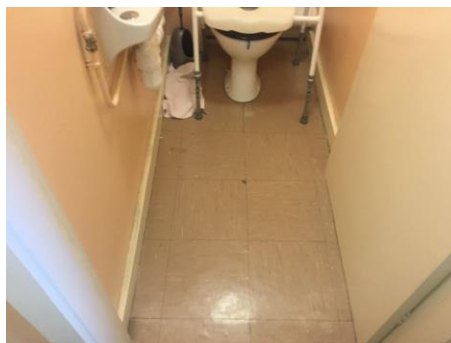
**a-304229-i04-03\_c01**

Adhesive to floor

No asbestos was detected in the material tested.

No further action is required.

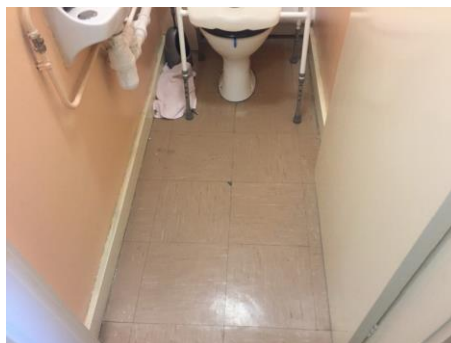
**a-304229-i04-04\_c02**

Beige floor tile

**No asbestos was detected in the material tested.**

**No further action is required.**

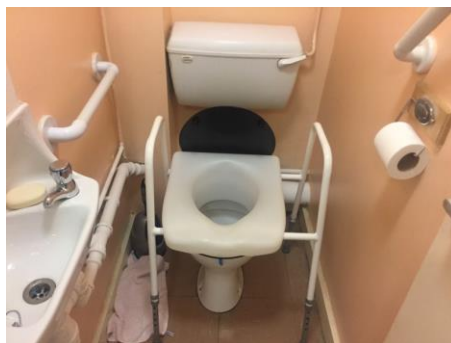
**a-304229-i04-05**

Resin seat

**No asbestos was detected in the material tested.**

**No further action is required.**

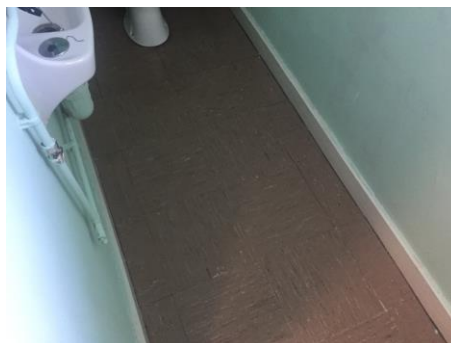
**a-304229-i05-06\_c01**

Adhesive to floor

**No asbestos was detected in the material tested.**

**No further action is required.**

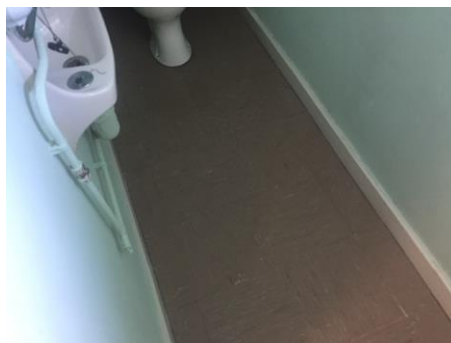
**a-304229-i05-07\_c02**

Beige floor tile

**No asbestos was detected in the material tested.**

**No further action is required.**

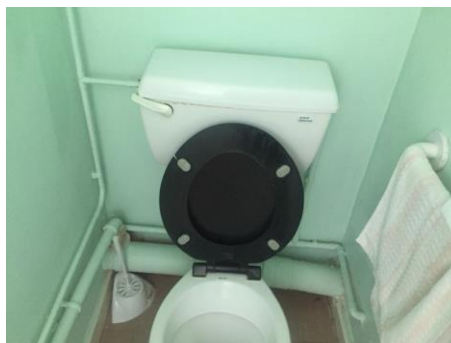
**a-304229-i05-08\_c05**

Resin seat

**No asbestos was detected in the material tested.**

**No further action is required.**
