# **Solihull Community Housing**

## **Asbestos Management Survey Report**

**I - 37 (Communal) Kingshurst  
House  
Stonebridge Croft  
Solihull  
B37 6JP**

**Date of Report: 20 Jan 2015**  
**Survey Ref: 257890000A**

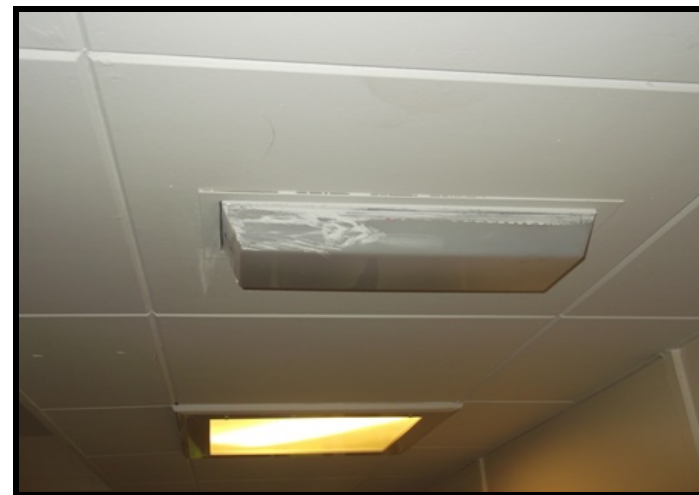
## SAMPLE REFERENCE 004

| 004 | Main Building (Ground Floor) | Landing | Ceiling | Insulation Board | No Asbestos Detected | 10.00m2 | Good condition | Sealed Board (Encapsulated) | - | - | - | NO ACTION REQUIRED | | |

Asbestos not detected in Sample

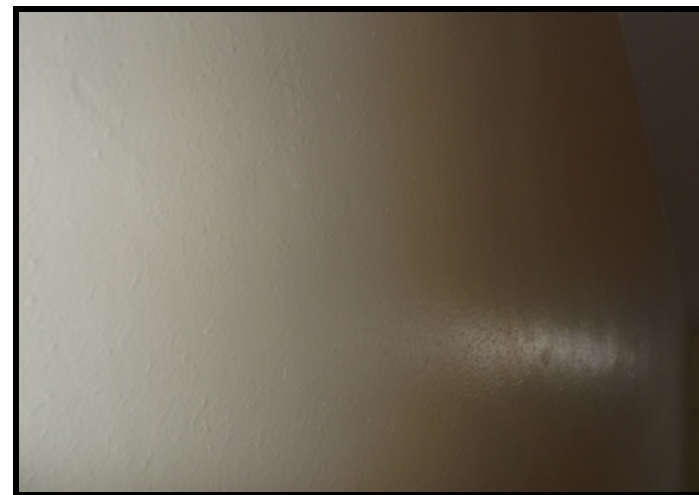
## SAMPLE REFERENCE 005

| Unique Sample No. | Building Reference (Floor) | Room Area | Description of Location | Product Description | Asbestos Type | Approx. Quantity | Material Condition | Surface Treatment | Material Risk Score | Priority Risk Score | Total Risk Score | Management Action | Next Review Date |
|---|---|---|---|---|---|---|---|---|---|---|---|---|---|
| 005 | Main Building (Ground Floor) | Landing | Wall | Textured Coating | No Asbestos Detected | 15.00m2 | Good condition | Textured Coating | - | - | - | NO ACTION REQUIRED | |

Asbestos not detected in Sample

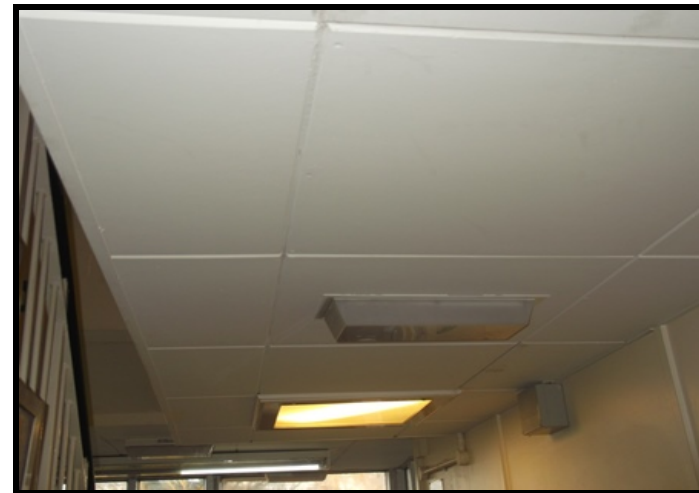
## SAMPLE REFERENCE 006

| Unique Sample No. | Building Reference (Floor) | Room Area | Description of Location | Product Description | Asbestos Type | Approx. Quantity | Material Condition | Surface Treatment | Material Risk Score | Priority Risk Score | Total Risk Score | Management Action | Next Review Date |
|---|---|---|---|---|---|---|---|---|---|---|---|---|---|
| 006 | Main Building (Ground Floor) | Stairwell | Ceiling | Insulation Board | No Asbestos Detected | 8.00m2 | Good condition | Sealed Board (Encapsulated) | - | - | - | NO ACTION REQUIRED | |

**No Asbestos Presumed in Sample**

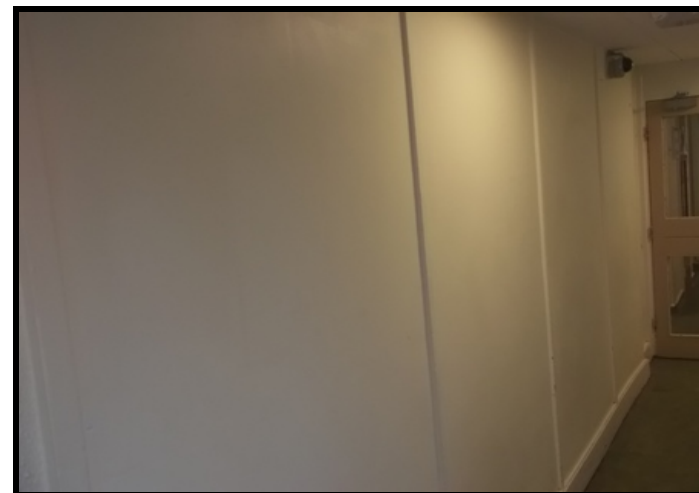
## SAMPLE REFERENCE 006a

| Unique Sample No. | Building Reference (Floor) | Room Area | Description of Location | Product Description | Asbestos Type | Approx. Quantity | Material Condition | Surface Treatment | Material Risk Score | Priority Risk Score | Total Risk Score | Management Action | Next Review Date |
|---|---|---|---|---|---|---|---|---|---|---|---|---|---|
| 006a | Main Building (Ground Floor) | Stairwell | Panel | Insulation Board | No Asbestos Detected | 15.00m2 | Low damage | Sealed Board (Encapsulated) | - | - | - | NO ACTION REQUIRED | |

Asbestos not detected in Sample

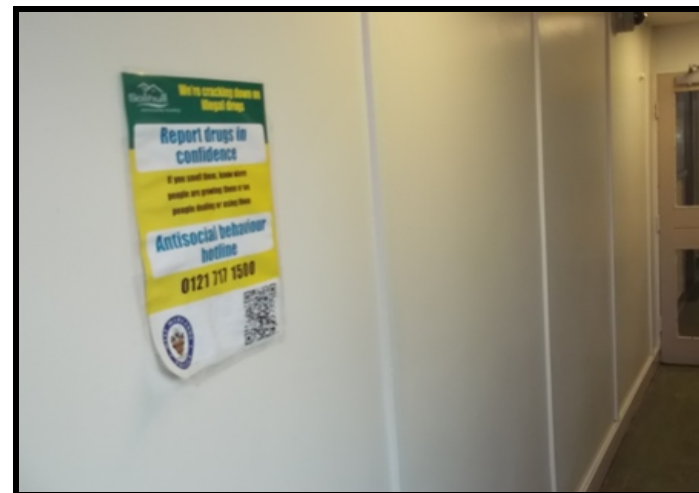
## SAMPLE REFERENCE 006b

| Unique Sample No. | Building Reference (Floor) | Room Area | Description of Location | Product Description | Asbestos Type | Approx. Quantity | Material Condition | Surface Treatment | Material Risk Score | Priority Risk Score | Total Risk Score | Management Action | Next Review Date |
|---|---|---|---|---|---|---|---|---|---|---|---|---|---|
| 006b | Main Building (Ground Floor) | Stairwell | Panel | Insulation Board | No Asbestos Detected | 15.00m2 | Low damage | Sealed Board (Encapsulated) | - | - | - | NO ACTION REQUIRED | |

**No Asbestos Presumed in Sample**

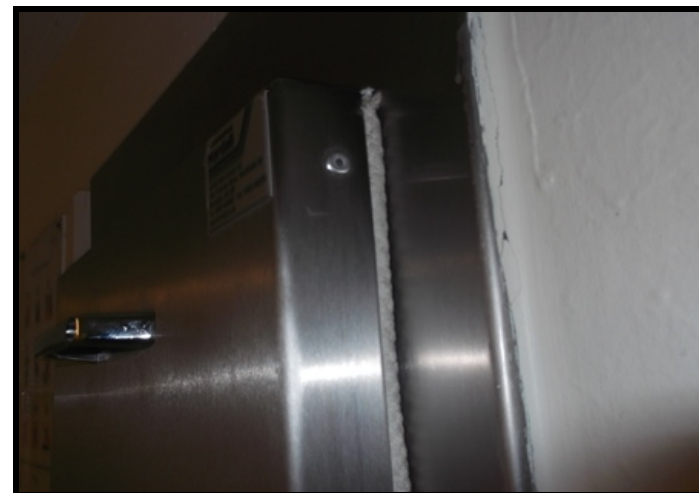
## SAMPLE REFERENCE 006c

| Unique Sample No. | Building Reference (Floor) | Room Area | Description of Location | Product Description | Asbestos Type | Approx. Quantity | Material Condition | Surface Treatment | Material Risk Score | Priority Risk Score | Total Risk Score | Management Action | Next Review Date |
|---|---|---|---|---|---|---|---|---|---|---|---|---|---|
| 006c | Main Building (Ground Floor) | Stairwell | Door | Rope | No Asbestos Detected | 1.00m2 | Low damage | Unsealed (1) | - | - | - | NO ACTION REQUIRED | |

Asbestos not detected in Sample

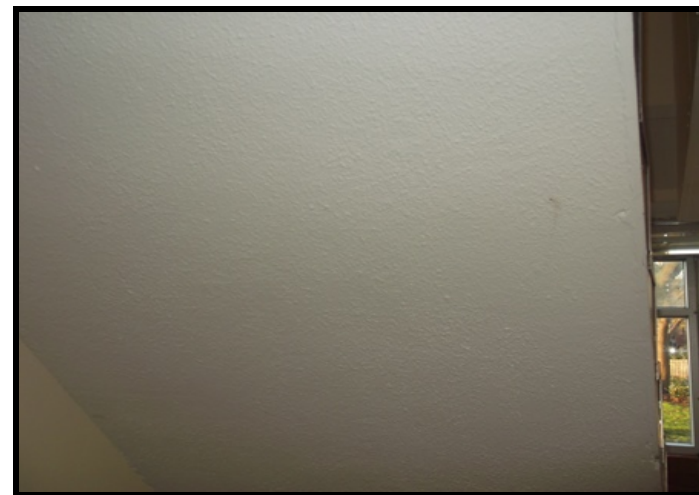
## SAMPLE REFERENCE 007

| Unique Sample No. | Building Reference (Floor) | Room Area | Description of Location | Product Description | Asbestos Type | Approx. Quantity | Material Condition | Surface Treatment | Material Risk Score | Priority Risk Score | Total Risk Score | Management Action | Next Review Date |
|---|---|---|---|---|---|---|---|---|---|---|---|---|---|
| 007 | Main Building (Ground Floor) | Stairwell | Ceiling | Textured Coating | Chrysotile | 4.00m2 | Good condition | Textured Coating | 2 | 1 | 3 | LABEL & MONITOR | 10 Dec 2015 |

**Asbestos detected in Sample**

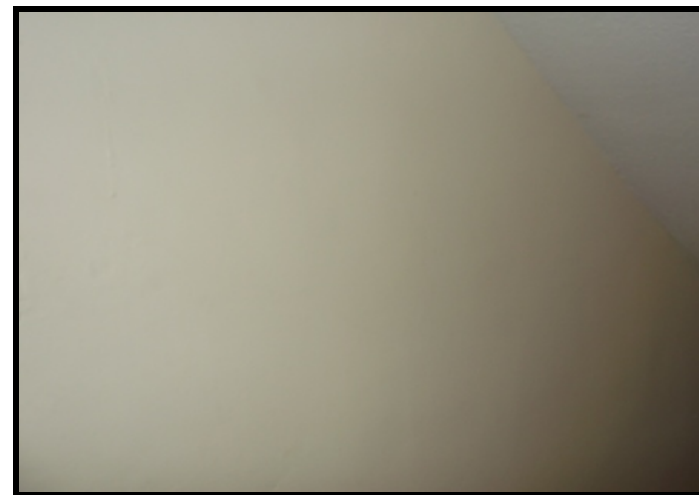
## SAMPLE REFERENCE 008

| Unique Sample No. | Building Reference (Floor) | Room Area | Description of Location | Product Description | Asbestos Type | Approx. Quantity | Material Condition | Surface Treatment | Material Risk Score | Priority Risk Score | Total Risk Score | Management Action | Next Review Date |
|---|---|---|---|---|---|---|---|---|---|---|---|---|---|
| 008 | Main Building (Ground Floor) | Stairwell | Wall | Textured Coating | No Asbestos Detected | 10.00m2 | Good condition | Textured Coating | - | - | - | NO ACTION REQUIRED | |

**No Asbestos Presumed in Sample**

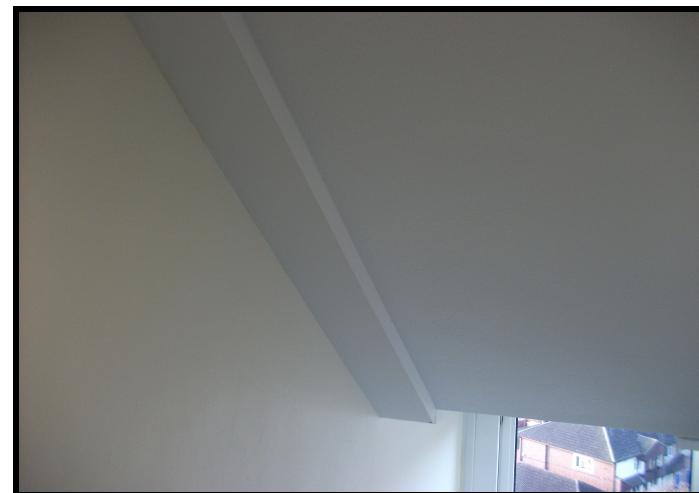
## SAMPLE REFERENCE 009

| Unique Sample No. | Building Reference (Floor) | Room Area | Description of Location | Product Description | Asbestos Type | Approx. Quantity | Material Condition | Surface Treatment | Material Risk Score | Priority Risk Score | Total Risk Score | Management Action | Next Review Date |
|---|---|---|---|---|---|---|---|---|---|---|---|---|---|
| 009 | Main Building (Ground Floor) | Stairwell | Boxing | Insulation Board | No Asbestos Detected | 2.00m2 | Good condition | Sealed Board (Encapsulated) | - | - | - | NO ACTION REQUIRED | |

Asbestos not detected in Sample

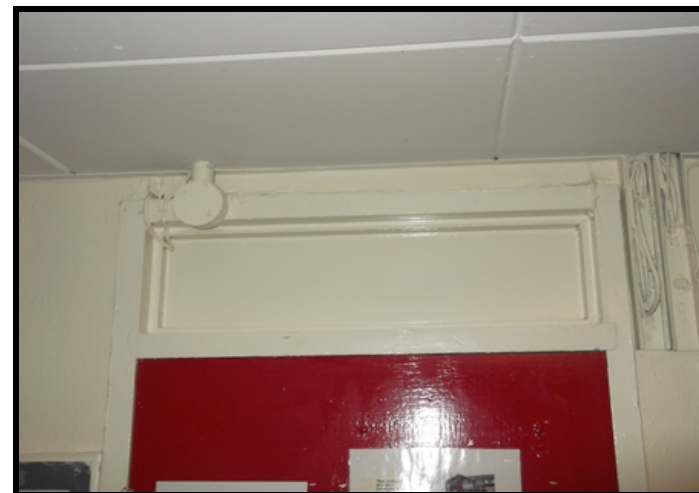
## SAMPLE REFERENCE 010

| Unique Sample No. | Building Reference (Floor) | Room Area | Description of Location | Product Description | Asbestos Type | Approx. Quantity | Material Condition | Surface Treatment | Material Risk Score | Priority Risk Score | Total Risk Score | Management Action | Next Review Date |
|---|---|---|---|---|---|---|---|---|---|---|---|---|---|
| 010 | Main Building (Ground Floor) | Dry Riser | Transom Panel | Insulation Board | No Asbestos Detected | 1.00m2 | Good condition | Sealed Board (Encapsulated) | - | - | - | NO ACTION REQUIRED | |

Asbestos not detected in Sample

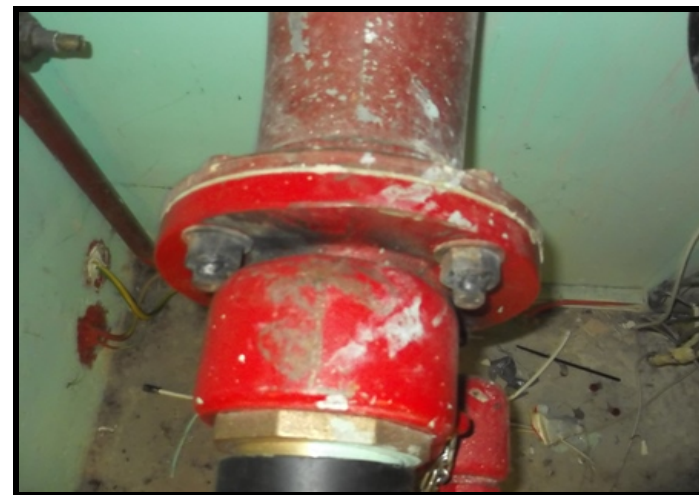
## SAMPLE REFERENCE 010a

| Unique Sample No. | Building Reference (Floor) | Room Area | Description of Location | Product Description | Asbestos Type | Approx. Quantity | Material Condition | Surface Treatment | Material Risk Score | Priority Risk Score | Total Risk Score | Management Action | Next Review Date |
|---|---|---|---|---|---|---|---|---|---|---|---|---|---|
| 010a | Main Building (Ground Floor) | Dry Riser | Pipe Work | Gasket | No Asbestos Detected | 1.00m2 | Low damage | Sealed (0) | - | - | - | NO ACTION REQUIRED | |

Asbestos not detected in Sample

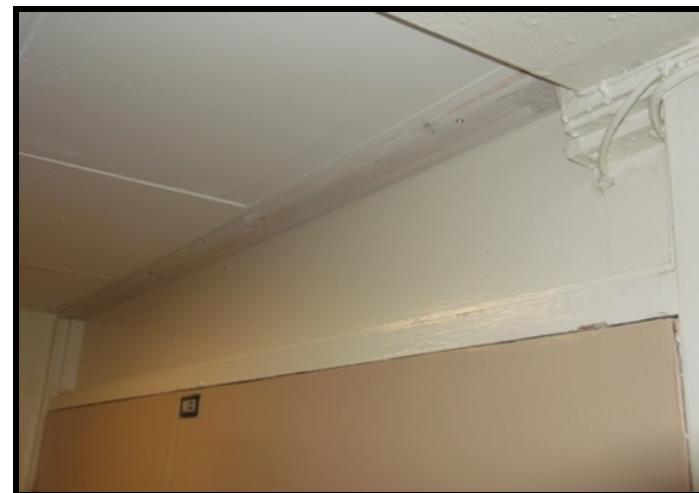
## SAMPLE REFERENCE 011

| Unique Sample No. | Building Reference (Floor) | Room Area | Description of Location | Product Description | Asbestos Type | Approx. Quantity | Material Condition | Surface Treatment | Material Risk Score | Priority Risk Score | Total Risk Score | Management Action | Next Review Date |
|---|---|---|---|---|---|---|---|---|---|---|---|---|---|
| 011 | Main Building (Ground Floor) | Electric Cupboard | Transom Panel | Insulation Board | No Asbestos Detected | 1.00m2 | Low damage | Sealed Board (Encapsulated) | - | - | - | NO ACTION REQUIRED | |

Asbestos not detected in Sample

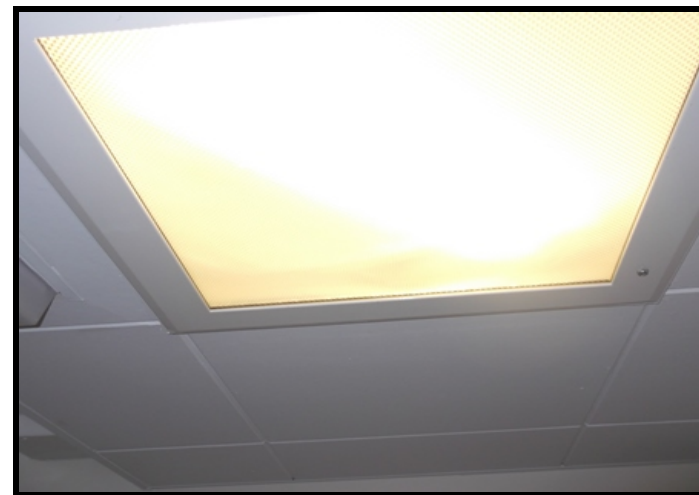
## SAMPLE REFERENCE 012

| Unique Sample No. | Building Reference (Floor) | Room Area | Description of Location | Product Description | Asbestos Type | Approx. Quantity | Material Condition | Surface Treatment | Material Risk Score | Priority Risk Score | Total Risk Score | Management Action | Next Review Date |
|---|---|---|---|---|---|---|---|---|---|---|---|---|---|
| 012 | Main Building (First Floor) | Landing | Ceiling | Insulation Board | No Asbestos Detected | 10.00m2 | Good condition | Sealed Board (Encapsulated) | - | - | - | NO ACTION REQUIRED | |

**No Asbestos Presumed in Sample**

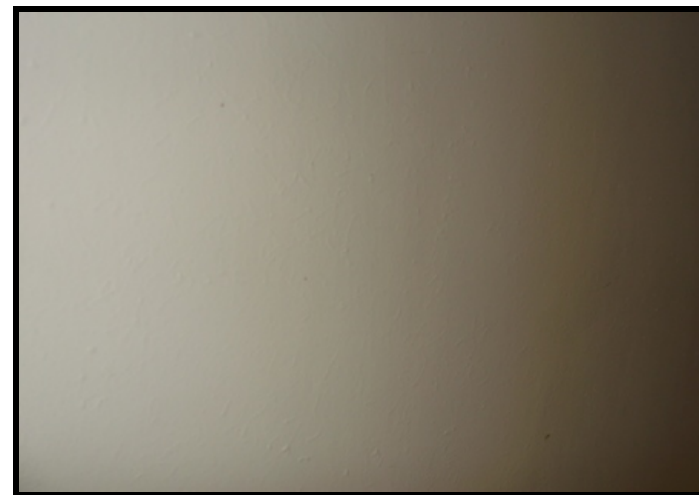
## SAMPLE REFERENCE 013

| Unique Sample No. | Building Reference (Floor) | Room Area | Description of Location | Product Description | Asbestos Type | Approx. Quantity | Material Condition | Surface Treatment | Material Risk Score | Priority Risk Score | Total Risk Score | Management Action | Next Review Date |
|---|---|---|---|---|---|---|---|---|---|---|---|---|---|
| 013 | Main Building (First Floor) | Landing | Wall | Textured Coating | No Asbestos Detected | 15.00m2 | Good condition | Textured Coating | - | - | - | NO ACTION REQUIRED | |

**No Asbestos Presumed in Sample**

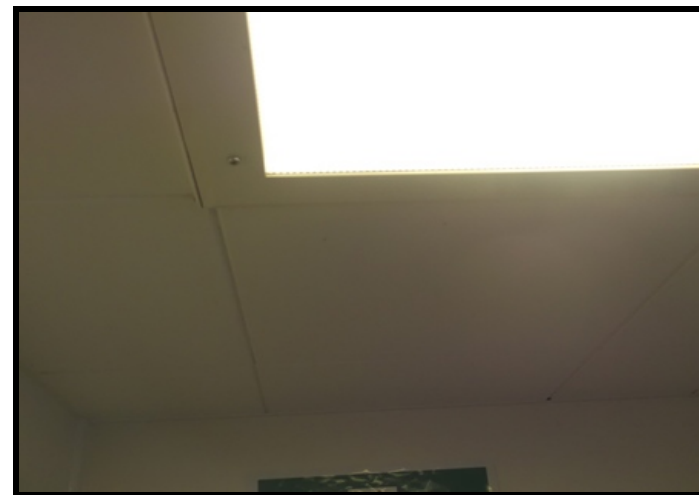
## SAMPLE REFERENCE 014

| Unique Sample No. | Building Reference (Floor) | Room Area | Description of Location | Product Description | Asbestos Type | Approx. Quantity | Material Condition | Surface Treatment | Material Risk Score | Priority Risk Score | Total Risk Score | Management Action | Next Review Date |
|---|---|---|---|---|---|---|---|---|---|---|---|---|---|
| 014 | Main Building (First Floor) | Stairwell | Ceiling | Insulation Board | No Asbestos Detected | 8.00m2 | Good condition | Sealed Board (Encapsulated) | - | - | - | NO ACTION REQUIRED | |

**No Asbestos Presumed in Sample**

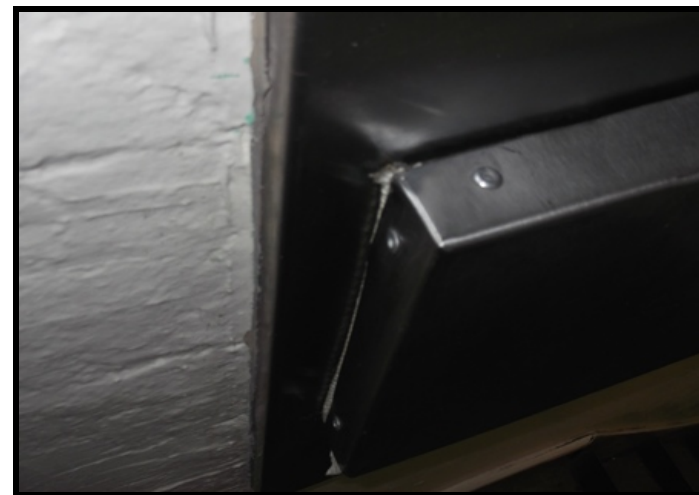
## SAMPLE REFERENCE 014a

| Unique Sample No. | Building Reference (Floor) | Room Area | Description of Location | Product Description | Asbestos Type | Approx. Quantity | Material Condition | Surface Treatment | Material Risk Score | Priority Risk Score | Total Risk Score | Management Action | Next Review Date |
|---|---|---|---|---|---|---|---|---|---|---|---|---|---|
| 014a | Main Building (First Floor) | Stairwell | Door | Rope | No Asbestos Detected | 1.00m2 | Low damage | Unsealed (1) | - | - | - | NO ACTION REQUIRED | |

**No Asbestos Presumed in Sample**

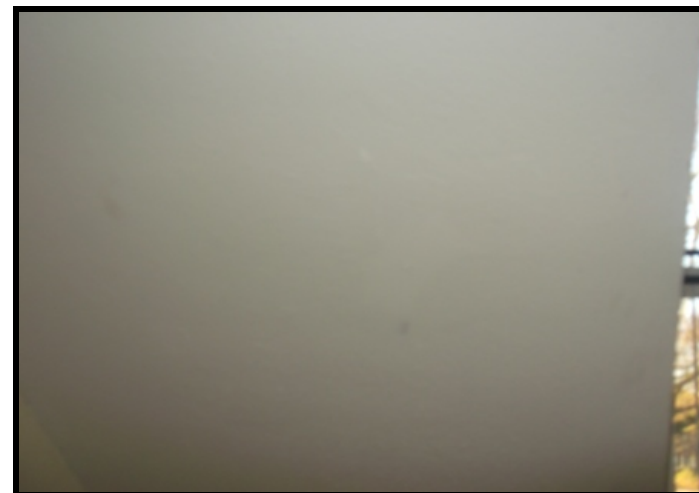
## SAMPLE REFERENCE 015

| Unique Sample No. | Building Reference (Floor) | Room Area | Description of Location | Product Description | Asbestos Type | Approx. Quantity | Material Condition | Surface Treatment | Material Risk Score | Priority Risk Score | Total Risk Score | Management Action | Next Review Date |
|---|---|---|---|---|---|---|---|---|---|---|---|---|---|
| 015 | Main Building (First Floor) | Stairwell | Ceiling | Textured Coating | Chrysotile | 4.00m2 | Good condition | Textured Coating | 2 | 1 | 3 | LABEL & MONITOR | 10 Dec 2015 |

**Asbestos Presumed**

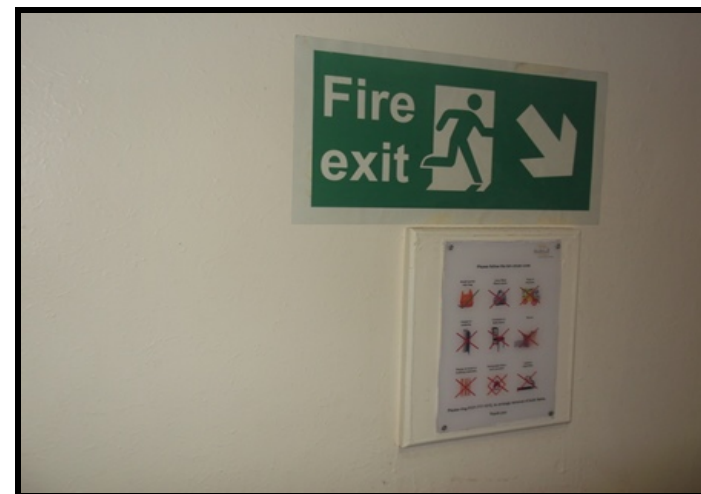
## SAMPLE REFERENCE 016

| Unique Sample No. | Building Reference (Floor) | Room Area | Description of Location | Product Description | Asbestos Type | Approx. Quantity | Material Condition | Surface Treatment | Material Risk Score | Priority Risk Score | Total Risk Score | Management Action | Next Review Date |
|---|---|---|---|---|---|---|---|---|---|---|---|---|---|
| 016 | Main Building (First Floor) | Stairwell | Wall | Textured Coating | No Asbestos Detected | 10.00m2 | Good condition | Textured Coating | - | - | - | NO ACTION REQUIRED | |

**No Asbestos Presumed in Sample**

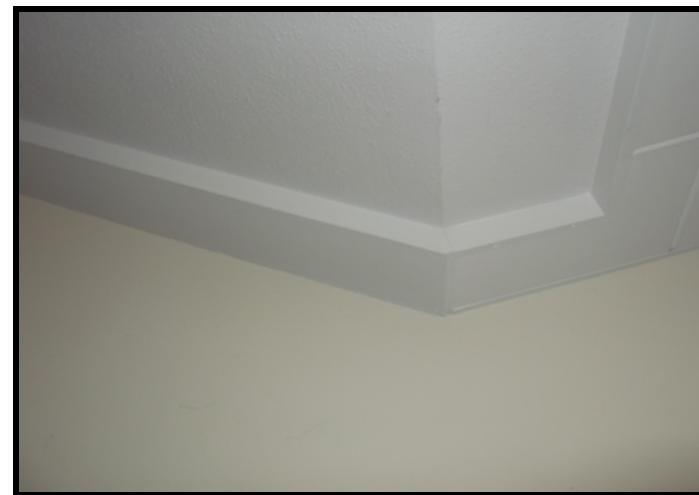
## SAMPLE REFERENCE 017

| Unique Sample No. | Building Reference (Floor) | Room Area | Description of Location | Product Description | Asbestos Type | Approx. Quantity | Material Condition | Surface Treatment | Material Risk Score | Priority Risk Score | Total Risk Score | Management Action | Next Review Date |
|---|---|---|---|---|---|---|---|---|---|---|---|---|---|
| 017 | Main Building (First Floor) | Stairwell | Boxing | Insulation Board | No Asbestos Detected | 2.00m2 | Good condition | Sealed Board (Encapsulated) | - | - | - | NO ACTION REQUIRED | |

**No Asbestos Presumed in Sample**

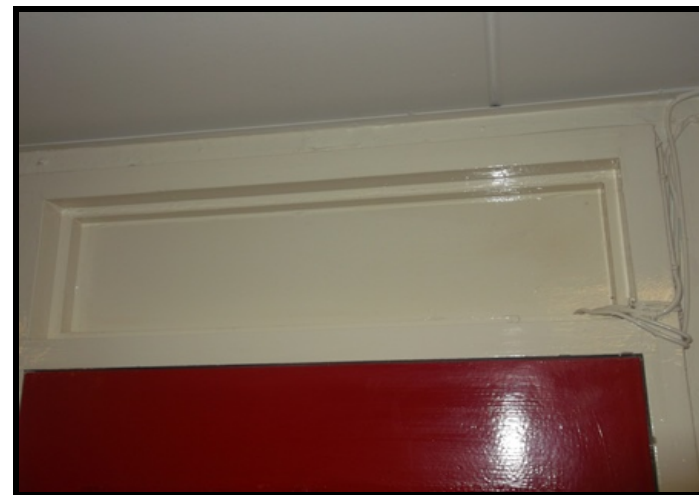
## SAMPLE REFERENCE 018

| Unique Sample No. | Building Reference (Floor) | Room Area | Description of Location | Product Description | Asbestos Type | Approx. Quantity | Material Condition | Surface Treatment | Material Risk Score | Priority Risk Score | Total Risk Score | Management Action | Next Review Date |
|---|---|---|---|---|---|---|---|---|---|---|---|---|---|
| 018 | Main Building (First Floor) | Dry Riser | Transom Panel | Insulation Board | No Asbestos Detected | 1.00m2 | Good condition | Sealed Board (Encapsulated) | - | - | - | NO ACTION REQUIRED | |

**No Asbestos Presumed in Sample**

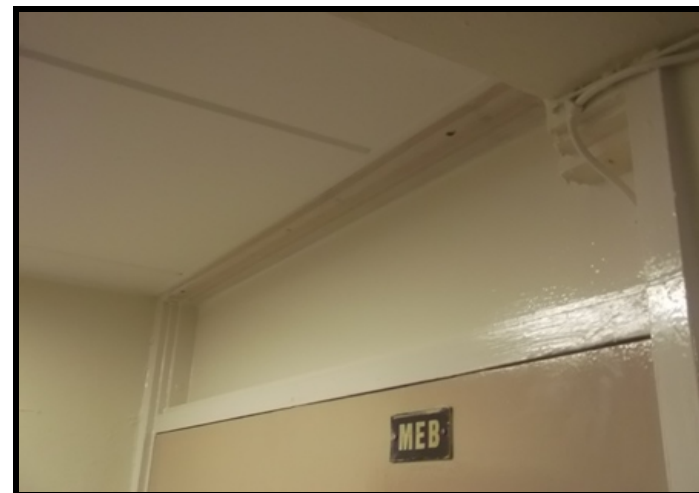
## SAMPLE REFERENCE 019

| Unique Sample No. | Building Reference (Floor) | Room Area | Description of Location | Product Description | Asbestos Type | Approx. Quantity | Material Condition | Surface Treatment | Material Risk Score | Priority Risk Score | Total Risk Score | Management Action | Next Review Date |
|---|---|---|---|---|---|---|---|---|---|---|---|---|---|
| 019 | Main Building (First Floor) | Electric Cupboard | Transom Panel | Insulation Board | No Asbestos Detected | 1.00m2 | Low damage | Sealed Board (Encapsulated) | - | - | - | NO ACTION REQUIRED | |

**No Asbestos Presumed in Sample**

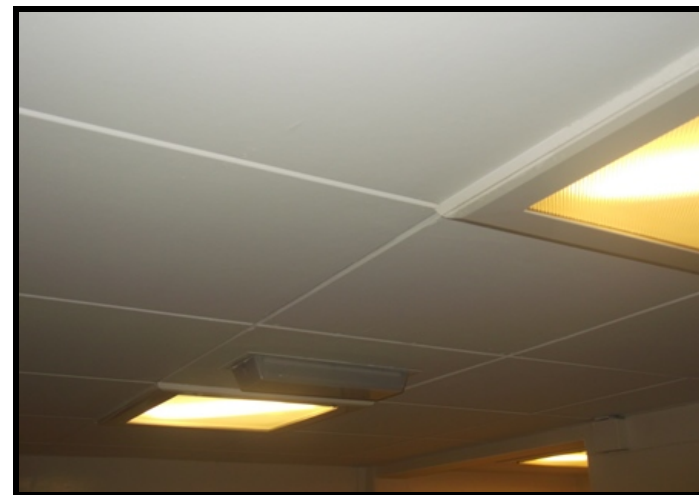
## SAMPLE REFERENCE 020

| Unique Sample No. | Building Reference (Floor) | Room Area | Description of Location | Product Description | Asbestos Type | Approx. Quantity | Material Condition | Surface Treatment | Material Risk Score | Priority Risk Score | Total Risk Score | Management Action | Next Review Date |
|---|---|---|---|---|---|---|---|---|---|---|---|---|---|
| 020 | Main Building (Second Floor) | Landing | Ceiling | Insulation Board | No Asbestos Detected | 10.00m2 | Good condition | Sealed Board (Encapsulated) | - | - | - | NO ACTION REQUIRED | |

**No Asbestos Presumed in Sample**

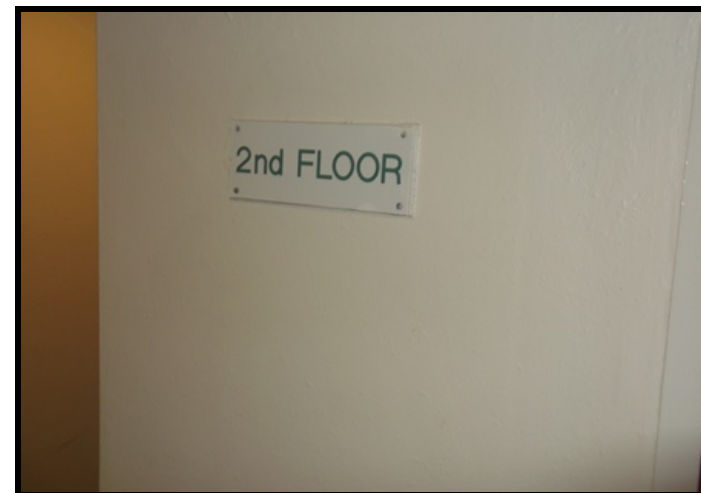
## SAMPLE REFERENCE 021

| Unique Sample No. | Building Reference (Floor) | Room Area | Description of Location | Product Description | Asbestos Type | Approx. Quantity | Material Condition | Surface Treatment | Material Risk Score | Priority Risk Score | Total Risk Score | Management Action | Next Review Date |
|---|---|---|---|---|---|---|---|---|---|---|---|---|---|
| 021 | Main Building (Second Floor) | Landing | Wall | Textured Coating | No Asbestos Detected | 15.00m2 | Good condition | Textured Coating | - | - | - | NO ACTION REQUIRED | |

**No Asbestos Presumed in Sample**

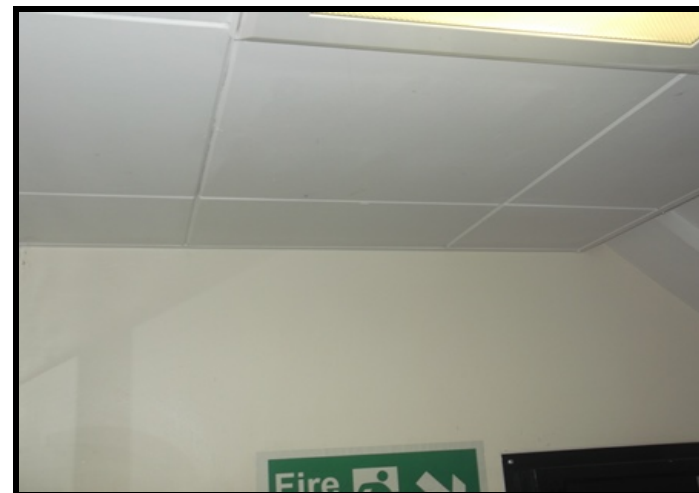
## SAMPLE REFERENCE 022

| Unique Sample No. | Building Reference (Floor) | Room Area | Description of Location | Product Description | Asbestos Type | Approx. Quantity | Material Condition | Surface Treatment | Material Risk Score | Priority Risk Score | Total Risk Score | Management Action | Next Review Date |
|---|---|---|---|---|---|---|---|---|---|---|---|---|---|
| 022 | Main Building (Second Floor) | Stairwell | Ceiling | Insulation Board | No Asbestos Detected | 8.00m2 | Good condition | Sealed Board (Encapsulated) | - | - | - | NO ACTION REQUIRED | |

**No Asbestos Presumed in Sample**

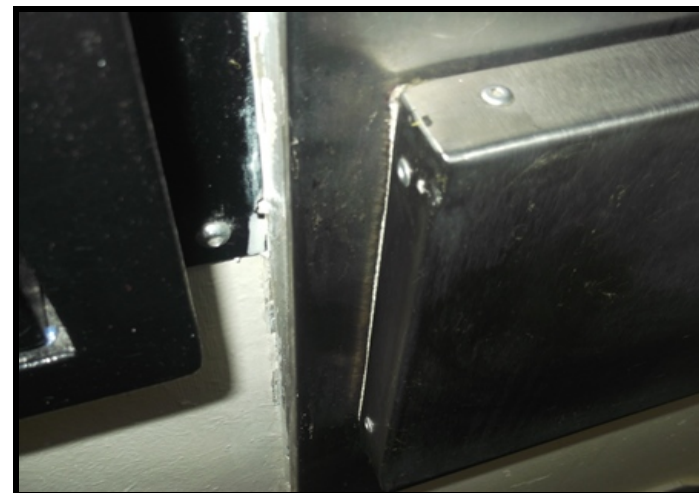
SAMPLE REFERENCE 022a

| Unique Sample No. | Building Reference (Floor) | Room Area | Description of Location | Product Description | Asbestos Type | Approx. Quantity | Material Condition | Surface Treatment | Material Risk Score | Priority Risk Score | Total Risk Score | Management Action | Next Review Date |
|---|---|---|---|---|---|---|---|---|---|---|---|---|---|
| 022a | Main Building (Second Floor) | Stairwell | Door | Rope | No Asbestos Detected | 1.00m2 | Low damage | Unsealed (I) | - | - | - | NO ACTION REQUIRED | |

**No Asbestos Presumed in Sample**

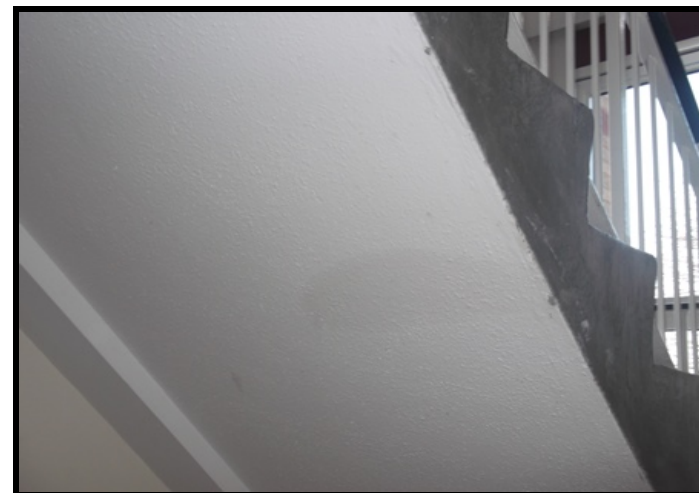
## SAMPLE REFERENCE 023

| Unique Sample No. | Building Reference (Floor) | Room Area | Description of Location | Product Description | Asbestos Type | Approx. Quantity | Material Condition | Surface Treatment | Material Risk Score | Priority Risk Score | Total Risk Score | Management Action | Next Review Date |
|---|---|---|---|---|---|---|---|---|---|---|---|---|---|
| 023 | Main Building (Second Floor) | Stairwell | Ceiling | Textured Coating | Chrysotile | 8.00m2 | Good condition | Textured Coating | 2 | 1 | 3 | LABEL & MONITOR | 10 Dec 2015 |

Asbestos Presumed

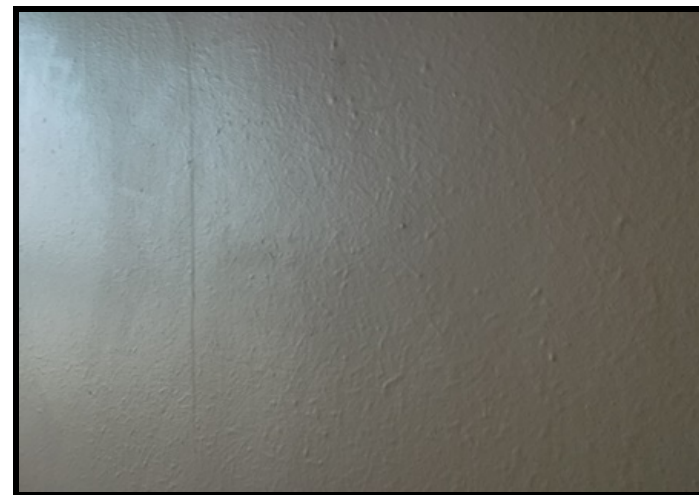
## SAMPLE REFERENCE 024

| Unique Sample No. | Building Reference (Floor) | Room Area | Description of Location | Product Description | Asbestos Type | Approx. Quantity | Material Condition | Surface Treatment | Material Risk Score | Priority Risk Score | Total Risk Score | Management Action | Next Review Date |
|---|---|---|---|---|---|---|---|---|---|---|---|---|---|
| 024 | Main Building (Second Floor) | Stairwell | Wall | Textured Coating | No Asbestos Detected | 15.00m2 | Good condition | Textured Coating | - | - | - | NO ACTION REQUIRED | |

**No Asbestos Presumed in Sample**

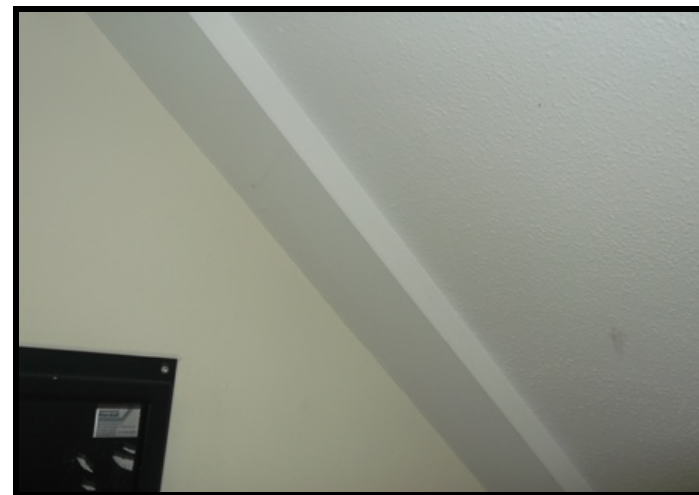
## SAMPLE REFERENCE 025

| Unique Sample No. | Building Reference (Floor) | Room Area | Description of Location | Product Description | Asbestos Type | Approx. Quantity | Material Condition | Surface Treatment | Material Risk Score | Priority Risk Score | Total Risk Score | Management Action | Next Review Date |
|---|---|---|---|---|---|---|---|---|---|---|---|---|---|
| 025 | Main Building (Second Floor) | Stairwell | Boxing | Insulation Board | No Asbestos Detected | 2.00m2 | Good condition | Sealed Board (Encapsulated) | - | - | - | NO ACTION REQUIRED | |

**No Asbestos Presumed in Sample**

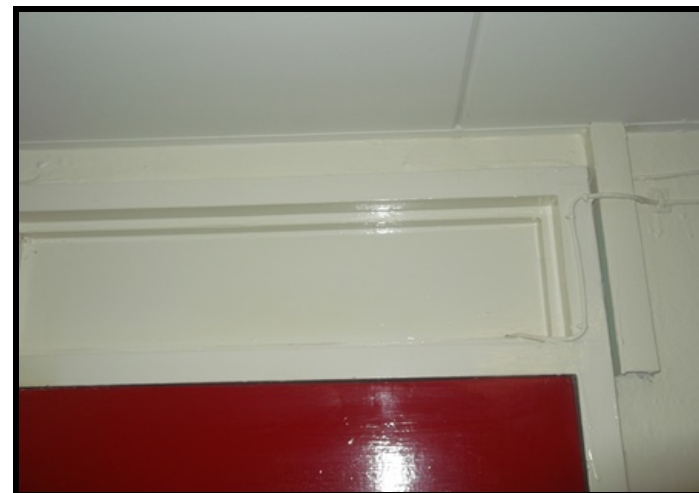
## SAMPLE REFERENCE 026

| Unique Sample No. | Building Reference (Floor) | Room Area | Description of Location | Product Description | Asbestos Type | Approx. Quantity | Material Condition | Surface Treatment | Material Risk Score | Priority Risk Score | Total Risk Score | Management Action | Next Review Date |
|---|---|---|---|---|---|---|---|---|---|---|---|---|---|
| 026 | Main Building (Second Floor) | Dry Riser | Transom Panel | Insulation Board | No Asbestos Detected | 1.00m2 | Good condition | Sealed Board (Encapsulated) | - | - | - | NO ACTION REQUIRED | |

**No Asbestos Presumed in Sample**

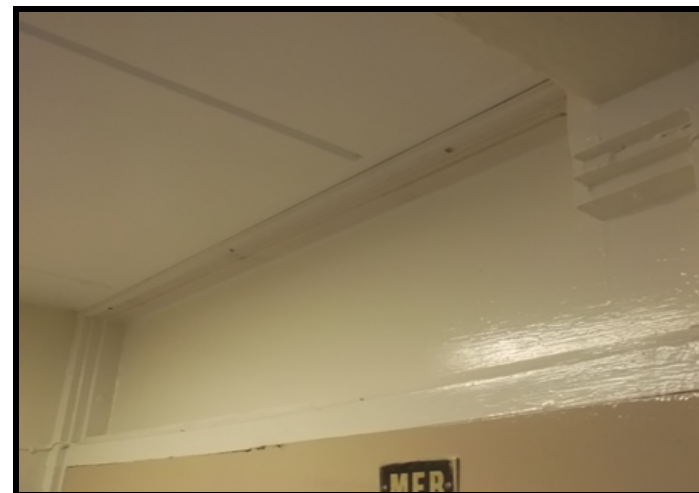
## SAMPLE REFERENCE 027

| Unique Sample No. | Building Reference (Floor) | Room Area | Description of Location | Product Description | Asbestos Type | Approx. Quantity | Material Condition | Surface Treatment | Material Risk Score | Priority Risk Score | Total Risk Score | Management Action | Next Review Date |
|---|---|---|---|---|---|---|---|---|---|---|---|---|---|
| 027 | Main Building (Second Floor) | Electric Cupboard | Transom Panel | Insulation Board | No Asbestos Detected | 1.00m2 | Low damage | Sealed Board (Encapsulated) | - | - | - | NO ACTION REQUIRED | |

**No Asbestos Presumed in Sample**

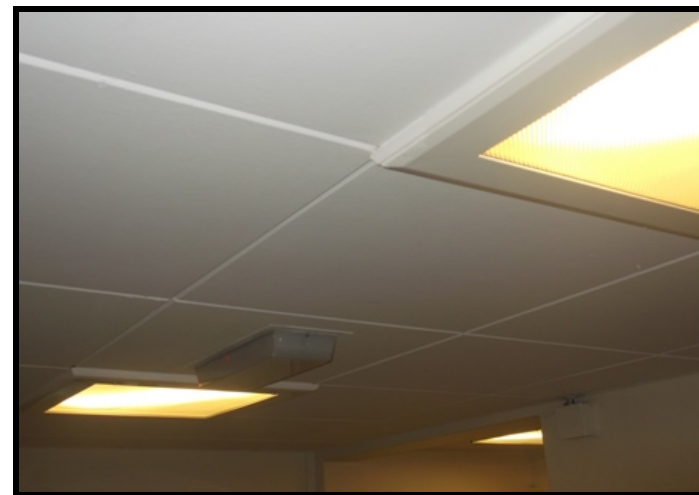
## SAMPLE REFERENCE 028

| Unique Sample No. | Building Reference (Floor) | Room Area | Description of Location | Product Description | Asbestos Type | Approx. Quantity | Material Condition | Surface Treatment | Material Risk Score | Priority Risk Score | Total Risk Score | Management Action | Next Review Date |
|---|---|---|---|---|---|---|---|---|---|---|---|---|---|
| 028 | Main Building (Third Floor) | Landing | Ceiling | Insulation Board | No Asbestos Detected | 10.00m2 | Good condition | Sealed Board (Encapsulated) | - | - | - | NO ACTION REQUIRED | |

**No Asbestos Presumed in Sample**

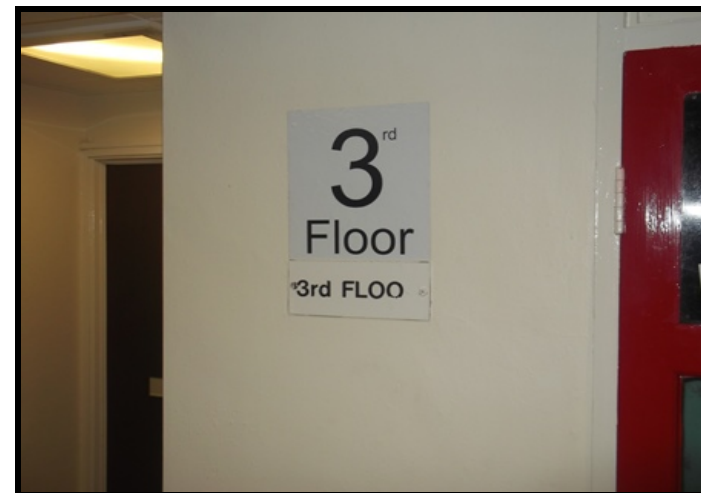
## SAMPLE REFERENCE 029

| Unique Sample No. | Building Reference (Floor) | Room Area | Description of Location | Product Description | Asbestos Type | Approx. Quantity | Material Condition | Surface Treatment | Material Risk Score | Priority Risk Score | Total Risk Score | Management Action | Next Review Date |
|---|---|---|---|---|---|---|---|---|---|---|---|---|---|
| 029 | Main Building (Third Floor) | Landing | Wall | Textured Coating | No Asbestos Detected | 15.00m2 | Good condition | Textured Coating | - | - | - | NO ACTION REQUIRED | |

**No Asbestos Presumed in Sample**

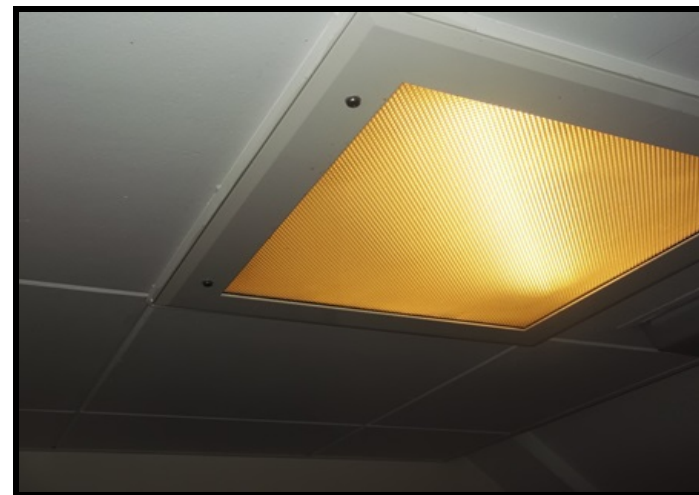
## SAMPLE REFERENCE 030

| Unique Sample No. | Building Reference (Floor) | Room Area | Description of Location | Product Description | Asbestos Type | Approx. Quantity | Material Condition | Surface Treatment | Material Risk Score | Priority Risk Score | Total Risk Score | Management Action | Next Review Date |
|---|---|---|---|---|---|---|---|---|---|---|---|---|---|
| 030 | Main Building (Third Floor) | Stairwell | Ceiling | Insulation Board | No Asbestos Detected | 10.00m2 | Good condition | Sealed Board (Encapsulated) | - | - | - | NO ACTION REQUIRED | |

**No Asbestos Presumed in Sample**

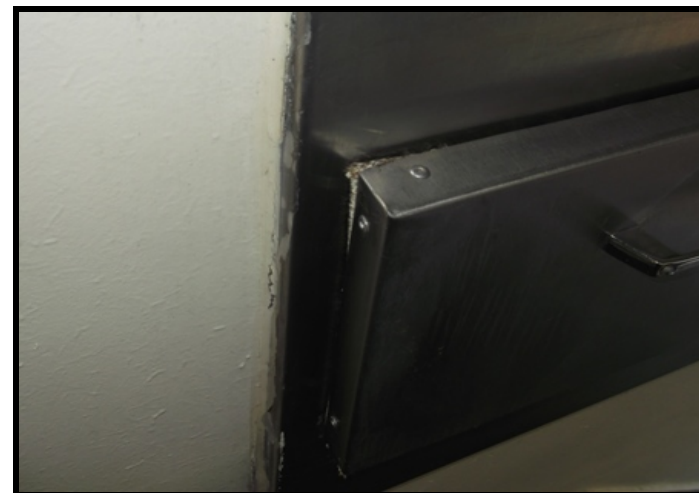
## SAMPLE REFERENCE 030a

| Unique Sample No. | Building Reference (Floor) | Room Area | Description of Location | Product Description | Asbestos Type | Approx. Quantity | Material Condition | Surface Treatment | Material Risk Score | Priority Risk Score | Total Risk Score | Management Action | Next Review Date |
|---|---|---|---|---|---|---|---|---|---|---|---|---|---|
| 030a | Main Building (Third Floor) | Stairwell | Door | Rope | No Asbestos Detected | 1.00m2 | Low damage | Unsealed (1) | - | - | - | NOT APPLICABLE | |

**No Asbestos Presumed in Sample**

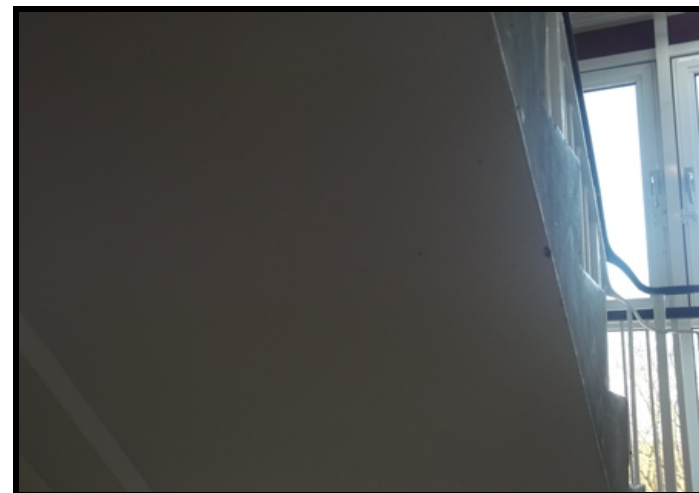
## SAMPLE REFERENCE 03 I

| Unique Sample No. | Building Reference (Floor) | Room Area | Description of Location | Product Description | Asbestos Type | Approx. Quantity | Material Condition | Surface Treatment | Material Risk Score | Priority Risk Score | Total Risk Score | Management Action | Next Review Date |
|---|---|---|---|---|---|---|---|---|---|---|---|---|---|
| 031 | Main Building (Third Floor) | Stairwell | Ceiling | Textured Coating | Chrysotile | 4.00m2 | Good condition | Textured Coating | 2 | 1 | 3 | LABEL & MONITOR | 10 Dec 2015 |

**Asbestos Presumed**

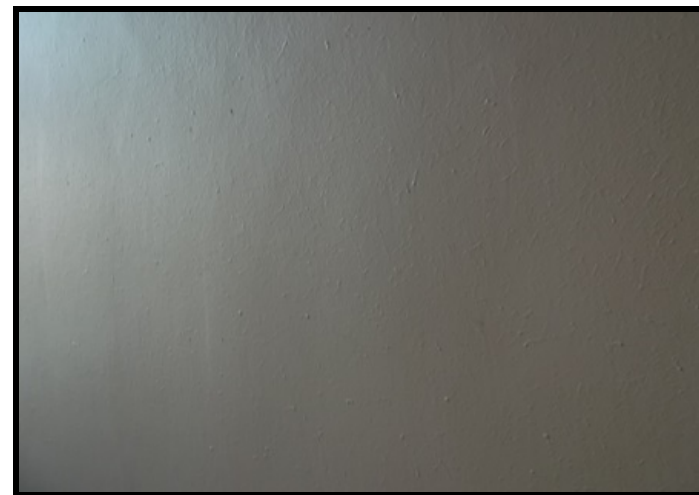
## SAMPLE REFERENCE 032

| Unique Sample No. | Building Reference (Floor) | Room Area | Description of Location | Product Description | Asbestos Type | Approx. Quantity | Material Condition | Surface Treatment | Material Risk Score | Priority Risk Score | Total Risk Score | Management Action | Next Review Date |
|---|---|---|---|---|---|---|---|---|---|---|---|---|---|
| 032 | Main Building (Third Floor) | Stairwell | Wall | Textured Coating | No Asbestos Detected | 10.00m2 | Good condition | Textured Coating | - | - | - | NO ACTION REQUIRED | |

**No Asbestos Presumed in Sample**

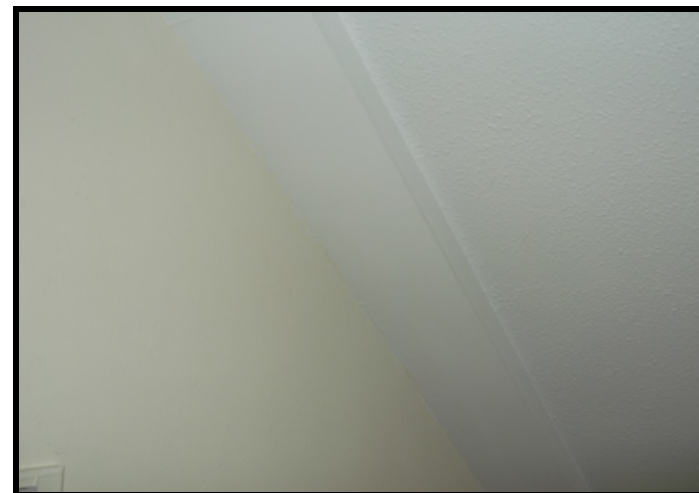
## SAMPLE REFERENCE 033

**No Asbestos Presumed in Sample**

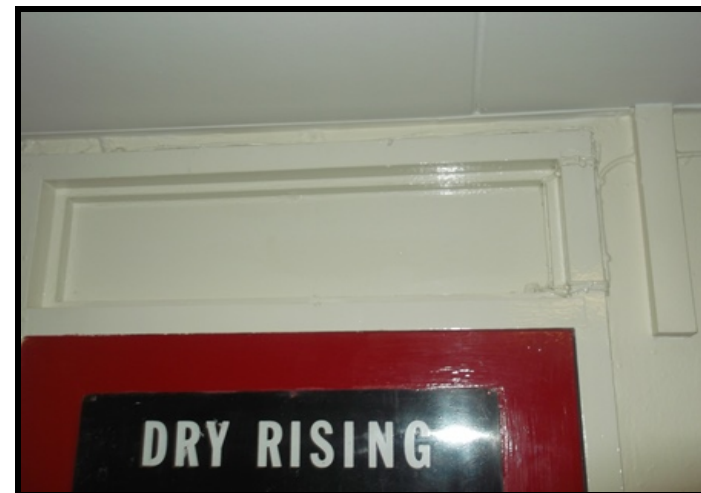
## SAMPLE REFERENCE 034

**No Asbestos Presumed in Sample**

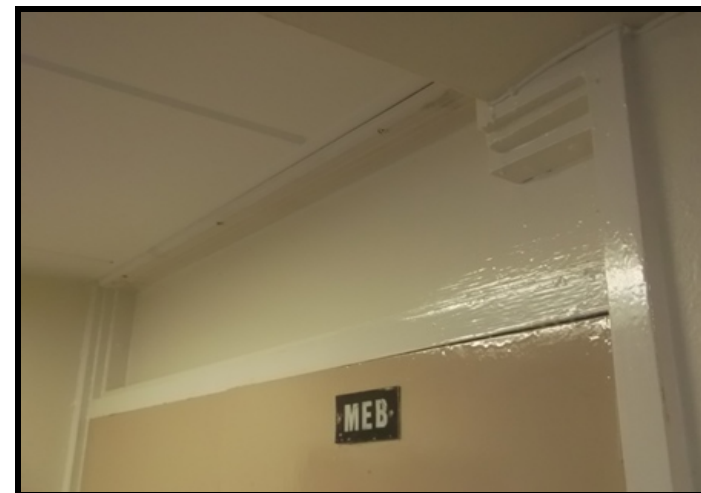
## SAMPLE REFERENCE 035

**No Asbestos Presumed in Sample**

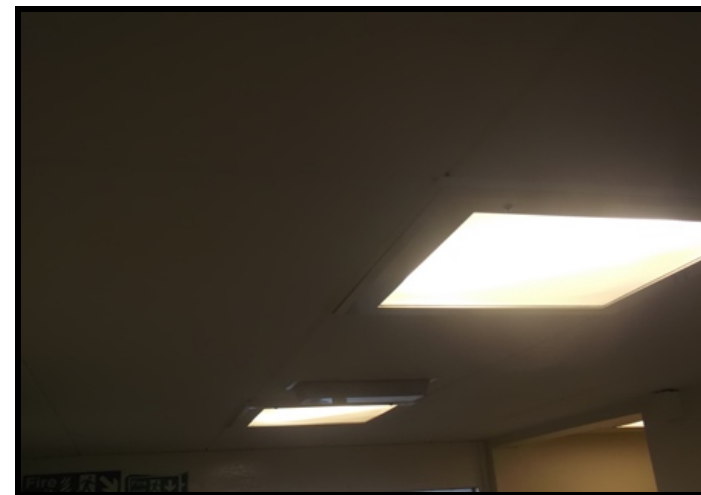
## SAMPLE REFERENCE 036

**No Asbestos Presumed in Sample**

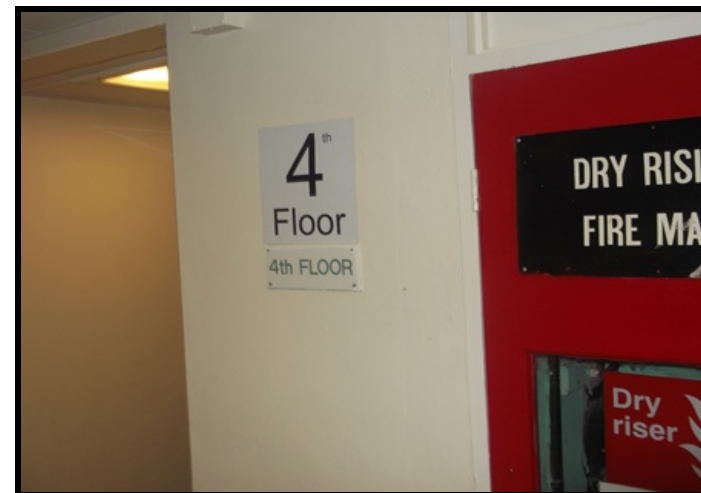
## SAMPLE REFERENCE 037

| Unique Sample No. | Building Reference (Floor) | Room Area | Description of Location | Product Description | Asbestos Type | Approx. Quantity | Material Condition | Surface Treatment | Material Risk Score | Priority Risk Score | Total Risk Score | Management Action | Next Review Date |
|---|---|---|---|---|---|---|---|---|---|---|---|---|---|
| 037 | Main Building (Fourth Floor) | Landing | Wall | Textured Coating | No Asbestos Detected | 15.00m2 | Good condition | Textured Coating | - | - | - | NO ACTION REQUIRED | |

**No Asbestos Presumed in Sample**

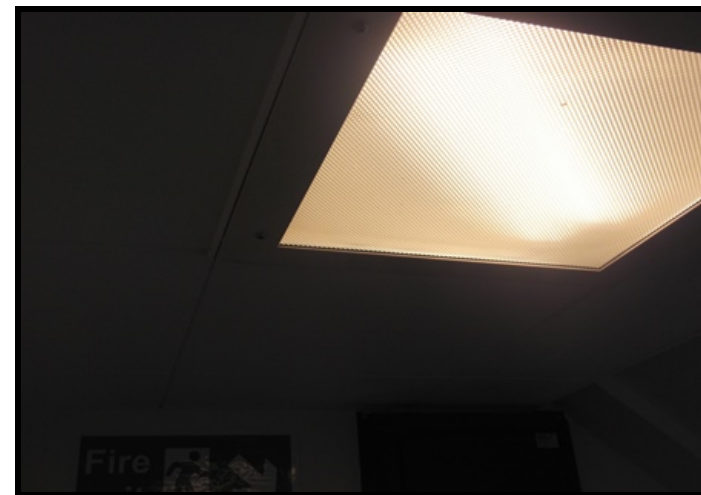
## SAMPLE REFERENCE 038

**No Asbestos Presumed in Sample**

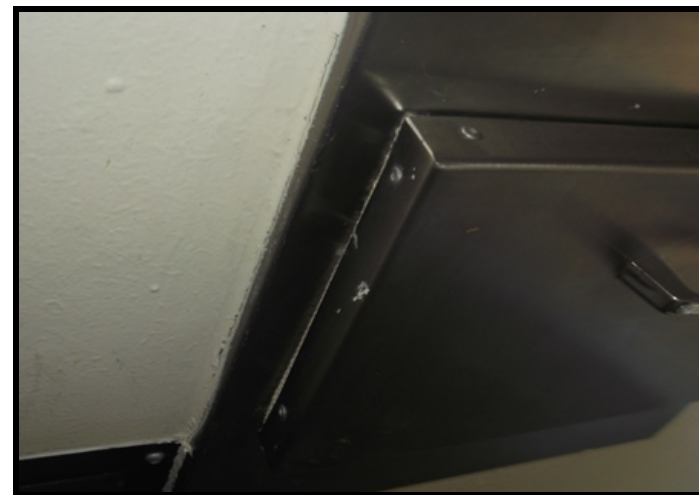
## SAMPLE REFERENCE 038a

**No Asbestos Presumed in Sample**

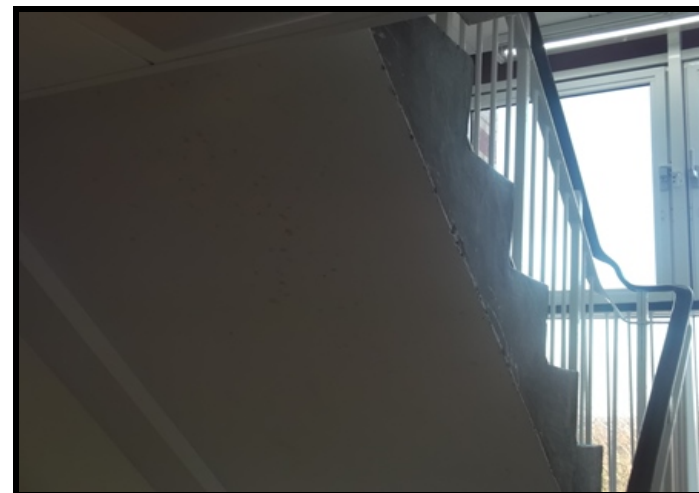
## SAMPLE REFERENCE 039

**Asbestos Presumed**

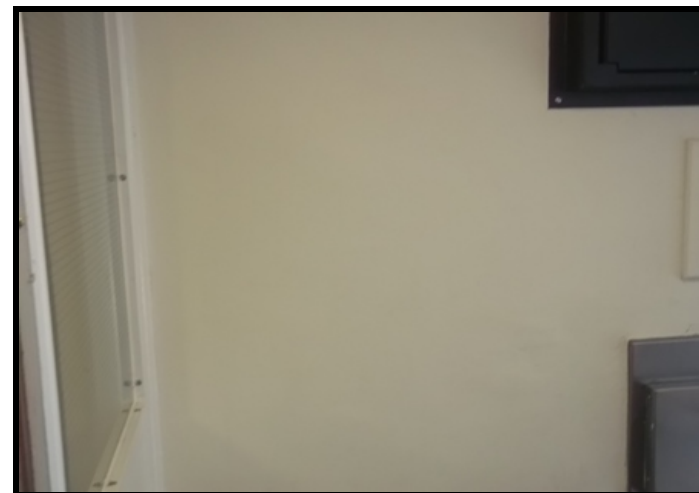
## SAMPLE REFERENCE 040

**No Asbestos Presumed in Sample**

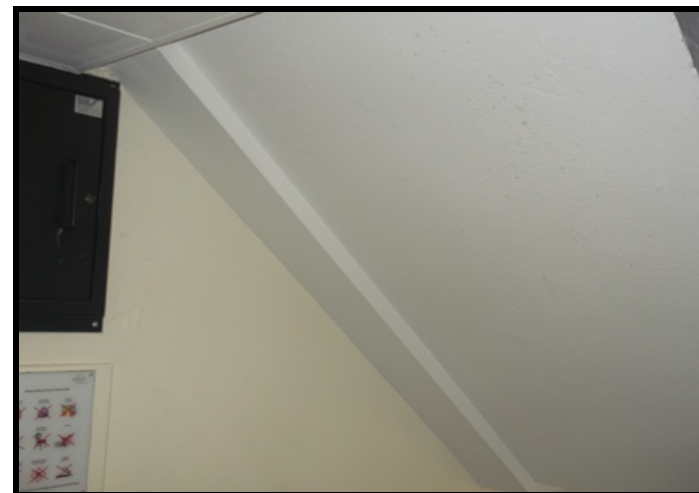
## SAMPLE REFERENCE 041

**No Asbestos Presumed in Sample**

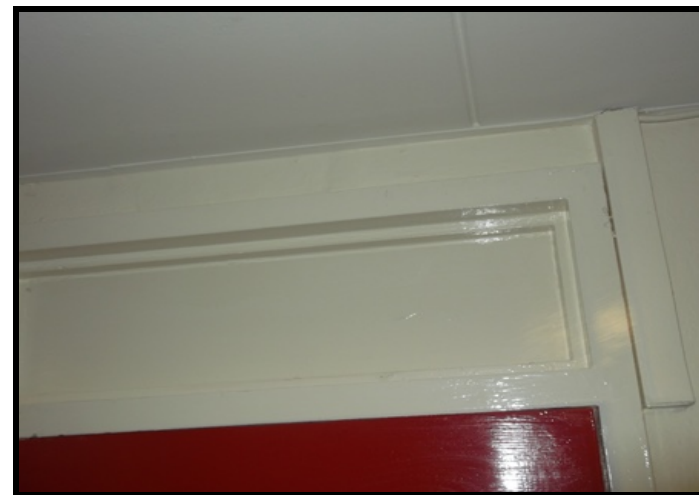
## SAMPLE REFERENCE 042

**No Asbestos Presumed in Sample**
