# **Solihull Community Housing**

## **Asbestos Management Survey Report**

**I - 37 (Communal) Kingshurst  
House  
Stonebridge Croft  
Solihull  
B37 6JP**

**Date of Report: 20 Jan 2015**  
**Survey Ref: 257890000A**

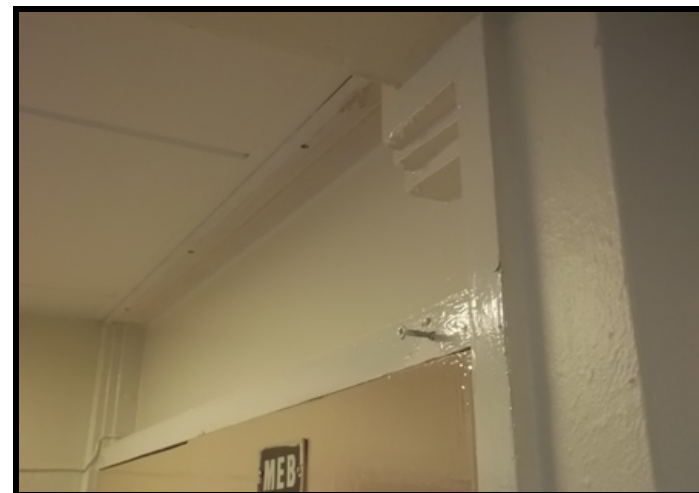
## SAMPLE REFERENCE 043

**No Asbestos Presumed in Sample**

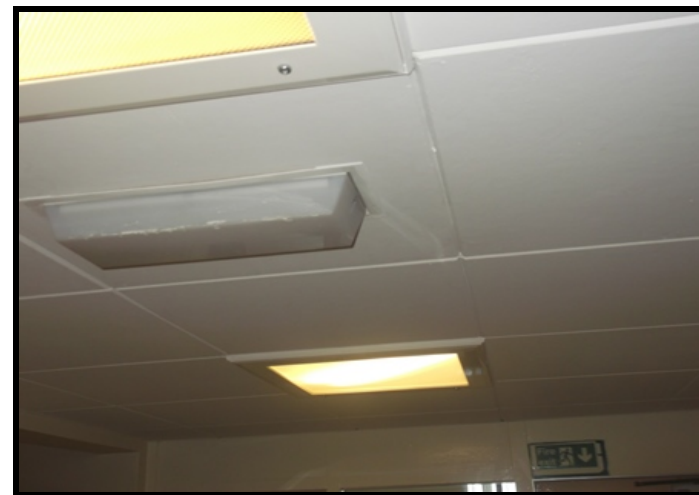
## SAMPLE REFERENCE 044

**No Asbestos Presumed in Sample**

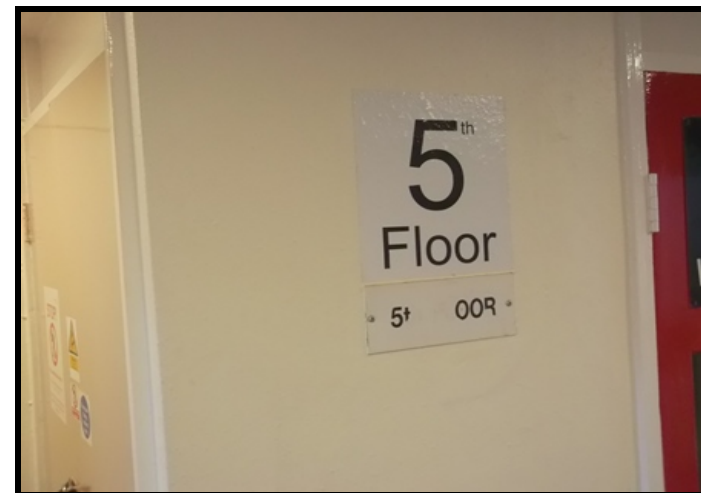
## SAMPLE REFERENCE 045

**No Asbestos Presumed in Sample**

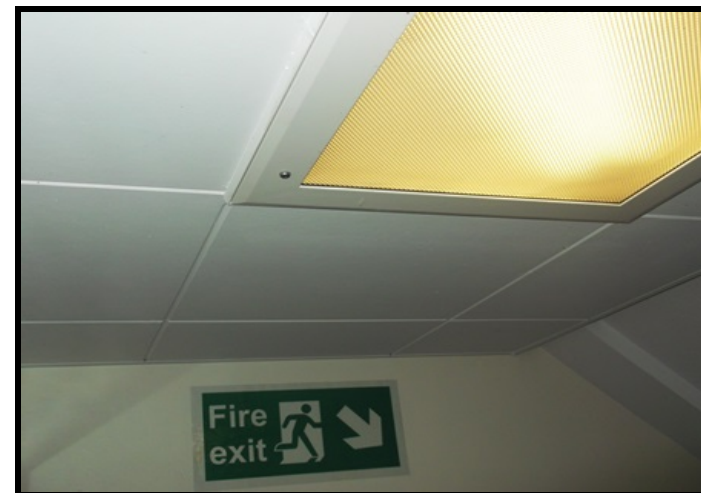
## SAMPLE REFERENCE 046

**No Asbestos Presumed in Sample**

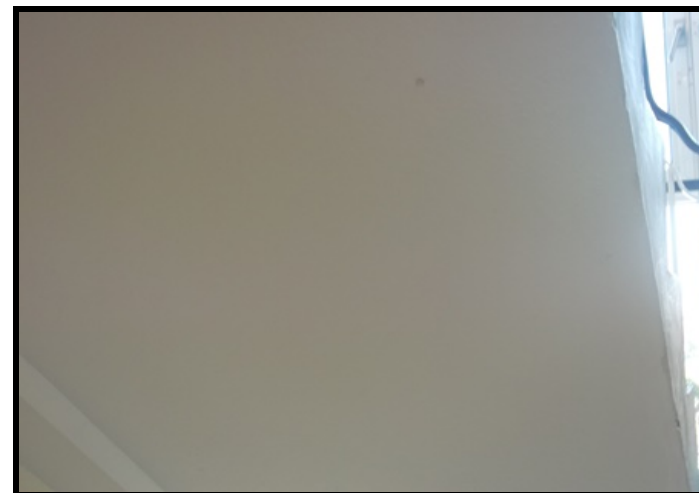
## SAMPLE REFERENCE 047

Asbestos Presumed

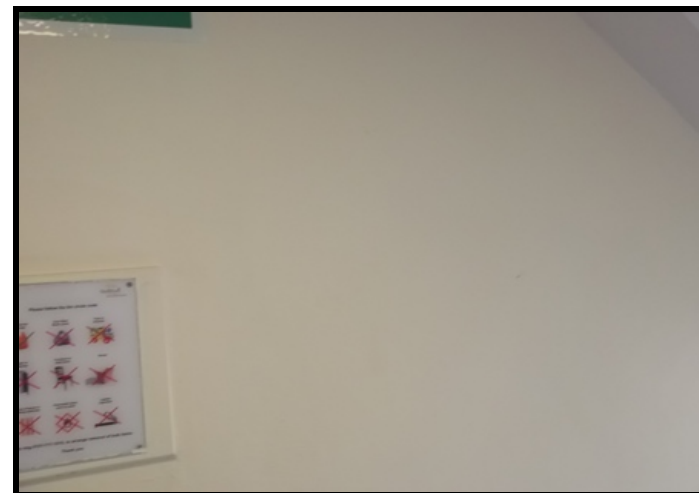
## SAMPLE REFERENCE 048

**No Asbestos Presumed in Sample**

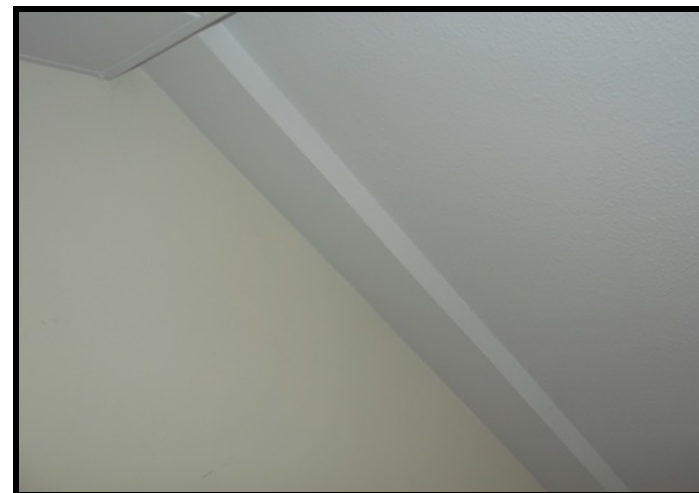
## SAMPLE REFERENCE 049

**No Asbestos Presumed in Sample**

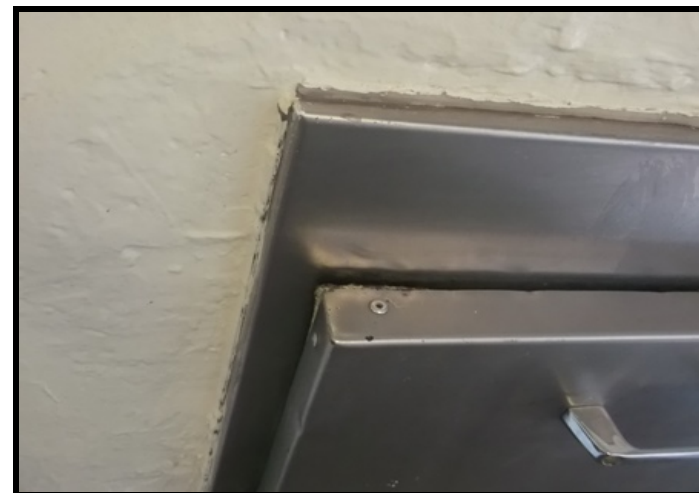
SAMPLE REFERENCE 049a

**No Asbestos Presumed in Sample**

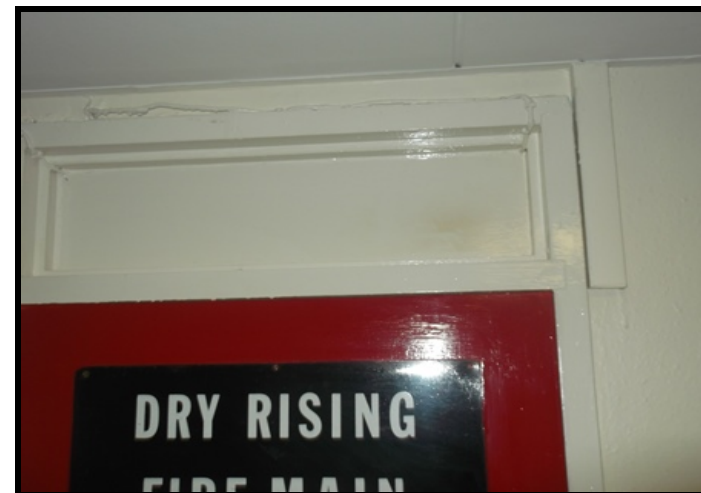
## SAMPLE REFERENCE 050

**No Asbestos Presumed in Sample**

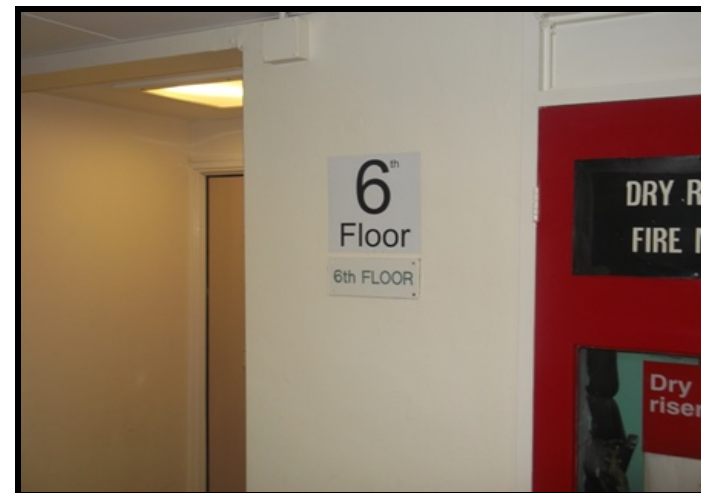
## SAMPLE REFERENCE 053

**No Asbestos Presumed in Sample**

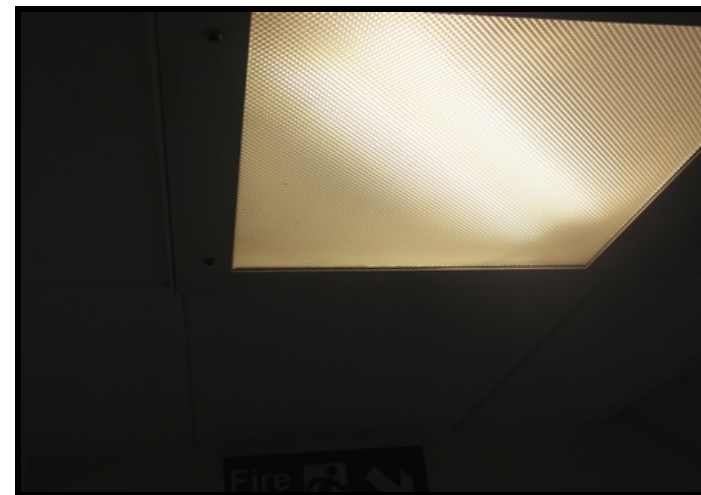
## SAMPLE REFERENCE 054

**No Asbestos Presumed in Sample**

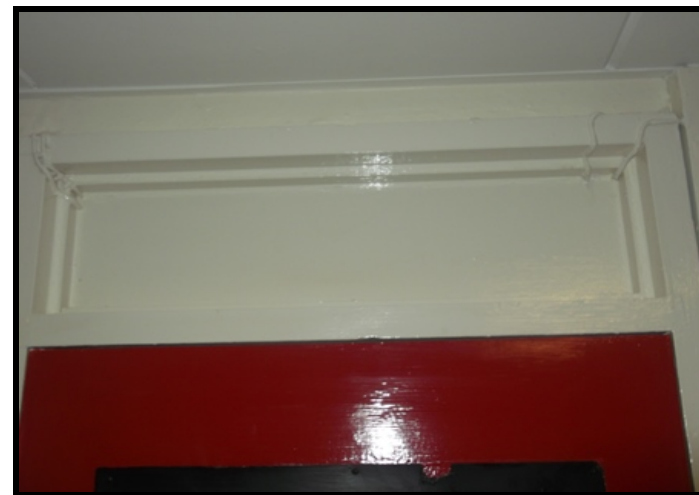
## SAMPLE REFERENCE 058

**No Asbestos Presumed in Sample**

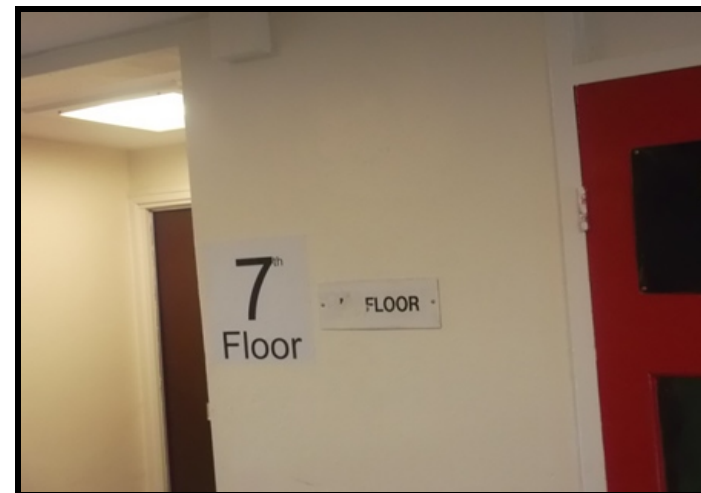
## SAMPLE REFERENCE 061

**No Asbestos Presumed in Sample**

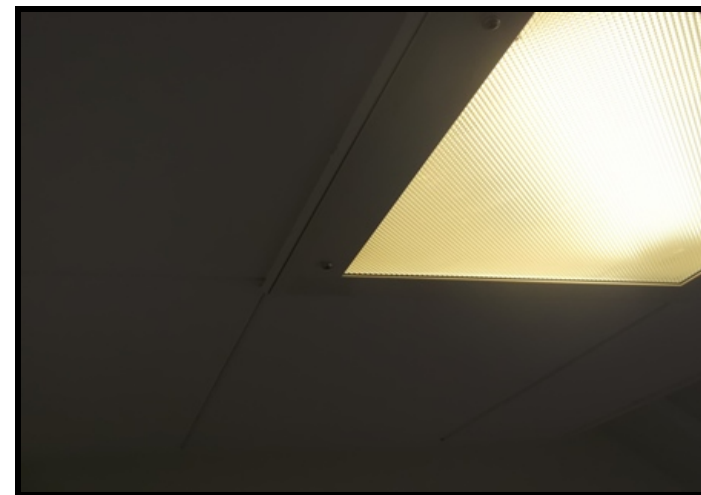
## SAMPLE REFERENCE 062

**No Asbestos Presumed in Sample**

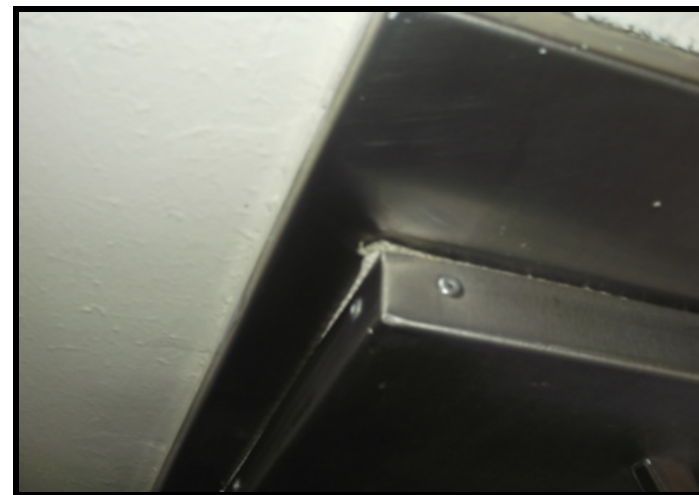
## SAMPLE REFERENCE 062a

**No Asbestos Presumed in Sample**

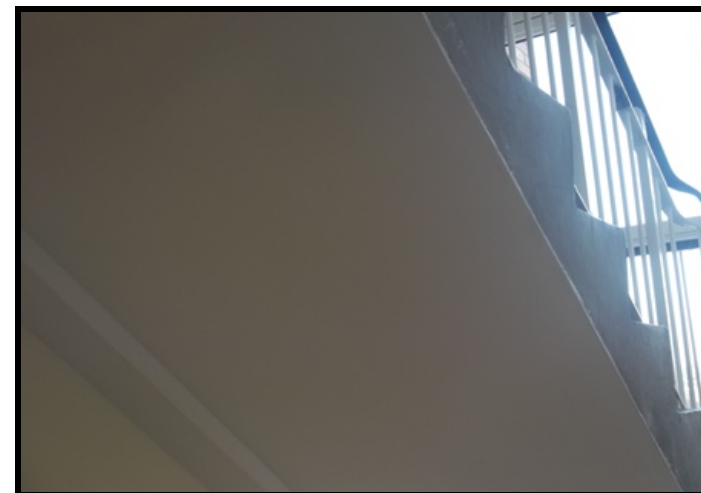
## SAMPLE REFERENCE 063

**Asbestos Presumed**

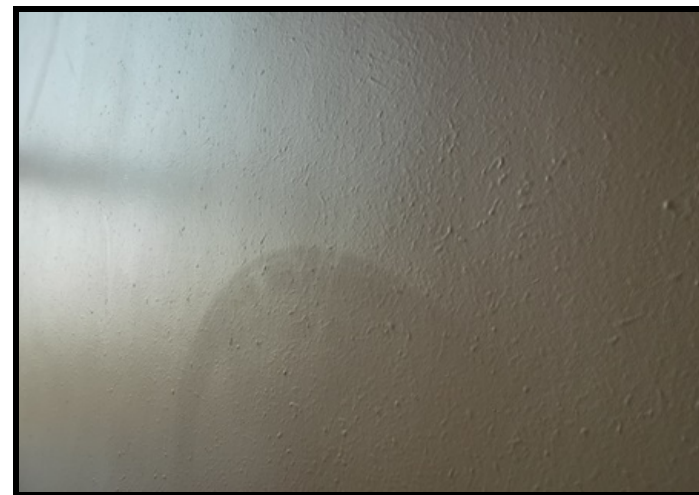
## SAMPLE REFERENCE 064

**No Asbestos Presumed in Sample**

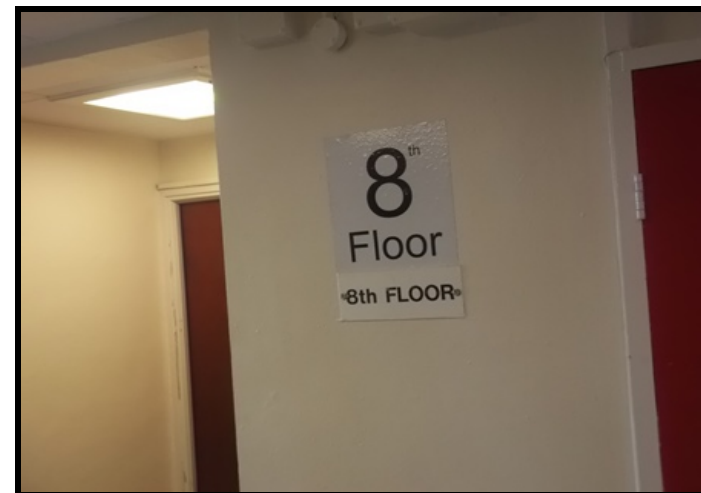
## SAMPLE REFERENCE 069

**No Asbestos Presumed in Sample**

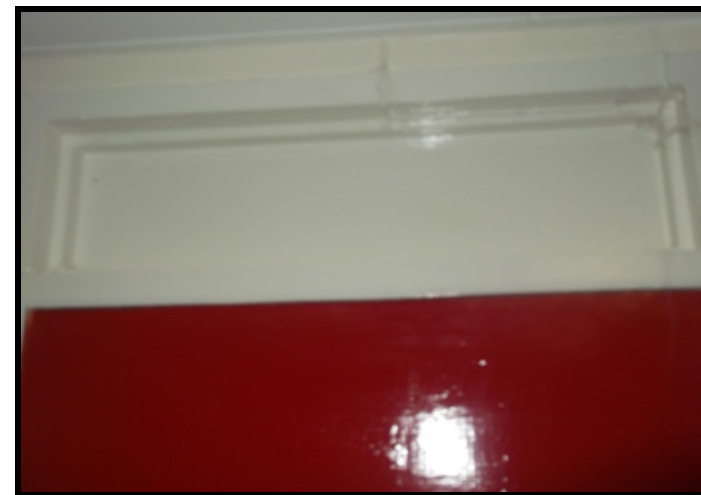
## SAMPLE REFERENCE 074

**No Asbestos Presumed in Sample**

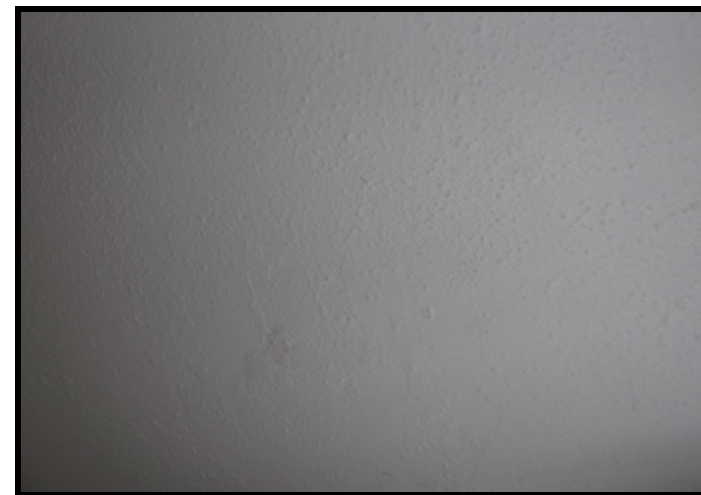
SAMPLE REFERENCE 082

Asbestos Presumed

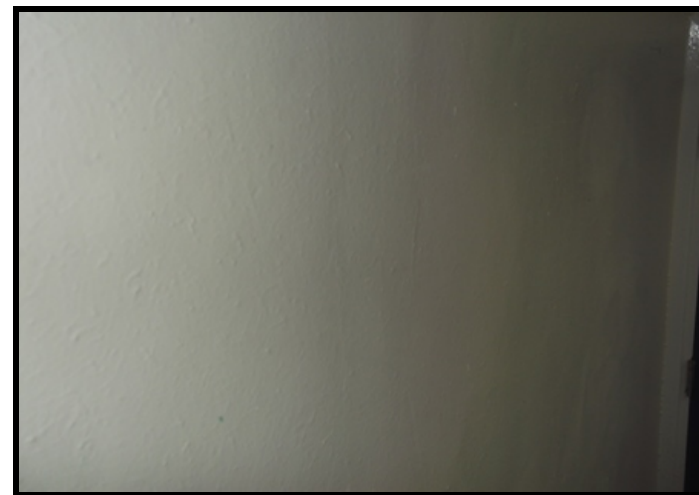
## SAMPLE REFERENCE 083

**No Asbestos Presumed in Sample**

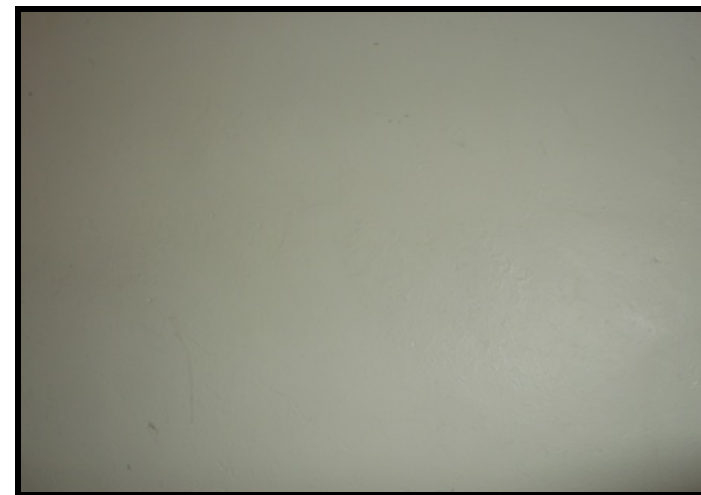
## SAMPLE REFERENCE 084

**No Asbestos Presumed in Sample**
