Solihull Community Housing

Asbestos Management Survey Report

**Linacre House
Heathmere Drive
Chelmsley Wood
B37 5EW**

Date of Report: 25 Apr 2012

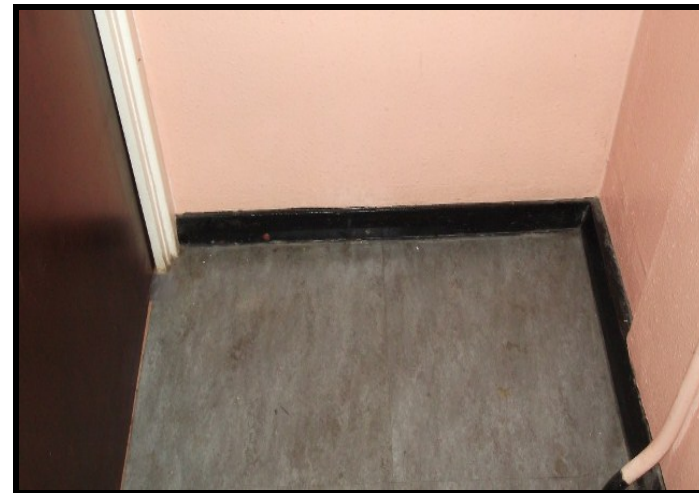
SAMPLE REFERENCE 002

Building	Floor	Room	Location	
Main Building	Tenth Floor	Bin Chute	Floor	
Description				
MATERIAL ASSESSMENT				SCORE
Product Type	Floor Tiles	Extent of Damage	Good condition	-
Asbestos Type	No Asbestos Detected	Surface Treatment	Composite materials	
PRIORITY ASSESSMENT				SCORE
Occupant Activity	Not Applicable	Extent / Amount	4.00 m2	-
Accessibility	Routinely disturbed	Location	Not Applicable	
Avg Time in Use	Not Applicable	Frequency of Use	Not Applicable	
No. of Occupants	Not Applicable	Secondary Activity	Not Applicable	
Maintenance	Not Applicable	Maintenance Frequency	Not Applicable	
MANAGEMENT ACTION				SCORE
Recommendation	NO ACTION REQUIRED			-
Recommendation Due		Next Inspection	None	
Apply Labels	No	Permit to Work Required	No	
Survey Type	Management	Lead Surveyor	Jane Openshaw	
Survey Date	22 Mar 2012	UKAS Laboratory	DMW Environmental Safety Ltd / [P-96017]	
Site Reference	I23350000A	Licensed Material	N/A

Asbestos not detected in Sample

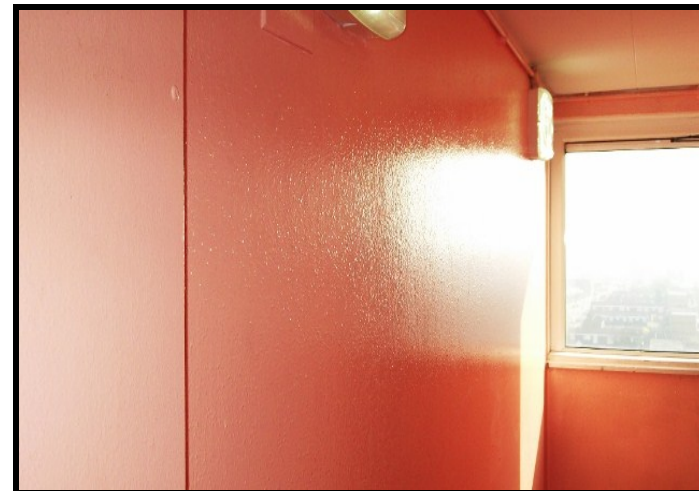
SAMPLE REFERENCE 003

Building	Floor	Room	Location	
Main Building	Tenth Floor	Corridor I	Walls	
Description	Timber boxing			
MATERIAL ASSESSMENT				SCORE
Product Type	Paint	Extent of Damage	Good condition	-
Asbestos Type	No Asbestos Detected	Surface Treatment	Sealed (I)	
PRIORITY ASSESSMENT				SCORE
Occupant Activity	Not Applicable	Extent / Amount	10.00 m2	-
Accessibility	Easily disturbed	Location	Not Applicable	
Avg Time in Use	Not Applicable	Frequency of Use	Not Applicable	
No. of Occupants	Not Applicable	Secondary Activity	Not Applicable	
Maintenance	Not Applicable	Maintenance Frequency	Not Applicable	
MANAGEMENT ACTION				SCORE
Recommendation	NO ACTION REQUIRED			-
Recommendation Due		Next Inspection	None	
Apply Labels	No	Permit to Work Required	No	
Survey Type	Management	Lead Surveyor	Jane Openshaw	
Survey Date	22 Mar 2012	UKAS Laboratory	NOT SAMPLED (Cross Referenced)	
Site Reference	I23350000A	Licensed Material	N/A

No Asbestos Presumed in Sample

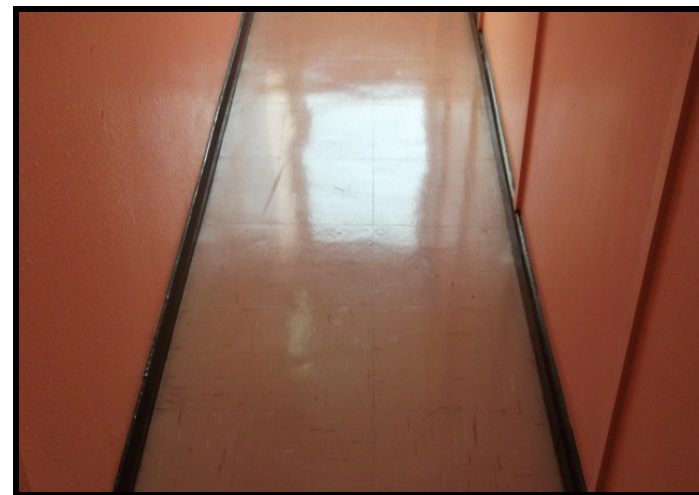
SAMPLE REFERENCE 004

Building	Floor	Room	Location	
Main Building	Tenth Floor	Corridor I	Floor	
Description	Timber boxing			
MATERIAL ASSESSMENT				SCORE
Product Type	Floor Tiles	Extent of Damage	Good condition	-
Asbestos Type	No Asbestos Detected	Surface Treatment	Composite materials	
PRIORITY ASSESSMENT				SCORE
Occupant Activity	Not Applicable	Extent / Amount	8.00 m2	-
Accessibility	Routinely disturbed	Location	Not Applicable	
Avg Time in Use	Not Applicable	Frequency of Use	Not Applicable	
No. of Occupants	Not Applicable	Secondary Activity	Not Applicable	
Maintenance	Not Applicable	Maintenance Frequency	Not Applicable	
MANAGEMENT ACTION				SCORE
Recommendation	NO ACTION REQUIRED			-
Recommendation Due		Next Inspection	None	
Apply Labels	No	Permit to Work Required	No	
Survey Type	Management	Lead Surveyor	Jane Openshaw	
Survey Date	22 Mar 2012	UKAS Laboratory	DMW Environmental Safety Ltd / [P-96017]	
Site Reference	I23350000A	Licensed Material	N/A

Asbestos not detected in Sample

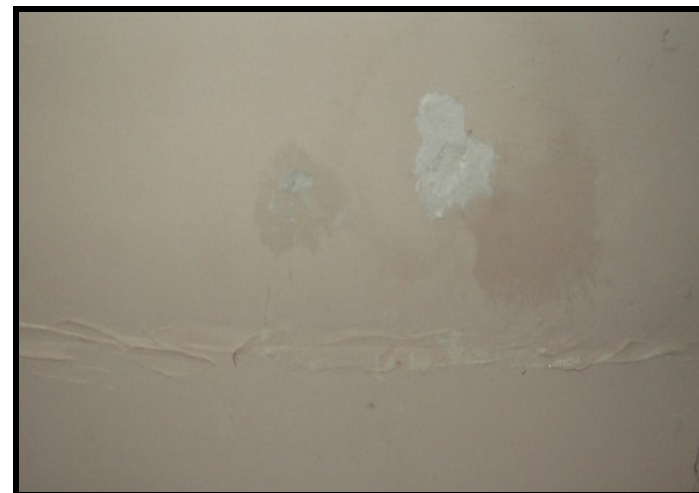
SAMPLE REFERENCE 005

Building	Floor	Room	Location	
Main Building	Tenth Floor	Dry Riser	Ceiling	
Description	Timber boxing			
MATERIAL ASSESSMENT				SCORE
Product Type	Board	Extent of Damage	Low damage	7
Asbestos Type	Amosite / Chrysotile	Surface Treatment	Unsealed (Board)	
PRIORITY ASSESSMENT				SCORE
Occupant Activity	Not Applicable	Extent / Amount	1.00 m2	1
Accessibility	Occasionally disturb	Location	Not Applicable	
Avg Time in Use	Not Applicable	Frequency of Use	Not Applicable	
No. of Occupants	Not Applicable	Secondary Activity	Not Applicable	
Maintenance	Not Applicable	Maintenance Frequency	Not Applicable	
MANAGEMENT ACTION				SCORE
Recommendation	ENCAPSULATE, LABEL & MONITOR			8
Recommendation Due		Next Inspection	None	
Apply Labels	No	Permit to Work Required	No	
Survey Type	Management	Lead Surveyor	Jane Openshaw	
Survey Date	22 Mar 2012	UKAS Laboratory	DMW Environmental Safety Ltd / [P-96017]	
Site Reference	I23350000A	Licensed Material	Yes

Asbestos detected in Sample

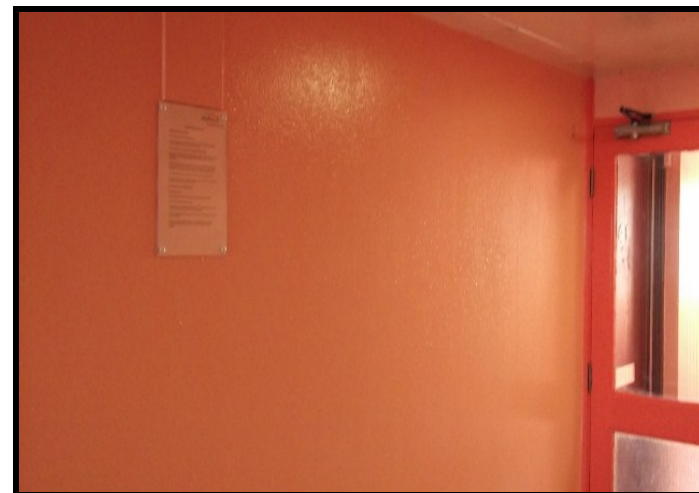
SAMPLE REFERENCE 007

Building	Floor	Room	Location	
Main Building	Tenth Floor	Lift Lobby	Walls	
Description				
MATERIAL ASSESSMENT				SCORE
Product Type	Paint	Extent of Damage	Good condition	-
Asbestos Type	No Asbestos Detected	Surface Treatment	Sealed (1)	
PRIORITY ASSESSMENT				SCORE
Occupant Activity	Not Applicable	Extent / Amount	15.00 m2	-
Accessibility	Easily disturbed	Location	Not Applicable	
Avg Time in Use	Not Applicable	Frequency of Use	Not Applicable	
No. of Occupants	Not Applicable	Secondary Activity	Not Applicable	
Maintenance	Not Applicable	Maintenance Frequency	Not Applicable	
MANAGEMENT ACTION				SCORE
Recommendation	NO ACTION REQUIRED			-
Recommendation Due		Next Inspection	None	
Apply Labels	No	Permit to Work Required	No	
Survey Type	Management	Lead Surveyor	Jane Openshaw	
Survey Date	22 Mar 2012	UKAS Laboratory	NOT SAMPLED (Cross Referenced)	
Site Reference	I23350000A	Licensed Material	N/A

No Asbestos Presumed in Sample

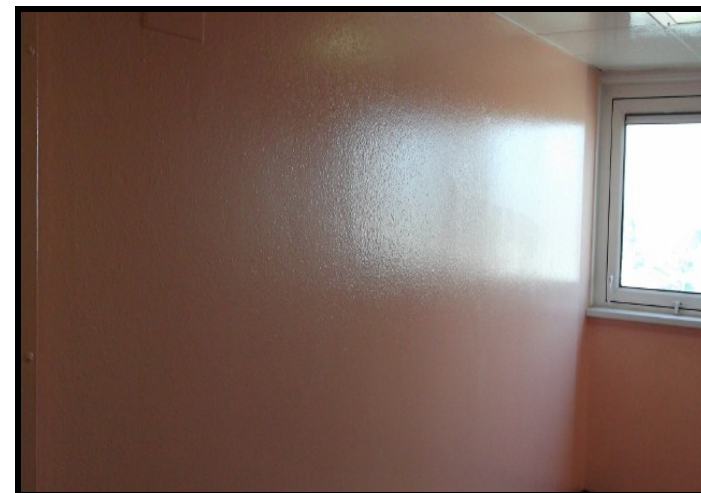
SAMPLE REFERENCE 008

Building	Floor	Room	Location	
Main Building	Tenth Floor	Corridor 2	Walls	
Description				
MATERIAL ASSESSMENT				SCORE
Product Type	Paint	Extent of Damage	Good condition	-
Asbestos Type	No Asbestos Detected	Surface Treatment	Sealed (1)	
PRIORITY ASSESSMENT				SCORE
Occupant Activity	Not Applicable	Extent / Amount	8.00 m2	-
Accessibility	Easily disturbed	Location	Not Applicable	
Avg Time in Use	Not Applicable	Frequency of Use	Not Applicable	
No. of Occupants	Not Applicable	Secondary Activity	Not Applicable	
Maintenance	Not Applicable	Maintenance Frequency	Not Applicable	
MANAGEMENT ACTION				SCORE
Recommendation	NO ACTION REQUIRED			-
Recommendation Due		Next Inspection	None	
Apply Labels	No	Permit to Work Required	No	
Survey Type	Management	Lead Surveyor	Jane Openshaw	
Survey Date	22 Mar 2012	UKAS Laboratory	NOT SAMPLED (Cross Referenced)	
Site Reference	I23350000A	Licensed Material	N/A

No Asbestos Presumed in Sample

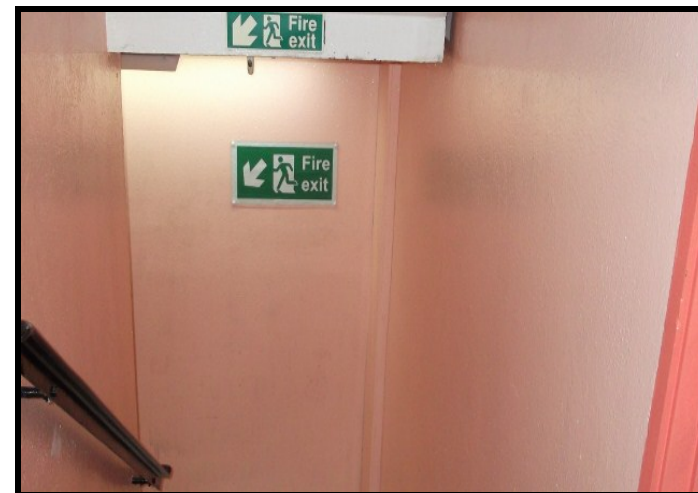
SAMPLE REFERENCE 011

Building	Floor	Room	Location	
Main Building	Tenth Floor	Stairs	Walls	
Description				
MATERIAL ASSESSMENT				SCORE
Product Type	Paint	Extent of Damage	Good condition	-
Asbestos Type	No Asbestos Detected	Surface Treatment	Sealed (I)	
PRIORITY ASSESSMENT				SCORE
Occupant Activity	Not Applicable	Extent / Amount	30.00 m2	-
Accessibility	Easily disturbed	Location	Not Applicable	
Avg Time in Use	Not Applicable	Frequency of Use	Not Applicable	
No. of Occupants	Not Applicable	Secondary Activity	Not Applicable	
Maintenance	Not Applicable	Maintenance Frequency	Not Applicable	
MANAGEMENT ACTION				SCORE
Recommendation	NO ACTION REQUIRED			-
Recommendation Due		Next Inspection	None	
Apply Labels	No	Permit to Work Required	No	
Survey Type	Management	Lead Surveyor	Jane Openshaw	
Survey Date	22 Mar 2012	UKAS Laboratory	NOT SAMPLED (Cross Referenced)	
Site Reference	I23350000A	Licensed Material	N/A

No Asbestos Presumed in Sample

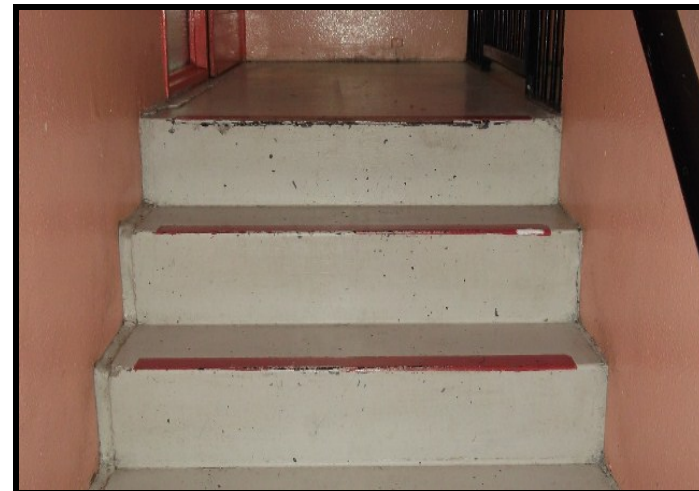
SAMPLE REFERENCE 012

Building	Floor	Room	Location
Main Building	Tenth Floor	Stairs	Staircase
Description			
MATERIAL ASSESSMENT			
Product Type	Bitumen	Extent of Damage	Low damage
Asbestos Type	Chrysotile	Surface Treatment	Composite materials
PRIORITY ASSESSMENT			
Occupant Activity	Not Applicable	Extent / Amount	15.00 small item(s)
Accessibility	Occasionally disturb	Location	Not Applicable
Avg Time in Use	Not Applicable	Frequency of Use	Not Applicable
No. of Occupants	Not Applicable	Secondary Activity	Not Applicable
Maintenance	Not Applicable	Maintenance Frequency	Not Applicable
MANAGEMENT ACTION			
Recommendation	LABEL & MONITOR		
Recommendation Due		Next Inspection	22 Mar 2013
Apply Labels	No	Permit to Work Required	No
Survey Type	Management	Lead Surveyor	Jane Openshaw
Survey Date	22 Mar 2012	UKAS Laboratory	DMW Environmental Safety Ltd / [P-96017]
Site Reference	I23350000A	Licensed Material	No

Asbestos detected in Sample

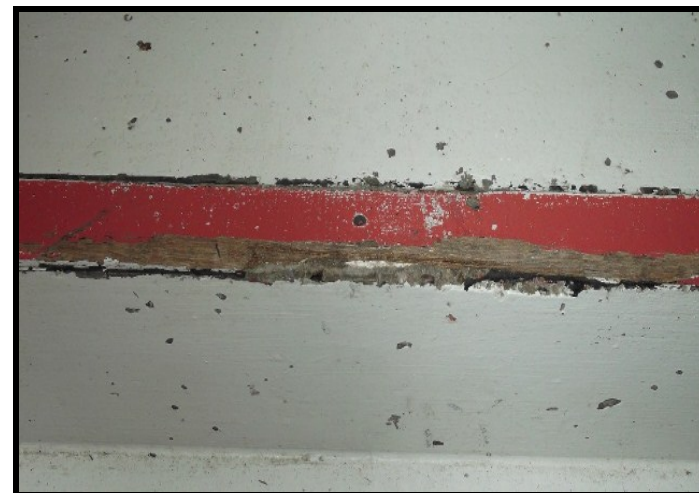
SAMPLE REFERENCE 013

Building	Floor	Room	Location	
Main Building	Tenth Floor	Stairs	Staircase	
Description				
MATERIAL ASSESSMENT				SCORE
Product Type	Bitumen	Extent of Damage	Medium damage	-
Asbestos Type	No Asbestos Detected	Surface Treatment	Composite materials	
PRIORITY ASSESSMENT				SCORE
Occupant Activity	Not Applicable	Extent / Amount	2.50 small item(s)	-
Accessibility	Occasionally disturb	Location	Not Applicable	
Avg Time in Use	Not Applicable	Frequency of Use	Not Applicable	
No. of Occupants	Not Applicable	Secondary Activity	Not Applicable	
Maintenance	Not Applicable	Maintenance Frequency	Not Applicable	
MANAGEMENT ACTION				SCORE
Recommendation	NO ACTION REQUIRED			-
Recommendation Due		Next Inspection	None	
Apply Labels	No	Permit to Work Required	No	
Survey Type	Management	Lead Surveyor	Jane Openshaw	
Survey Date	22 Mar 2012	UKAS Laboratory	DMW Environmental Safety Ltd / [P-96017]	
Site Reference	I23350000A	Licensed Material	N/A

Asbestos not detected in Sample

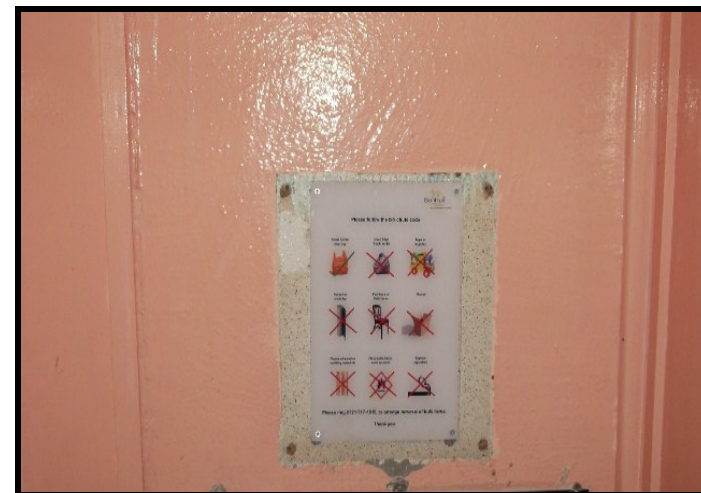
SAMPLE REFERENCE 015

Building	Floor	Room	Location	
Main Building	Nineth Floor	Bin Chute	Walls	
Description				
MATERIAL ASSESSMENT				SCORE
Product Type	Paint	Extent of Damage	Good condition	-
Asbestos Type	No Asbestos Detected	Surface Treatment	Sealed (1)	
PRIORITY ASSESSMENT				SCORE
Occupant Activity	Not Applicable	Extent / Amount	12.00 m2	-
Accessibility	Easily disturbed	Location	Not Applicable	
Avg Time in Use	Not Applicable	Frequency of Use	Not Applicable	
No. of Occupants	Not Applicable	Secondary Activity	Not Applicable	
Maintenance	Not Applicable	Maintenance Frequency	Not Applicable	
MANAGEMENT ACTION				SCORE
Recommendation	NO ACTION REQUIRED			-
Recommendation Due		Next Inspection	None	
Apply Labels	No	Permit to Work Required	No	
Survey Type	Management	Lead Surveyor	Jane Openshaw	
Survey Date	22 Mar 2012	UKAS Laboratory	DMW Environmental Safety Ltd / [P-96017]	
Site Reference	I23350000A	Licensed Material	N/A

Asbestos not detected in Sample

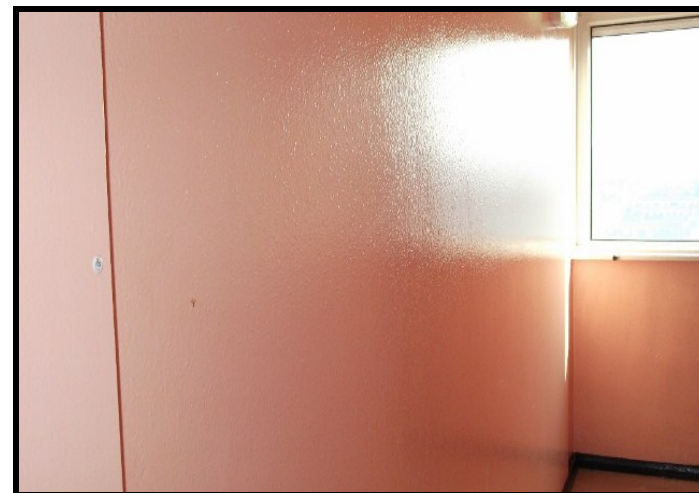
SAMPLE REFERENCE 018

Building	Floor	Room	Location	
Main Building	Nineth Floor	Corridor I	Walls	
Description				
MATERIAL ASSESSMENT				SCORE
Product Type	Paint	Extent of Damage	Good condition	-
Asbestos Type	No Asbestos Detected	Surface Treatment	Sealed (I)	
PRIORITY ASSESSMENT				SCORE
Occupant Activity	Not Applicable	Extent / Amount	10.00 m2	-
Accessibility	Easily disturbed	Location	Not Applicable	
Avg Time in Use	Not Applicable	Frequency of Use	Not Applicable	
No. of Occupants	Not Applicable	Secondary Activity	Not Applicable	
Maintenance	Not Applicable	Maintenance Frequency	Not Applicable	
MANAGEMENT ACTION				SCORE
Recommendation	NO ACTION REQUIRED			-
Recommendation Due		Next Inspection	None	
Apply Labels	No	Permit to Work Required	No	
Survey Type	Management	Lead Surveyor	Jane Openshaw	
Survey Date	22 Mar 2012	UKAS Laboratory	NOT SAMPLED (Cross Referenced)	
Site Reference	I23350000A	Licensed Material	N/A

No Asbestos Presumed in Sample

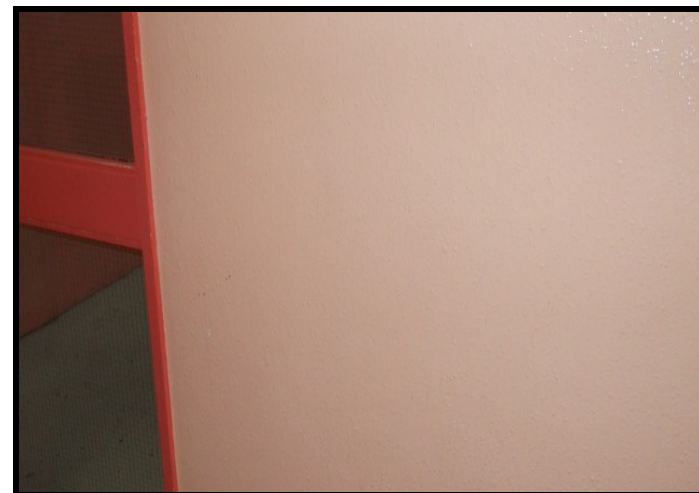
SAMPLE REFERENCE 022

Building	Floor	Room	Location	
Main Building	Nineth Floor	Lift Lobby	Walls	
Description				
MATERIAL ASSESSMENT				SCORE
Product Type	Paint	Extent of Damage	Low damage	-
Asbestos Type	No Asbestos Detected	Surface Treatment	Sealed (1)	
PRIORITY ASSESSMENT				SCORE
Occupant Activity	Not Applicable	Extent / Amount	15.00 m2	-
Accessibility	Easily disturbed	Location	Not Applicable	
Avg Time in Use	Not Applicable	Frequency of Use	Not Applicable	
No. of Occupants	Not Applicable	Secondary Activity	Not Applicable	
Maintenance	Not Applicable	Maintenance Frequency	Not Applicable	
MANAGEMENT ACTION				SCORE
Recommendation	NO ACTION REQUIRED			-
Recommendation Due		Next Inspection	None	
Apply Labels	No	Permit to Work Required	No	
Survey Type	Management	Lead Surveyor	Jane Openshaw	
Survey Date	22 Mar 2012	UKAS Laboratory	NOT SAMPLED (Cross Referenced)	
Site Reference	I23350000A	Licensed Material	N/A

No Asbestos Presumed in Sample

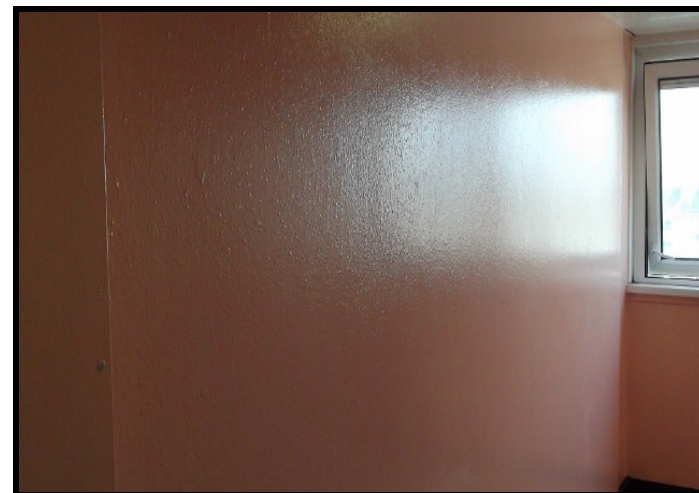
SAMPLE REFERENCE 023

Building	Floor	Room	Location	
Main Building	Nineth Floor	Corridor 2	Walls	
Description				
MATERIAL ASSESSMENT				SCORE
Product Type	Paint	Extent of Damage	Good condition	-
Asbestos Type	No Asbestos Detected	Surface Treatment	Sealed (1)	
PRIORITY ASSESSMENT				SCORE
Occupant Activity	Not Applicable	Extent / Amount	8.00 m2	-
Accessibility	Easily disturbed	Location	Not Applicable	
Avg Time in Use	Not Applicable	Frequency of Use	Not Applicable	
No. of Occupants	Not Applicable	Secondary Activity	Not Applicable	
Maintenance	Not Applicable	Maintenance Frequency	Not Applicable	
MANAGEMENT ACTION				SCORE
Recommendation	NO ACTION REQUIRED			-
Recommendation Due		Next Inspection	None	
Apply Labels	No	Permit to Work Required	No	
Survey Type	Management	Lead Surveyor	Jane Openshaw	
Survey Date	22 Mar 2012	UKAS Laboratory	NOT SAMPLED (Cross Referenced)	
Site Reference	I23350000A	Licensed Material	N/A

No Asbestos Presumed in Sample

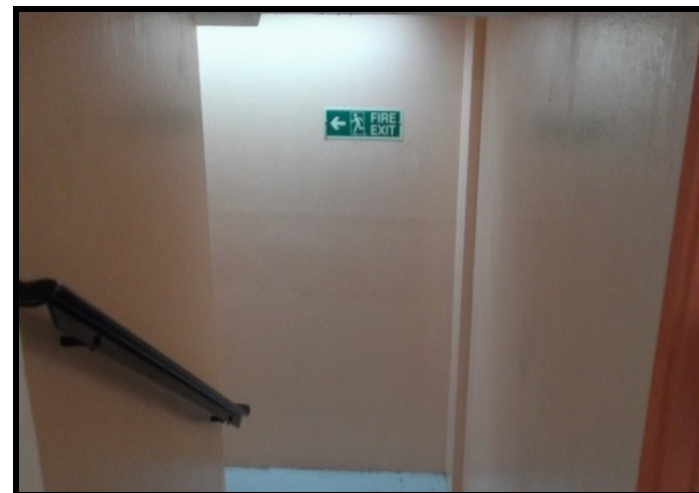
SAMPLE REFERENCE 026

Building	Floor	Room	Location	
Main Building	Nineth Floor	Stairs	Walls	
Description				
MATERIAL ASSESSMENT				SCORE
Product Type	Paint	Extent of Damage	Good condition	-
Asbestos Type	No Asbestos Detected	Surface Treatment	Sealed (I)	
PRIORITY ASSESSMENT				SCORE
Occupant Activity	Not Applicable	Extent / Amount	40.00 m2	-
Accessibility	Easily disturbed	Location	Not Applicable	
Avg Time in Use	Not Applicable	Frequency of Use	Not Applicable	
No. of Occupants	Not Applicable	Secondary Activity	Not Applicable	
Maintenance	Not Applicable	Maintenance Frequency	Not Applicable	
MANAGEMENT ACTION				SCORE
Recommendation	NO ACTION REQUIRED			-
Recommendation Due		Next Inspection	None	
Apply Labels	No	Permit to Work Required	No	
Survey Type	Management	Lead Surveyor	Jane Openshaw	
Survey Date	22 Mar 2012	UKAS Laboratory	NOT SAMPLED (Cross Referenced)	
Site Reference	I23350000A	Licensed Material	N/A

No Asbestos Presumed in Sample

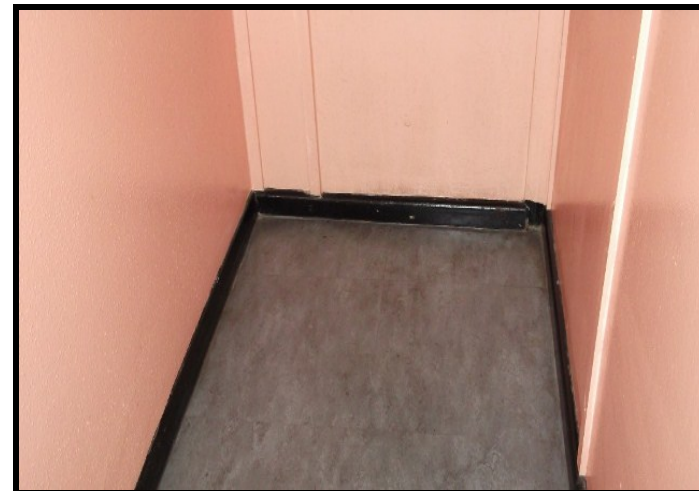
SAMPLE REFERENCE 029

Building	Floor	Room	Location	
Main Building	Eighth Floor	Bin Chute	Walls	
Description				
MATERIAL ASSESSMENT				SCORE
Product Type	Paint	Extent of Damage	Low damage	-
Asbestos Type	No Asbestos Detected	Surface Treatment	Sealed (1)	
PRIORITY ASSESSMENT				SCORE
Occupant Activity	Not Applicable	Extent / Amount	12.00 m2	-
Accessibility	Easily disturbed	Location	Not Applicable	
Avg Time in Use	Not Applicable	Frequency of Use	Not Applicable	
No. of Occupants	Not Applicable	Secondary Activity	Not Applicable	
Maintenance	Not Applicable	Maintenance Frequency	Not Applicable	
MANAGEMENT ACTION				SCORE
Recommendation	NO ACTION REQUIRED			-
Recommendation Due		Next Inspection	None	
Apply Labels	No	Permit to Work Required	No	
Survey Type	Management	Lead Surveyor	Jane Openshaw	
Survey Date	22 Mar 2012	UKAS Laboratory	NOT SAMPLED (Cross Referenced)	
Site Reference	I23350000A	Licensed Material	N/A

No Asbestos Presumed in Sample

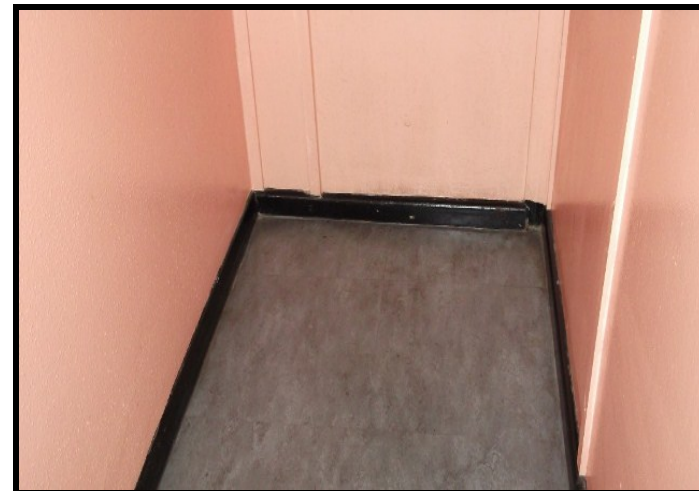
SAMPLE REFERENCE 030

Building	Floor	Room	Location	
Main Building	Eighth Floor	Bin Chute	Floor	
Description				
MATERIAL ASSESSMENT				SCORE
Product Type	Floor Tiles	Extent of Damage	Good condition	-
Asbestos Type	No Asbestos Detected	Surface Treatment	Composite materials	
PRIORITY ASSESSMENT				SCORE
Occupant Activity	Not Applicable	Extent / Amount	4.00 m2	-
Accessibility	Routinely disturbed	Location	Not Applicable	
Avg Time in Use	Not Applicable	Frequency of Use	Not Applicable	
No. of Occupants	Not Applicable	Secondary Activity	Not Applicable	
Maintenance	Not Applicable	Maintenance Frequency	Not Applicable	
MANAGEMENT ACTION				SCORE
Recommendation	NO ACTION REQUIRED			-
Recommendation Due		Next Inspection	None	
Apply Labels	No	Permit to Work Required	No	
Survey Type	Management	Lead Surveyor	Jane Openshaw	
Survey Date	22 Mar 2012	UKAS Laboratory	NOT SAMPLED (Cross Referenced)	
Site Reference	I23350000A	Licensed Material	N/A

No Asbestos Presumed in Sample

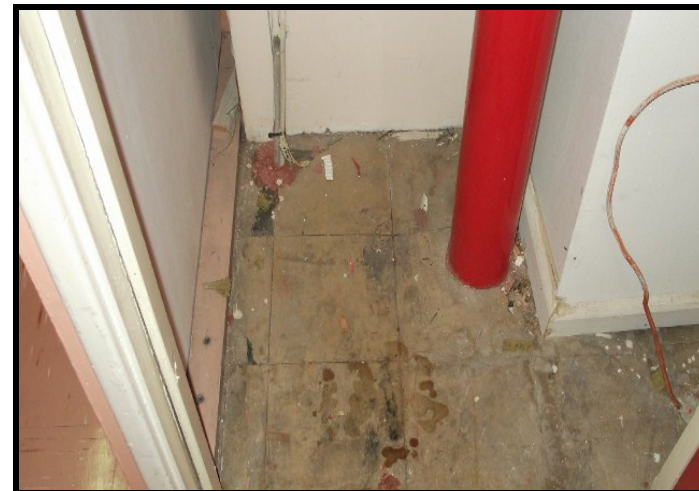
SAMPLE REFERENCE 034

Building	Floor	Room	Location
Main Building	Eighth Floor	Dry Riser	Floor
Description			
MATERIAL ASSESSMENT			
Product Type	Floor Tiles	Extent of Damage	Low damage
Asbestos Type	Chrysotile	Surface Treatment	Composite materials
PRIORITY ASSESSMENT			
Occupant Activity	Not Applicable	Extent / Amount	1.00 m2
Accessibility	Routinely disturbed	Location	Not Applicable
Avg Time in Use	Not Applicable	Frequency of Use	Not Applicable
No. of Occupants	Not Applicable	Secondary Activity	Not Applicable
Maintenance	Not Applicable	Maintenance Frequency	Not Applicable
MANAGEMENT ACTION			
Recommendation	LABEL & MONITOR		
Recommendation Due		Next Inspection	22 Mar 2013
Apply Labels	No	Permit to Work Required	No
Survey Type	Management	Lead Surveyor	Jane Openshaw
Survey Date	22 Mar 2012	UKAS Laboratory	NOT SAMPLED (Cross Referenced)
Site Reference	I23350000A	Licensed Material	No

Asbestos Presumed in Sample

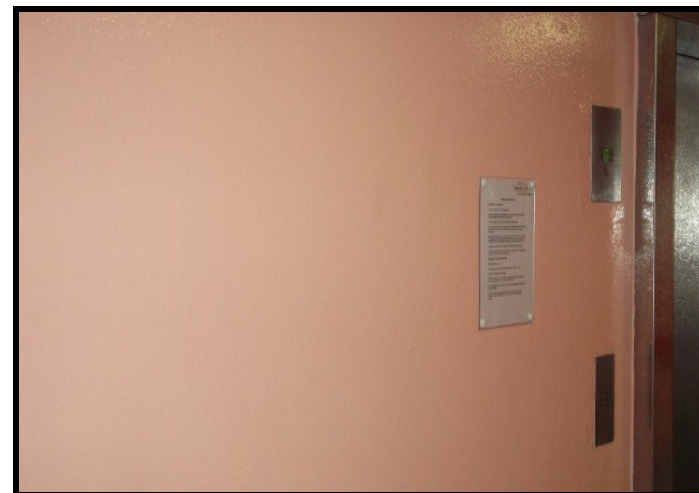
SAMPLE REFERENCE 035

Building	Floor	Room	Location	
Main Building	Eighth Floor	Lift Lobby	Walls	
Description				
MATERIAL ASSESSMENT				SCORE
Product Type	Paint	Extent of Damage	Good condition	-
Asbestos Type	No Asbestos Detected	Surface Treatment	Sealed (1)	
PRIORITY ASSESSMENT				SCORE
Occupant Activity	Not Applicable	Extent / Amount	15.00 m2	-
Accessibility	Easily disturbed	Location	Not Applicable	
Avg Time in Use	Not Applicable	Frequency of Use	Not Applicable	
No. of Occupants	Not Applicable	Secondary Activity	Not Applicable	
Maintenance	Not Applicable	Maintenance Frequency	Not Applicable	
MANAGEMENT ACTION				SCORE
Recommendation	NO ACTION REQUIRED			-
Recommendation Due		Next Inspection	None	
Apply Labels	No	Permit to Work Required	No	
Survey Type	Management	Lead Surveyor	Jane Openshaw	
Survey Date	22 Mar 2012	UKAS Laboratory	NOT SAMPLED (Cross Referenced)	
Site Reference	I23350000A	Licensed Material	N/A

No Asbestos Presumed in Sample

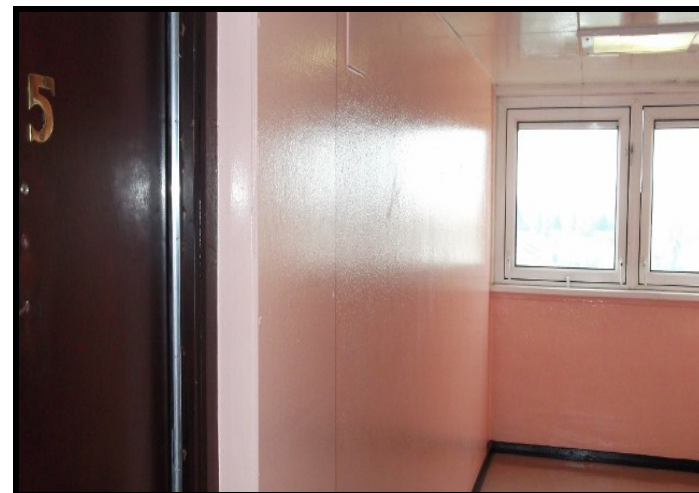
SAMPLE REFERENCE 036

Building	Floor	Room	Location	
Main Building	Eighth Floor	Corridor 2	Walls	
Description				
MATERIAL ASSESSMENT				SCORE
Product Type	Paint	Extent of Damage	Good condition	-
Asbestos Type	No Asbestos Detected	Surface Treatment	Sealed (1)	
PRIORITY ASSESSMENT				SCORE
Occupant Activity	Not Applicable	Extent / Amount	8.00 m2	-
Accessibility	Easily disturbed	Location	Not Applicable	
Avg Time in Use	Not Applicable	Frequency of Use	Not Applicable	
No. of Occupants	Not Applicable	Secondary Activity	Not Applicable	
Maintenance	Not Applicable	Maintenance Frequency	Not Applicable	
MANAGEMENT ACTION				SCORE
Recommendation	NO ACTION REQUIRED			-
Recommendation Due		Next Inspection	None	
Apply Labels	No	Permit to Work Required	No	
Survey Type	Management	Lead Surveyor	Jane Openshaw	
Survey Date	22 Mar 2012	UKAS Laboratory	NOT SAMPLED (Cross Referenced)	
Site Reference	I23350000A	Licensed Material	N/A

No Asbestos Presumed in Sample

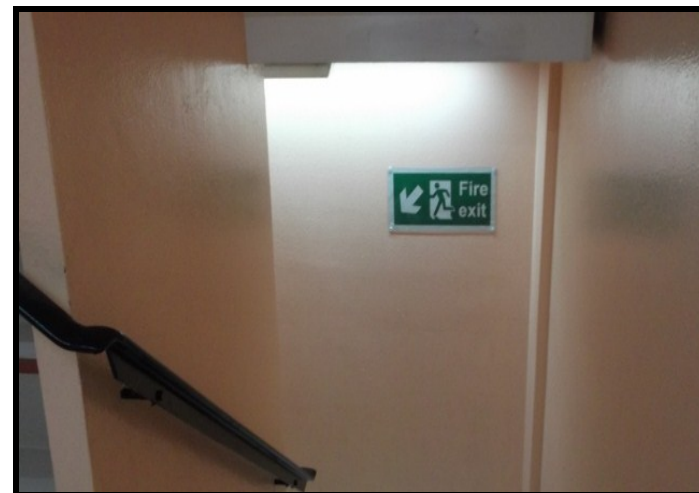
SAMPLE REFERENCE 039

Building	Floor	Room	Location	
Main Building	Eighth Floor	Stairs	Walls	
Description				
MATERIAL ASSESSMENT				SCORE
Product Type	Paint	Extent of Damage	Good condition	-
Asbestos Type	No Asbestos Detected	Surface Treatment	Sealed (1)	
PRIORITY ASSESSMENT				SCORE
Occupant Activity	Not Applicable	Extent / Amount	40.00 m2	-
Accessibility	Easily disturbed	Location	Not Applicable	
Avg Time in Use	Not Applicable	Frequency of Use	Not Applicable	
No. of Occupants	Not Applicable	Secondary Activity	Not Applicable	
Maintenance	Not Applicable	Maintenance Frequency	Not Applicable	
MANAGEMENT ACTION				SCORE
Recommendation	NO ACTION REQUIRED			-
Recommendation Due		Next Inspection	None	
Apply Labels	No	Permit to Work Required	No	
Survey Type	Management	Lead Surveyor	Jane Openshaw	
Survey Date	22 Mar 2012	UKAS Laboratory	NOT SAMPLED (Cross Referenced)	
Site Reference	I23350000A	Licensed Material	N/A

No Asbestos Presumed in Sample

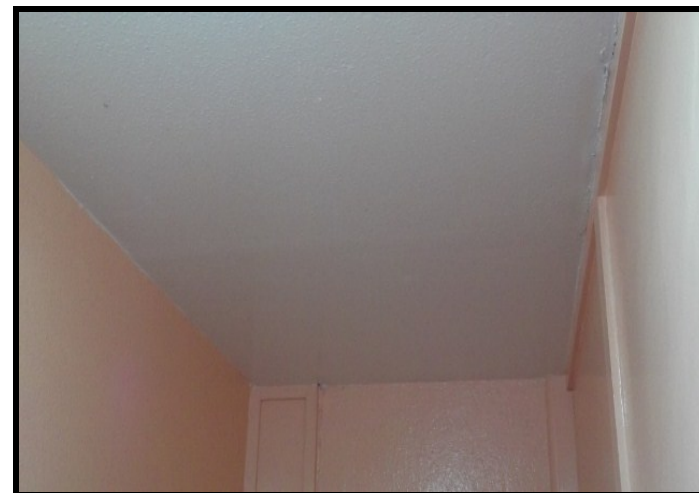
SAMPLE REFERENCE 04I

Building	Floor	Room	Location	
Main Building	Seventh Floor	Bin Chute	Ceiling	
Description				
MATERIAL ASSESSMENT				SCORE
Product Type	Paint	Extent of Damage	Good condition	-
Asbestos Type	No Asbestos Detected	Surface Treatment	Sealed (1)	
PRIORITY ASSESSMENT				SCORE
Occupant Activity	Not Applicable	Extent / Amount	4.00 m2	-
Accessibility	Occasionally disturb	Location	Not Applicable	
Avg Time in Use	Not Applicable	Frequency of Use	Not Applicable	
No. of Occupants	Not Applicable	Secondary Activity	Not Applicable	
Maintenance	Not Applicable	Maintenance Frequency	Not Applicable	
MANAGEMENT ACTION				SCORE
Recommendation	NO ACTION REQUIRED			-
Recommendation Due		Next Inspection	None	
Apply Labels	No	Permit to Work Required	No	
Survey Type	Management	Lead Surveyor	Jane Openshaw	
Survey Date	22 Mar 2012	UKAS Laboratory	NOT SAMPLED (Cross Referenced)	
Site Reference	I23350000A	Licensed Material	N/A

No Asbestos Presumed in Sample

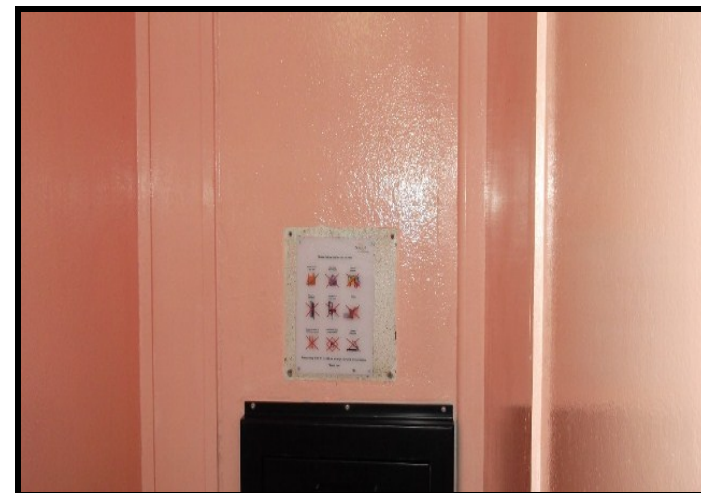
SAMPLE REFERENCE 042

No Asbestos Presumed in Sample

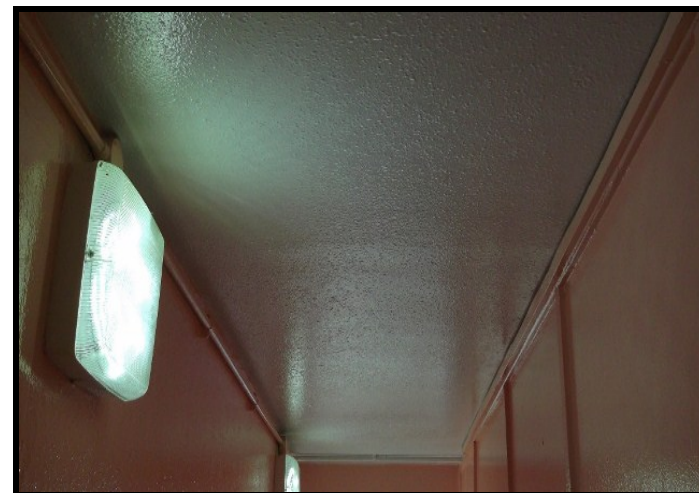
SAMPLE REFERENCE 044

No Asbestos Presumed in Sample

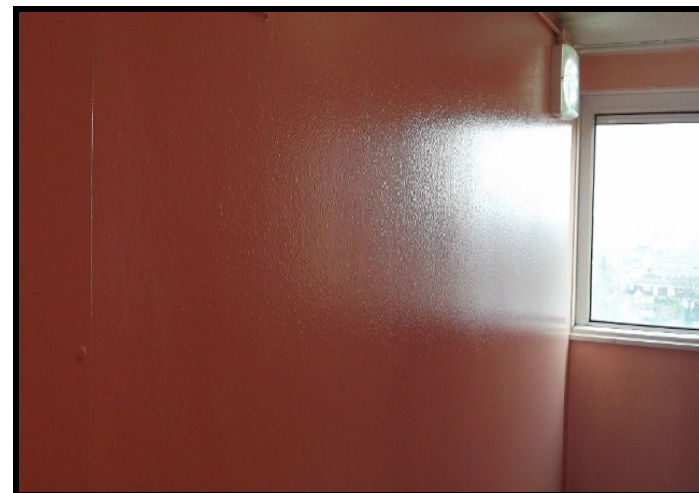
SAMPLE REFERENCE 046

No Asbestos Presumed in Sample

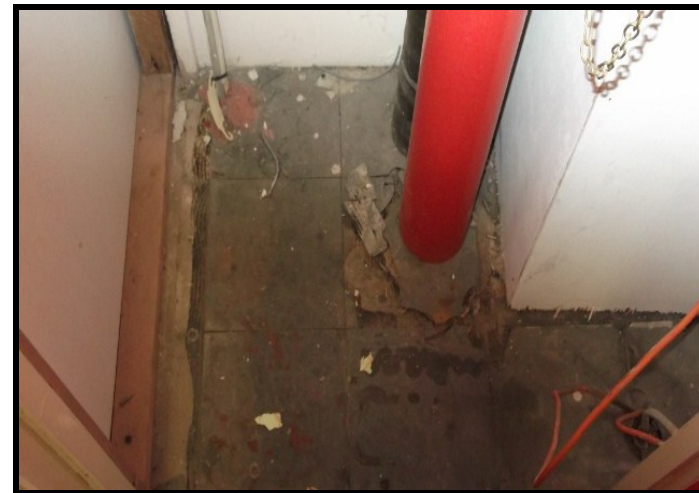
SAMPLE REFERENCE 047

Asbestos Presumed in Sample

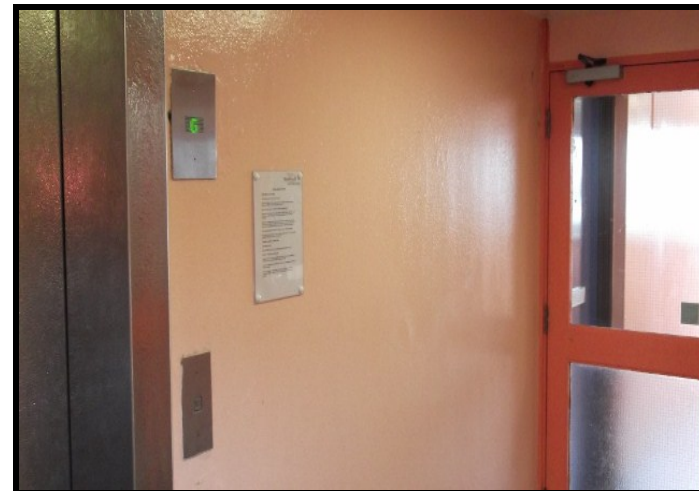
SAMPLE REFERENCE 048

No Asbestos Presumed in Sample

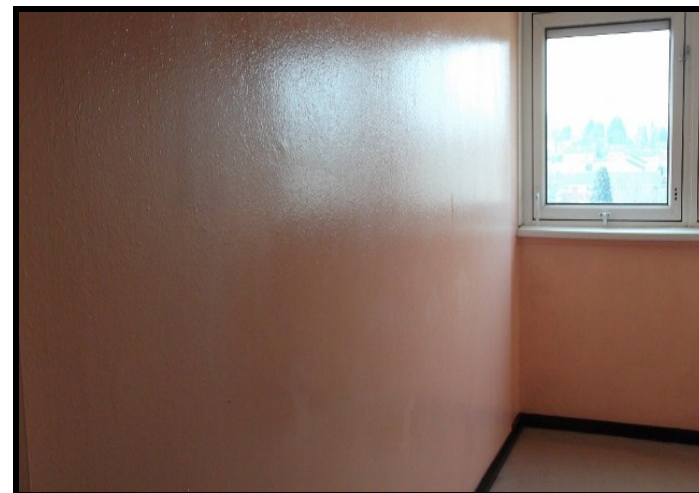
SAMPLE REFERENCE 049

No Asbestos Presumed in Sample

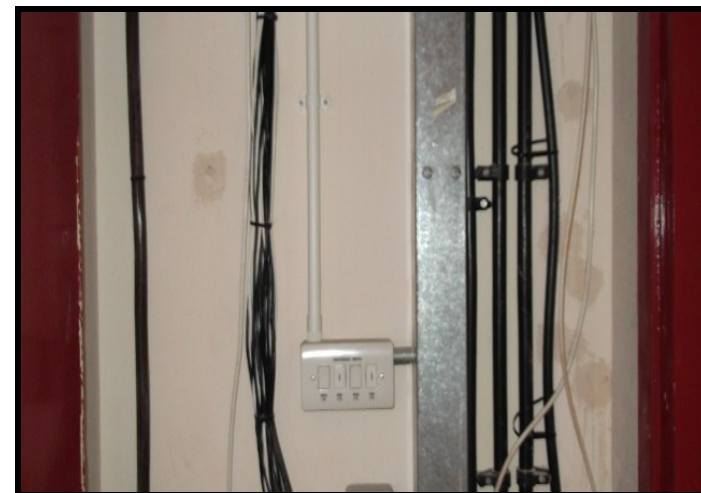
SAMPLE REFERENCE 05 I

No Asbestos Presumed in Sample

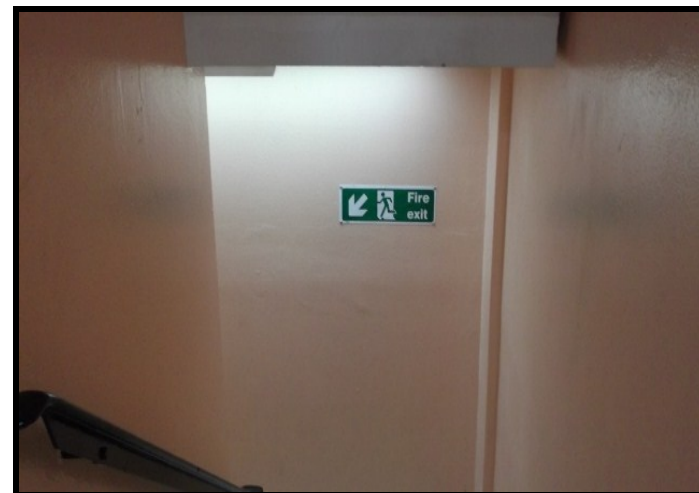
SAMPLE REFERENCE 052

No Asbestos Presumed in Sample

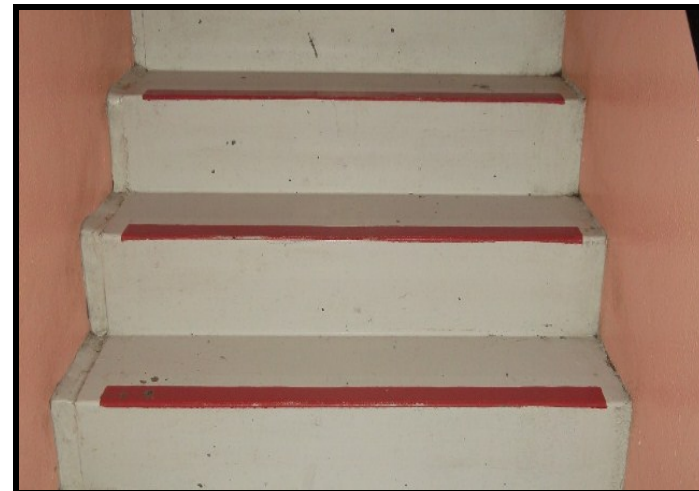
SAMPLE REFERENCE 053

Asbestos Presumed in Sample

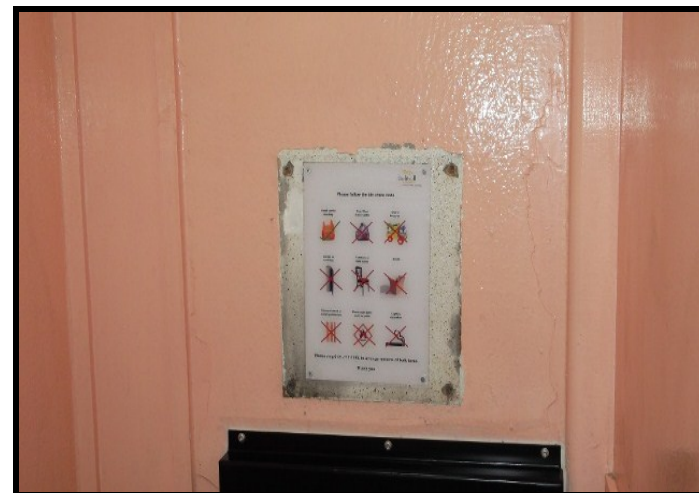
SAMPLE REFERENCE 055

Asbestos not detected in Sample

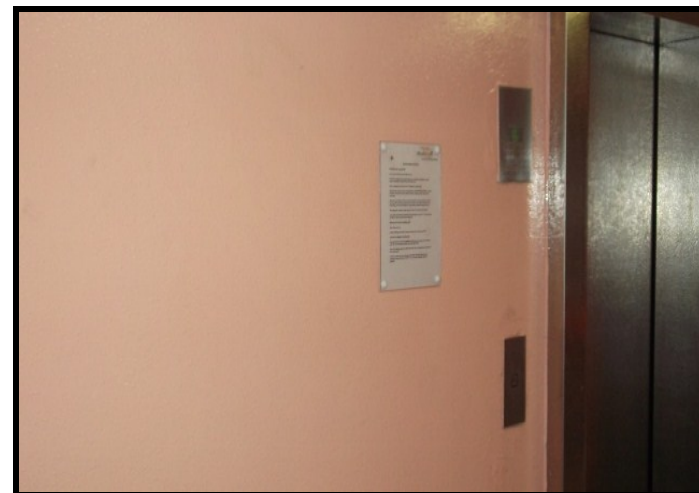
SAMPLE REFERENCE 060

No Asbestos Presumed in Sample

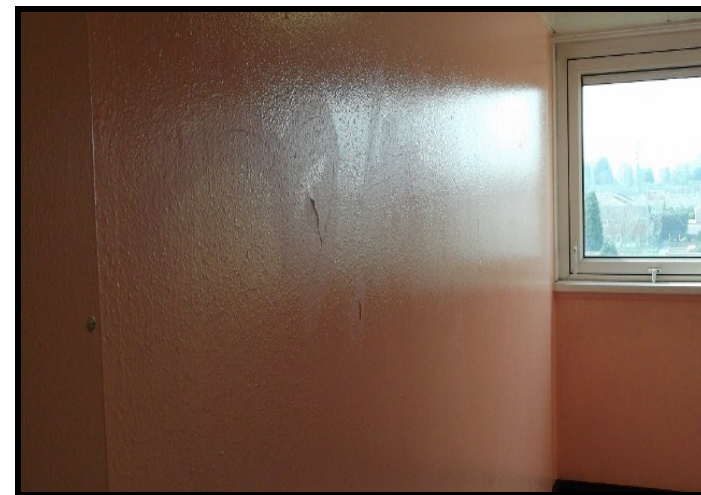
SAMPLE REFERENCE 061

No Asbestos Presumed in Sample

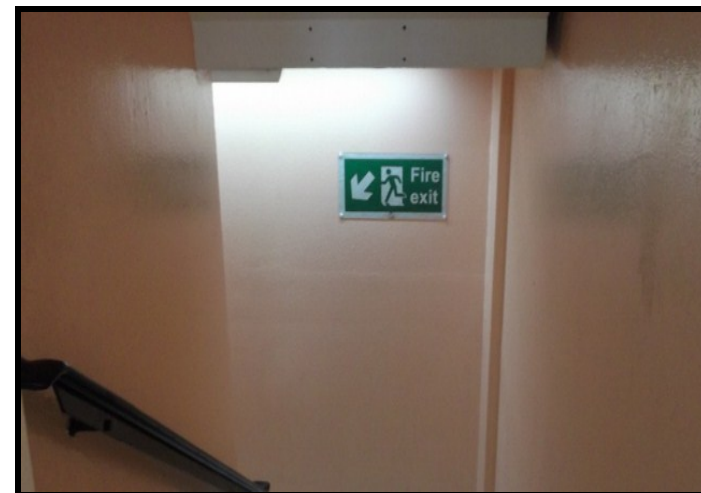
SAMPLE REFERENCE 064

No Asbestos Presumed in Sample

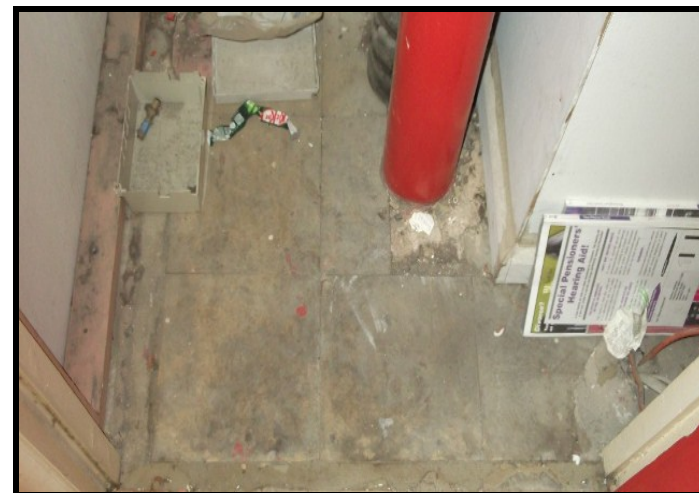
SAMPLE REFERENCE 066

Asbestos Presumed in Sample

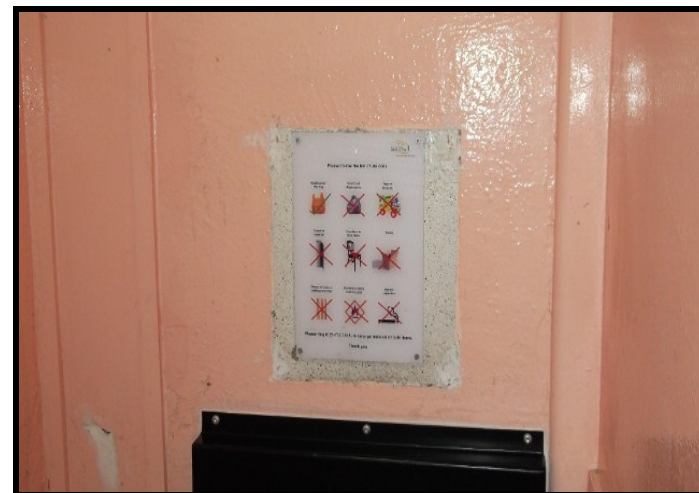
SAMPLE REFERENCE 068

No Asbestos Presumed in Sample

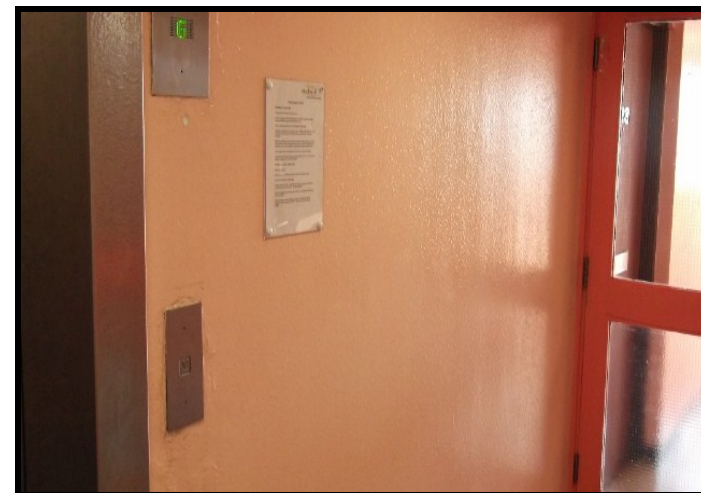
SAMPLE REFERENCE 075

No Asbestos Presumed in Sample

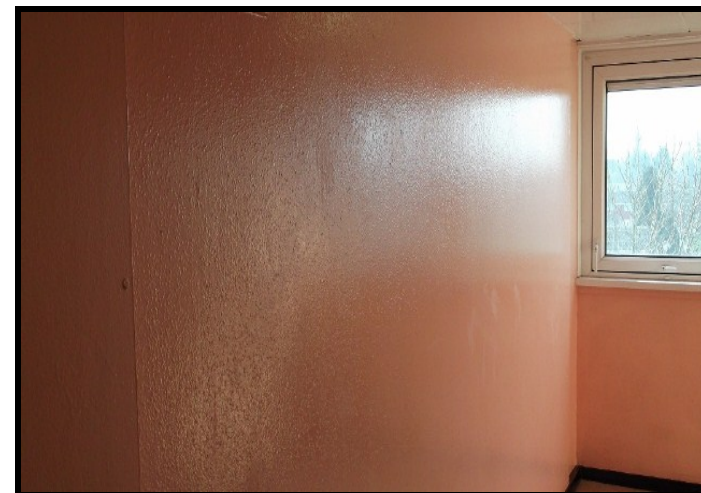
SAMPLE REFERENCE 076

No Asbestos Presumed in Sample

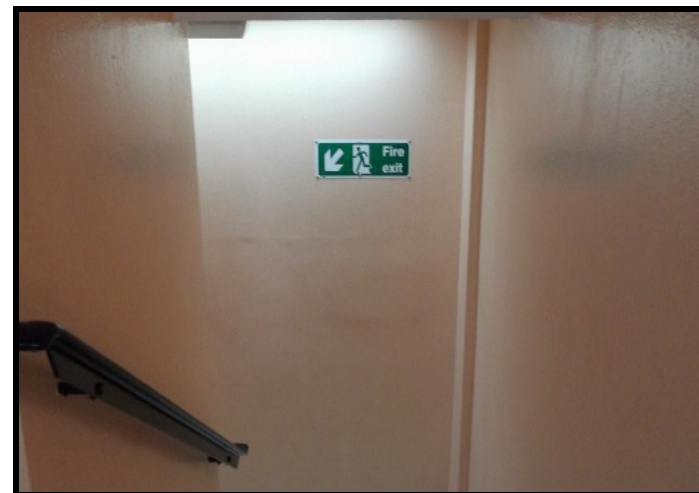
SAMPLE REFERENCE 079

No Asbestos Presumed in Sample

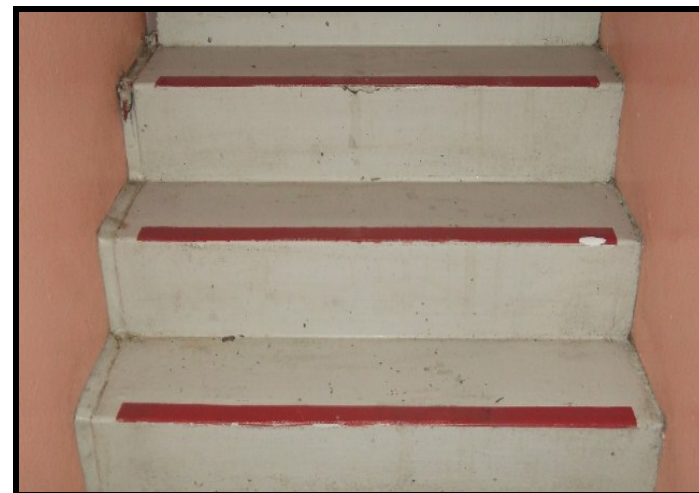
SAMPLE REFERENCE 080

Asbestos detected in Sample

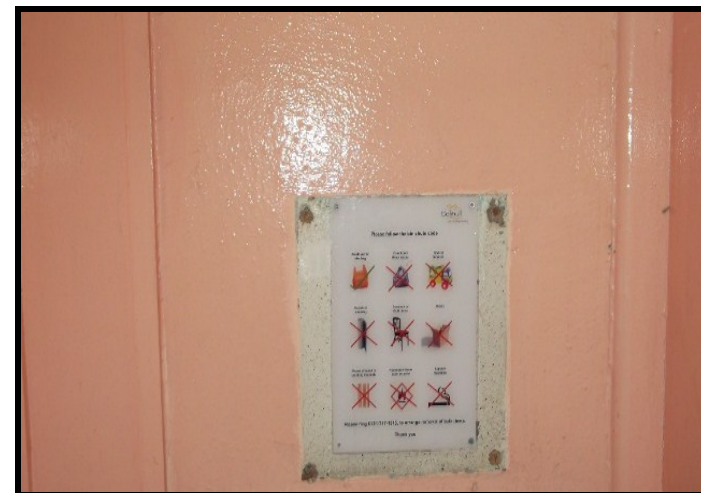
SAMPLE REFERENCE 082

Asbestos not detected in Sample

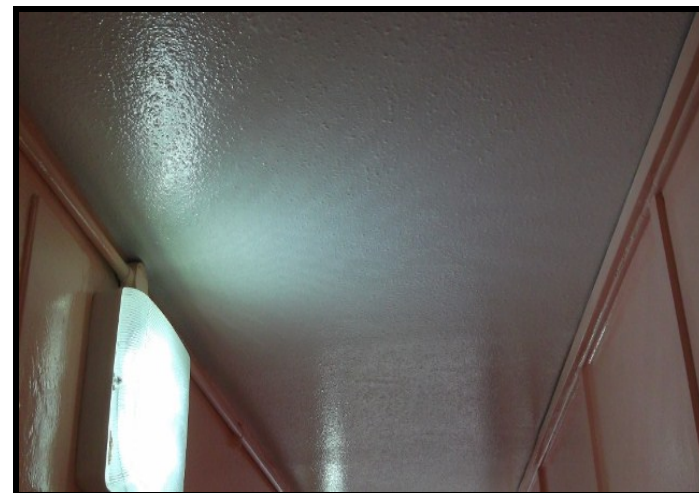
SAMPLE REFERENCE 084

No Asbestos Presumed in Sample

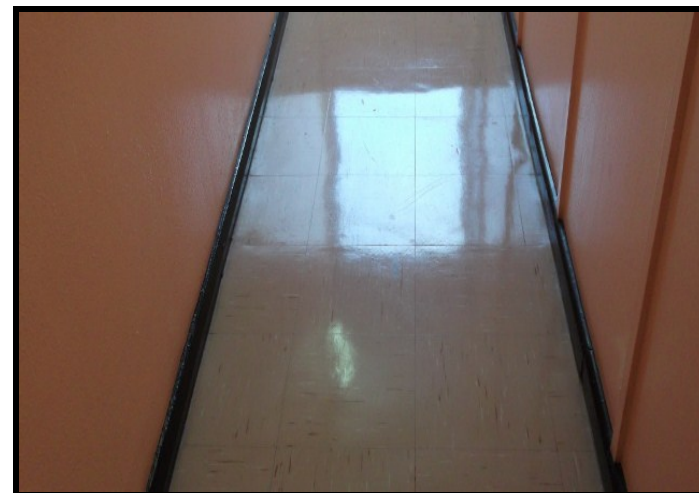
SAMPLE REFERENCE 086

No Asbestos Presumed in Sample

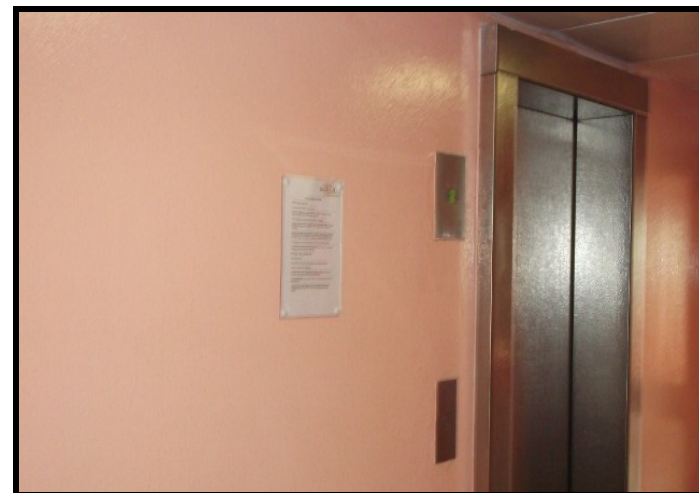
SAMPLE REFERENCE 087

No Asbestos Presumed in Sample

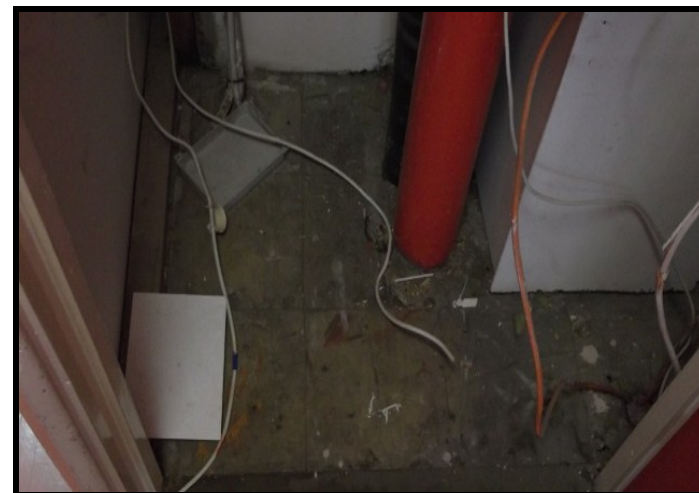
SAMPLE REFERENCE 088

Asbestos Presumed in Sample

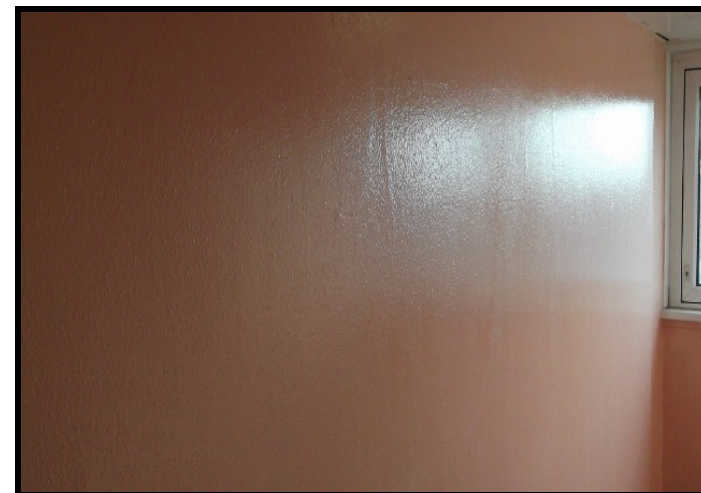
SAMPLE REFERENCE 089

No Asbestos Presumed in Sample

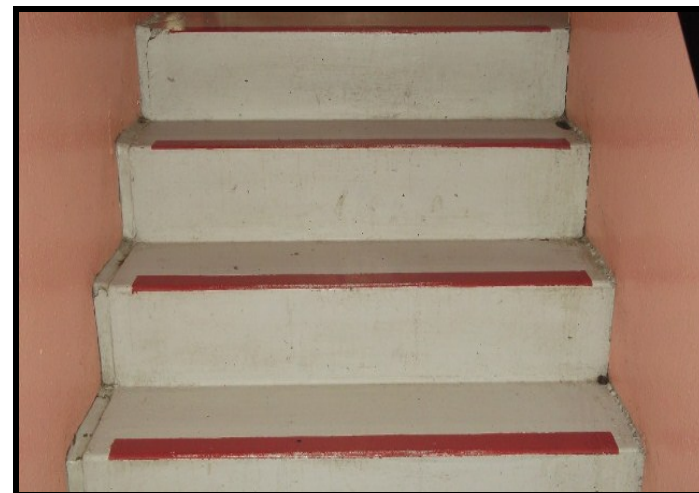
SAMPLE REFERENCE 093

Asbestos Presumed in Sample

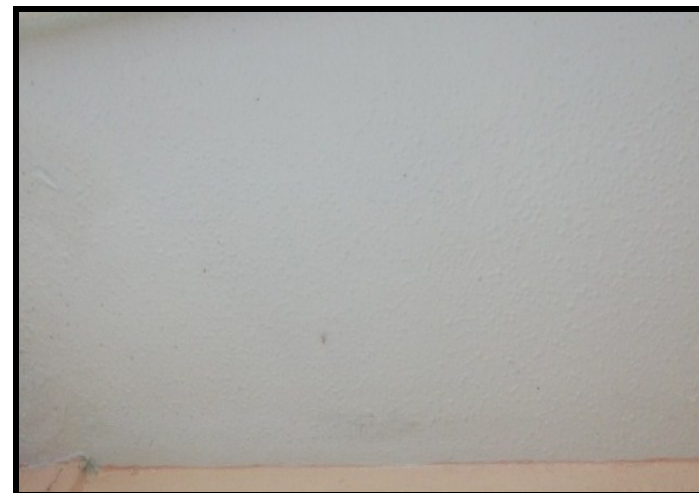
SAMPLE REFERENCE 094

No Asbestos Presumed in Sample
