Solihull Community Housing

Asbestos Management Survey Report

**Linacre House
Heathmere Drive
Chelmsley Wood
B37 5EW**

Date of Report: 25 Apr 2012

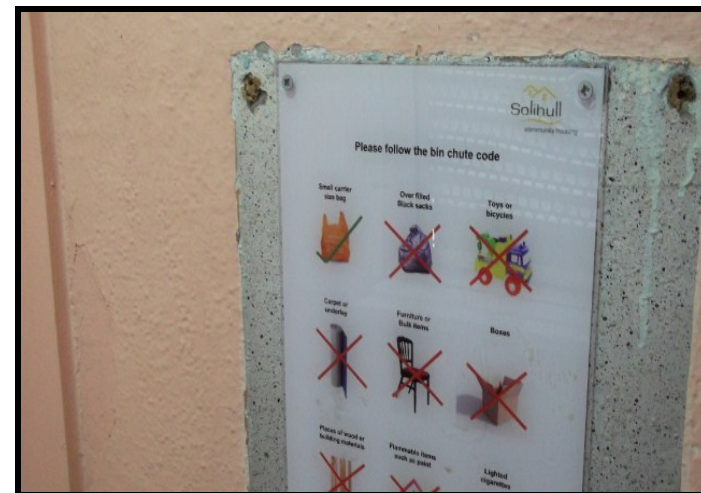
SAMPLE REFERENCE 095

No Asbestos Presumed in Sample

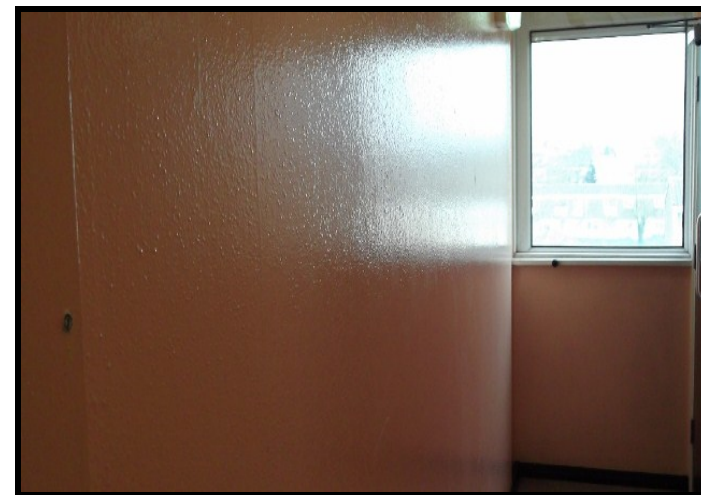
SAMPLE REFERENCE 098

No Asbestos Presumed in Sample

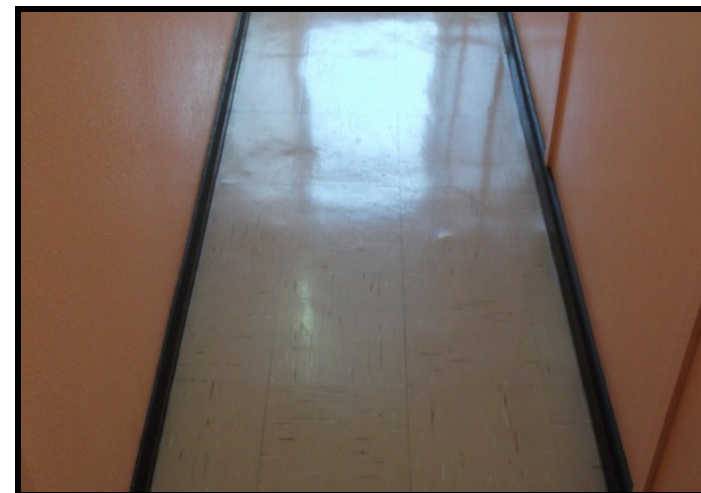
SAMPLE REFERENCE 099

No Asbestos Presumed in Sample

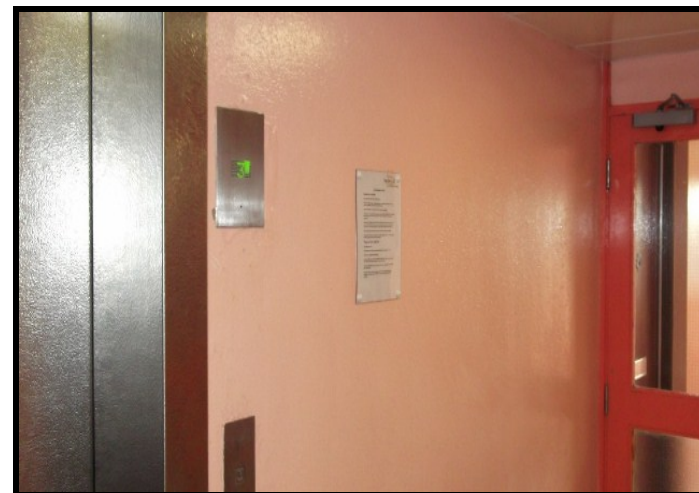
SAMPLE REFERENCE 101

No Asbestos Presumed in Sample

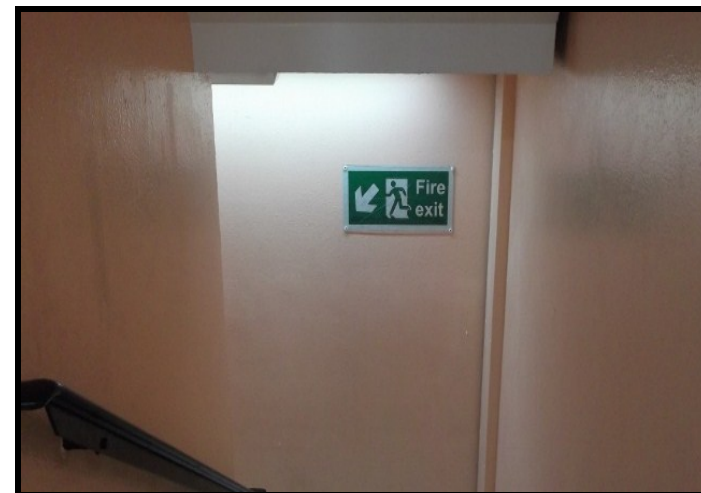
SAMPLE REFERENCE 105

No Asbestos Presumed in Sample

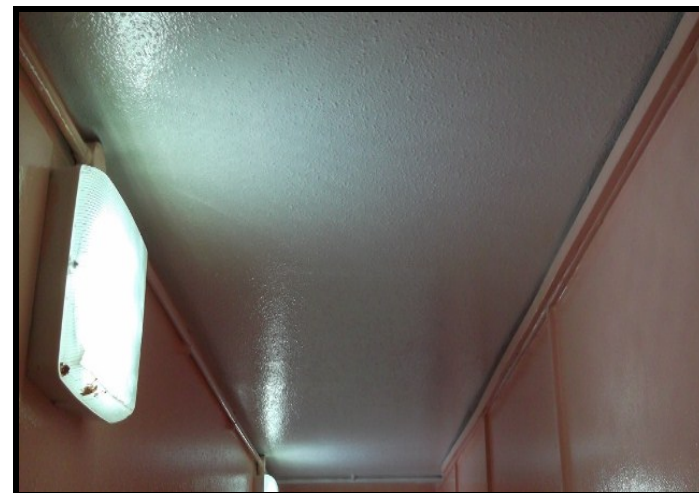
SAMPLE REFERENCE I I 0

No Asbestos Presumed in Sample

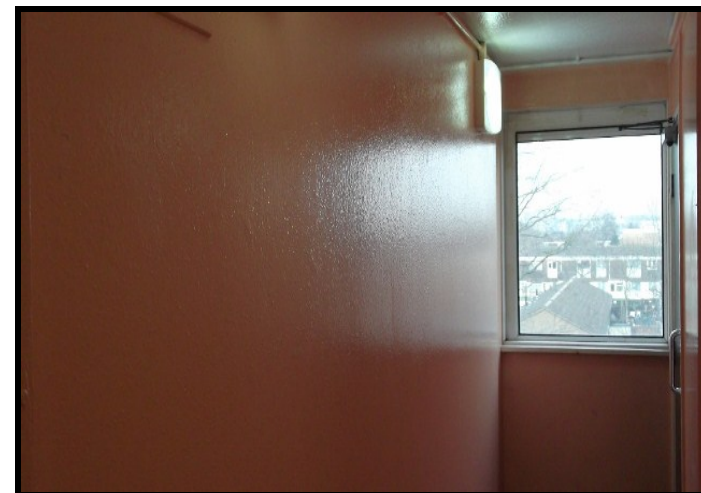
SAMPLE REFERENCE I I I

No Asbestos Presumed in Sample

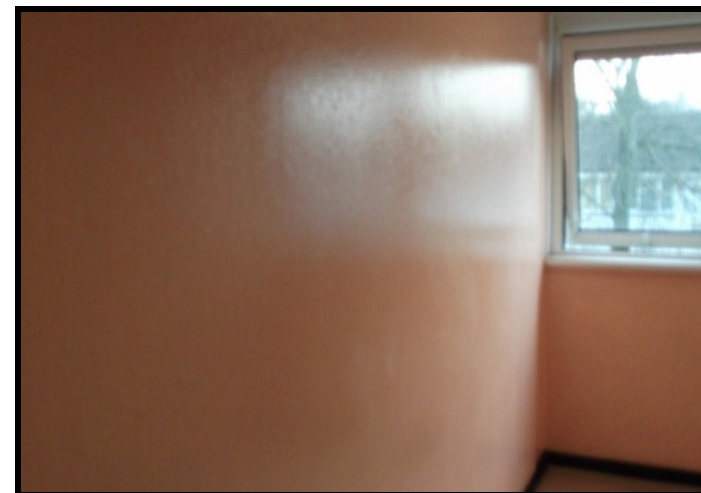
SAMPLE REFERENCE I I 5

No Asbestos Presumed in Sample

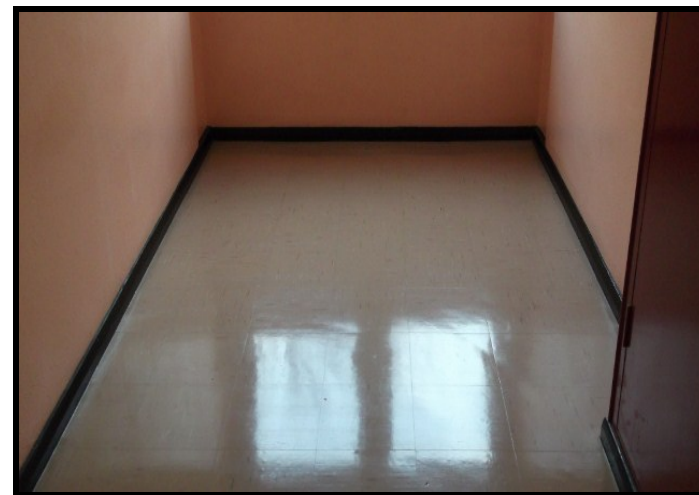
SAMPLE REFERENCE I I 6

No Asbestos Presumed in Sample

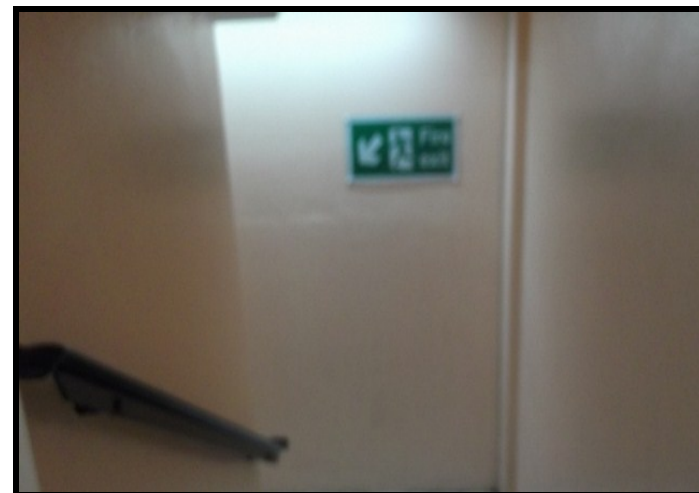
SAMPLE REFERENCE I 18

No Asbestos Presumed in Sample

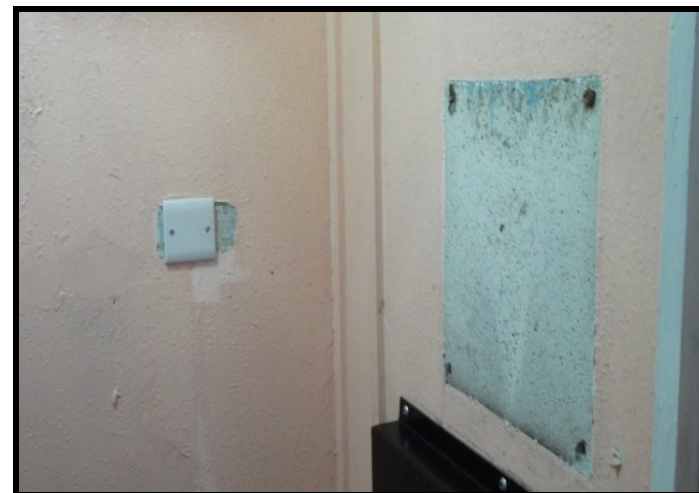
SAMPLE REFERENCE 121

No Asbestos Presumed in Sample

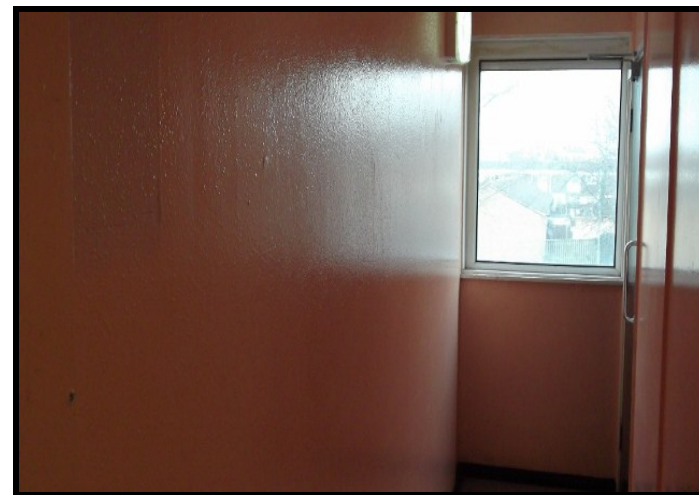
SAMPLE REFERENCE 124

No Asbestos Presumed in Sample

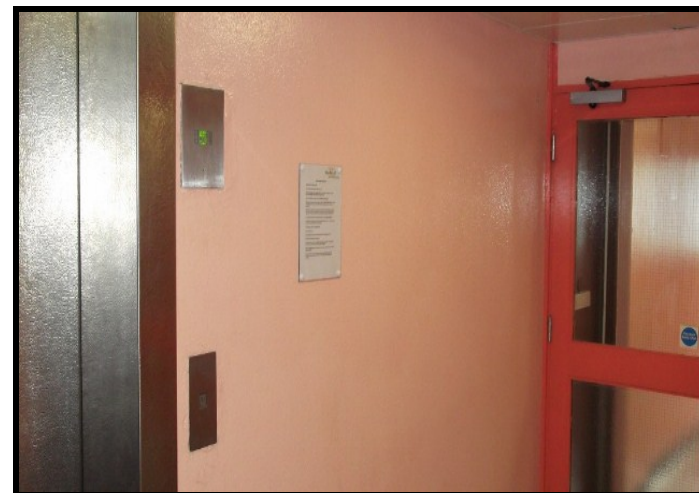
SAMPLE REFERENCE 127

No Asbestos Presumed in Sample

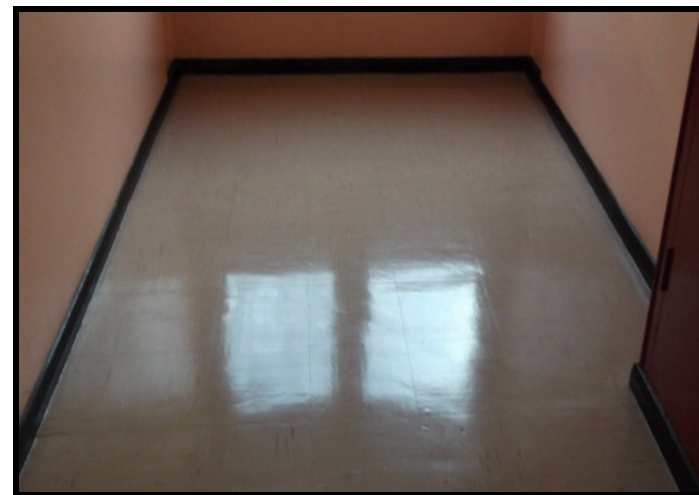
SAMPLE REFERENCE 129

No Asbestos Presumed in Sample

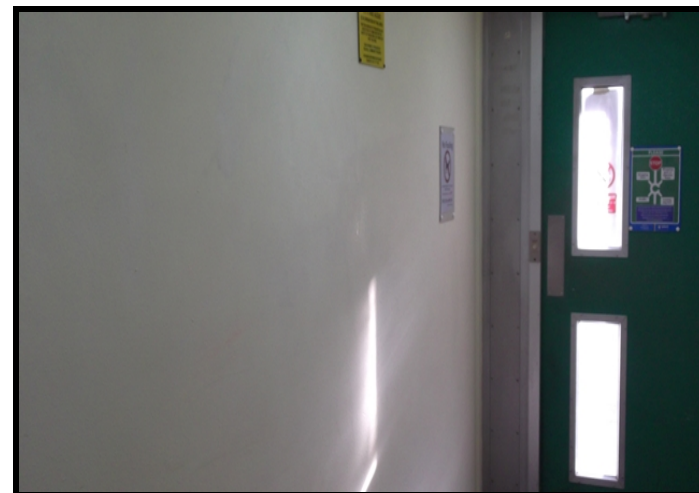
SAMPLE REFERENCE I35

No Asbestos Presumed in Sample

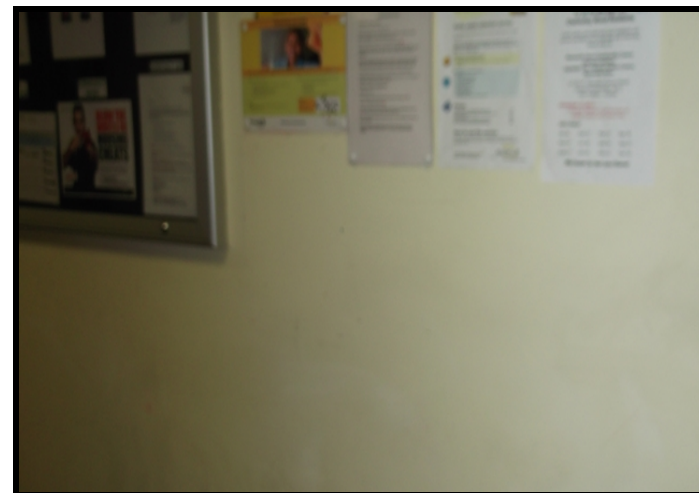
SAMPLE REFERENCE I36

No Asbestos Presumed in Sample

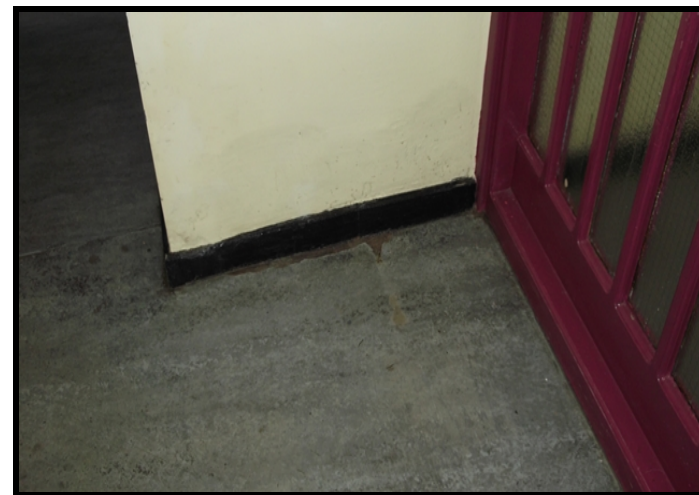
SAMPLE REFERENCE 137

Asbestos not detected in Sample

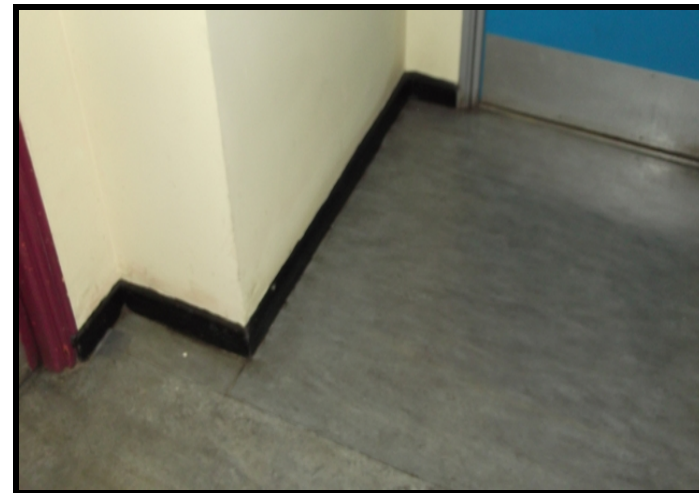
SAMPLE REFERENCE I38

Asbestos not detected in Sample

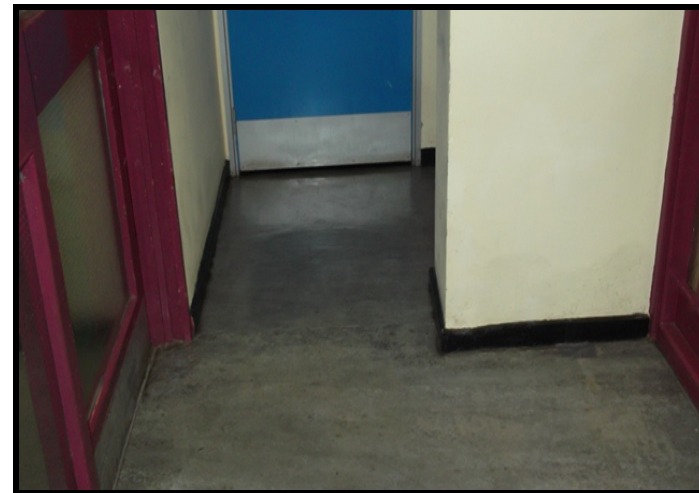
SAMPLE REFERENCE 139

No Asbestos Presumed in Sample

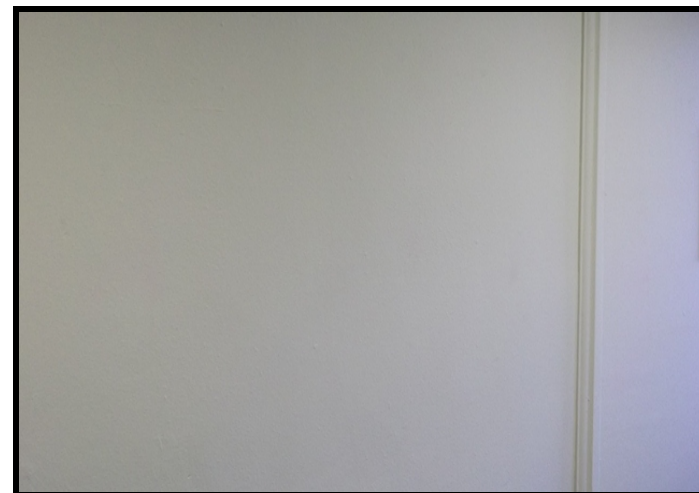
SAMPLE REFERENCE I40

No Asbestos Presumed in Sample

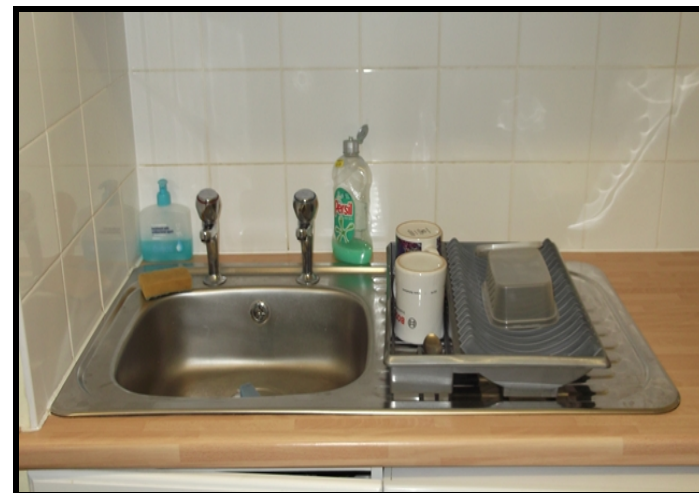
SAMPLE REFERENCE I56

Asbestos not detected in Sample

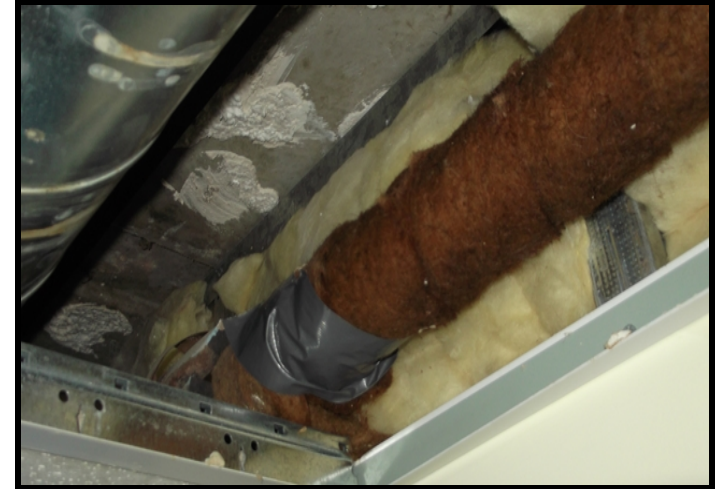
SAMPLE REFERENCE I57

Asbestos not detected in Sample
