# **Solihull Community Housing**

## **Asbestos Management Survey Report**

**Mansfield House I-45 (Communal)  
Woodlands Way  
Solihull  
B37 6RT**

**Date of Report: 25 Feb 2015**

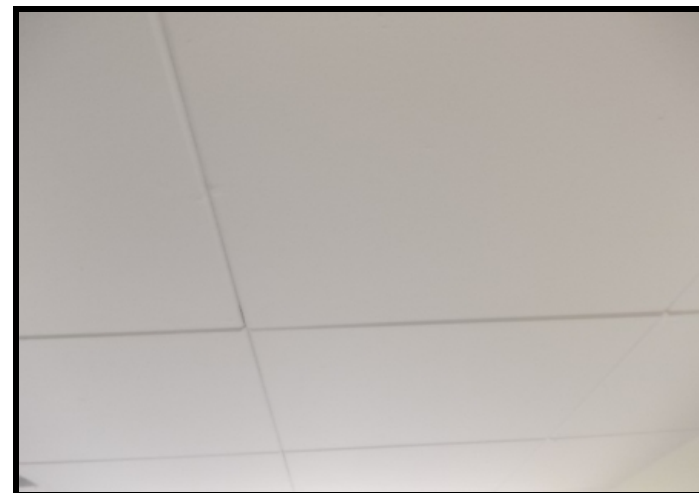
## SAMPLE REFERENCE 001

| 001 | Main Building (Ground Floor) | Front Entrance | Ceiling | Insulation Board | No Asbestos Detected | 10.00m2 | Good condition | Sealed Board (Encapsulated) | - | - | - | NO ACTION REQUIRED | | |

Asbestos not detected in Sample

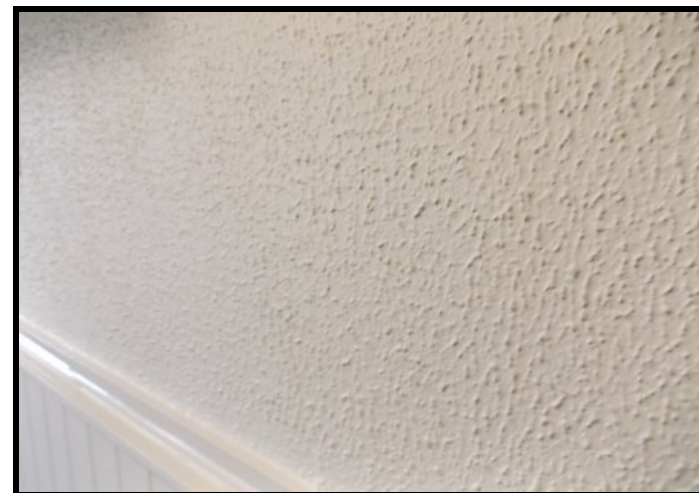
## SAMPLE REFERENCE 002

| 002 | Main Building (Ground Floor) | Front Entrance | Wall | Textured Coating | No Asbestos Detected | 18.00m2 | Good condition | Textured Coating | - | - | - | NO ACTION REQUIRED | | |

Asbestos not detected in Sample

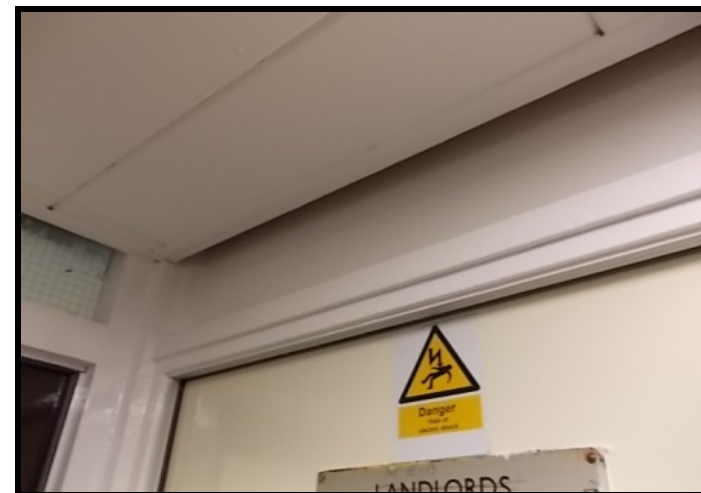
## SAMPLE REFERENCE 003

| 003 | Main Building (Ground Floor) | Landlord Services | Transom Panel | Insulation Board | No Asbestos Detected | 1.00m2 | Good condition | Sealed Board (Encapsulated) | - | - | - | NO ACTION REQUIRED | | |

Asbestos not detected in Sample

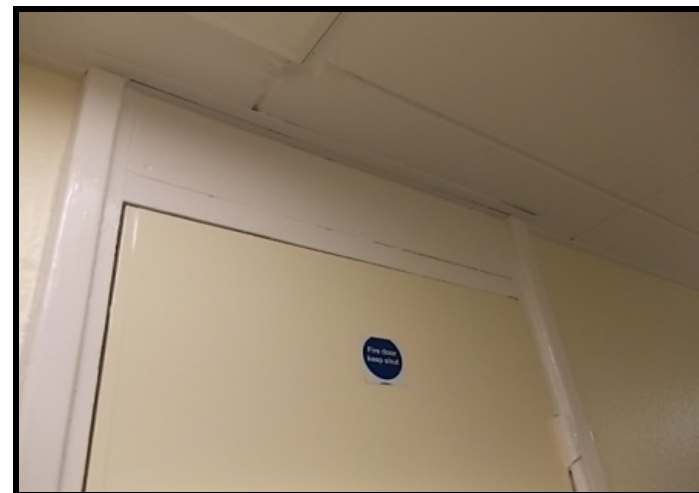
## SAMPLE REFERENCE 004

| 004 | Main Building (Ground Floor) | Riser 1 | Transom Panel | Insulation Board | No Asbestos Detected | 1.00m2 | Good condition | Sealed Board (Encapsulated) | - | - | - | NO ACTION REQUIRED | | |

**No Asbestos Presumed in Sample**

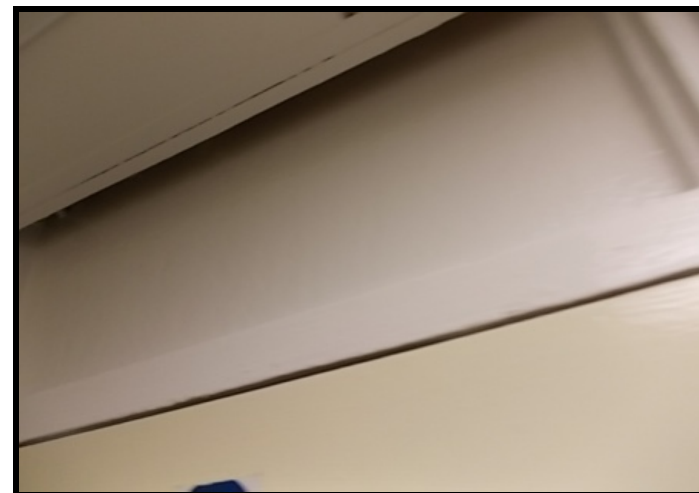
## SAMPLE REFERENCE 005

| Unique Sample No. | Building Reference (Floor) | Room Area | Description of Location | Product Description | Asbestos Type | Approx. Quantity | Material Condition | Surface Treatment | Material Risk Score | Priority Risk Score | Total Risk Score | Management Action | Next Review Date |
|---|---|---|---|---|---|---|---|---|---|---|---|---|---|
| 005 | Main Building (Ground Floor) | Riser 2 | Transom Panel | Insulation Board | No Asbestos Detected | 1.00m2 | Good condition | Sealed Board (Encapsulated) | - | - | - | NO ACTION REQUIRED | |

**No Asbestos Presumed in Sample**

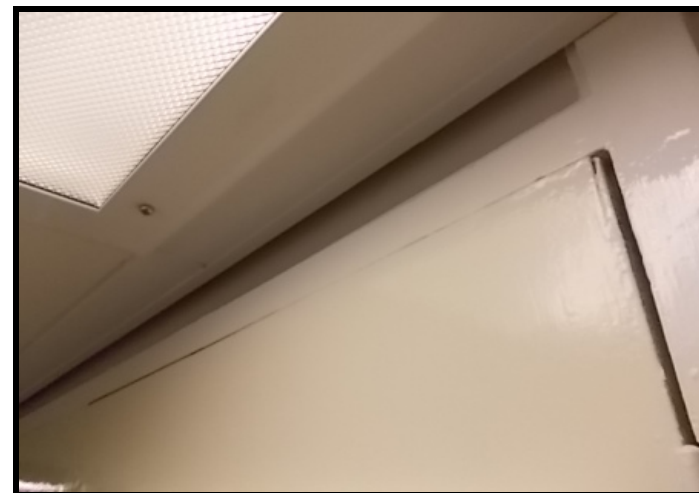
## SAMPLE REFERENCE 006

| Unique Sample No. | Building Reference (Floor) | Room Area | Description of Location | Product Description | Asbestos Type | Approx. Quantity | Material Condition | Surface Treatment | Material Risk Score | Priority Risk Score | Total Risk Score | Management Action | Next Review Date |
|---|---|---|---|---|---|---|---|---|---|---|---|---|---|
| 006 | Main Building (Ground Floor) | Meter Cupboard | Transom Panel | Insulation Board | No Asbestos Detected | 3.00m2 | Good condition | Unsealed (Board) | - | - | - | NO ACTION REQUIRED | |

**Asbestos not detected in Sample**

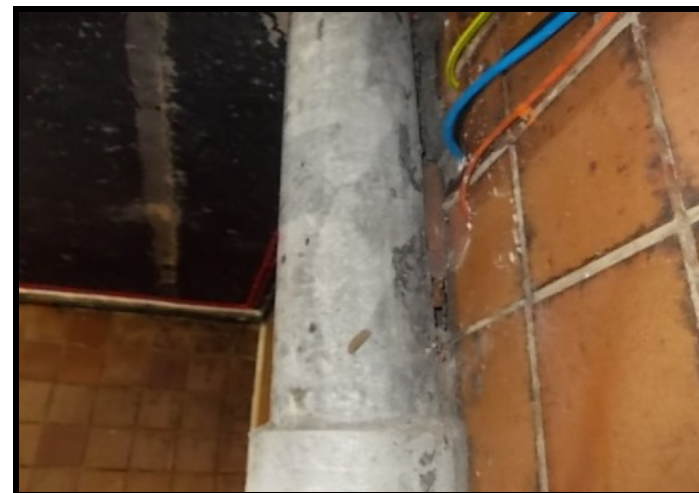
## SAMPLE REFERENCE 008

| Unique Sample No. | Building Reference (Floor) | Room Area | Description of Location | Product Description | Asbestos Type | Approx. Quantity | Material Condition | Surface Treatment | Material Risk Score | Priority Risk Score | Total Risk Score | Management Action | Next Review Date |
|---|---|---|---|---|---|---|---|---|---|---|---|---|---|
| 008 | Main Building (Ground Floor) | Bin Store | Pipe Work | Cement | Chrysotile | 2.00lm | Good condition | Sealed (Cement products) | 3 | 1 | 4 | LABEL & MONITOR | 02 Dec 2015 |

Asbestos detected in Sample

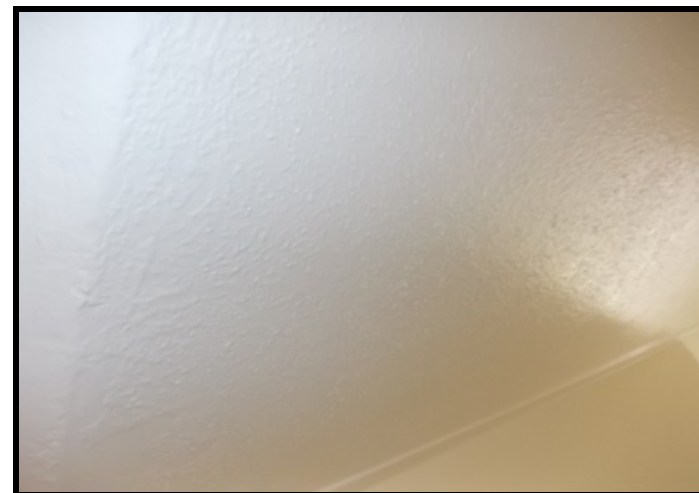
## SAMPLE REFERENCE 009

| Unique Sample No. | Building Reference (Floor) | Room Area | Description of Location | Product Description | Asbestos Type | Approx. Quantity | Material Condition | Surface Treatment | Material Risk Score | Priority Risk Score | Total Risk Score | Management Action | Next Review Date |
|---|---|---|---|---|---|---|---|---|---|---|---|---|---|
| 009 | Main Building (Ground Floor) | Stairwell | Ceiling | Textured Coating | No Asbestos Detected | 8.00m2 | Good condition | Textured Coating | - | - | - | NO ACTION REQUIRED | |

**Asbestos not detected in Sample**

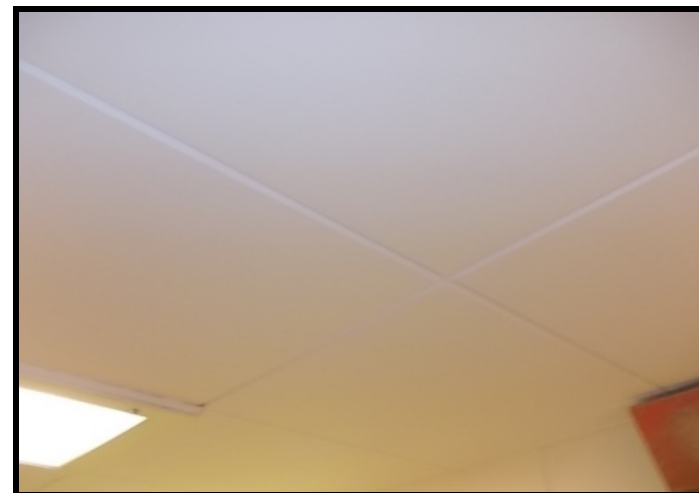
## SAMPLE REFERENCE 010

| Unique Sample No. | Building Reference (Floor) | Room Area | Description of Location | Product Description | Asbestos Type | Approx. Quantity | Material Condition | Surface Treatment | Material Risk Score | Priority Risk Score | Total Risk Score | Management Action | Next Review Date |
|---|---|---|---|---|---|---|---|---|---|---|---|---|---|
| 010 | Main Building (First Floor) | Landing | Ceiling | Insulation Board | No Asbestos Detected | 10.00m2 | Good condition | Sealed Board (Encapsulated) | - | - | - | NO ACTION REQUIRED | |

**No Asbestos Presumed in Sample**

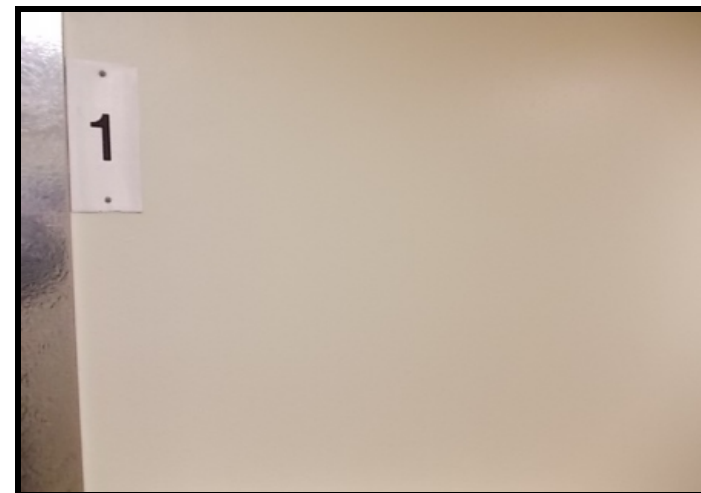
## SAMPLE REFERENCE 011

| Unique Sample No. | Building Reference (Floor) | Room Area | Description of Location | Product Description | Asbestos Type | Approx. Quantity | Material Condition | Surface Treatment | Material Risk Score | Priority Risk Score | Total Risk Score | Management Action | Next Review Date |
|---|---|---|---|---|---|---|---|---|---|---|---|---|---|
| 011 | Main Building (First Floor) | Landing | Wall | Textured Coating | No Asbestos Detected | 25.00m2 | Good condition | Textured Coating | - | - | - | NO ACTION REQUIRED | |

Asbestos not detected in Sample

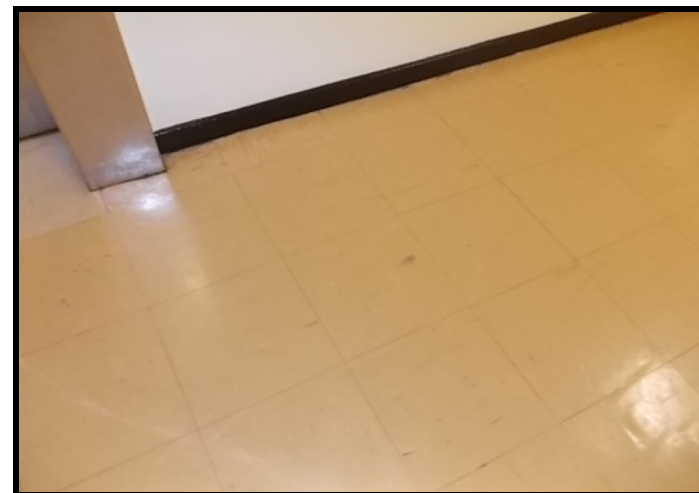
## SAMPLE REFERENCE 012

| Unique Sample No. | Building Reference (Floor) | Room Area | Description of Location | Product Description | Asbestos Type | Approx. Quantity | Material Condition | Surface Treatment | Material Risk Score | Priority Risk Score | Total Risk Score | Management Action | Next Review Date |
|---|---|---|---|---|---|---|---|---|---|---|---|---|---|
| 012 | Main Building (First Floor) | Landing | Floor | Floor Tiles | No Asbestos Detected | 10.00m2 | Good condition | Composite materials | - | - | - | NO ACTION REQUIRED | |

Asbestos not detected in Sample

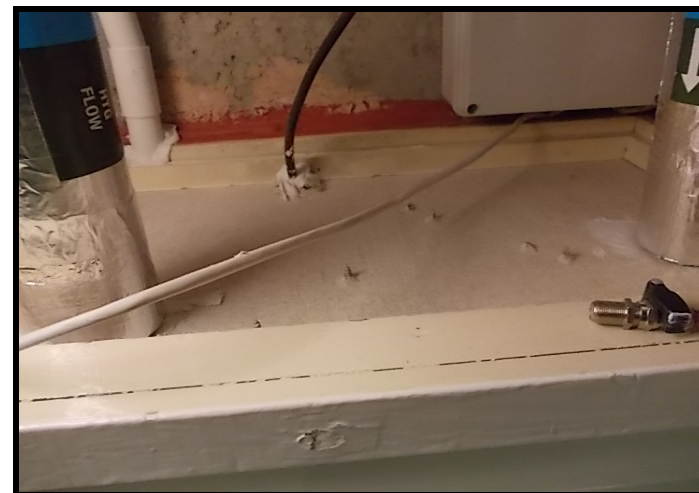
## SAMPLE REFERENCE 013

| Unique Sample No. | Building Reference (Floor) | Room Area | Description of Location | Product Description | Asbestos Type | Approx. Quantity | Material Condition | Surface Treatment | Material Risk Score | Priority Risk Score | Total Risk Score | Management Action | Next Review Date |
|---|---|---|---|---|---|---|---|---|---|---|---|---|---|
| 013 | Main Building (First Floor) | Service Cupboard 1 | Transom Panel | Insulation Board | No Asbestos Detected | 1.00m2 | Good condition | Sealed Board (Encapsulated) | - | - | - | NO ACTION REQUIRED | |

**No Asbestos Presumed in Sample**

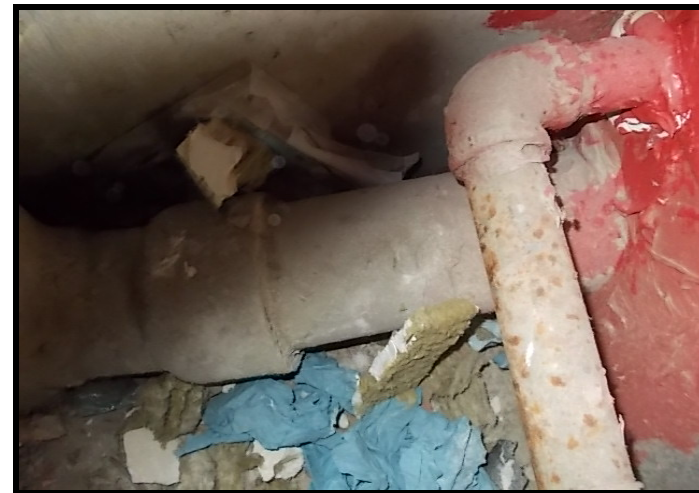
## SAMPLE REFERENCE 014a

| Unique Sample No. | Building Reference (Floor) | Room Area | Description of Location | Product Description | Asbestos Type | Approx. Quantity | Material Condition | Surface Treatment | Material Risk Score | Priority Risk Score | Total Risk Score | Management Action | Next Review Date |
|---|---|---|---|---|---|---|---|---|---|---|---|---|---|
| 014a | Main Building (First Floor) | Service Cupboard 2 | Pipe Work | Cement | Amosite / Chrysotile / Crocidolite | 2.00m2 | Low damage | Unsealed (Cement products) | 6 | 0 | 6 | LABEL & MONITOR | 02 Dec 2015 |

Asbestos Presumed

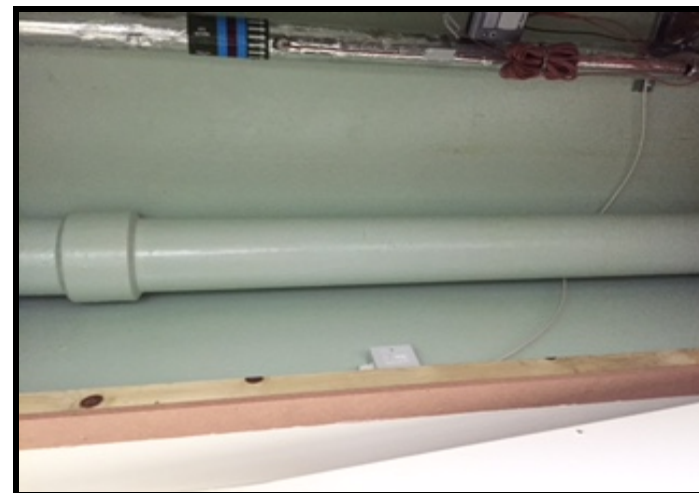
## SAMPLE REFERENCE 016

| Unique Sample No. | Building Reference (Floor) | Room Area | Description of Location | Product Description | Asbestos Type | Approx. Quantity | Material Condition | Surface Treatment | Material Risk Score | Priority Risk Score | Total Risk Score | Management Action | Next Review Date |
|---|---|---|---|---|---|---|---|---|---|---|---|---|---|
| 016 | Main Building (First Floor) | Bin Store | Pipe Work | Cement | Chrysotile | 2.00lm | Good condition | Sealed (Cement products) | 3 | 1 | 4 | LABEL & MONITOR | 02 Dec 2015 |

**Asbestos Presumed**

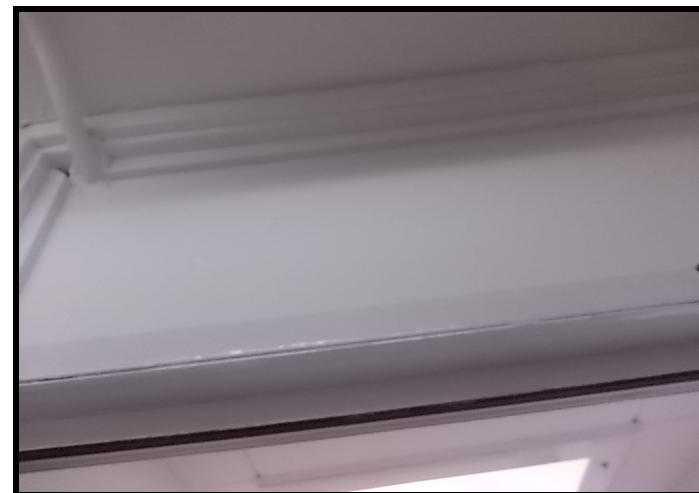
## SAMPLE REFERENCE 017

| Unique Sample No. | Building Reference (Floor) | Room Area | Description of Location | Product Description | Asbestos Type | Approx. Quantity | Material Condition | Surface Treatment | Material Risk Score | Priority Risk Score | Total Risk Score | Management Action | Next Review Date |
|---|---|---|---|---|---|---|---|---|---|---|---|---|---|
| 017 | Main Building (First Floor) | Bin Store | Transom Panel | Insulation Board | No Asbestos Detected | 1.00m2 | Good condition | Sealed Board (Encapsulated) | - | - | - | NO ACTION REQUIRED | |

Asbestos not detected in Sample

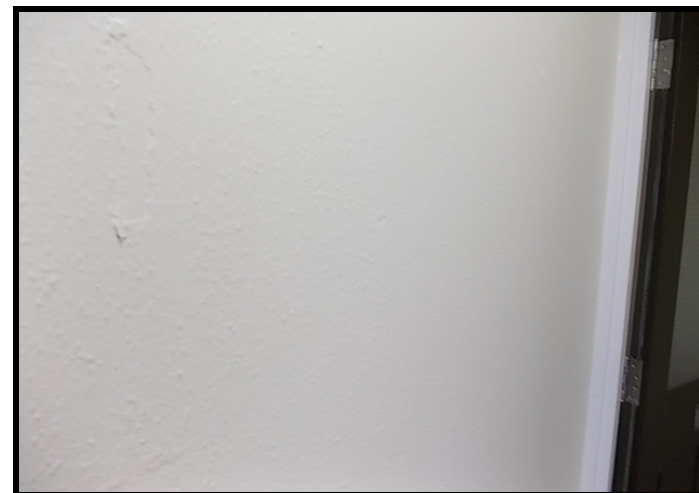
## SAMPLE REFERENCE 018

| Unique Sample No. | Building Reference (Floor) | Room Area | Description of Location | Product Description | Asbestos Type | Approx. Quantity | Material Condition | Surface Treatment | Material Risk Score | Priority Risk Score | Total Risk Score | Management Action | Next Review Date |
|---|---|---|---|---|---|---|---|---|---|---|---|---|---|
| 018 | Main Building (First Floor) | Bin Store | Wall | Textured Coating | No Asbestos Detected | 25.00m2 | Good condition | Textured Coating | - | - | - | NO ACTION REQUIRED | |

**No Asbestos Presumed in Sample**

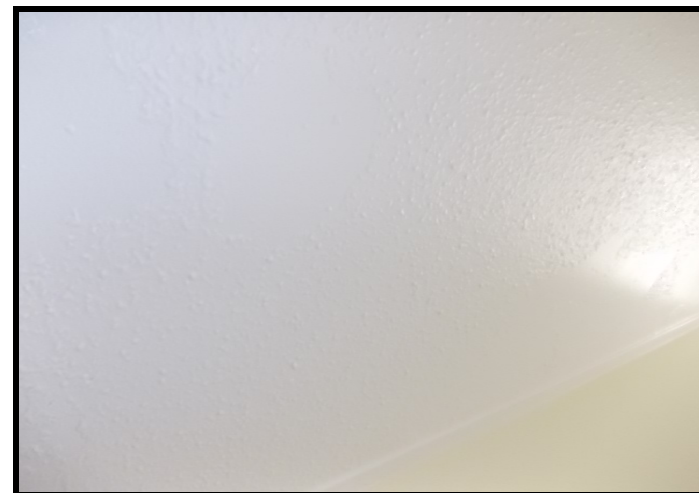
## SAMPLE REFERENCE 019

| Unique Sample No. | Building Reference (Floor) | Room Area | Description of Location | Product Description | Asbestos Type | Approx. Quantity | Material Condition | Surface Treatment | Material Risk Score | Priority Risk Score | Total Risk Score | Management Action | Next Review Date |
|---|---|---|---|---|---|---|---|---|---|---|---|---|---|
| 019 | Main Building (First Floor) | Stairwell | Ceiling | Textured Coating | No Asbestos Detected | 8.00m2 | Good condition | Textured Coating | - | - | - | NO ACTION REQUIRED | |

**No Asbestos Presumed in Sample**

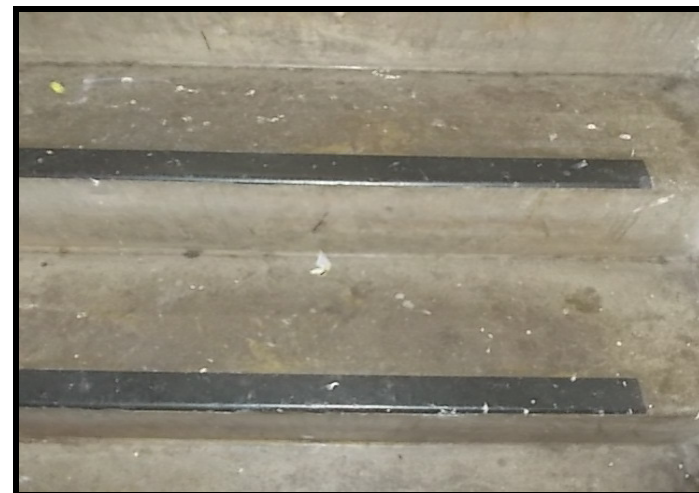
## SAMPLE REFERENCE 019a

| Unique Sample No. | Building Reference (Floor) | Room Area | Description of Location | Product Description | Asbestos Type | Approx. Quantity | Material Condition | Surface Treatment | Material Risk Score | Priority Risk Score | Total Risk Score | Management Action | Next Review Date |
|---|---|---|---|---|---|---|---|---|---|---|---|---|---|
| 019a | Main Building (First Floor) | Stairwell | Staircase | Resin | Chrysotile | 14.00small item(s) | Low damage | Composite materials | 2 | 1 | 3 | LABEL & MONITOR | 02 Dec 2015 |

**Asbestos detected in Sample**

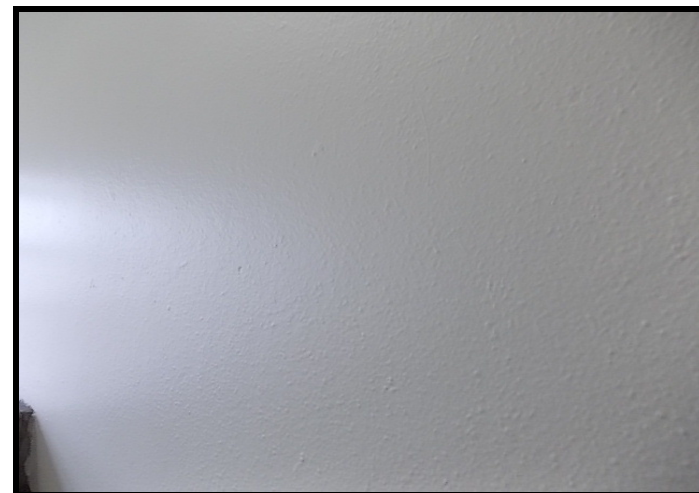
## SAMPLE REFERENCE 020

| Unique Sample No. | Building Reference (Floor) | Room Area | Description of Location | Product Description | Asbestos Type | Approx. Quantity | Material Condition | Surface Treatment | Material Risk Score | Priority Risk Score | Total Risk Score | Management Action | Next Review Date |
|---|---|---|---|---|---|---|---|---|---|---|---|---|---|
| 020 | Main Building (First Floor) | Stairwell | Ceiling | Textured Coating | No Asbestos Detected | 10.00m2 | Good condition | Textured Coating | - | - | - | NO ACTION REQUIRED | |

**No Asbestos Presumed in Sample**

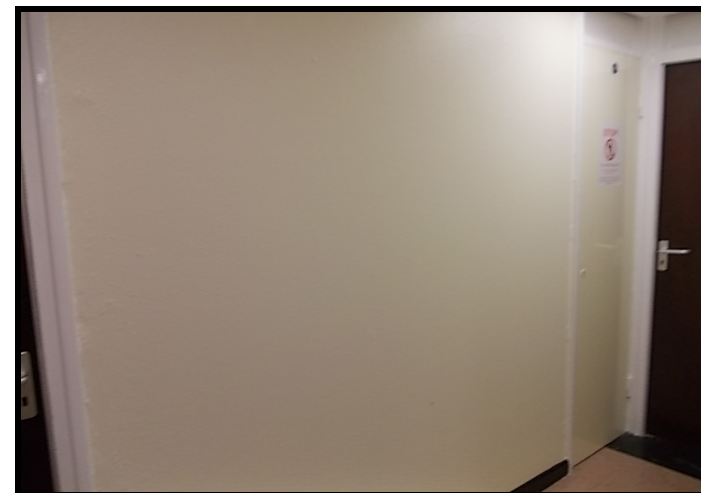
## SAMPLE REFERENCE 021

| Unique Sample No. | Building Reference (Floor) | Room Area | Description of Location | Product Description | Asbestos Type | Approx. Quantity | Material Condition | Surface Treatment | Material Risk Score | Priority Risk Score | Total Risk Score | Management Action | Next Review Date |
|---|---|---|---|---|---|---|---|---|---|---|---|---|---|
| 021 | Main Building (Second Floor) | Landing | Wall | Textured Coating | No Asbestos Detected | 10.00m2 | Good condition | Textured Coating | - | - | - | NO ACTION REQUIRED | |

**No Asbestos Presumed in Sample**

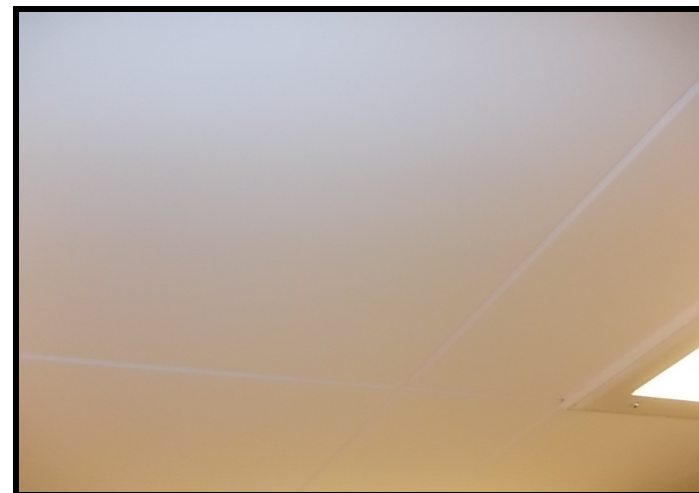
## SAMPLE REFERENCE 022

| Unique Sample No. | Building Reference (Floor) | Room Area | Description of Location | Product Description | Asbestos Type | Approx. Quantity | Material Condition | Surface Treatment | Material Risk Score | Priority Risk Score | Total Risk Score | Management Action | Next Review Date |
|---|---|---|---|---|---|---|---|---|---|---|---|---|---|
| 022 | Main Building (Second Floor) | Landing | Ceiling | Insulation Board | No Asbestos Detected | 10.00m2 | Good condition | Sealed Board (Encapsulated) | - | - | - | NO ACTION REQUIRED | |

**No Asbestos Presumed in Sample**

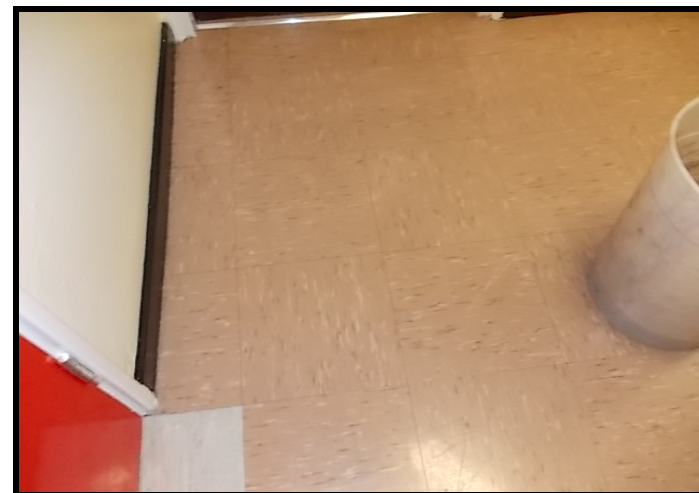
## SAMPLE REFERENCE 023

| Unique Sample No. | Building Reference (Floor) | Room Area | Description of Location | Product Description | Asbestos Type | Approx. Quantity | Material Condition | Surface Treatment | Material Risk Score | Priority Risk Score | Total Risk Score | Management Action | Next Review Date |
|---|---|---|---|---|---|---|---|---|---|---|---|---|---|
| 023 | Main Building (Second Floor) | Landing | Floor | Floor Tiles | No Asbestos Detected | 10.00m2 | Good condition | Composite materials | - | - | - | NO ACTION REQUIRED | |

Asbestos not detected in Sample

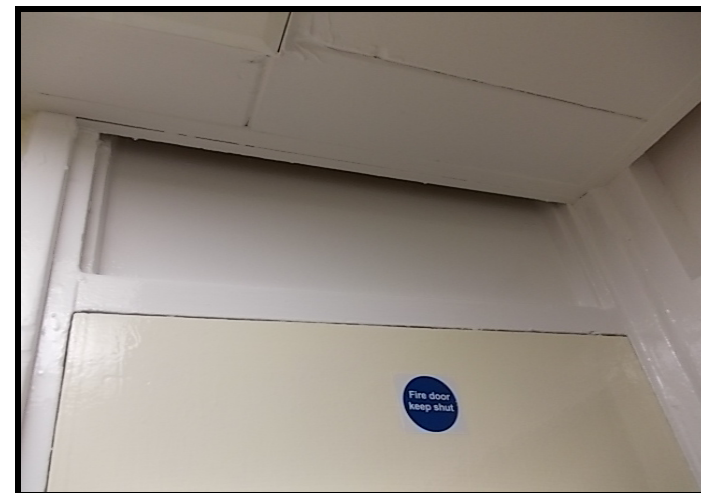
## SAMPLE REFERENCE 024

| Unique Sample No. | Building Reference (Floor) | Room Area | Description of Location | Product Description | Asbestos Type | Approx. Quantity | Material Condition | Surface Treatment | Material Risk Score | Priority Risk Score | Total Risk Score | Management Action | Next Review Date |
|---|---|---|---|---|---|---|---|---|---|---|---|---|---|
| 024 | Main Building (Second Floor) | Service Cupboard 1 | Transom Panel | Insulation Board | No Asbestos Detected | 1.00m2 | Good condition | Sealed Board (Encapsulated) | - | - | - | NO ACTION REQUIRED | |

**No Asbestos Presumed in Sample**

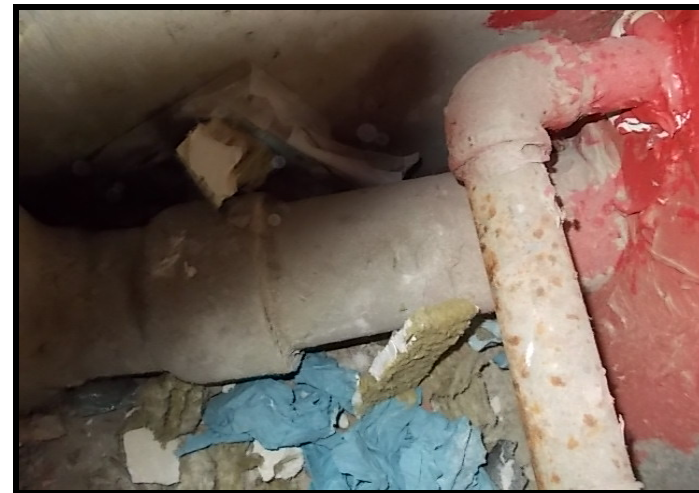
## SAMPLE REFERENCE 024a

| Unique Sample No. | Building Reference (Floor) | Room Area | Description of Location | Product Description | Asbestos Type | Approx. Quantity | Material Condition | Surface Treatment | Material Risk Score | Priority Risk Score | Total Risk Score | Management Action | Next Review Date |
|---|---|---|---|---|---|---|---|---|---|---|---|---|---|
| 024a | Main Building (Second Floor) | Service Cupboard 1 | Pipe Work | Cement | Amosite / Chrysotile / Crocidolite | 2.00m2 | Low damage | Unsealed (Cement products) | 6 | 0 | 6 | LABEL & MONITOR | 02 Dec 2015 |

Asbestos Presumed

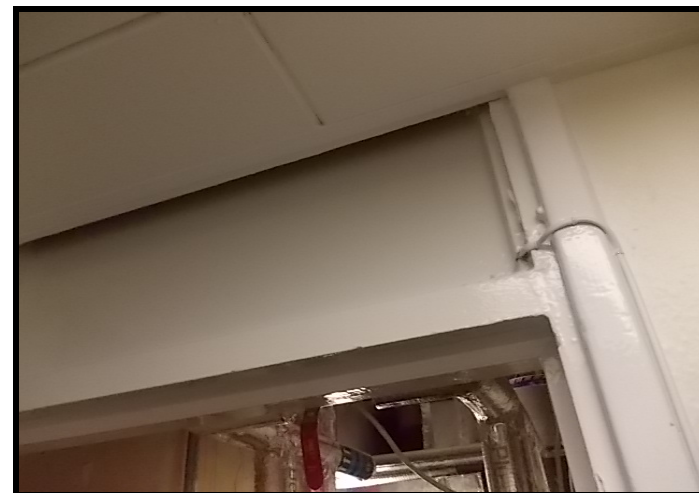
## SAMPLE REFERENCE 025

| Unique Sample No. | Building Reference (Floor) | Room Area | Description of Location | Product Description | Asbestos Type | Approx. Quantity | Material Condition | Surface Treatment | Material Risk Score | Priority Risk Score | Total Risk Score | Management Action | Next Review Date |
|---|---|---|---|---|---|---|---|---|---|---|---|---|---|
| 025 | Main Building (Second Floor) | Service Cupboard 2 | Transom Panel | Insulation Board | No Asbestos Detected | 1.00m2 | Good condition | Sealed Board (Encapsulated) | - | - | - | NO ACTION REQUIRED | |

**No Asbestos Presumed in Sample**

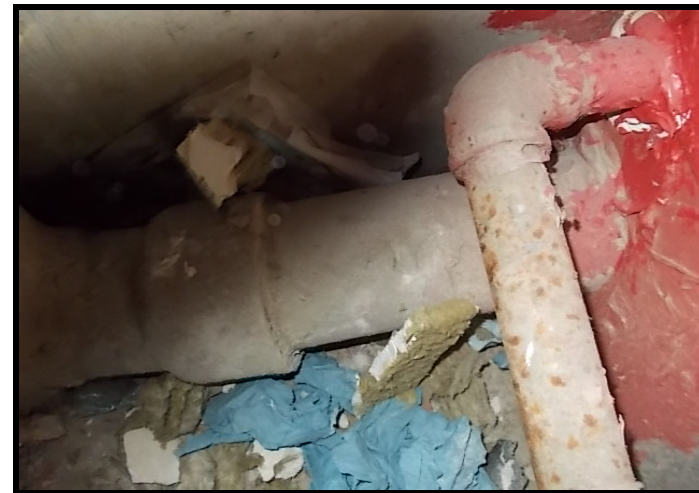
## SAMPLE REFERENCE 025a

| Unique Sample No. | Building Reference (Floor) | Room Area | Description of Location | Product Description | Asbestos Type | Approx. Quantity | Material Condition | Surface Treatment | Material Risk Score | Priority Risk Score | Total Risk Score | Management Action | Next Review Date |
|---|---|---|---|---|---|---|---|---|---|---|---|---|---|
| 025a | Main Building (Second Floor) | Service Cupboard 2 | Pipe Work | Cement | Amosite / Chrysotile / Crocidolite | 2.00m2 | Low damage | Unsealed (Cement products) | 6 | 0 | 6 | LABEL & MONITOR | 02 Dec 2015 |

Asbestos Presumed

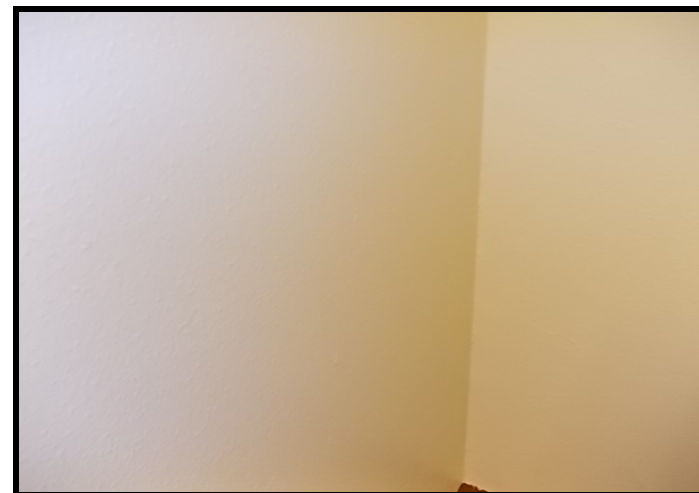
## SAMPLE REFERENCE 027

| Unique Sample No. | Building Reference (Floor) | Room Area | Description of Location | Product Description | Asbestos Type | Approx. Quantity | Material Condition | Surface Treatment | Material Risk Score | Priority Risk Score | Total Risk Score | Management Action | Next Review Date |
|---|---|---|---|---|---|---|---|---|---|---|---|---|---|
| 027 | Main Building (Second Floor) | Bin Store | Wall | Textured Coating | No Asbestos Detected | 5.00m2 | Good condition | Textured Coating | - | - | - | NO ACTION REQUIRED | |

**No Asbestos Presumed in Sample**

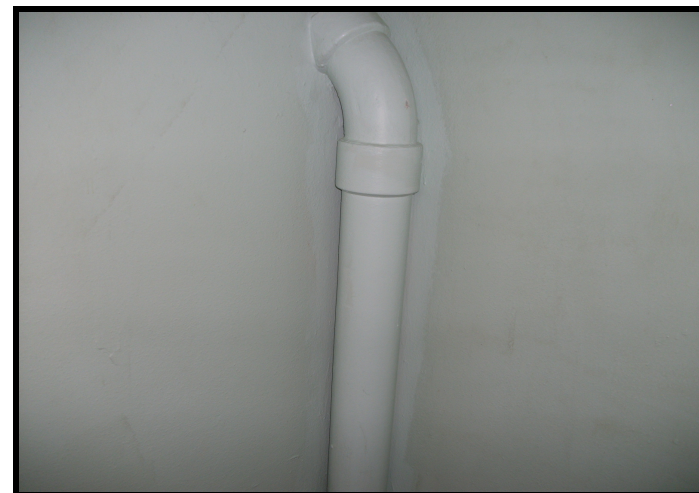
## SAMPLE REFERENCE 028

| Unique Sample No. | Building Reference (Floor) | Room Area | Description of Location | Product Description | Asbestos Type | Approx. Quantity | Material Condition | Surface Treatment | Material Risk Score | Priority Risk Score | Total Risk Score | Management Action | Next Review Date |
|---|---|---|---|---|---|---|---|---|---|---|---|---|---|
| 028 | Main Building (Second Floor) | Bin Store | Pipe Work | Cement | Chrysotile | 2.00lm | Good condition | Sealed (Cement products) | 3 | 1 | 4 | LABEL & MONITOR | 02 Dec 2015 |

**Asbestos Presumed**

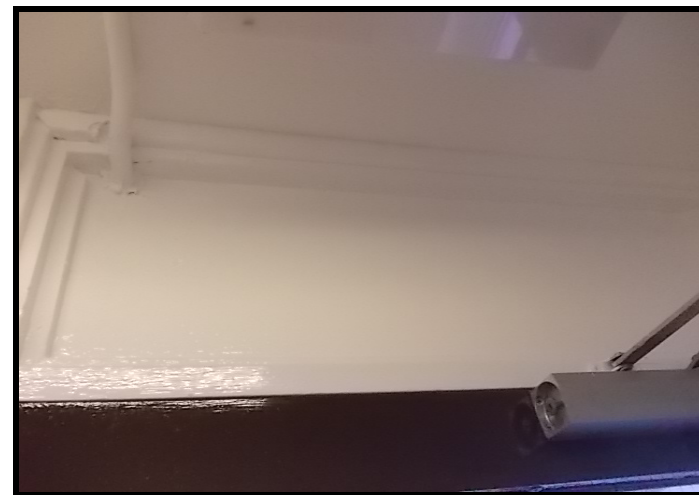
## SAMPLE REFERENCE 029

| Unique Sample No. | Building Reference (Floor) | Room Area | Description of Location | Product Description | Asbestos Type | Approx. Quantity | Material Condition | Surface Treatment | Material Risk Score | Priority Risk Score | Total Risk Score | Management Action | Next Review Date |
|---|---|---|---|---|---|---|---|---|---|---|---|---|---|
| 029 | Main Building (Second Floor) | Bin Store | Transom Panel | Insulation Board | No Asbestos Detected | 1.00m2 | Good condition | Sealed Board (Encapsulated) | - | - | - | NO ACTION REQUIRED | |

**No Asbestos Presumed in Sample**

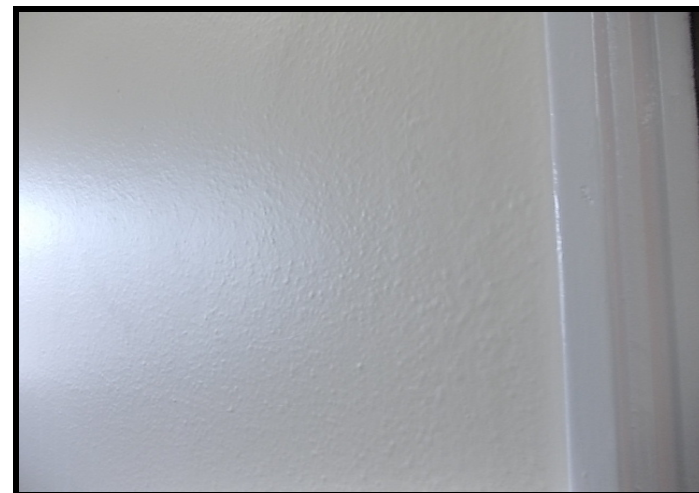
## SAMPLE REFERENCE 030

| Unique Sample No. | Building Reference (Floor) | Room Area | Description of Location | Product Description | Asbestos Type | Approx. Quantity | Material Condition | Surface Treatment | Material Risk Score | Priority Risk Score | Total Risk Score | Management Action | Next Review Date |
|---|---|---|---|---|---|---|---|---|---|---|---|---|---|
| 030 | Main Building (Second Floor) | Stairwell | Wall | Textured Coating | No Asbestos Detected | 10.00m2 | Good condition | Textured Coating | - | - | - | NO ACTION REQUIRED | |

**No Asbestos Presumed in Sample**

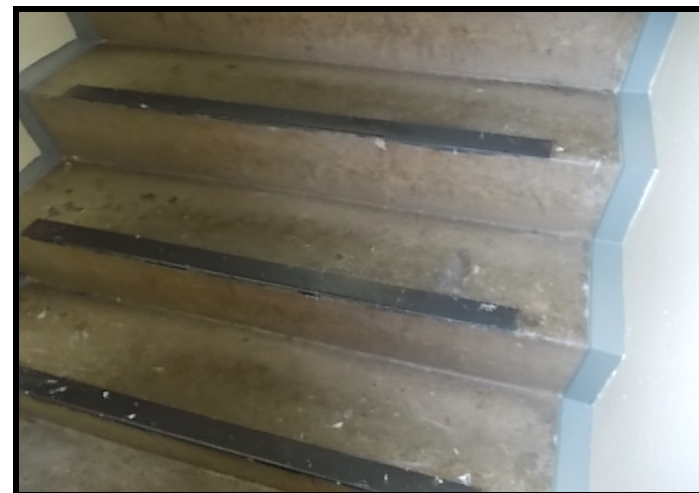
## SAMPLE REFERENCE 030a

| Unique Sample No. | Building Reference (Floor) | Room Area | Description of Location | Product Description | Asbestos Type | Approx. Quantity | Material Condition | Surface Treatment | Material Risk Score | Priority Risk Score | Total Risk Score | Management Action | Next Review Date |
|---|---|---|---|---|---|---|---|---|---|---|---|---|---|
| 030a | Main Building (Second Floor) | Stairwell | Staircase | Resin | Chrysotile | 14.00small item(s) | Low damage | Composite materials | 2 | 1 | 3 | LABEL & MONITOR | 02 Dec 2015 |

**Asbestos Presumed**

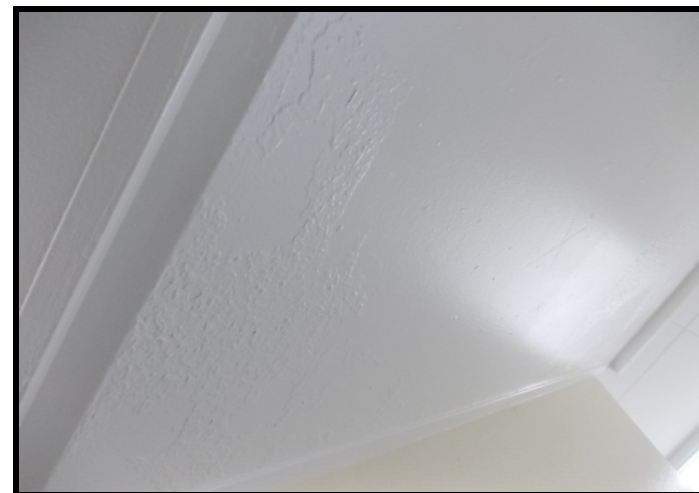
## SAMPLE REFERENCE 03 I

| Unique Sample No. | Building Reference (Floor) | Room Area | Description of Location | Product Description | Asbestos Type | Approx. Quantity | Material Condition | Surface Treatment | Material Risk Score | Priority Risk Score | Total Risk Score | Management Action | Next Review Date |
|---|---|---|---|---|---|---|---|---|---|---|---|---|---|
| 031 | Main Building (Second Floor) | Stairwell | Ceiling | Textured Coating | No Asbestos Detected | 8.00m2 | Good condition | Textured Coating | - | - | - | NO ACTION REQUIRED | |

**No Asbestos Presumed in Sample**

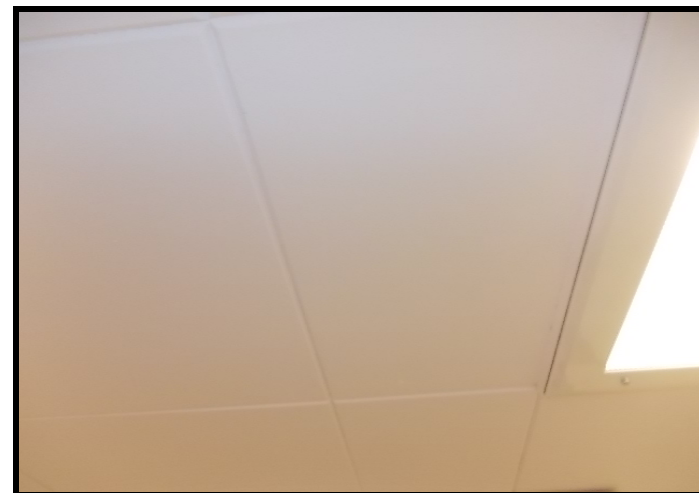
## SAMPLE REFERENCE 032

| Unique Sample No. | Building Reference (Floor) | Room Area | Description of Location | Product Description | Asbestos Type | Approx. Quantity | Material Condition | Surface Treatment | Material Risk Score | Priority Risk Score | Total Risk Score | Management Action | Next Review Date |
|---|---|---|---|---|---|---|---|---|---|---|---|---|---|
| 032 | Main Building (Third Floor) | Landing | Ceiling | Insulation Board | No Asbestos Detected | 10.00m2 | Good condition | Sealed Board (Encapsulated) | - | - | - | NO ACTION REQUIRED | |

**No Asbestos Presumed in Sample**

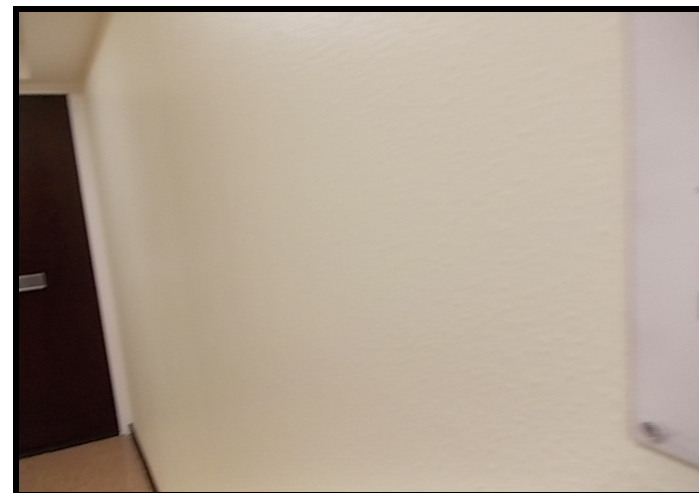
## SAMPLE REFERENCE 033

**No Asbestos Presumed in Sample**

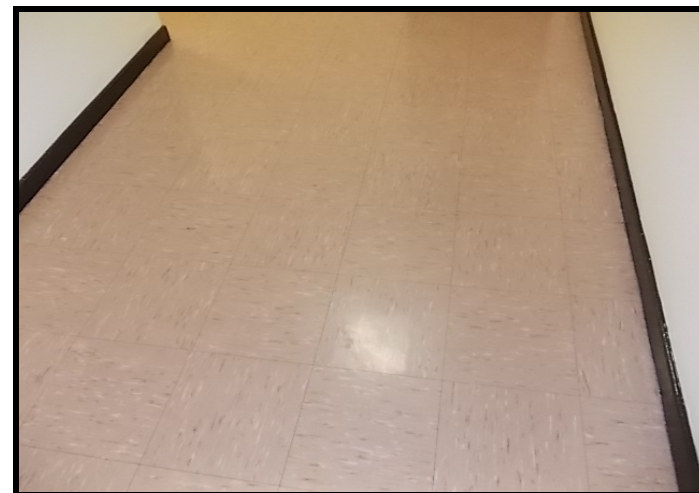
## SAMPLE REFERENCE 034

**No Asbestos Presumed in Sample**

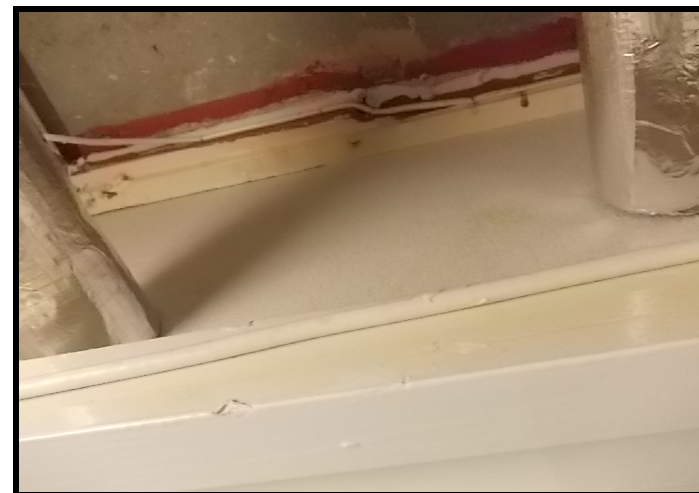
## SAMPLE REFERENCE 035

**No Asbestos Presumed in Sample**

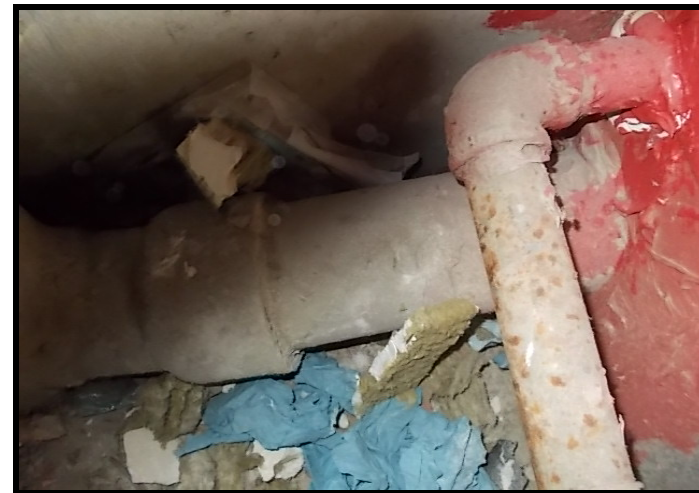
## SAMPLE REFERENCE 035a

Asbestos Presumed

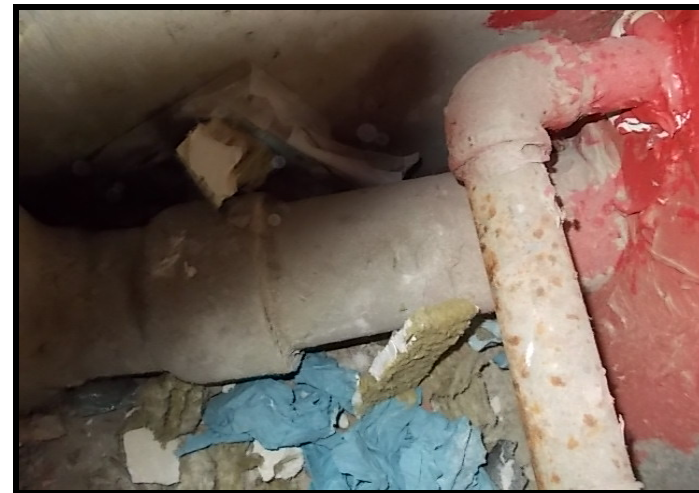
## SAMPLE REFERENCE 036a

Asbestos Presumed

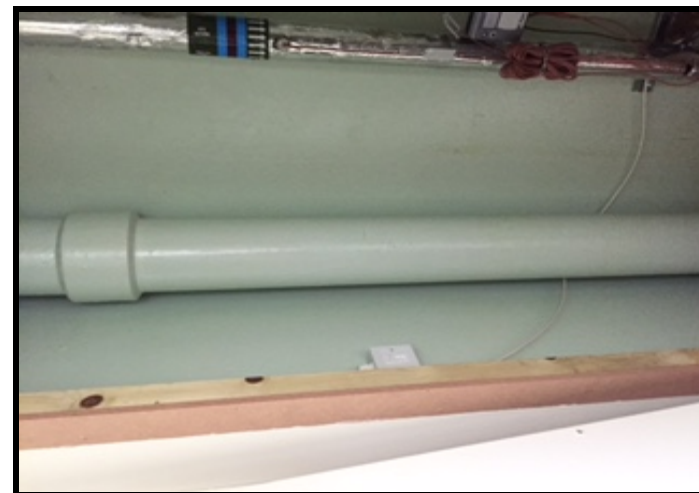
## SAMPLE REFERENCE 039

**Asbestos Presumed**

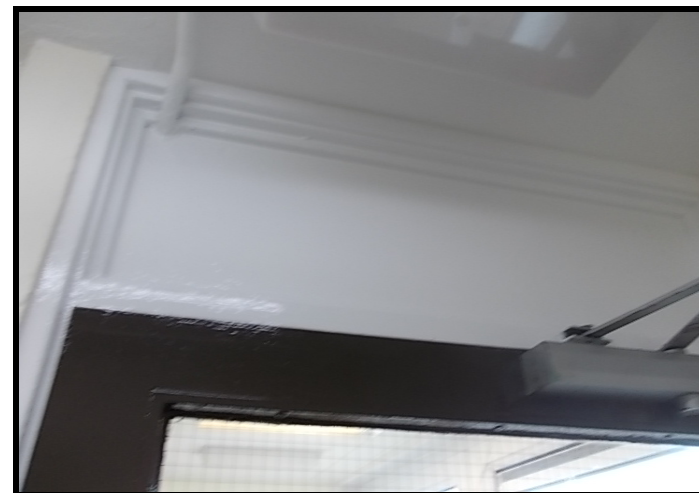
## SAMPLE REFERENCE 040

**No Asbestos Presumed in Sample**

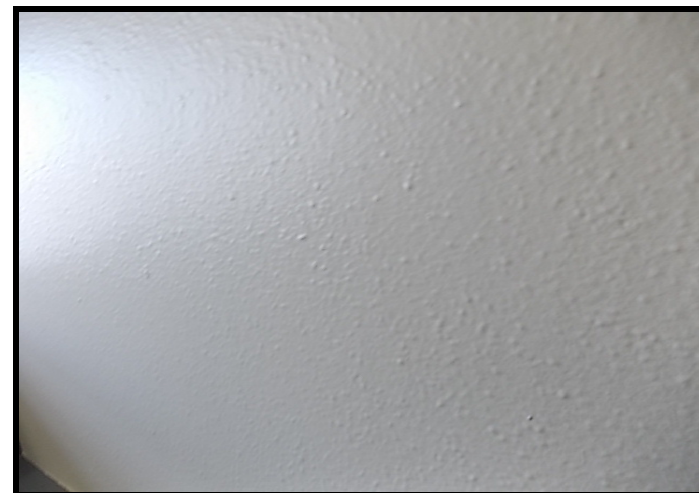
## SAMPLE REFERENCE 041

**No Asbestos Presumed in Sample**

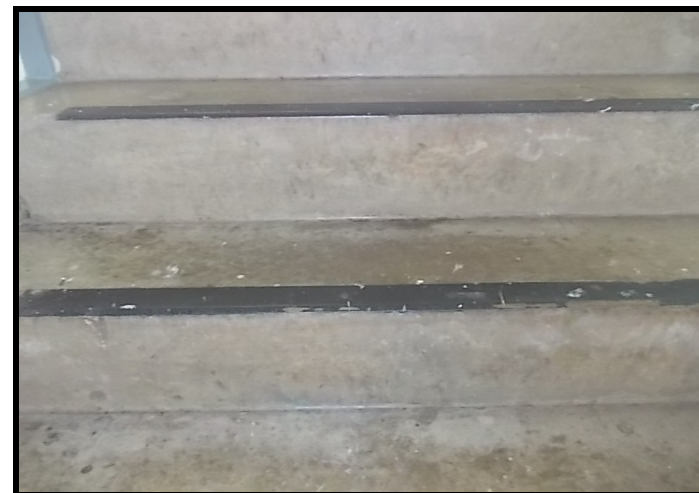
## SAMPLE REFERENCE 041a

**Asbestos Presumed**

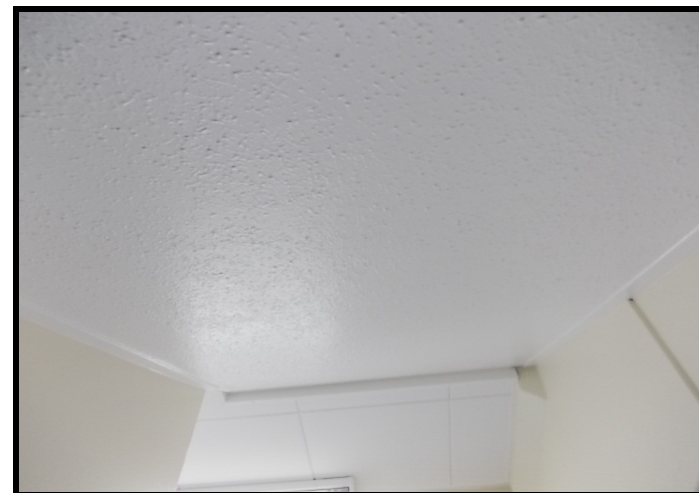
## SAMPLE REFERENCE 042

**No Asbestos Presumed in Sample**

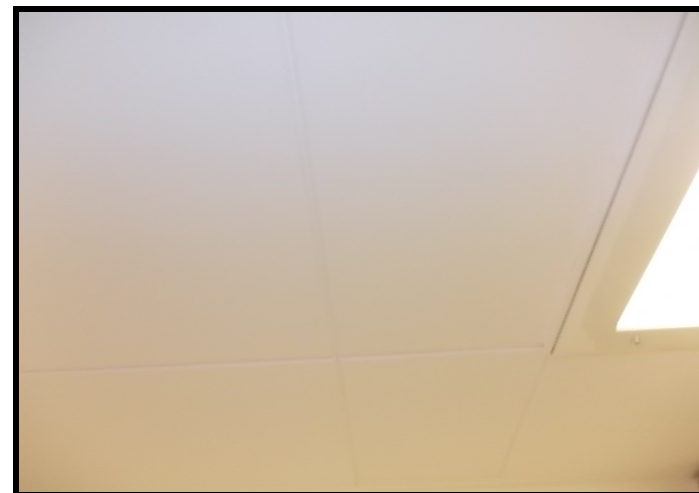
## SAMPLE REFERENCE 043

**No Asbestos Presumed in Sample**

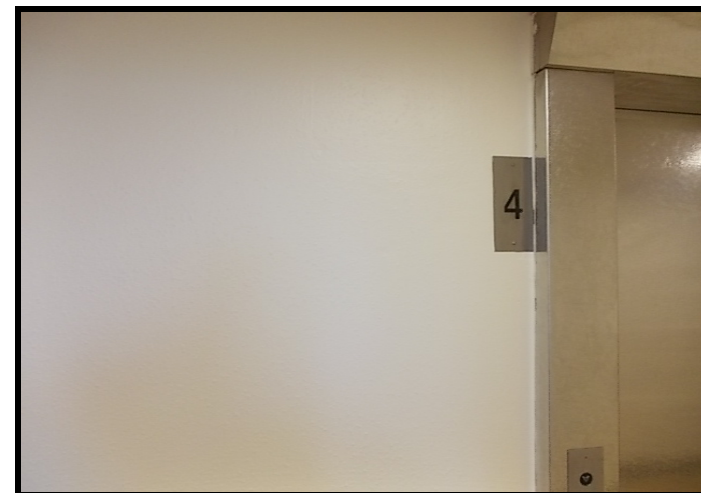
## SAMPLE REFERENCE 044

**No Asbestos Presumed in Sample**

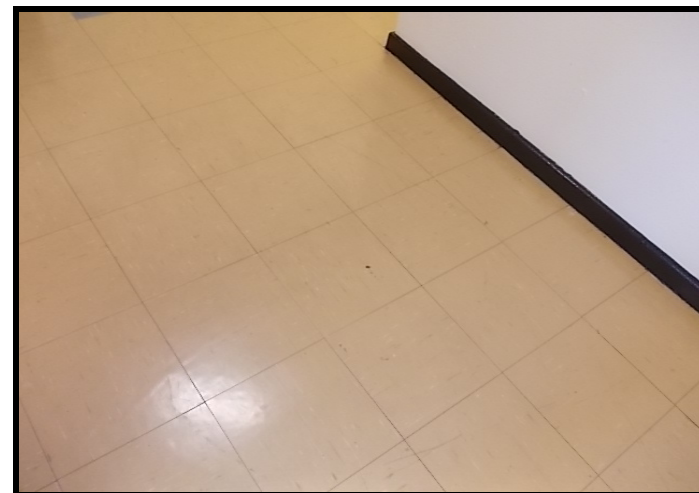
## SAMPLE REFERENCE 045

**No Asbestos Presumed in Sample**

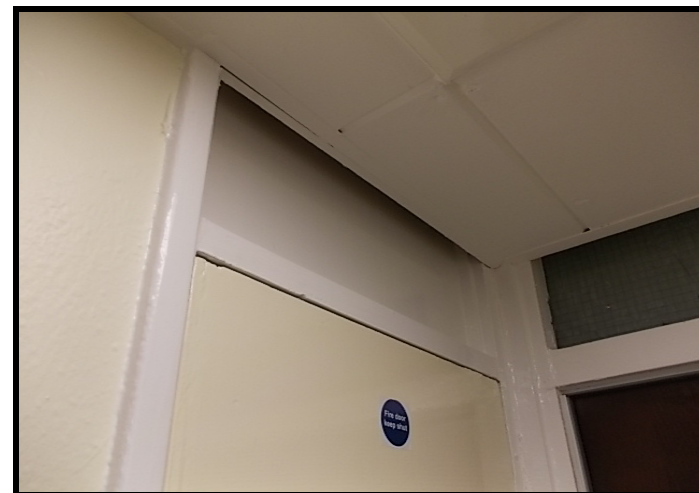
## SAMPLE REFERENCE 046

**No Asbestos Presumed in Sample**

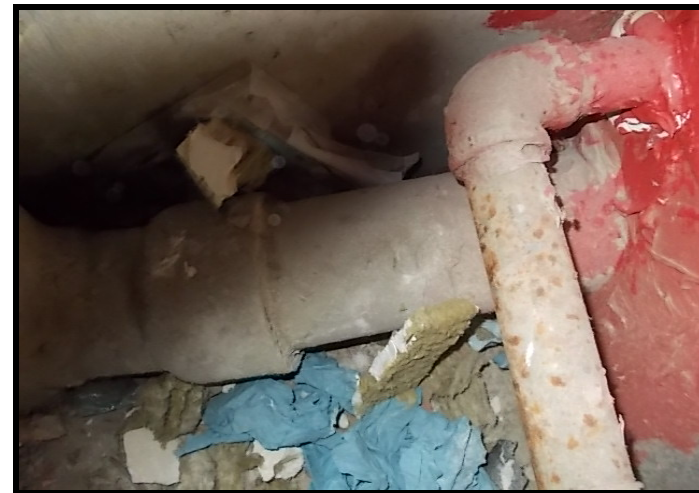
## SAMPLE REFERENCE 046a

Asbestos Presumed

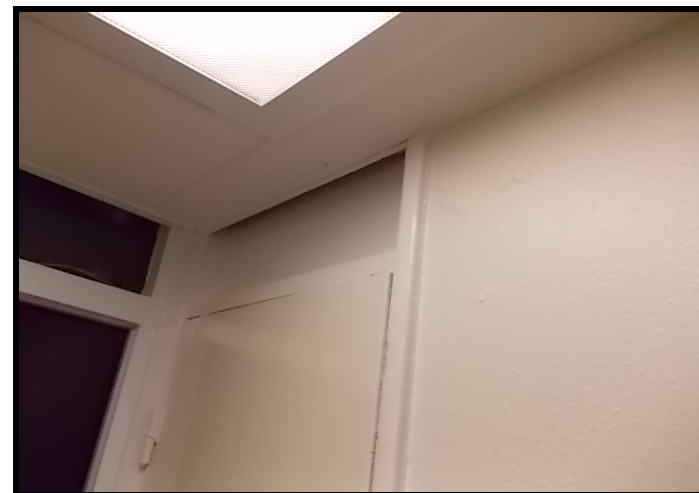
## SAMPLE REFERENCE 047

**No Asbestos Presumed in Sample**

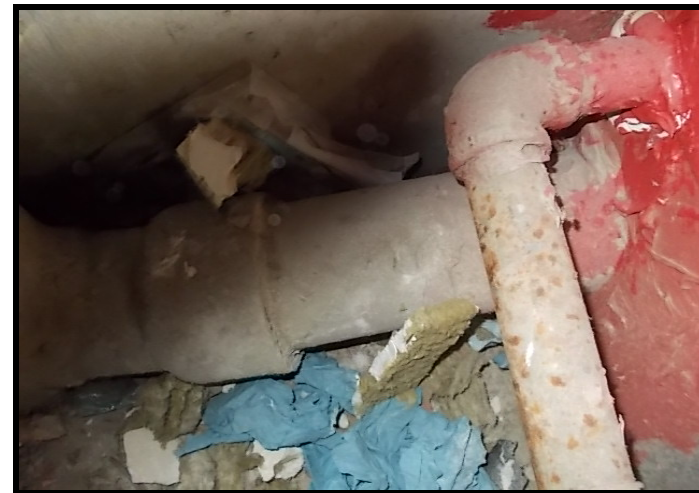
## SAMPLE REFERENCE 047a

Asbestos Presumed
