# **Solihull Community Housing**

## **Asbestos Management Survey Report**

**Mansfield House I-45 (Communal)  
Woodlands Way  
Solihull  
B37 6RT**

**Date of Report: 25 Feb 2015**

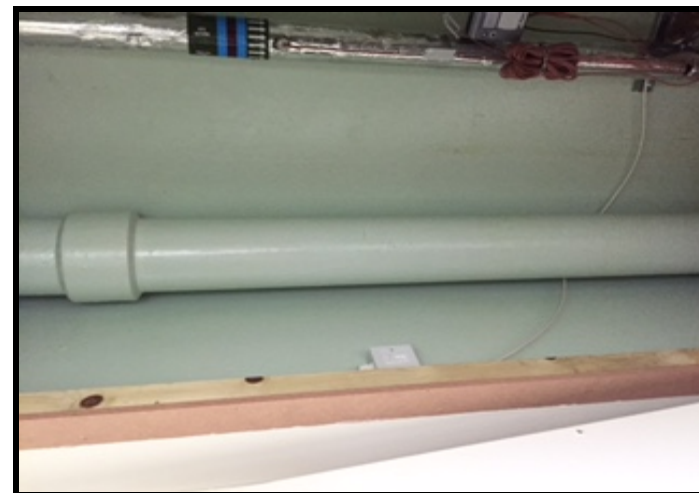
## SAMPLE REFERENCE 049

**Asbestos Presumed**

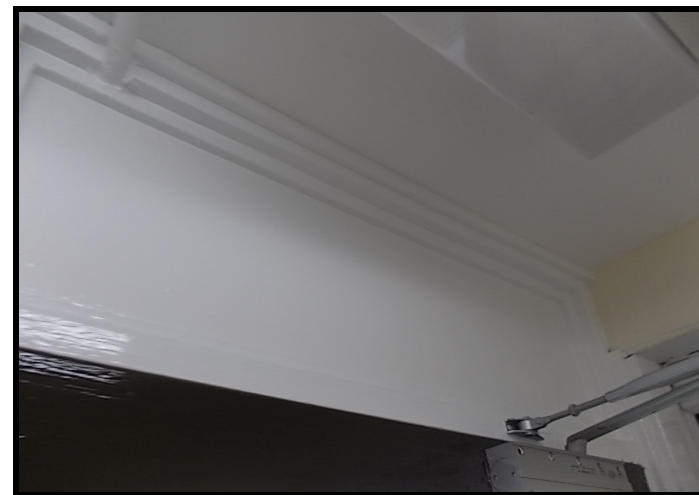
## SAMPLE REFERENCE 050

**No Asbestos Presumed in Sample**

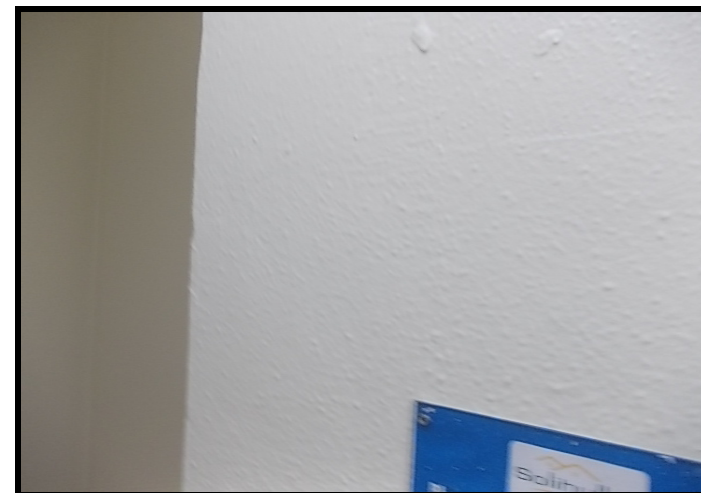
## SAMPLE REFERENCE 051

**No Asbestos Presumed in Sample**

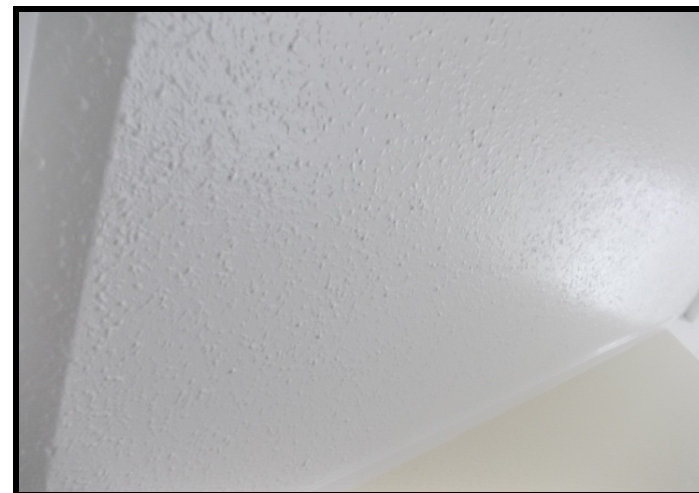
## SAMPLE REFERENCE 052

**No Asbestos Presumed in Sample**

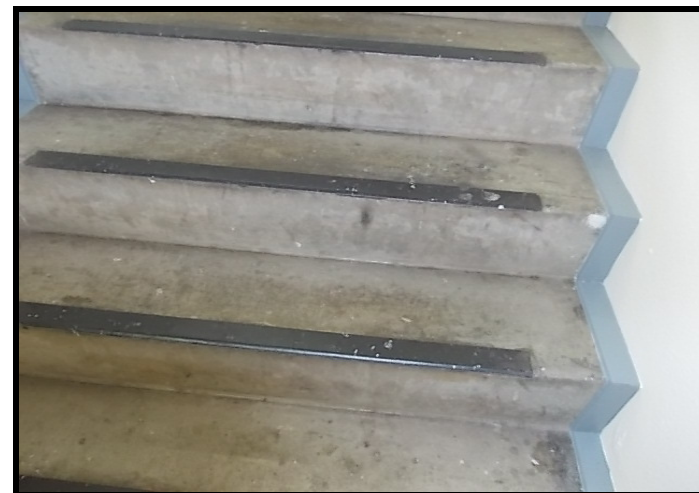
## SAMPLE REFERENCE 052a

Asbestos Presumed

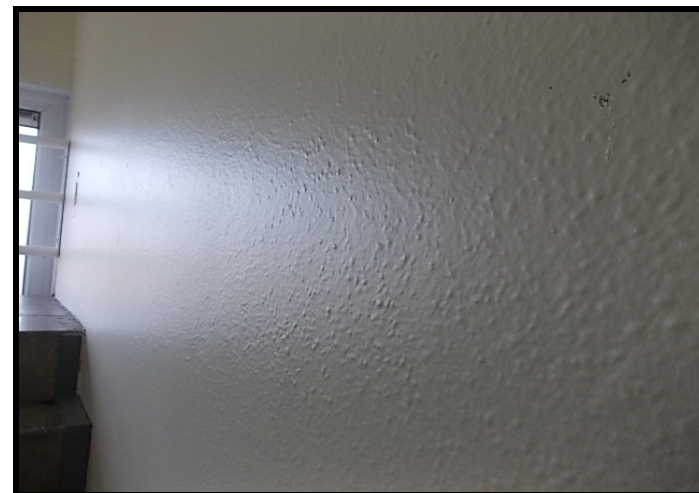
## SAMPLE REFERENCE 053

**No Asbestos Presumed in Sample**

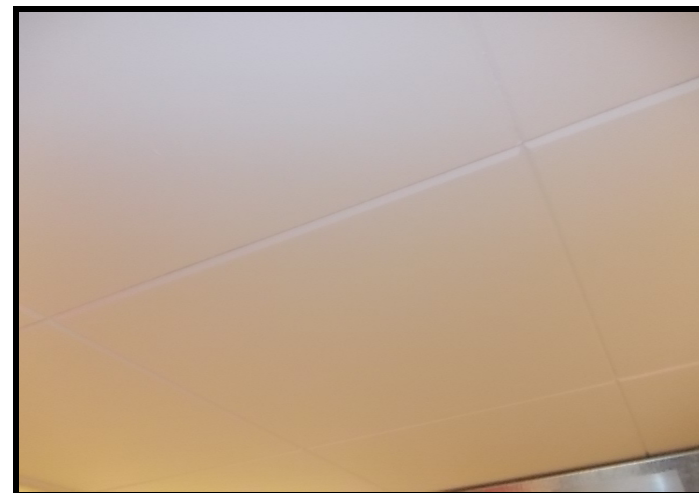
## SAMPLE REFERENCE 054

**No Asbestos Presumed in Sample**

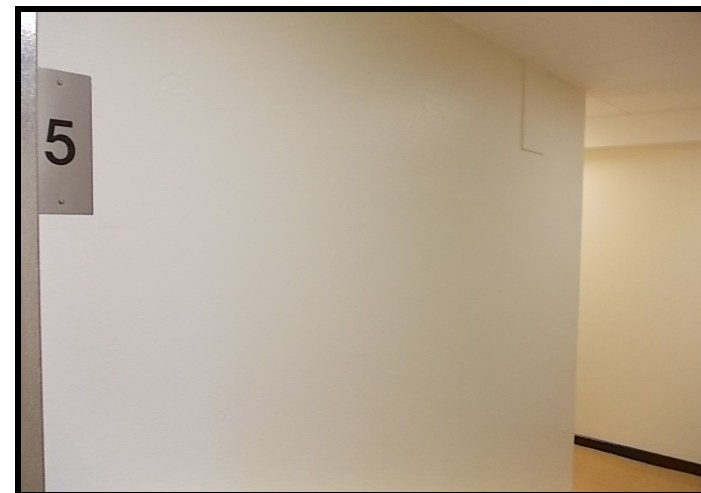
## SAMPLE REFERENCE 055

**No Asbestos Presumed in Sample**

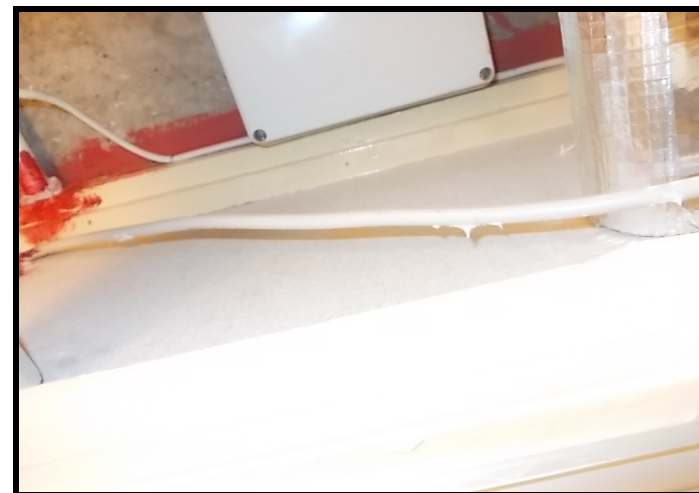
## SAMPLE REFERENCE 057

**No Asbestos Presumed in Sample**

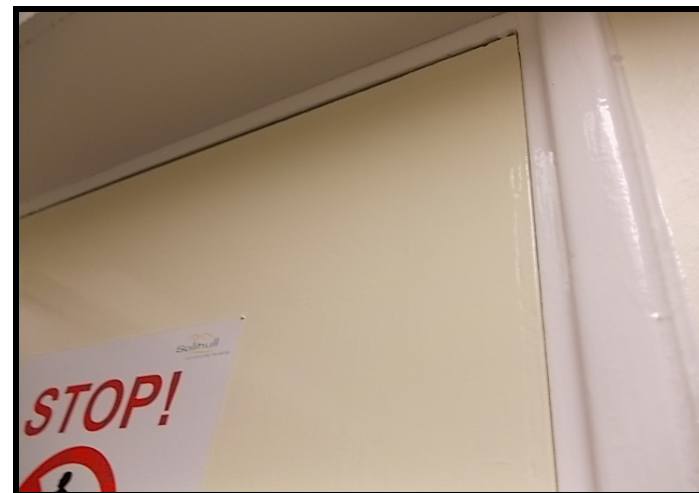
## SAMPLE REFERENCE 058

**No Asbestos Presumed in Sample**

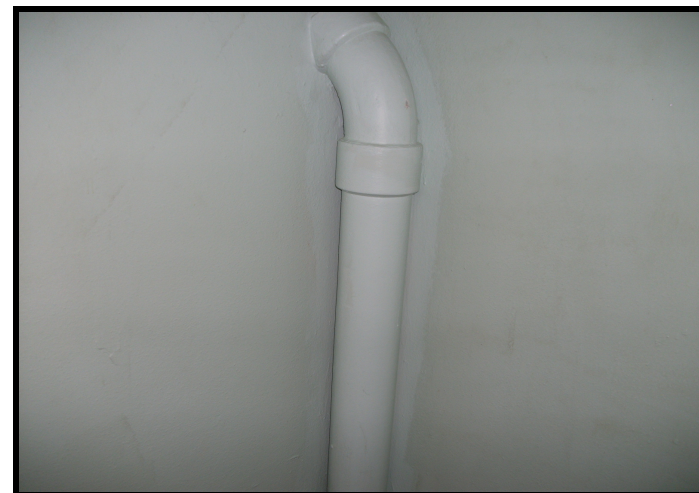
## SAMPLE REFERENCE 060

Asbestos Presumed

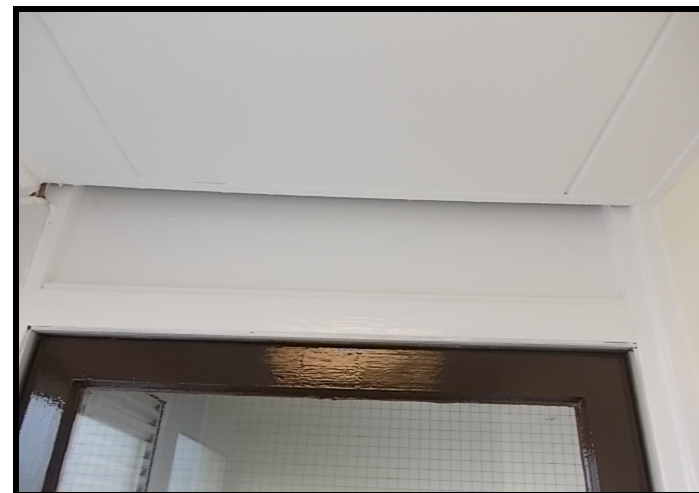
## SAMPLE REFERENCE 061

**No Asbestos Presumed in Sample**

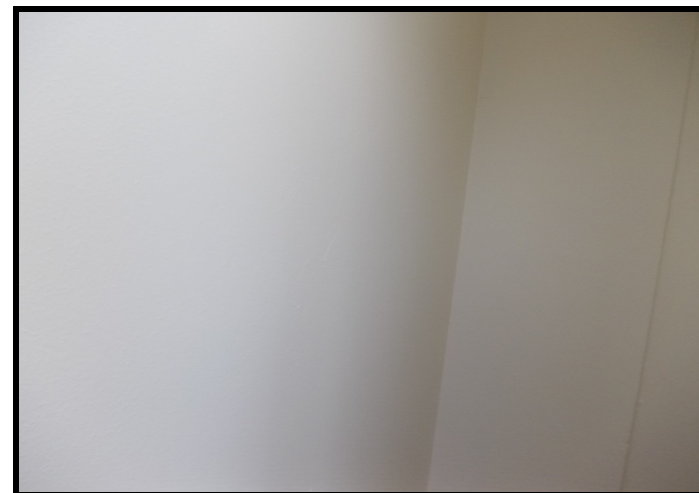
## SAMPLE REFERENCE 062

**No Asbestos Presumed in Sample**

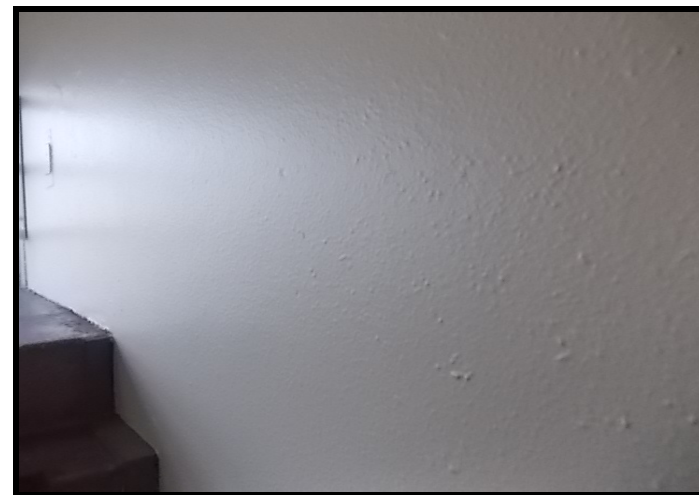
## SAMPLE REFERENCE 075

**No Asbestos Presumed in Sample**

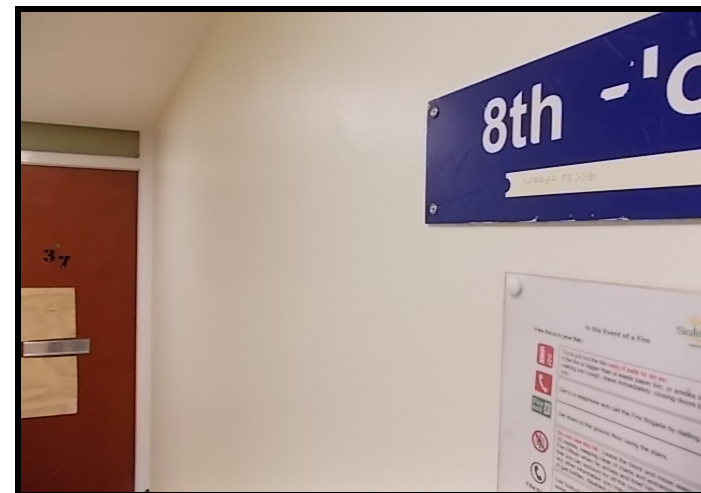
## SAMPLE REFERENCE 088

**No Asbestos Presumed in Sample**

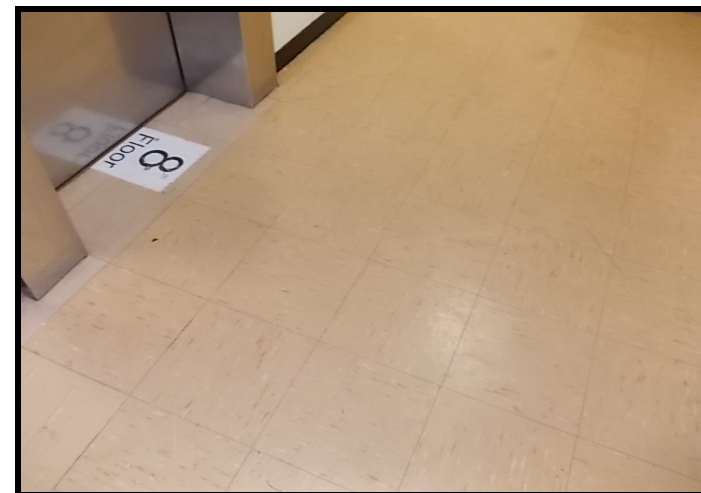
## SAMPLE REFERENCE 089

**No Asbestos Presumed in Sample**

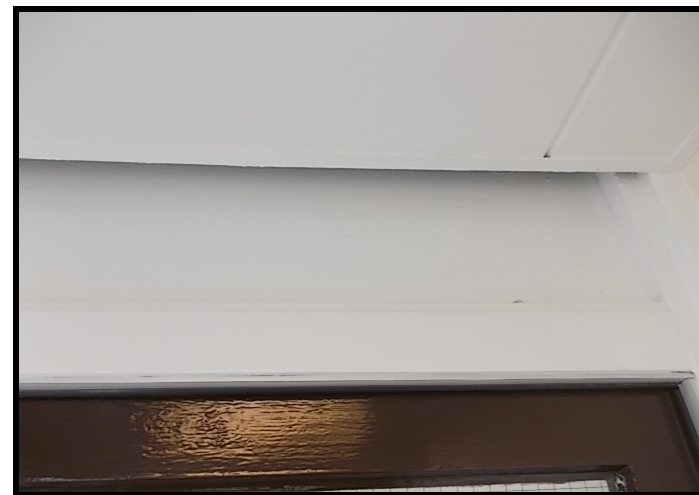
## SAMPLE REFERENCE 094

**No Asbestos Presumed in Sample**

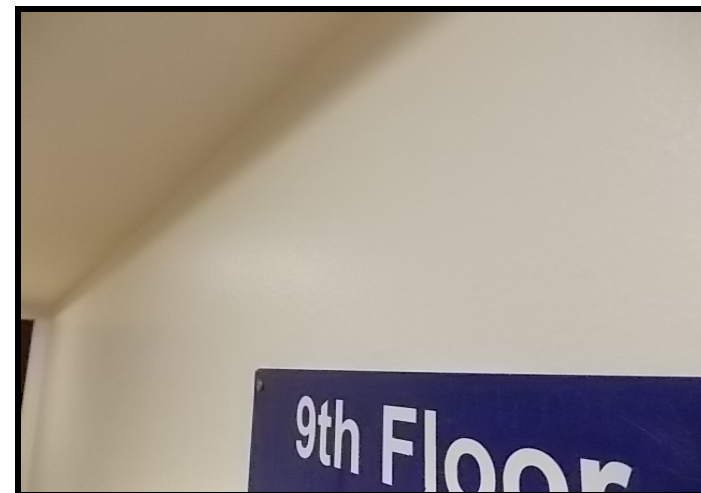
## SAMPLE REFERENCE 099

**No Asbestos Presumed in Sample**
