Solihull Community Housing

Asbestos Management Survey Report

Merton House I-43 (Communal)
Crabtree Drive
Solihull
B37 5BX

Date of Report: 25 Feb 2015

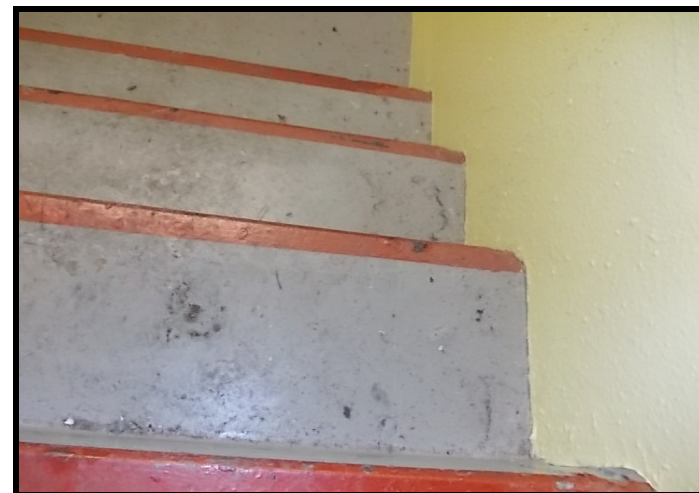
SAMPLE REFERENCE 003a

Building	Floor	Room	Location
Main Building	Roof - 10th Floor	Stairwell	Floor
Description			
MATERIAL ASSESSMENT			
Product Type	Bitumen	Extent of Damage	Low damage
Asbestos Type	Chrysotile	Surface Treatment	Composite materials
PRIORITY ASSESSMENT			
Occupant Activity	Not Applicable	Extent / Amount	14.00 small item(s)
Accessibility	Routinely disturbed	Location	Not Applicable
Avg Time in Use	Not Applicable	Frequency of Use	Not Applicable
No. of Occupants	Not Applicable	Secondary Activity	Not Applicable
Maintenance	Not Applicable	Maintenance Frequency	Not Applicable
MANAGEMENT ACTION			
Recommendation	LABEL & MONITOR		
Recommendation Due		Next Inspection	11 Dec 2015
Apply Labels	No	Permit to Work Required	No
Survey Type	Management	Lead Surveyor	Gavin Hooper
Survey Date	11 Dec 2014	UKAS Laboratory	DMW Environmental Safety Ltd / [A-9279]
Site Reference	113030000A	Licensed Material	No
		Notifiable Non Licensed Work	No

Asbestos detected in Sample

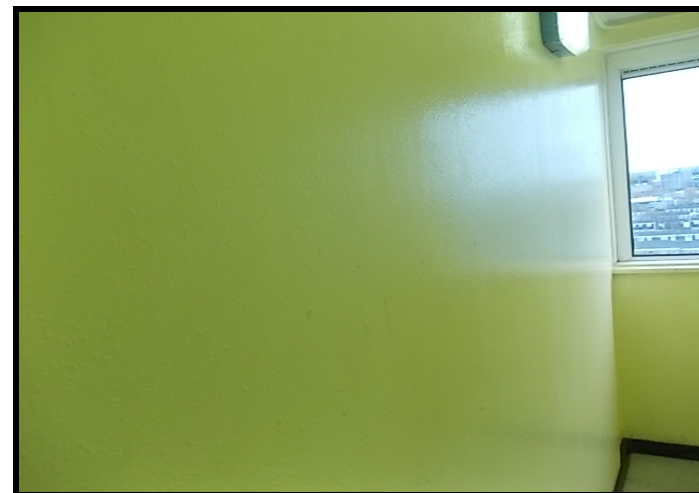
SAMPLE REFERENCE 004

Building	Floor	Room	Location		
Main Building	10th Floor	Lobby 1	Wall		
Description					
MATERIAL ASSESSMENT					SCORE
Product Type	Textured Coating	Extent of Damage	Low damage		-
Asbestos Type	No Asbestos Detected	Surface Treatment	Textured Coating		
PRIORITY ASSESSMENT					SCORE
Occupant Activity	Not Applicable	Extent / Amount	10.00 m2		-
Accessibility	Occasionally disturb	Location	Not Applicable		
Avg Time in Use	Not Applicable	Frequency of Use	Not Applicable		
No. of Occupants	Not Applicable	Secondary Activity	Not Applicable		
Maintenance	Not Applicable	Maintenance Frequency	Not Applicable		
MANAGEMENT ACTION					SCORE
Recommendation	NO ACTION REQUIRED				-
Recommendation Due		Next Inspection	None		
Apply Labels	No	Permit to Work Required	No		
Survey Type	Management	Lead Surveyor	Gavin Hooper		
Survey Date	11 Dec 2014	UKAS Laboratory	NOT SAMPLED (Cross Referenced)		
Site Reference	113030000A	Licensed Material	N/A	Notifiable Non Licensed Work	N/A

No Asbestos Presumed in Sample

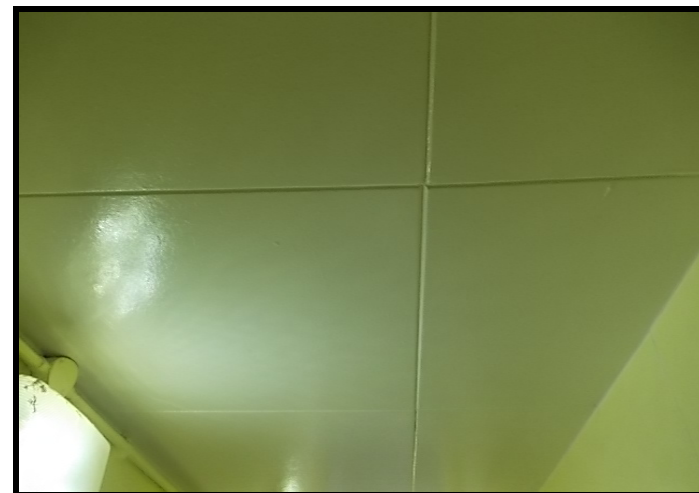
SAMPLE REFERENCE 005

Building	Floor	Room	Location
Main Building	10th Floor	Lobby 1	Ceiling
Description			
MATERIAL ASSESSMENT			
Product Type	Insulation Board	Extent of Damage	Low damage
Asbestos Type	No Asbestos Detected	Surface Treatment	Sealed Board (Encapsulated)
PRIORITY ASSESSMENT			
Occupant Activity	Not Applicable	Extent / Amount	10.00 m2
Accessibility	Easily disturbed	Location	Not Applicable
Avg Time in Use	Not Applicable	Frequency of Use	Not Applicable
No. of Occupants	Not Applicable	Secondary Activity	Not Applicable
Maintenance	Not Applicable	Maintenance Frequency	Not Applicable
MANAGEMENT ACTION			
Recommendation	NO ACTION REQUIRED		
Recommendation Due		Next Inspection	None
Apply Labels	No	Permit to Work Required	No
Survey Type	Management	Lead Surveyor	Gavin Hooper
Survey Date	11 Dec 2014	UKAS Laboratory	DMW Environmental Safety Ltd / [A-9279]
Site Reference	113030000A	Licensed Material	N/A
		Notifiable Non Licensed Work	N/A

Asbestos not detected in Sample

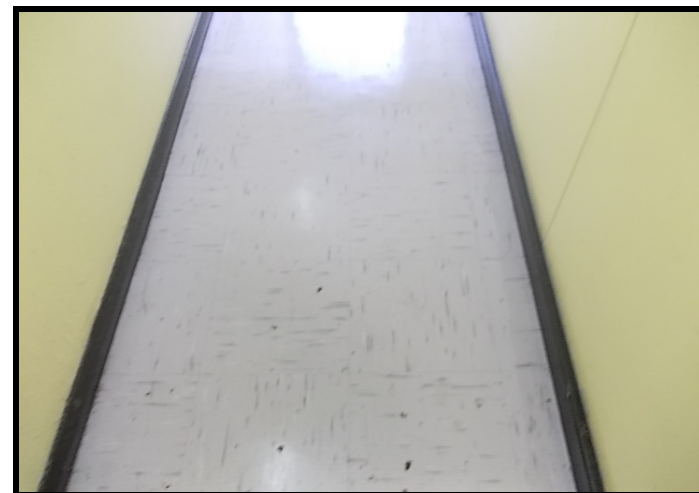
SAMPLE REFERENCE 005a

Building	Floor	Room	Location		
Main Building	10th Floor	Lobby 1	Floor		
Description					
MATERIAL ASSESSMENT					
Product Type	Floor Tiles	Extent of Damage	Low damage		
Asbestos Type	Chrysotile	Surface Treatment	Composite materials		
PRIORITY ASSESSMENT					
Occupant Activity	Not Applicable	Extent / Amount	6.00 m2		
Accessibility	Routinely disturbed	Location	Not Applicable		
Avg Time in Use	Not Applicable	Frequency of Use	Not Applicable		
No. of Occupants	Not Applicable	Secondary Activity	Not Applicable		
Maintenance	Not Applicable	Maintenance Frequency	Not Applicable		
MANAGEMENT ACTION					
Recommendation	LABEL & MONITOR				
Recommendation Due		Next Inspection	11 Dec 2015		
Apply Labels	No	Permit to Work Required	No		
Survey Type	Management	Lead Surveyor	Gavin Hooper		
Survey Date	11 Dec 2014	UKAS Laboratory	NOT SAMPLED (Cross Referenced)		
Site Reference	113030000A	Licensed Material	No	Notifiable Non Licensed Work	No

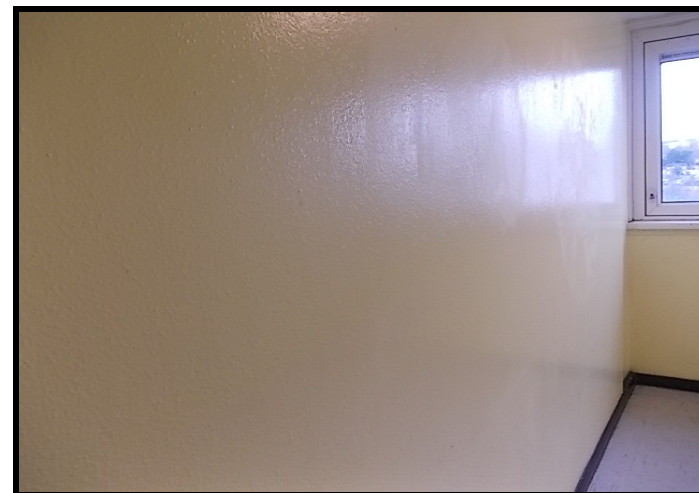
SAMPLE REFERENCE 006

Building	Floor	Room	Location		
Main Building	10th Floor	Lobby 2	Wall		
Description					
MATERIAL ASSESSMENT					SCORE
Product Type	Textured Coating	Extent of Damage	Low damage		-
Asbestos Type	No Asbestos Detected	Surface Treatment	Textured Coating		
PRIORITY ASSESSMENT					SCORE
Occupant Activity	Not Applicable	Extent / Amount	10.00 m2		-
Accessibility	Occasionally disturb	Location	Not Applicable		
Avg Time in Use	Not Applicable	Frequency of Use	Not Applicable		
No. of Occupants	Not Applicable	Secondary Activity	Not Applicable		
Maintenance	Not Applicable	Maintenance Frequency	Not Applicable		
MANAGEMENT ACTION					SCORE
Recommendation	NO ACTION REQUIRED				-
Recommendation Due		Next Inspection	None		
Apply Labels	No	Permit to Work Required	No		
Survey Type	Management	Lead Surveyor	Gavin Hooper		
Survey Date	11 Dec 2014	UKAS Laboratory	NOT SAMPLED (Cross Referenced)		
Site Reference	113030000A	Licensed Material	N/A	Notifiable Non Licensed Work	N/A

No Asbestos Presumed in Sample

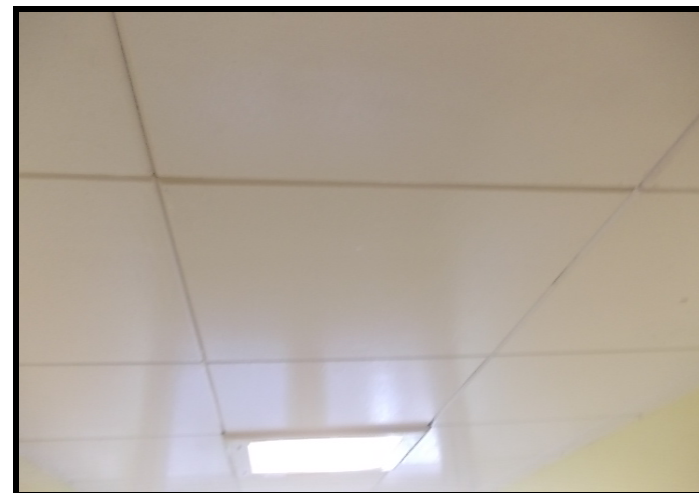
SAMPLE REFERENCE 007

Building	Floor	Room	Location		
Main Building	10th Floor	Lobby 2	Ceiling		
Description					
MATERIAL ASSESSMENT					SCORE
Product Type	Insulation Board	Extent of Damage	Low damage		-
Asbestos Type	No Asbestos Detected	Surface Treatment	Sealed Board (Encapsulated)		
PRIORITY ASSESSMENT					SCORE
Occupant Activity	Not Applicable	Extent / Amount	10.00 m2		-
Accessibility	Easily disturbed	Location	Not Applicable		
Avg Time in Use	Not Applicable	Frequency of Use	Not Applicable		
No. of Occupants	Not Applicable	Secondary Activity	Not Applicable		
Maintenance	Not Applicable	Maintenance Frequency	Not Applicable		
MANAGEMENT ACTION					SCORE
Recommendation	NO ACTION REQUIRED				-
Recommendation Due		Next Inspection	None		
Apply Labels	No	Permit to Work Required	No		
Survey Type	Management	Lead Surveyor	Gavin Hooper		
Survey Date	11 Dec 2014	UKAS Laboratory	NOT SAMPLED (Cross Referenced)		
Site Reference	113030000A	Licensed Material	N/A	Notifiable Non Licensed Work	N/A

No Asbestos Presumed in Sample

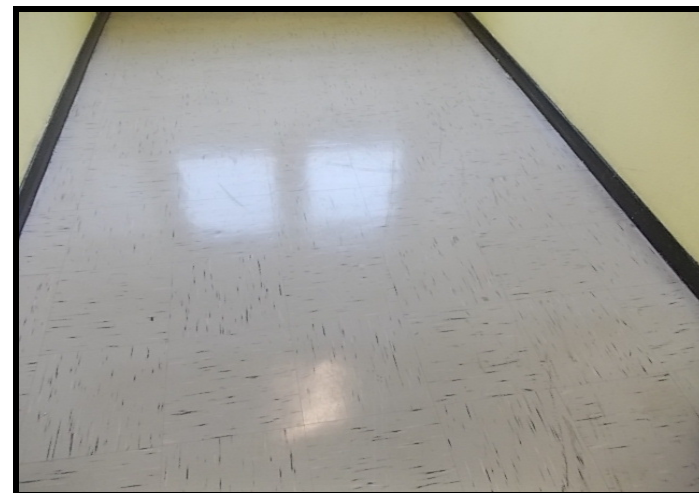
SAMPLE REFERENCE 008

Building	Floor	Room	Location		
Main Building	10th Floor	Lobby 2	Floor		
Description					
MATERIAL ASSESSMENT					
Product Type	Floor Tiles	Extent of Damage	Low damage		
Asbestos Type	Chrysotile	Surface Treatment	Composite materials		
PRIORITY ASSESSMENT					
Occupant Activity	Not Applicable	Extent / Amount	10.00 m2		
Accessibility	Occasionally disturb	Location	Not Applicable		
Avg Time in Use	Not Applicable	Frequency of Use	Not Applicable		
No. of Occupants	Not Applicable	Secondary Activity	Not Applicable		
Maintenance	Not Applicable	Maintenance Frequency	Not Applicable		
MANAGEMENT ACTION					
Recommendation	LABEL & MONITOR				
Recommendation Due		Next Inspection	11 Dec 2015		
Apply Labels	No	Permit to Work Required	No		
Survey Type	Management	Lead Surveyor	Gavin Hooper		
Survey Date	11 Dec 2014	UKAS Laboratory	DMW Environmental Safety Ltd / [A-9279]		
Site Reference	113030000A	Licensed Material	No	Notifiable Non Licensed Work	No

Asbestos detected in Sample

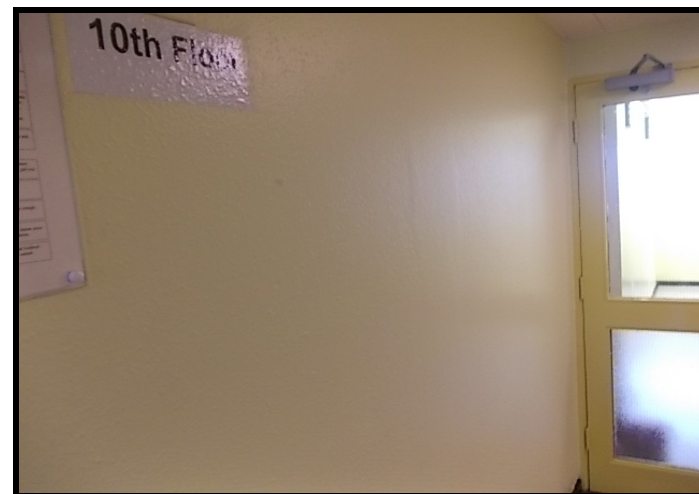
SAMPLE REFERENCE 008a

Building	Floor	Room	Location		
Main Building	10th Floor	Main Lobby	Walls		
Description					
MATERIAL ASSESSMENT					SCORE
Product Type	Textured Coating	Extent of Damage	Low damage		-
Asbestos Type	No Asbestos Detected	Surface Treatment	Textured Coating		
PRIORITY ASSESSMENT					SCORE
Occupant Activity	Not Applicable	Extent / Amount	16.00 m2		-
Accessibility	Easily disturbed	Location	Not Applicable		
Avg Time in Use	Not Applicable	Frequency of Use	Not Applicable		
No. of Occupants	Not Applicable	Secondary Activity	Not Applicable		
Maintenance	Not Applicable	Maintenance Frequency	Not Applicable		
MANAGEMENT ACTION					SCORE
Recommendation	NOT APPLICABLE				-
Recommendation Due		Next Inspection	None		
Apply Labels	No	Permit to Work Required	No		
Survey Type	Management	Lead Surveyor	Gavin Hooper		
Survey Date	11 Dec 2014	UKAS Laboratory	DMW Environmental Safety Ltd / [A-9279]		
Site Reference	113030000A	Licensed Material	N/A	Notifiable Non Licensed Work	N/A

Asbestos not detected in Sample

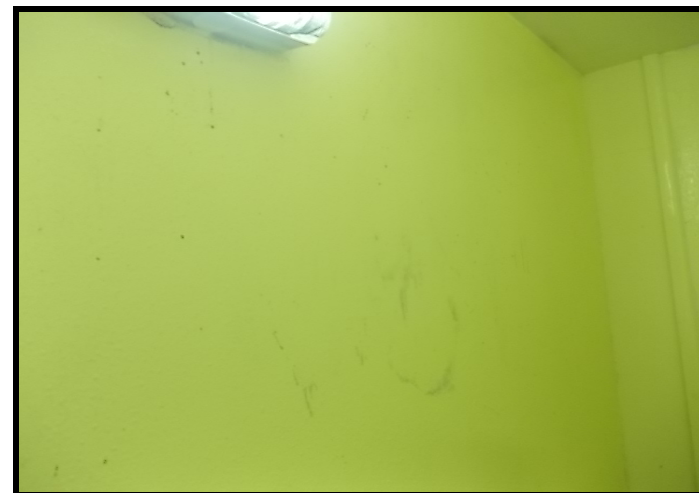
SAMPLE REFERENCE 009

Building	Floor	Room	Location		
Main Building	10th Floor	Bin Shute	Wall		
Description					
MATERIAL ASSESSMENT					SCORE
Product Type	Textured Coating	Extent of Damage	Low damage		-
Asbestos Type	No Asbestos Detected	Surface Treatment	Textured Coating		
PRIORITY ASSESSMENT					SCORE
Occupant Activity	Not Applicable	Extent / Amount	10.00 m2		-
Accessibility	Occasionally disturb	Location	Not Applicable		
Avg Time in Use	Not Applicable	Frequency of Use	Not Applicable		
No. of Occupants	Not Applicable	Secondary Activity	Not Applicable		
Maintenance	Not Applicable	Maintenance Frequency	Not Applicable		
MANAGEMENT ACTION					SCORE
Recommendation	NO ACTION REQUIRED				-
Recommendation Due		Next Inspection	None		
Apply Labels	No	Permit to Work Required	No		
Survey Type	Management	Lead Surveyor	Gavin Hooper		
Survey Date	11 Dec 2014	UKAS Laboratory	NOT SAMPLED (Cross Referenced)		
Site Reference	113030000A	Licensed Material	N/A	Notifiable Non Licensed Work	N/A

No Asbestos Presumed in Sample

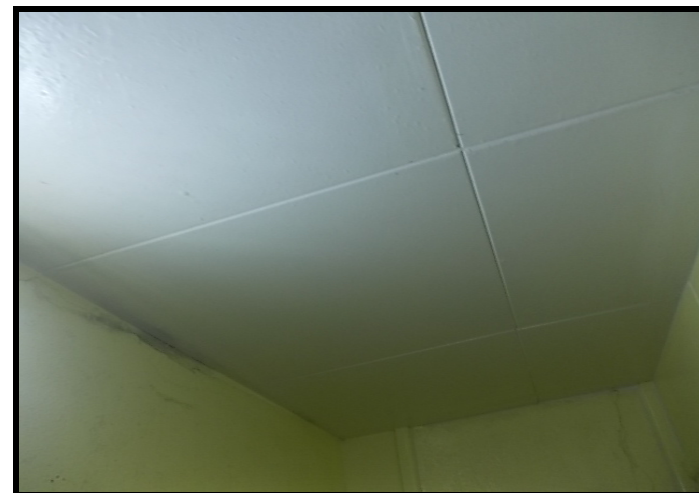
SAMPLE REFERENCE 010

Building	Floor	Room	Location
Main Building	10th Floor	Bin Shute	Ceiling
Description			
MATERIAL ASSESSMENT			
Product Type	Insulation Board	Extent of Damage	Low damage
Asbestos Type	No Asbestos Detected	Surface Treatment	Sealed Board (Encapsulated)
PRIORITY ASSESSMENT			
Occupant Activity	Not Applicable	Extent / Amount	5.00 m2
Accessibility	Easily disturbed	Location	Not Applicable
Avg Time in Use	Not Applicable	Frequency of Use	Not Applicable
No. of Occupants	Not Applicable	Secondary Activity	Not Applicable
Maintenance	Not Applicable	Maintenance Frequency	Not Applicable
MANAGEMENT ACTION			
Recommendation	NO ACTION REQUIRED		
Recommendation Due		Next Inspection	None
Apply Labels	No	Permit to Work Required	No
Survey Type	Management	Lead Surveyor	Gavin Hooper
Survey Date	11 Dec 2014	UKAS Laboratory	NOT SAMPLED (Cross Referenced)
Site Reference	113030000A	Licensed Material	N/A
		Notifiable Non Licensed Work	N/A

No Asbestos Presumed in Sample

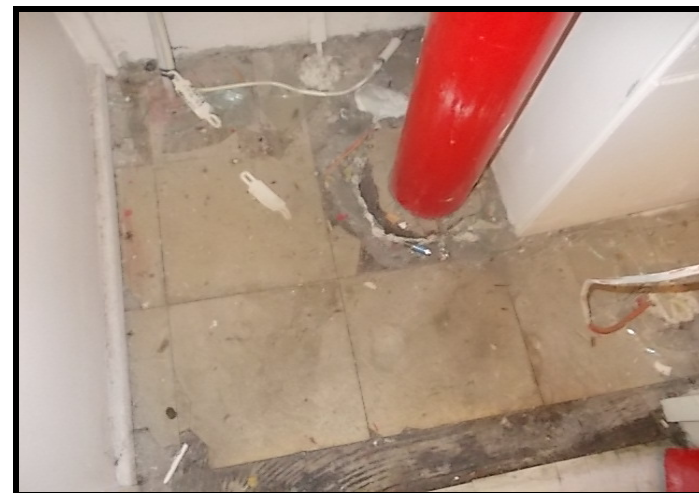
SAMPLE REFERENCE 012

Building	Floor	Room	Location
Main Building	10th Floor	Dry Riser	Floor
Description			
MATERIAL ASSESSMENT			
Product Type	Floor Tiles	Extent of Damage	Low damage
Asbestos Type	Chrysotile	Surface Treatment	Composite materials
PRIORITY ASSESSMENT			
Occupant Activity	Not Applicable	Extent / Amount	5.00 m2
Accessibility	Easily disturbed	Location	Not Applicable
Avg Time in Use	Not Applicable	Frequency of Use	Not Applicable
No. of Occupants	Not Applicable	Secondary Activity	Not Applicable
Maintenance	Not Applicable	Maintenance Frequency	Not Applicable
MANAGEMENT ACTION			
Recommendation	LABEL & MONITOR		
Recommendation Due		Next Inspection	11 Dec 2015
Apply Labels	No	Permit to Work Required	No
Survey Type	Management	Lead Surveyor	Gavin Hooper
Survey Date	11 Dec 2014	UKAS Laboratory	NOT SAMPLED (Cross Referenced)
Site Reference	113030000A	Licensed Material	No
		Notifiable Non Licensed Work	No

Asbestos Presumed

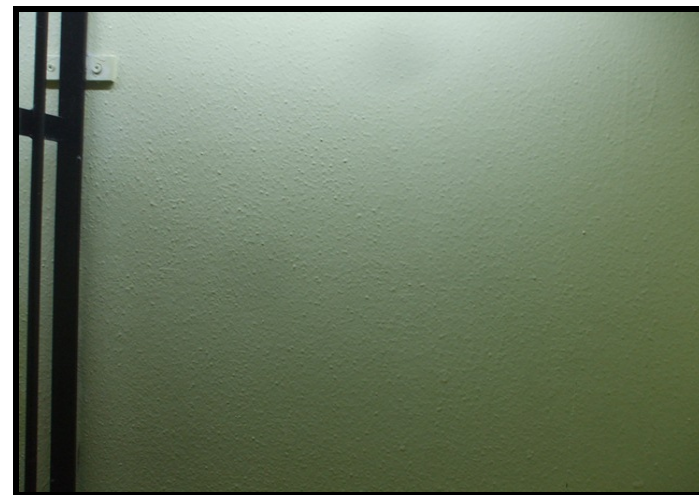
SAMPLE REFERENCE 016

Building	Floor	Room	Location		
Main Building	10th - 9th Floor	Stairwell	Wall		
Description	Textured coating now removed				
MATERIAL ASSESSMENT				SCORE	
Product Type	Textured Coating	Extent of Damage	Low damage		-
Asbestos Type	No Asbestos Detected	Surface Treatment	Textured Coating		
PRIORITY ASSESSMENT				SCORE	
Occupant Activity	Not Applicable	Extent / Amount	10.00 m2		-
Accessibility	Occasionally disturb	Location	Not Applicable		
Avg Time in Use	Not Applicable	Frequency of Use	Not Applicable		
No. of Occupants	Not Applicable	Secondary Activity	Not Applicable		
Maintenance	Not Applicable	Maintenance Frequency	Not Applicable		
MANAGEMENT ACTION				SCORE	
Recommendation	NO ACTION REQUIRED			-	
Recommendation Due		Next Inspection	None		
Apply Labels	No	Permit to Work Required	No		
Survey Type	Management	Lead Surveyor	Gavin Hooper		
Survey Date	11 Dec 2014	UKAS Laboratory	NOT SAMPLED (Cross Referenced)		
Site Reference	113030000A	Licensed Material	N/A	Notifiable Non Licensed Work	N/A

No Asbestos Presumed in Sample

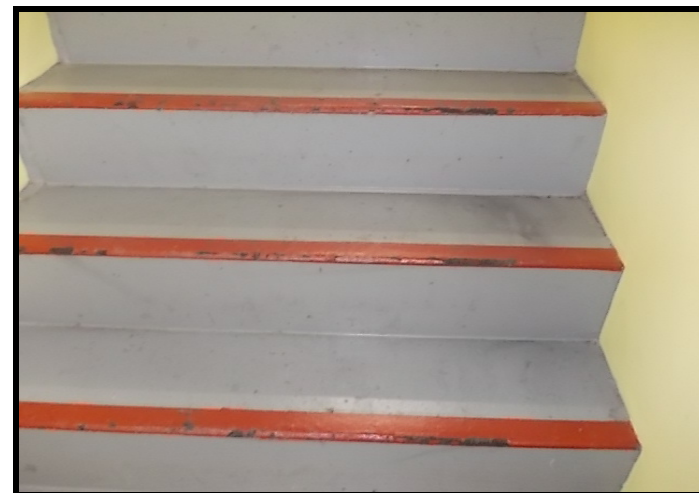
SAMPLE REFERENCE 016a

Building	Floor	Room	Location
Main Building	10th - 9th Floor	Stairwell	Floor
Description			
MATERIAL ASSESSMENT			
Product Type	Bitumen	Extent of Damage	Low damage
Asbestos Type	Chrysotile	Surface Treatment	Composite materials
PRIORITY ASSESSMENT			
Occupant Activity	Not Applicable	Extent / Amount	14.00 small item(s)
Accessibility	Routinely disturbed	Location	Not Applicable
Avg Time in Use	Not Applicable	Frequency of Use	Not Applicable
No. of Occupants	Not Applicable	Secondary Activity	Not Applicable
Maintenance	Not Applicable	Maintenance Frequency	Not Applicable
MANAGEMENT ACTION			
Recommendation	LABEL & MONITOR		
Recommendation Due		Next Inspection	11 Dec 2015
Apply Labels	No	Permit to Work Required	No
Survey Type	Management	Lead Surveyor	Gavin Hooper
Survey Date	11 Dec 2014	UKAS Laboratory	NOT SAMPLED (Cross Referenced)
Site Reference	113030000A	Licensed Material	No
		Notifiable Non Licensed Work	No

Asbestos Presumed

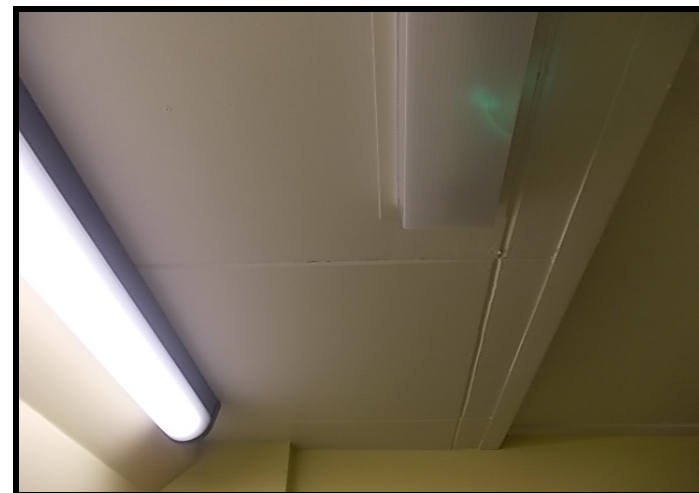
SAMPLE REFERENCE 017

Building	Floor	Room	Location		
Main Building	10th - 9th Floor	Stairwell	Ceiling		
Description					
MATERIAL ASSESSMENT					SCORE
Product Type	Insulation Board	Extent of Damage	Low damage		-
Asbestos Type	No Asbestos Detected	Surface Treatment	Sealed Board (Encapsulated)		
PRIORITY ASSESSMENT					SCORE
Occupant Activity	Not Applicable	Extent / Amount	10.00 m2		-
Accessibility	Easily disturbed	Location	Not Applicable		
Avg Time in Use	Not Applicable	Frequency of Use	Not Applicable		
No. of Occupants	Not Applicable	Secondary Activity	Not Applicable		
Maintenance	Not Applicable	Maintenance Frequency	Not Applicable		
MANAGEMENT ACTION					SCORE
Recommendation	NO ACTION REQUIRED				-
Recommendation Due		Next Inspection	None		
Apply Labels	No	Permit to Work Required	No		
Survey Type	Management	Lead Surveyor	Gavin Hooper		
Survey Date	11 Dec 2014	UKAS Laboratory	NOT SAMPLED (Cross Referenced)		
Site Reference	113030000A	Licensed Material	N/A	Notifiable Non Licensed Work	N/A

No Asbestos Presumed in Sample

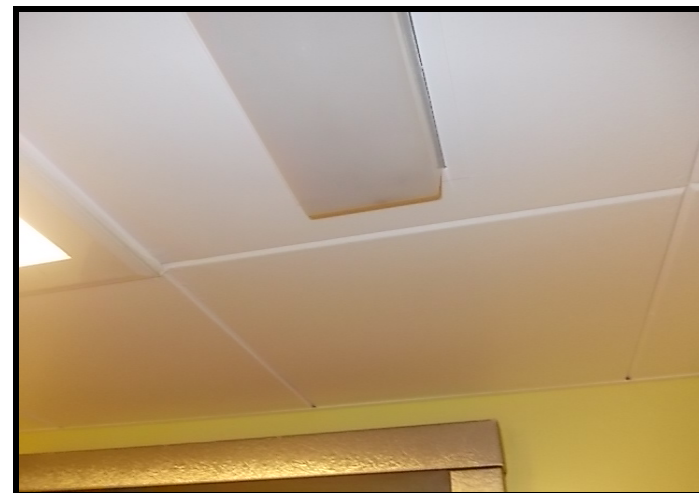
SAMPLE REFERENCE 019

Building	Floor	Room	Location		
Main Building	9th Floor	Lift Lobby I	Ceiling		
Description					
MATERIAL ASSESSMENT					SCORE
Product Type	Insulation Board	Extent of Damage	Low damage		-
Asbestos Type	No Asbestos Detected	Surface Treatment	Sealed Board (Encapsulated)		
PRIORITY ASSESSMENT					SCORE
Occupant Activity	Not Applicable	Extent / Amount	10.00 m2		-
Accessibility	Easily disturbed	Location	Not Applicable		
Avg Time in Use	Not Applicable	Frequency of Use	Not Applicable		
No. of Occupants	Not Applicable	Secondary Activity	Not Applicable		
Maintenance	Not Applicable	Maintenance Frequency	Not Applicable		
MANAGEMENT ACTION					SCORE
Recommendation	NO ACTION REQUIRED				-
Recommendation Due		Next Inspection	None		
Apply Labels	No	Permit to Work Required	No		
Survey Type	Management	Lead Surveyor	Gavin Hooper		
Survey Date	11 Dec 2014	UKAS Laboratory	NOT SAMPLED (Cross Referenced)		
Site Reference	113030000A	Licensed Material	N/A	Notifiable Non Licensed Work	N/A

No Asbestos Presumed in Sample

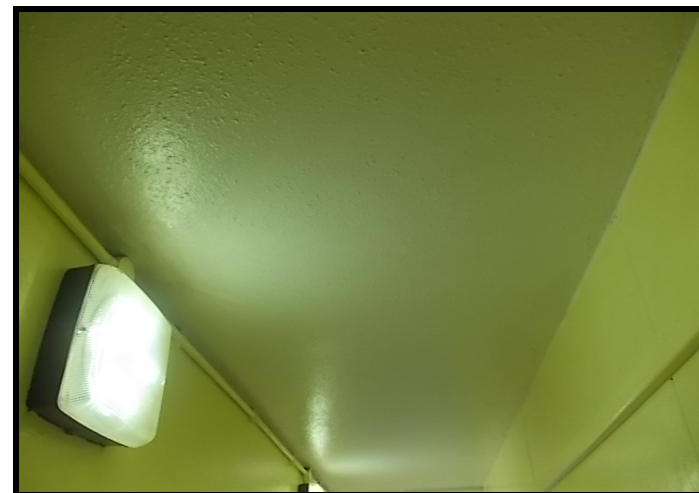
SAMPLE REFERENCE 019a

Building	Floor	Room	Location		
Main Building	9th Floor	Lobby 1	Ceiling		
Description					
MATERIAL ASSESSMENT					SCORE
Product Type	Textured Coating	Extent of Damage	Good condition		-
Asbestos Type	No Asbestos Detected	Surface Treatment	Textured Coating		
PRIORITY ASSESSMENT					SCORE
Occupant Activity	Not Applicable	Extent / Amount	5.00 m2		-
Accessibility	Occasionally disturb	Location	Not Applicable		
Avg Time in Use	Not Applicable	Frequency of Use	Not Applicable		
No. of Occupants	Not Applicable	Secondary Activity	Not Applicable		
Maintenance	Not Applicable	Maintenance Frequency	Not Applicable		
MANAGEMENT ACTION					SCORE
Recommendation	NO ACTION REQUIRED				-
Recommendation Due		Next Inspection	None		
Apply Labels	No	Permit to Work Required	No		
Survey Type	Management	Lead Surveyor	Gavin Hooper		
Survey Date	11 Dec 2014	UKAS Laboratory	NOT SAMPLED (Cross Referenced)		
Site Reference	113030000A	Licensed Material	N/A	Notifiable Non Licensed Work	N/A

No Asbestos Presumed in Sample

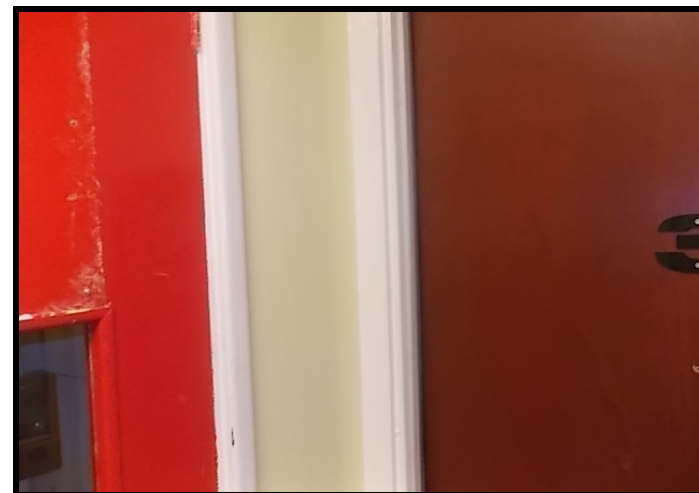
SAMPLE REFERENCE 019b

Building	Floor	Room	Location
Main Building	9th Floor	Lobby 1	Panel
Description			
MATERIAL ASSESSMENT			
Product Type	Cement	Extent of Damage	Good condition
Asbestos Type	Chrysotile	Surface Treatment	Sealed (Cement products)
PRIORITY ASSESSMENT			
Occupant Activity	Not Applicable	Extent / Amount	3.00 small item(s)
Accessibility	Occasionally disturb	Location	Not Applicable
Avg Time in Use	Not Applicable	Frequency of Use	Not Applicable
No. of Occupants	Not Applicable	Secondary Activity	Not Applicable
Maintenance	Not Applicable	Maintenance Frequency	Not Applicable
MANAGEMENT ACTION			
Recommendation	LABEL & MONITOR		
Recommendation Due		Next Inspection	11 Dec 2015
Apply Labels	No	Permit to Work Required	No
Survey Type	Management	Lead Surveyor	Gavin Hooper
Survey Date	11 Dec 2014	UKAS Laboratory	NOT SAMPLED (Cross Referenced)
Site Reference	113030000A	Licensed Material	No
		Notifiable Non Licensed Work	No

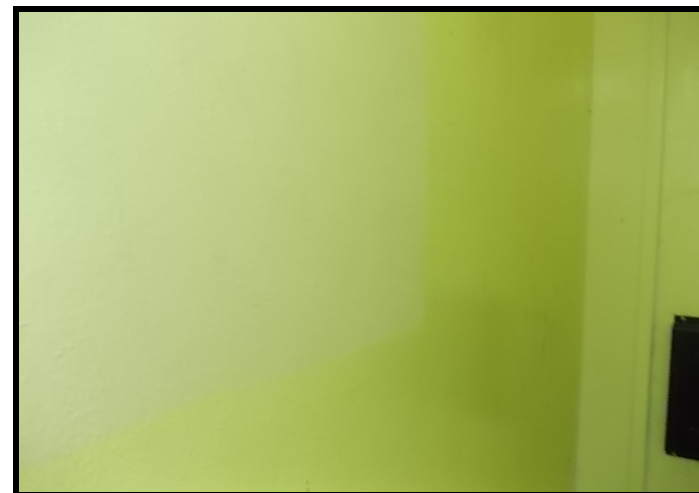
SAMPLE REFERENCE 020

Building	Floor	Room	Location		
Main Building	9th Floor	Bin Shute	Wall		
Description					
MATERIAL ASSESSMENT					SCORE
Product Type	Textured Coating	Extent of Damage	Low damage		-
Asbestos Type	No Asbestos Detected	Surface Treatment	Textured Coating		
PRIORITY ASSESSMENT					SCORE
Occupant Activity	Not Applicable	Extent / Amount	10.00 m2		-
Accessibility	Occasionally disturb	Location	Not Applicable		
Avg Time in Use	Not Applicable	Frequency of Use	Not Applicable		
No. of Occupants	Not Applicable	Secondary Activity	Not Applicable		
Maintenance	Not Applicable	Maintenance Frequency	Not Applicable		
MANAGEMENT ACTION					SCORE
Recommendation	NO ACTION REQUIRED				-
Recommendation Due		Next Inspection	None		
Apply Labels	No	Permit to Work Required	No		
Survey Type	Management	Lead Surveyor	Gavin Hooper		
Survey Date	11 Dec 2014	UKAS Laboratory	NOT SAMPLED (Cross Referenced)		
Site Reference	113030000A	Licensed Material	N/A	Notifiable Non Licensed Work	N/A

No Asbestos Presumed in Sample

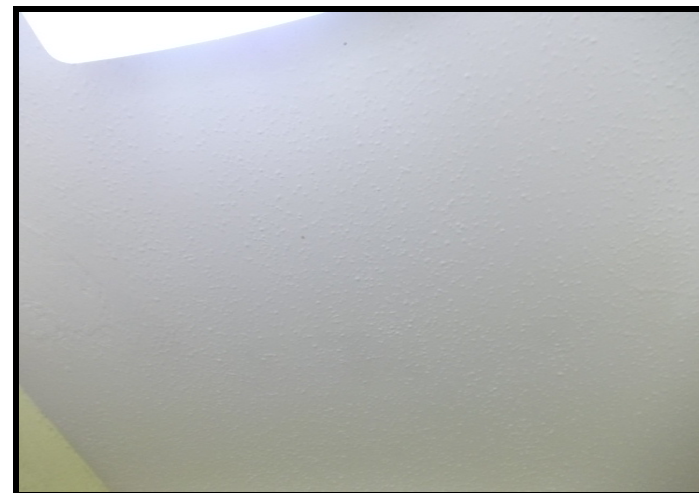
SAMPLE REFERENCE 021

Building	Floor	Room	Location
Main Building	9th Floor	Bin Shute	Ceiling
Description			
MATERIAL ASSESSMENT			
Product Type	Insulation Board	Extent of Damage	Low damage
Asbestos Type	No Asbestos Detected	Surface Treatment	Sealed Board (Encapsulated)
PRIORITY ASSESSMENT			
Occupant Activity	Not Applicable	Extent / Amount	5.00 m2
Accessibility	Easily disturbed	Location	Not Applicable
Avg Time in Use	Not Applicable	Frequency of Use	Not Applicable
No. of Occupants	Not Applicable	Secondary Activity	Not Applicable
Maintenance	Not Applicable	Maintenance Frequency	Not Applicable
MANAGEMENT ACTION			
Recommendation	NO ACTION REQUIRED		
Recommendation Due		Next Inspection	None
Apply Labels	No	Permit to Work Required	No
Survey Type	Management	Lead Surveyor	Gavin Hooper
Survey Date	11 Dec 2014	UKAS Laboratory	NOT SAMPLED (Cross Referenced)
Site Reference	113030000A	Licensed Material	N/A
		Notifiable Non Licensed Work	N/A

No Asbestos Presumed in Sample

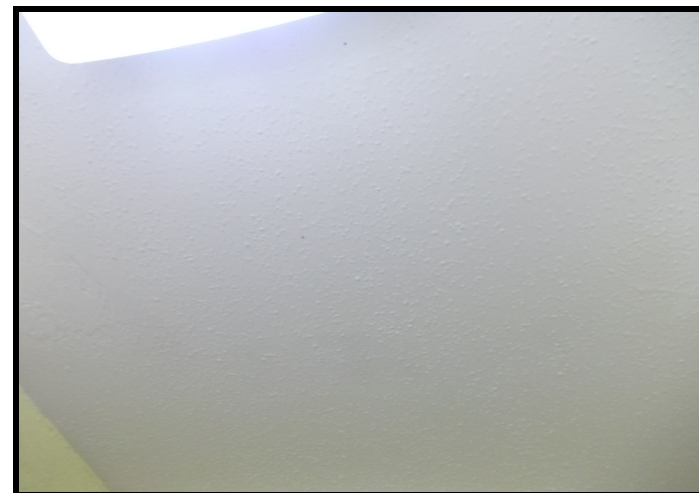
SAMPLE REFERENCE 021a

Building	Floor	Room	Location		
Main Building	9th Floor	Bin Shute	Ceiling		
Description					
MATERIAL ASSESSMENT					SCORE
Product Type	Textured Coating	Extent of Damage	Low damage		-
Asbestos Type	No Asbestos Detected	Surface Treatment	Textured Coating		
PRIORITY ASSESSMENT					SCORE
Occupant Activity	Not Applicable	Extent / Amount	3.00 m2		-
Accessibility	Occasionally disturb	Location	Not Applicable		
Avg Time in Use	Not Applicable	Frequency of Use	Not Applicable		
No. of Occupants	Not Applicable	Secondary Activity	Not Applicable		
Maintenance	Not Applicable	Maintenance Frequency	Not Applicable		
MANAGEMENT ACTION					SCORE
Recommendation	NO ACTION REQUIRED				-
Recommendation Due		Next Inspection	None		
Apply Labels	No	Permit to Work Required	No		
Survey Type	Management	Lead Surveyor	Gavin Hooper		
Survey Date	11 Dec 2014	UKAS Laboratory	DMW Environmental Safety Ltd / [A-9279]		
Site Reference	113030000A	Licensed Material	N/A	Notifiable Non Licensed Work	N/A

Asbestos not detected in Sample

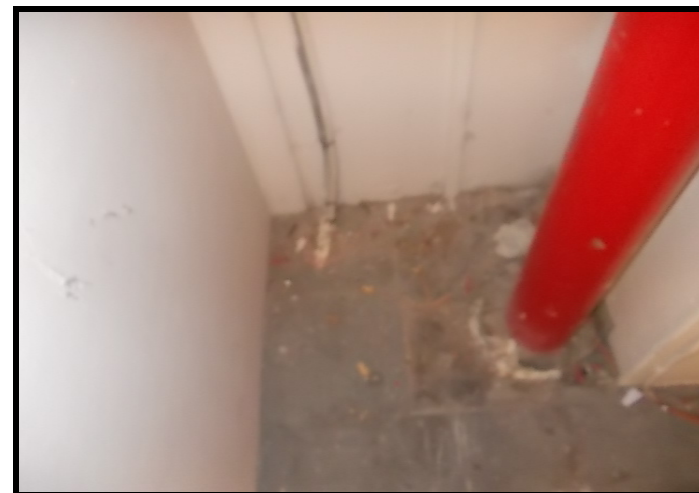
SAMPLE REFERENCE 023

Building	Floor	Room	Location
Main Building	9th Floor	Dry Riser	Floor
Description			
MATERIAL ASSESSMENT			
Product Type	Floor Tiles	Extent of Damage	Low damage
Asbestos Type	Chrysotile	Surface Treatment	Composite materials
PRIORITY ASSESSMENT			
Occupant Activity	Not Applicable	Extent / Amount	5.00 m2
Accessibility	Easily disturbed	Location	Not Applicable
Avg Time in Use	Not Applicable	Frequency of Use	Not Applicable
No. of Occupants	Not Applicable	Secondary Activity	Not Applicable
Maintenance	Not Applicable	Maintenance Frequency	Not Applicable
MANAGEMENT ACTION			
Recommendation	LABEL & MONITOR		
Recommendation Due		Next Inspection	11 Dec 2015
Apply Labels	No	Permit to Work Required	No
Survey Type	Management	Lead Surveyor	Gavin Hooper
Survey Date	11 Dec 2014	UKAS Laboratory	NOT SAMPLED (Cross Referenced)
Site Reference	113030000A	Licensed Material	No
		Notifiable Non Licensed Work	No

Asbestos Presumed

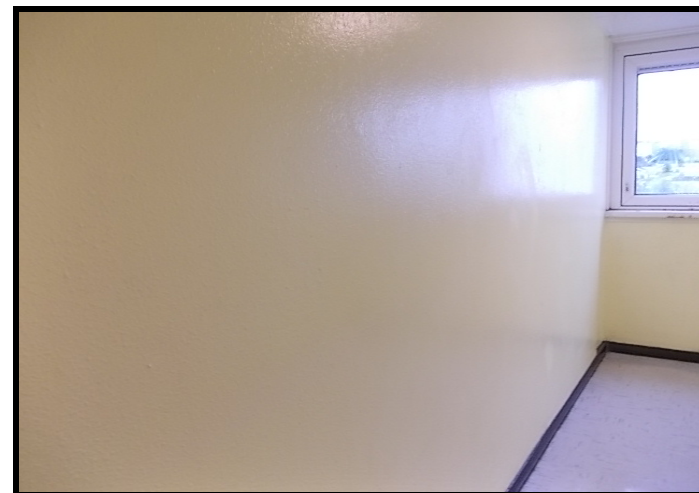
SAMPLE REFERENCE 026

Building	Floor	Room	Location		
Main Building	9th Floor	Lobby 2	Wall		
Description					
MATERIAL ASSESSMENT					SCORE
Product Type	Textured Coating	Extent of Damage	Low damage		-
Asbestos Type	No Asbestos Detected	Surface Treatment	Textured Coating		
PRIORITY ASSESSMENT					SCORE
Occupant Activity	Not Applicable	Extent / Amount	10.00 m2		-
Accessibility	Occasionally disturb	Location	Not Applicable		
Avg Time in Use	Not Applicable	Frequency of Use	Not Applicable		
No. of Occupants	Not Applicable	Secondary Activity	Not Applicable		
Maintenance	Not Applicable	Maintenance Frequency	Not Applicable		
MANAGEMENT ACTION					SCORE
Recommendation	NO ACTION REQUIRED				-
Recommendation Due		Next Inspection	None		
Apply Labels	No	Permit to Work Required	No		
Survey Type	Management	Lead Surveyor	Gavin Hooper		
Survey Date	11 Dec 2014	UKAS Laboratory	NOT SAMPLED (Cross Referenced)		
Site Reference	113030000A	Licensed Material	N/A	Notifiable Non Licensed Work	N/A

No Asbestos Presumed in Sample

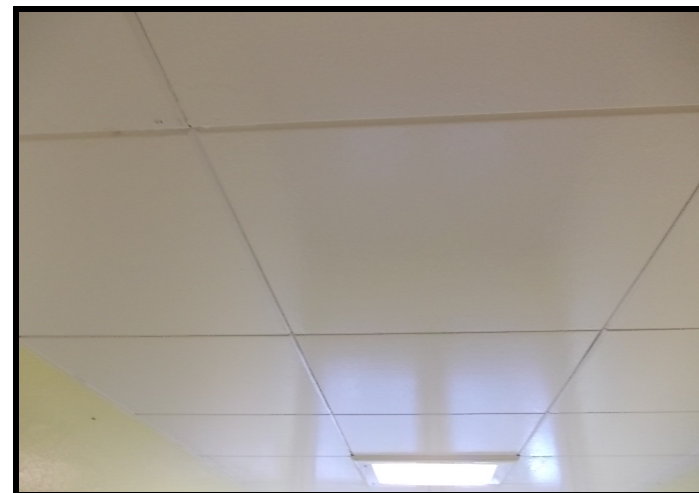
SAMPLE REFERENCE 027

Building	Floor	Room	Location		
Main Building	9th Floor	Lobby 2	Ceiling		
Description					
MATERIAL ASSESSMENT					SCORE
Product Type	Insulation Board	Extent of Damage	Low damage		-
Asbestos Type	No Asbestos Detected	Surface Treatment	Sealed Board (Encapsulated)		
PRIORITY ASSESSMENT					SCORE
Occupant Activity	Not Applicable	Extent / Amount	10.00 m2		-
Accessibility	Easily disturbed	Location	Not Applicable		
Avg Time in Use	Not Applicable	Frequency of Use	Not Applicable		
No. of Occupants	Not Applicable	Secondary Activity	Not Applicable		
Maintenance	Not Applicable	Maintenance Frequency	Not Applicable		
MANAGEMENT ACTION					SCORE
Recommendation	NO ACTION REQUIRED				-
Recommendation Due		Next Inspection	None		
Apply Labels	No	Permit to Work Required	No		
Survey Type	Management	Lead Surveyor	Gavin Hooper		
Survey Date	11 Dec 2014	UKAS Laboratory	NOT SAMPLED (Cross Referenced)		
Site Reference	113030000A	Licensed Material	N/A	Notifiable Non Licensed Work	N/A

No Asbestos Presumed in Sample

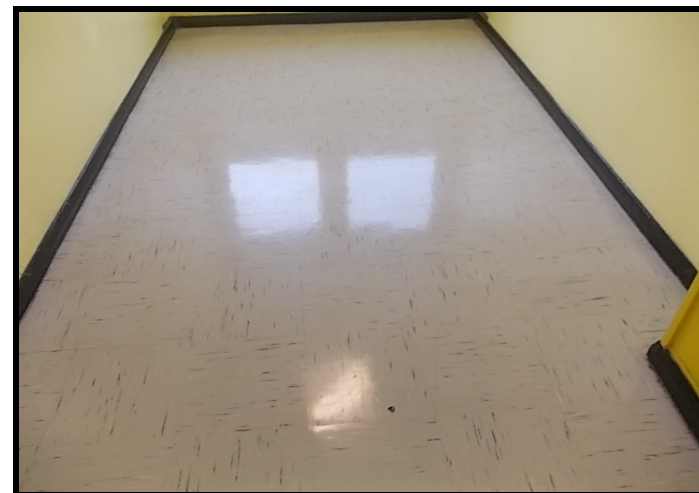
SAMPLE REFERENCE 028

Asbestos Presumed

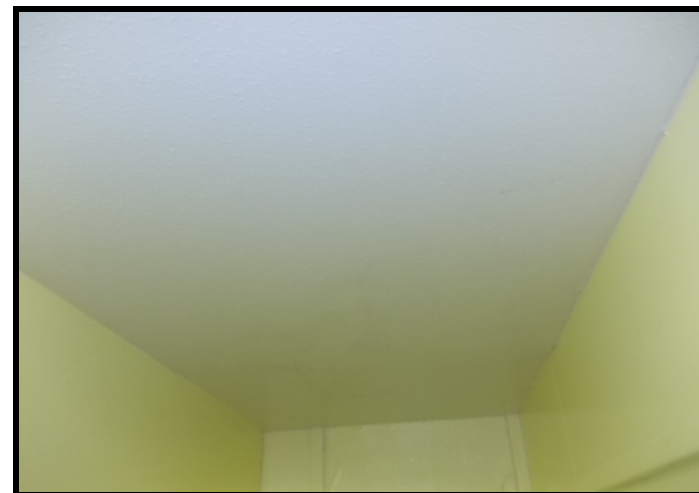
SAMPLE REFERENCE 036

Asbestos not detected in Sample

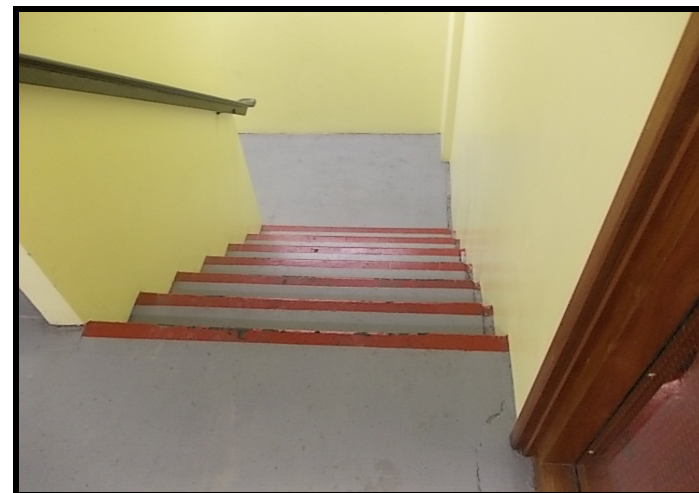
SAMPLE REFERENCE 055a

Asbestos Presumed

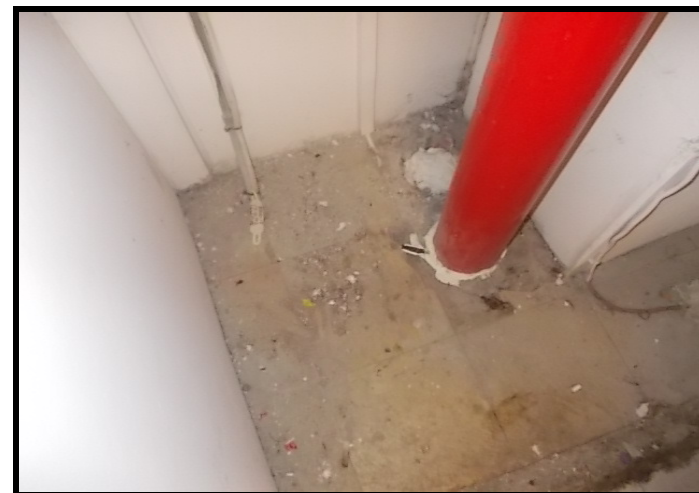
SAMPLE REFERENCE 061b

Asbestos Presumed

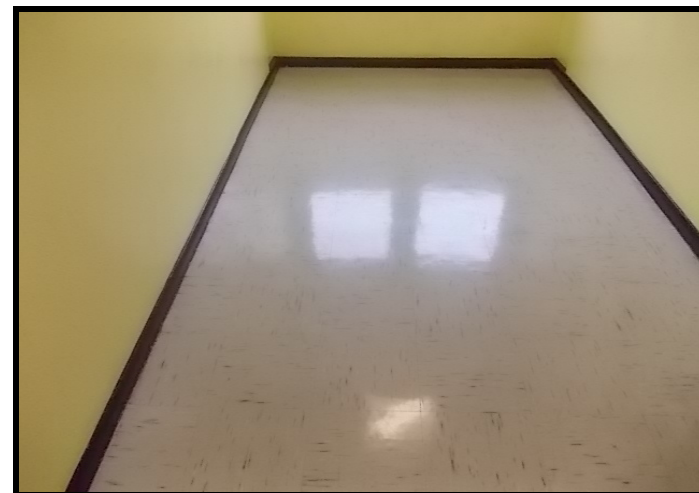
SAMPLE REFERENCE 064

Asbestos Presumed

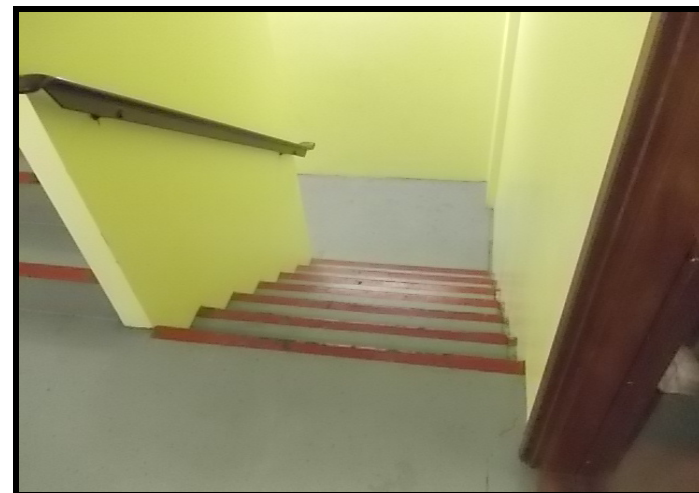
SAMPLE REFERENCE 067a

Asbestos Presumed
