# Solihull Community Housing

## Asbestos Management Survey Report

**I-51 Newnham House  
(Communal)  
Sheppey Drive  
Smiths Wood  
B36 0LU**

**Date of Report: 22 Apr 2015**

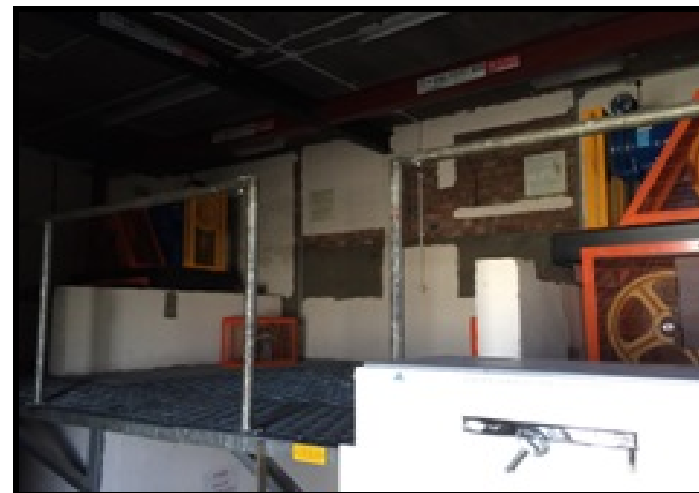
## SAMPLE REFERENCE 001a

**Asbestos Presumed**

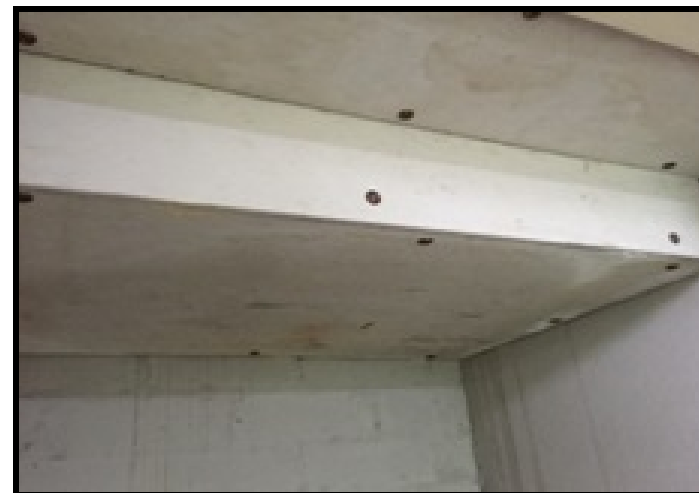
## SAMPLE REFERENCE 002

**Asbestos detected in Sample**

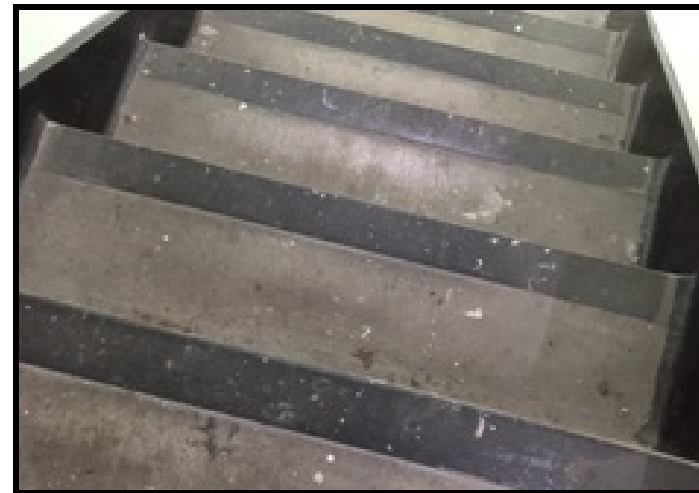
## SAMPLE REFERENCE 003

**Asbestos detected in Sample**

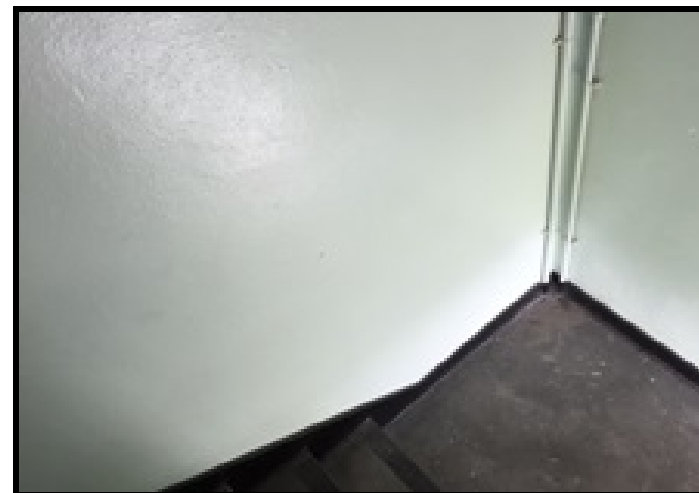
## SAMPLE REFERENCE 004

**Asbestos not detected in Sample**

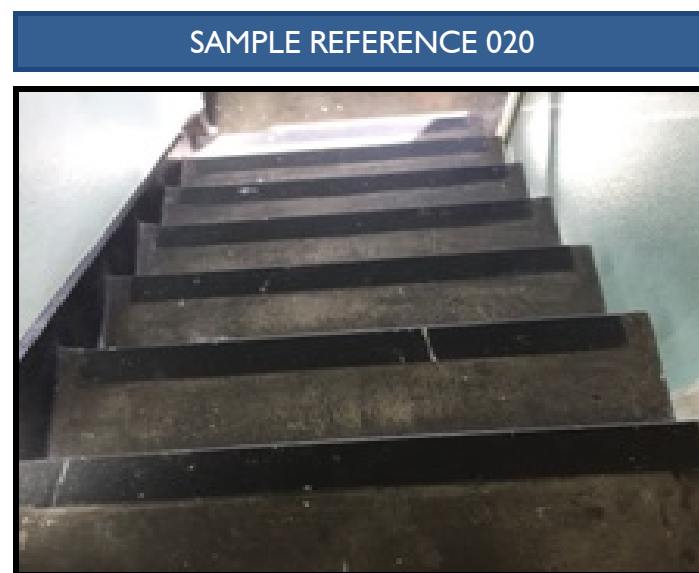
## Asbestos Presumed

MANAGEMENT ACTION				SCORE
Recommendation	LABEL & MONITOR			3
Recommendation Due		Next Inspection	14 Apr 2016	
Apply Labels	No	Permit to Work Required	No

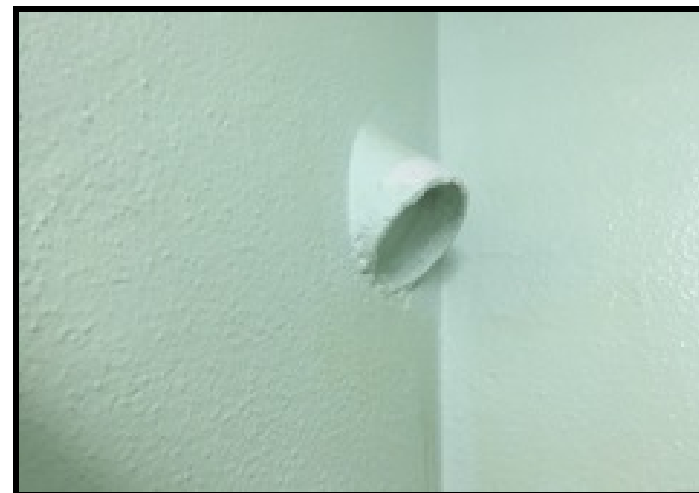
## SAMPLE REFERENCE 027

**Asbestos detected in Sample**

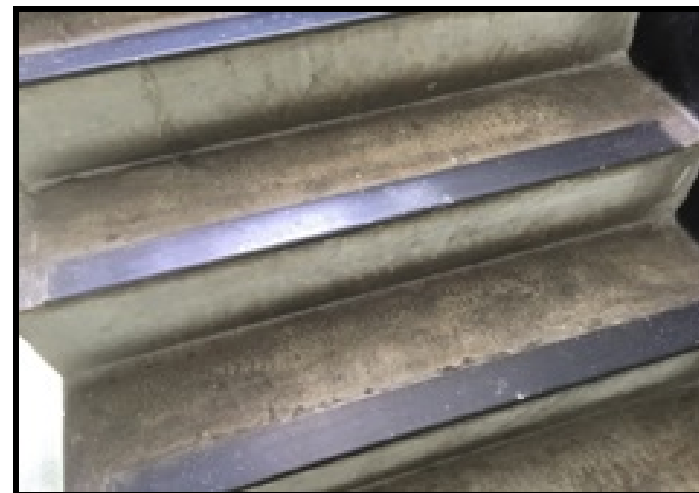
## SAMPLE REFERENCE 029

## Asbestos Presumed

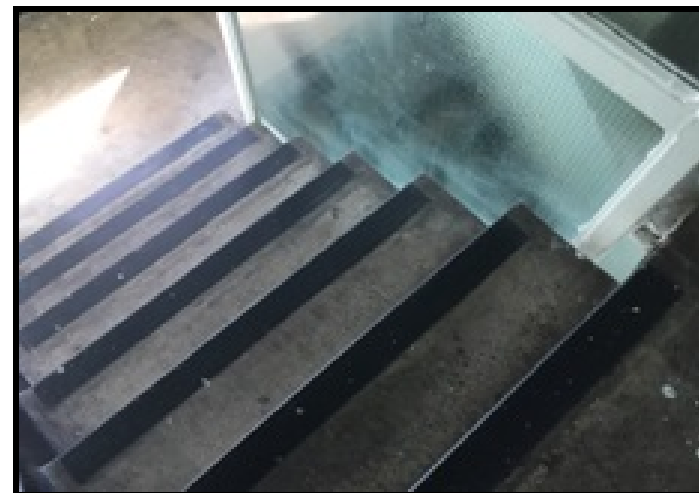
## SAMPLE REFERENCE 036

**Asbestos Presumed**

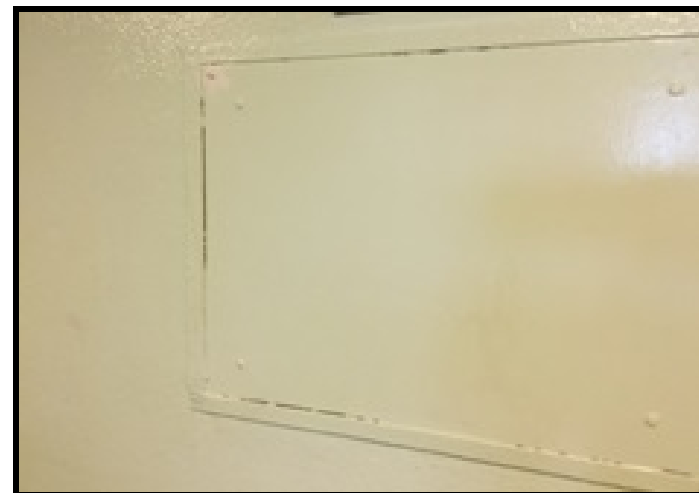
## SAMPLE REFERENCE 041

Asbestos not detected in Sample

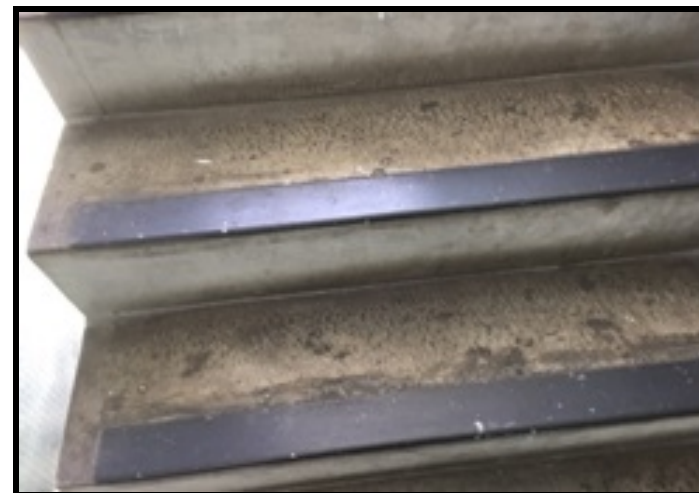
## SAMPLE REFERENCE 044

**Asbestos Presumed**

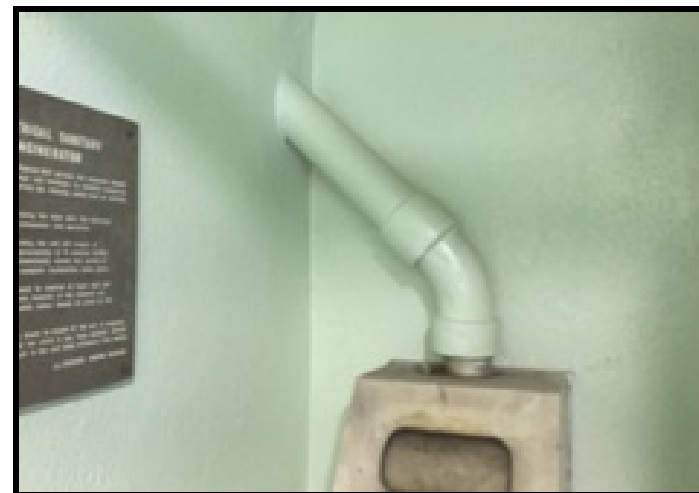
## SAMPLE REFERENCE 051

Asbestos Presumed

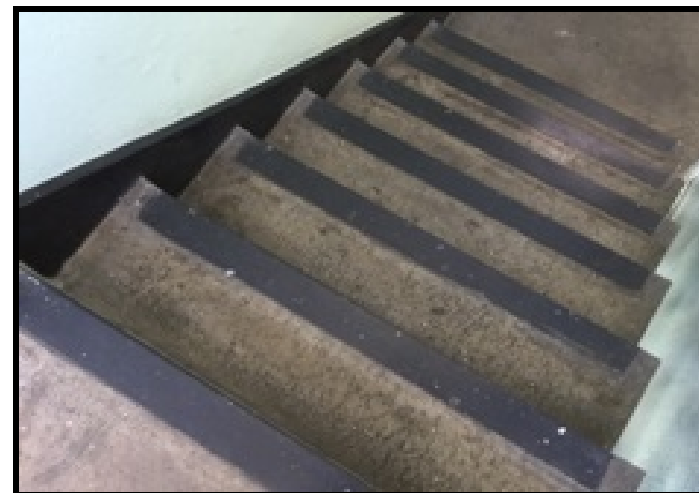
## SAMPLE REFERENCE 060

**Asbestos Presumed**

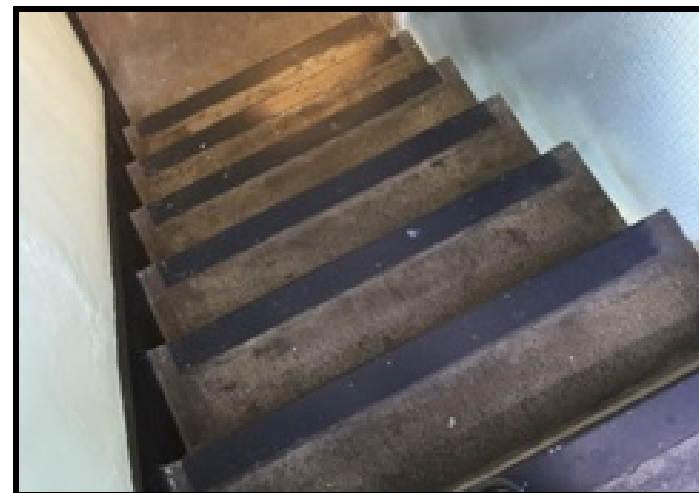
## SAMPLE REFERENCE 068

## Asbestos Presumed

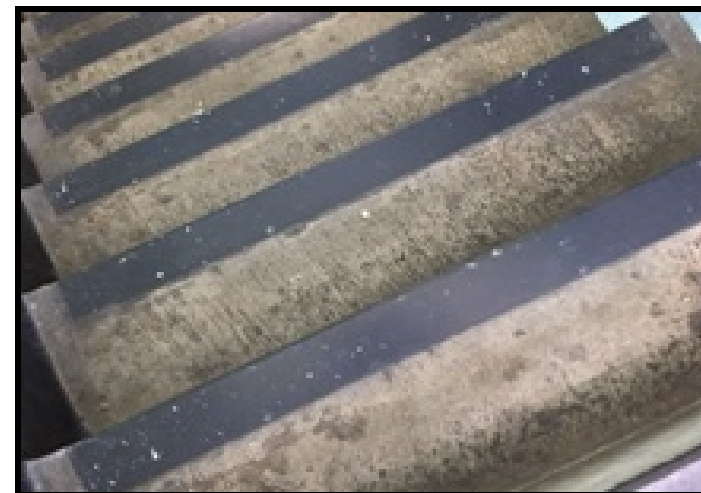
**SAMPLE REFERENCE 077**

## Asbestos Presumed

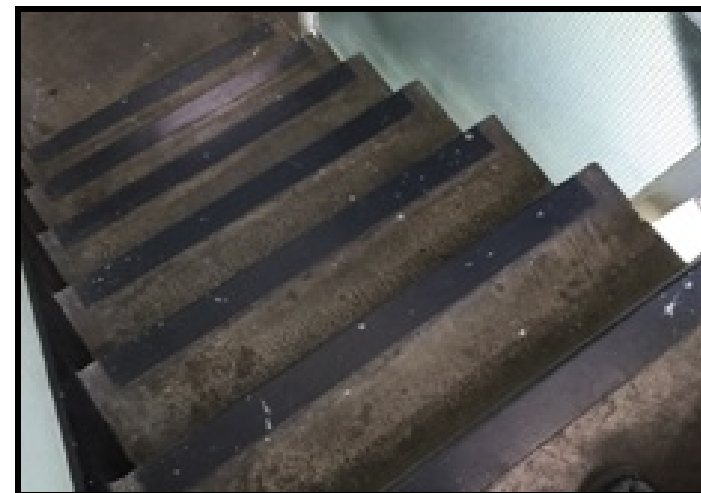
## SAMPLE REFERENCE 092

**Asbestos Presumed**

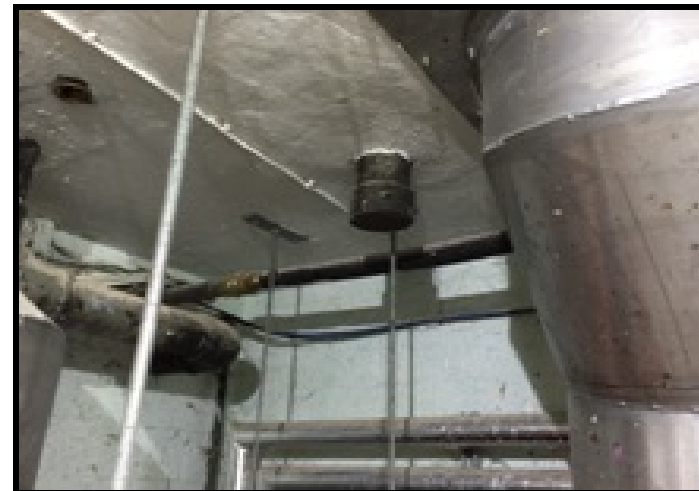
## SAMPLE REFERENCE I 17

**Asbestos Presumed**
