# **Solihull Community Housing**

## **Asbestos Management Survey Report**

**Oriel House  
Blackcat Close  
Chelmsley Wood  
B37 5DG**

**Date of Report: 14 May 2012**

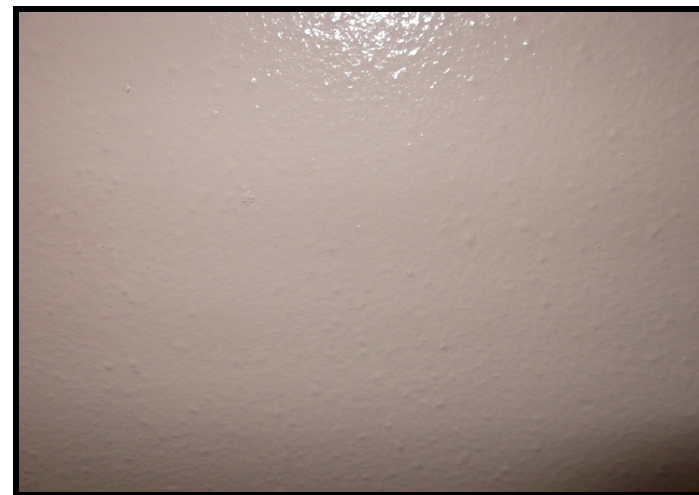
## SAMPLE REFERENCE 001

| 001 | Main Building (Eleventh Floor) | Landing | Walls | Textured Coating | No Asbestos Detected | 60.00m2 | Low damage | Textured Coating | - | - | - | NO ACTION REQUIRED | | |

**Asbestos not detected in Sample**

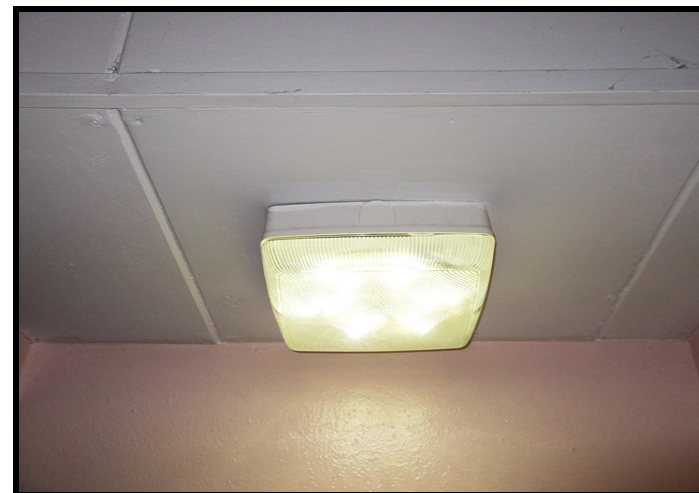
## SAMPLE REFERENCE 002

| 002 | Main Building (Eleventh Floor) | Landing | Ceiling | Board | No Asbestos Detected | 1.00m2 | Low damage | Sealed Board (Encapsulated) | - | - | - | NO ACTION REQUIRED | | |

Asbestos not detected in Sample

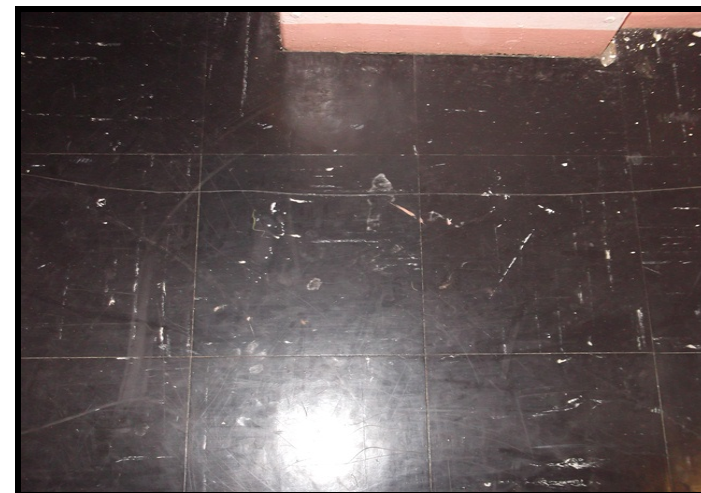
## SAMPLE REFERENCE 003

| 003 | Main Building (Tenth Floor) | Corridor 1 | Floor | Floor Tiles & Adhesive | No Asbestos Detected | 15.00m2 | Low damage | Composite materials | - | - | - | NO ACTION REQUIRED | | |

**Asbestos not detected in Sample**

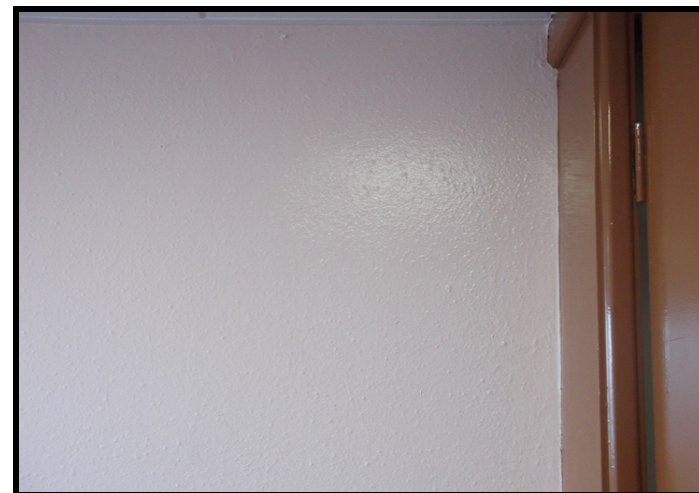
## SAMPLE REFERENCE 004

| 004 | Main Building (Tenth Floor) | Corridor 1 | Walls | Textured Coating | No Asbestos Detected | 20.00m2 | Low damage | Textured Coating | - | - | - | NO ACTION REQUIRED | | |

**Asbestos not detected in Sample**

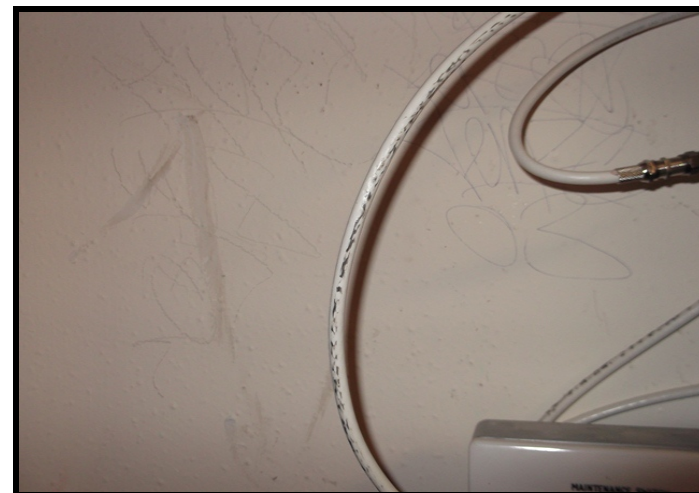
## SAMPLE REFERENCE 005

| Unique Sample No. | Building Reference (Floor) | Room Area | Description of Location | Product Description | Asbestos Type | Approx. Quantity | Material Condition | Surface Treatment | Material Risk Score | Priority Risk Score | Total Risk Score | Management Action | Next Review Date |
|---|---|---|---|---|---|---|---|---|---|---|---|---|---|
| 005 | Main Building (Tenth Floor) | Electric Store | Walls | Textured Coating | No Asbestos Detected | 2.00m2 | Low damage | Textured Coating | - | - | - | NO ACTION REQUIRED | |

**No Asbestos Presumed in Sample**

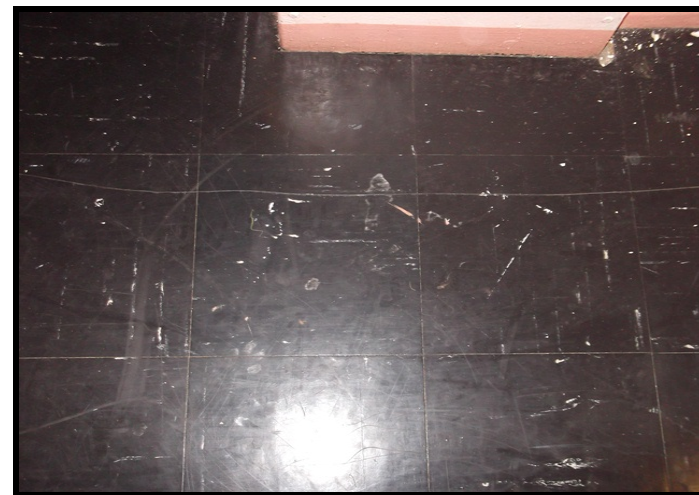
## SAMPLE REFERENCE 006

| Unique Sample No. | Building Reference (Floor) | Room Area | Description of Location | Product Description | Asbestos Type | Approx. Quantity | Material Condition | Surface Treatment | Material Risk Score | Priority Risk Score | Total Risk Score | Management Action | Next Review Date |
|---|---|---|---|---|---|---|---|---|---|---|---|---|---|
| 006 | Main Building (Tenth Floor) | Corridor 2 | Floor | Floor Tiles | No Asbestos Detected | 12.00m2 | Low damage | Composite materials | - | - | - | NO ACTION REQUIRED | |

**Asbestos not detected in Sample**

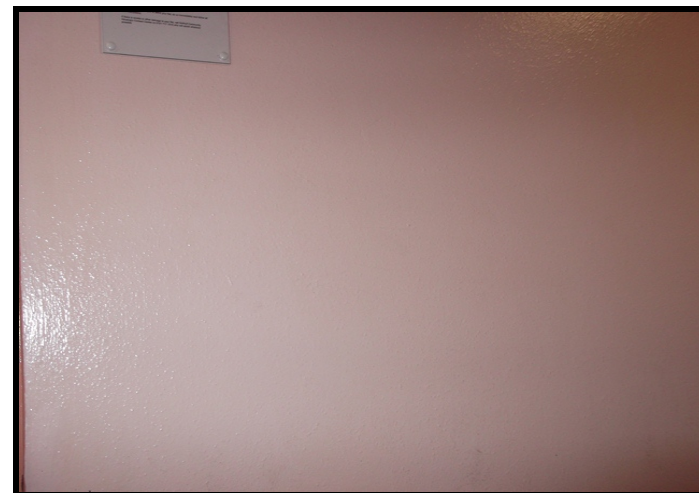
## SAMPLE REFERENCE 007

| Unique Sample No. | Building Reference (Floor) | Room Area | Description of Location | Product Description | Asbestos Type | Approx. Quantity | Material Condition | Surface Treatment | Material Risk Score | Priority Risk Score | Total Risk Score | Management Action | Next Review Date |
|---|---|---|---|---|---|---|---|---|---|---|---|---|---|
| 007 | Main Building (Tenth Floor) | Corridor 2 | Walls | Textured Coating | No Asbestos Detected | 20.00m2 | Low damage | Textured Coating | - | - | - | NO ACTION REQUIRED | |

**No Asbestos Presumed in Sample**

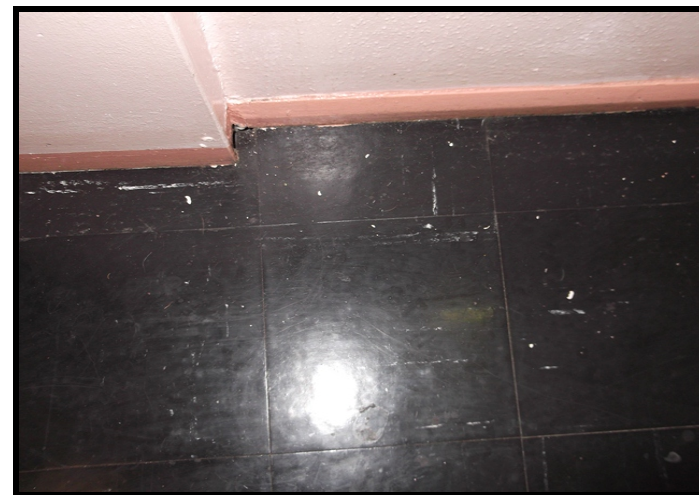
## SAMPLE REFERENCE 008

| Unique Sample No. | Building Reference (Floor) | Room Area | Description of Location | Product Description | Asbestos Type | Approx. Quantity | Material Condition | Surface Treatment | Material Risk Score | Priority Risk Score | Total Risk Score | Management Action | Next Review Date |
|---|---|---|---|---|---|---|---|---|---|---|---|---|---|
| 008 | Main Building (Tenth Floor) | Corridor 3 | Floor | Floor Tiles & Adhesive | No Asbestos Detected | 15.00m2 | Low damage | Composite materials | - | - | - | NO ACTION REQUIRED | |

**No Asbestos Presumed in Sample**

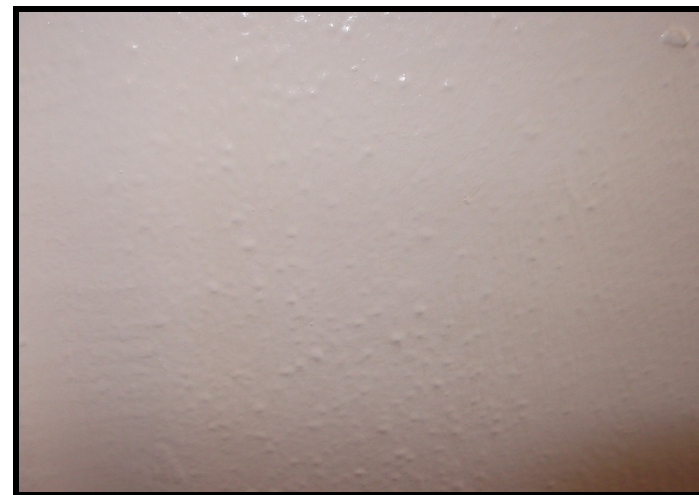
## SAMPLE REFERENCE 009

| Unique Sample No. | Building Reference (Floor) | Room Area | Description of Location | Product Description | Asbestos Type | Approx. Quantity | Material Condition | Surface Treatment | Material Risk Score | Priority Risk Score | Total Risk Score | Management Action | Next Review Date |
|---|---|---|---|---|---|---|---|---|---|---|---|---|---|
| 009 | Main Building (Tenth Floor) | Corridor 3 | Walls | Textured Coating | No Asbestos Detected | 20.00m2 | Low damage | Textured Coating | - | - | - | NO ACTION REQUIRED | |

**No Asbestos Presumed in Sample**

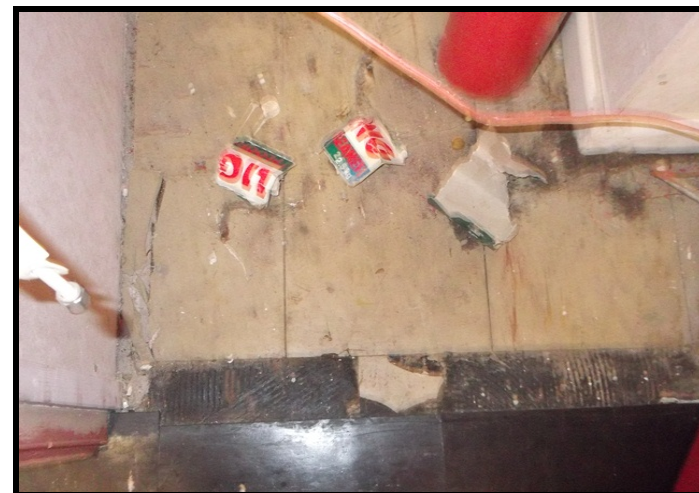
## SAMPLE REFERENCE 010

| Unique Sample No. | Building Reference (Floor) | Room Area | Description of Location | Product Description | Asbestos Type | Approx. Quantity | Material Condition | Surface Treatment | Material Risk Score | Priority Risk Score | Total Risk Score | Management Action | Next Review Date |
|---|---|---|---|---|---|---|---|---|---|---|---|---|---|
| 010 | Main Building (Tenth Floor) | Dry Riser | Floor | Floor Tiles & Adhesive | Chrysotile | 1.00m2 | Medium damage | Composite materials | 4 | 1 | 5 | LABEL & MONITOR | 22 Mar 2013 |

**Asbestos detected in Sample**

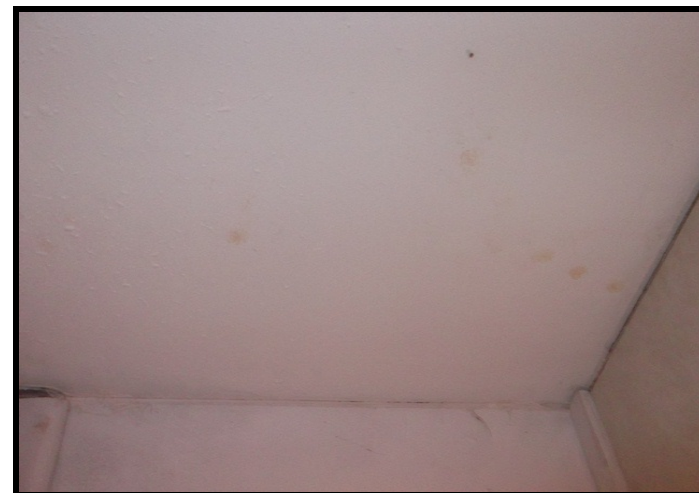
## SAMPLE REFERENCE 011

| Unique Sample No. | Building Reference (Floor) | Room Area | Description of Location | Product Description | Asbestos Type | Approx. Quantity | Material Condition | Surface Treatment | Material Risk Score | Priority Risk Score | Total Risk Score | Management Action | Next Review Date |
|---|---|---|---|---|---|---|---|---|---|---|---|---|---|
| 011 | Main Building (Tenth Floor) | Dry Riser | Ceiling | Textured Coating | No Asbestos Detected | 1.00m2 | Low damage | Textured Coating | - | - | - | NO ACTION REQUIRED | |

**No Asbestos Presumed in Sample**

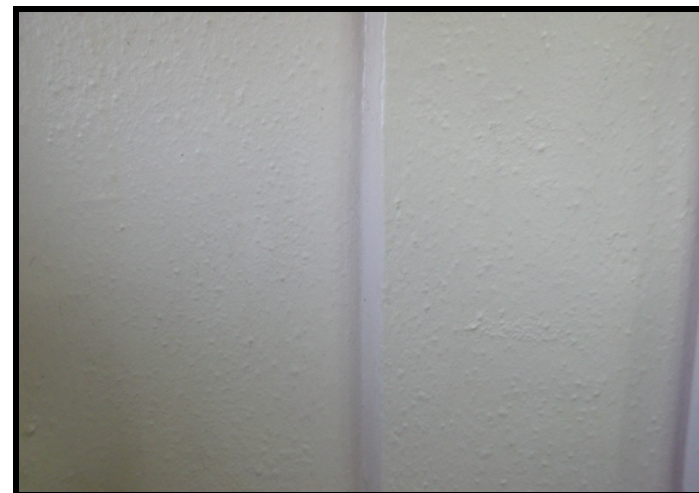
## SAMPLE REFERENCE 013

| Unique Sample No. | Building Reference (Floor) | Room Area | Description of Location | Product Description | Asbestos Type | Approx. Quantity | Material Condition | Surface Treatment | Material Risk Score | Priority Risk Score | Total Risk Score | Management Action | Next Review Date |
|---|---|---|---|---|---|---|---|---|---|---|---|---|---|
| 013 | Main Building (Tenth Floor) | Bin Shoot | Walls | Textured Coating | No Asbestos Detected | 8.00m2 | Low damage | Textured Coating | - | - | - | NO ACTION REQUIRED | |

**No Asbestos Presumed in Sample**

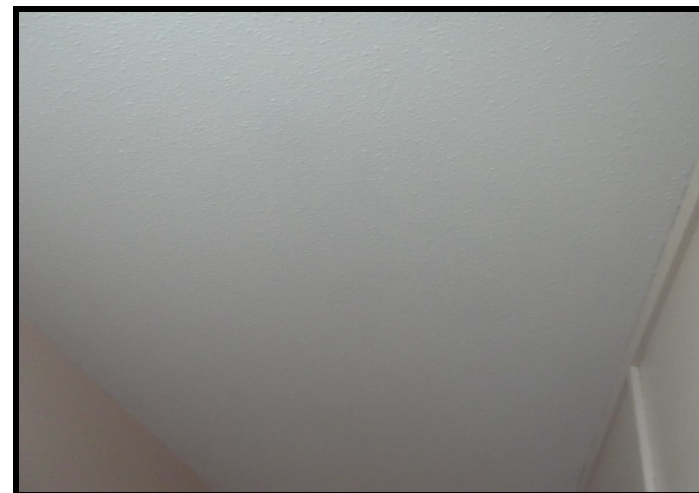
## SAMPLE REFERENCE 014

| Unique Sample No. | Building Reference (Floor) | Room Area | Description of Location | Product Description | Asbestos Type | Approx. Quantity | Material Condition | Surface Treatment | Material Risk Score | Priority Risk Score | Total Risk Score | Management Action | Next Review Date |
|---|---|---|---|---|---|---|---|---|---|---|---|---|---|
| 014 | Main Building (Tenth Floor) | Bin Shoot | Ceiling | Textured Coating | No Asbestos Detected | 4.00m2 | Low damage | Textured Coating | - | - | - | NO ACTION REQUIRED | |

**No Asbestos Presumed in Sample**

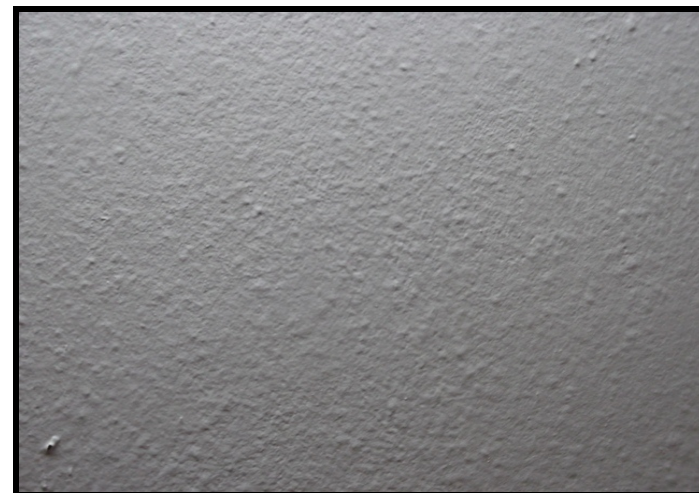
## SAMPLE REFERENCE 015

| Unique Sample No. | Building Reference (Floor) | Room Area | Description of Location | Product Description | Asbestos Type | Approx. Quantity | Material Condition | Surface Treatment | Material Risk Score | Priority Risk Score | Total Risk Score | Management Action | Next Review Date |
|---|---|---|---|---|---|---|---|---|---|---|---|---|---|
| 015 | Main Building (Tenth Floor) | Landing | Ceiling | Textured Coating | No Asbestos Detected | 15.00m2 | Low damage | Textured Coating | - | - | - | NO ACTION REQUIRED | |

**No Asbestos Presumed in Sample**

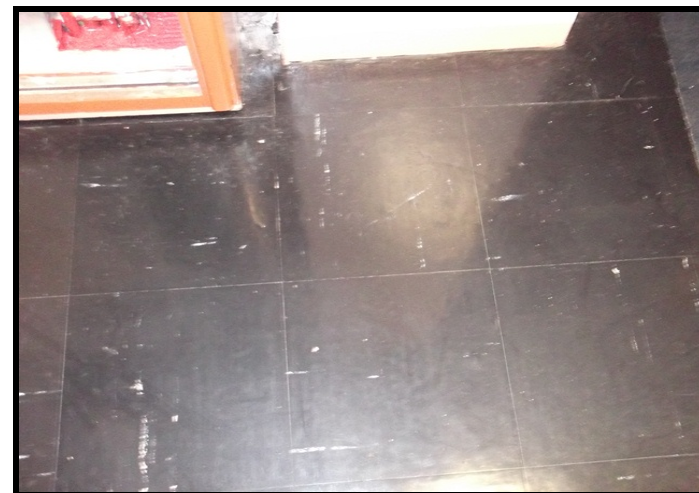
## SAMPLE REFERENCE 016

| Unique Sample No. | Building Reference (Floor) | Room Area | Description of Location | Product Description | Asbestos Type | Approx. Quantity | Material Condition | Surface Treatment | Material Risk Score | Priority Risk Score | Total Risk Score | Management Action | Next Review Date |
|---|---|---|---|---|---|---|---|---|---|---|---|---|---|
| 016 | Main Building (Nineth Floor) | Corridor 1 | Floor | Paper | No Asbestos Detected | 15.00m2 | Low damage | Sealed (1) | - | - | - | NO ACTION REQUIRED | |

Asbestos not detected in Sample

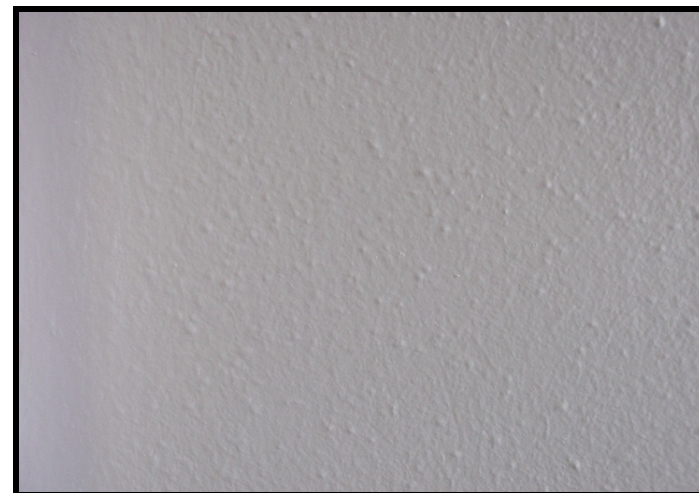
## SAMPLE REFERENCE 017

| Unique Sample No. | Building Reference (Floor) | Room Area | Description of Location | Product Description | Asbestos Type | Approx. Quantity | Material Condition | Surface Treatment | Material Risk Score | Priority Risk Score | Total Risk Score | Management Action | Next Review Date |
|---|---|---|---|---|---|---|---|---|---|---|---|---|---|
| 017 | Main Building (Nineth Floor) | Corridor 1 | Walls | Textured Coating | No Asbestos Detected | 20.00m2 | Low damage | Textured Coating | - | - | - | NO ACTION REQUIRED | |

**Asbestos not detected in Sample**

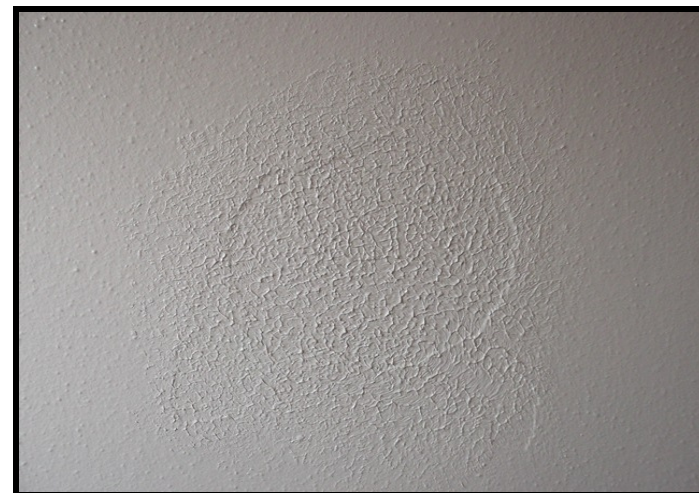
## SAMPLE REFERENCE 018

| Unique Sample No. | Building Reference (Floor) | Room Area | Description of Location | Product Description | Asbestos Type | Approx. Quantity | Material Condition | Surface Treatment | Material Risk Score | Priority Risk Score | Total Risk Score | Management Action | Next Review Date |
|---|---|---|---|---|---|---|---|---|---|---|---|---|---|
| 018 | Main Building (Nineth Floor) | Corridor 1 | Ceiling | Textured Coating | No Asbestos Detected | 1.00m2 | Low damage | Textured Coating | - | - | - | NO ACTION REQUIRED | |

**Asbestos not detected in Sample**

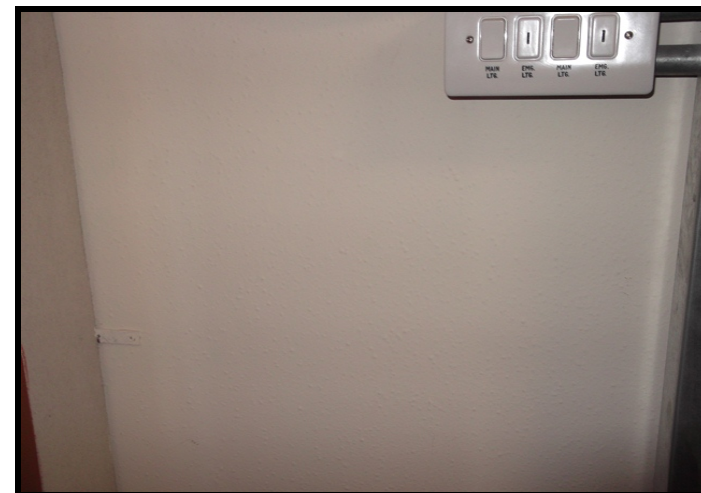
## SAMPLE REFERENCE 019

| Unique Sample No. | Building Reference (Floor) | Room Area | Description of Location | Product Description | Asbestos Type | Approx. Quantity | Material Condition | Surface Treatment | Material Risk Score | Priority Risk Score | Total Risk Score | Management Action | Next Review Date |
|---|---|---|---|---|---|---|---|---|---|---|---|---|---|
| 019 | Main Building (Nineth Floor) | Electric Store | Walls | Textured Coating | No Asbestos Detected | 2.00m2 | Low damage | Textured Coating | - | - | - | NO ACTION REQUIRED | |

**No Asbestos Presumed in Sample**

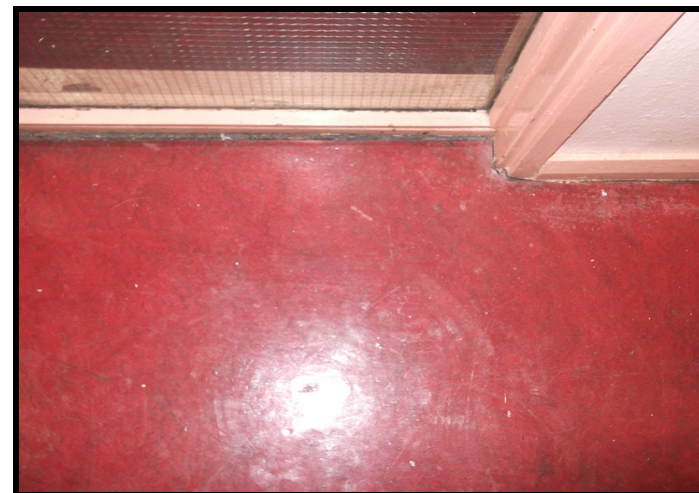
## SAMPLE REFERENCE 020

| Unique Sample No. | Building Reference (Floor) | Room Area | Description of Location | Product Description | Asbestos Type | Approx. Quantity | Material Condition | Surface Treatment | Material Risk Score | Priority Risk Score | Total Risk Score | Management Action | Next Review Date |
|---|---|---|---|---|---|---|---|---|---|---|---|---|---|
| 020 | Main Building (Nineth Floor) | Corridor 2 | Floor | Paper | No Asbestos Detected | 12.00m2 | Low damage | Sealed (0) | - | - | - | NO ACTION REQUIRED | |

**Asbestos not detected in Sample**

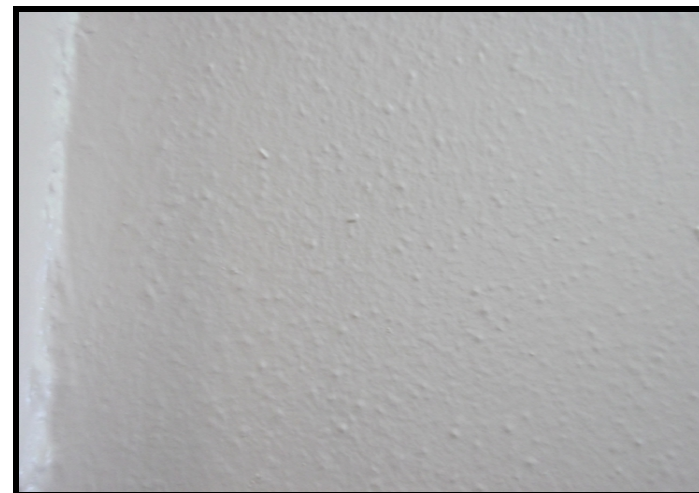
## SAMPLE REFERENCE 022

| Unique Sample No. | Building Reference (Floor) | Room Area | Description of Location | Product Description | Asbestos Type | Approx. Quantity | Material Condition | Surface Treatment | Material Risk Score | Priority Risk Score | Total Risk Score | Management Action | Next Review Date |
|---|---|---|---|---|---|---|---|---|---|---|---|---|---|
| 022 | Main Building (Nineth Floor) | Corridor 3 | Walls | Textured Coating | No Asbestos Detected | 20.00m2 | Low damage | Textured Coating | - | - | - | NO ACTION REQUIRED | |

**No Asbestos Presumed in Sample**

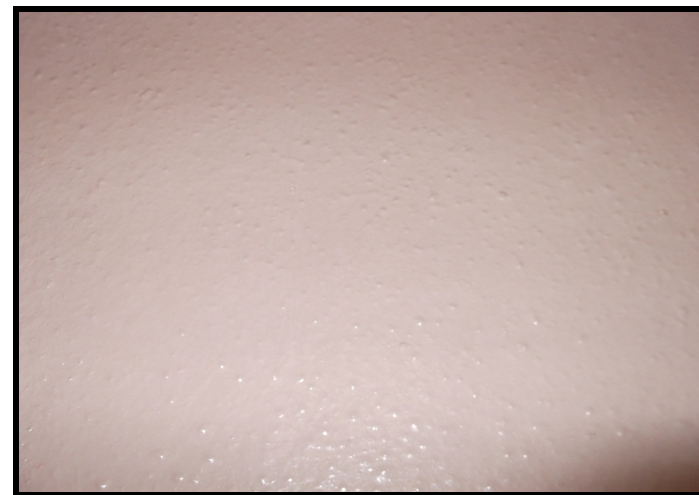
## SAMPLE REFERENCE 025

| Unique Sample No. | Building Reference (Floor) | Room Area | Description of Location | Product Description | Asbestos Type | Approx. Quantity | Material Condition | Surface Treatment | Material Risk Score | Priority Risk Score | Total Risk Score | Management Action | Next Review Date |
|---|---|---|---|---|---|---|---|---|---|---|---|---|---|
| 025 | Main Building (Nineth Floor) | Bin Shaft | Walls | Textured Coating | No Asbestos Detected | 8.00m2 | Low damage | Textured Coating | - | - | - | NO ACTION REQUIRED | |

**No Asbestos Presumed in Sample**

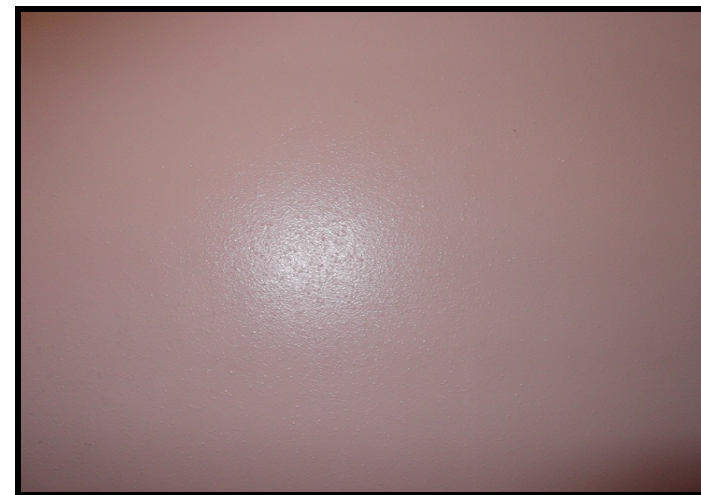
## SAMPLE REFERENCE 026

| Unique Sample No. | Building Reference (Floor) | Room Area | Description of Location | Product Description | Asbestos Type | Approx. Quantity | Material Condition | Surface Treatment | Material Risk Score | Priority Risk Score | Total Risk Score | Management Action | Next Review Date |
|---|---|---|---|---|---|---|---|---|---|---|---|---|---|
| 026 | Main Building (Nineth Floor) | Landing | Walls | Textured Coating | No Asbestos Detected | 1.00m2 | Low damage | Textured Coating | - | - | - | NO ACTION REQUIRED | |

**No Asbestos Presumed in Sample**

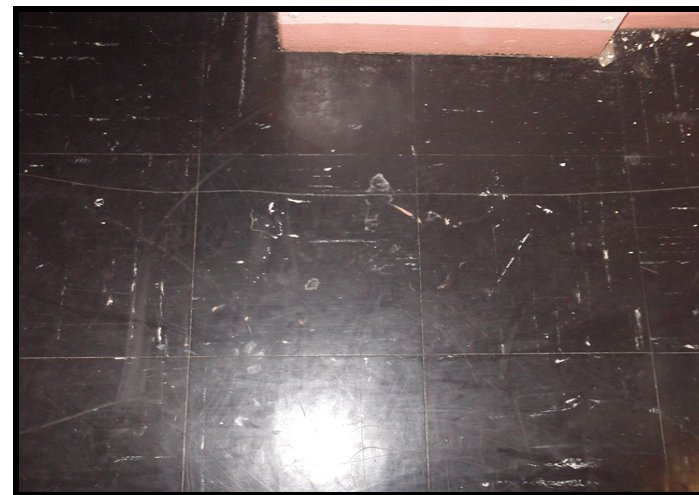
## SAMPLE REFERENCE 027

| Unique Sample No. | Building Reference (Floor) | Room Area | Description of Location | Product Description | Asbestos Type | Approx. Quantity | Material Condition | Surface Treatment | Material Risk Score | Priority Risk Score | Total Risk Score | Management Action | Next Review Date |
|---|---|---|---|---|---|---|---|---|---|---|---|---|---|
| 027 | Main Building (Eighth Floor) | Corridor 1 | Floor | Floor Tiles & Adhesive | No Asbestos Detected | 15.00m2 | Low damage | Composite materials | - | - | - | NO ACTION REQUIRED | |

**Asbestos not detected in Sample**

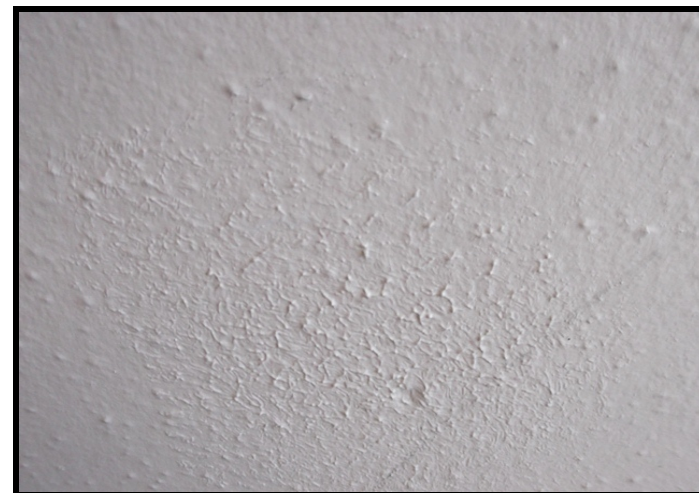
## SAMPLE REFERENCE 028

| Unique Sample No. | Building Reference (Floor) | Room Area | Description of Location | Product Description | Asbestos Type | Approx. Quantity | Material Condition | Surface Treatment | Material Risk Score | Priority Risk Score | Total Risk Score | Management Action | Next Review Date |
|---|---|---|---|---|---|---|---|---|---|---|---|---|---|
| 028 | Main Building (Eighth Floor) | Corridor 1 | Ceiling | Textured Coating | No Asbestos Detected | 20.00m2 | Low damage | Textured Coating | - | - | - | NO ACTION REQUIRED | |

Asbestos not detected in Sample

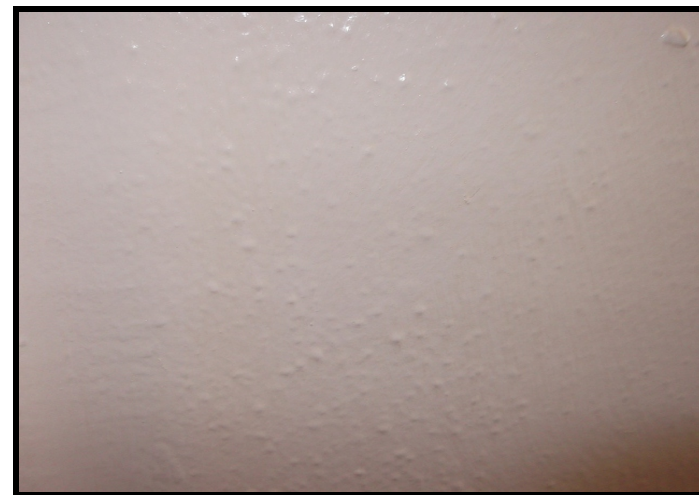
## SAMPLE REFERENCE 029

| Unique Sample No. | Building Reference (Floor) | Room Area | Description of Location | Product Description | Asbestos Type | Approx. Quantity | Material Condition | Surface Treatment | Material Risk Score | Priority Risk Score | Total Risk Score | Management Action | Next Review Date |
|---|---|---|---|---|---|---|---|---|---|---|---|---|---|
| 029 | Main Building (Eighth Floor) | Corridor 1 | Walls | Textured Coating | No Asbestos Detected | 1.00m2 | Good condition | Textured Coating | - | - | - | NO ACTION REQUIRED | |

**Asbestos not detected in Sample**

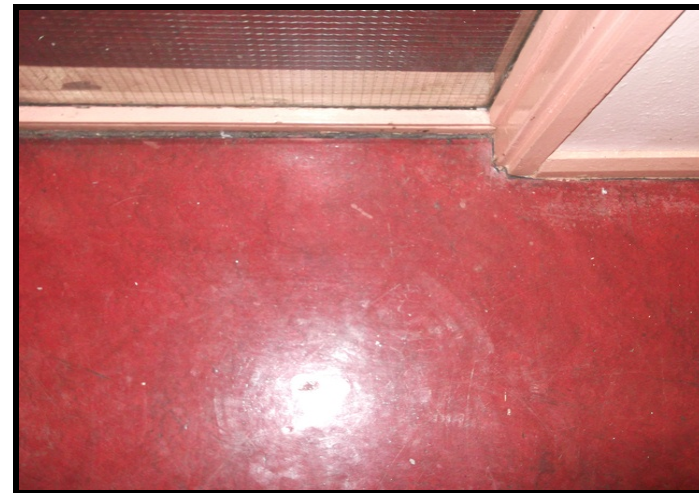
## SAMPLE REFERENCE 031

| Unique Sample No. | Building Reference (Floor) | Room Area | Description of Location | Product Description | Asbestos Type | Approx. Quantity | Material Condition | Surface Treatment | Material Risk Score | Priority Risk Score | Total Risk Score | Management Action | Next Review Date |
|---|---|---|---|---|---|---|---|---|---|---|---|---|---|
| 031 | Main Building (Eighth Floor) | Corridor 2 | Floor | Paper | No Asbestos Detected | 12.00m2 | Low damage | Sealed (0) | - | - | - | NO ACTION REQUIRED | |

Asbestos not detected in Sample

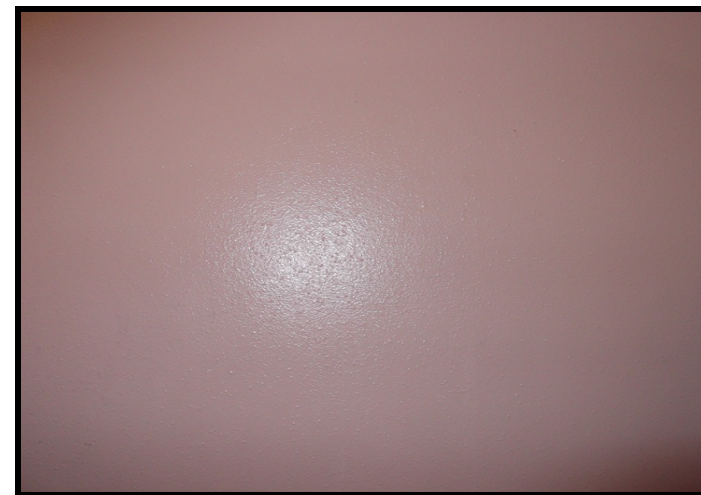
## SAMPLE REFERENCE 032

| Unique Sample No. | Building Reference (Floor) | Room Area | Description of Location | Product Description | Asbestos Type | Approx. Quantity | Material Condition | Surface Treatment | Material Risk Score | Priority Risk Score | Total Risk Score | Management Action | Next Review Date |
|---|---|---|---|---|---|---|---|---|---|---|---|---|---|
| 032 | Main Building (Eighth Floor) | Corridor 2 | Wall | Textured Coating | No Asbestos Detected | 20.00m2 | Low damage | Textured Coating | - | - | - | NO ACTION REQUIRED | |

**No Asbestos Presumed in Sample**

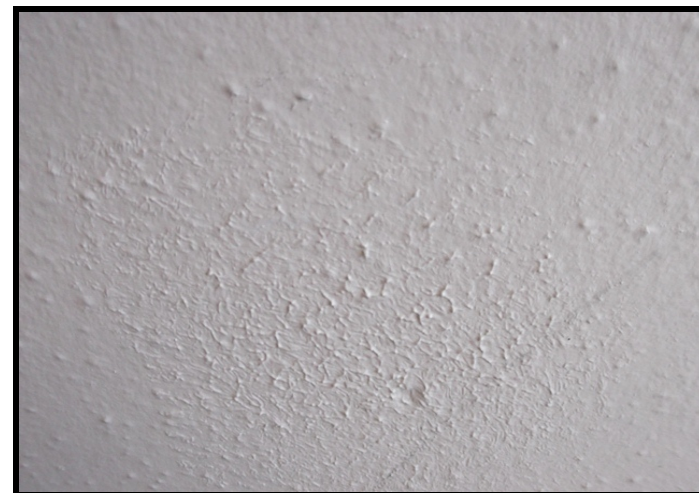
## SAMPLE REFERENCE 035

| Unique Sample No. | Building Reference (Floor) | Room Area | Description of Location | Product Description | Asbestos Type | Approx. Quantity | Material Condition | Surface Treatment | Material Risk Score | Priority Risk Score | Total Risk Score | Management Action | Next Review Date |
|---|---|---|---|---|---|---|---|---|---|---|---|---|---|
| 035 | Main Building (Eighth Floor) | Corridor 3 | Ceiling | Textured Coating | No Asbestos Detected | 6.00m2 | Low damage | Textured Coating | - | - | - | NO ACTION REQUIRED | |

**Asbestos not detected in Sample**

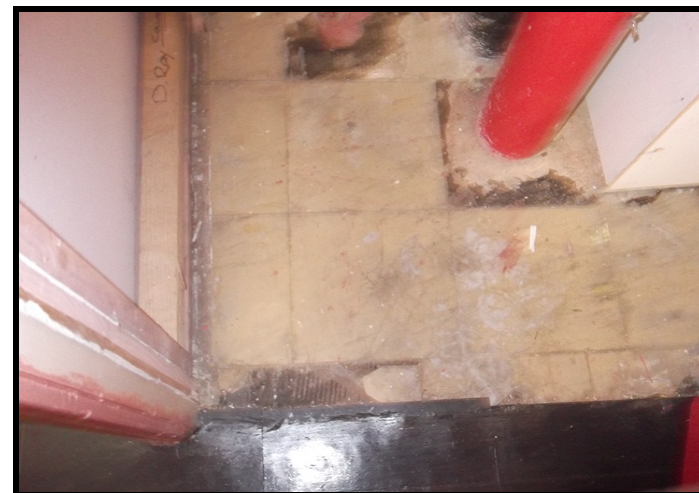
## SAMPLE REFERENCE 036

| Unique Sample No. | Building Reference (Floor) | Room Area | Description of Location | Product Description | Asbestos Type | Approx. Quantity | Material Condition | Surface Treatment | Material Risk Score | Priority Risk Score | Total Risk Score | Management Action | Next Review Date |
|---|---|---|---|---|---|---|---|---|---|---|---|---|---|
| 036 | Main Building (Eighth Floor) | Dry Riser | Floor | Floor Tiles & Adhesive | Chrysotile | 1.00m2 | Medium damage | Composite materials | 4 | 1 | 5 | LABEL & MONITOR | 22 Mar 2013 |

**Asbestos detected in Sample**

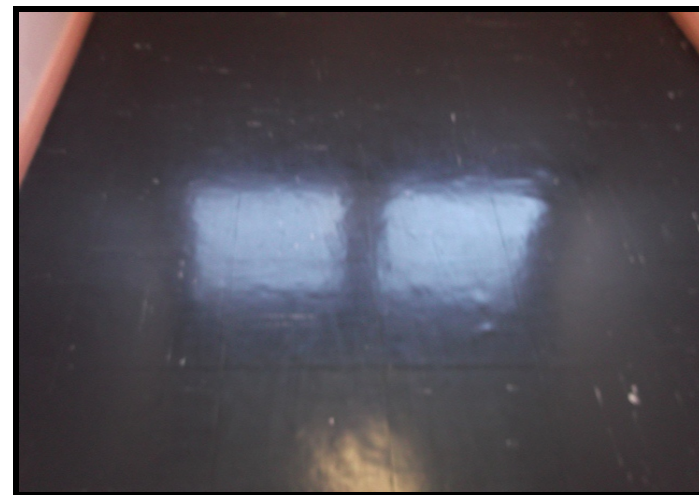
## SAMPLE REFERENCE 038

| Unique Sample No. | Building Reference (Floor) | Room Area | Description of Location | Product Description | Asbestos Type | Approx. Quantity | Material Condition | Surface Treatment | Material Risk Score | Priority Risk Score | Total Risk Score | Management Action | Next Review Date |
|---|---|---|---|---|---|---|---|---|---|---|---|---|---|
| 038 | Main Building (Seventh Floor) | Corridor 1 | Floor | Floor Tiles & Adhesive | No Asbestos Detected | 15.00m2 | Low damage | Composite materials | - | - | - | NO ACTION REQUIRED | |

**No Asbestos Presumed in Sample**

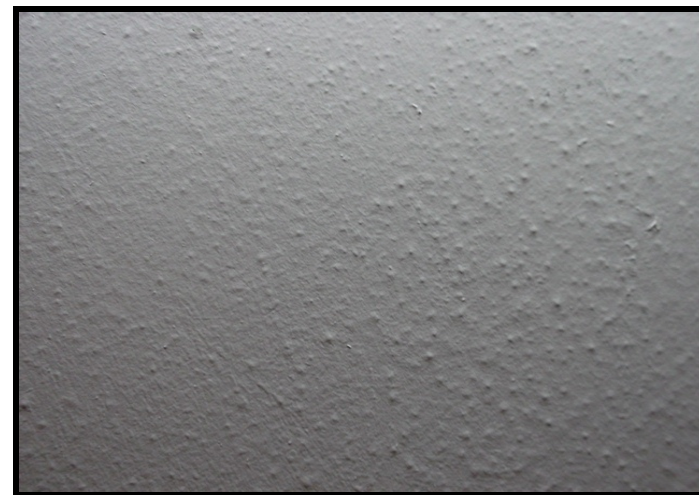
## SAMPLE REFERENCE 040

| Unique Sample No. | Building Reference (Floor) | Room Area | Description of Location | Product Description | Asbestos Type | Approx. Quantity | Material Condition | Surface Treatment | Material Risk Score | Priority Risk Score | Total Risk Score | Management Action | Next Review Date |
|---|---|---|---|---|---|---|---|---|---|---|---|---|---|
| 040 | Main Building (Seventh Floor) | Corridor 1 | Walls | Textured Coating | No Asbestos Detected | 1.00m2 | Good condition | Textured Coating | - | - | - | NO ACTION REQUIRED | |

**No Asbestos Presumed in Sample**

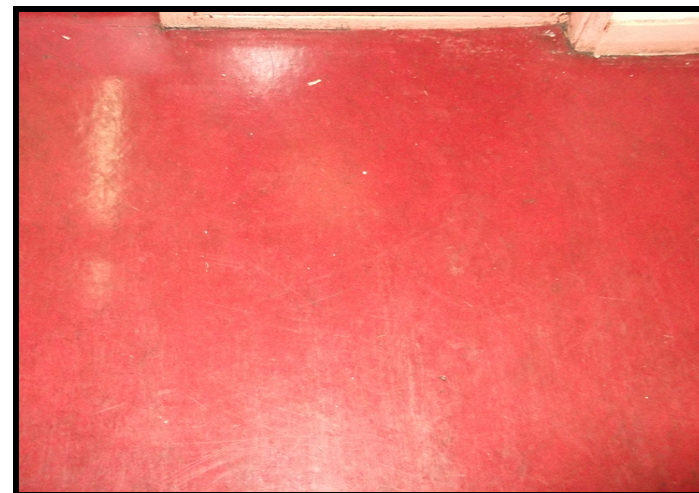
## SAMPLE REFERENCE 041

| Unique Sample No. | Building Reference (Floor) | Room Area | Description of Location | Product Description | Asbestos Type | Approx. Quantity | Material Condition | Surface Treatment | Material Risk Score | Priority Risk Score | Total Risk Score | Management Action | Next Review Date |
|---|---|---|---|---|---|---|---|---|---|---|---|---|---|
| 041 | Main Building (Seventh Floor) | Corridor 2 | Floor | Paper | No Asbestos Detected | 12.00m2 | Low damage | Sealed (0) | - | - | - | NO ACTION REQUIRED | |

**No Asbestos Presumed in Sample**

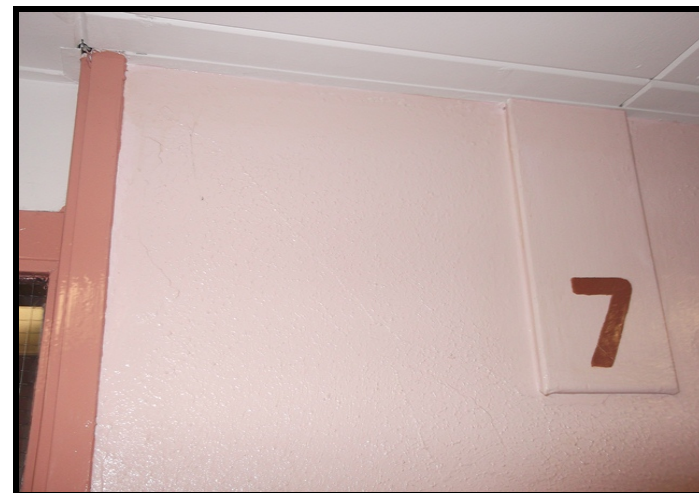
## SAMPLE REFERENCE 042

| Unique Sample No. | Building Reference (Floor) | Room Area | Description of Location | Product Description | Asbestos Type | Approx. Quantity | Material Condition | Surface Treatment | Material Risk Score | Priority Risk Score | Total Risk Score | Management Action | Next Review Date |
|---|---|---|---|---|---|---|---|---|---|---|---|---|---|
| 042 | Main Building (Seventh Floor) | Corridor 2 | Wall | Textured Coating | No Asbestos Detected | 2.00m2 | Low damage | Textured Coating | - | - | - | NO ACTION REQUIRED | |

**No Asbestos Presumed in Sample**

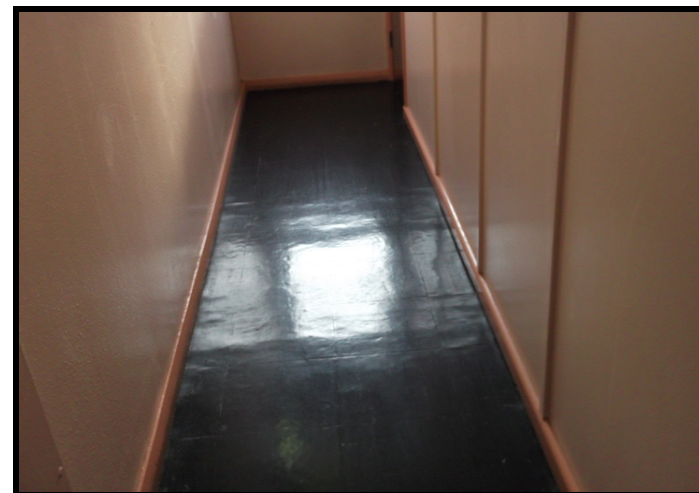
## SAMPLE REFERENCE 043

**No Asbestos Presumed in Sample**

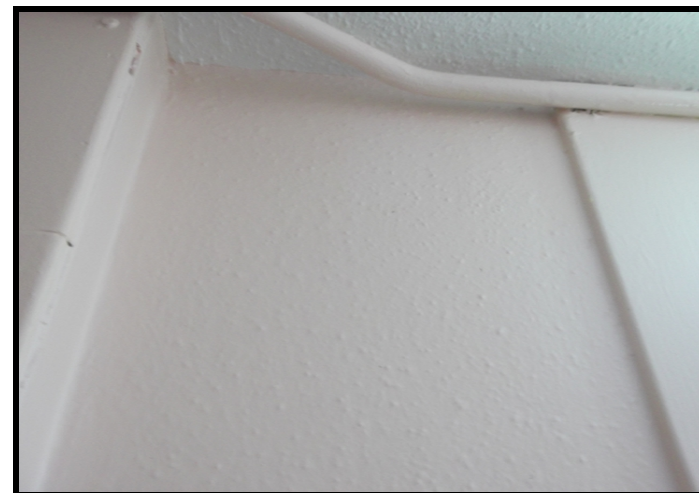
## SAMPLE REFERENCE 044

**No Asbestos Presumed in Sample**

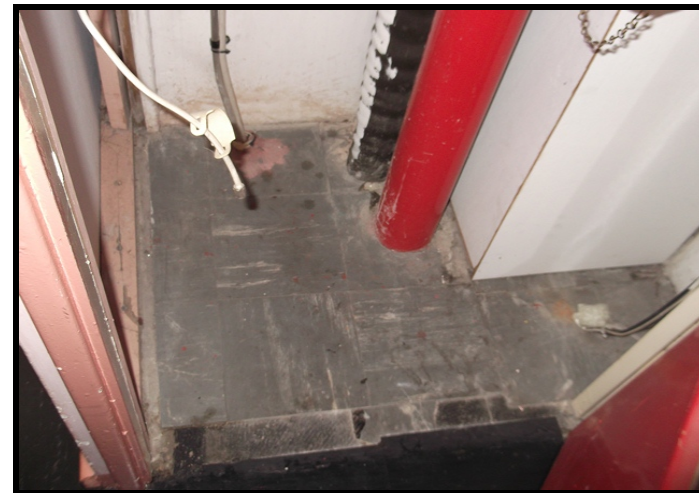
## SAMPLE REFERENCE 045

**Asbestos Presumed in Sample**

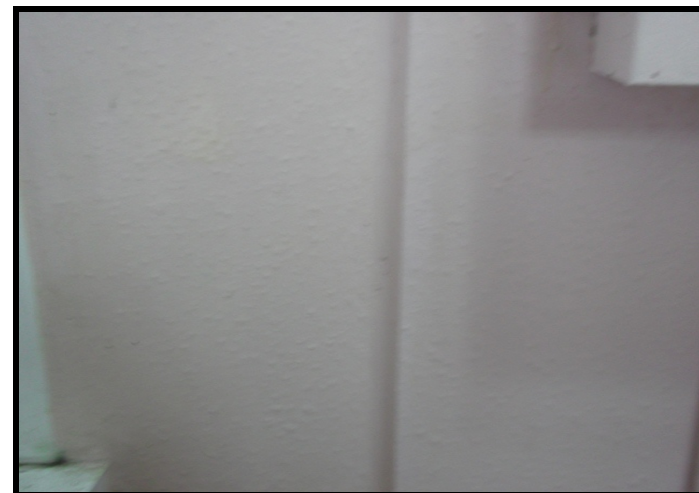
## SAMPLE REFERENCE 047

**No Asbestos Presumed in Sample**

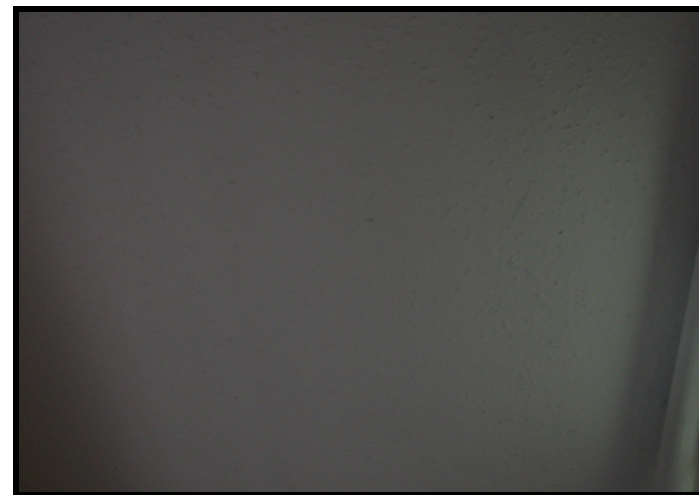
## SAMPLE REFERENCE 048

**No Asbestos Presumed in Sample**

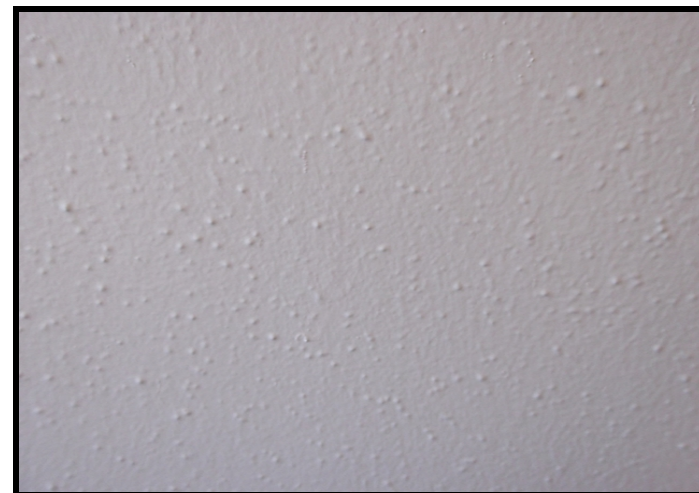
## SAMPLE REFERENCE 049

**No Asbestos Presumed in Sample**

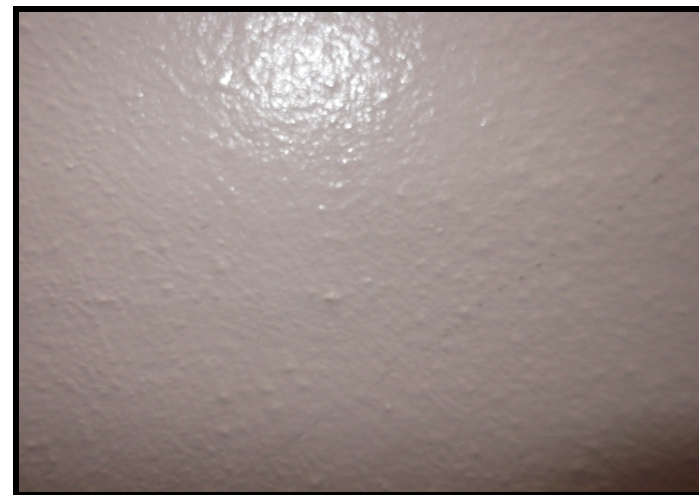
## SAMPLE REFERENCE 050

**No Asbestos Presumed in Sample**

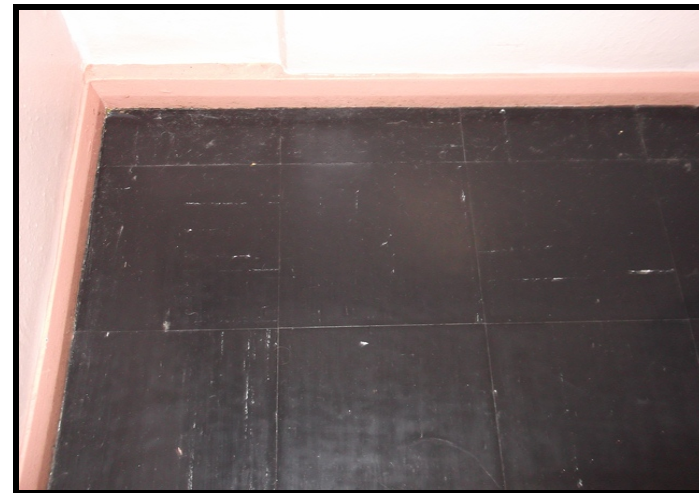
## SAMPLE REFERENCE 051

**No Asbestos Presumed in Sample**

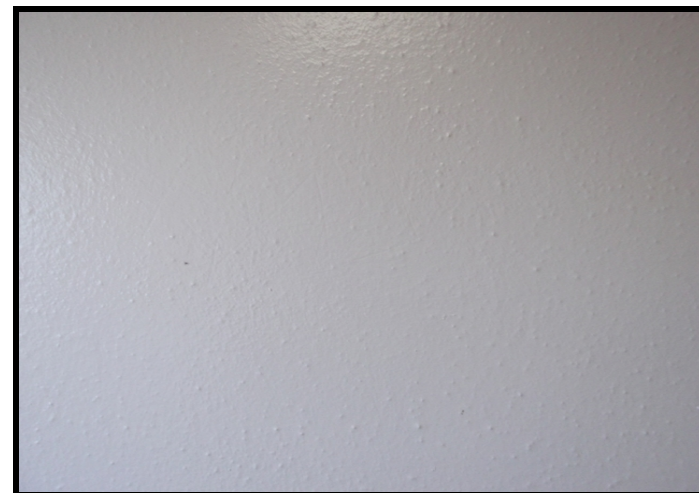
## SAMPLE REFERENCE 052

**No Asbestos Presumed in Sample**

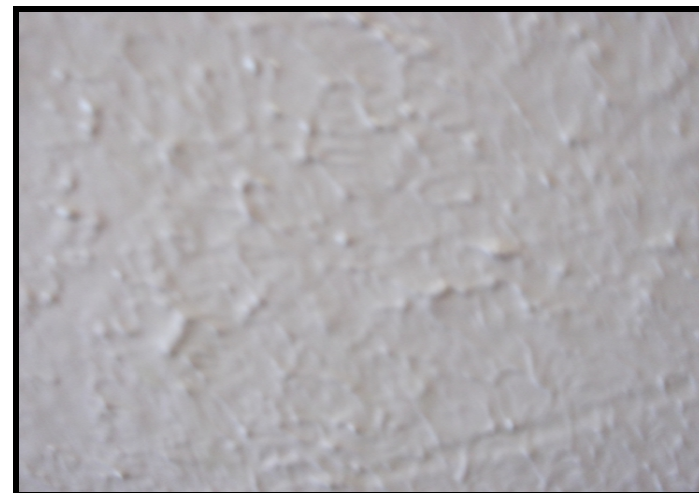
## SAMPLE REFERENCE 053

**No Asbestos Presumed in Sample**

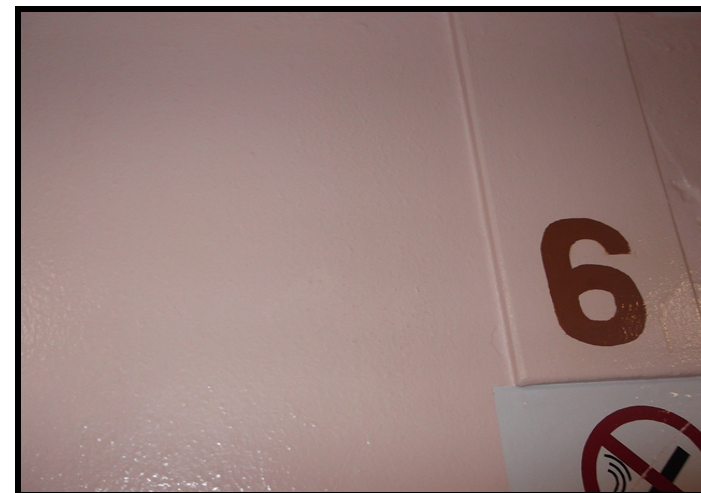
## SAMPLE REFERENCE 057

**No Asbestos Presumed in Sample**

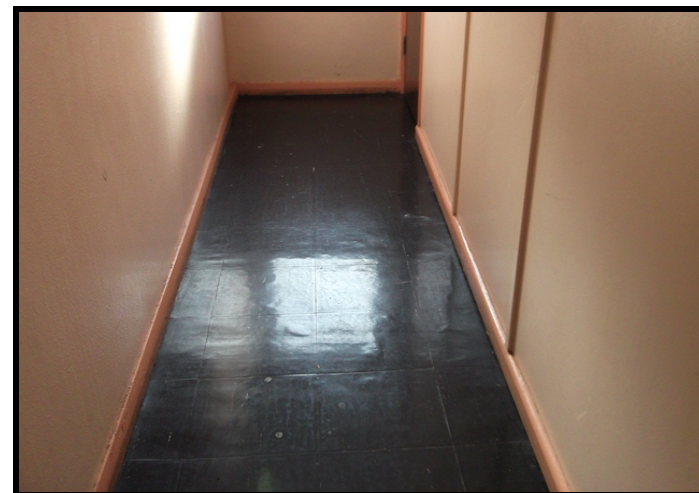
## SAMPLE REFERENCE 058

**No Asbestos Presumed in Sample**

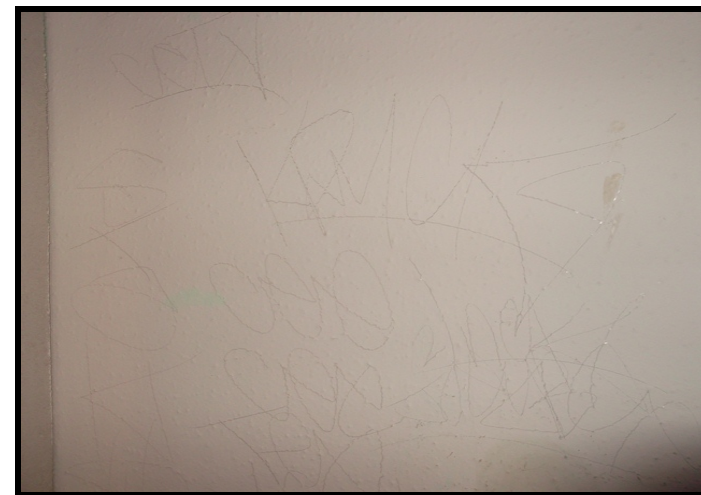
## SAMPLE REFERENCE 060

**No Asbestos Presumed in Sample**

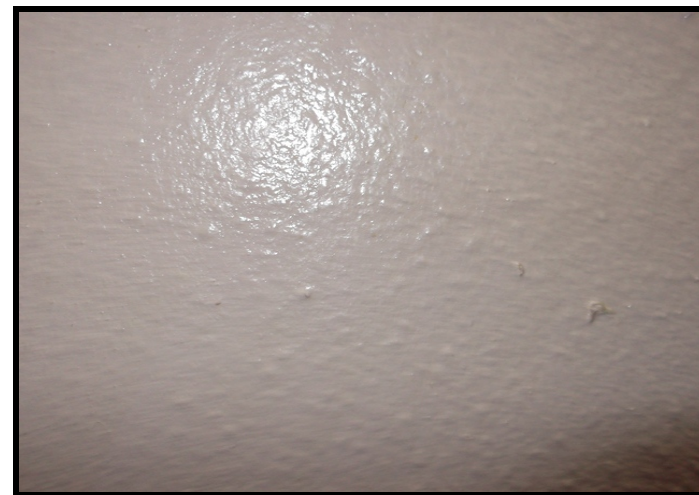
## SAMPLE REFERENCE 061

**No Asbestos Presumed in Sample**

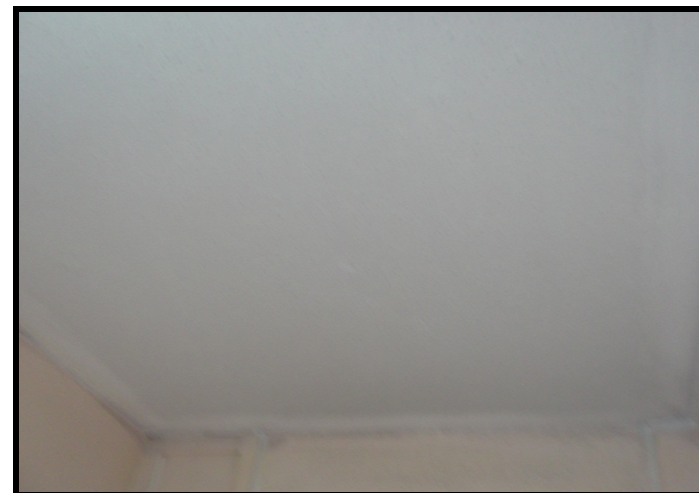
## SAMPLE REFERENCE 063

**No Asbestos Presumed in Sample**

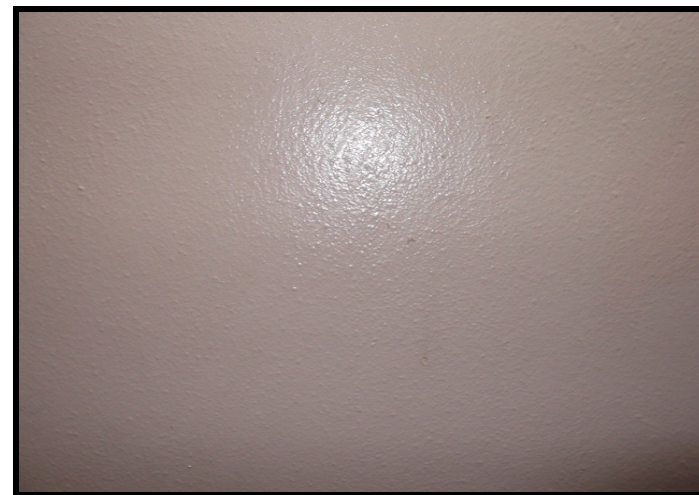
## SAMPLE REFERENCE 064

**No Asbestos Presumed in Sample**

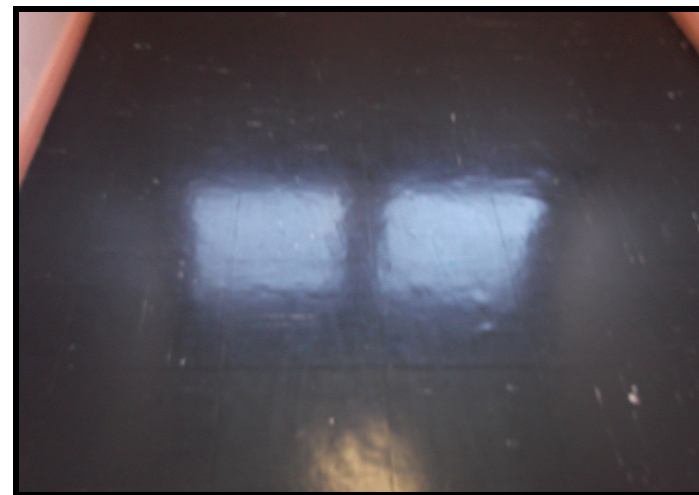
## SAMPLE REFERENCE 065

**No Asbestos Presumed in Sample**
