# **Solihull Community Housing**

## **Asbestos Management Survey Report**

**Oriel House  
Blackcat Close  
Chelmsley Wood  
B37 5DG**

**Date of Report: 14 May 2012**

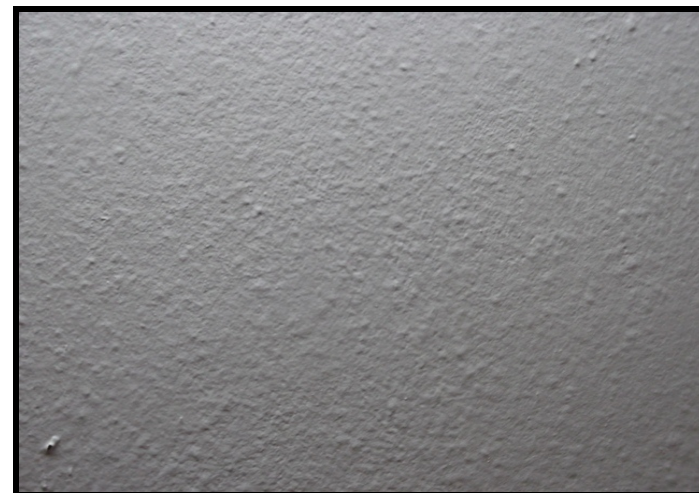
## SAMPLE REFERENCE 066

**No Asbestos Presumed in Sample**

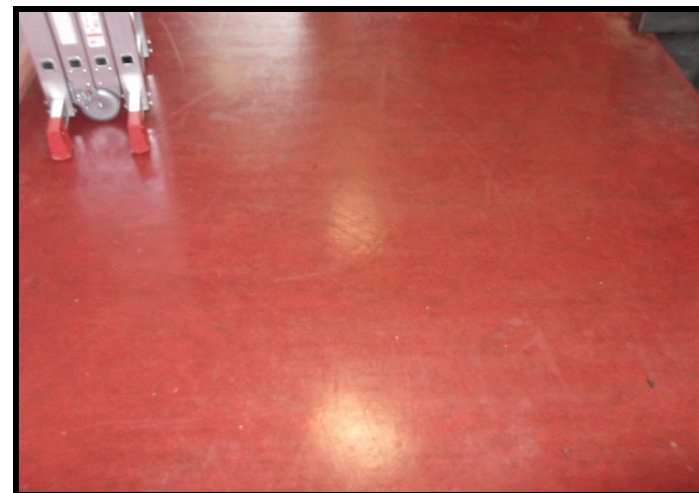
## SAMPLE REFERENCE 067

**Asbestos not detected in Sample**

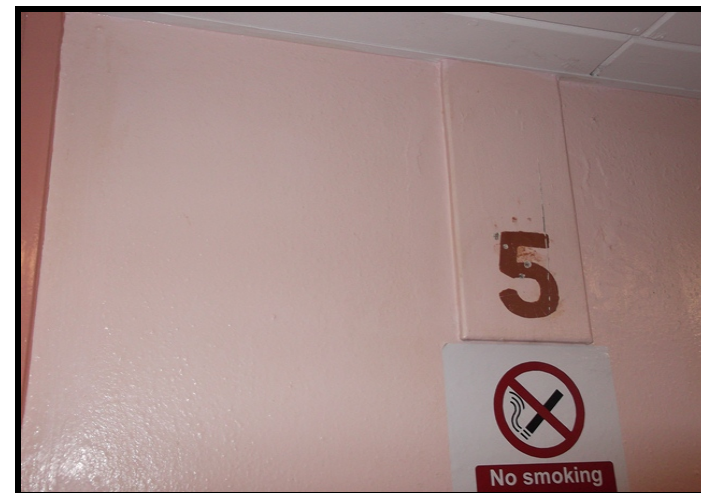
## SAMPLE REFERENCE 068

**No Asbestos Presumed in Sample**

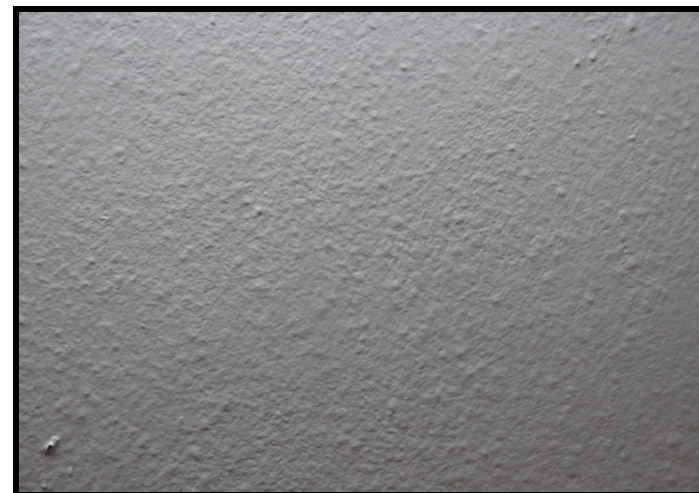
## SAMPLE REFERENCE 069

**No Asbestos Presumed in Sample**

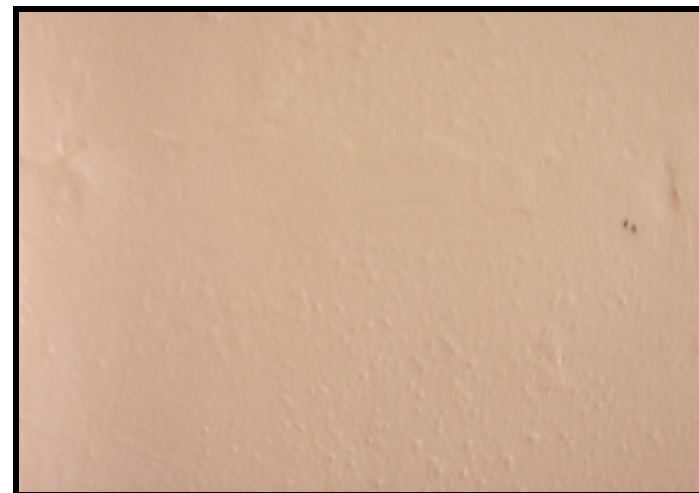
## SAMPLE REFERENCE 071

**No Asbestos Presumed in Sample**

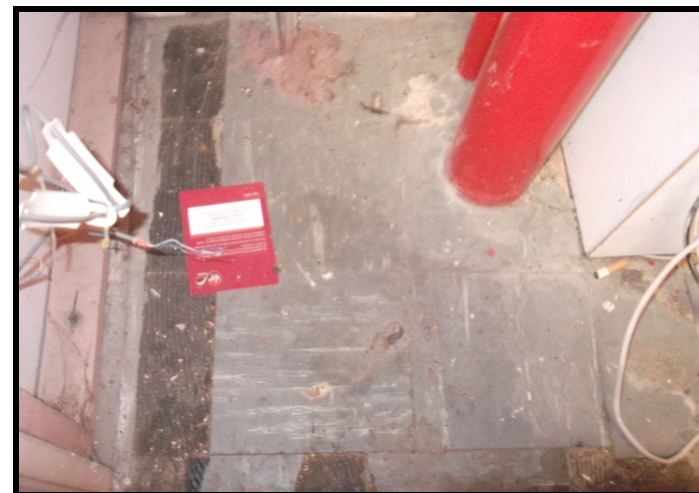
## SAMPLE REFERENCE 072

**Asbestos detected in Sample**

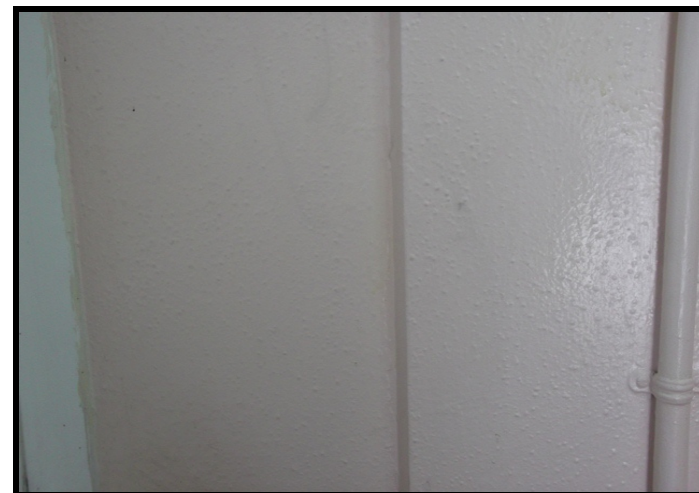
## SAMPLE REFERENCE 074

**No Asbestos Presumed in Sample**

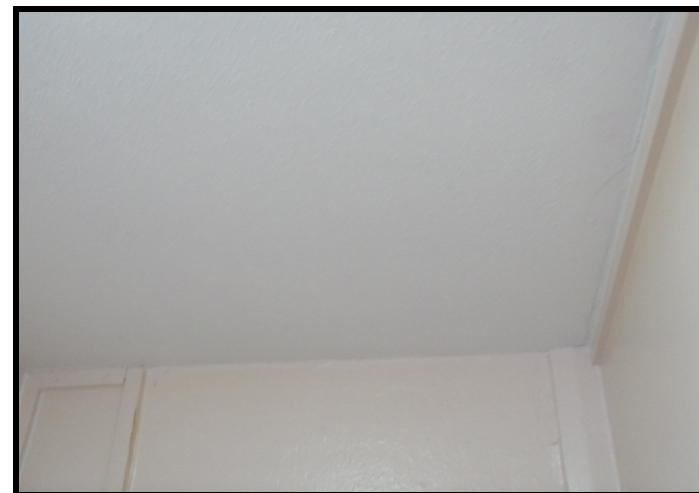
## SAMPLE REFERENCE 075

**No Asbestos Presumed in Sample**

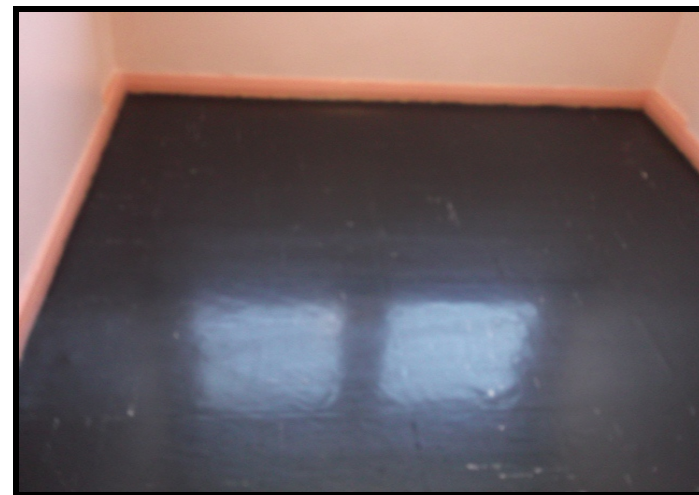
## SAMPLE REFERENCE 077

**No Asbestos Presumed in Sample**

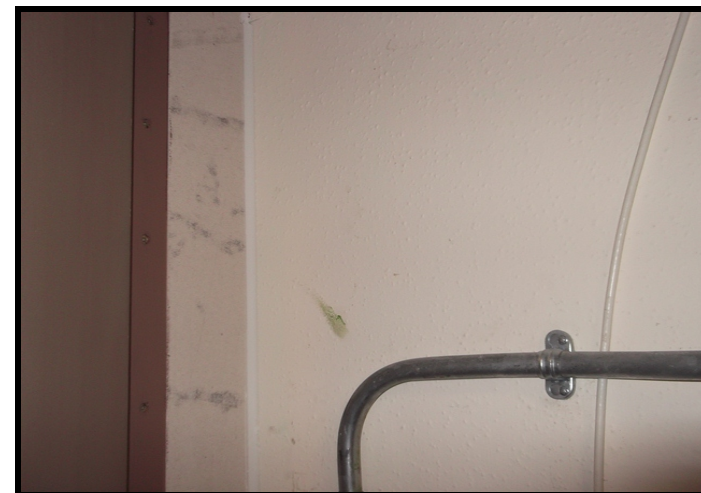
## SAMPLE REFERENCE 079

**No Asbestos Presumed in Sample**

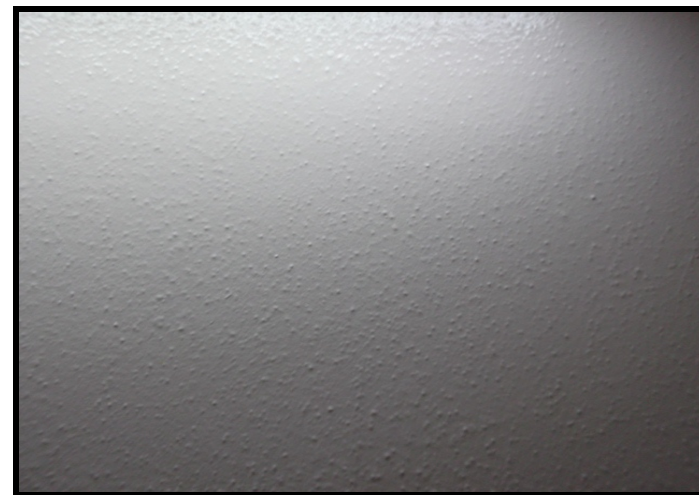
## SAMPLE REFERENCE 088

**No Asbestos Presumed in Sample**

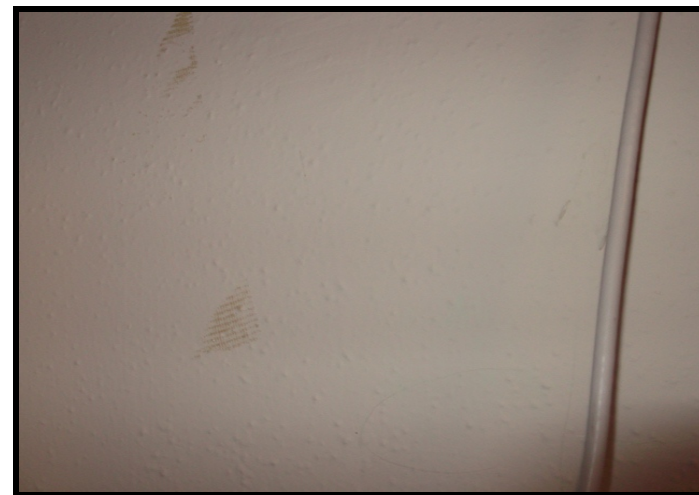
## SAMPLE REFERENCE 091

**No Asbestos Presumed in Sample**

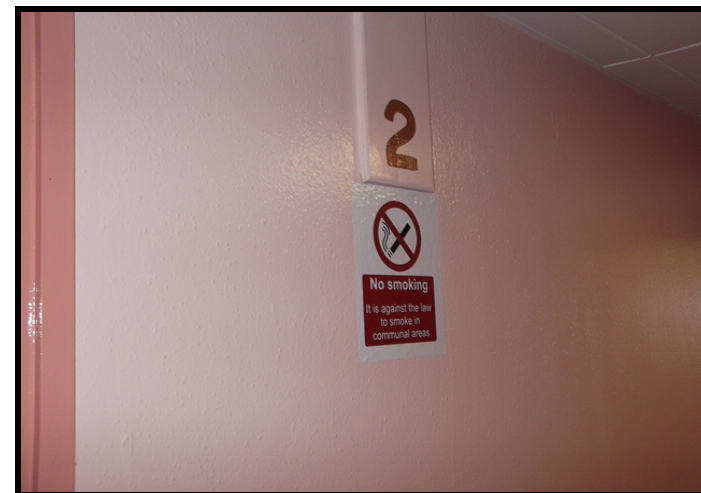
## SAMPLE REFERENCE 104

**No Asbestos Presumed in Sample**

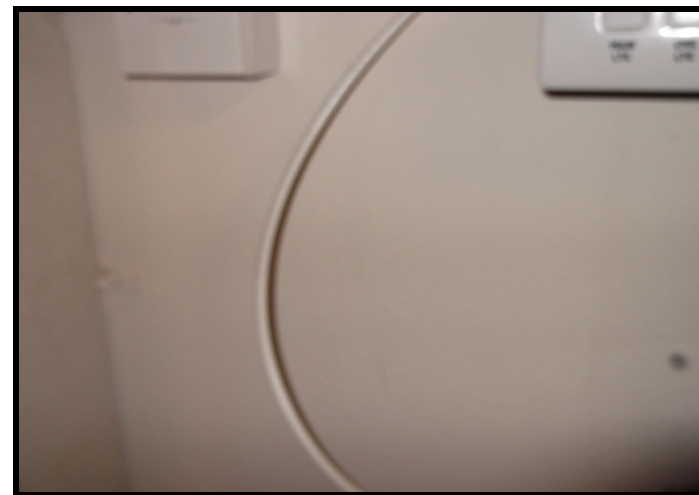
## SAMPLE REFERENCE 113

**No Asbestos Presumed in Sample**

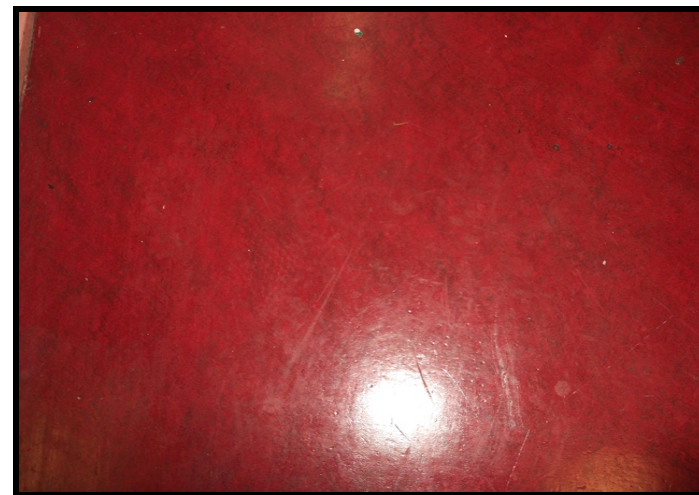
## SAMPLE REFERENCE 114

**No Asbestos Presumed in Sample**

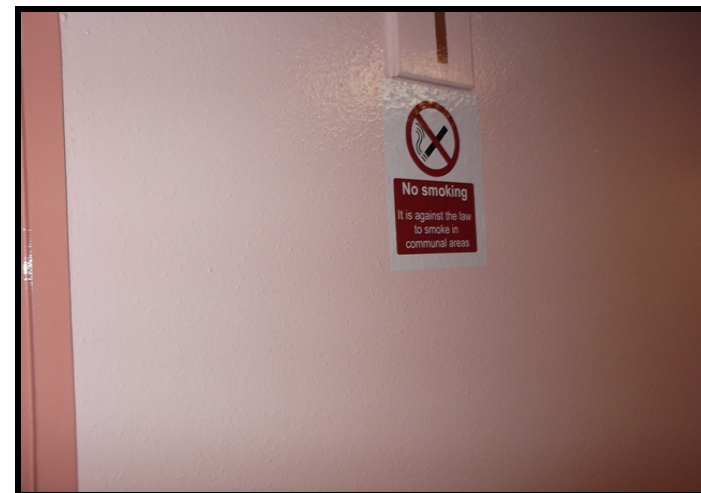
## SAMPLE REFERENCE I15

**No Asbestos Presumed in Sample**

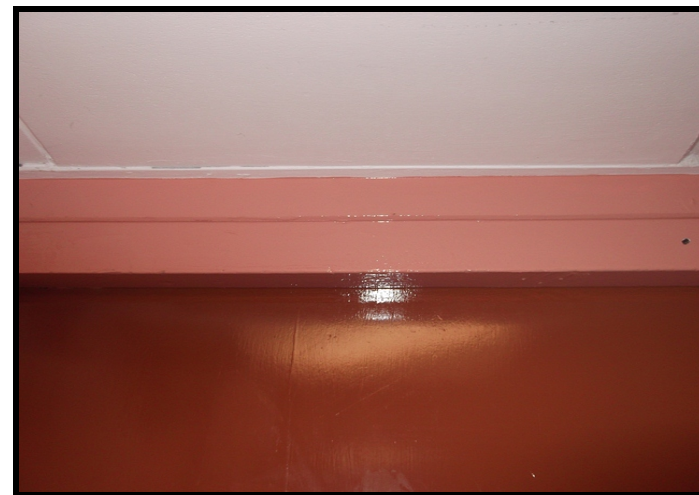
## SAMPLE REFERENCE 129

**Asbestos not detected in Sample**

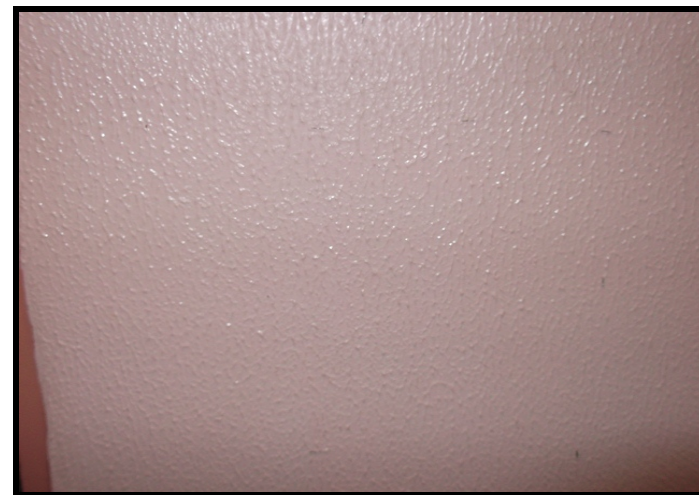
## SAMPLE REFERENCE I30

**No Asbestos Presumed in Sample**

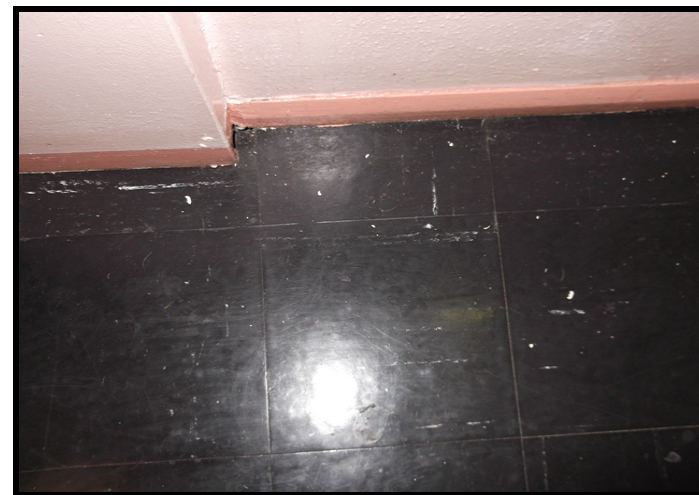
## SAMPLE REFERENCE 131

Asbestos not detected in Sample
