Site ID: **a-309621**

Management with Targeted Refurbishment Survey – PART 1

1-61 Pembroke House
Barle Grove
Chelmsley Wood
Solihull
West Midlands
B36 0UA
United Kingdom

12th June 2021

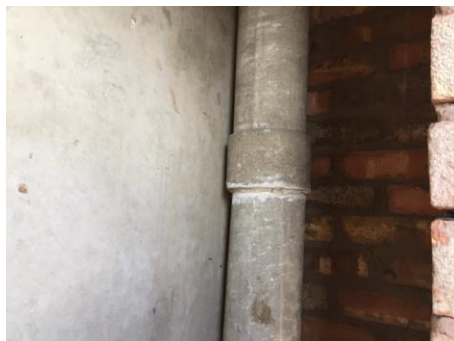
Cement flue from incinerator.

The material was seen to be in fair condition at the time of the initial inspection.

The condition of the material should be managed by a competent person/company and its presence made aware to those at risk, as part of a Control of Asbestos Regulations (CAR) 2012 compliant management strategy.

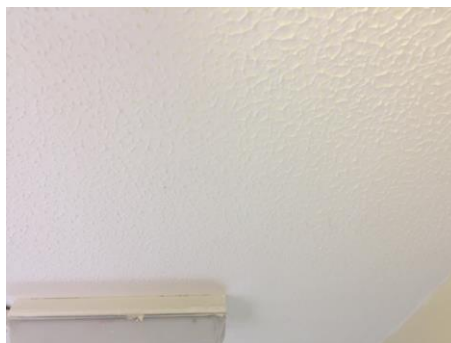
Stipple pattern textured coating.

The material was seen to be in fair condition at the time of the initial inspection.

The condition of the material should be managed by a competent person/company and its presence made aware to those at risk, as part of a Control of Asbestos Regulations (CAR) 2012 compliant management strategy.

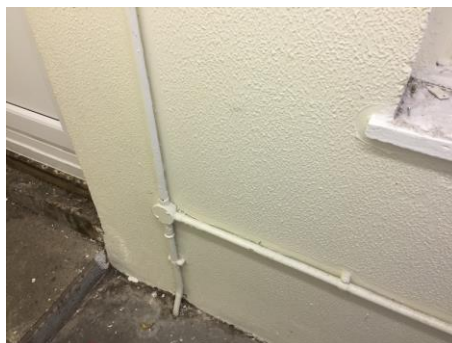
Stipple pattern textured coating.

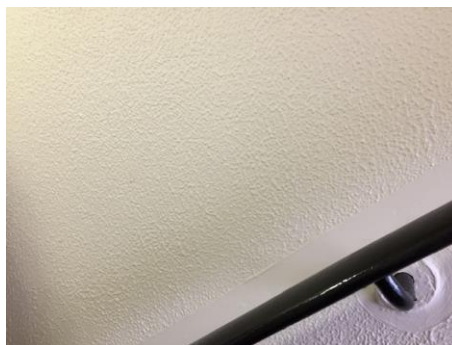
Stipple pattern textured coating.

The material was seen to be in fair condition at the time of the initial inspection.

The condition of the material should be managed by a competent person/company and its presence made aware to those at risk, as part of a Control of Asbestos Regulations (CAR) 2012 compliant management strategy.

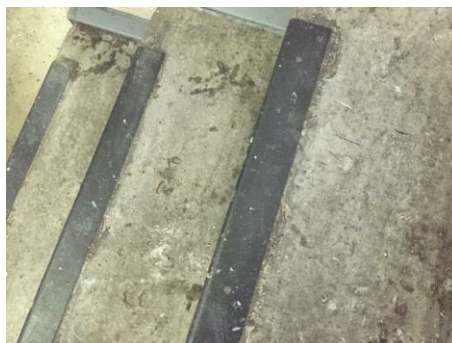
Resin nosing to edge of stairs.

The material was seen to be in fair condition at the time of the initial inspection.

The condition of the material should be managed by a competent person/company and its presence made aware to those at risk, as part of a Control of Asbestos Regulations (CAR) 2012 compliant management strategy.

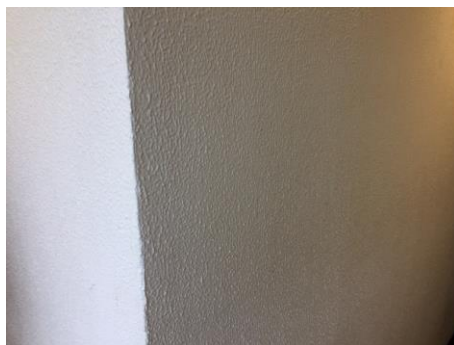
Stipple pattern textured coating.

The material was seen to be in fair condition at the time of the initial inspection.

The condition of the material should be managed by a competent person/company and its presence made aware to those at risk, as part of a Control of Asbestos Regulations (CAR) 2012 compliant management strategy.

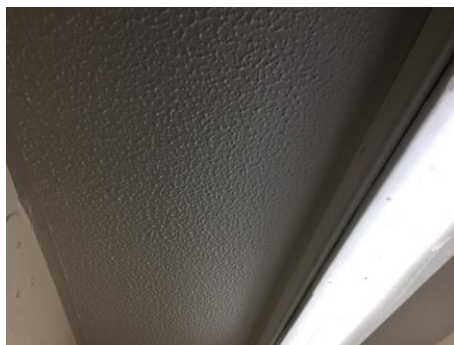
Stipple pattern textured coating.

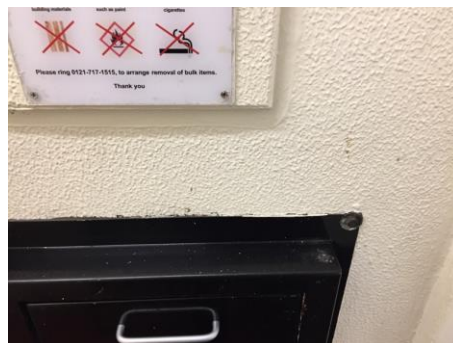
Stipple pattern textured coating.

The material was seen to be in fair condition at the time of the initial inspection.

The condition of the material should be managed by a competent person/company and its presence made aware to those at risk, as part of a Control of Asbestos Regulations (CAR) 2012 compliant management strategy.

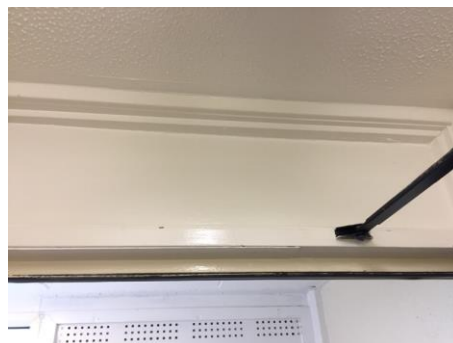
Insulating board transom panel.

The material was seen to be in fair condition at the time of the initial inspection.

The condition of the material should be managed by a competent person/company and its presence made aware to those at risk, as part of a Control of Asbestos Regulations (CAR) 2012 compliant management strategy.

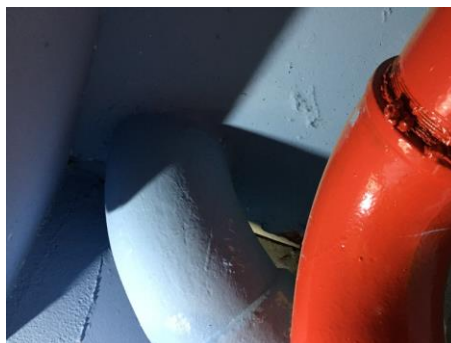
Cement flue from incinerator.

The material was seen to be in fair condition at the time of the initial inspection.

The condition of the material should be managed by a competent person/company and its presence made aware to those at risk, as part of a Control of Asbestos Regulations (CAR) 2012 compliant management strategy.

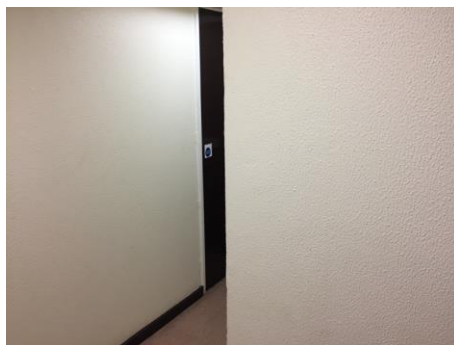
Stipple pattern textured coating.

The material was seen to be in fair condition at the time of the initial inspection.

The condition of the material should be managed by a competent person/company and its presence made aware to those at risk, as part of a Control of Asbestos Regulations (CAR) 2012 compliant management strategy.

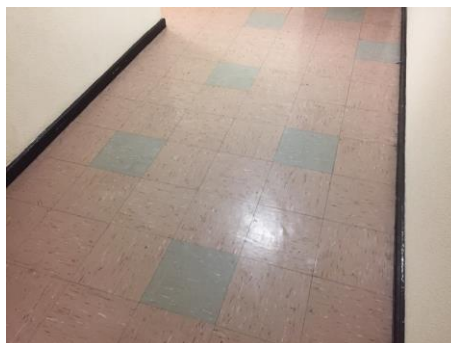
Pink and grey floor tiles.

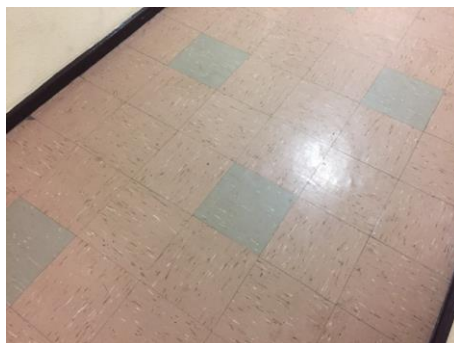
Bitumen adhesive beneath floor tiles.

The material was seen to be in fair condition at the time of the initial inspection.

The condition of the material should be managed by a competent person/company and its presence made aware to those at risk, as part of a Control of Asbestos Regulations (CAR) 2012 compliant management strategy.

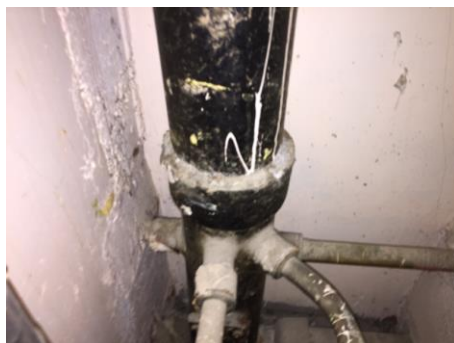
Lagging packing to joints of soil pipe.

The material was seen to be in fair condition at the time of the initial inspection.

The condition of the material should be managed by a competent person/company and its presence made aware to those at risk, as part of a Control of Asbestos Regulations (CAR) 2012 compliant management strategy.

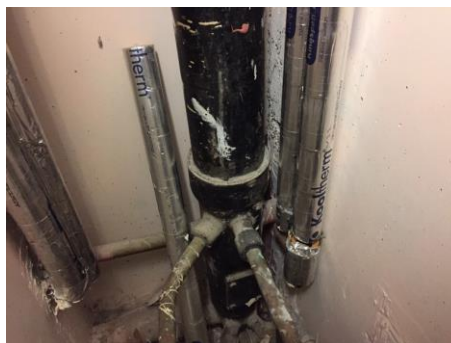
Lagging packing to joints of soil pipe.

The material was seen to be in fair condition at the time of the initial inspection.

The condition of the material should be managed by a competent person/company and its presence made aware to those at risk, as part of a Control of Asbestos Regulations (CAR) 2012 compliant management strategy.

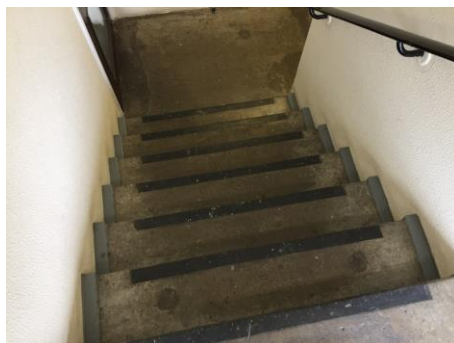
Resin nosing to edge of stairs.

The material was seen to be in fair condition at the time of the initial inspection.

The condition of the material should be managed by a competent person/company and its presence made aware to those at risk, as part of a Control of Asbestos Regulations (CAR) 2012 compliant management strategy.

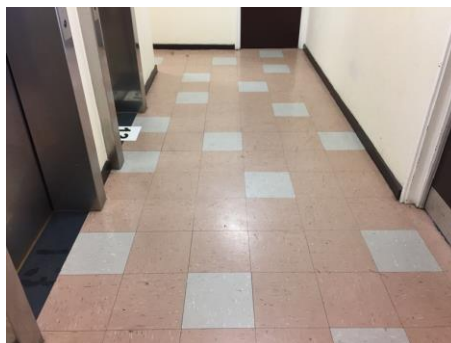
Bitumen adhesive beneath floor tiles.

The material was seen to be in fair condition at the time of the initial inspection.

The condition of the material should be managed by a competent person/company and its presence made aware to those at risk, as part of a Control of Asbestos Regulations (CAR) 2012 compliant management strategy.

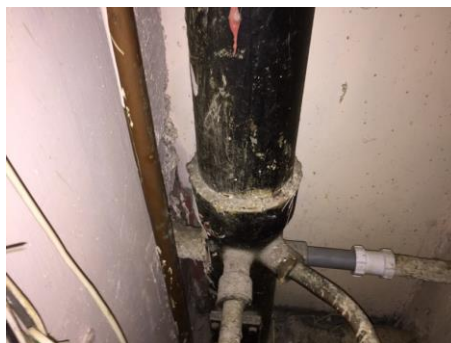
Lagging packing to joints of soil pipe.

The material was seen to be in fair condition at the time of the initial inspection.

The condition of the material should be managed by a competent person/company and its presence made aware to those at risk, as part of a Control of Asbestos Regulations (CAR) 2012 compliant management strategy.

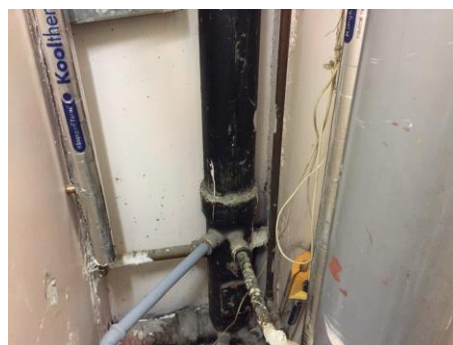
Lagging packing to joints of soil pipe.

The material was seen to be in fair condition at the time of the initial inspection.

The condition of the material should be managed by a competent person/company and its presence made aware to those at risk, as part of a Control of Asbestos Regulations (CAR) 2012 compliant management strategy.

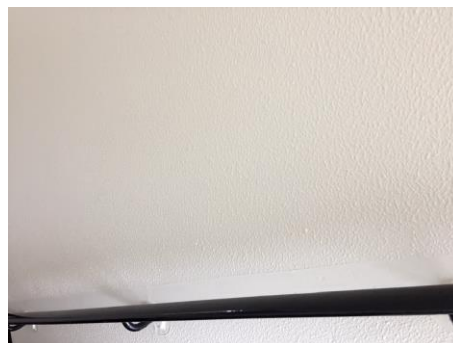
Stipple pattern textured coating.

The material was seen to be in fair condition at the time of the initial inspection.

The condition of the material should be managed by a competent person/company and its presence made aware to those at risk, as part of a Control of Asbestos Regulations (CAR) 2012 compliant management strategy.

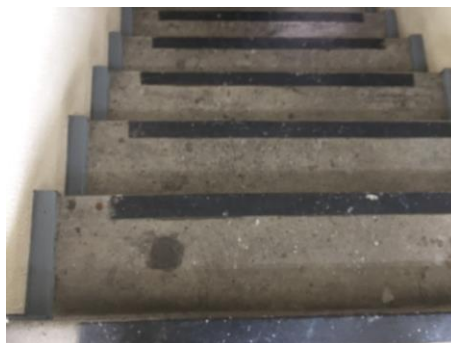
Resin nosing to edge of stairs.

The material was seen to be in fair condition at the time of the initial inspection.

The condition of the material should be managed by a competent person/company and its presence made aware to those at risk, as part of a Control of Asbestos Regulations (CAR) 2012 compliant management strategy.

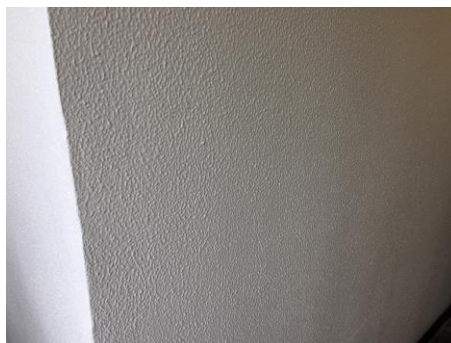
Stipple pattern textured coating.

The material was seen to be in fair condition at the time of the initial inspection.

The condition of the material should be managed by a competent person/company and its presence made aware to those at risk, as part of a Control of Asbestos Regulations (CAR) 2012 compliant management strategy.

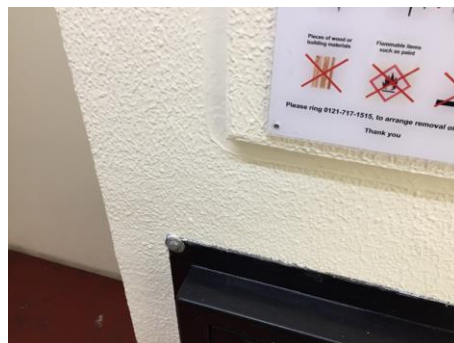
Stipple pattern textured coating.

The material was seen to be in fair condition at the time of the initial inspection.

The condition of the material should be managed by a competent person/company and its presence made aware to those at risk, as part of a Control of Asbestos Regulations (CAR) 2012 compliant management strategy.

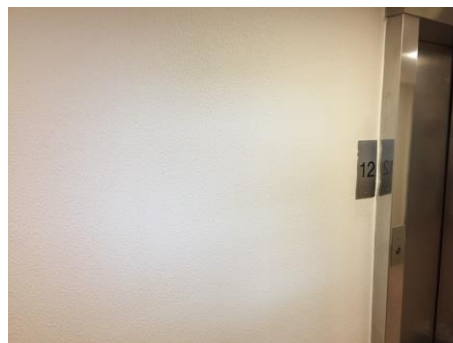
Stipple pattern textured coating.

The material was seen to be in fair condition at the time of the initial inspection.

The condition of the material should be managed by a competent person/company and its presence made aware to those at risk, as part of a Control of Asbestos Regulations (CAR) 2012 compliant management strategy.

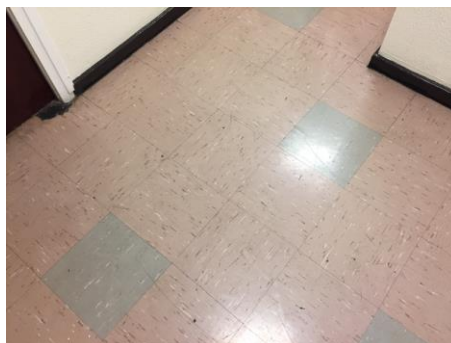
Bitumen adhesive beneath floor tiles.

The material was seen to be in fair condition at the time of the initial inspection.

The condition of the material should be managed by a competent person/company and its presence made aware to those at risk, as part of a Control of Asbestos Regulations (CAR) 2012 compliant management strategy.

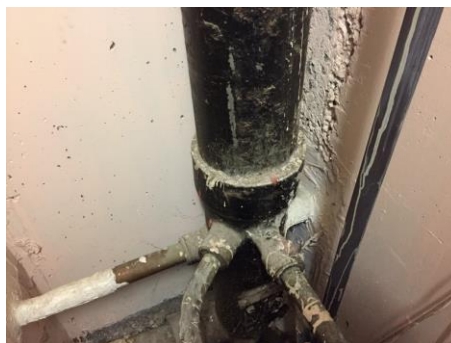
Lagging packing to joints of soil pipe.

The material was seen to be in fair condition at the time of the initial inspection.

The condition of the material should be managed by a competent person/company and its presence made aware to those at risk, as part of a Control of Asbestos Regulations (CAR) 2012 compliant management strategy.

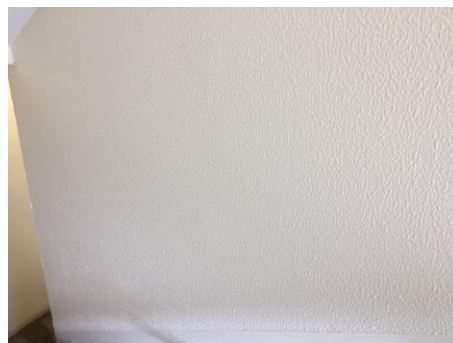
Stipple pattern textured coating.

The material was seen to be in fair condition at the time of the initial inspection.

The condition of the material should be managed by a competent person/company and its presence made aware to those at risk, as part of a Control of Asbestos Regulations (CAR) 2012 compliant management strategy.

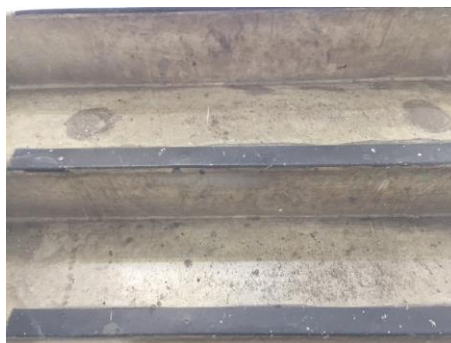
Resin nosing to edge of stairs.

The material was seen to be in fair condition at the time of the initial inspection.

The condition of the material should be managed by a competent person/company and its presence made aware to those at risk, as part of a Control of Asbestos Regulations (CAR) 2012 compliant management strategy.

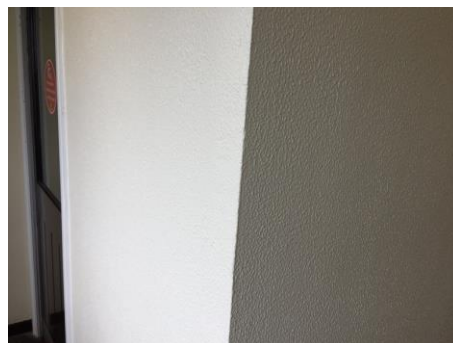
Stipple pattern textured coating.

The material was seen to be in fair condition at the time of the initial inspection.

The condition of the material should be managed by a competent person/company and its presence made aware to those at risk, as part of a Control of Asbestos Regulations (CAR) 2012 compliant management strategy.

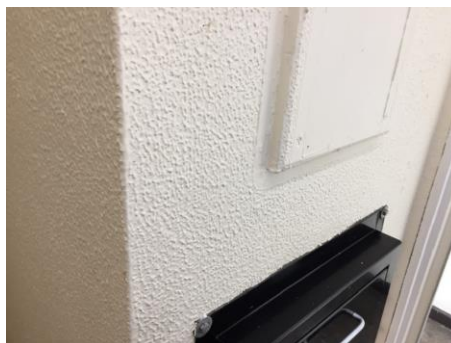
Stipple pattern textured coating.

The material was seen to be in fair condition at the time of the initial inspection.

The condition of the material should be managed by a competent person/company and its presence made aware to those at risk, as part of a Control of Asbestos Regulations (CAR) 2012 compliant management strategy.

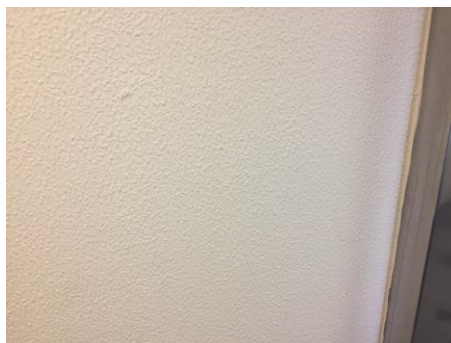
Stipple pattern textured coating.

The material was seen to be in fair condition at the time of the initial inspection.

The condition of the material should be managed by a competent person/company and its presence made aware to those at risk, as part of a Control of Asbestos Regulations (CAR) 2012 compliant management strategy.

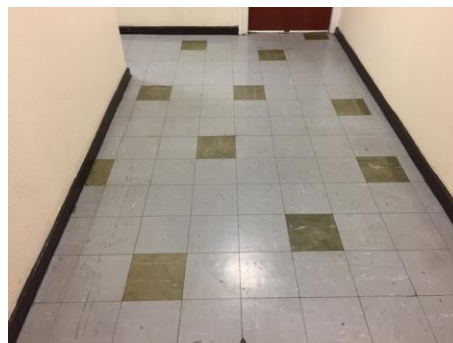
Green and grey floor tiles.

The material was seen to be in fair condition at the time of the initial inspection.

The condition of the material should be managed by a competent person/company and its presence made aware to those at risk, as part of a Control of Asbestos Regulations (CAR) 2012 compliant management strategy.

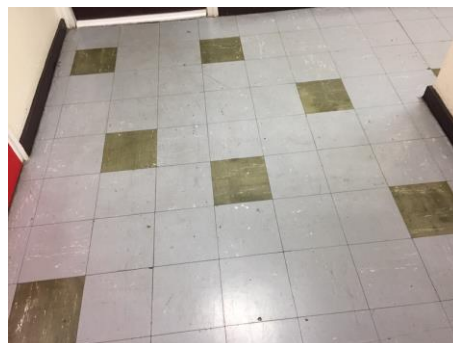
Bitumen adhesive beneath floor tiles.

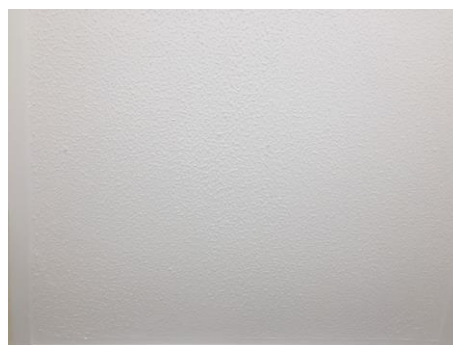
Stipple pattern textured coating.

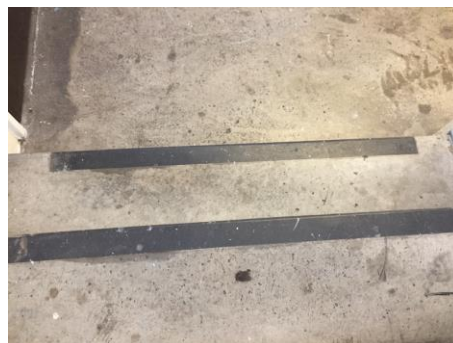
Resin nosing to edge of stairs.

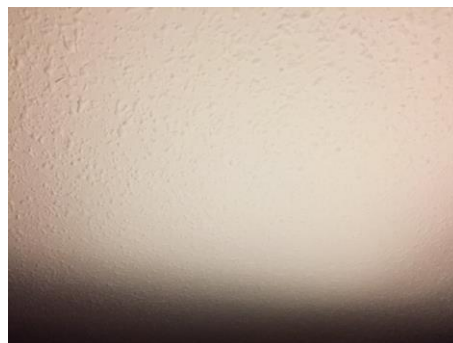
Spatter pattern textured coating above suspended ceiling.

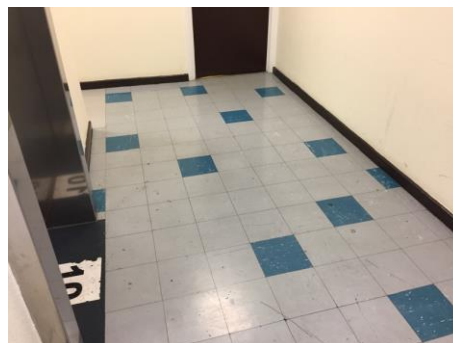
Blue and grey floor tiles.

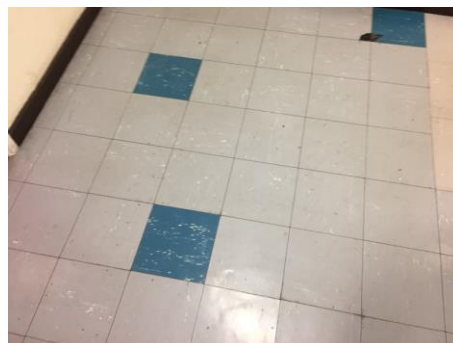
Bitumen adhesive beneath floor tiles.

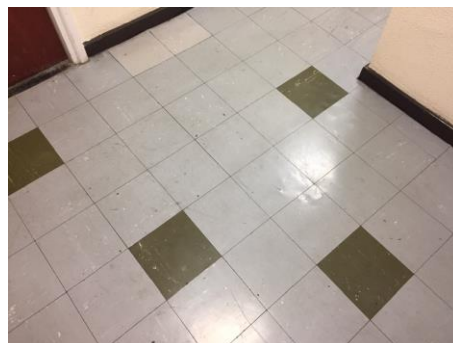
Green and grey floor tiles.

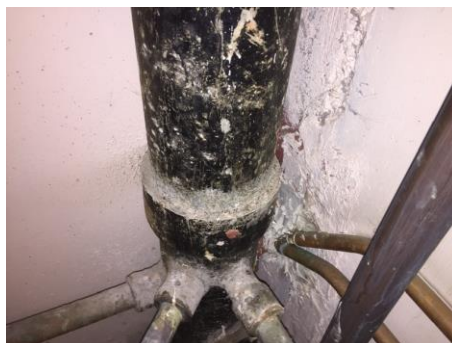
Lagging packing to joints of soil pipe.

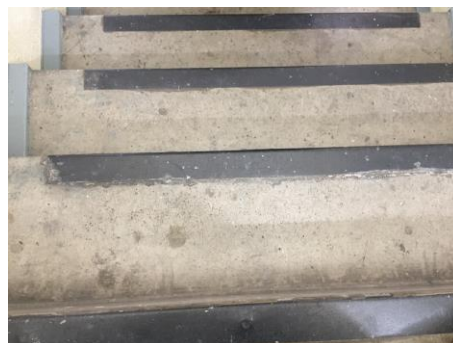
Resin nosing to edge of stairs.

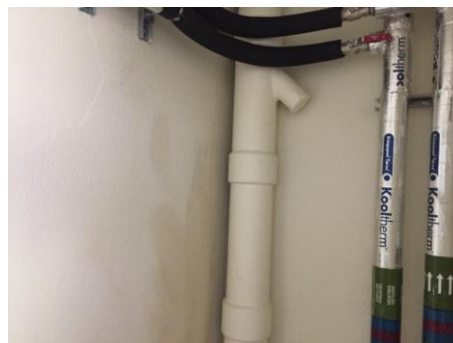
Cement flue for incinerator.

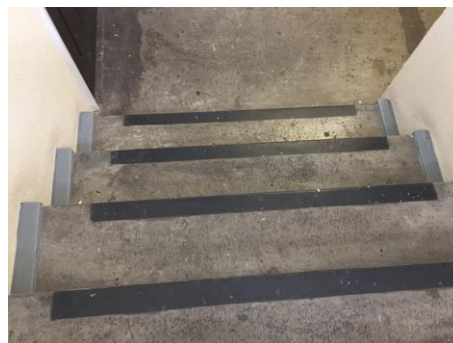
Resin nosing to edge of stairs.

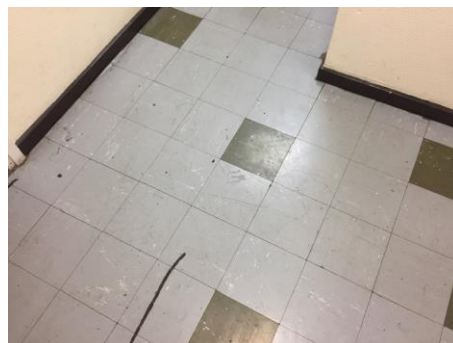
Green and grey floor tiles.

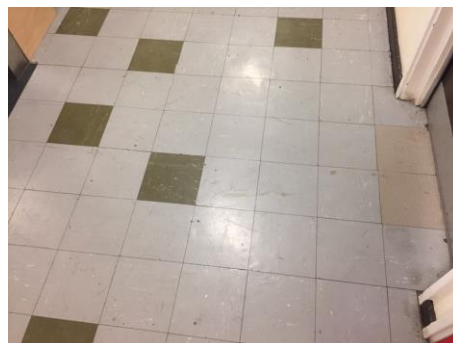
Bitumen adhesive beneath floor tiles.

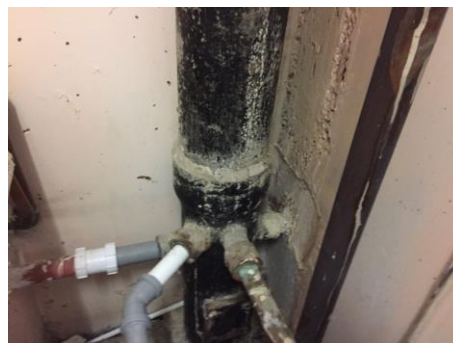
Lagging packing to joints of soil pipe.
