Management with Targeted Refurbishment Survey – PART 2

1-61 Pembroke House
Barle Grove
Chelmsley Wood
Solihull
B36 0UA
United Kingdom

12th June 2021

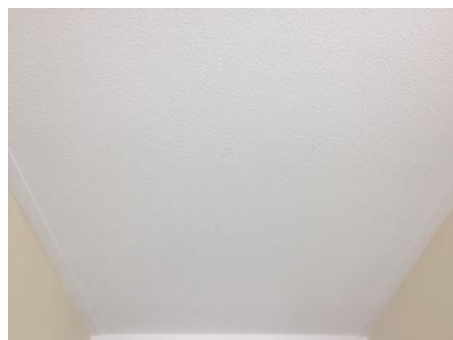
Stipple pattern textured coating.

The material was seen to be in fair condition at the time of the initial inspection.

The condition of the material should be managed by a competent person/company and its presence made aware to those at risk, as part of a Control of Asbestos Regulations (CAR) 2012 compliant management strategy.

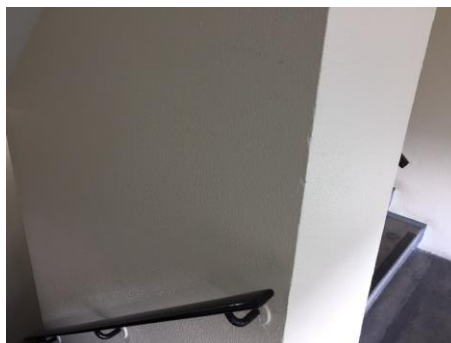
Stipple pattern textured coating.

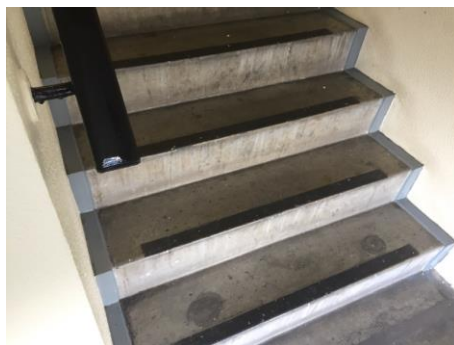
Resin nosing to edge of stairs.

The material was seen to be in fair condition at the time of the initial inspection.

The condition of the material should be managed by a competent person/company and its presence made aware to those at risk, as part of a Control of Asbestos Regulations (CAR) 2012 compliant management strategy.

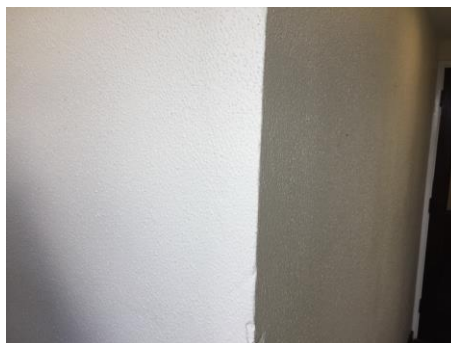
Stipple pattern textured coating.

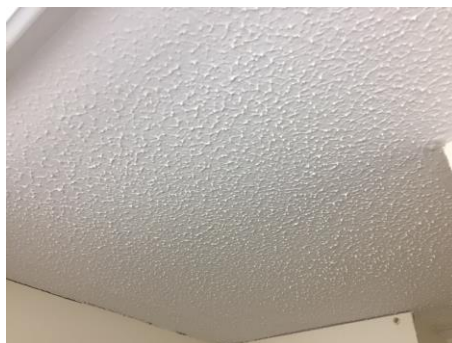
Stipple pattern textured coating.

The material was seen to be in fair condition at the time of the initial inspection.

The condition of the material should be managed by a competent person/company and its presence made aware to those at risk, as part of a Control of Asbestos Regulations (CAR) 2012 compliant management strategy.

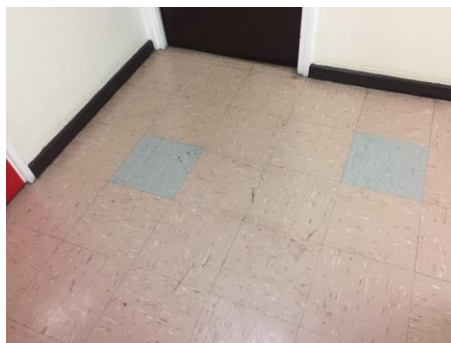
Pink and grey floor tiles.

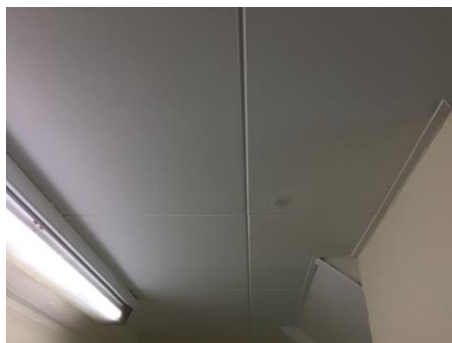
Spatter pattern textured coating above suspended ceiling.

The material was seen to be in fair condition at the time of the initial inspection.

The condition of the material should be managed by a competent person/company and its presence made aware to those at risk, as part of a Control of Asbestos Regulations (CAR) 2012 compliant management strategy.

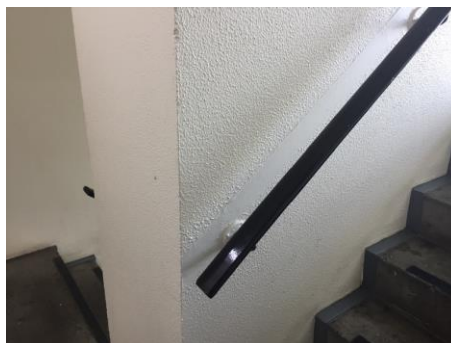
Stipple pattern textured coating.

The material was seen to be in fair condition at the time of the initial inspection.

The condition of the material should be managed by a competent person/company and its presence made aware to those at risk, as part of a Control of Asbestos Regulations (CAR) 2012 compliant management strategy.

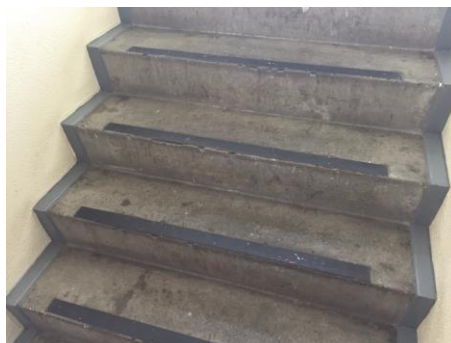
Resin nosing to edge of stairs.

The material was seen to be in fair condition at the time of the initial inspection.

The condition of the material should be managed by a competent person/company and its presence made aware to those at risk, as part of a Control of Asbestos Regulations (CAR) 2012 compliant management strategy.

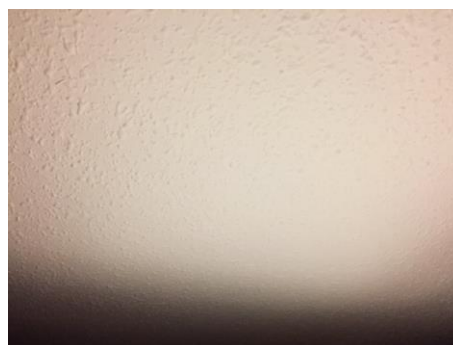
Spatter pattern textured coating above suspended ceiling.

The material was seen to be in fair condition at the time of the initial inspection.

The condition of the material should be managed by a competent person/company and its presence made aware to those at risk, as part of a Control of Asbestos Regulations (CAR) 2012 compliant management strategy.

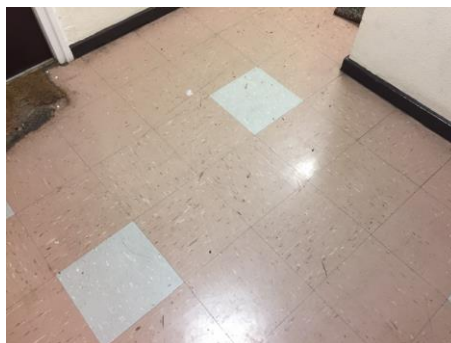
Bitumen adhesive beneath floor tiles.

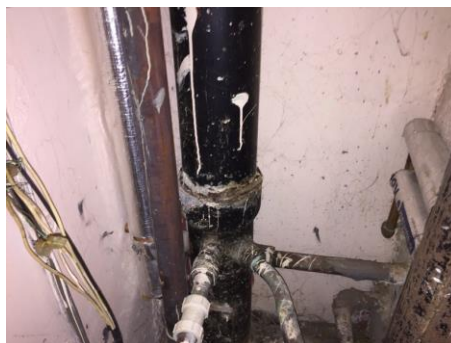
Condition **High Damage**

Lagging packing to joints of soil pipe.

The material was seen to be in fair condition at the time of the initial inspection.

The condition of the material should be managed by a competent person/company and its presence made aware to those at risk, as part of a Control of Asbestos Regulations (CAR) 2012 compliant management strategy.

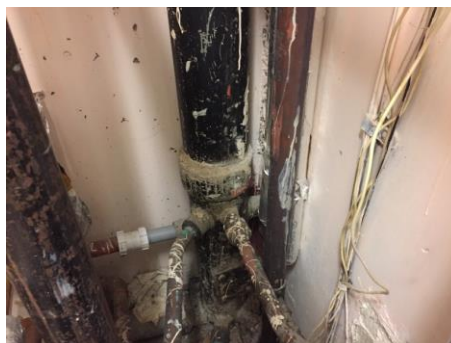
Condition **High Damage**

Lagging packing to joints of soil pipe.

The material was seen to be in fair condition at the time of the initial inspection.

The condition of the material should be managed by a competent person/company and its presence made aware to those at risk, as part of a Control of Asbestos Regulations (CAR) 2012 compliant management strategy.

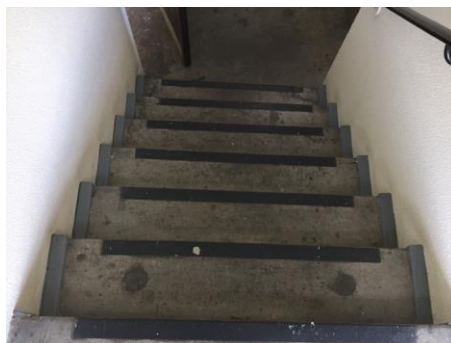
Resin nosing to edge of stairs.

The material was seen to be in fair condition at the time of the initial inspection.

The condition of the material should be managed by a competent person/company and its presence made aware to those at risk, as part of a Control of Asbestos Regulations (CAR) 2012 compliant management strategy.

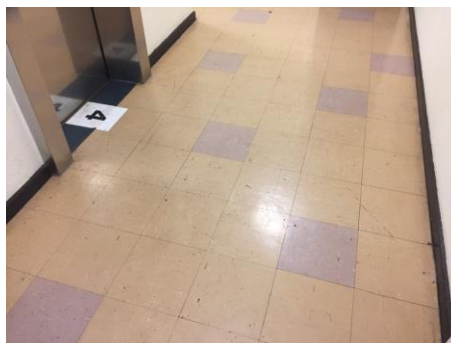
Bitumen adhesive beneath floor tiles.

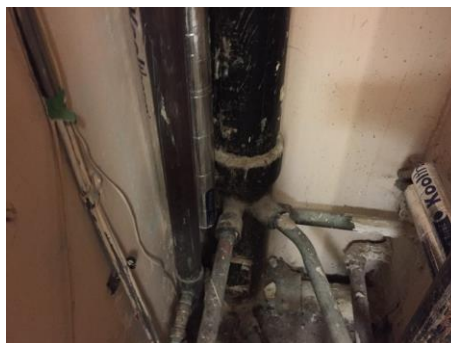
Condition **High Damage**

Lagging packing to joints of soil pipe.

The material was seen to be in fair condition at the time of the initial inspection.

The condition of the material should be managed by a competent person/company and its presence made aware to those at risk, as part of a Control of Asbestos Regulations (CAR) 2012 compliant management strategy.

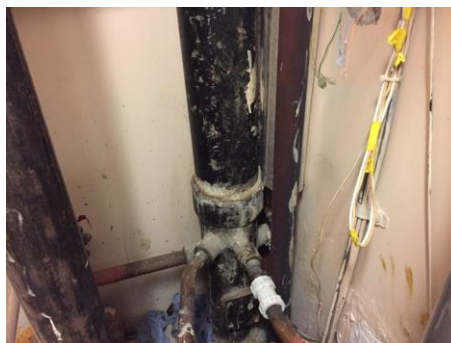
Condition **High Damage**

Lagging packing to joints of soil pipe.

The material was seen to be in fair condition at the time of the initial inspection.

The condition of the material should be managed by a competent person/company and its presence made aware to those at risk, as part of a Control of Asbestos Regulations (CAR) 2012 compliant management strategy.

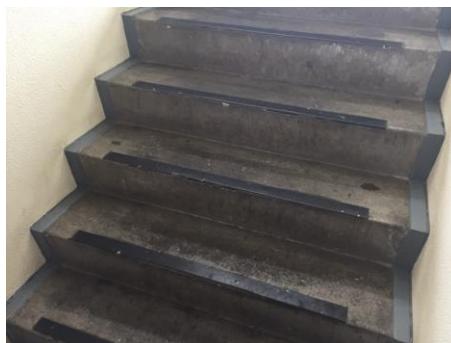
Resin nosing to edge of stairs.

The material was seen to be in fair condition at the time of the initial inspection.

The condition of the material should be managed by a competent person/company and its presence made aware to those at risk, as part of a Control of Asbestos Regulations (CAR) 2012 compliant management strategy.

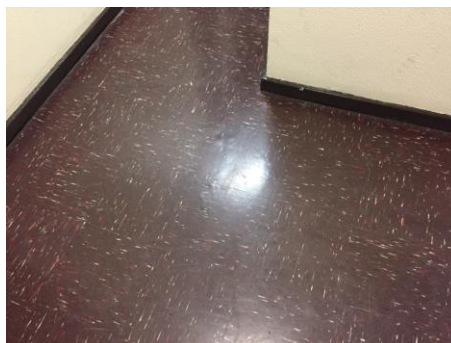
Brown floor tiles.

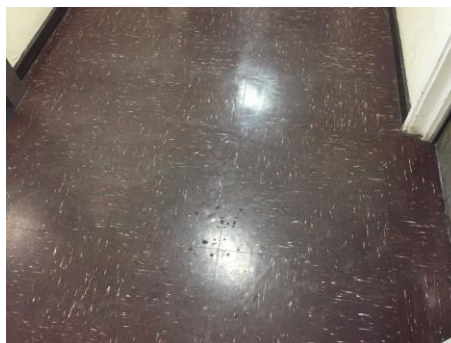
Bitumen adhesive beneath floor tiles.

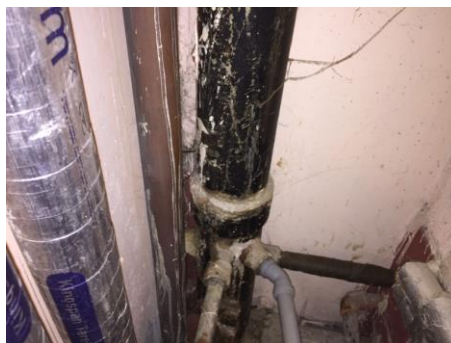
Condition **High Damage**

Lagging packing to joints of soil pipe.

The material was seen to be in fair condition at the time of the initial inspection.

The condition of the material should be managed by a competent person/company and its presence made aware to those at risk, as part of a Control of Asbestos Regulations (CAR) 2012 compliant management strategy.

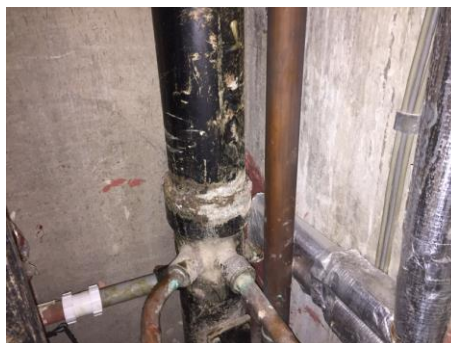
Condition **High Damage**

Lagging packing to joints of soil pipe.

The material was seen to be in fair condition at the time of the initial inspection.

The condition of the material should be managed by a competent person/company and its presence made aware to those at risk, as part of a Control of Asbestos Regulations (CAR) 2012 compliant management strategy.

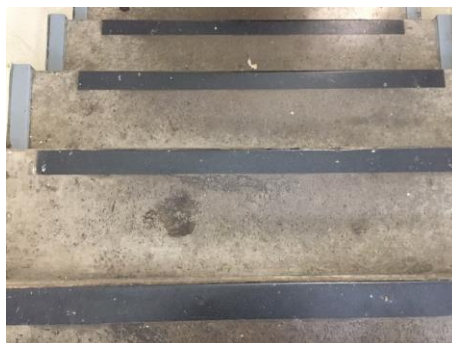
Resin nosing to edge of stairs.

The material was seen to be in fair condition at the time of the initial inspection.

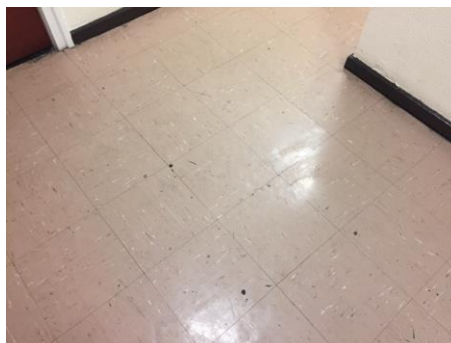
Pink floor tiles.

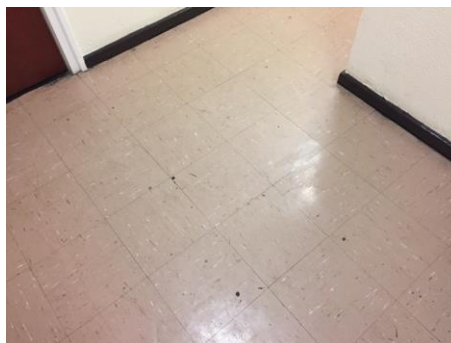
Bitumen adhesive beneath floor tiles.

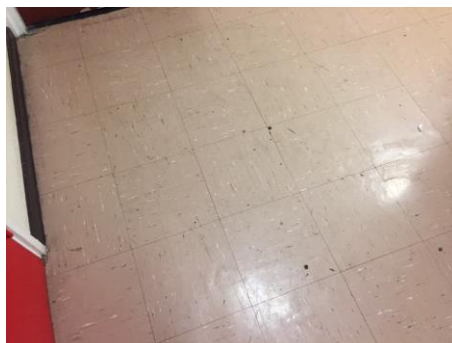
Grey floor tiles beneath pink tiles.

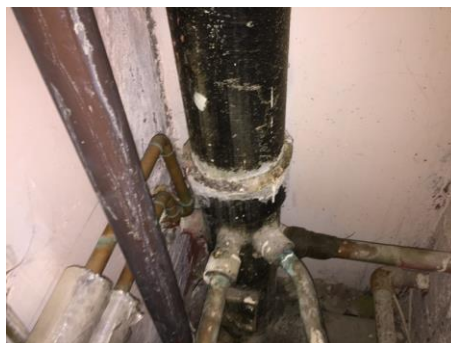
Lagging packing to joints of soil pipe.

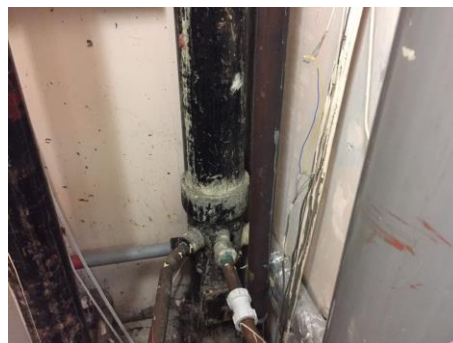
Lagging packing to joints of soil pipe.

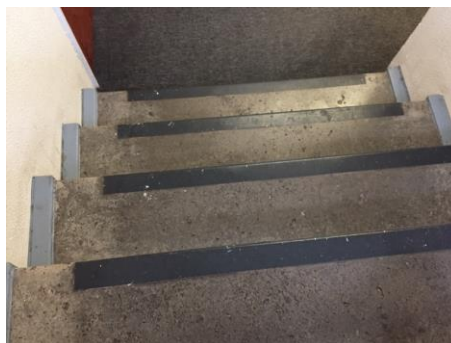
Resin nosing to edge of stairs.
