Management with Targeted Refurbishment Survey – PART 1

1-68 Redwood House
30 Broomcroft Road
Kingshurst
Solihull
West Midlands
B37 6HB
United Kingdom

21st April 2021

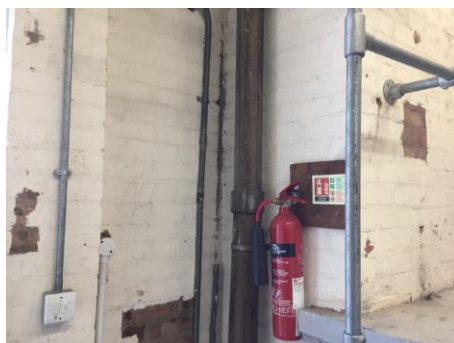
Cement flue.

The material was seen to be in fair condition at the time of the initial inspection.

The condition of the material should be managed by a competent person/company and its presence made aware to those at risk, as part of a Control of Asbestos Regulations (CAR) 2012 compliant management strategy.

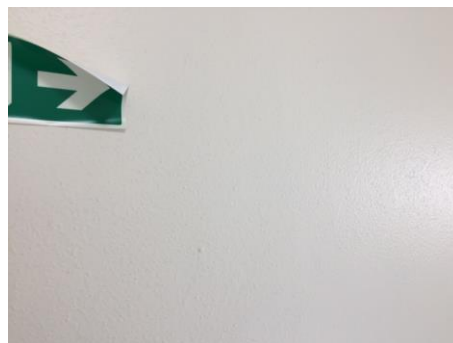
Spatter pattern textured coating.

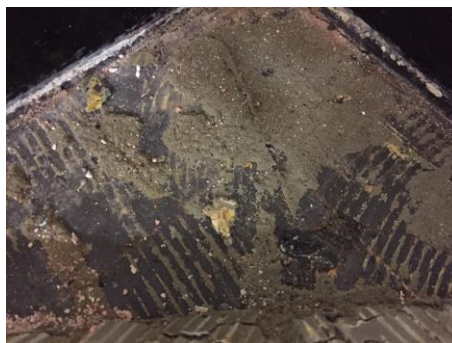
Black floor tiles.

The material was seen to be in fair condition at the time of the initial inspection.

The condition of the material should be managed by a competent person/company and its presence made aware to those at risk, as part of a Control of Asbestos Regulations (CAR) 2012 compliant management strategy.

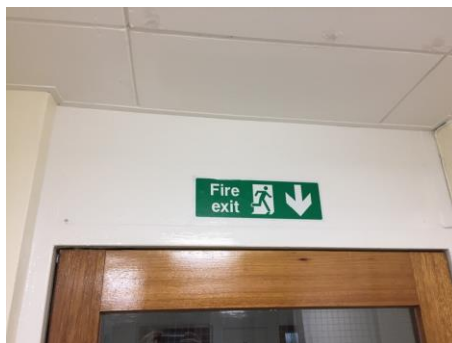
Supalux transom panel above door adjoining lobbies.

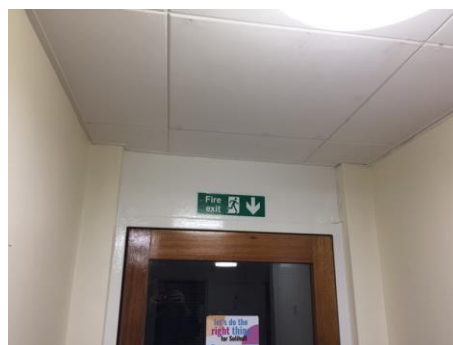
Supalux transom panel above door adjoining lobbies.

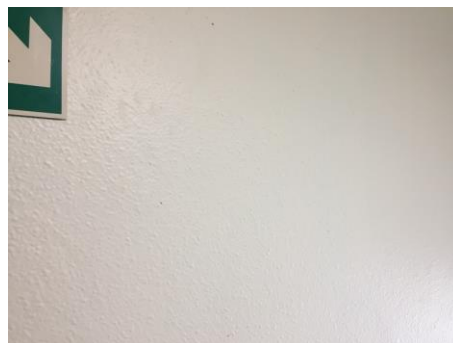
Spatter pattern textured coating.

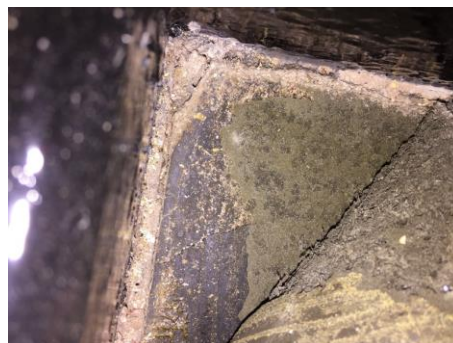
Black floor tiles.

The material was seen to be in fair condition at the time of the initial inspection.

The condition of the material should be managed by a competent person/company and its presence made aware to those at risk, as part of a Control of Asbestos Regulations (CAR) 2012 compliant management strategy.

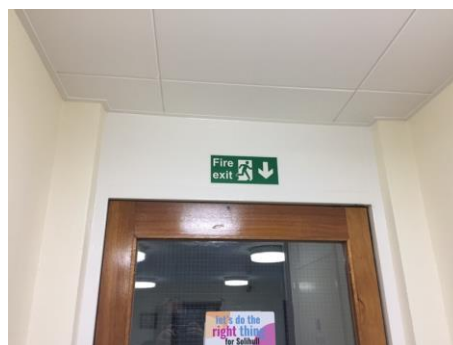
Supalux transom panel above door adjoining lobbies.

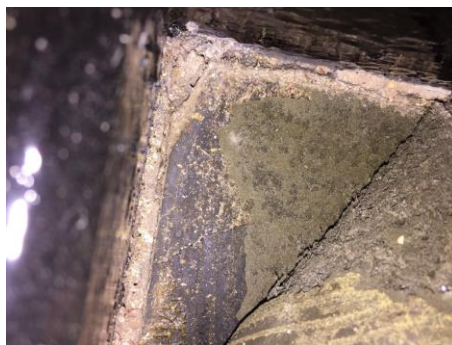
Bitumen adhesive beneath floor tiles.

The material was seen to be in fair condition at the time of the initial inspection.

The condition of the material should be managed by a competent person/company and its presence made aware to those at risk, as part of a Control of Asbestos Regulations (CAR) 2012 compliant management strategy.

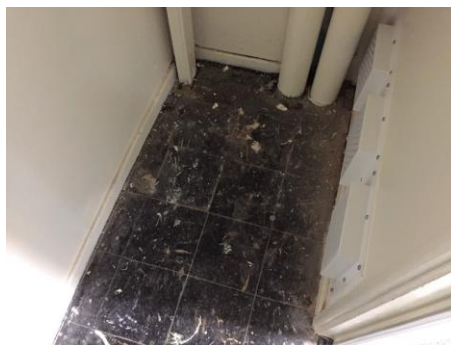
Bitumen adhesive beneath floor tiles.

The material was seen to be in fair condition at the time of the initial inspection.

The condition of the material should be managed by a competent person/company and its presence made aware to those at risk, as part of a Control of Asbestos Regulations (CAR) 2012 compliant management strategy.

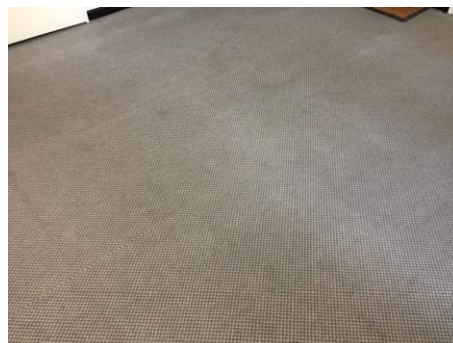
Black floor tiles.

The material was seen to be in fair condition at the time of the initial inspection.

The condition of the material should be managed by a competent person/company and its presence made aware to those at risk, as part of a Control of Asbestos Regulations (CAR) 2012 compliant management strategy.

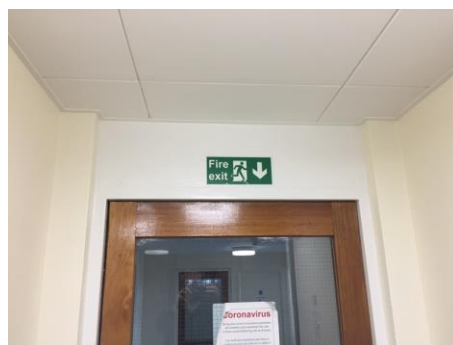
Supalux transom panel above door to adjoining lobby.

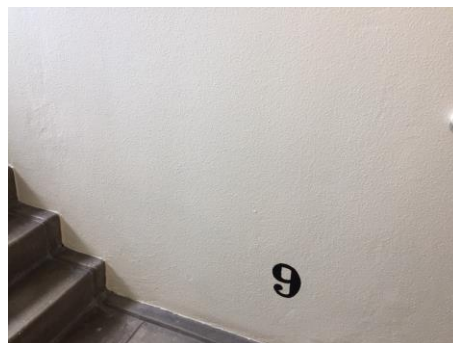
Spatter pattern textured coating.

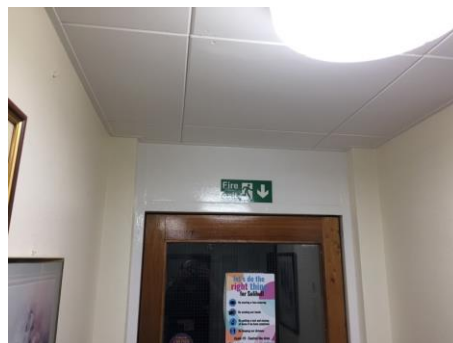
Supalux transom panel above door to adjoining lobby.

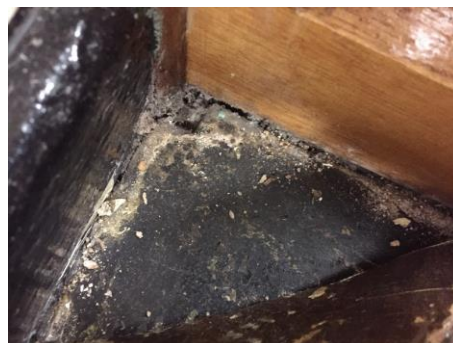
Black floor tiles.

The material was seen to be in fair condition at the time of the initial inspection.

The condition of the material should be managed by a competent person/company and its presence made aware to those at risk, as part of a Control of Asbestos Regulations (CAR) 2012 compliant management strategy.

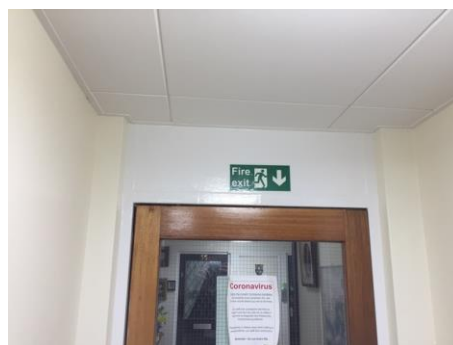
Supalux transom panel above door to adjoining lobby.

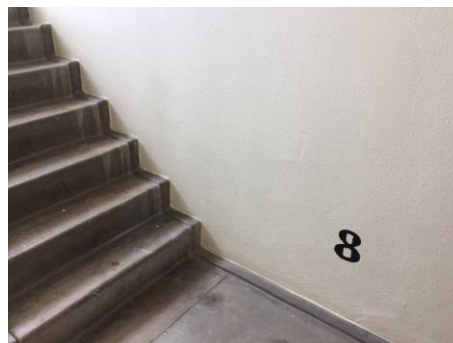
Spatter pattern textured coating.

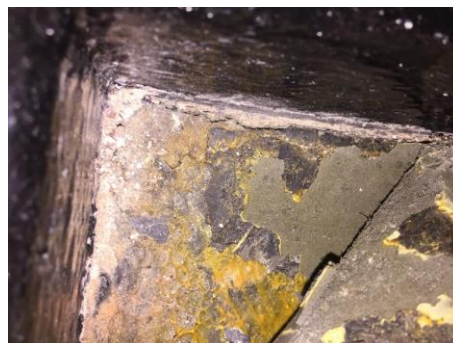
Black floor tiles.

The material was seen to be in fair condition at the time of the initial inspection.

The condition of the material should be managed by a competent person/company and its presence made aware to those at risk, as part of a Control of Asbestos Regulations (CAR) 2012 compliant management strategy.

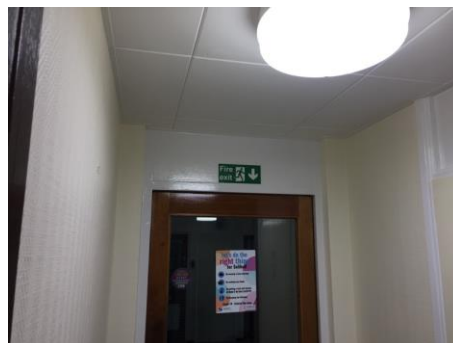
Supalux transom panel above door to adjoining lobby.

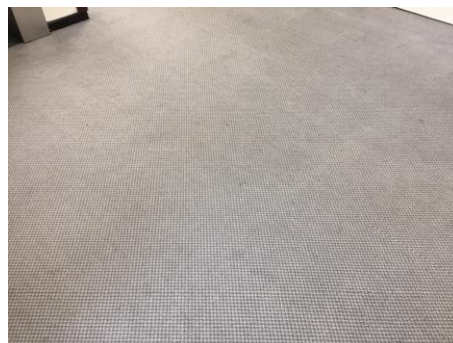
Black floor tiles.

The material was seen to be in fair condition at the time of the initial inspection.

The condition of the material should be managed by a competent person/company and its presence made aware to those at risk, as part of a Control of Asbestos Regulations (CAR) 2012 compliant management strategy.

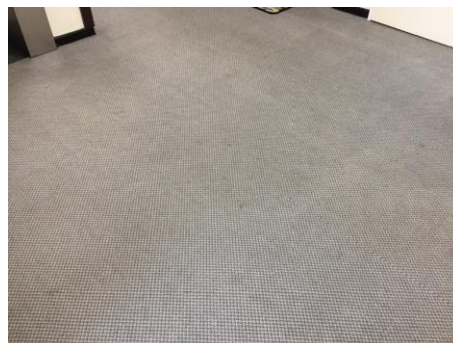
Bitumen adhesive beneath floor tiles.

The material was seen to be in fair condition at the time of the initial inspection.

The condition of the material should be managed by a competent person/company and its presence made aware to those at risk, as part of a Control of Asbestos Regulations (CAR) 2012 compliant management strategy.

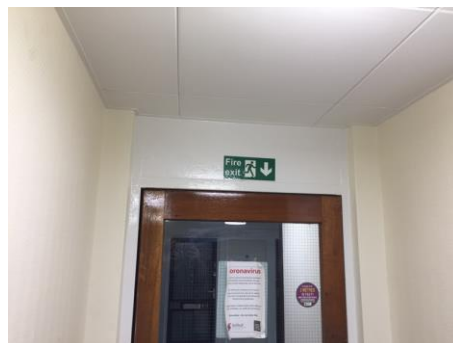
Supalux transom panel above door to adjoining lobby.

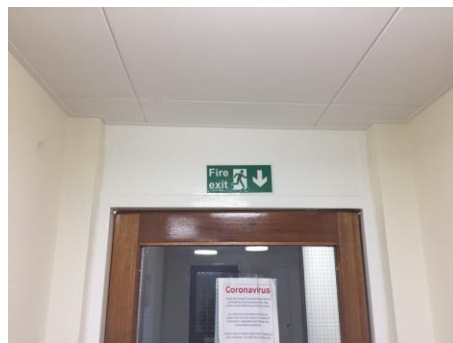
Supalux transom panel above door to adjoining lobby.

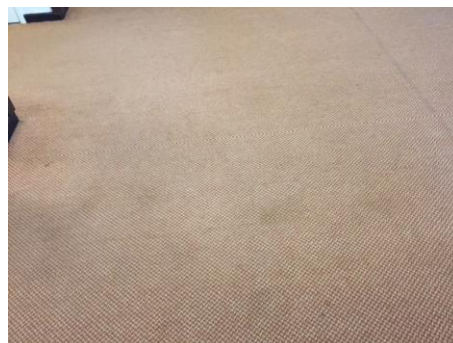
Black floor tiles.

The material was seen to be in fair condition at the time of the initial inspection.

The condition of the material should be managed by a competent person/company and its presence made aware to those at risk, as part of a Control of Asbestos Regulations (CAR) 2012 compliant management strategy.

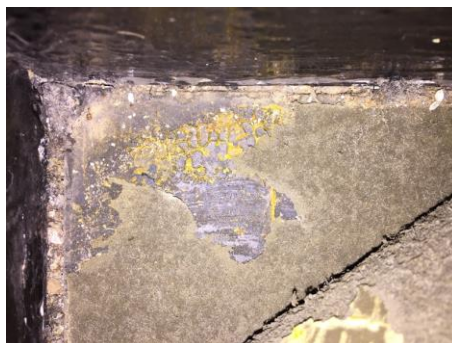
Bitumen adhesive beneath floor tiles.

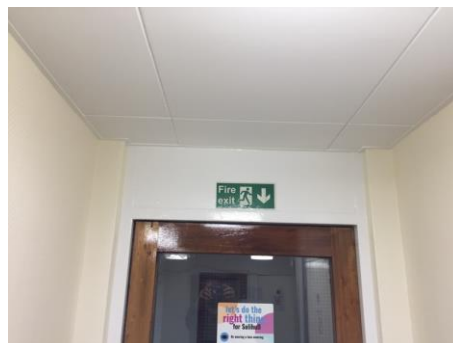
Supalux transom panel above door to adjoining lobby.

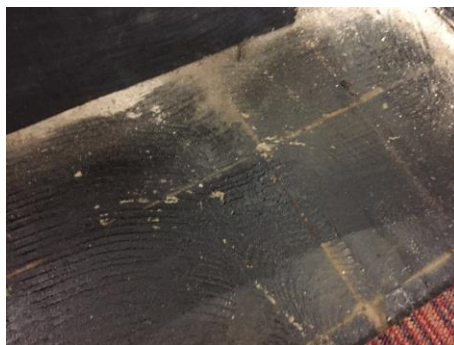
Bitumen adhesive beneath carpet.

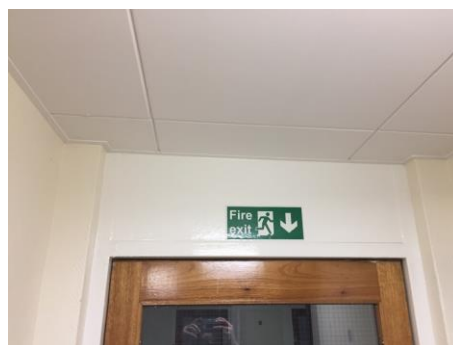
Supalux transom panel above door to adjoining lobby.

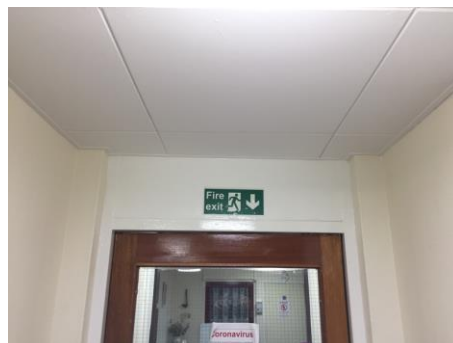
Supalux transom panel above door to adjoining lobby.

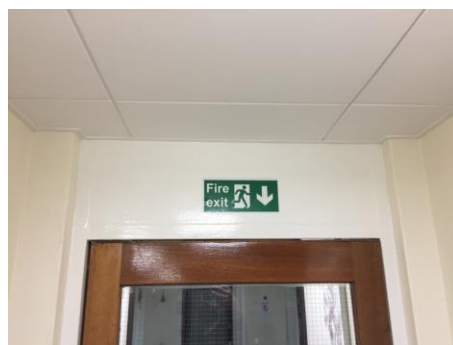
Supalux transom panel above door to adjoining lobby.

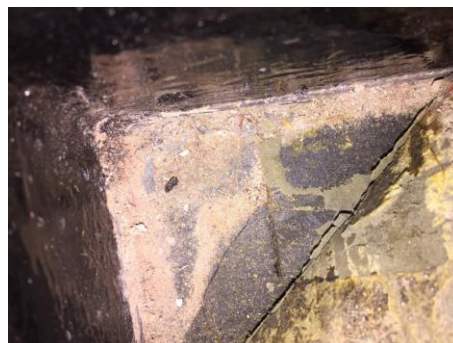
Black floor tiles.

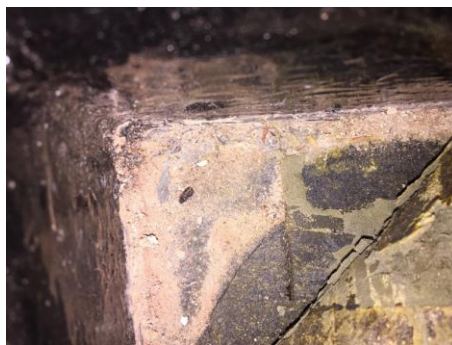
Bitumen adhesive beneath floor tiles.

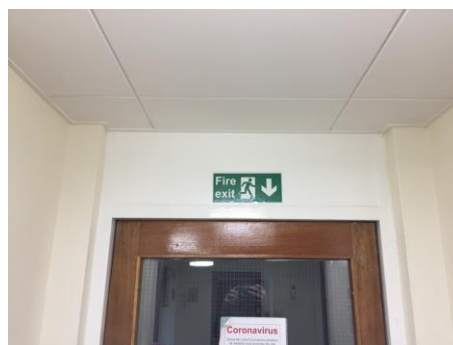
Supalux transom panel above door to adjoining lobby.

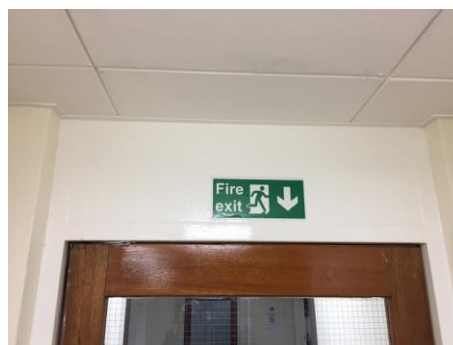
Supalux transom panel above door to adjoining lobby.

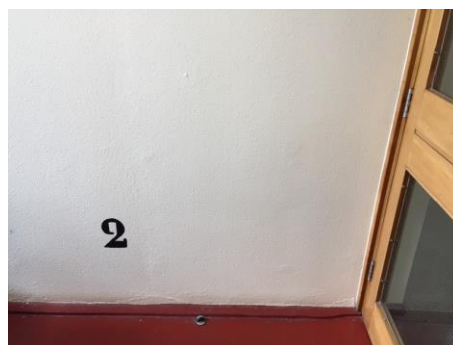
Spatter pattern textured coating.

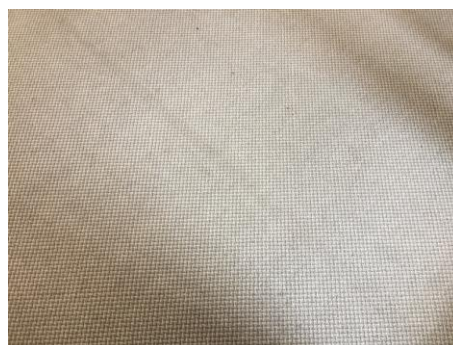
Black floor tiles.

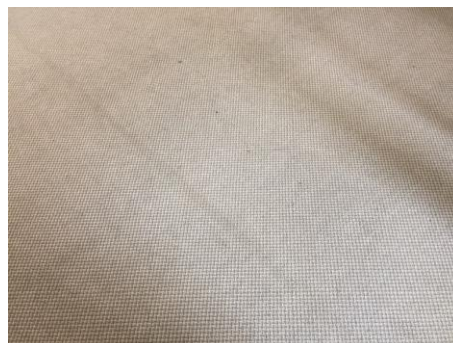
Bitumen adhesive beneath floor tiles.

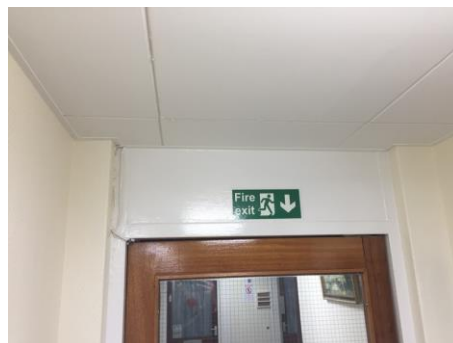
Supalux transom panel above door to adjoining lobby.

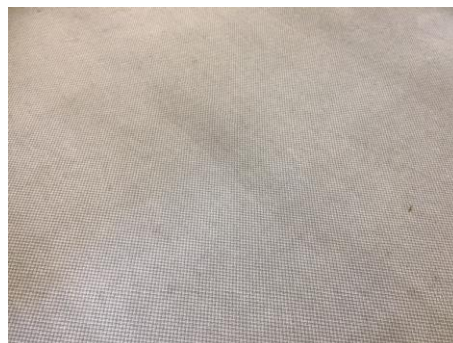
Black floor tiles.

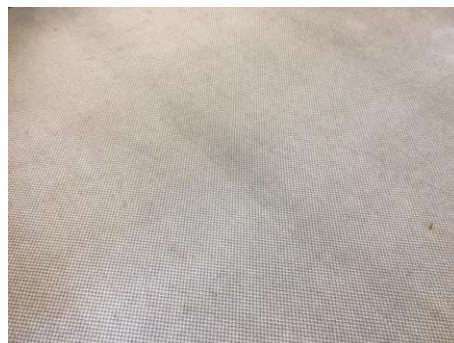
Bitumen adhesive beneath floor tiles.

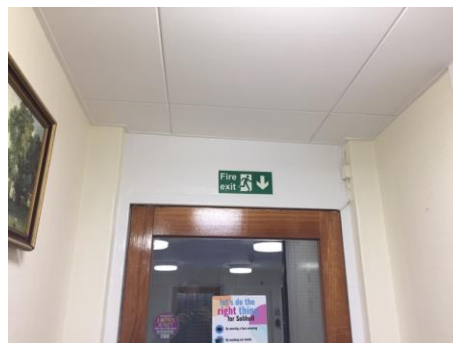
Supalux transom panel above door to adjoining lobby.

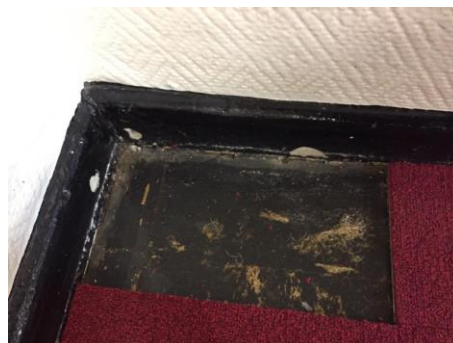
Black floor tiles.

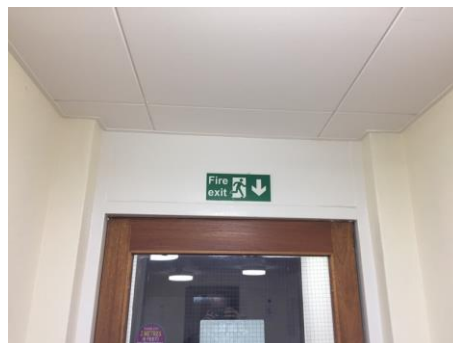
Supalux transom panel above door to adjoining lobby.

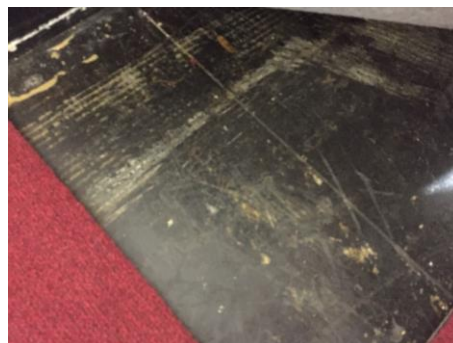
Black floor tiles.

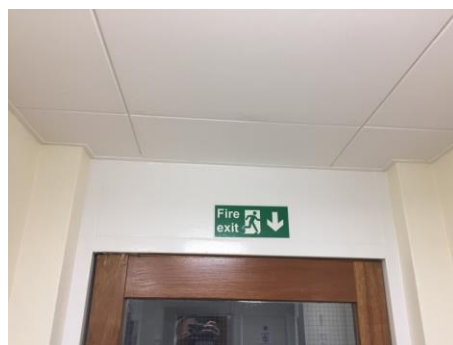
Supalux transom panel above door to adjoining lobby.

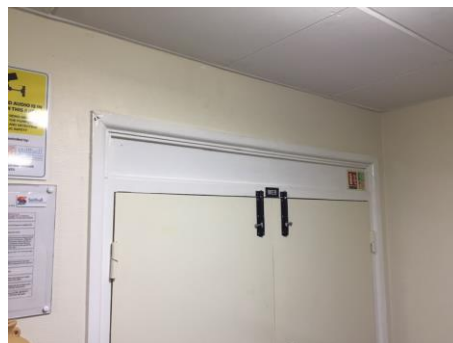
Supalux transom panel above MEB cupboard.

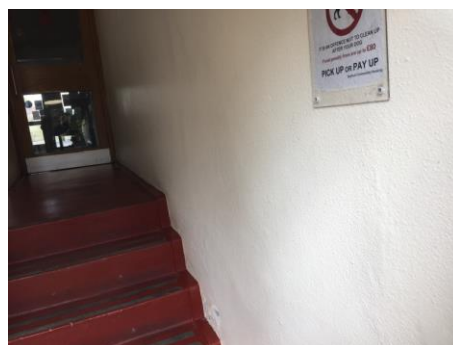
Spatter pattern textured coating.

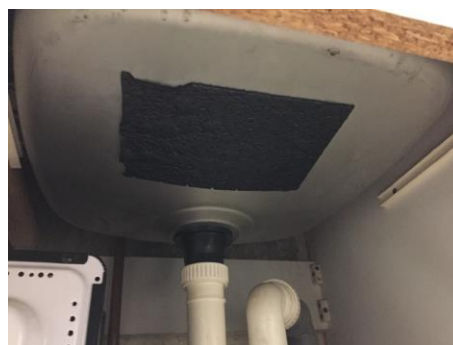
Pad to underside of sink unit.

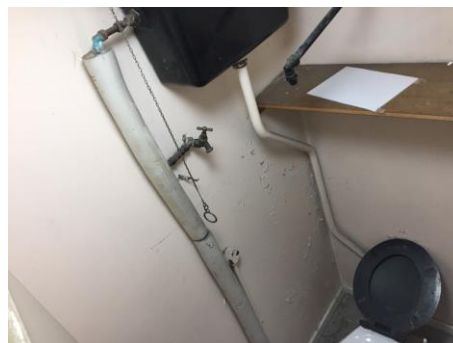
Resin toilet cistern and seat.

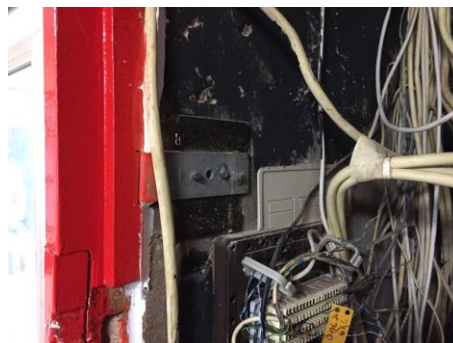
Felt packer to metal door frame fixture.

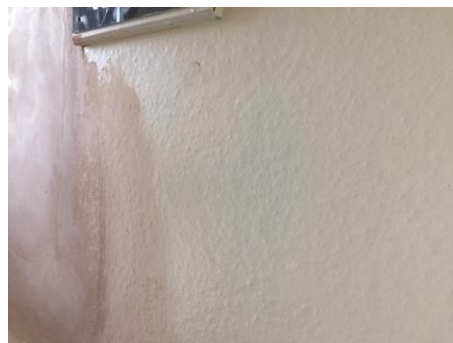
Spatter pattern textured coating.
