Management with Targeted Refurbishment Survey – PART 2

1-68 Redwood House
30 Broomcroft Road
Kingshurst
Solihull
West Midlands
B37 6HB
United Kingdom

21st April 2021

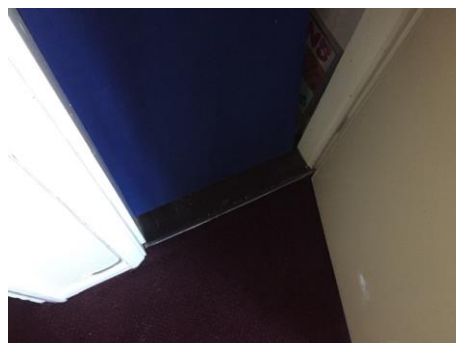
a-303104-i02-01

Adhesive to floor

No asbestos was detected in the material tested.

No further action is required.

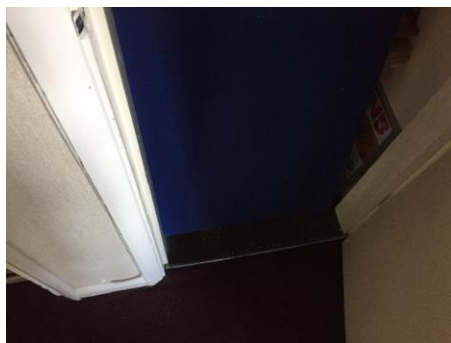
a-303104-i02-02

Brown floor tile

No asbestos was detected in the material tested.

No further action is required.

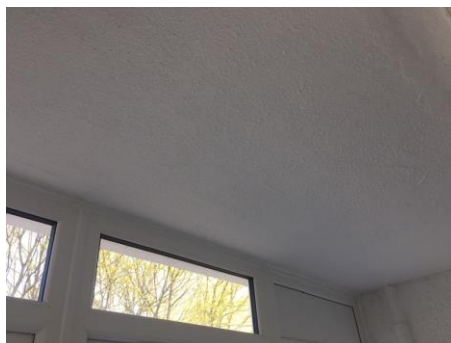
a-303104-i03-03

Stipple pattern to ceiling

No asbestos was detected in the material tested.

No further action is required.

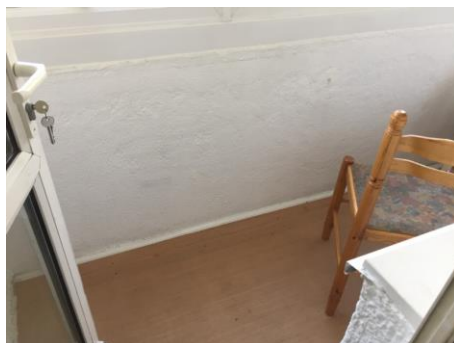
a-303104-i03-04

Stipple patent to walls

No asbestos was detected in the material tested.

No further action is required.

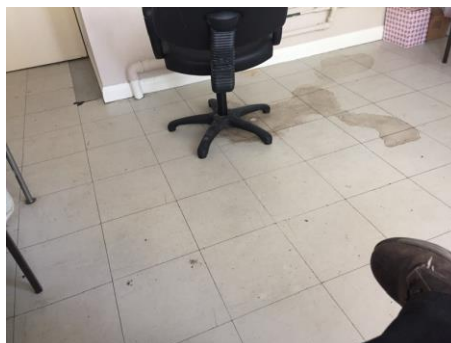
a-303104-i06-05_c01

Adhesive to floor

No asbestos was detected in the material tested.

No further action is required.

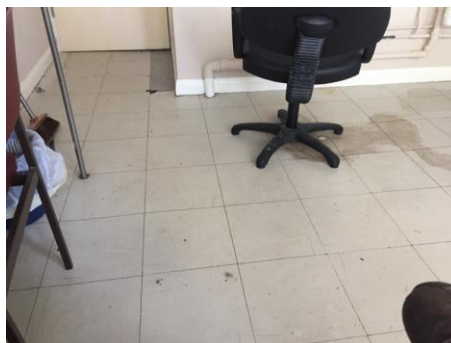
a-303104-i06-06

Light grey floor tile

No asbestos was detected in the material tested.

No further action is required.

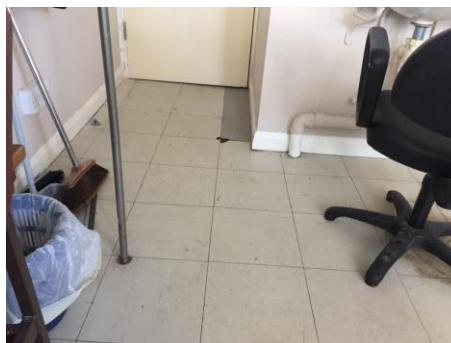
a-303104-i06-07

Dark grey floor tile patching floor

No asbestos was detected in the material tested.

No further action is required.

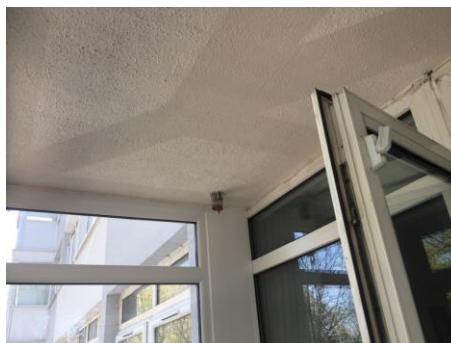
a-303104-i07-08_c03

Stipple pattern to ceiling

No asbestos was detected in the material tested.

No further action is required.

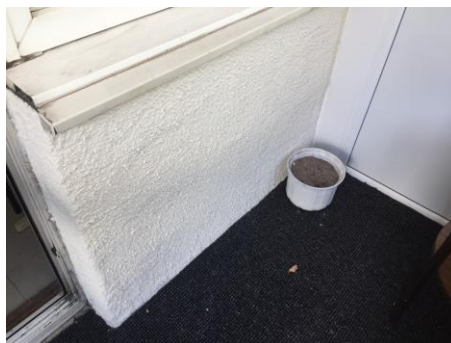
a-303104-i07-09_c04

Stipple patent to walls

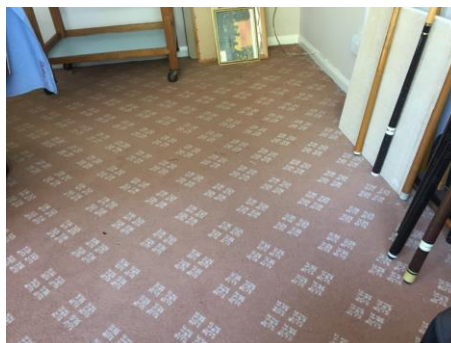
Condition **Low Damage**

Brown floor tile below carpet

The material was seen to be in fair condition at the time of the initial inspection.

The condition of the material should be managed by a competent person/company and its presence made aware to those at risk, as part of a Control of Asbestos Regulations (CAR) 2012 compliant management strategy.

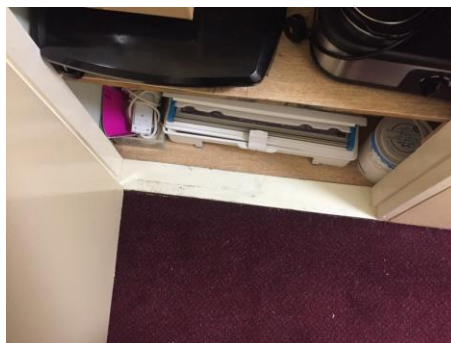
Condition **Low Damage**

Brown floor tile below lino

The material was seen to be in fair condition at the time of the initial inspection.

The condition of the material should be managed by a competent person/company and its presence made aware to those at risk, as part of a Control of Asbestos Regulations (CAR) 2012 compliant management strategy.
