# **Solihull Community Housing**

## **Asbestos Management Survey Report**

**I-49 Richmond House  
(Communal)  
Marlene Croft  
Solihull  
B37 7JS**

**Date of Report: 06 Feb 2015**

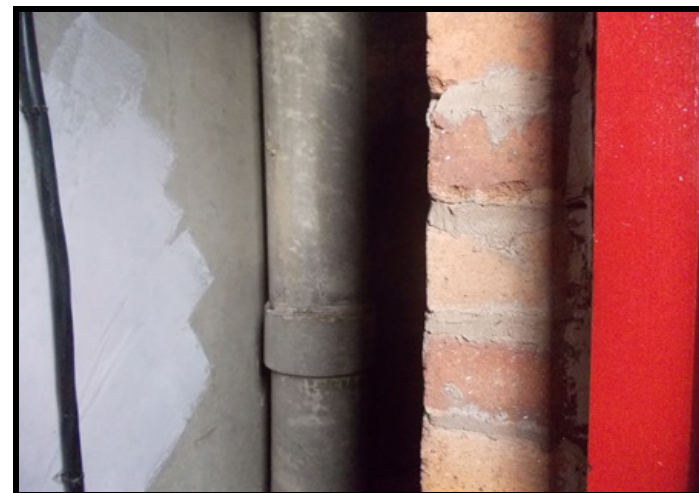
## SAMPLE REFERENCE 005

Building	Floor	Room	Location			
Main Building	Roof	Dry Riser	Flue			
Description						
MATERIAL ASSESSMENT				SCORE		
Product Type	Cement Flue	Extent of Damage	Low damage		4	
Asbestos Type	Chrysotile	Surface Treatment	Unsealed (Cement products)			
PRIORITY ASSESSMENT				SCORE		
Occupant Activity	Not Applicable	Extent / Amount	4.00 small item(s)		0	
Accessibility	Occasionally disturb	Location	Not Applicable			
Avg Time in Use	Not Applicable	Frequency of Use	Not Applicable			
No. of Occupants	Not Applicable	Secondary Activity	Not Applicable			
Maintenance	Not Applicable	Maintenance Frequency	Not Applicable			
MANAGEMENT ACTION				SCORE		
Recommendation	LABEL & MONITOR			4		
Recommendation Due		Next Inspection	29 Jan 2016			
Apply Labels	No	Permit to Work Required	No			
Survey Type	Management	Lead Surveyor	Gavin Hooper			
Survey Date	29 Jan 2015	UKAS Laboratory	DMW Environmental Safety Ltd / [A-13971]			
Site Reference	I43760000A	Licensed Material	No	Notifiable Non Licensed Work	No

**Asbestos detected in Sample**

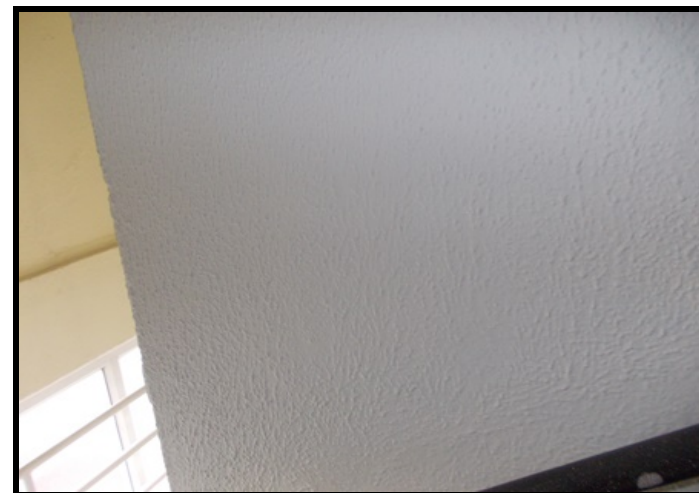
## SAMPLE REFERENCE 005b

Building	Floor	Room	Location		
Main Building	Roof	Stairwell	Walls		
Description					
MATERIAL ASSESSMENT					SCORE
Product Type	Textured Coating	Extent of Damage	Good condition		-
Asbestos Type	No Asbestos Detected	Surface Treatment	Textured Coating		
PRIORITY ASSESSMENT					SCORE
Occupant Activity	Not Applicable	Extent / Amount	10.00 m2		-
Accessibility	Easily disturbed	Location	Not Applicable		
Avg Time in Use	Not Applicable	Frequency of Use	Not Applicable		
No. of Occupants	Not Applicable	Secondary Activity	Not Applicable		
Maintenance	Not Applicable	Maintenance Frequency	Not Applicable		
MANAGEMENT ACTION					SCORE
Recommendation	NO ACTION REQUIRED				-
Recommendation Due		Next Inspection	None		
Apply Labels	No	Permit to Work Required	No		
Survey Type	Management	Lead Surveyor	Gavin Hooper		
Survey Date	29 Jan 2015	UKAS Laboratory	DMW Environmental Safety Ltd / [A-13971]		
Site Reference	I43760000A	Licensed Material	N/A	Notifiable Non Licensed Work	N/A

**Asbestos not detected in Sample**

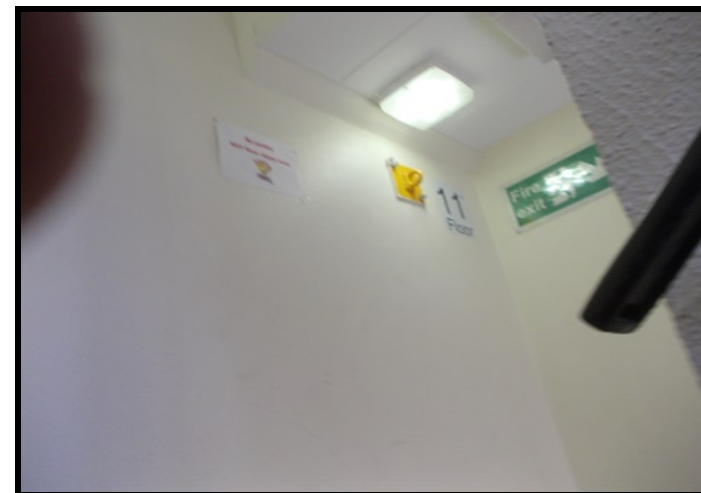
## SAMPLE REFERENCE 006

Building	Floor	Room	Location		
Main Building	Eleventh Floor	Stairwell	Wall		
Description					
MATERIAL ASSESSMENT					SCORE
Product Type	Textured Coating	Extent of Damage	Low damage		-
Asbestos Type	No Asbestos Detected	Surface Treatment	Textured Coating		
PRIORITY ASSESSMENT					SCORE
Occupant Activity	Not Applicable	Extent / Amount	16.00 m2		-
Accessibility	Easily disturbed	Location	Not Applicable		
Avg Time in Use	Not Applicable	Frequency of Use	Not Applicable		
No. of Occupants	Not Applicable	Secondary Activity	Not Applicable		
Maintenance	Not Applicable	Maintenance Frequency	Not Applicable		
MANAGEMENT ACTION					SCORE
Recommendation	NO ACTION REQUIRED				-
Recommendation Due		Next Inspection	None		
Apply Labels	No	Permit to Work Required	No		
Survey Type	Management	Lead Surveyor	Gavin Hooper		
Survey Date	29 Jan 2015	UKAS Laboratory	DMW Environmental Safety Ltd / [A-13971]		
Site Reference	I43760000A	Licensed Material	N/A	Notifiable Non Licensed Work	N/A

**Asbestos not detected in Sample**

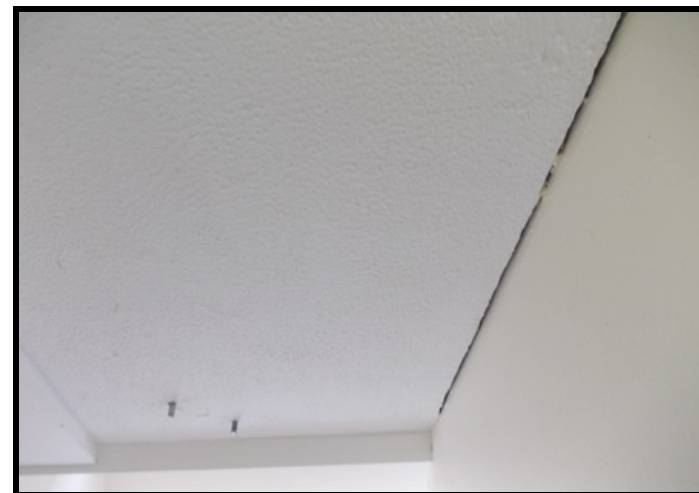
## SAMPLE REFERENCE 007

Building	Floor	Room	Location		
Main Building	Eleventh Floor	Stairwell	Ceiling		
Description					
MATERIAL ASSESSMENT					SCORE
Product Type	Textured Coating	Extent of Damage	Low damage		-
Asbestos Type	No Asbestos Detected	Surface Treatment	Textured Coating		
PRIORITY ASSESSMENT					SCORE
Occupant Activity	Not Applicable	Extent / Amount	6.00 m2		-
Accessibility	Occasionally disturb	Location	Not Applicable		
Avg Time in Use	Not Applicable	Frequency of Use	Not Applicable		
No. of Occupants	Not Applicable	Secondary Activity	Not Applicable		
Maintenance	Not Applicable	Maintenance Frequency	Not Applicable		
MANAGEMENT ACTION					SCORE
Recommendation	NO ACTION REQUIRED				-
Recommendation Due		Next Inspection	None		
Apply Labels	No	Permit to Work Required	No		
Survey Type	Management	Lead Surveyor	Gavin Hooper		
Survey Date	29 Jan 2015	UKAS Laboratory	DMW Environmental Safety Ltd / [A-13971]		
Site Reference	I43760000A	Licensed Material	N/A	Notifiable Non Licensed Work	N/A

Asbestos not detected in Sample

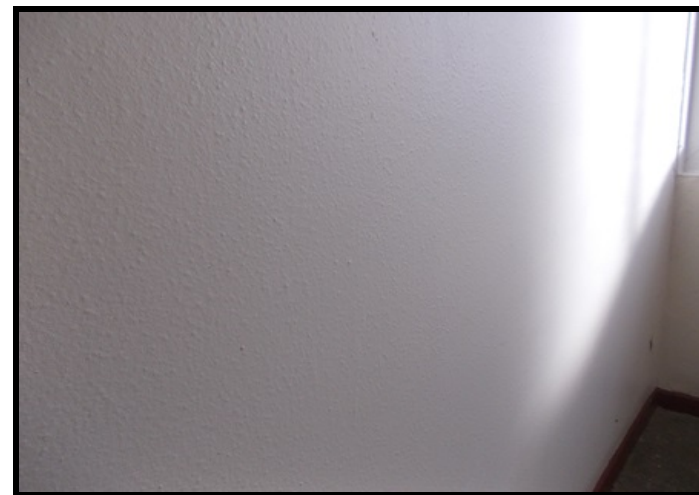
## SAMPLE REFERENCE 008

**No Asbestos Presumed in Sample**

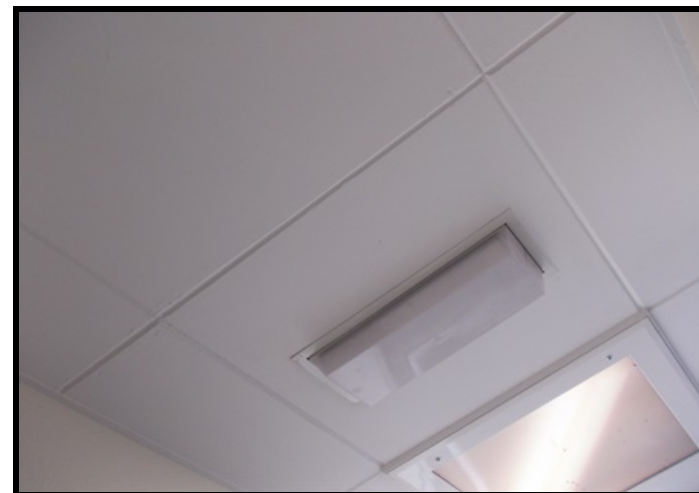
## SAMPLE REFERENCE 010

Building	Floor	Room	Location		
Main Building	Eleventh Floor	Bin Chute	Ceiling		
Description					
MATERIAL ASSESSMENT					SCORE
Product Type	Insulation Board	Extent of Damage	Low damage		-
Asbestos Type	No Asbestos Detected	Surface Treatment	Sealed Board (Encapsulated)		
PRIORITY ASSESSMENT					SCORE
Occupant Activity	Not Applicable	Extent / Amount	6.00 m2		-
Accessibility	Occasionally disturb	Location	Not Applicable		
Avg Time in Use	Not Applicable	Frequency of Use	Not Applicable		
No. of Occupants	Not Applicable	Secondary Activity	Not Applicable		
Maintenance	Not Applicable	Maintenance Frequency	Not Applicable		
MANAGEMENT ACTION					SCORE
Recommendation	NO ACTION REQUIRED				-
Recommendation Due		Next Inspection	None		
Apply Labels	No	Permit to Work Required	No		
Survey Type	Management	Lead Surveyor	Gavin Hooper		
Survey Date	29 Jan 2015	UKAS Laboratory	DMW Environmental Safety Ltd / [A-13971]		
Site Reference	I43760000A	Licensed Material	N/A	Notifiable Non Licensed Work	N/A

**Asbestos not detected in Sample**

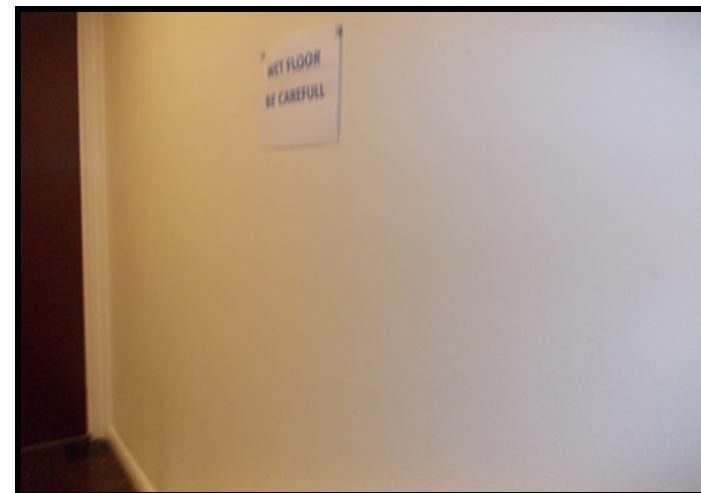
## SAMPLE REFERENCE 011

Building	Floor	Room	Location		
Main Building	Eleventh Floor	Lobby	Wall		
Description					
MATERIAL ASSESSMENT					SCORE
Product Type	Textured Coating	Extent of Damage	Low damage		-
Asbestos Type	No Asbestos Detected	Surface Treatment	Textured Coating		
PRIORITY ASSESSMENT					SCORE
Occupant Activity	Not Applicable	Extent / Amount	30.00 m2		-
Accessibility	Easily disturbed	Location	Not Applicable		
Avg Time in Use	Not Applicable	Frequency of Use	Not Applicable		
No. of Occupants	Not Applicable	Secondary Activity	Not Applicable		
Maintenance	Not Applicable	Maintenance Frequency	Not Applicable		
MANAGEMENT ACTION					SCORE
Recommendation	NO ACTION REQUIRED				-
Recommendation Due		Next Inspection	None		
Apply Labels	No	Permit to Work Required	No		
Survey Type	Management	Lead Surveyor	Gavin Hooper		
Survey Date	29 Jan 2015	UKAS Laboratory	NOT SAMPLED (Cross Referenced)		
Site Reference	I43760000A	Licensed Material	N/A	Notifiable Non Licensed Work	N/A

**No Asbestos Presumed in Sample**

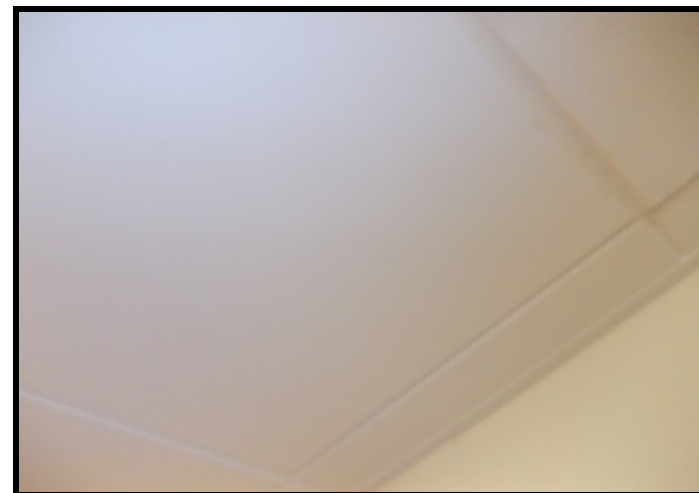
## SAMPLE REFERENCE 012

Building	Floor	Room	Location			
Main Building	Eleventh Floor	Lobby	Ceiling			
Description						
MATERIAL ASSESSMENT				SCORE		
Product Type	Insulation Board	Extent of Damage	Low damage		-	
Asbestos Type	No Asbestos Detected	Surface Treatment	Sealed Board (Encapsulated)			
PRIORITY ASSESSMENT				SCORE		
Occupant Activity	Not Applicable	Extent / Amount	20.00 m2		-	
Accessibility	Occasionally disturb	Location	Not Applicable			
Avg Time in Use	Not Applicable	Frequency of Use	Not Applicable			
No. of Occupants	Not Applicable	Secondary Activity	Not Applicable			
Maintenance	Not Applicable	Maintenance Frequency	Not Applicable			
MANAGEMENT ACTION				SCORE		
Recommendation	NO ACTION REQUIRED			-		
Recommendation Due		Next Inspection	None			
Apply Labels	No	Permit to Work Required	No			
Survey Type	Management	Lead Surveyor	Gavin Hooper			
Survey Date	29 Jan 2015	UKAS Laboratory	NOT SAMPLED (Cross Referenced)			
Site Reference	I43760000A	Licensed Material	N/A	Notifiable Non Licensed Work	N/A

**No Asbestos Presumed in Sample**

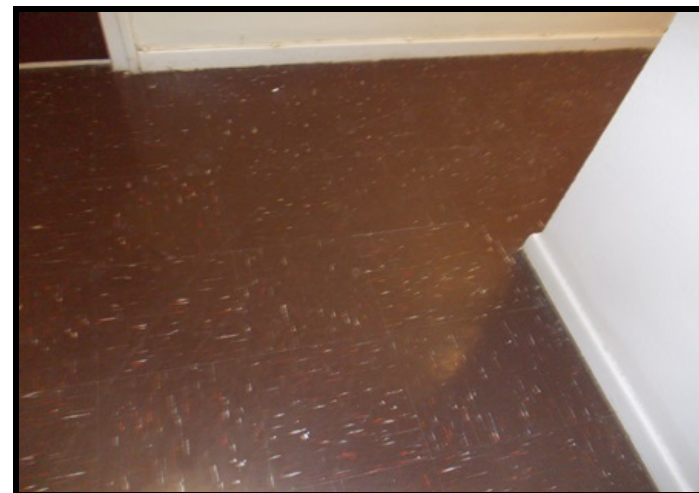
## SAMPLE REFERENCE 013

Building	Floor	Room	Location		
Main Building	Eleventh Floor	Lobby	Floor		
Description					
MATERIAL ASSESSMENT					SCORE
Product Type	Floor Tiles	Extent of Damage	Low damage		-
Asbestos Type	No Asbestos Detected	Surface Treatment	Composite materials		
PRIORITY ASSESSMENT					SCORE
Occupant Activity	Not Applicable	Extent / Amount	20.00 m2		-
Accessibility	Occasionally disturb	Location	Not Applicable		
Avg Time in Use	Not Applicable	Frequency of Use	Not Applicable		
No. of Occupants	Not Applicable	Secondary Activity	Not Applicable		
Maintenance	Not Applicable	Maintenance Frequency	Not Applicable		
MANAGEMENT ACTION					SCORE
Recommendation	NO ACTION REQUIRED				-
Recommendation Due		Next Inspection	None		
Apply Labels	No	Permit to Work Required	No		
Survey Type	Management	Lead Surveyor	Gavin Hooper		
Survey Date	29 Jan 2015	UKAS Laboratory	DMW Environmental Safety Ltd / [A-13971]		
Site Reference	I43760000A	Licensed Material	N/A	Notifiable Non Licensed Work	N/A

**Asbestos not detected in Sample**

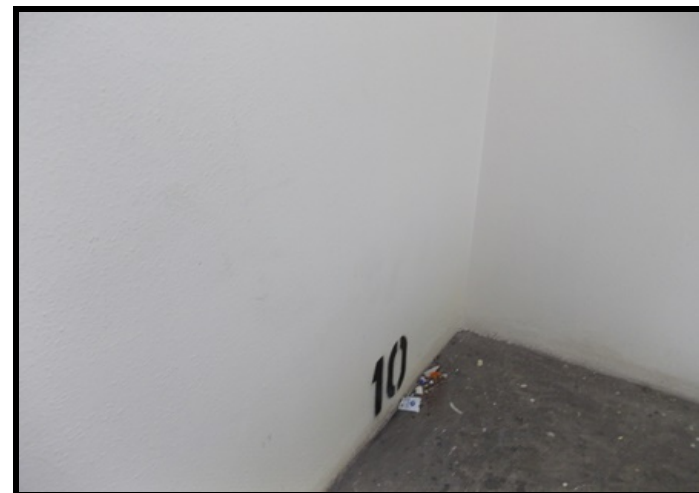
## SAMPLE REFERENCE 017

Building	Floor	Room	Location		
Main Building	Tenth Floor	Stairwell	Wall		
Description					
MATERIAL ASSESSMENT					SCORE
Product Type	Textured Coating	Extent of Damage	Low damage		-
Asbestos Type	No Asbestos Detected	Surface Treatment	Textured Coating		
PRIORITY ASSESSMENT					SCORE
Occupant Activity	Not Applicable	Extent / Amount	16.00 m2		-
Accessibility	Easily disturbed	Location	Not Applicable		
Avg Time in Use	Not Applicable	Frequency of Use	Not Applicable		
No. of Occupants	Not Applicable	Secondary Activity	Not Applicable		
Maintenance	Not Applicable	Maintenance Frequency	Not Applicable		
MANAGEMENT ACTION					SCORE
Recommendation	NO ACTION REQUIRED				-
Recommendation Due		Next Inspection	None		
Apply Labels	No	Permit to Work Required	No		
Survey Type	Management	Lead Surveyor	Gavin Hooper		
Survey Date	29 Jan 2015	UKAS Laboratory	NOT SAMPLED (Cross Referenced)		
Site Reference	I43760000A	Licensed Material	N/A	Notifiable Non Licensed Work	N/A

**No Asbestos Presumed in Sample**

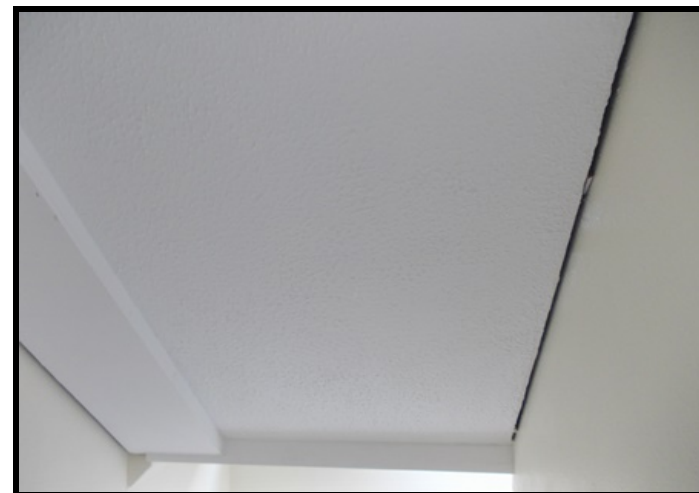
## SAMPLE REFERENCE 018

Building	Floor	Room	Location		
Main Building	Tenth Floor	Stairwell	Ceiling		
Description					
MATERIAL ASSESSMENT					SCORE
Product Type	Textured Coating	Extent of Damage	Low damage		-
Asbestos Type	No Asbestos Detected	Surface Treatment	Textured Coating		
PRIORITY ASSESSMENT					SCORE
Occupant Activity	Not Applicable	Extent / Amount	6.00 m2		-
Accessibility	Occasionally disturb	Location	Not Applicable		
Avg Time in Use	Not Applicable	Frequency of Use	Not Applicable		
No. of Occupants	Not Applicable	Secondary Activity	Not Applicable		
Maintenance	Not Applicable	Maintenance Frequency	Not Applicable		
MANAGEMENT ACTION					SCORE
Recommendation	NO ACTION REQUIRED				-
Recommendation Due		Next Inspection	None		
Apply Labels	No	Permit to Work Required	No		
Survey Type	Management	Lead Surveyor	Gavin Hooper		
Survey Date	29 Jan 2015	UKAS Laboratory	NOT SAMPLED (Cross Referenced)		
Site Reference	I43760000A	Licensed Material	N/A	Notifiable Non Licensed Work	N/A

**No Asbestos Presumed in Sample**

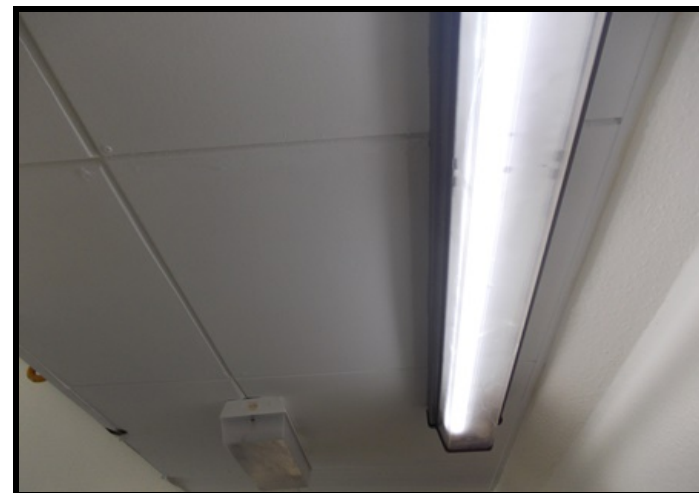
## SAMPLE REFERENCE 019

Building	Floor	Room	Location			
Main Building	Tenth Floor	Stairwell	Ceiling			
Description						
MATERIAL ASSESSMENT				SCORE		
Product Type	Insulation Board	Extent of Damage	Low damage		-	
Asbestos Type	No Asbestos Detected	Surface Treatment	Sealed Board (Encapsulated)			
PRIORITY ASSESSMENT				SCORE		
Occupant Activity	Not Applicable	Extent / Amount	6.00 m2		-	
Accessibility	Occasionally disturb	Location	Not Applicable			
Avg Time in Use	Not Applicable	Frequency of Use	Not Applicable			
No. of Occupants	Not Applicable	Secondary Activity	Not Applicable			
Maintenance	Not Applicable	Maintenance Frequency	Not Applicable			
MANAGEMENT ACTION				SCORE		
Recommendation	NO ACTION REQUIRED			-		
Recommendation Due		Next Inspection	None			
Apply Labels	No	Permit to Work Required	No			
Survey Type	Management	Lead Surveyor	Gavin Hooper			
Survey Date	29 Jan 2015	UKAS Laboratory	NOT SAMPLED (Cross Referenced)			
Site Reference	I43760000A	Licensed Material	N/A	Notifiable Non Licensed Work	N/A

**No Asbestos Presumed in Sample**

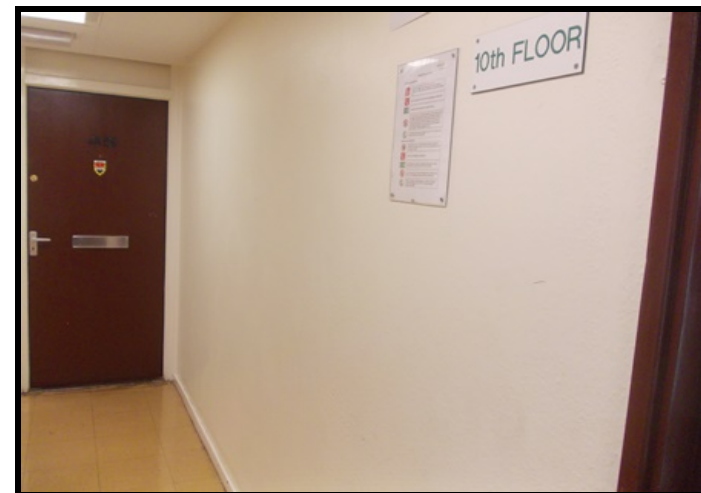
## SAMPLE REFERENCE 020

Building	Floor	Room	Location		
Main Building	Tenth Floor	Lobby	Wall		
Description					
MATERIAL ASSESSMENT					SCORE
Product Type	Textured Coating	Extent of Damage	Low damage		-
Asbestos Type	No Asbestos Detected	Surface Treatment	Textured Coating		
PRIORITY ASSESSMENT					SCORE
Occupant Activity	Not Applicable	Extent / Amount	16.00 m2		-
Accessibility	Easily disturbed	Location	Not Applicable		
Avg Time in Use	Not Applicable	Frequency of Use	Not Applicable		
No. of Occupants	Not Applicable	Secondary Activity	Not Applicable		
Maintenance	Not Applicable	Maintenance Frequency	Not Applicable		
MANAGEMENT ACTION					SCORE
Recommendation	NO ACTION REQUIRED				-
Recommendation Due		Next Inspection	None		
Apply Labels	No	Permit to Work Required	No		
Survey Type	Management	Lead Surveyor	Gavin Hooper		
Survey Date	29 Jan 2015	UKAS Laboratory	NOT SAMPLED (Cross Referenced)		
Site Reference	I43760000A	Licensed Material	N/A	Notifiable Non Licensed Work	N/A

**No Asbestos Presumed in Sample**

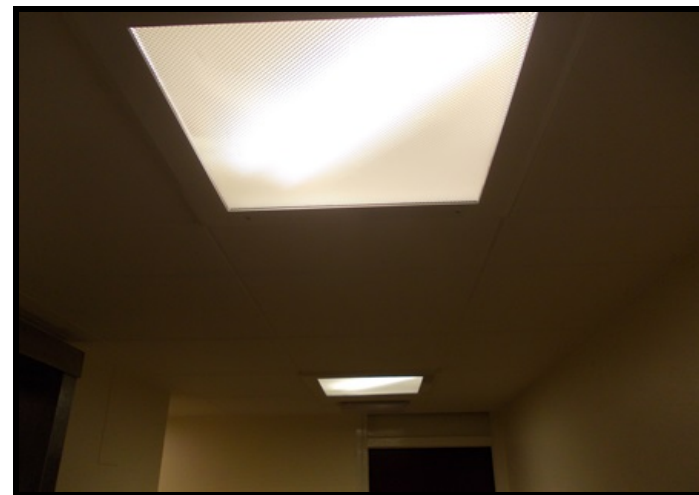
## SAMPLE REFERENCE 021

Building	Floor	Room	Location		
Main Building	Tenth Floor	Lobby	Ceiling		
Description					
MATERIAL ASSESSMENT					SCORE
Product Type	Insulation Board	Extent of Damage	Low damage		-
Asbestos Type	No Asbestos Detected	Surface Treatment	Sealed Board (Encapsulated)		
PRIORITY ASSESSMENT					SCORE
Occupant Activity	Not Applicable	Extent / Amount	20.00 m2		-
Accessibility	Occasionally disturb	Location	Not Applicable		
Avg Time in Use	Not Applicable	Frequency of Use	Not Applicable		
No. of Occupants	Not Applicable	Secondary Activity	Not Applicable		
Maintenance	Not Applicable	Maintenance Frequency	Not Applicable		
MANAGEMENT ACTION					SCORE
Recommendation	NO ACTION REQUIRED				-
Recommendation Due		Next Inspection	None		
Apply Labels	No	Permit to Work Required	No		
Survey Type	Management	Lead Surveyor	Gavin Hooper		
Survey Date	29 Jan 2015	UKAS Laboratory	NOT SAMPLED (Cross Referenced)		
Site Reference	I43760000A	Licensed Material	N/A	Notifiable Non Licensed Work	N/A

**No Asbestos Presumed in Sample**

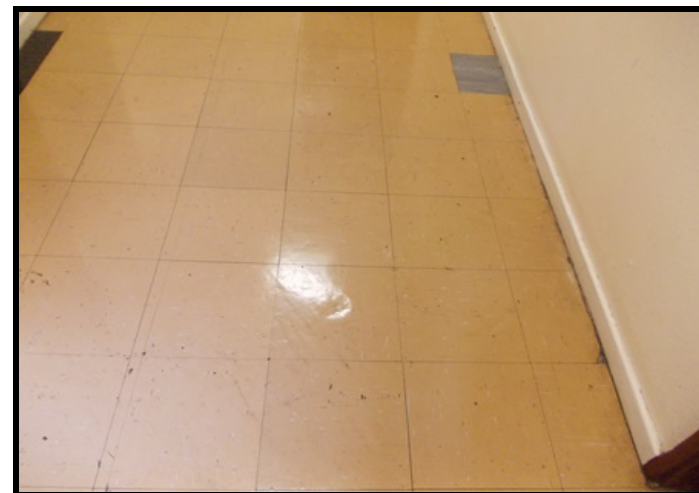
## SAMPLE REFERENCE 022

**No Asbestos Presumed in Sample**

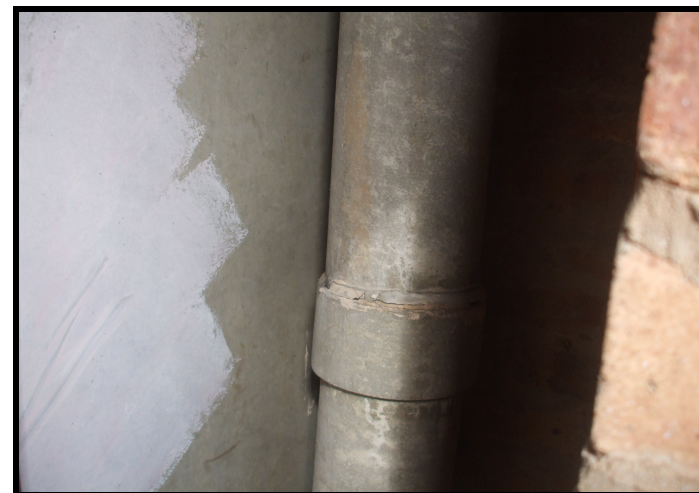
## SAMPLE REFERENCE 024

**Asbestos Presumed**
