Site ID: **a-312479** Management with Targeted Refurbishment Survey

Solihull Community Housing

1-53 Selwyn House
2 Waterson Croft
Chelmsley Wood
Solihull
B37 6TT
United Kingdom

23rd June 2021

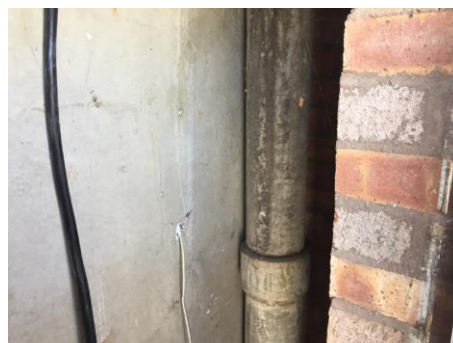
Cement incinerator flue.

The material was seen to be in fair condition at the time of the initial inspection.

The condition of the material should be managed by a competent person/company and its presence made aware to those at risk, as part of a Control of Asbestos Regulations (CAR) 2012 compliant management strategy.

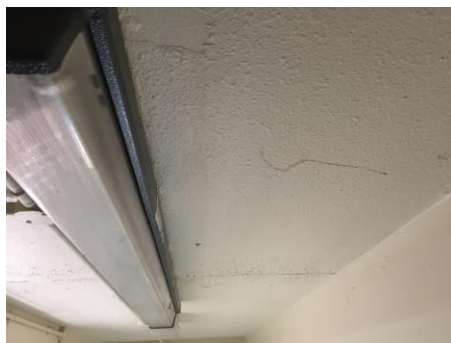
Spatter pattern textured coating.

The material was seen to be in fair condition at the time of the initial inspection.

The condition of the material should be managed by a competent person/company and its presence made aware to those at risk, as part of a Control of Asbestos Regulations (CAR) 2012 compliant management strategy.

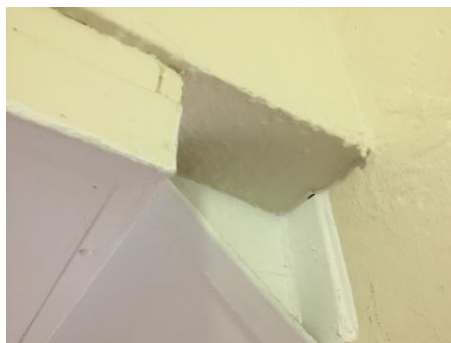
Spatter pattern textured coating above suspended ceiling.

The material was seen to be in fair condition at the time of the initial inspection.

The condition of the material should be managed by a competent person/company and its presence made aware to those at risk, as part of a Control of Asbestos Regulations (CAR) 2012 compliant management strategy.

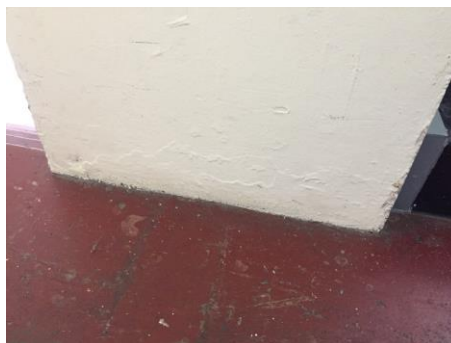
Spatter pattern textured coating, only visible in certain areas of wall. Possible previous poor removal works.

The material was seen to be in fair condition at the time of the initial inspection.

The condition of the material should be managed by a competent person/company and its presence made aware to those at risk, as part of a Control of Asbestos Regulations (CAR) 2012 compliant management strategy.

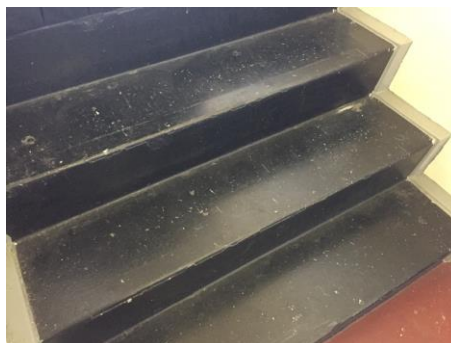
Resin nosing to edge of stairs.

The material was seen to be in fair condition at the time of the initial inspection.

The condition of the material should be managed by a competent person/company and its presence made aware to those at risk, as part of a Control of Asbestos Regulations (CAR) 2012 compliant management strategy.

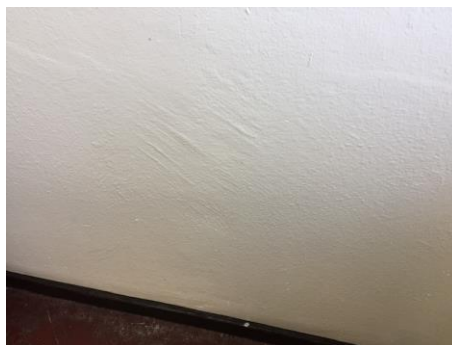
Spatter pattern textured coating.

The material was seen to be in fair condition at the time of the initial inspection.

The condition of the material should be managed by a competent person/company and its presence made aware to those at risk, as part of a Control of Asbestos Regulations (CAR) 2012 compliant management strategy.

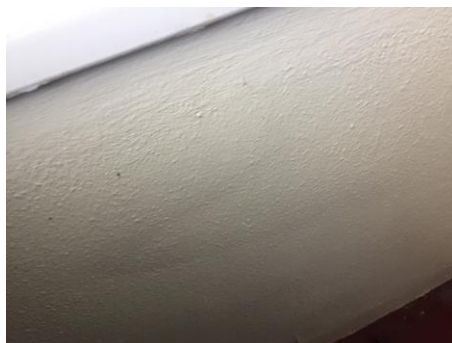
The material was seen to be in fair condition at the time of the initial inspection.

The condition of the material should be managed by a competent person/company and its presence made aware to those at risk, as part of a Control of Asbestos Regulations (CAR) 2012 compliant management strategy.

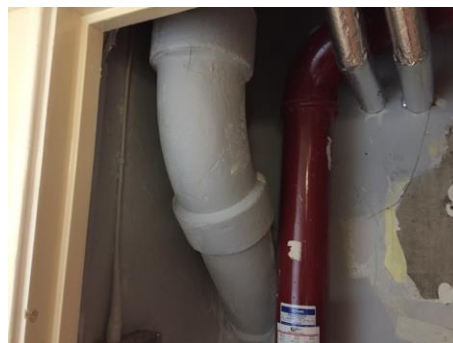
Cement incinerator flue.

The material was seen to be in fair condition at the time of the initial inspection.

The condition of the material should be managed by a competent person/company and its presence made aware to those at risk, as part of a Control of Asbestos Regulations (CAR) 2012 compliant management strategy.

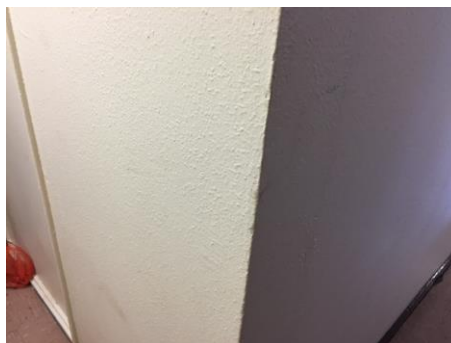
Spatter pattern textured coating.

The material was seen to be in fair condition at the time of the initial inspection.

The condition of the material should be managed by a competent person/company and its presence made aware to those at risk, as part of a Control of Asbestos Regulations (CAR) 2012 compliant management strategy.

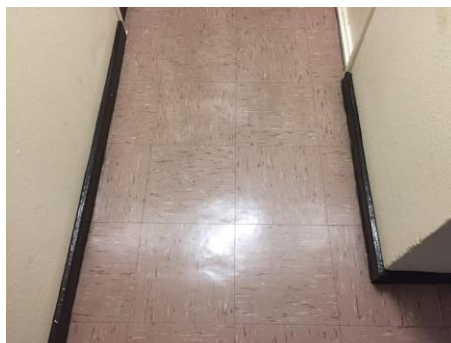
Pink floor tiles.

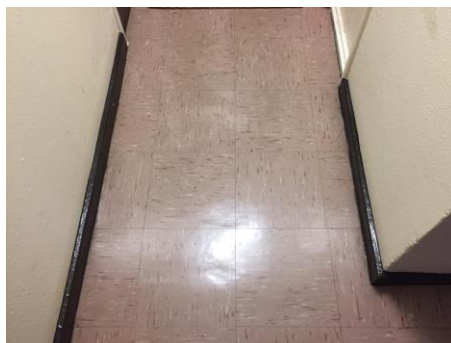
Bitumen adhesive beneath floor tiles.

The material was seen to be in fair condition at the time of the initial inspection.

The condition of the material should be managed by a competent person/company and its presence made aware to those at risk, as part of a Control of Asbestos Regulations (CAR) 2012 compliant management strategy.

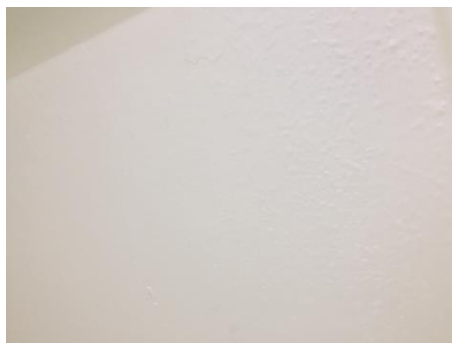
Spatter pattern textured coating.

The material was seen to be in fair condition at the time of the initial inspection.

The condition of the material should be managed by a competent person/company and its presence made aware to those at risk, as part of a Control of Asbestos Regulations (CAR) 2012 compliant management strategy.

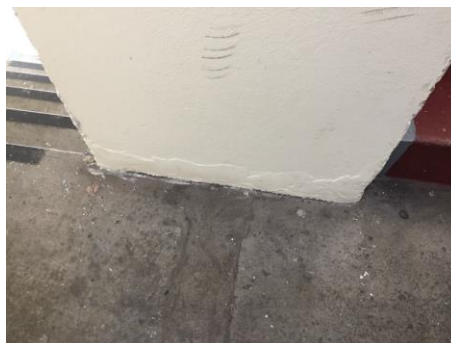
Spatter pattern textured coating, only visible in certain areas of wall. Possible previous poor removal works.

The material was seen to be in fair condition at the time of the initial inspection.

The condition of the material should be managed by a competent person/company and its presence made aware to those at risk, as part of a Control of Asbestos Regulations (CAR) 2012 compliant management strategy.

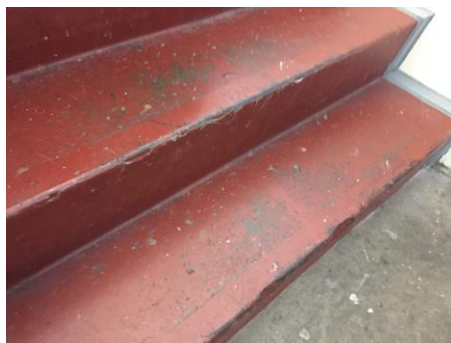
Resin nosing to edge of stairs.

The material was seen to be in fair condition at the time of the initial inspection.

The condition of the material should be managed by a competent person/company and its presence made aware to those at risk, as part of a Control of Asbestos Regulations (CAR) 2012 compliant management strategy.

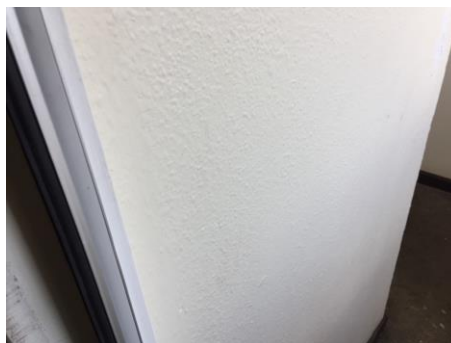
Spatter pattern textured coating.

The material was seen to be in fair condition at the time of the initial inspection.

The condition of the material should be managed by a competent person/company and its presence made aware to those at risk, as part of a Control of Asbestos Regulations (CAR) 2012 compliant management strategy.

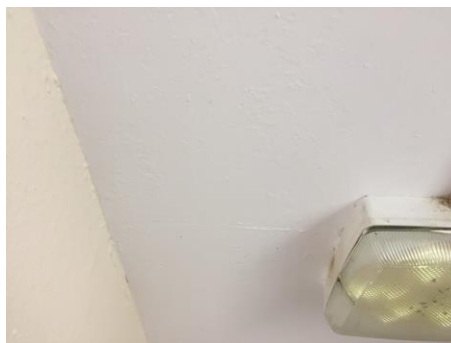
Spatter pattern textured coating. Visible only in certain areas. Possible previous poor removal works.

The material was seen to be in fair condition at the time of the initial inspection.

The condition of the material should be managed by a competent person/company and its presence made aware to those at risk, as part of a Control of Asbestos Regulations (CAR) 2012 compliant management strategy.

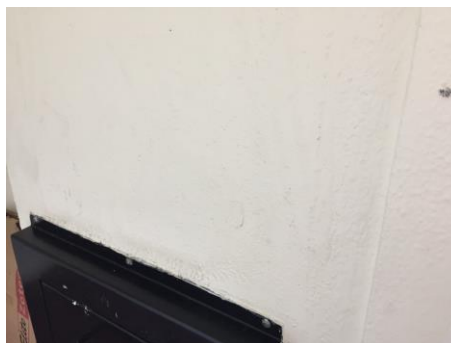
Spatter pattern textured coating.

The material was seen to be in fair condition at the time of the initial inspection.

The condition of the material should be managed by a competent person/company and its presence made aware to those at risk, as part of a Control of Asbestos Regulations (CAR) 2012 compliant management strategy.

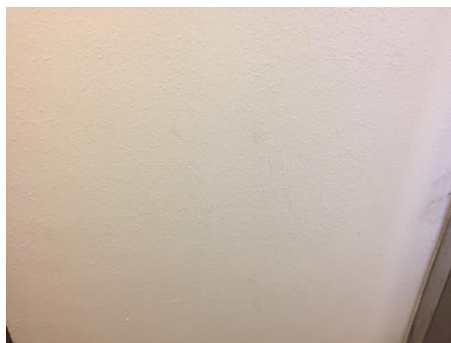
Spatter pattern textured coating.

The material was seen to be in fair condition at the time of the initial inspection.

The condition of the material should be managed by a competent person/company and its presence made aware to those at risk, as part of a Control of Asbestos Regulations (CAR) 2012 compliant management strategy.

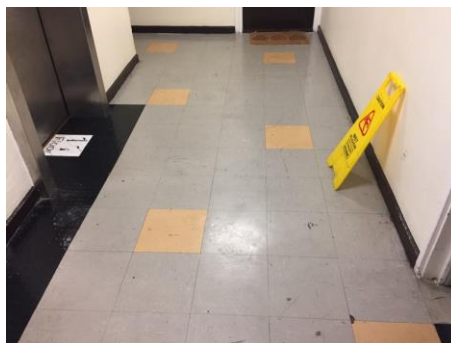
Grey and beige floor tiles.

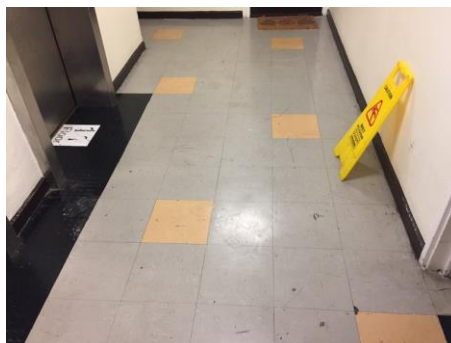
Bitumen adhesive beneath floor tiles.

The material was seen to be in fair condition at the time of the initial inspection.

The condition of the material should be managed by a competent person/company and its presence made aware to those at risk, as part of a Control of Asbestos Regulations (CAR) 2012 compliant management strategy.

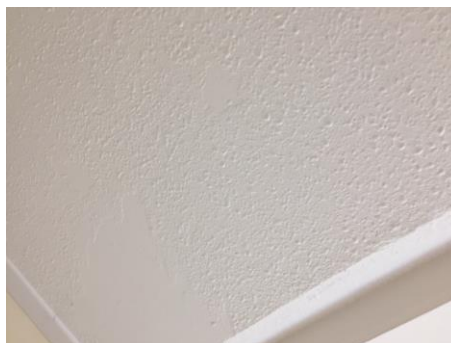
Spatter pattern textured coating.

The material was seen to be in fair condition at the time of the initial inspection.

The condition of the material should be managed by a competent person/company and its presence made aware to those at risk, as part of a Control of Asbestos Regulations (CAR) 2012 compliant management strategy.

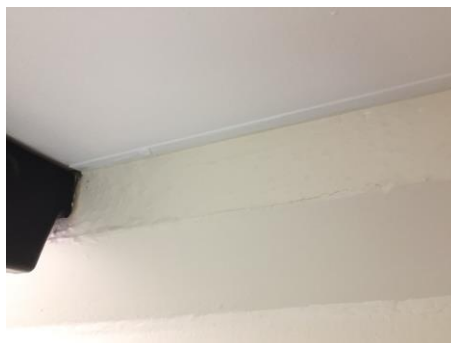
Spatter pattern textured coating, only visible in certain areas of wall. Possible previous poor removal works.

The material was seen to be in fair condition at the time of the initial inspection.

The condition of the material should be managed by a competent person/company and its presence made aware to those at risk, as part of a Control of Asbestos Regulations (CAR) 2012 compliant management strategy.

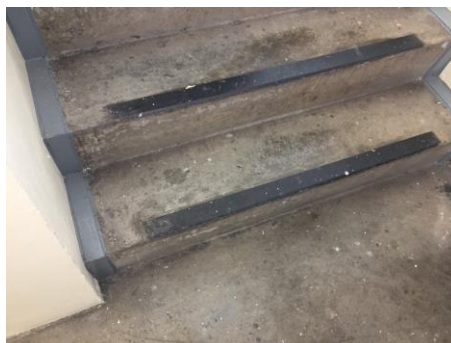
The material was seen to be in fair condition at the time of the initial inspection.

The condition of the material should be managed by a competent person/company and its presence made aware to those at risk, as part of a Control of Asbestos Regulations (CAR) 2012 compliant management strategy.

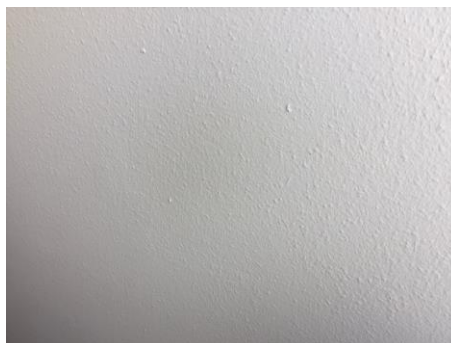
Spatter pattern textured coating.

The material was seen to be in fair condition at the time of the initial inspection.

The condition of the material should be managed by a competent person/company and its presence made aware to those at risk, as part of a Control of Asbestos Regulations (CAR) 2012 compliant management strategy.

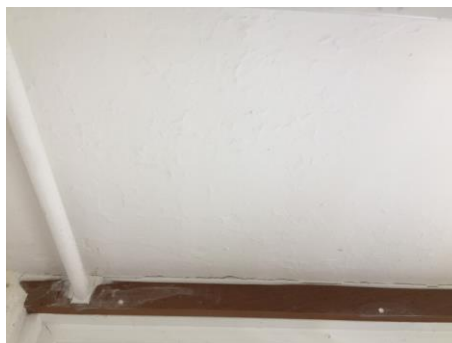
Spatter pattern textured coating. Visible only in certain areas. Possible previous poor removal works.

The material was seen to be in fair condition at the time of the initial inspection.

The condition of the material should be managed by a competent person/company and its presence made aware to those at risk, as part of a Control of Asbestos Regulations (CAR) 2012 compliant management strategy.

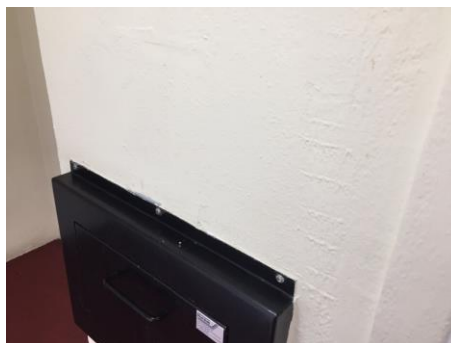
Spatter pattern textured coating.

The material was seen to be in fair condition at the time of the initial inspection.

The condition of the material should be managed by a competent person/company and its presence made aware to those at risk, as part of a Control of Asbestos Regulations (CAR) 2012 compliant management strategy.

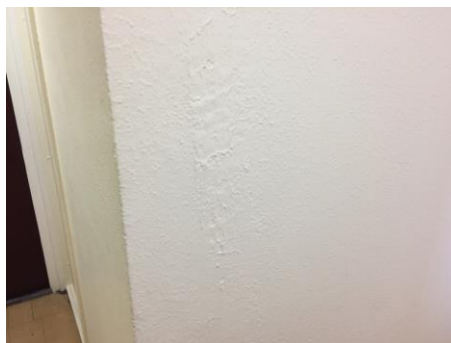
Spatter pattern textured coating.

The material was seen to be in fair condition at the time of the initial inspection.

The condition of the material should be managed by a competent person/company and its presence made aware to those at risk, as part of a Control of Asbestos Regulations (CAR) 2012 compliant management strategy.

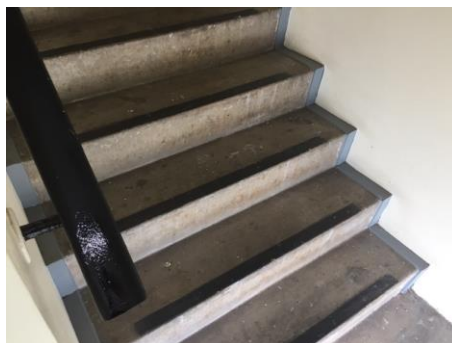
Resin nosing to edge of stairs.

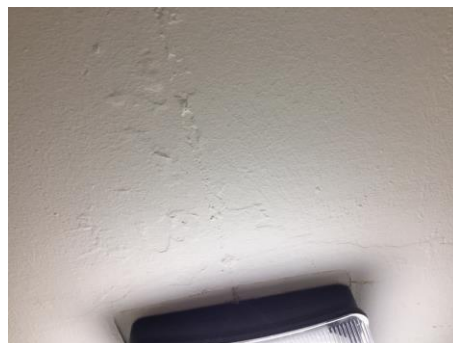
Spatter pattern textured coating. Visible only in certain areas. Possible previous poor removal works.

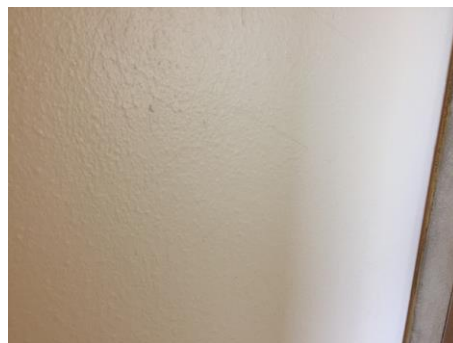
Spatter pattern textured coating.

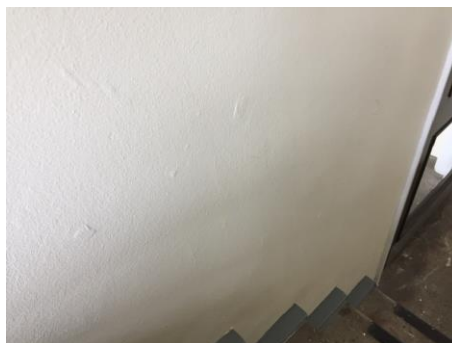
Spatter pattern textured coating, only visible in certain areas of wall. Possible previous poor removal works.

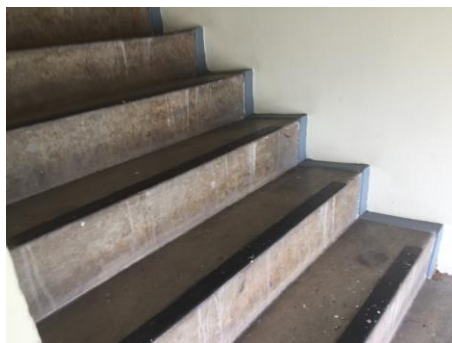
Resin nosing to edge of stairs.

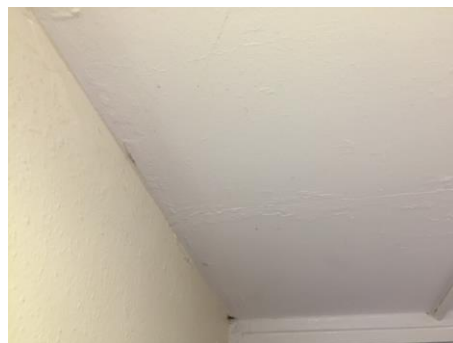
Spatter pattern textured coating. Visible only in certain areas. Possible previous poor removal works.

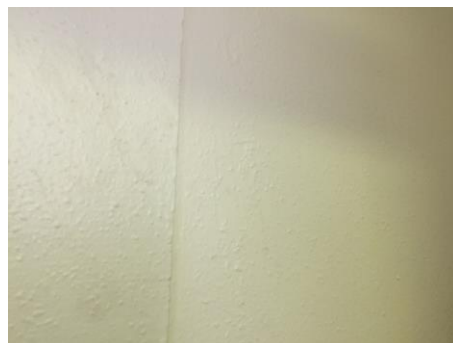
Spatter pattern textured coating.

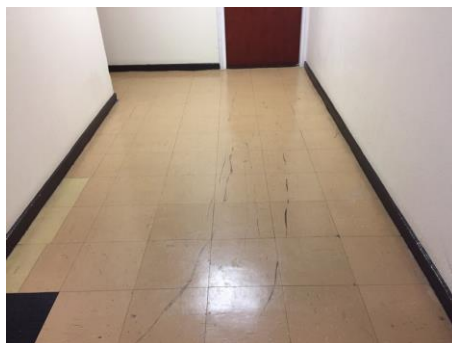
Bitumen adhesive beneath floor tiles.

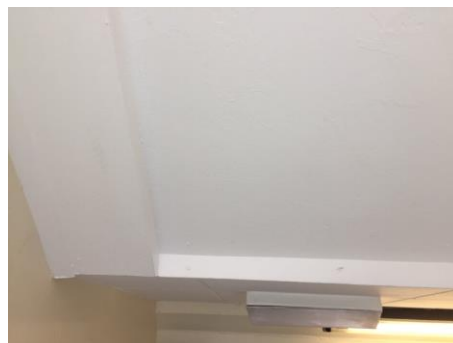
Spatter pattern textured coating.

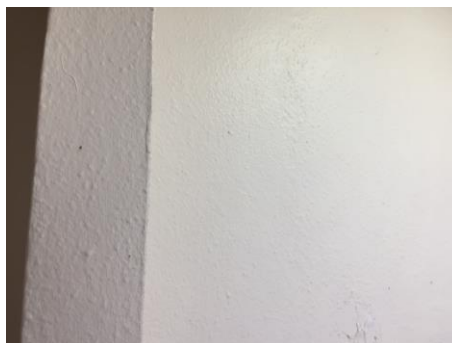
Spatter pattern textured coating.

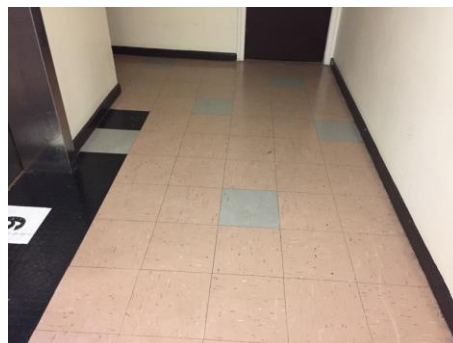
Beige and grey floor tiles.

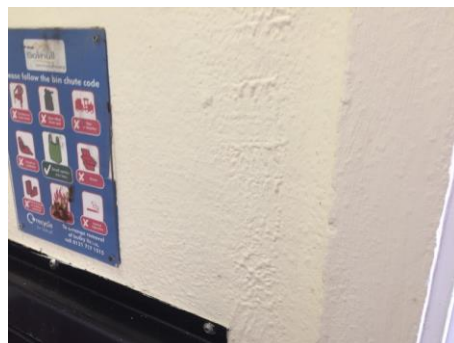
Spatter pattern textured coating.

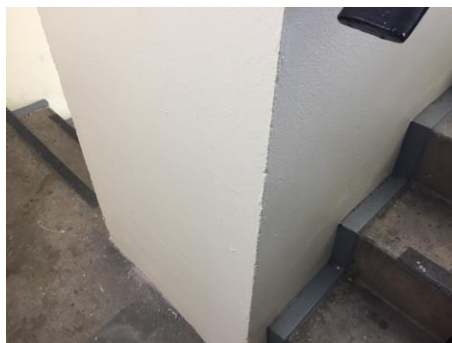
Spatter pattern textured coating, only visible in certain areas of wall. Possible previous poor removal works.

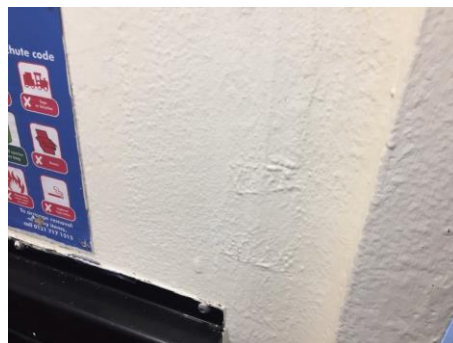
Spatter pattern textured coating.

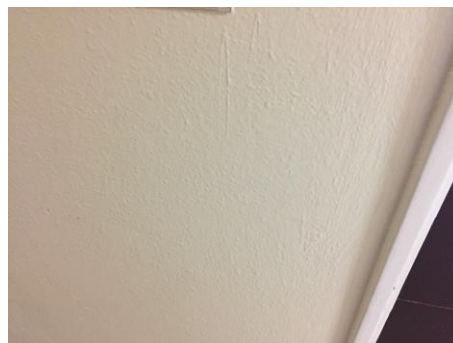
Spatter pattern textured coating.

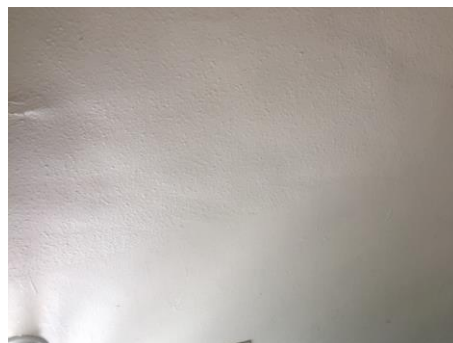
Spatter pattern textured coating, only visible in certain areas of wall. Possible previous poor removal works.

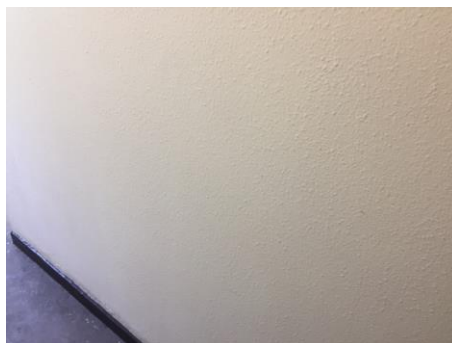
Spatter pattern textured coating.

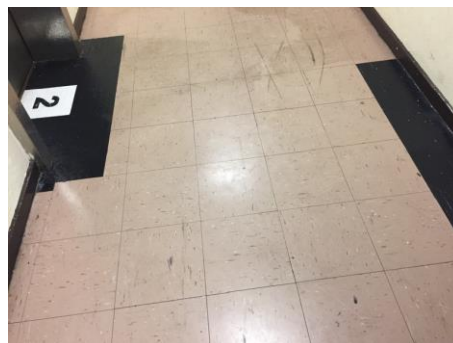
Pink floor tiles.

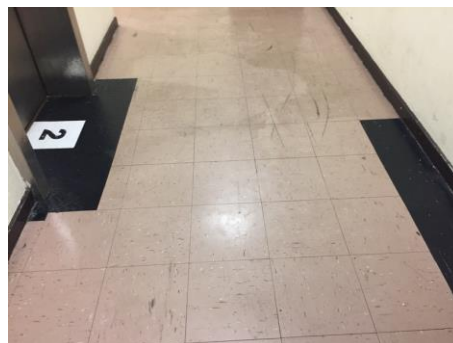
Bitumen adhesive beneath floor tiles.

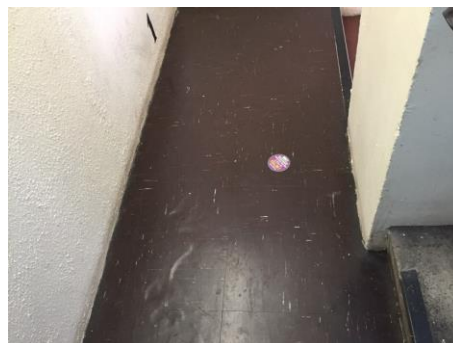
Brown floor tiles.

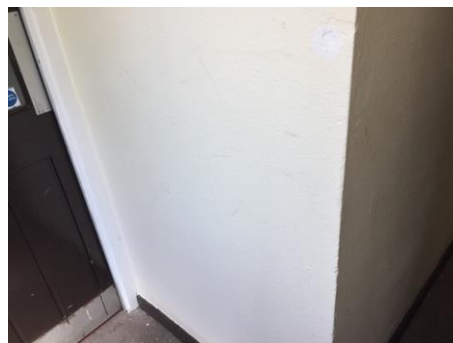
Spatter pattern textured coating.

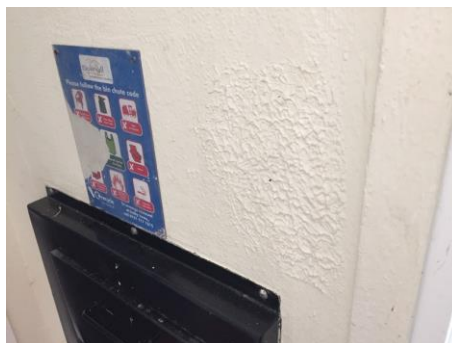
Spatter pattern textured coating.

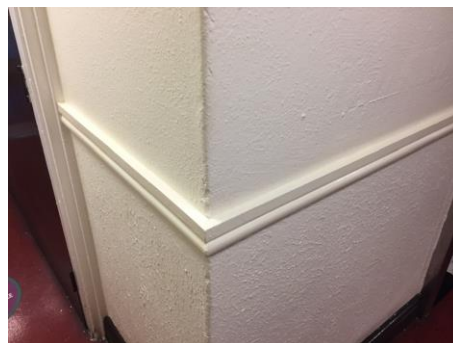
Spatter pattern textured coating beneath more modern stipple pattern in areas.

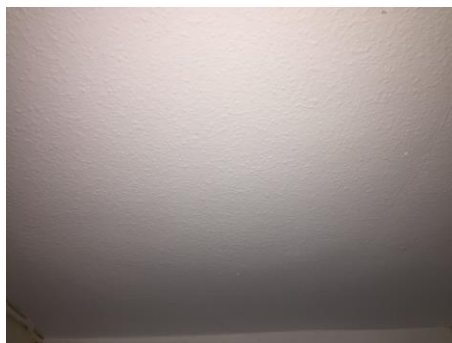
Spatter pattern textured coating.

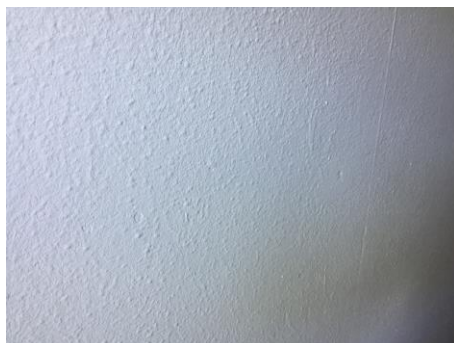
Spatter pattern textured coating, only visible in certain areas of wall. Possible previous poor removal works.

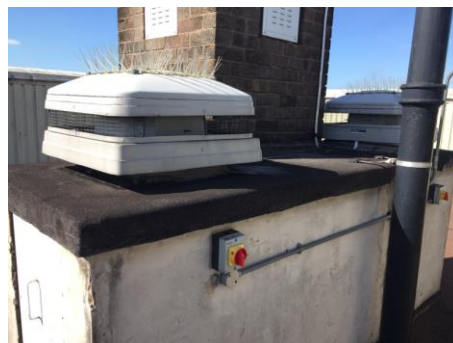
Hard set bitumen lining to brick and concrete plinths to roof.
