# **Solihull Community Housing**

## **Asbestos Management Survey Report**

**I - 53 (Communal) Somerville  
House  
Waterson Croft  
Solihull  
B37 6TY**

**Date of Report: 23 Jan 2013**  
**Survey Ref: 159910000A**

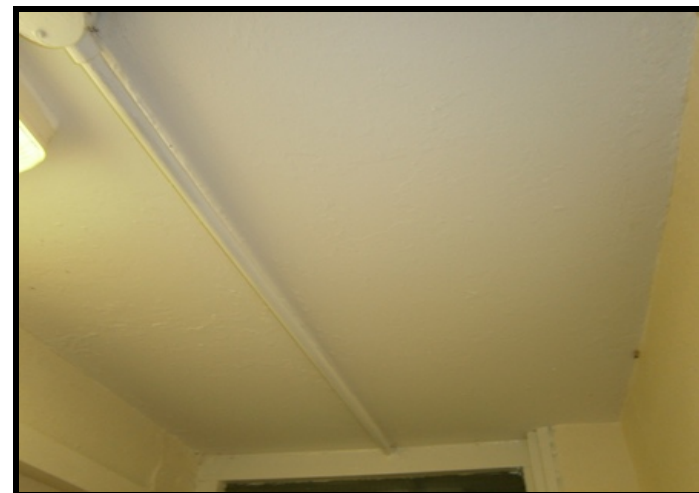
## SAMPLE REFERENCE 001a

| 001a | Main (First Floor) | Waste Chute Area | Ceiling | Textured Coating | Chrysotile | 2.00m2 | Good condition | Textured Coating | 2 | 1 | 3 | LABEL & MONITOR | 11 Dec 2013 | |

Asbestos Presumed in Sample

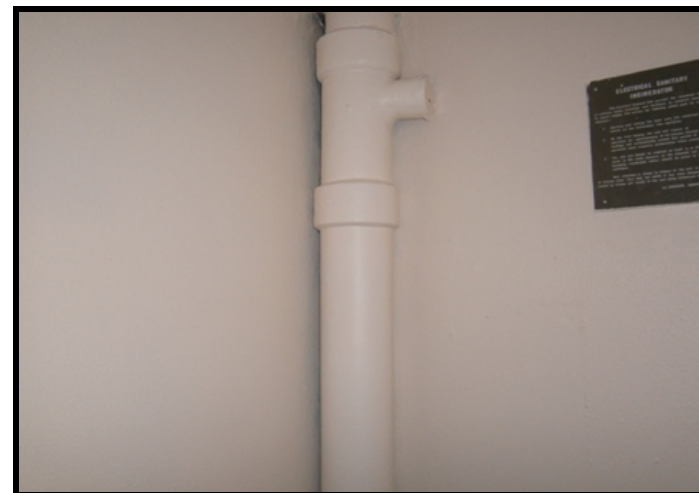
## SAMPLE REFERENCE 001b

| 001b | Main (First Floor) | Waste Chute Area | Pipe Work | Cement Pipe | Chrysotile | 2.00small item(s) | Good condition | Sealed (Cement products) | 3 | 0 | 3 | LABEL & MONITOR | 11 Dec 2013 | |

**Asbestos Presumed in Sample**

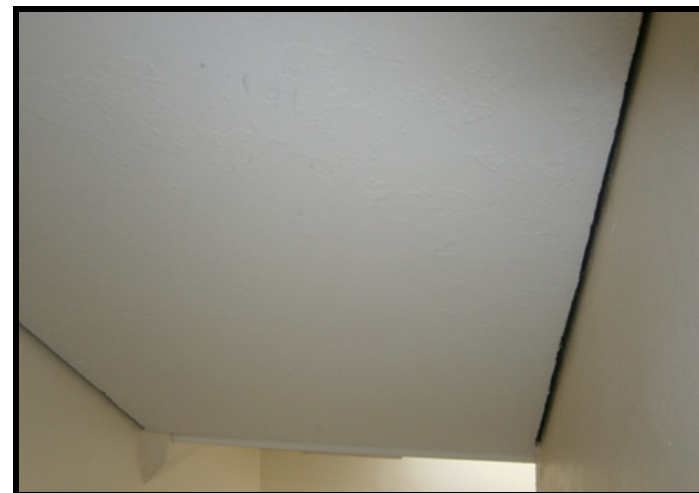
## SAMPLE REFERENCE 009

| Unique Sample No. | Building Reference (Floor) | Room Area | Description of Location | Product Description | Asbestos Type | Approx. Quantity | Material Condition | Surface Treatment | Material Risk Score | Priority Risk Score | Total Risk Score | Management Action | Next Review Date |
|---|---|---|---|---|---|---|---|---|---|---|---|---|---|
| 009 | Main (Second Floor) | Stairwell | Ceiling | Textured Coating | Chrysotile | 8.00m2 | Good condition | Textured Coating | 2 | 1 | 3 | LABEL & MONITOR | 11 Dec 2013 |

**Asbestos Presumed in Sample**

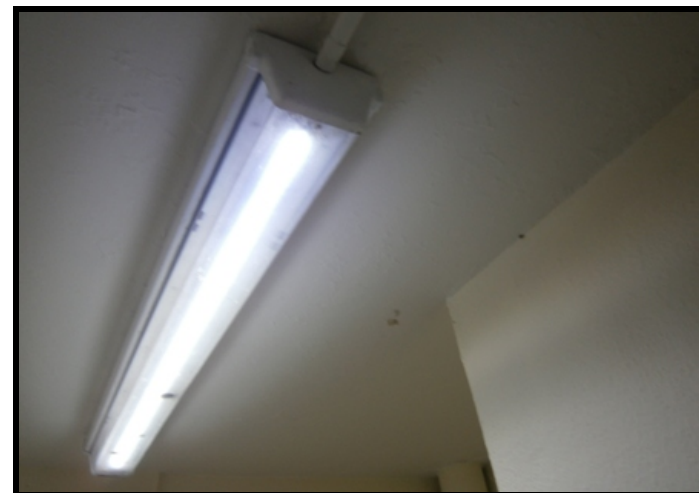
## SAMPLE REFERENCE 020

| Unique Sample No. | Building Reference (Floor) | Room Area | Description of Location | Product Description | Asbestos Type | Approx. Quantity | Material Condition | Surface Treatment | Material Risk Score | Priority Risk Score | Total Risk Score | Management Action | Next Review Date |
|---|---|---|---|---|---|---|---|---|---|---|---|---|---|
| 020 | Main (Second Floor) | Waste Chute Area | Ceiling | Textured Coating | Chrysotile | 2.00m2 | Good condition | Textured Coating | 2 | 1 | 3 | LABEL & MONITOR | 11 Dec 2013 |

Asbestos Presumed in Sample

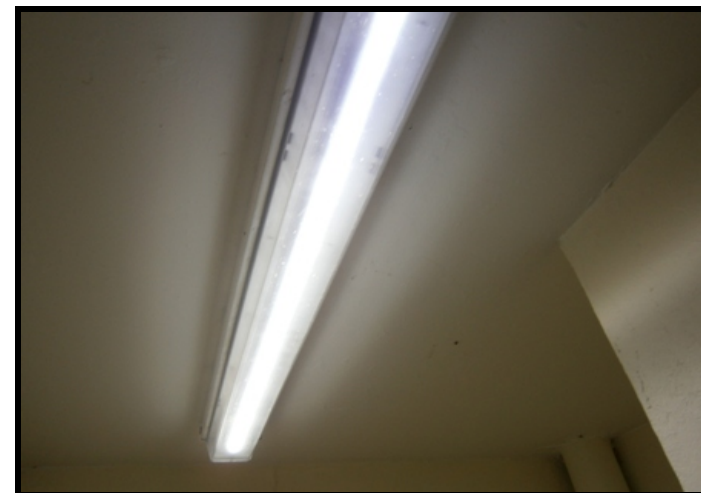
## SAMPLE REFERENCE 036

| Unique Sample No. | Building Reference (Floor) | Room Area | Description of Location | Product Description | Asbestos Type | Approx. Quantity | Material Condition | Surface Treatment | Material Risk Score | Priority Risk Score | Total Risk Score | Management Action | Next Review Date |
|---|---|---|---|---|---|---|---|---|---|---|---|---|---|
| 036 | Main (Third Floor) | Waste Chute Area | Ceiling | Textured Coating | Chrysotile | 2.00m2 | Good condition | Textured Coating | 2 | 1 | 3 | LABEL & MONITOR | 11 Dec 2013 |

Asbestos Presumed in Sample

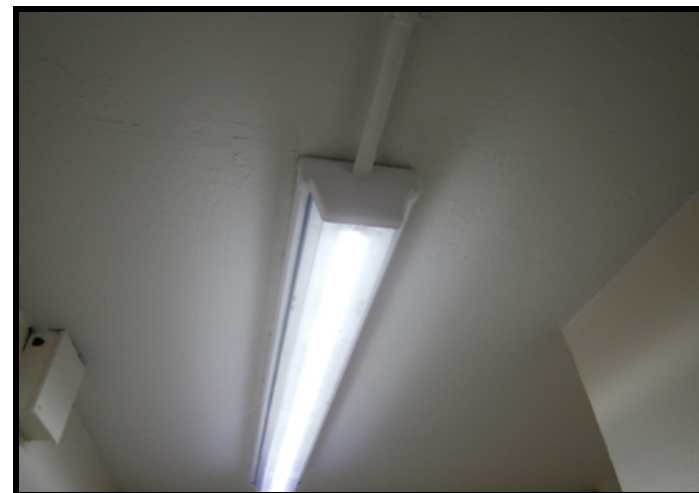
## SAMPLE REFERENCE 052

| Unique Sample No. | Building Reference (Floor) | Room Area | Description of Location | Product Description | Asbestos Type | Approx. Quantity | Material Condition | Surface Treatment | Material Risk Score | Priority Risk Score | Total Risk Score | Management Action | Next Review Date |
|---|---|---|---|---|---|---|---|---|---|---|---|---|---|
| 052 | Main (Fourth Floor) | Waste Chute Area | Ceiling | Textured Coating | Chrysotile | 2.00m2 | Good condition | Textured Coating | 2 | 1 | 3 | LABEL & MONITOR | 11 Dec 2013 |

Asbestos Presumed in Sample

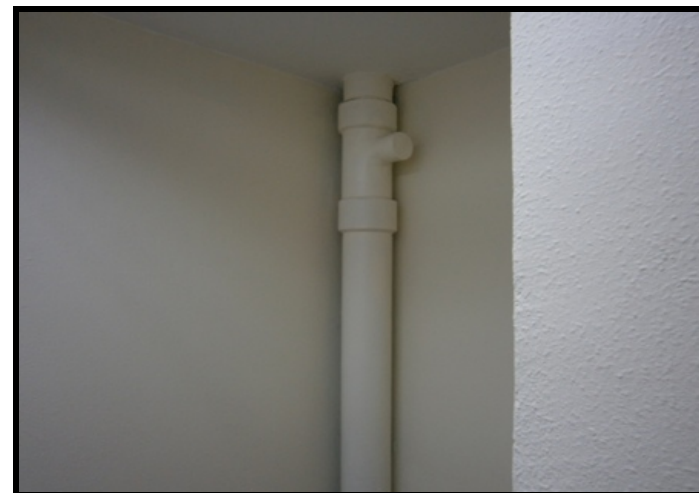
## SAMPLE REFERENCE 054

| Unique Sample No. | Building Reference (Floor) | Room Area | Description of Location | Product Description | Asbestos Type | Approx. Quantity | Material Condition | Surface Treatment | Material Risk Score | Priority Risk Score | Total Risk Score | Management Action | Next Review Date |
|---|---|---|---|---|---|---|---|---|---|---|---|---|---|
| 054 | Main (Fourth Floor) | Waste Chute Area | Pipe Work | Cement Pipe | Chrysotile | 2.00m2 | Good condition | Sealed (Cement products) | 3 | 1 | 4 | LABEL & MONITOR | 11 Dec 2013 |

Asbestos Presumed in Sample

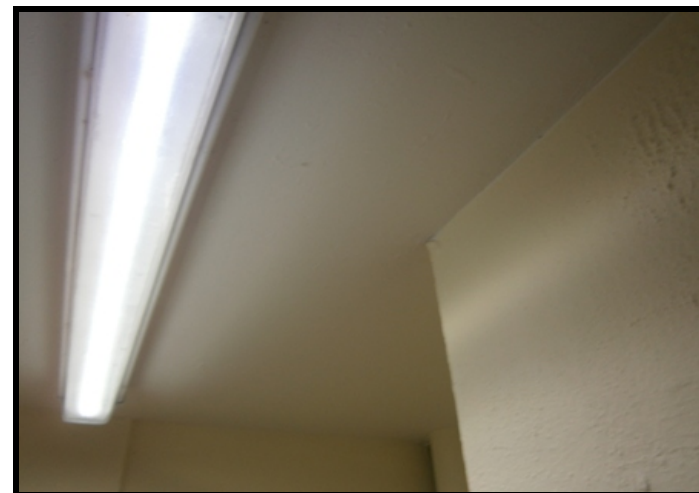
## SAMPLE REFERENCE 068

Asbestos Presumed in Sample

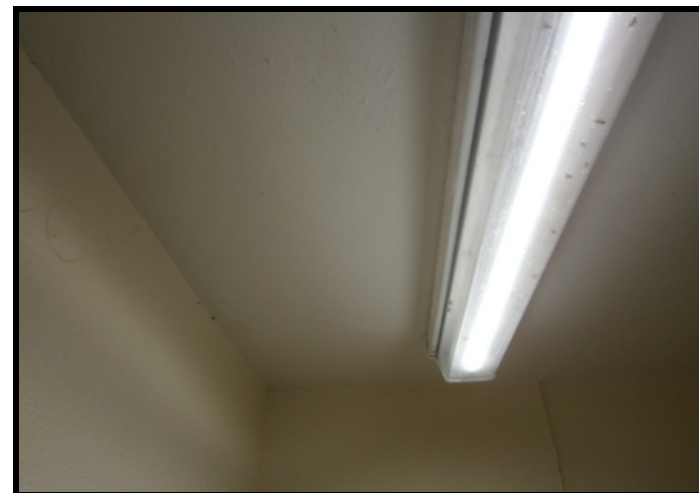
## SAMPLE REFERENCE 084

**Asbestos Presumed in Sample**

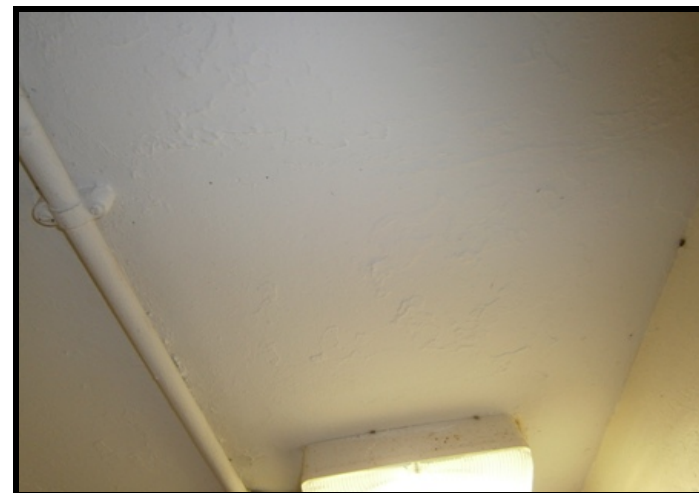
## SAMPLE REFERENCE 100

Asbestos Presumed in Sample

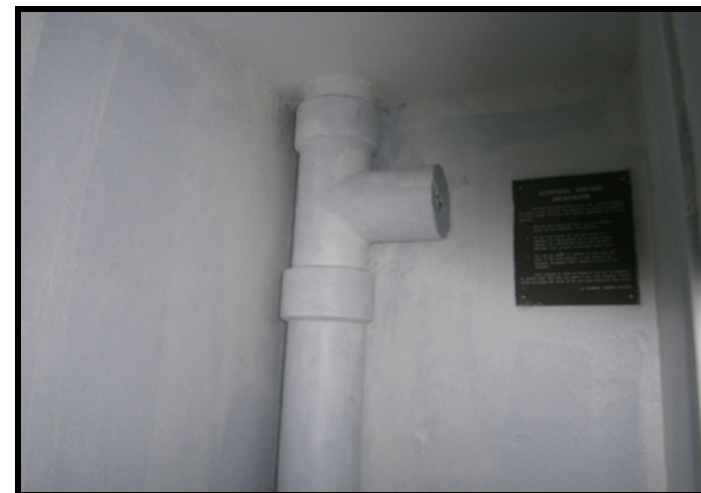
## SAMPLE REFERENCE 102

Asbestos Presumed in Sample

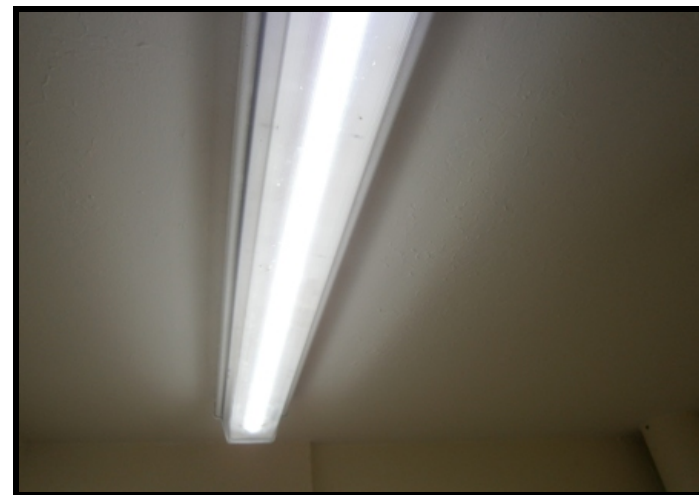
## SAMPLE REFERENCE I17

Asbestos Presumed in Sample

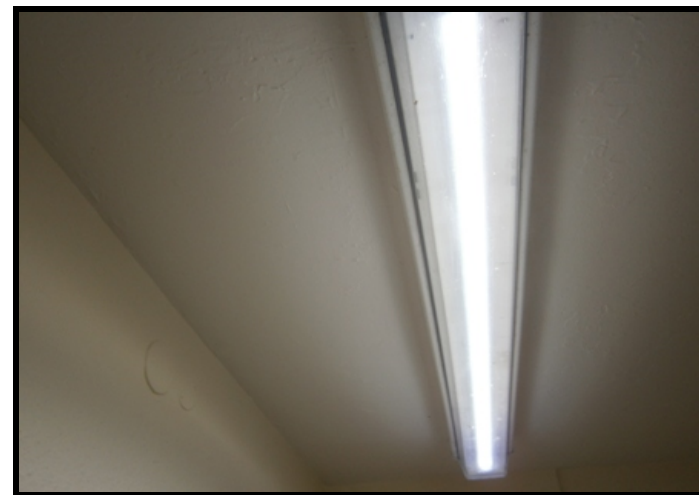
## SAMPLE REFERENCE I33

**Asbestos Presumed in Sample**

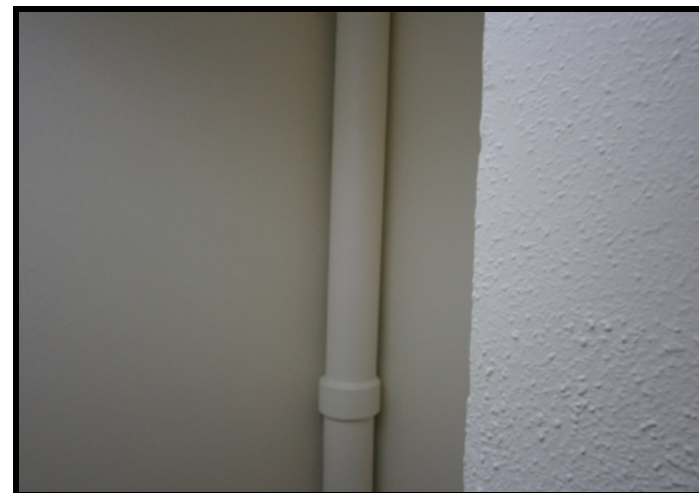
## SAMPLE REFERENCE I35

Asbestos Presumed in Sample

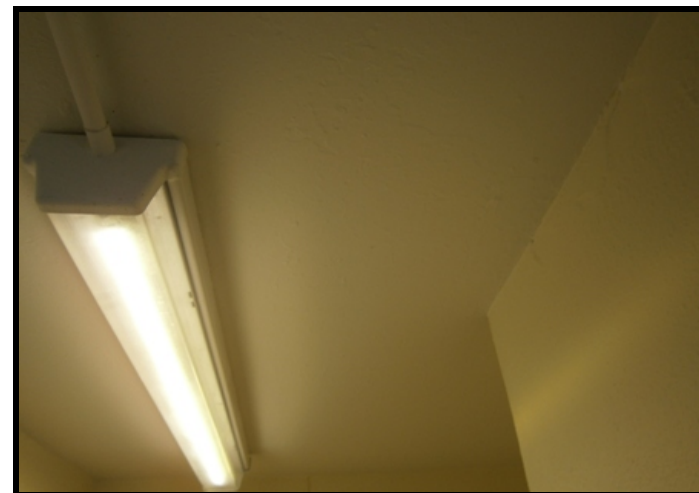
## SAMPLE REFERENCE I49

**Asbestos Presumed in Sample**

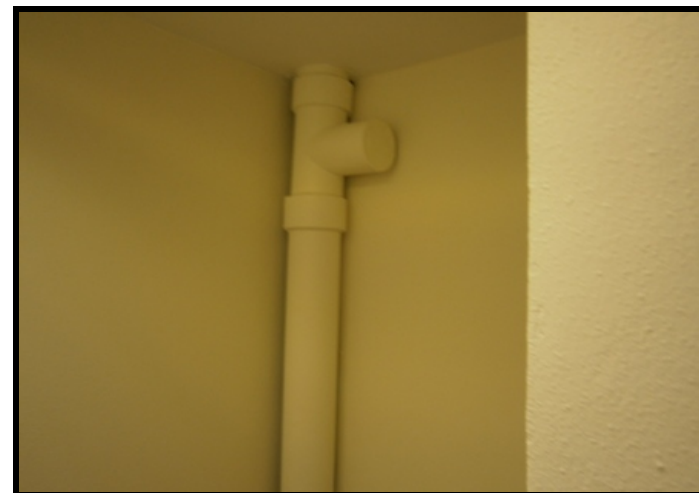
## SAMPLE REFERENCE 151

Asbestos Presumed in Sample

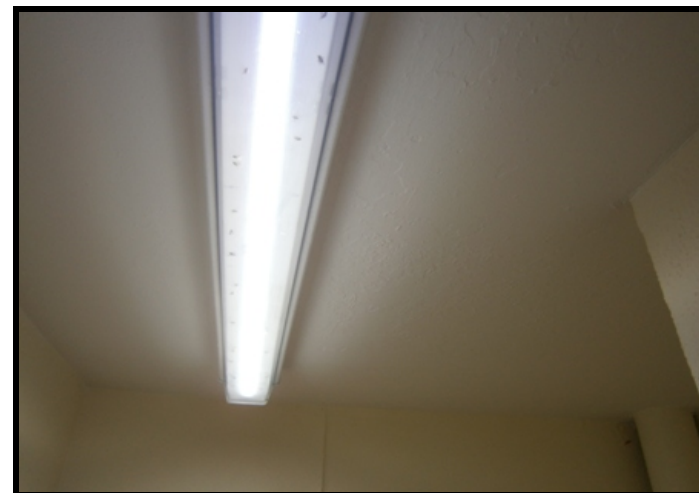
## SAMPLE REFERENCE I65

Asbestos Presumed in Sample

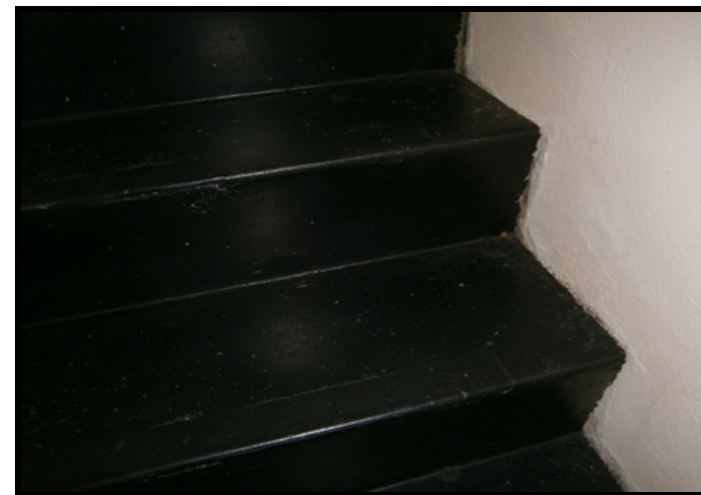
## SAMPLE REFERENCE 172

Asbestos Presumed in Sample

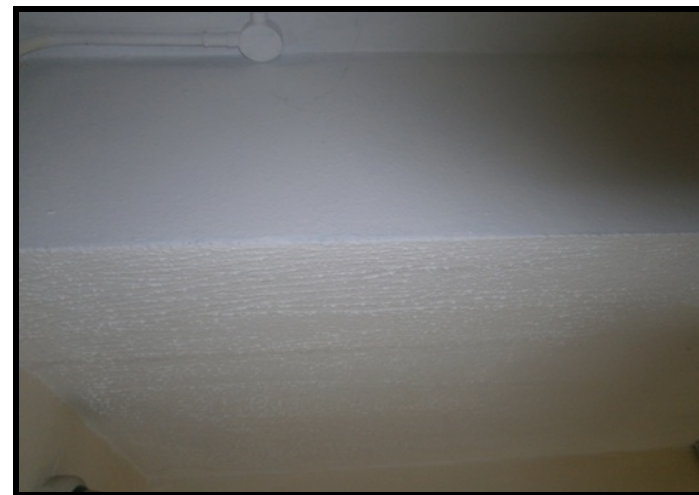
## SAMPLE REFERENCE I87a

Asbestos Presumed in Sample

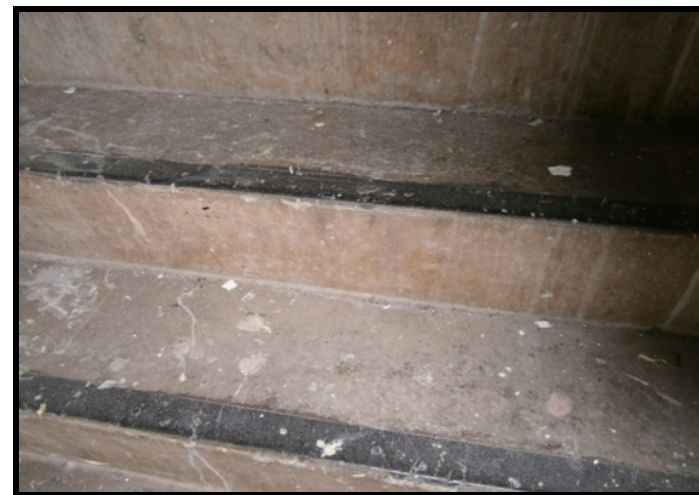
## SAMPLE REFERENCE I87b

Asbestos Presumed in Sample

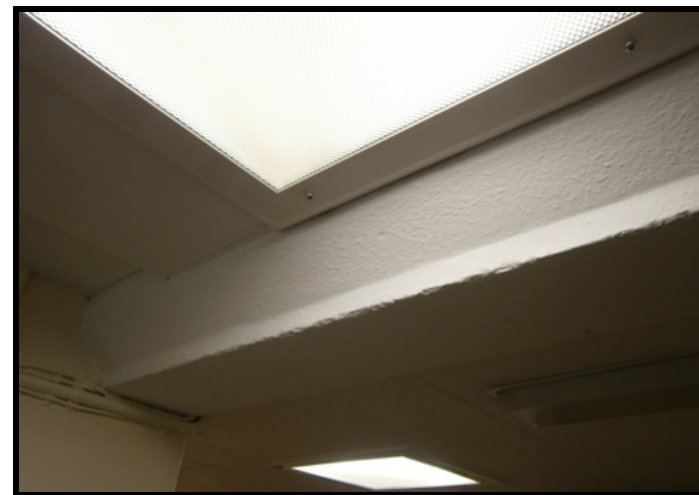
## SAMPLE REFERENCE 208

**Asbestos Presumed in Sample**
