Solihull Community Housing

Asbestos Management Survey Report

**I - 45 (Communal) Trevelyan
House
Marlene Croft
Solihull
B37 7JR**

Date of Report: 07 Jan 2013

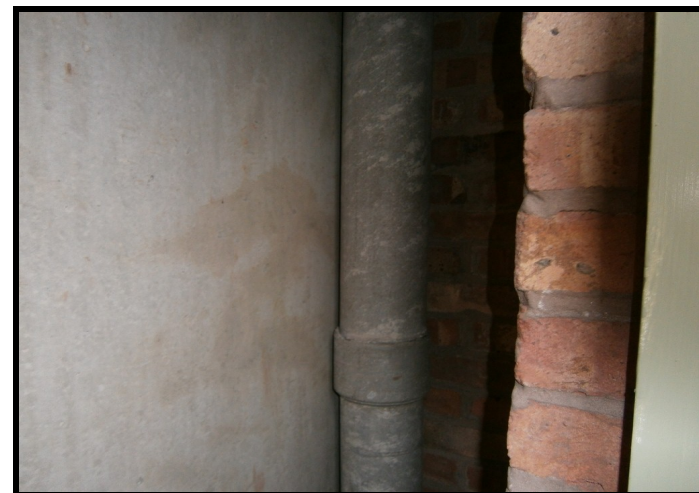
SAMPLE REFERENCE 003

Asbestos detected in Sample

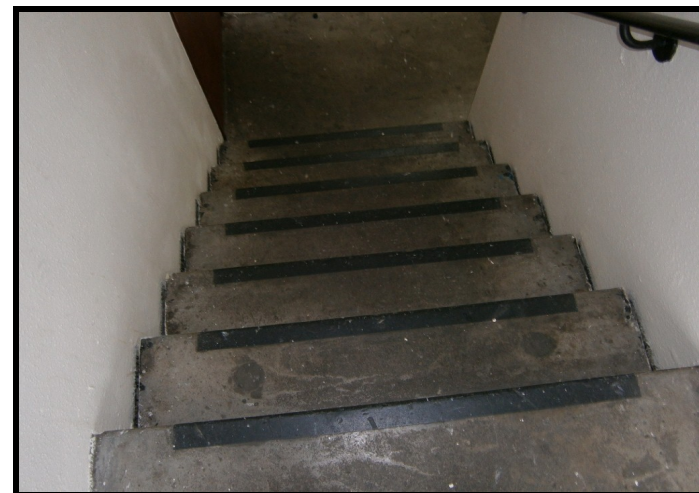
SAMPLE REFERENCE 003a

Asbestos detected in Sample

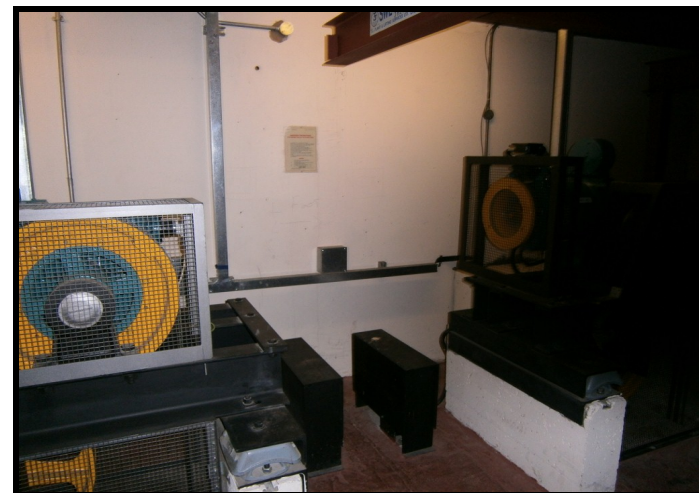
SAMPLE REFERENCE 003b

Building	Floor	Room	Location
Main	Roof	Lift Motor Room	Lift Motor
Description			
MATERIAL ASSESSMENT			
Product Type	Flash Pad	Extent of Damage	Low damage
Asbestos Type	Chrysotile	Surface Treatment	Unsealed (3)
PRIORITY ASSESSMENT			
Occupant Activity	Not Applicable	Extent / Amount	1.00 m2
Accessibility	Occasionally disturb	Location	Not Applicable
Avg Time in Use	Not Applicable	Frequency of Use	Not Applicable
No. of Occupants	Not Applicable	Secondary Activity	Not Applicable
Maintenance	Not Applicable	Maintenance Frequency	Not Applicable
MANAGEMENT ACTION			
Recommendation	LABEL & MONITOR		
Recommendation Due		Next Inspection	11 Jun 2012
Apply Labels	No	Permit to Work Required	No
Survey Type	Re-Inspection	Lead Surveyor	Gavin Hooper
Survey Date	11 Dec 2012	UKAS Laboratory	NOT SAMPLED
Site Reference	I43770000A	Licensed Material	Yes
		Notifiable Non Licensed Work	No

Asbestos Presumed in Sample

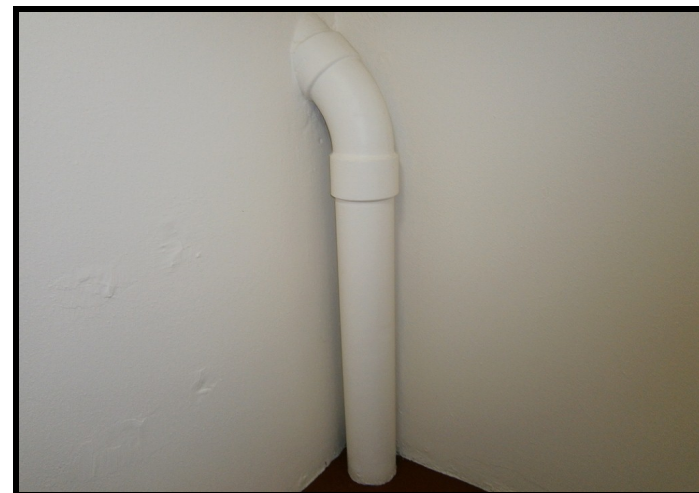
SAMPLE REFERENCE 009

Building	Floor	Room	Location
Main	Tenth Floor	Chute Room	Flue
Description			
MATERIAL ASSESSMENT			
Product Type	Cement Flue	Extent of Damage	Good condition
Asbestos Type	Chrysotile	Surface Treatment	Sealed (Cement products)
PRIORITY ASSESSMENT			
Occupant Activity	Not Applicable	Extent / Amount	2.00 small item(s)
Accessibility	Occasionally disturb	Location	Not Applicable
Avg Time in Use	Not Applicable	Frequency of Use	Not Applicable
No. of Occupants	Not Applicable	Secondary Activity	Not Applicable
Maintenance	Not Applicable	Maintenance Frequency	Not Applicable
MANAGEMENT ACTION			
Recommendation	LABEL & MONITOR		
Recommendation Due		Next Inspection	11 Dec 2013
Apply Labels	No	Permit to Work Required	No
Survey Type	Re-Inspection	Lead Surveyor	Gavin Hooper
Survey Date	11 Dec 2012	UKAS Laboratory	NOT SAMPLED (Cross Referenced)
Site Reference	I43770000A	Licensed Material	No
		Notifiable Non Licensed Work	No

Asbestos Presumed in Sample

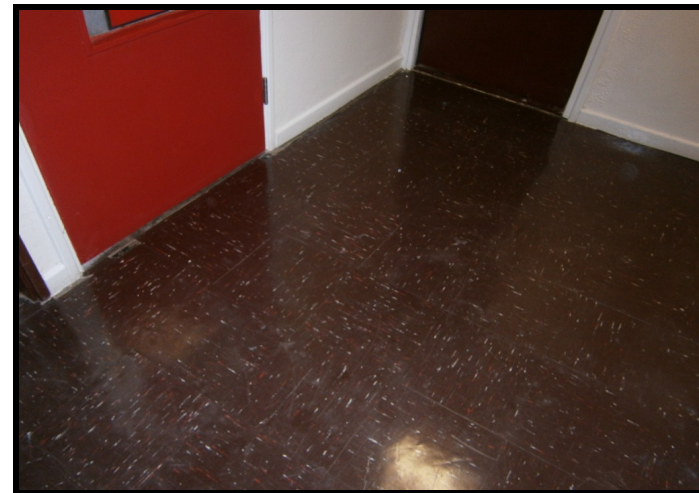
SAMPLE REFERENCE 009a

Building	Floor	Room	Location			
Main	Tenth Floor	Lobby	Floor			
Description	Brown floor tiles and adhesive					
MATERIAL ASSESSMENT				SCORE		
Product Type	Bitumen	Extent of Damage	Low damage		3	
Asbestos Type	Chrysotile	Surface Treatment	Composite materials			
PRIORITY ASSESSMENT				SCORE		
Occupant Activity	Not Applicable	Extent / Amount	10.00 m2		1	
Accessibility	Easily disturbed	Location	Not Applicable			
Avg Time in Use	Not Applicable	Frequency of Use	Not Applicable			
No. of Occupants	Not Applicable	Secondary Activity	Not Applicable			
Maintenance	Not Applicable	Maintenance Frequency	Not Applicable			
MANAGEMENT ACTION				SCORE		
Recommendation	LABEL & MONITOR			4		
Recommendation Due		Next Inspection	11 Dec 2013			
Apply Labels	No	Permit to Work Required	No			
Survey Type	Re-Inspection	Lead Surveyor	Gavin Hooper			
Survey Date	11 Dec 2012	UKAS Laboratory	DMW Environmental Safety Ltd / [D-15258]			
Site Reference	143770000A	Licensed Material	No	Notifiable Non Licensed Work	No

Asbestos detected in Sample

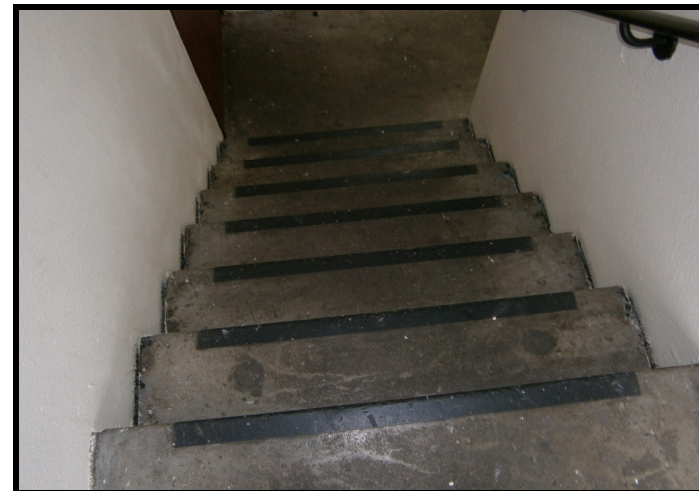
SAMPLE REFERENCE 009b

Asbestos Presumed in Sample

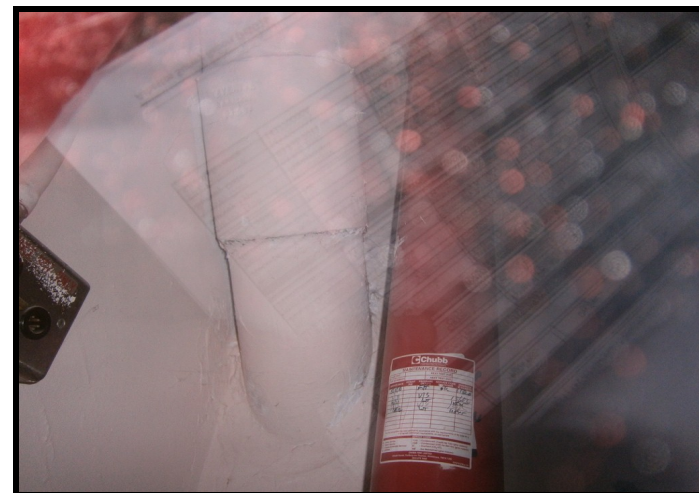
SAMPLE REFERENCE 012

Building	Floor	Room	Location
Main	Tenth Floor	Dry Riser	Flue
Description			
MATERIAL ASSESSMENT			
Product Type	Cement Flue	Extent of Damage	Good condition
Asbestos Type	Chrysotile	Surface Treatment	Sealed (Cement products)
PRIORITY ASSESSMENT			
Occupant Activity	Not Applicable	Extent / Amount	1.00 small item(s)
Accessibility	Occasionally disturb	Location	Not Applicable
Avg Time in Use	Not Applicable	Frequency of Use	Not Applicable
No. of Occupants	Not Applicable	Secondary Activity	Not Applicable
Maintenance	Not Applicable	Maintenance Frequency	Not Applicable
MANAGEMENT ACTION			
Recommendation	LABEL & MONITOR		
Recommendation Due		Next Inspection	11 Dec 2013
Apply Labels	No	Permit to Work Required	No
Survey Type	Re-Inspection	Lead Surveyor	Gavin Hooper
Survey Date	11 Dec 2012	UKAS Laboratory	NOT SAMPLED (Cross Referenced)
Site Reference	I43770000A	Licensed Material	No
		Notifiable Non Licensed Work	No

Asbestos Presumed in Sample

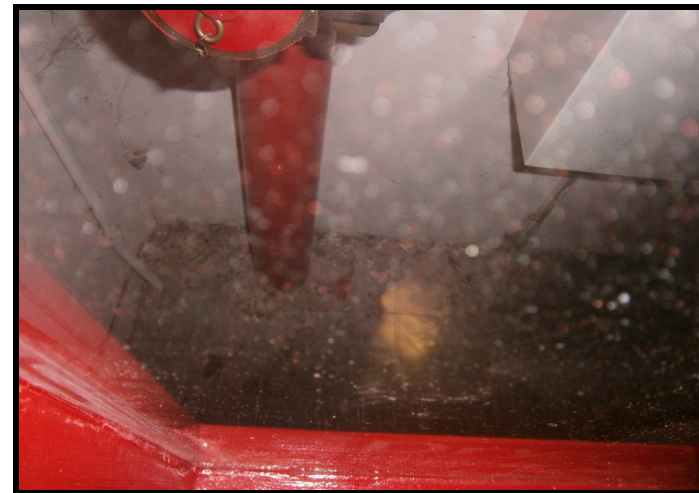
SAMPLE REFERENCE 013

Building	Floor	Room	Location	
Main	Tenth Floor	Dry Riser	Floor	
Description				
MATERIAL ASSESSMENT				SCORE
Product Type	Floor Tiles	Extent of Damage	Low damage	3
Asbestos Type	Chrysotile	Surface Treatment	Composite materials	
PRIORITY ASSESSMENT				SCORE
Occupant Activity	Not Applicable	Extent / Amount	1.00 m2	1
Accessibility	Occasionally disturb	Location	Not Applicable	
Avg Time in Use	Not Applicable	Frequency of Use	Not Applicable	
No. of Occupants	Not Applicable	Secondary Activity	Not Applicable	
Maintenance	Not Applicable	Maintenance Frequency	Not Applicable	
MANAGEMENT ACTION				SCORE
Recommendation	LABEL & MONITOR			4
Recommendation Due		Next Inspection	11 Dec 2013	
Apply Labels	No	Permit to Work Required	No	
Survey Type	Re-Inspection	Lead Surveyor	Gavin Hooper	
Survey Date	11 Dec 2012	UKAS Laboratory	DMW Environmental Safety Ltd / [P-72925]	
Site Reference	I43770000A	Licensed Material	No	Notifiable Non Licensed Work No

Asbestos detected in Sample

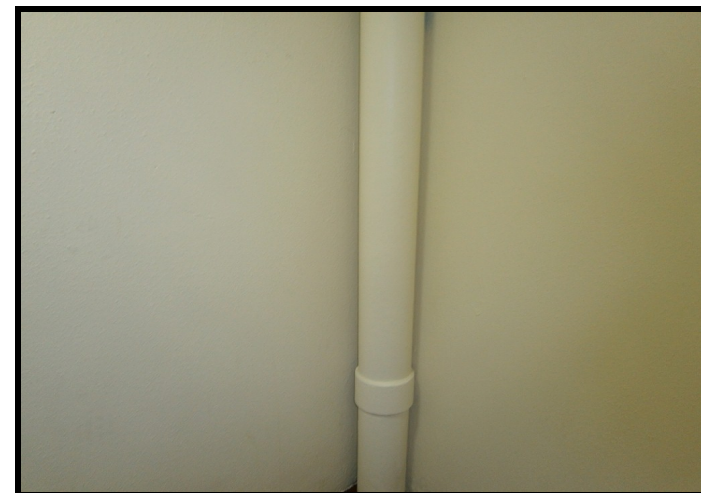
SAMPLE REFERENCE 019

Building	Floor	Room	Location
Main	Ninth Floor	Chute Room	Flue
Description			
MATERIAL ASSESSMENT			
Product Type	Cement Flue	Extent of Damage	Good condition
Asbestos Type	Chrysotile	Surface Treatment	Sealed (Cement products)
PRIORITY ASSESSMENT			
Occupant Activity	Not Applicable	Extent / Amount	2.00 small item(s)
Accessibility	Occasionally disturb	Location	Not Applicable
Avg Time in Use	Not Applicable	Frequency of Use	Not Applicable
No. of Occupants	Not Applicable	Secondary Activity	Not Applicable
Maintenance	Not Applicable	Maintenance Frequency	Not Applicable
MANAGEMENT ACTION			
Recommendation	LABEL & MONITOR		
Recommendation Due		Next Inspection	11 Dec 2013
Apply Labels	No	Permit to Work Required	No
Survey Type	Re-Inspection	Lead Surveyor	Gavin Hooper
Survey Date	11 Dec 2012	UKAS Laboratory	NOT SAMPLED (Cross Referenced)
Site Reference	I43770000A	Licensed Material	No
		Notifiable Non Licensed Work	No

Asbestos Presumed in Sample

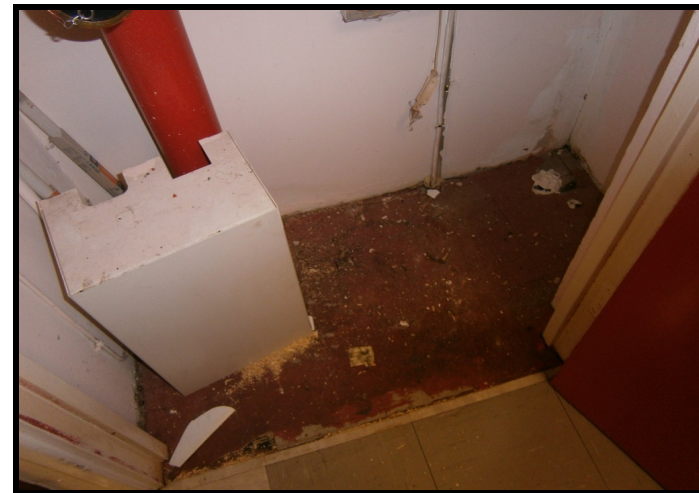
SAMPLE REFERENCE 023

Building	Floor	Room	Location			
Main	Ninth Floor	Dry Riser	Floor			
Description						
MATERIAL ASSESSMENT				SCORE		
Product Type	Floor Tiles	Extent of Damage	Low damage		3	
Asbestos Type	Chrysotile	Surface Treatment	Composite materials			
PRIORITY ASSESSMENT				SCORE		
Occupant Activity	Not Applicable	Extent / Amount	1.00 m2		1	
Accessibility	Occasionally disturb	Location	Not Applicable			
Avg Time in Use	Not Applicable	Frequency of Use	Not Applicable			
No. of Occupants	Not Applicable	Secondary Activity	Not Applicable			
Maintenance	Not Applicable	Maintenance Frequency	Not Applicable			
MANAGEMENT ACTION				SCORE		
Recommendation	LABEL & MONITOR			4		
Recommendation Due		Next Inspection	11 Dec 2013			
Apply Labels	No	Permit to Work Required	No			
Survey Type	Re-Inspection	Lead Surveyor	Gavin Hooper			
Survey Date	11 Dec 2012	UKAS Laboratory	DMW Environmental Safety Ltd / [P-72925]			
Site Reference	I43770000A	Licensed Material	No	Notifiable Non Licensed Work	No

Asbestos detected in Sample

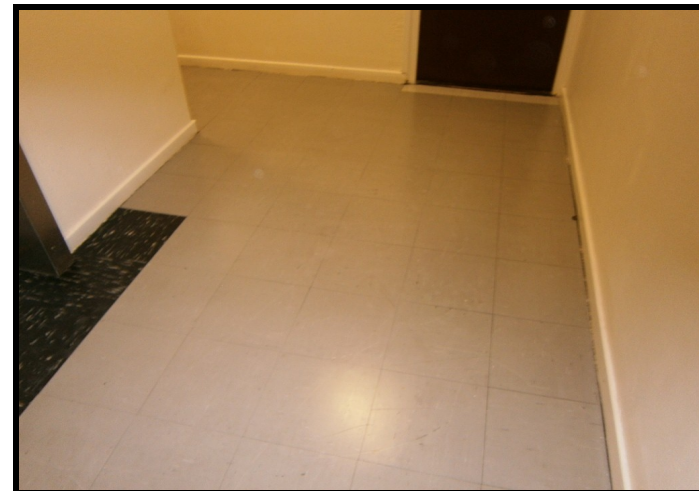
SAMPLE REFERENCE 027

Building	Floor	Room	Location			
Main	Ninth Floor	Lobby	Floor			
Description						
MATERIAL ASSESSMENT				SCORE		
Product Type	Floor Tiles	Extent of Damage	Low damage		3	
Asbestos Type	Chrysotile	Surface Treatment	Composite materials			
PRIORITY ASSESSMENT				SCORE		
Occupant Activity	Not Applicable	Extent / Amount	10.00 m2		1	
Accessibility	Occasionally disturb	Location	Not Applicable			
Avg Time in Use	Not Applicable	Frequency of Use	Not Applicable			
No. of Occupants	Not Applicable	Secondary Activity	Not Applicable			
Maintenance	Not Applicable	Maintenance Frequency	Not Applicable			
MANAGEMENT ACTION				SCORE		
Recommendation	LABEL & MONITOR			4		
Recommendation Due		Next Inspection	11 Dec 2013			
Apply Labels	No	Permit to Work Required	No			
Survey Type	Re-Inspection	Lead Surveyor	Gavin Hooper			
Survey Date	11 Dec 2012	UKAS Laboratory	DMW Environmental Safety Ltd / [P-72925]			
Site Reference	I43770000A	Licensed Material	No	Notifiable Non Licensed Work	No

Asbestos detected in Sample

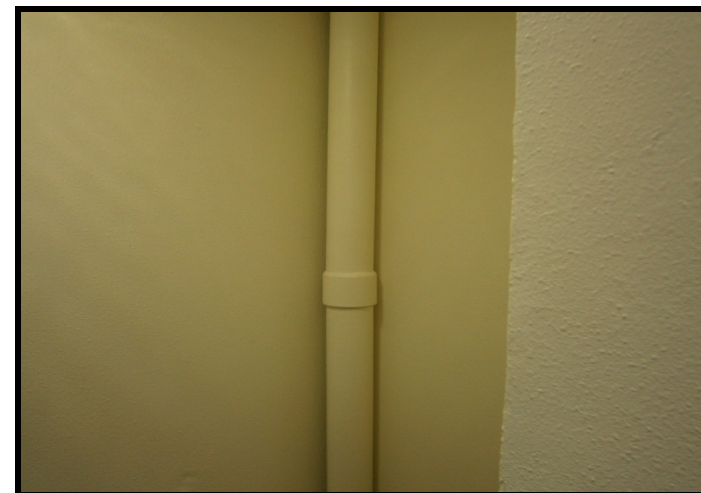
SAMPLE REFERENCE 029

Building	Floor	Room	Location
Main	Eighth Floor	Chute Room	Flue
Description			
MATERIAL ASSESSMENT			
Product Type	Cement Flue	Extent of Damage	Good condition
Asbestos Type	Chrysotile	Surface Treatment	Sealed (Cement products)
PRIORITY ASSESSMENT			
Occupant Activity	Not Applicable	Extent / Amount	2.00 small item(s)
Accessibility	Occasionally disturb	Location	Not Applicable
Avg Time in Use	Not Applicable	Frequency of Use	Not Applicable
No. of Occupants	Not Applicable	Secondary Activity	Not Applicable
Maintenance	Not Applicable	Maintenance Frequency	Not Applicable
MANAGEMENT ACTION			
Recommendation	LABEL & MONITOR		
Recommendation Due		Next Inspection	11 Dec 2013
Apply Labels	No	Permit to Work Required	No
Survey Type	Re-Inspection	Lead Surveyor	Gavin Hooper
Survey Date	11 Dec 2012	UKAS Laboratory	NOT SAMPLED (Cross Referenced)
Site Reference	I43770000A	Licensed Material	No
		Notifiable Non Licensed Work	No

Asbestos Presumed in Sample

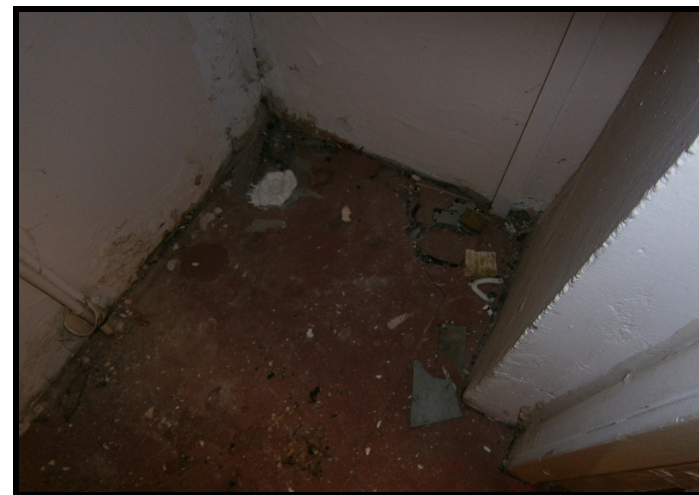
SAMPLE REFERENCE 033

Building	Floor	Room	Location		
Main	Eighth Floor	Dry Riser	Floor		
Description					
MATERIAL ASSESSMENT				SCORE	
Product Type	Floor Tiles	Extent of Damage	Medium damage		4
Asbestos Type	Chrysotile	Surface Treatment	Composite materials		
PRIORITY ASSESSMENT				SCORE	
Occupant Activity	Not Applicable	Extent / Amount	1.00 m2		1
Accessibility	Occasionally disturb	Location	Not Applicable		
Avg Time in Use	Not Applicable	Frequency of Use	Not Applicable		
No. of Occupants	Not Applicable	Secondary Activity	Not Applicable		
Maintenance	Not Applicable	Maintenance Frequency	Not Applicable		
MANAGEMENT ACTION				SCORE	
Recommendation	REMOVAL BY LICENSED CONTRACTOR				5
Recommendation Due		Next Inspection	11 Dec 2013		
Apply Labels	No	Permit to Work Required	No		
Survey Type	Re-Inspection	Lead Surveyor	Gavin Hooper		
Survey Date	11 Dec 2012	UKAS Laboratory	NOT SAMPLED (Cross Referenced)		
Site Reference	I43770000A	Licensed Material	No	Notifiable Non Licensed Work	No

Asbestos Presumed in Sample

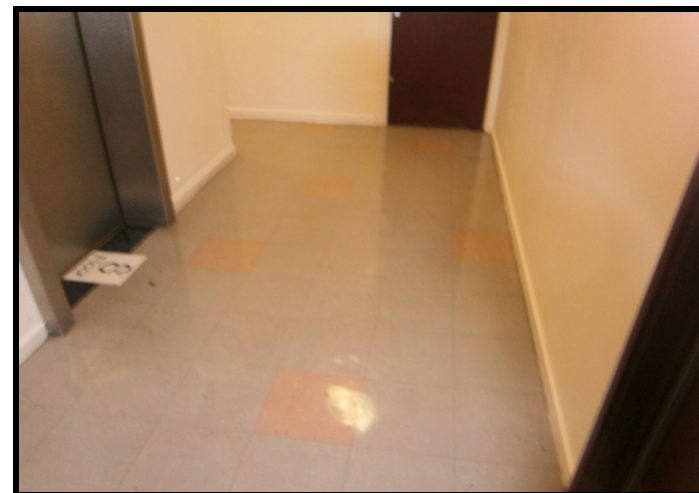
SAMPLE REFERENCE 037

Building	Floor	Room	Location			
Main	Eighth Floor	Lobby	Floor			
Description						
MATERIAL ASSESSMENT				SCORE		
Product Type	Floor Tiles	Extent of Damage	Low damage		3	
Asbestos Type	Chrysotile	Surface Treatment	Composite materials			
PRIORITY ASSESSMENT				SCORE		
Occupant Activity	Not Applicable	Extent / Amount	10.00 m2		1	
Accessibility	Occasionally disturb	Location	Not Applicable			
Avg Time in Use	Not Applicable	Frequency of Use	Not Applicable			
No. of Occupants	Not Applicable	Secondary Activity	Not Applicable			
Maintenance	Not Applicable	Maintenance Frequency	Not Applicable			
MANAGEMENT ACTION				SCORE		
Recommendation	LABEL & MONITOR			4		
Recommendation Due		Next Inspection	11 Dec 2013			
Apply Labels	No	Permit to Work Required	No			
Survey Type	Re-Inspection	Lead Surveyor	Gavin Hooper			
Survey Date	11 Dec 2012	UKAS Laboratory	NOT SAMPLED (Cross Referenced)			
Site Reference	I43770000A	Licensed Material	No	Notifiable Non Licensed Work	No

Asbestos Presumed in Sample

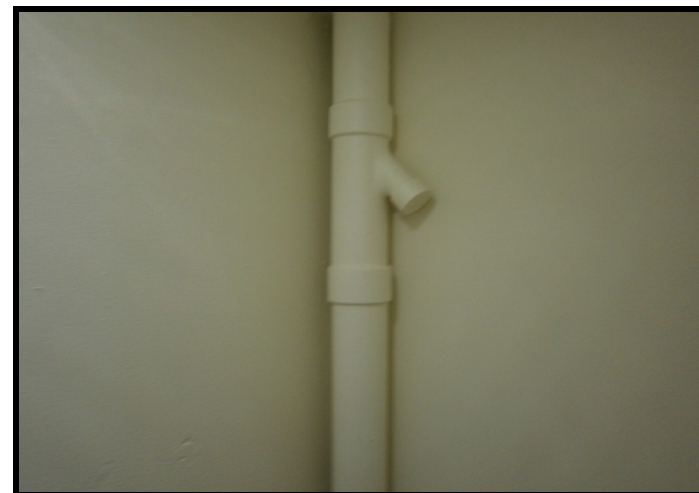
SAMPLE REFERENCE 039

Asbestos Presumed in Sample

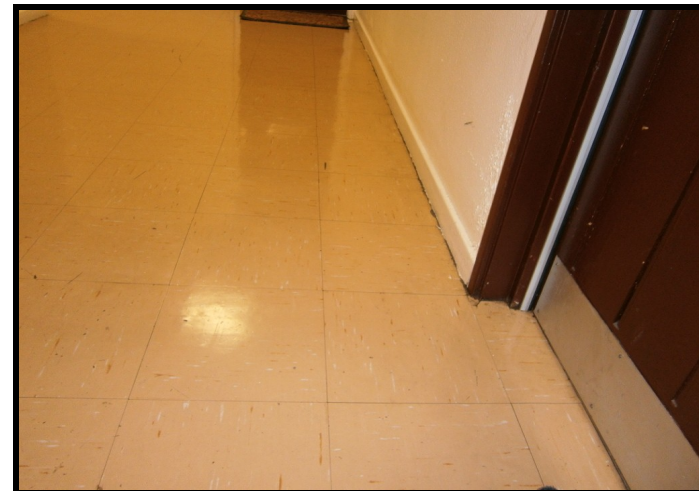
SAMPLE REFERENCE 039b

Building	Floor	Room	Location		
Main	Seventh Floor	Lobby	Floor		
Description	Buff floor tiles and adhesive				
MATERIAL ASSESSMENT					SCORE
Product Type	Bitumen	Extent of Damage	Low damage		3
Asbestos Type	Chrysotile	Surface Treatment	Composite materials		
PRIORITY ASSESSMENT					SCORE
Occupant Activity	Not Applicable	Extent / Amount	10.00 m2		1
Accessibility	Occasionally disturb	Location	Not Applicable		
Avg Time in Use	Not Applicable	Frequency of Use	Not Applicable		
No. of Occupants	Not Applicable	Secondary Activity	Not Applicable		
Maintenance	Not Applicable	Maintenance Frequency	Not Applicable		
MANAGEMENT ACTION					SCORE
Recommendation	LABEL & MONITOR				4
Recommendation Due		Next Inspection	11 Dec 2013		
Apply Labels	No	Permit to Work Required	No		
Survey Type	Re-Inspection	Lead Surveyor	Gavin Hooper		
Survey Date	11 Dec 2012	UKAS Laboratory	DMW Environmental Safety Ltd / [D-15258]		
Site Reference	143770000A	Licensed Material	No	Notifiable Non Licensed Work	No

Asbestos detected in Sample

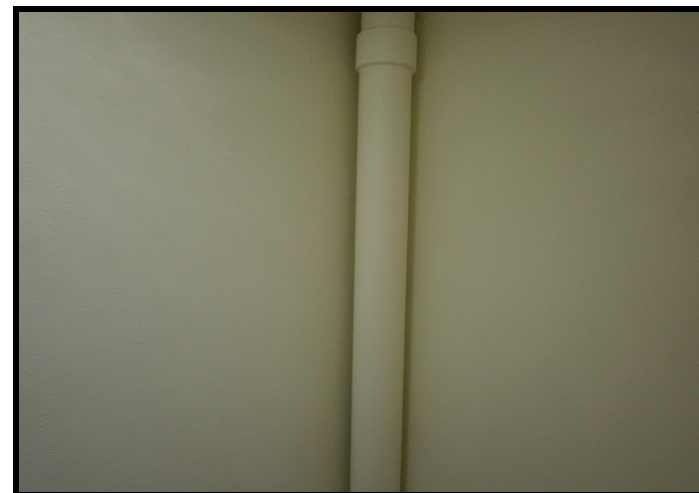
SAMPLE REFERENCE 049

Asbestos Presumed in Sample

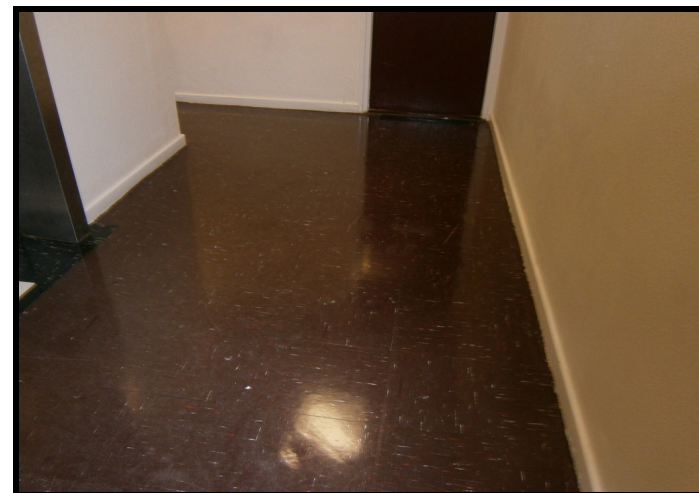
SAMPLE REFERENCE 049c

Asbestos Presumed in Sample

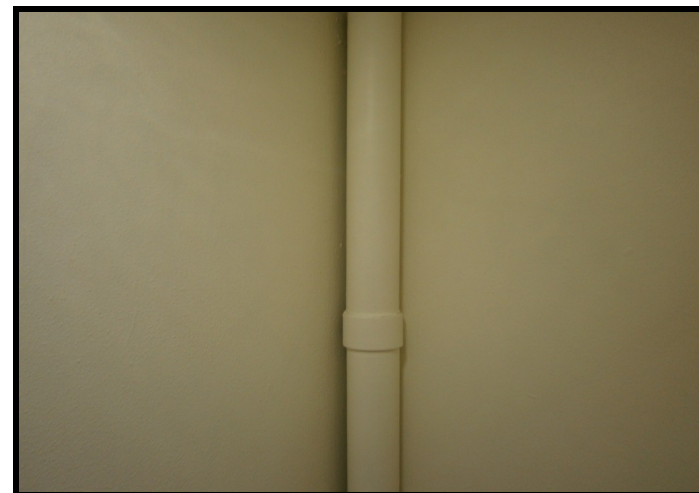
SAMPLE REFERENCE 059

Asbestos Presumed in Sample

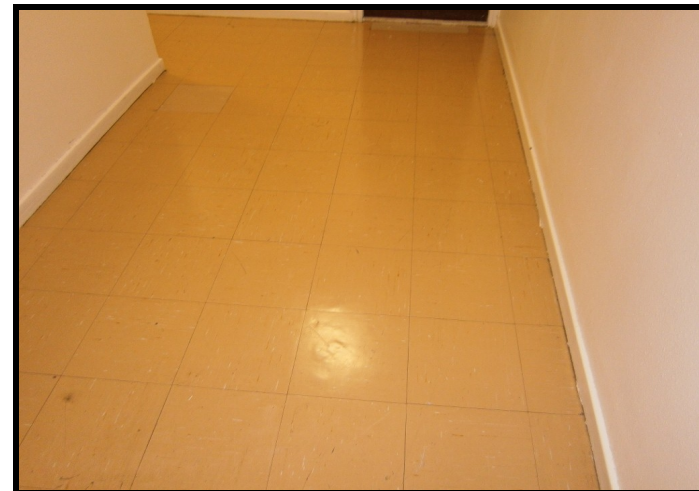
SAMPLE REFERENCE 059a

Asbestos Presumed in Sample

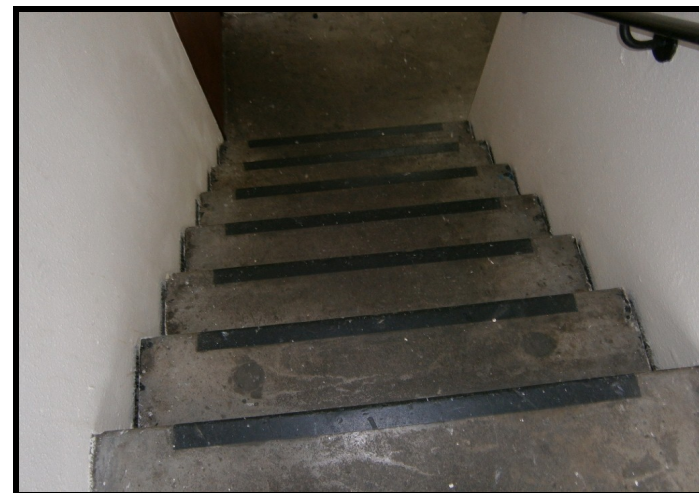
SAMPLE REFERENCE 059c

Asbestos Presumed in Sample

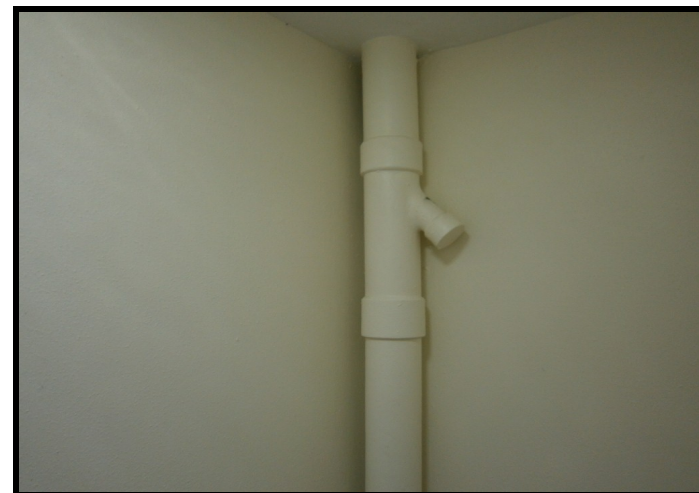
SAMPLE REFERENCE 069

Asbestos Presumed in Sample

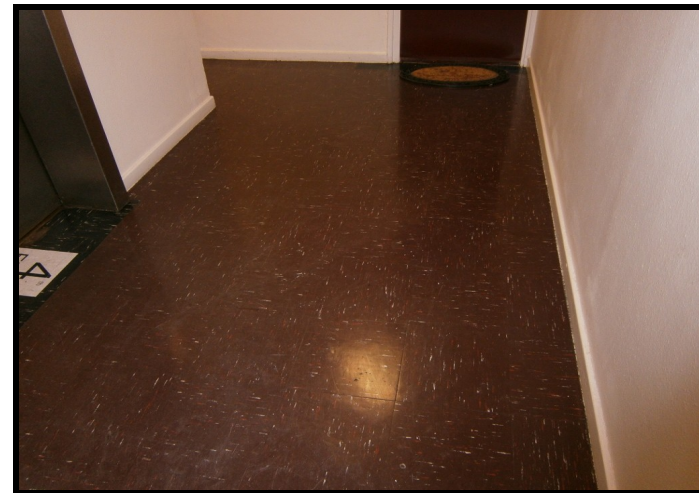
SAMPLE REFERENCE 069a

Asbestos Presumed in Sample

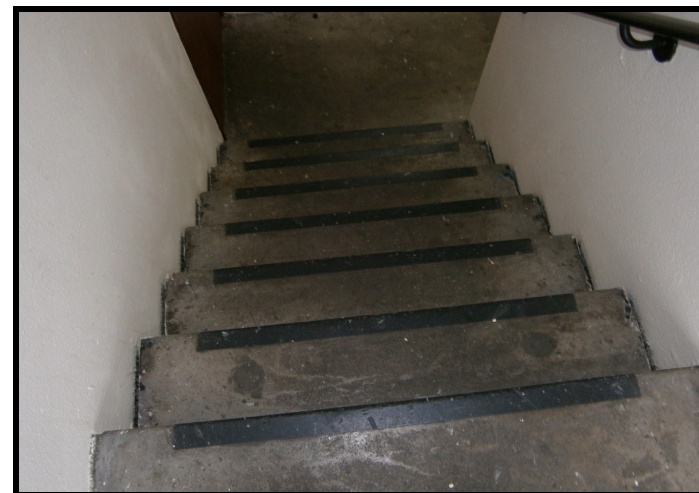
SAMPLE REFERENCE 069c

Asbestos Presumed in Sample

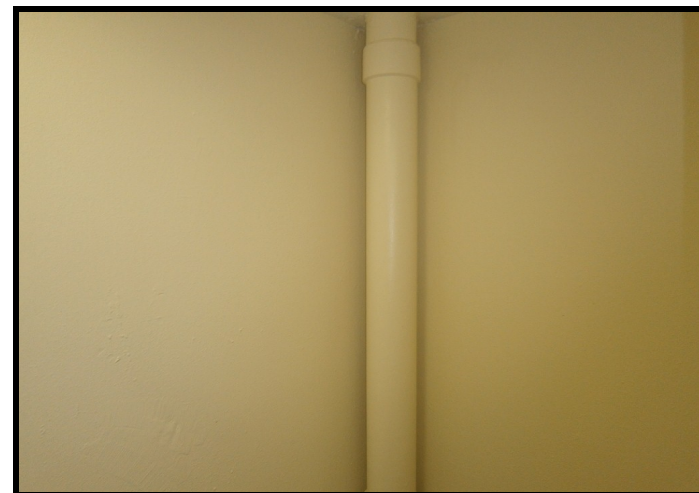
SAMPLE REFERENCE 079

Asbestos Presumed in Sample

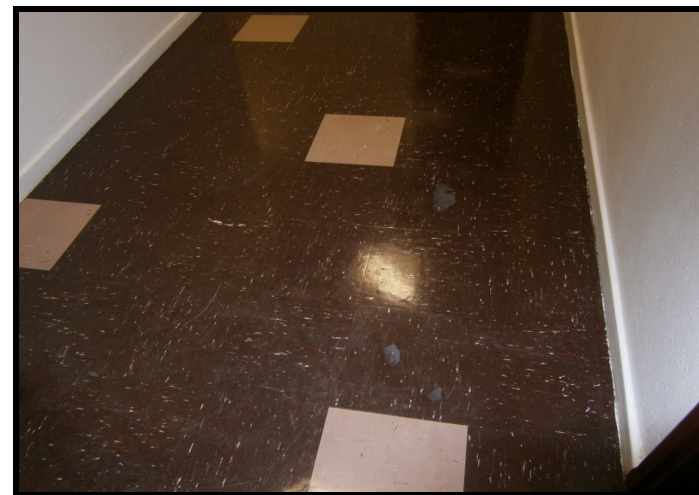
SAMPLE REFERENCE 079a

Asbestos detected in Sample

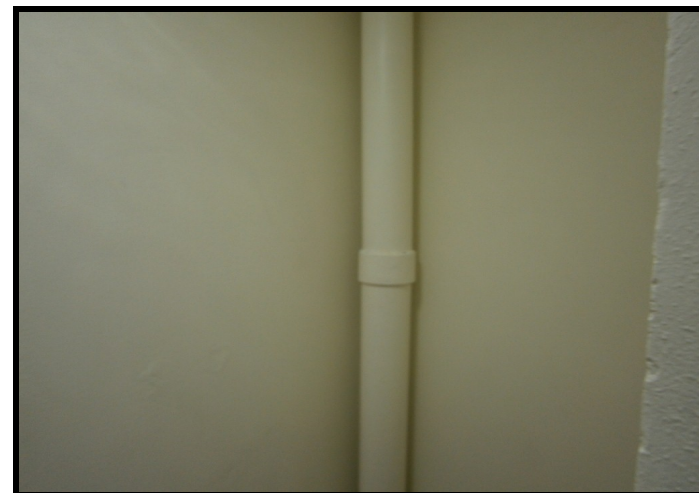
SAMPLE REFERENCE 089

Asbestos Presumed in Sample

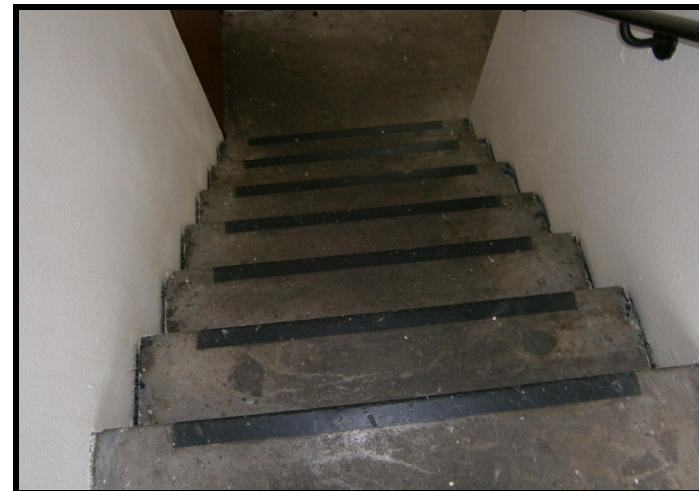
SAMPLE REFERENCE 089a

Asbestos Presumed in Sample

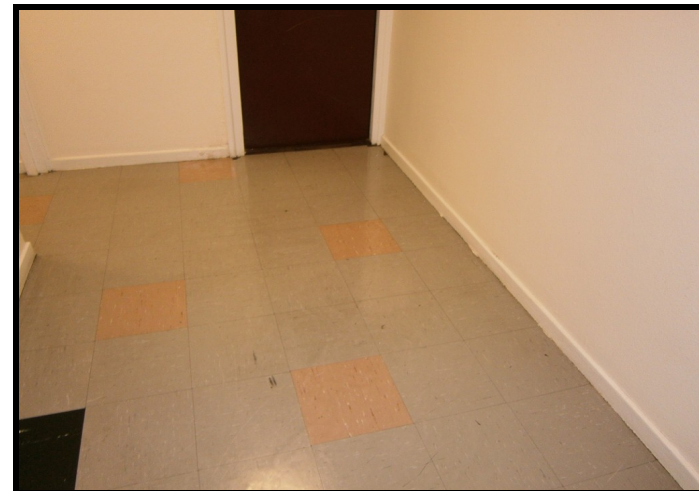
SAMPLE REFERENCE 097

Asbestos Presumed in Sample

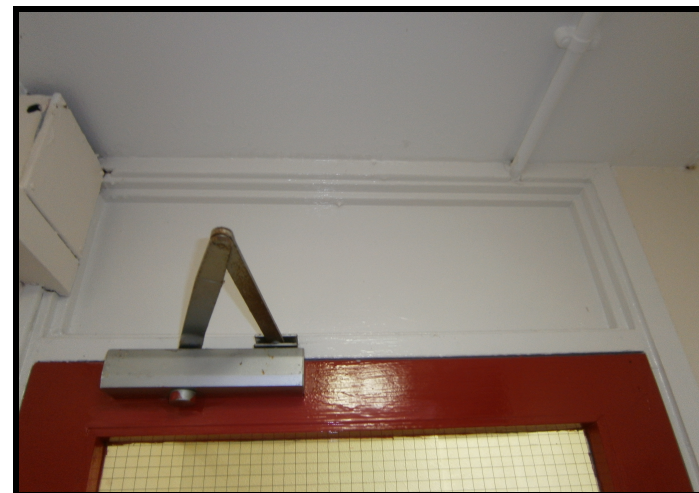
SAMPLE REFERENCE 099b

Asbestos detected in Sample

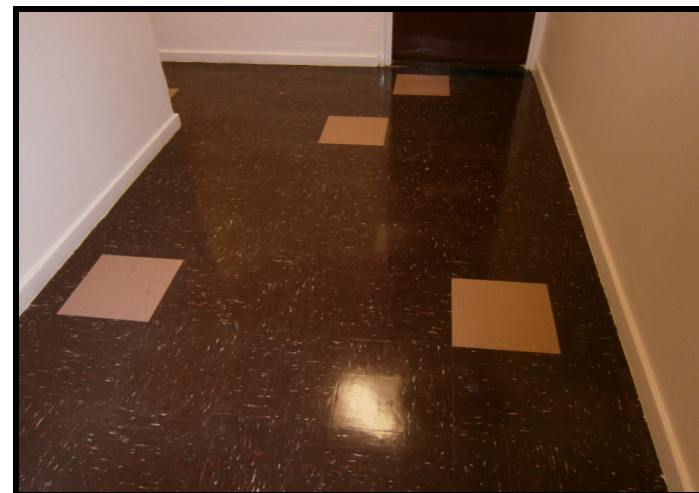
SAMPLE REFERENCE 099d

Asbestos Presumed in Sample

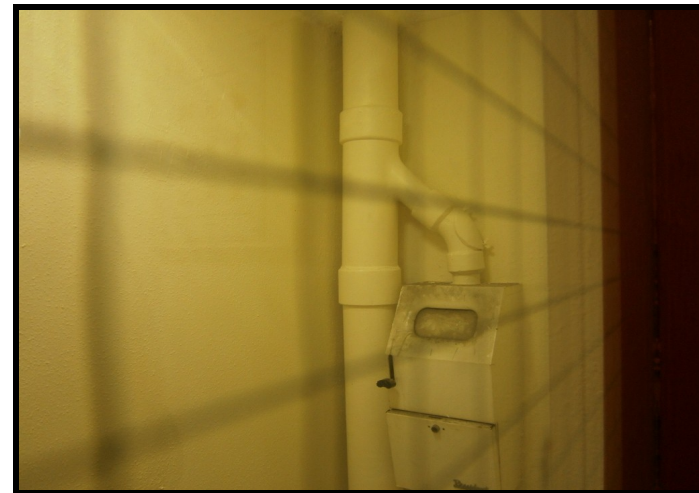
SAMPLE REFERENCE 099f

Asbestos Presumed in Sample

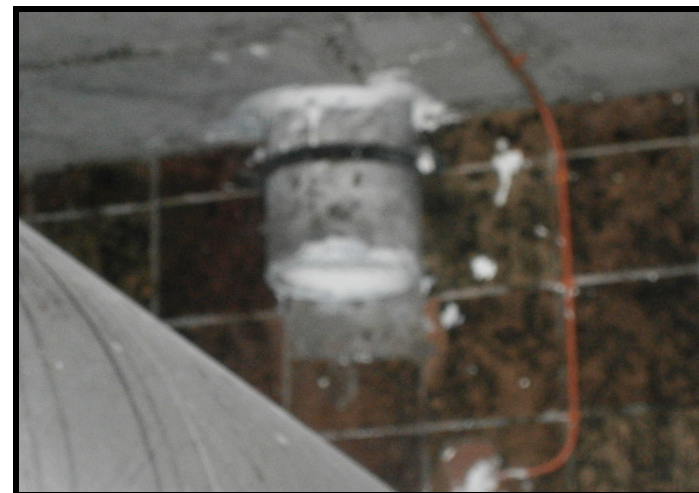
SAMPLE REFERENCE 128

Asbestos Presumed in Sample
