Site ID: **a-304391**

Management with Targeted Refurbishment Survey

1-41 Warwick Court
Hedingham Close
Chelmsley Wood
West Midlands
B37 7TW
United Kingdom

29th April 2021

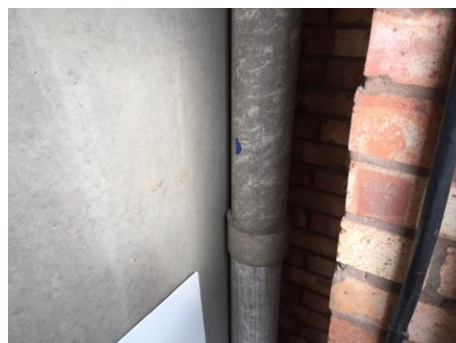
Cement flue.

The material was seen to be in fair condition at the time of the initial inspection.

The condition of the material should be managed by a competent person/company and its presence made aware to those at risk, as part of a Control of Asbestos Regulations (CAR) 2012 compliant management strategy.

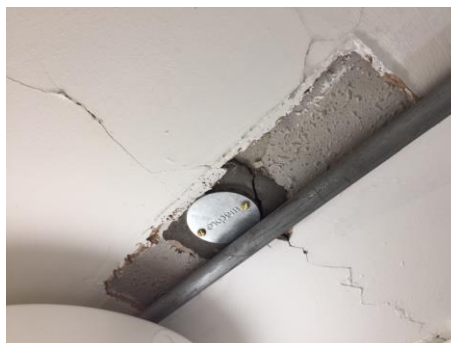
Spatter pattern textured coating above plaster.

The material was seen to be in fair condition at the time of the initial inspection.

The condition of the material should be managed by a competent person/company and its presence made aware to those at risk, as part of a Control of Asbestos Regulations (CAR) 2012 compliant management strategy.

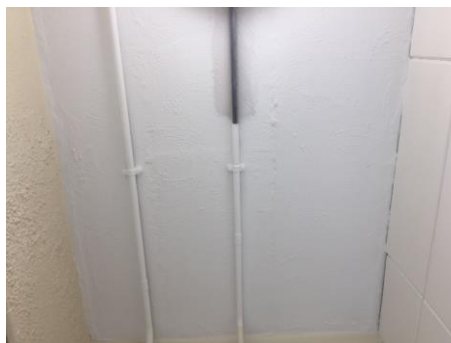
Swirl pattern textured coating above half landing. Checked by another analyst

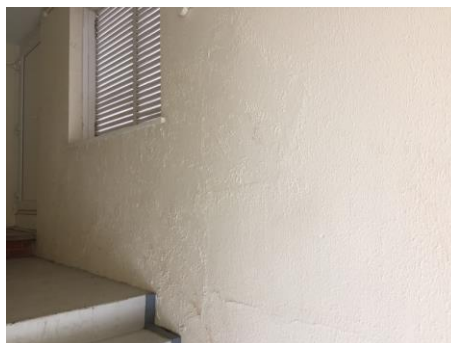
Stipple pattern textured coating.

The material was seen to be in fair condition at the time of the initial inspection.

The condition of the material should be managed by a competent person/company and its presence made aware to those at risk, as part of a Control of Asbestos Regulations (CAR) 2012 compliant management strategy.

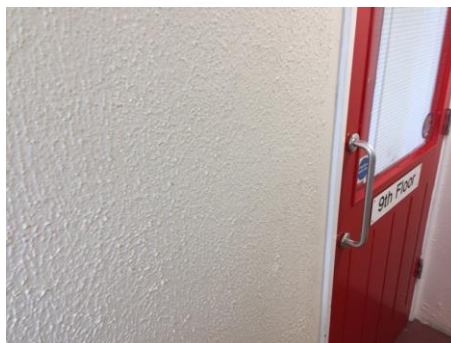
Stipple pattern textured coating.

The material was seen to be in fair condition at the time of the initial inspection.

The condition of the material should be managed by a competent person/company and its presence made aware to those at risk, as part of a Control of Asbestos Regulations (CAR) 2012 compliant management strategy.

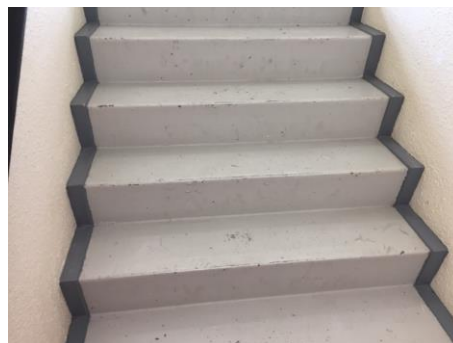
Resin nosing to edges of stairs.

The material was seen to be in fair condition at the time of the initial inspection.

The condition of the material should be managed by a competent person/company and its presence made aware to those at risk, as part of a Control of Asbestos Regulations (CAR) 2012 compliant management strategy.

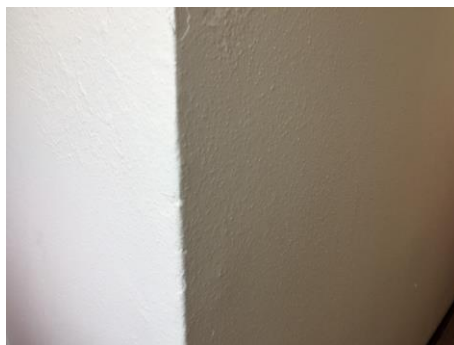
Stipple pattern textured coating.

The material was seen to be in fair condition at the time of the initial inspection.

The condition of the material should be managed by a competent person/company and its presence made aware to those at risk, as part of a Control of Asbestos Regulations (CAR) 2012 compliant management strategy.

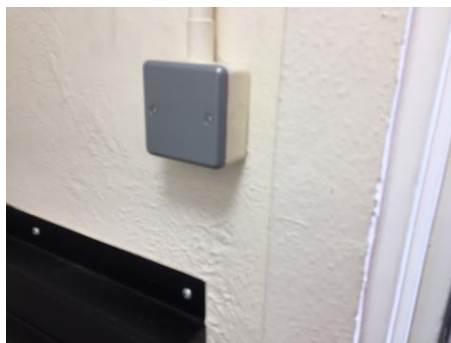
Stipple pattern textured coating.

The material was seen to be in fair condition at the time of the initial inspection.

The condition of the material should be managed by a competent person/company and its presence made aware to those at risk, as part of a Control of Asbestos Regulations (CAR) 2012 compliant management strategy.

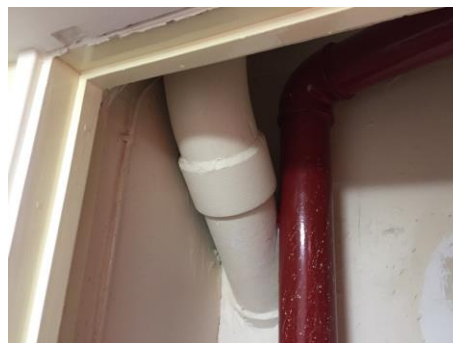
Cement flue.

The material was seen to be in fair condition at the time of the initial inspection.

The condition of the material should be managed by a competent person/company and its presence made aware to those at risk, as part of a Control of Asbestos Regulations (CAR) 2012 compliant management strategy.

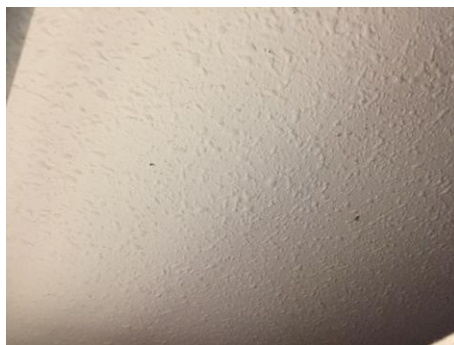
Spatter pattern textured coating above Supalux suspended ceiling.

The material was seen to be in fair condition at the time of the initial inspection.

The condition of the material should be managed by a competent person/company and its presence made aware to those at risk, as part of a Control of Asbestos Regulations (CAR) 2012 compliant management strategy.

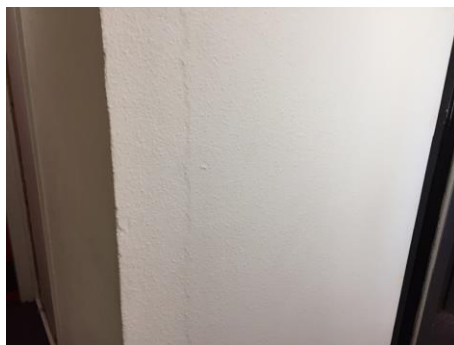
Spatter pattern textured coating above Supalux suspended ceiling.

The material was seen to be in fair condition at the time of the initial inspection.

The condition of the material should be managed by a competent person/company and its presence made aware to those at risk, as part of a Control of Asbestos Regulations (CAR) 2012 compliant management strategy.

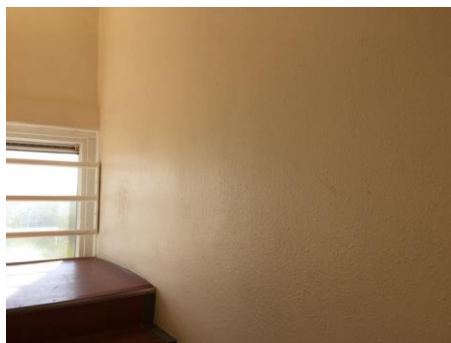
Stipple pattern textured coating.

The material was seen to be in fair condition at the time of the initial inspection.

The condition of the material should be managed by a competent person/company and its presence made aware to those at risk, as part of a Control of Asbestos Regulations (CAR) 2012 compliant management strategy.

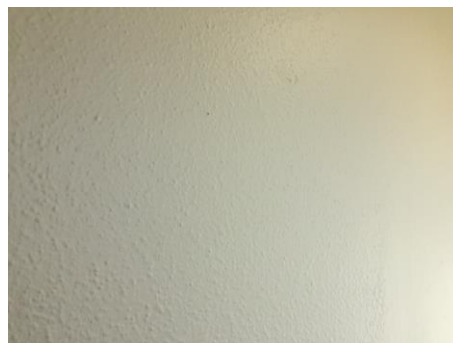
Stipple pattern textured coating.

The material was seen to be in fair condition at the time of the initial inspection.

The condition of the material should be managed by a competent person/company and its presence made aware to those at risk, as part of a Control of Asbestos Regulations (CAR) 2012 compliant management strategy.

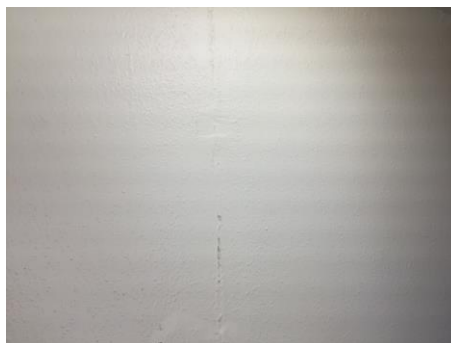
Stipple pattern textured coating.

The material was seen to be in fair condition at the time of the initial inspection.

The condition of the material should be managed by a competent person/company and its presence made aware to those at risk, as part of a Control of Asbestos Regulations (CAR) 2012 compliant management strategy.

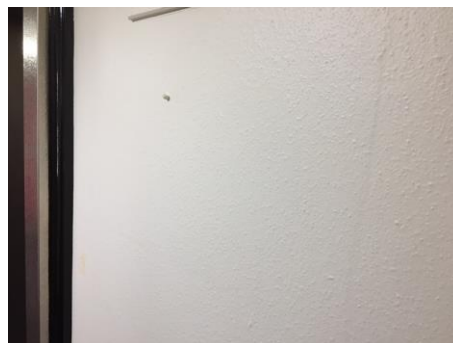
Stipple pattern textured coating.

The material was seen to be in fair condition at the time of the initial inspection.

The condition of the material should be managed by a competent person/company and its presence made aware to those at risk, as part of a Control of Asbestos Regulations (CAR) 2012 compliant management strategy.

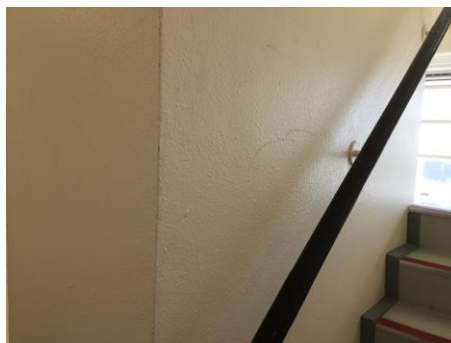
Stipple pattern textured coating.

The material was seen to be in fair condition at the time of the initial inspection.

The condition of the material should be managed by a competent person/company and its presence made aware to those at risk, as part of a Control of Asbestos Regulations (CAR) 2012 compliant management strategy.

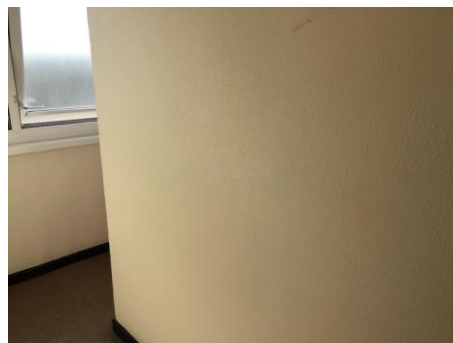
Stipple pattern textured coating.

The material was seen to be in fair condition at the time of the initial inspection.

The condition of the material should be managed by a competent person/company and its presence made aware to those at risk, as part of a Control of Asbestos Regulations (CAR) 2012 compliant management strategy.

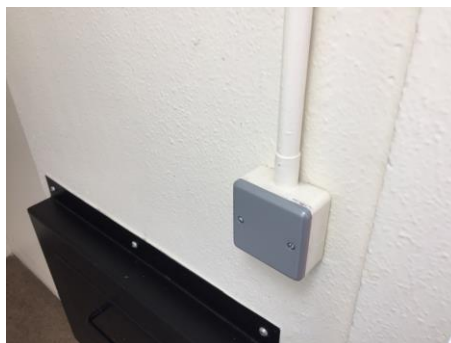
Stipple pattern textured coating.

The material was seen to be in fair condition at the time of the initial inspection.

The condition of the material should be managed by a competent person/company and its presence made aware to those at risk, as part of a Control of Asbestos Regulations (CAR) 2012 compliant management strategy.

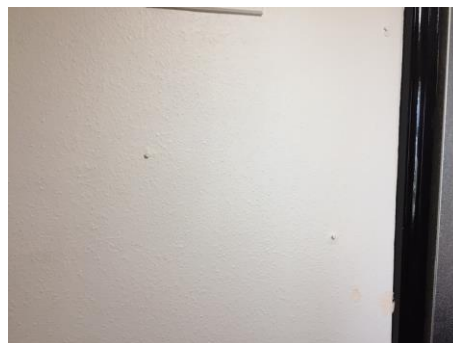
Stipple pattern textured coating.

The material was seen to be in fair condition at the time of the initial inspection.

The condition of the material should be managed by a competent person/company and its presence made aware to those at risk, as part of a Control of Asbestos Regulations (CAR) 2012 compliant management strategy.

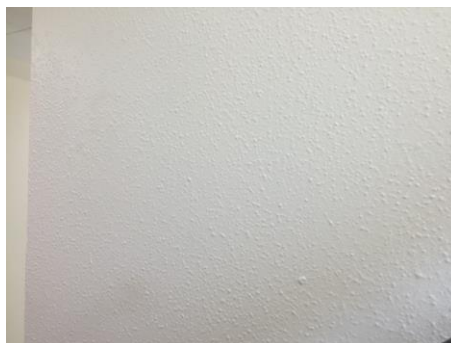
Stipple pattern textured coating.

The material was seen to be in fair condition at the time of the initial inspection.

The condition of the material should be managed by a competent person/company and its presence made aware to those at risk, as part of a Control of Asbestos Regulations (CAR) 2012 compliant management strategy.

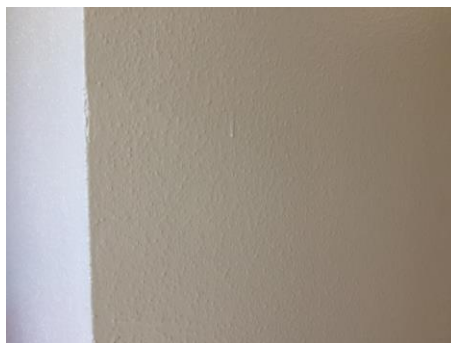
Stipple pattern textured coating.

The material was seen to be in fair condition at the time of the initial inspection.

The condition of the material should be managed by a competent person/company and its presence made aware to those at risk, as part of a Control of Asbestos Regulations (CAR) 2012 compliant management strategy.

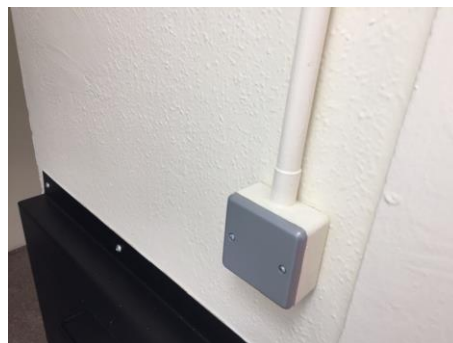
Stipple pattern textured coating.

The material was seen to be in fair condition at the time of the initial inspection.

The condition of the material should be managed by a competent person/company and its presence made aware to those at risk, as part of a Control of Asbestos Regulations (CAR) 2012 compliant management strategy.

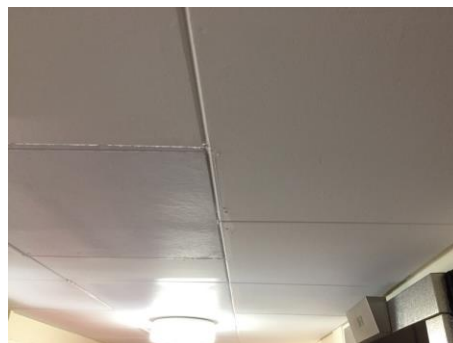
Spatter pattern textured coating above Supalux suspended ceiling.

The material was seen to be in fair condition at the time of the initial inspection.

The condition of the material should be managed by a competent person/company and its presence made aware to those at risk, as part of a Control of Asbestos Regulations (CAR) 2012 compliant management strategy.

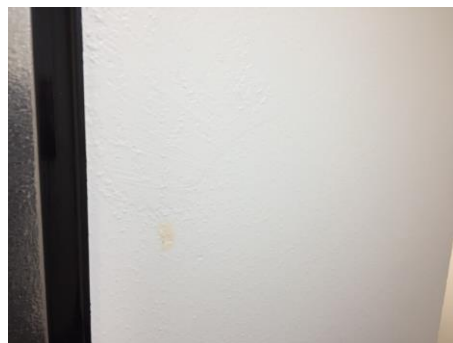
Spatter pattern textured coating above Supalux suspended ceiling.

The material was seen to be in fair condition at the time of the initial inspection.

The condition of the material should be managed by a competent person/company and its presence made aware to those at risk, as part of a Control of Asbestos Regulations (CAR) 2012 compliant management strategy.

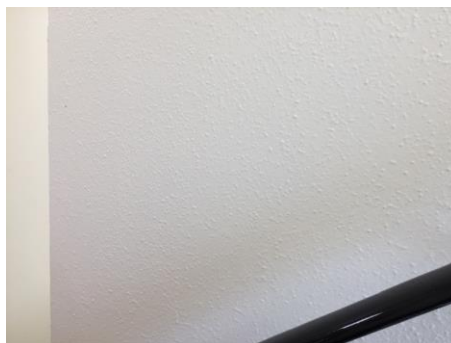
Stipple pattern textured coating.

The material was seen to be in fair condition at the time of the initial inspection.

The condition of the material should be managed by a competent person/company and its presence made aware to those at risk, as part of a Control of Asbestos Regulations (CAR) 2012 compliant management strategy.

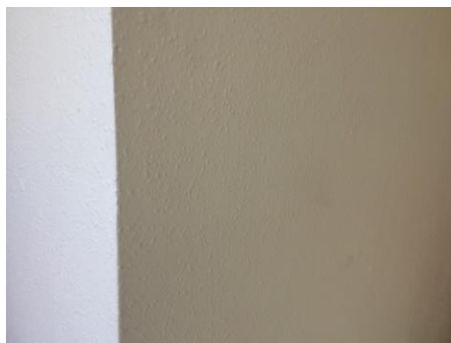
Stipple pattern textured coating.

The material was seen to be in fair condition at the time of the initial inspection.

The condition of the material should be managed by a competent person/company and its presence made aware to those at risk, as part of a Control of Asbestos Regulations (CAR) 2012 compliant management strategy.

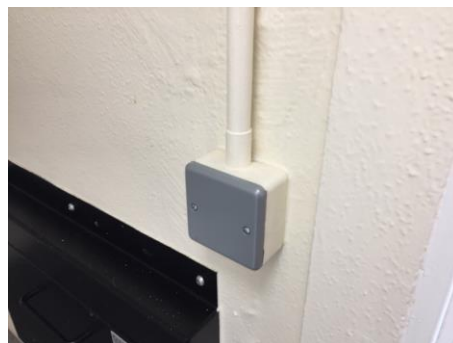
Stipple pattern textured coating.

The material was seen to be in fair condition at the time of the initial inspection.

The condition of the material should be managed by a competent person/company and its presence made aware to those at risk, as part of a Control of Asbestos Regulations (CAR) 2012 compliant management strategy.

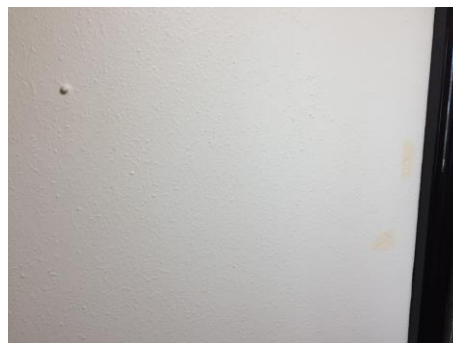
Stipple pattern textured coating.

The material was seen to be in fair condition at the time of the initial inspection.

The condition of the material should be managed by a competent person/company and its presence made aware to those at risk, as part of a Control of Asbestos Regulations (CAR) 2012 compliant management strategy.

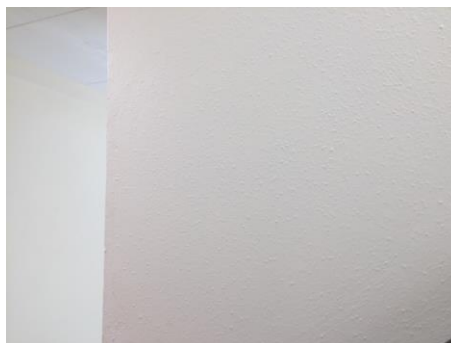
Stipple pattern textured coating.

The material was seen to be in fair condition at the time of the initial inspection.

The condition of the material should be managed by a competent person/company and its presence made aware to those at risk, as part of a Control of Asbestos Regulations (CAR) 2012 compliant management strategy.

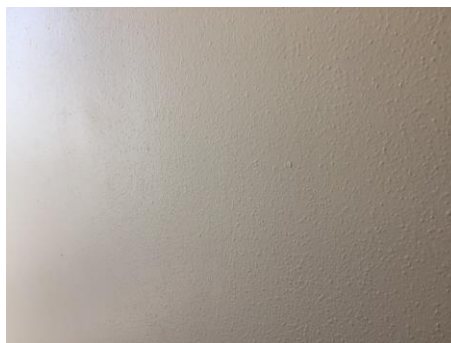
Stipple pattern textured coating.

The material was seen to be in fair condition at the time of the initial inspection.

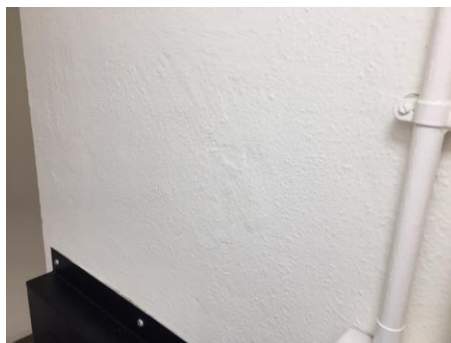
Stipple pattern textured coating.

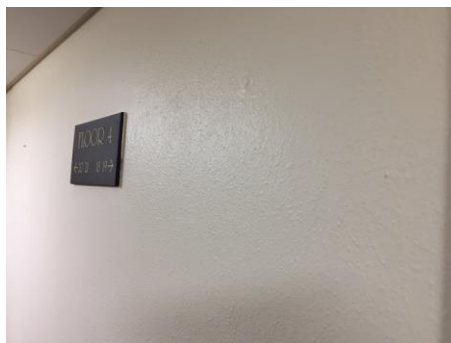
Stipple pattern textured coating.

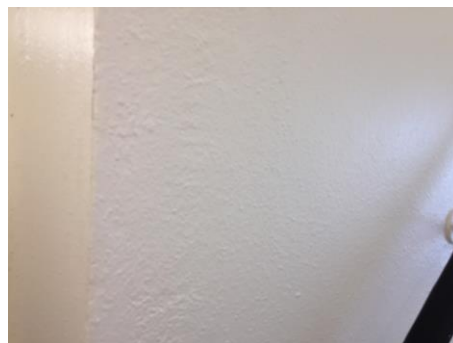
Stipple pattern textured coating.

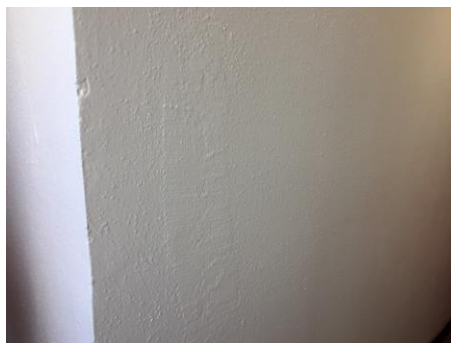
Stipple pattern textured coating.

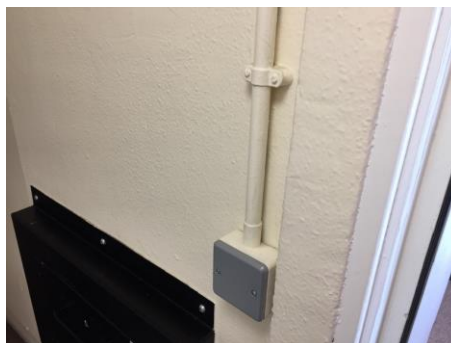
Stipple pattern textured coating.

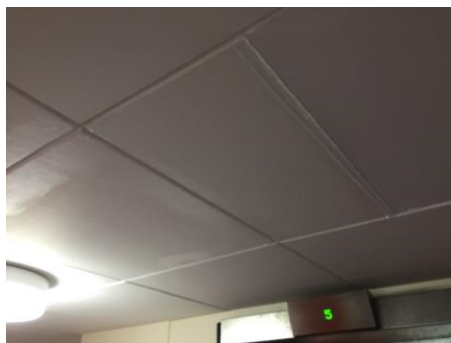
Spatter pattern textured coating above Supalux suspended ceiling.

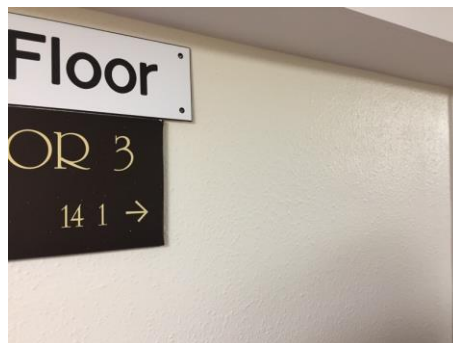
Spatter pattern textured coating above Supalux suspended ceiling.

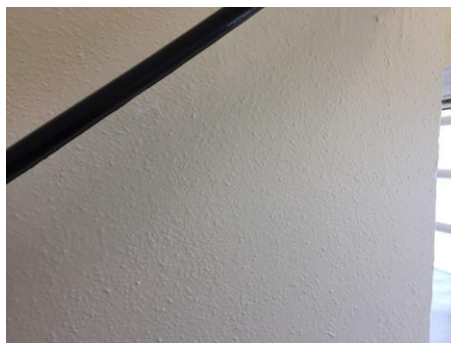
Stipple pattern textured coating.

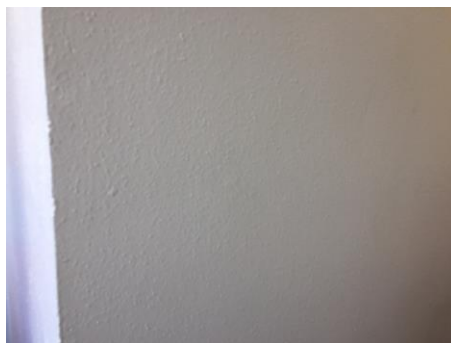
Stipple pattern textured coating.

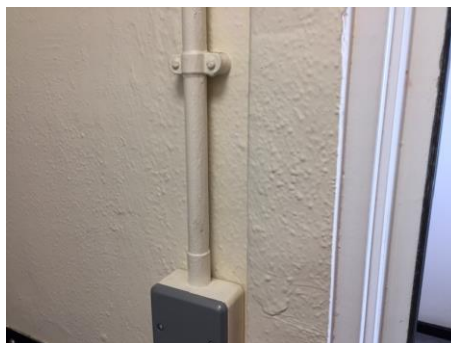
Stipple pattern textured coating.

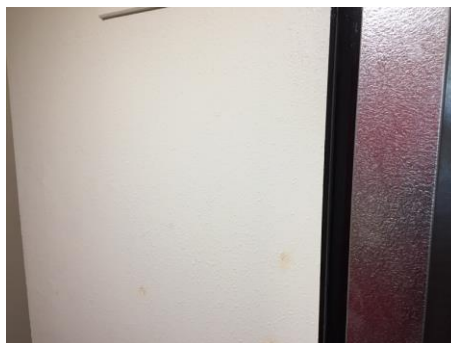
Stipple pattern textured coating.

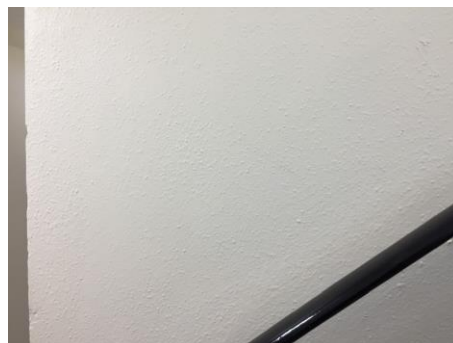
Stipple pattern textured coating.

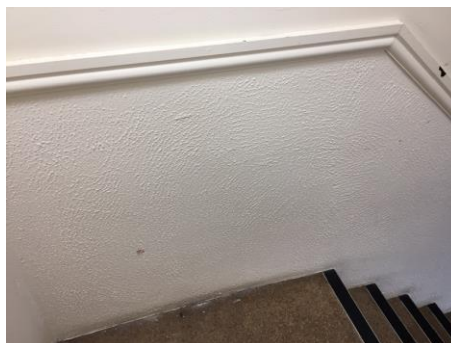
Stipple pattern textured coating.

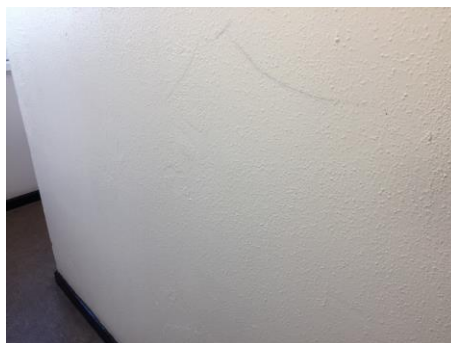
Stipple pattern textured coating.

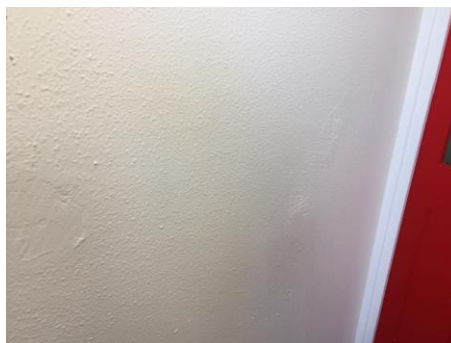
Stipple pattern textured coating.

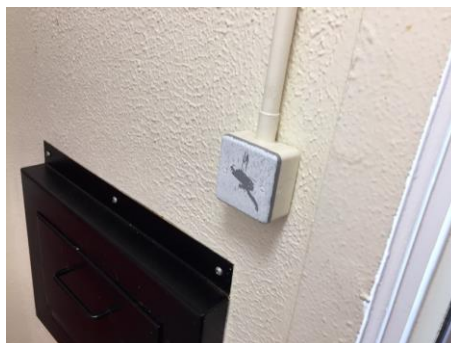
Stipple pattern textured coating.

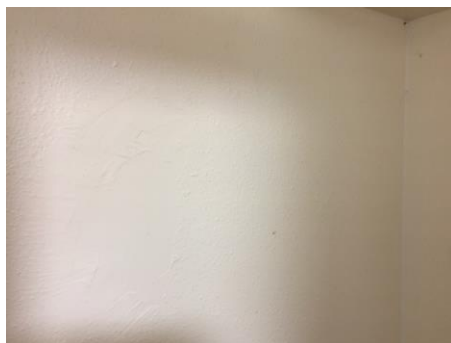
Stipple pattern textured coating.

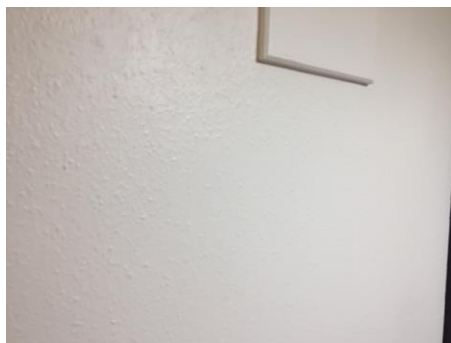
Stipple pattern textured coating.

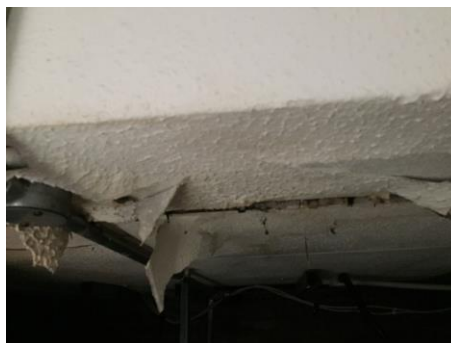
Stipple pattern textured coating, peeling in areas and covering older textured coating and modern Supalux ceiling tiles. Checked by another analyst

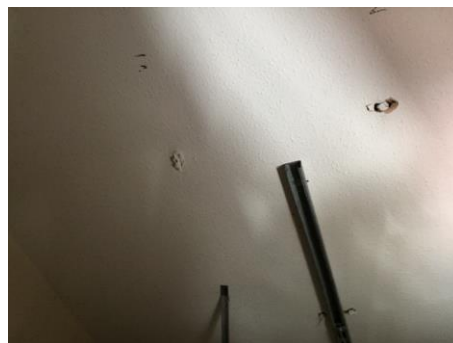
Spatter pattern textured coating.

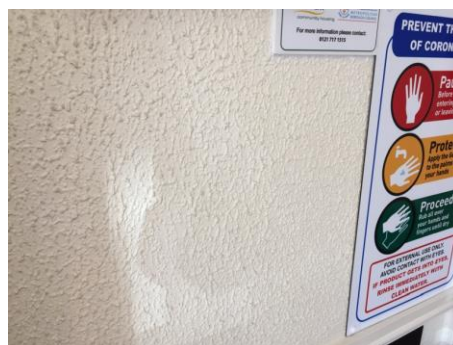
Sandtex like stipple pattern.

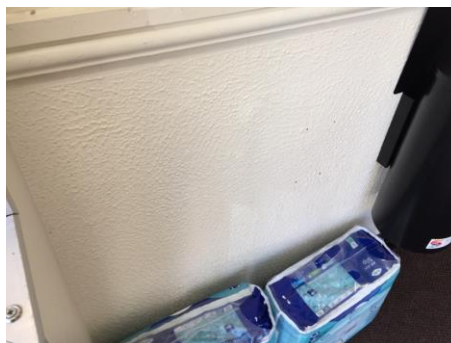
Stipple pattern. Checked by 2 analysts

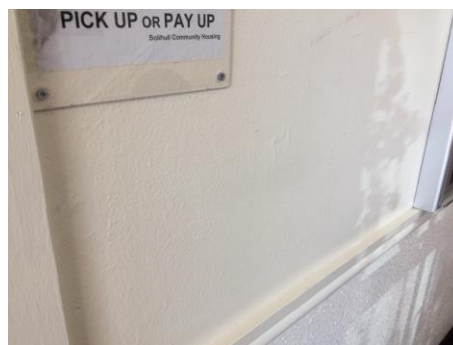
Spatter pattern textured coating. Checked by 2 analysts

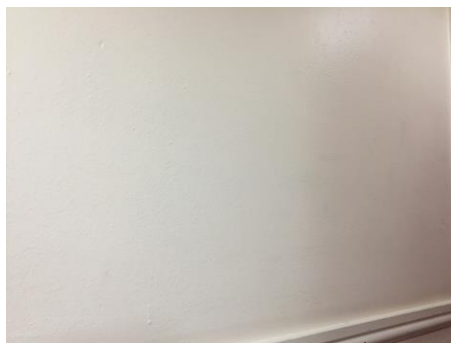
Spatter pattern textured coating.

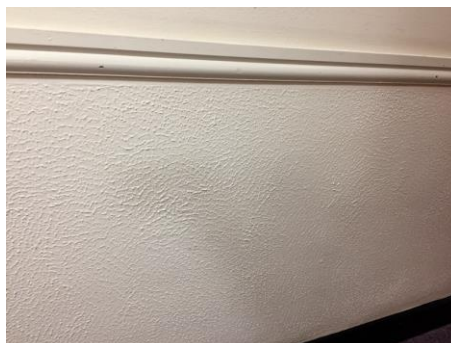
Stipple pattern textured coating.

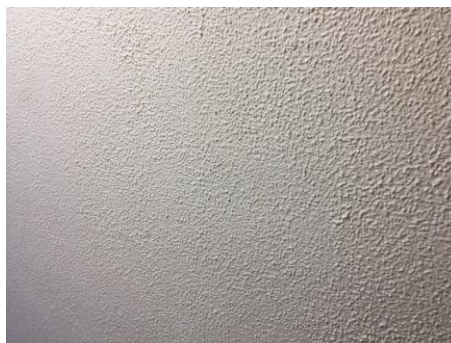
Sandtex like stipple pattern textured coating.

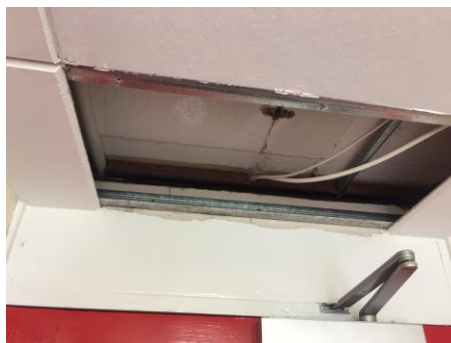
Spatter pattern textured coating above suspended ceiling.

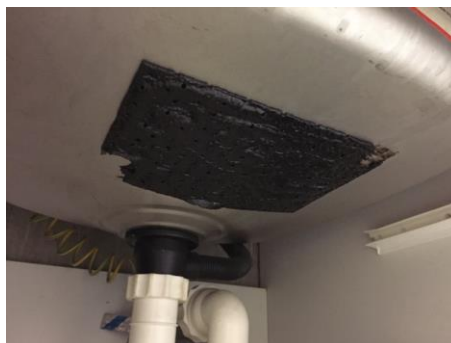
Pad to underside of sink.

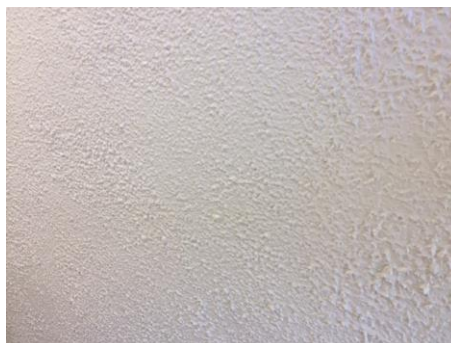
Sandtex like stipple pattern textured coating.

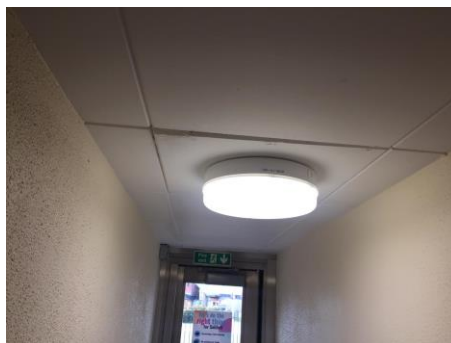
Spatter pattern textured coating above suspended ceiling.
