Site ID: **a-301467** Management with Targeted Refurbishment Survey

Wedgewood House
Forth Drive
Chelmsley Wood
Solihull
B37 6PX
United Kingdom

15th April 2021

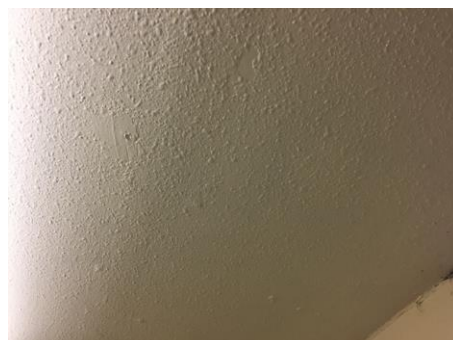
Spatter pattern textured coating.

The material was seen to be in fair condition at the time of the initial inspection.

The condition of the material should be managed by a competent person/company and its presence made aware to those at risk, as part of a Control of Asbestos Regulations (CAR) 2012 compliant management strategy.

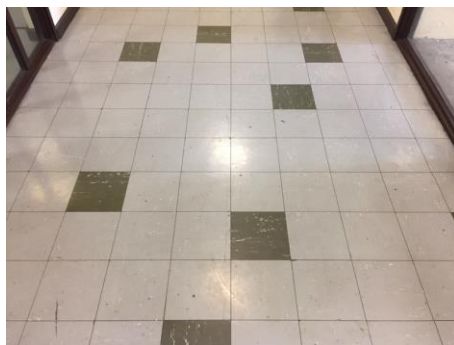
Bitumen adhesive beneath floor tiles.

The material was seen to be in fair condition at the time of the initial inspection.

The condition of the material should be managed by a competent person/company and its presence made aware to those at risk, as part of a Control of Asbestos Regulations (CAR) 2012 compliant management strategy.

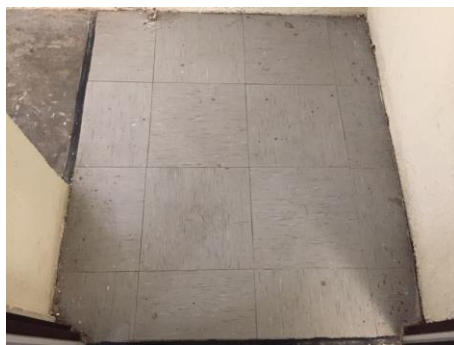
Bitumen adhesive beneath floor tiles.

The material was seen to be in fair condition at the time of the initial inspection.

The condition of the material should be managed by a competent person/company and its presence made aware to those at risk, as part of a Control of Asbestos Regulations (CAR) 2012 compliant management strategy.

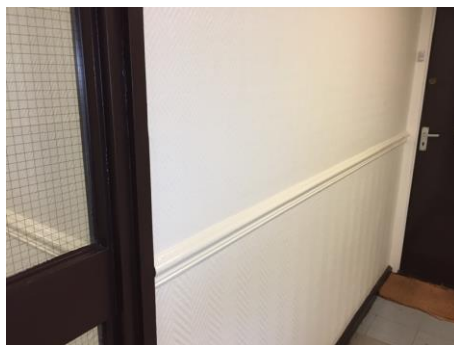
Spatter pattern textured coating behind wallpaper.

The material was seen to be in fair condition at the time of the initial inspection.

The condition of the material should be managed by a competent person/company and its presence made aware to those at risk, as part of a Control of Asbestos Regulations (CAR) 2012 compliant management strategy.

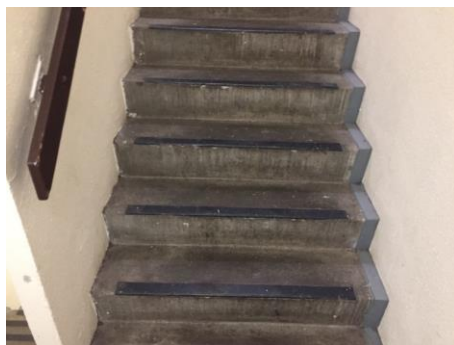
Resin nosing to edge of stairs.

The material was seen to be in fair condition at the time of the initial inspection.

The condition of the material should be managed by a competent person/company and its presence made aware to those at risk, as part of a Control of Asbestos Regulations (CAR) 2012 compliant management strategy.

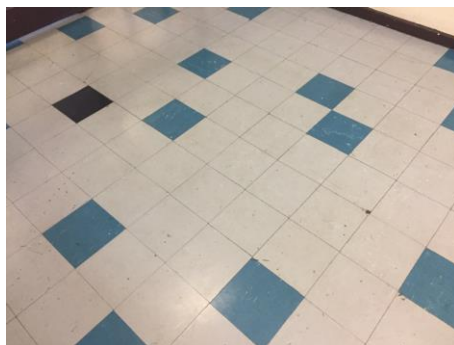
Bitumen adhesive beneath floor tiles.

The material was seen to be in fair condition at the time of the initial inspection.

The condition of the material should be managed by a competent person/company and its presence made aware to those at risk, as part of a Control of Asbestos Regulations (CAR) 2012 compliant management strategy.

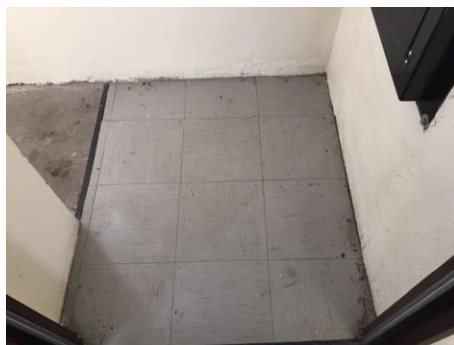
Bitumen adhesive beneath floor tiles.

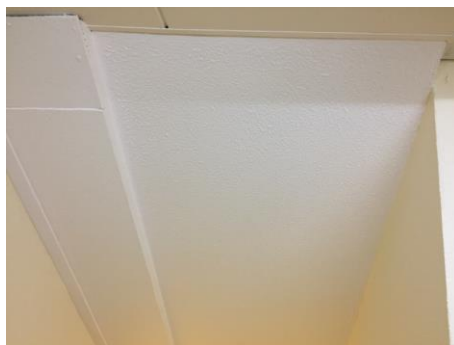
Stipple pattern textured coating.

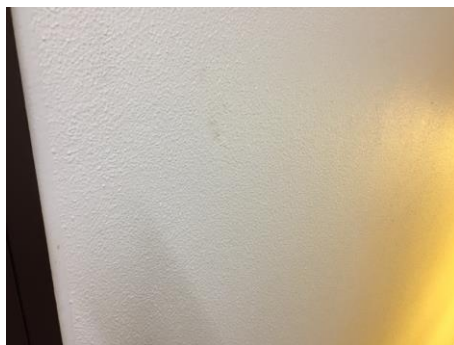
Stipple pattern textured coating.

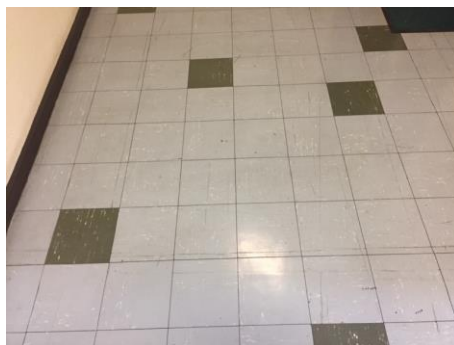
Green and grey floor tiles.

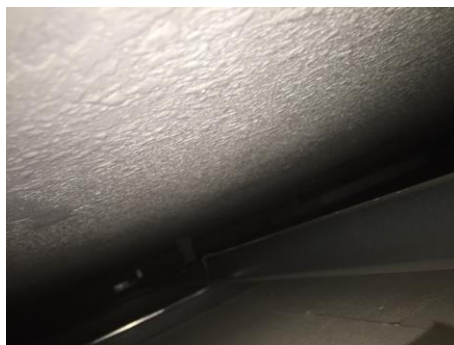
Bubble pattern textured coating.

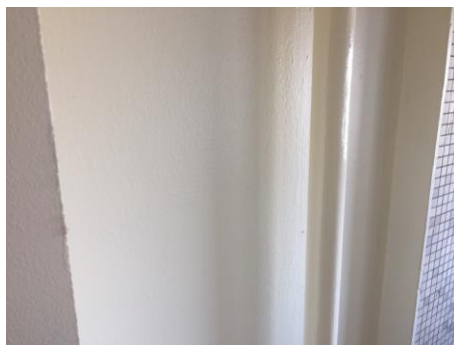
Spatter pattern textured coating.

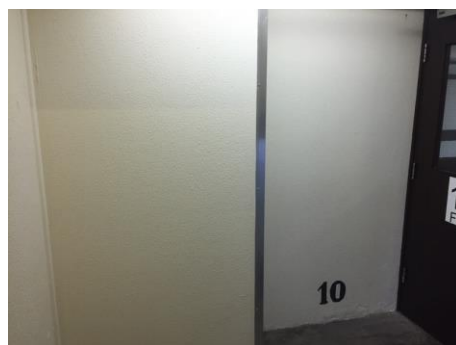
Insulating board sub main riser with texture coated timber cladding.

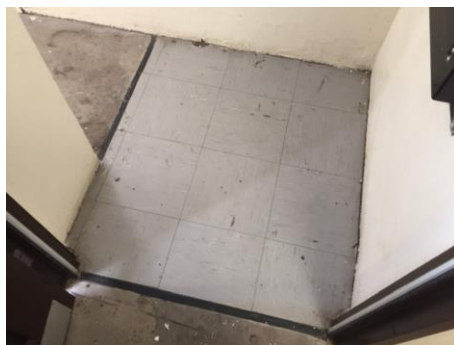
Bitumen adhesive beneath floor tiles.

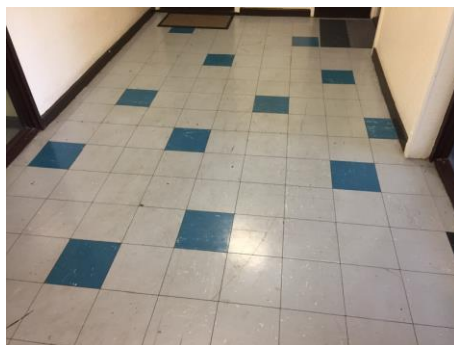
Bitumen adhesive beneath floor tiles.

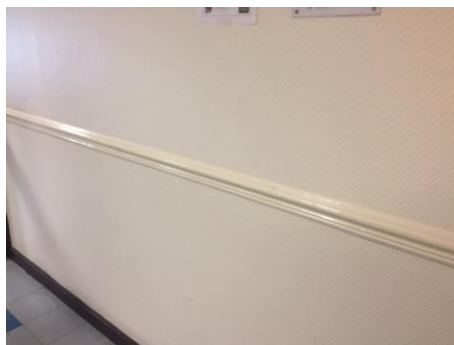
Spatter pattern textured coating behind wallpaper.

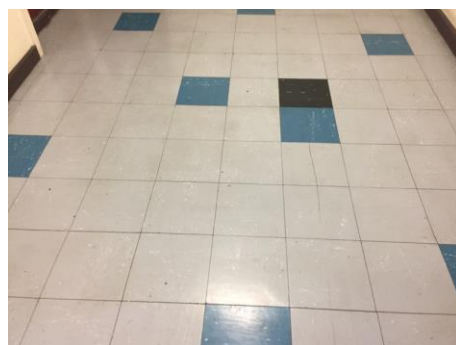
Bitumen adhesive beneath floor tiles.

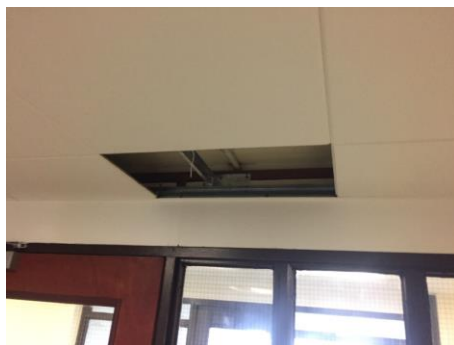
Bubble pattern textured coating above suspended ceiling.

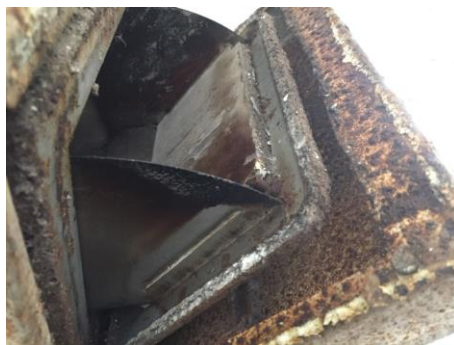
Rope seal to drawer.

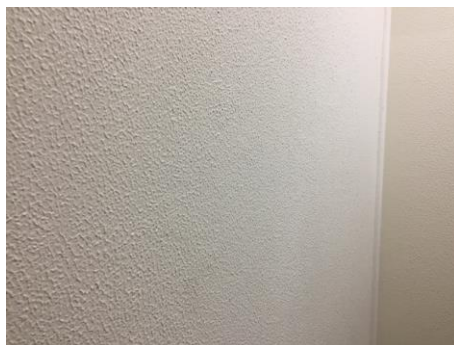
Stipple pattern textured coating.

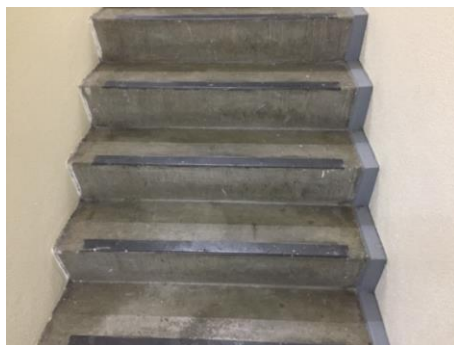
Resin nosing to edge of stairs.

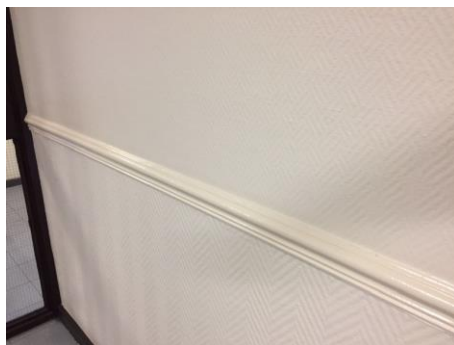
Spatter pattern textured coating behind wallpaper.

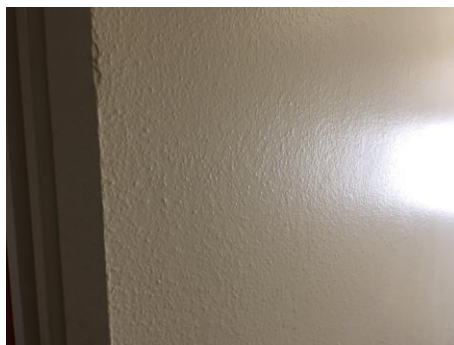
Spatter pattern textured coating.

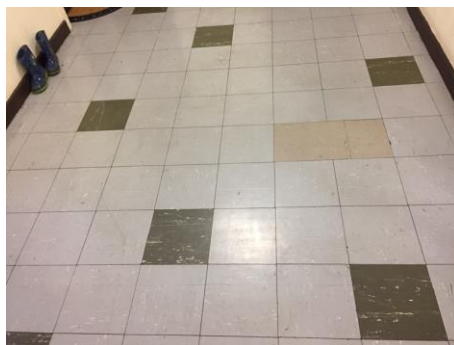
Bitumen adhesive beneath floor tiles.

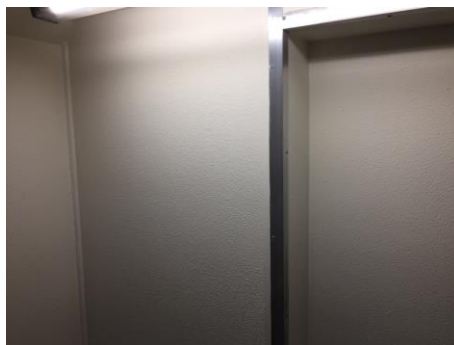
Insulating board sub main riser with texture coated timber cladding.

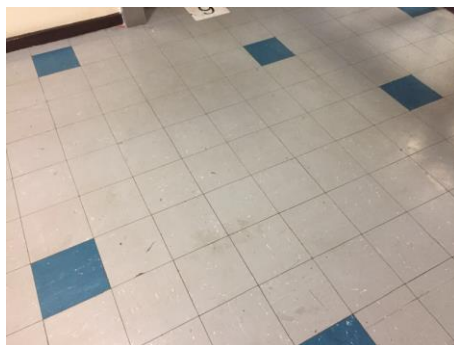
Bitumen adhesive beneath floor tiles.

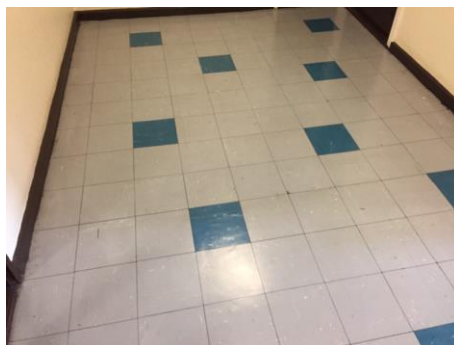
Blue and grey floor tiles.

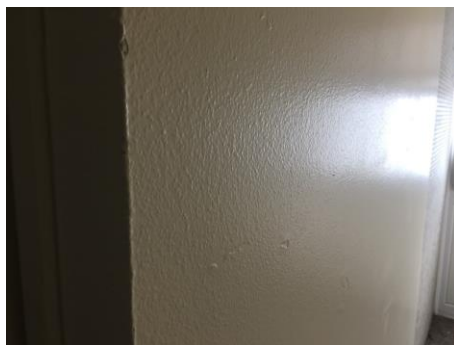
Spatter pattern textured coating.

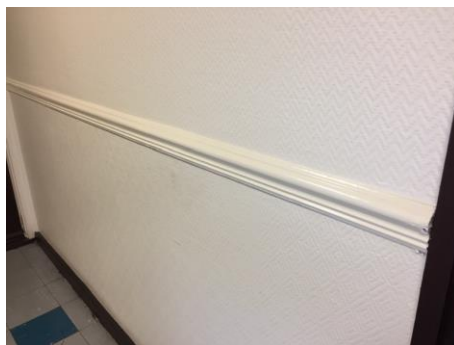
Spatter pattern textured coating behind wallpaper.

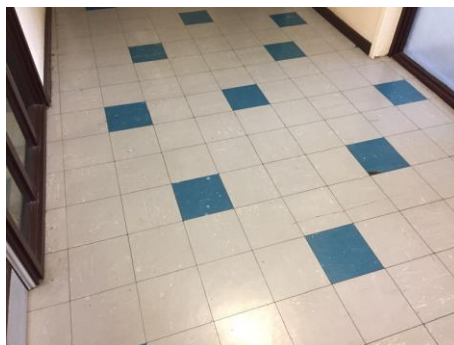
Blue and grey floor tiles.

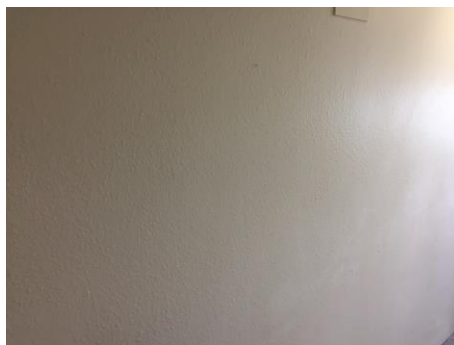
Spatter pattern textured coating.

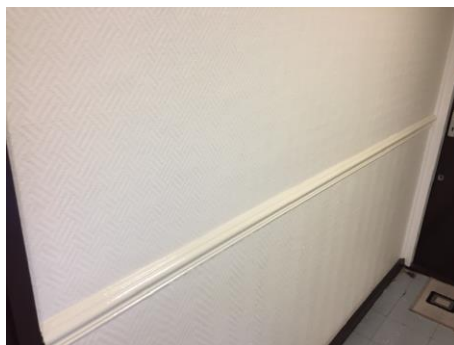
Spatter pattern textured coating behind wallpaper.

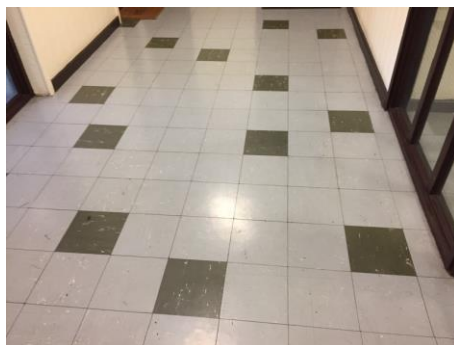
Green and grey floor tiles.

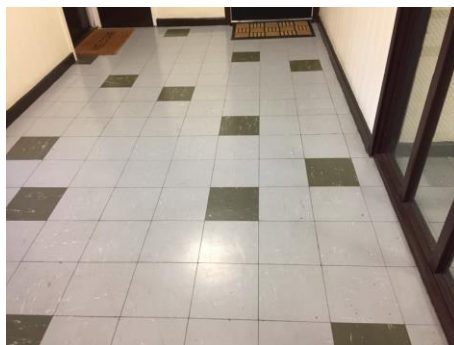
Bitumen adhesive beneath floor tiles.

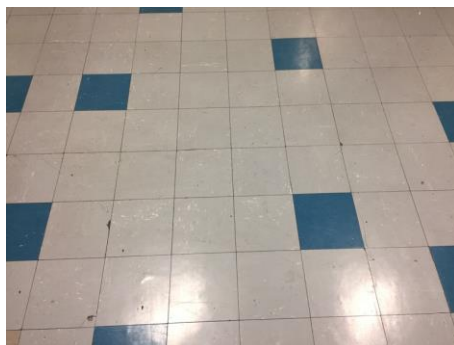
Bitumen adhesive beneath floor tiles.

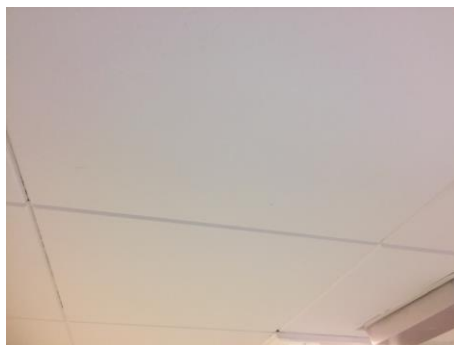
Bubble pattern textured coating above Supalux suspended ceiling.

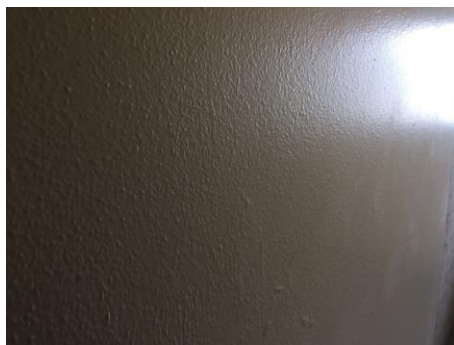
Spatter pattern textured coating.

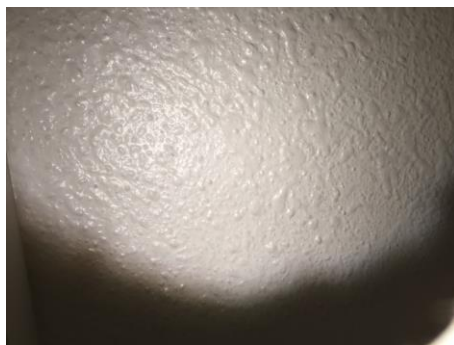
Bubble pattern textured coating above suspended ceiling.

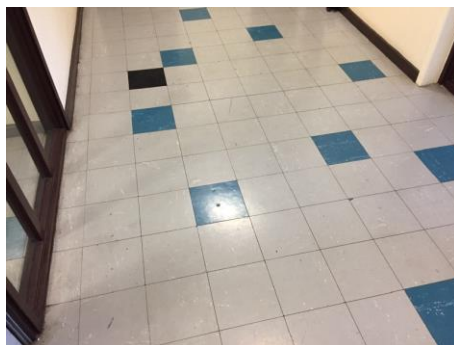
Bitumen adhesive beneath floor tiles.

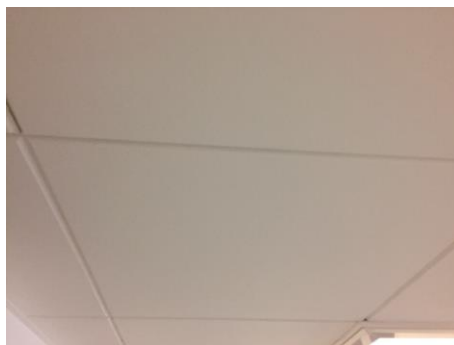
Bubble pattern textured coating above Supalux suspended ceiling.

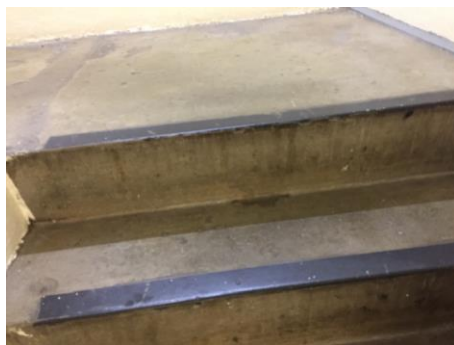
Resin nosing to edge of stairs.

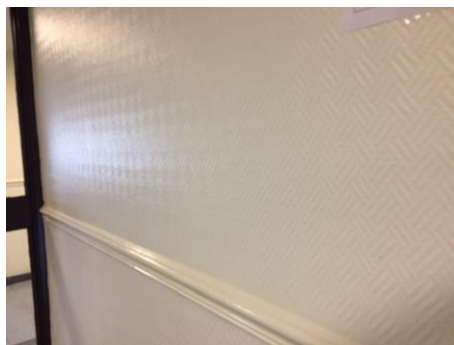
Spatter pattern textured coating behind wallpaper.

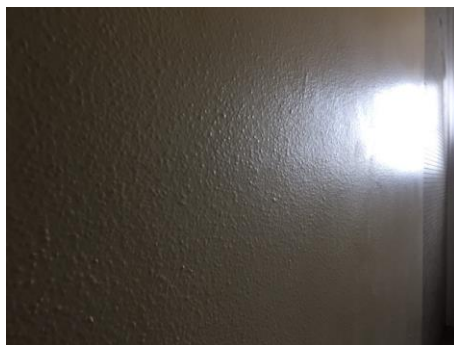
Spatter pattern textured coating.

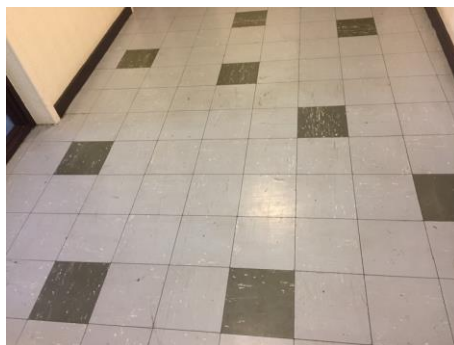
Green and grey floor tiles.

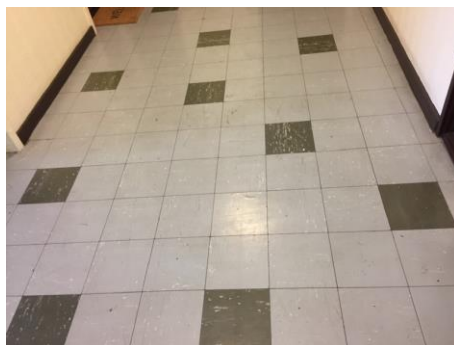
Bitumen adhesive beneath floor tiles.

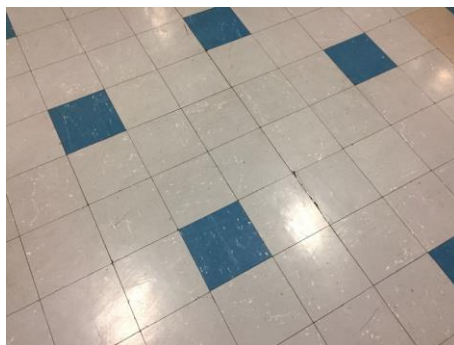
Blue and grey floor tiles.

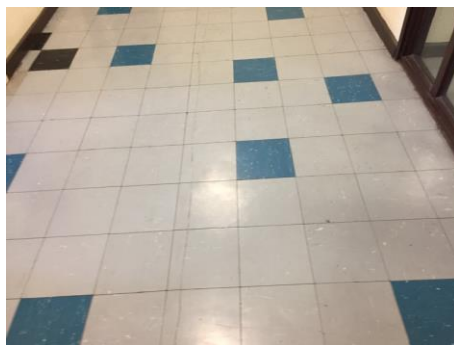
Blue and grey floor tiles.

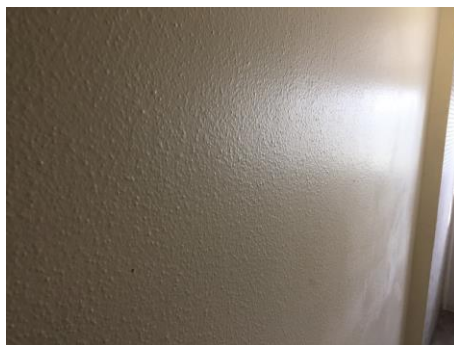
Spatter pattern textured coating.

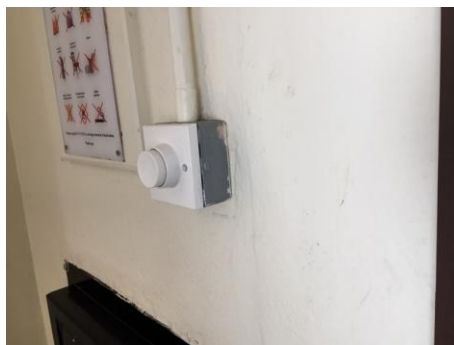
Spatter pattern textured coating.

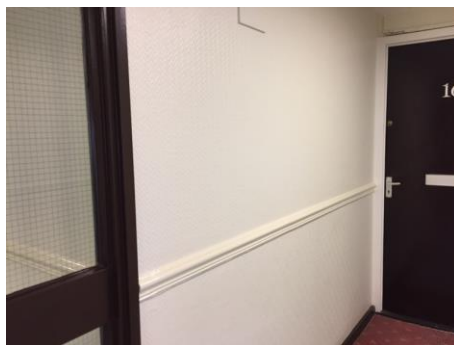
Spatter pattern textured coating behind wallpaper.

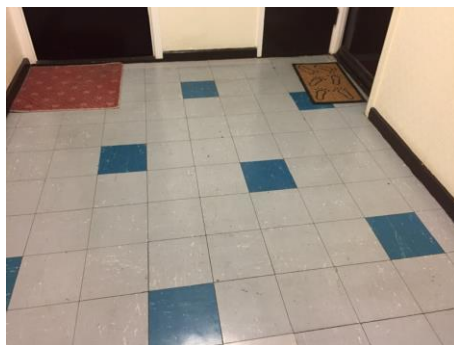
Bitumen adhesive beneath floor tiles.

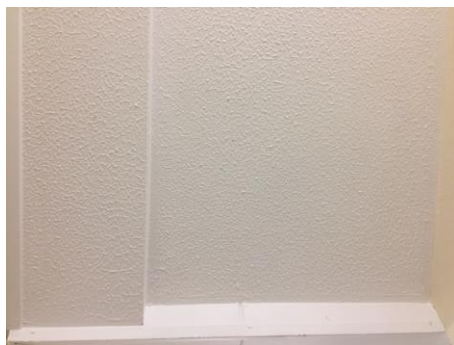
Stipple pattern textured coating.

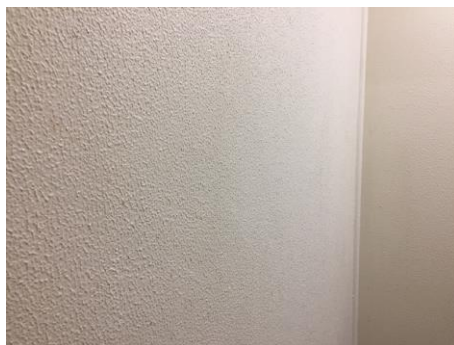
Stipple pattern textured coating.

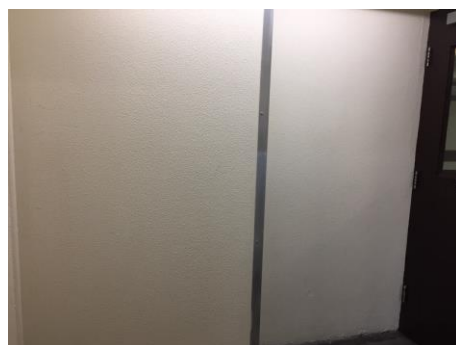
Insulating board sub main riser with texture coated timber cladding.
